# National

Service Bulletin FSN-30

Subject: NC-300 Changes

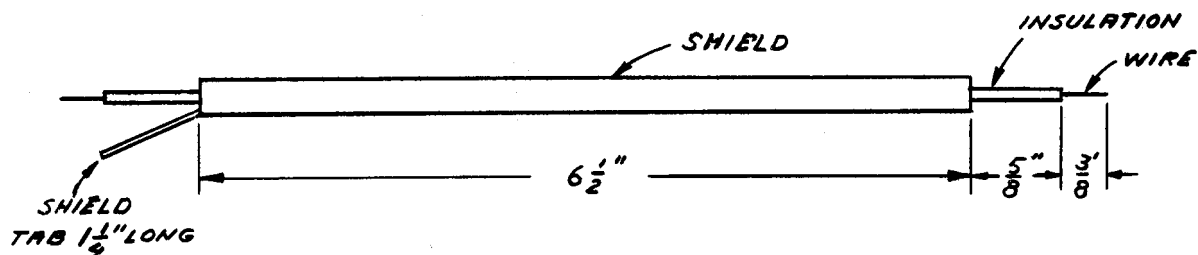
A considerable improvement in the response of the NC-300 receiver to this spurious frequency can be effected by the following modifications:

A shielded lead should be constructed as shown below:

- A. Replace shielded lead from L4 to grid of second converter, V3 with above lead, placing it under phasing control shaft as shown in the pictorial diagram below.

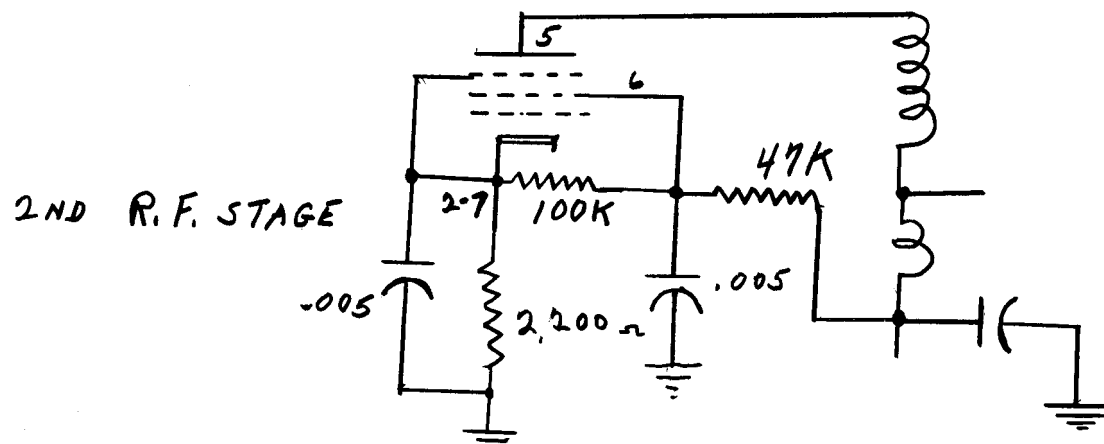
The following changes are recommended in the 6-meter converter to reduce cross-modulation:

Change cathode resistor in 6AK5 2nd R.F. amplifier stage from 470 ohms  $\frac{1}{2}$  watt to 2200 ohms  $\frac{1}{2}$  watt

A 100,000 ohm  $\frac{1}{2}$  watt resistor should be connected between Pin #6 and Pin #2 - 7 of the same 6AK5 2nd R.F. stage

Revised circuit below:

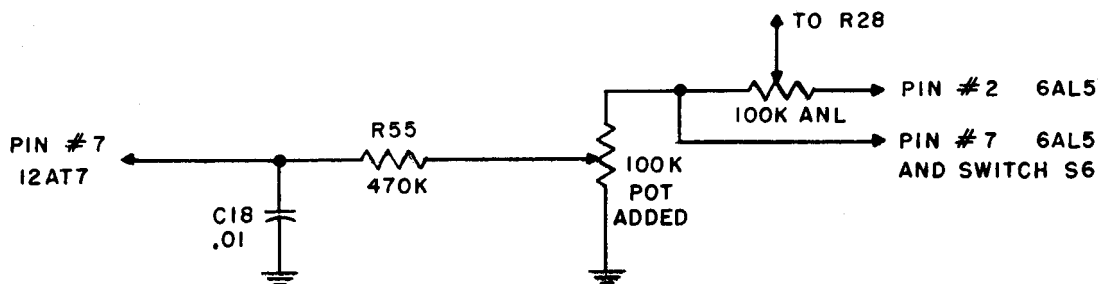
Some users of the NC-300 have complained about the fact that the "S" meter on the NC-300 seemed too sensitive. This may be adjusted in two ways to satisfy the individual user.

1. To decrease sensitivity of the "S" meter by a fixed amount, decrease the value of R-30 (68K 1/2 watt).
2. To decrease or increase the sensitivity of the "S" meter by a variable amount, replace R-43 (33K 1/2 watt) and R-30 (68K 1/2 watt) with 100 K potentiometer, connect arm of potentiometer to R-55 (47-0K 1/2 watt).

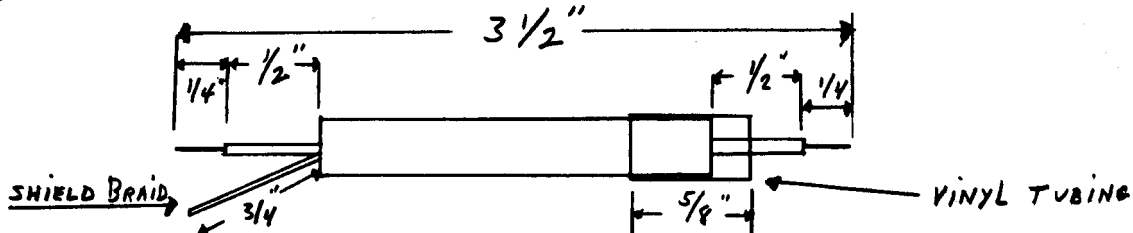
Subject: Additional Notes on Reduction of Spurious Responses  
and B.C.I. in NC-300 Receivers

1. One shielded cable should be substituted for the blue lead connecting the plate of the first mixer (V2 Pin No. 9) to T3 (B). Drawing of cable below. The vinyl tubing is used to prevent grounds to other sections of the circuitry. Shield tab can be connected to the slug cup of L2-A which should already be grounded in accordance with FSN-33. It may be necessary to repeak L2-A after installation of this shielded lead.

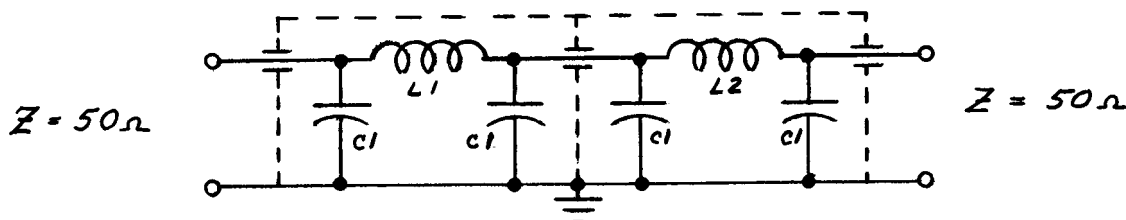
In certain metropolitan areas, I.T.V. is experienced on the 21 mc, 28 mc and X bands of the NC-300. This can be minimized by proper selection of antenna and the use of a low pass filter shown in the diagram below. This filter should be inserted in series with the antenna and located as close as practicable to the antenna terminals on the back of the chassis. A good earth ground helps considerably.

$L_1$  = .4 uh      10 Turns #20 on 3/8" form spaced 1/2"

$C_1$  = 80 uuf Ceramic

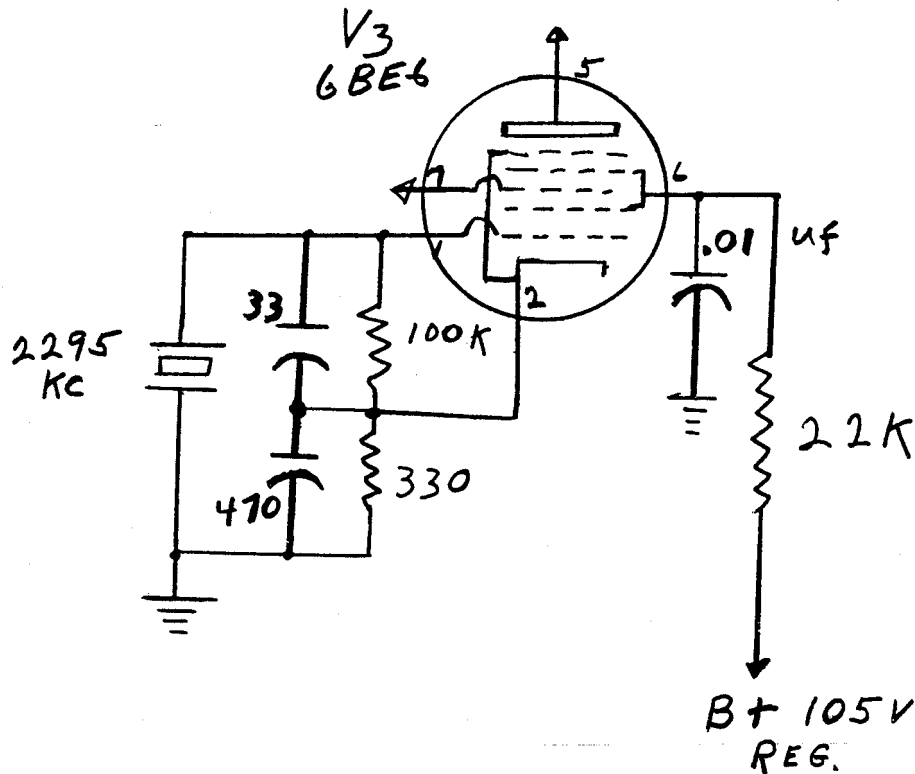
This time of year with relatively high heat and humidity usually brings sporadic reports of calibration errors and ineffective crystal filter action in the NC-300. This is due to the second conversion oscillator coil having drifted off its correct frequency of 2295 kc.

In most instances all that is necessary is that L6 in T5 be trimmed to the correct frequency by means of the slug in it. There are other rare cases where the second conversion oscillator will not maintain its frequency for more than a period of a month or so. These reports usually originate in areas of high humidity such as Florida and Louisiana and other localized areas.

In these instances we recommend crystal control of the second conversion oscillator as per the attached schematic. It should be remembered that there are now two crystals in the circuit which must be properly coordinated if the receiver is to work at maximum efficiency. Normal production tolerances in the grinding of the crystals may allow a situation to exist where the difference in frequency of the crystal in the crystal filter (2215 kc) and the crystal in the second conversion oscillator (2295 kc) is not exactly 80 kc (second IF).

If this is so the second IF strip must be adjusted accordingly either slightly higher or slightly lower to compensate.
