Service Bulletin FSN-30

Subject: NC-300 Changes

Bulletin Number FSN-33

NC-300 REVISIONS

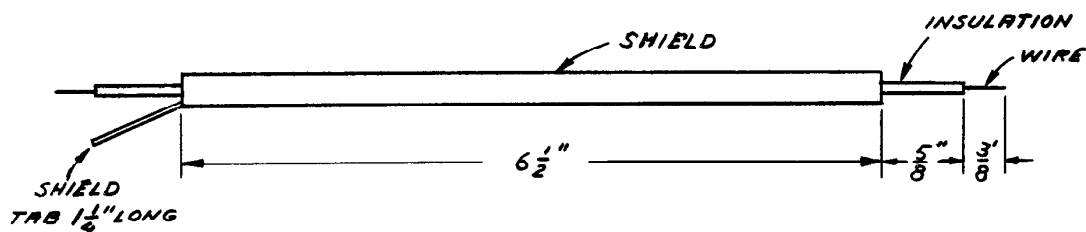
Through a clerical error in transmittal of information from our Engineering Test Section to our Production Test Section, certain NC-300 receivers were allowed to pass through test with:

1. Unsatisfactory attenuation of spurious responses 40 kc. ($\frac{1}{2}$ the 80 kc. I.F.) removed from a strong signal's frequency.
2. Crystal filter improperly aligned for satisfactory bandwidth in the three crystal positions.

A shielded lead should be constructed as shown below:

- A. Replace shielded lead from L4 to grid of second converter, V3 with above lead, placing it under phasing control shaft as shown in the pictorial diagram below.

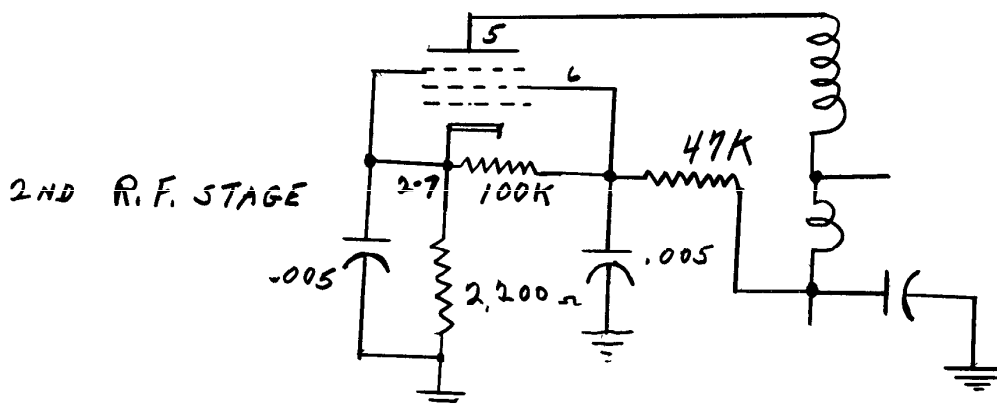
The following changes are recommended in the 6-meter converter to reduce cross-modulation:

Change cathode resistor in 6AK5 2nd R.F. amplifier stage from 470 ohms $\frac{1}{2}$ watt to 2200 ohms $\frac{1}{2}$ watt

A 100,000 ohm $\frac{1}{2}$ watt resistor should be connected between Pin #6 and Pin #2 - 7 of the same 6AK5 2nd R.F. stage

Revised circuit below:

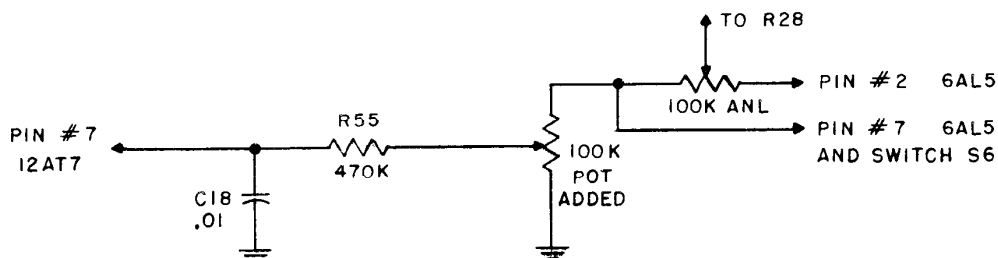
Some users of the NC-300 have complained about the fact that the "S" meter on the NC-300 seemed too sensitive. This may be adjusted in two ways to satisfy the individual user.

1. To decrease sensitivity of the "S" meter by a fixed amount, decrease the value of R-30 (68K 1/2 watt).
2. To decrease or increase the sensitivity of the "S" meter by a variable amount, replace R-43 (33K 1/2 watt) and R-30 (68K 1/2 watt) with 100 K potentiometer, connect arm of potentiometer to R-55 (470K 1/2 watt).

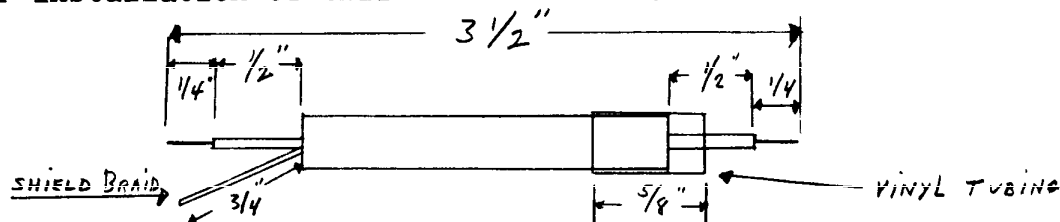
Subject: Additional Notes on Reduction of Spurious Responses
and B.C.I. in NC-300 Receivers

1. One shielded cable should be substituted for the blue lead connecting the plate of the first mixer (V2 Pin No. 9) to T3 (B). Drawing of cable below. The vinyl tubing is used to prevent grounds to other sections of the circuitry. Shield tab can be connected to the slug cup of L2-A which should already be grounded in accordance with FSN-33. It may be necessary to repeak L2-A after installation of this shielded lead.

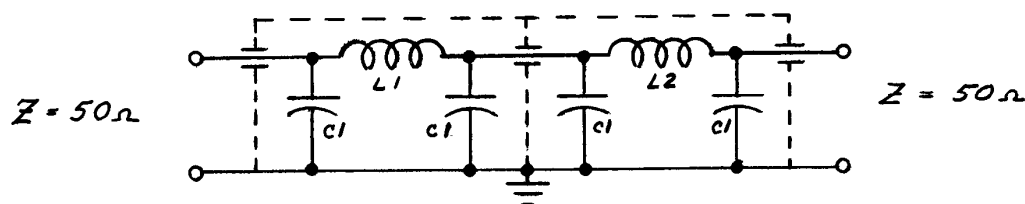
In certain metropolitan areas, I.T.V. is experienced on the 21 mc, 28 mc and X bands of the NC-300. This can be minimized by proper selection of antenna and the use of a low pass filter shown in the diagram below. This filter should be inserted in series with the antenna and located as close as practicable to the antenna terminals on the back of the chassis. A good earth ground helps considerably.

$L1 = .4 \text{ uh}$ 10 Turns #20 on 3/8" form spaced 1/2"
 $L2 = .4 \text{ uh}$
 $C1 = 80 \text{ uuf Ceramic}$

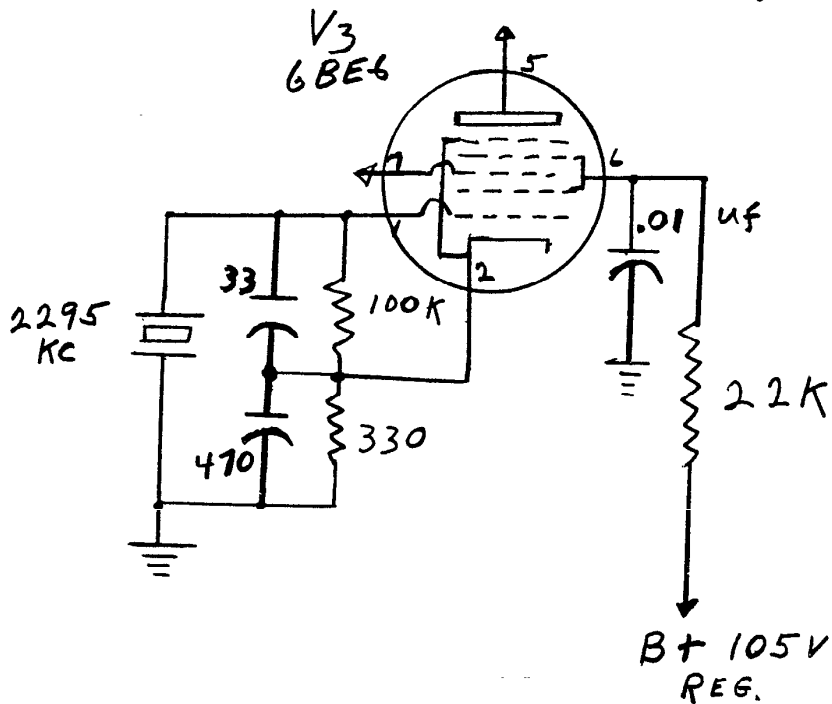
This time of year with relatively high heat and humidity usually brings sporadic reports of calibration errors and ineffective crystal filter action in the NC-300. This is due to the second conversion oscillator coil having drifted off its correct frequency of 2295 kc.

In most instances all that is necessary is that L6 in T5 be trimmed to the correct frequency by means of the slug in it. There are other rare cases where the second conversion oscillator will not maintain its frequency for more than a period of a month or so. These reports usually originate in areas of high humidity such as Florida and Louisiana and other localized areas.

In these instances we recommend crystal control of the second conversion oscillator as per the attached schematic. It should be remembered that there are now two crystals in the circuit which must be properly coordinated if the receiver is to work at maximum efficiency. Normal production tolerances in the grinding of the crystals may allow a situation to exist where the difference in frequency of the crystal in the crystal filter (2215 kc) and the crystal in the second conversion oscillator (2295 kc) is not exactly 80 kc (second IF).

If this is so the second IF strip must be adjusted accordingly either slightly higher or slightly lower to compensate.

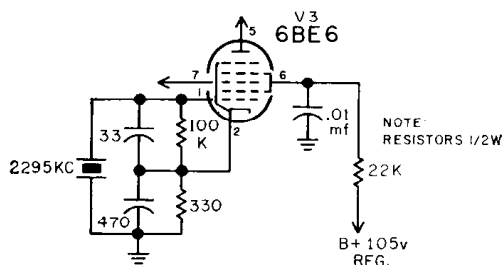
Fig. 1—Crystal controlled second converter.

The summer months of the year occasionally bring reports of calibration errors and ineffective crystal filter action in the NC-300, particularly in areas of high humidity. This is due to the second conversion oscillator drifting off its normal frequency of 2295 *kc*. This situation is evidenced by calibration errors on the dial in one direction on the high frequency ranges and in the opposite direction on the low frequency ranges and also by erratic operation of the crystal filter.

It is a simple matter to crystal control the second converter oscillator which effectively eliminates these problems.

The crystal and its associated components may be mounted in the shield can which formerly housed L6 the second conversion oscillator coil.

It should be remembered that there are now two crystals in the circuit which must be properly coordinated if the receiver is to work at maximum efficiency. Normal production tolerances in the grinding of the crystals may allow a situation to exist where the difference in frequency of the crystal in the filter (2215 *kc*) and the crystal in the second conversion oscillator (2295 *kc*) is not exactly 80 *kc* (second *IF*). If this is so the second *IF* strip must be adjusted accordingly, either slightly higher or slightly lower in frequency to compensate.
