1996 API Coke Drum Survey

Final Report

NOVEMBER 2003

**FOR
AMERICAN PETROLEUM INSTITUTE
Subcommittee on Inspection
Coke Drum Task Group**

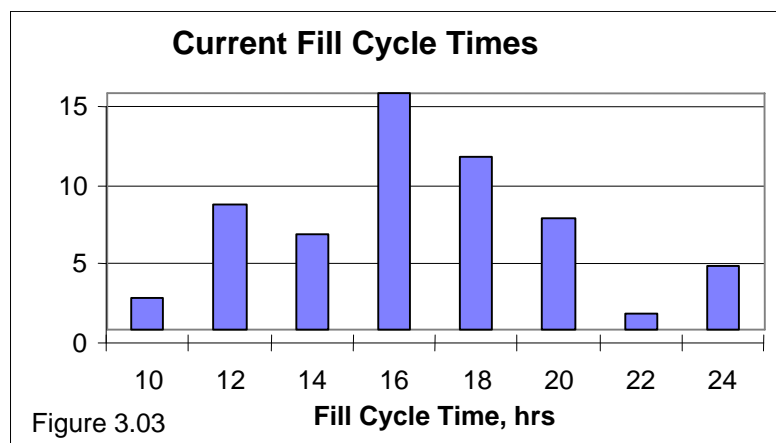
Figure 3.03

Fill cycle duration, shown in Figure 3.03, ranged from 10 hours to 24 hours. The vertical axis is the number of survey responses. Each vertical bar represents the range from the preceding bar up to the indicated hours, i.e., the bar at "12" includes drums with 11 and 12 hour fill cycles. Average fill time was found to be 15 to 16 hours.

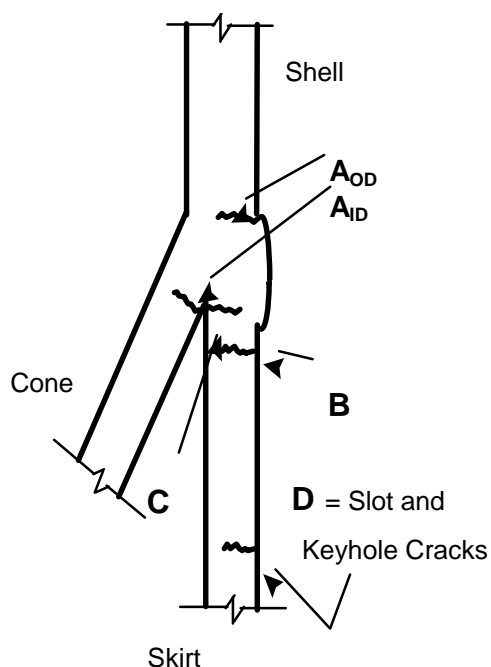
Table 5.1.1
Skirt Cracking Results

Table 5.1 gives a break down of the various types of skirt cracking while Figure 5.1 displays a sketch of the crack locations. Evaluating the combined cracking at skirt to shell welds (A,B,&C), 56% had experienced some cracking either above or below this weld. The more serious cracking, i.e. cracks that had propagated into the shell, accounted for 43% of reported cracks. There were reports of two types of shell cracking; cracks that start from the OD (labeled A_{OD}), and cracks that start from the ID of the skirt (labeled A_{ID}). The survey did not distinguish between these two locations, however, informal polling of user representatives indicated that the OD cracking was more common but ID cracks have been found. Slightly less cracking was confined to the skirt, with 39% of surveys experiencing cracks at this location.

Cracking was found to propagate on the skirt from both the outside and inside of the skirt (location B and C). The most common cracking took place from the outside with 63%, while 26% of cracking occurred from the inside only. Eleven percent of the surveys had cracking both on the inside and outside. The length of service time until cracks were noticed varied from 1 year to 10 years. Skirt cracks varied in length from 1/8" to the complete circumference of the vessel.

The most common location of cracking was at the keyholes and slots (location D). Over 71% of the users experienced cracking at the keyhole while 36% saw cracking at slots. A combination of the two, cracking at keyholes and slots, was slightly more with 76%. Generally the cracks at the slots were much shorter than those at the skirt weld.

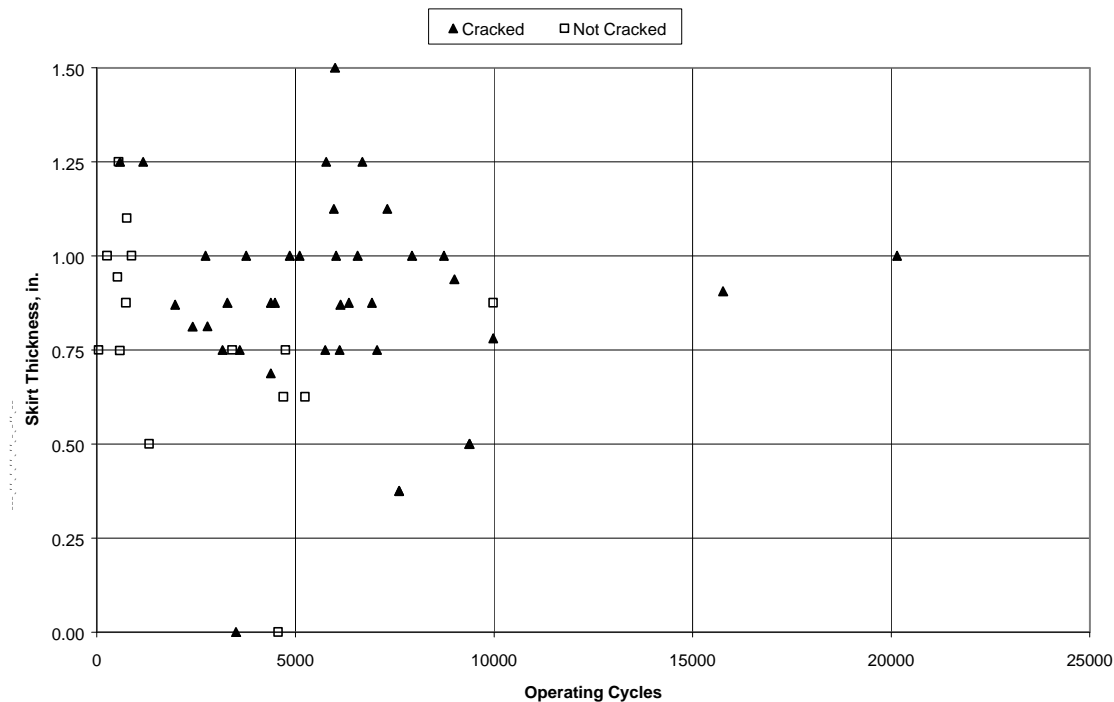
Figure 10.04 has a variable of skirt thickness. No direct correlation with skirt thickness was seen in this chart. A correlation was indicated when comparing cycles to the first skirt crack versus calculated skirt compressive stress. A simplified value for skirt compressive stress was derived from skirt diameter, skirt wall thickness and drum design capacity in tons of coke. This value was compared to cycles to the first skirt crack. Figure 10.05 indicates somewhat of a trend of increasing skirt compressive stress increased the number of cycles to first skirt crack.

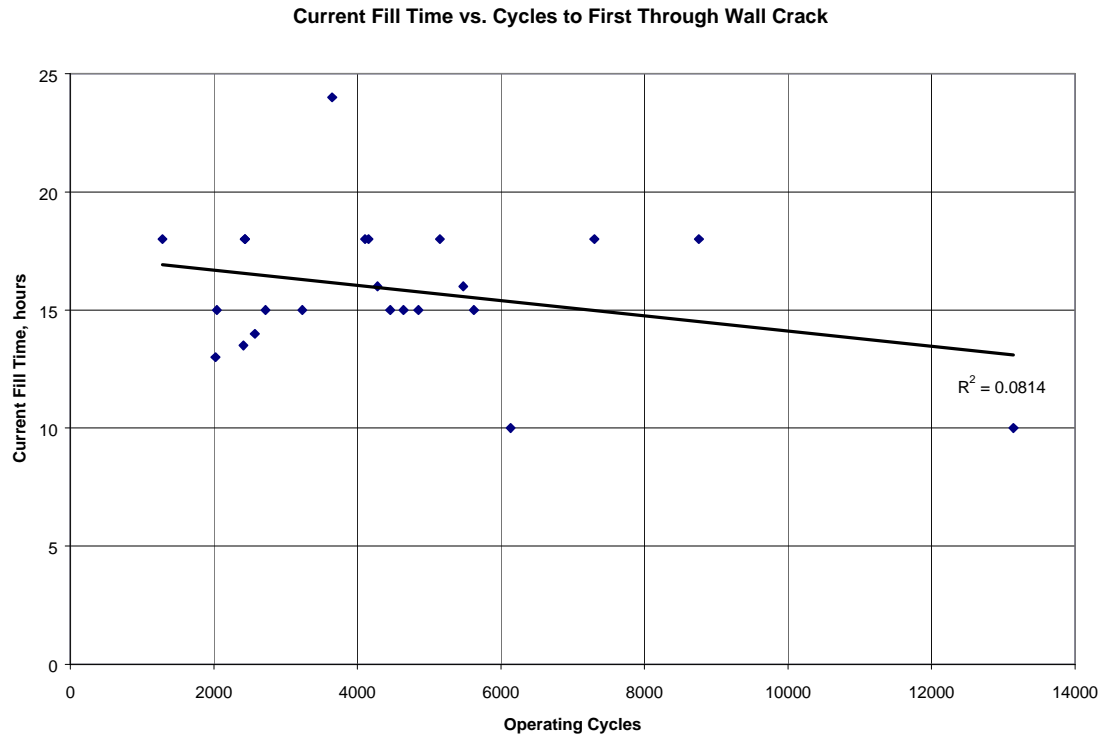
Figure 11.15 shows the correlation of current fill time versus cycles to first through wall crack. The curve points downward (longer life for shorter cycles), however, the poor curve fit ($R^2 = 0.08$) indicates that there is no correlation. Similar lack of correlation was seen in comparing duration of steam stripping versus cycles to first through wall crack shown in Figure 11.16. Comparing the preheat duration versus cycles to the first skirt crack, shown in Figure 11.17, indicated that there was not a discernible correlation for this parameter.
