Causation Factors for the Banjar Panji No. 1 Blowout

***Neal Adams Services
September 15, 2006
Jakarta, Indonesia***

RE: Report as Per Consulting Services Agreement
Causation Factors for the Banjar Panji No. 1 Blowout

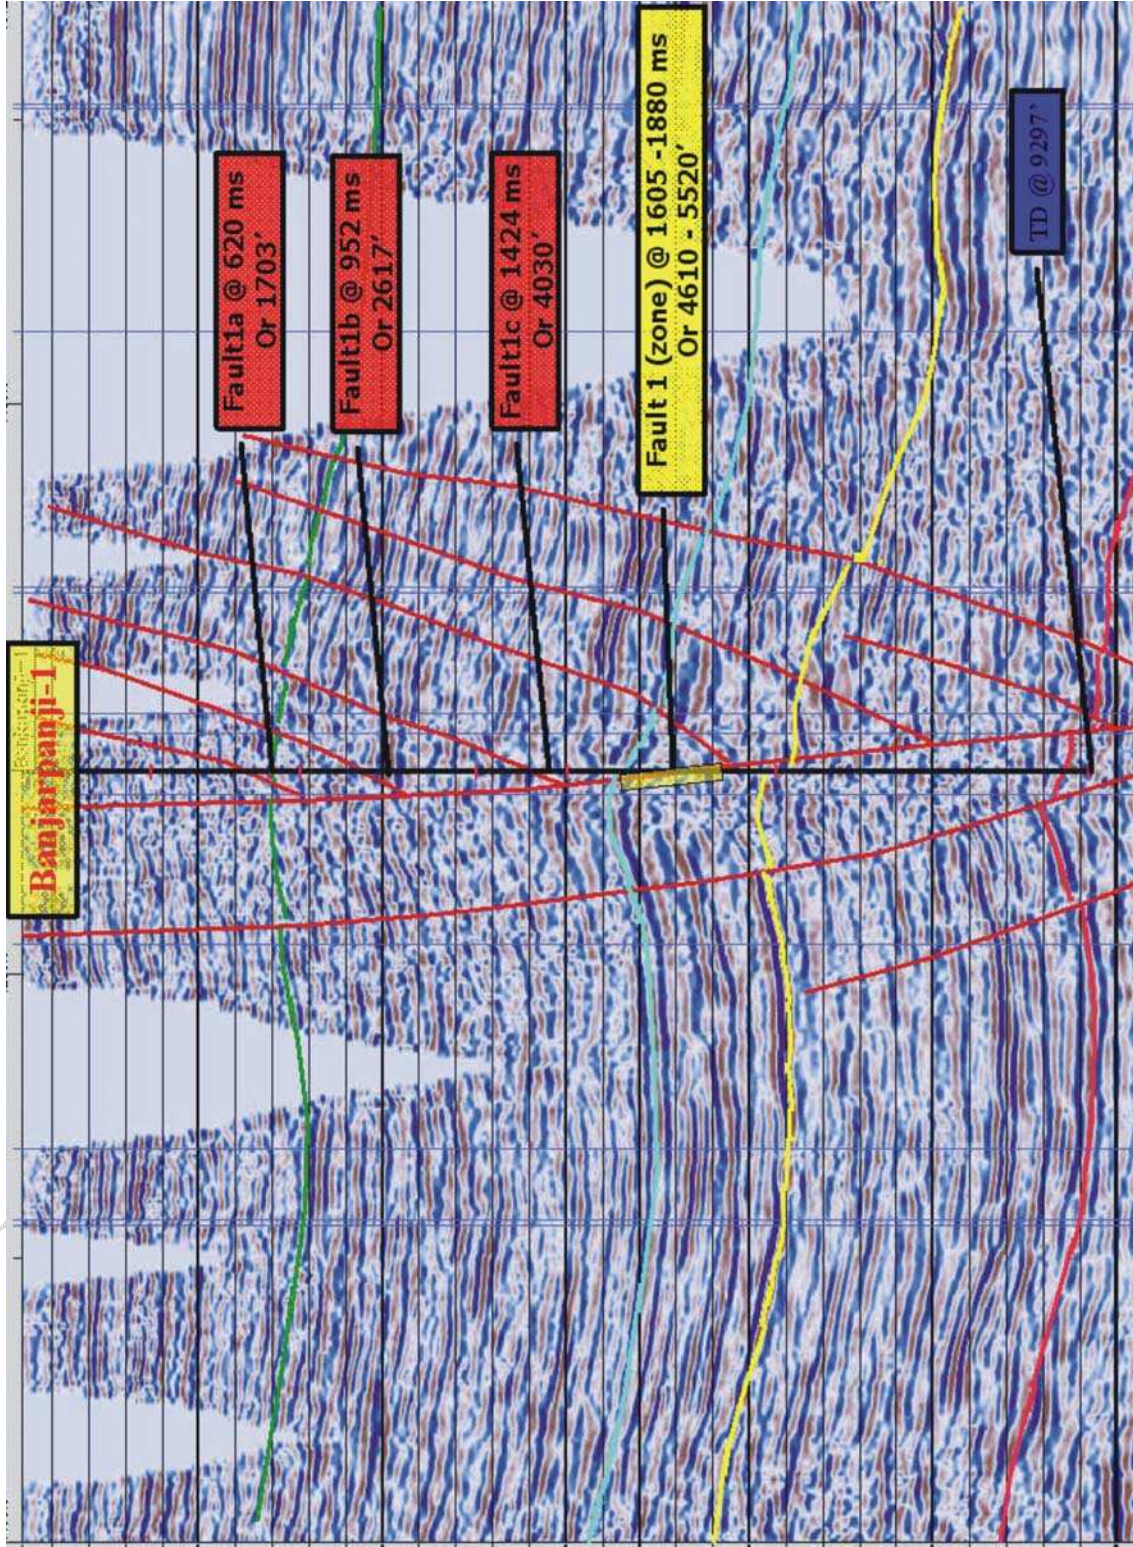
Figure 5.2 Seismic Data Showing Faults and the BJP well.

Drill site selection in a faulted area such as that shown in Figure 5.2 must be done with caution. Faults can be associated with lost circulation and unstable hole conditions. Kick fluids can move through sections of a fault if unsealed.

It is recommended to avoid selected a drill site in an area proximate to a fault(s). If a requirement for drilling exists, the recommended approach is to select a site in a fault-free area and directional drill to the primary target. Proper planning is important and should involve individuals from seismic, geology and drilling groups.

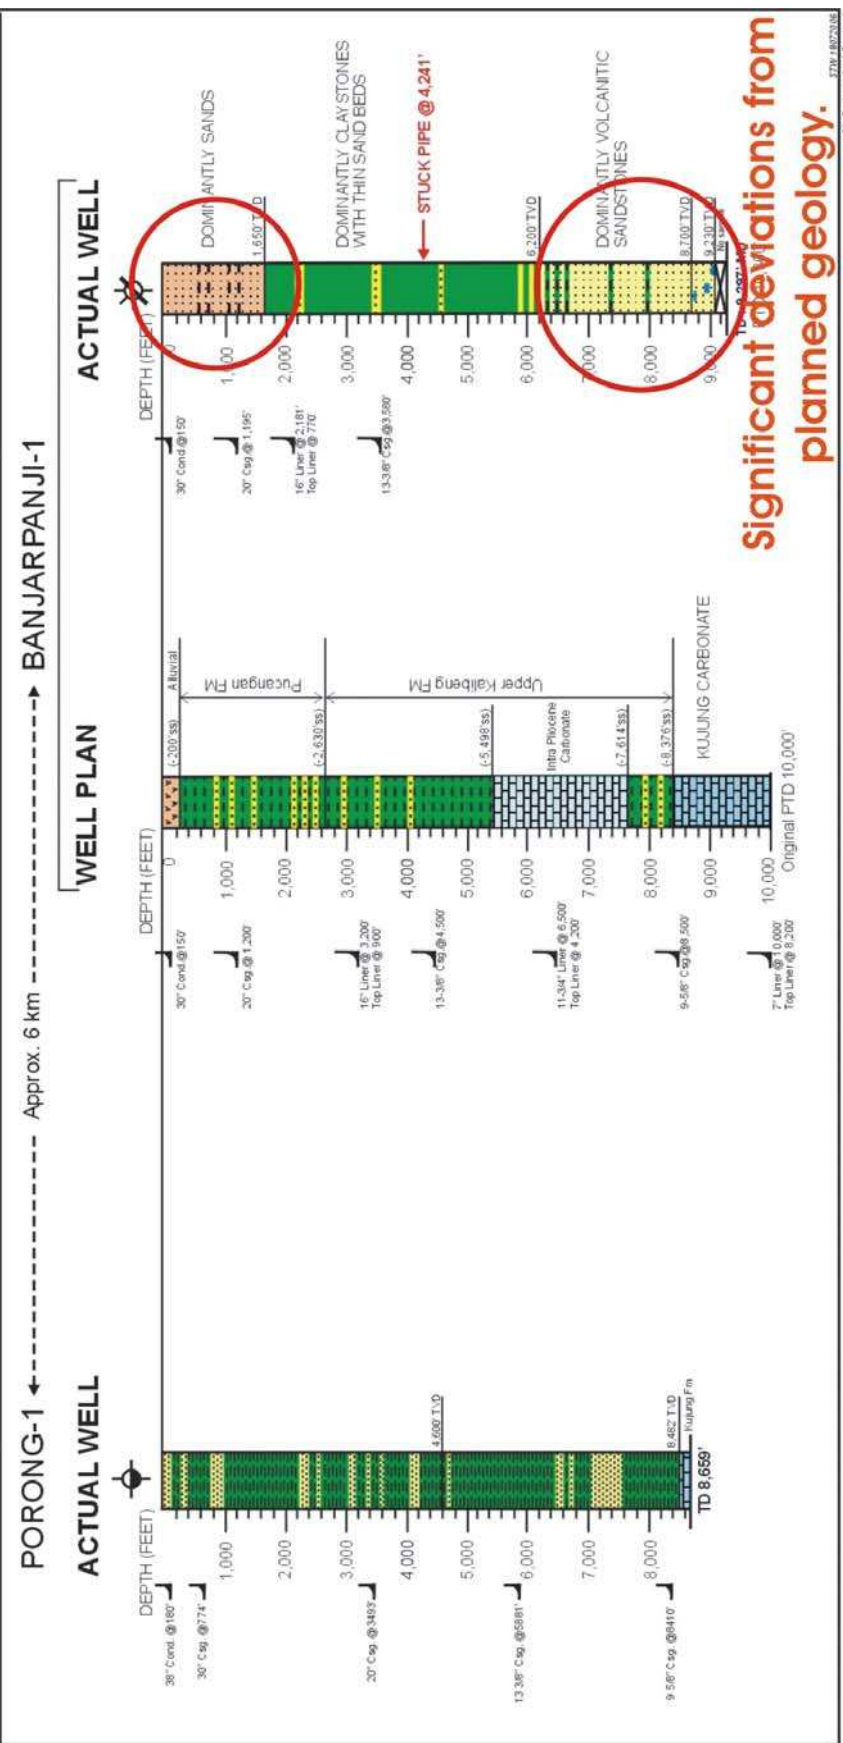
Figure 6.1 Comparison of “As Planned” and “As Drilled” Geology

The substantially different geological conditions between "As Planned" and "As Drilled" should have given rise to intensive discussions and a re-evaluation of the Well Plan as soon as the new conditions were observed. The Well Plan for the Banjar Panji well "As Planned" would probably require some modification before the well could be safely drilled. However, uncertainty associated with the geology in the deeper hole section made it unlikely that the well could be confidently drilled and not pose hazards. The available information used in preparing this report does not contain any indication that Lapindo gave any consideration to the necessary modifications to the Well Plan.

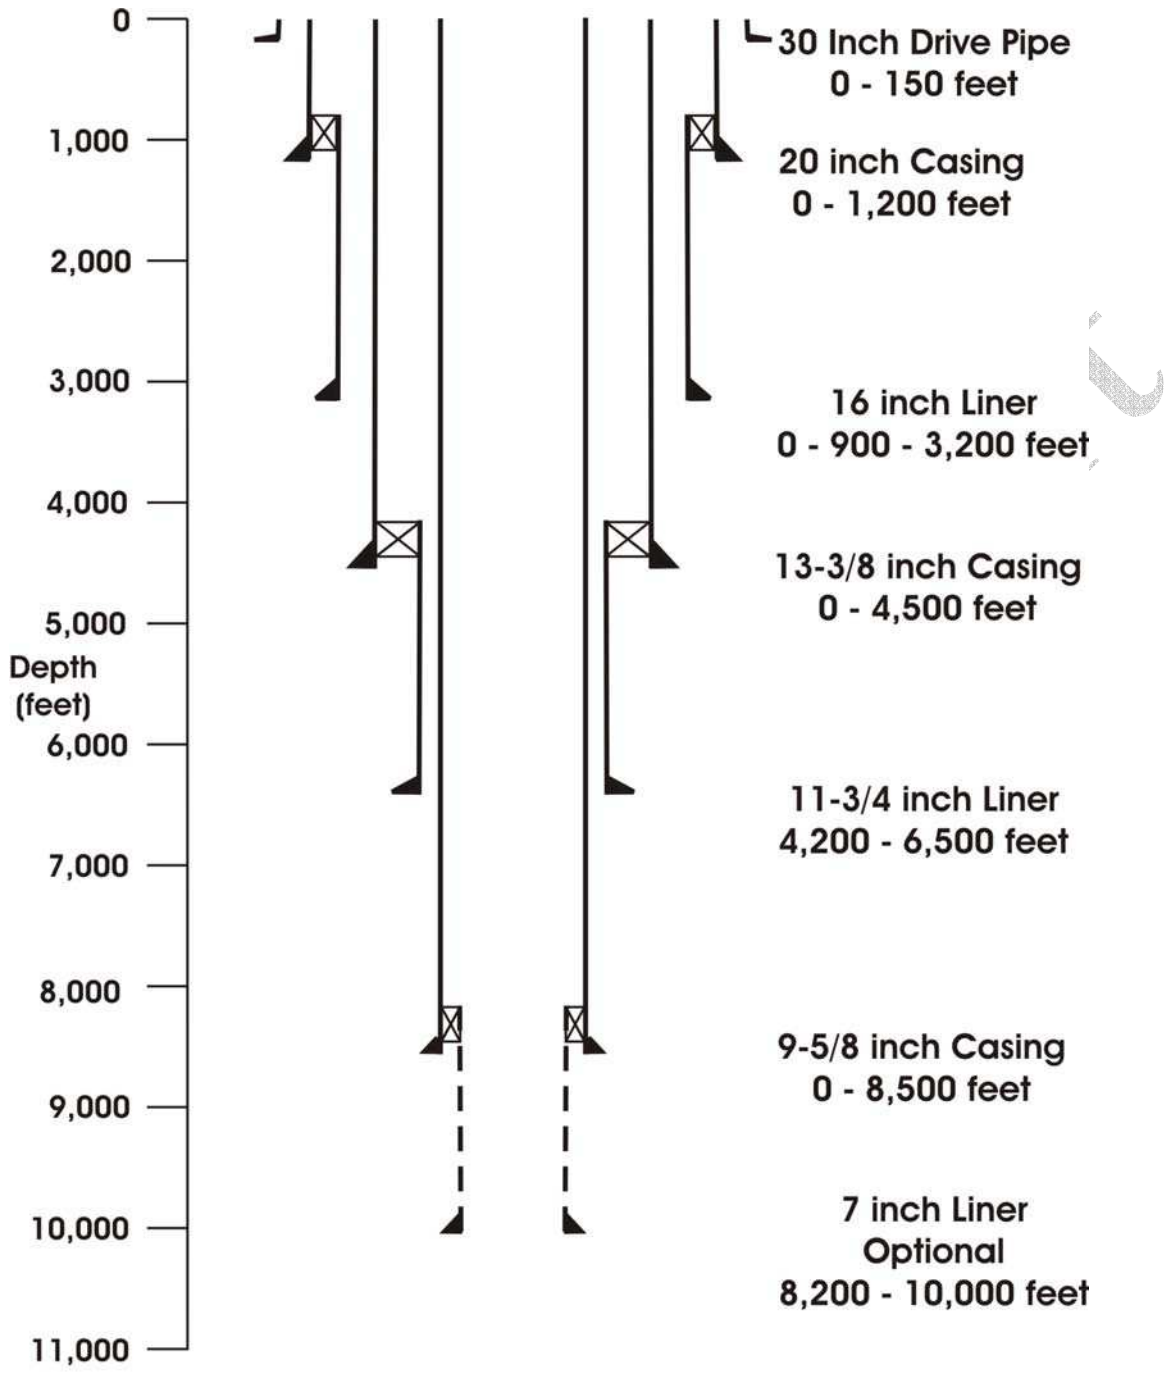
Figure 7.1 "As Planned" Well Schematic

The proposed well schematic shown in Figure 7.1 is improperly designed to address the formation pressures in Figure 7.3. Nonetheless, it is likely this well schematic would have prevented the blowout if it had been properly implemented.

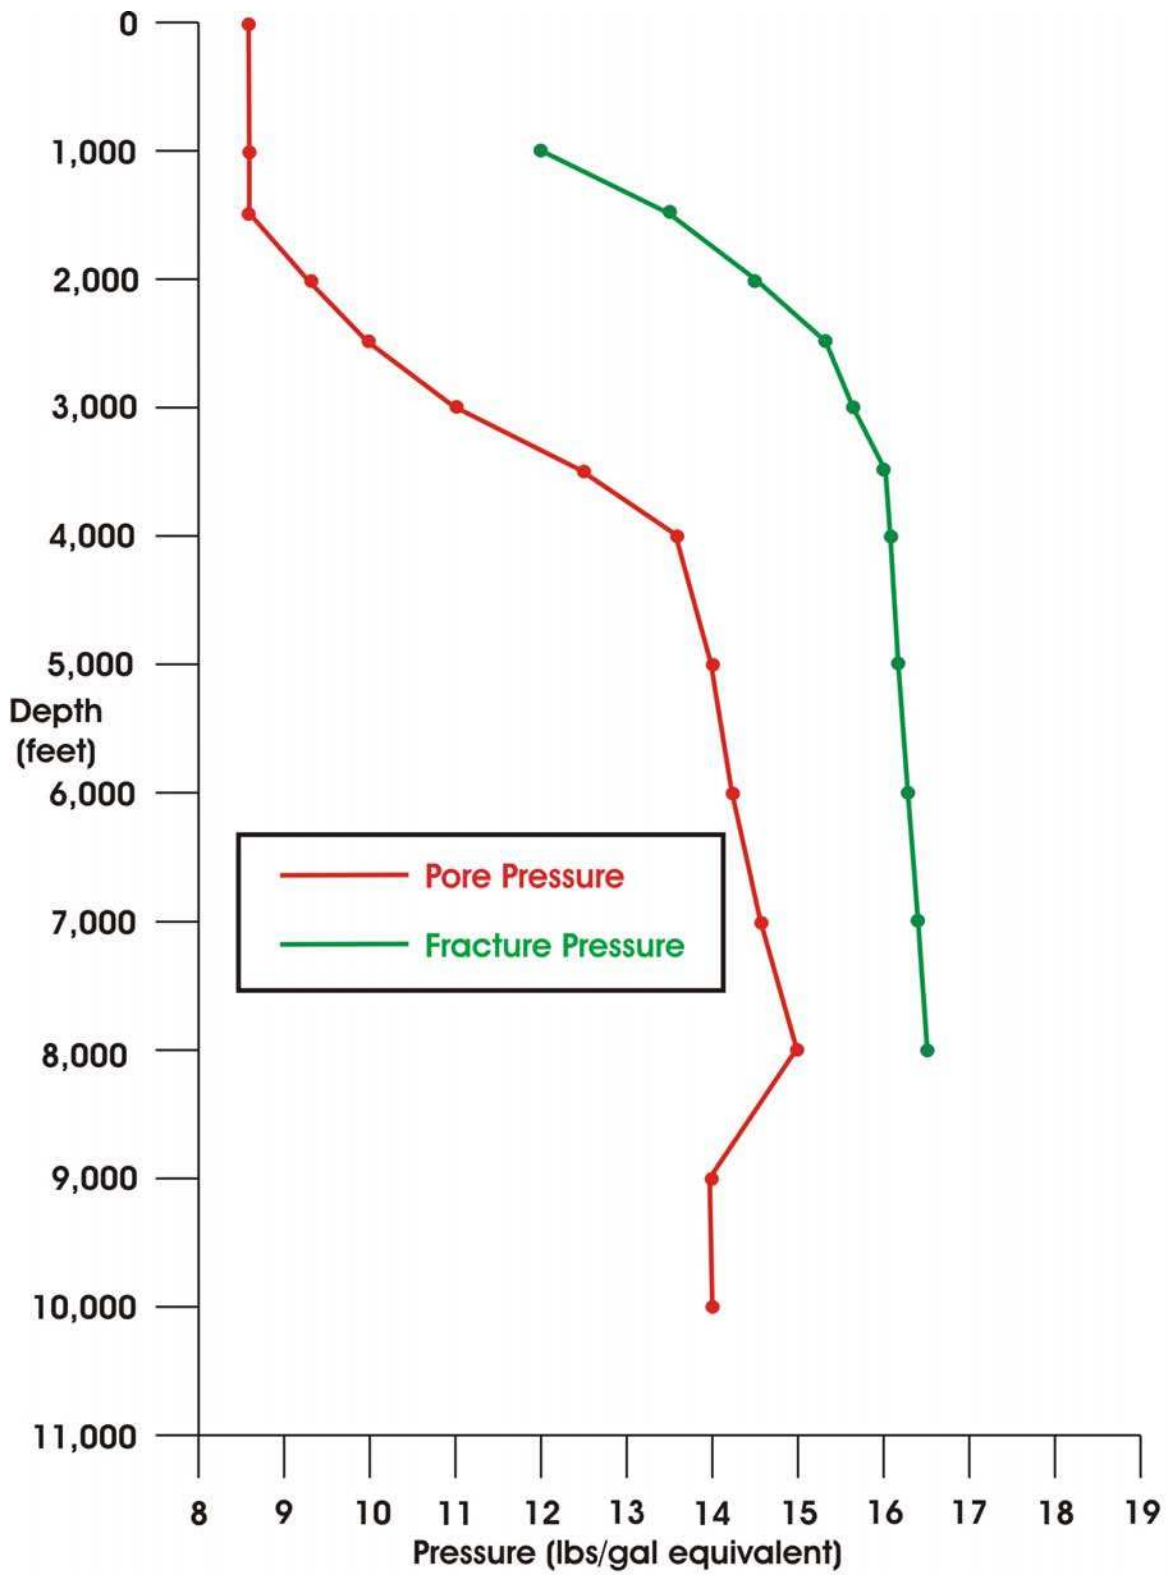
Figure 7.3 Anticipated Pore Pressure/Fracture Pressure Conditions for the Banjar Pangi 1 Well

Figure 7.3 shows the anticipated pore pressures and fracture pressures for the BJP well. The Well Plan does not indicate the source of this critical data. The fracture pressures from 0 – 2,000 feet were not provided. Also, the same pressures for the 8,000 feet to 10,000 feet interval were not available. A proper well plan can not be generated without a complete understanding of fracture pressures throughout all sections of the well.

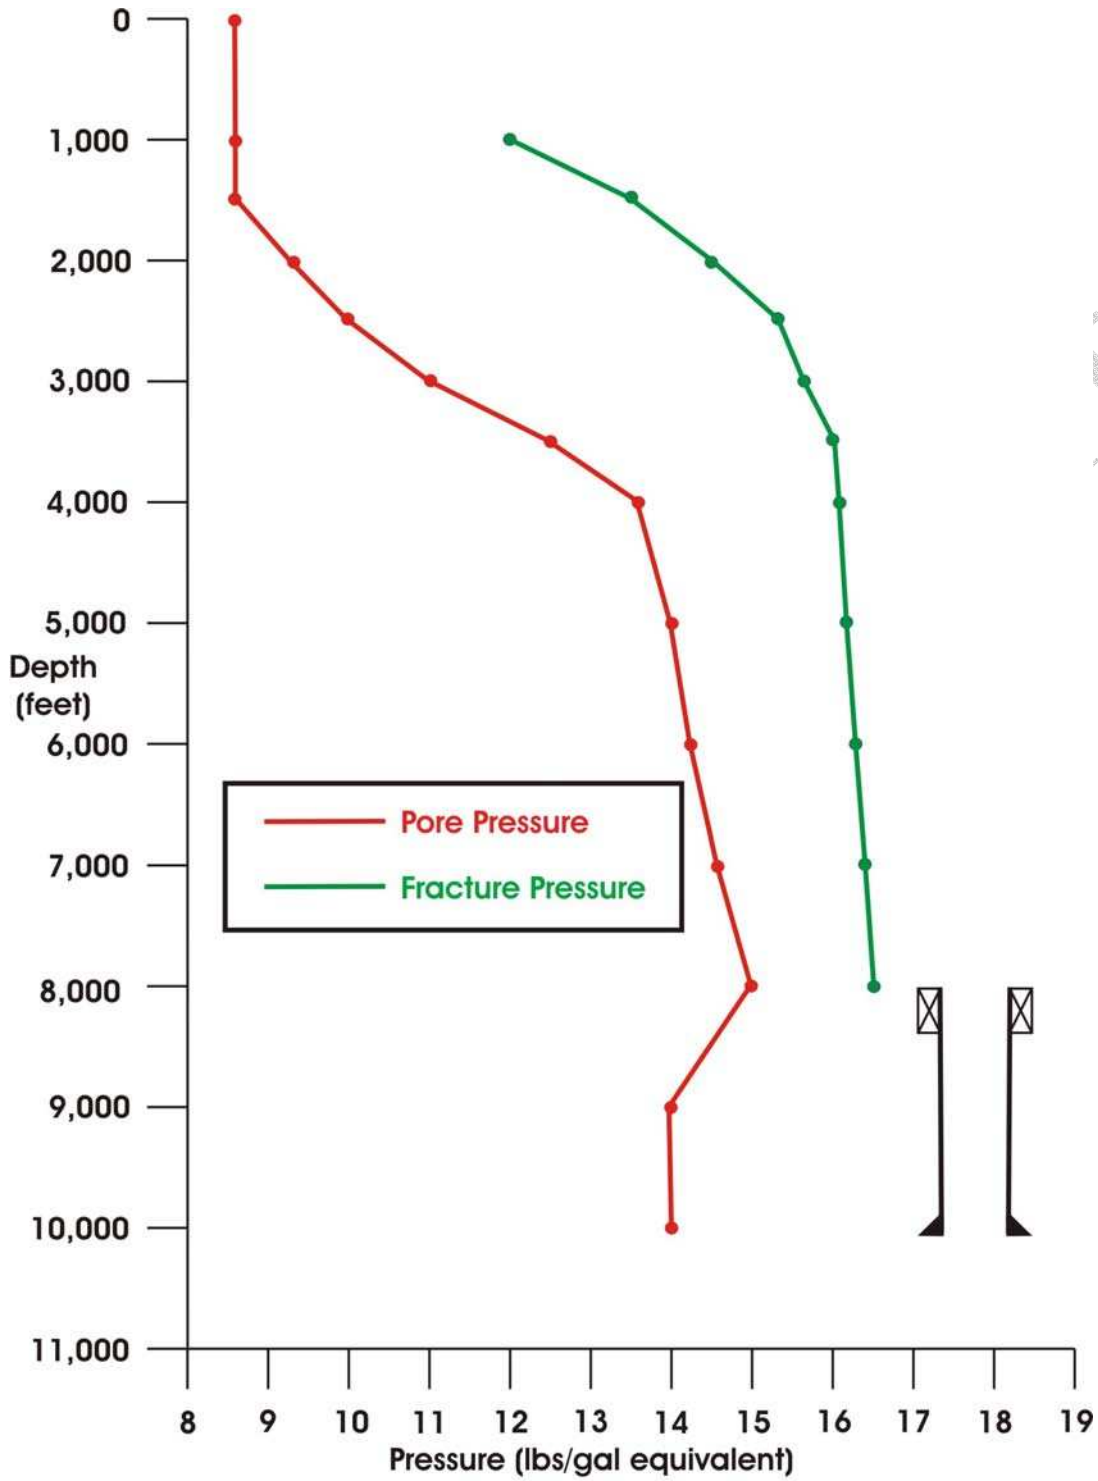
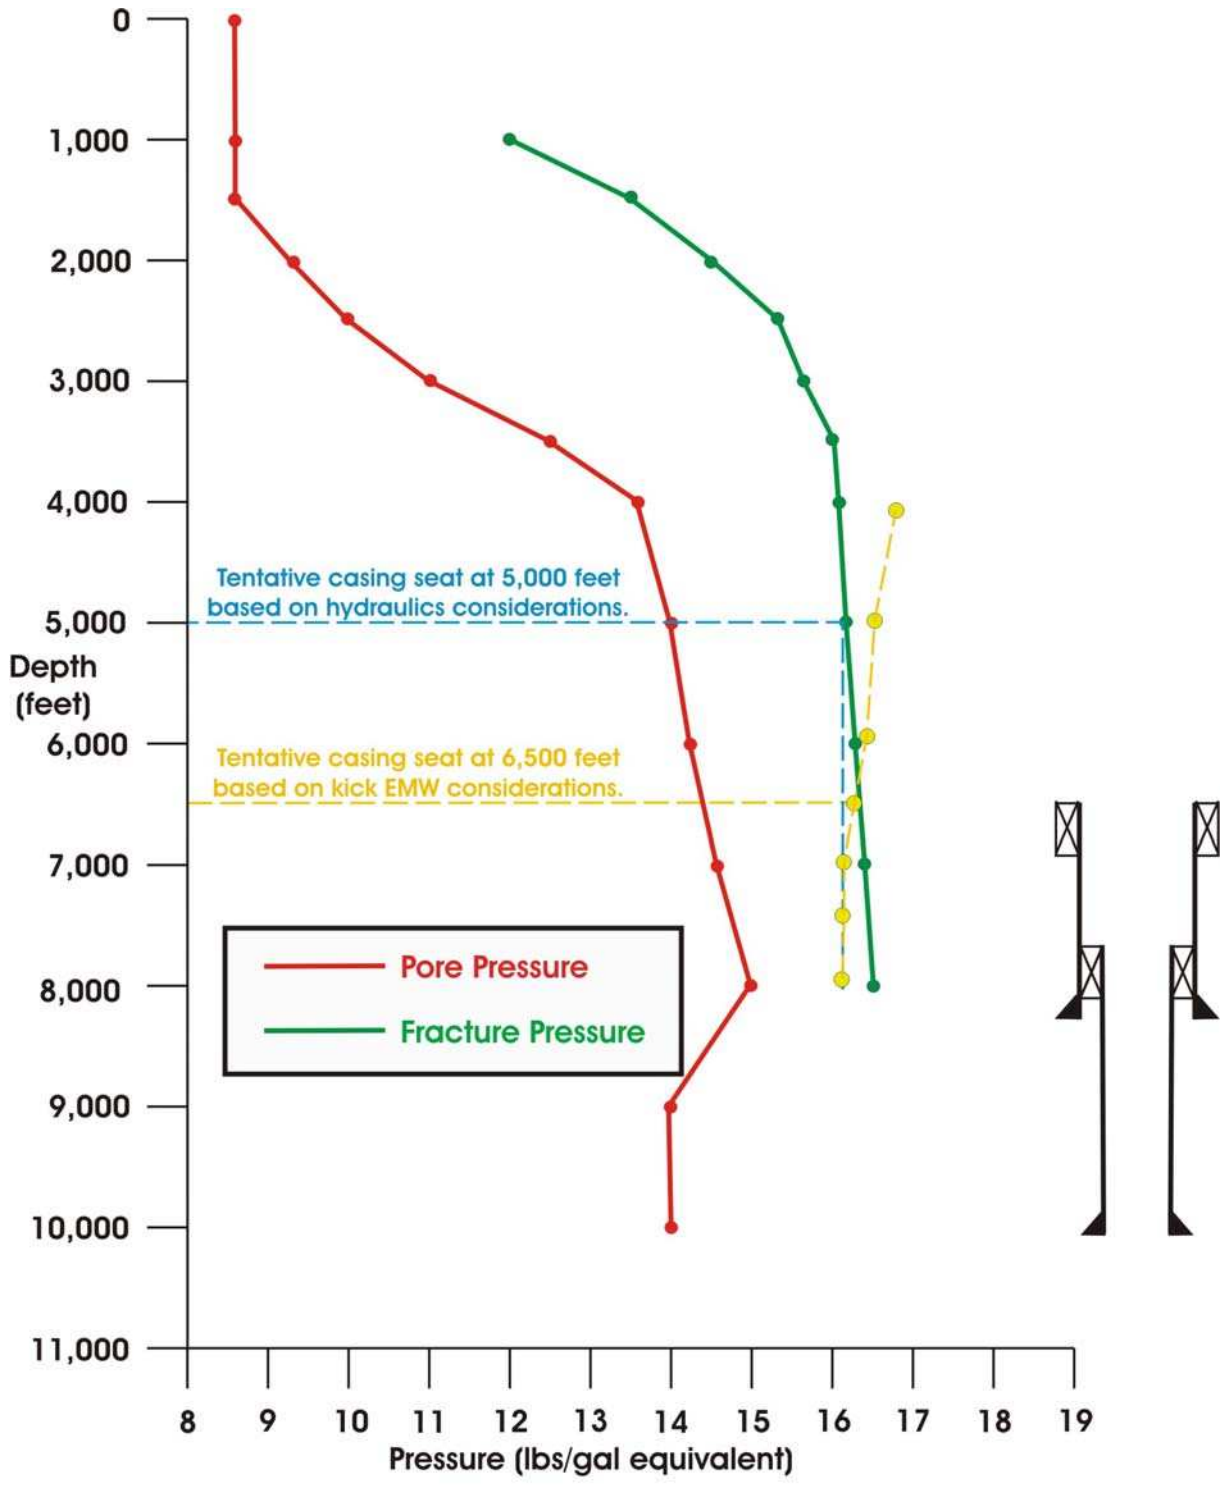
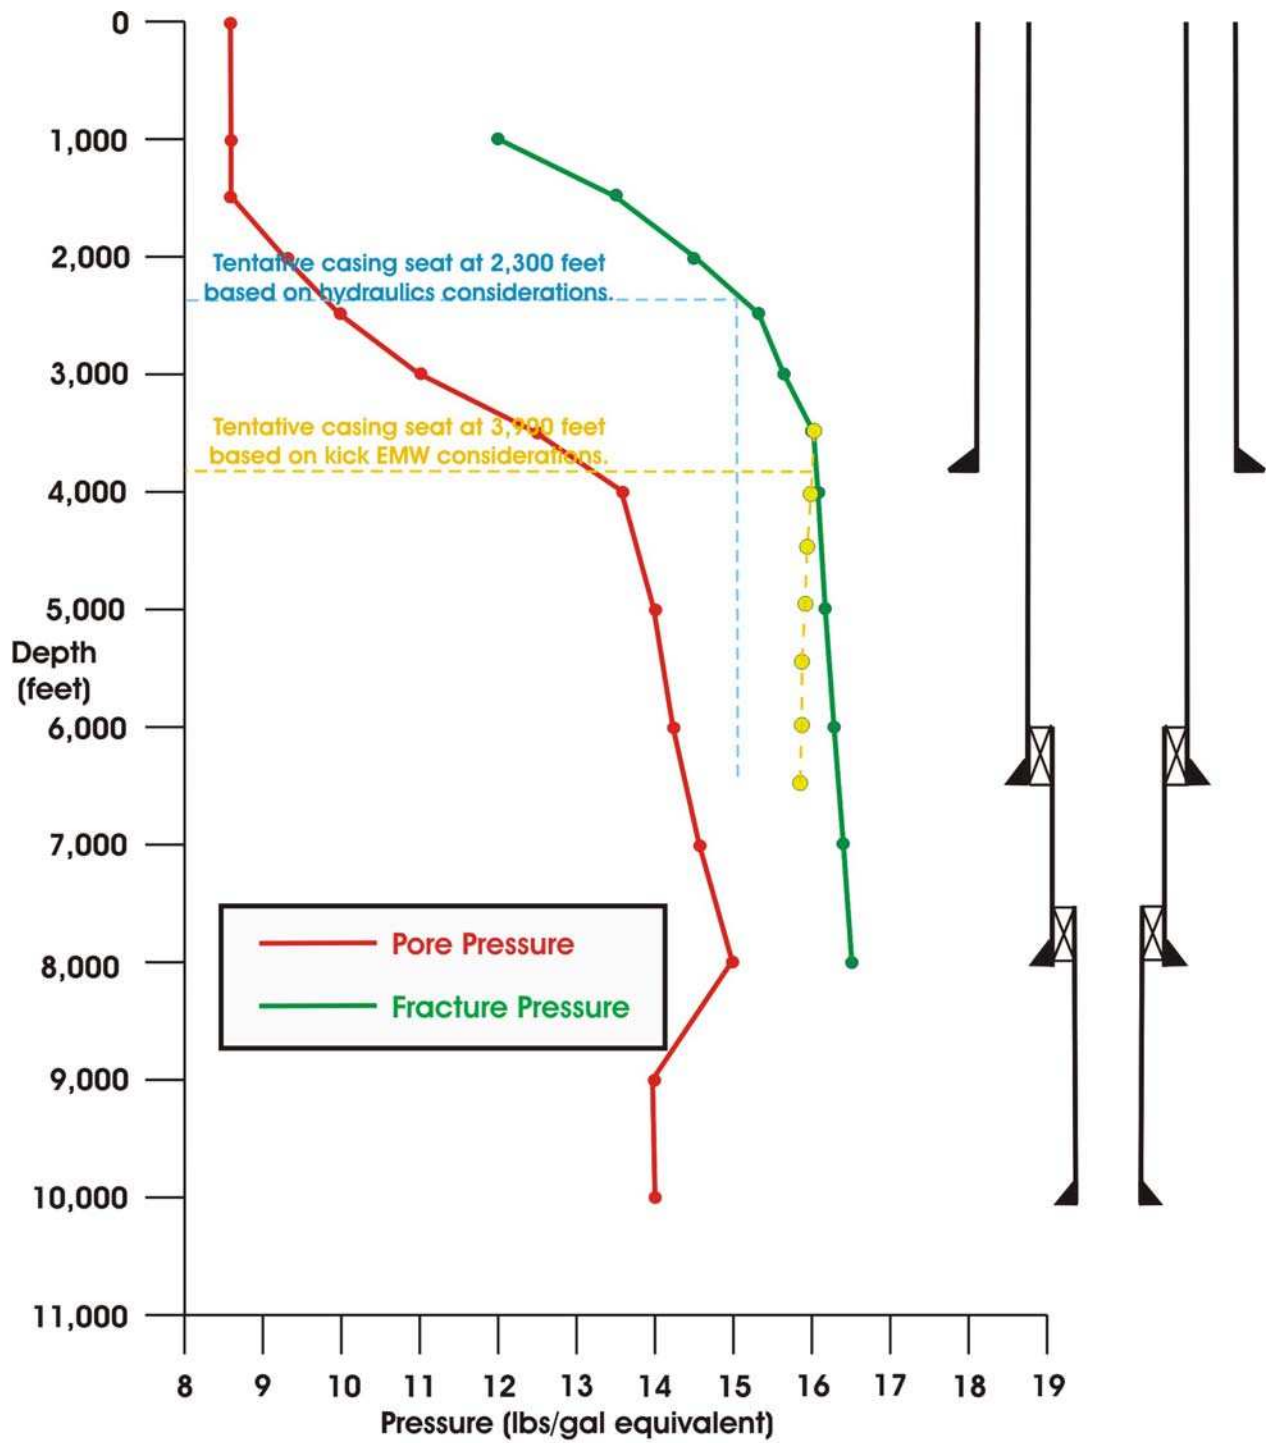
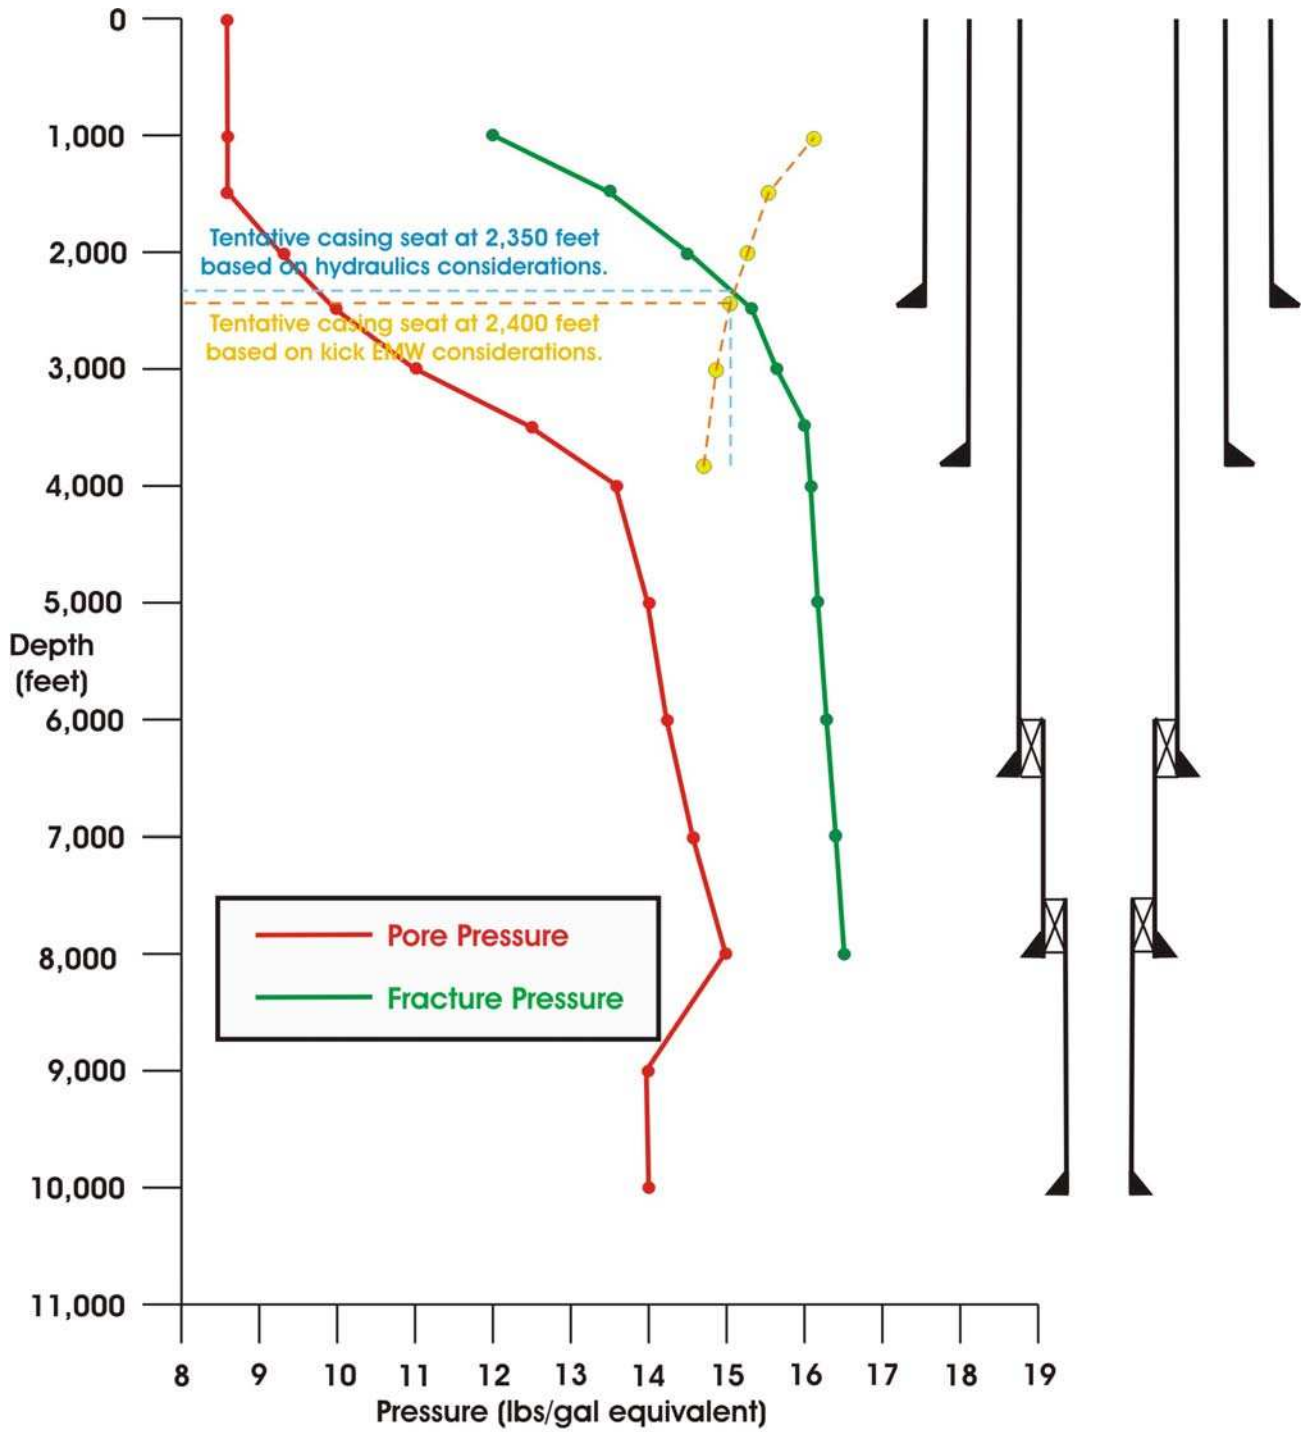
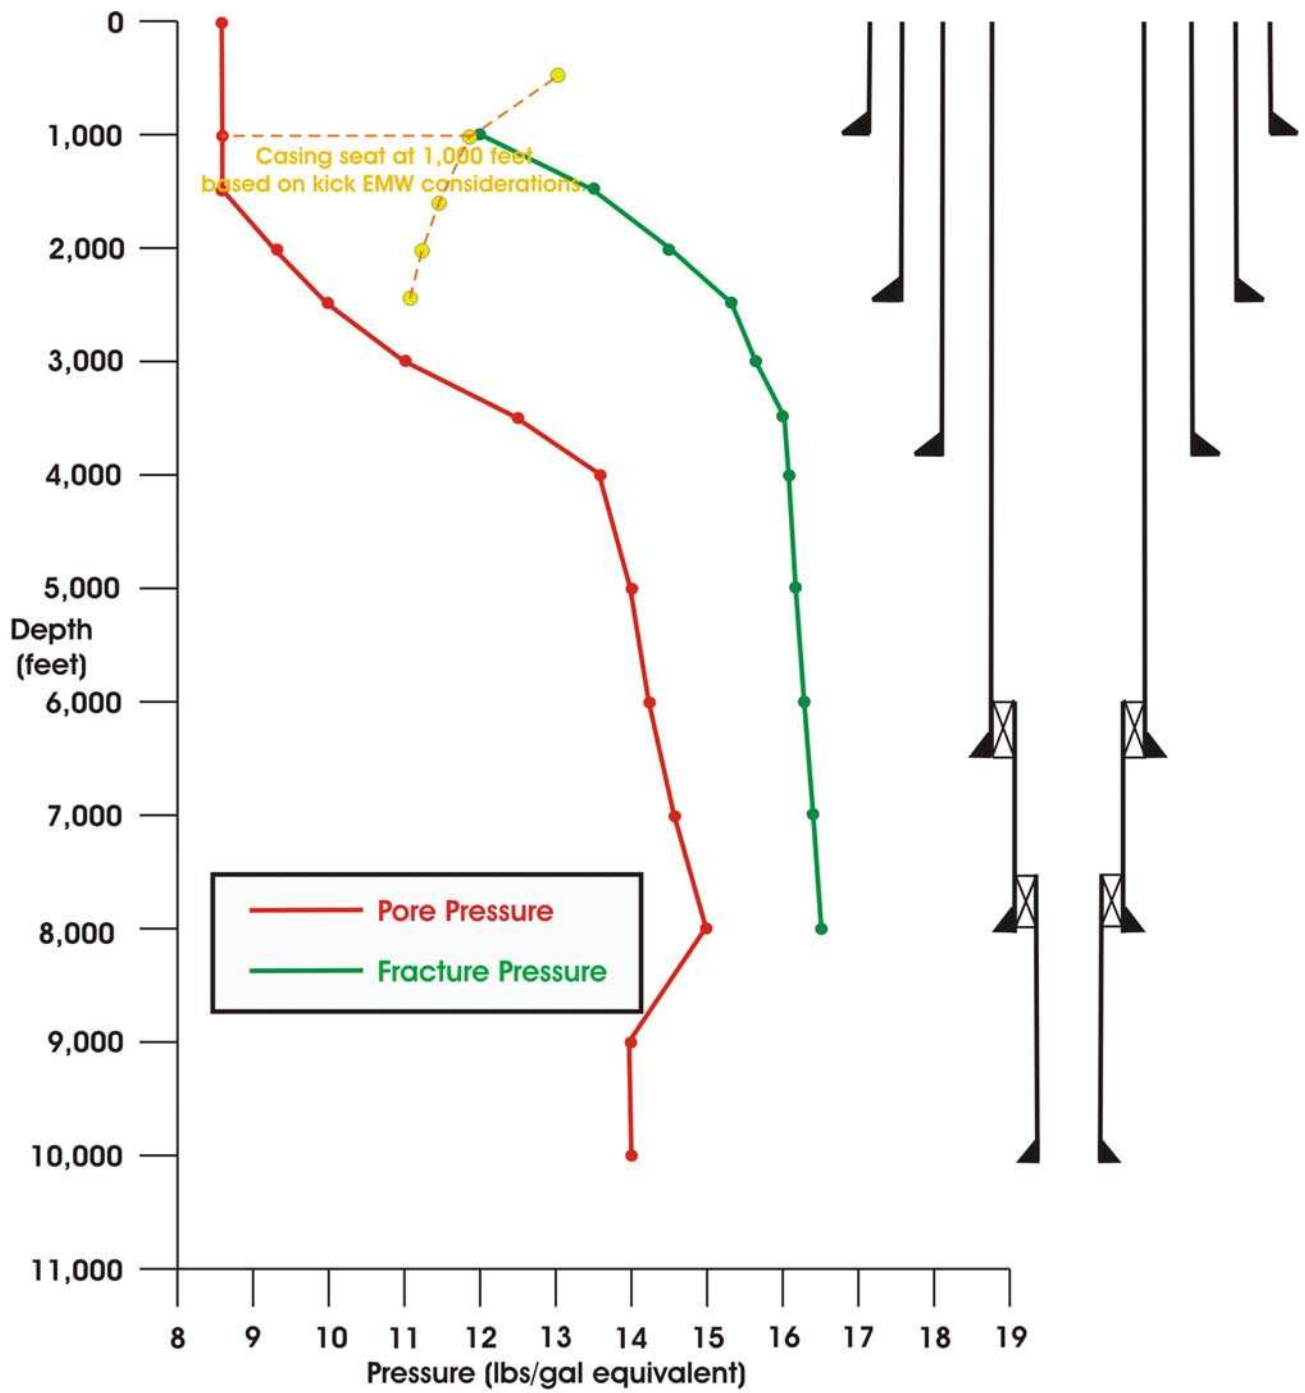
This technique by Adams has been applied for the formation pressure and fracture pressure data shown in Figure 7.3. The results are shown in Figure 7.4 to Figure 7.8. Casing and/or liner depths are shown. Pipe and hole sizes, not shown here, would be developed on several other variables.

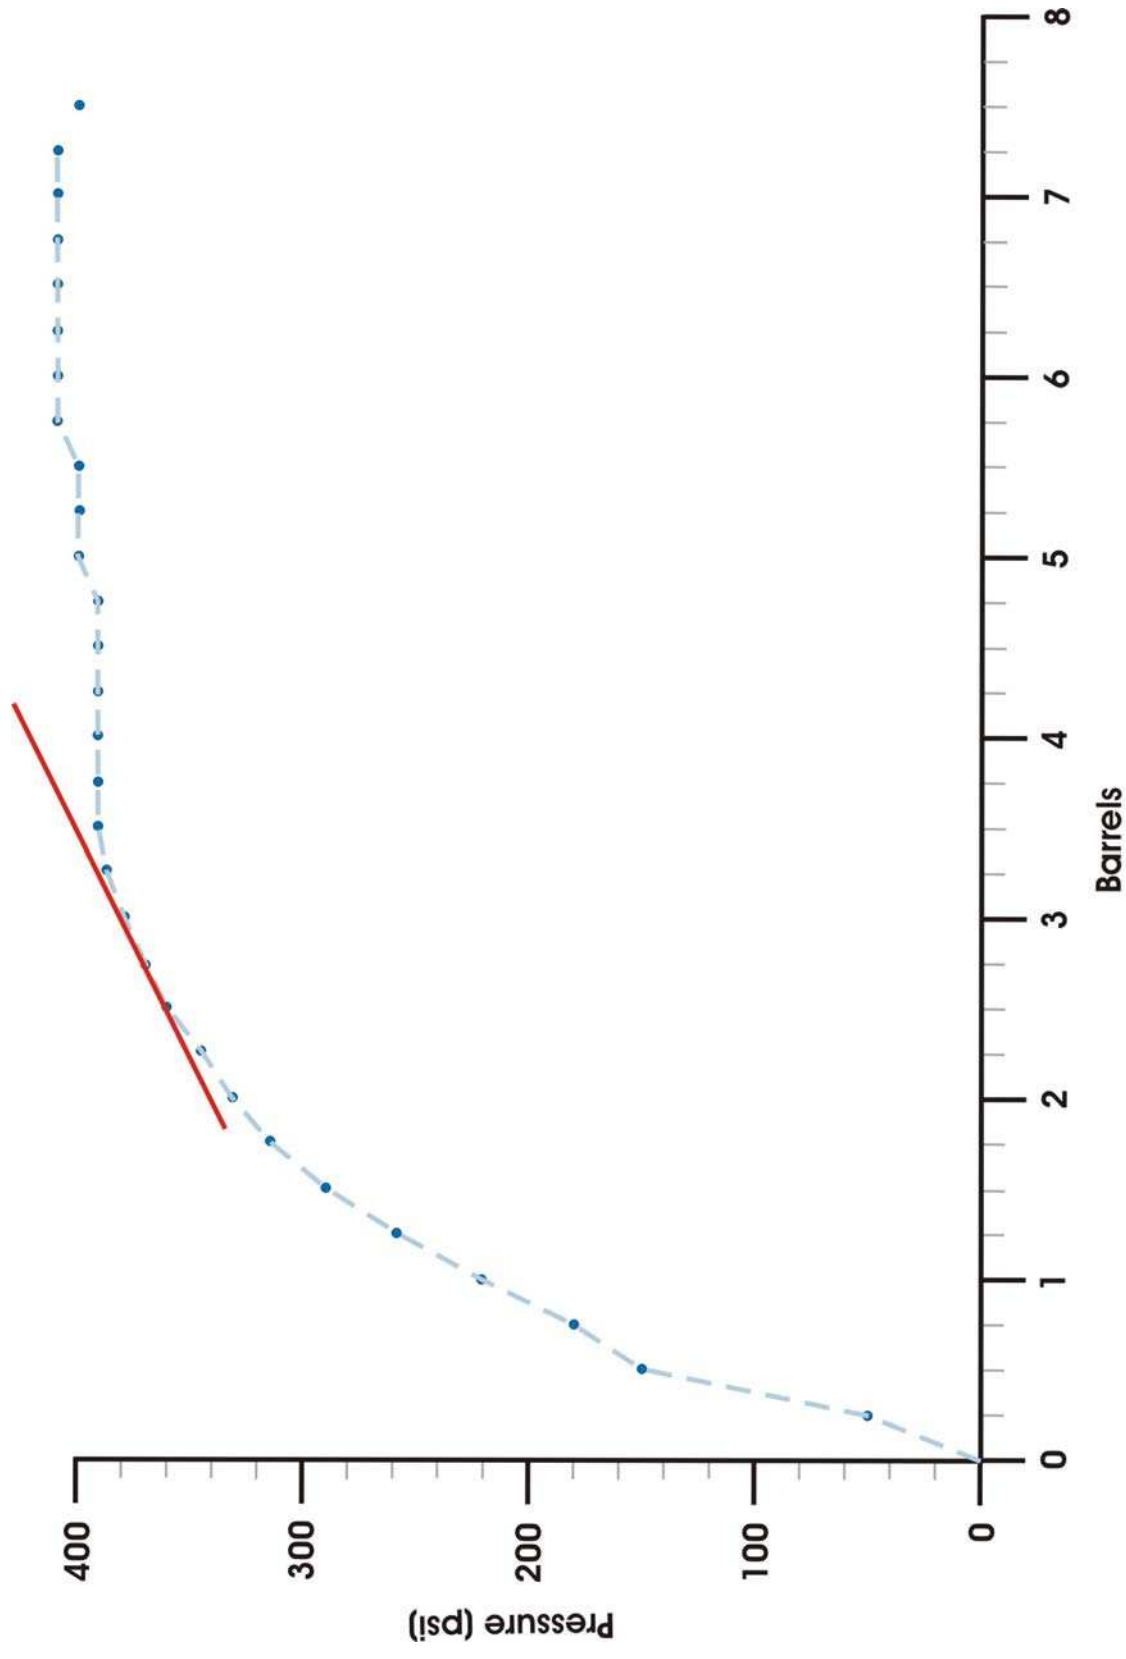
Figure 8.1 Analysis of LOT Data for the 13-3/8 inch Casing.

Leak off tests were performed on each casing string after the float shoe was drilled. The LOT pressure results shown in the DDRs show the gauges used to capture the pressures resulting in reading variations. As an example, the LOT data for the 16 inch liner had pressure readings from three gauges, all which were different. The LOT program relies on accurate gauge readings, which may not have been in play in this case. Specific data points for plotting the LOT results were available only for the 16 inch liner.

Also, LOT interpretation on the 16 inch liner, which was the only casing LOT where the data were available, shows a questionable practice when gathering the data. The LOT should be stopped when the initial leak off is observed. This occurred after approximately three barrels of mud were pumped. However, the Operator continued injection to eight barrels, which would have caused the testing fracture to be extended beyond the length required to achieve a good test. A LOT similar analyses could not be performed on the shallower casing strings as a complete data set was not available.

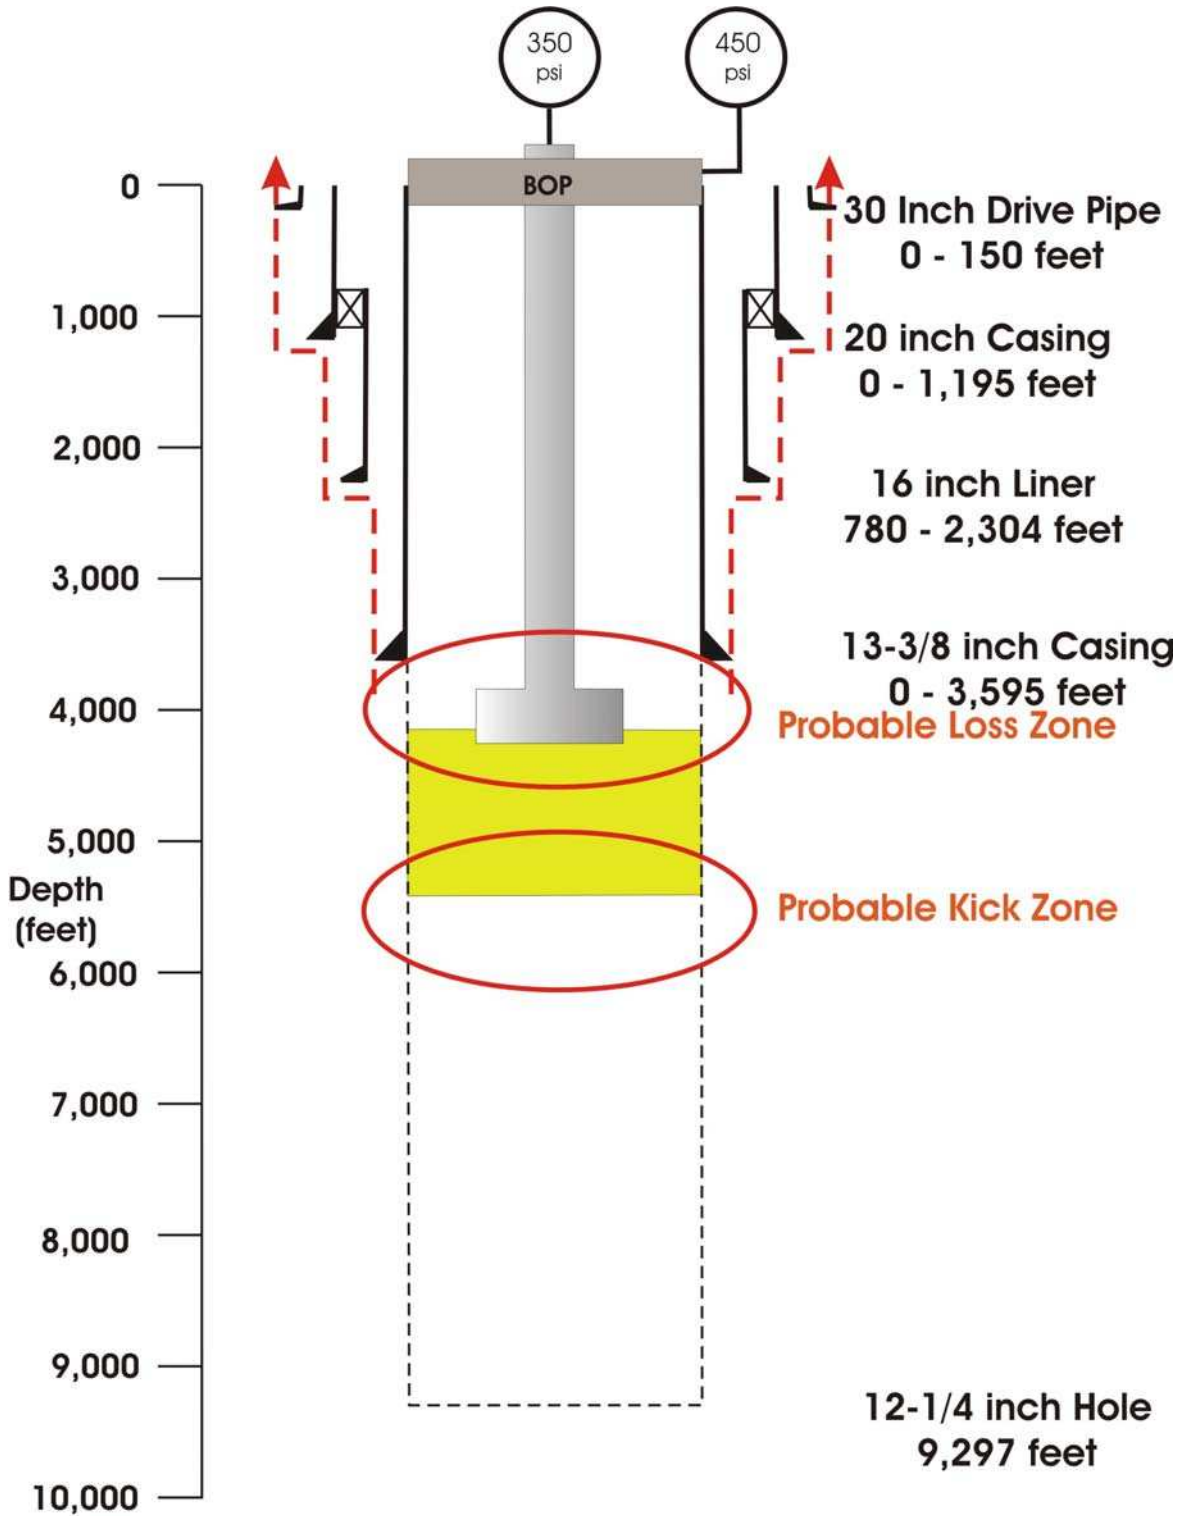
Figure 8.2 Kick Zone and Surface Flow Path

The well did not die as suggested by the DDR. The likely scenario is that an underground blowout ("UGBO") was in progress. The flow path was probably vertically in the poorly cemented casing annulus. Gas bubbling observed soon after this observation confirms that a UGBO was in progress. The likely flow origin was proximate to the bit's location at 4,291 feet and the flow exiting from the hole path was the 13-3/8 inch liner seat at 3,580 feet. The loss of 300 barrels of mud further supports the argument that an UGBO was in progress. It should have been considered by competent rig site personnel.

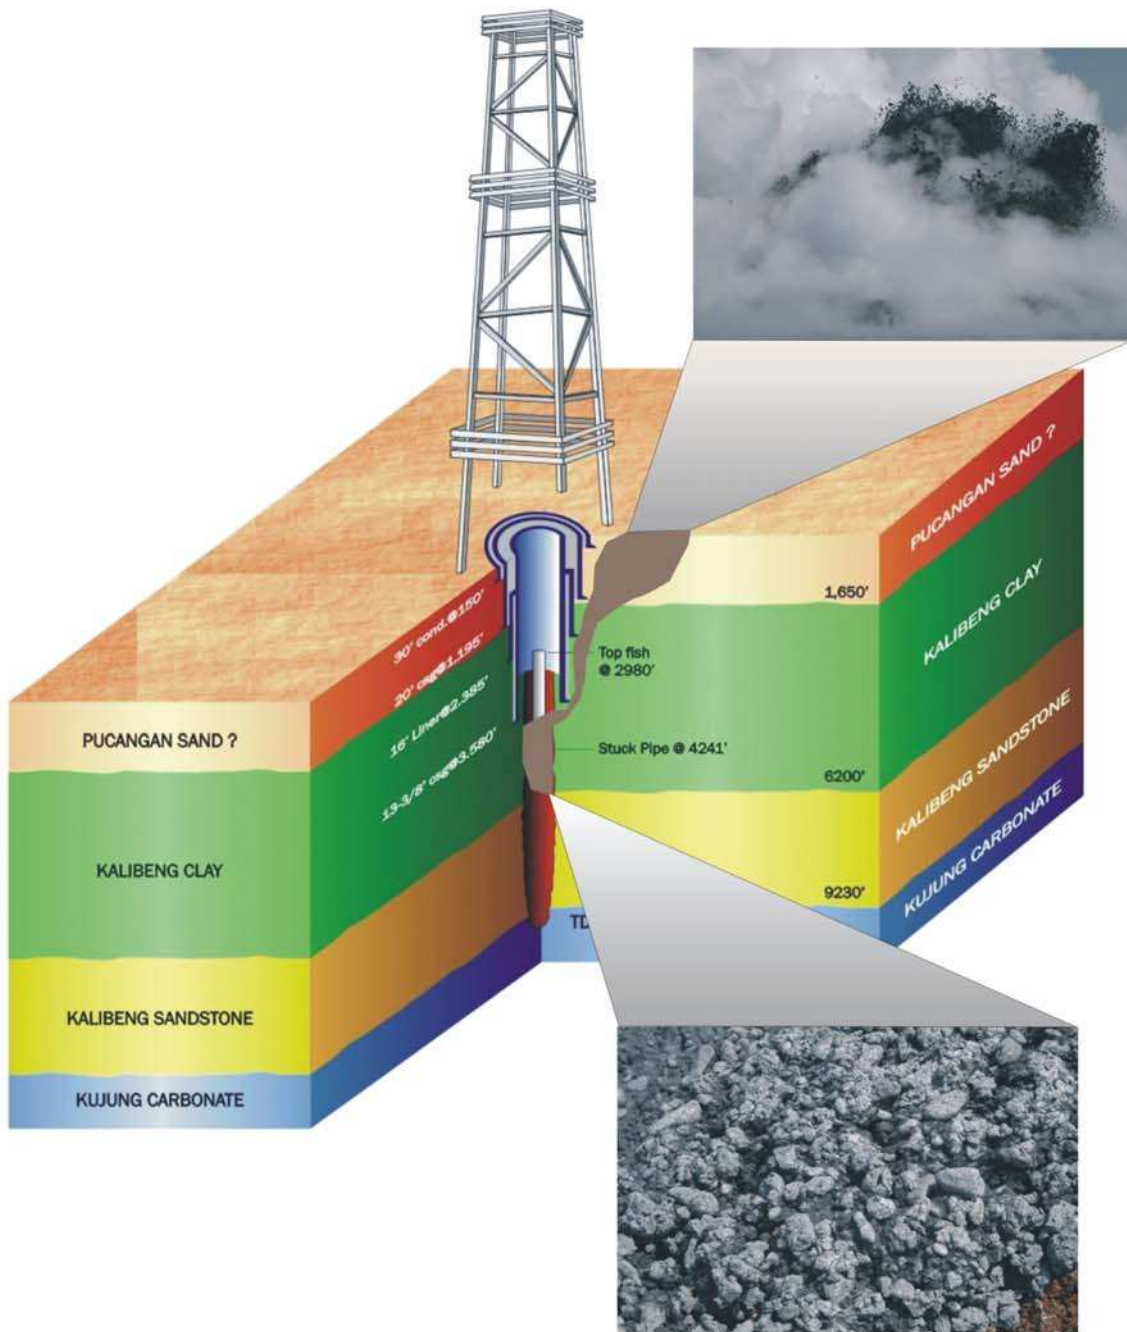
Figure 8.3 Kick Entry Zone and Flow To Surface

Rock debris from the 6,200 feet zone.
