# fractography in failure analysis

A symposium presented at May Committee Week AMERICAN SOCIETY FOR TESTING AND MATERIALS 1-6 May 1977, Toronto, Canada

ASTM SPECIAL TECHNICAL PUBLICATION 645 B. M. Strauss, Gulf Research and Development Company, and W. H. Cullen, Jr., U.S. Naval Research Laboratory, editors

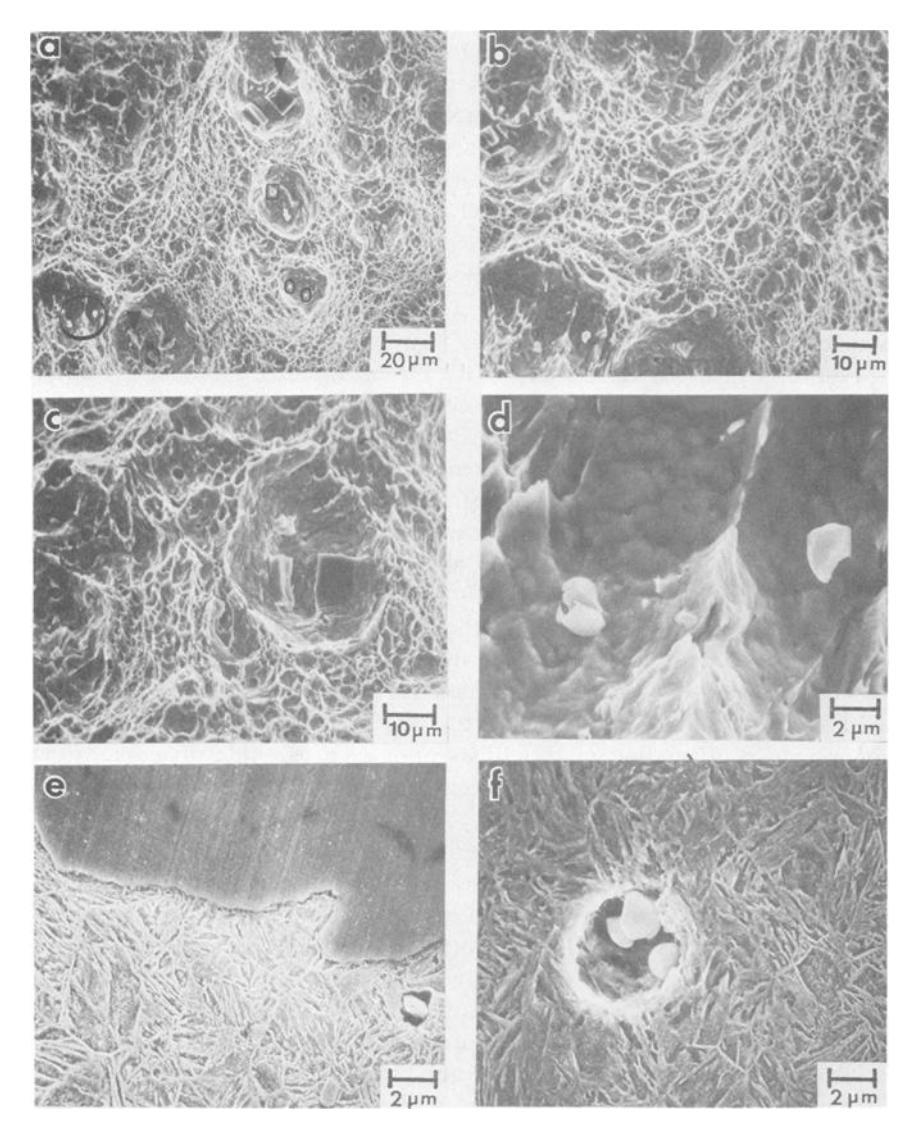
FIG. 11—Scanning micrographs illustrating fracture surface morphology and profiles from room temperature notched three-point bend specimens. Circles in (a) indicate rare earth sulfides, arrows titanium carbonitride, and squares iron rich particles. (c) and (d) are higher magnification micrographs of microvoids containing a titanium carbonitride particle and rare earth sulfide particles, respectively. (e) and (f) show the fracture surface profile, and a microvoid formed away from the main fracture path.

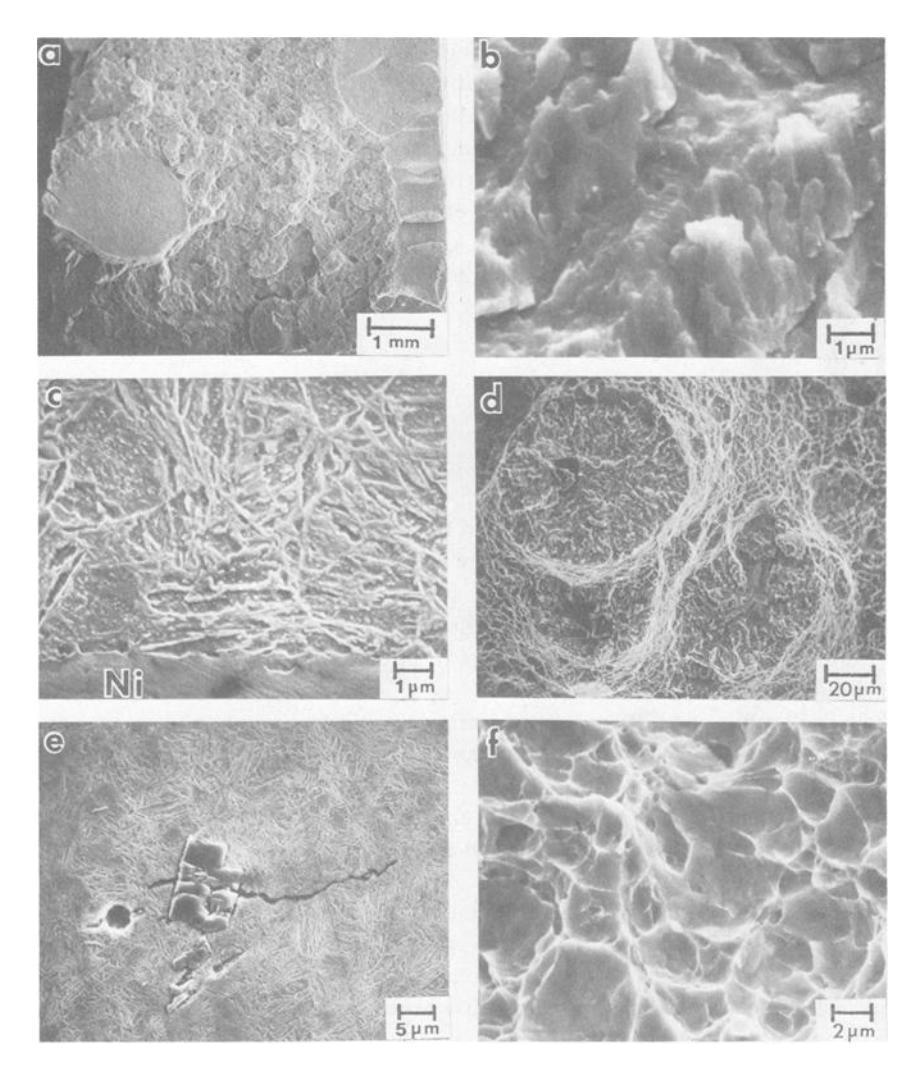
The central region of the specimens exhibited the same type of interlath boundary morphology in small circular regions such as observed in Fig. 12(d). These appear to have been formed by crack nucleation at titanium carbonitride particles. A metallographic section showing this type of crack initiation is presented in Fig. 12(e). In addition, the central part of the fracture contains microvoid regions (dimple rupture) which appear to link the inter-lath cracks. Their morphology is illustrated in Fig. 12(f).

FIG. 12—Scanning micrographs illustrating hydrogen charged three-point notched bend fracture morphology. (a) Low magnification showing macroscopic appearance, (b) lath boundary topography on flat regions. (c) nickel plated cross-section of lath boundary fracture, (d) lath boundary cracks formed by cleavage of titanium carbonitride particles, (e) cross section illustrating same effect as shown in (d), and (f) dimple rupture observed in central region.
These fractographic-microstructure observations, although not conclusive, suggest that hydrogen embrittlement may not be the cause of the low bend ductility in this plate of steel. Additional studies are currently being conducted to determine whether lower hydrogen concentrations can affect microvoid formation and growth during ductile rupture in this steel. These observations also indicate the following conclusions: (a) quasicleavage in this plate steel exhibits a distinct relationship to microstructure in the size of the facets and in the size and spatial arrangements of the smaller blocky regions relative to substructure occurring within the tempered martensite packets. (b) Hydrogen charging can embrittle martensite lath boundaries producing a distinctive fractographic appearance. (c) Cleavage of titanium carbonitride particles can nucleate lath boundary crack propogation in hydrogen charged specimens and large microvoids during ductile rupture.

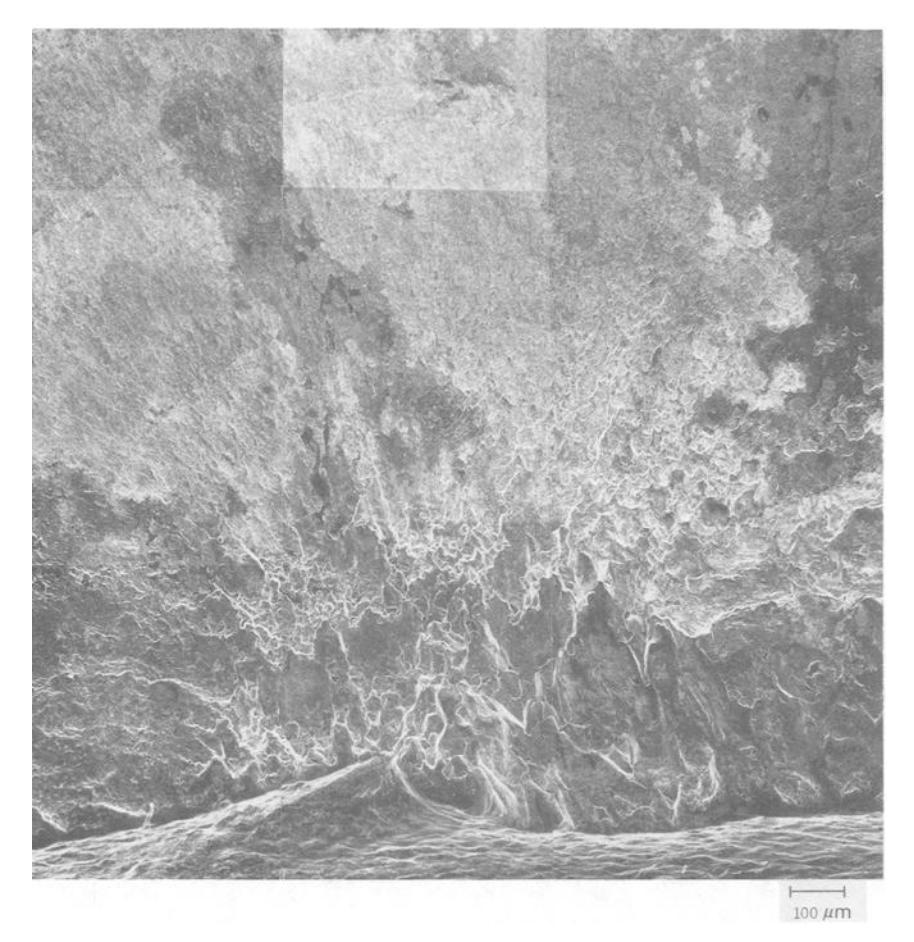
FIG. 3-Scanning electron fractograph showing the origin.

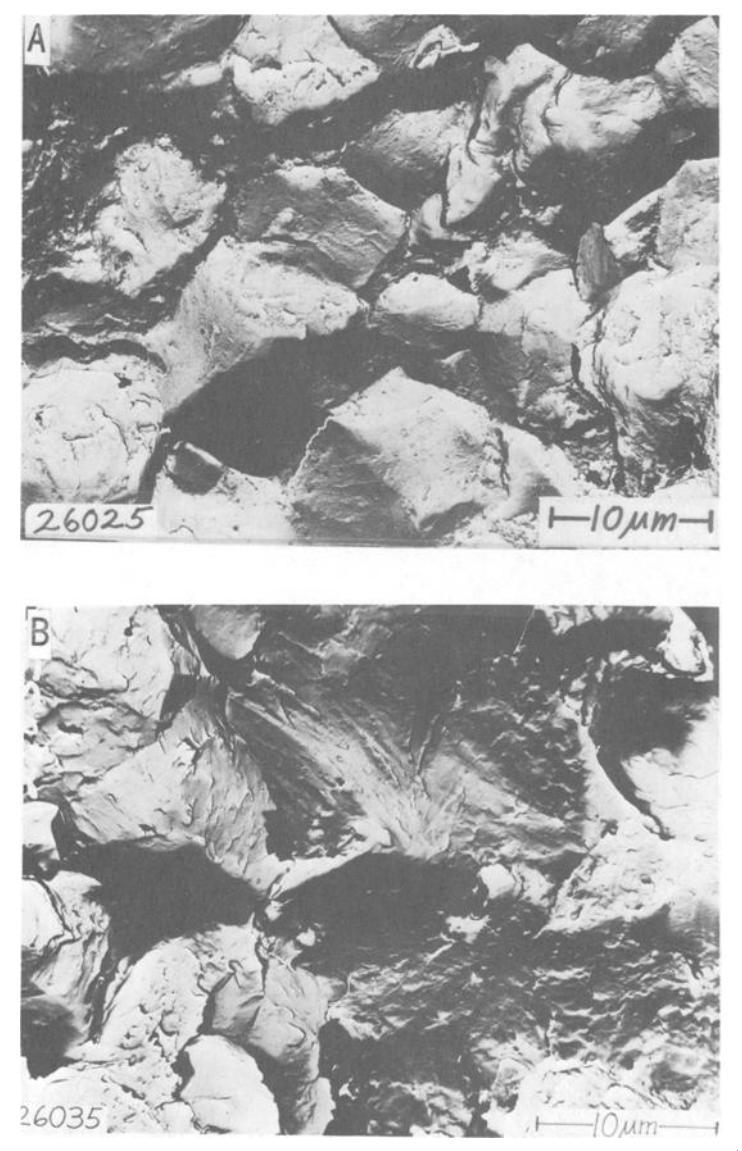
FIG. 4—Catapult lug fracture surface (two stage replica, TEMs). (a) Nearly 100<sup>1</sup> percent intergranular at origin of slow crack region. (b) Mixed intergranular with transgranular cleavage and dimples midway through slow crack area. (c) 100 percent dimples within slow crack area near onset of fast fracture.

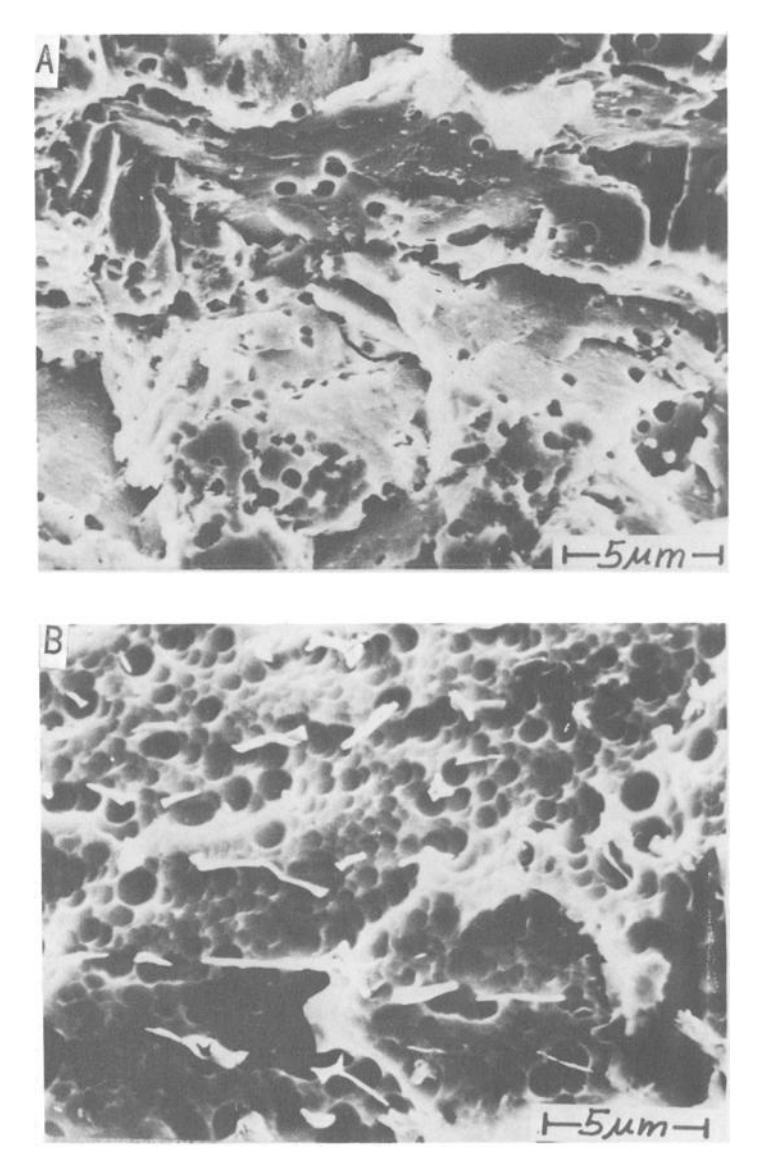
FIG. 8—Turbojet engine compressor blade (Ti-8Al-1Mo-1V) fracture (SEMs). (a) Cleavage with pits or voids near origin of fracture half A. (b) Apparent dimples, same area as (a).

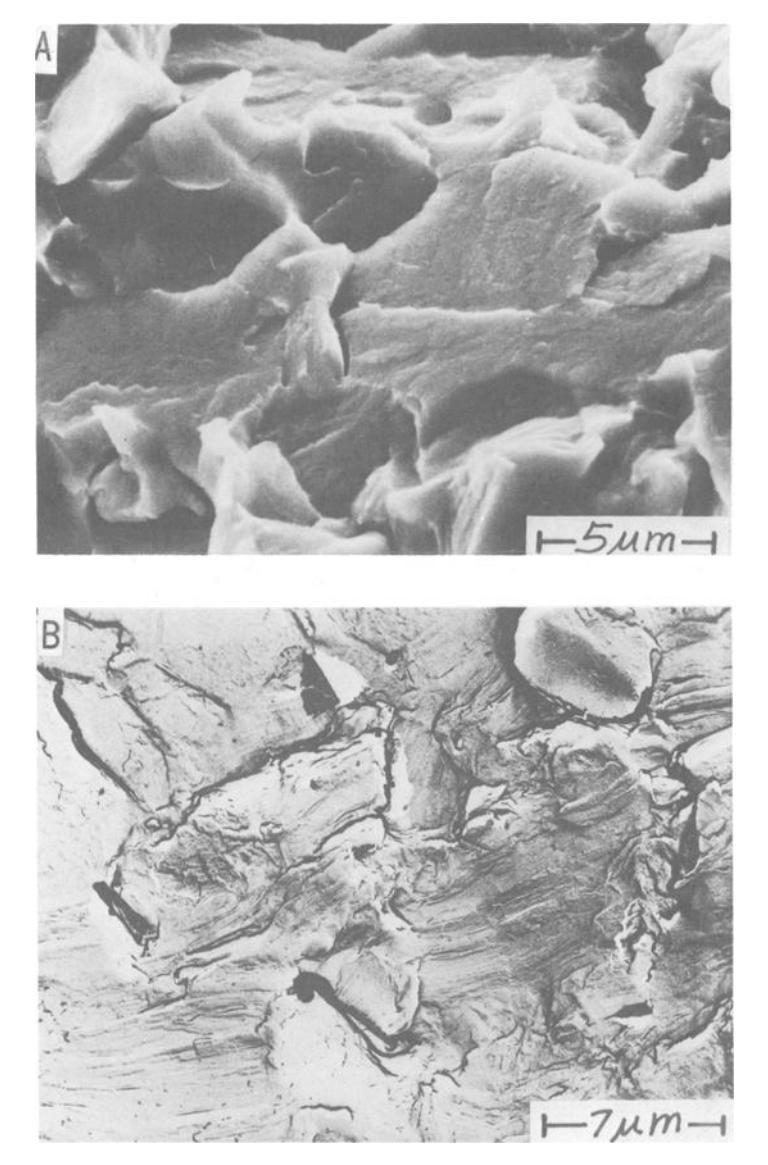
FIG. 9—Turbojet engine compressor blade (Ti-8Al-1Mo-1V). (a) Demonstrating clean, pitfree cleavage near origin of fracture half B (SEM). (b) Coarse striations near end of slow crack area (two-stage replica, TEM).

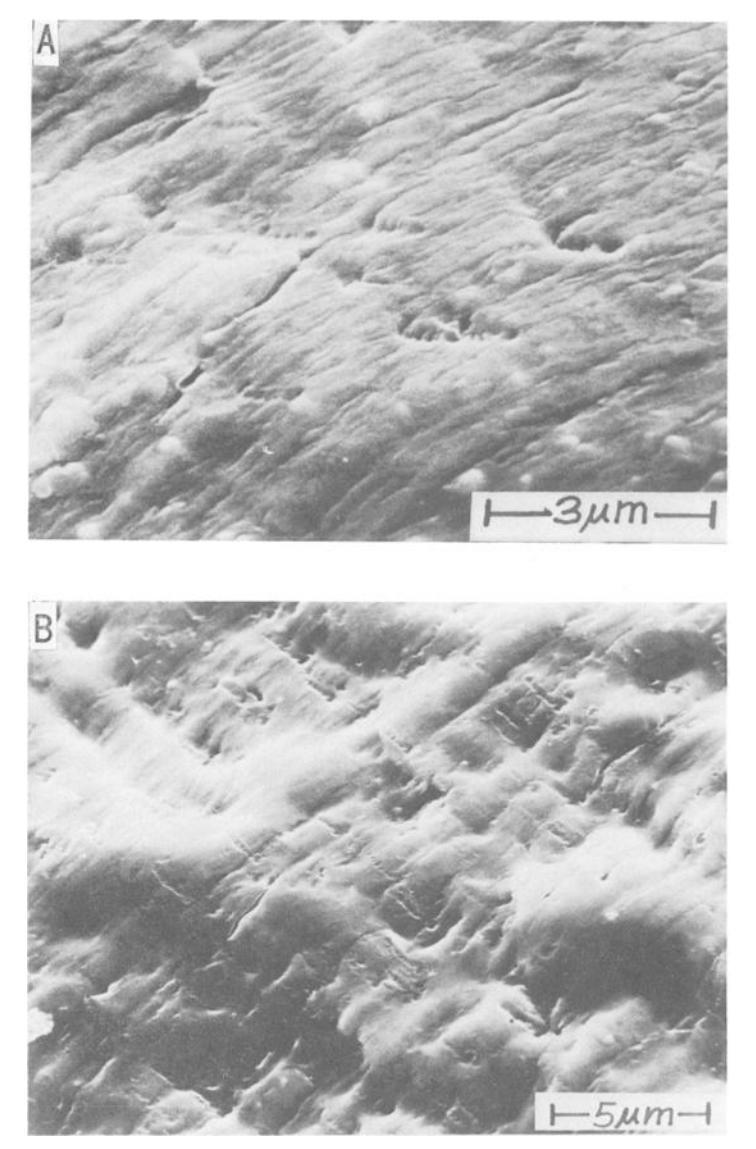
FIG. 10—Jet aircraft bulkhead (2024-T3) crack fracture surface (SEMs). (a) Fatigue striations near origin. (b) Coarse fatigue striations with "tire tracks" near end of slow crack area.

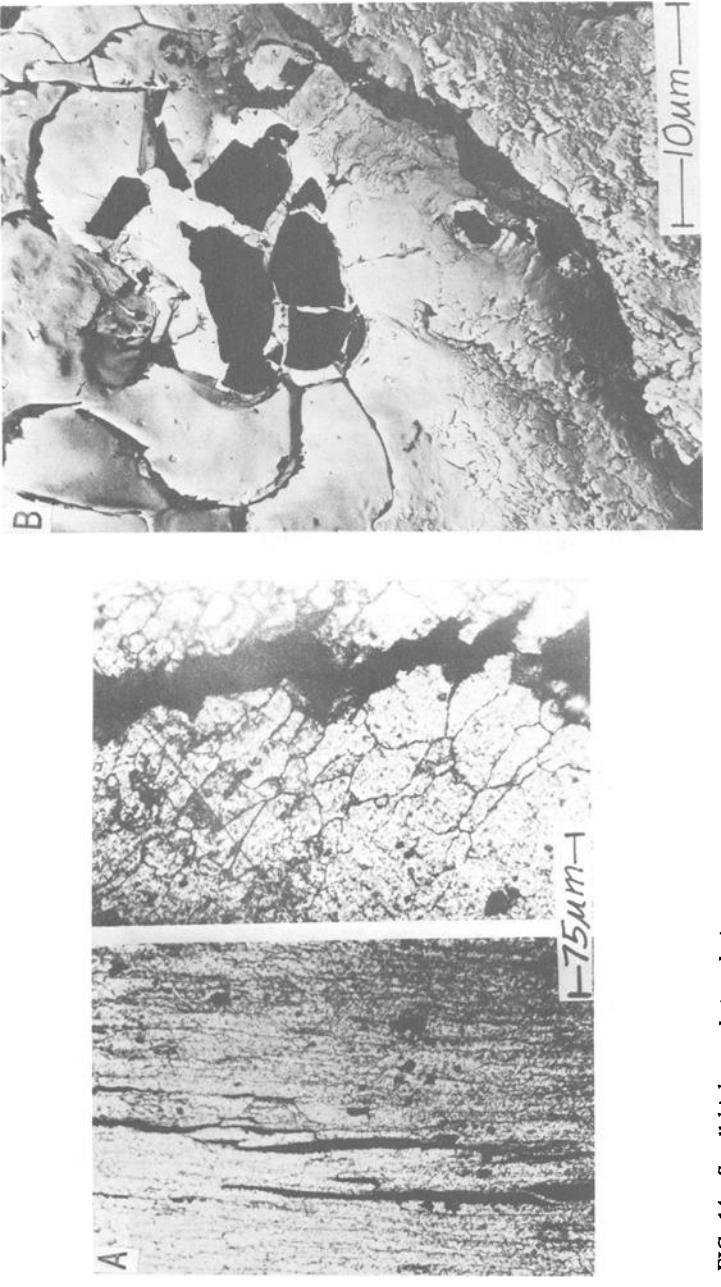
FIG. 14-Small high speed ship deck plate (5456-H321) cracks. (a) Cross sections (polished and etched, light optical micrographs). (b) Mud crack appearance of fracture surfaces (two-stage replica, TEMs).

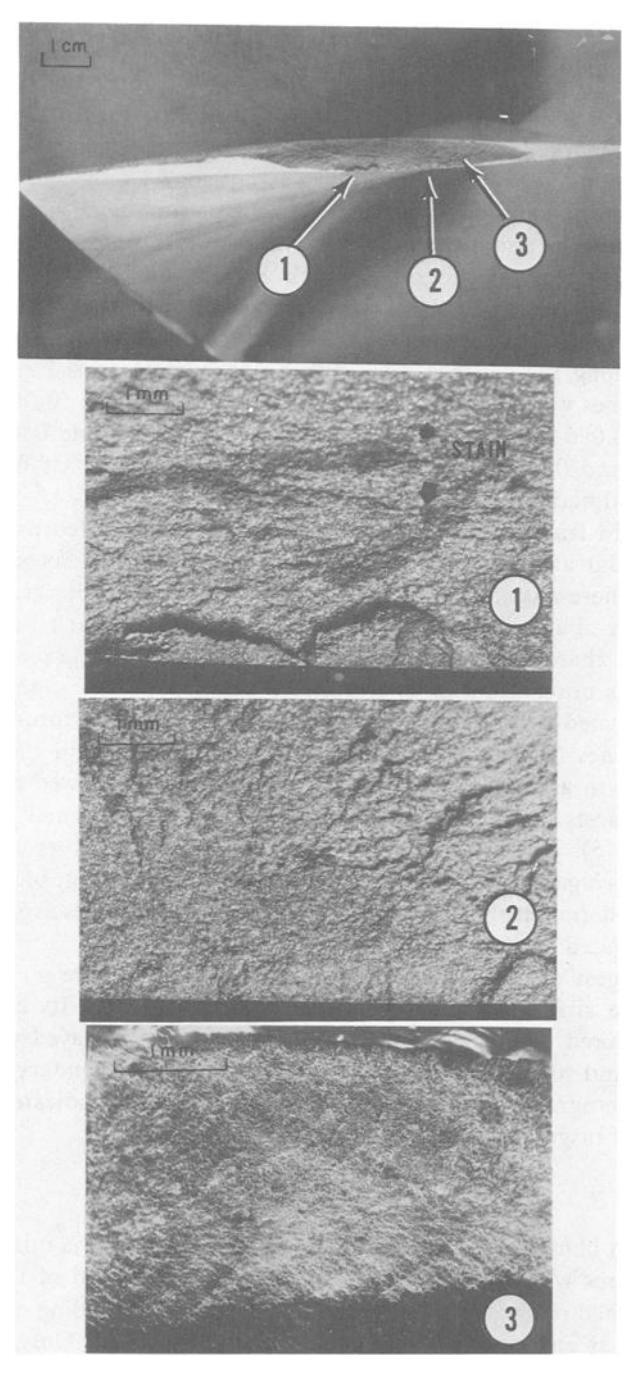
FIG. 2-Fracture surface of Fan Blade A.

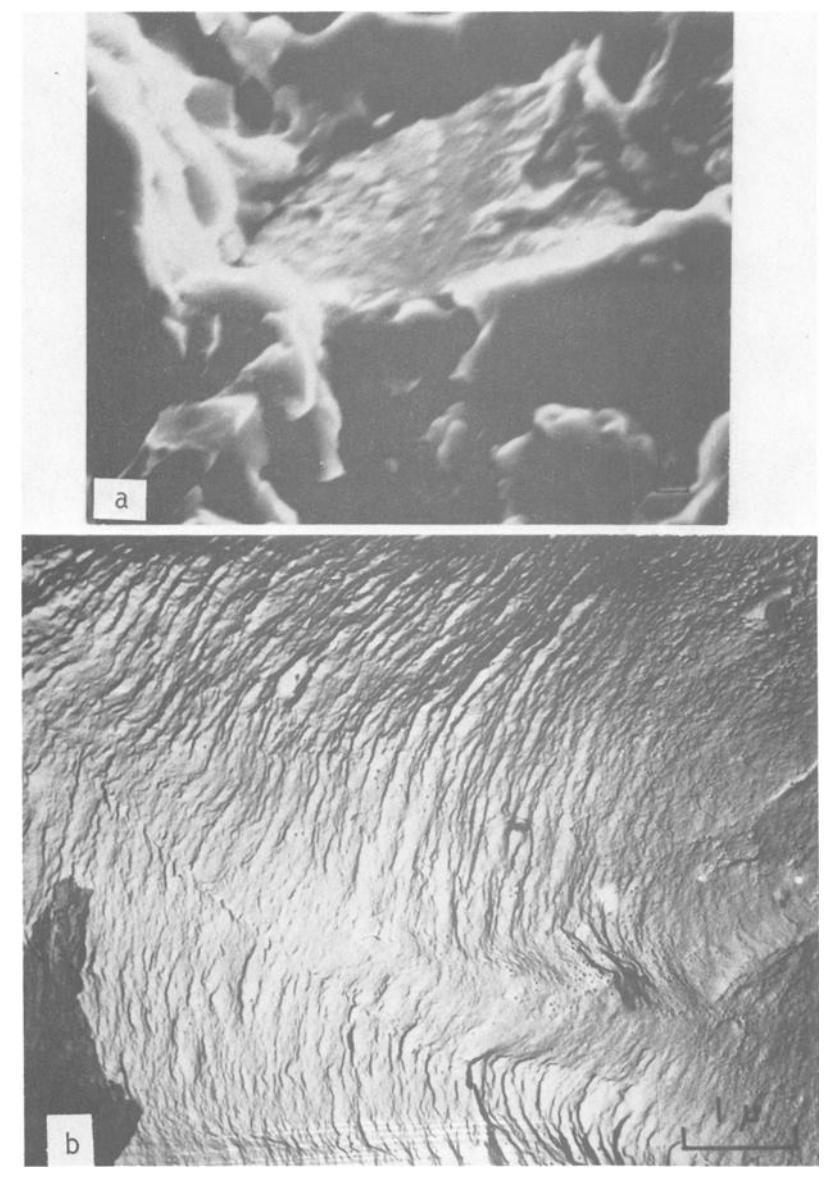
FIG. 5—SEM and TEM fractographs outside of discolored zones in subcritical crack growth area of Fan Blade A: (a) SEM fractograph, and (b) TEM fractograph.

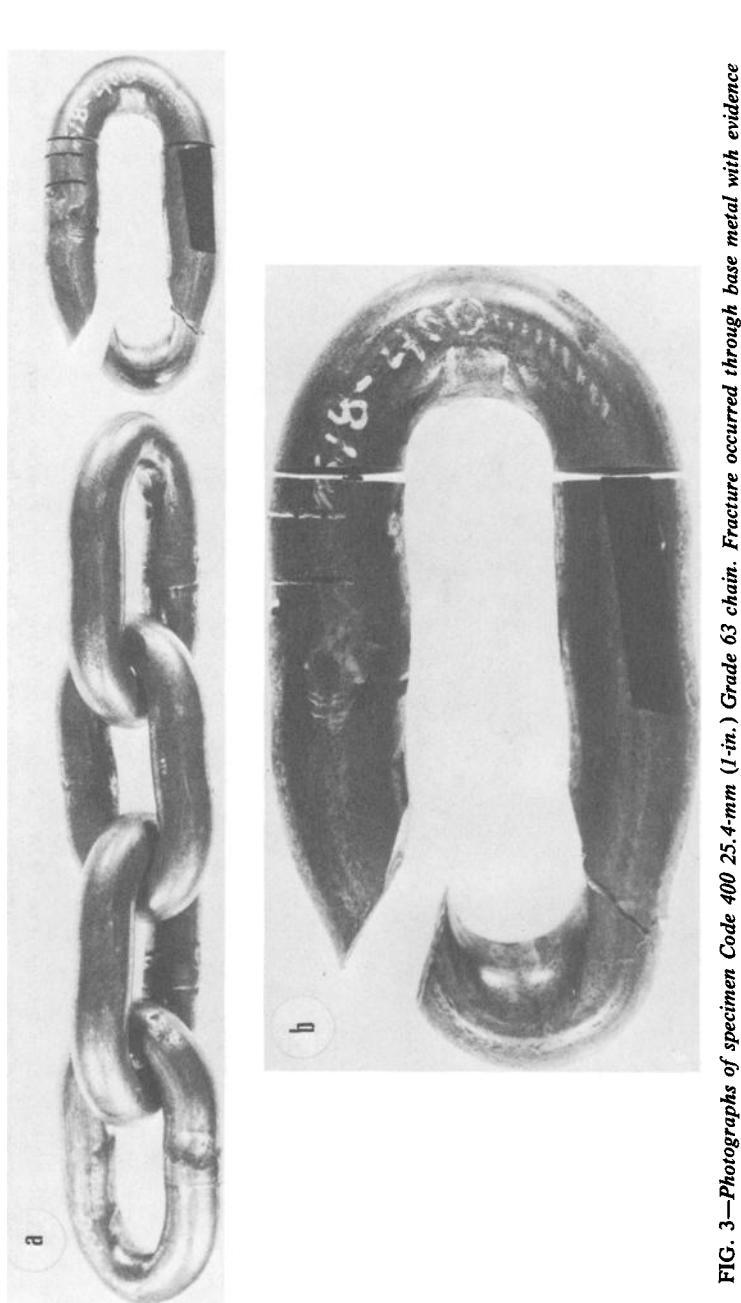
FIG. 3—Photographs of specimen Code 400 25.4-mm (1-in.) Grade 63 chain. Fracture occurred through base metal with evidence of prefracture deformation. (a) Five-link full-size chain test,  $\times 0.3$ . (b) Fractured link in full-size chain test,  $\times 0.75$ .

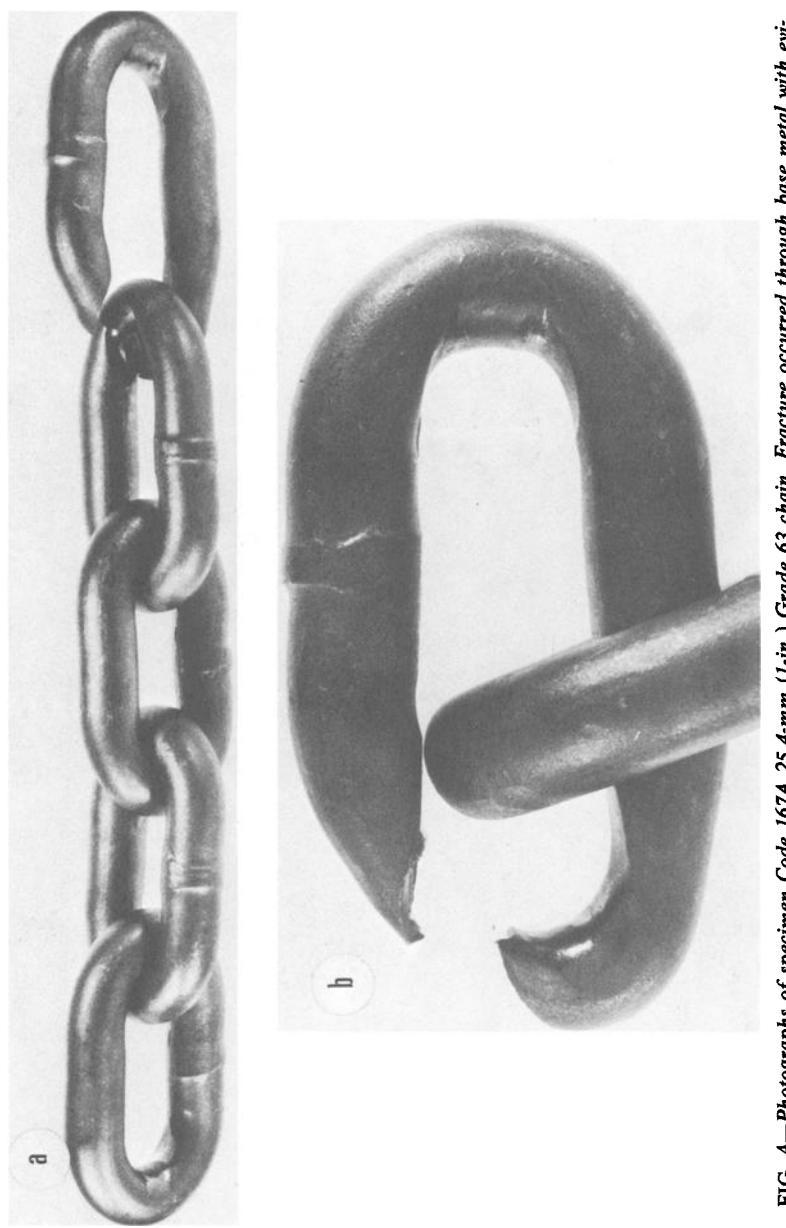
FIG. 4—Photographs of specimen Code 167A 25.4-mm (1-in.) Grade 63 chain. Fracture occurred through base metal with evidence of prefracture deformation. (a) Five-link full-size chain test, ×0.3. (b) Fractured link in full-size chain test, ×0.75.

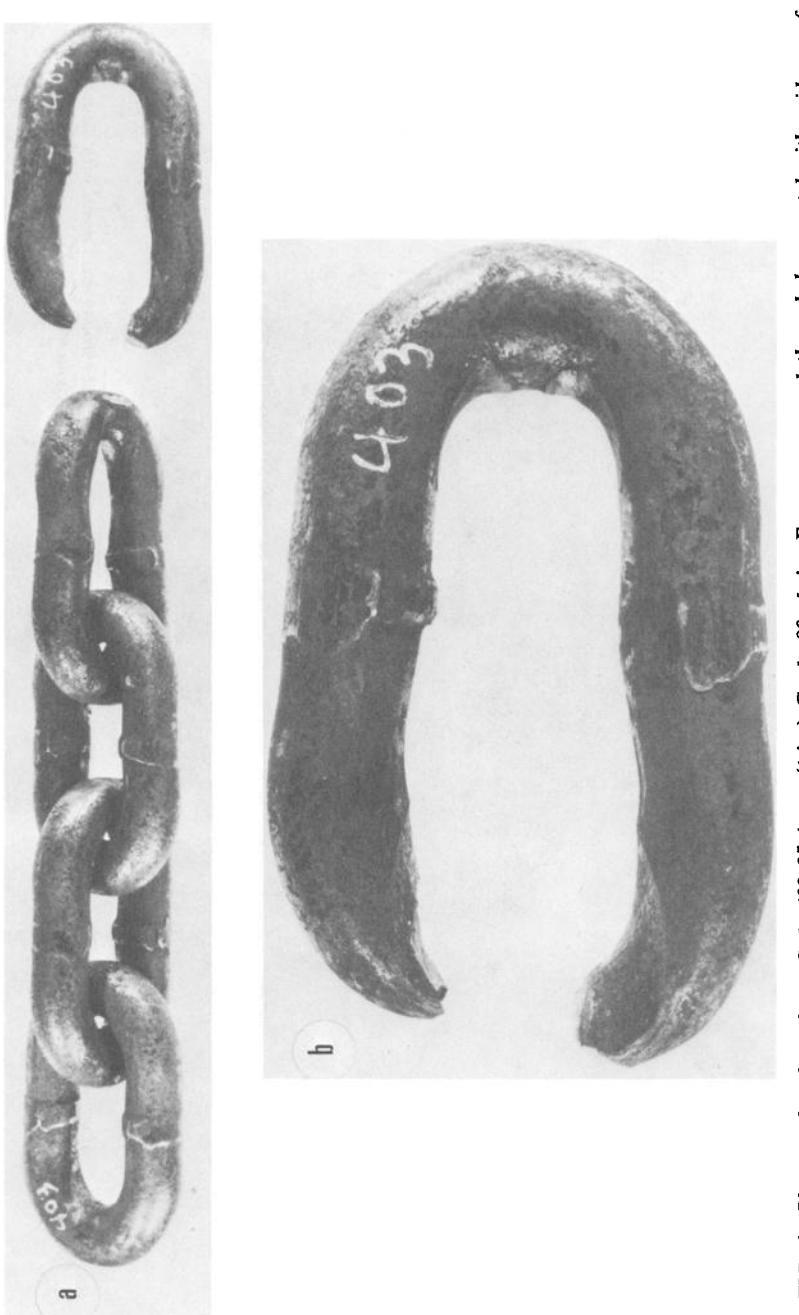
FIG. 6—Photographs of specimen Code 403 25.4-mm (1-in.) Grade 80 chain. Fracture occurred through base metal with evidence of prefracture deformation. (a) Five-link full-size chain test, ×0.75.

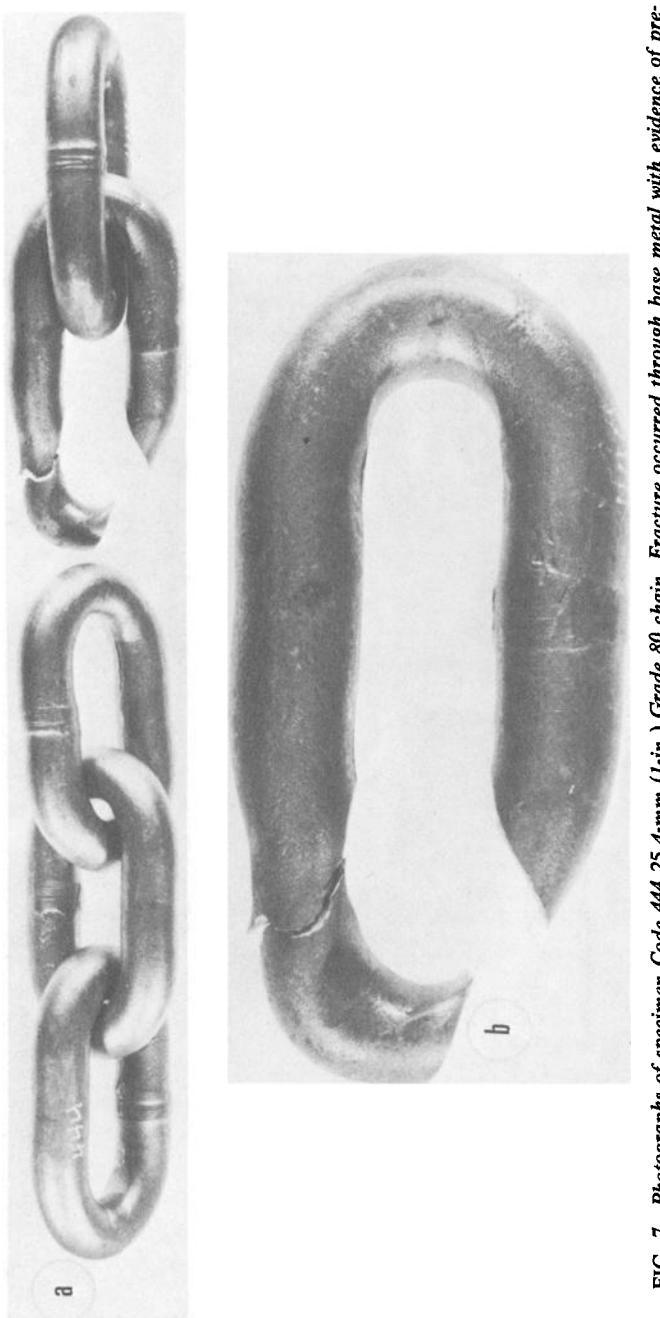
FIG. 7—Photographs of specimen Code 444 25.4-mm (1-in.) Grade 80 chain. Fracture occurred through base metal with evidence of pre-fracture deformation. (a) Five-link full-size chain test, ×0.3. (b) Fractured link in full-size chain test, ×0.75.

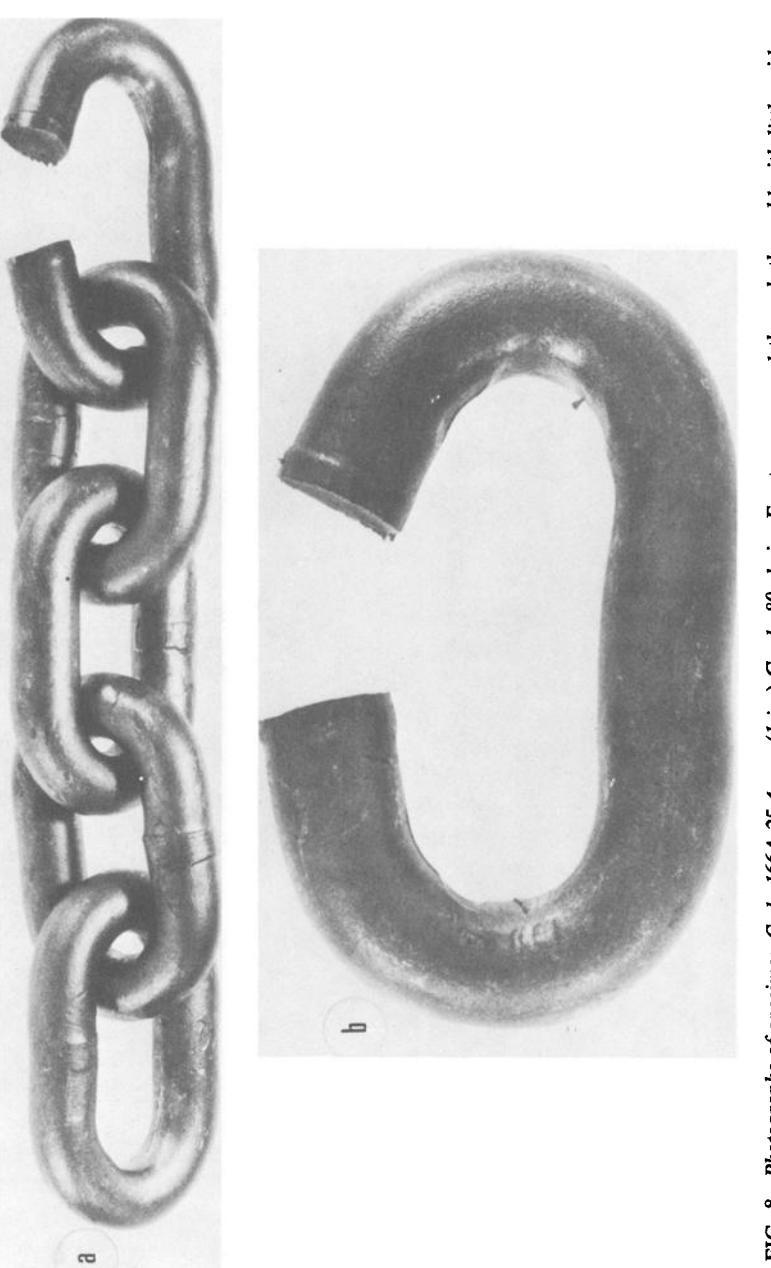
FIG. 8—Photographs of specimen Code 166A 25.4-mm (1-in.) Grade 80 chain. Fracture occurred through the weld with little evidence of prefracture deformation. (a) Five-link full-size chain test, ×0.3. (b) Fractured link in full-size chain test, ×0.75.
