Cadillac Gage V-100 Commando 1960-71

Lathrop & J McDonald • Illustrated by J Laurier

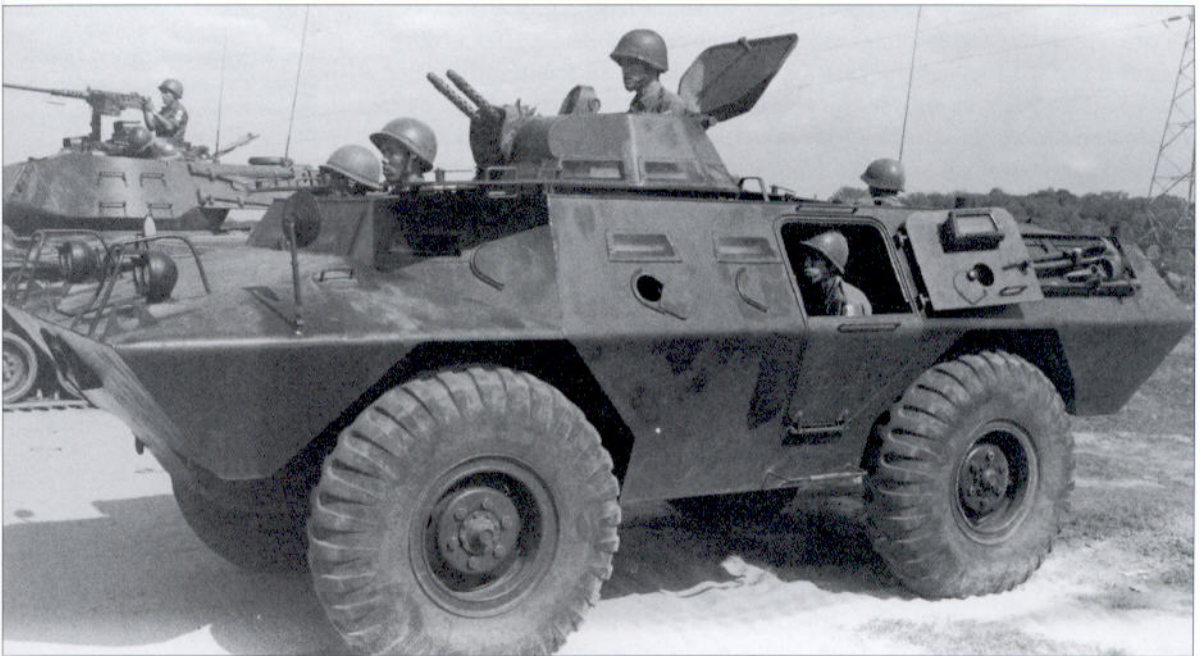
An early production V-100 shown at a firing range in South Vietnam, this vehicle was one of the first to be delivered to the ARVN troops. ARVN experience with the V-100 would lead to a number of improvements. An M41 Walker Bulldog light tank is pictured in the background.

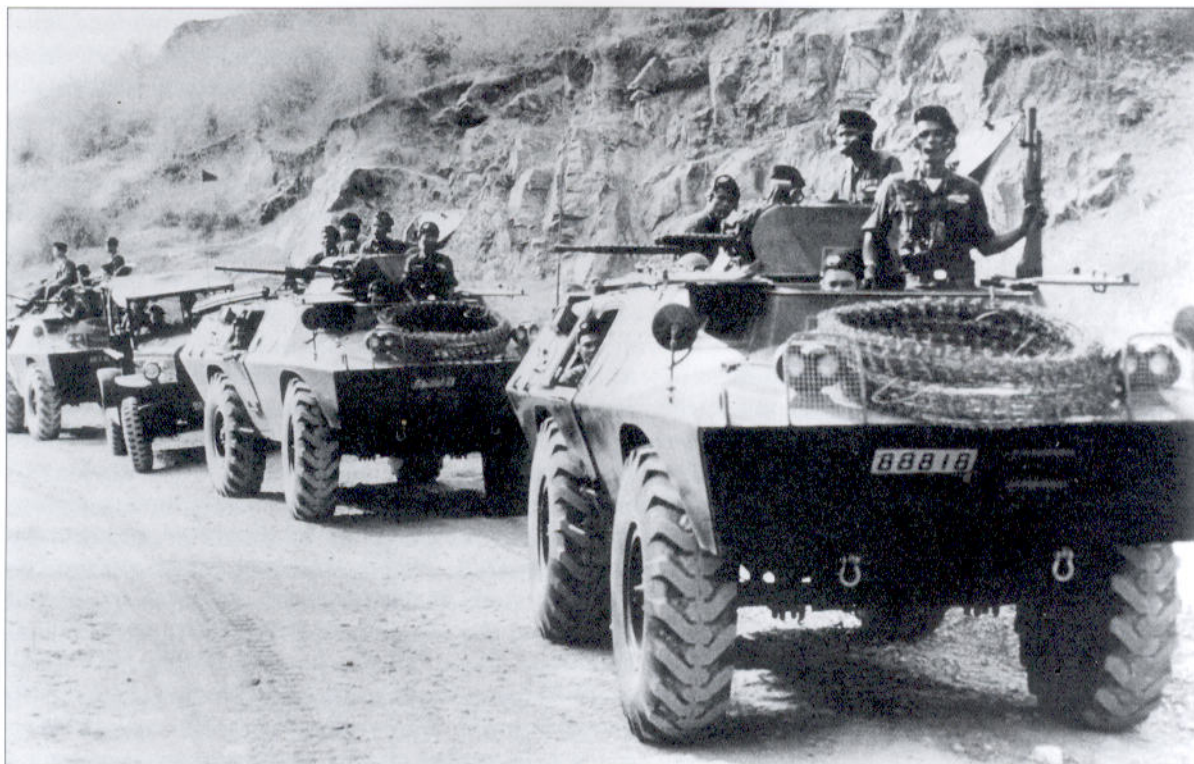
The XM706s began to arrive in South Vietnam shortly after yet another coup orchestrated by General Nguyen Cao Ky. These coups had caused the ARVN commanders to hold their new equipment and vehicles in reserve in the event of yet another coup, and this remained the situation until the South Vietnam elections of 1967.

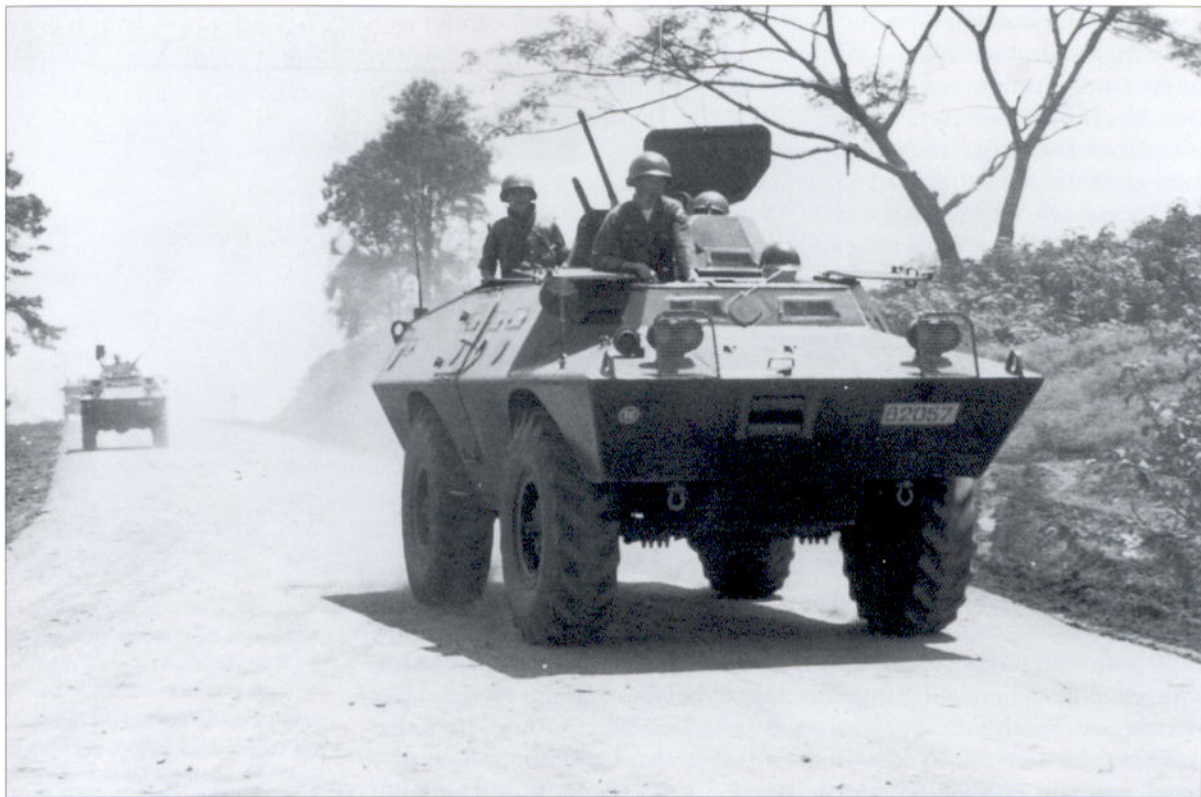
Two V-100s patrolling along a road. The yellow lettered "TC" within a red circle signifies that this is a V-100 belonging to an ARVN cavalry unit. These two V-100s are armed with a combination-mount, consisting of a .30 M37 or M1919A4 machine gun and a .50 M2 machine gun. (Copyright Cadillac Gage Textron Inc.)

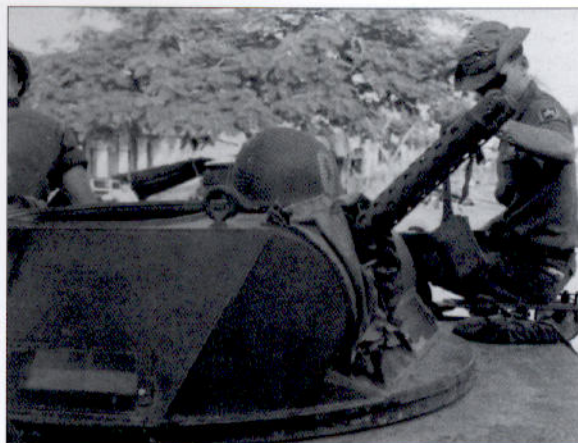
Detail of the twin M37 or M1919A4 .30-caliber machine guns mounted on the T-50 turret. This is a later turret, as the earlier models had a narrower vision block in the front to compensate for the width of the .30 M37/.50 M2 machine gun mount.

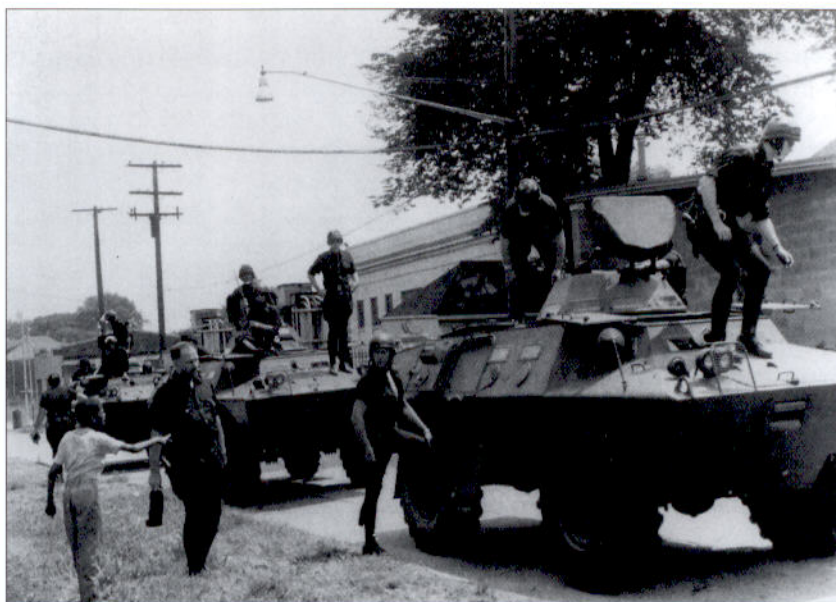
and 2nd tactical zones; and the 89th MP group, which controlled the MP units stationed in the south, the 3rd and 4th tactical zones. The purpose of the 18th Military Police Brigade was to create a better organization and to exercise control of the military police units in South Vietnam. Until the activation of the 18th Brigade, the independent military police units had been under the control of commanders of the four tactical zones in South Vietnam. At the height of the war, there were over 6,000 military policemen in Vietnam. The first large-scale operation of the 18th Brigade was providing convoy security and traffic control during Operation Deckhouse and Operation Attleboro in November 1966.

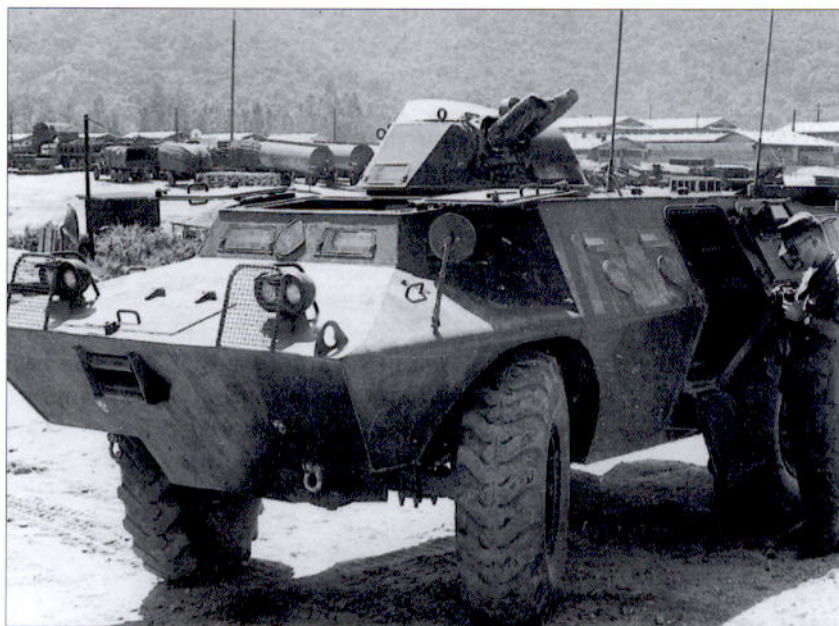
Military policemen of the 504th collect an early evaluation V-100 at a depot in Vietnam. Notice that 18th Military Police emblems have been painted on the front of the vehicle.

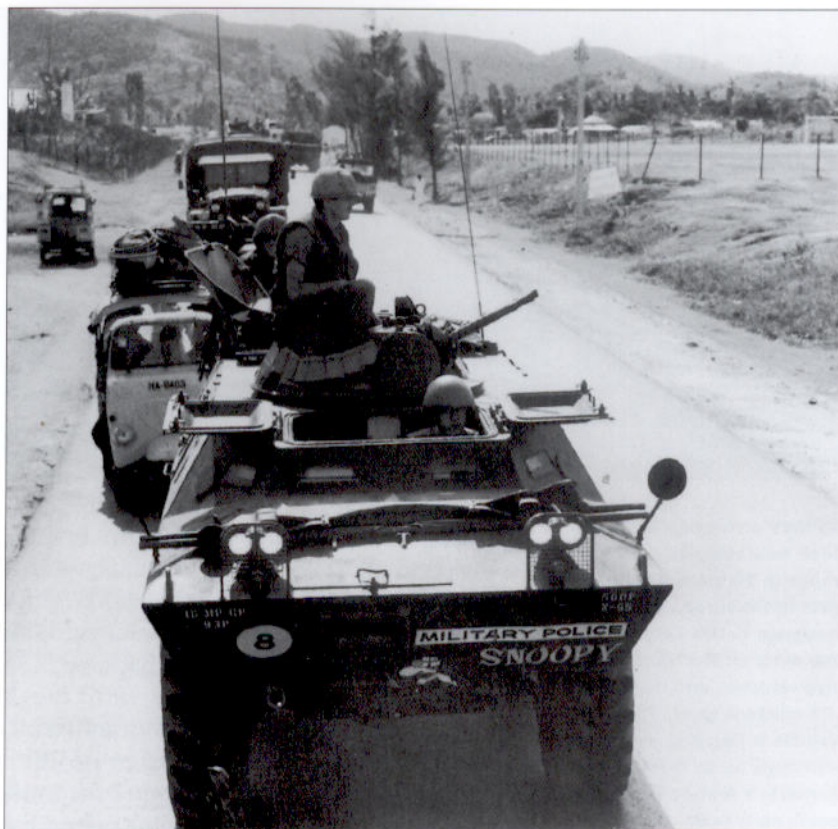
"Snoopy", a V-100 of the 560th MPs maintains watch while escorting a convoy. This is a later production V-100, a fact evidenced by the raised hatches. The gunner has attached a bandolier of M16 magazines around the exterior of the vehicle. Artwork of Snoopy flying his trademark doghouse in an MP's helmet is clearly visible. Notice that the crew are each wearing a different helmet. The driver wears a combat vehicle crewman's helmet, the gunner the standard US Army helmet with cover, and the rear radio operator wears a helicopter pilot's helmet. The helicopter helmet was popular with crews as it combined the helmet, headset, and microphone into one unit, along with a visor to protect the eyes.

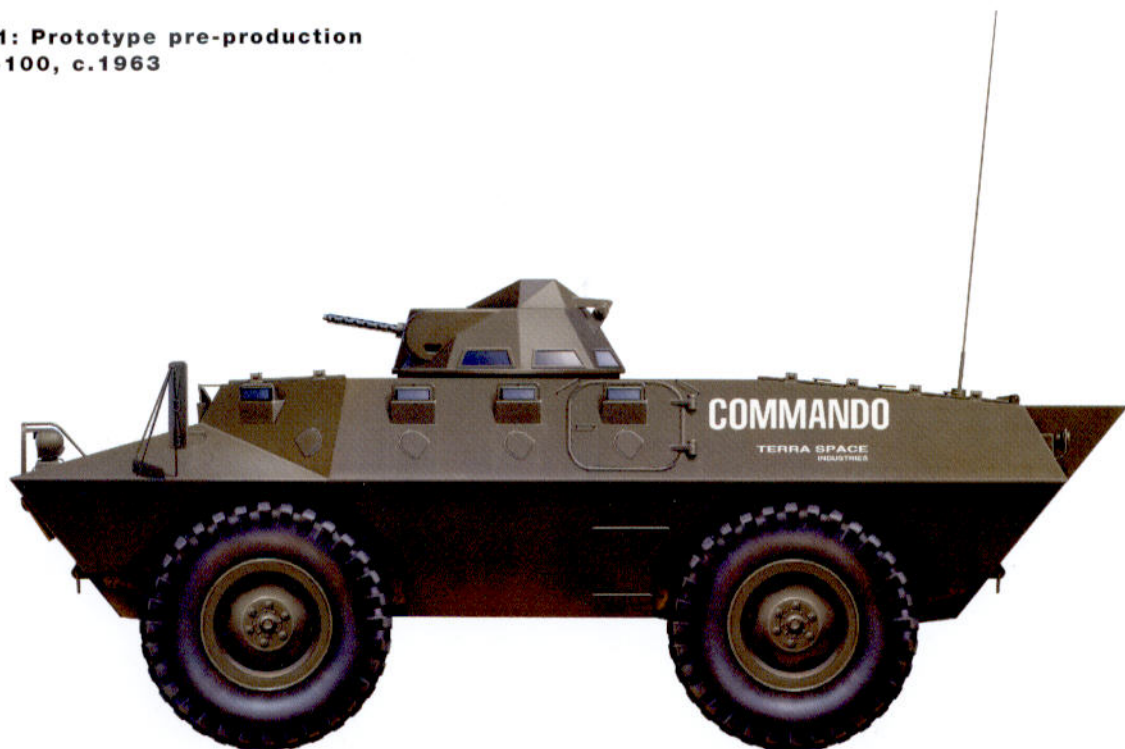
**A2: Early-production V-100
(XM706), c.1966**

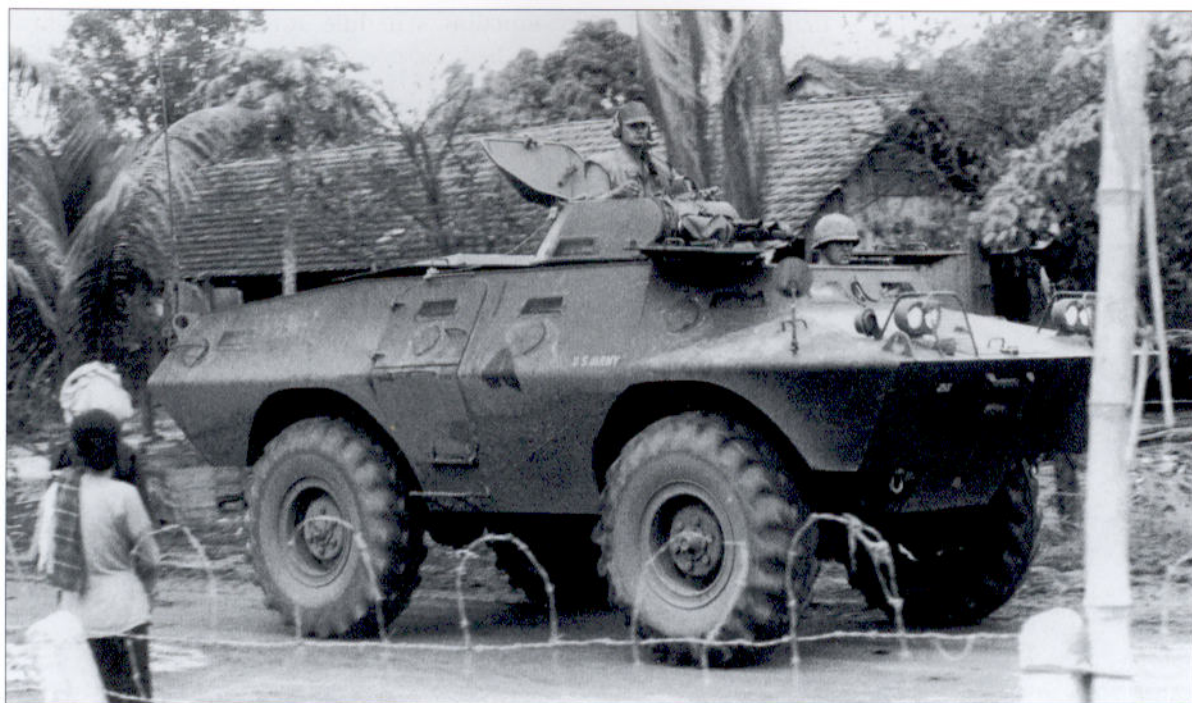
In a complete reversal of their 1966 evaluation of the V-100, the 716th MP Battalion could not overemphasize the importance of the V-100 in an urban combat situation. The 716th now felt that the V-100 offered ideal shape, size, and maneuverability in builtup areas. Additionally, it offered the deterrent capacity of other armored vehicles without destroying the streets as tracked vehicles did. The only recommendation that the 716th MP Battalion made was for a heavier weapon, possibly either twin .50-caliber machine guns or twin 20mm cannons, which was yet another carryover from earlier USARV reports from the ARVN.

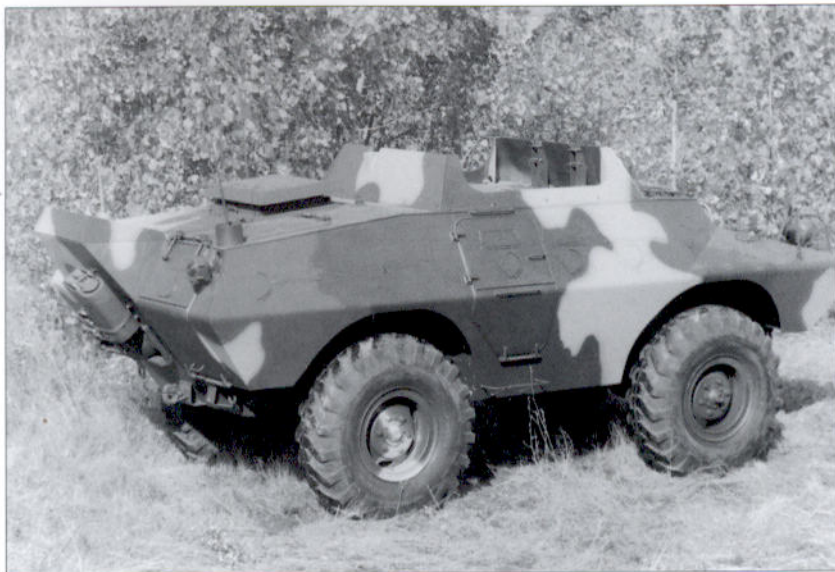
A freshly painted US Air Force V-100 illustrated against a woodland backdrop. USAF V-100s served as a mobile strongpoint and arms carrier for responding to intrusions and enemy attacks on air bases in Vietnam and Thailand. (Copyright Cadillac Gage Textron Inc.)

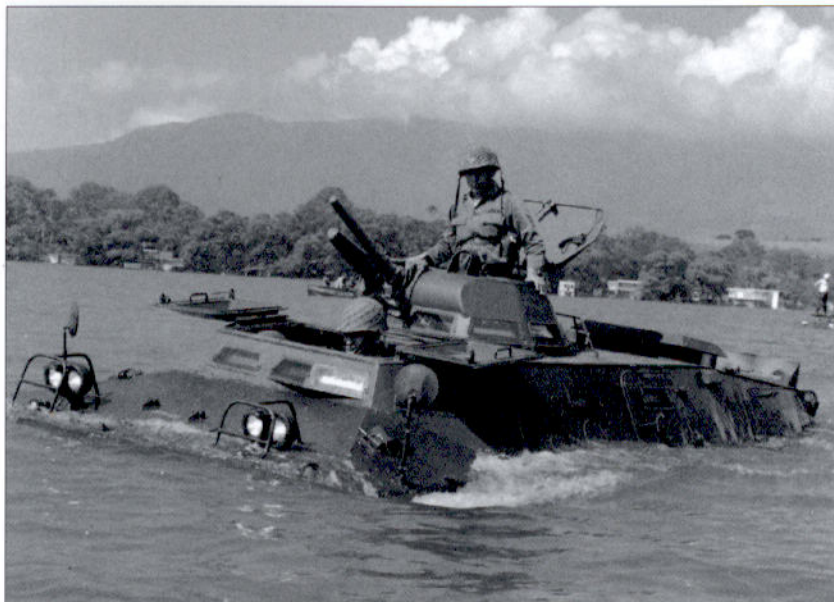
V-100 crews undergoing amphibious training in Lake Atmalan, Guatemala.

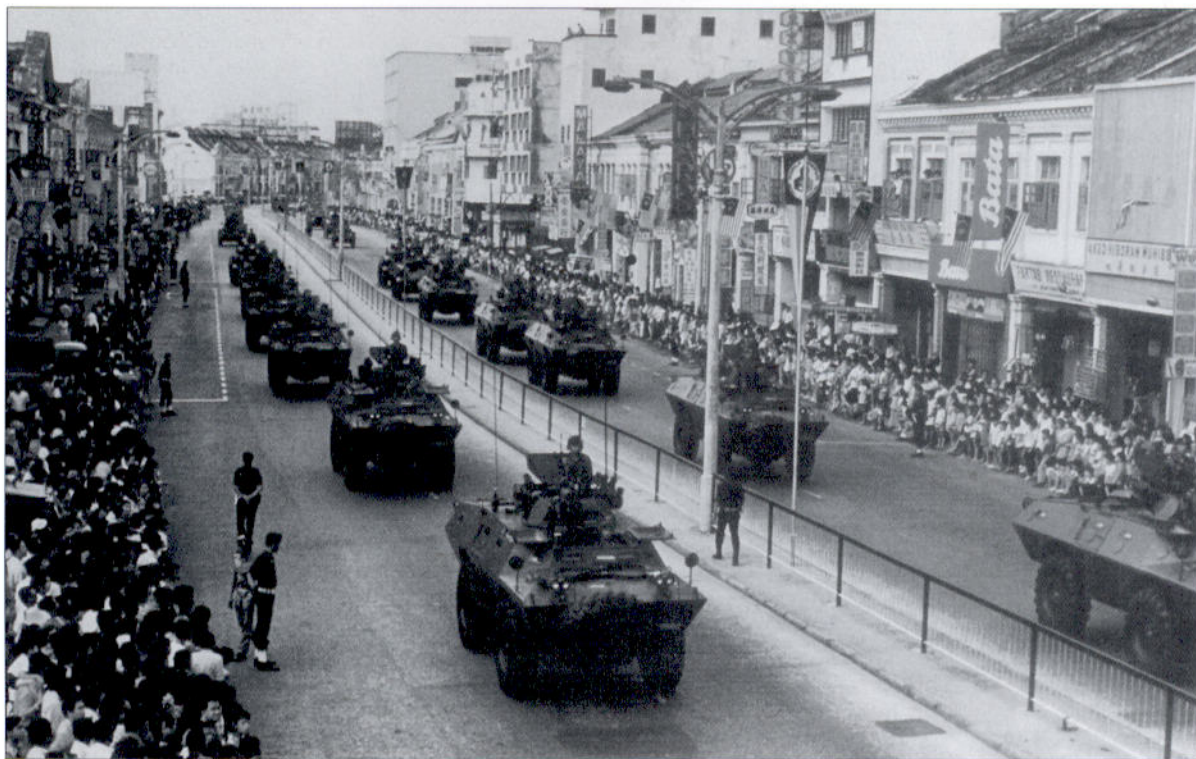
COLOR PLATE COMMENTARY

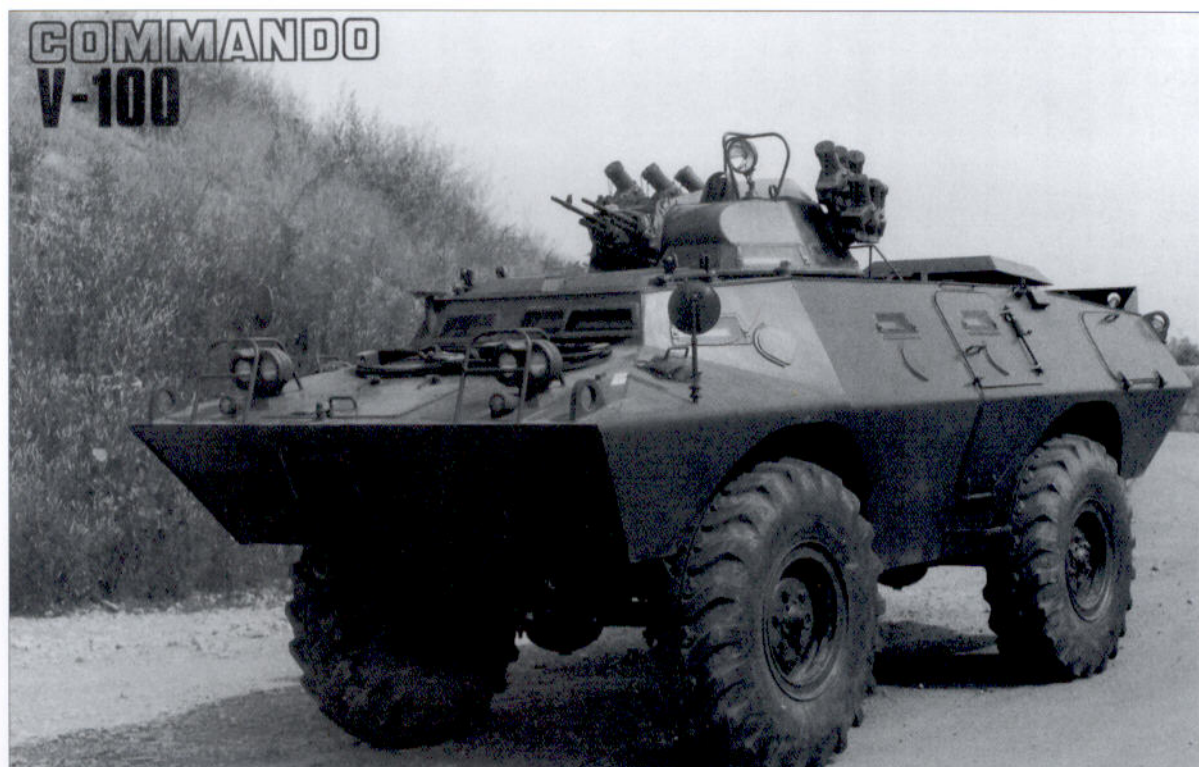
C2: MID-PRODUCTION V-100 WITH GRENADE LAUNCHER TURRET (XM706E1)
