# German Battleships 1939–45

Gordon Williamson • Illustrated by Ian Palmer

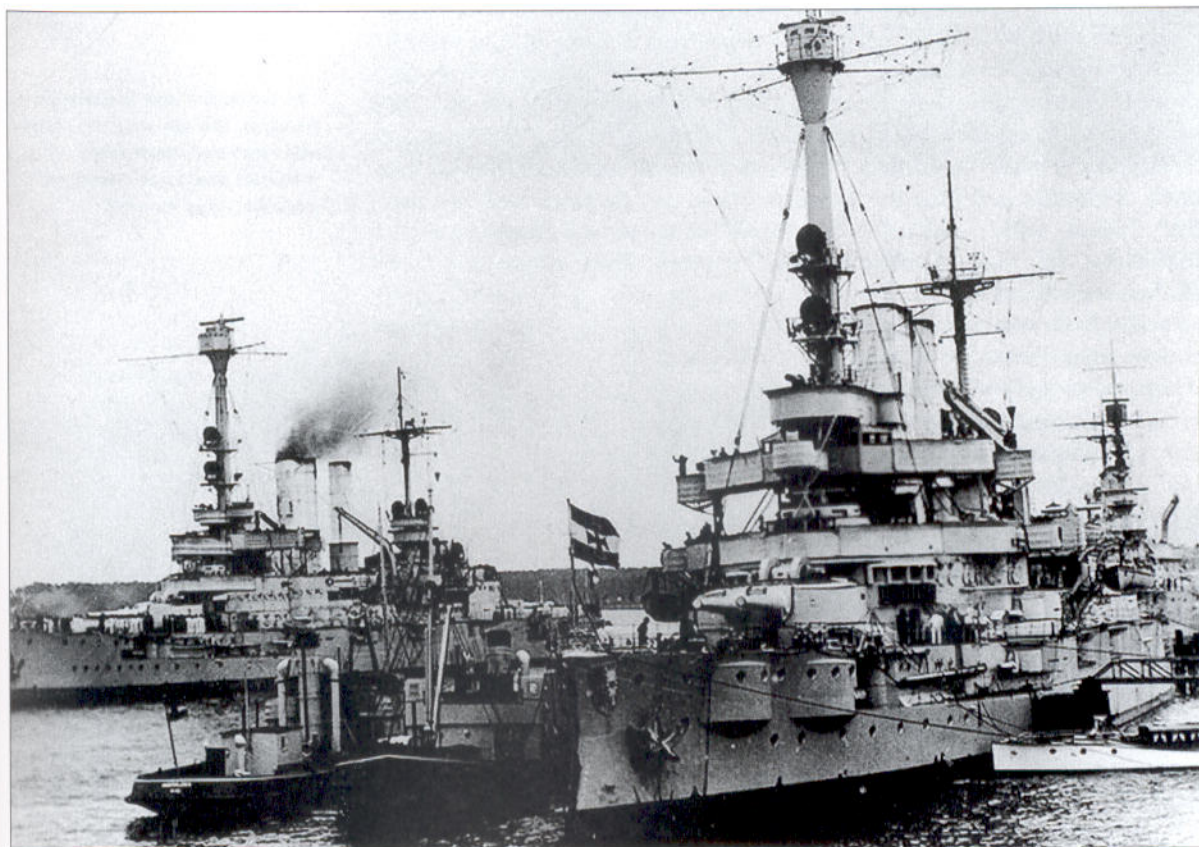
The two dreadnoughts *Schlesien* (left) and *Schleswig-Holstein* (right) in their post-refit form, with the forward funnel removed. This pre-1935 photograph shows the old flag of the Reichsmarine being flown on the bow flagstaff.

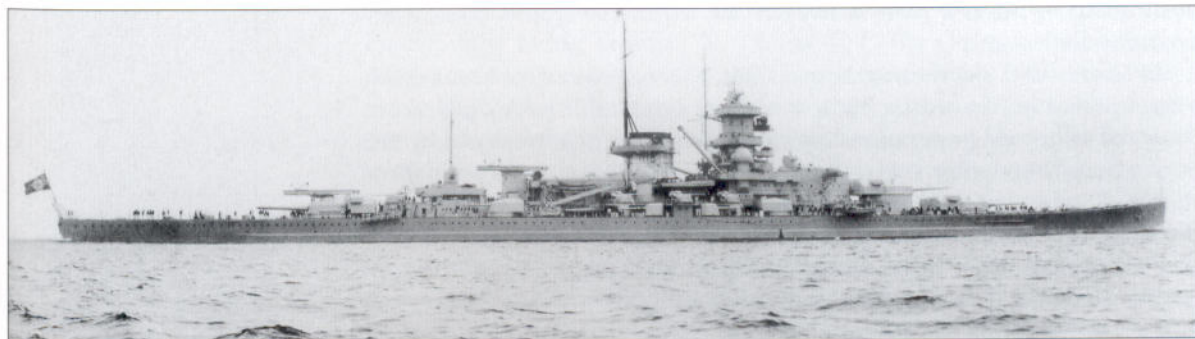
An excellent broadside study of *Scharnhorst* as originally completed. At this point she was almost identical to *Gneisenau*.

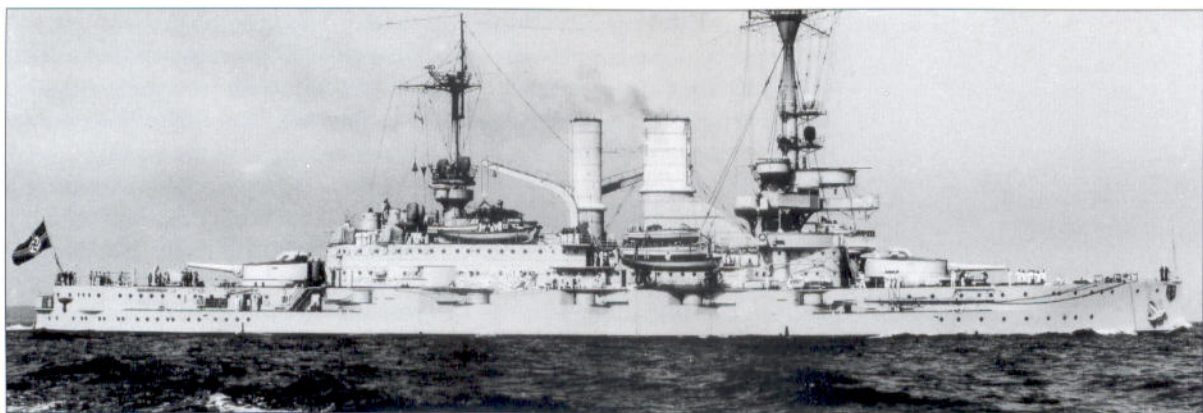
*Schleswig-Holstein* after her refit. Note the new *Reichskriegsflagge* being flown in this post-1935 photograph. Note also the large bronze eagle and swastika mounted on her hullside near the stern.

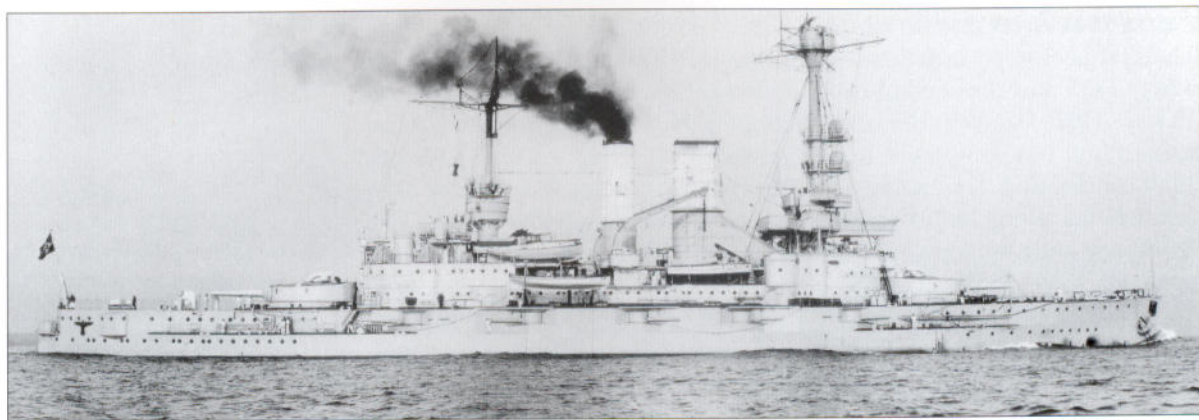
**Schlesien**, post-refit. The two sisters were virtually identical by this point.

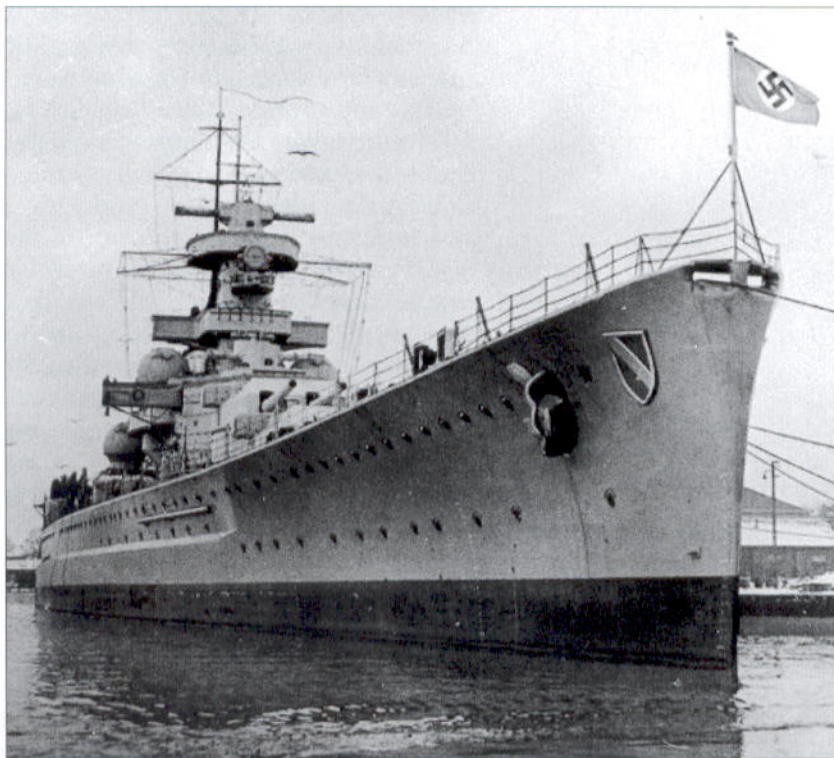
A bow view of the *Scharnhorst* in her initial form with straight stem. The 'mattress' radar antenna for the FuMO system has not yet been fitted to the rangefinder on her foretop. During her refit, the anchors were also moved from the hullside ports to clunes on the edge of the deck.

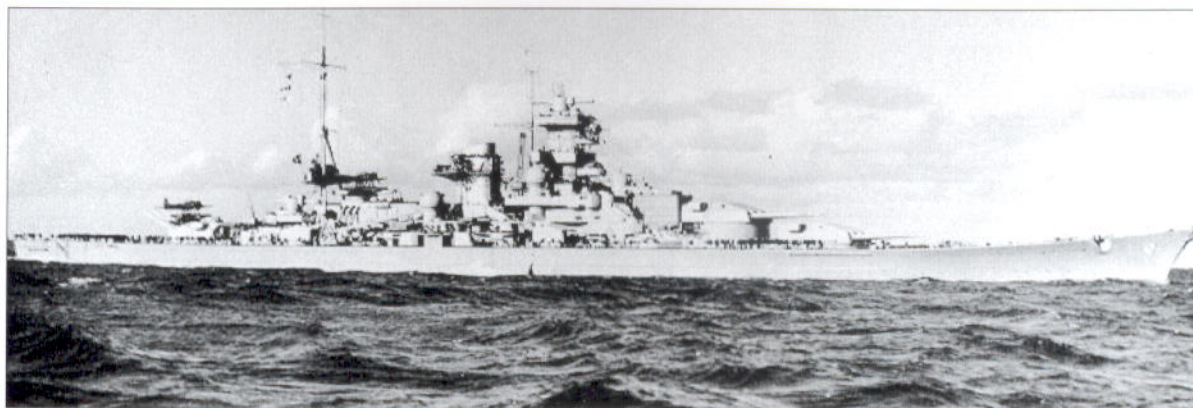
**Scharnhorst** in post-refit form with 'Atlantic' bow and angled funnel cap, but still retaining the second aircraft catapult on turret 'Caesar'. Although very similar to *Gneisenau*, her identity is immediately established by the siting of the mainmast, which on *Gneisenau* remained sited to the rear of the funnel.

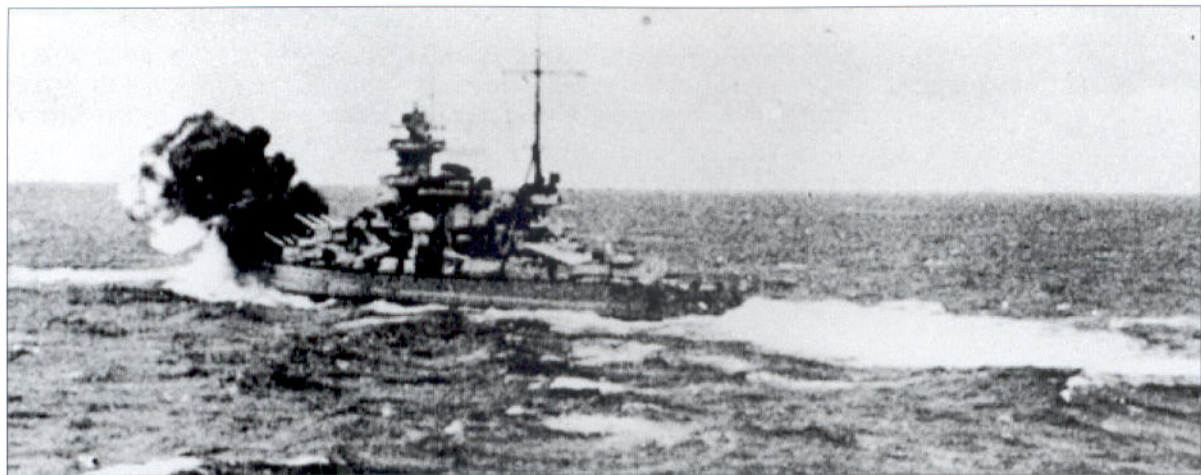
**Scharnhorst at sea during the engagement with *Rawalpindi*. She has just fired a salvo from her forward main armament.**

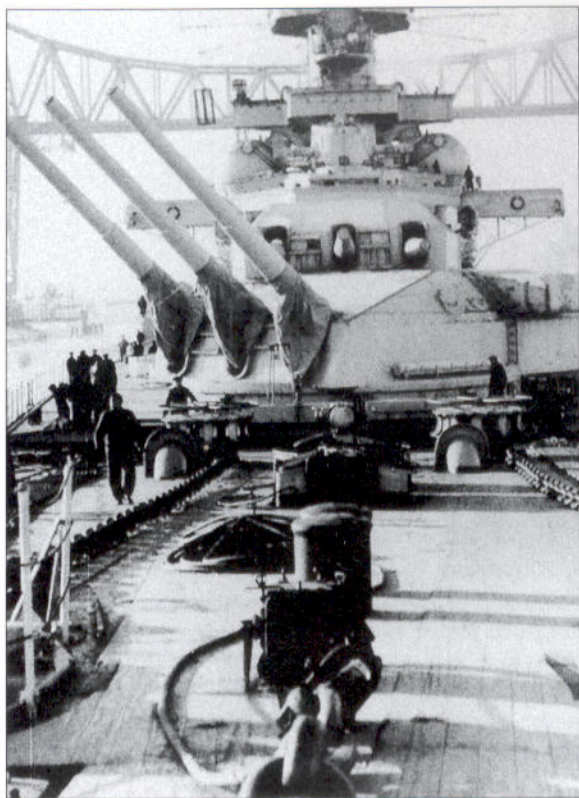
The view towards the forward turrets 'Anton' and 'Bruno' from the bow of *Scharnhorst*, gives a good impression of the huge size of her main armament. Note that the canvas blast bags are fitted on the gun barrels of turret 'Anton' only. This shot also gives a good view of the large searchlight mounted on the face of her tower just above the bridge.

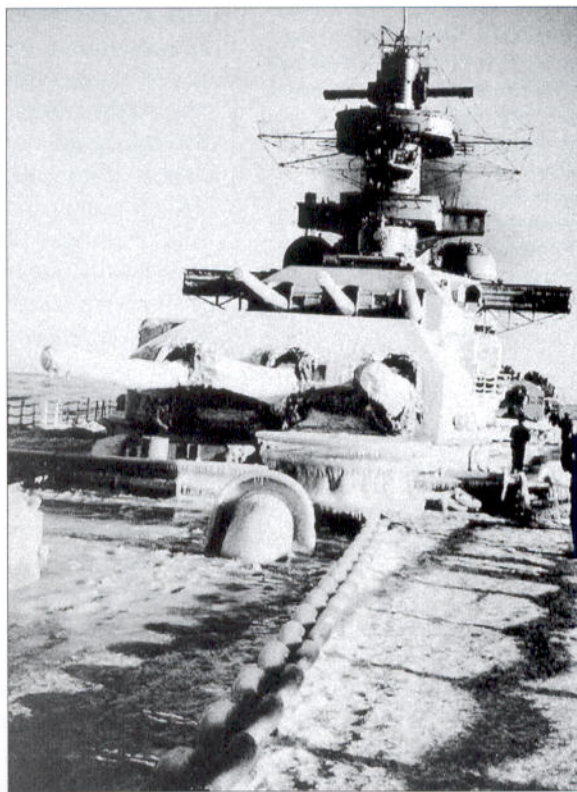
A further view from the bow of *Scharnhorst* shows just how heavily iced this area became during severe winter weather, a problem exacerbated by her tendency to ship vast amounts of water over the fo'c'sle in heavy seas.

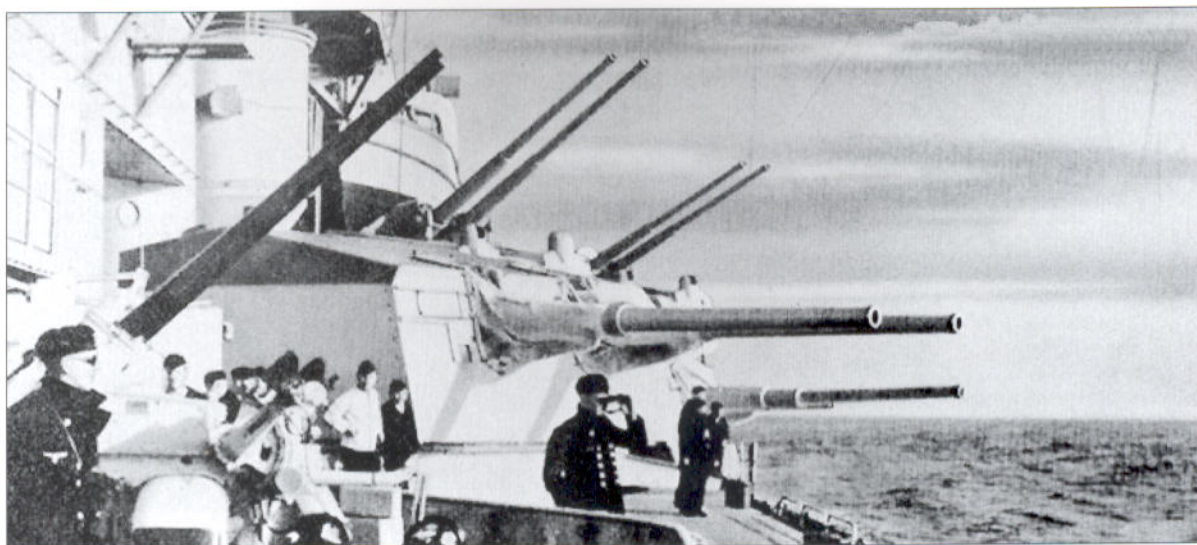
An excellent view of one of *Scharnhorst's* secondary turrets, mounting 15cm guns. The guns shown at high elevation behind this turret are those of her main 10.5cm flak batteries. One of the ship's boats can be seen just above these flak guns.

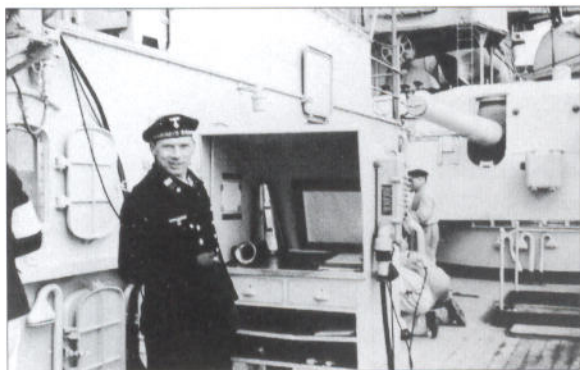
Another detail view taken on *Scharnhorst's* starboard side main deck looking forward towards one of her secondary armament turrets.

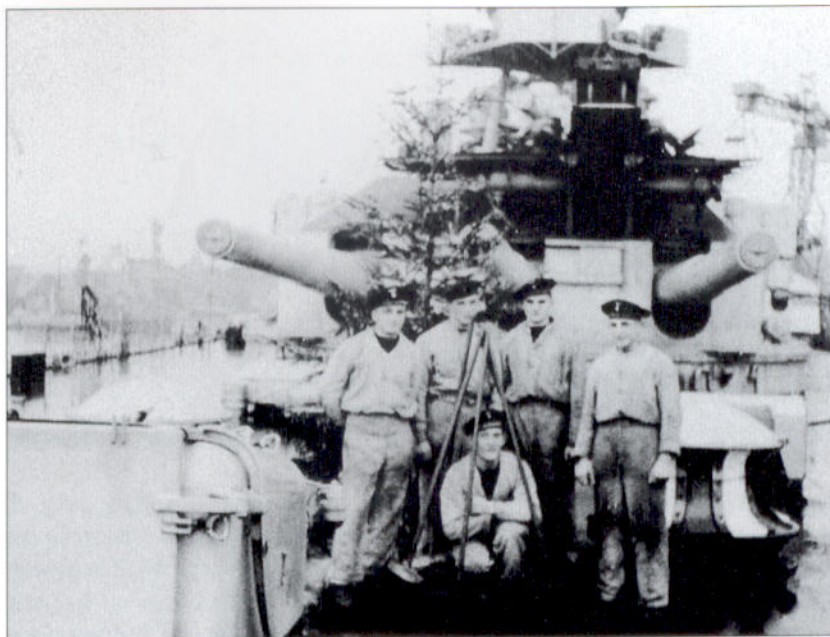
Crewmen in working rig pose for a photograph on *Scharnhorst's* quarterdeck. The catapult on turret 'Caesar' can just be discerned, as can the darker red-coloured paint on the turret roof. Given the tree visible behind these crewmen, it is assumed that this photo was taken around Christmas time.

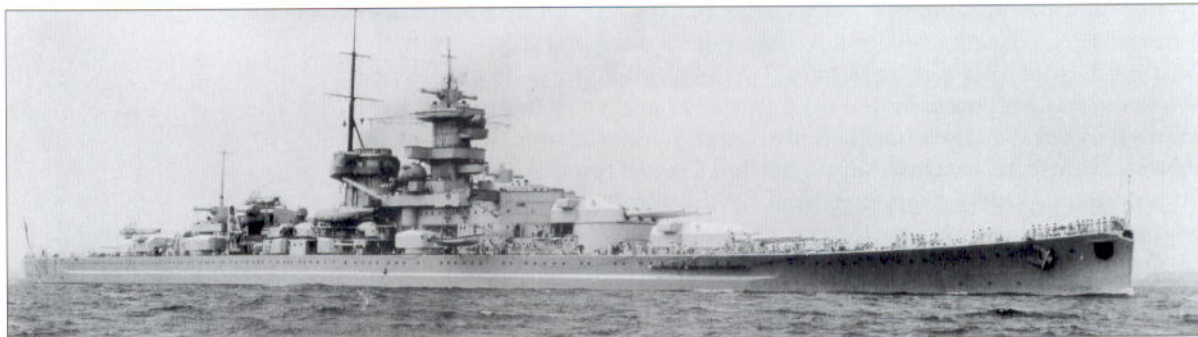
With several of her crew members in their summer whites on the fo'c'sle, *Gneisenau* ploughs through the calm waters of the Baltic.

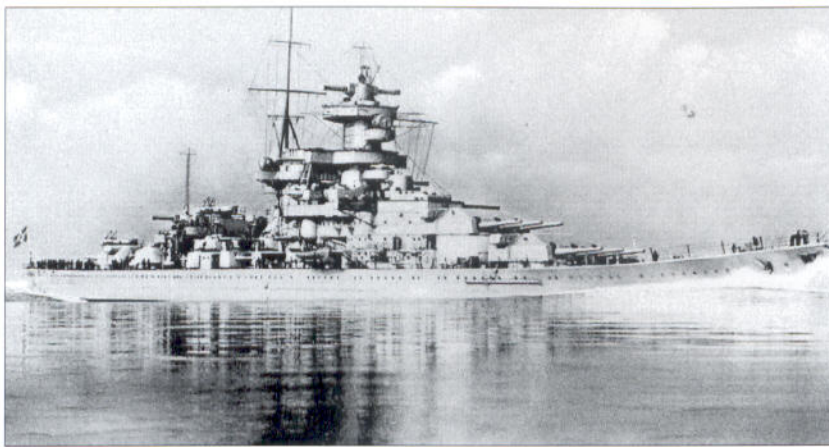
*Gneisenau* is seen here in her initial form, with straight stem and with the catapult still fitted over turret 'Caesar'. Given the flat calm seas and the sizeable bow wave (compared to the previous photograph), it seems likely that this shows her at high speed during her trials.

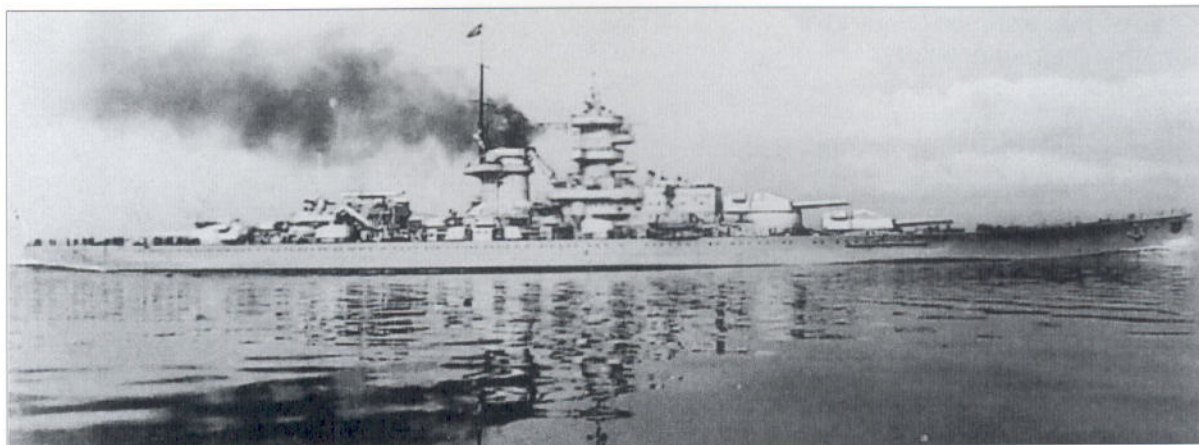
**Gneisenau** as depicted on a period propaganda photograph. This shows her graceful lines to good advantage.

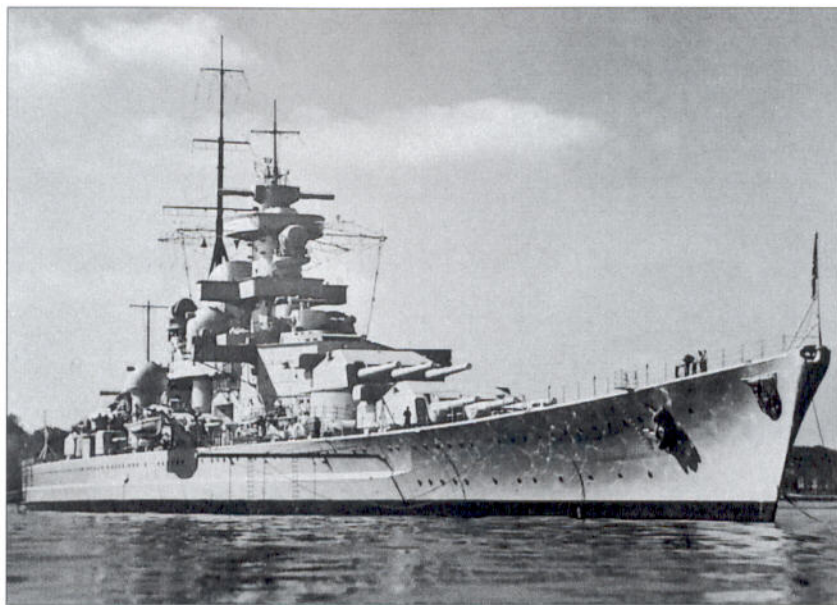
This view shows *Gneisenau* after her refit, now sporting the raked 'Atlantic' bow, which did little to cure her tendency to ship considerable amounts of water over her fo'c'sle at speed or in heavy seas. The angled funnel cap can just be seen by the base of her mainmast. That this is a pre-war photograph is confirmed by the presence of the ship's crest on the bow. It was removed on the outbreak of war.

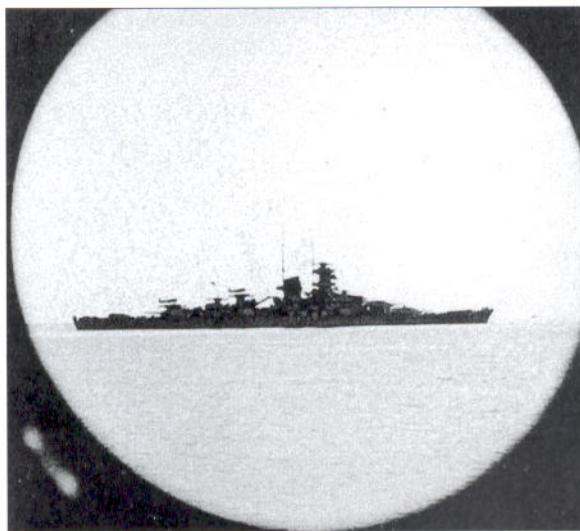
*Gneisenau*, framed by one of the portholes on her sister, the *Scharnhorst*. Though this shows her in post-refit form, she still sports the catapult on turret 'Caesar'. The tiny silhouettes of her Arado 196 seaplanes can be clearly seen.

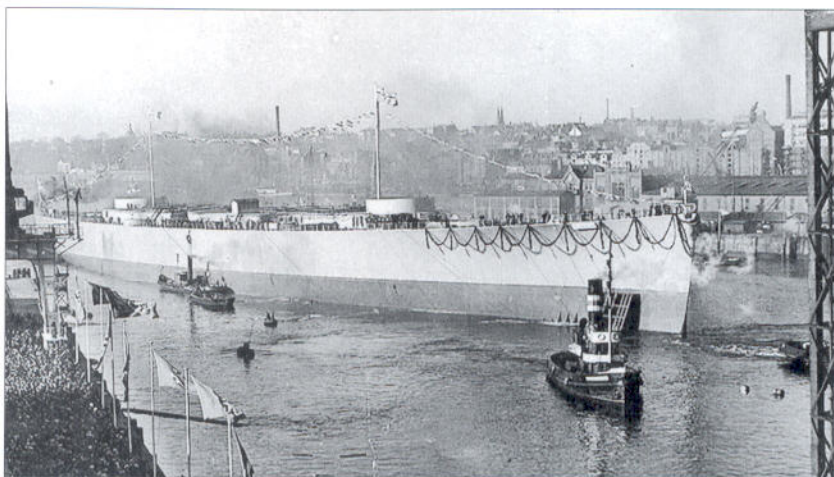
*Bismarck's* hull slides onto the waters at the Blohm & Voss yard in Hamburg on 14 February 1939. She has the original straight stem that was replaced by an 'Atlantic' bow during her fitting out. Only the first level of superstructure has been completed along with the raised barbettes for turrets 'Bruno' and 'Caesar'.

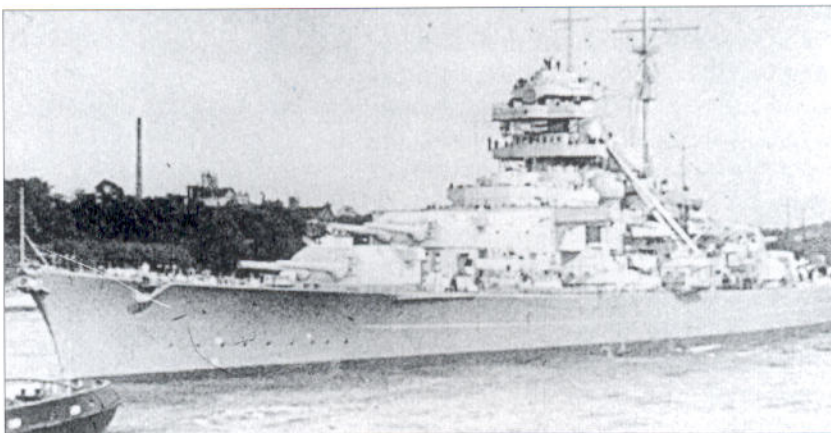
The *Bismarck* shortly after her completion and commissioning, immaculate in her fresh light grey paintwork. Note that the main fire control rangefinder on her foretop has not yet been fitted.

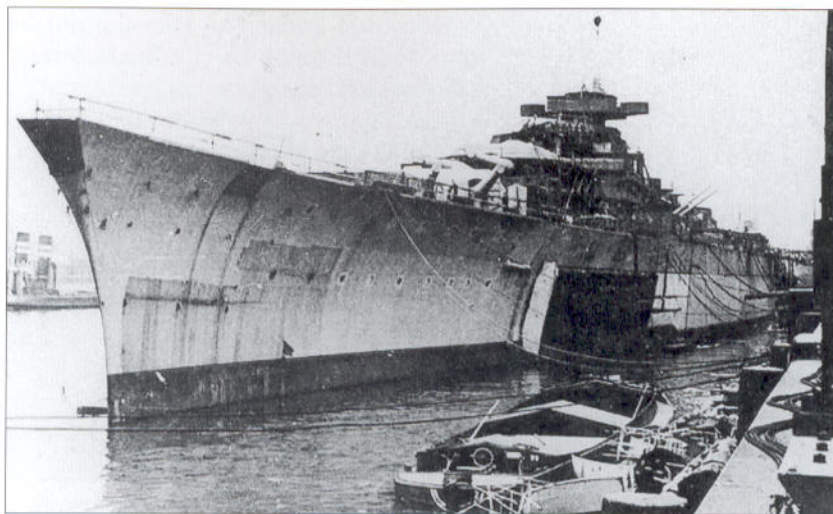
***Bismarck* during fitting out. The straight stem originally fitted has already been replaced by the 'Atlantic' bow.**

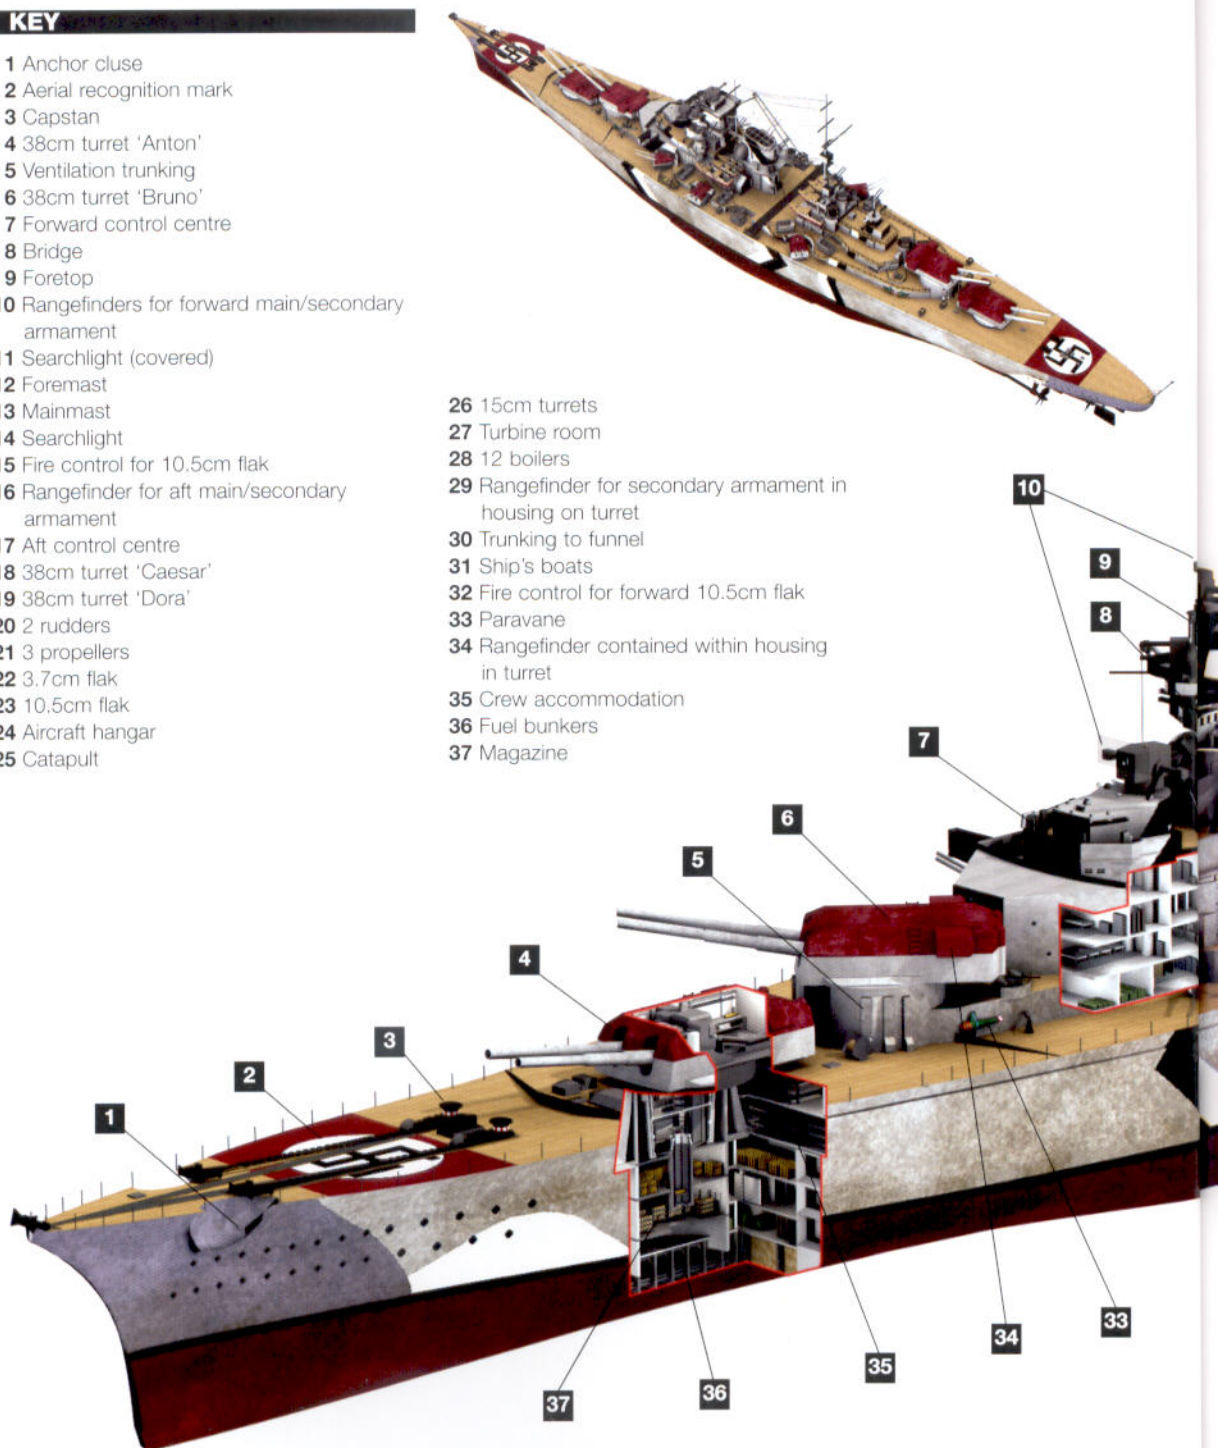
# D: CUTAWAY VIEW - *BISMARCK*-CLASS BATTLESHIP

- 1 Anchor cluse
- 2 Aerial recognition mark
- 3 Capstan
- 4 38cm turret 'Anton'
- 5 Ventilation trunking
- 6 38cm turret 'Bruno'
- 7 Forward control centre
- 8 Bridge
- 9 Foretop
- 10 Rangefinders for forward main/secondary armament
- 11 Searchlight (covered)
- 12 Foremast
- 13 Mainmast
- 14 Searchlight
- 15 Fire control for 10.5cm flak
- 16 Rangefinder for aft main/secondary armament
- 17 Aft control centre
- 18 38cm turret 'Caesar'
- 19 38cm turret 'Dora'
- 20 2 rudders
- 21 3 propellers
- 22 3.7cm flak
- 23 10.5cm flak
- 24 Aircraft hangar
- 25 Catapult
- 26 15cm turrets
- 27 Turbine room
- 28 12 boilers
- 29 Rangefinder for secondary armament in housing on turret
- 30 Trunking to funnel
- 31 Ship's boats
- 32 Fire control for forward 10.5cm flak
- 33 Paravane
- 34 Rangefinder contained within housing in turret
- 35 Crew accommodation
- 36 Fuel bunkers
- 37 Magazine

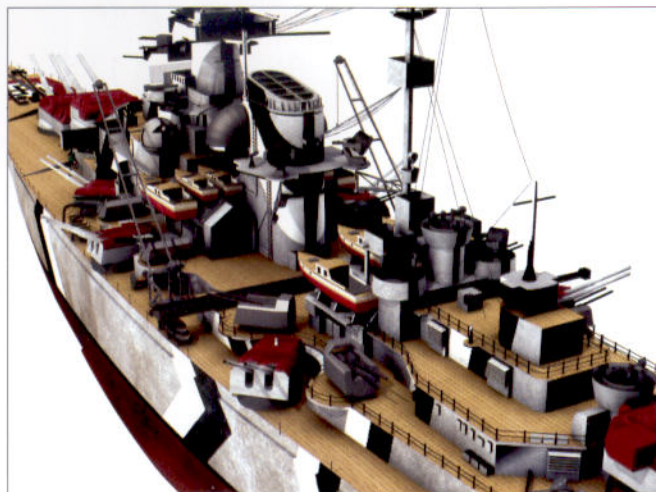
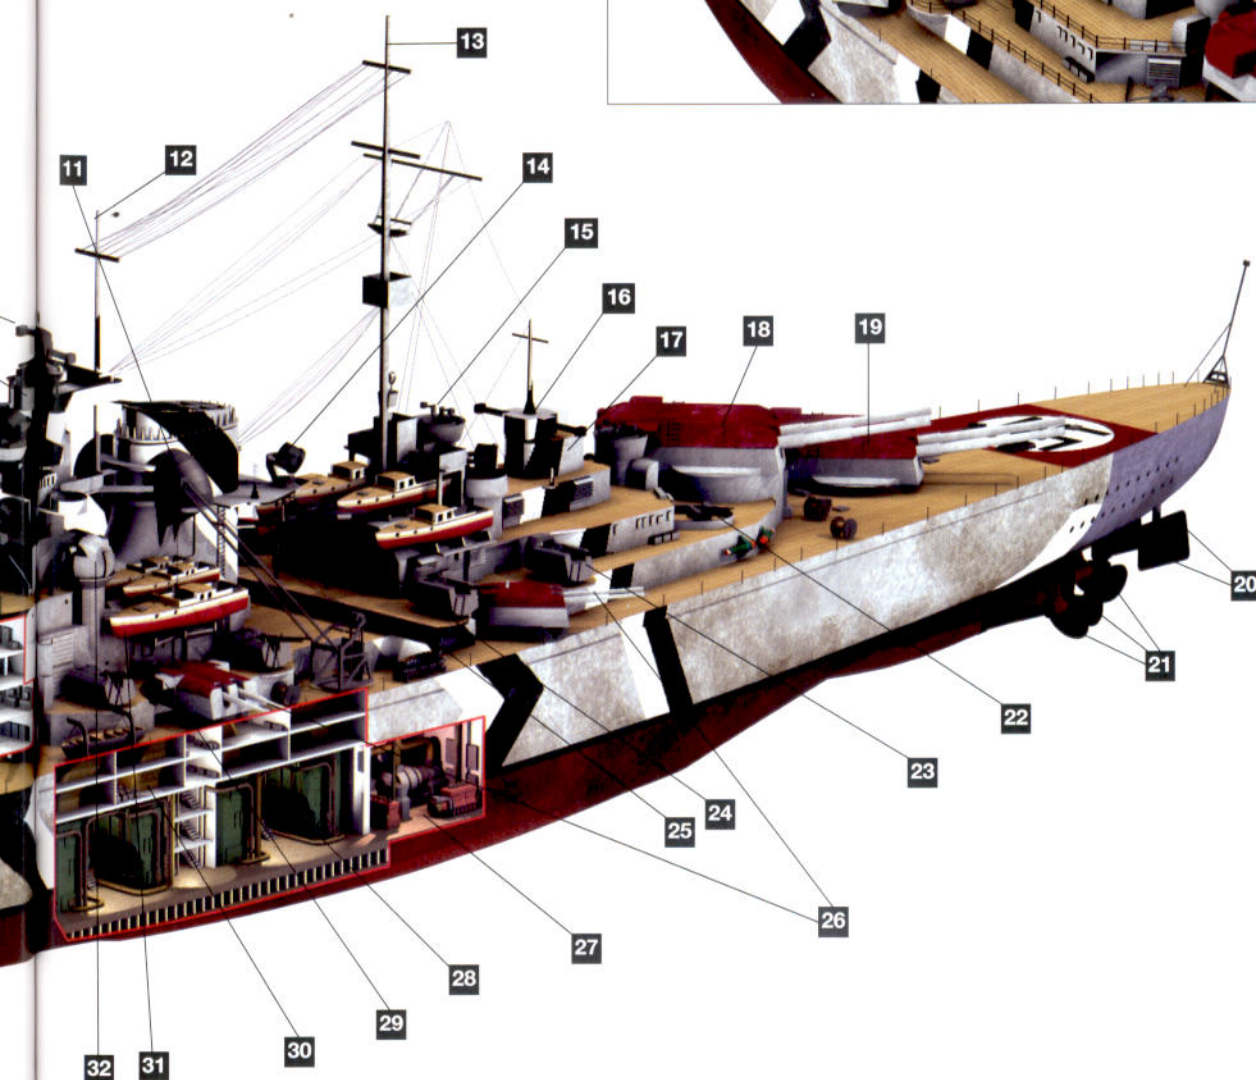
16 x 3.7cm flak guns

20 x 2cm flak guns

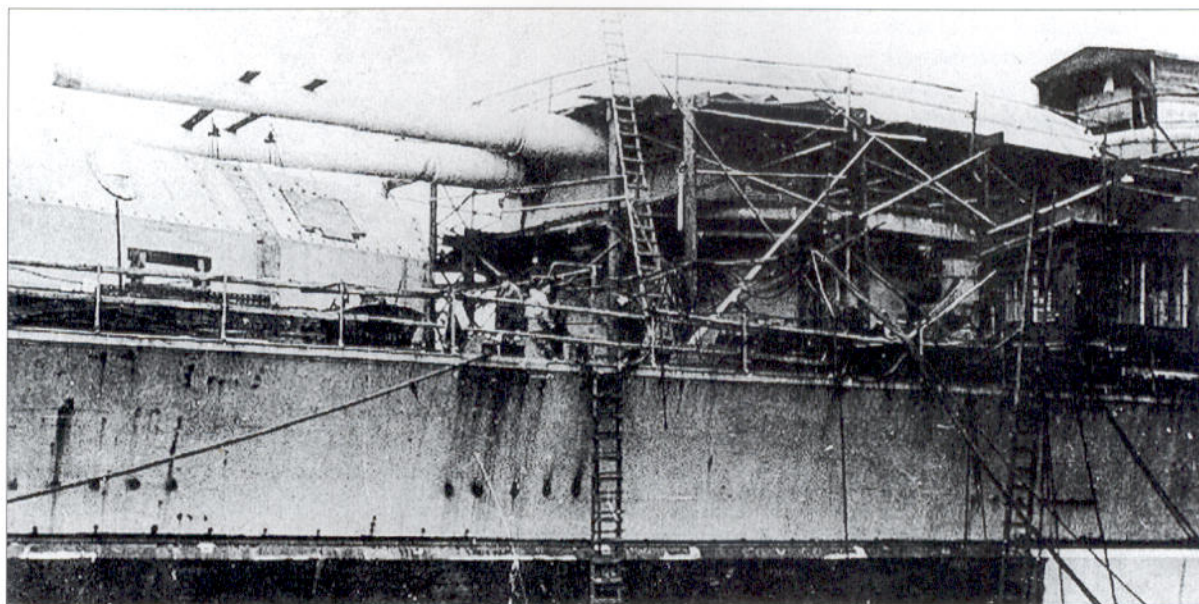
Construction of the main 38cm gun turret 'Bruno' during fitting out. The guns are in place and work is ongoing in building the armoured turret around them. The plethora of scaffolding and ladders is typical of a ship under construction.

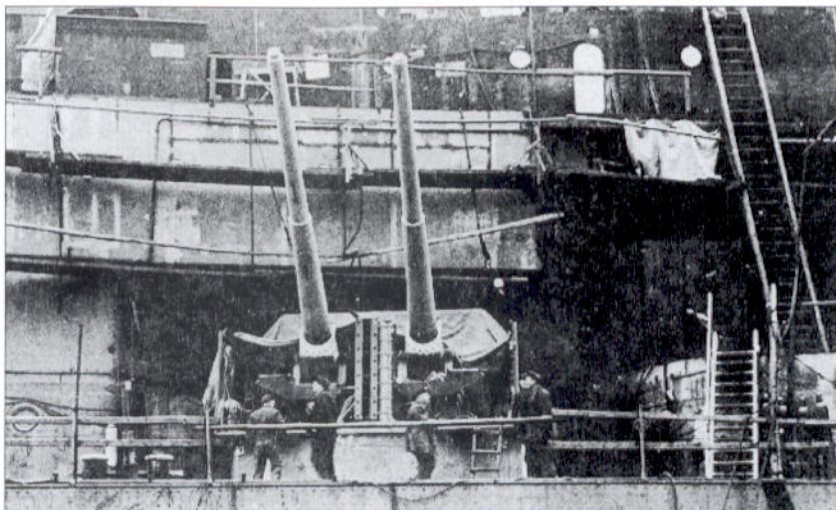
Construction of one of *Bismarck's* 10.5cm twin heavy flak guns. Note how the barrels are first installed on the base mount, and then the turret housing built around them.

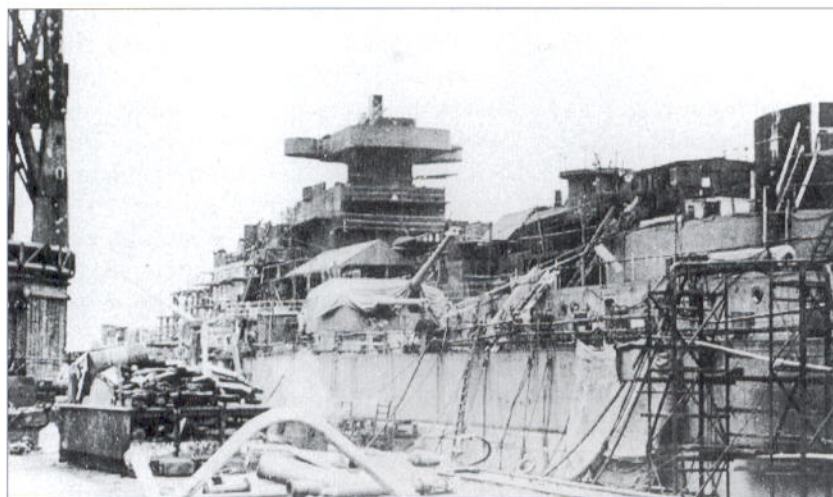
Bearing little resemblance to the sleek, graceful ship she would soon become, *Bismarck* is covered with clutter and liberally draped with electrical cabling to power the workers' tools and provide lighting to the ship's interior. The roofed structure just visible above the secondary turret is the port hangar for the ship's Arado 196 floatplanes.

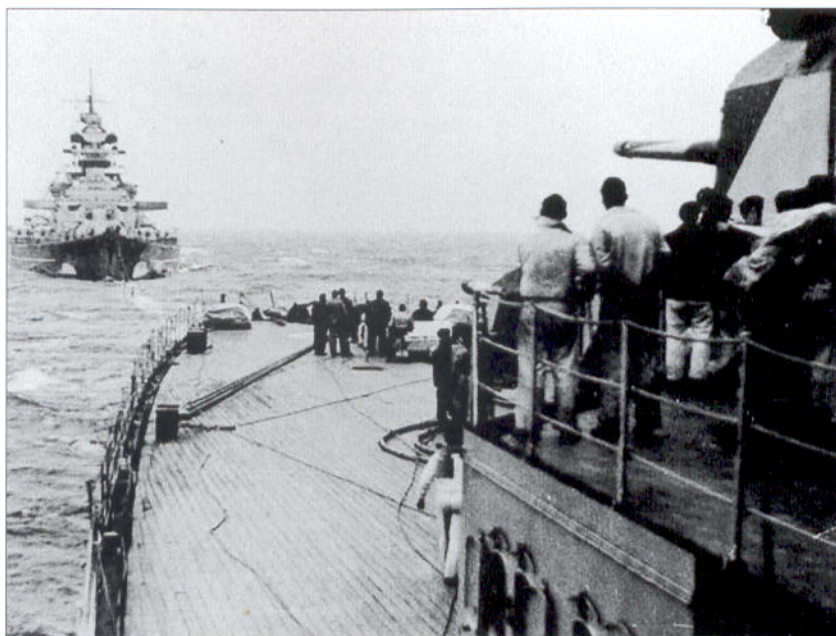
*Bismarck* carrying out refuelling from *Prinz Eugen* during training exercises. The massive beam of this huge warship can be seen to good effect here. The dark grey forward part of the hull and false bow waves can also be seen clearly.

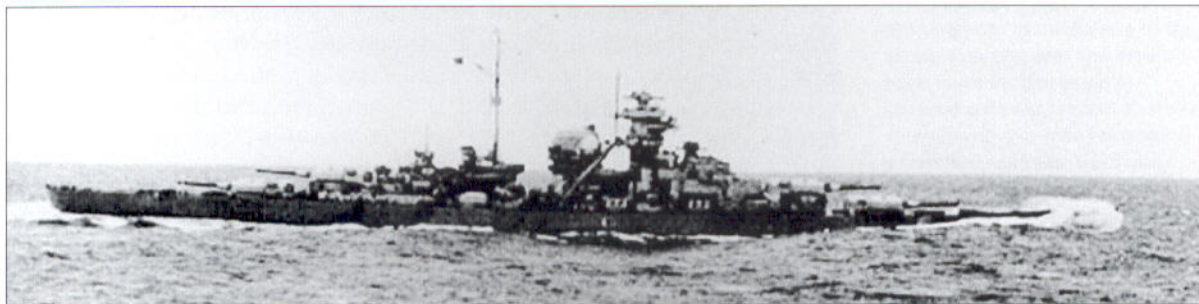
One of the last photographs taken of *Bismarck*. Shot from *Prinz Eugen*, she can be seen to be down by the bows having shipped a considerable amount of water through the hole caused by a direct hit from *Prince of Wales*.

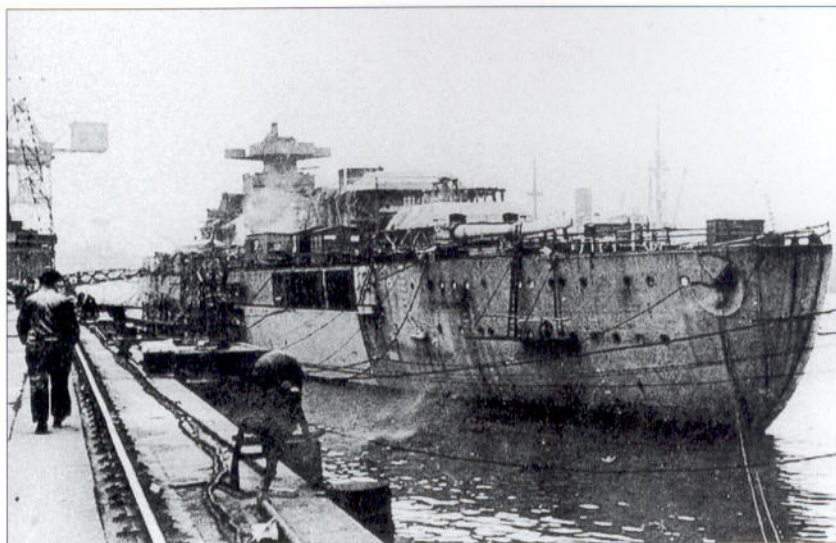
The massive turret 'Dora' can be seen in this stern view of *Bismarck* during her fitting out.

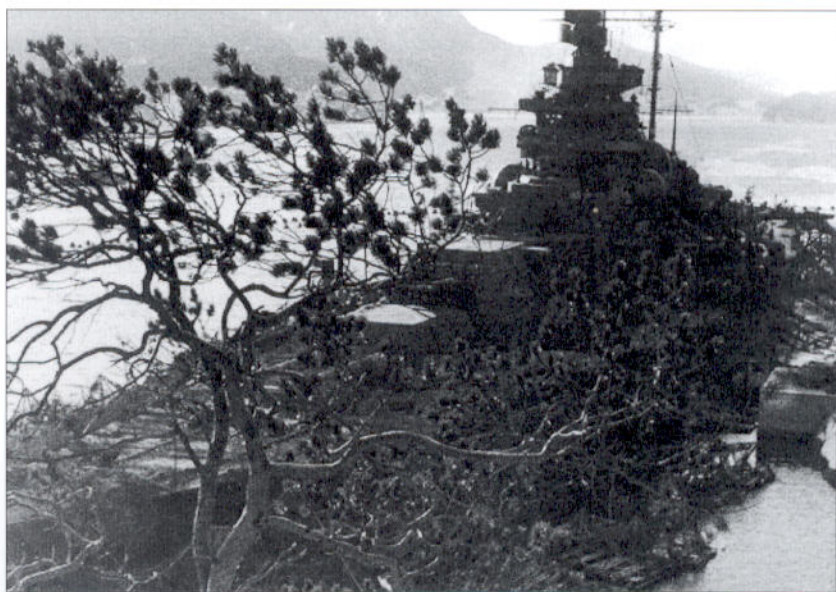
This atmospheric shot shows *Tirpitz* at her anchorage. Note the light/dark grey splinter-pattern disruptive camouflage. This was one of several paint schemes sported by *Tirpitz* during her service career. Additional quad 2cm anti-aircraft guns have been fitted to the roof of turret 'Bruno' and the forward part of her main superstructure, and the ship is surrounded by anti-torpedo netting.

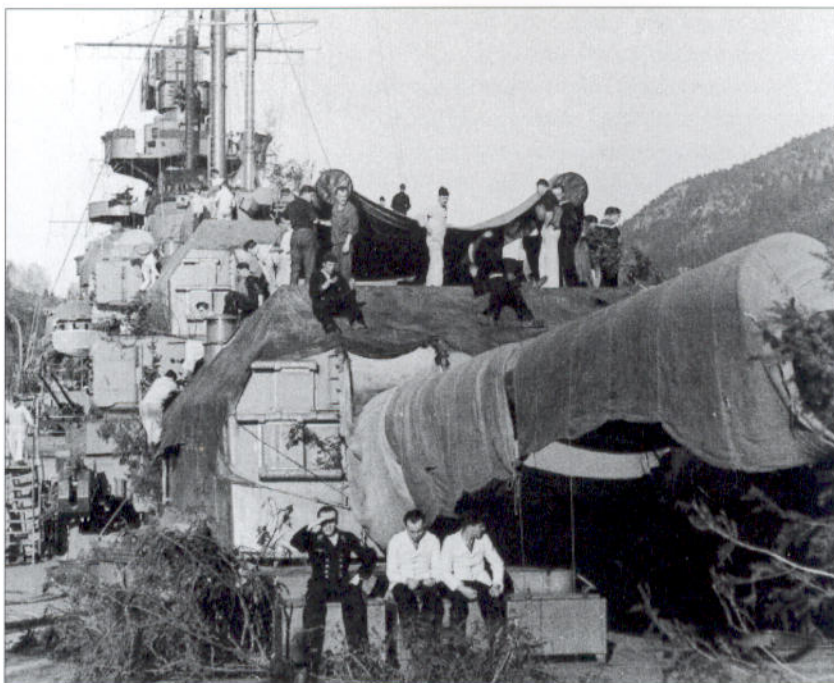
Both *Bismarck* and *Tirpitz* began their careers with the typical pale grey colour scheme of the early war period. During their training and trials, both used the so-called 'Baltic' scheme of bold black/white angular stripes across the hull and superstructure and with darkened forward and stern hull portions intended to give the impression of a shorter hull length, emphasised by the addition of false bow and stern waves. The

turret roofs of the main armament and principal secondary armament were painted red during this period.

*Bismarck* had her camouflage scheme painted out before departing on the fateful Operation *Rheinübung*. *Tirpitz* went on to sport a number of camouflage schemes. From summer 1942 to spring 1944 she featured variants of a dark grey splinter scheme over her basic paler grey surfaces. Thereafter her hull, 'Anton' and 'Dora' turrets and lower superstructure were finished in dark grey with the remainder in paler grey.

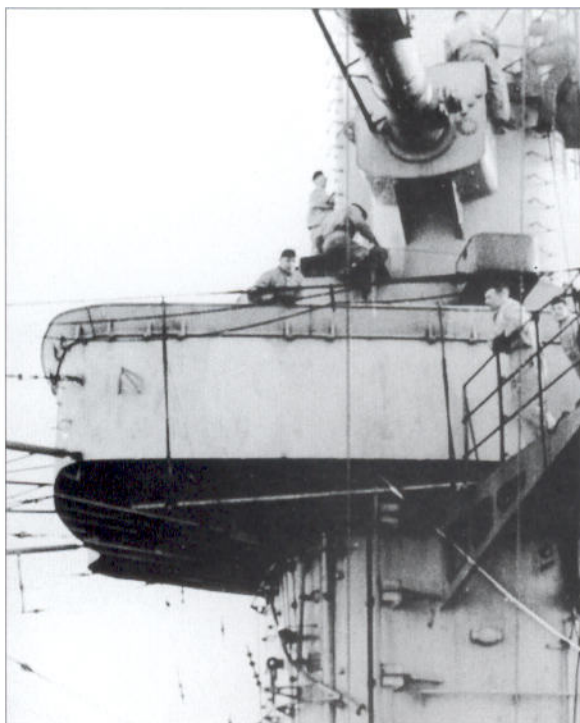
A view from astern, looking up towards *Scharnhorst's* foretop with the principal rangefinder for controlling the main armament.

Each of the main armament turrets in the *Scharnhorst*- and *Bismarck*-class battleships, with the exception of turret 'Anton' in the *Bismarck*, was provided with 10.5m rangefinders. The viewing ports for these are within the projecting housings, which may be seen in the rear corners of these turrets. The centre of each of the three main secondary armament turrets of the *Bismarck* class were also provided with their own basic 7m rangefinder devices.

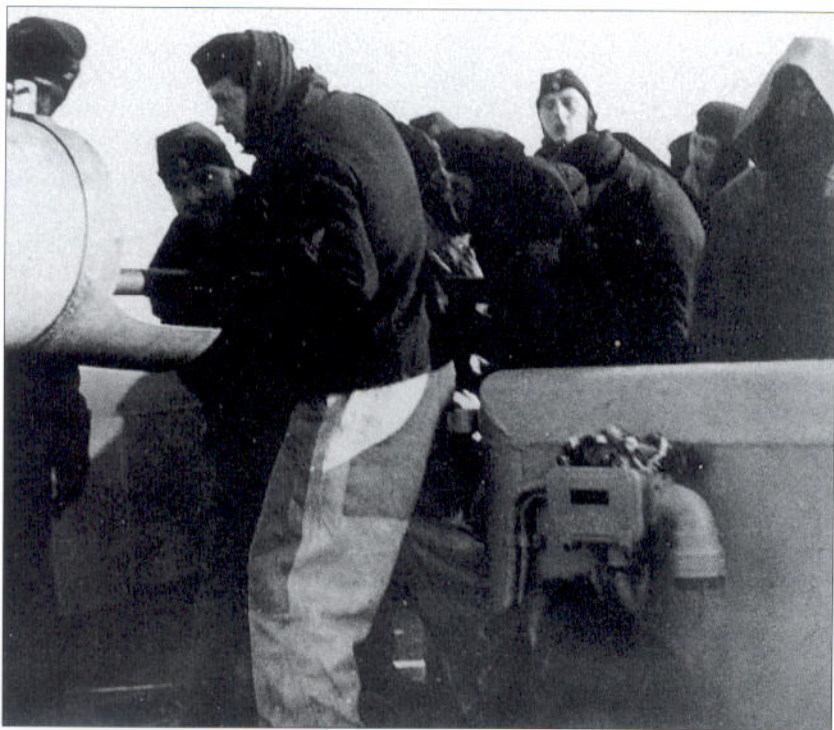
**Heavy work for crewmen of the *Scharnhorst* as they clean out the bore of one of the main 28cm guns.**

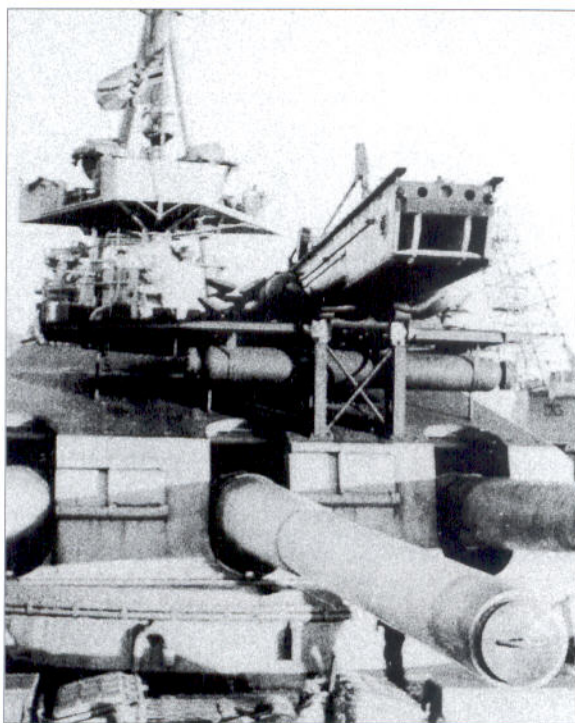
**This view of turret 'Caesar' on *Scharnhorst* gives excellent detail of the second aircraft catapult, subsequently removed. Note the tompons that have been fitted to the ends of the gun barrels to protect the bore when not in use.**

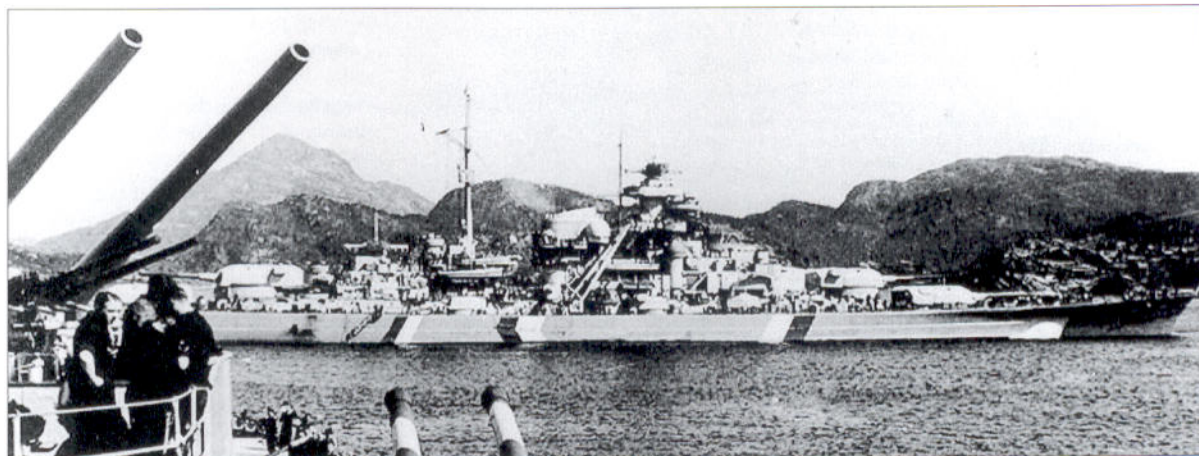
ABOVE *Bismarck* is seen here still sporting her 'Baltic' camouflage scheme of bold black/white angular stripes. Note the darker area on the forward part of her hull, and the false bow wave painted where this meets the light grey of the major portion of her hull. This scheme was painted out before she set off on Operation *Rheinübung*.

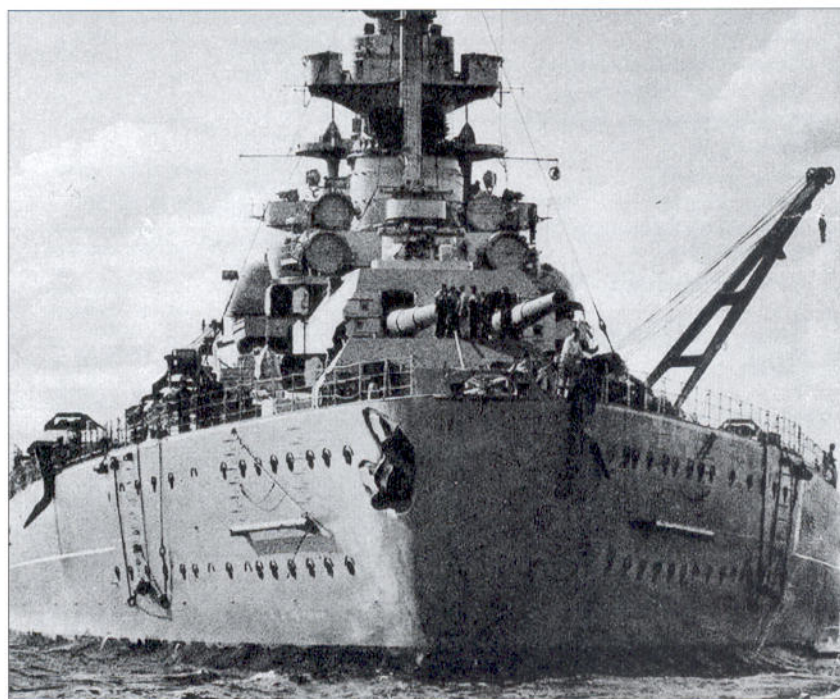
LEFT The sheer bulk of *Bismarck* is clear from this stern view. The size of the turrets can be gauged by the crew figures standing on the roof of turret 'Dora'. The large derrick seen to starboard is used for recovering the ship's boats and the Arado floatplanes.
