ARMOR in the Western Desert

by
Walter J. Spielberger
and
Uwe Feist

ARMOR IN THE WESTERN DESERT

(A GERMAN VIEWPOINT)

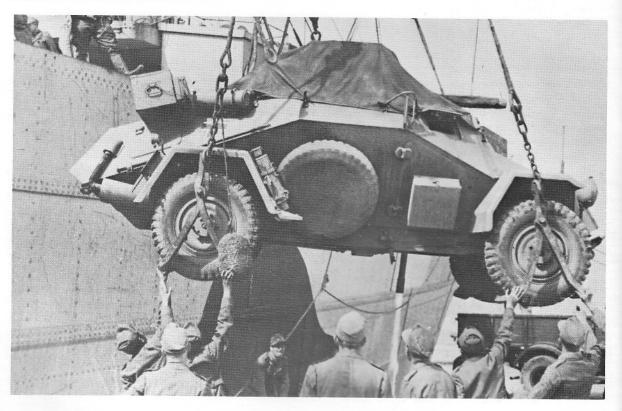
Upon arrival in Libya, armored cars are unloaded and made ready for Rommel's first offensive against British forces. Picture shows an Sd. Kfz. 222, a light German reconnaissance vehicle.

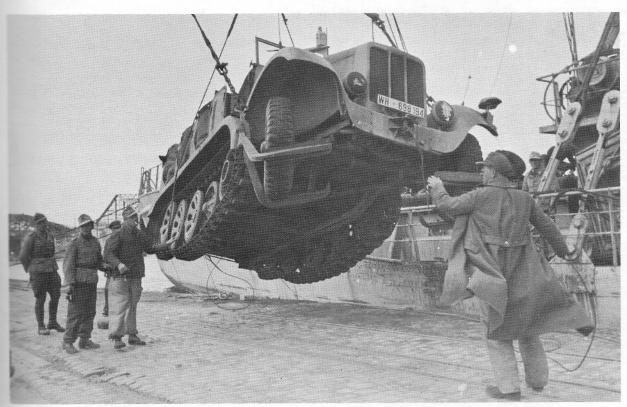
Used in substantial numbers for towing medium and heavy artillery, German half-track tractors are being taken off boats. Vehicle shown is a 5-ton medium artillery tractor.

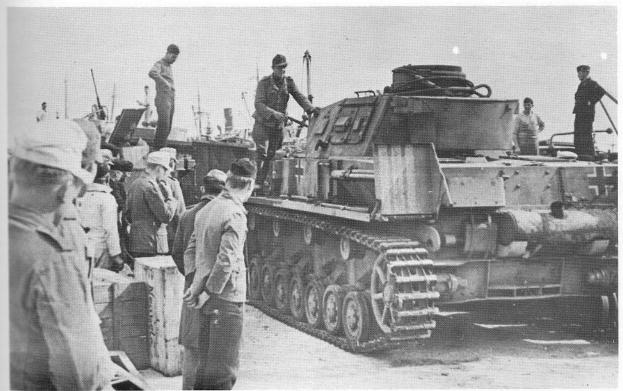
A Panzer IV has just been put on a pier in North Africa. This is an F version of one of the most versatile fighting vehicles of the German armored force.

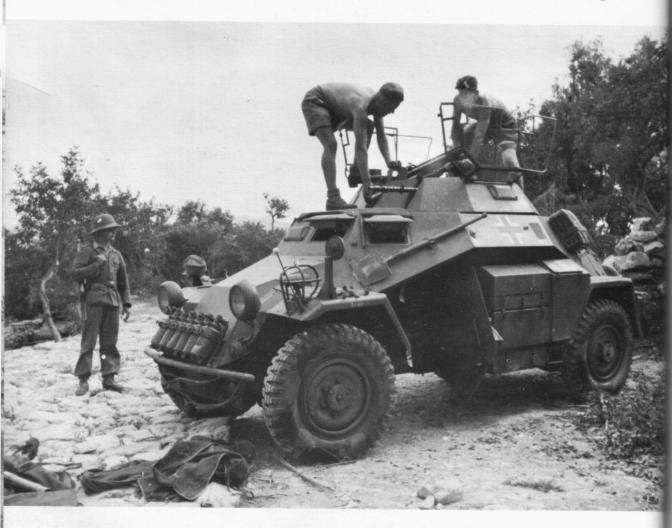
Spearheading the German advance were armored cars of the Fifth Light and the 15th armored divisions. Continuous fighting forced the crew of this Sd. Kfz. 222 to replace its main armament, a 2 cm gun.

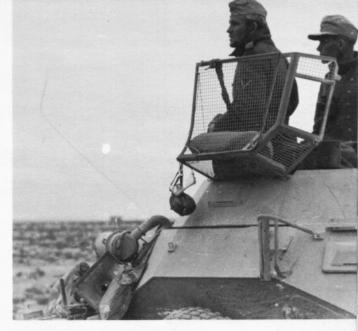
It was soon a common sight in the western desert to see German scout cars on reconnoiter missions. The open turret of this standard German light armored car was protected by means of a wire mesh.

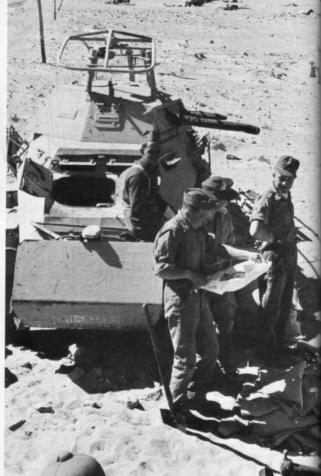
All of the German vehicles used during this campaign had received basic alterations to make them more suitable for this theater of war. Cooling fans and air filters were changed and the maintenance crews trained to cope with the different environments. This German 8-wheeled armored car has protection for its main armament and shows the additional armor shield mounted on the bow of the vehicle.

Engine failures, however, were numerous, since the basic vehicles had never been designed for this hot climate.

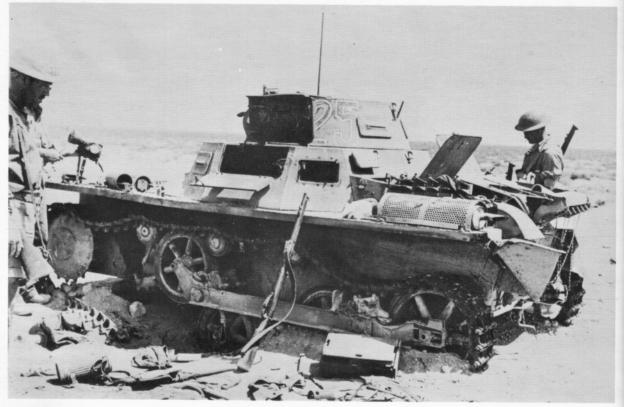
These light German vehicles soon fell prey to British anti-tank weapons and to land mines. This vehicle, an Ausfuehrung A of the Panzer I, was put out of action by a mine which did considerable damage to its running gear.

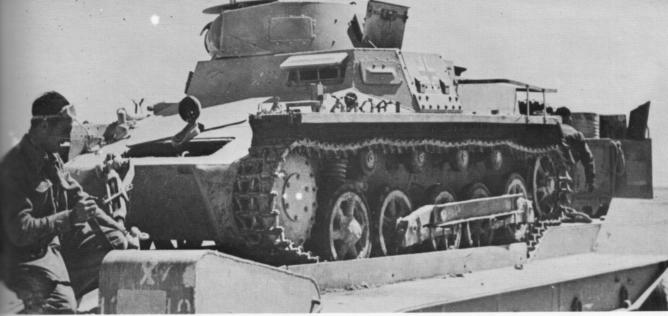
The Ausfuehrung B of the same vehicle was more numerous but could also only be used as a reconnaissance vehicle. It provided the British with a first inside view into German tank designs and all captured vehicles were subjected to intensive investigations.

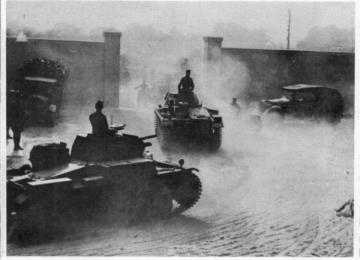
Also based upon the Panzer I chassis was this command version, an important vehicle to provide vital communication between armored formations. This unit was equipped with only one machine gun.

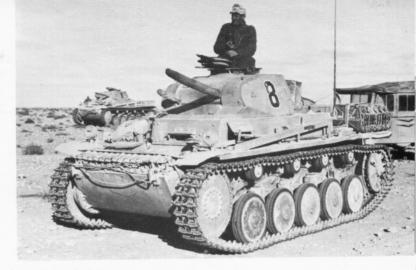
The second vehicle in the German tank inventory was the Panzer II. A light tank with a crew of three, it was armed with one 20 mm gun and an MG in a rotating turret. Available in substantial numbers, it had played an important part during previous campaigns. It again proved most reliable during the battles in Africa.

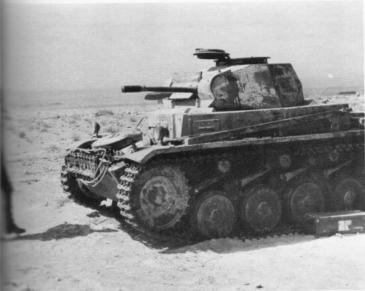
The effects of sand storms in the Libyan desert can be seen on this Panzer II. Paint was removed as quickly as it was applied. Antenna protection is evident on the left side of the vehicle.

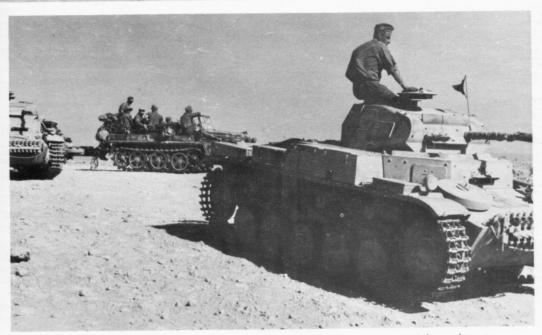
Panzer II ready for action. This vehicle is used by armored engineers mainly to detect enemy mine fields. Half-track vehicle in back is a 1-ton tractor, used frequently to tow the 50 mm antitank gun.

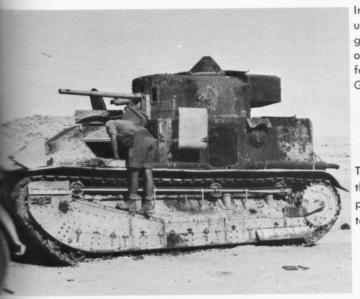
Interesting is this picture of a captured British medium Mark II. This "veteran" was still in use at the beginning of the campaign, despite the fact that its origin dated back as far as 1926. Passenger car in foreground is a standard medium staff car of the German Army.

These vehicles were completely obsolete against the German tanks but had held their own during previous encounters with the Italians. Note that the tank must have been on fire.

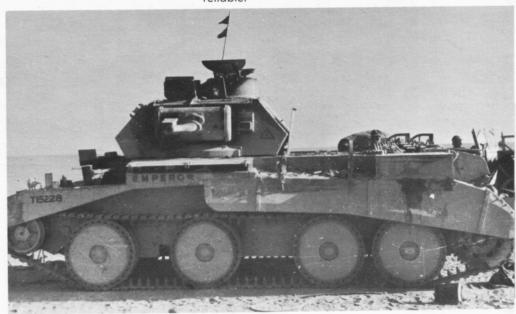
The long series of "Cruiser" tanks encountered in Africa led by this Mark IV A, a vehicle equipped with a 40 mm gun. They were fast but technically not too reliable.

Out-gunned by the German Panzer III, these vehicles were captured in numbers during the initial phases of the North African campaign.

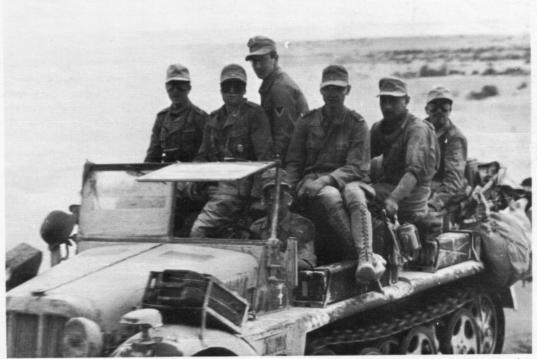
The smallest of the German half-track tractors used in Africa was the 1-ton Zgkw. It was the main prime mover for anti-tank guns and also served as a troop carrier.

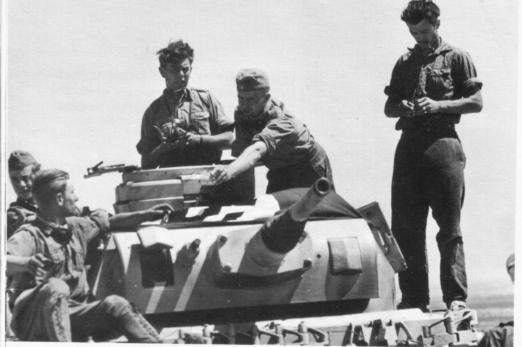
The tank which did most of the fighting on the German side during the initial phases of the campaign was the Panzer III. Initially equipped with a 37 mm gun, vehicles used in Africa generally had the 50 mm KwK L/42. Later German tanks had a five-man crew.

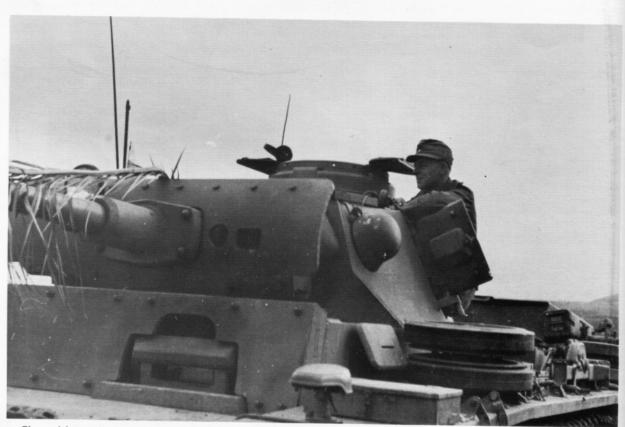
The additional spaced armor, mounted to the front portions of the vehicle, was provided to off-set the effectiveness of the latest British anti-tank weapons. Note the gunner exit on the left side of the turret.

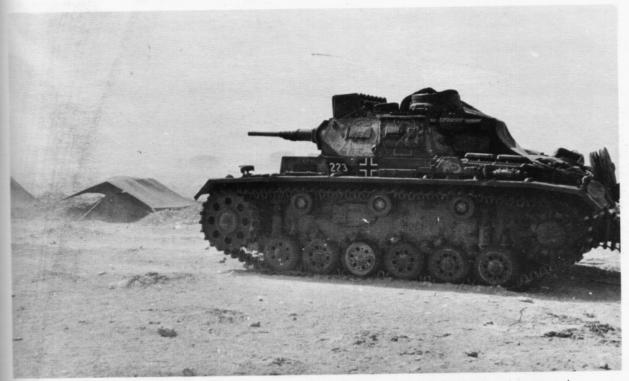
An Ausfuehrung F of the Panzer III, recognizable by its final drive and idler wheels. Jerry cans stored on the turret roof contain water.

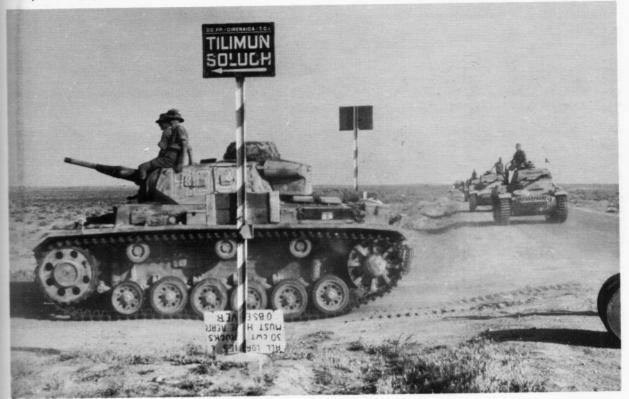
Crew members readying a Panzer III for further action. The abrasive impact of the desert sand necessitated tight closing of all openings. Spare track links were carried on the front plate to afford additional protection.

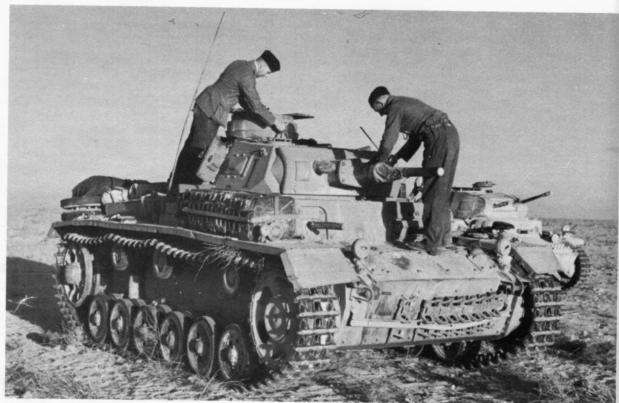
This is the Ausf. H of the same vehicle. Note the difference in final drive and idler wheels and also the different spacing of the return rollers. 400 mm tracks were used for the first time.

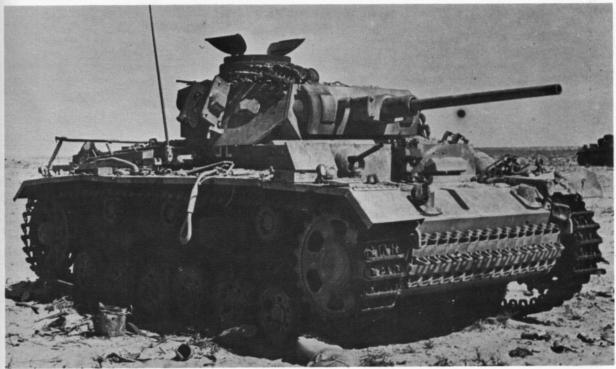
As of 1942, the longer barrelled 5 cm tank guns became available and were soon installed in the J version of the Panzer III. Armor penetration was increased considerably.

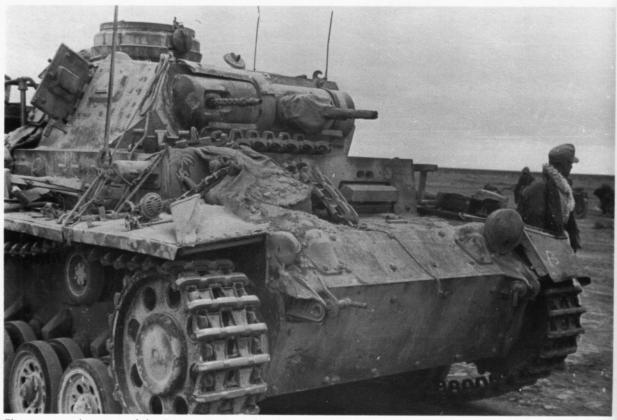
The command version of the Panzer III carried a dummy main armament and had one MG 34 installed in the mantlet of its fixed turret. This vehicle had obviously received a hit which did not penetrate.

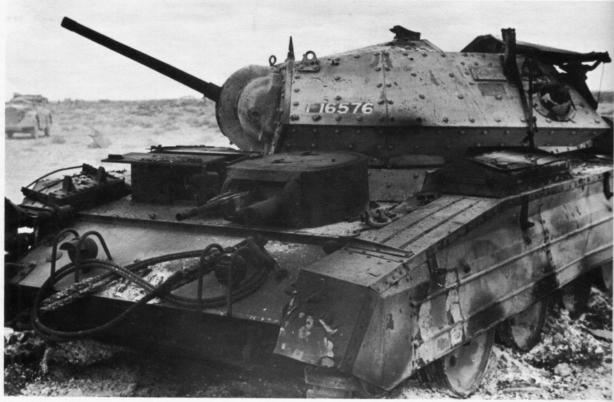
The British Crusader tank series replacing earlier Cruisers started with this version. Note the machine gun turret mounted on the left front plate of the superstructure, a typical identification feature for this Mark.

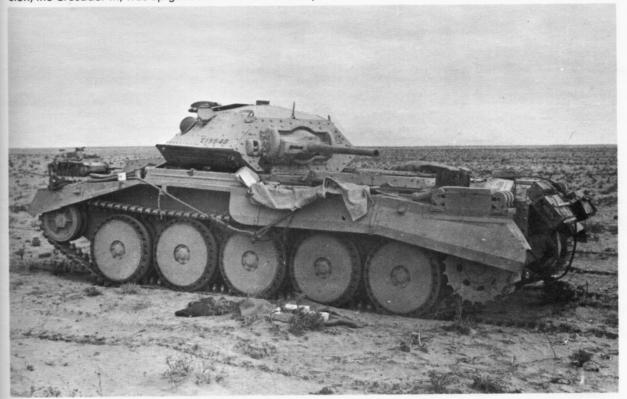
Crusader II tanks had slightly increased armor protection and other minor modifications. The final version, the Crusader III, was up-gunned with a 57 mm weapon.

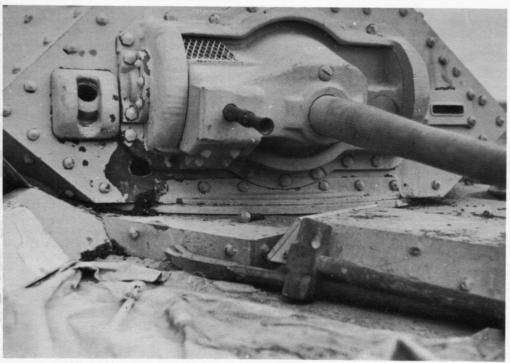
The impact of German tank and anti-tank weapons is clearly demonstrated by this penetration of a 50 mm shell right below the gun mantlet.

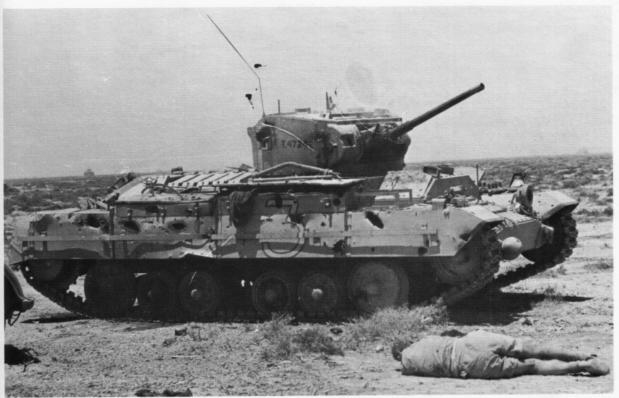
Apart from the Cruiser tanks, the so-called Infantry tanks played an important role in the Royal Tank Corps. Picture shows a Mark III Valentine Infantry tank put out of action by German tank guns.

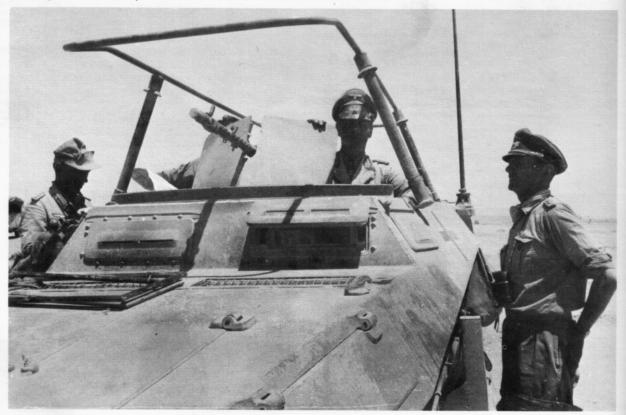
Armored half-tracks also served as vital communication centers to guide armored forces widely scattered throughout the desert. Note the typical frame antenna used on most armored radio vehicles of this period.

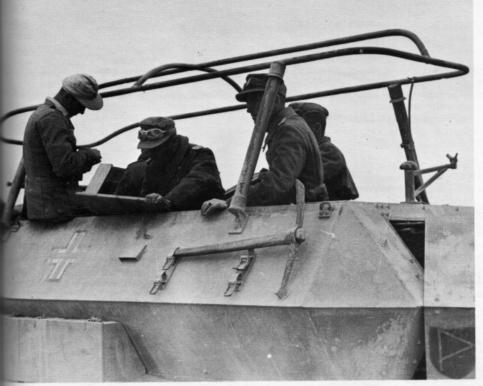
An armored communication vehicle with its fighting compartment protected by means of a canvas cover waits for further orders. An MG 34 on a tripod is set up for use against British fighter bombers.

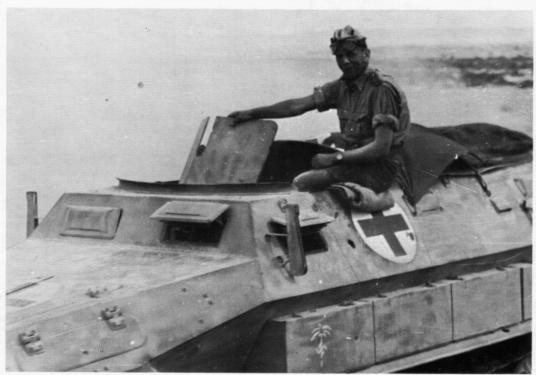
Platoon leader half-track vehicles had the standard 37 mm anti-tank gun mounted behind the original armor shield. They were intended to support armored infantry units.

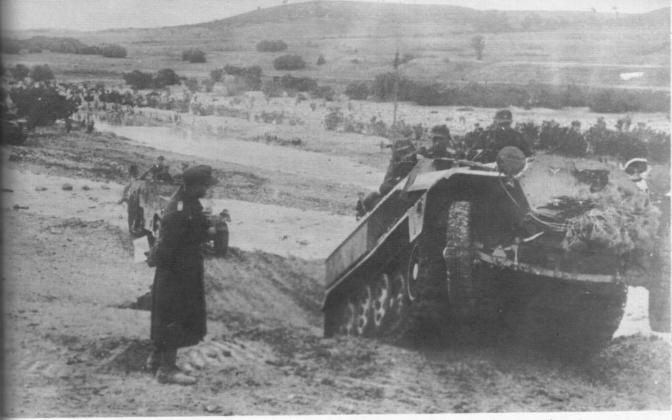
A battle scene in Tunisia, toward the end of the campaign, shows a German armored personnel carrier accompanied by its captured American counter-part. Contrary to the American version, the front axle of the German vehicle was not driven.

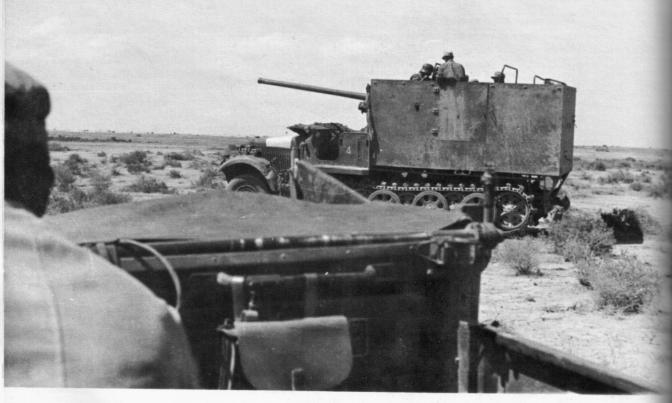
A Russian 7.62 cm anti-tank gun mounted on the Czech Praga 38 t chassis was used in numbers on the Russian front. Some of them found their way to Africa, where they complicated considerably the already over-extended supply system. The weapon itself was capable of destroying any existing Allied armor.

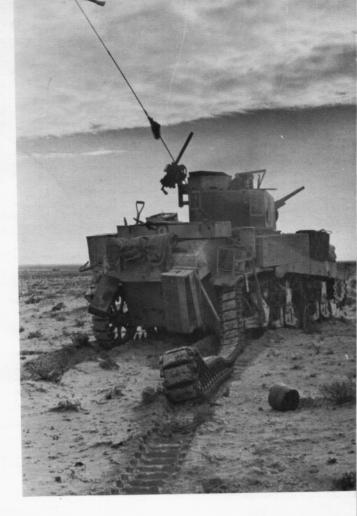
Although quite a surprise to the Germans, these M 3 medium tanks with their excellent firepower fell victim to attacking German tank outfits. Note the addition of sand shields by the British.

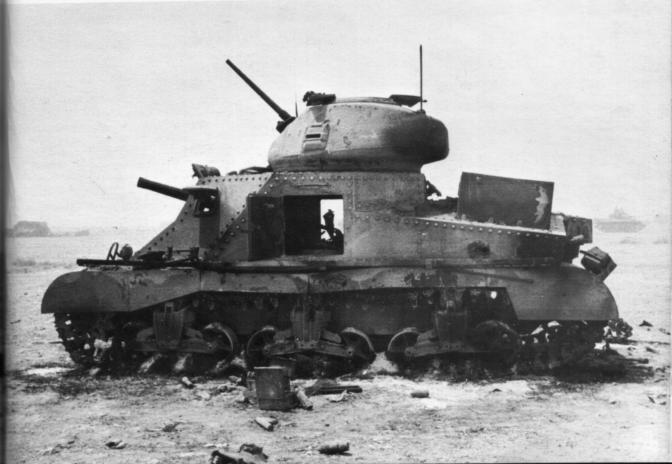
Exploding ammunition left nothing but a pile of junk iron of this M 3 tank. Note the limited traverse provided for the 75 mm gun. Its heavy armor protected it against smaller German weapons.

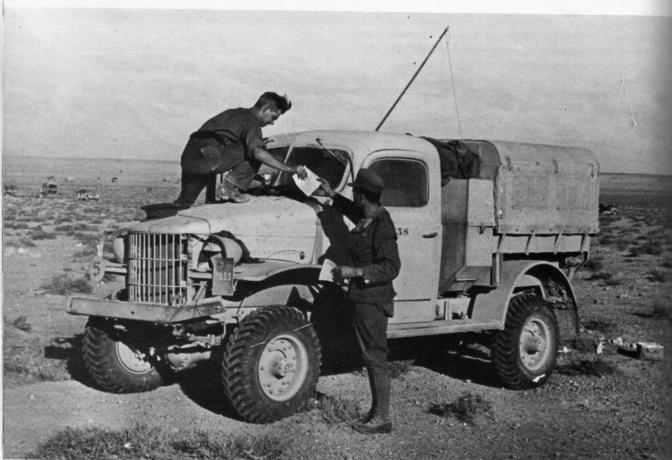
Canada and the United States also supplied a large percentage of the soft-skinned transport vehicles to the British Army. Picture shows a four-wheel drive Dodge truck used in numbers by the English.

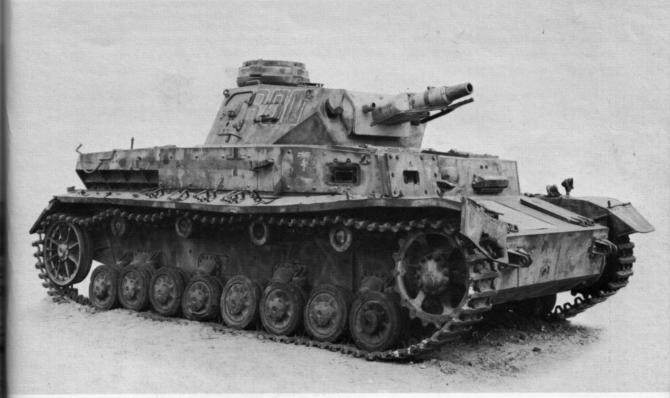
The only German armored fighting vehicle, designed before the war and continued to be produced throughout the war, was the Panzer IV. Originally intended only as a support vehicle for the Panzer III, it soon became the main battle tank of the German armored forces.

Its main armament was originally a short-barrelled, low-velocity 75 mm gun which was rather ineffective against enemy armor.

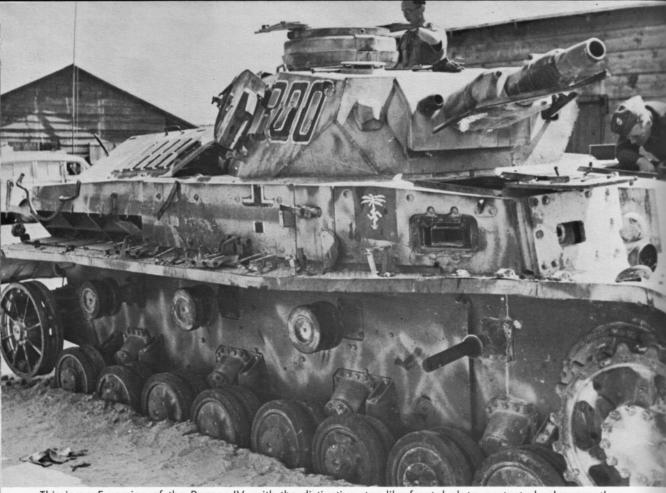
This is an E version of the Panzer IV, with the distinctive step-like frontal plate, protected subsequently by additional armor.

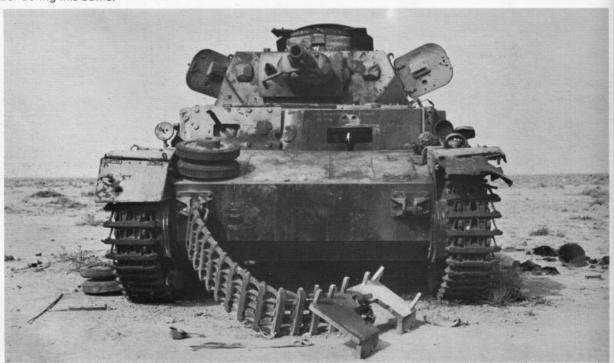
Far-sighted planning allowed for a turret race on the original vehicle which could very well accommodate larger guns. Note the African-style helmet on the side of the vehicle.

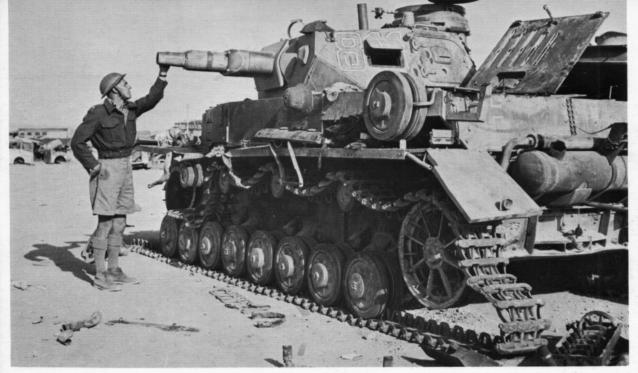
Again forced upon the Germans by their experience in Russia, a long-barrelled, high-velocity weapon was substituted, enabling this vehicle to engage any existing enemy armor. The first version of the 7.5 cm KwK 40 L/43 still had a single baffle, ball-shaped muzzle brake. Vehicle is an Ausfuehrung F 2.

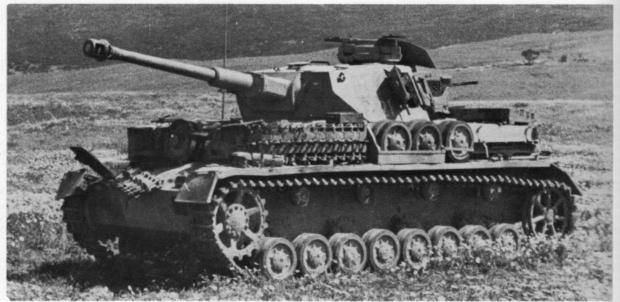
The following G version had the same gun, but a double baffle muzzle brake. Starting with the F version, all Panzer IV received the double turret hatches of the Panzer III. Turret side vision slots were also eliminated.

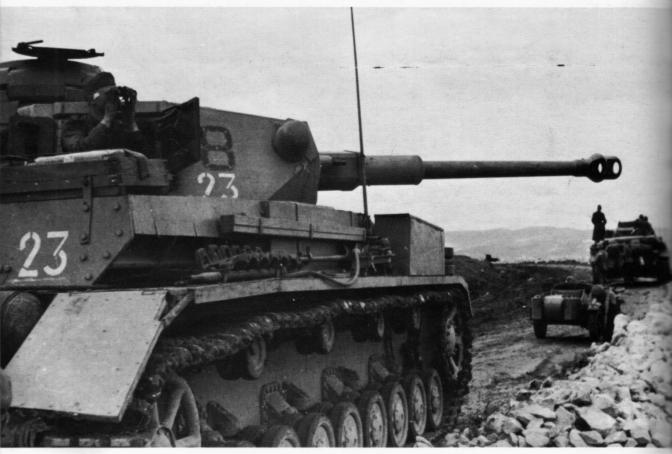
The last two versions of the Panzer IV, the Ausfuehrung H and J, had an even longer gun, the 7.5 cm KwK 40 L/48. Vehicle is shown during the final stages of the campaign in Tunisia.

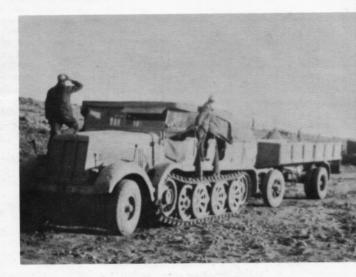
The 12-ton half-track tractor served as a prime mover for heavy artillery and was also used for supply purposes. Here it is shown towing an Italian trailer.

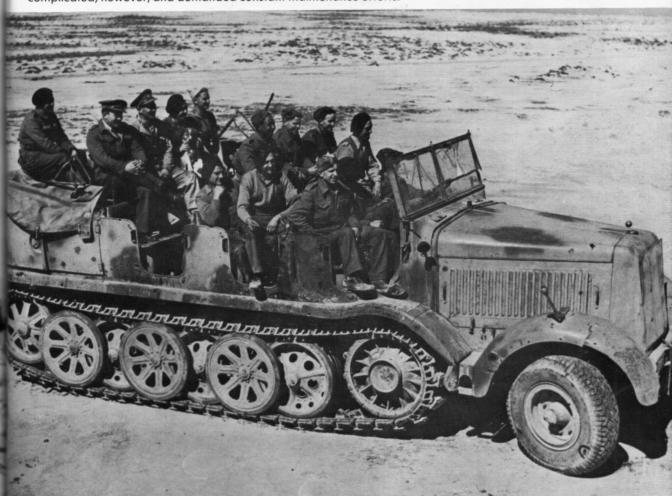
Abandoned by the Germans, this 12-ton Zgkw is being used by British soldiers as a "sight-seeing" bus during a desert excursion. The half-track German series was one of the finest in existence. It was too complicated, however, and demanded constant maintenance efforts.

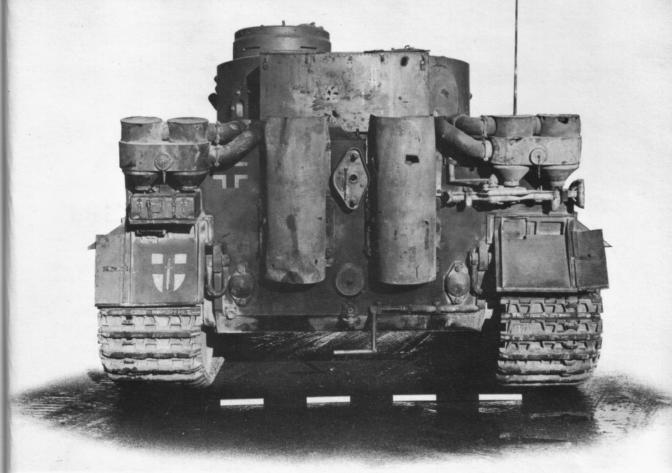
Elaborate dust cleaning filters were necessary to keep the desert sand from entering into the sensitive Maybach engines. Similar arrangements had also been made on tanks operating in the southern part of Russia.

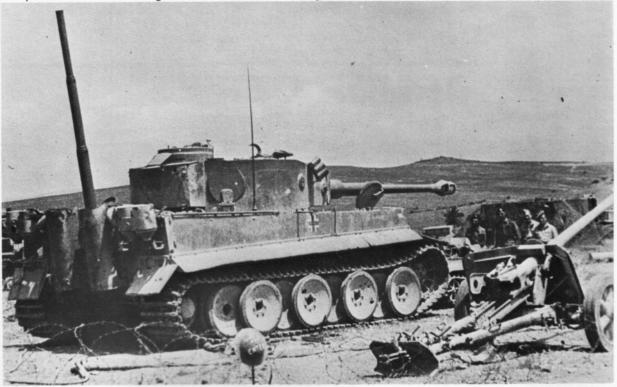
Captured Tiger tanks afforded the Allies an inside view of the German tank industry and their latest creations. Note the snorkel tube fitted to the engine compartment to allow deep fording of these vehicle. A captured 75 mm anti-tank gun can be seen next to the Tiger.
