Identification, Repair, and Mitigation of Cracking of Steel Equipment in Fuel Ethanol Service

API BULLETIN 939-E
SECOND EDITION, AUGUST 2013

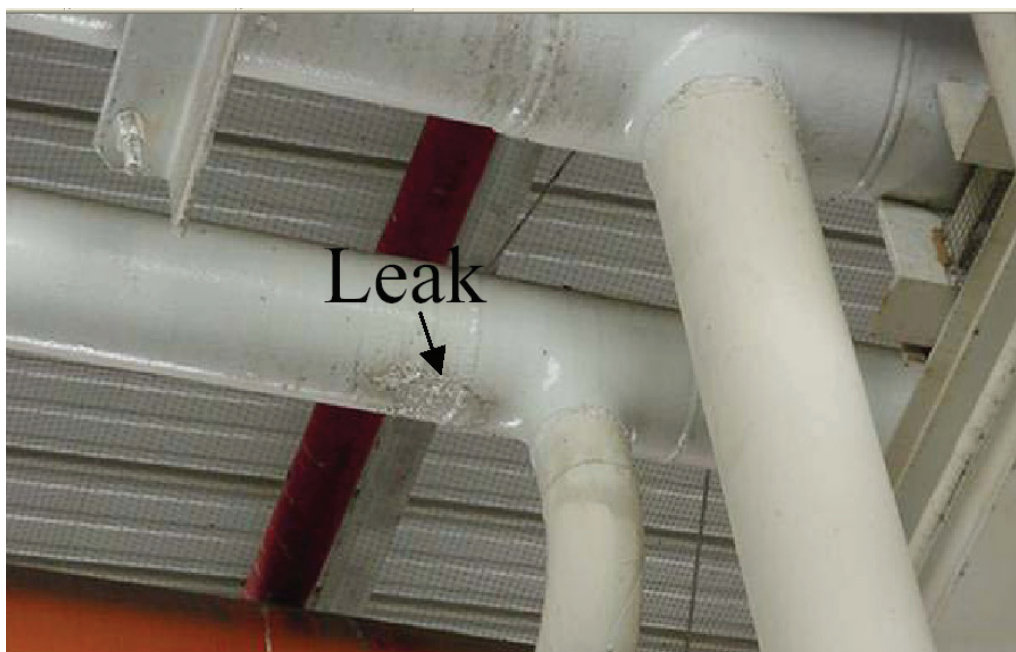
NOTE Leak and bubbles in paint adjacent to welded fitting.

Figure C.3—Leak in Piping Resulting from a Crack Adjacent to the Weld

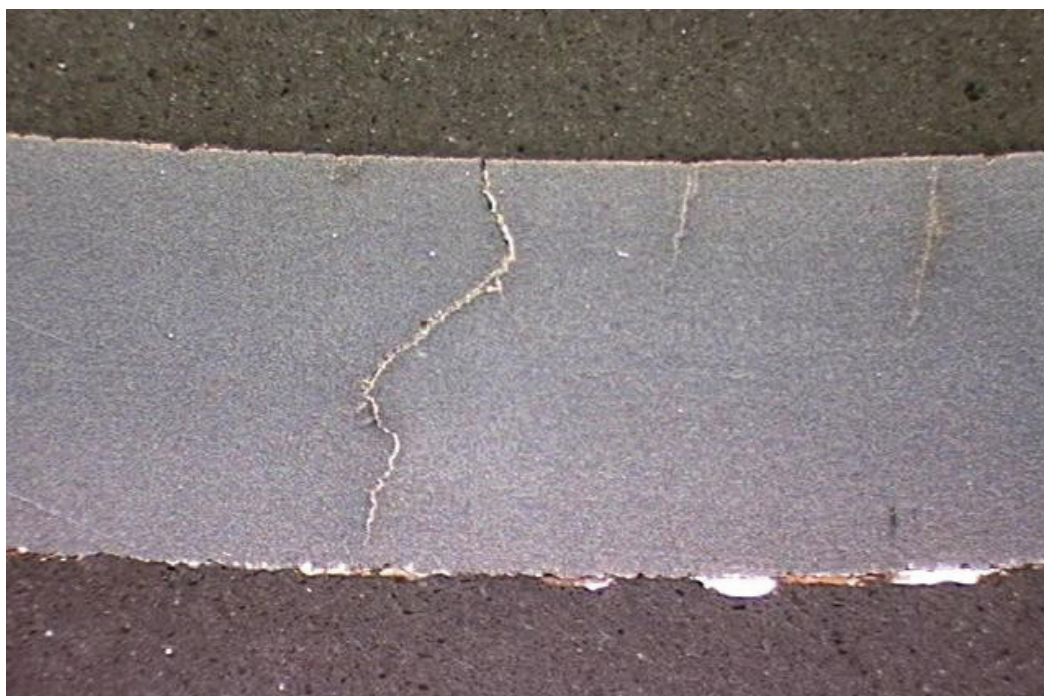
Figure C.4—Characteristics of SCC in Steel Exposed to Fuel Ethanol, Showing Multiple Crack Initiations and Through-thickness Propagation in Piping

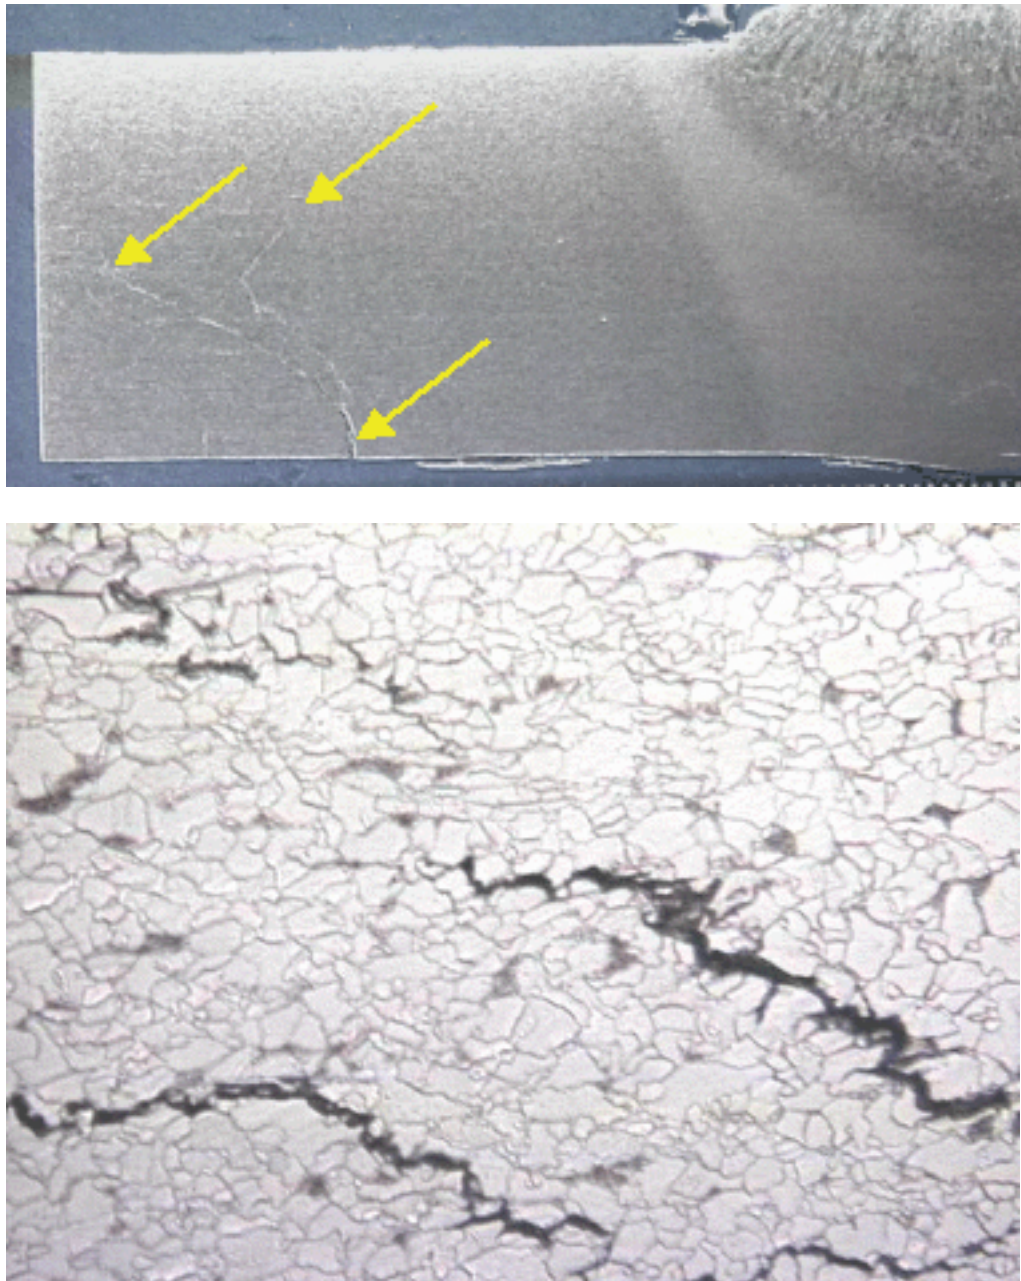
NOTE Top—Branched cracking in base metal adjacent to weld.

Bottom—Micrograph cracking shown above with predominately intergranular cracking (380X—nital etch).

Figure C.8—Cracking of Another Pipe Sample from Same Situation as Noted in the Previous Figure
