RESULTS OF RANGE-FINDING TESTING OF LEAK DETECTION AND LEAK LOCATION TECHNOLOGIES FOR UNDERGROUND PIPELINES

HEALTH AND ENVIRONMENTAL AFFAIRS DEPARTMENT
PUBLICATION NUMBER 346
NOVEMBER 1998

API PUBLICATION NUMBER 346

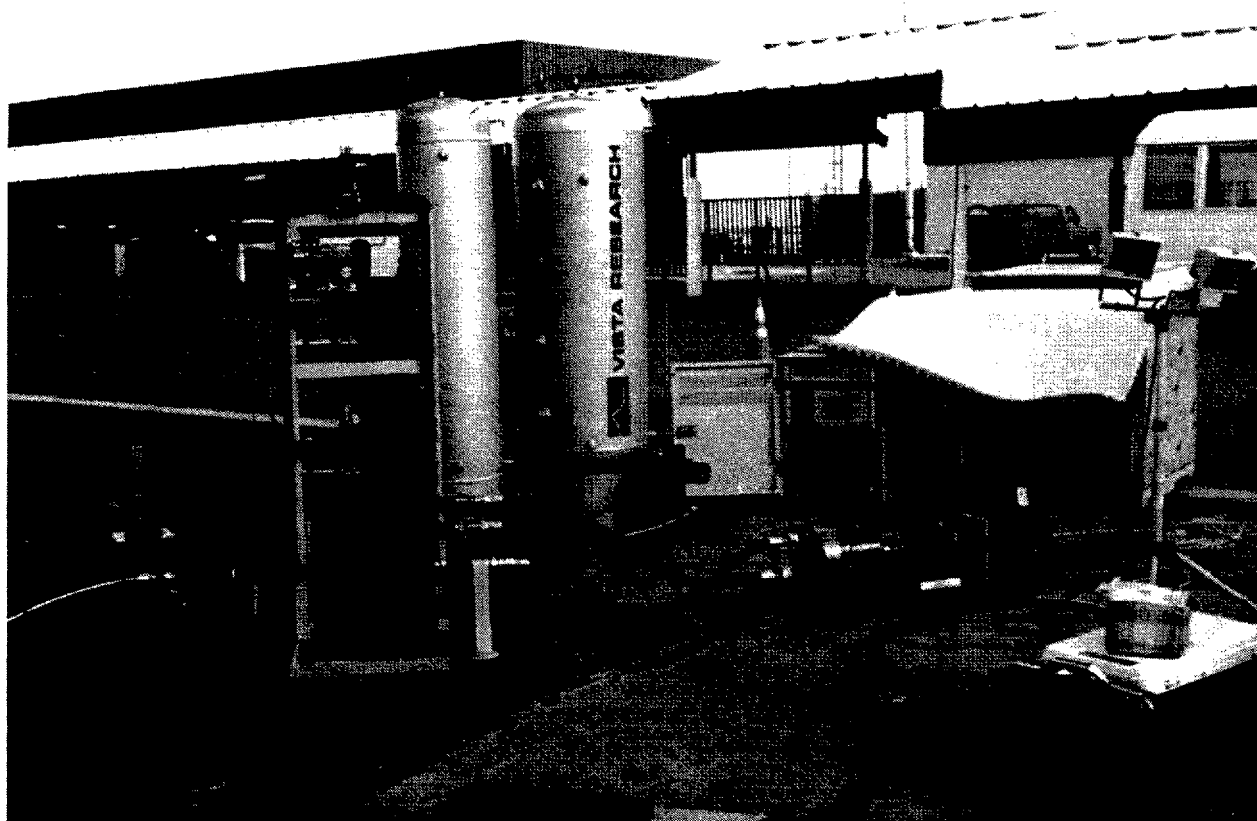
Figure 3. The Large Volumetric System

Because the technical approach is essentially the same for both the large and small volumetric systems, they are discussed together. The systems are used to perform a static leak detection test with existing product in the line. The line is packed with product and then isolated from the tank(s) or other lines. During a test, the volumetric system measures the change in volume of fuel in the line at two different pressures, each of which is held constant while the measurement is taken.

Once the system has been installed and checked out, a formal test requires 2 hours of data. Typically the first hour of data is collected at low (generally atmospheric) pressure. This is followed by 1 hour of data at high (operating) pressure. The low pressure test was conducted at near atmospheric pressure but with a slight head pressure because the product in the test reservoir was elevated a few feet above the line. The high pressure test was conducted at 50 psi for the smaller and 150 psi for the larger system. For both stages, the last 20 minutes of data were used.

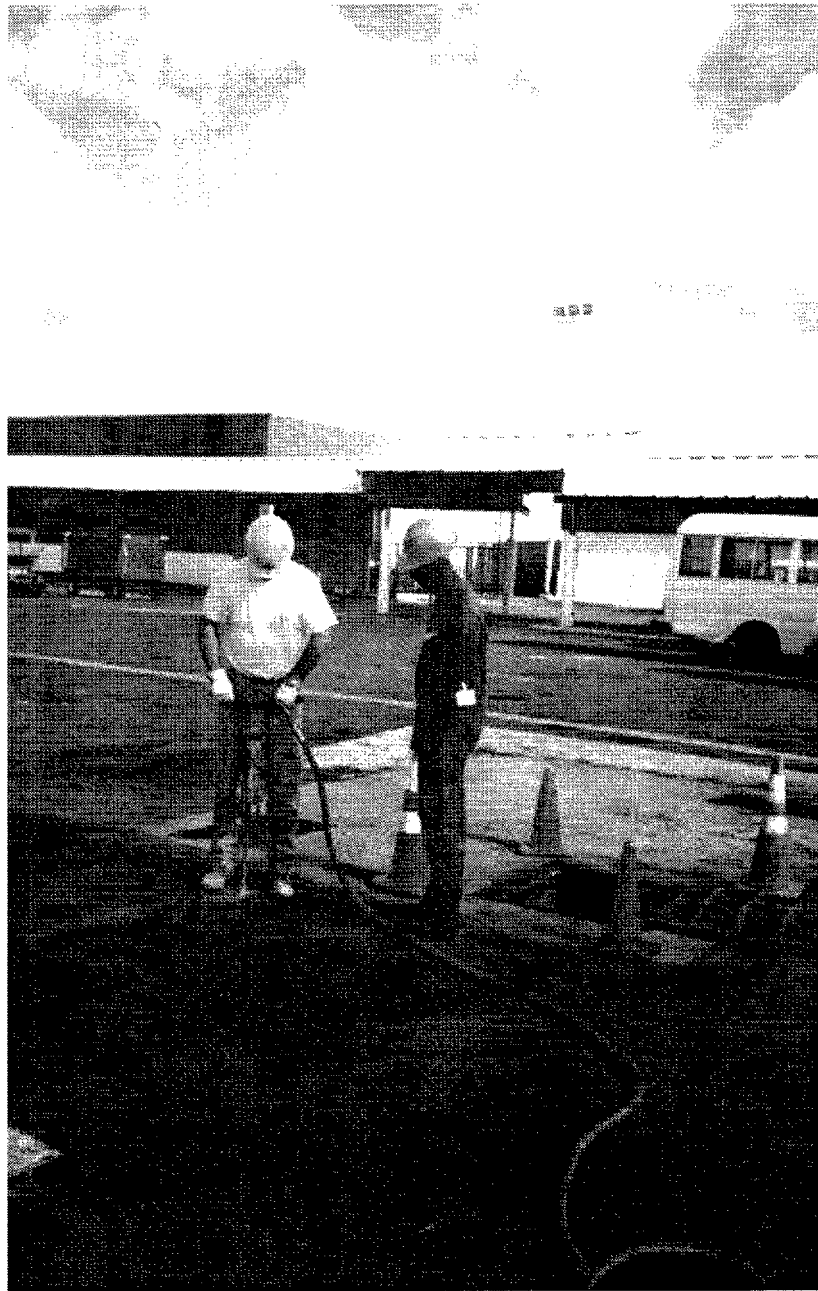
Figure 8. Drilling to Install Tracer Ports

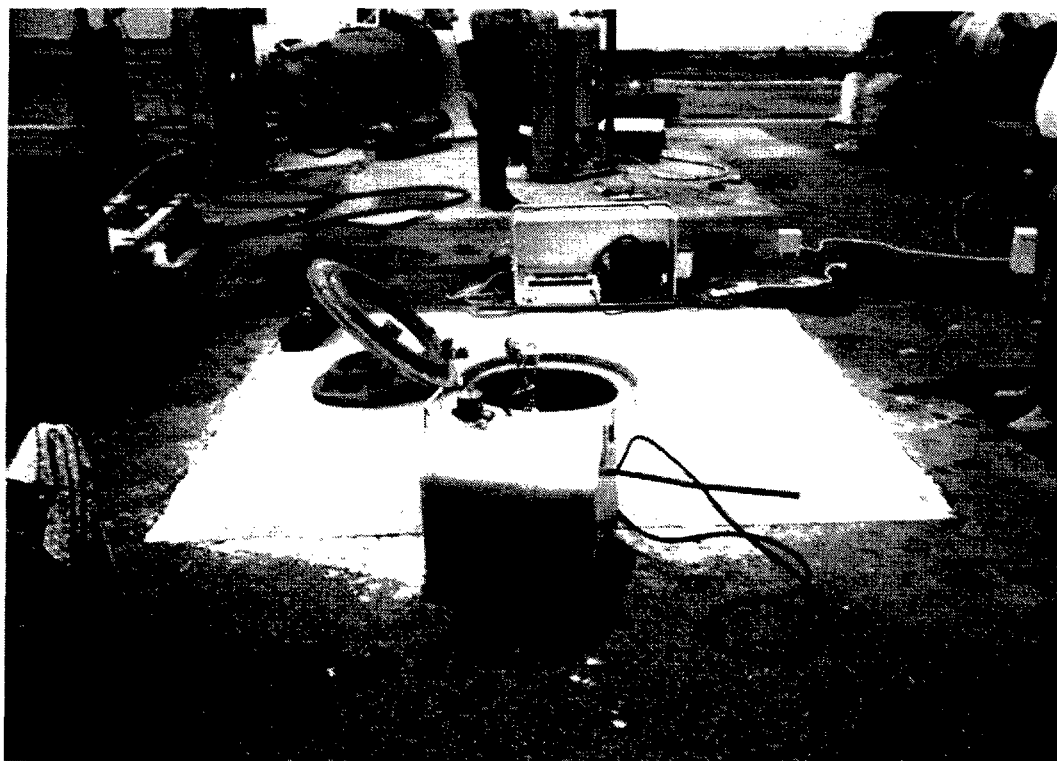
Figure 17. The Pressure Decay System Installed

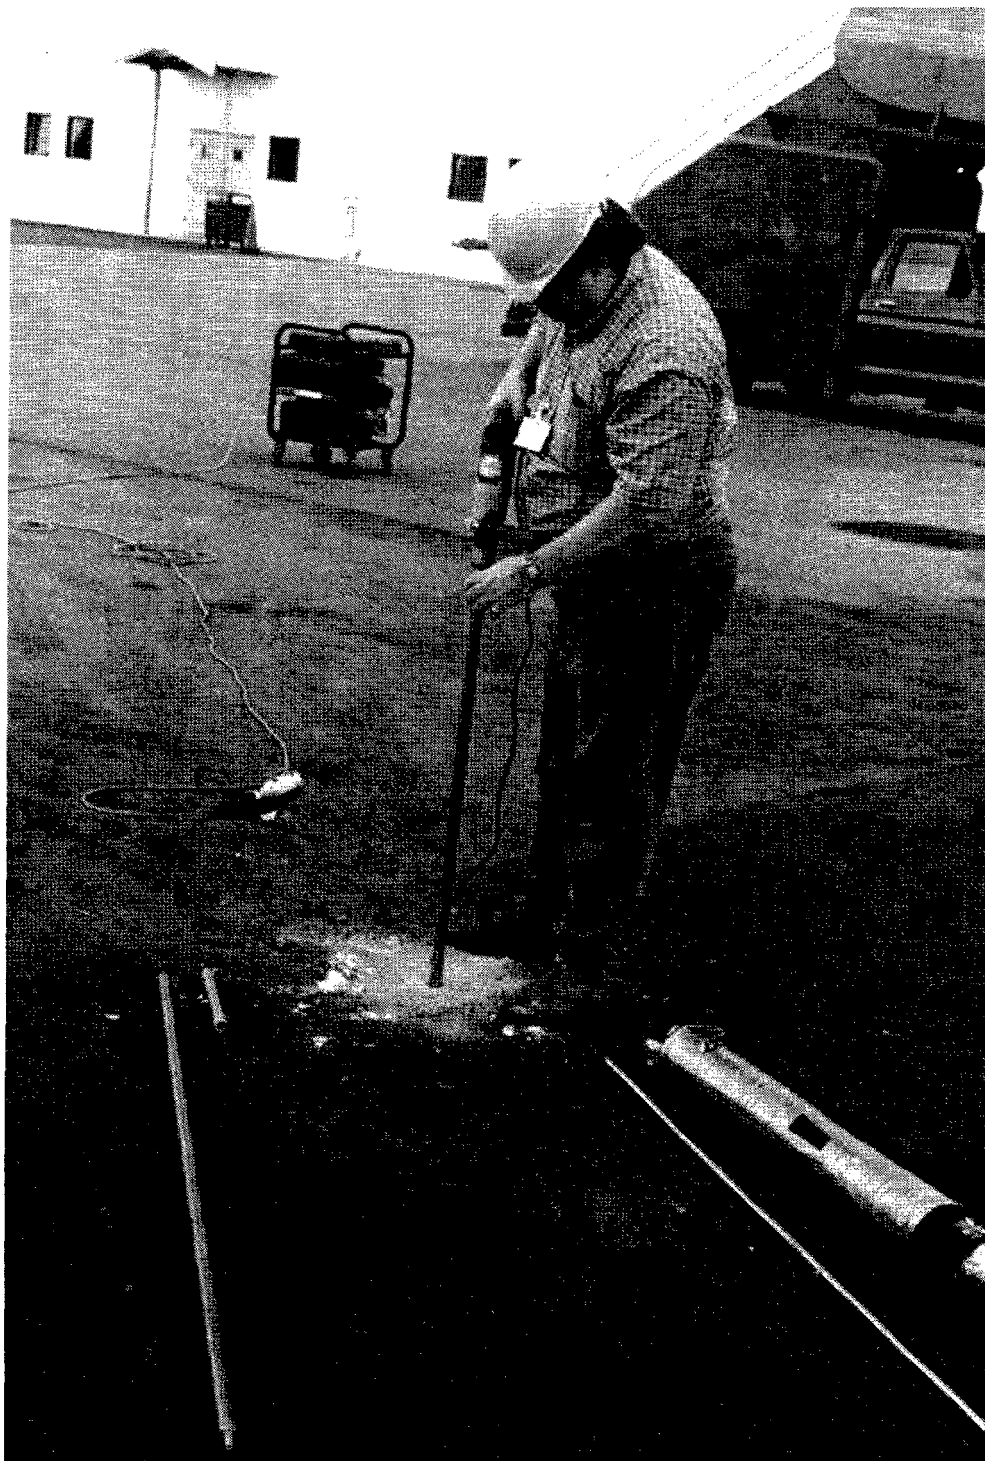
Figure 19. Drilling to Get Access to Pipe for Acoustic Emissions System

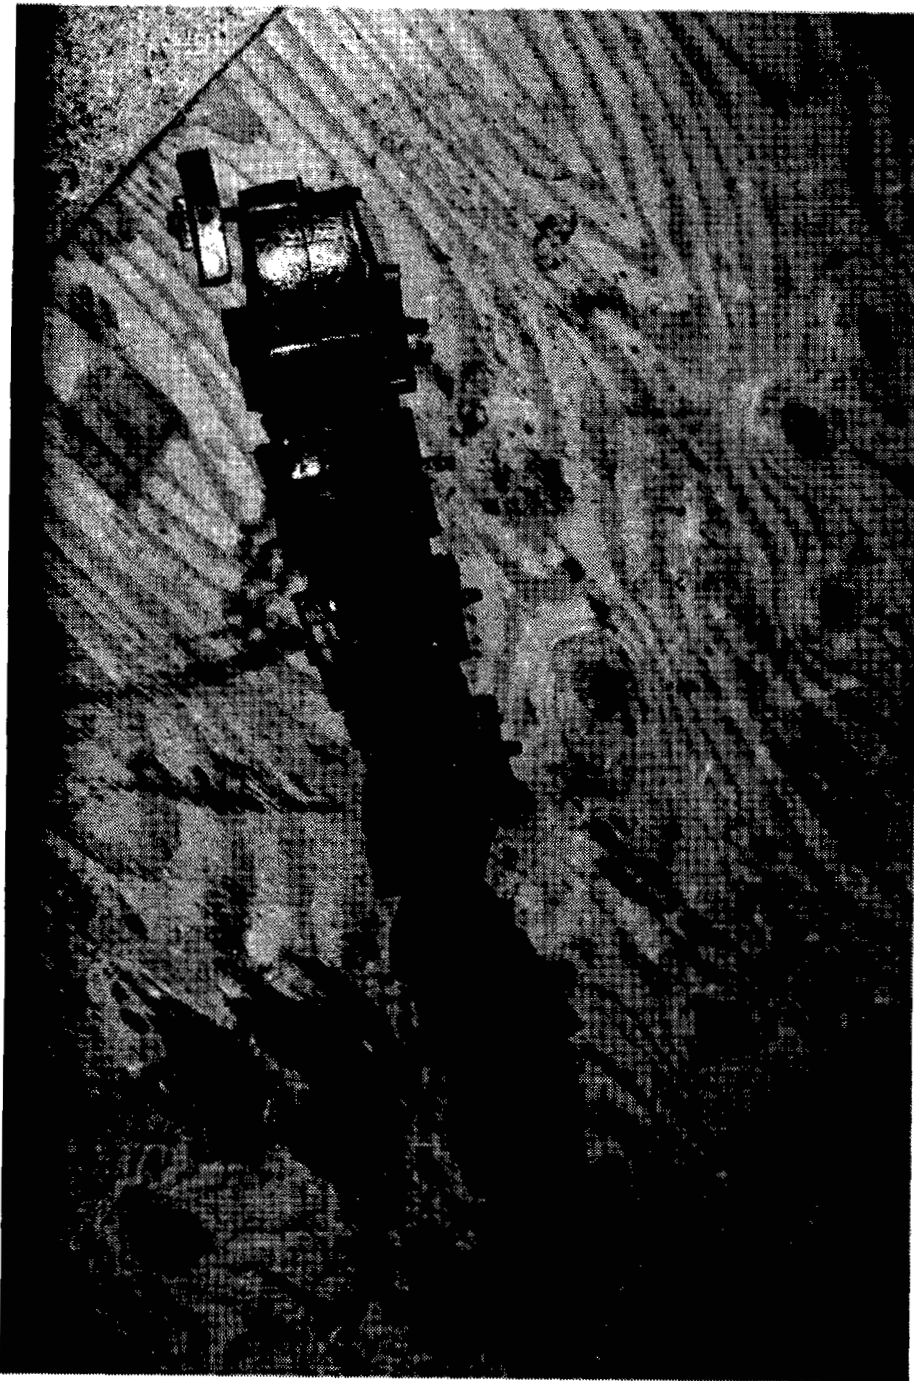
Figure 21. Link Seal after Removal
