In-service Inspection of Mooring Hardware for Floating Structures

API RECOMMENDED PRACTICE 2I
THIRD EDITION, APRIL 2008

Upstream Segment

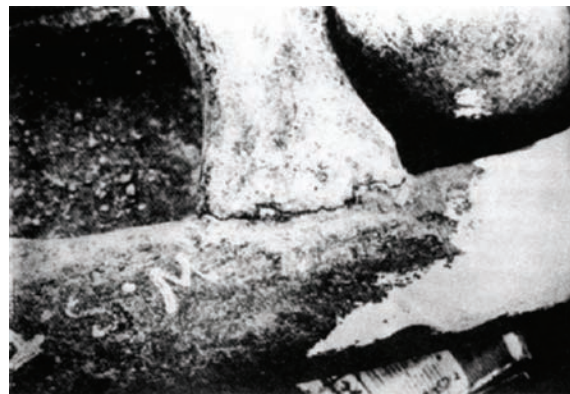
Figure 1—Typical Chain Stud Problems

a) Loose stud in 3-in. ORQ chain

b) Cracked stud weld in 3-in. ORQ chain

Loose studs caused by manufacturing defects, abusive handling, or excessive corrosion between the link and the stud, allowing excessive stretching of chain, causing higher bending stresses in the chain. A typical loose stud is shown in Figure 1a.

Surface cracks, flash-weld cracks, and stud-weld cracks may propagate under cyclic loading, resulting in premature chain failure. A typical stud-weld crack is shown in Figure 1b.

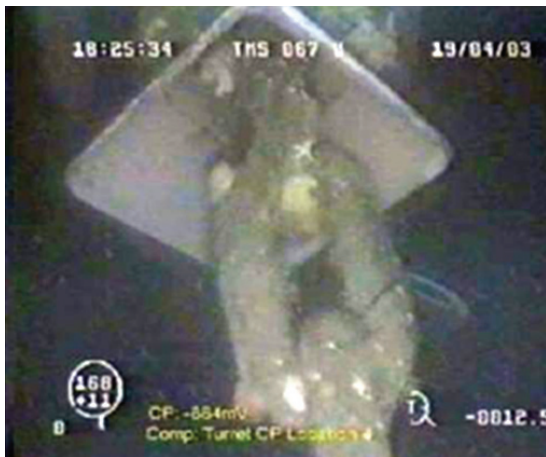
Figure 26—Chain Details Recorded by Work Class and Micro-ROV

a) Chain at trumpet recorded by typical work class

b) Chain at trumpet recorded by micro-ROV

Although MODU chain inspection is primarily based on direct measurement of the chain links at specified intervals, for permanent mooring systems all measurements have to be made *in situ* by ROV or by diver, and in many cases the only information available is video or photo. Figure 26 shows the level of details that can be recorded by different ROV inspection techniques.

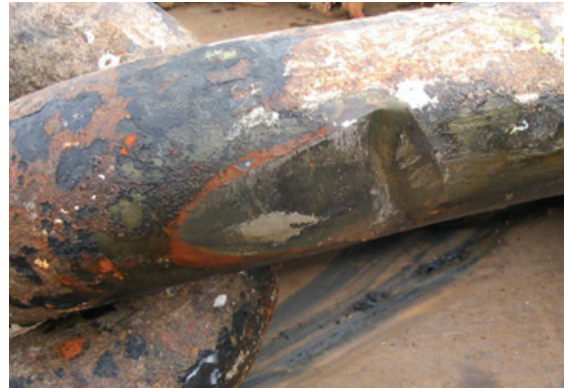
Figure 28—Example of Chain Wear at Hawse Pipe

a) Typical FPSO chain stopper arrangement

b) Wear notch from contact with hawse

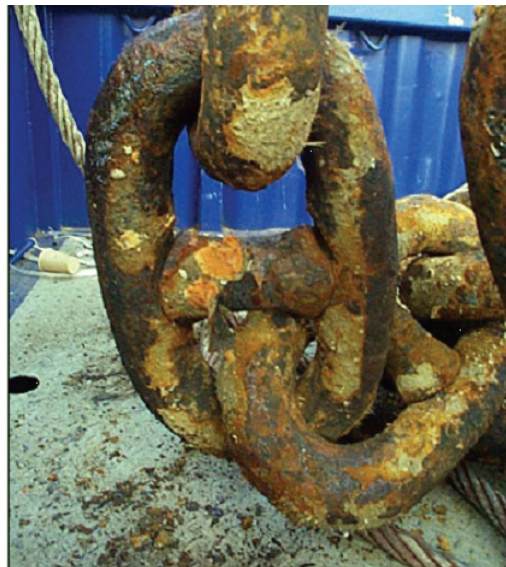
Figure 29—Example of Heavy Marine Growth and Chain Corrosion at Splash Zone

a) Marine growth

b) Chain corrosion

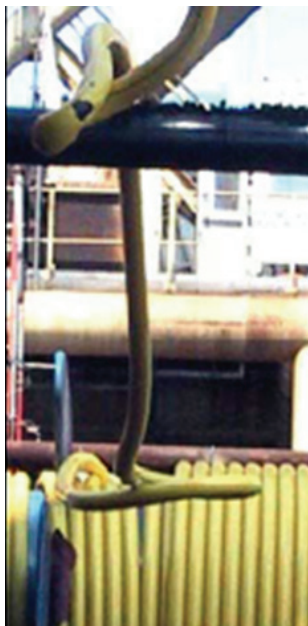
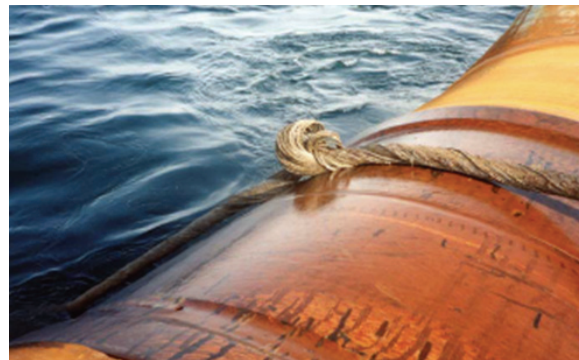
**b) Bird caging****Figure 33—Example of Bird Caging and Kinking of Spiral Strand During Installation**

**a) Kinking**
