Process Plant Tent Responses to Vapor Cloud Explosions—Results of the American Petroleum Institute Tent Testing Program

API TECHNICAL REPORT 756-1
SEPTEMBER 2014

Prepared for API by:
Raymond H. Bennett, P.E., Ph.D.
Martin Goodrich, P.E.
Brad Horn

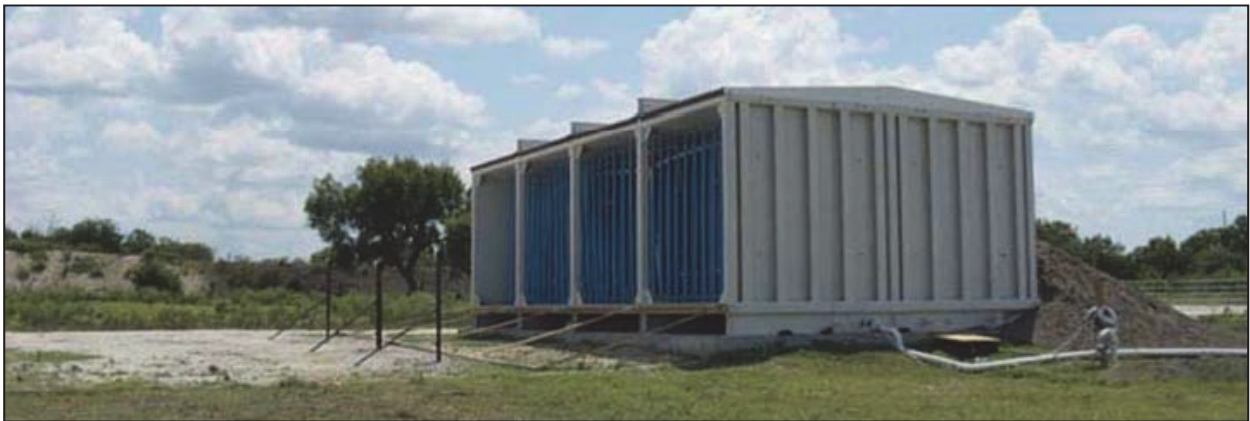
BakerRisk designed and constructed the Deflagration Load Generator (DLG) test rig used for these tests. The test rig measures 48 ft. long by 24 ft. deep by 12 ft. tall and has three rigid walls, a rigid roof and floor, and one open wall facing the structure being tested, as shown in Figure 1. The interior of the rig is fitted with congestion. The test rig is filled with a propane/air mixture and ignited, causing a VCE.

Figure 1. VCE Deflagration Load Generator Test Rig

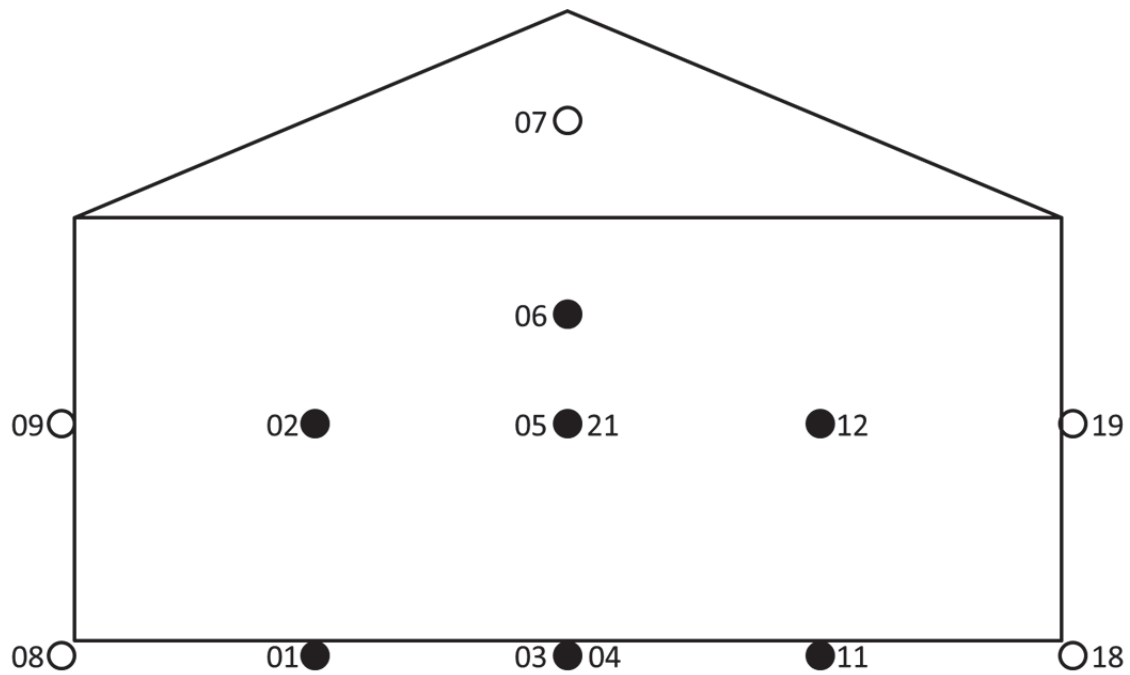
The pressure measurement system consisted of dynamic pressure gages connected to line-powered signal conditioners via microdots and BNC cables. The pressure sensors were amplified by various amounts based on the expected pressure at each gage location. Each pressure sensor was sampled by a PXI National Instruments system at 10,000 samples per second. Each pressure gage was mounted in a 1/2-inch thick steel plate and either mounted to a tent pole or placed in the ground.

Figure 3. Pressure Gauge Layout – Front View of Tent – Facing Explosion

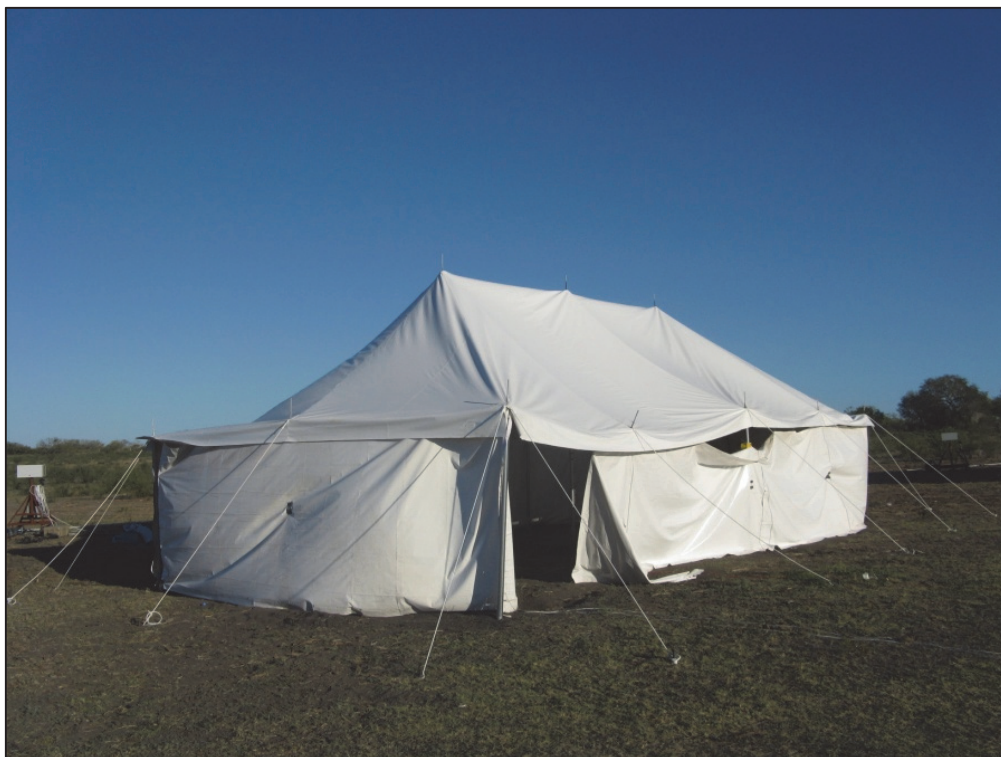
Figure 13. Damage to Non-Wind Rated Pole Tent with Sides, Test A03

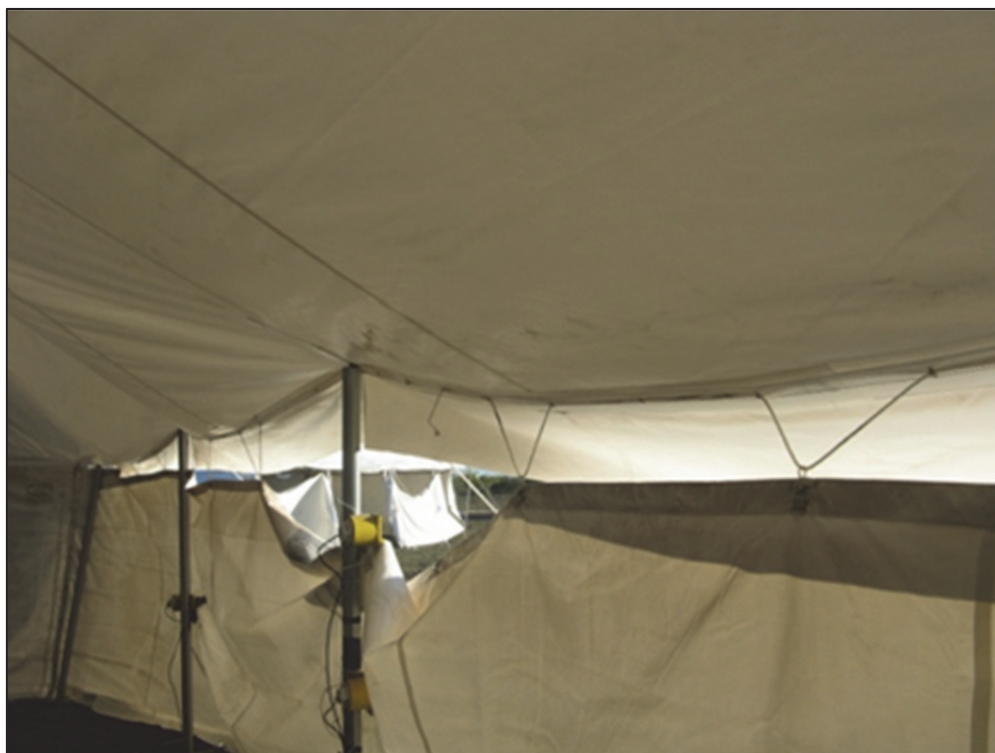
Figure 14. Rope to Wall Panel Connection, Non-Wind Rated Pole Tent w/ Sides, Test A03

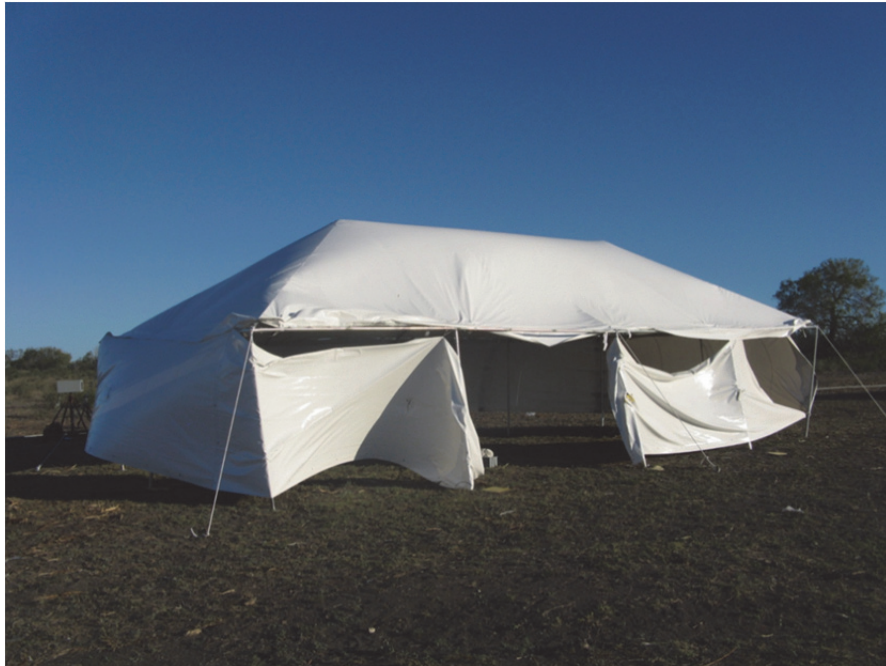
Figure 15. Damage to Light Frame Tent, Test A03

The light framed tent suffered one failed side panel and the bending of some frame components as shown in Figure 15 and Figure 16. Diagrams showing the frame deformations are provided in Figure 17 and Figure 18. Larger versions of these diagrams are provided in Annex B.

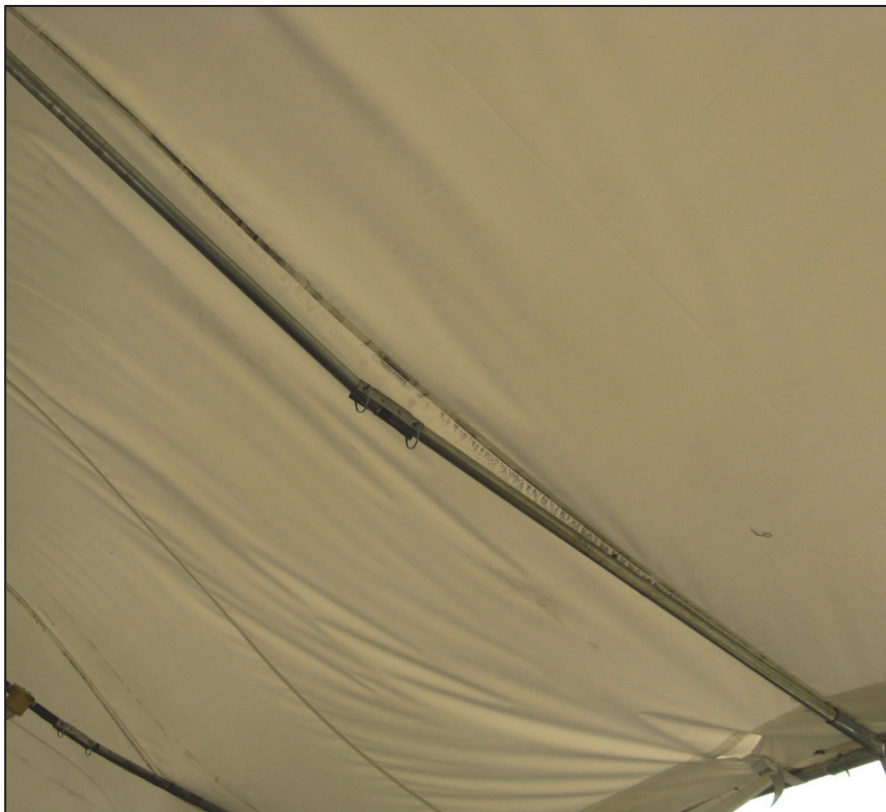
Figure 16. Damage to Hinge of Roof Frame Member, Light Frame Tent, Test A03

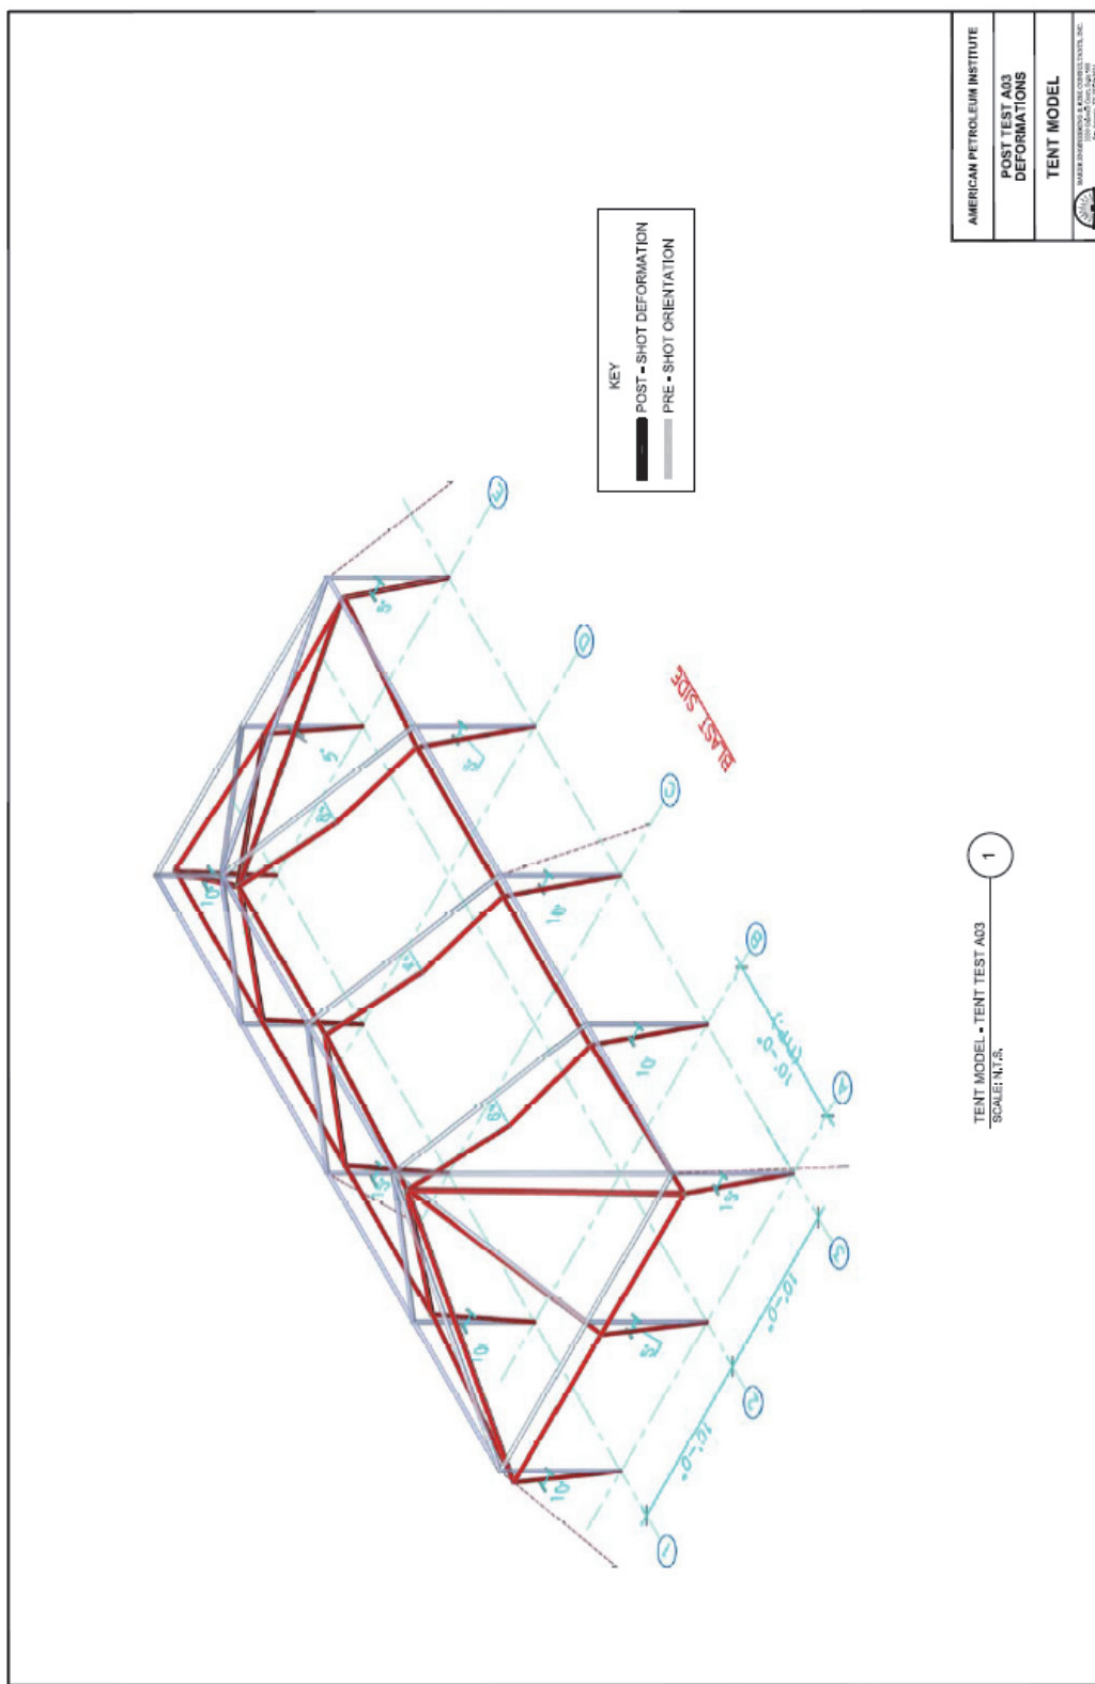
Figure 18. 3D Rendering of Deformed Light Frame Tent, Test A03

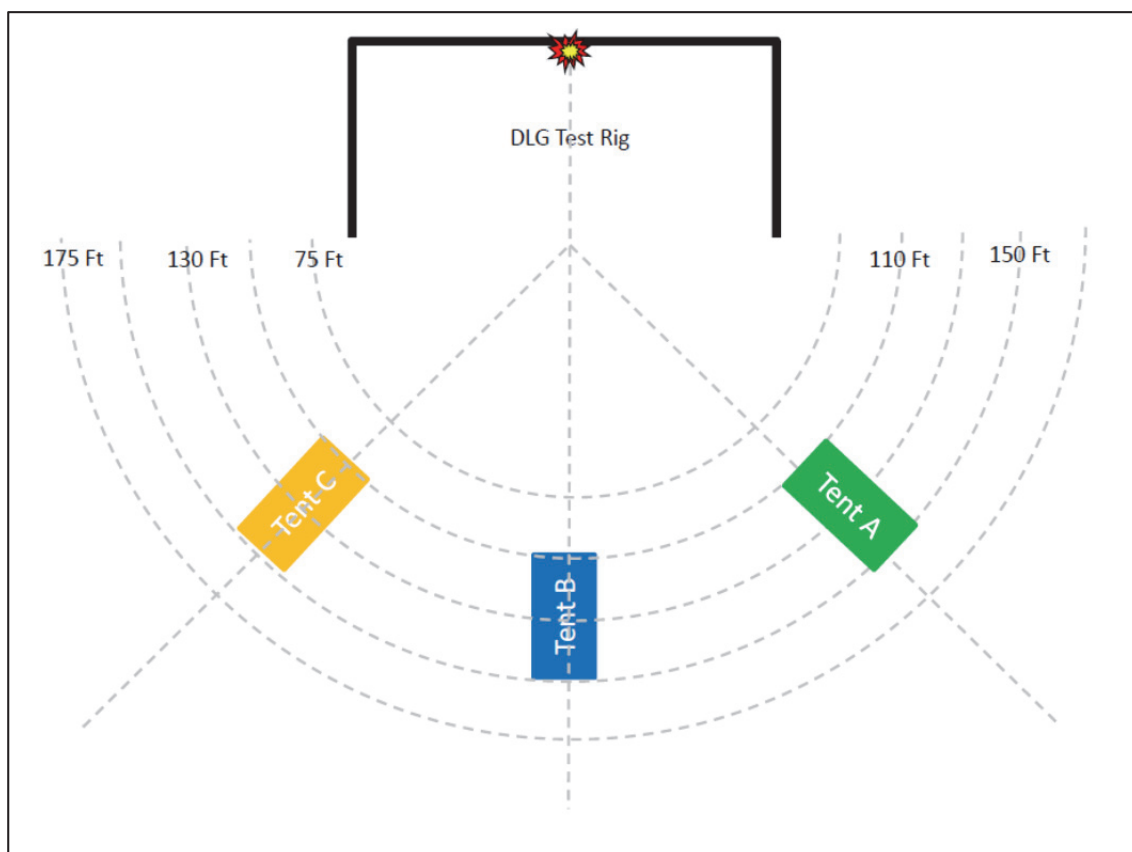
Figure 19. Layout of Tents for Test Series B

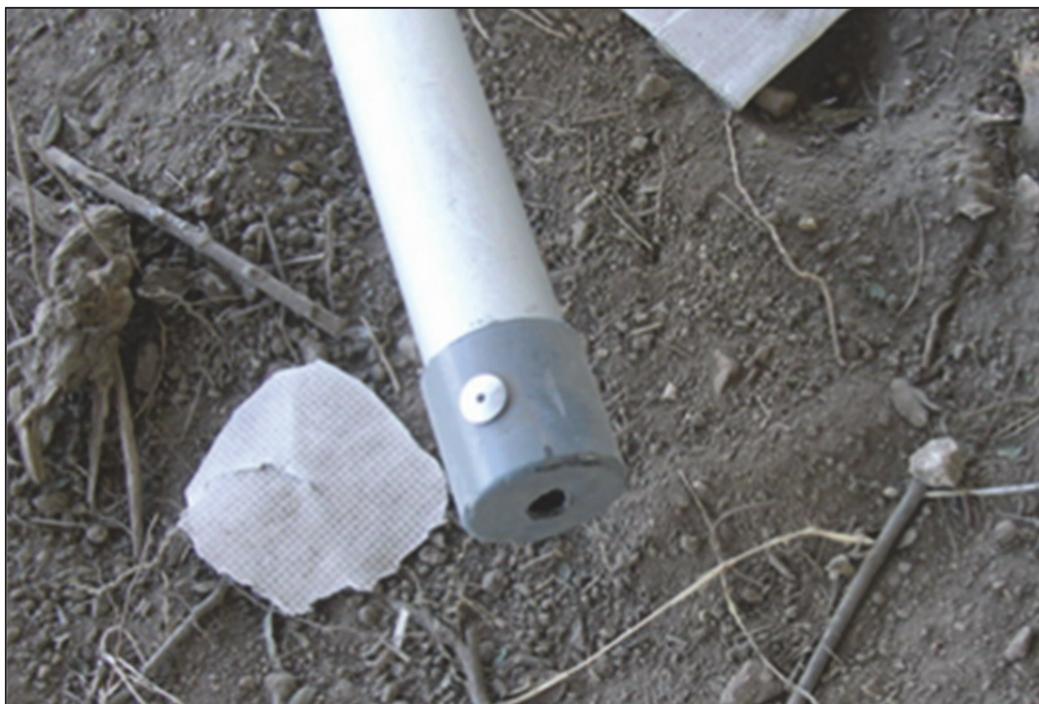
Figure 63. Damage to Connector at Top of Perimeter Pole

Post-test photos of the pole tent are shown in Figure 61 to Figure 64. The damage to the pole tent consisted of:

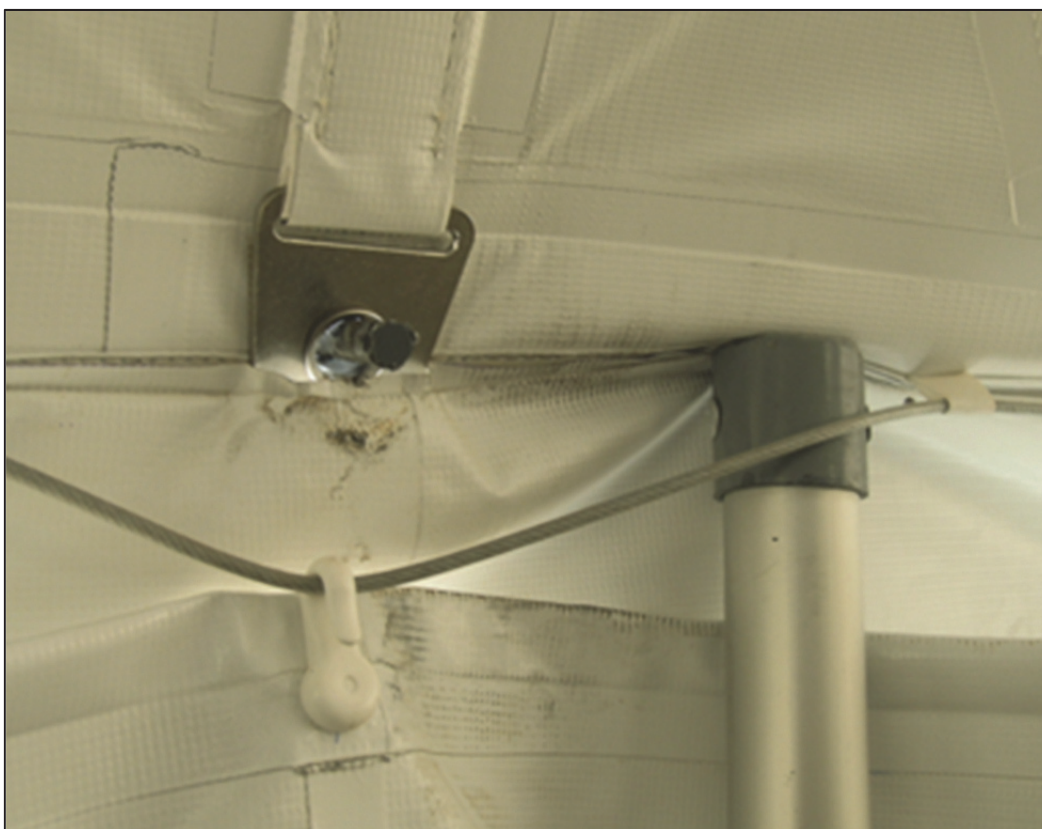
Figure 64. Example of Failed Connector at Top of Side Pole

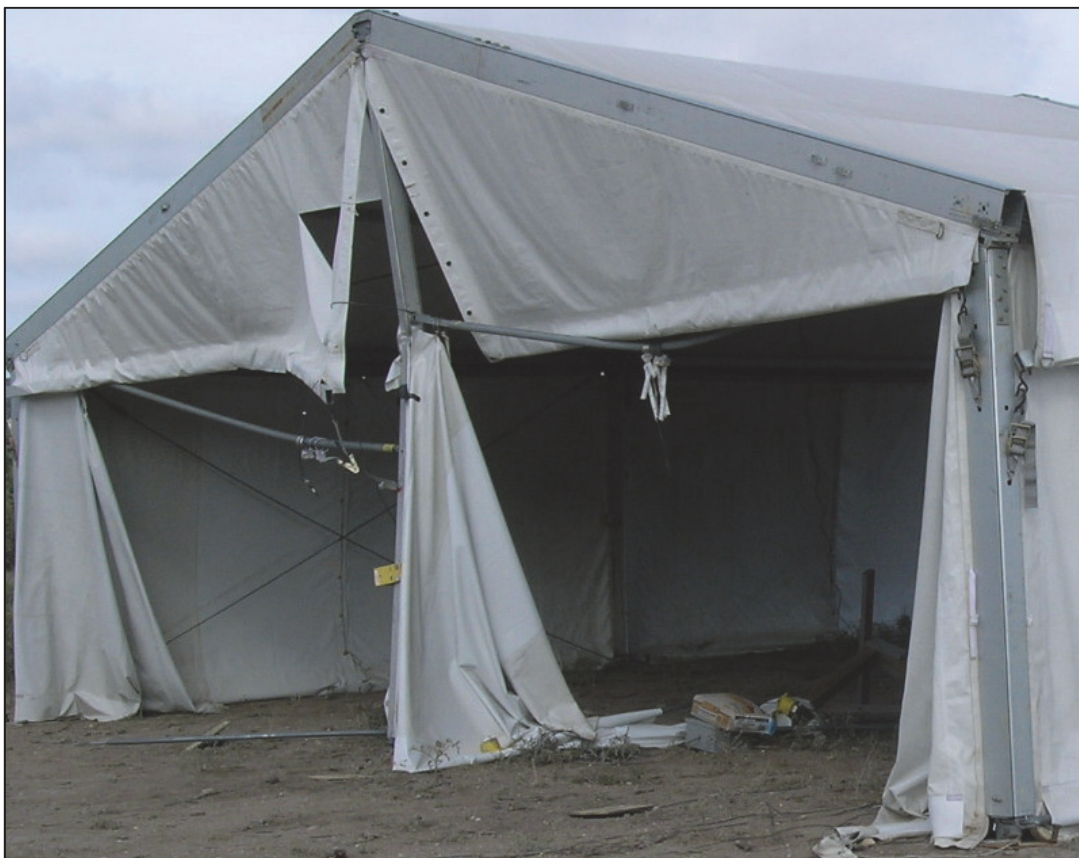
Figure 66. Damage to Front of Framed Tent – Test C01

The moment frame tent suffered more damage than did the pole tent. The damage to the moment frame tent included:

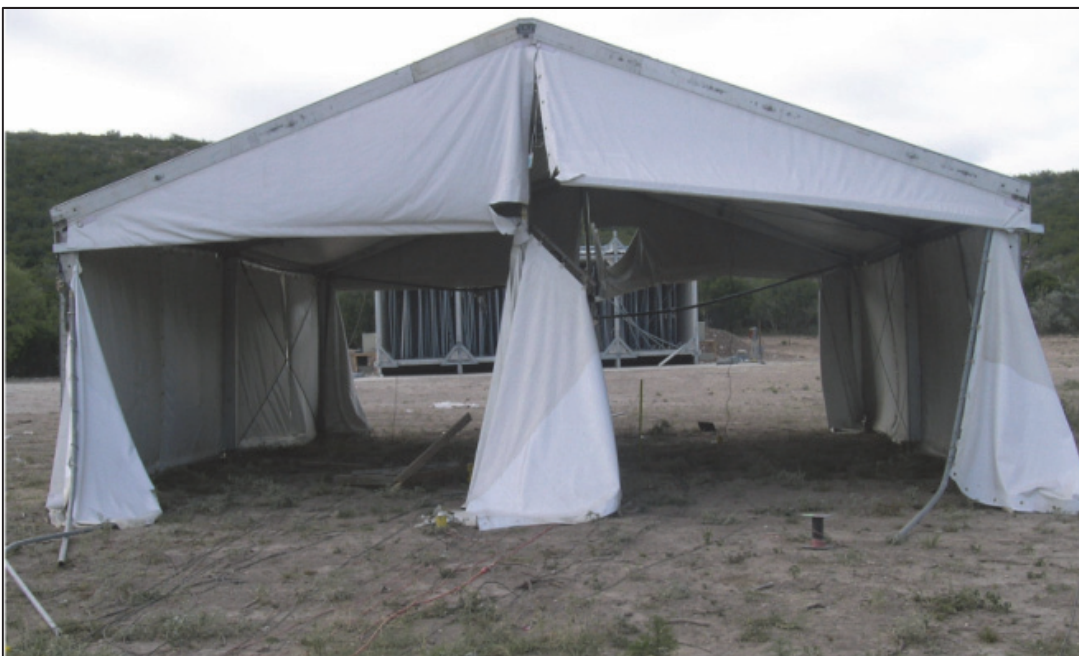
Figure 67. Damage to Rear of Framed Tent – Test C01

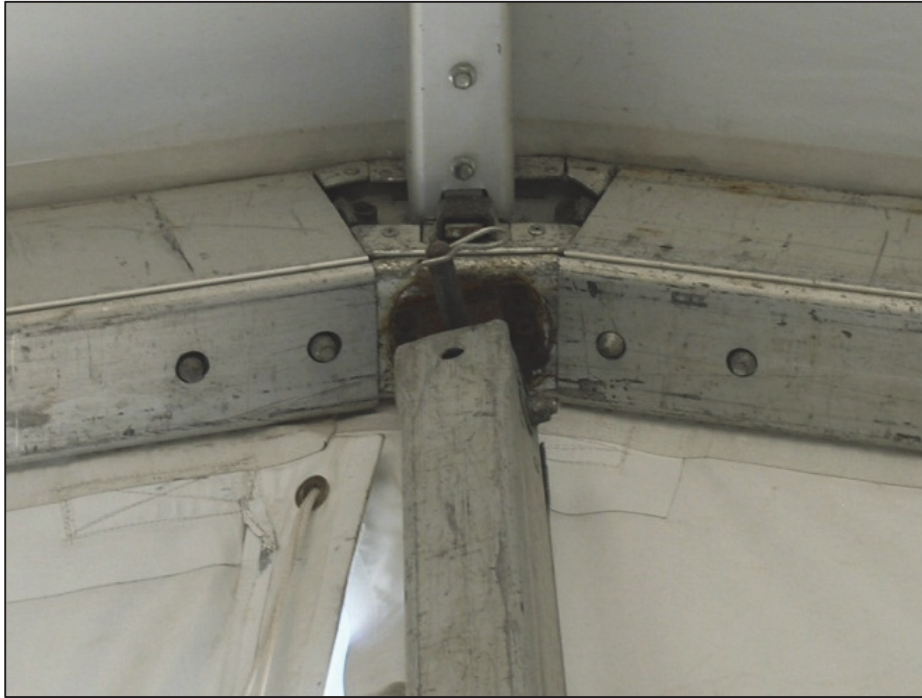
Figure 68. Damage to Framing Joint – Test C01

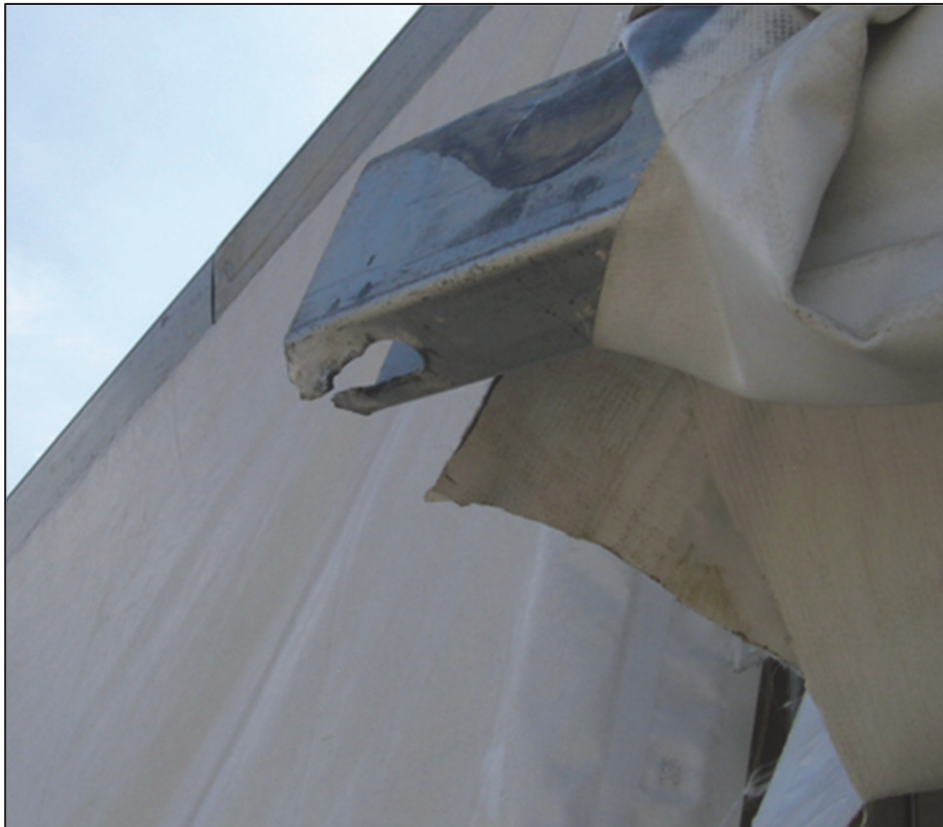
Figure 69. Failed Bolted Connection of Framed Tent – Test C01

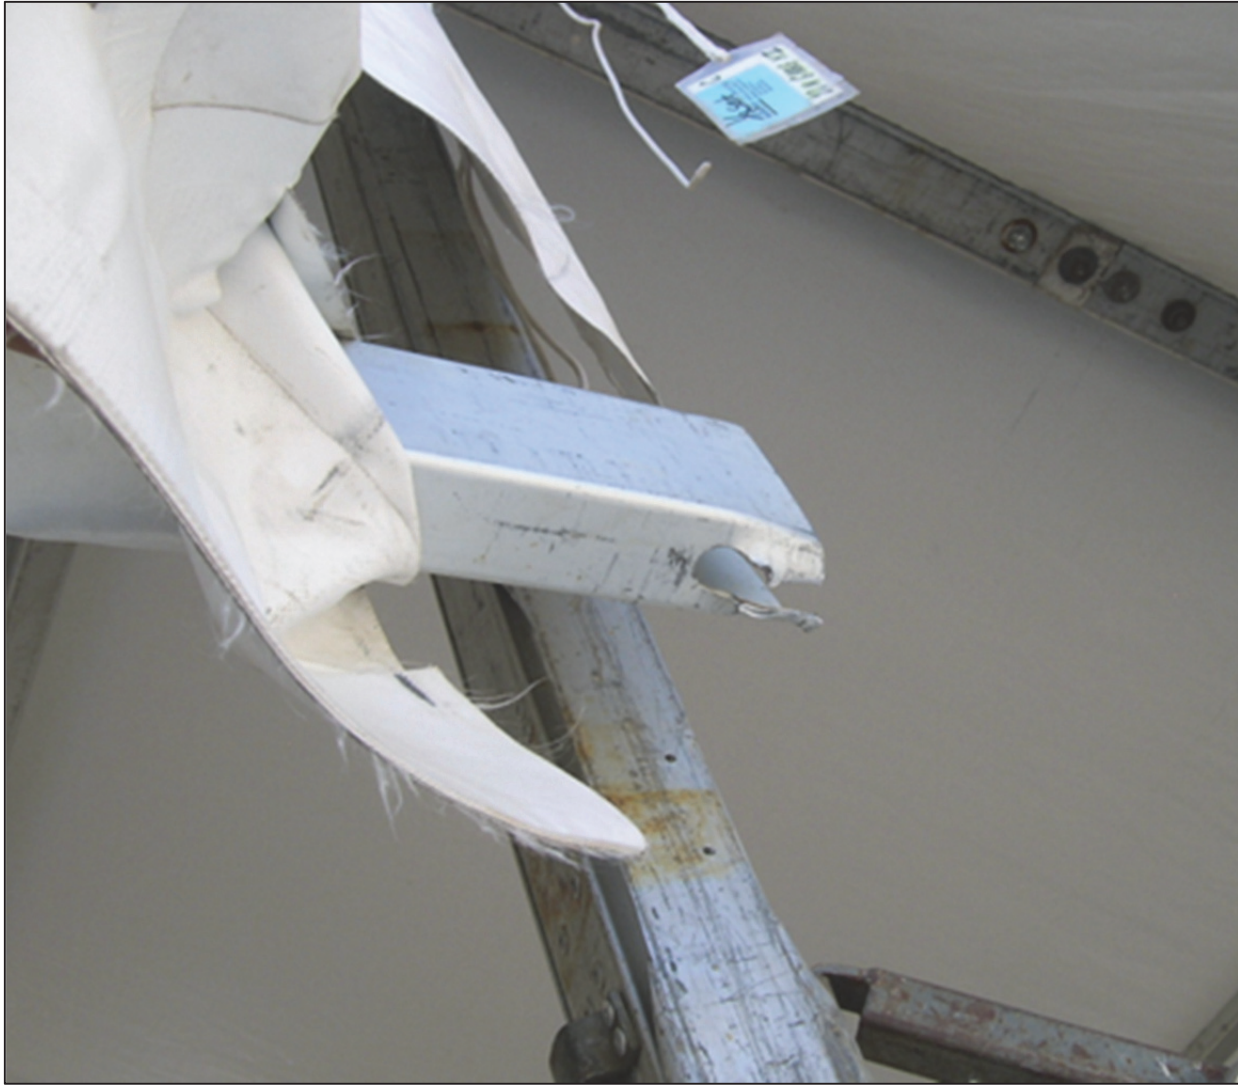
Figure 70. Detail of Failed Horizontal Member – Test C01

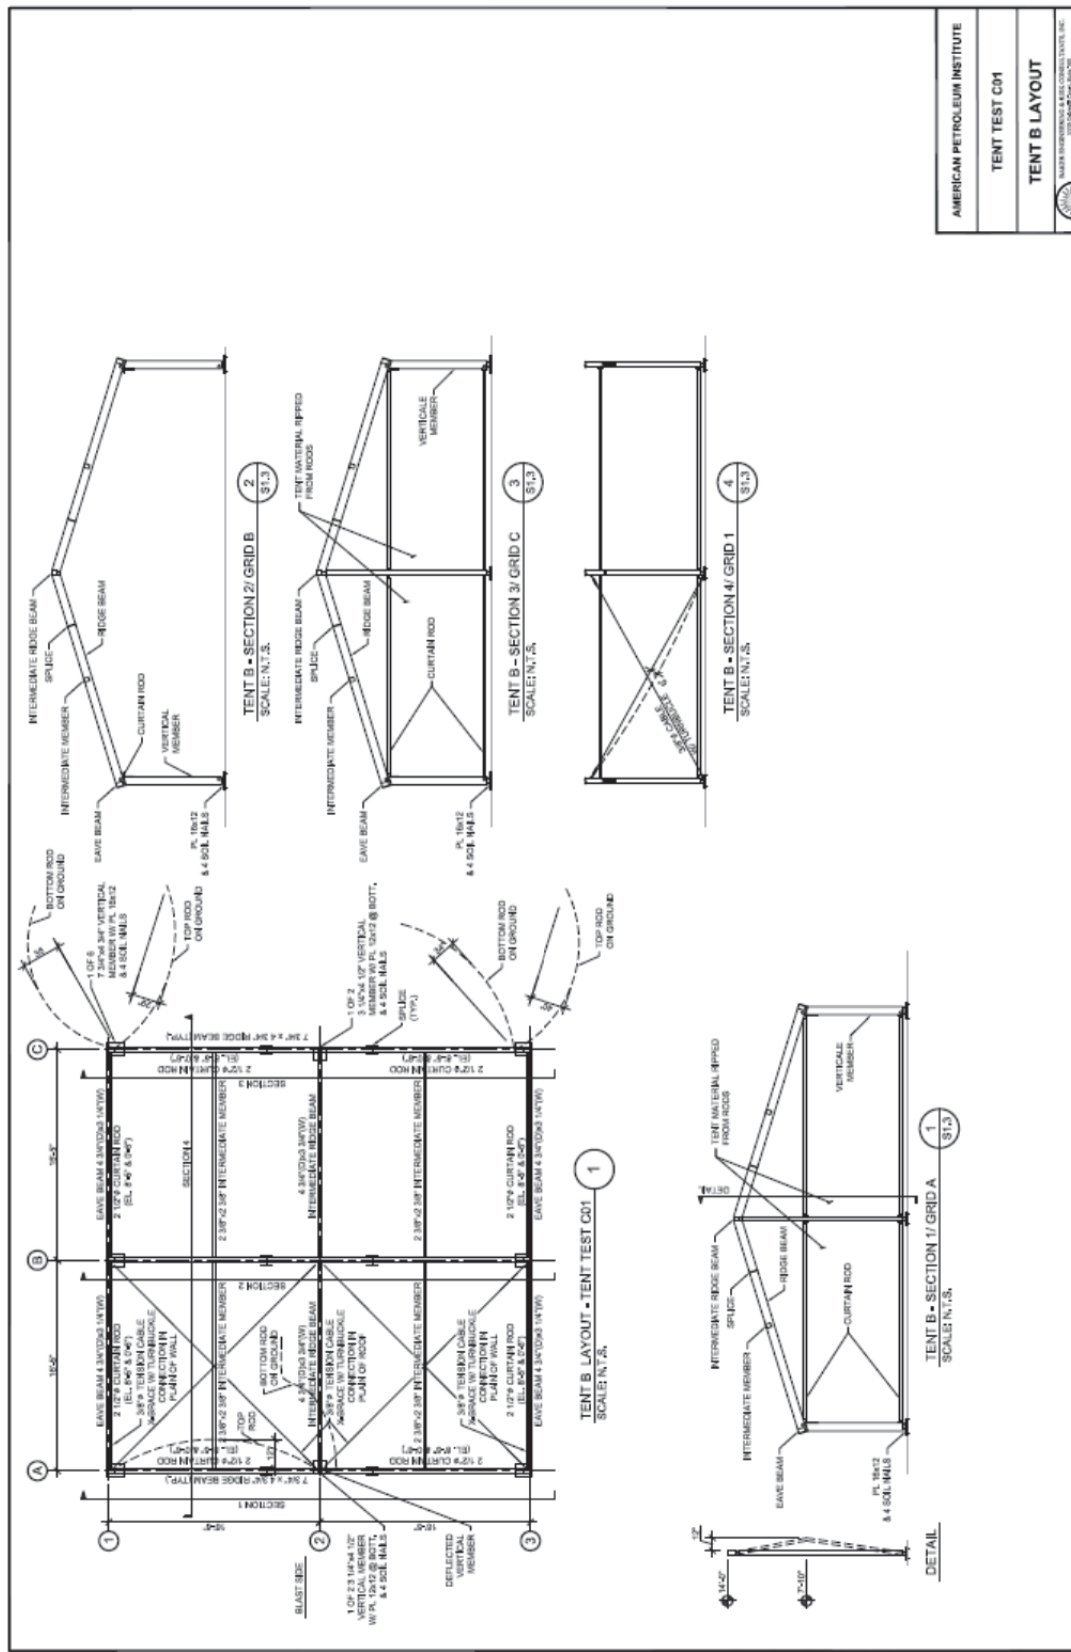
Figure 71. Deformations of Framed Tent – Test C01

The deformations of the moment framed tent are shown in Figure 71.

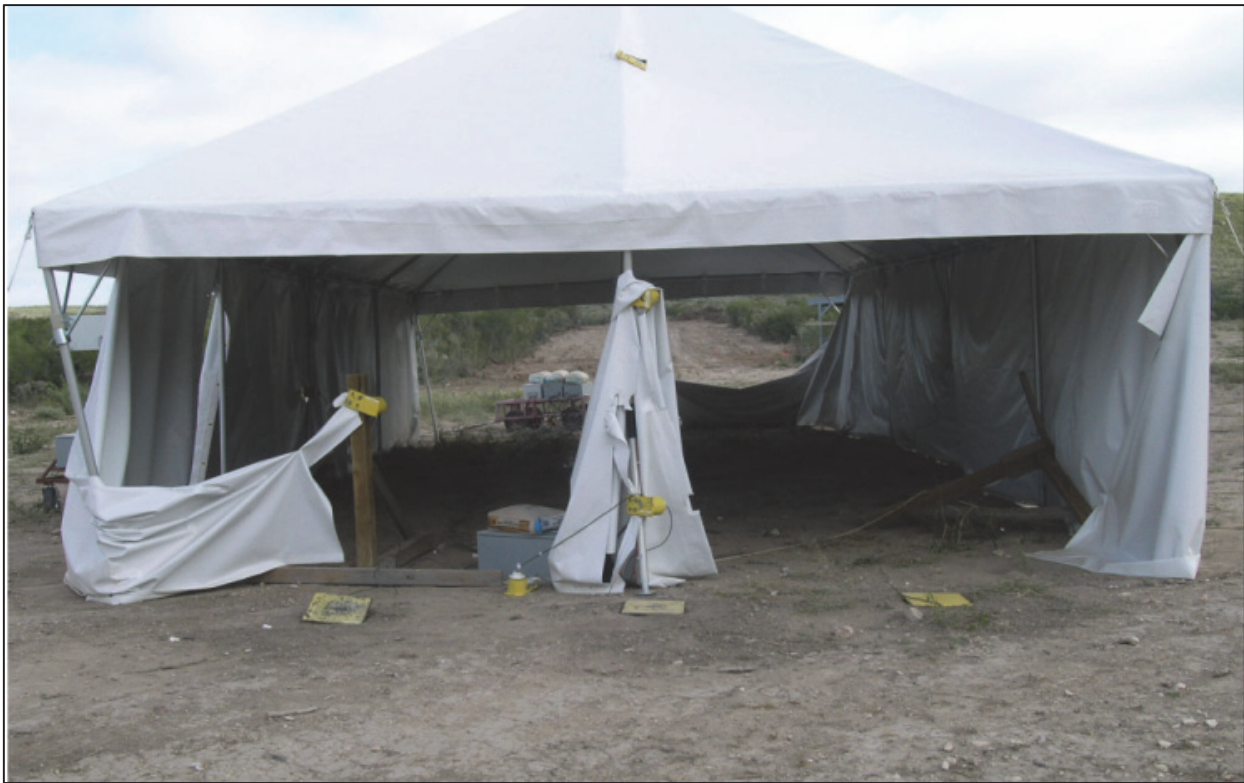
Figure 72. Damage to Front of Light Framed Tent – Test C01

All of the damage is visible in Figure 72. The deformations of the light frame tent are shown in Figure 73.

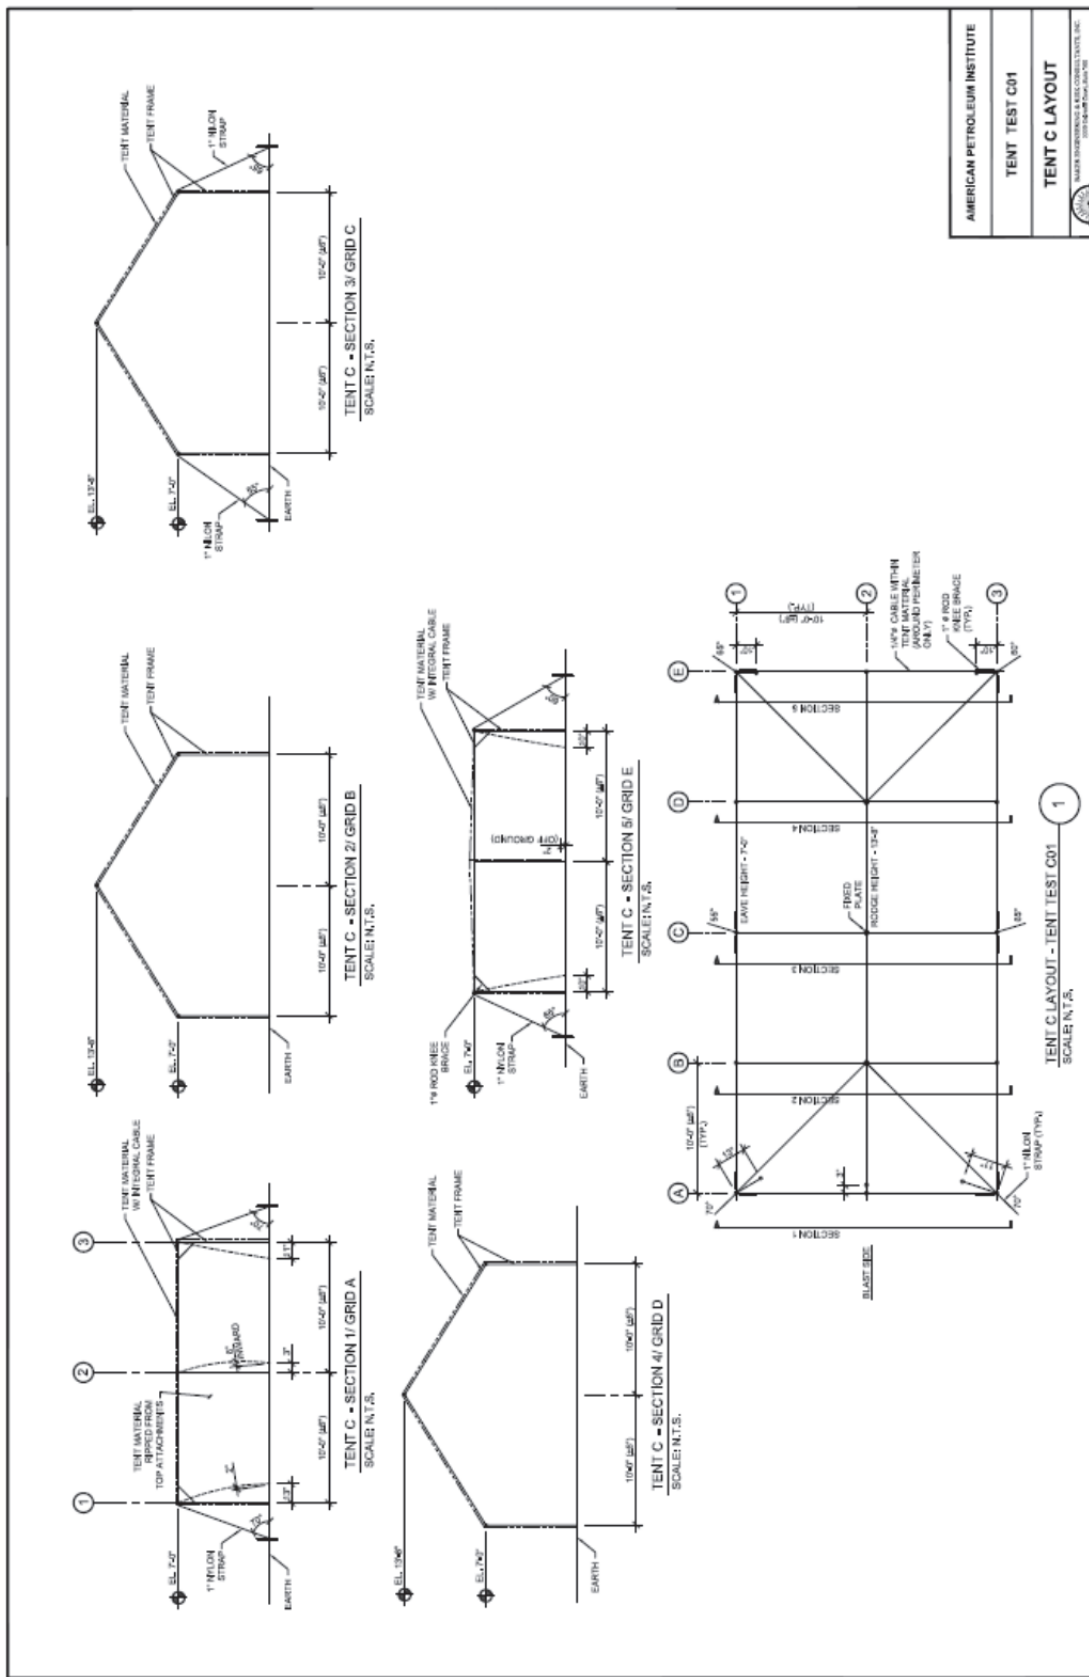
Figure 73. Deformations of Light Framed Tent – Test C01

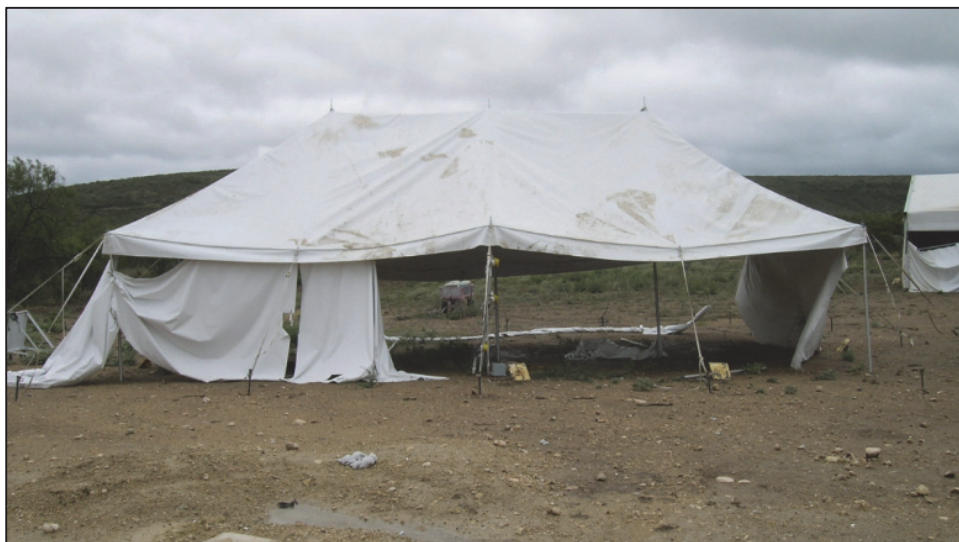
Figure 75. Damage to Pole Tent – Test C02

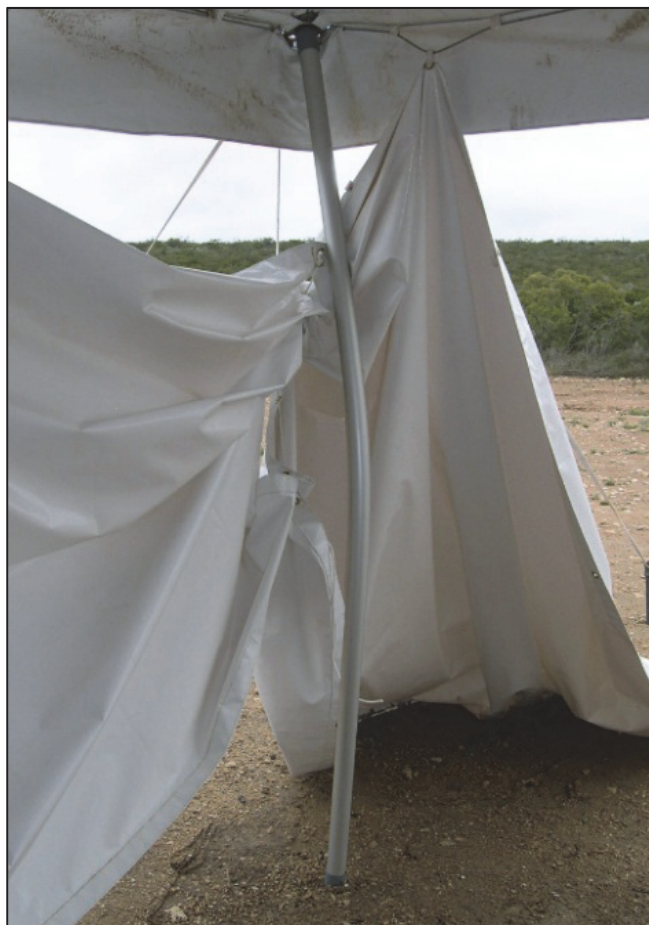
Figure 76. Bent Pole on Pole Tent – Test C02

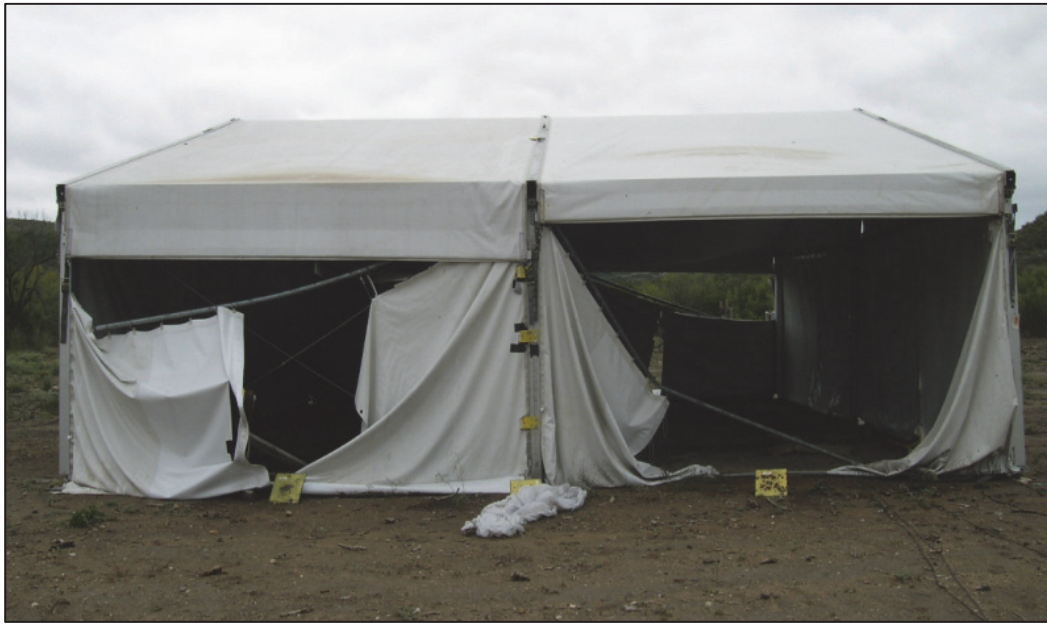
Figure 78. Damage to Side of Framed Tent – Test C2

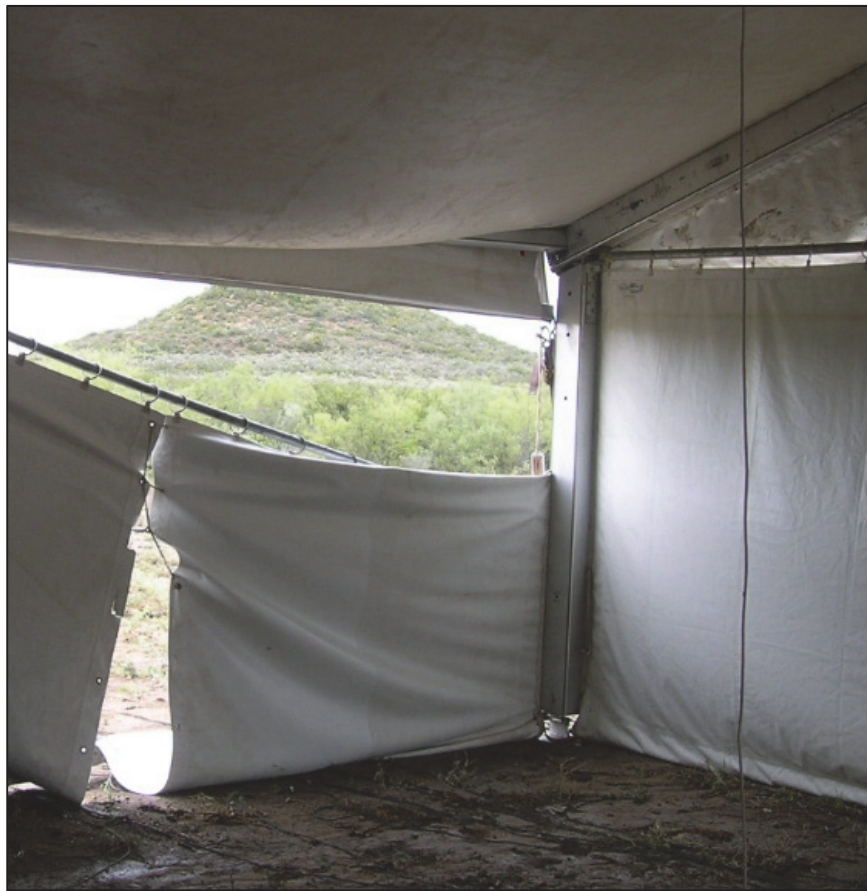
Figure 79. Damage to Rear of Framed Tent – Test C02

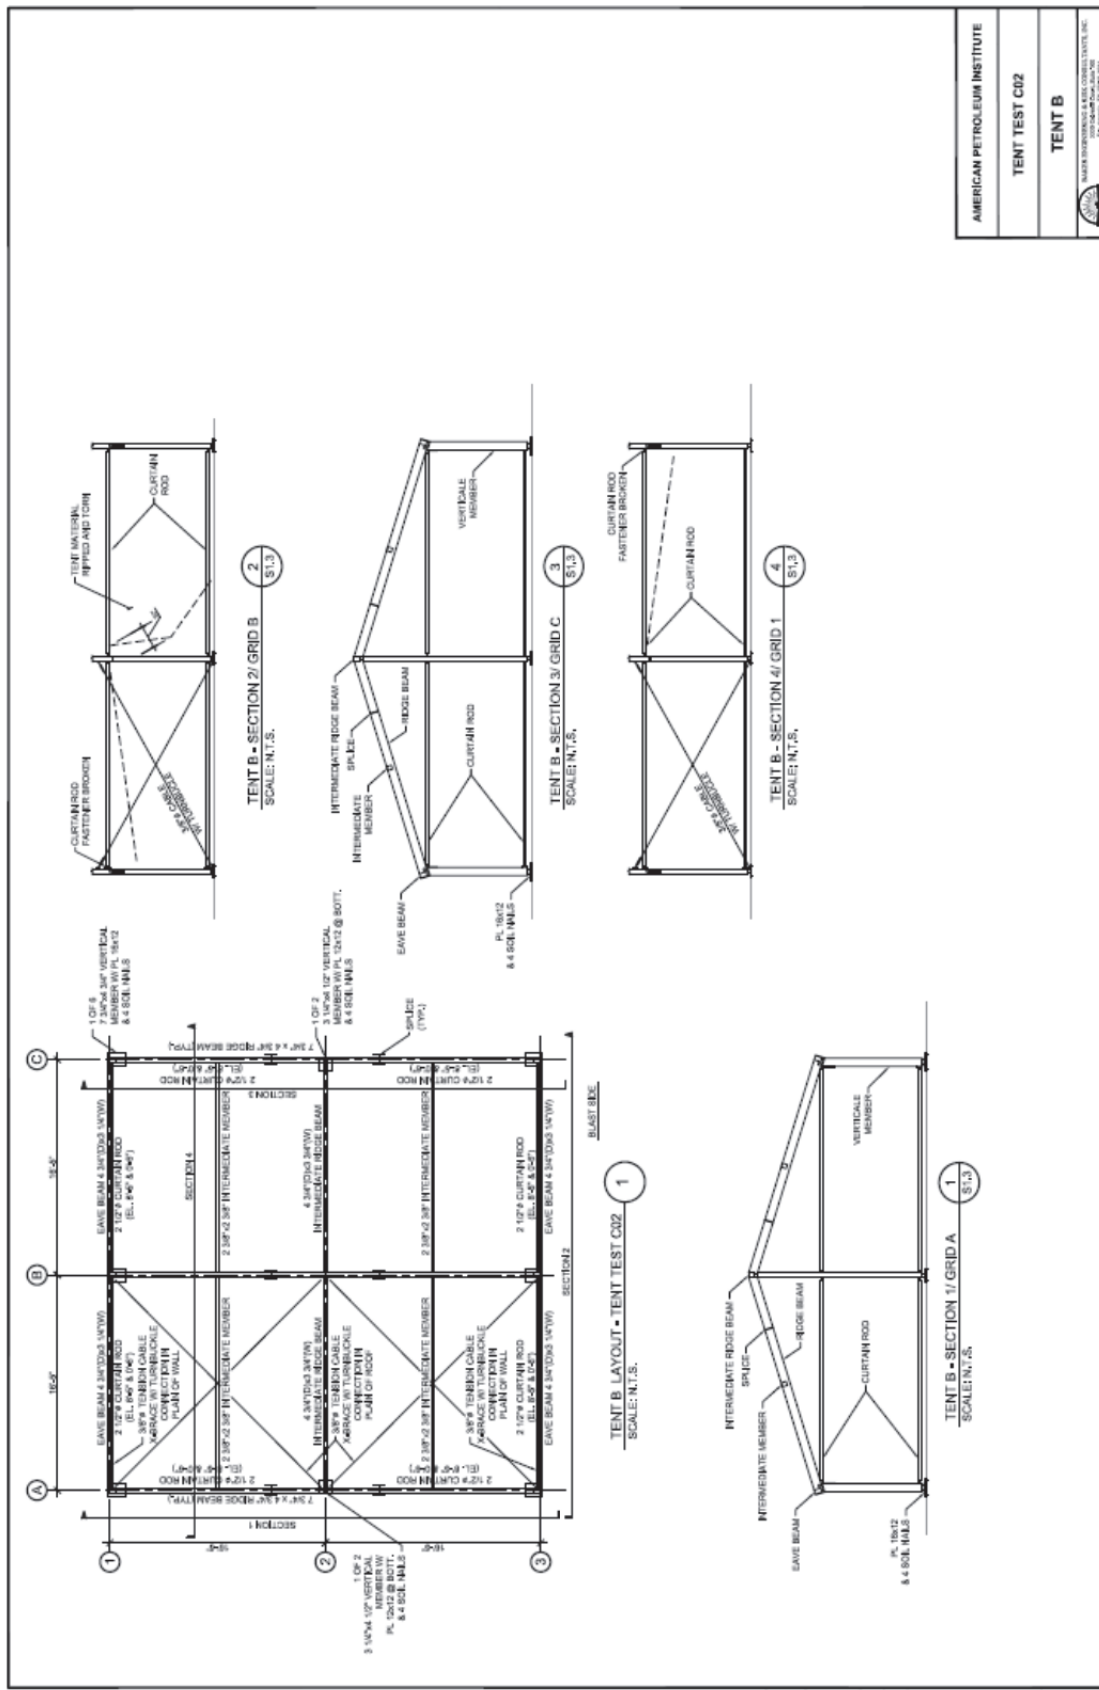
Figure 80. Deformations of Framed Tent – Test C02

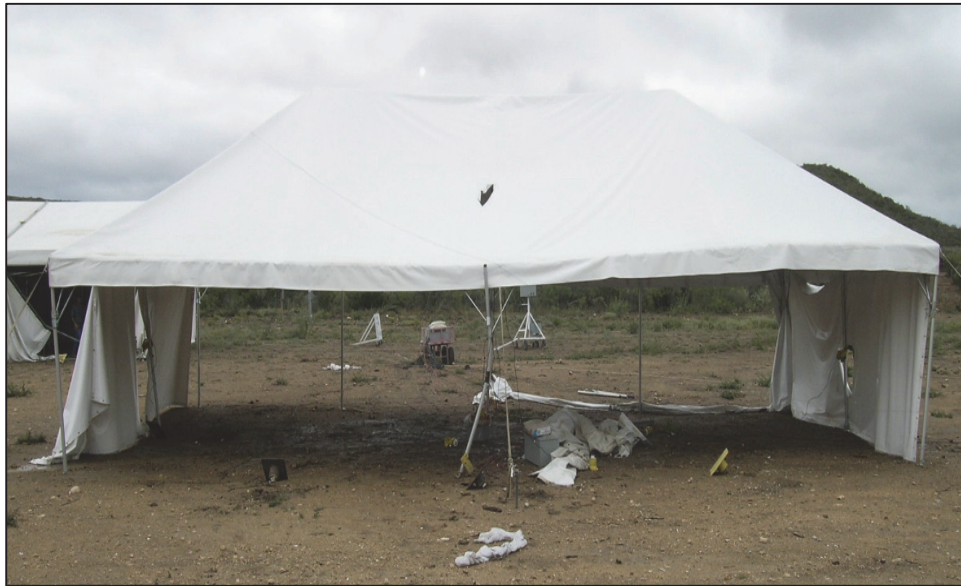
Figure 81. Damage to Light Framed Tent – Test C02
