Process Plant Tent Responses to Vapor Cloud Explosions—Results of the American Petroleum Institute Tent Testing Program

API TECHNICAL REPORT 756-1
SEPTEMBER 2014

Prepared for API by:
Raymond H. Bennett, P.E., Ph.D.
Martin Goodrich, P.E.
Brad Horn

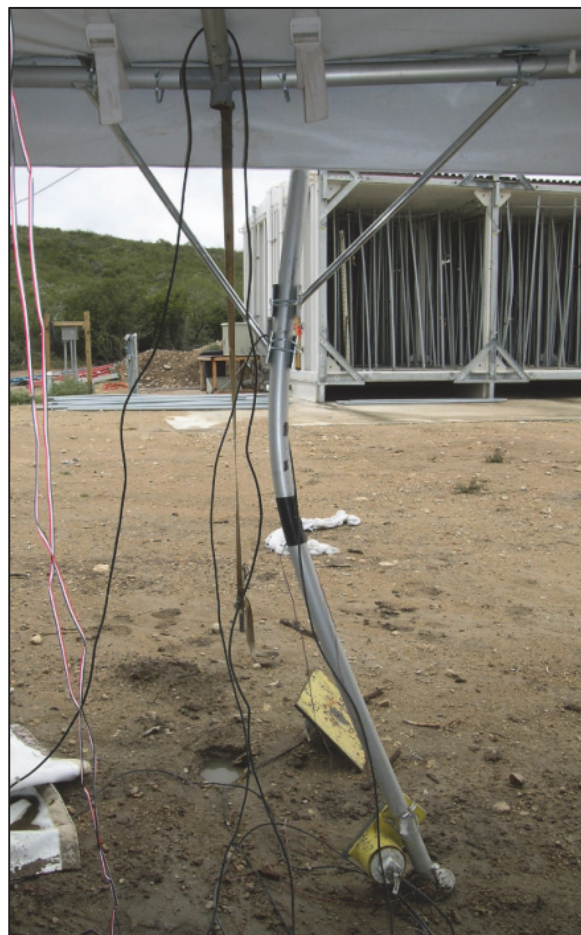
Figure 82. Bending of Side Frame – Test C02

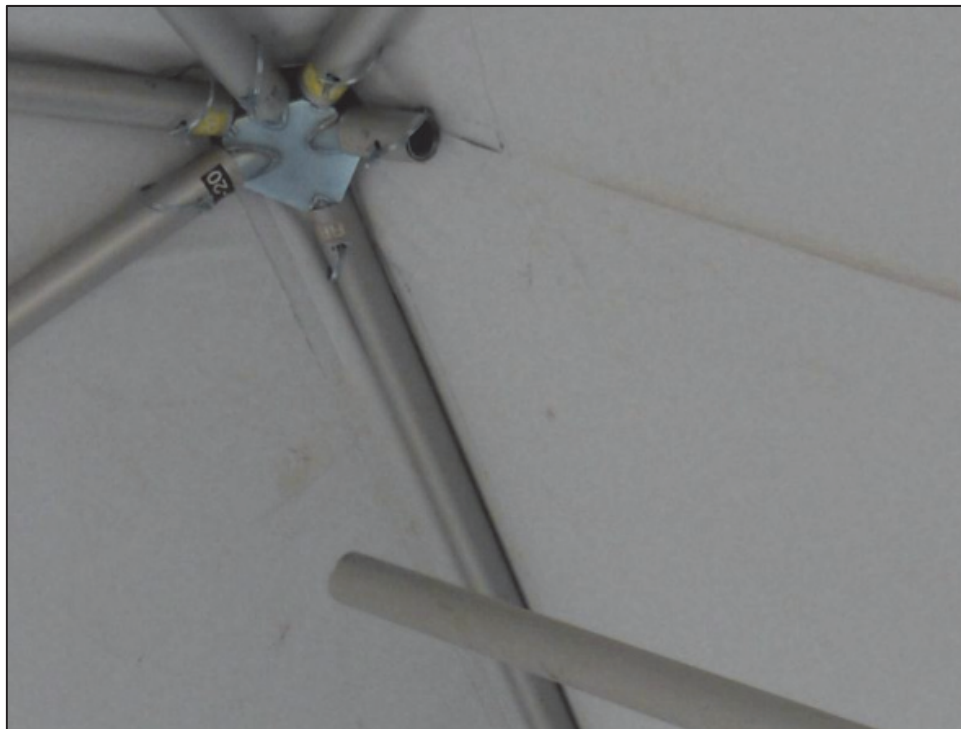
Figure 84. Failure of Roof Frame Connector – Test C02

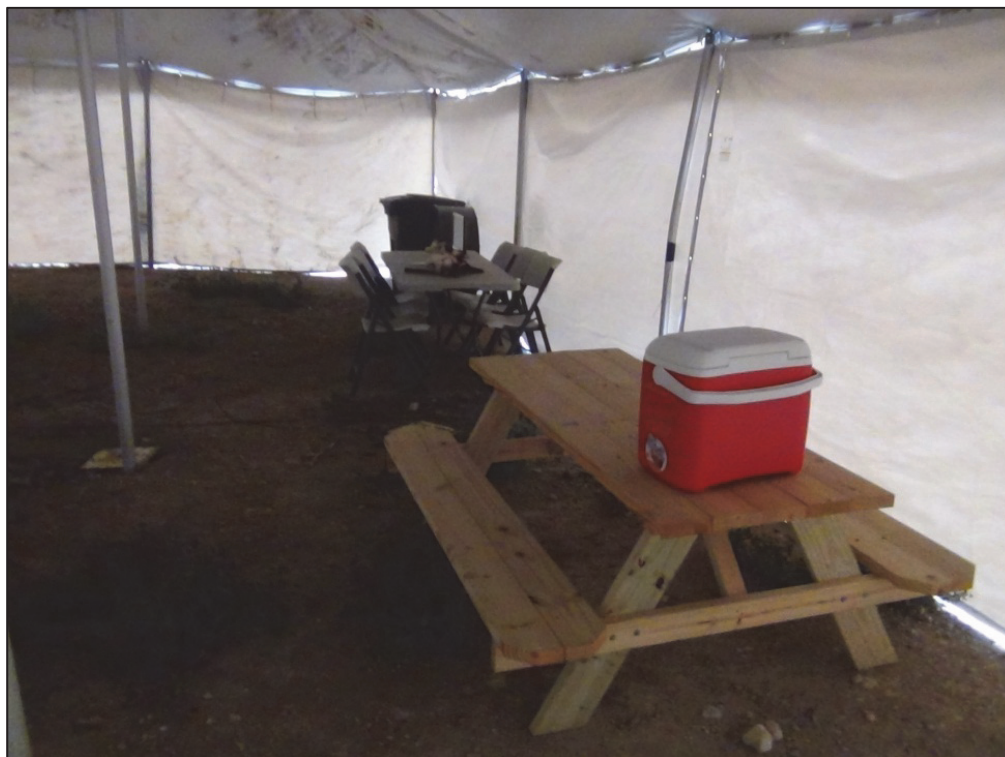
Figure 86. Pre-Test Photo of Tent Contents

For the tests conducted by BakerRisk, several items were placed in the pole tent described in Section 5. The contents are shown in Figure 86 and Figure 87. The contents included a heavy wood picnic table with a filled cooler on top and a lightweight table and folding chairs with a tool belt and computer monitor set on top of the table. A typical wheeled trash container and fan were included as well. The post-test condition of these items is shown in Figure 87 and Figure 88. The item displacement was due to being struck by the tent wall fabric and the collapsing side pole.

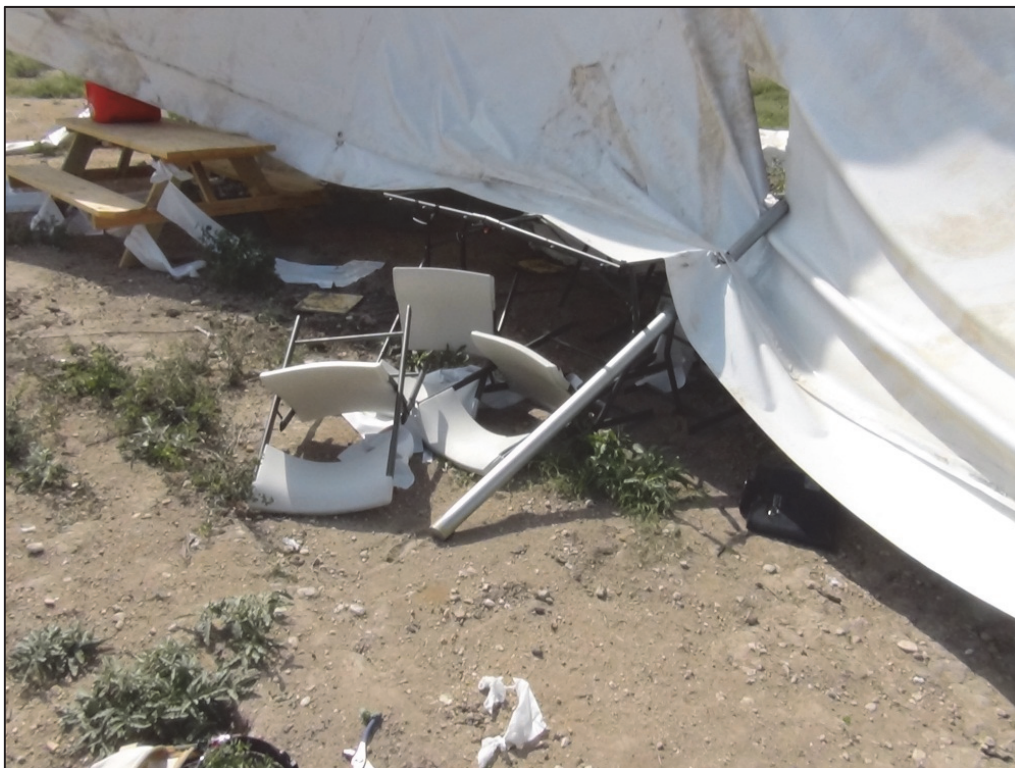
Figure 89. Damage to Pole Tent and Displacement of Table and Chairs

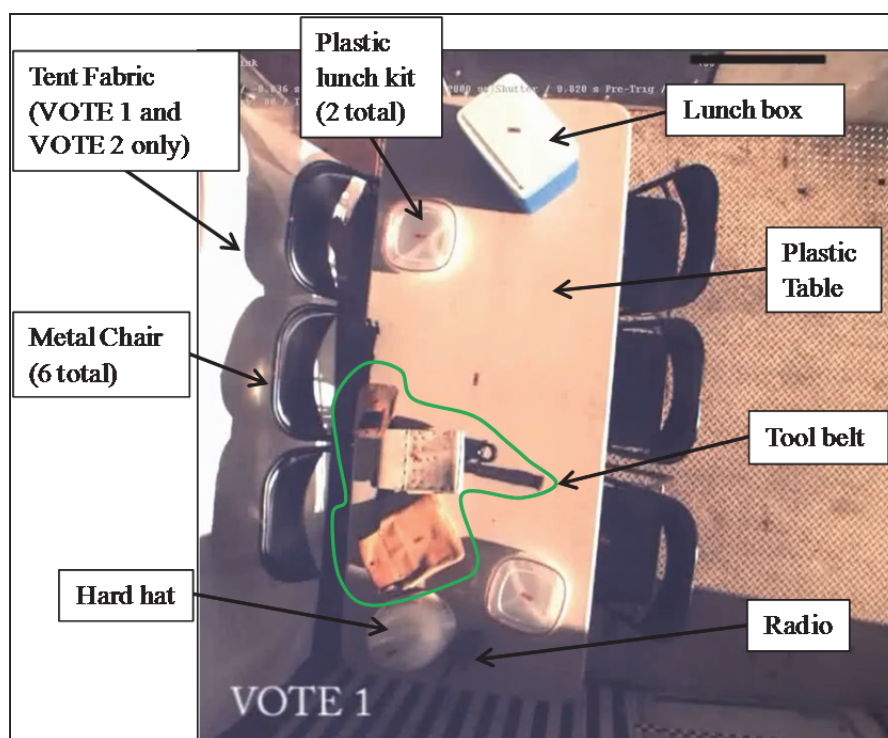
Layout A represents a typical lunch room or break room, and includes a lightweight plastic table with metal folding chairs. The table was oriented so that its long side was parallel to the tent fabric, and was positioned in close proximity to the fabric. A number of typical lunch room items were also positioned on the table: lunch boxes, plastic food containers, a hard hat, portable radio, and a tool belt with multiple pouches and containing some tools.

Figure 90. Test Layout A, Lunch Room with Plastic Table

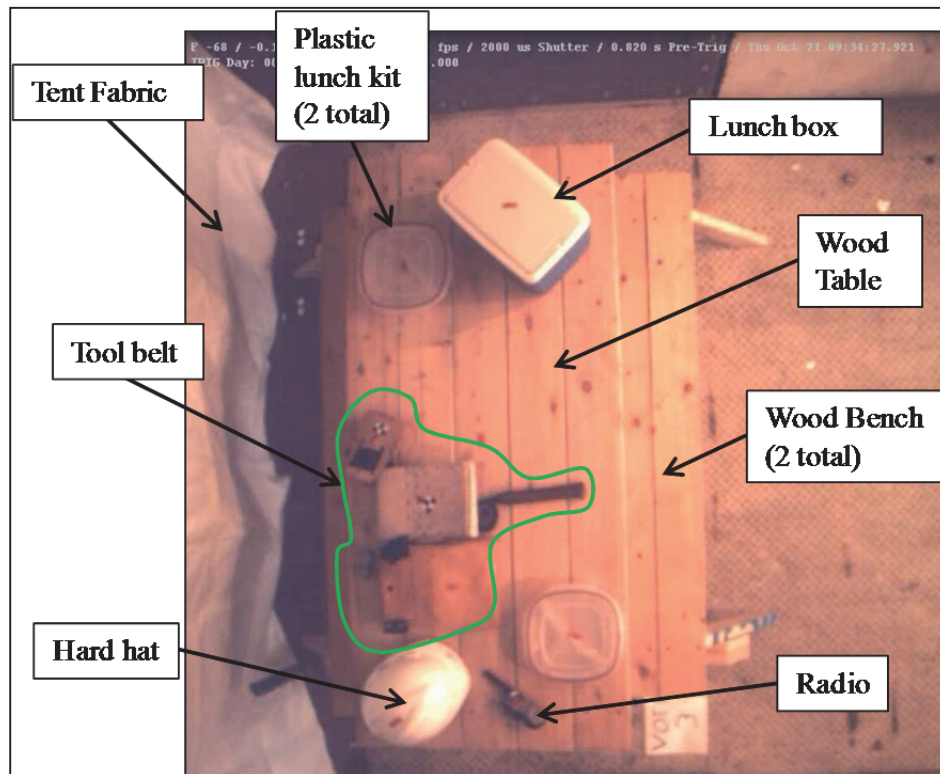
Figure 91. Test Layout A', Lunch Room with Wooden Table

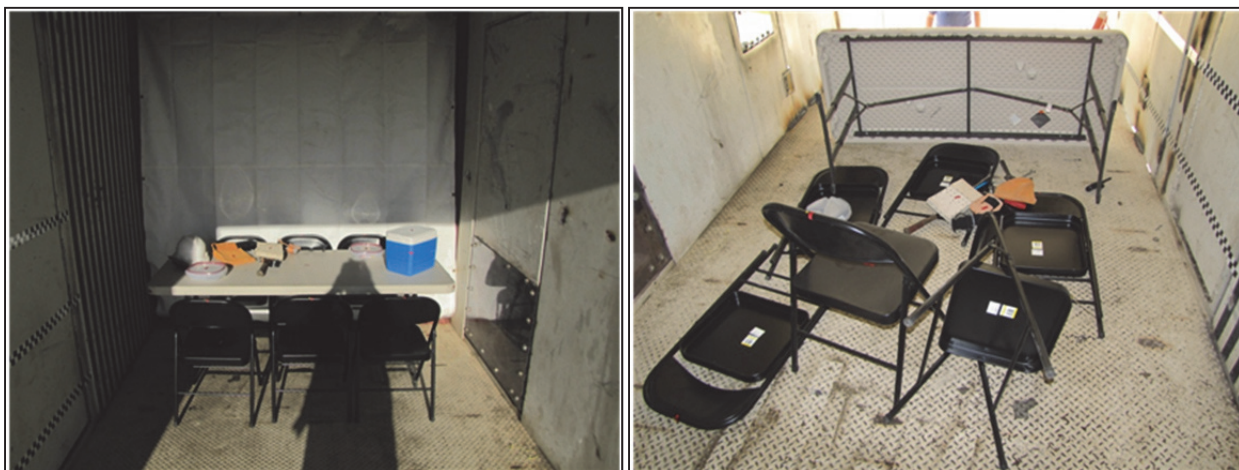
Figure 96. Test 1, Pre- and Post-Test Photographs

Test Conditions				Object	Mass		Velocity	
Test No.	Layout	Pressure (psi)	Impulse (psi-ms)		lbm	kg	Ft/s	m/s
1	A	1	20	Table	35	16	12	3.6
				Chair	7.8	3.5	16	4.8
				Lunchbox	2.2	1.0	18	5.6
2	A	2.5	50	Table	36	16	16	4.8
				Chair	7.8	3.5	24	7.4
				Tool Belt	11	5.0	14	4.3
3	A'	2.9	55	Table	35	15.7	7.4	2.2
				Lunchbox	2.2	1.0	25	7.6
5	A – No Fabric	2.9	50	Lunchbox	2.2	1.0	3.1	0.9
				Hard Hat	0.8	0.4	12	3.6
6	C	1	20	Lamp	11	4.9	13	3.8
8	D	2.9	57	Water Cooler Bottle	40	18	18	5.6
9	E	1	20	Supply Box B	6	2.7	17	5.1
				Supply Box C	8.8	4.0	17	5.1
				Microwave	32	15	17	5.1
10	B	2.9	50	Chair 3	7.8	3.5	10	3.0
				Chair 4	7.8	3.5	12	3.6
				Lunchbox	2.2	1.0	5.9	1.8
				Tool Belt	11	5.0	13	3.8
				Table	35	16	13	4.1

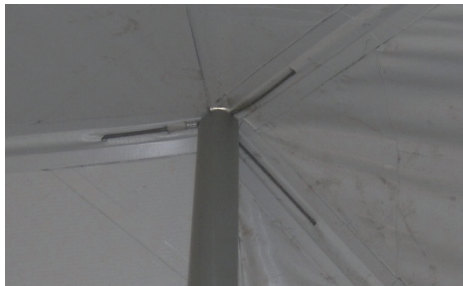
- The top fabric seams included a $\frac{1}{4}$ in. dia. 7 x 19 aircraft cable with a minimum breaking strength of 2250 lbs. as shown in Figure A-13. The same cable was included in the roof panels at the eaves.
- The guy ropes were replaced with 1-inch wide nylon straps with a specified minimum breaking strength of 5600 lbs.

Figure A-13—Top of Interior Pole Showing Cables Embedded in Fabric

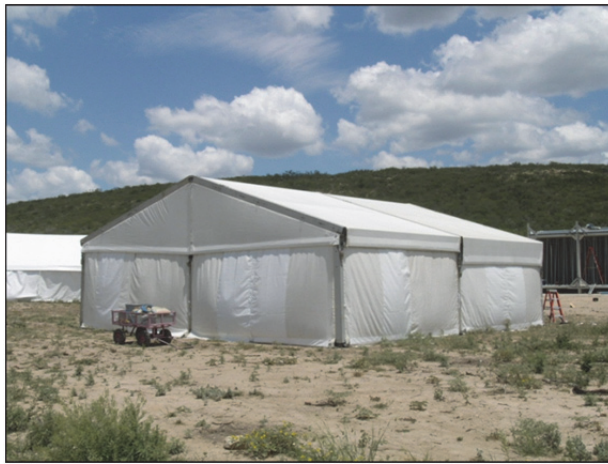
The rigid frame tent is shown in Figure A-15. The tent was 10 m (33 feet) square and supported in the longitudinal direction by three rigid moment frames. The lateral resistance along the length was provided by cable cross bracing. The frames and cross bracing can be seen in Figure A-16. The tent side walls were designed to be slid open and were supported on “curtain rods”. The failure of these rods dominated the response of the tent, and may not be representative of industrial applications.

Figure A-15—Rigid Frame Tent

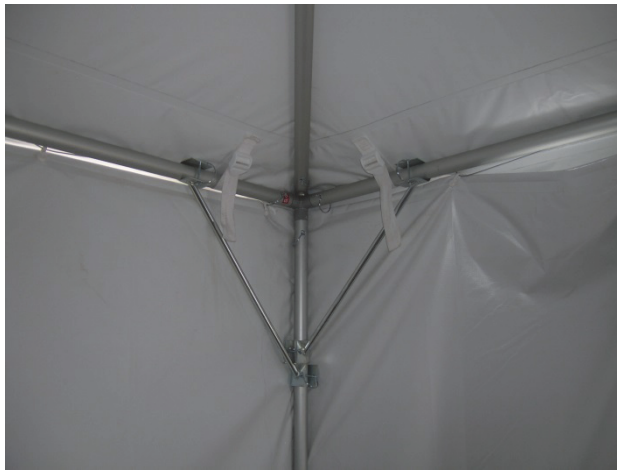
- The guy ropes were replaced with 1-inch wide nylon straps with a specified minimum breaking strength of 5600 lbs. This same change was made for the wind rated pole tent.
- The connections between the side poles and eave struts were braced as shown in Figure A-24 and Figure A-25 with ASTM A512 Steel Tubing.
- The hub connectors were more robust as shown in Figure A-26 and Figure A-27. The connection hubs were hot rolled steel type 1000 ASTM A513 schedule 10 pipes, welded to steel plates.

Figure A-24—Tubular Bracing at Corners
