**Atmospheric Corrosion
Investigation of
Aluminum-Coated,
Zinc-Coated, and
Copper-Bearing
STEEL WIRE and
WIRE PRODUCTS**

A THIRTY-TWO YEAR REPORT

**Sponsored by ASTM Committee A5 on
Metallic-Coated Iron and Steel Products**

ASTM Data Series: DS 65
Revision of STP 585A
ASTM Publication Code Number (PCN):
05-015950-02

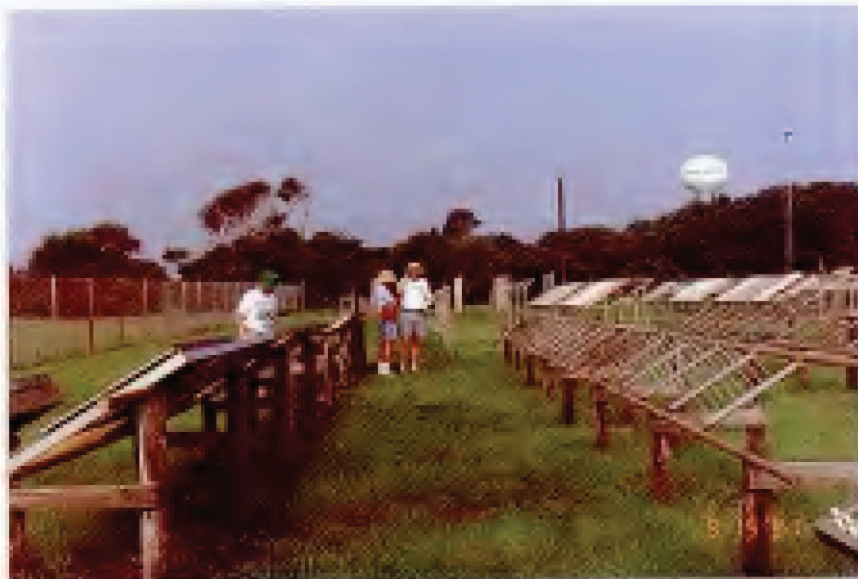
FIG. 1. Overall View of the Kure Beach, NC 800-ft Test Site illustrates the mounting of the unfabricated test wire specimens.

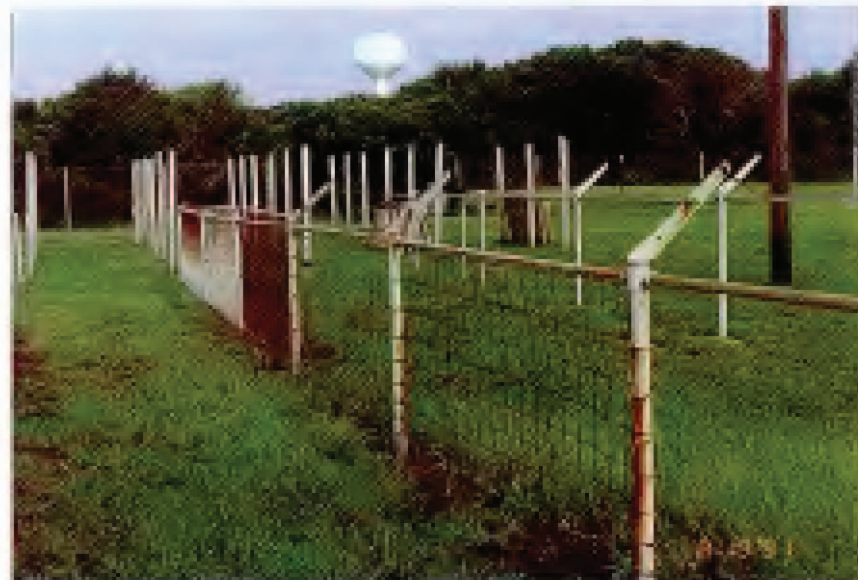
FIG. 2. Overall View of the Kure Beach, NC 800-ft Test Site illustrates the mounting of the field fence, barbed wire, and chain link fabric test specimens.

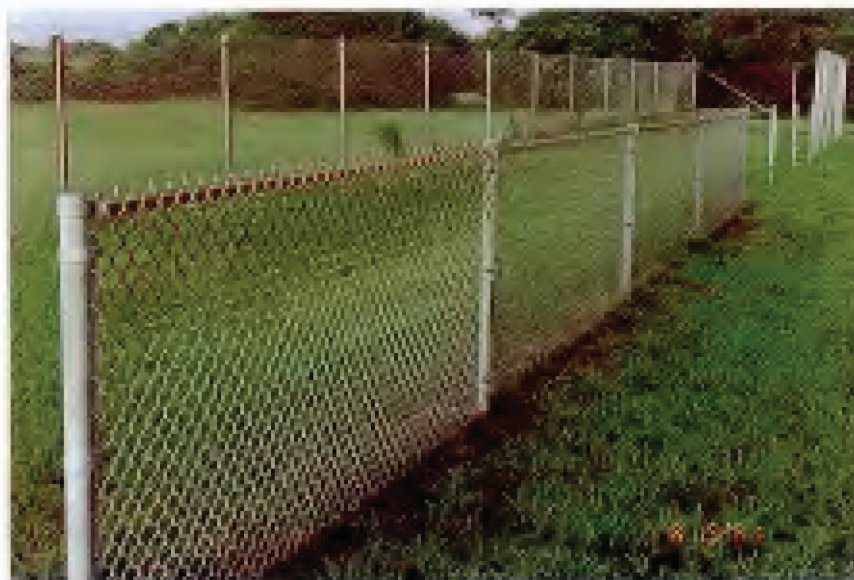
FIG. 3. Overall View of the Kure Beach, NC 800-ft Test Site illustrates the mounting of the chain link fabric test specimens.

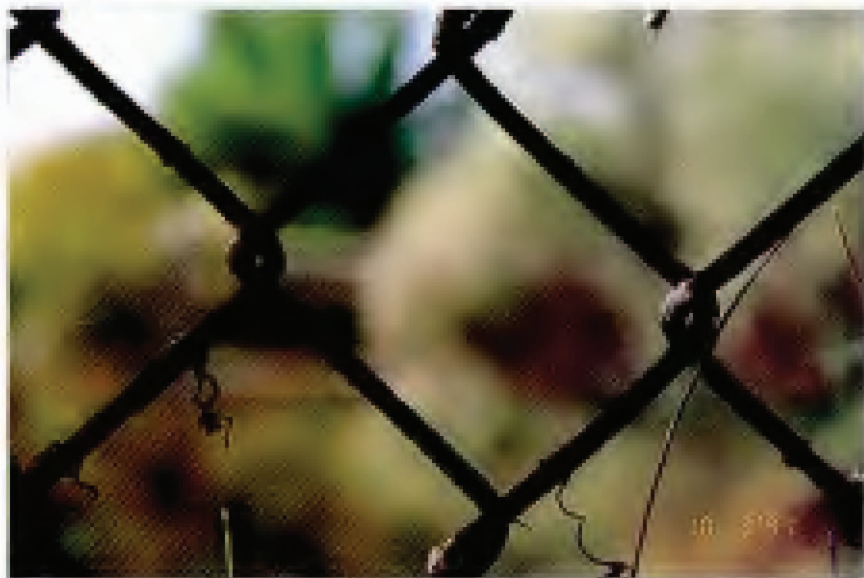
FIG. 4. Specimen 32 – Hot-dip Galvanized Chain Link Fabric. Original coating weight: 1.77 oz/ft² (540 g/m²). Exposure site: Brazos River, TX. 30-year condition of links (see Table 13): 95R, 5wc.

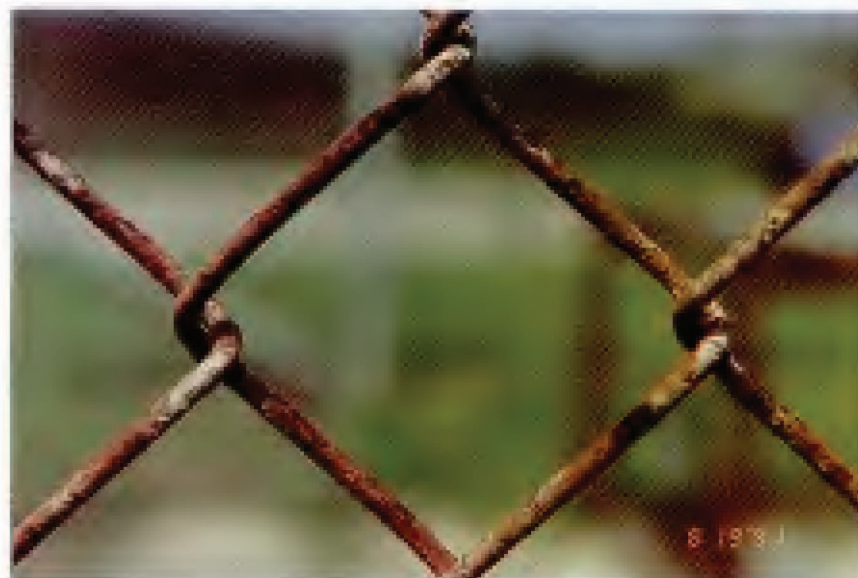
FIG. 5. Specimen 32 – Hot-dip Galvanized Chain Link Fabric. Original coating weight: 1.77 oz/ft² (540 g/m²). Exposure site: Kure Beach, NC (80-ft site). 30-year condition of links (see Table 13): 100R.

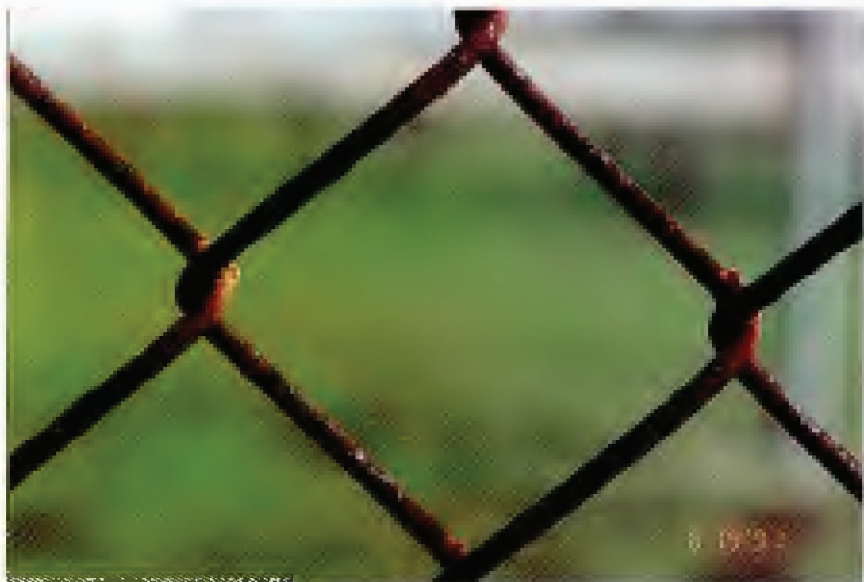
FIG. 6. Specimen 32 – Hot-dip Galvanized Chain Link Fabric. Original coating weight: 1.77 oz/ft² (540 g/m²). Exposure site: Kure Beach, NC (800-ft site). 30-year condition of links (see Table 13): 95R, 5wc.

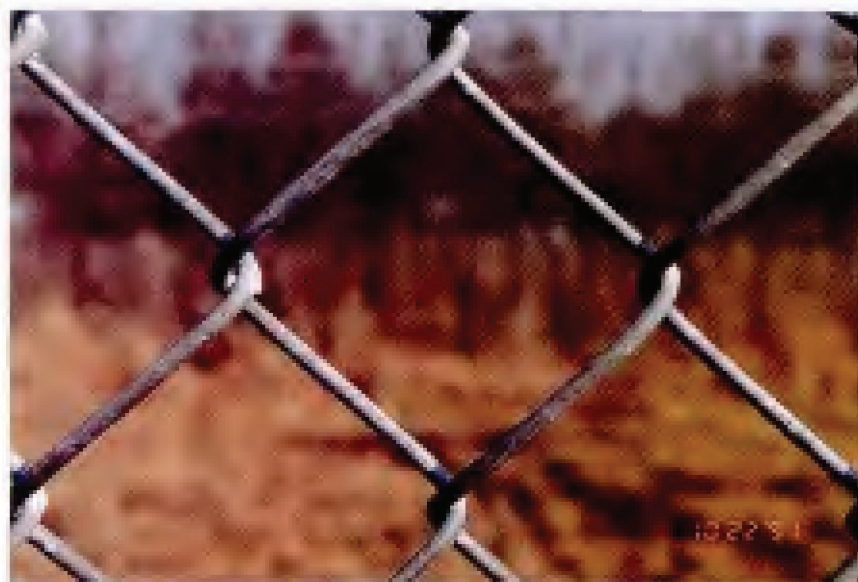
FIG. 7. Specimen 32 – Hot-dip Galvanized Chain Link Fabric. Original coating weight: 1.77 oz/ft² (540 g/m²). Exposure site: Manhattan, KS. 30-year condition of links (see Table 13): 40G, 60Y.

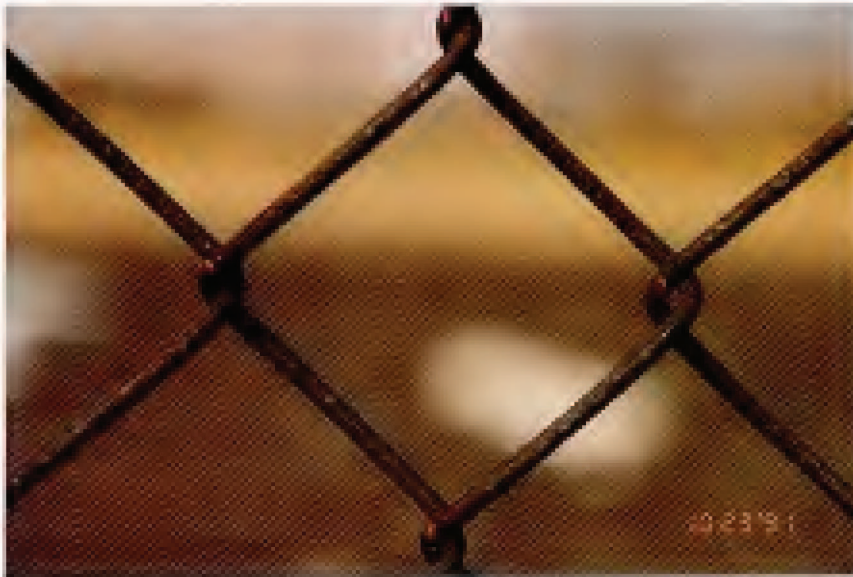
FIG. 8. Specimen 32 – Hot-dip Galvanized Chain Link Fabric. Original coating weight: 1.77 oz/ft² (540 g/m²). Exposure site: Newark-Kearny, NJ. 30-year condition of links (see Table 13): 100R.

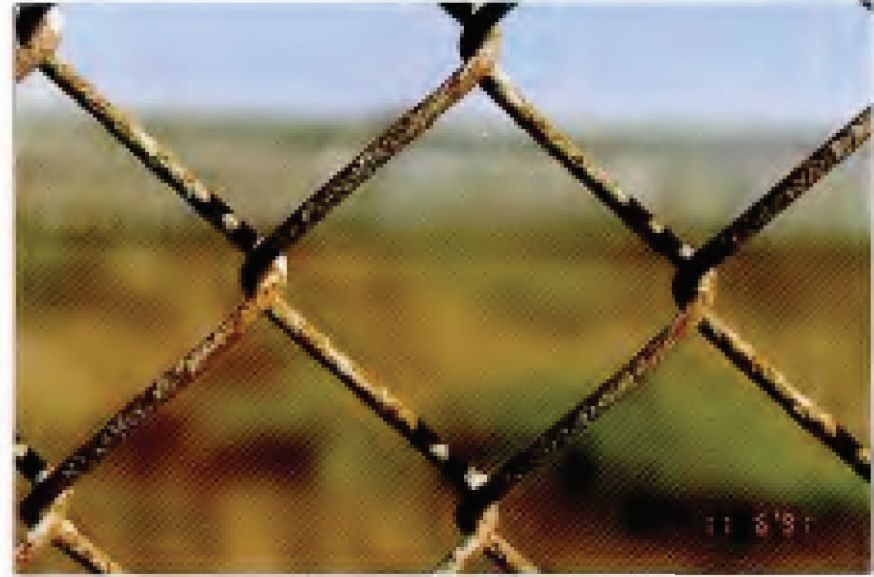
FIG. 9. Specimen 32 – Hot-dip Galvanized Chain Link Fabric. Original coating weight: 1.77 oz/ft² (540 g/m²). Exposure site: Point Reyes, CA. 30-year condition of links (see Table 13): 60R, 40wc.

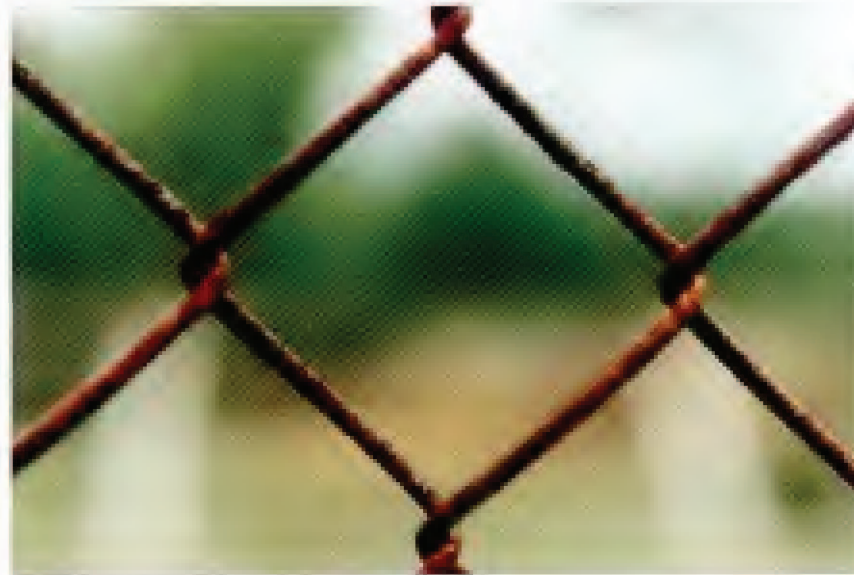
FIG. 10. Specimen 32 – Hot-dip Galvanized Chain Link Fabric. Original coating weight: 1.77 oz/ft² (540 g/m²). Exposure site: State College, PA. 30-year condition of links (see Table 13): 95R, 5Y.

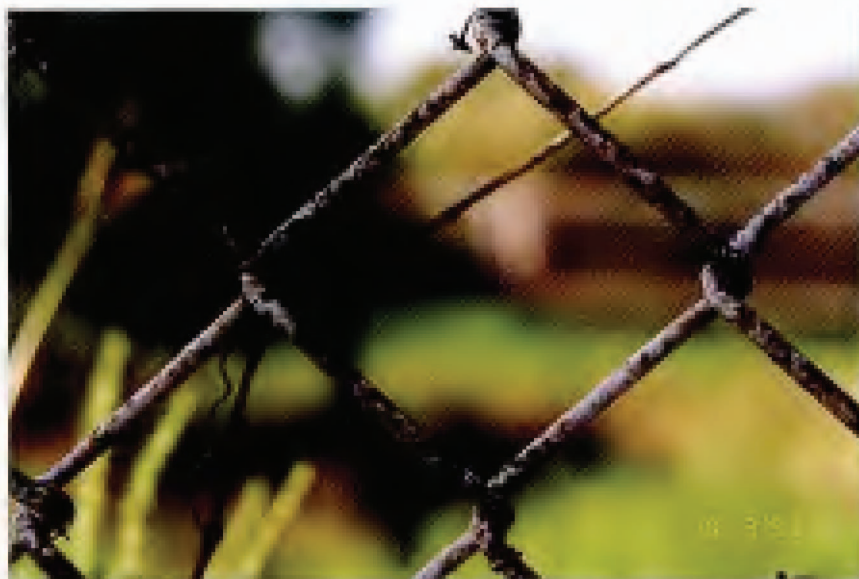
FIG. 11. Specimen 33 – Hot-dip Galvanized Chain Link Fabric. Original coating weight: 2.81 oz/ft² (857 g/m²). Exposure site: Brazos River, TX. 30-year condition of links (see Table 13): 60R, 40wc.

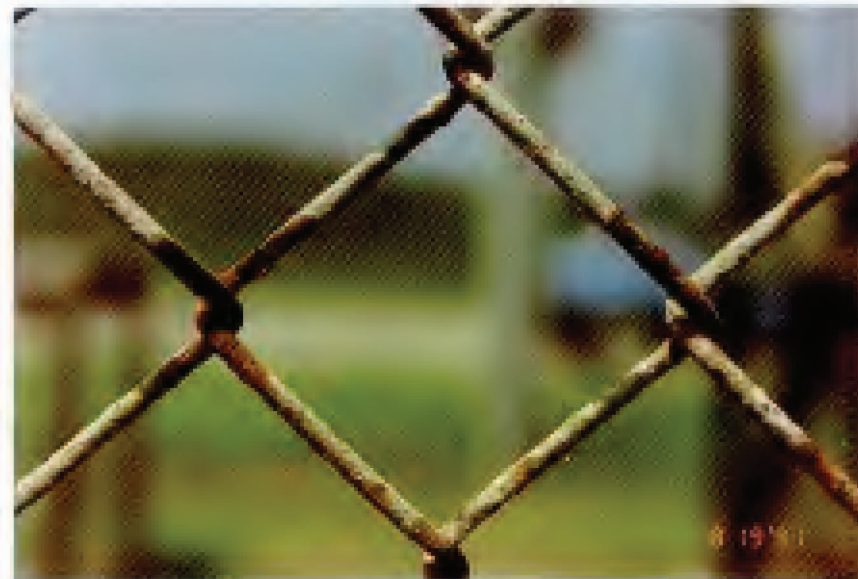
FIG. 12. Specimen 33 – Hot-dip Galvanized Chain Link Fabric. Original coating weight: 2.81 oz/ft² (857 g/m²). Exposure site: Kure Beach, NC (80-ft site). 30-year condition of links (see Table 13): 95R, 5wc.

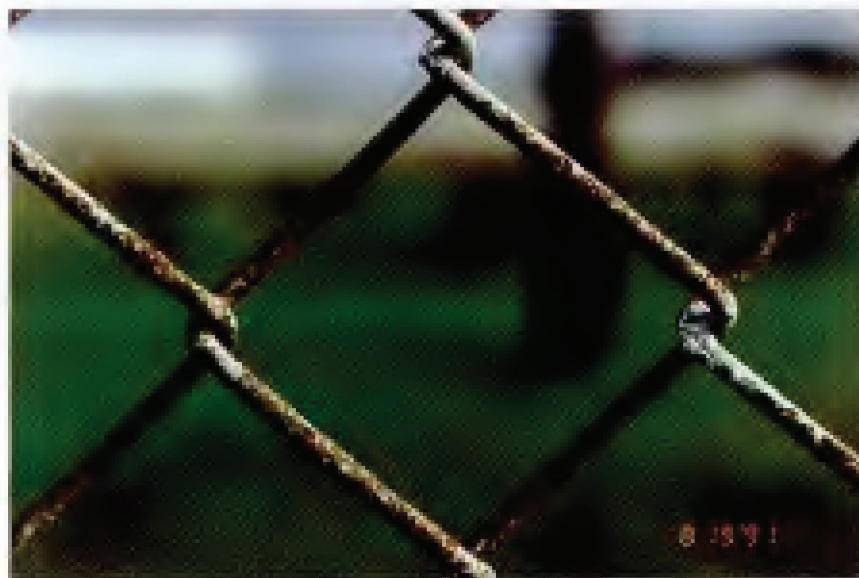
FIG. 13. Specimen 33 – Hot-dip Galvanized Chain Link Fabric. Original coating weight: 2.81 oz/ft² (857 g/m²). Exposure site: Kure Beach, NC (800-ft site). 30-year condition of links (see Table 13): 40R, 60wc.

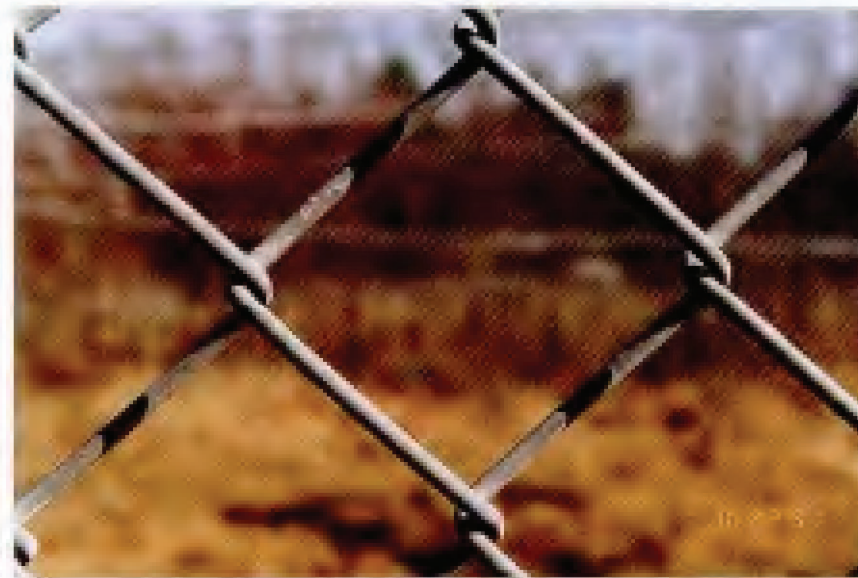
FIG. 14. Specimen 33 – Hot-dip Galvanized Chain Link Fabric. Original coating weight: 2.81 oz/ft² (857 g/m²). Exposure site: Manhattan, KS. 30-year condition of links (see Table 13): 40G, 60Y.

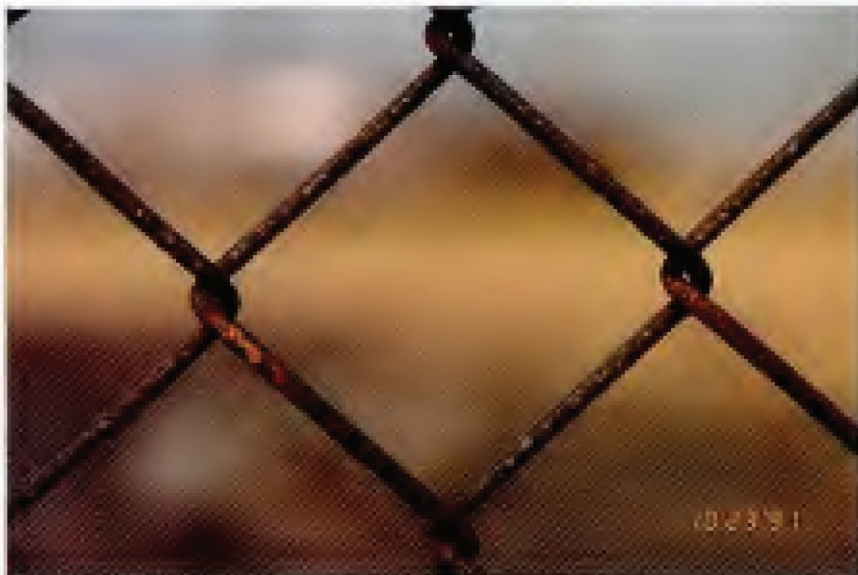
FIG. 15. Specimen 33 – Hot-dip Galvanized Chain Link Fabric. Original coating weight: 2.81 oz/ft² (857 g/m²). Exposure site: Newark-Kearny, NJ. 30-year condition of links (see Table 13): 100R.

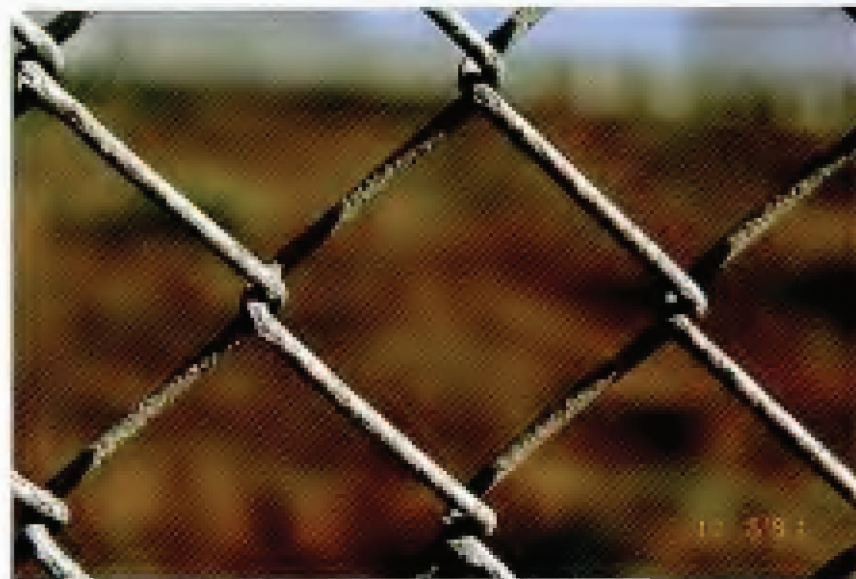
FIG. 16. Specimen 33 – Hot-dip Galvanized Chain Link Fabric. Original coating weight: 2.81 oz/ft² (857 g/m²). Exposure site: Point Reyes, CA. 30-year condition of links (see Table 13): 5PPR, 95wc.

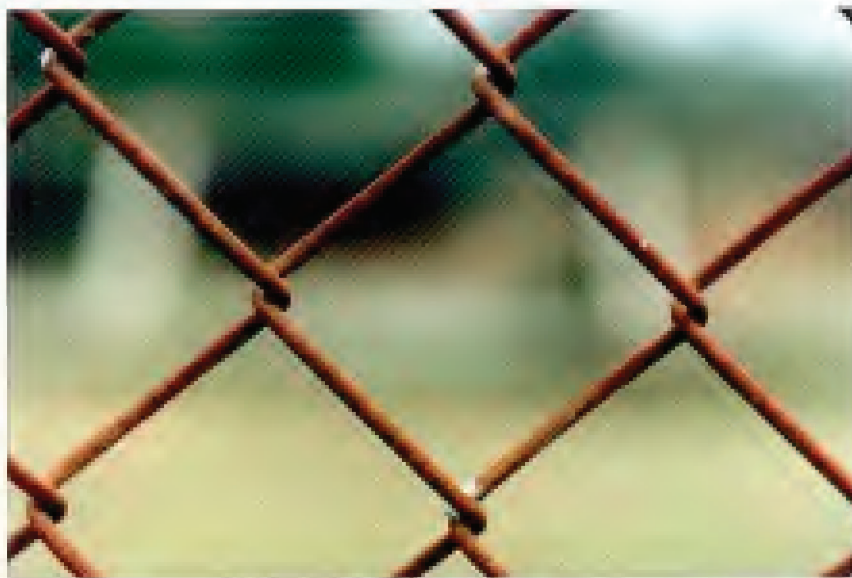
FIG. 17. Specimen 33 – Hot-dip Galvanized Chain Link Fabric. Original coating weight: 2.81 oz/ft² (857 g/m²). Exposure site: State College, PA. 30-year condition of links (see Table 13): 5G, 95Y.

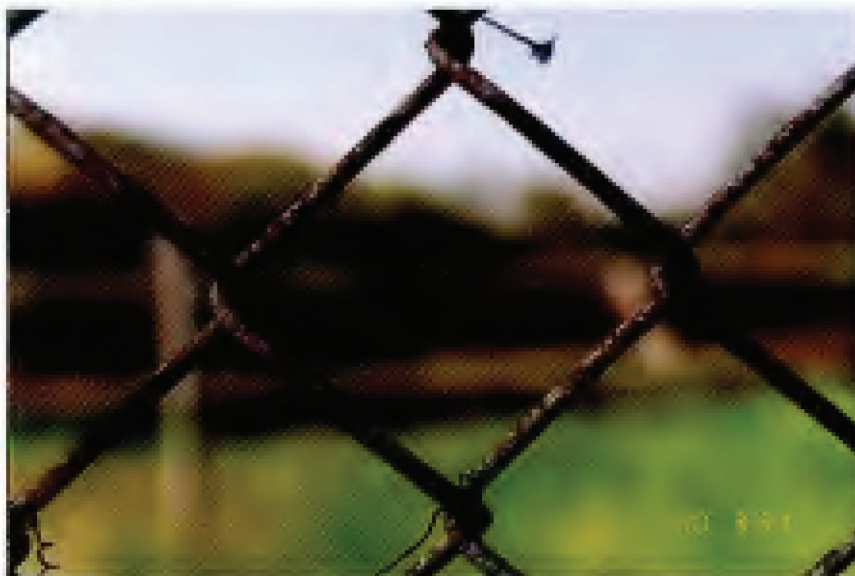
FIG. 18. Specimen 34 – Zinc Electroplated Chain Link Fabric. Original coating weight: 1.53 oz/ft² (467 g/m²). Exposure site: Brazos River, TX. 30-year condition of links (see Table 13): 80R, 20wc.

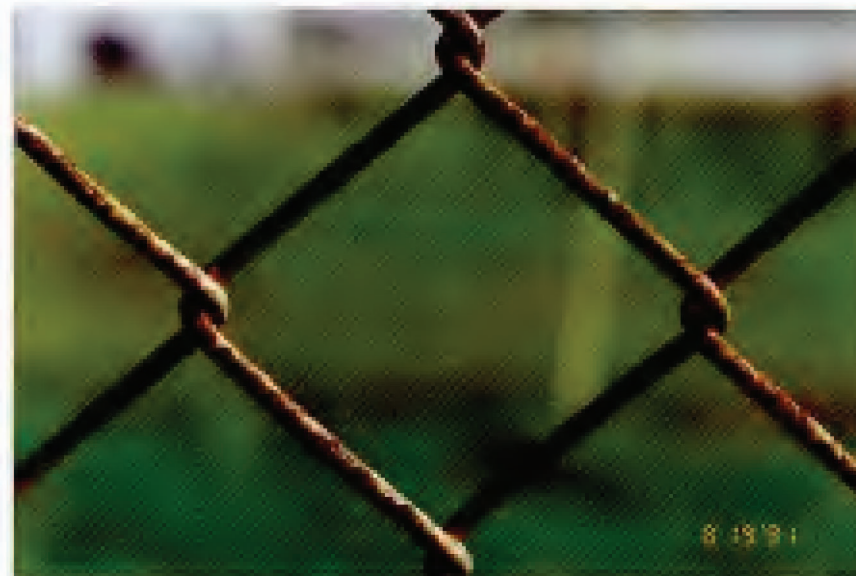
FIG. 19. Specimen 34 – Zinc Electroplated Chain Link Fabric. Original coating weight: 1.53 oz/ft² (467 g/m²). Exposure site: Kure Beach, NC (800-ft site). 30-year condition of links (see Table 13): 60R, 35wc, 5G.

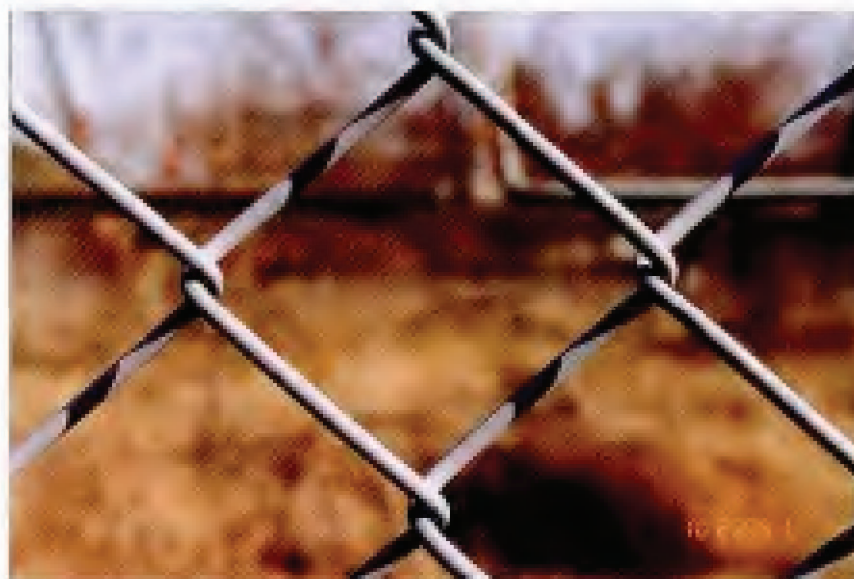
FIG. 20. Specimen 34 – Zinc Electroplated Chain Link Fabric. Original coating weight: 1.53 oz/ft² (467 g/m²). Exposure site: Manhattan, KS. 30-year condition of links (see Table 13): 100G.

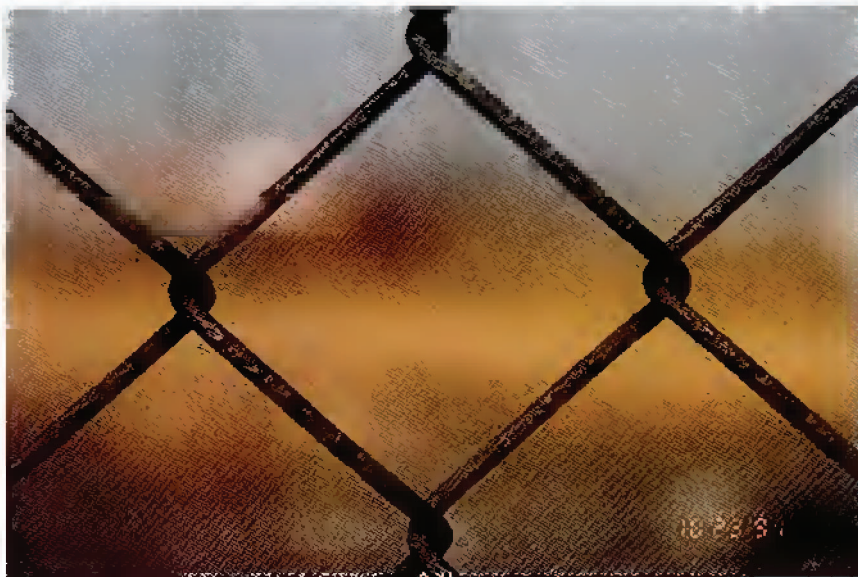
FIG. 21. Specimen 34 – Zinc Electroplated Chain Link Fabric. Original coating weight: 1.53 oz/ft² (467 g/m²). Exposure site: Newark-Kearny, NJ. 30-year condition of links (see Table 13): 100R.

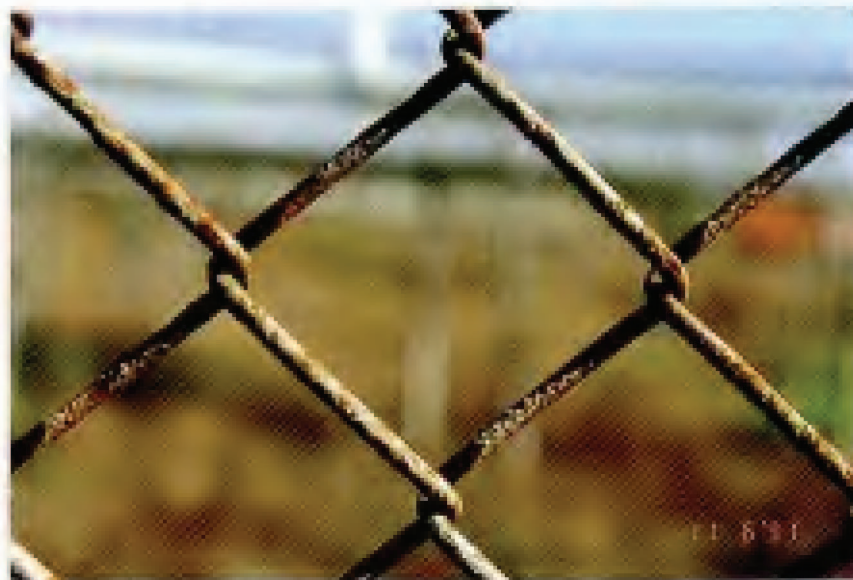
FIG. 22. Specimen 34 – Zinc Electroplated Chain Link Fabric. Original coating weight: 1.53 oz/ft² (467 g/m²). Exposure site: Point Reyes, CA. 30-year condition of links (see Table 13): 50R, 20wc, 30G.

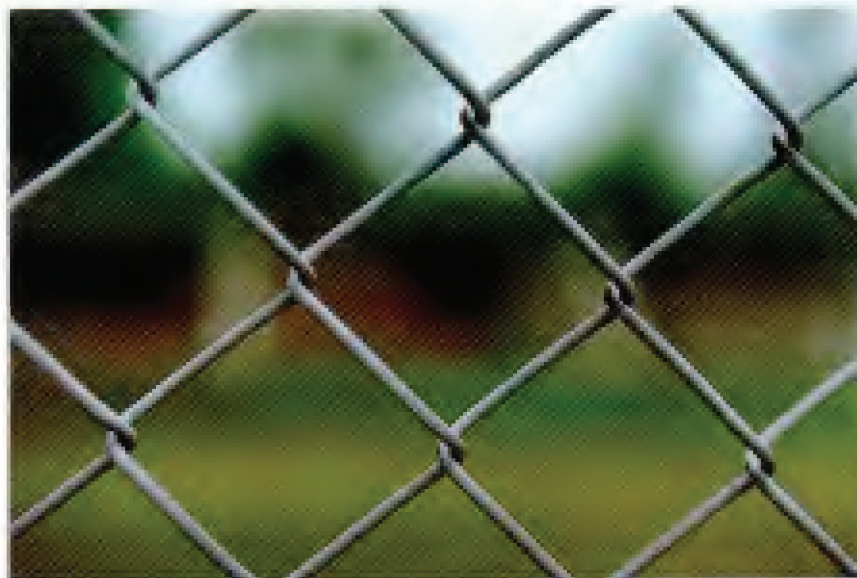
FIG. 23. Specimen 34 – Zinc Electroplated Chain Link Fabric. Original coating weight: 1.53 oz/ft² (467 g/m²). Exposure site: State College, PA. 30-year condition of links (see Table 13): 100G.

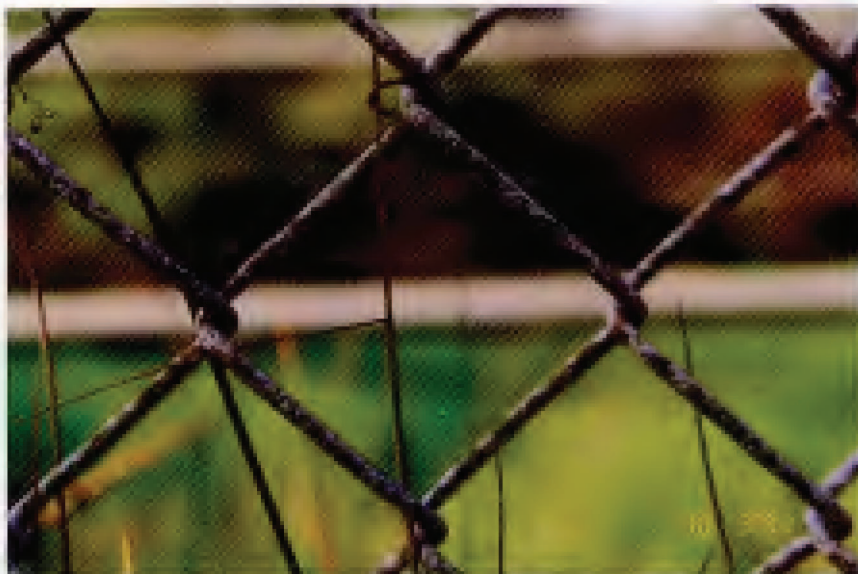
FIG. 24. Specimen 35 – Zinc Electroplated Chain Link Fabric. Original coating weight: 2.23 oz/ft² (680 g/m²). Exposure site: Brazos River, TX. 30-year condition of links (see Table 13): 15R, 85wc.

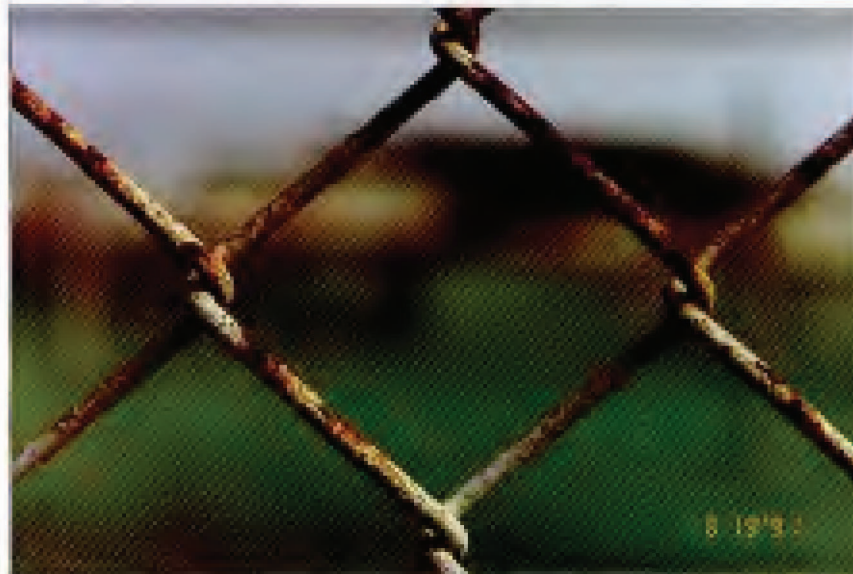
FIG. 25. Specimen 35 – Zinc Electroplated Chain Link Fabric. Original coating weight: 2.23 oz/ft² (680 g/m²). Exposure site: Kure Beach, NC (800-ft site). 30-year condition of links (see Table 13): 30R, 60wc, 10G.

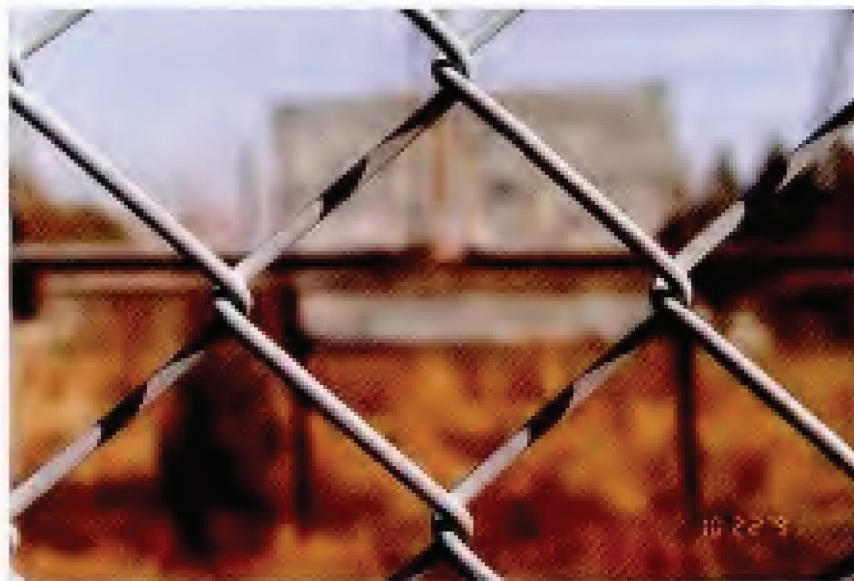
FIG. 26. Specimen 35 – Zinc Electroplated Chain Link Fabric. Original coating weight: 2.23 oz/ft² (680 g/m²). Exposure site: Manhattan, KS. 30-year condition of links (see Table 13): 100G.

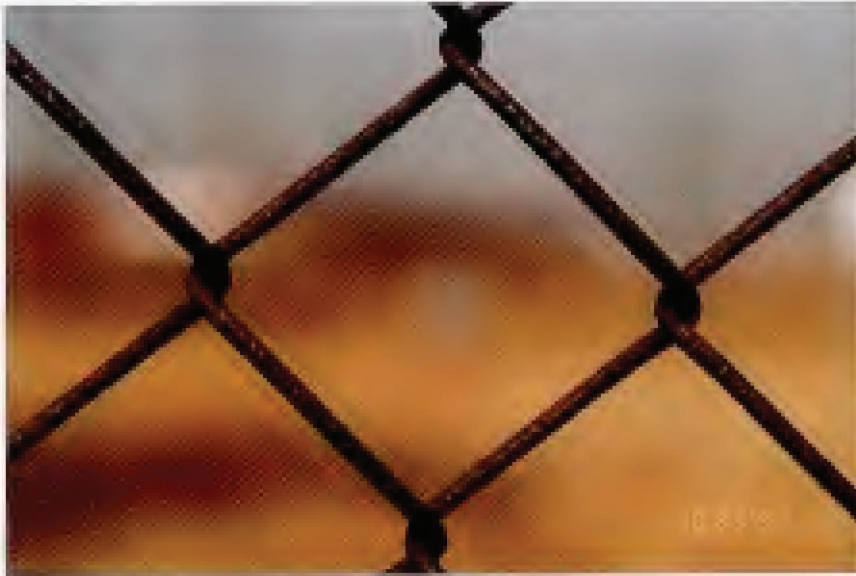
FIG. 27. Specimen 35 – Zinc Electroplated Chain Link Fabric.
Original coating weight: 2.23 oz/ft² (680 g/m²). *Exposure site:* Newark-Kearny, NJ. 30-year condition of links (see Table 13): 100R.

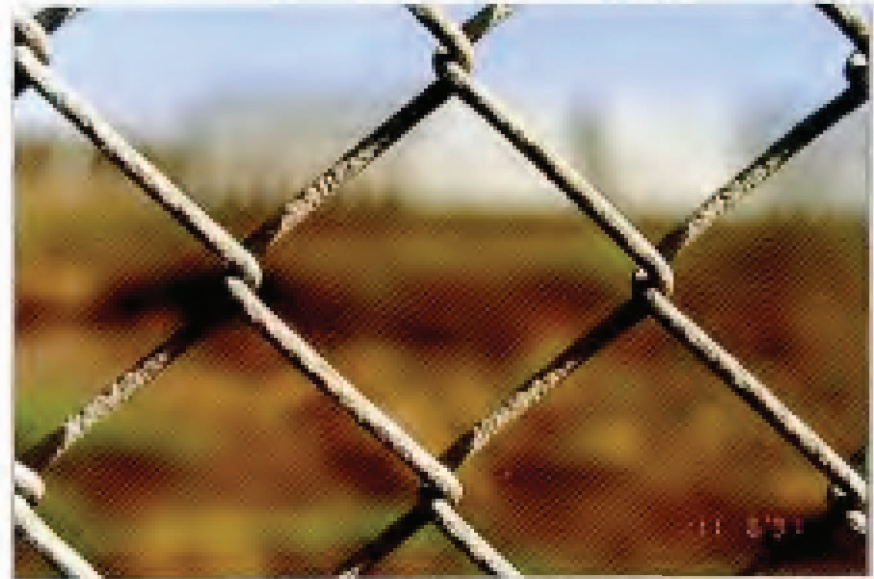
FIG. 28. Specimen 35 – Zinc Electroplated Chain Link Fabric.
Original coating weight: 2.23 oz/ft² (680 g/m²). *Exposure site:* Point Reyes, CA. 30-year condition of links (see Table 13): 5R, 75wc, 20G.

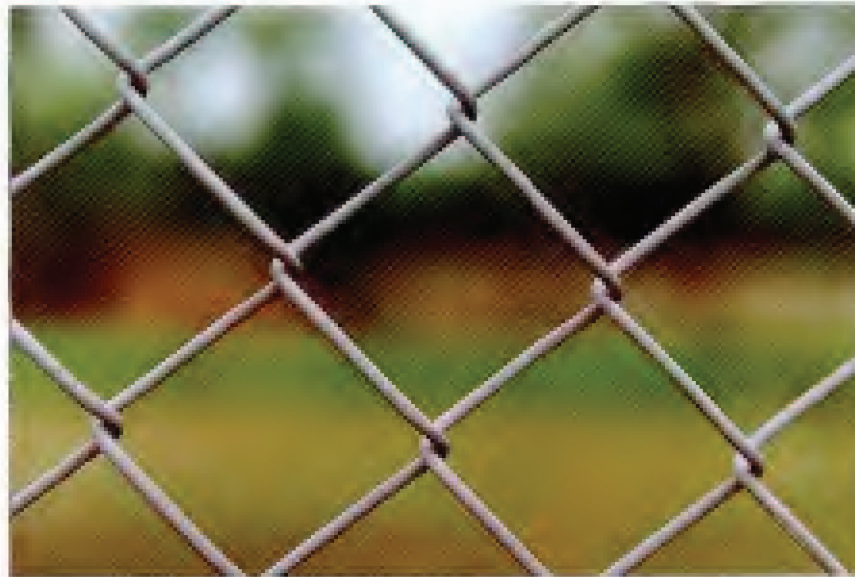
FIG. 29. Specimen 35 – Zinc Electroplated Chain Link Fabric.
Original coating weight: 2.23 oz/ft² (680 g/m²). *Exposure site:* State College, PA. 30-year condition of links (see Table 13): 100G.

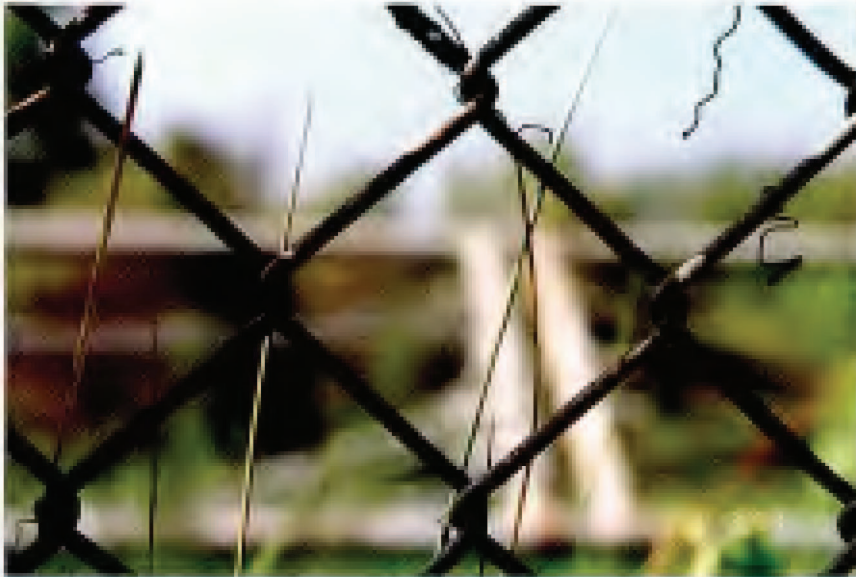
FIG. 30. Specimen 36 – Hot-Dip Aluminized Chain Link Fabric. Original coating weight: 0.57 oz/ft² (174 g/m²). Exposure site: Brazos River, TX. 30-year condition of links (see Table 13): 10R, 15wc, 75G.

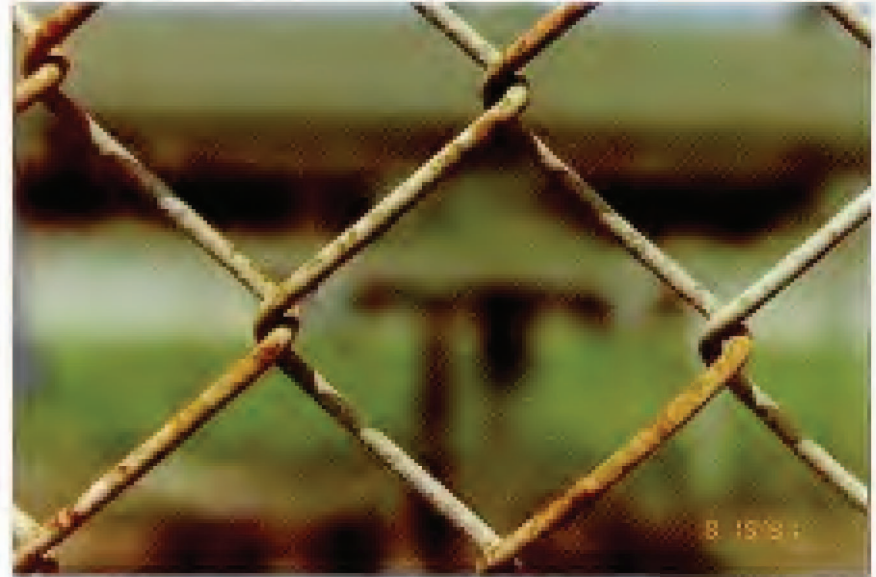
FIG. 31. Specimen 36 – Hot-Dip Aluminized Chain Link Fabric. Original coating weight: 0.57 oz/ft² (174 g/m²). Exposure site: Kure Beach, NC (80-ft site). 30-year condition of links (see Table 13): 30R, 20Y, 50G, trM.

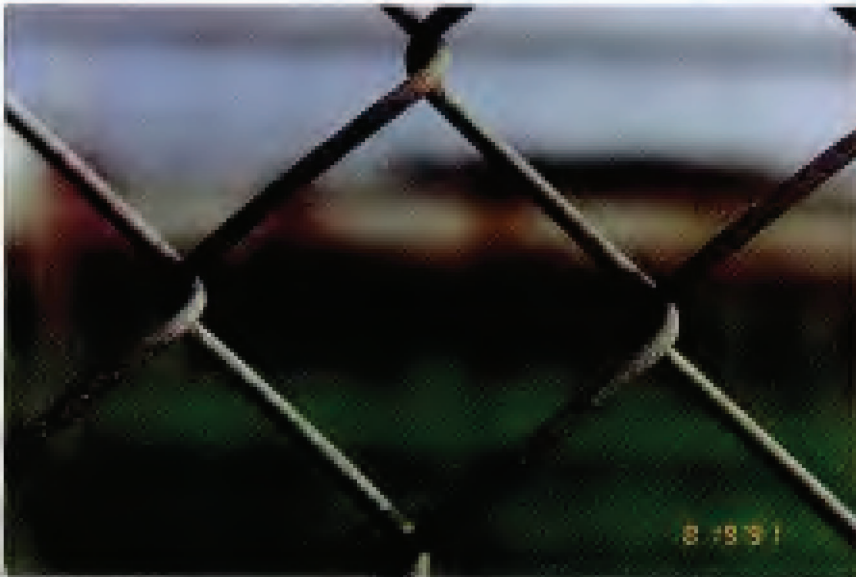
FIG. 32. Specimen 36 – Hot-Dip Aluminized Chain Link Fabric. Original coating weight: 0.57 oz/ft² (174 g/m²). Exposure site: Kure Beach, NC (800-ft site). 30-year condition of links (see Table 13): 2R, 10wc, 78G, 10M.

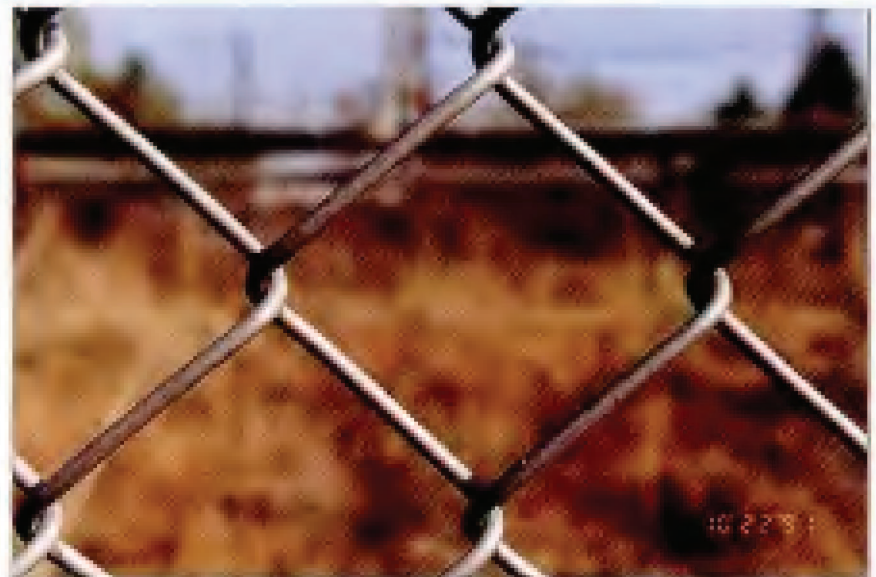
FIG. 33. Specimen 36 – Hot-Dip Aluminized Chain Link Fabric. Original coating weight: 0.57 oz/ft² (174 g/m²). Exposure site: Manhattan, KS. 30-year condition of links (see Table 13): 50M, 50G.

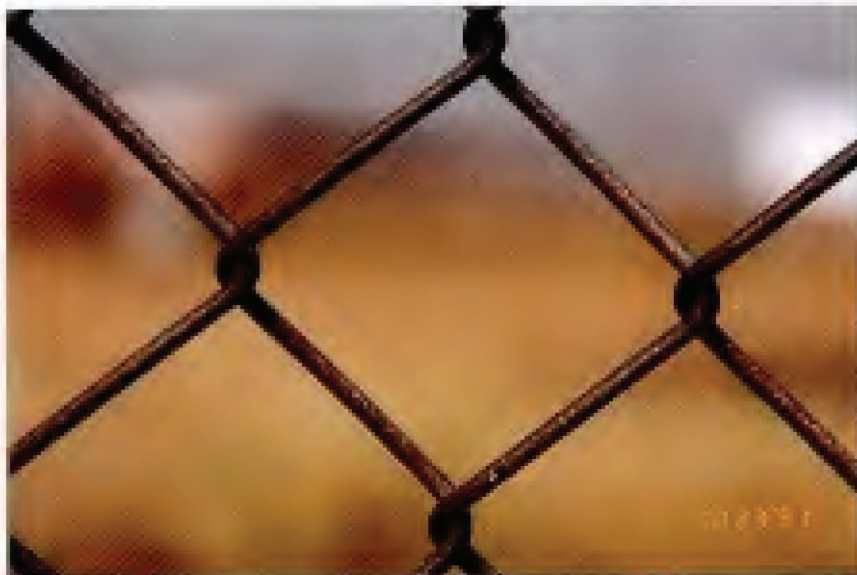
FIG. 34. Specimen 36 – Hot-Dip Aluminized Chain Link Fabric. Original coating weight: 0.57 oz/ft² (174 g/m²). Exposure site: Newark-Kearny, NJ. 30-year condition of links (see Table 13): 10PPR, 90BLK.

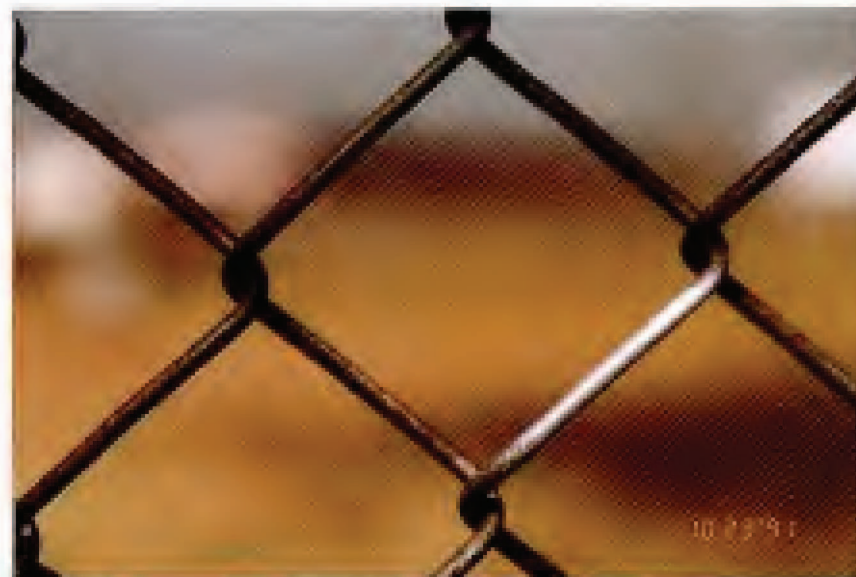
FIG. 35. Specimen 36 – Hot-Dip Aluminized Chain Link Fabric. Note: This is same specimen as illustrated in Fig. 34, with black corrosion product removed on one straight wire segment to illustrate that aluminum coating is still intact.

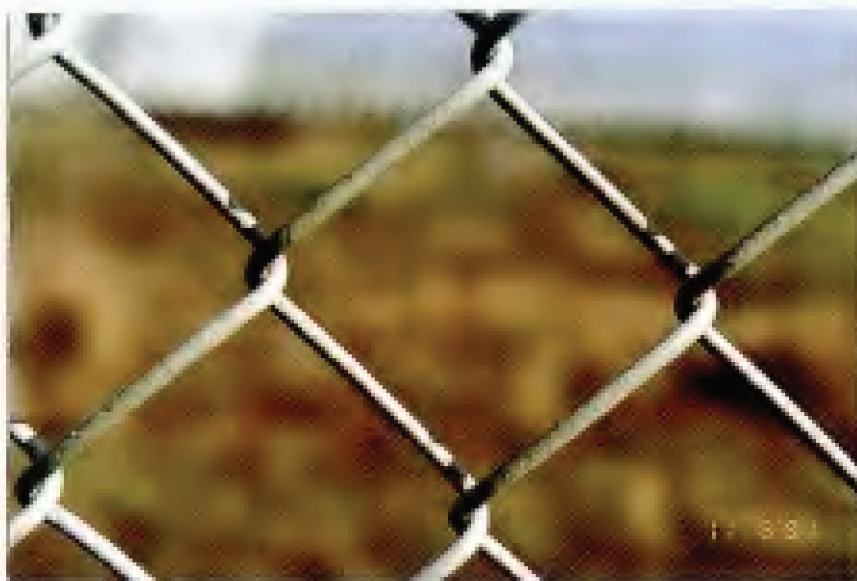
FIG. 36. Specimen 36 – Hot-Dip Aluminized Chain Link Fabric. Original coating weight: 0.57 oz/ft² (174 g/m²). Exposure site: Point Reyes, CA. 30-year condition of links (see Table 13): 50M, 50G.

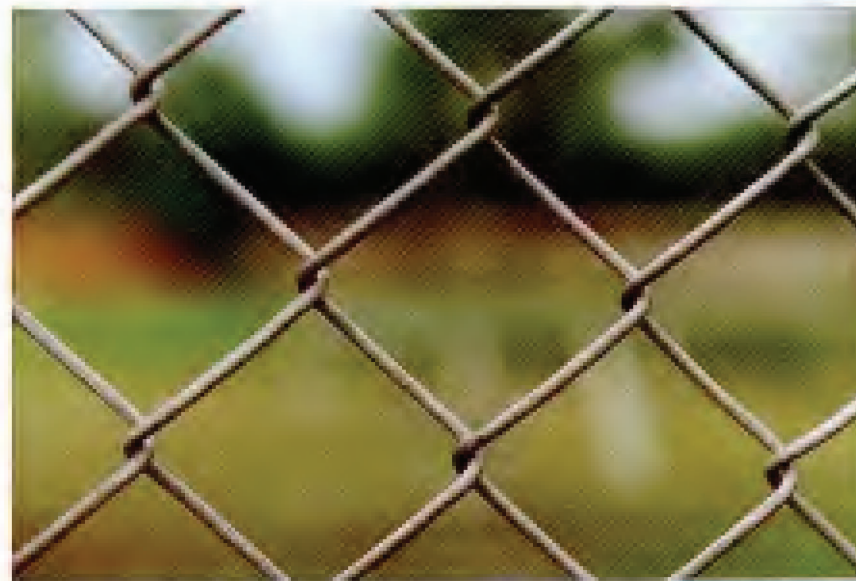
FIG. 37. Specimen 36 – Hot-Dip Aluminized Chain Link Fabric. Original coating weight: 0.57 oz/ft² (174 g/m²). Exposure site: State College, PA. 30-year condition of links (see Table 13): 100G.

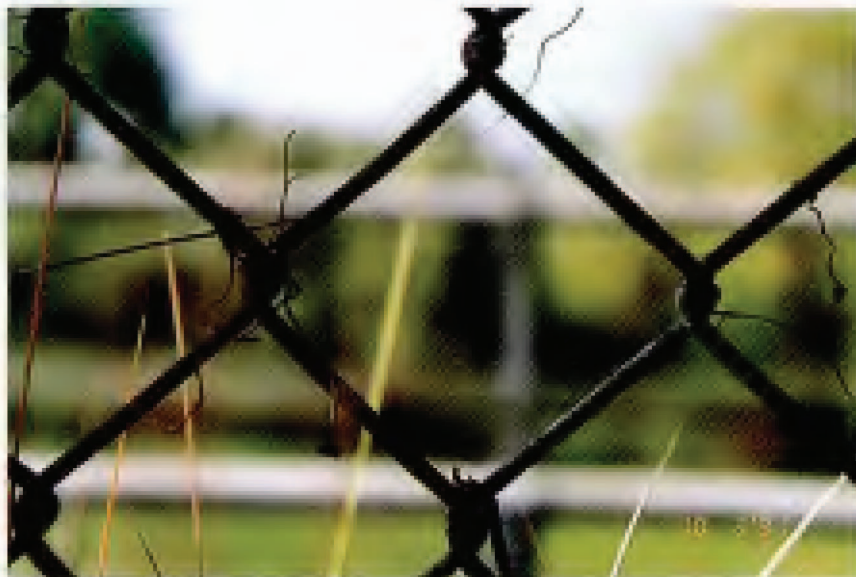
FIG. 38. Specimen 37 – Hot-Dip Aluminized Chain Link Fabric. Original coating weight: 0.44 oz/ft² (134 g/m²). Exposure site: Brazos River, TX. 30-year condition of links (see Table 13): 15R, 75wc, 10G.

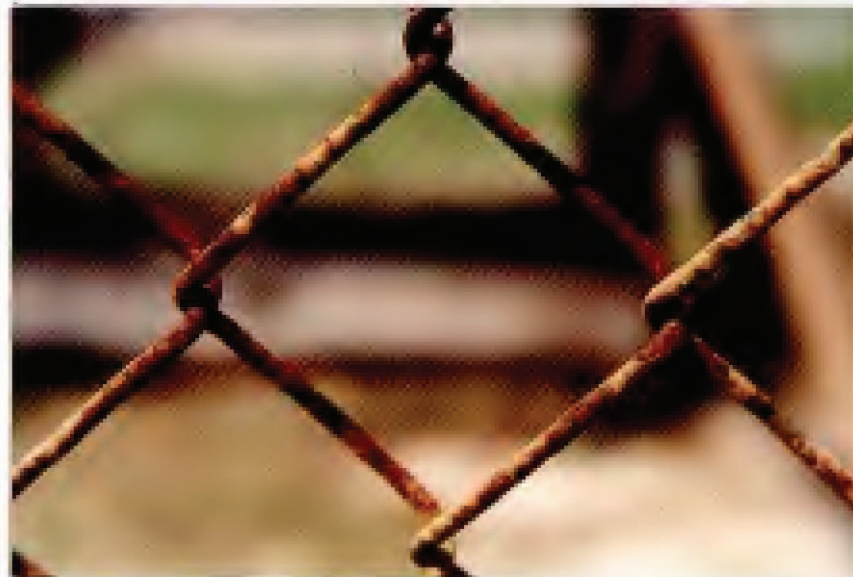
FIG. 39. Specimen 37 – Hot-Dip Aluminized Chain Link Fabric. Original coating weight: 0.44 oz/ft² (134 g/m²). Exposure site: Kure Beach, NC (80-ft site). 30-year condition of links (see Table 13): 55R, 25Y, 20G.

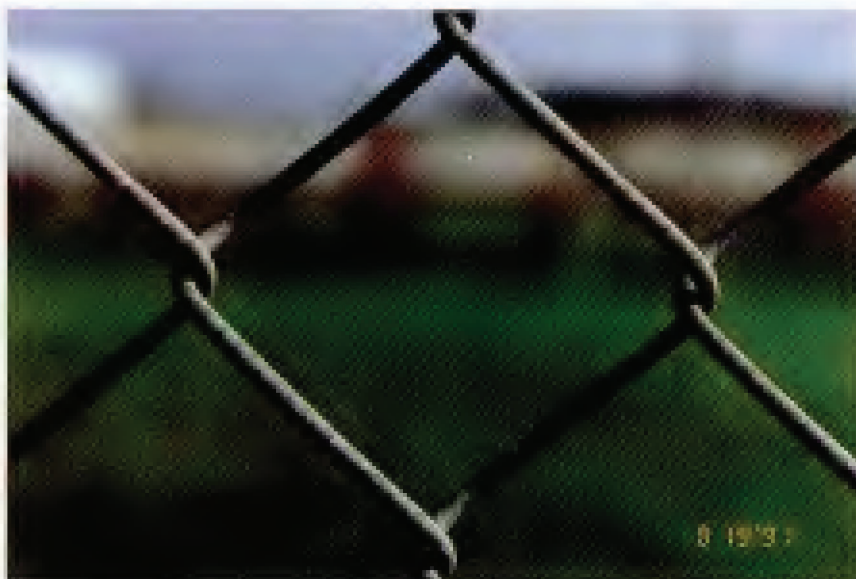
FIG. 40. Specimen 37 – Hot-Dip Aluminized Chain Link Fabric. Original coating weight: 0.44 oz/ft² (134 g/m²). Exposure site: Kure Beach, NC (800-ft site). 30-year condition of links (see Table 13): 1R, 20wc, 74G, 5M.

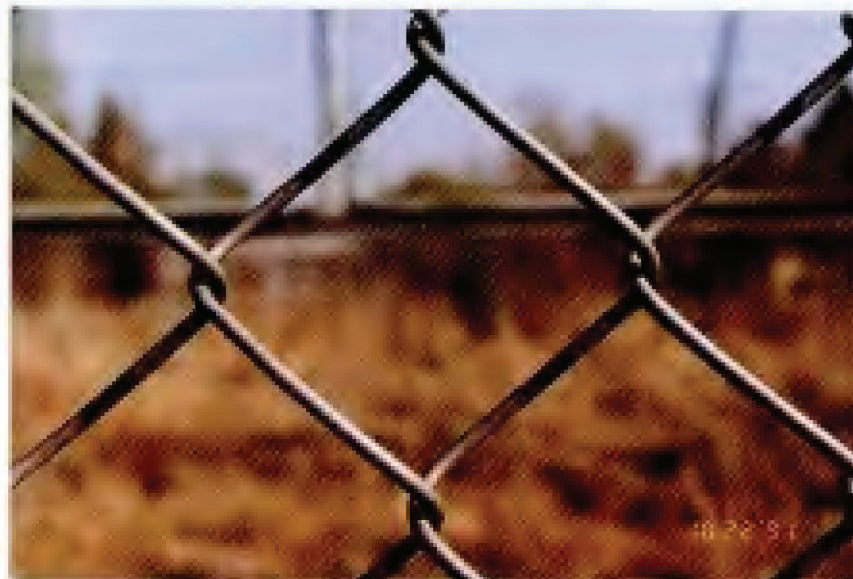
FIG. 41. Specimen 37 – Hot-Dip Aluminized Chain Link Fabric. Original coating weight: 0.44 oz/ft² (134 g/m²). Exposure site: Manhattan, KS. 30-year condition of links (see Table 13): 40M, 60st.
