**Atmospheric Corrosion
Investigation of
Aluminum-Coated,
Zinc-Coated, and
Copper-Bearing
STEEL WIRE and
WIRE PRODUCTS**

A THIRTY-TWO YEAR REPORT

**Sponsored by ASTM Committee A5 on
Metallic-Coated Iron and Steel Products**

ASTM Data Series: DS 65
Revision of STP 585A
ASTM Publication Code Number (PCN):
05-015950-02

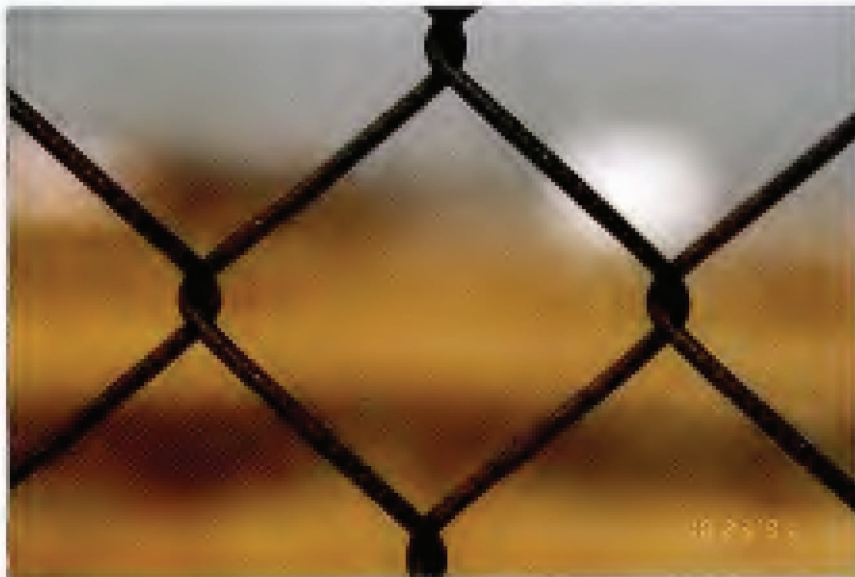
FIG. 42. Specimen 37 – Hot-Dip Aluminized Chain Link Fabric. Original coating weight: 0.44 oz/ft² (134 g/m²). Exposure site: Newark-Kearny, NJ. 30-year condition of links (see Table 13): 10PPR, 90blk.

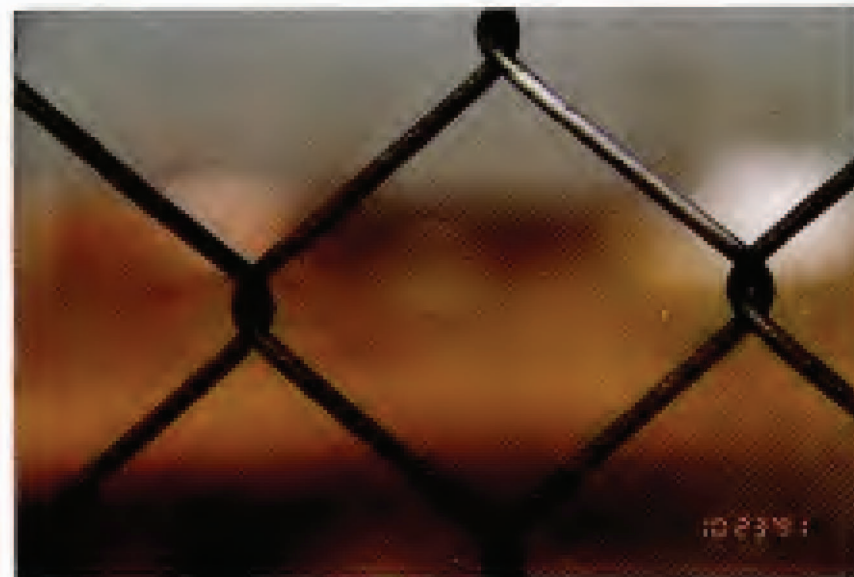
FIG. 43. Specimen 37 – Hot-Dip Aluminized Chain Link Fabric. Note: This is same specimen as illustrated in Fig. 42, with black corrosion product removed on one straight wire segment to illustrate that aluminum coating is still intact.

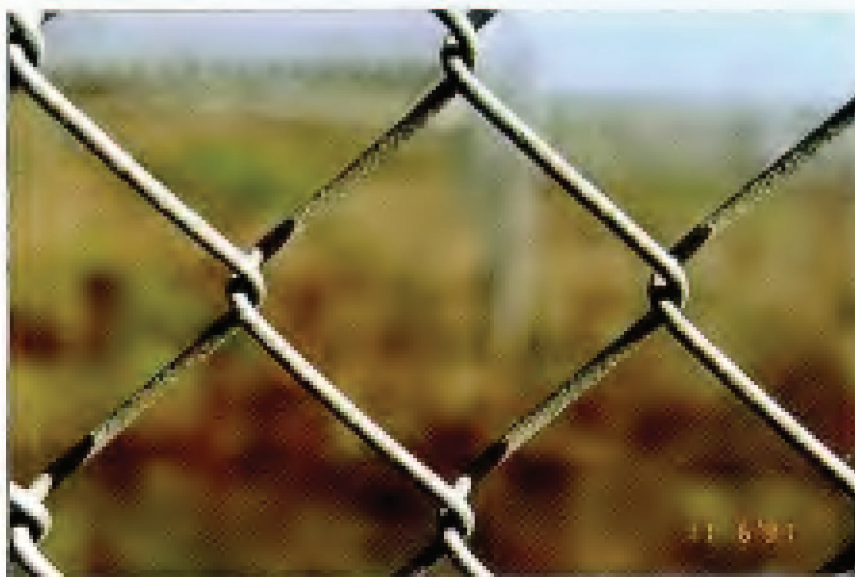
FIG. 44. Specimen 37 – Hot-Dip Aluminized Chain Link Fabric. Original coating weight: 0.44 oz/ft² (134 g/m²). Exposure site: Point Reyes, CA. 30-year condition of links (see Table 13): 1PPR, 99wc.

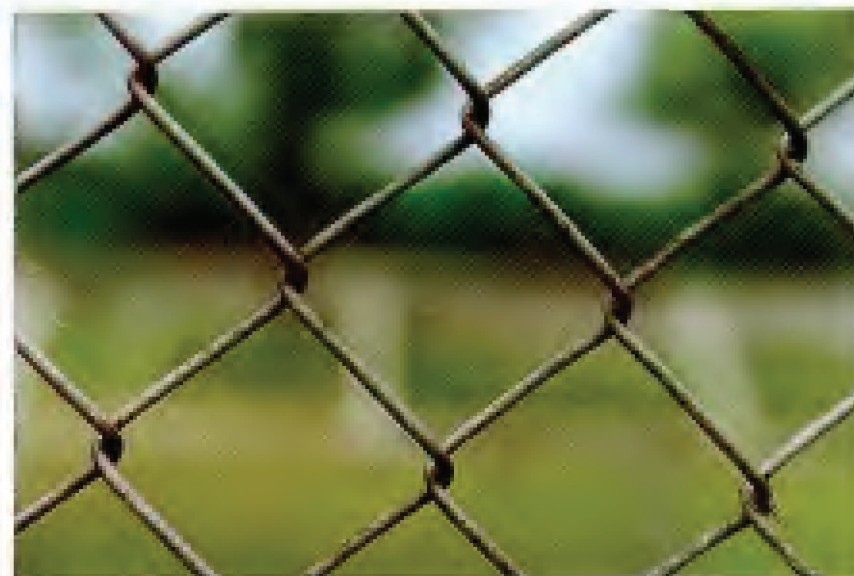
FIG. 45. Specimen 37 – Hot-Dip Aluminized Chain Link Fabric. Original coating weight: 0.44 oz/ft² (134 g/m²). Exposure site: State College, PA. 30-year condition of links (see Table 13): 15PPR, 15Y, 70G.

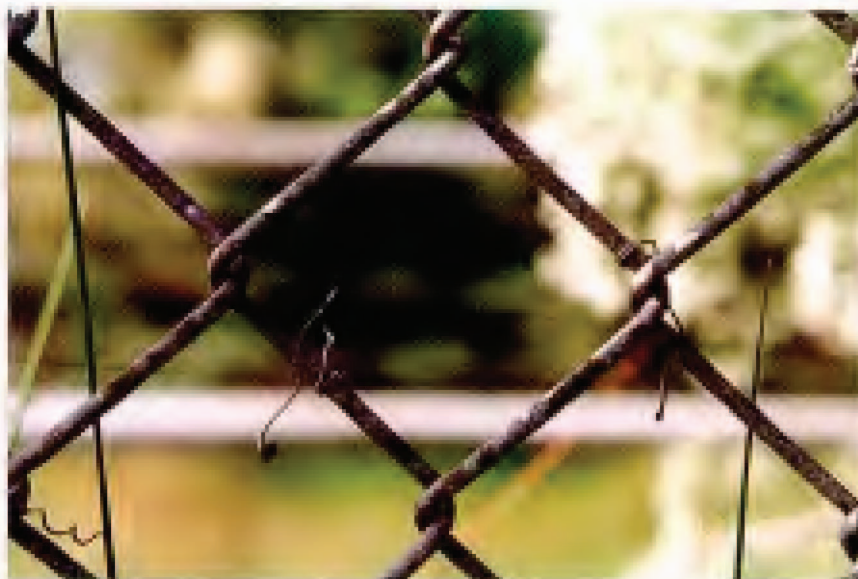
FIG. 46. Specimen 38 – Hot-Dip Aluminized Chain Link Fabric. Original coating weight: 0.54 oz/ft² (165 g/m²). Exposure site: Brazos River, TX. 30-year condition of links (see Table 13): 5R, 20wc, 75G.

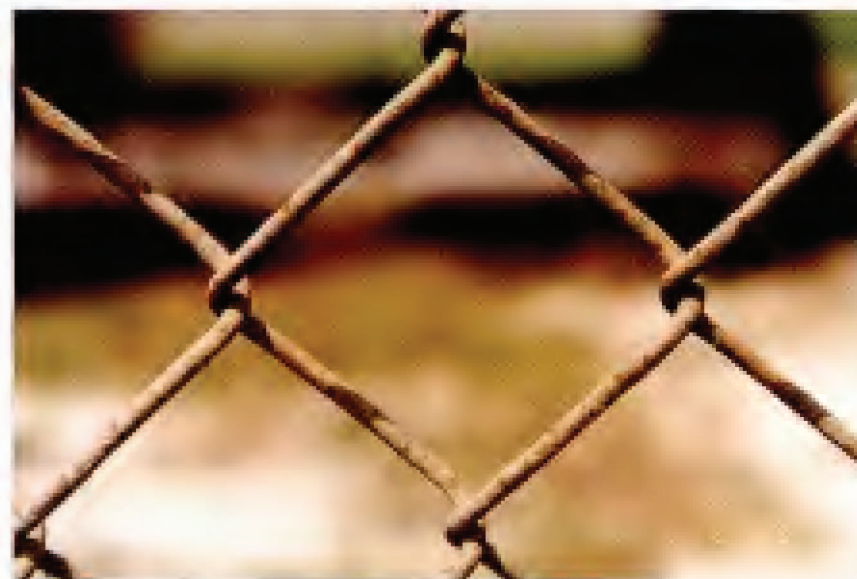
FIG. 47. Specimen 38 – Hot-Dip Aluminized Chain Link Fabric. Original coating weight: 0.54 oz/ft² (165 g/m²). Exposure site: Kure Beach, NC (80-ft site). 30-year condition of links (see Table 13): 50R, 25Y, 25G.

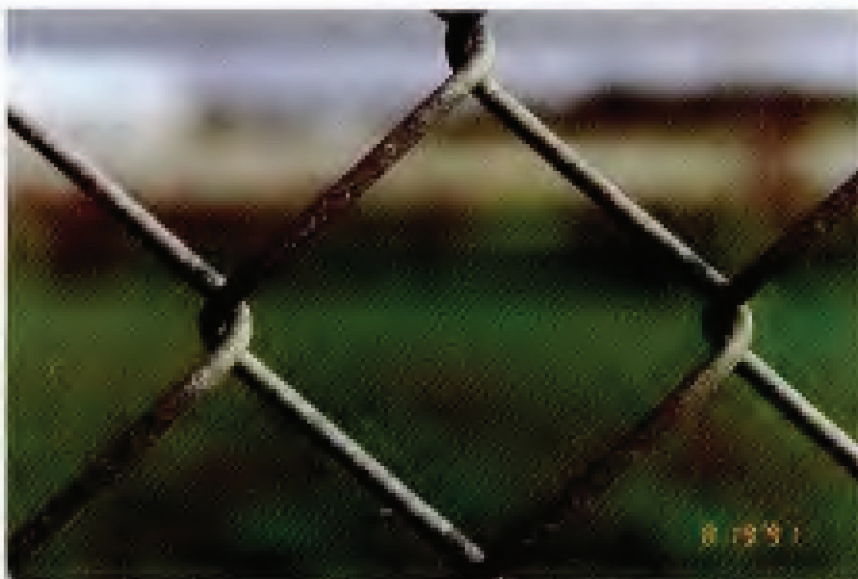
FIG. 48. Specimen 38 – Hot-Dip Aluminized Chain Link Fabric. Original coating weight: 0.54 oz/ft² (165 g/m²). Exposure site: Kure Beach, NC (800 ft site). 30-year condition of links (see Table 13): trR, trY, 40wc, 50G, 10M.

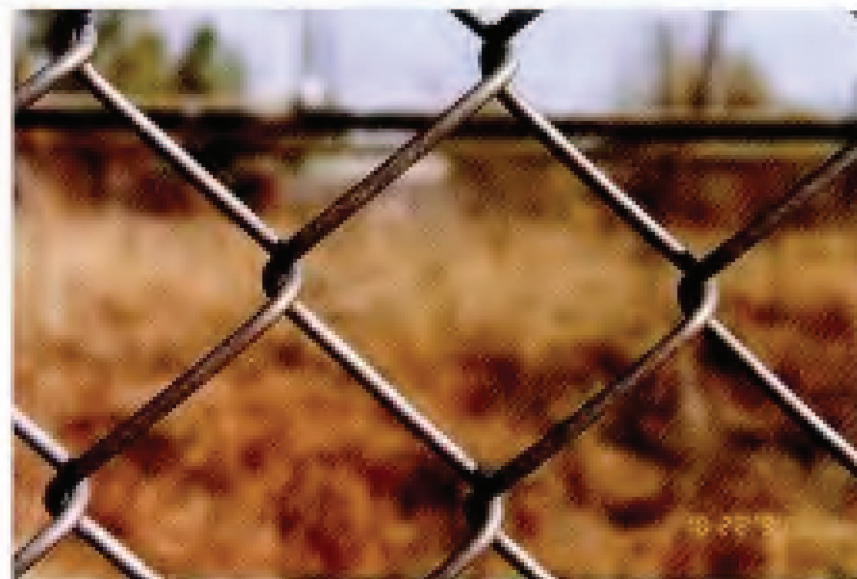
FIG. 49. Specimen 38 – Hot-Dip Aluminized Chain Link Fabric. Original coating weight: 0.54 oz/ft² (165 g/m²). Exposure site: Manhattan, KS. 30-year condition of links (see Table 13): 50M, 50st.

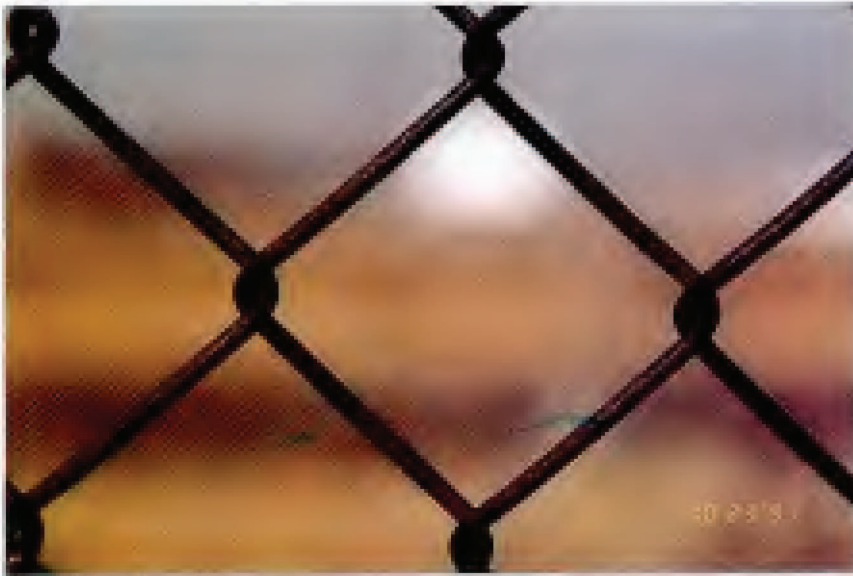
FIG. 50. Specimen 38 – Hot-Dip Aluminized Chain Link Fabric. Original coating weight: 0.54 oz/ft² (165 g/m²). Exposure site: Newark-Kearny, NJ. 30-year condition of links (see Table 13): 10PPR, 90 blk.

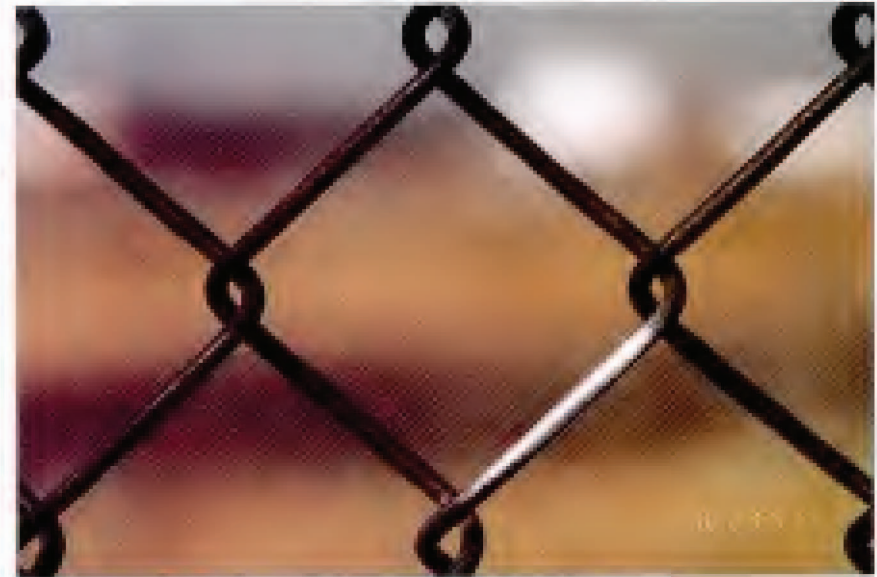
FIG. 51. Specimen 38 – Hot-Dip Aluminized Chain Link Fabric. Note: This is same specimen as illustrated in Fig. 50, with black corrosion product removed on one straight wire segment to illustrate that aluminum coating is still intact.

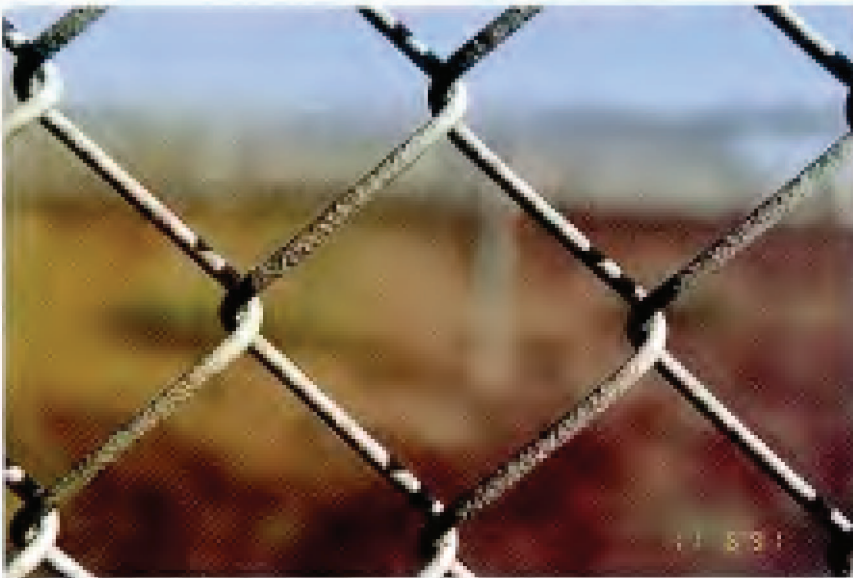
FIG. 52. Specimen 38 – Hot-Dip Aluminized Chain Link Fabric. Original coating weight: 0.54 oz/ft² (165 g/m²). Exposure site: Point Reyes, CA. 30-year condition of links (see Table 13): 5PPR, 95wc.

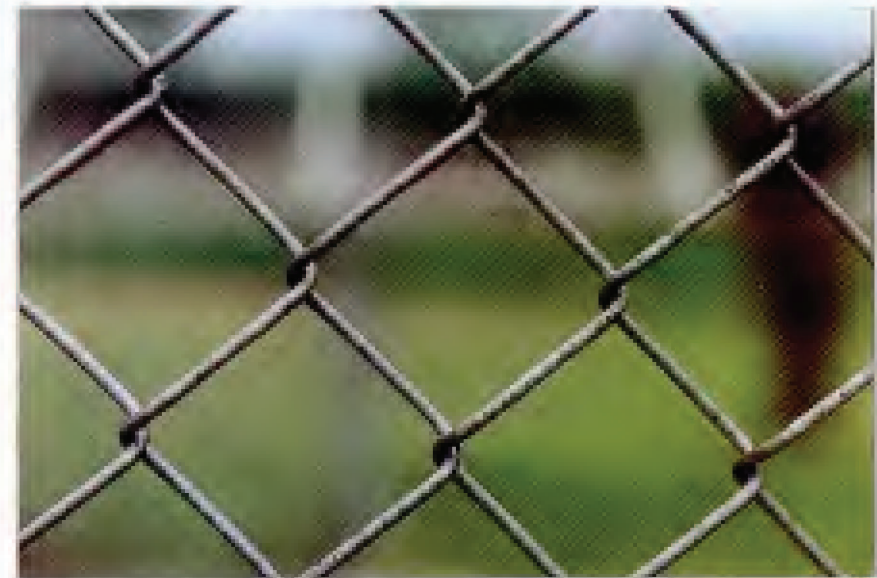
FIG. 53. Specimen 38 – Hot-Dip Aluminized Chain Link Fabric. Original coating weight: 0.54 oz/ft² (165 g/m²). Exposure site: State College, PA. 30-year condition of links (see Table 13): 15PPR, 5Y, 80G.
