# ***Corrosion Rates of Steel in Concrete***

*Neal S. Berke, Victor Chaker, and David Whiting, editors*

Proceedings of a symposium held in Baltimore, Md , June 29, 1988 and sponsored by the ASTM Committee G-1 on Corrosion of Metals and others

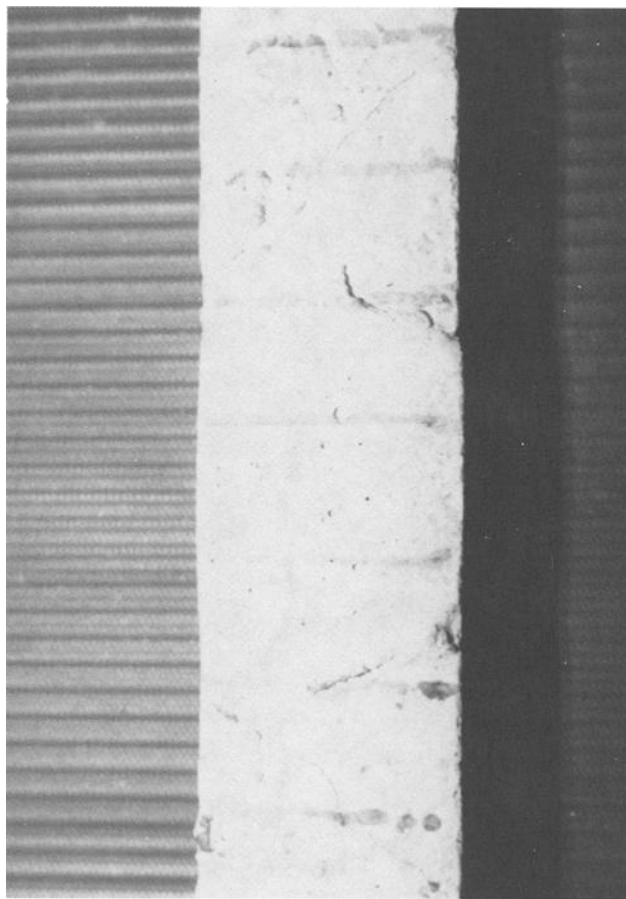
FIG. 8a—Close up view of repaired specimens after eight cycles, cracks near patch.

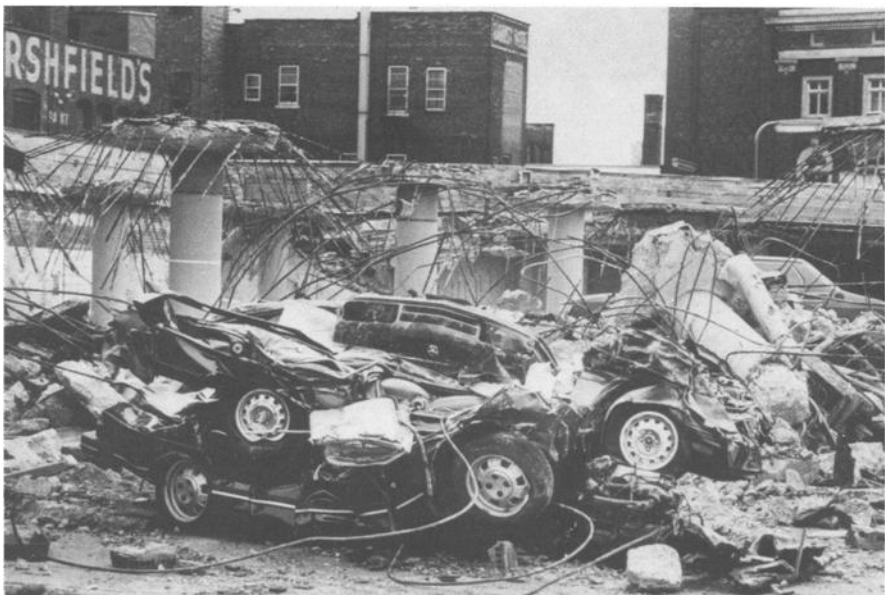
FIG. 2—*Collapse of a salt-damaged parking garage [6].*

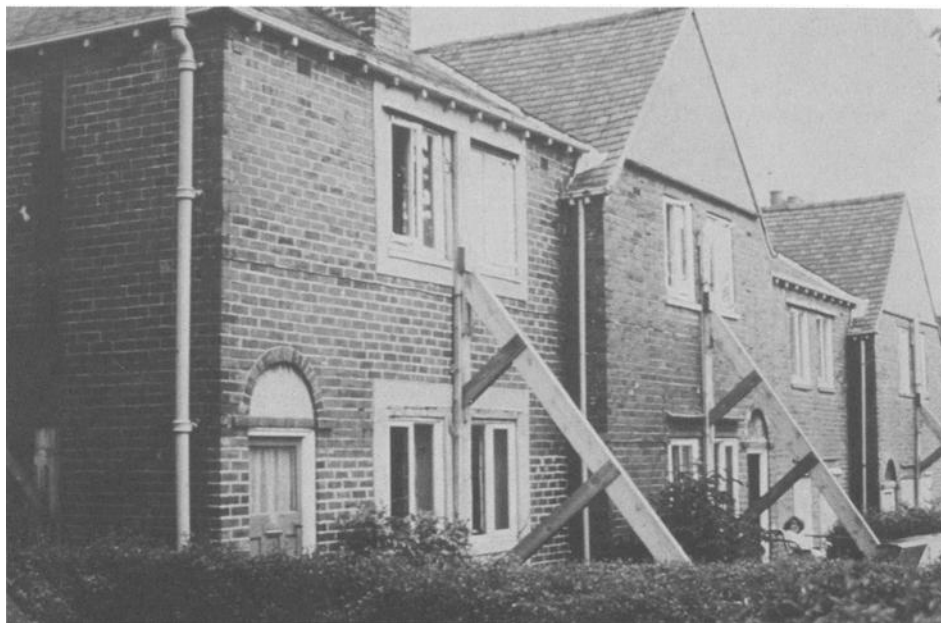
FIG. 4—*Collapse of masonry walls due to corroded wall ties.*

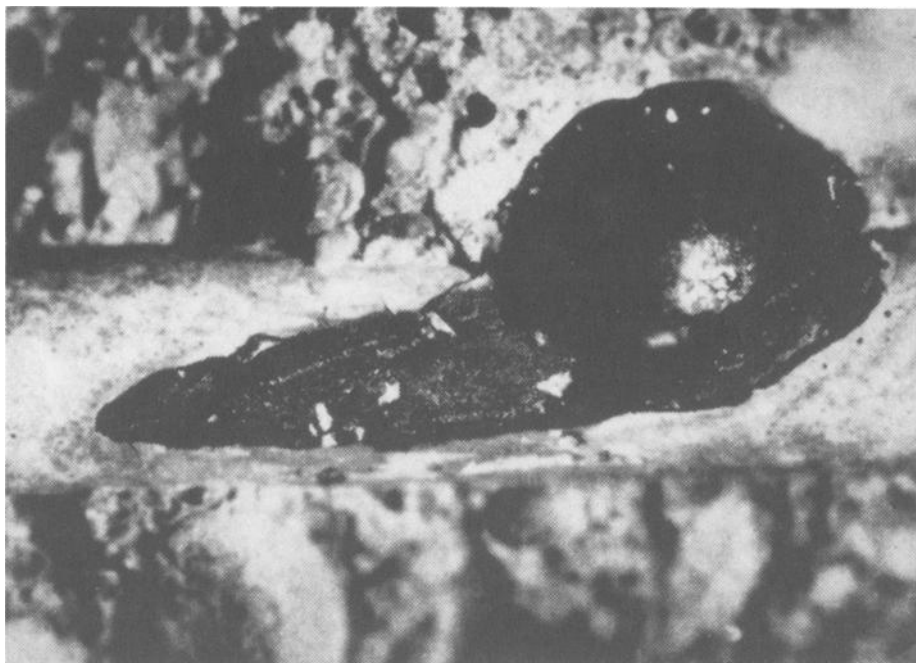
FIG. 7—Corrosion at void in concrete [60].

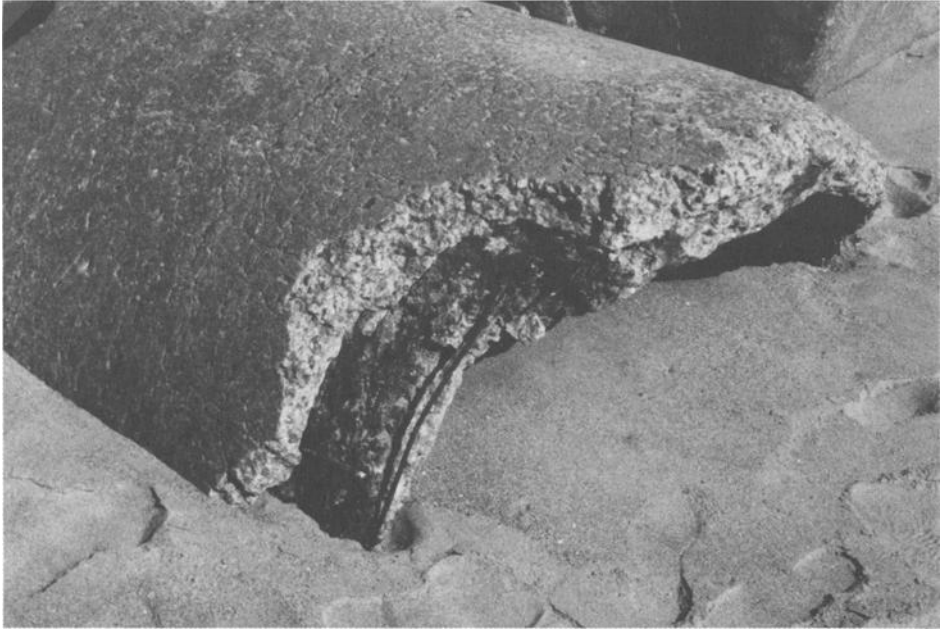
FIG. 10—Corrosion on reinforced concrete drain pipe on beach in Ventura, California.
