Corrosion Forms & Control for Infrastructure

Victor Chaker, editor

ASTM STP 1137

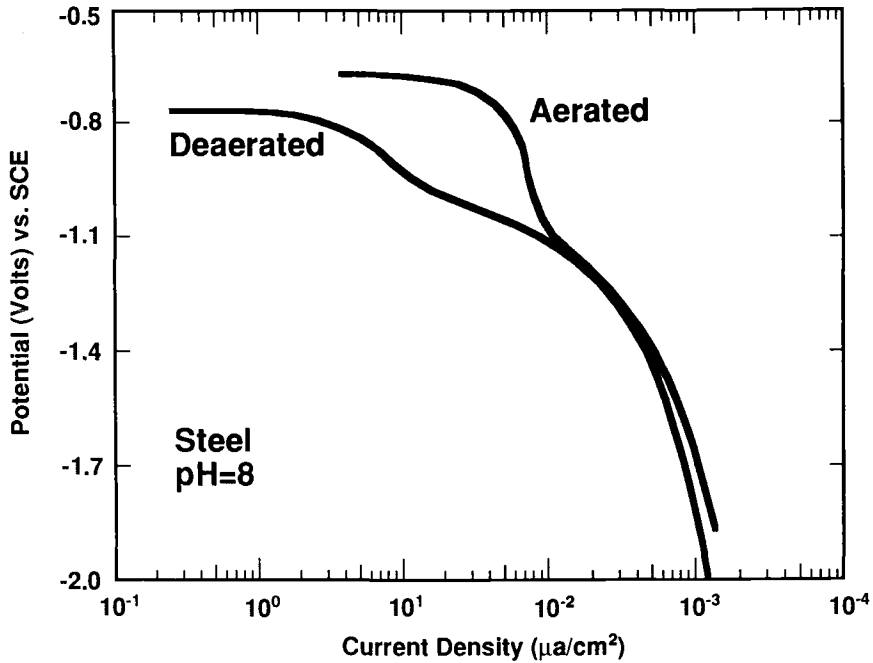
FIGURE 6 Cathodic Potentiodynamic Polarization Curves in ASTM Corrosive Water

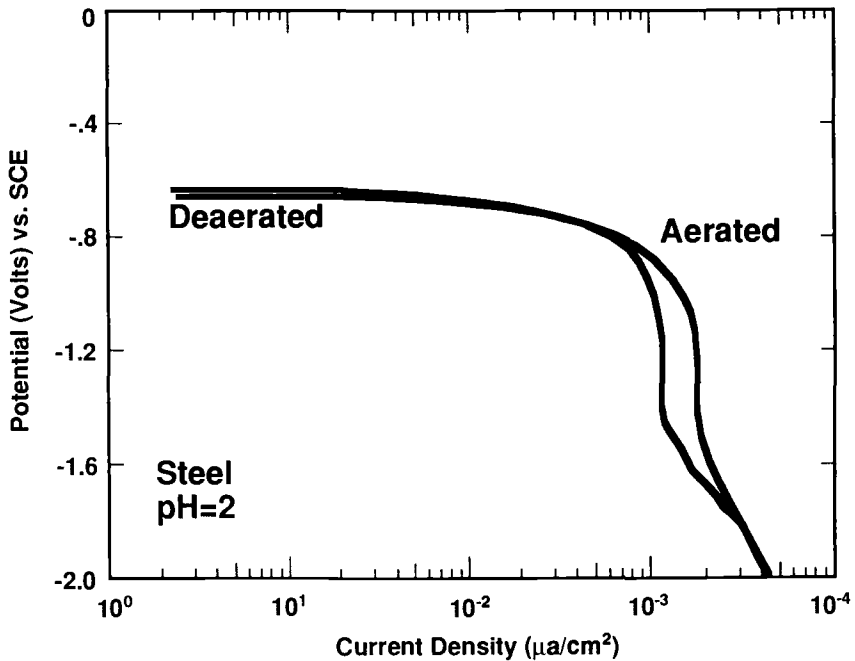
FIGURE 7 Cathodic Potentiodynamic Polarization Curves in ASTM Corrosive Water Acidified With Synthetic Acid Rain

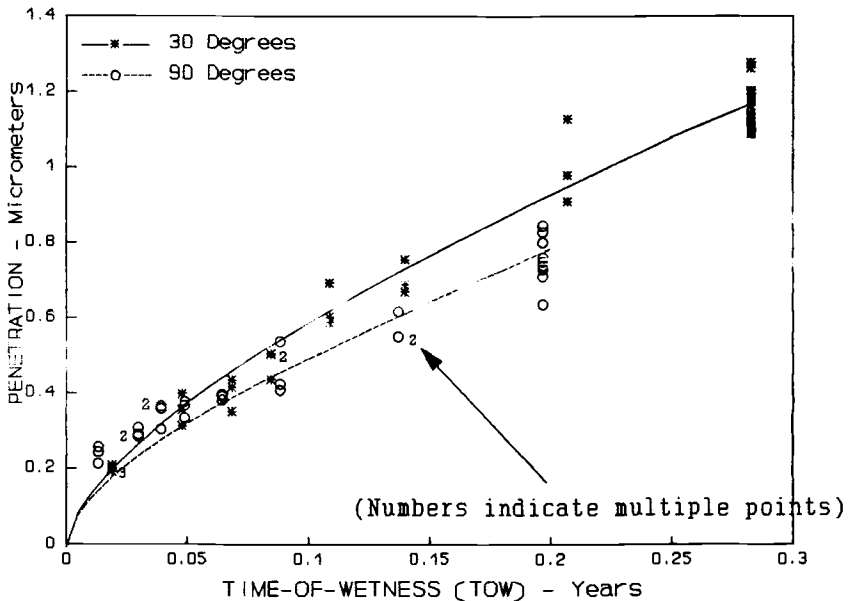
Fig. 6.--Corrosion of galvanized steel coupons as a function of TOW.

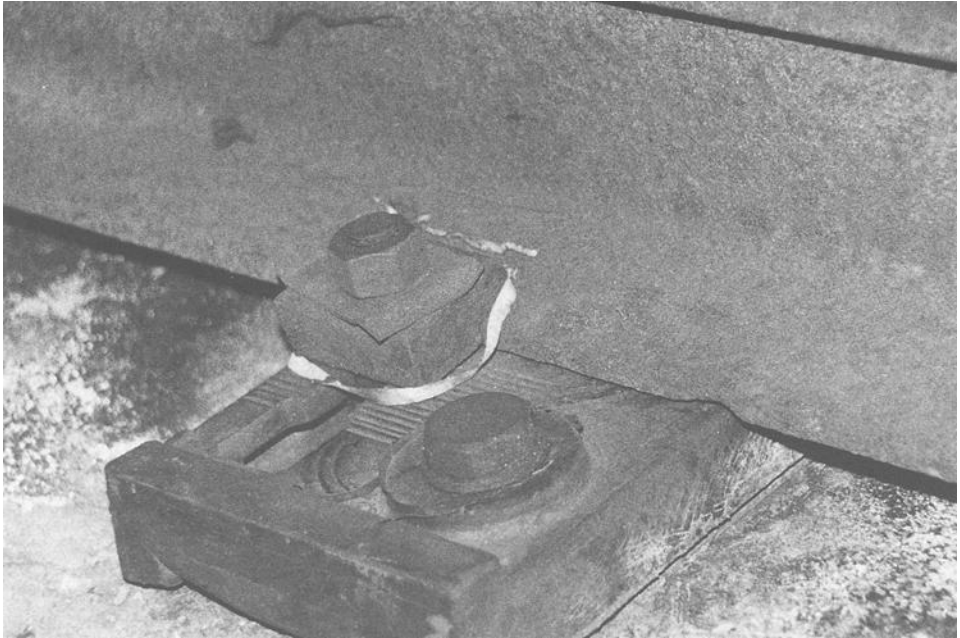
Figure 4. Photograph of Fastener on BART System with Notch in Rail due to Corrosion.

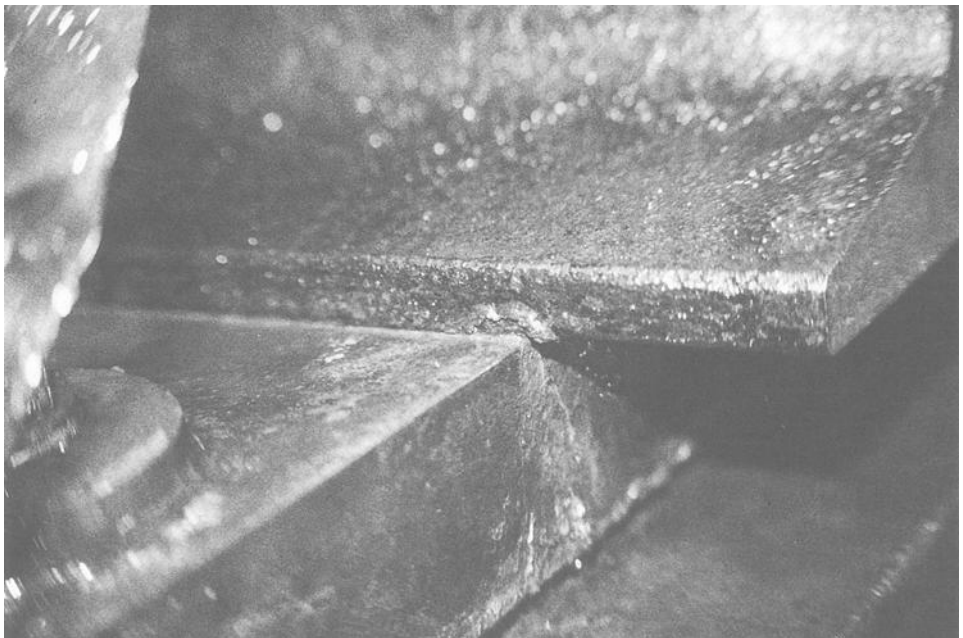
Figure 5. Photograph of Fastener in Test Chamber with Notch in Rail after one week of Accelerated Testing.

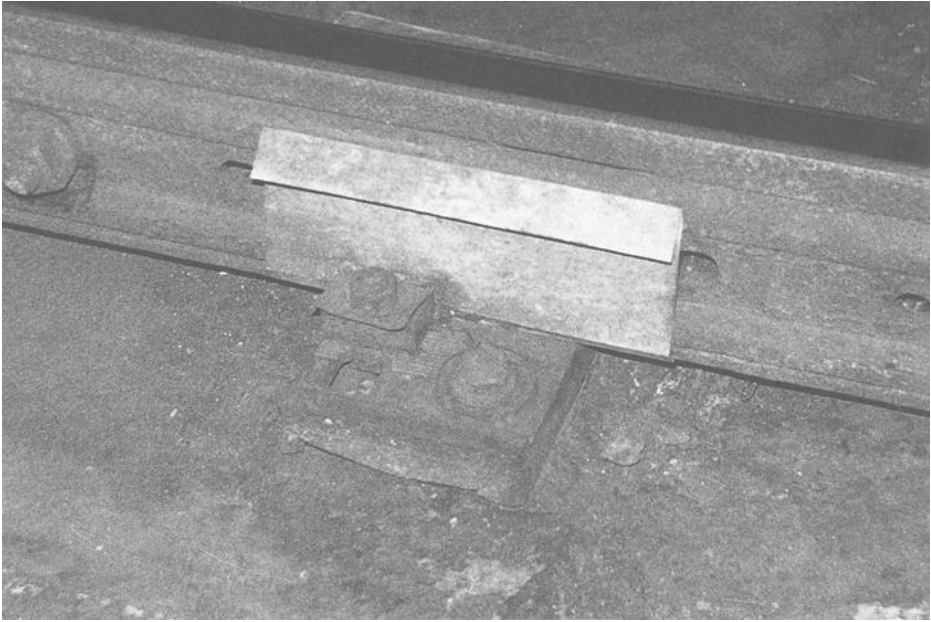
Figure 7. Photograph of Plastic Insulator on the BART System where Cracking was Common.

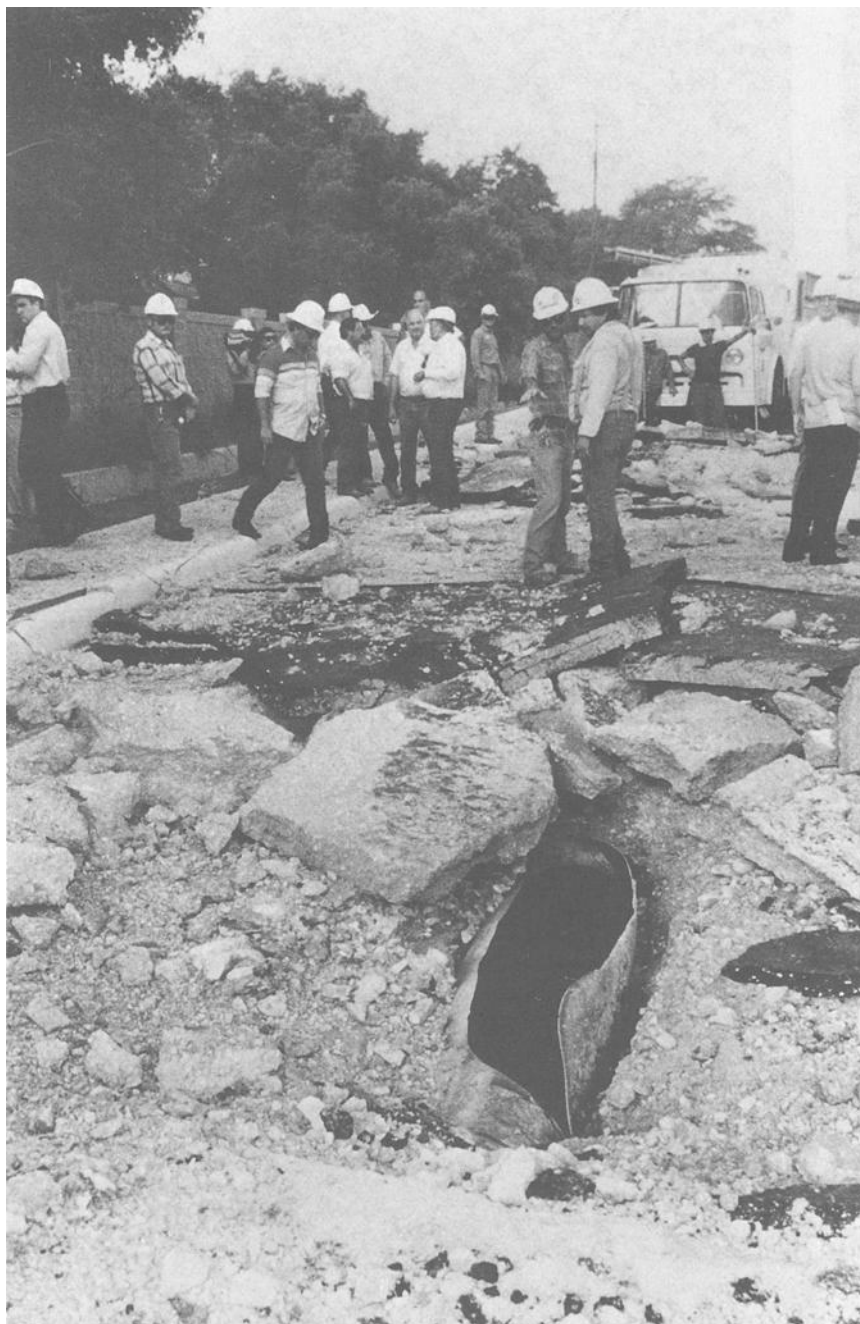
FIG. 1 Photograph of ruptured corroded pipeline.
