**Design and
Construction,
Problems
and Repair**

STP 1180

*Masonry: Design and
Construction, Problems and Repair*

John M. Melander and Lynn R. Lauersdorf, editors

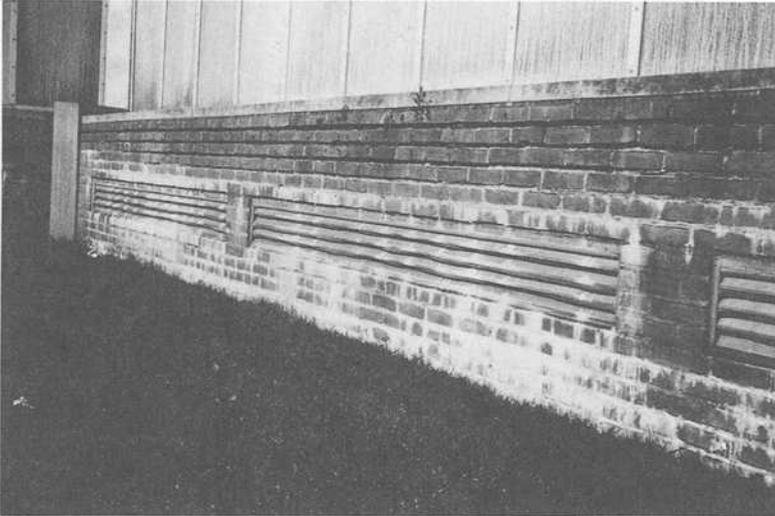
Fig. 1 - View of efflorescence on brick masonry wall

The presence of efflorescence on the surface of brick masonry walls is normally unsightly and, therefore, adversely affects the aesthetics of the wall and building. Efflorescence on the surface of brick masonry walls normally does not, per se, affect the strength or durability of the wall. However, when efflorescence is deposited behind the surface of the wall within pores in the bricks, forces produced from confinement of continuing efflorescence deposits in the pores can lead to cracking and spalling of bricks which adversely affect the strength and durability, as well as the appearance of the wall.

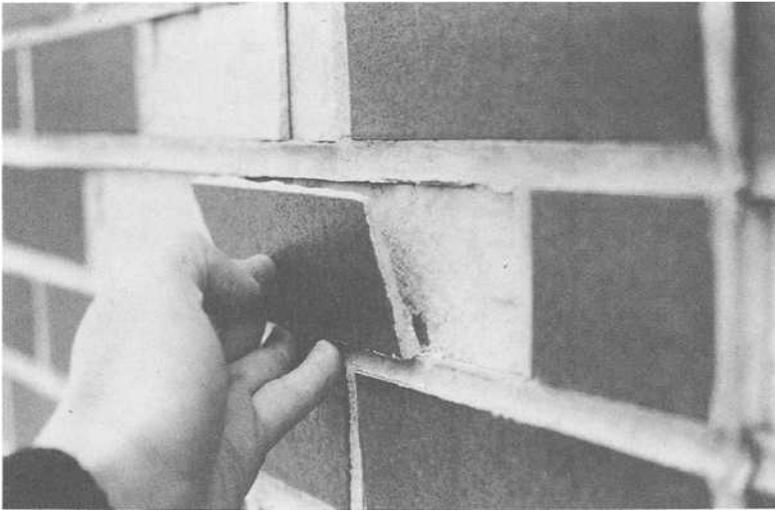
Fig. 2 - Spalling of glazed brick due to efflorescence build-up behind glaze

Confinement of continuing efflorescence deposits by the glaze on glazed brick units in brick masonry walls or by "water proofing" and "water repellent" coatings applied on the surface of brick masonry walls, can produce forces that can cause spalling of bricks, as shown in Figs. 2 and 3. Spalling of the type pictured can also be caused by forces

resulting from freezing of water trapped inside the brick by the water-impermeable glaze or coating.

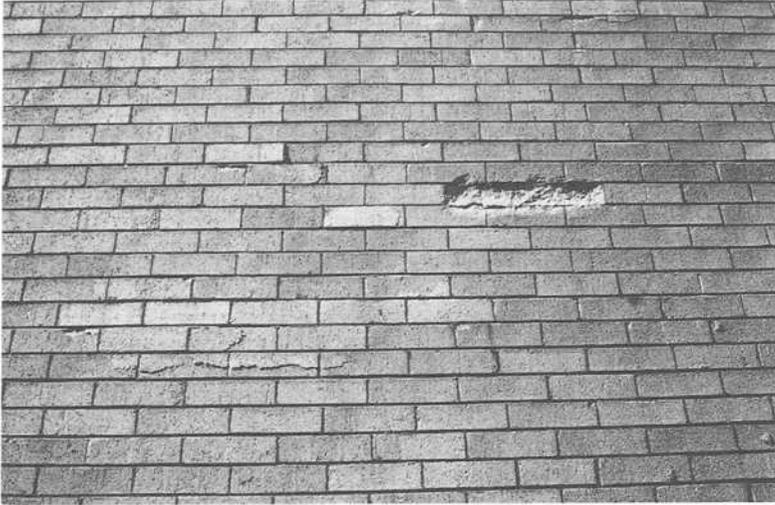
Fig. 3 - Spalling of bricks due to efflorescence build-up behind "water repellent" coating

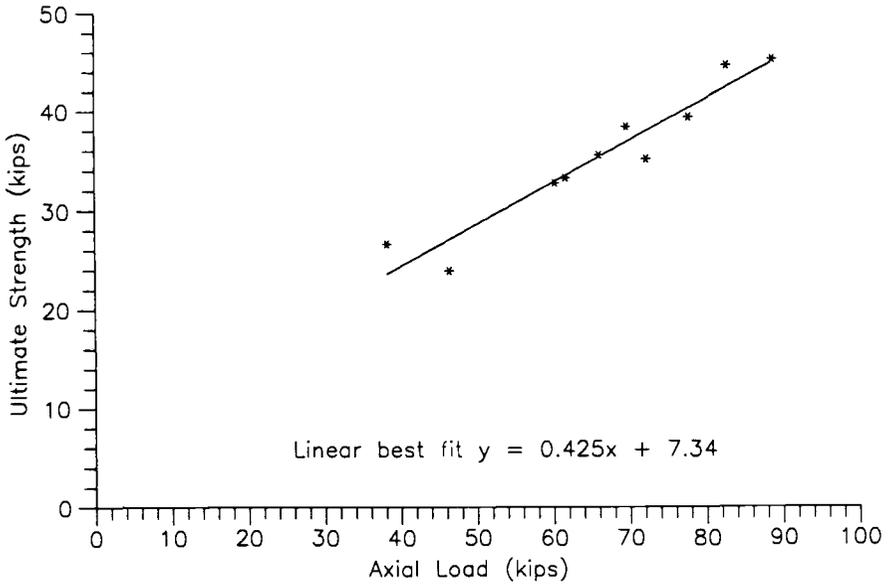
Figure 13--Effect of axial load on ultimate shear strength

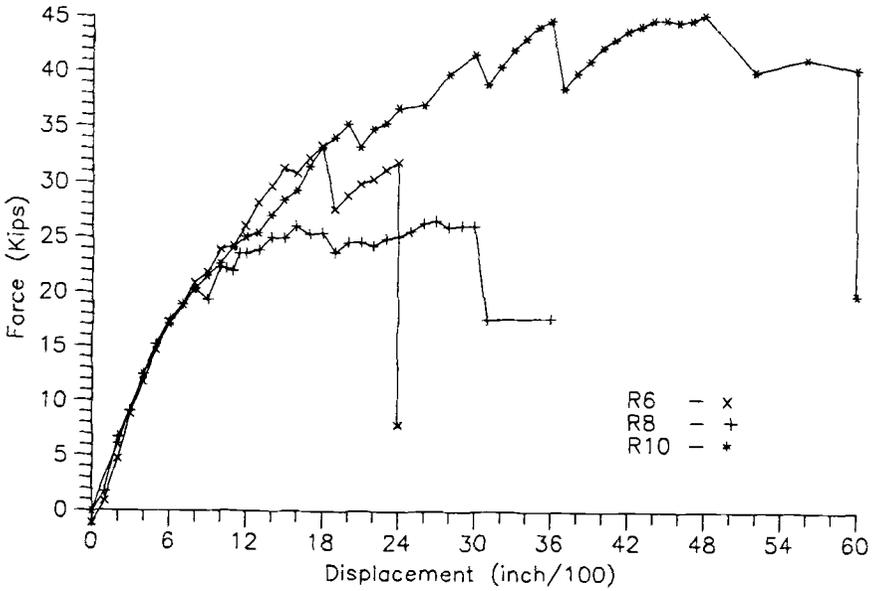
Figure 19--Shear load - deflection envelope comparison of RWall 6, 8, and 10

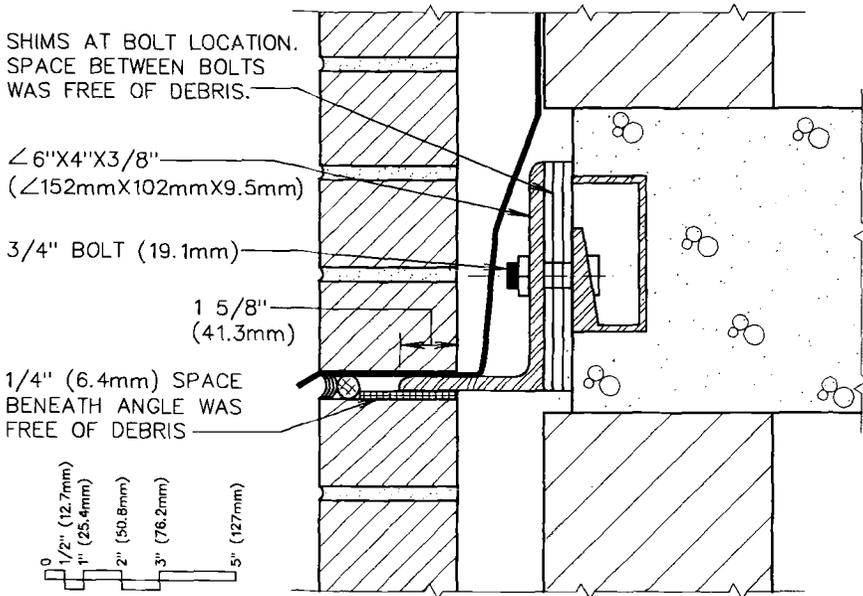
Fig. 1 - Details of construction for case study

The case study that will be reviewed throughout this paper is illustrated in Fig. 1. Twenty-three feet (seven meters) of masonry was supported by an L6x4x3/8 (L152mm x 102mm x 9.5mm) shelf angle, long leg vertical. The 30 ft (9.1m) shelf angle was anchored to a concrete structure with bolts spaced at 6 ft 6 in. (1980mm) in the most severe case. The wall was clay masonry with Type N masonry cement mortar. Because of tolerance problems encountered in the original construction, the masonry was placed near the edge of the shelf angle, having approximately 1 5/8 in. (41.3mm) of bearing. A continuous relief joint was provided beneath the shelf angle. Observations indicated that this joint was present and was free of obstructions.

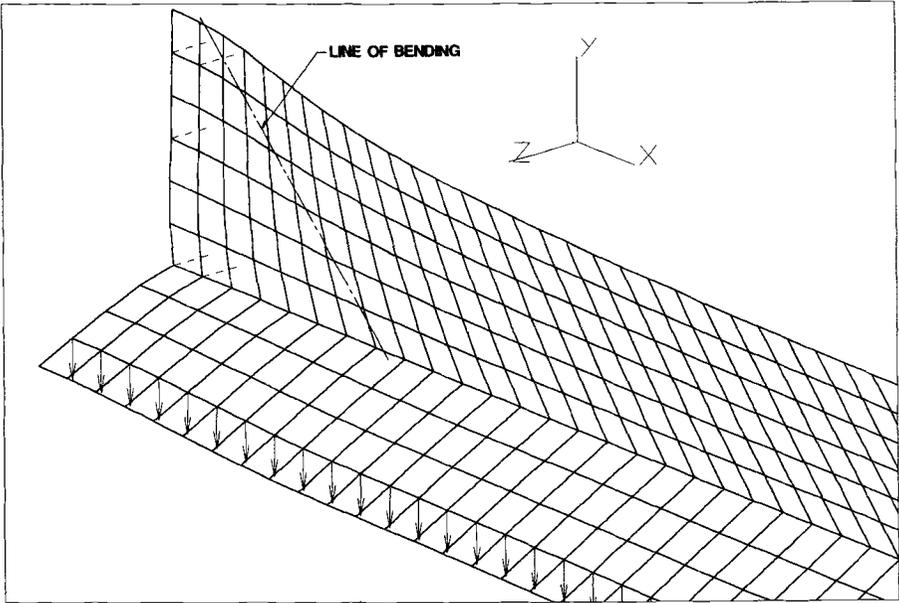
Fig. 2 - Deflection per assumed loading

The total deflection at the centerline was 0.123 in. (3.12mm). The deflection at the support was 0.074 in. (1.88mm). The difference in deflections was very similar to that when the shelf angle was loaded by only 39 in. (990mm) of uniformly distributed masonry. The localized stresses near the support exceed the nominal yield stress within a 2 in. (50mm) distance, as shown in Fig. 3. If the modeling reasonably represents actual conditions, some localized yielding and stress redistribution would occur. The average maximum principal stress over the 10 in. (254mm) region was approximately 30 ksi (207mPa). In conclusion, the deflections and average stresses of the FEM analysis, without considering the friction component, are in good agreement with the results obtained by the simplified analysis presented earlier.

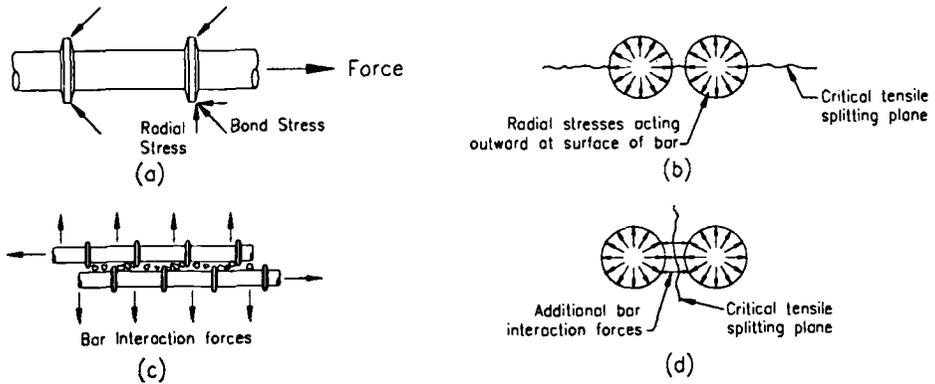
Figure 5--Mechanical bond stresses and bar interaction forces.

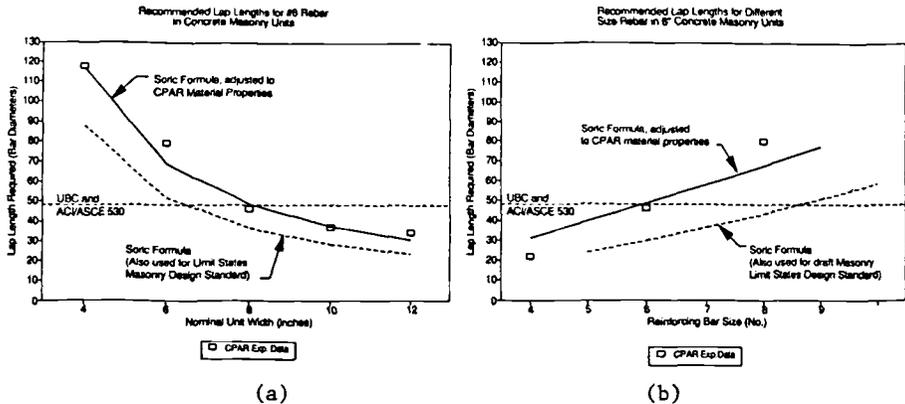
Figure 9--Comparison between lap splice lengths required by current design standards and CPAR experimental results. Note that the lap length required is expressed in terms of bar diameters. (a) Recommended lap splice lengths for number 6 reinforcing bars in concrete masonry units with different widths; (b) lap splice lengths for different size reinforcing bars in 8-inch concrete masonry units (1 inch = 25.4 mm).

The formula adopted in the draft Masonry Limit States Design Standard (Equation 8) provides a rational approach to the determination of lap splice length and considers the important parameters of grout tensile strength, reinforcement yield strength, and the thickness of the

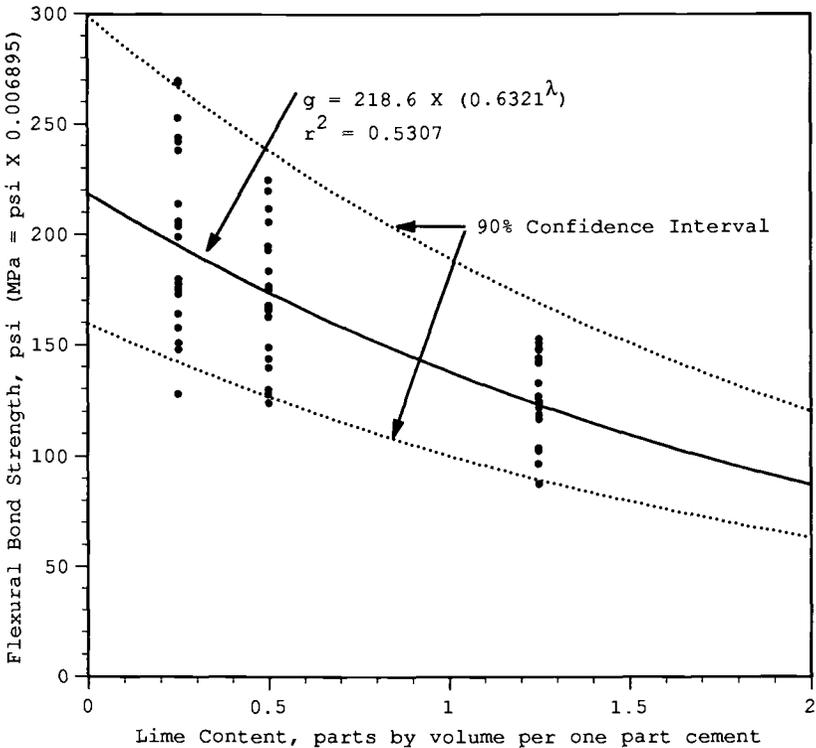
FIG. 2--Relationship of flexural bond strength to lime content of mortars for MICC PCL data.

The MICC data provides information on the relationship of flexural bond strength of masonry using PCL mortars to the proportions of

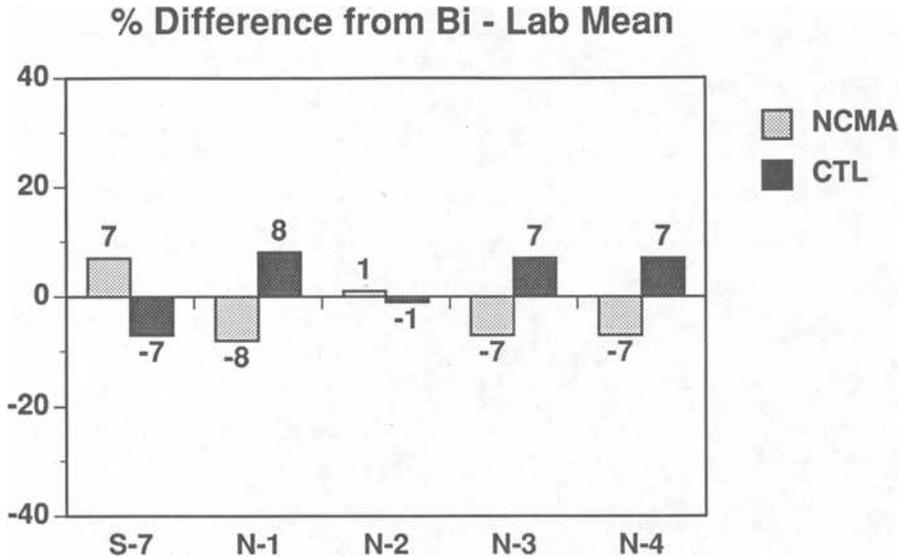
FIG. 4--Comparison of Bond Wrench Results, Type S and Type N Masonry Cement Mortars

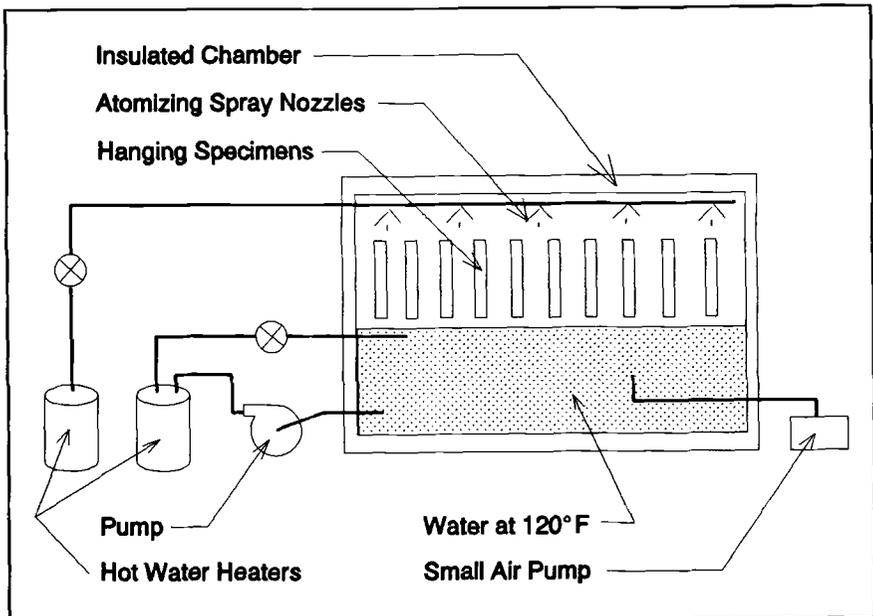
FIG 1 - Schematic Diagram of Test Chamber Construction

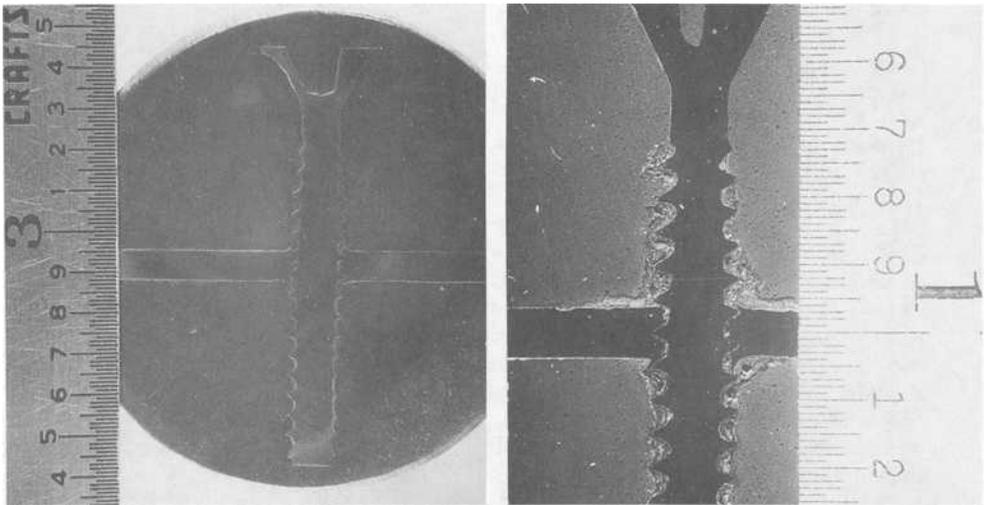
FIG. 5 - Cross-section through stud/screw interface.

The representative photographs in Figures 3 and 4 show the widening area of corrosion on the surface of the stud and the deterioration of the screw heads with time. Figure 5 shows cross-sections through the stud/screw interface. It is clear that the major corrosion attack is outside the engaged threads, and is concentrated within the area of the screw surrounded by the gypsum sheathing.

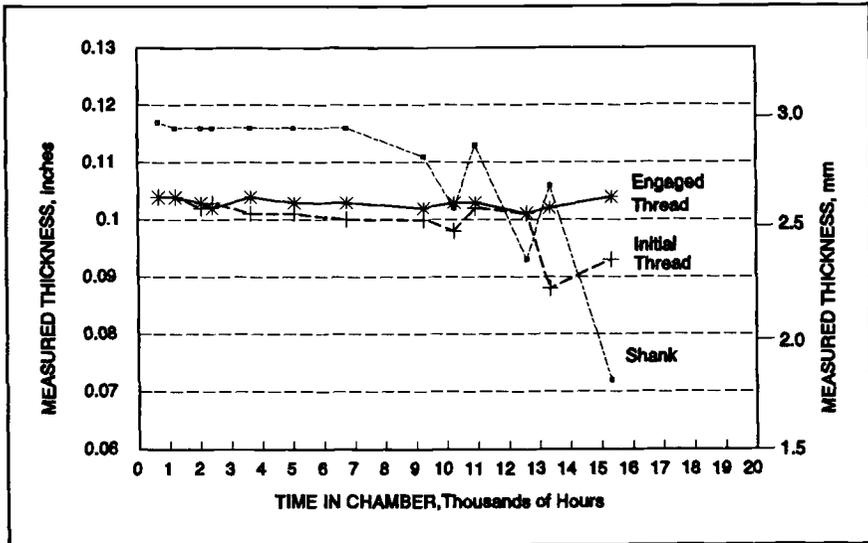
FIG. 8 - Measurements on the shank, initial thread area, and threads engaged in the stud of cleaned bugle-head screws.

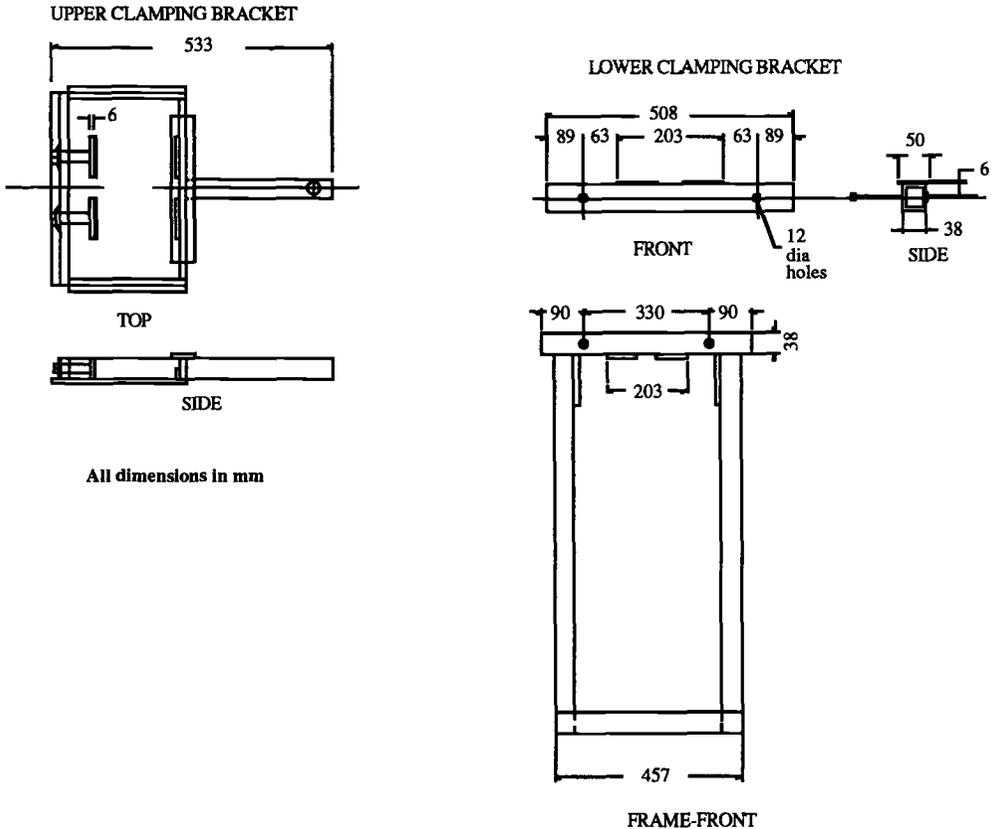
Figure 4 Upper and Lower Clamping Bracket Modified Configurations

clamping brackets with individual bearing pads (see Figure 4). Since these pads may have contributed to the stress concentrations, the pads on the upper clamping bracket were replaced with solid bearing surfaces. Bond wrench tests were repeated for a gauge height of approximately 12 mm (0.5 in) above the lower clamping bracket. Three tests were run.

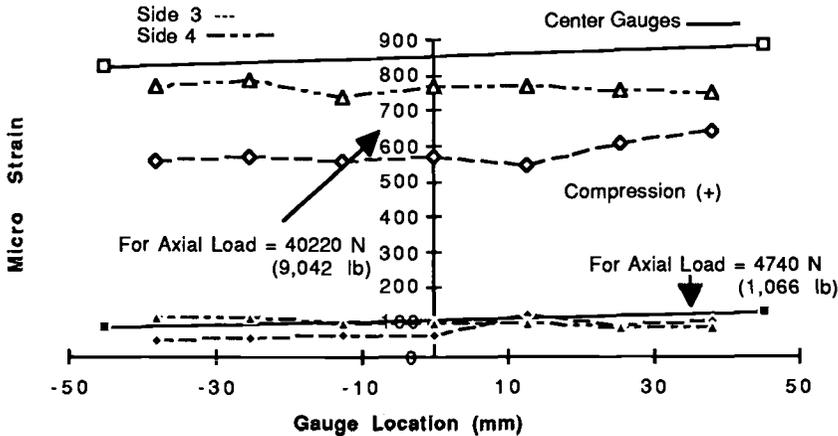
Figure 6 Strain Distribution Across the Depth of the Axially Loaded Block

Figure 6 shows a typical strain distribution within the axially loaded block. It appears that there are strain concentration effects caused by misalignments within the testing machine and imperfections in the bearing surfaces, especially at higher stress levels. However, a linear regression performed on the average stress and strain values for all three tests yielded an elastic modulus of 3,330 MPa (480,000 psi), with an error, R², of 0.998.

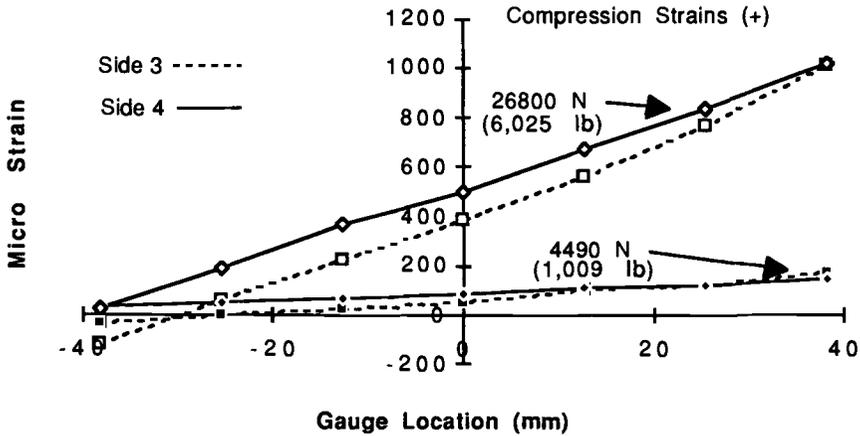
Figure 7 Block Strains on Faces 3 and 4 for an Axial Load and an Eccentricity of 19 mm (0.75 in)

Furthermore, it appears that when an eccentricity is introduced in the loading, better performance of the system results. Figure 7 shows good agreement between strains measured on block faces 3 and 4, for an eccentricity of 19 mm (0.75 in). As shown in Figure 8, there is also good agreement

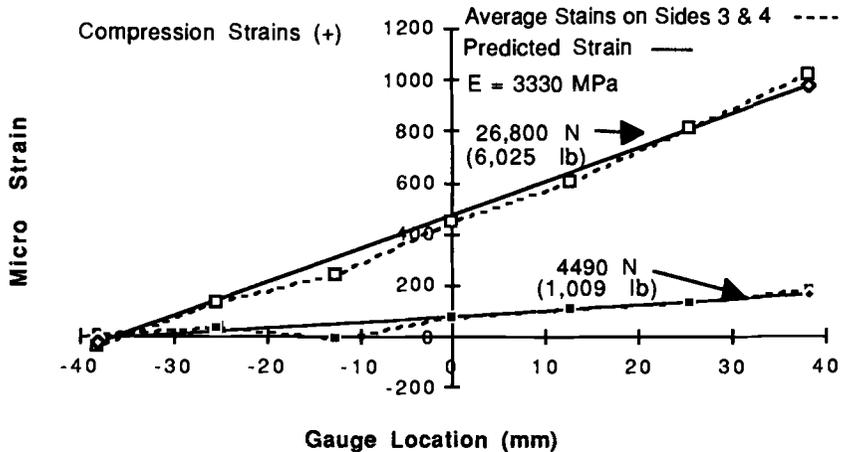
Figure 8 A Comparison of Average Strains on Sides 3 & 4 to Predicted Strains, e = 19 mm (0.75 in)

between the predicted strains and the average of the strains measured on sides 3 and 4. This agreement between predicted and average measured strain was also observed for an eccentricity of 38 mm (1.5 in), as shown in Figure 9. Predicted strains were calculated using the average measured elastic modulus.

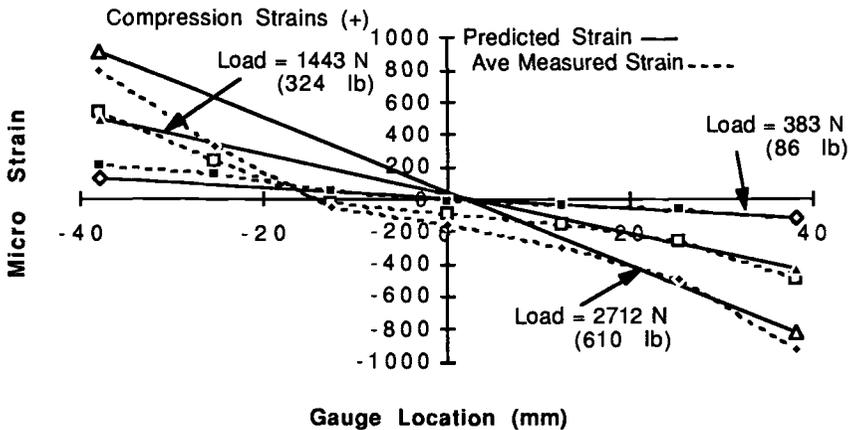
Figure 12 Predicted Versus Average Measured Strains on Side 3 and 4 Using Separate Bearing Pads and a Gauge Height Above the Lower Clamping Bracket of 38 mm (1.5 in).

Figure 12 shows the average of strains measured on sides 3 and 4 when the gauge elevation is increased to 38 mm (1.5 in) above the lower clamping bracket. A significantly more linear strain distribution and better agreement with predicted strains were observed, especially in the compression zone of the specimen. These results suggest that the lower clamping bracket caused a significant portion of the stress concentration effects and better test results may be obtained by defining a minimum distance between the lower clamping bracket and the mortar joint being tested. It also appears that the configuration of the lower clamping bracket must be re-evaluated.

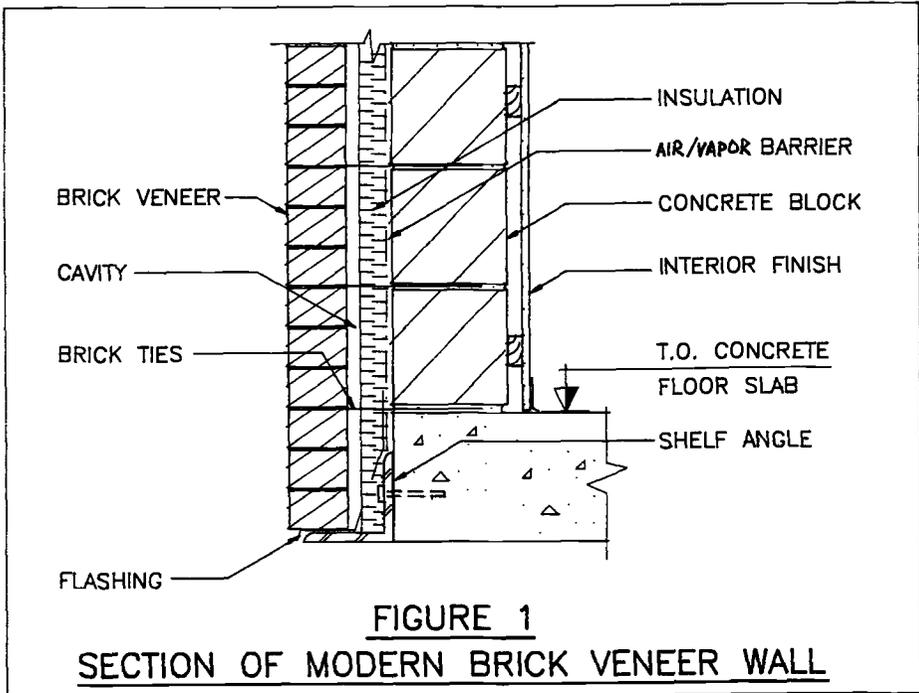
Figure 1 shows a section of a modern brick veneer wall. The insulation is located inboard of the cavity behind the brick veneer, so that the brick temperature is much closer to the outdoor temperature. The first cold surface encountered by indoor air leaking through a poor air barrier is the backside of the brick, and if indoor air is moist enough, condensate and frost will be deposited on this surface. In general buildings are less leaky, and mechanical humidification and ventilation systems are able to provide higher indoor humidities and to force indoor air out through air barrier flaws to prevent drafts. The vapour barrier prevents moisture diffusion through the inner wall in both directions, so that once the brick is wet it cannot dry to the interior. The new architectural style provides vast expanses of flat facade unmarked by corbels and protrusions, and unable to direct rain and meltwater away from the brick surfaces.

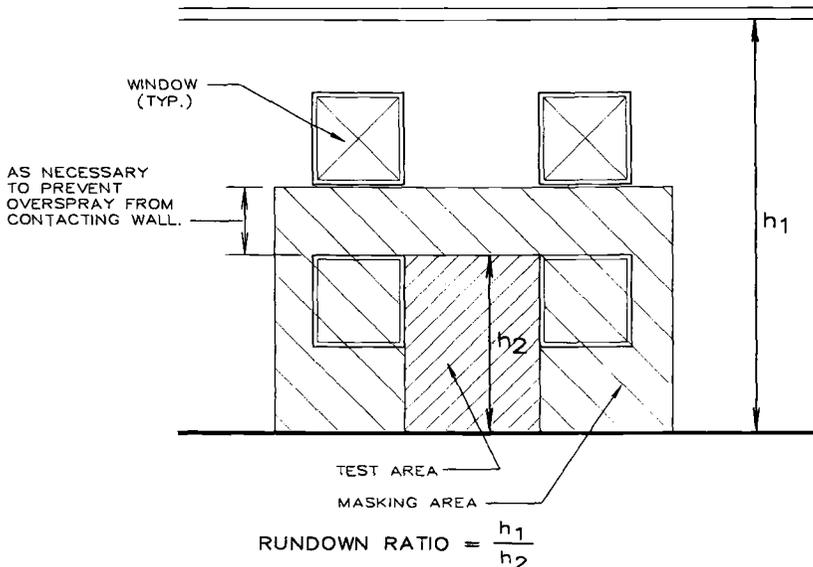
Fig. 6 - Typical masking system

3. If the ASTM E 1105 testing is needed to determine the source of leakage, all areas above and at the sides of test area are to be masked as necessary to isolate the test area as shown in Fig. 6. The masking can be performed with polyethylene sheets taped in place or held in place with wood furring. The masonry wall can be divided into several components testing from the bottom to the top in order to isolate contributions to leakage.

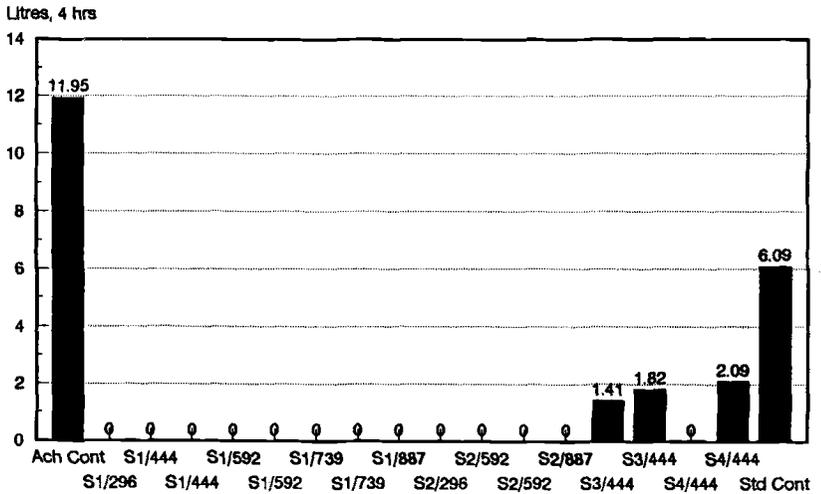
Fig. 1--ASTM E 514-90 4 h leakage from cavity.

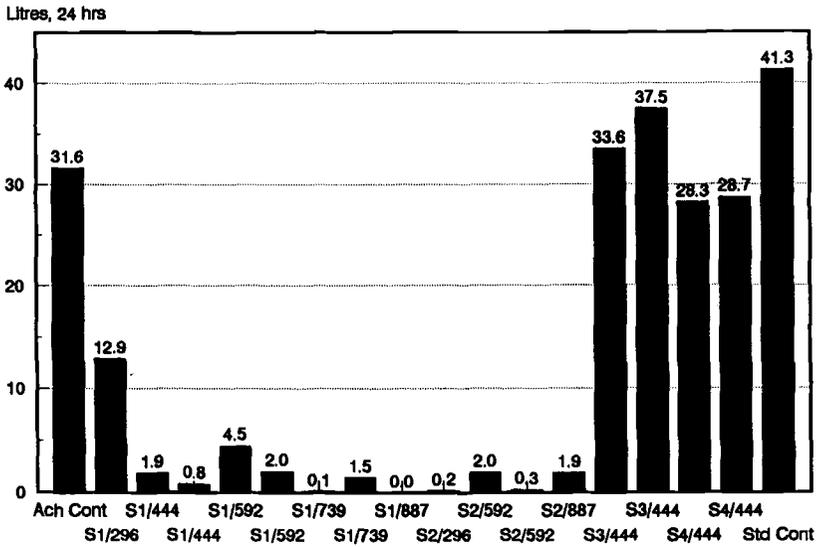
Fig. 2--24 h leakage from cavity into bottom trough.

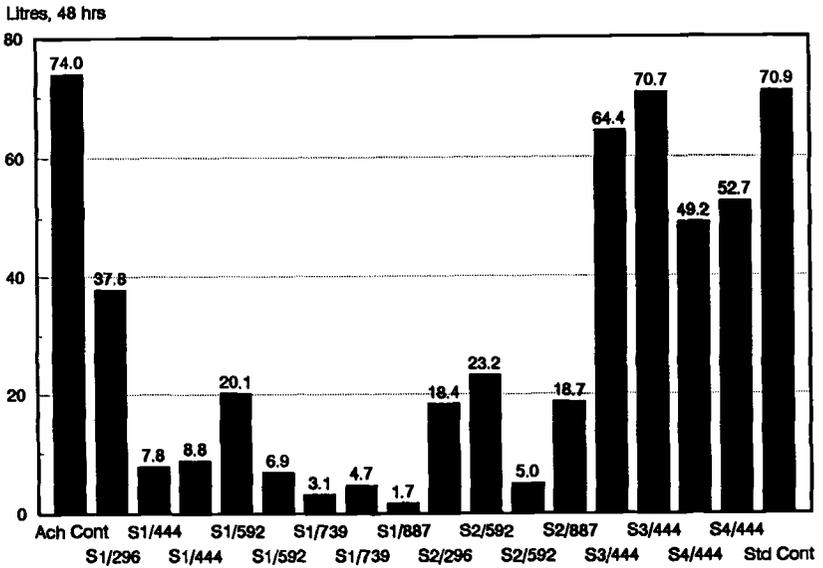
Fig. 3--48 h leakage from cavity into bottom trough.

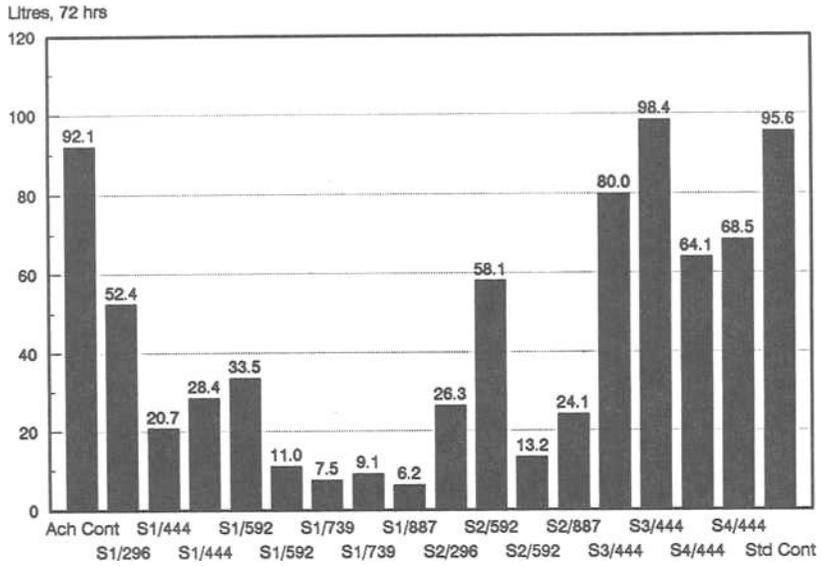
Fig. 4--72 h leakage from cavity into bottom trough.

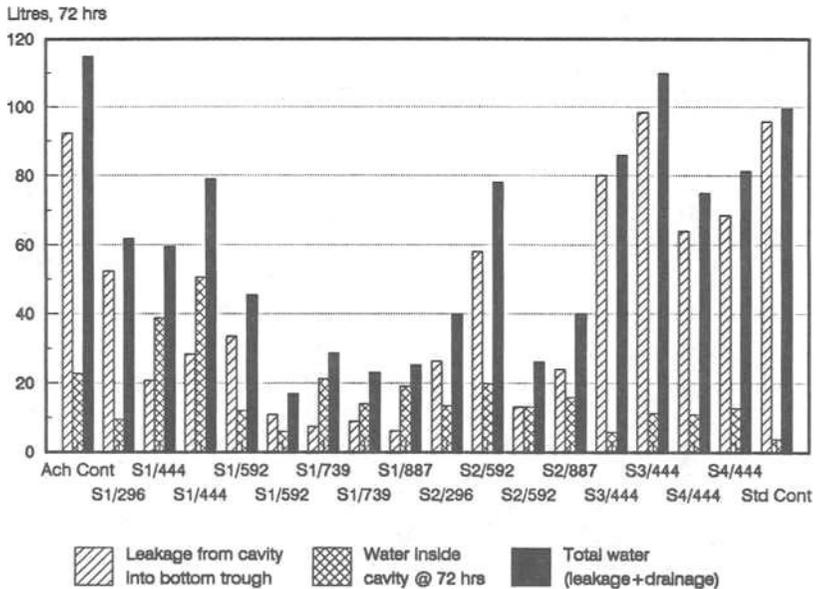
Fig. 5--Total water (leakage + drainage) collected from cavity into bottom trough at 72 h.

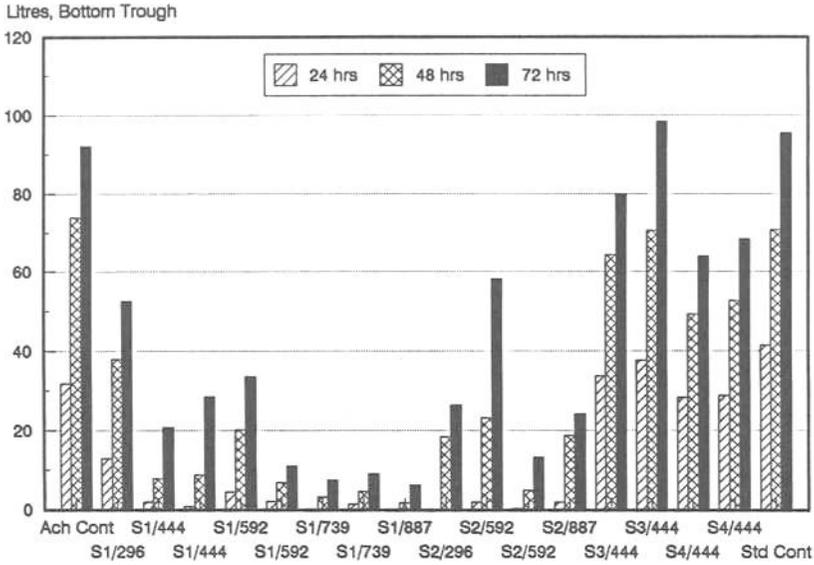
Fig. 6--Comparison of 24, 48 and 72 h leakage from cavity into bottom trough.

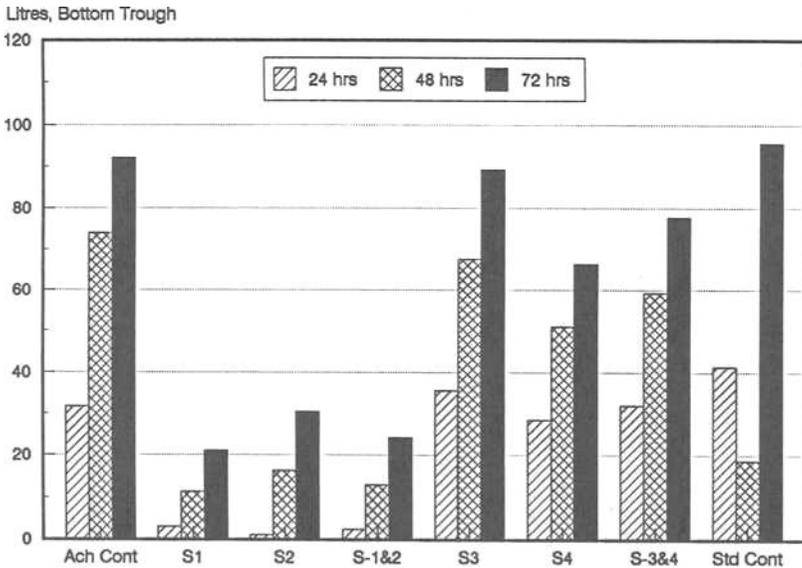
Fig. 7--Average leakage from cavity for different IWRs.

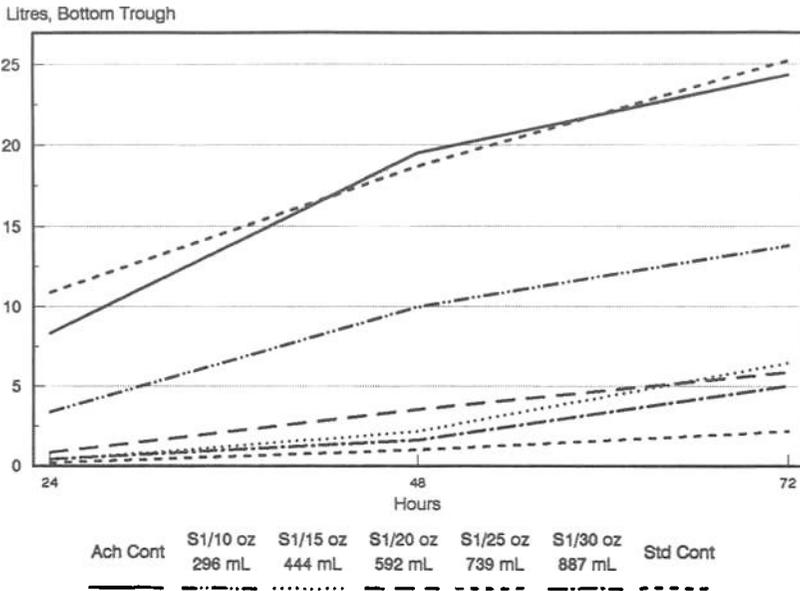
Fig. 8--Effect of S1 dosage upon leakage from cavity.

The effect of admixture addition rate upon performance is summarized in Figures 8 - 12 and it can be seen that the rate of leakage into the cavity as a function of time decreases as addition rate for the S1/S2 admixtures increases. For S1, tests were done with concrete block containing 296, 444, 592, 739 and 887 mL S1/45.36 kg cement (10, 15, 20, 25 and 30 oz S1/cwt). There is a large reduction in leakage between 0 to 296 mL (0 to 10 oz), 296 to 444 mL (10 to 15 oz), and 444 to 739/887 mL (15 to 25/30 oz); the minimum leakage occurs between 739 to 887 mL (25 to 30 oz), which is the recommended addition rate.

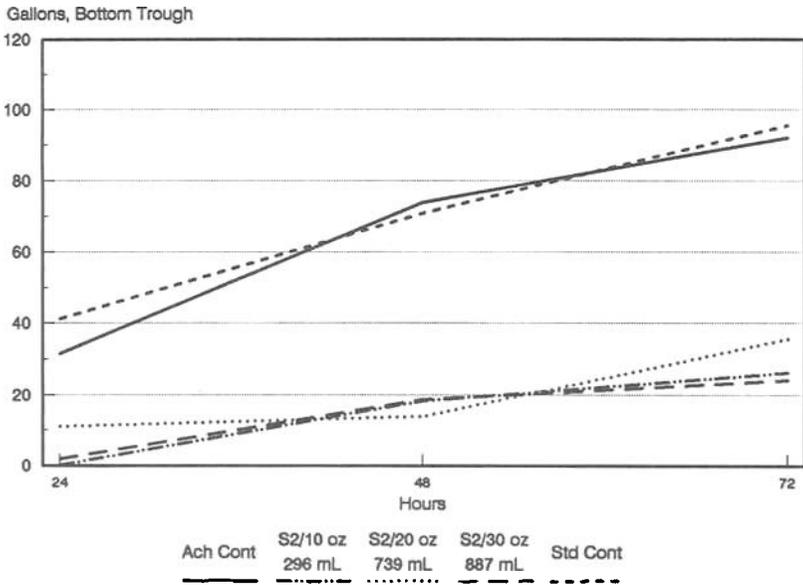
Fig. 9--Effect of S2 dosage upon leakage from cavity.

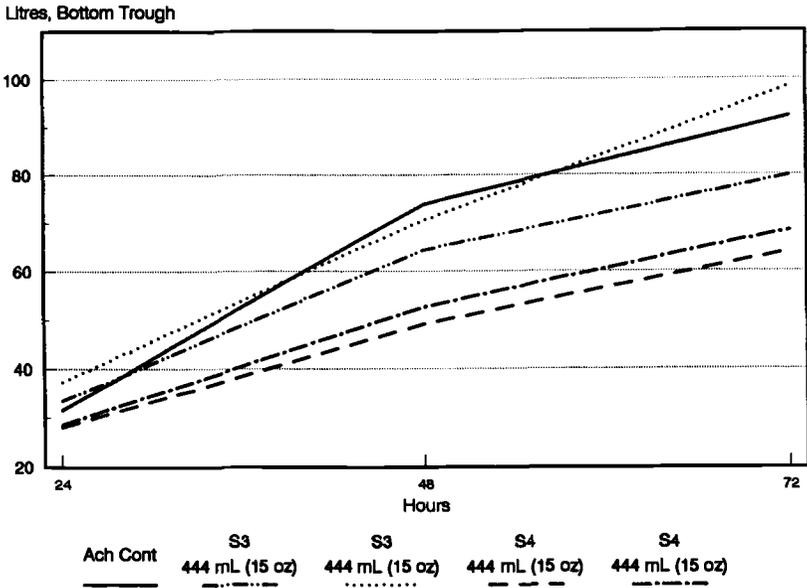
Fig.10--Effect of S3 and S4 upon leakage from cavity.

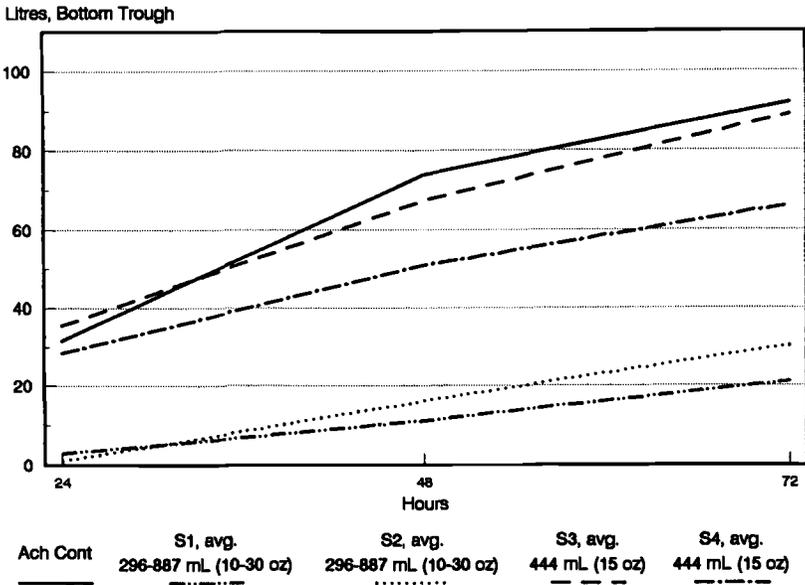
Fig. 11--Comparison of S1/S2 and S3/S4 upon leakage from cavity.

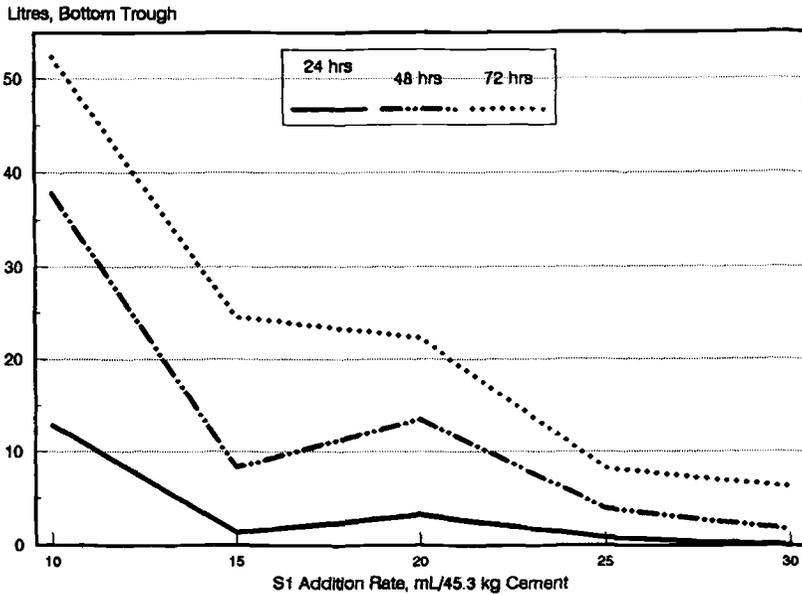
Fig. 12--Effect of S1 dosage and time upon leakage from cavity.

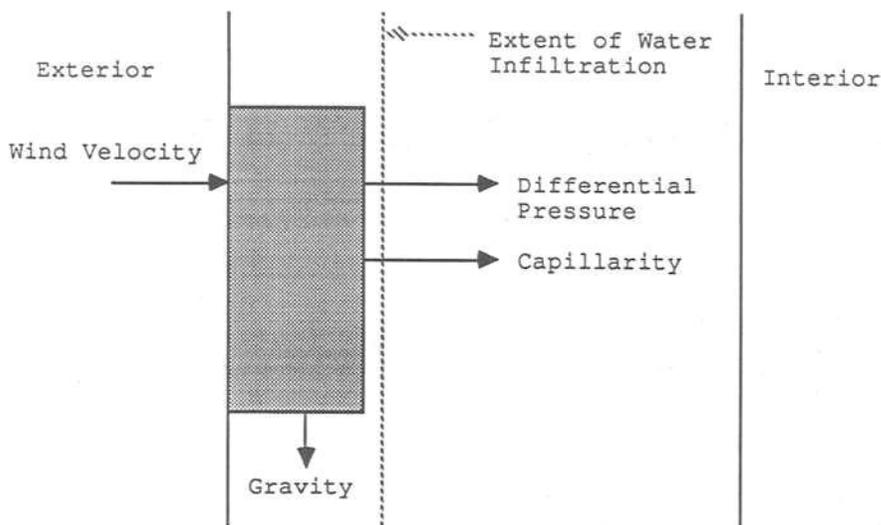
Figure 2. Control volume of saturated masonry material.

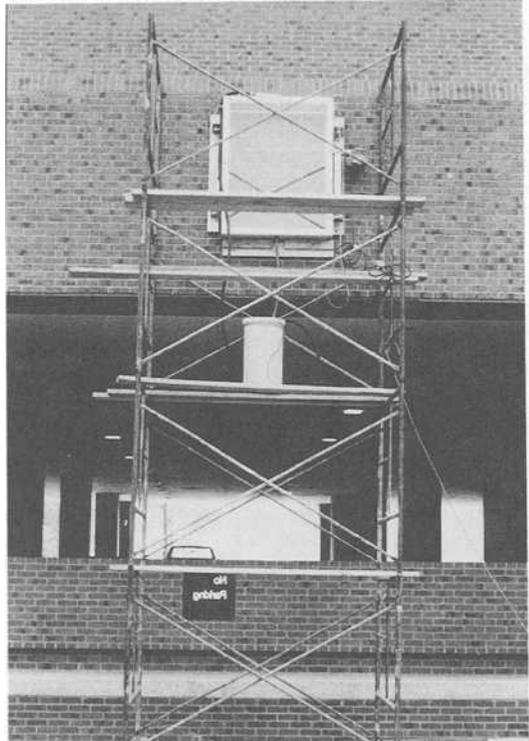
FIG. 1 -- Typical set-up for modified E 514 test.

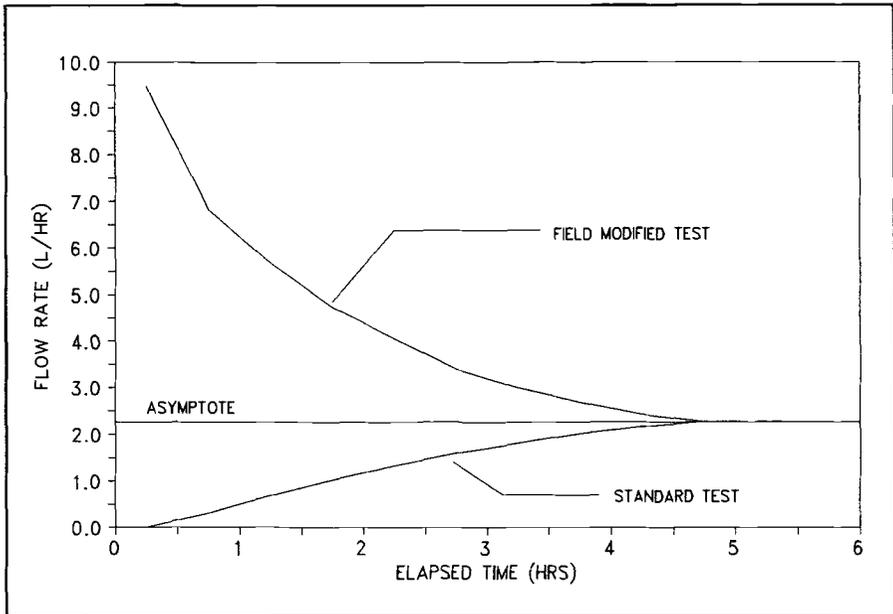
FIG. 2 -- Comparison of permeance rate plots for standard and modified E 514 tests.

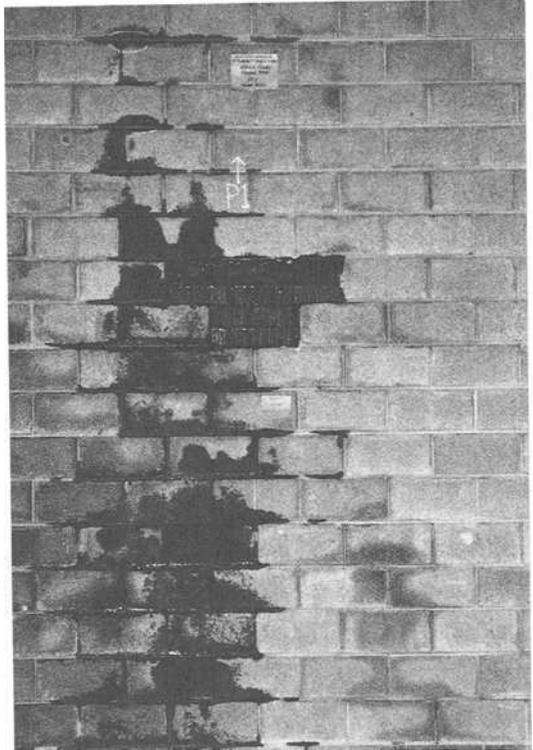
FIG. 3 -- Interior side of CMU back-up is saturated during field E 514 test due to water bridging cavity space.

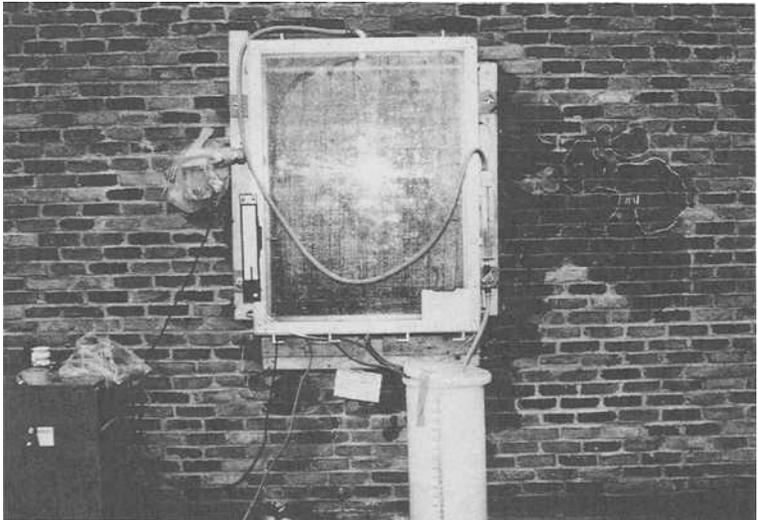
FIG. 5 -- Wet areas adjacent to test chamber caused by lateral migration of water.

One way to control lateral migration of water from a test area is to isolate it by cutting through the outer masonry wythe around the perimeter of the test chamber and sealing the cut surfaces. The result closely resembles the laboratory E 514 specimen. This method is both costly and time consuming, and results in undesirable damage to the wall being tested.

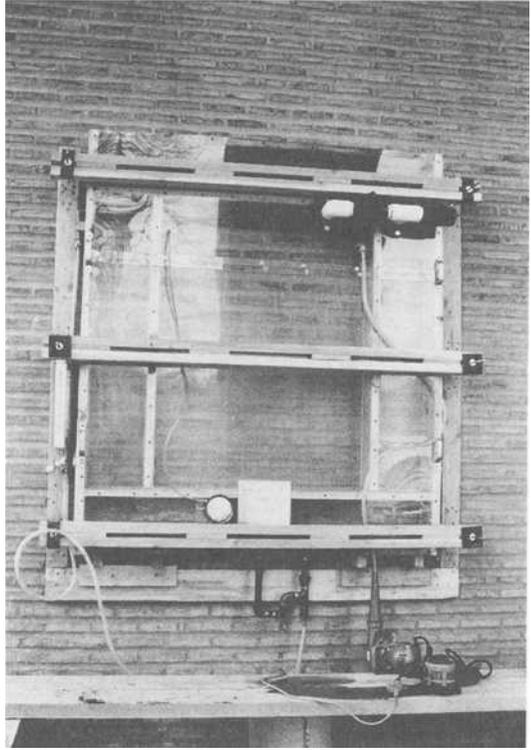
FIG. 6 -- Typical set-up for field E 514 test with double chamber.

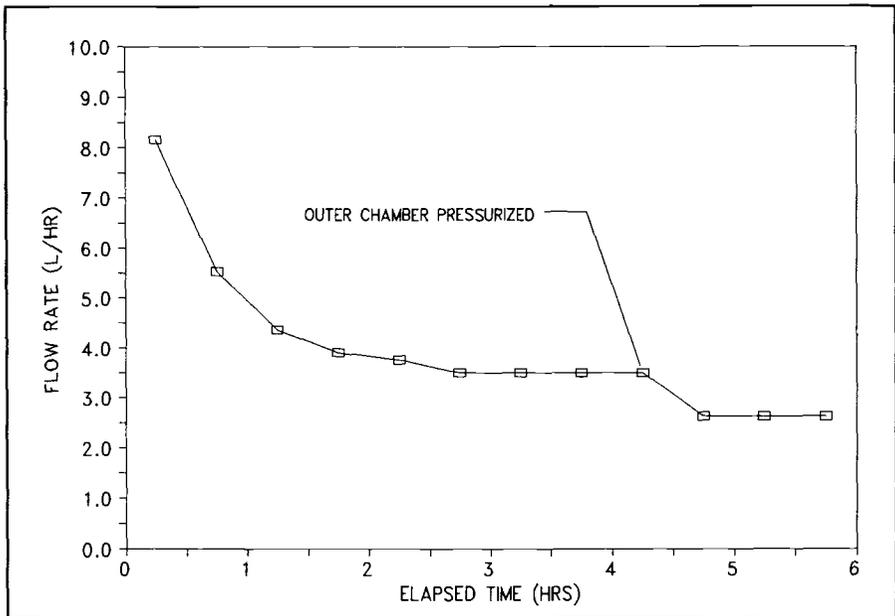
FIG. 7 -- Permeance rate plot using double chamber on wall with substantial lateral migration.

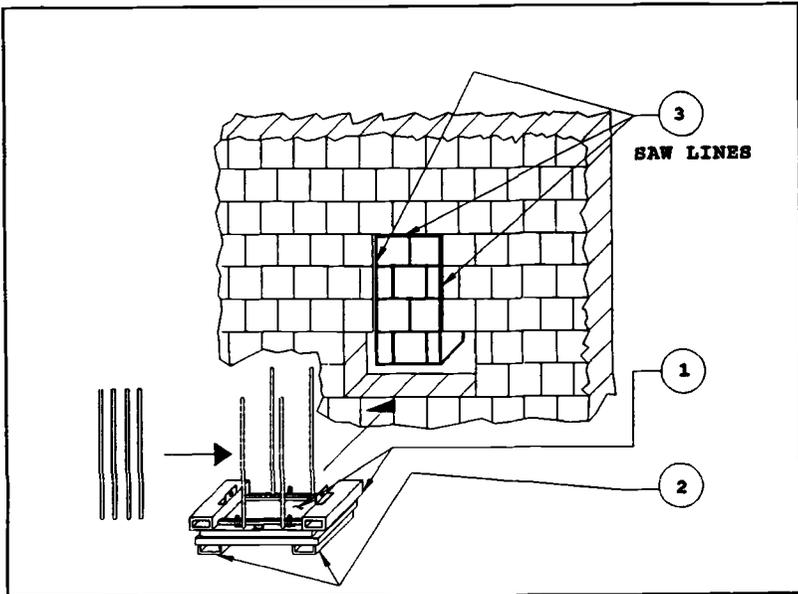
Fig. 5. A schematic showing the fixture base and subbase ready to be lifted into place under a 2-ft by 4-ft (610 mm by 1 219 mm) prism.

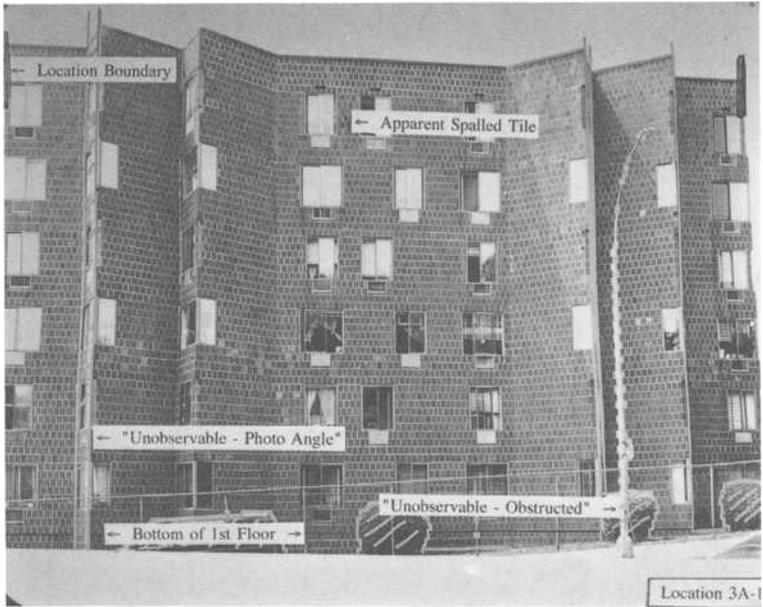
FIG. 2--Typical Wall Elevation with Counting Boundaries
