**Design and
Construction,
Problems
and Repair**

STP 1180

*Masonry: Design and
Construction, Problems and Repair*

John M. Melander and Lynn R. Lauersdorf, editors

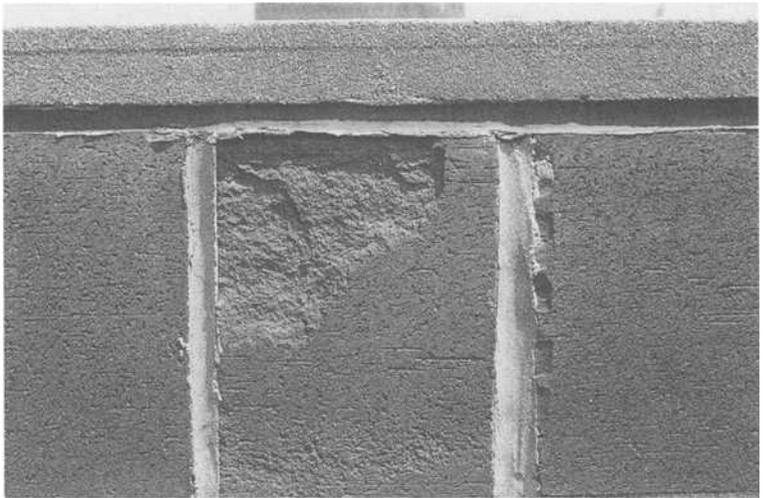
FIG. 3--Spalled Tile at Parapet Coping

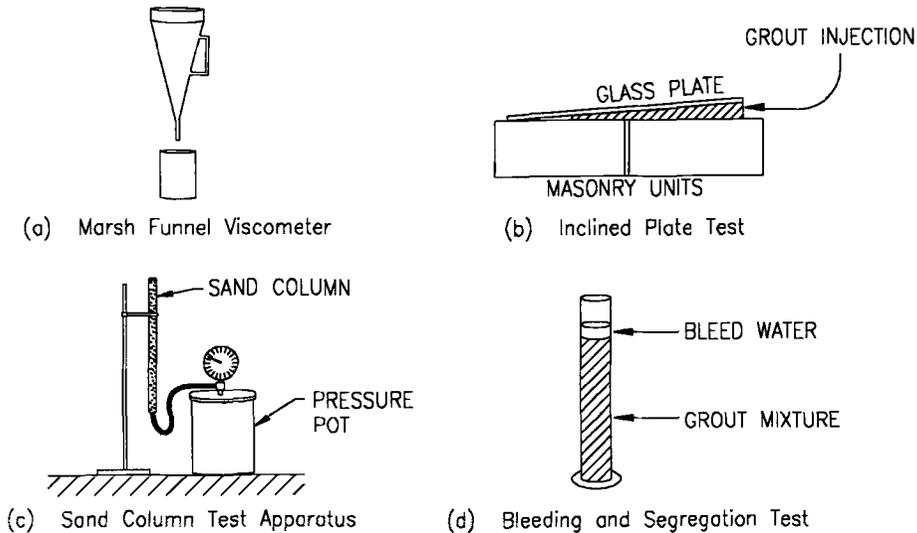
Figure 1--Apparatus used for evaluation of grout mix fluidity, injectability, and stability.

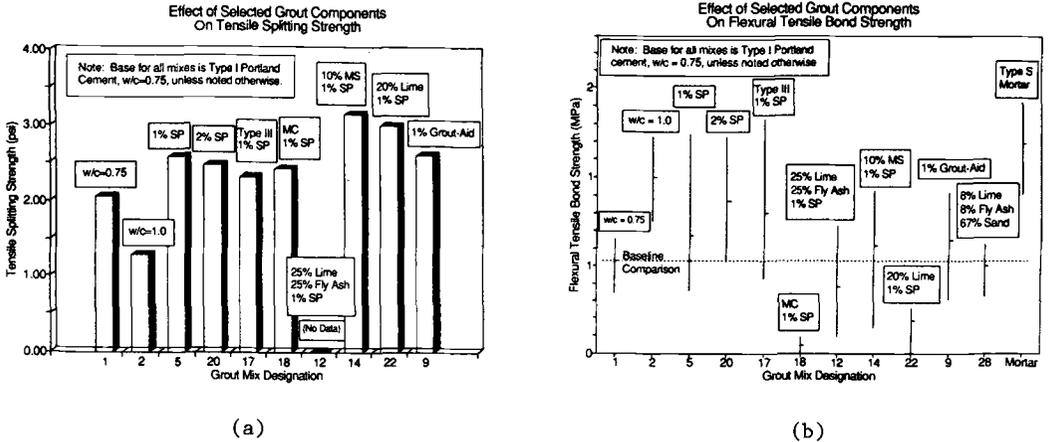
Figure 4--Representative results showing the effect of various grout components on: (a) tensile splitting strength; (b) bond strength. Note: SP = superplasticizer, MC = masonry cement, MS = microsilica.

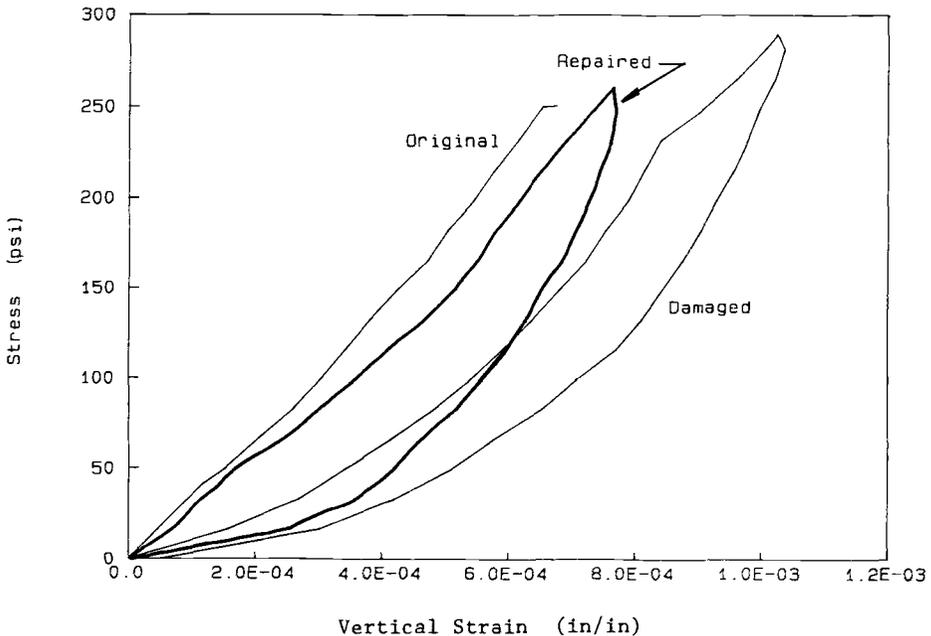
Figure 5--Compressive behavior of masonry test wall for the original and damaged states, and following repair by grout injection (145 psi = 1.0 MPa).

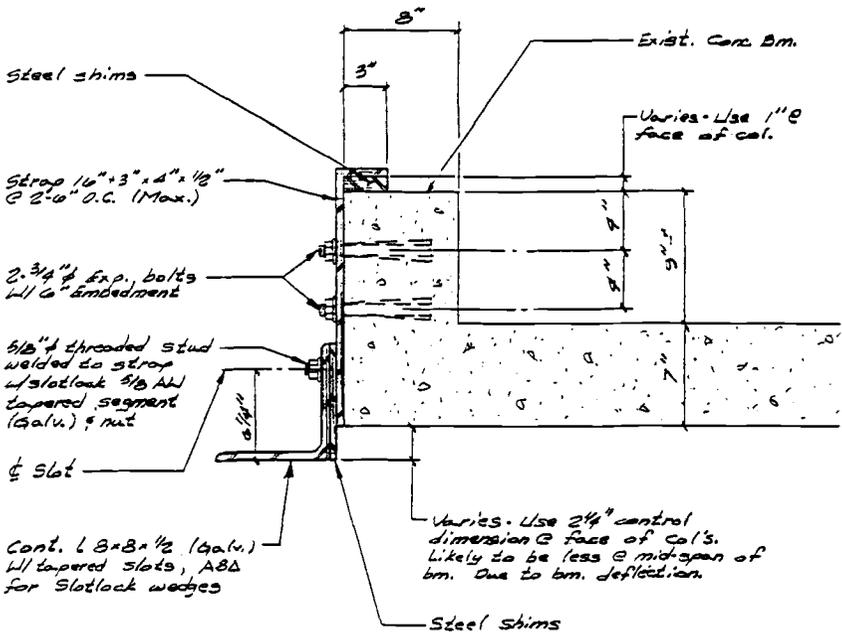
FIG. 7--Relieving angle attachment detail.

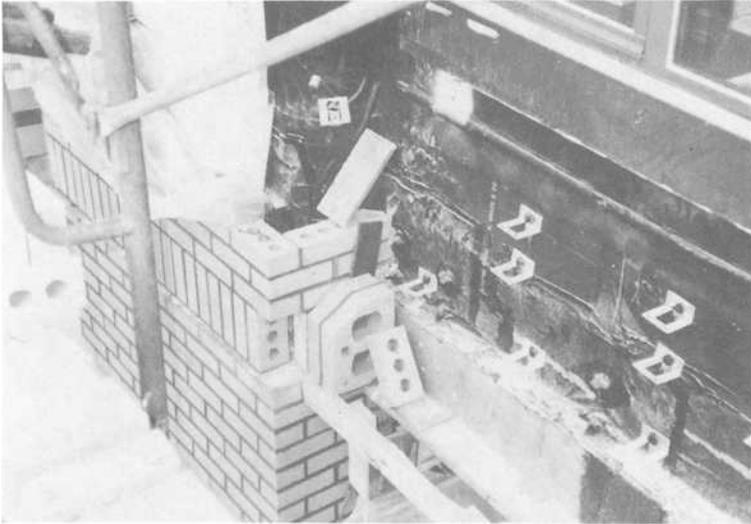
FIG. 9--Tie layout on spandrel panel beneath windows.

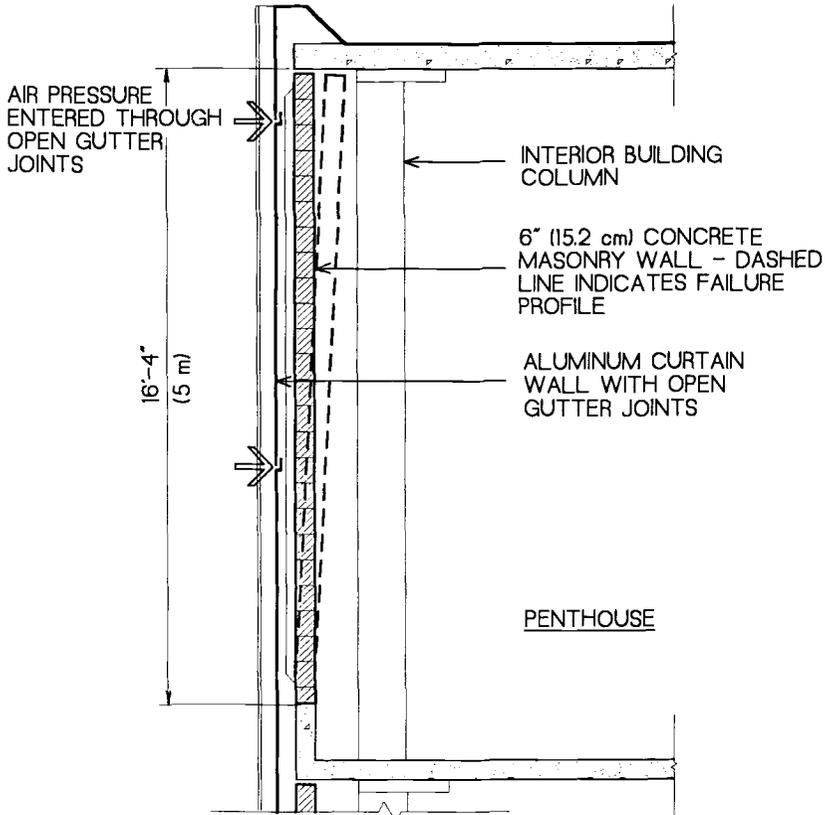
Fig. 1 -- Case Study 1: Wall Section

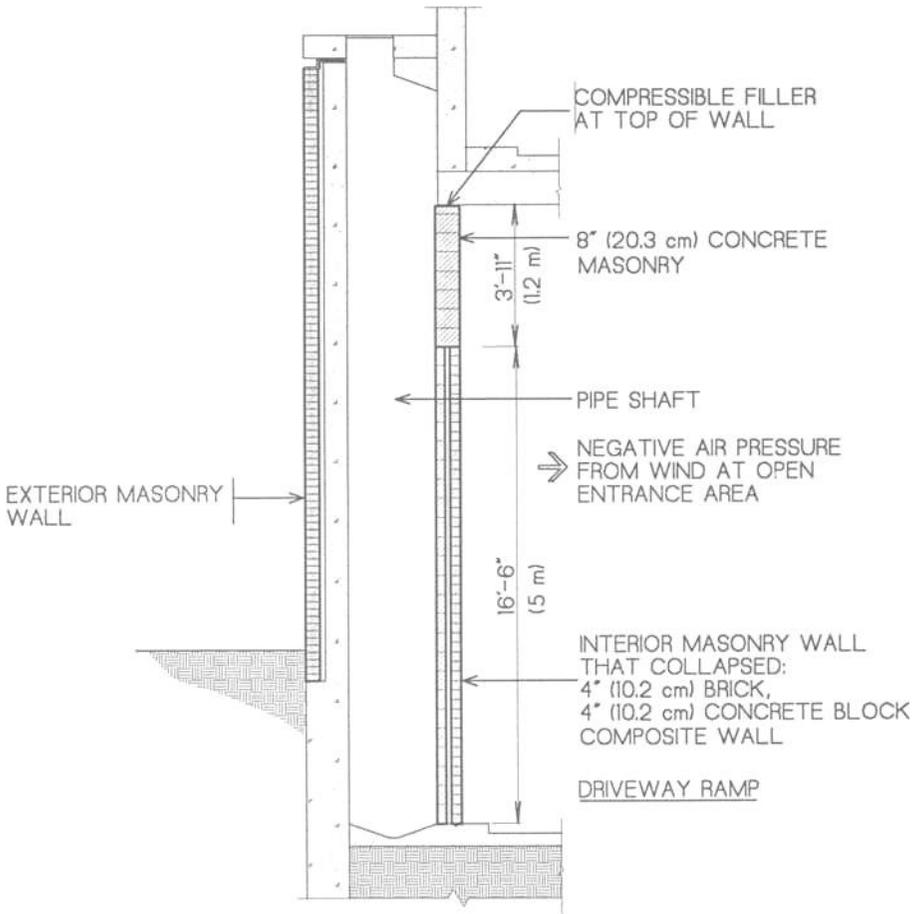
Fig. 2 -- Case Study 2: Wall Section

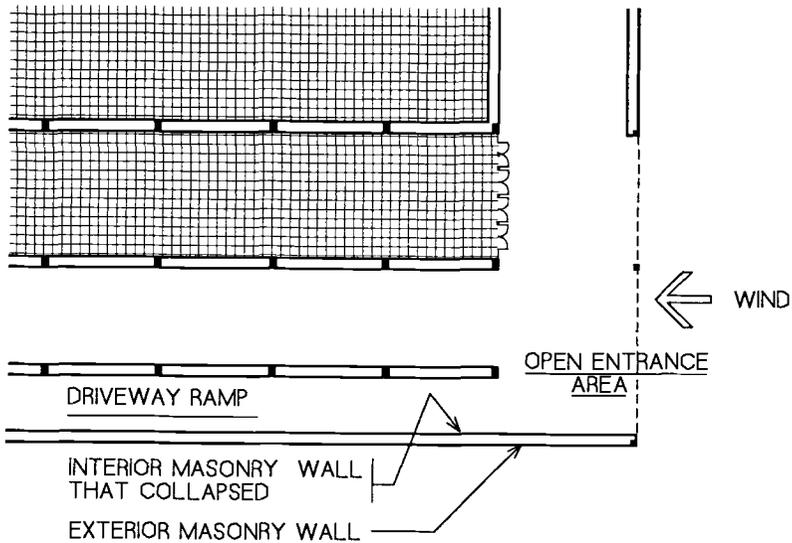
Fig. 3 -- Case Study 2: Partial Building Plan

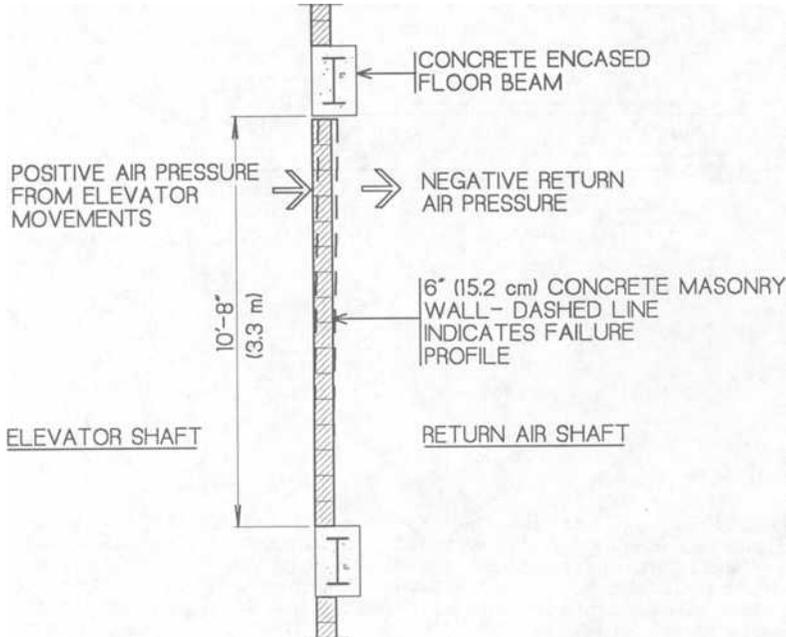
Fig. 4 -- Case Study 3: Wall Section

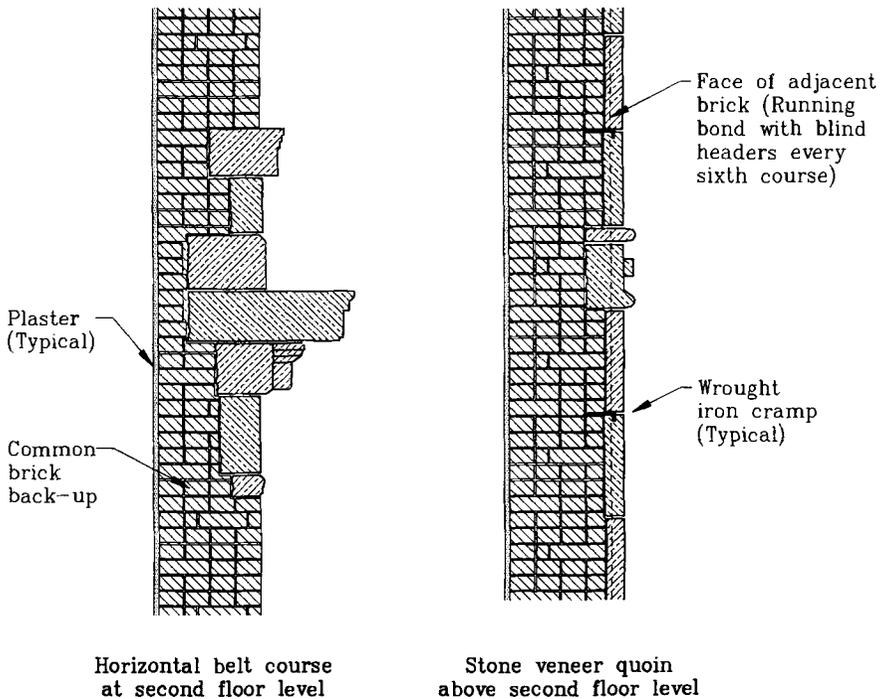
FIG. 2--Typical wall sections.

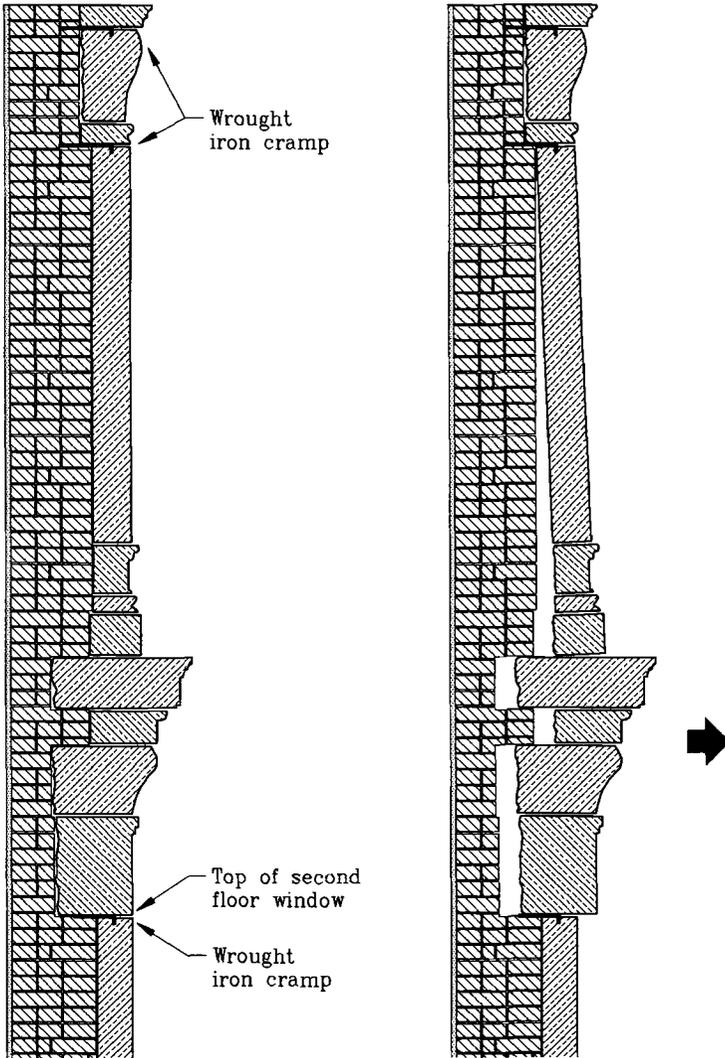
FIG. 3--Schematic illustration of bulging masonry at third floor window sill.

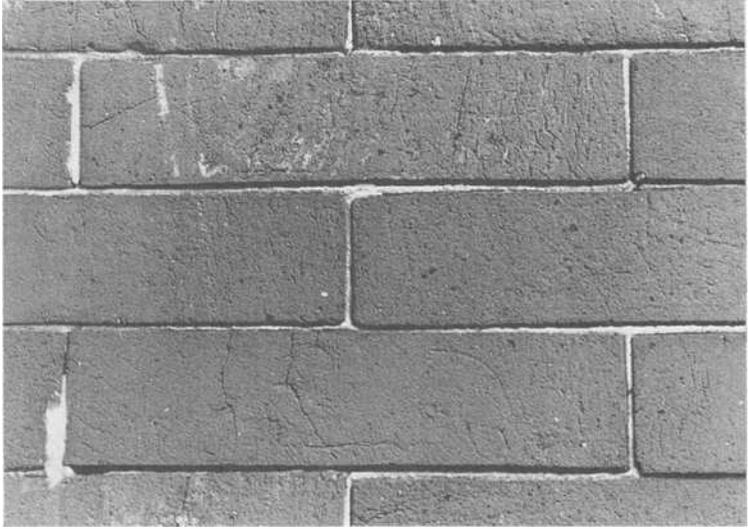
Fig. 4 -- Sandblasted face brick exposing voids and fissures.

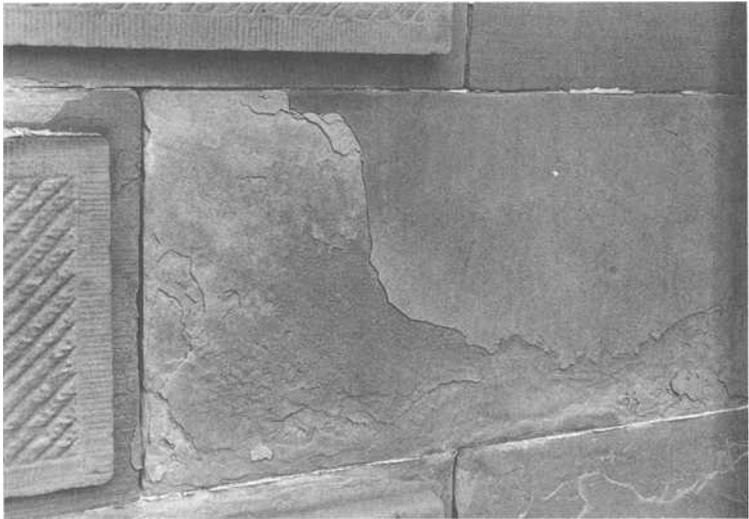
Fig. 5 -- Typical delamination of sandstone units.

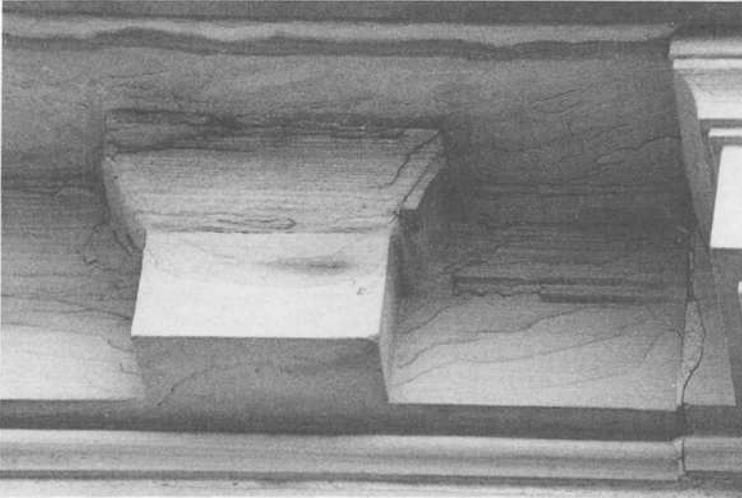
Fig. 6 -- Delaminations form a wave-like pattern in stone beneath horizontal projections.

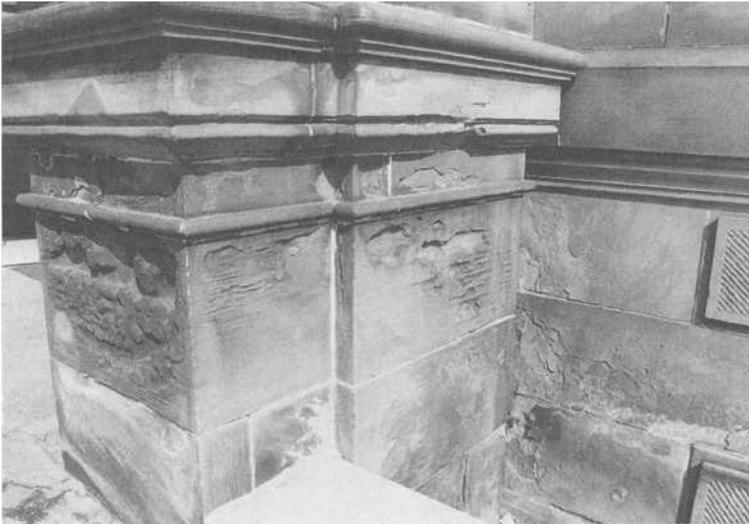
Fig. 7 -- Severe deterioration of sandstone at south entrance.
