Microbiologically Influenced Corrosion Testing

STP 1232

Jeffery R. Kearns and Brenda J. Little, Editors

The symposium on Microbiologically Influenced Corrosion Testing was presented at Miami, Florida on 16–17 Nov. 1992. ASTM Committee G-1 on Corrosion of Metals sponsored the symposium. Jeffery R. Kearns, Allegheny Ludlum Corporation, and Brenda J. Little, Naval Research Laboratory, served as co-chairs for the symposium and were co-editors of the resulting publication.

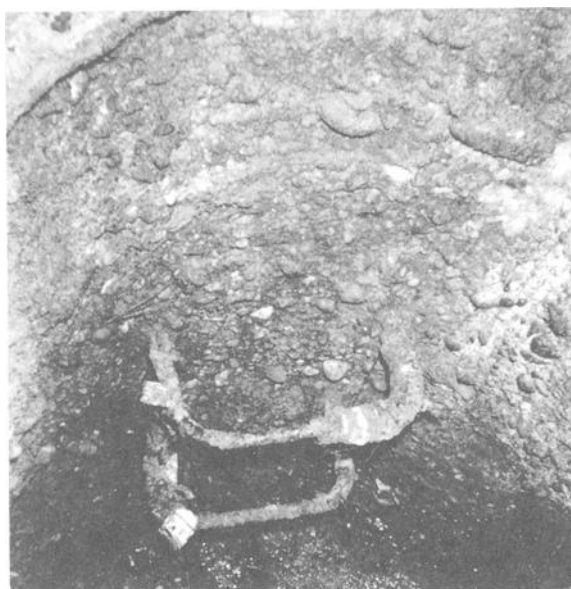
FIG. 3—Corroded manhole of ordinary Portland concrete, Arcachon sewer, France.

As described above, H_2S will react with oxygen to sulfur that is deposited on the wall surface. If thiobacilli are present, sulfur will be oxidized to sulfuric acid causing corrosion of susceptible mineral materials.
