# MASONRY

*Materials, Testing, and Applications*

STP 1356

# ***Masonry: Materials, Testing, and Applications***

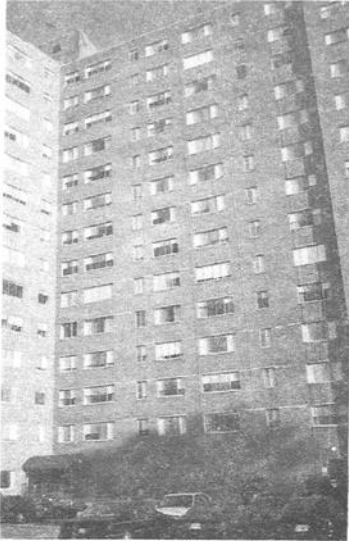
(nominal dimensions), and are of general construction typical of the 1950s and 60s. There are windows in punched openings at each floor level and continuous brick piers that run the full height of the building between the window openings (Figure 1). Each elevation is similar in its detailing and contains little or no ornamentation, other than cast stone head and sill elements that project from the face of the building.

- The most obvious forms of distress are concentrated around the shelf angles. At shelf angles the faces of the brick veneer are often spalled, and the walls are bowed (in a scallop shape) near shelf angles. The distress is most severe at the lower floors and reduces at the upper floors, although there is similar distress throughout the height of the building.
- Previous attempts were made to repair the brick spalls adjacent to the shelf angles using a colored “mastic” type material.
- Several of the cast stone lintels that span across the continuous brick piers are spalled and have fallen.
- There are vertical cracks adjacent to inside and outside corners running the full height of the building.
