# Geosynthetics in Subsurface Drainage

STP 1390

Proceedings of a symposium held in Seattle, Wash., June 29, 1999.

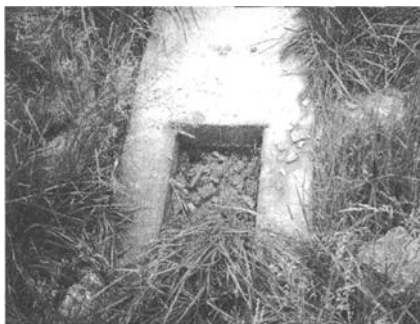
Figure 2 - Clogged headwall.

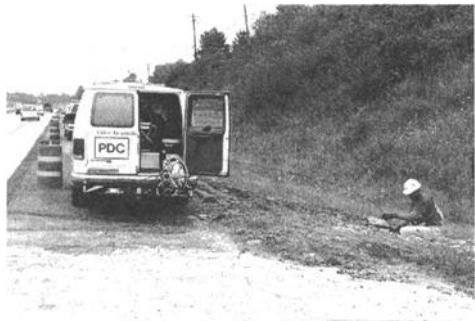
Figure 5 - Contractor personnel pushing camera into edge drain outlet for QC inspection.

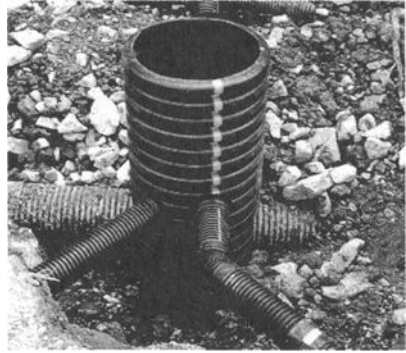
Figure 9 - Construction of ditchline collector system, and vertical inspection port.

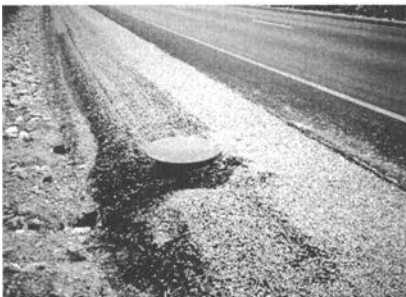
Figure 12 - View of temporary cover for top of edge drain collector and inspection port.
