Masonry:

OPPORTUNITIES *for the* 21st CENTURY

STP 1432

Papers of the Tenth Symposium on Masonry: Opportunities for the 21st Century, held in Salt Lake City, Utah, June 25, 2002.

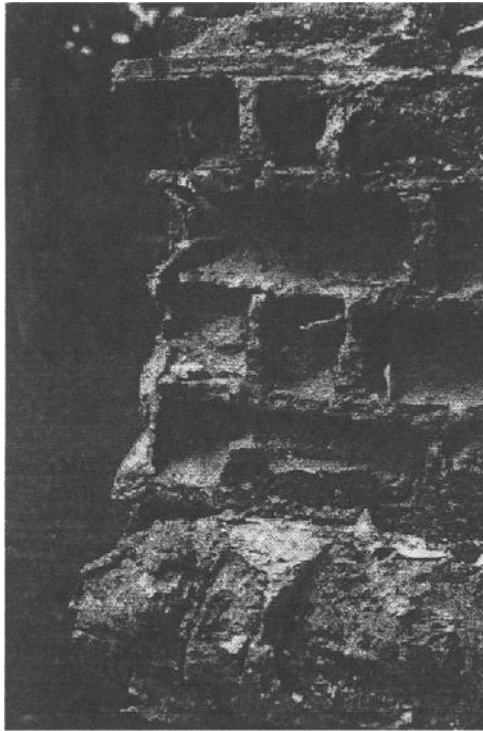
differences (as noted above) between the original tabby and its stucco—both made with lime, and the portland cement repairs. For example, Cannon's Point Plantation, constructed of tabby in the decades following 1794, was owned and operated by the Couper family on St. Simons Island and underwent such repointing and restuccoing—with disastrous results. In particular, the house chimney was repointed with a neat portland cement mortar (cement and water only) and stands today as a honeycombed testament to the problems that arise when incompatible materials are used. The bricks have been completely destroyed, eroding away due to the dense, neat cement mortar.

FIG. 1 – *The Effects of Incompatibility: Portland Cement Mortar with Handmade Tabby Bricks* [20].

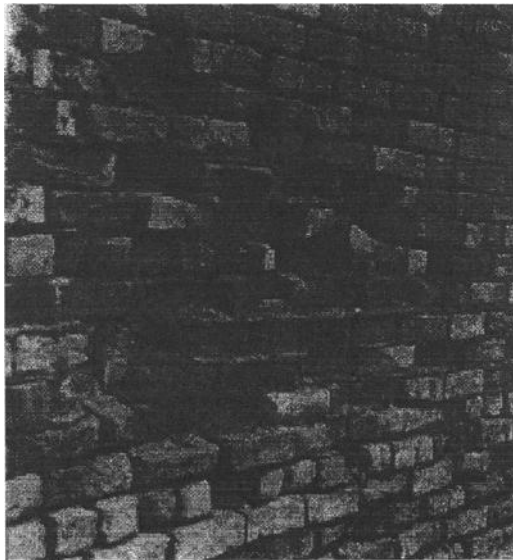
Alternative hypotheses exist, however. This condition is reminiscent of that observed at Cannon's Point Plantation, where the problem was clearly related to the inappropriate use of portland cement in the repair of an historic tabby structure. This suggests that in some cases, the deterioration of the soft Mexican brick may have been accelerated by the inappropriate use of hard, impermeable, portland cement mortar.

FIG. 2—*Deteriorated wall on building constructed of Mexican handmade brick.* [29]

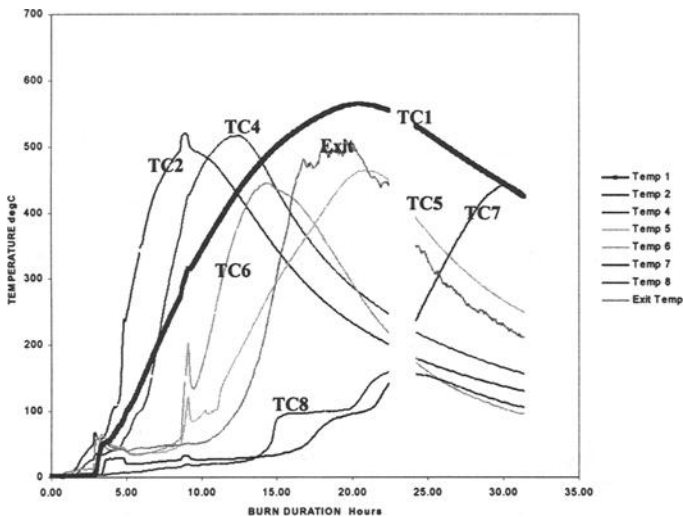
lower left section of the kiln, perhaps indicating an inhomogeneity in fuel distribution at this point. As burning progressed up through the kiln temperature maxima decrease to approximately 450°C. Burning is neither static nor uniform throughout the kiln, and indicates the differing calcination conditions that occur in the kiln-fill.

Figure 4. Temperature distributions with time for ELK burn 3. See Fig 2 for locations of thermocouples.

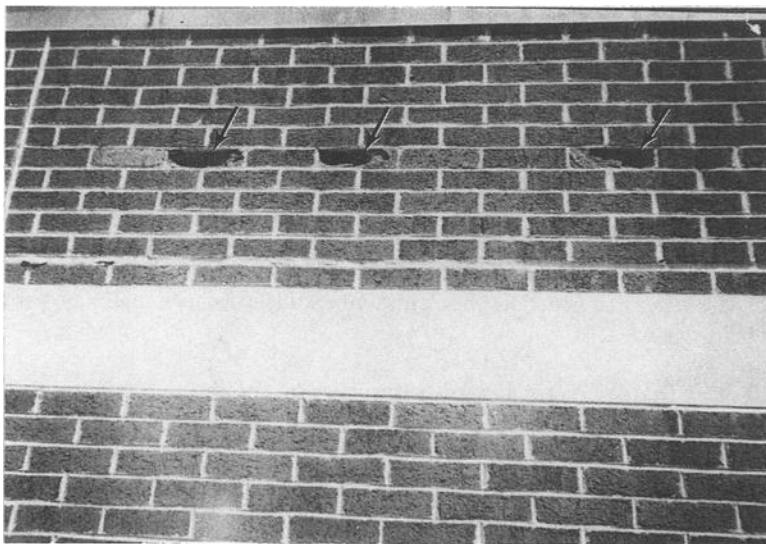
The dubrick in the header course span across the collar joint in the wall. This configuration made the dubrick more exposed to water that penetrated the wall than the standard size stretcher brick that did not span across the collar joint.

Figure 1--View of spalled dubrick due to cyclic freezing of saturated brick

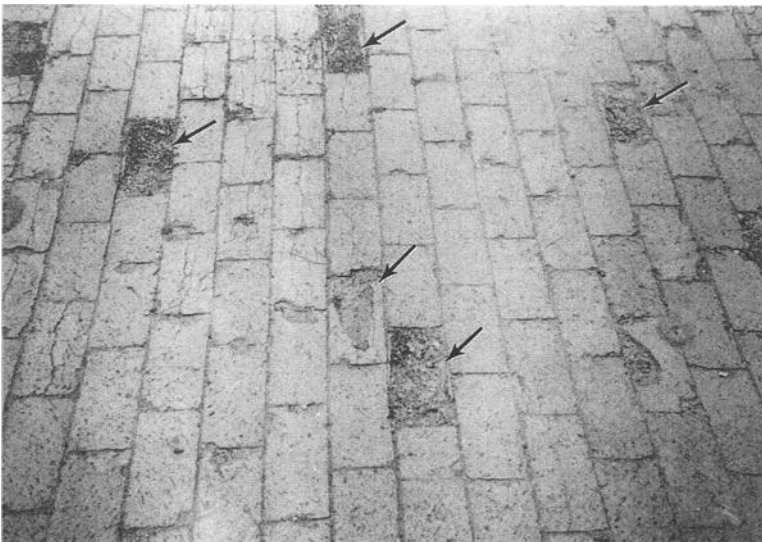
Figure 2--View of spalled paving brick due to cyclic freezing of saturated brick

This type of brick spalling can be minimized by sloping the top of the paving at least $\frac{1}{4}$ in. per foot (20 mm per m), place sand in the joints between brick units, and provide a well compacted sub base with good vertical drainage characteristics [4].

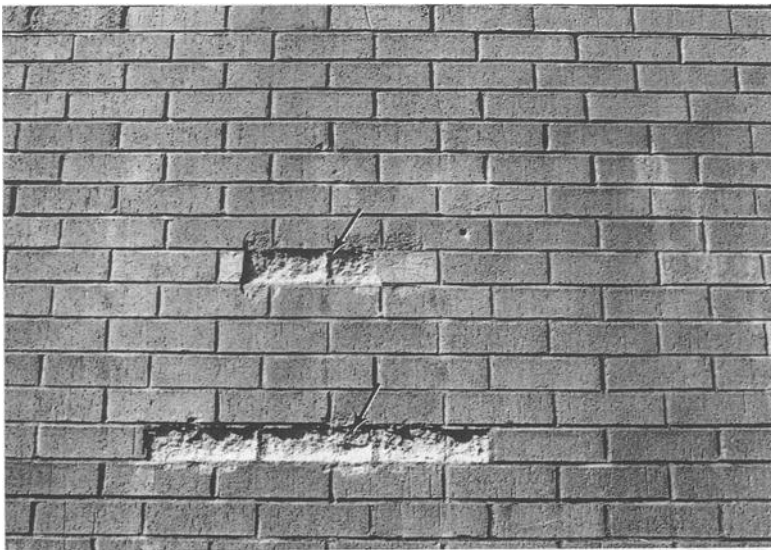
Figure 6--View of spalled brick due to cryptoflorescence behind coating on brick

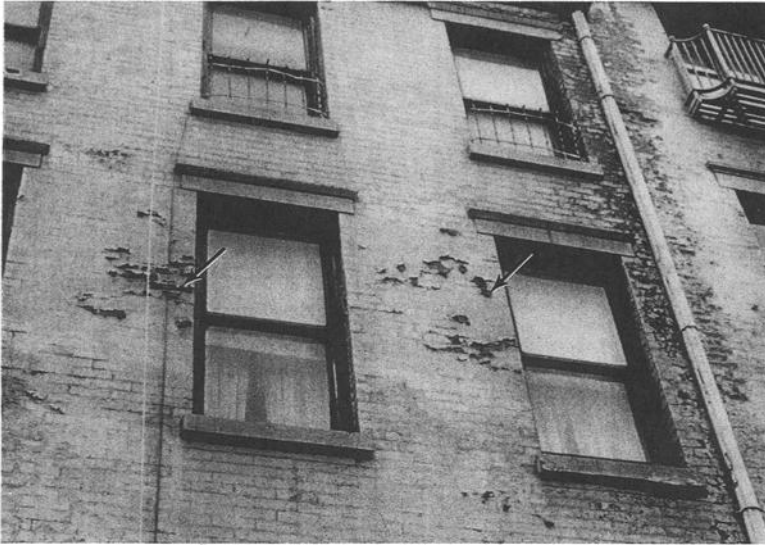
Figure 7--View of spalled brick due to cyclic freezing of moisture trapped by paint on brick

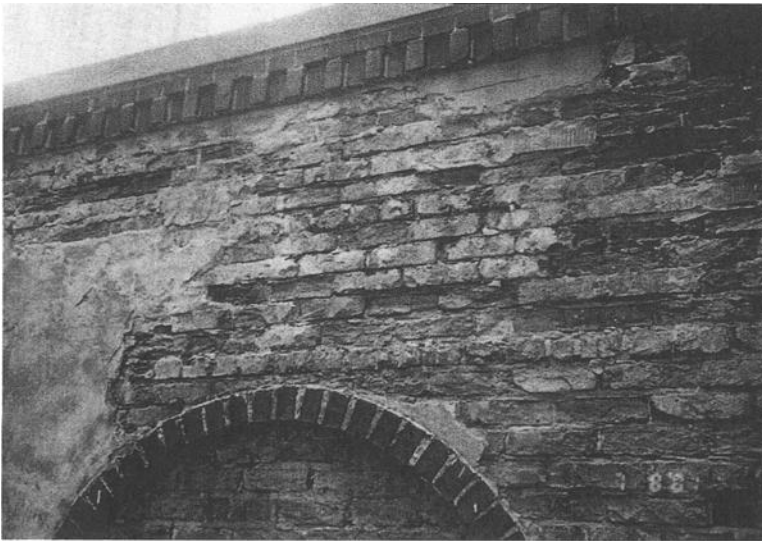
Figure 8 - View of spalled brick due to cyclic freezing of moisture and to cyptoflorescence behind stucco coating on brickwork

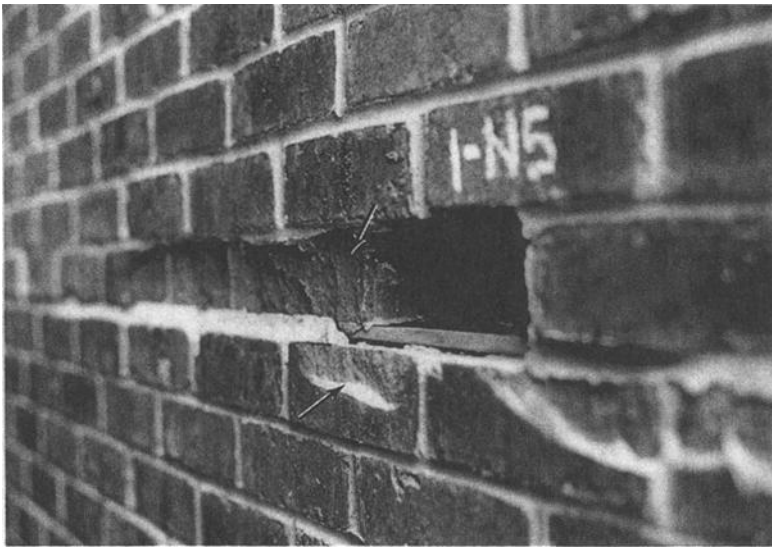
Figure 9--View of spalled brick due to compressive forces at shelf angle

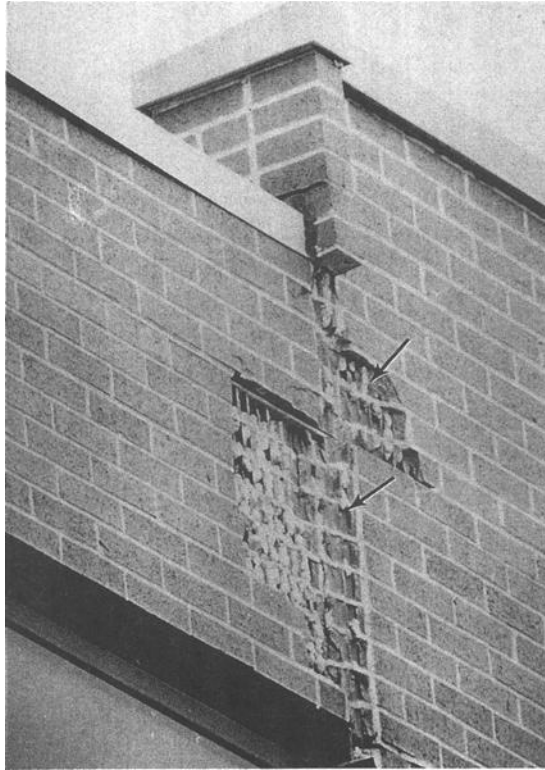
Figure 11--*View of spalled brick due to horizontal compressive stresses in wall*

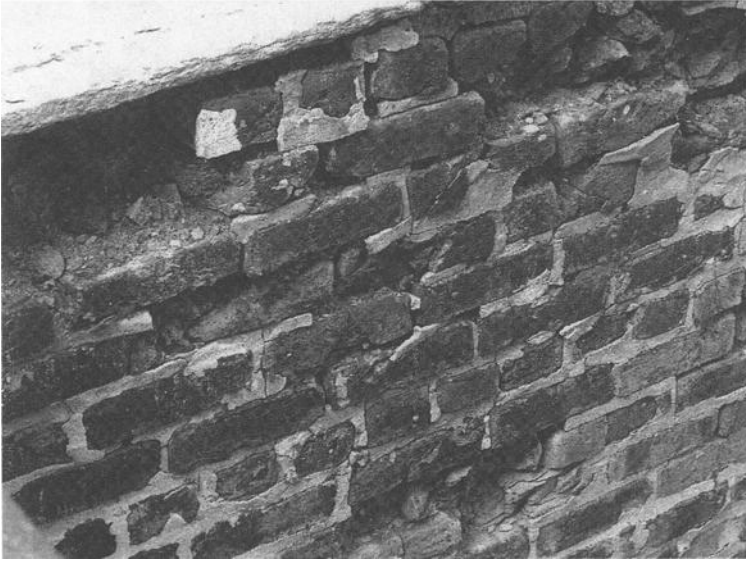
Figure 2 – *Severe freeze-thaw damage of brickwork*

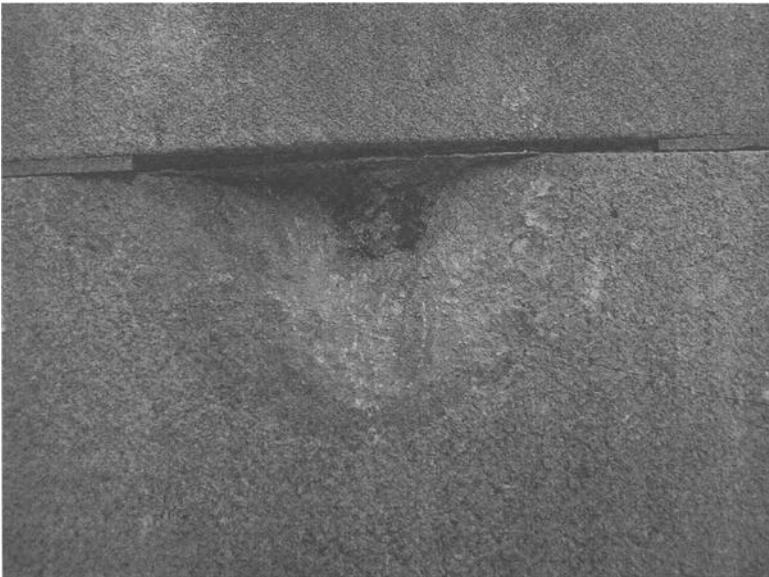
Figure 6 – *Localized spalling caused by corrosion of embedded anchor*

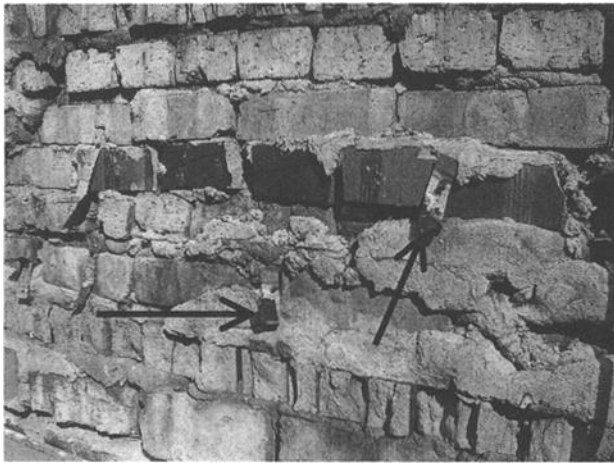
Figure 8 – *Corroded lateral strap anchors*

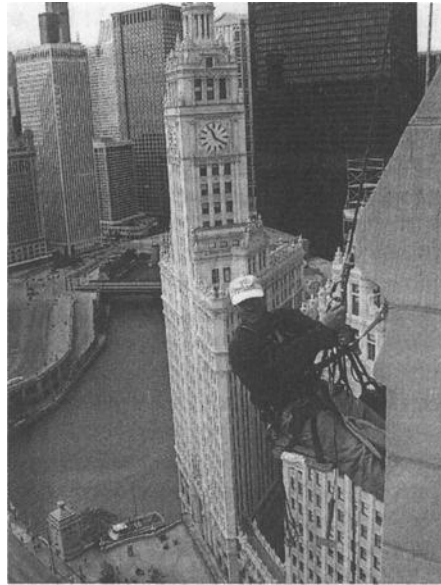
Another procedure that can be used when appropriate is rappelling. This system offers the advantage of speed of set-up and inspection, but there are some limitations if further investigations of a particular area are required. In many instances rappelling may be the only realistic technique available to access certain portions of the buildings for close-up inspection (Figure 10). Again, all staging should comply with applicable standards and only qualified, properly trained, personnel should perform inspections using rappelling techniques.

Figure 10 – *Inspection being performed by rappelling techniques*

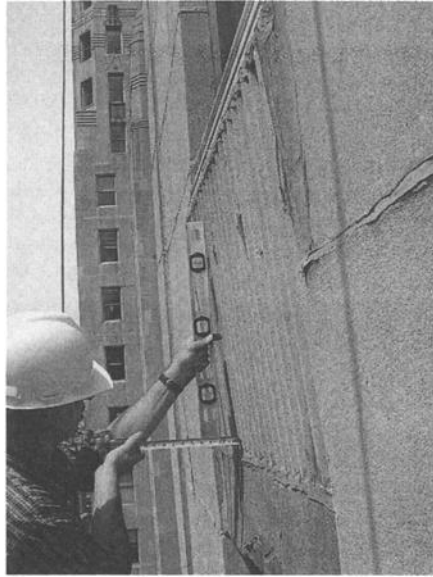
Checking the plumbness of portions of a facade is another effective method of evaluating the condition of a facade. Localized displacements can be easily determined using a 4-foot (1.2 m) or shorter level if appropriate (Figure 11). Modifications can be made to a level or other straight edge to determine localized bowing of a panel. By raising the ends of straight edge a fixed distance, the displacement between the raised ends can be determined by measuring the difference between the ends and the midpoint. Alternatively, displacements of panels can be determined using a straight edge set on the joint between panels. For larger areas of walls, a plumb-bob can be used. Horizontal displacements can be determined by using a string line.

Figure 11 – *Checking plumbness of limestone panel*
