STP 1486

Pavement Surface Condition/ Performance Assessment:

**Reliability and Relevancy
of Procedures and Technologies**

Bouzid Choubane
editor

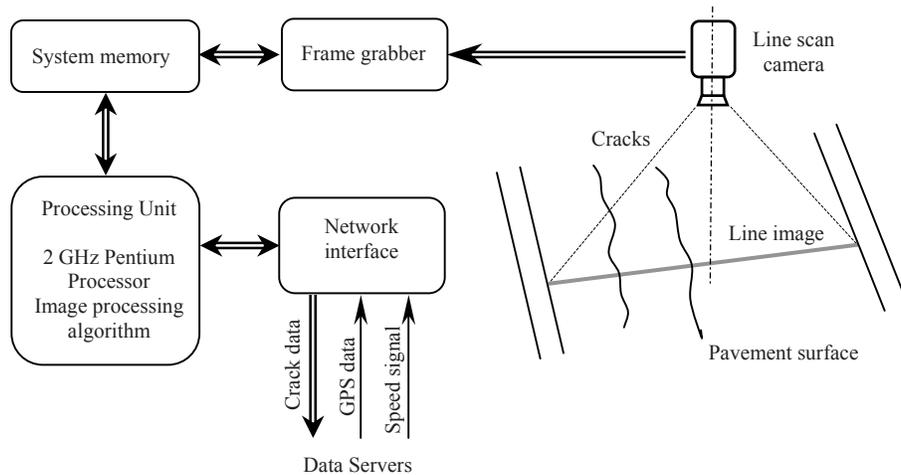
Figure 1 shows the diagram of the system configuration. The line scan camera, connected to the frame grabber via the Camlink interface, is synchronized by an encoded vehicle speed signal to ensure every scanned line covers the same gap on the pavement when the travel speed varies. The camera exposure time is adjusted dynamically to maintain the consistency of the brightness of images when the road and lighting conditions change. The camera captures a line image of 2048 pixels in the front of the survey vehicle. A frame of 512 lines covering 0.9-m long pavement is accumulated by the frame grabber, giving a resolution of 1.786 mm per pixel. It takes less than 5 milliseconds to transfer an image from the frame grabber to the system memory for the processing. The image grabbed to the system memory is in the 8-bit grayscale format. A network interface card is installed to receive the GPS data and vehicle speed signal broadcast from the central computer. The GPS data are integrated into the crack report and used to record the time and geographical locations of the collected distress data.

FIG. 1—Pavement image acquisition and processing system.

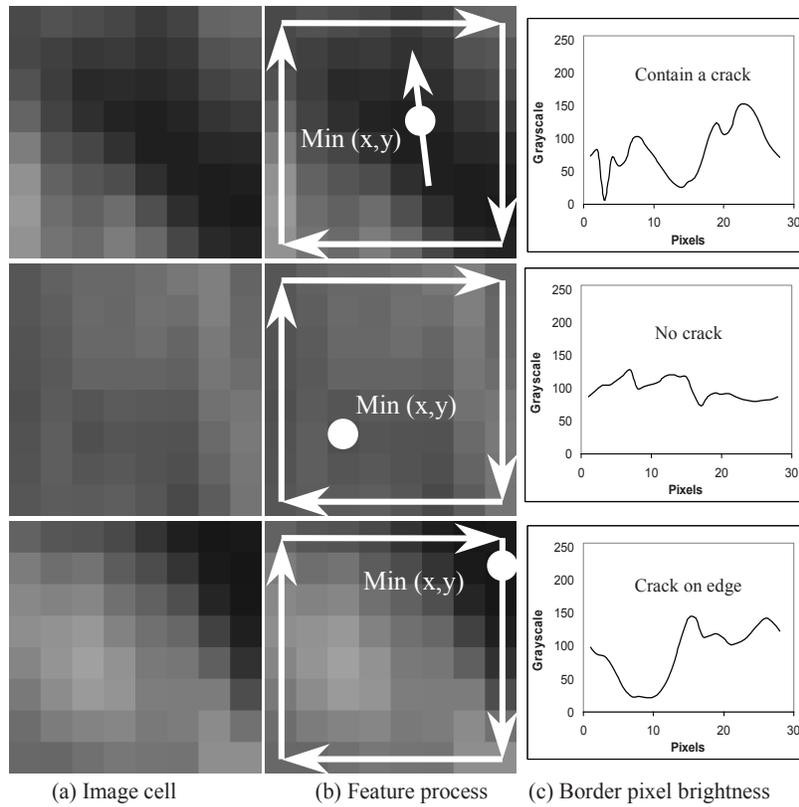
Figure 2a shows three cases of grid cells extracted from a pavement image. A search is conducted around each cell's border as indicated by arrows in Fig. 2b. The average grayscale of the border pixels is used to represent the average brightness of the cell. The minimum grayscale value in a cell and its coordinate are recorded for later crack detection. The coordinate will be used for allocating the axis of a crack, calculating the crack length, and checking the width and contrast of the crack. In the case of a cell containing a crack, border pixels show two valleys as shown in the top plot of Fig. 2c. The coordinate of the minimum grayscale is determined by these two valleys. If there is no crack in the cell or no clear valley in its border pixels, the coordinate is allocated by the darkest pixel in the cell. This cell will be eliminated from further processing. If there is only one valley with high contrast to its neighboring border pixels, the cell may be an edge of a crack. The coordinate is assigned according to the darkness of pixels in the edge area. Further analysis on this cell will be conducted to confirm the existence of a crack. Only this process needs the access to the pixels of the whole image and takes about one-third of the entire processing time. The rest of the analysis will concentrate on the area where cracks may exist.

FIG. 2—Cell characteristics in a pavement image.

Figure 5a shows all checked seeds for the image in Fig. 2a. Compared to the original image, the volume of data has been dramatically reduced. The detection and verification of different cracks will be based on the found seeds.

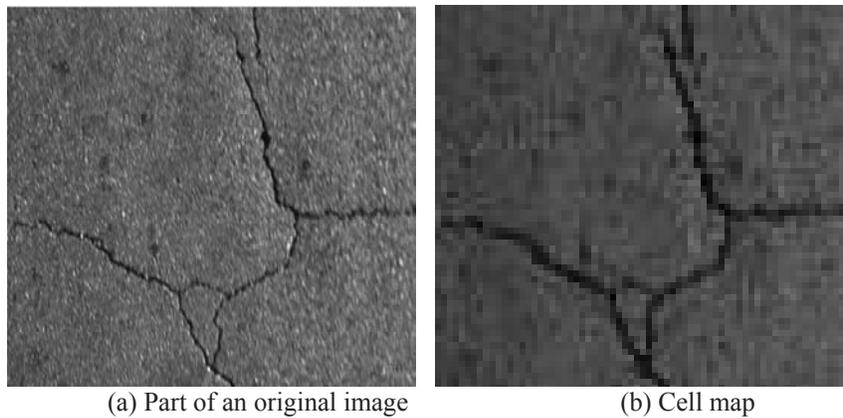
After all of the cells have been analyzed, a cell map can be drawn using the identified minimum values as shown in Fig. 3b. This cell data structure carries most crack information from the original image while sized in a much smaller scale. It will be used in a seed validation process to classify cells into crack seeds or non-crack cells.

FIG. 3—A part of a pavement image and its cell map.

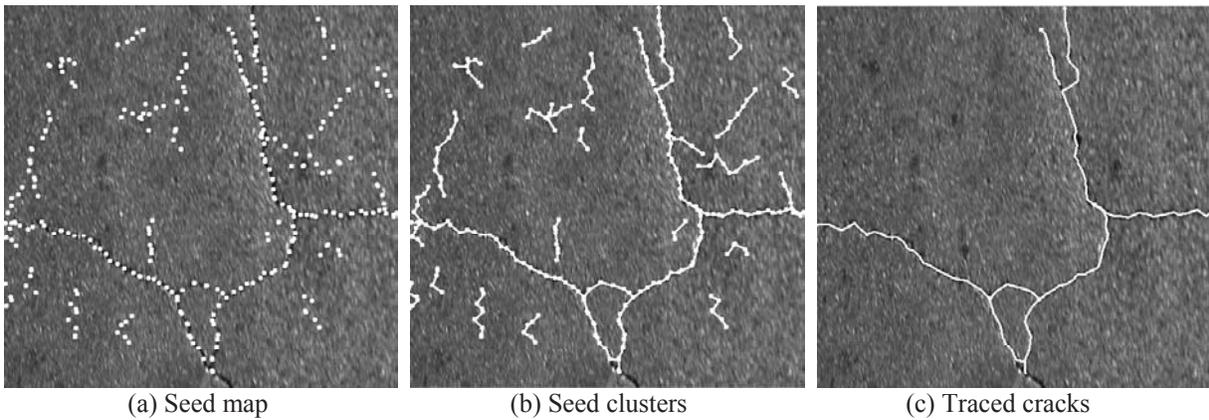
FIG. 5—Crack detection steps.

The next step is to connect individual seeds into seed clusters as shown in Fig. 5b. Each seed cluster contains information of its weight or the number of seeds in the cluster, all seed parameters on its path, the direction, and the start and end coordinates. Seed clusters provide a guide for crack tracing. When there is more than one path to trace a crack, the process will follow the seed clusters that provide the resultant crack with the maximum length.

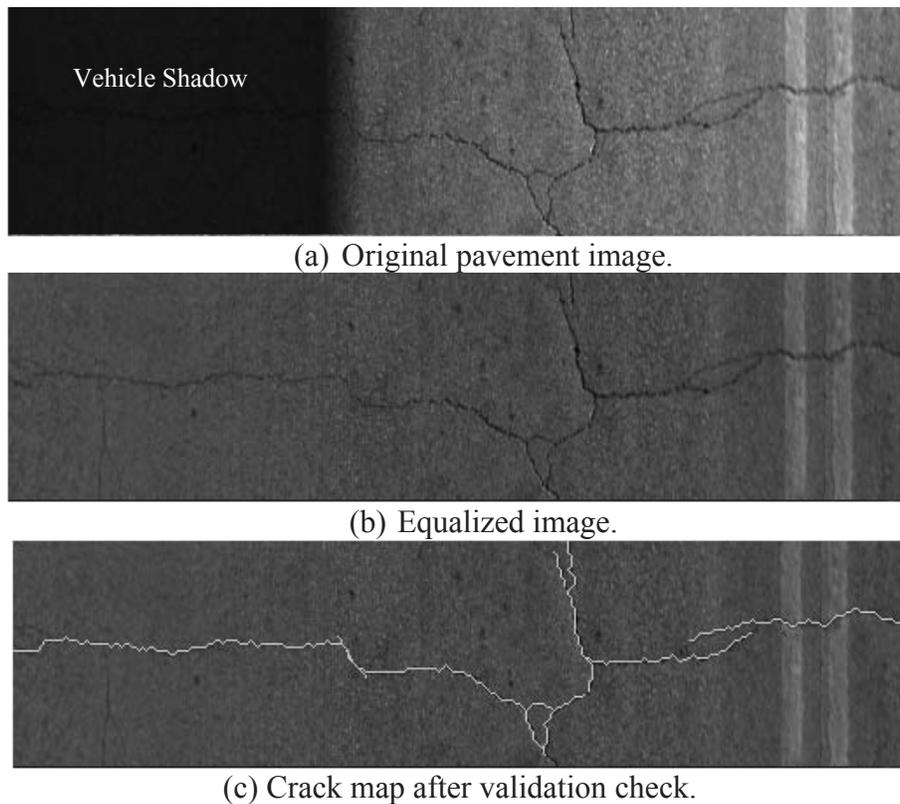
As mentioned earlier, shadows are unavoidable in some pavement images under natural lighting. Shadows may be caused by overhead construction, roadside objects, and the vehicle, and the size and shape change with the driving direction. As the seed validation emphasizes the presence of dark stripes in small cells, the chance to identify a shadow as a crack is minimized. On the other hand, in a large shadow area caused by the vehicle body, cracks are still detectable if the brightness and contrast in the shadowed area can be enhanced. An equalization function is designed based on the vertical projections of the average brightness of each cell. It stretches the brightness distribution uniformly over the entire histogram so that the contrast in a shadowed area can be improved. Figure 6a shows a shadowed image. After being equalized, the cracks and lane marks are preserved, while the shadow is diminished in Fig. 6b. This equalization is performed at the grid cell level and takes only a fraction of a millisecond.

FIG. 6—A pavement image with shadow and the traced cracks.

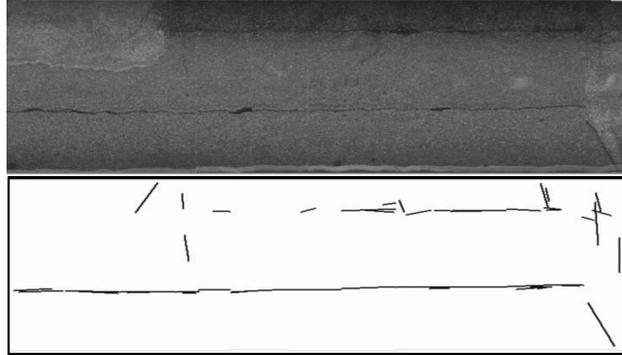
The system offers an image-capturing function for saving long-distance images for visual confirmation of the analyzed results. It continuously grabs a one km (0.62 mile) full size image, or a 16 km (10 mile) compressed image over a full pavement lane. The full size image can be processed offline and used for visual verifications, while the compressed image can be used for training or documentation. Figure 7 shows a sample of a 10-m pavement section with its crack

map. The crack data from individual frames can be combined to show long cracks that run across multiple frames. For pavement surveys, crack length, direction, and start and end locations are useful for mapping the cracks.

FIG. 7—Reconstructed 10 m (32 ft) pavement and crack map.

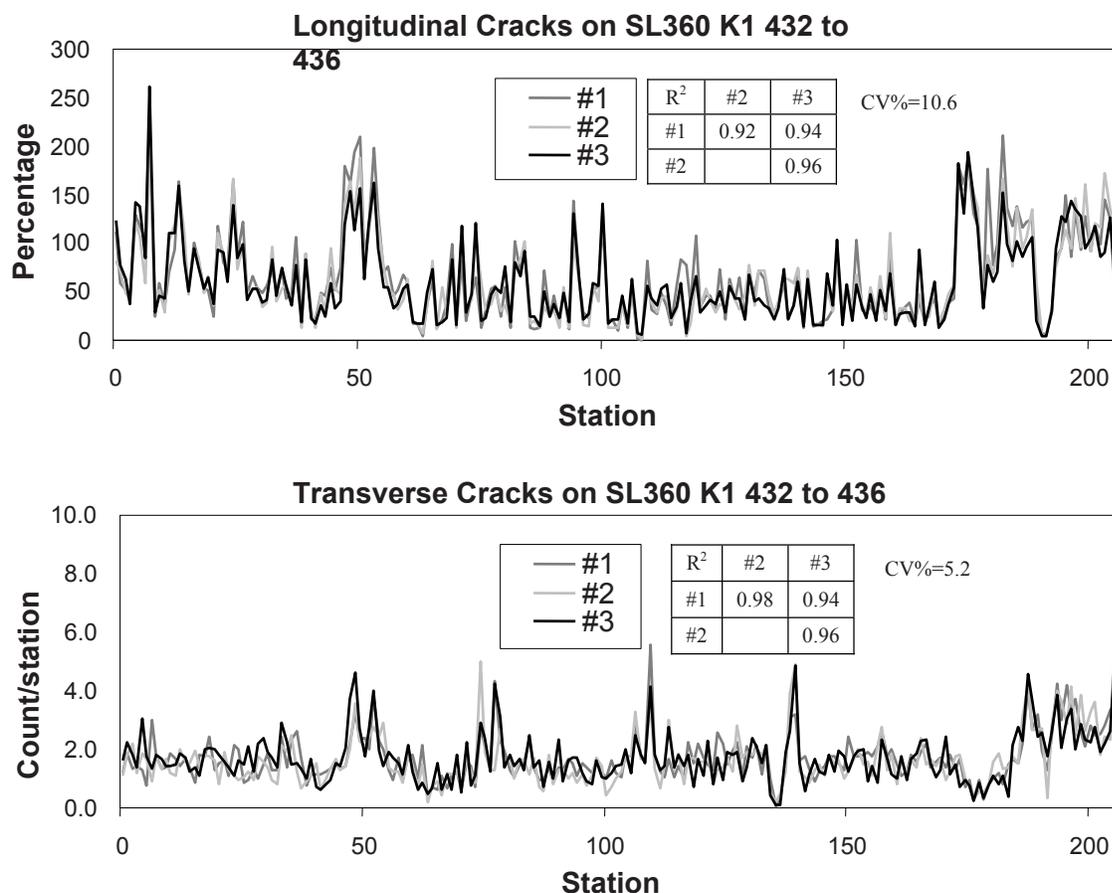
Figure 8 shows the results of a repeatability test of multiple scans. Surveys were repeated on the same pavement section at nearly constant speed of 88 km/h (55 mph) in a short period of time. The high correlations among the three scans indicate that the system is capable of providing coherent results for the same pavement distress under similar conditions. The shift of the driving path in different scans is one of the main sources of variations in the output.

FIG. 8—Repeatability test with multiple scans.

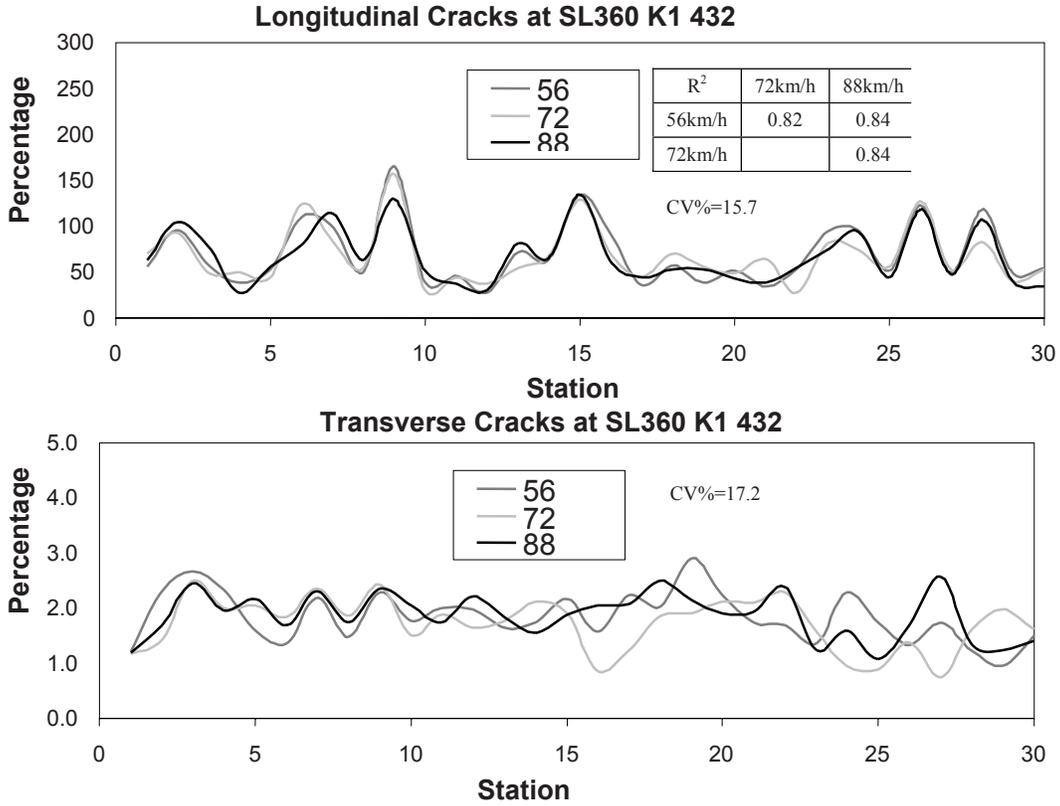
Surveys at different travel speeds were conducted over a 30-station long pavement section, a relatively short distance to avoid traffic lights or other speed disturbances. Since the data were processed at the station level, details of distresses for each station are emphasized. It is understandable that data at the station level have larger variations than those at the record level. Both data plots and the statistical results in Fig. 9 indicate an acceptable level of correlations between surveys at different speeds. In addition, as there are only few transverse cracks existing in the scanned pavement, a small number of false positive or negative records may change the station level data appreciably. However, the value of this change is limited and will not affect the overall result of the distress magnitude at the record level.

FIG. 9—Survey at different travel speeds.

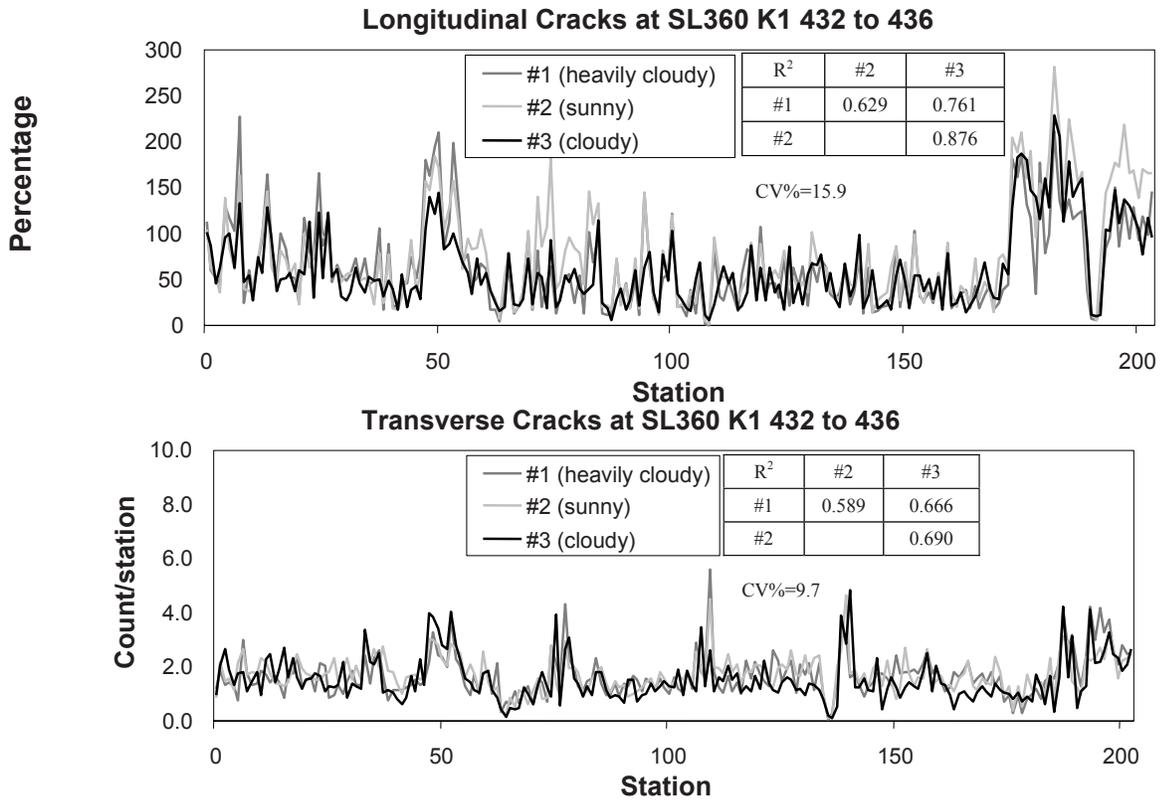
The weather and lighting conditions are the most important factors to the image quality for a system that uses natural lighting. Although the image processing algorithm can give consistent results to every pass, it could rate differently on the same pavement when the image quality changes. Figure 10 shows survey results in three extremely different weather conditions. It shows the system performance under the influence of all environmental conditions, which include lighting, speed, and multiple passes. The correlations and coefficients of variation are acceptable for such a complicated survey system. More accuracy and consistent results can be achieved if the environmental conditions are controlled.

FIG. 10—Surveys under different weather conditions.

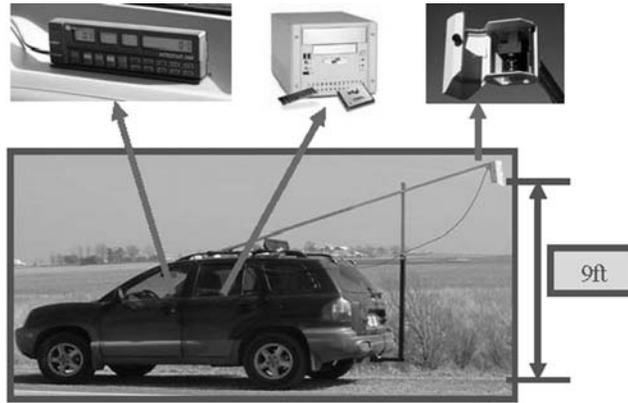
As shown in Fig. 1, the AICS adopted for this study is composed of the off-the-shelf area scan digital video camera mounted on a vehicle, DMI, and a PC with image processing board. This digital area scan camera can capture an image with 776×582 pixel resolution at 0.001 s of exposure time. The DMI

FIG. 1—Automated Image Collection System (AICS) adopted for this study.

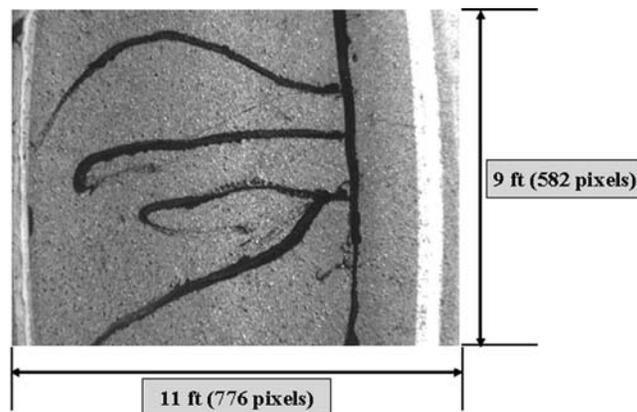
FIG. 2—Sample Pavement Surface Image captured by the AICS.

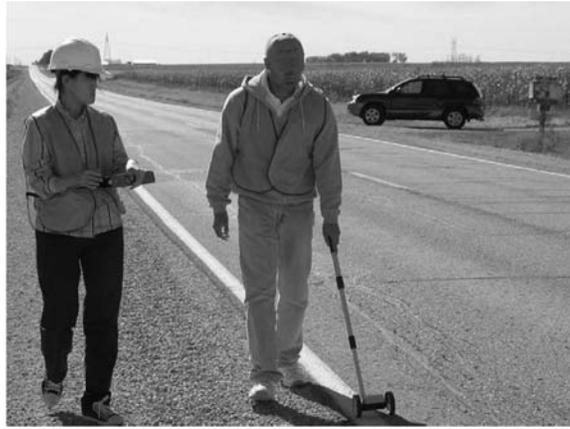
FIG. 3—Picture of the MDCS process of the pavement test section in the field.

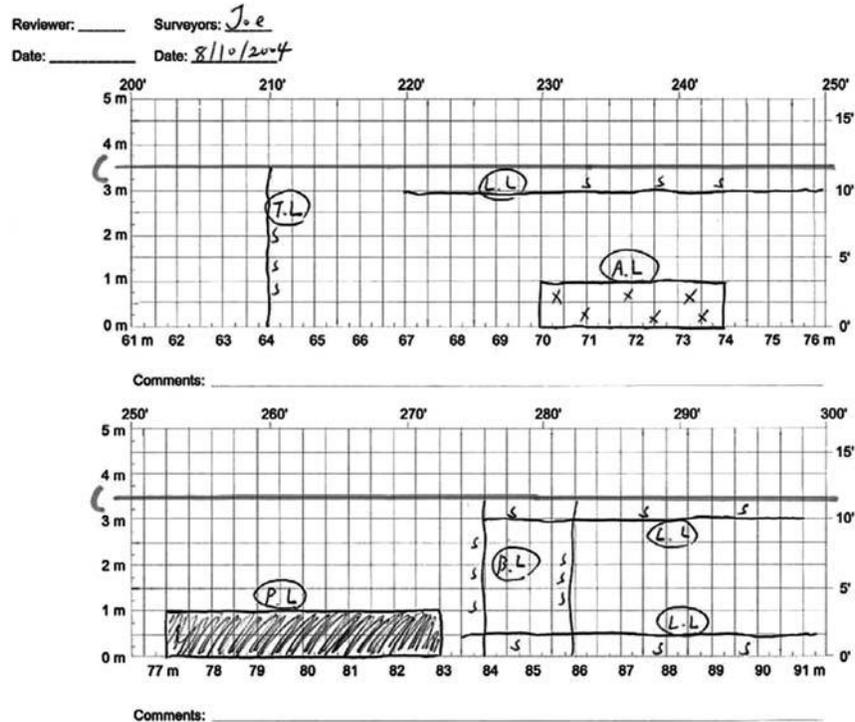
FIG. 4—Distress map drawn on grid paper using MDCS based on SHRP protocol.

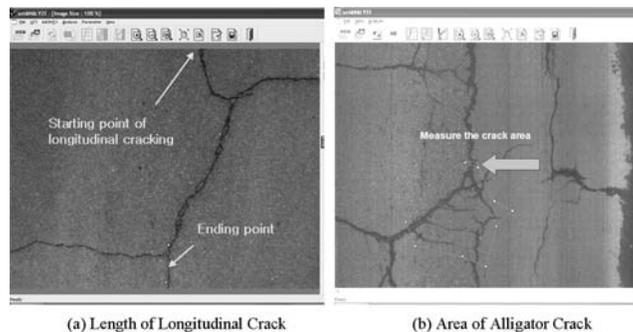
MIAS allows an operator to measure the extent and severity of various types of distress from a computer screen. As shown in Fig. 5(a), an operator can measure a length of a crack by tracing a crack using a mouse on a computer screen. From the starting point of a crack a user holds down the left mouse button and drags the mouse to the ending point of a crack. In order to measure the extent of alligator cracking, as shown in Fig. 5(b), the operator can draw a polygon along the boundary of cracked area. The MIAS automatically computes the extent of an alligator crack as measured in the field. To measure the severity of cracking, the image is zoomed at the predetermined level and the operator can measure a crack width

FIG. 5—MIAS screen shots demonstrating crack measuring process.

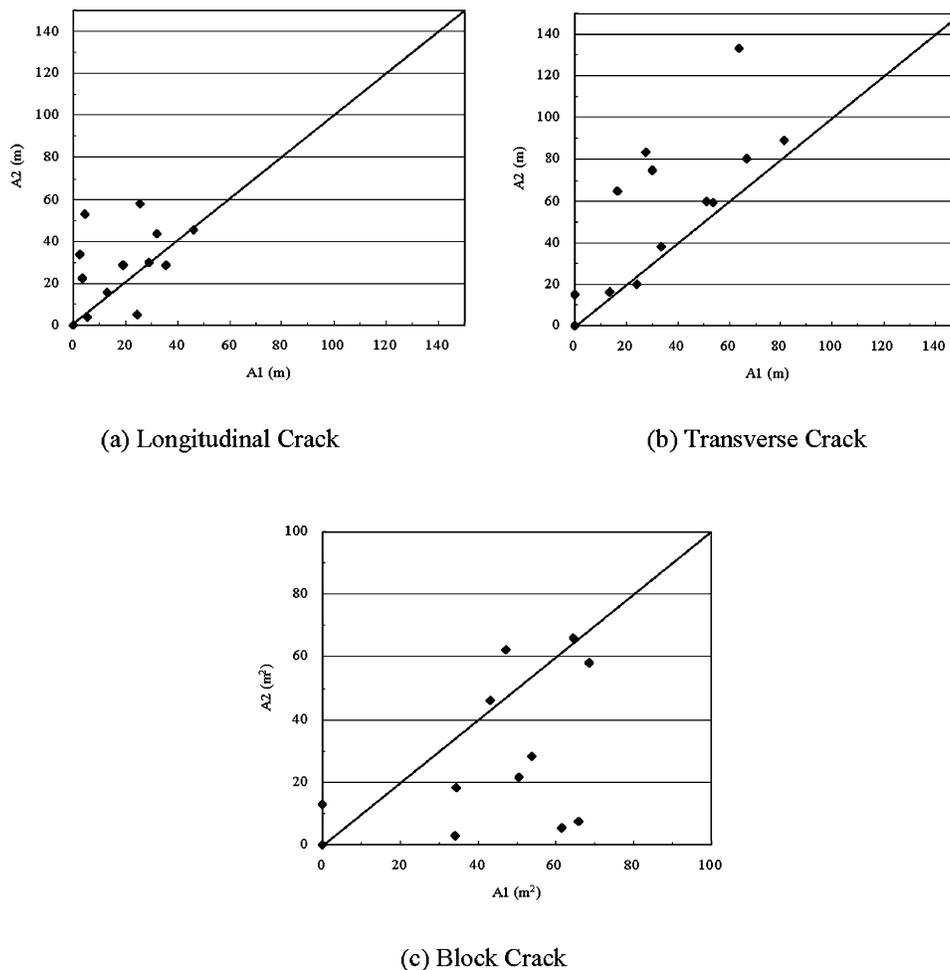
As shown in Fig. 6, for all three cracking types, longitudinal, transverse, and block, measurements by individual A are scattered away from the 45-deg equality line. It is interesting to note that, in the second round, individual A identified more longitudinal and transverse cracks whereas he identified less block cracks. It can be postulated that he could have misclassified some block cracks as either longitudinal or

FIG. 6—Comparison between first and second Data of MDAS by Investigator A.

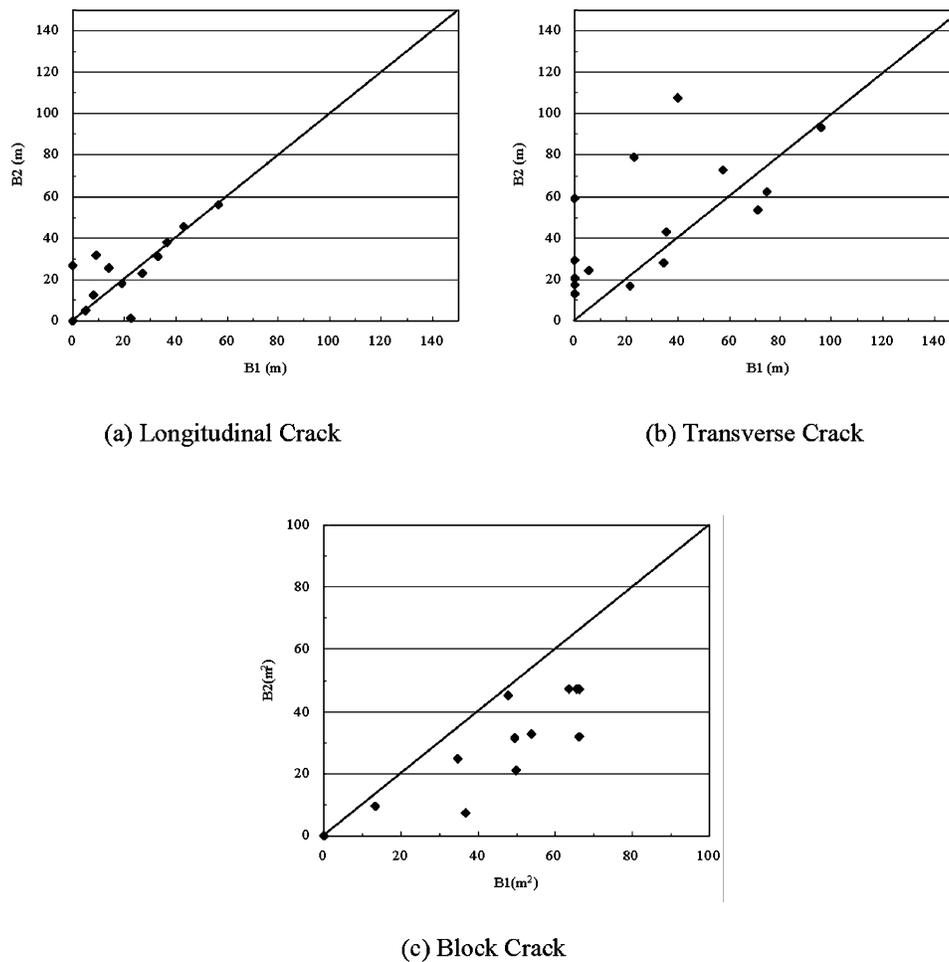
FIG. 7—Comparison between first and second Data of MDAS by Investigator B.

As shown in Fig. 7, individual B repeated the two measurements consistently for longitudinal crack, overestimated transverse cracks, and underestimated block cracks in the second round. It can be postulated that he could have misclassified some block cracks as transverse cracks in the second round. It can be shown from Table 2 that, on the average in the second round, he overestimated longitudinal cracks by 2.6 m and transverse crack by 17.3 m per 100-ft (30.5-m) station whereas he underestimated block cracks by 13.4 m². To determine the repeatability of individual B, the average values of the absolute difference between two measurements were computed as 6.5 m for longitudinal cracks, 23.3 m for transverse cracks, and 13.4 m² for block cracks. These values are relatively large given that the average lengths of these cracks were 19.6 m, 39.4 m, and 29.8 m² per 100-ft (30.5-m) station, respectively. We then computed the relative precisions for three cracking types by dividing the average absolute difference by the average value resulting in 33, 59, and 45 %, respectively. Compared to the individual A, the repeatability of the individual was better in longitudinal and block cracks but worse in transverse cracks. These large relative precision values indicate that the distress collection and analysis result from individual B using MDCS/MDAS should not be considered repeatable.

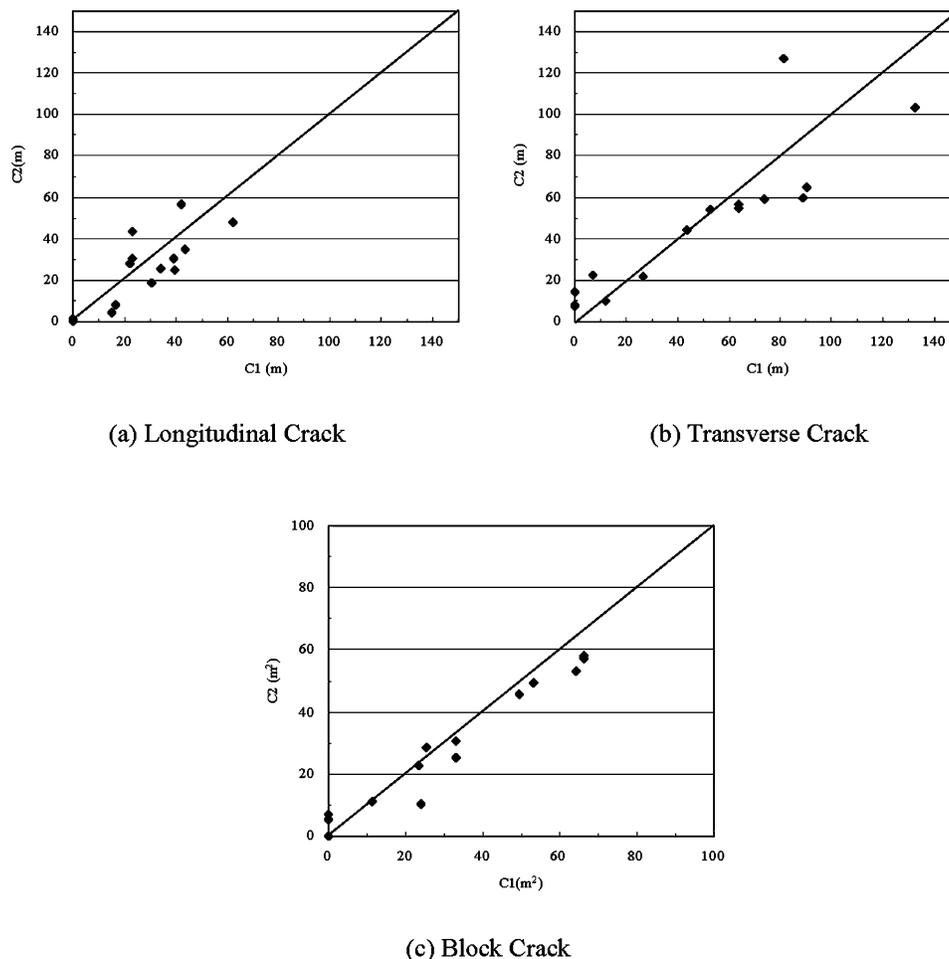
FIG. 8—Comparison between first and second Data of MDAS by Investigator C.

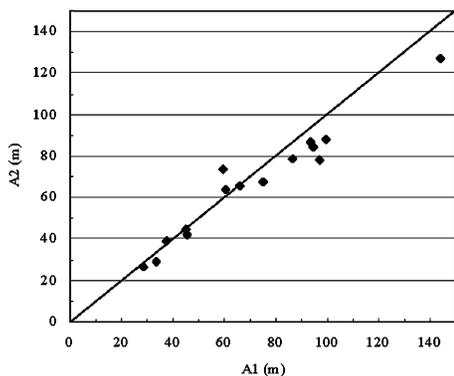
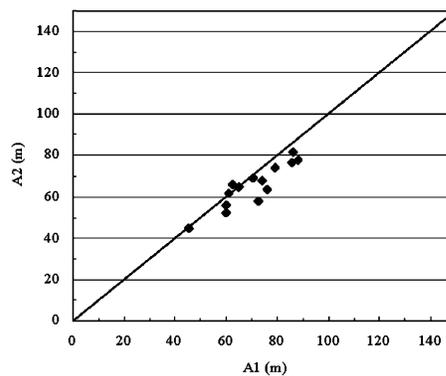
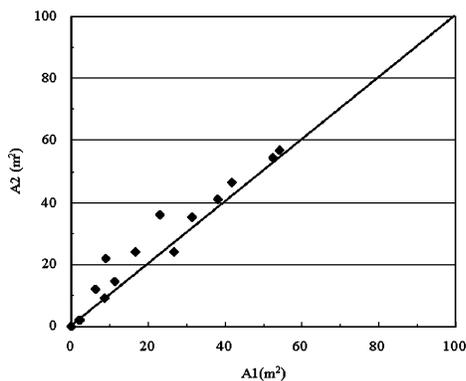
FIG. 9—Comparison between first and second data of MIAS by Investigator A.

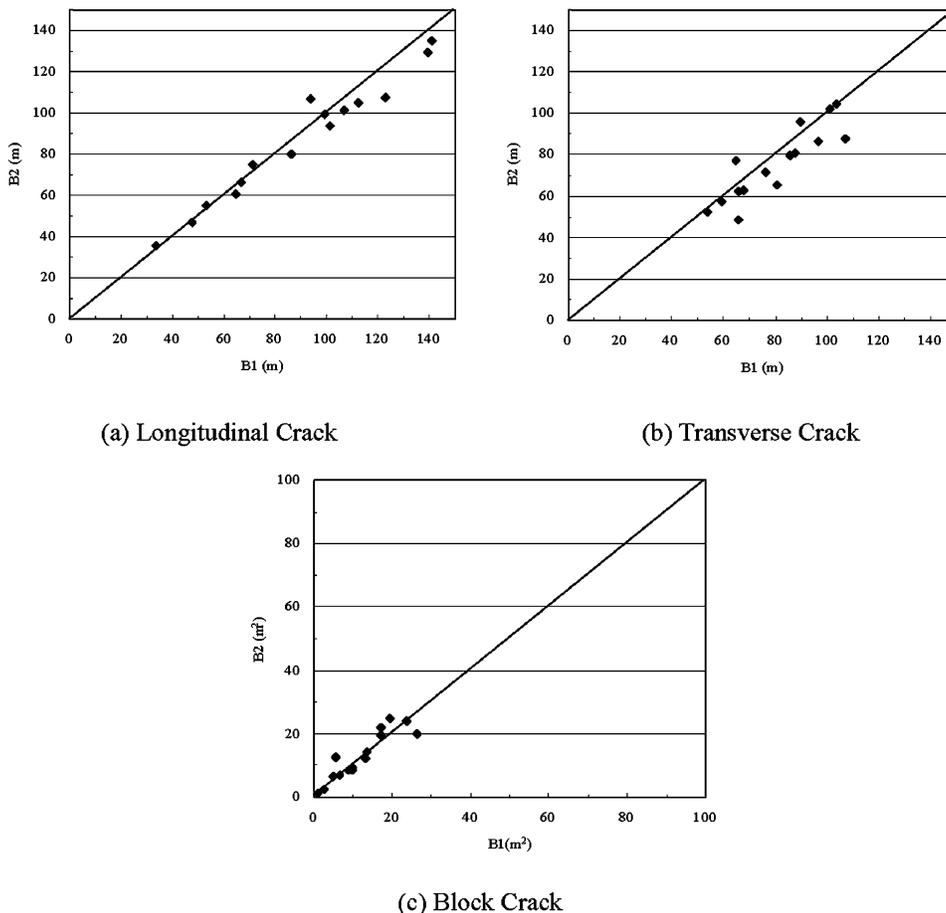
FIG. 10—Comparison between first and second data of MIAS by Investigator B.

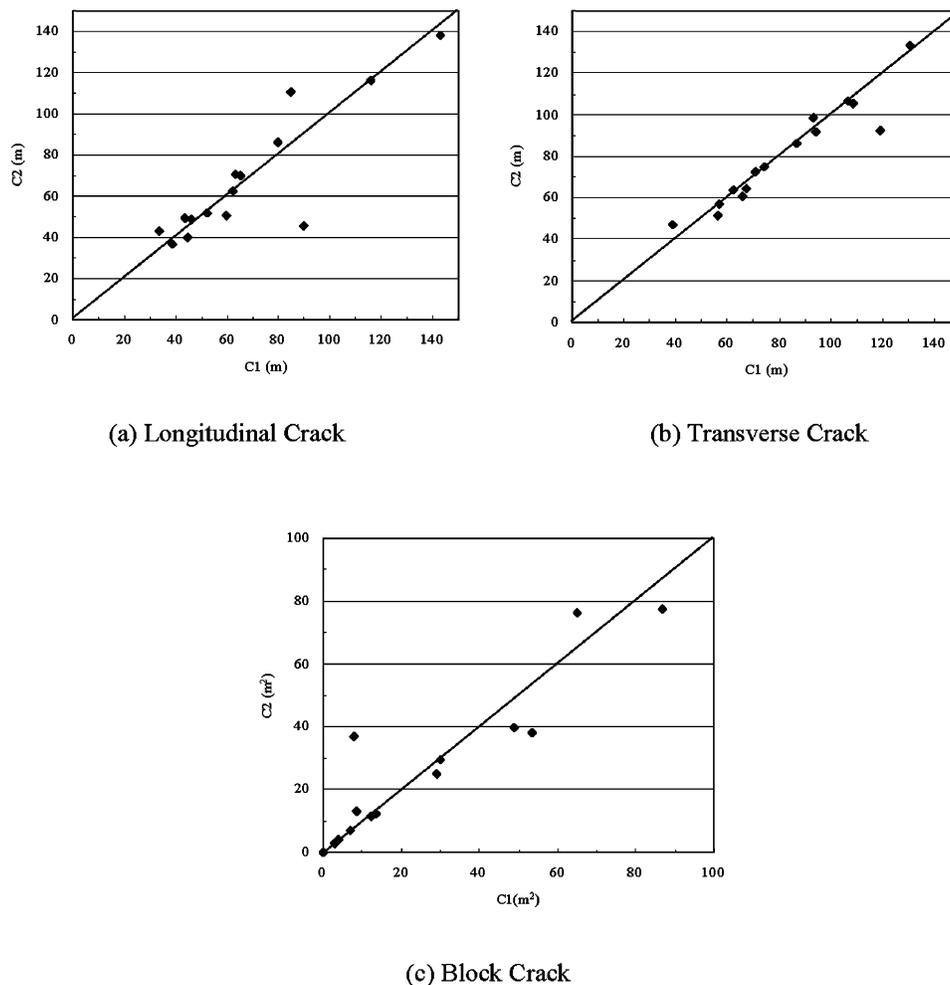
FIG. 11—Comparison between first and second data of MIAS by Investigator C.

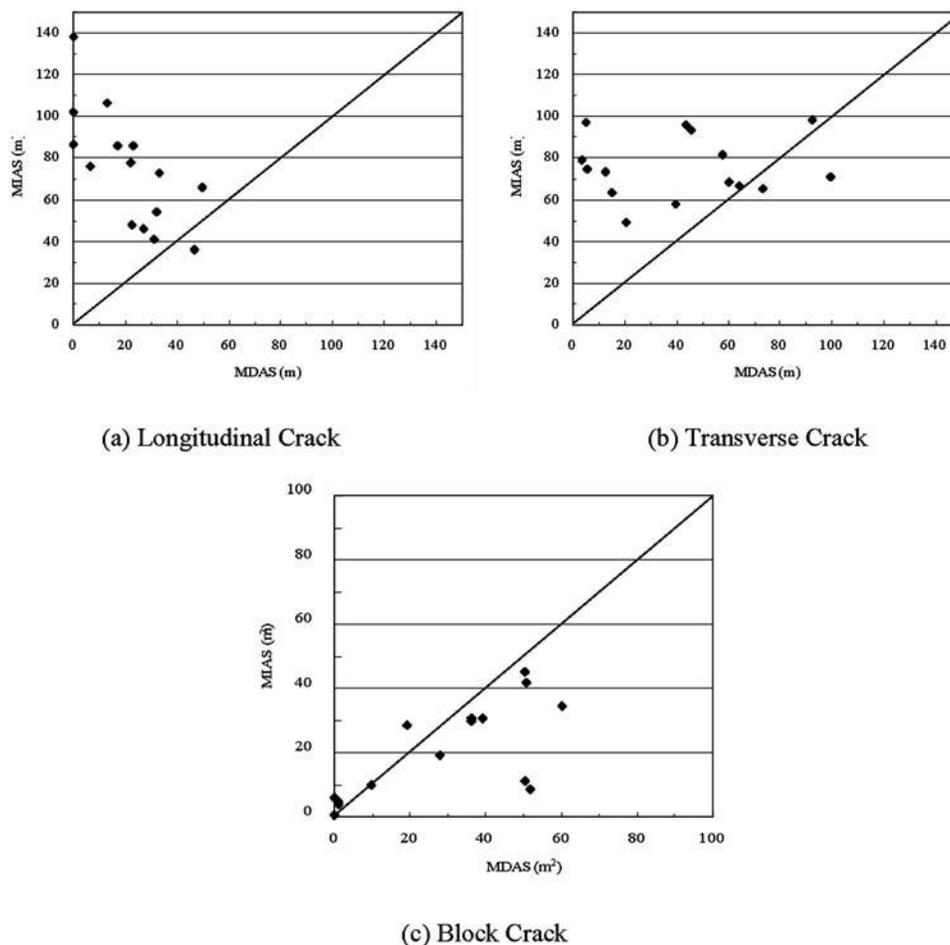
As shown in Fig. 12, for all three cracking types, longitudinal, transverse, and block, average measurements by two methods are scattered away from the 45-deg equality line. It is interesting to note that, using the AICS/MIAS, all three individuals identified many more cracks in longitudinal and transverse

FIG. 12—Comparison between MDAS and MIAS.

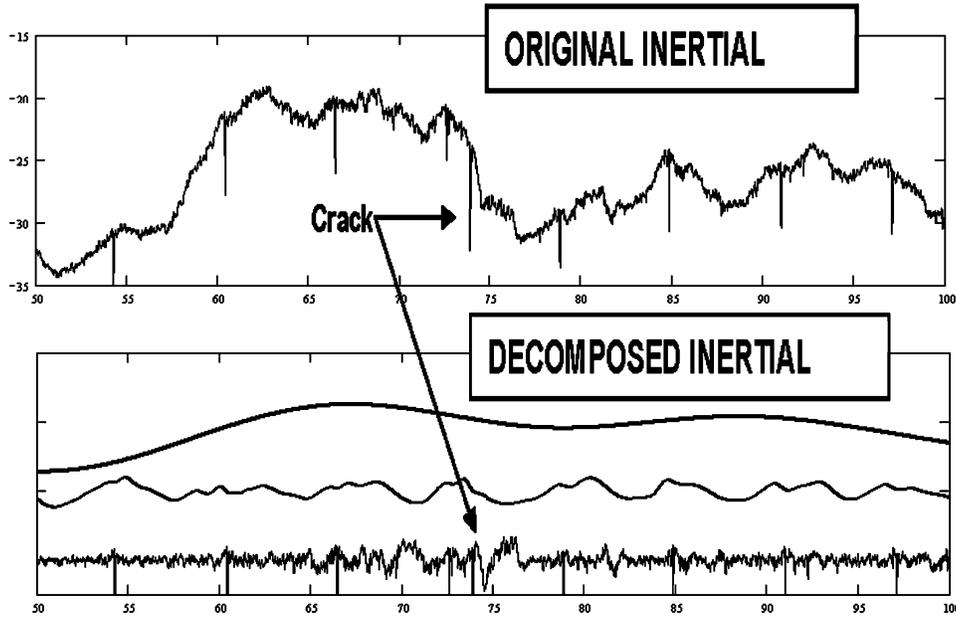
FIG. 1—Plots of inertial profile, string line sag, warp and curl, and other components.

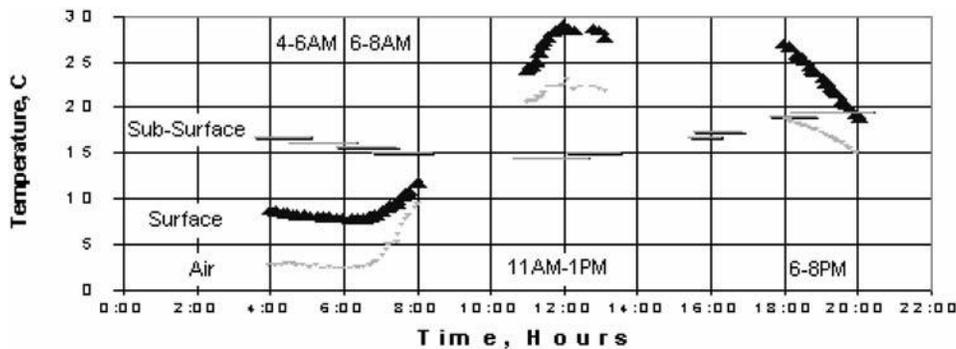
FIG. 2—Air, surface, and subsurface temperatures versus time of day from the weather station.

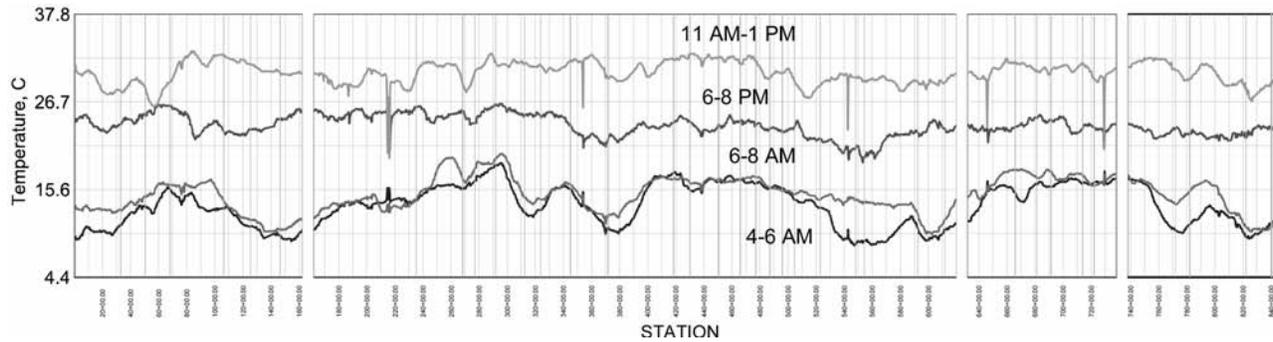
FIG. 3—Pavement surface passing lane temperature versus station (0+00–840+00).

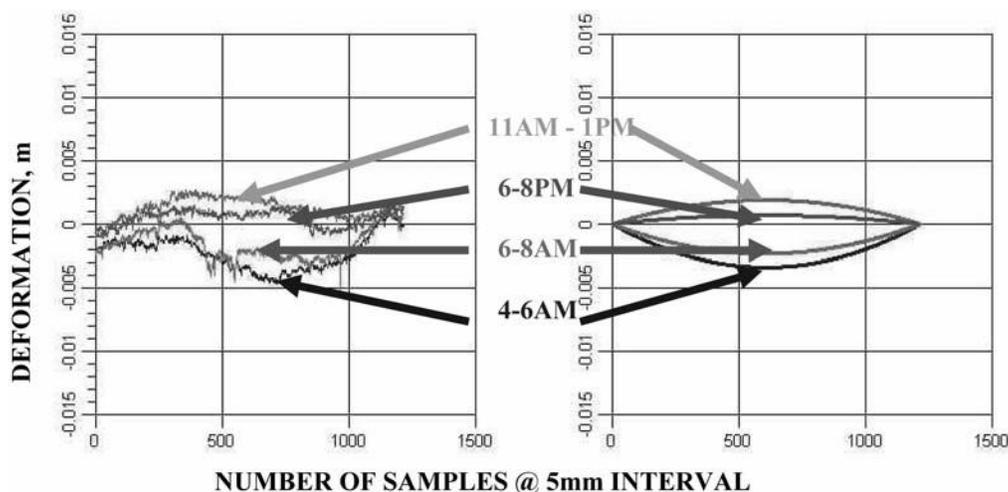
FIG. 4—Measured surface profiles and idealized shapes of one 6.1-m slab.

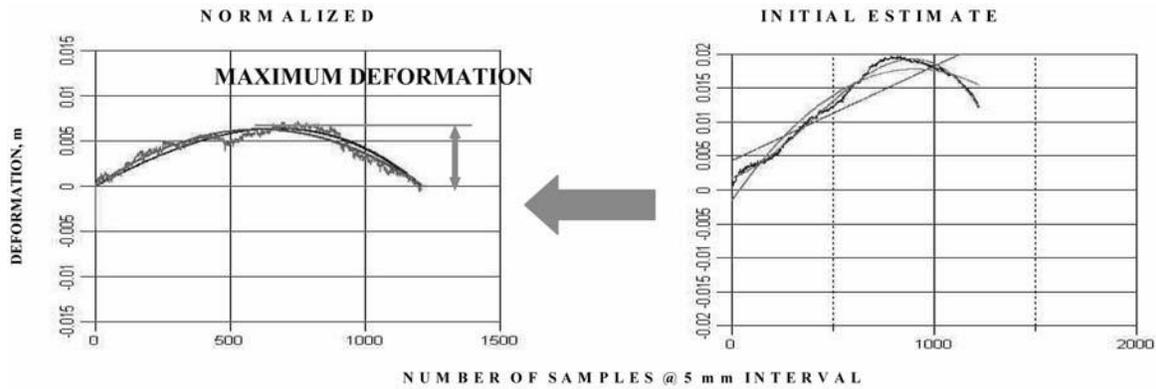
FIG. 5—Graphical definition of maximum deformation.

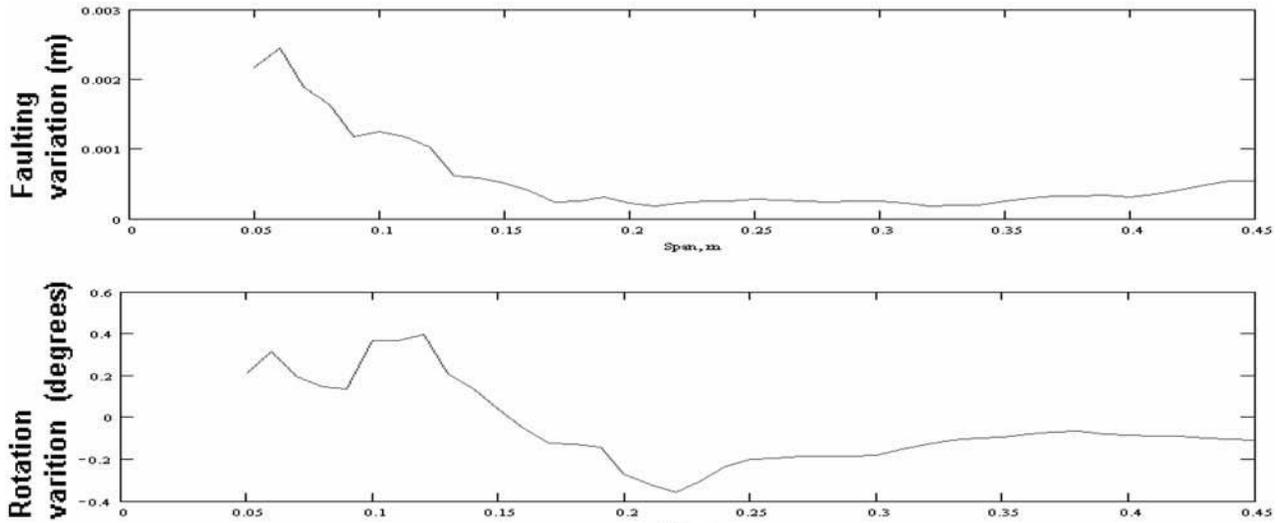
FIG. 6—Typical fault estimates and joint rotation variation versus span length.

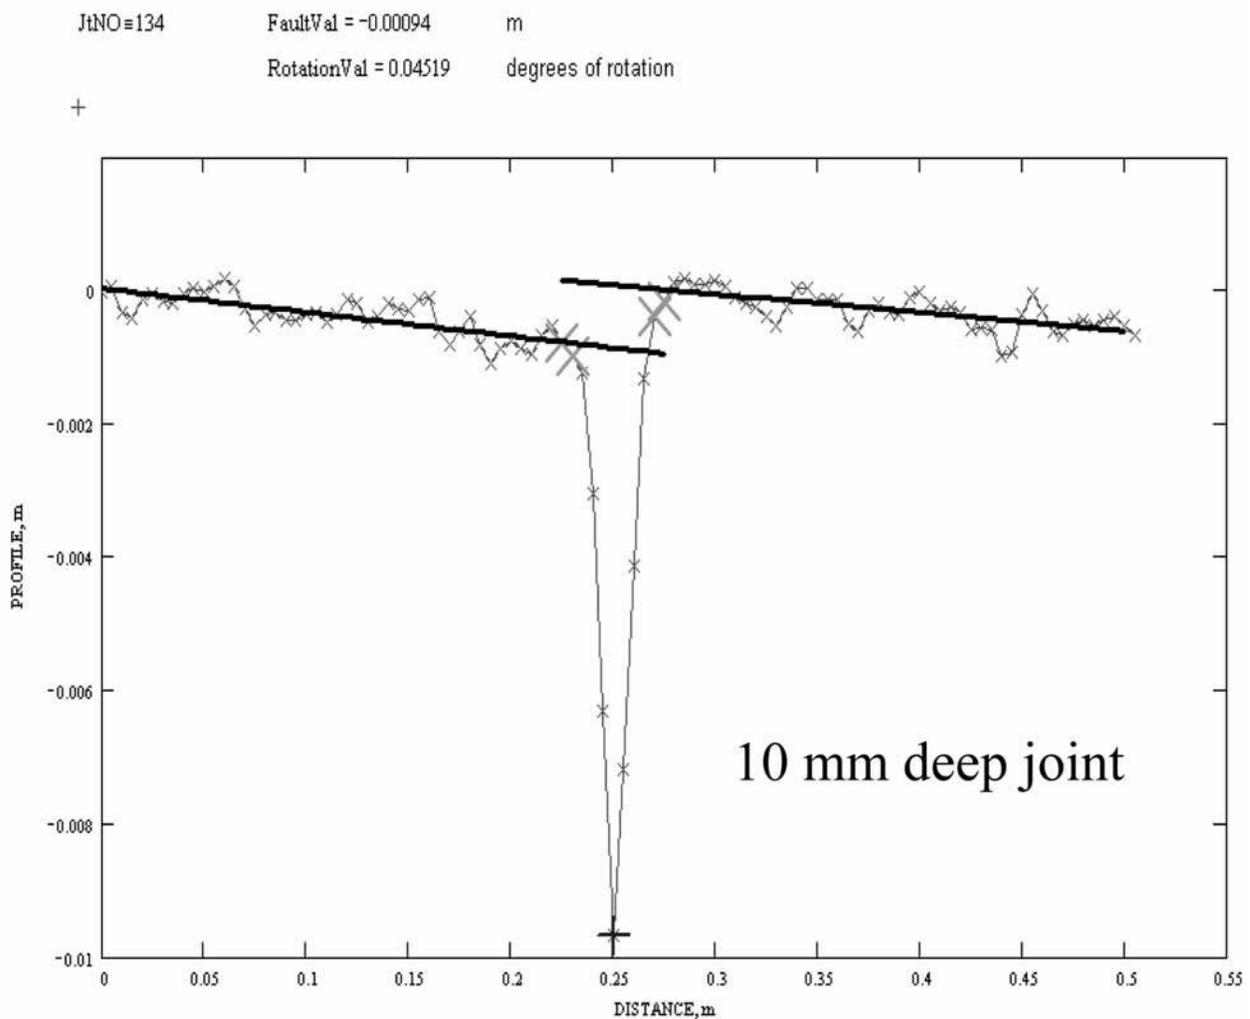
FIG. 7—Positive faulting, negative rotation.

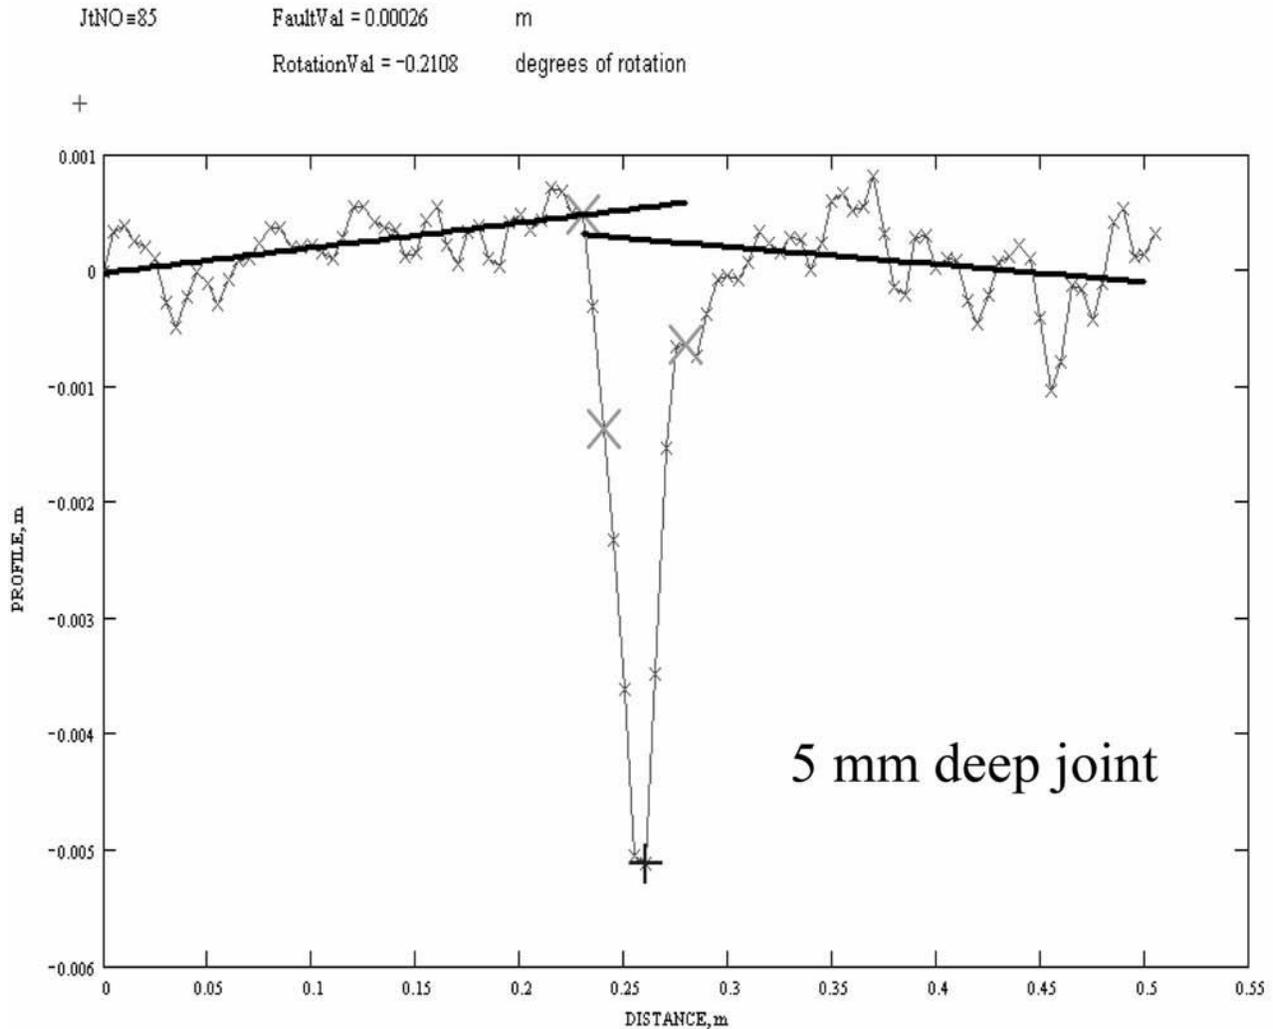
FIG. 8—Negative faulting, positive rotation.
