STP 1486

Pavement Surface Condition/ Performance Assessment:

**Reliability and Relevancy
of Procedures and Technologies**

Bouzid Choubane
editor

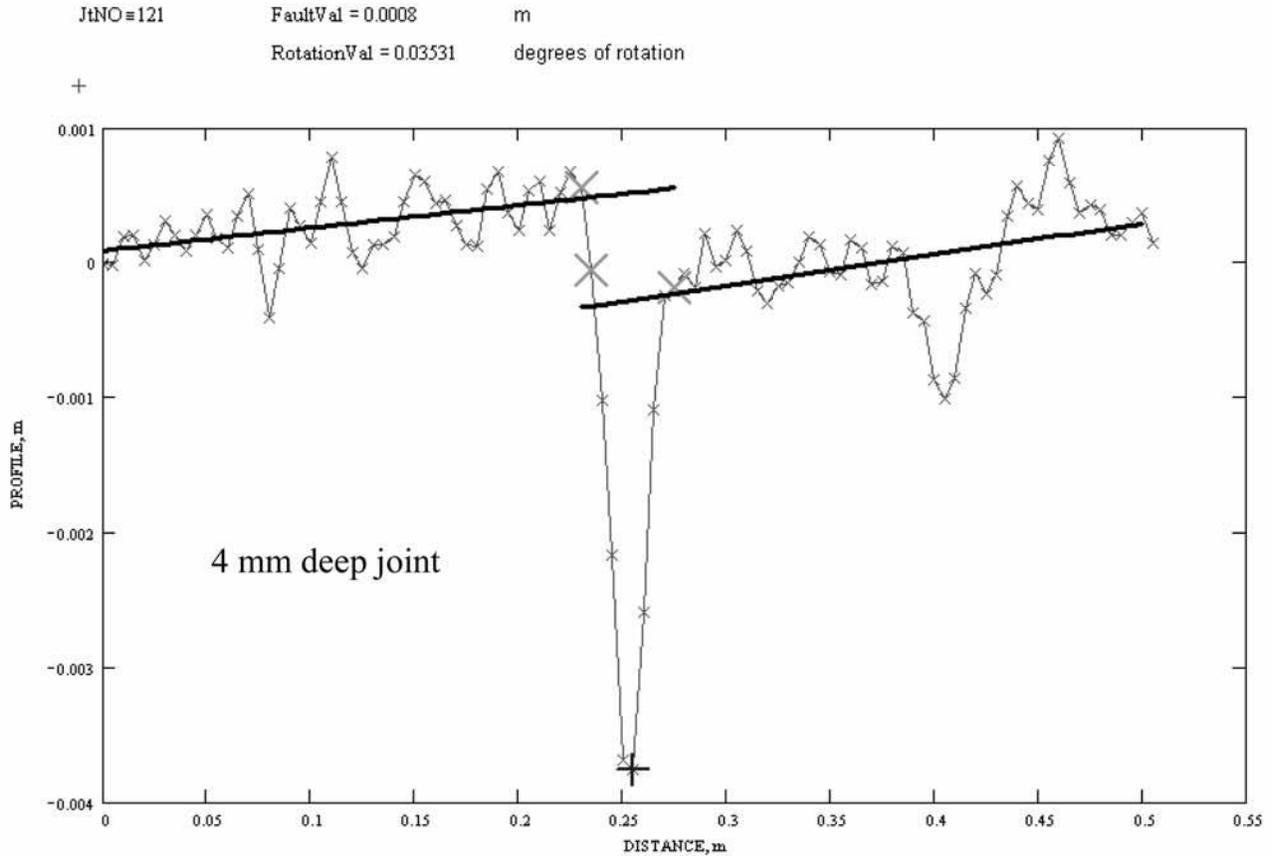
FIG. 9—Positive faulting, positive rotation.

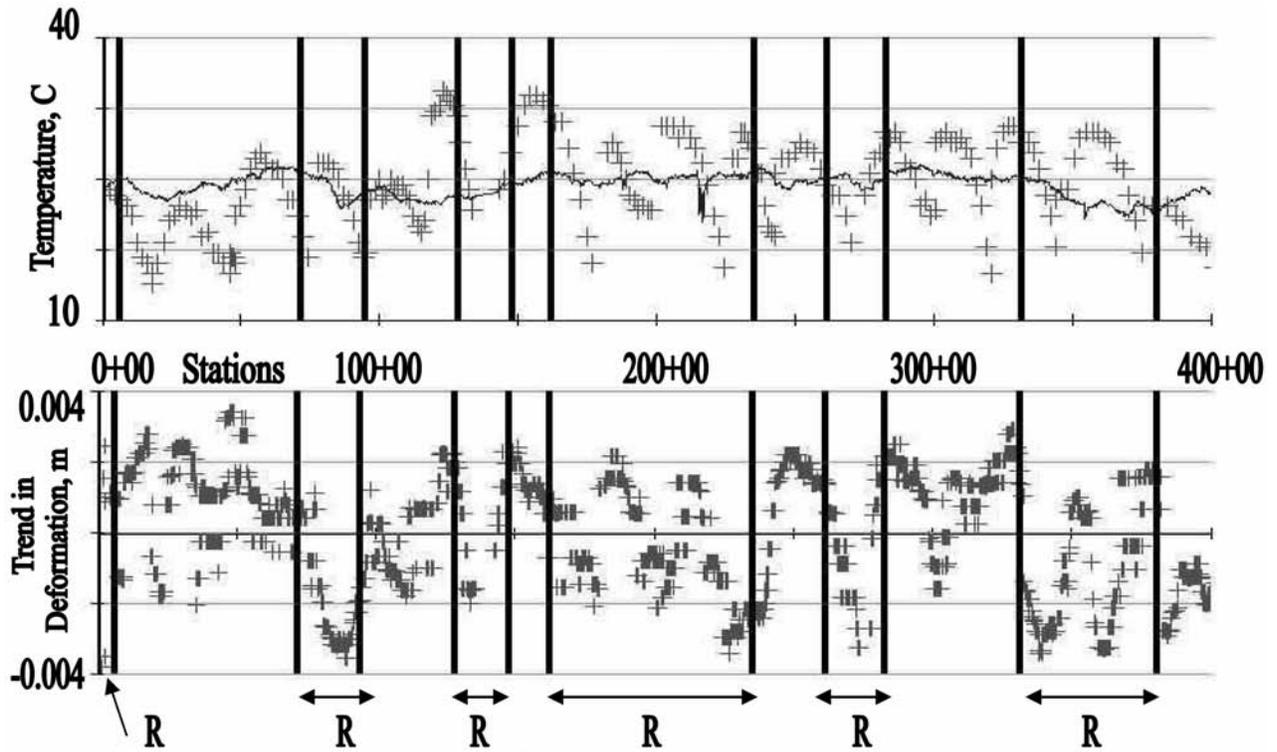
FIG. 10—Temperature at time of construction and at data collection, trend in maximum deformation (left lane, 6–8 p.m. time window), and Reconstruct (R) boundaries versus Station.

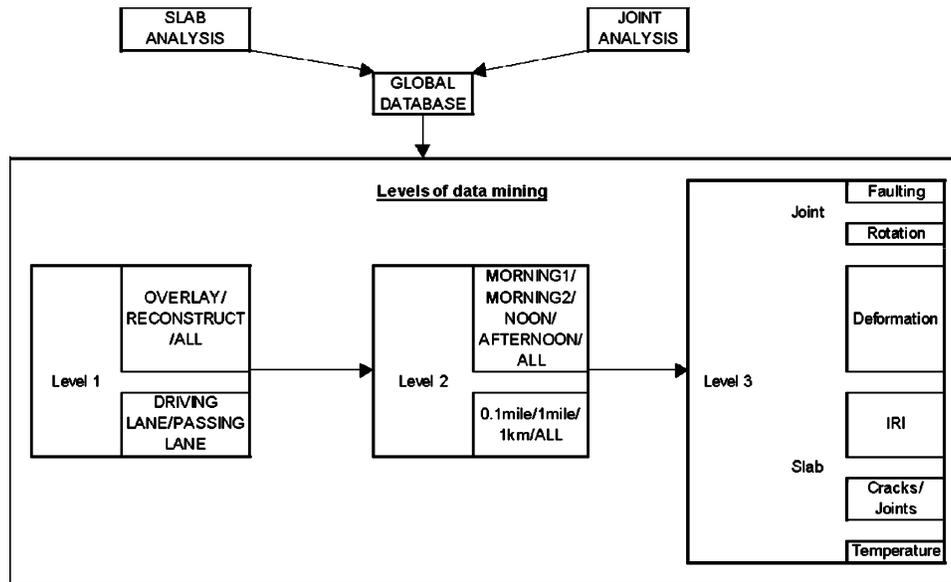
FIG. 11—Flow of data mining from fusion of analyses to levels of subdivision.

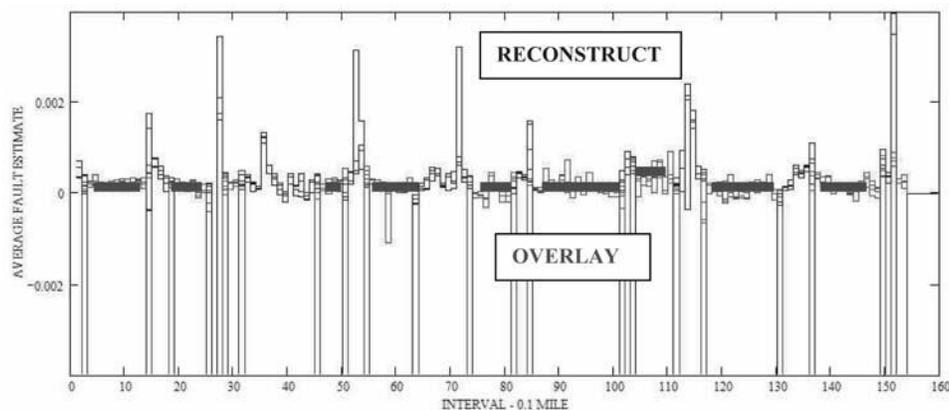
FIG. 12—Average fault estimate (m) versus interval (0.1 mile), red = overlay, blue = reconstruct.

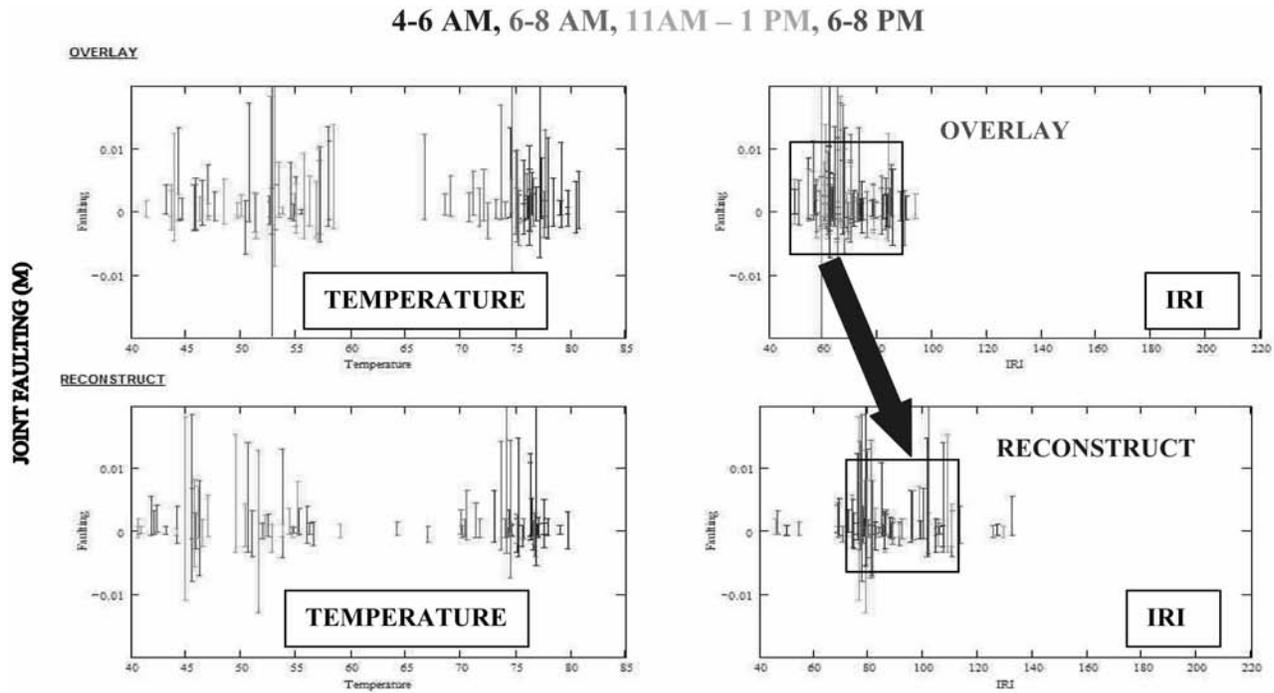
FIG. 13—Joint faulting versus temperature °C and IRI, for overlay and reconstruct sections separated—four time windows color-coded.

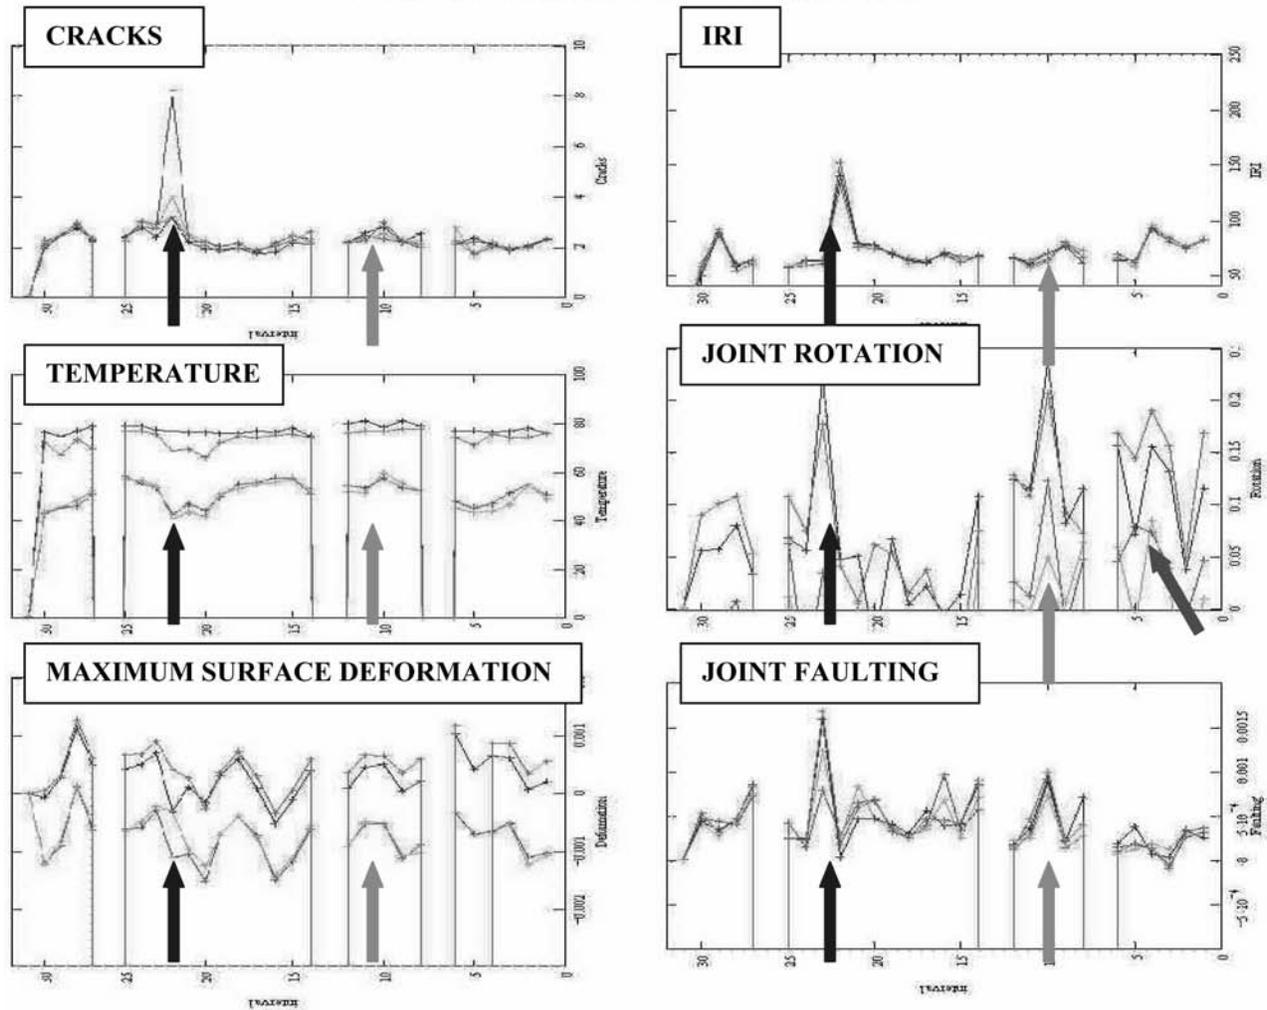
FIG. 14—Temperature °C, maximum deformation, number of cracks, joint rotation, joint faulting, and IRI versus Station for overlay sections—four time windows color-coded.

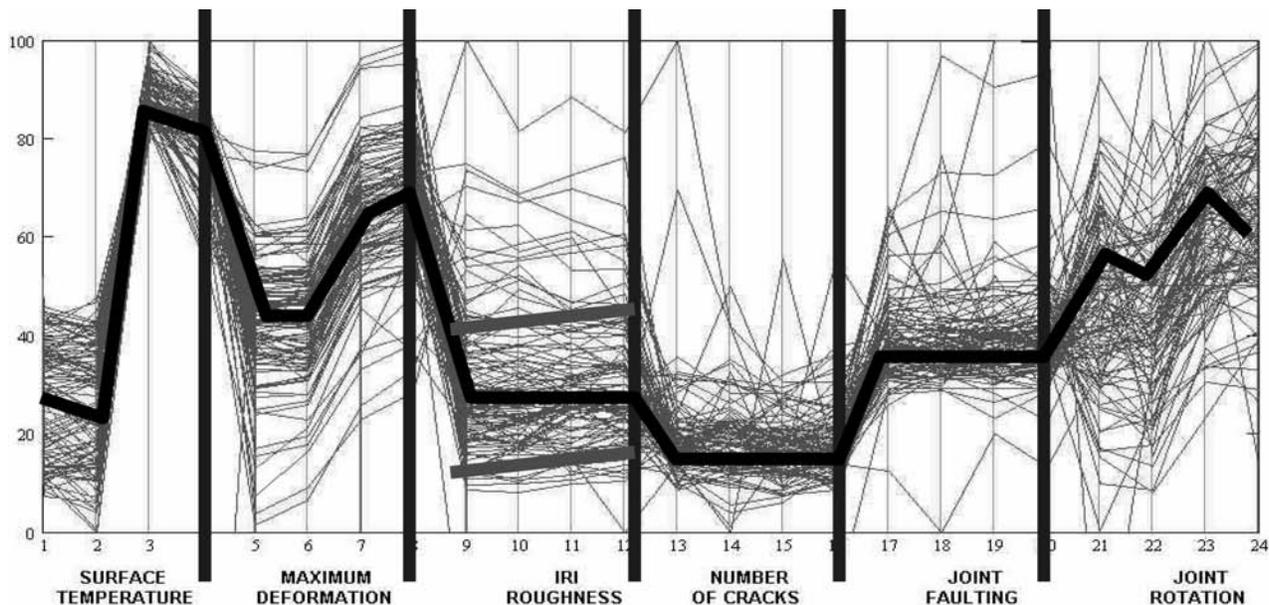
Finally, in order to identify those slabs which perform differently, parallel coordinate plots were used to visualize the relationship between all the parameters. Figure 15 shows such plots. In this case, six parameters are plotted encompassing four time windows within each parameter. Heavy vertical lines delineate each parameter. The three thin vertical lines are the three time windows, 4–6 a.m., 6–8 a.m., 11 a.m.–1 p.m., and the heavy vertical line which delineates the parameters is also the 6–8 p.m. time window. The heavy horizontal line shows the trend in the data. A cluster of slabs working similarly about the trend line become immediately apparent. Those slabs or groups of slabs that deviate from the trend correspond to those that have failed (cracked) or have non-working joints. The temperature and maximum deformation pattern are similar. The crack, fault, and IRI patterns are flat. The joint rotation pattern is the most unstable of the six parameters represented. Further work to cluster the slabs into more than two

FIG. 15—Plot of six parameters for four time windows in parallel coordinate plot.

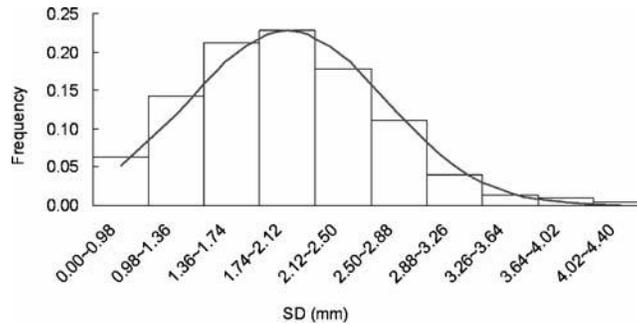
Constructing a histogram for smoothness data entails subdividing measurements into class intervals as shown in Figs. 1 and 2 for straightedge and profiler, respectively. These two figures resemble a normal distribution in that the frequency is centered on the sample mean and is symmetrical about this point. It is

FIG. 1—Smoothness data based on standard deviation.

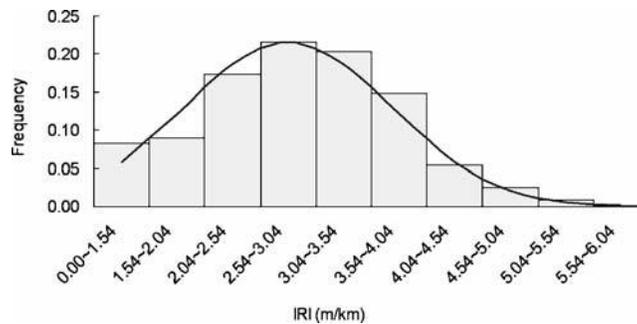
FIG. 2—Smoothness data based on IRI.

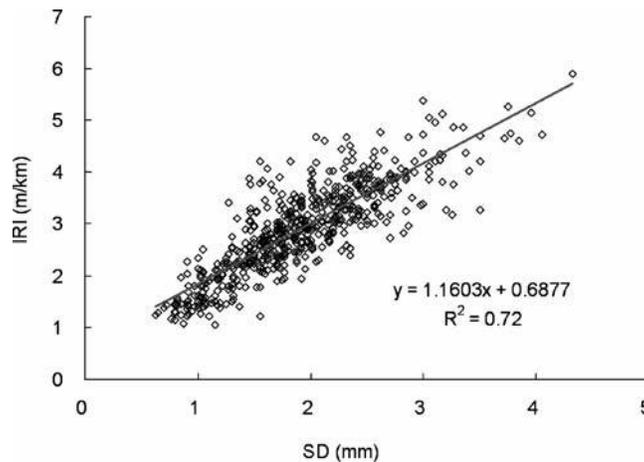
As shown in Fig. 3, measured smoothness for standard deviation and IRI as explanatory and response variables, respectively, demonstrates a significant relationship that allows construction of a corresponding equation. The coefficient of determination, the R^2 value, equals to 0.72, and consequently, the explained

FIG. 3—Relationship of pavement smoothness index.

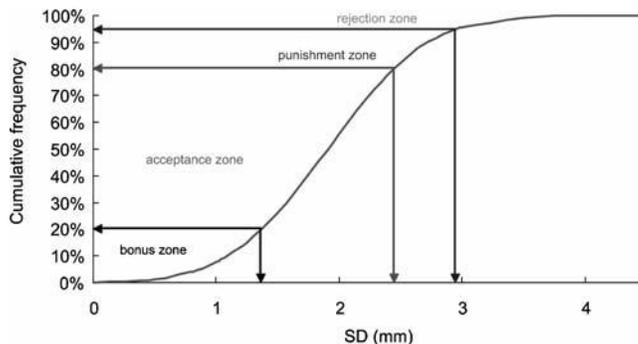
FIG. 4—Cumulative frequency distribution of standard deviation.

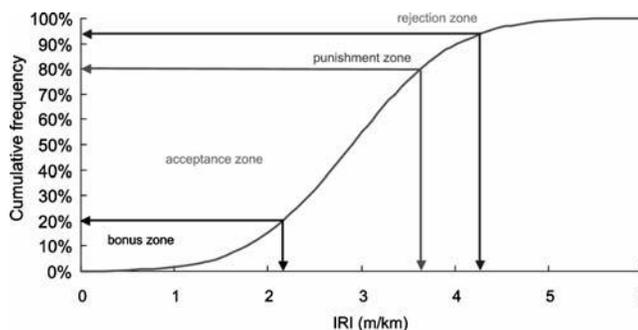
FIG. 5—Cumulative frequency distribution of International Roughness Index.

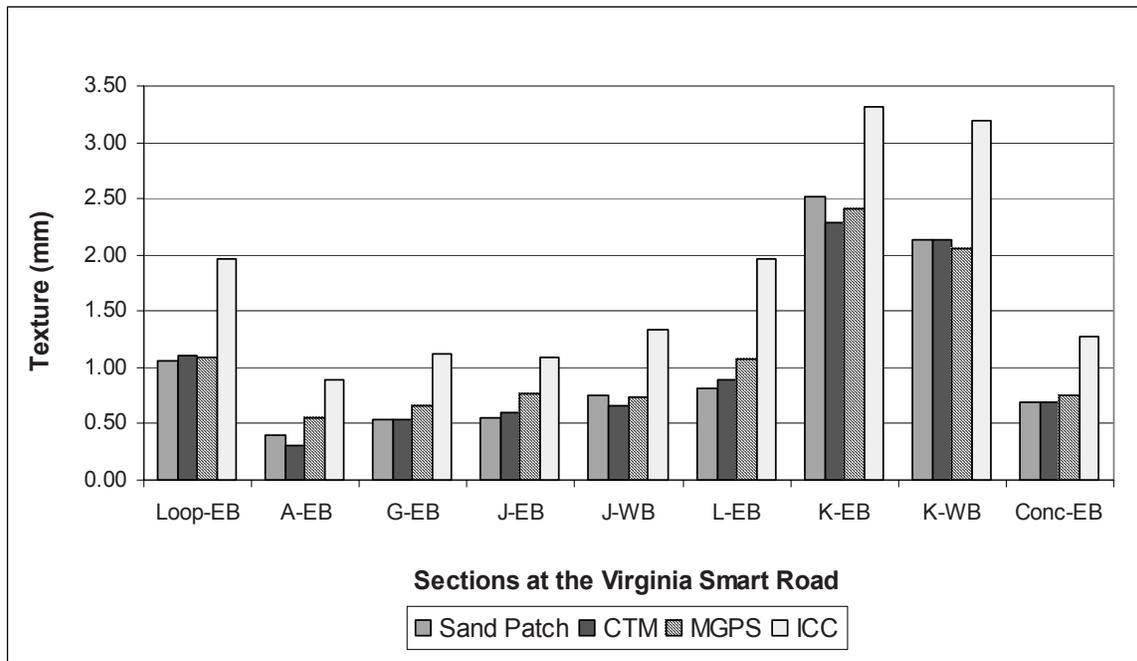
The macrotexture measurements obtained with these four devices for each section are compared in Fig. 1. The ICC macrotexture values are, in general, larger than others: on average 89 % larger than the sand patch MTD, 96 % larger than the CTMeter MPD, and 65 % larger than the MGPS MPD. The large difference between the ICC measurements and the other measurements may be due to the specific method used by the ICC profiler to calculate the MPD. While the ICC MPD is estimated using a proprietary algorithm, not consistent with ASTM E 1845, the other devices calculate the MPD using the ASTM method. Hence, the ICC macrotexture measurements are referred as ICC Texture (ICCTEX), rather than MPD, in this paper.

FIG. 1—Comparisons of laser-based macrotexture measurements.

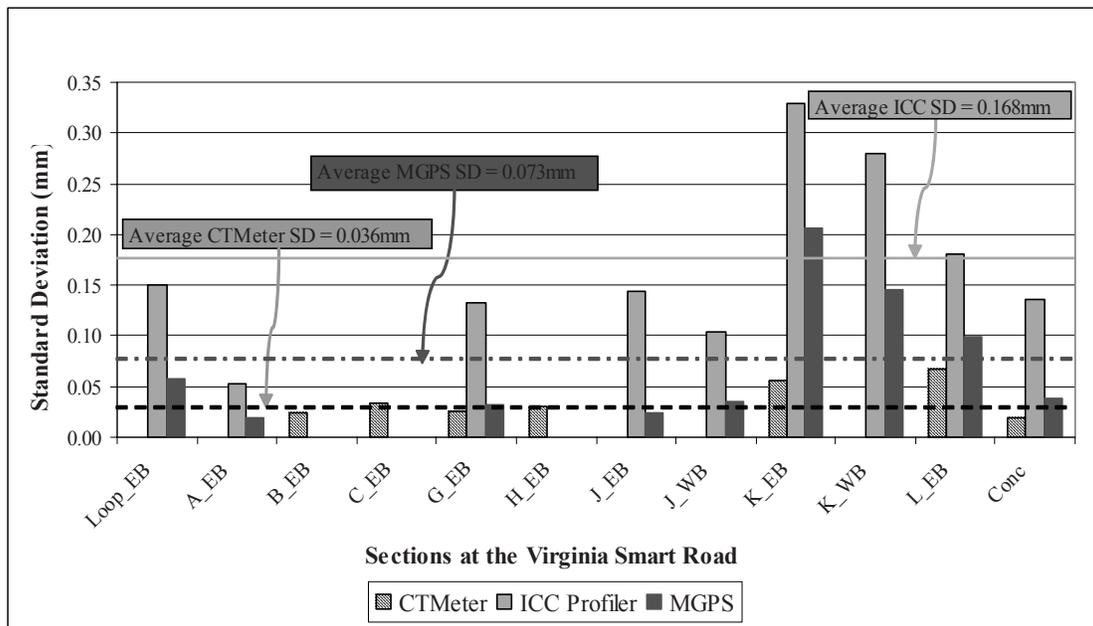
FIG. 2—Standard deviation of laser-based macrotexture measurements.

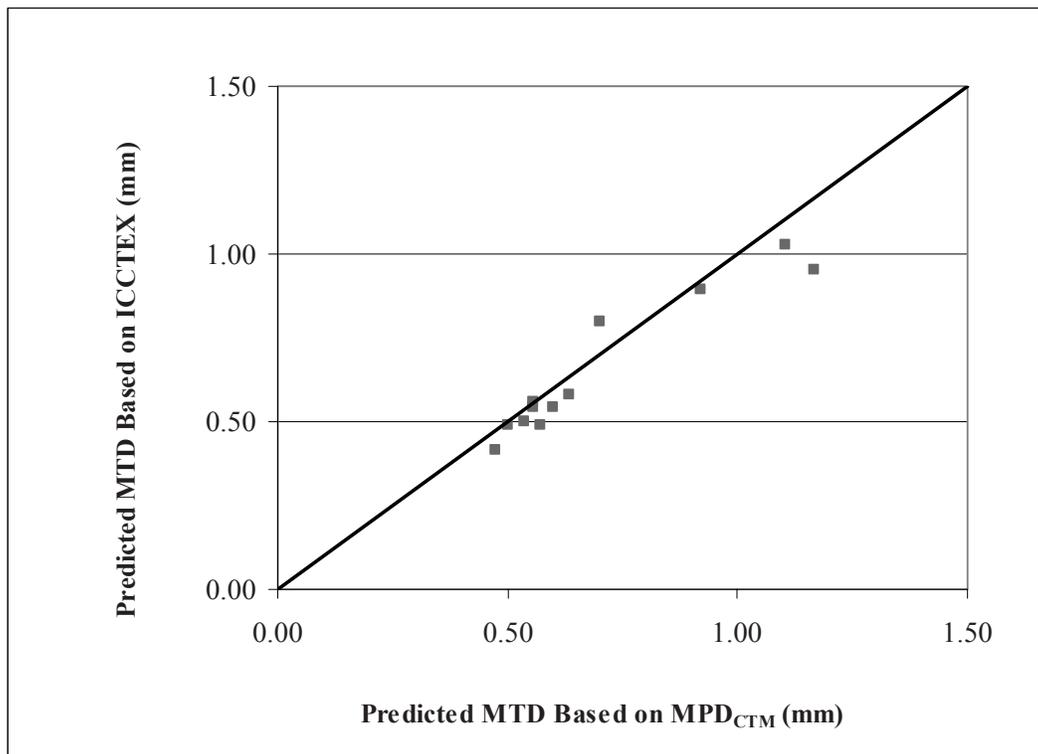
FIG. 3—Comparison of MTD predictions based measurements at the Virginia Smart Road.

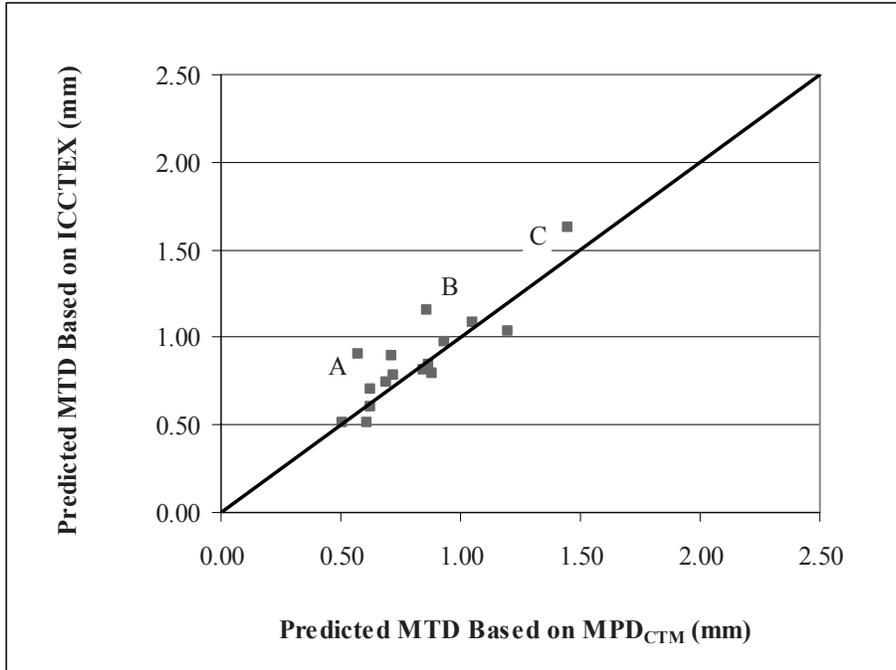
FIG. 4—MTD predictions based on average ICCTEX and CTM_{MPD} measurements on newly constructed highway pavements.

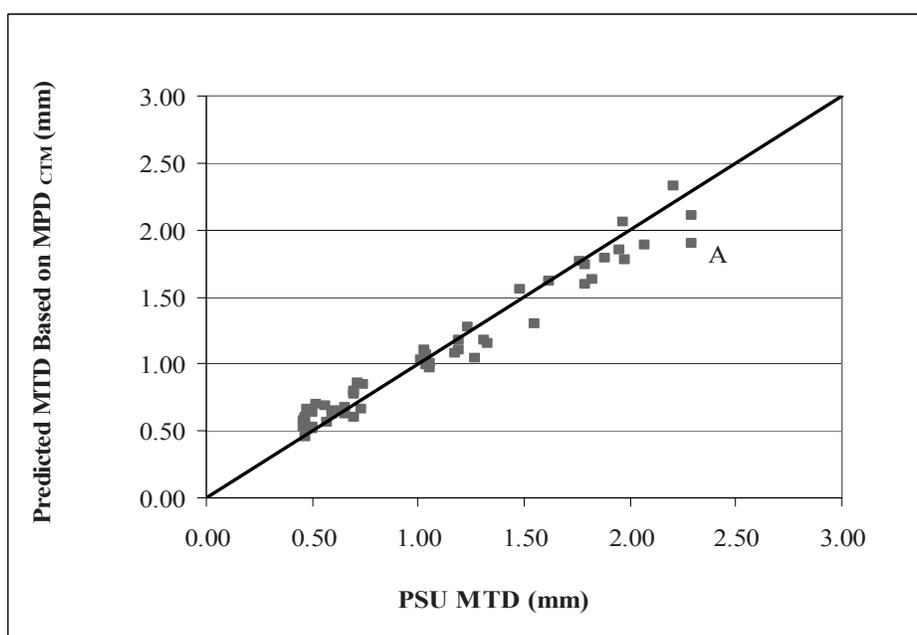
FIG. 5—*MTD predictions based on CTMeter measurements on airport surfaces.*

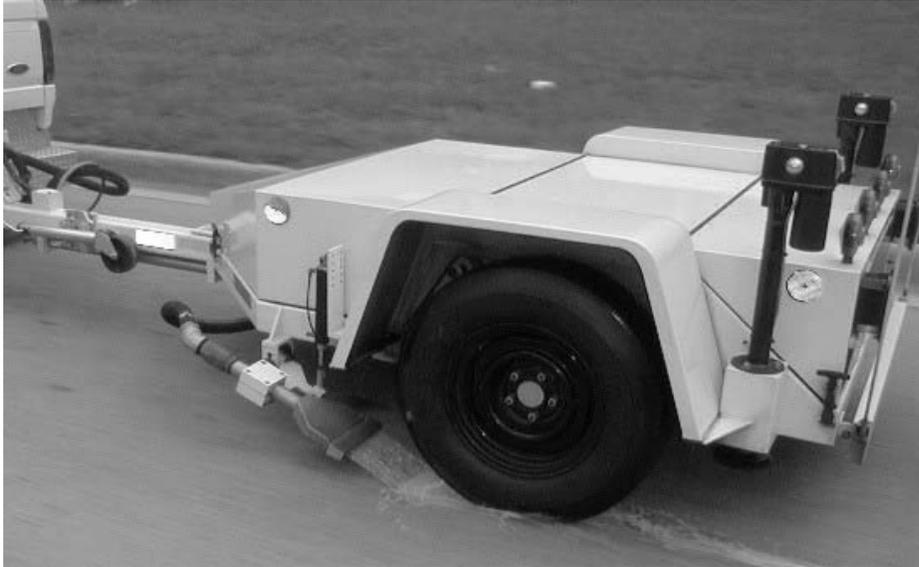
FIG. 1—Typical FDOT pavement friction testing unit performing a test.

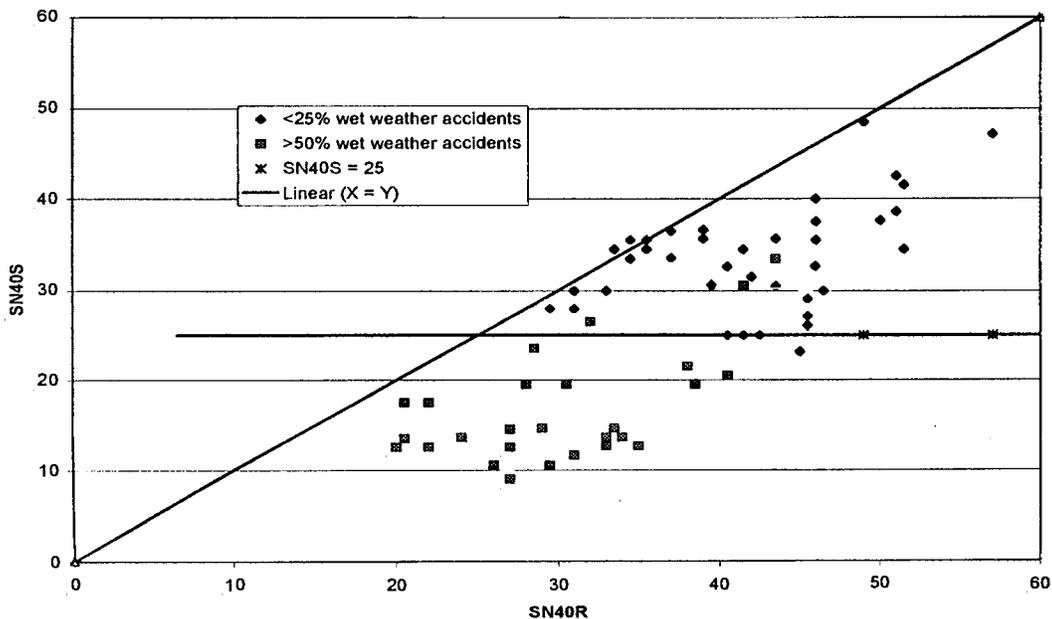
FIG. 2—Ribbed-tire versus smooth-tire friction numbers for Florida pavements [6].

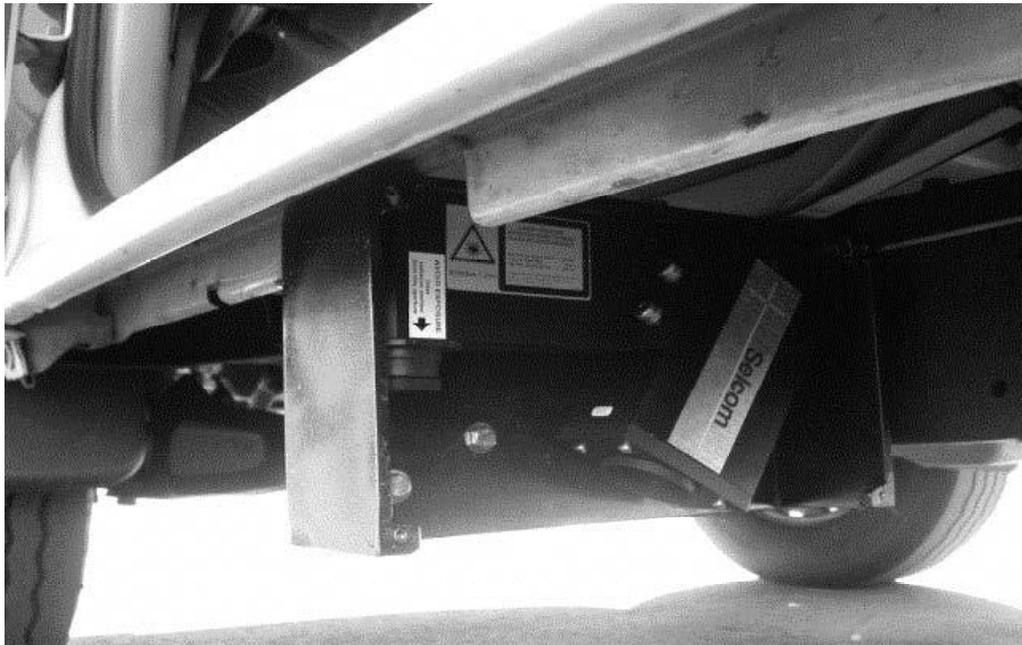
FIG. 4—FDOT skid test unit instrumented with LMI Technologies, Selcom, Optiocator 64 kHz, high-speed laser system.

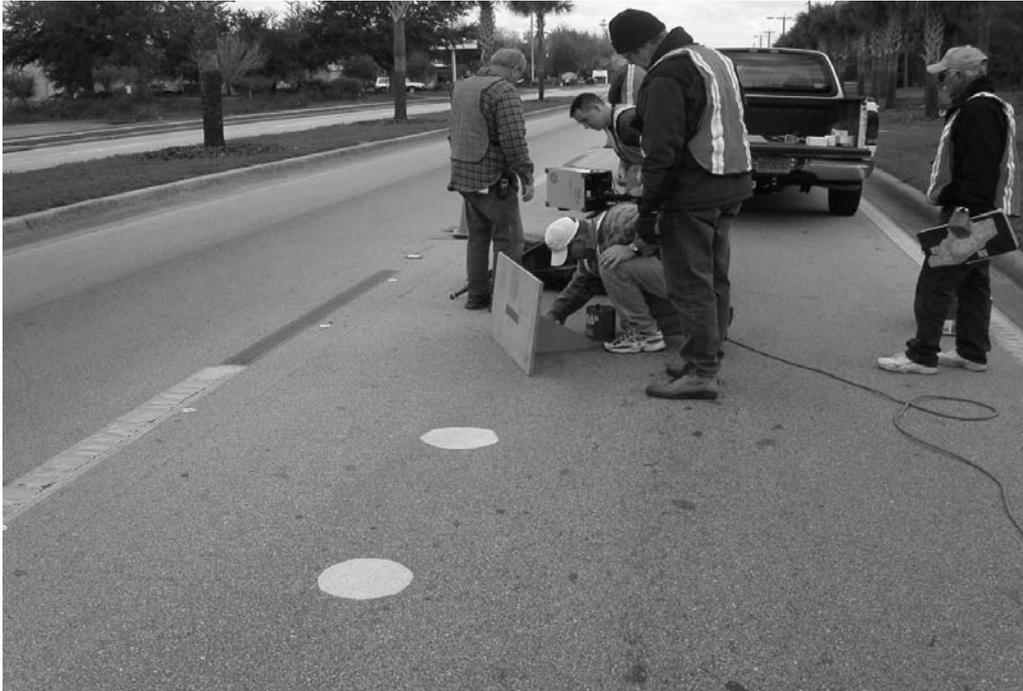
FIG. 5—Sand patch testing (ASTM E 965) within the wheel lock-up zone of a typical FDOT calibration test section.

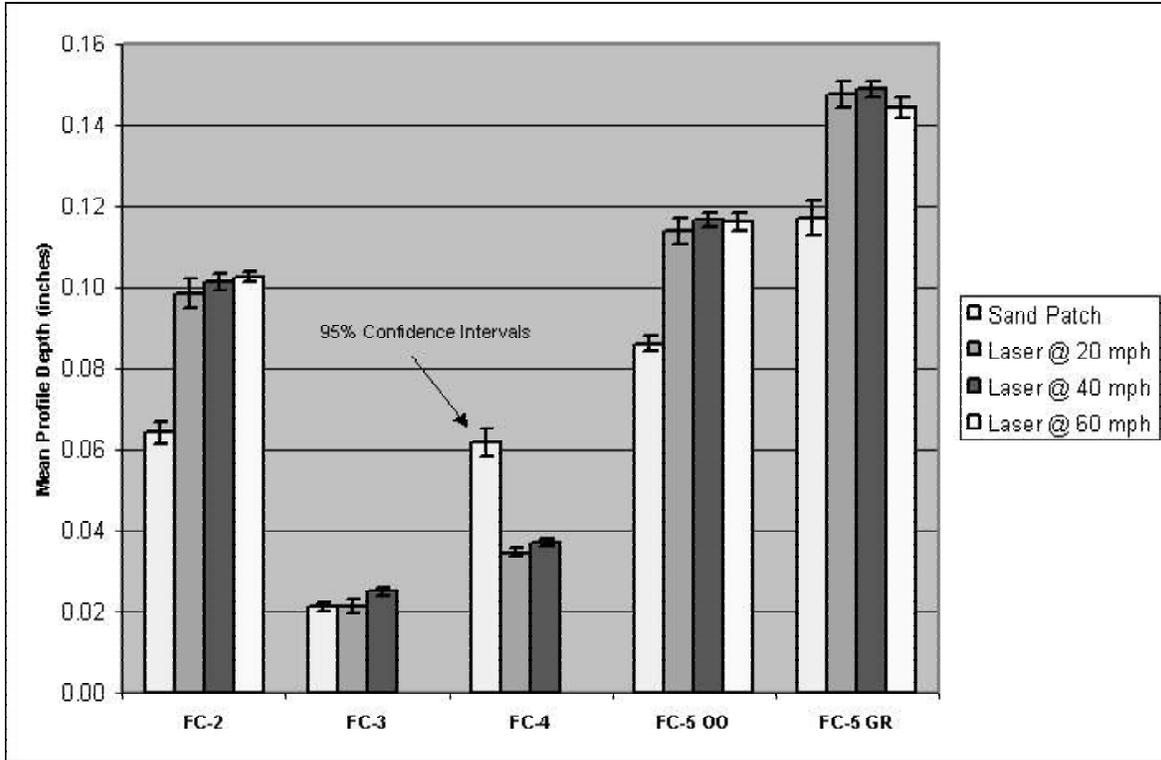
FIG. 6—Mean Profile Depth (MPD) at 20, 40, and 60 mph.

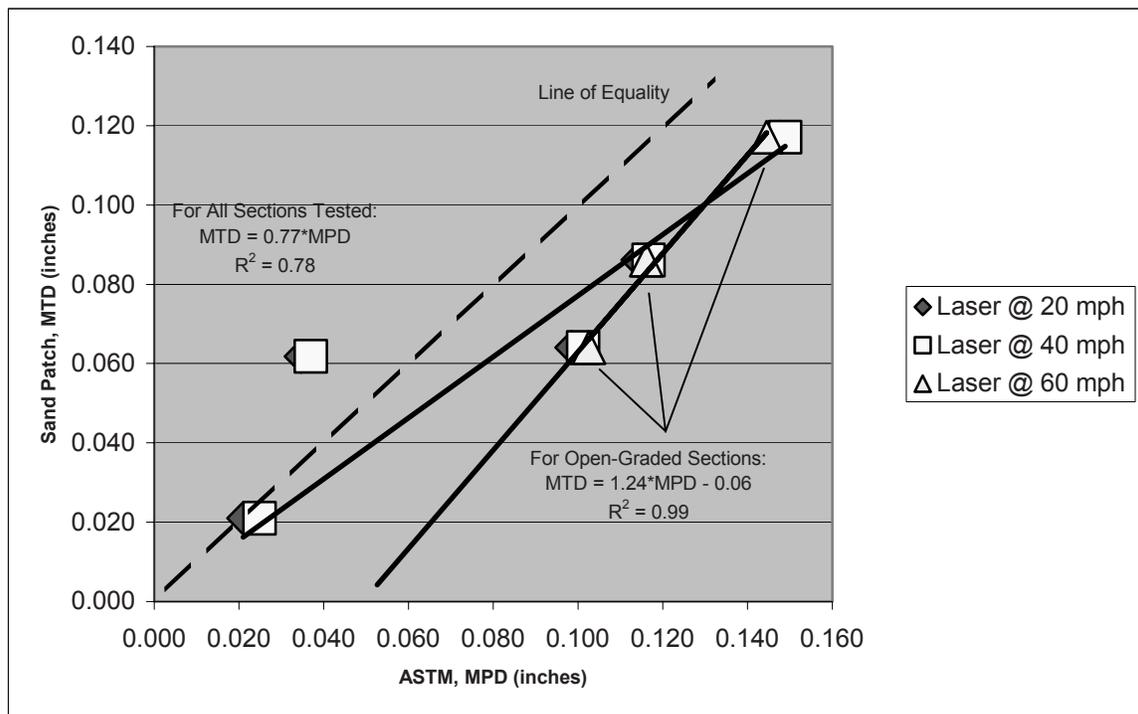
FIG. 7—Mean Profile Depth (MPD) versus Mean Texture Depth (MTD).

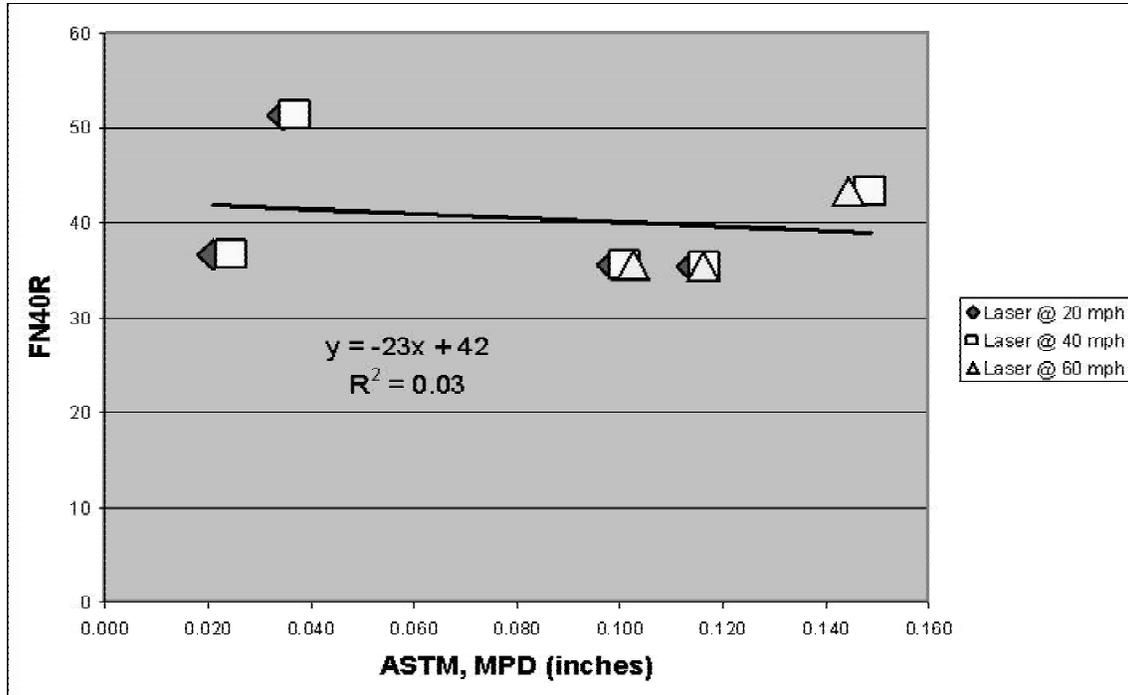
FIG. 8—Mean Profile Depth (MPD) versus Mean Friction Number (FN_{40R}).

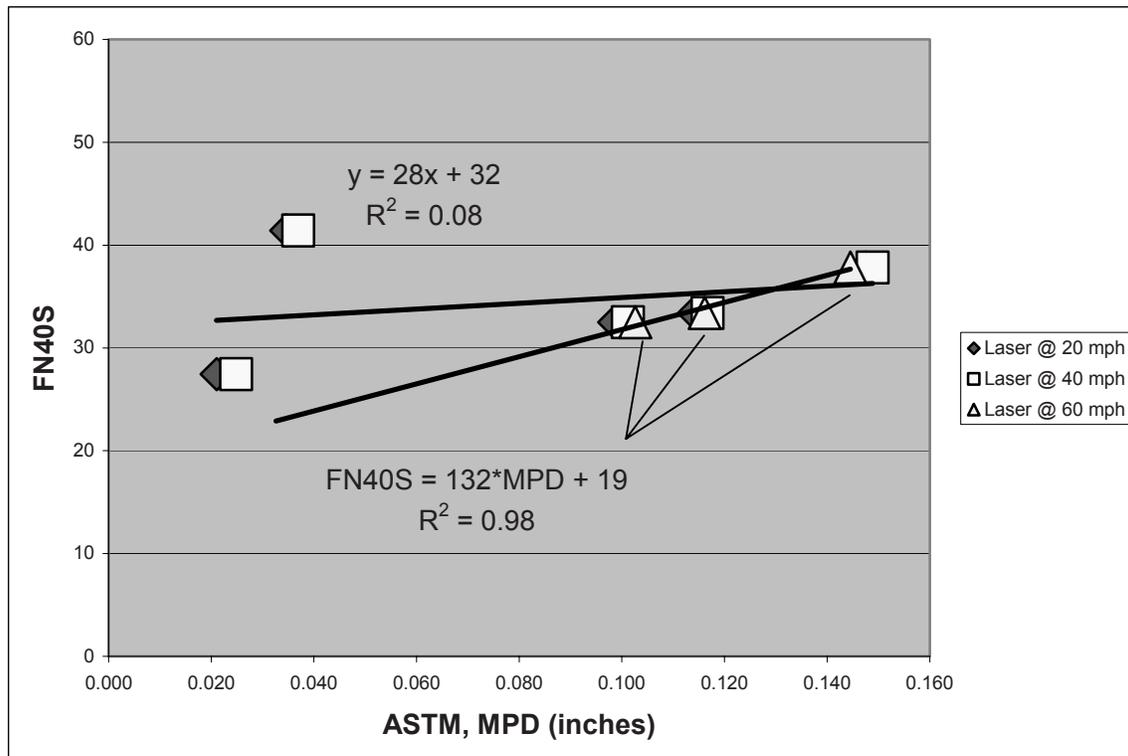
FIG. 9—Mean Profile Depth (MPD) versus Mean Friction Number (FN_{40S}).

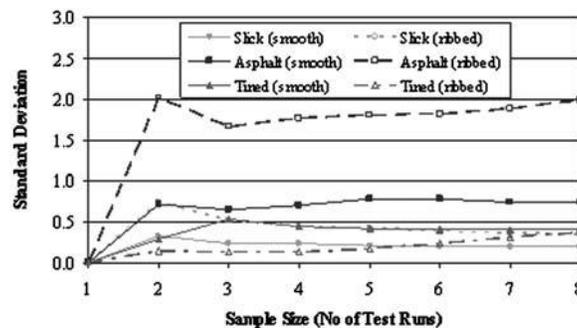
FIG. 1—Standard deviation versus sample size.

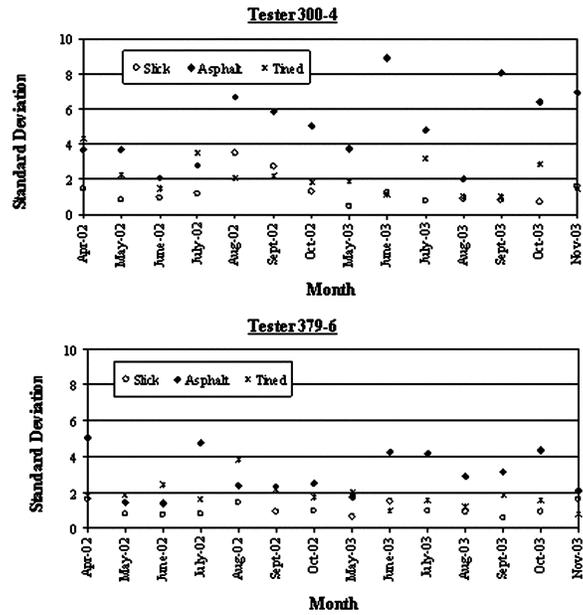
FIG. 2—Standard deviations with smooth tire.

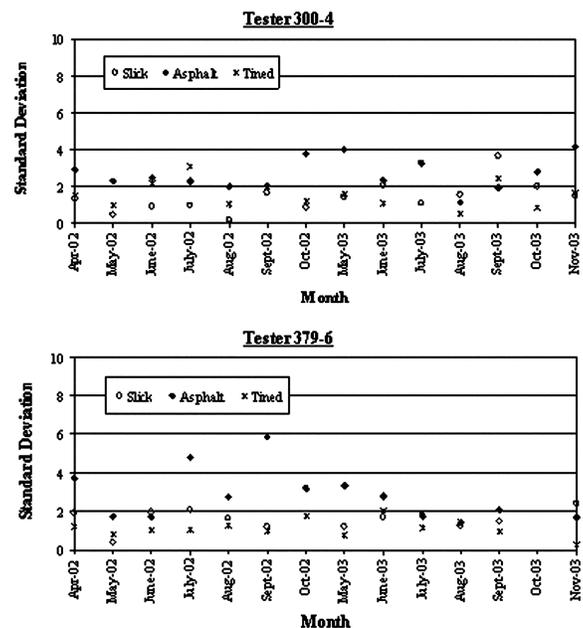
FIG. 3—Standard deviations with ribbed tire.

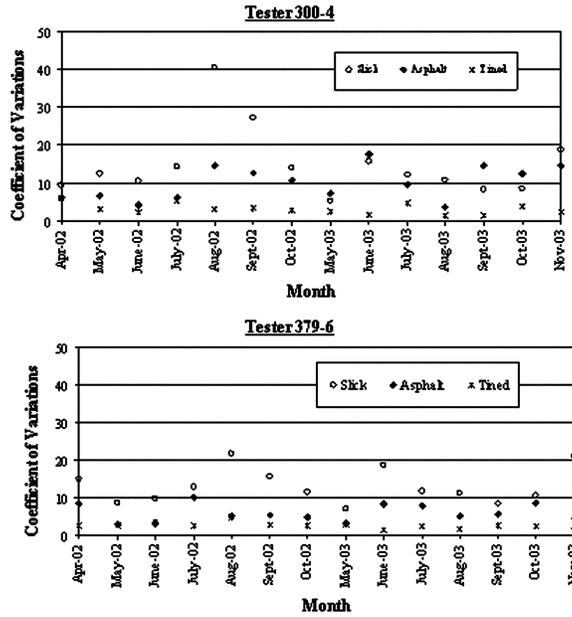
FIG. 4—Coefficients of variations with smooth tire.

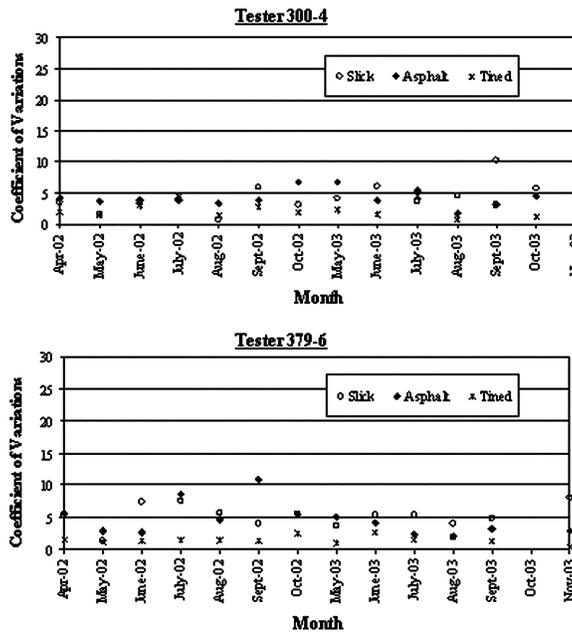
FIG. 5—Coefficients of variations with ribbed tire.
