# ELECTRON FRACTOGRAPHY

A symposium  
presented at the  
Seventieth Annual Meeting  
AMERICAN SOCIETY FOR  
TESTING AND MATERIALS  
Boston, Mass., 25-30 June, 1967

ASTM SPECIAL TECHNICAL PUBLICATION NO. 436

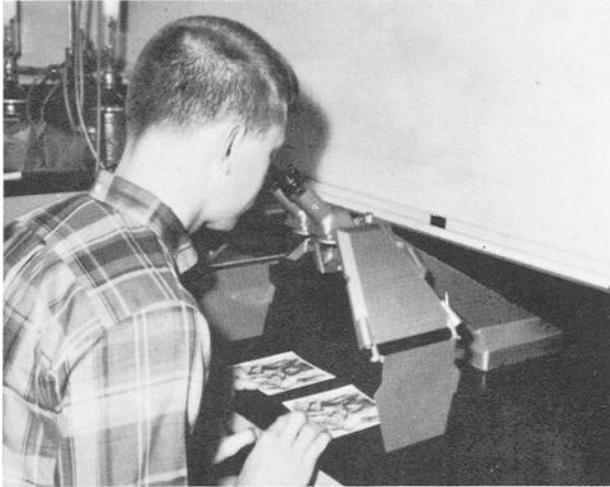
FIG. 5—Examination of stereo-pairs in a special viewer to observe the three-dimensional characteristics of a fracture.

slightly different angles in the electron microscope. When these pairs are viewed in a special stereo viewer, as shown in Fig. 5, the three-dimensional characteristics of a fracture can be observed and studied. This type of viewing is particularly useful for studies of fractures, since the true topographic appearance of the fracture can be seen readily. Furthermore, the topographic structure of a fracture can be quantitatively analyzed from the stereo pairs by use of a parallax bar. This type of information has proved useful in both theoretical and applied studies concerning the micromechanisms of certain types of fractures.

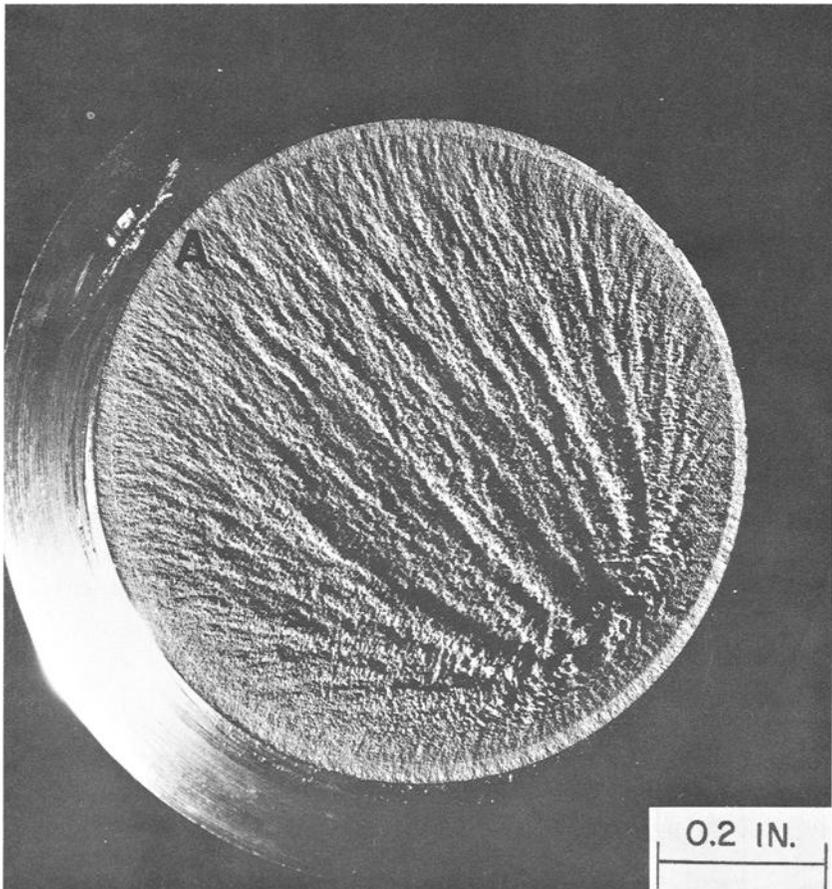
FIG. 1—Fracture surface of 0.45C-Ni-Cr-Mo steel with 0.008 weight per cent sulfur.

The macroscopic appearance of the fracture surface of the 0.45C low-alloy steel containing 0.008 per cent sulfur is shown in Fig. 1. The fracture surfaces of the other steels of different sulfur contents looked

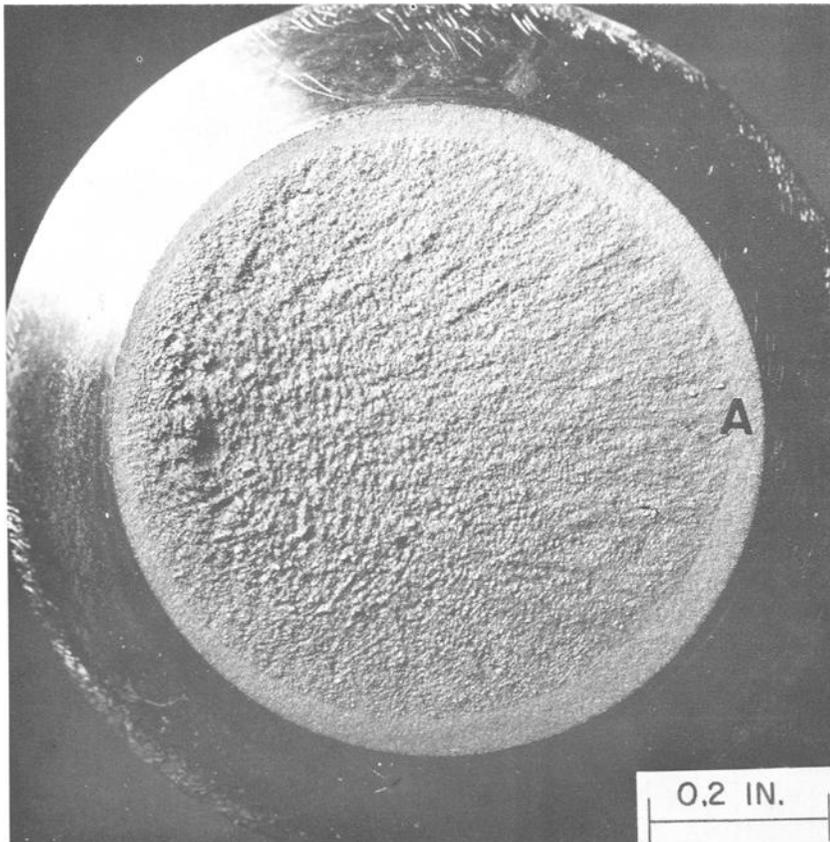
FIG. 2—Fracture surface of 250-grade maraging steel.

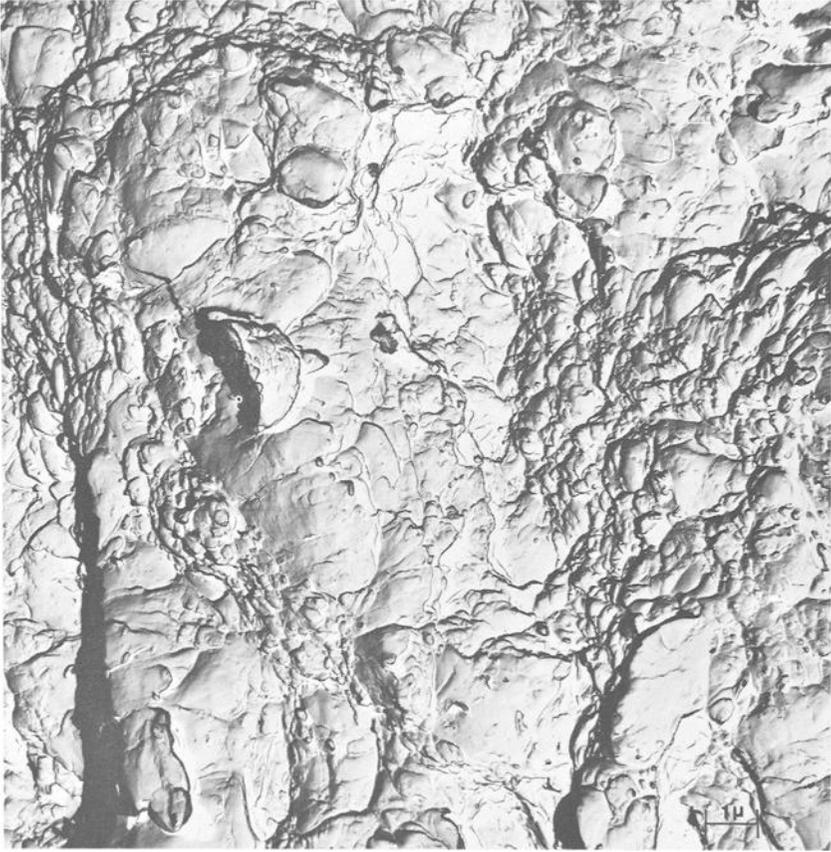
FIG. 3—Fracture surface of 0.45C-Ni-Cr-Mo steel with 0.008 per cent sulfur showing area adjacent to fatigue crack.

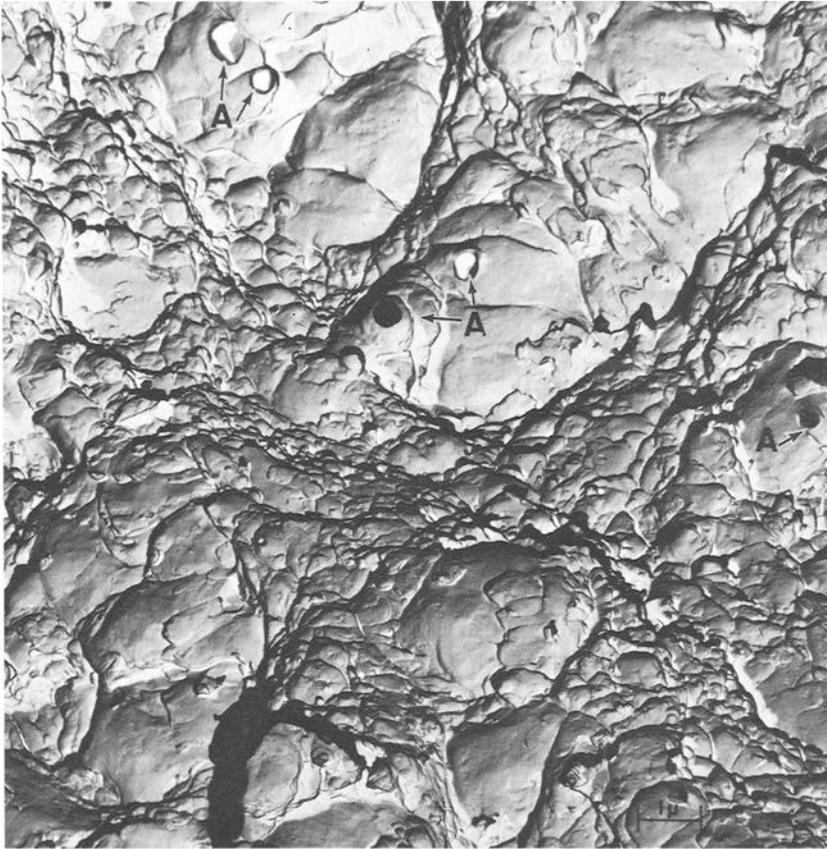
FIG. 4—Fracture surface of 0.45C-Ni-Cr-Mo steel with 0.049 per cent sulfur showing area adjacent to fatigue crack.

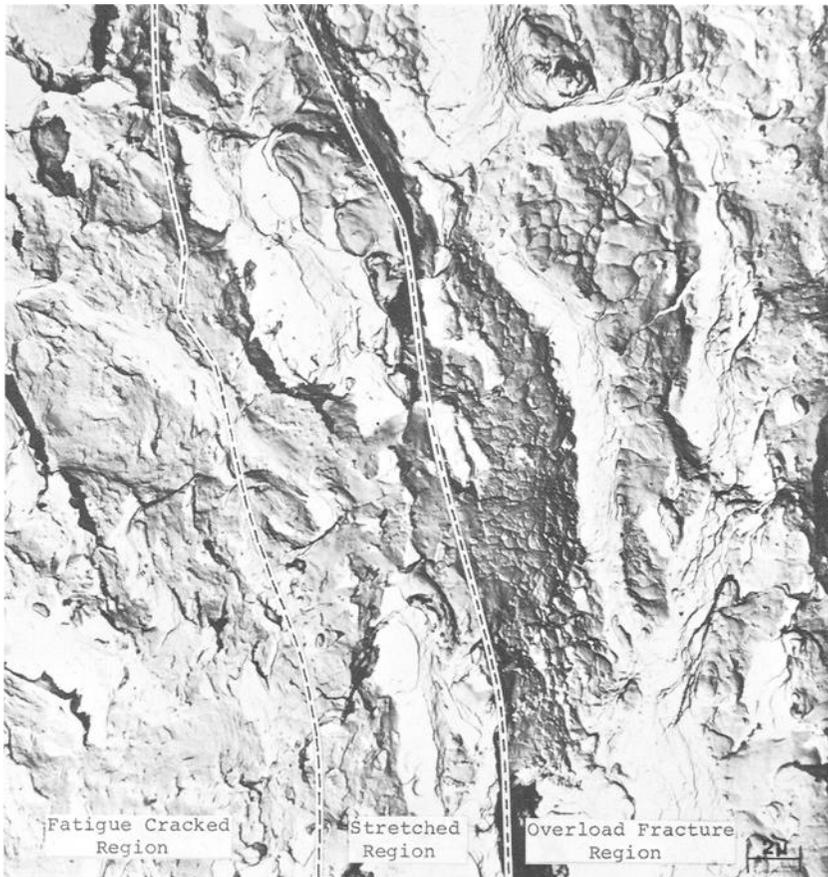
FIG. 5—Fracture surface of 0.45C-Ni-Cr-Mo steel with 0.008 per cent sulfur showing area between fatigue crack and overload fracture regions.

steels, namely, a “stretched” region between the fatigue starter crack and the main overload fracture [8]. Such a region in the fracture surface of the steel containing 0.008 per cent sulfur is shown in Fig. 5. A region of this kind could not be found in the steel containing 0.049 per cent sulfur; either it did not exist or was too narrow to be detected. The fracture surfaces of the two steels of intermediate sulfur contents were not examined specifically for this feature. It is possible that this stretched zone corresponds to a region of crack extension through the plastic zone that existed at the tip of the fatigue crack just prior to the onset of the rapid, main fracturing process; the stretching might be involved in the separation process, or perhaps it represents localized plastic flow in the crack surfaces resulting from the bending that accompanies the crack opening. In either case, it is reasonable to think

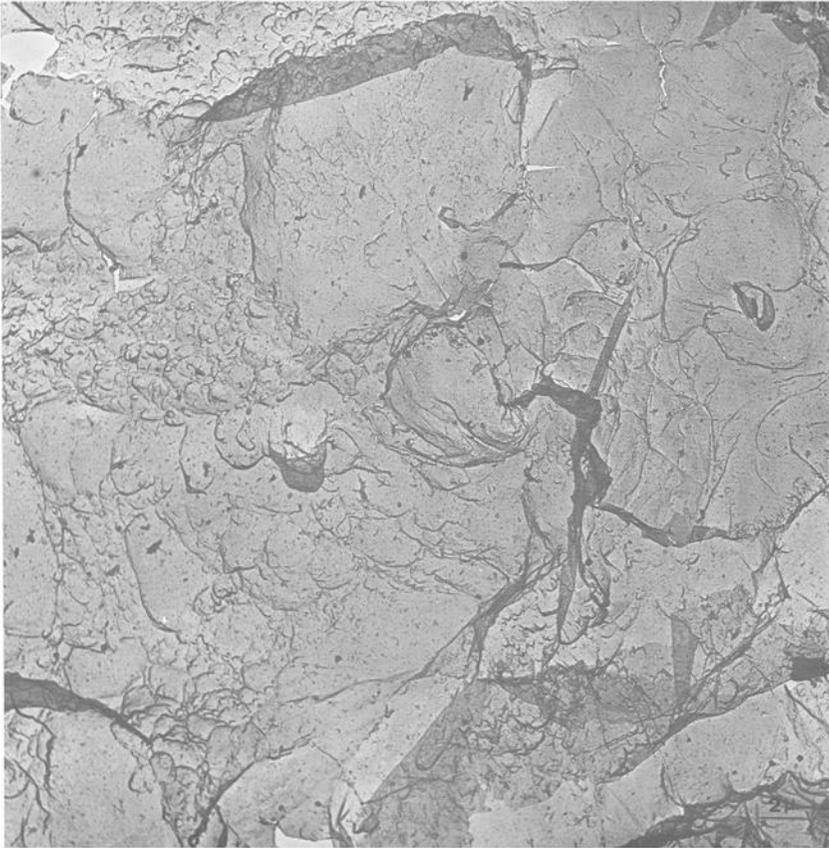
FIG. 6—Fracture surface of 250-grade maraging steel showing area adjacent to fatigue crack.

The fracture surfaces of the 250-grade and of the 300-grade 18Ni maraging steels exhibited a wide range of dimple size throughout the fracture surfaces, as shown in the typical fractographs of Figs. 6 and 7, respectively. Although many inclusions appeared in the fracture sur-

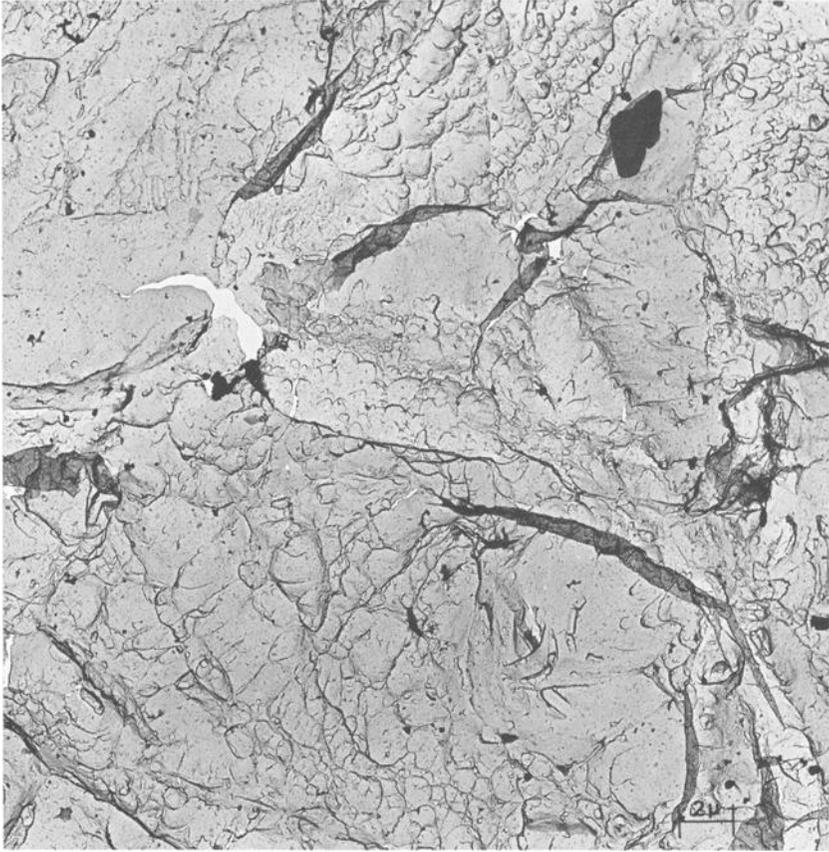
FIG. 7—Fracture surface of 300-grade maraging steel showing area adjacent to fatigue crack.

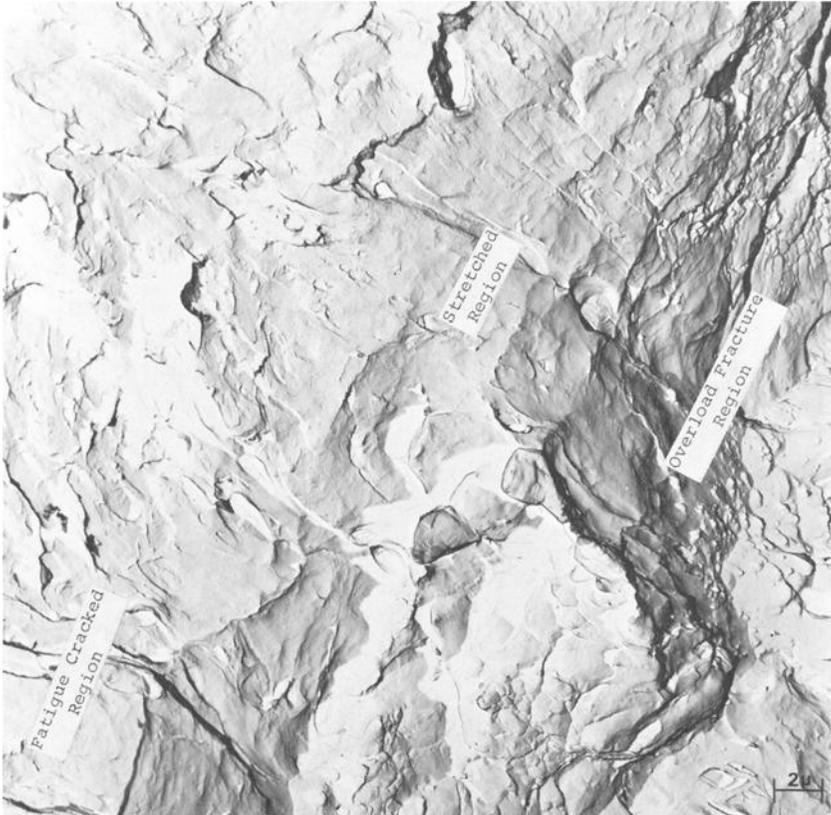
FIG. 8—Fracture surface of 250-grade maraging steel showing area between fatigue crack and overload fracture regions.

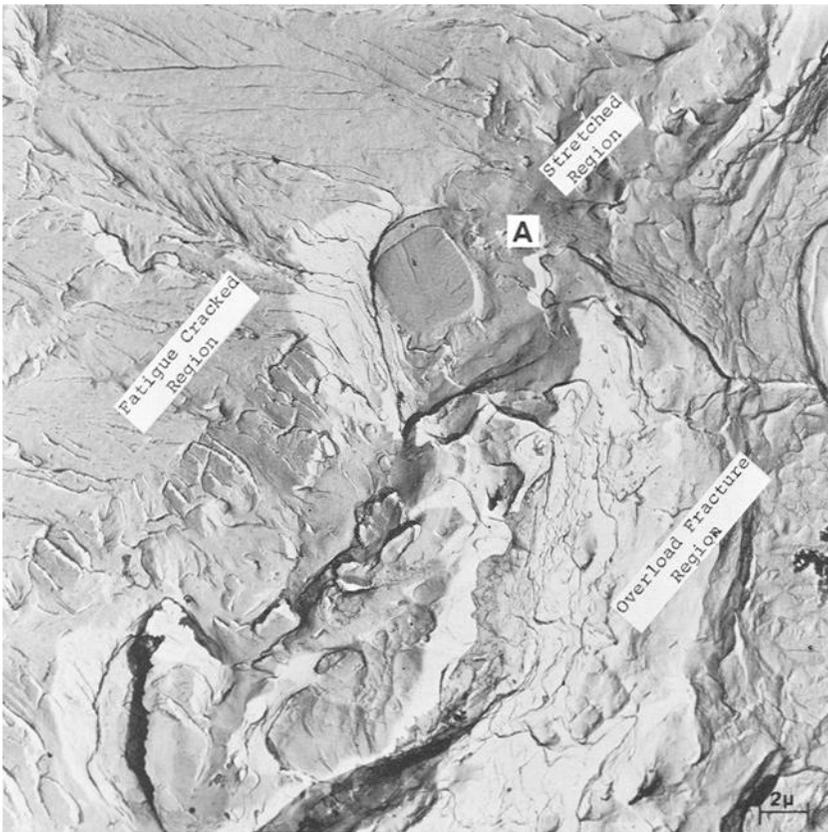
FIG. 9—Fracture surface of 300-grade maraging steel showing area between fatigue crack and overload fracture regions.

faces (for example, A in Fig. 9), there was no obvious correlation between the inclusion frequency or spacing, dimple size, and the measured values of plane-strain fracture toughness ( $K_{Ic}$ ). Stretched zones between fatigue cracked and overload fracture regions were observed in both steels, as shown in Figs. 8 and 9, and the width of the stretched zone was greater in the 250-grade steel having the greater plane-strain fracture toughness. However, for these steels, the measured widths of the stretched zones were more than an order of magnitude smaller than the process zone sizes calculated from mechanical property data for similar steels [3], on the basis of the present Krafft model [7]. Thus, the most readily measured microscopic features of the fracture surfaces of these two maraging steels (dimple size, or inclusion spacing, and width of stretched zone) have not provided a very satisfactory explanation for the measured differences in their plane-strain fracture

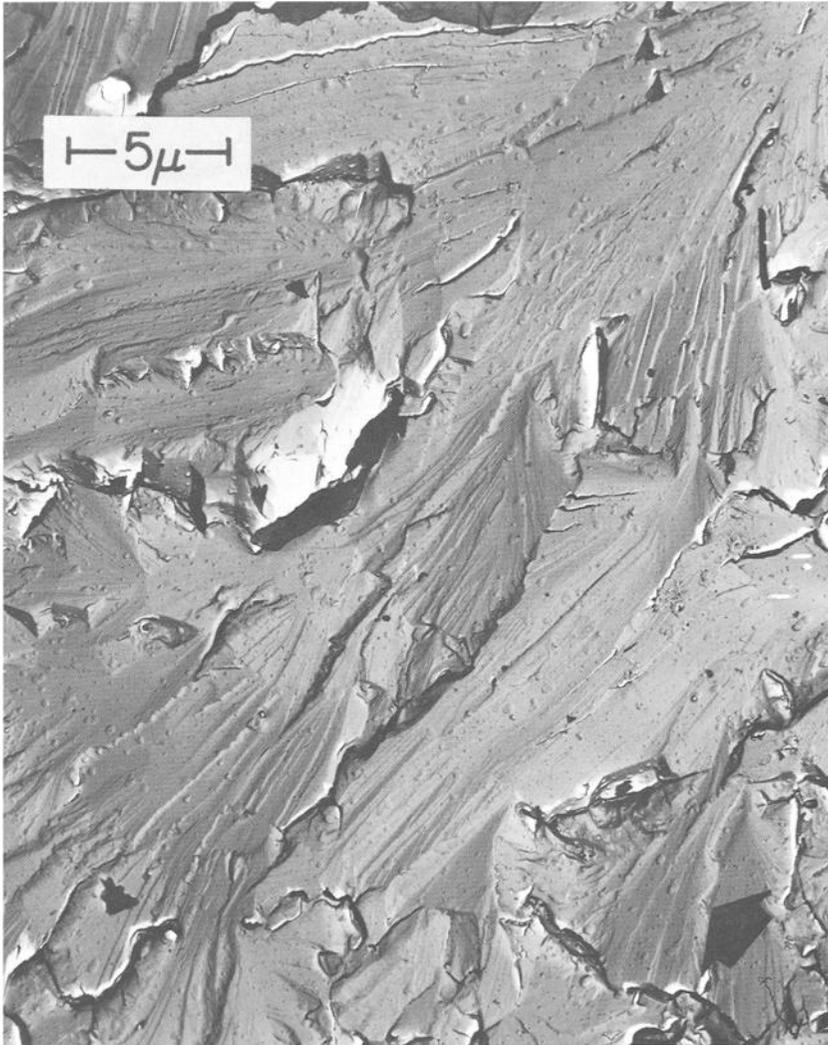
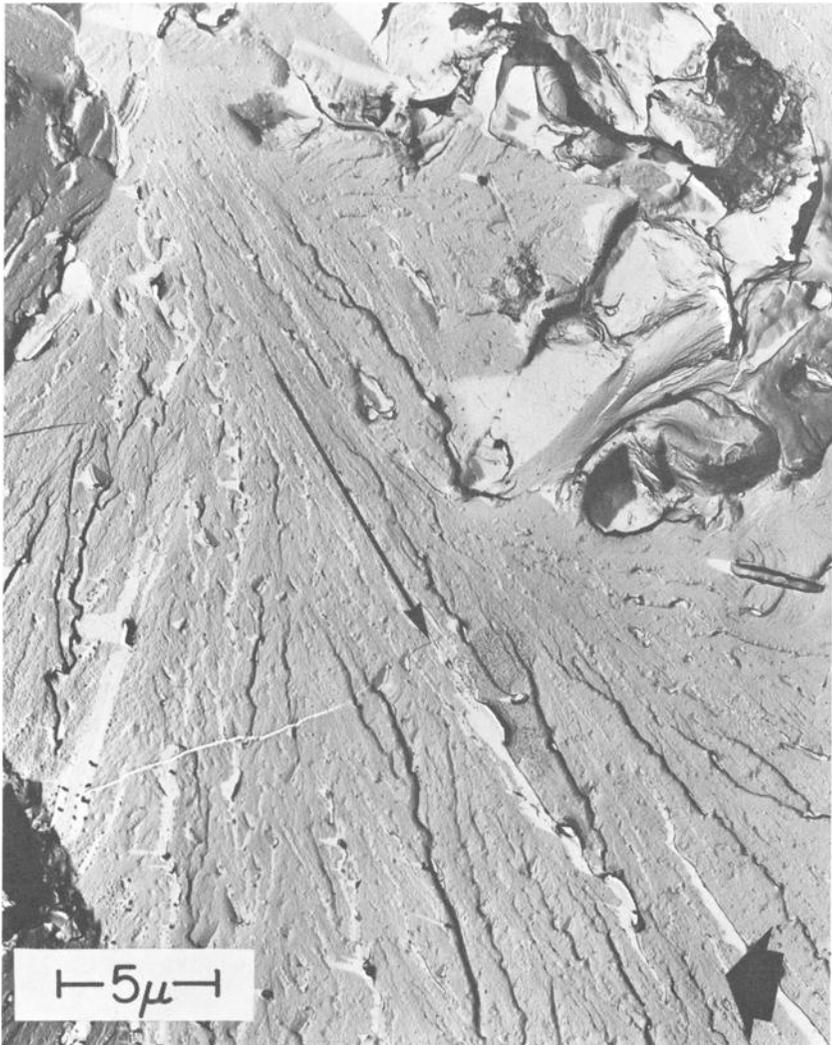
(a) Molybdenum:  $-320$  F. Two-stage plastic-carbon replica ( $\times 5000$ ).

FIG. 7—*Cleavage facets observed in low-temperature impact fractures of molybdenum and steel.*

(b) A 302B Steel:  $-98$  F. Long arrow indicates local direction of crack propagation. After Burghard and Davidson [4]. Two-stage plastic-carbon replica ( $\times 5000$ ).

<sup>4</sup> In Figs. 7, 9, 10, and 12, the block arrow in one corner indicates the macroscopic crack propagation direction.

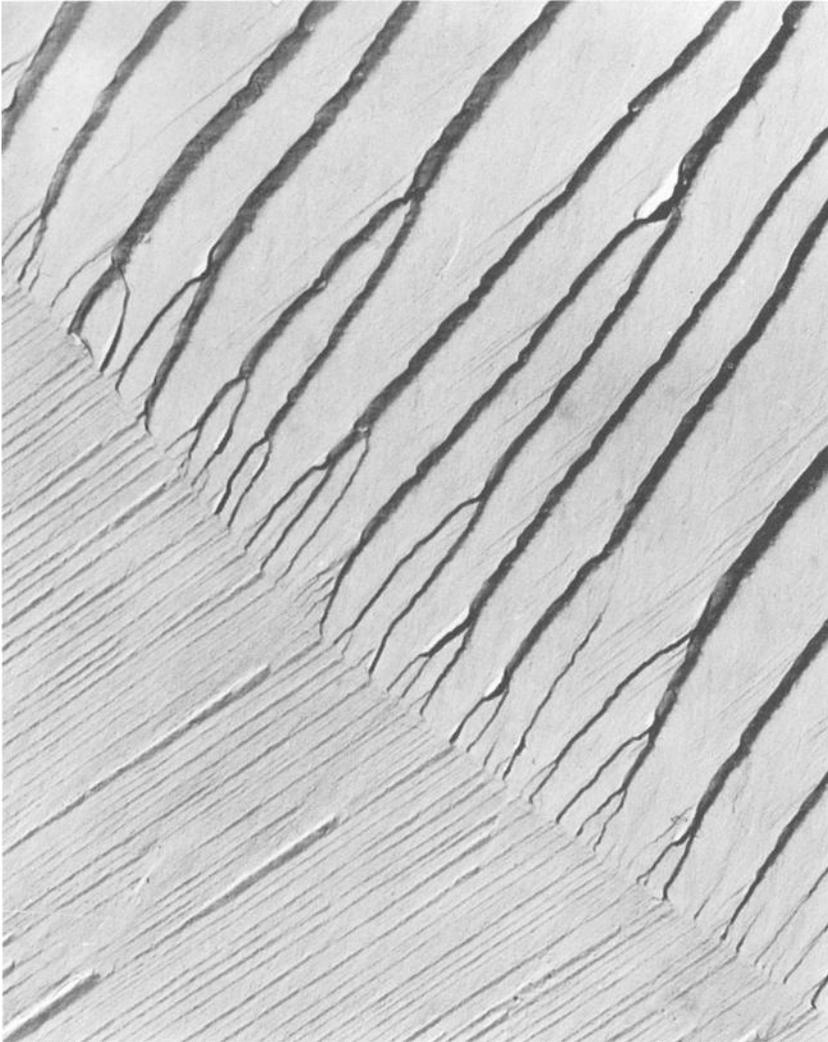
FIG. 8—River patterns on cleavage surface of ordered Fe-49Co-2V. After Johnston *et al* [14]. ( $\times 30,000$ ).

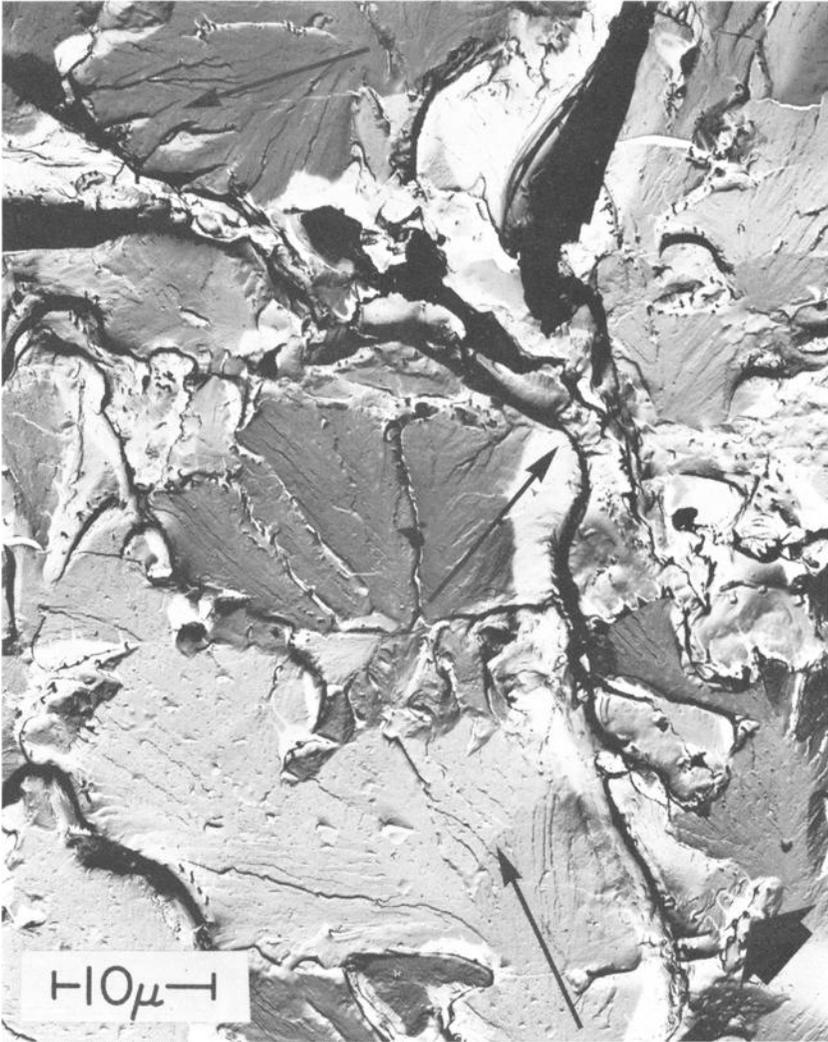
FIG. 9—Fracture surface topography of A 302B steel impact specimens broken at  $-98^{\circ}\text{F}$ . Arrows indicate local direction of crack propagation in individual facets. After Burghard and Davidson [4]. Two-stage plastic-carbon replica ( $\times 2500$ ).

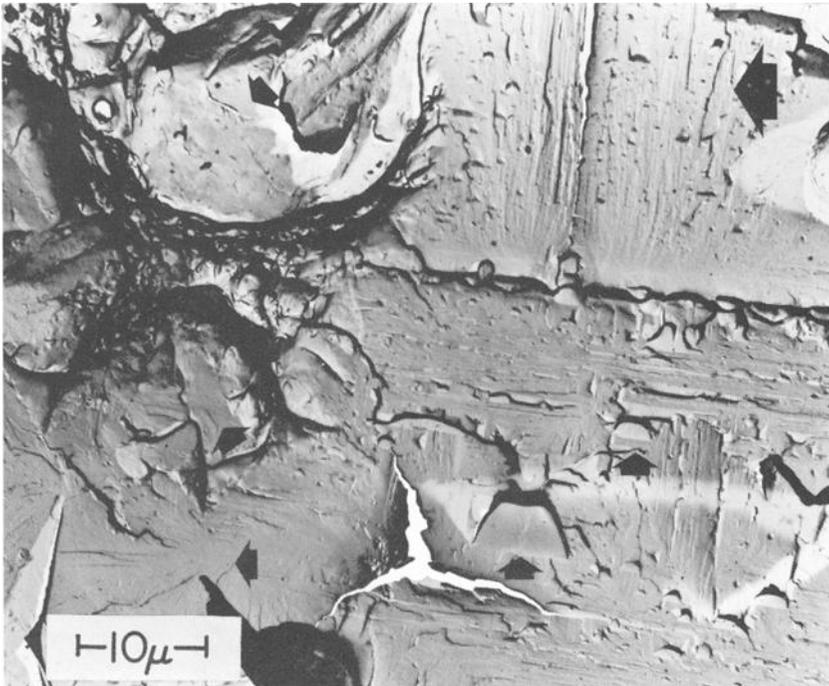
(a) Test temperature 72 F. Note patch of dimples (oblique arrows), facet with river pattern (horizontal arrows) and cleavage tongues (vertical arrows). Two-stage plastic-carbon replica ( $\times 2500$ ).

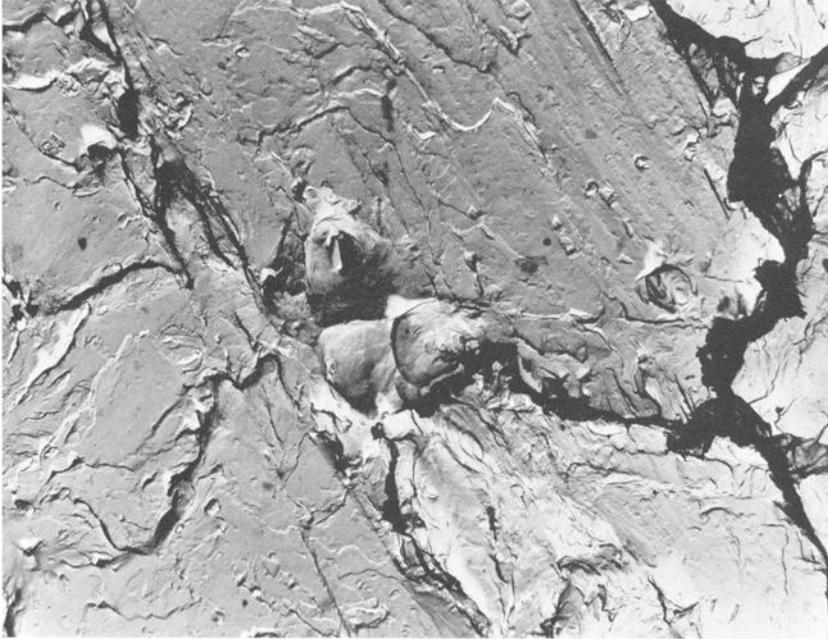
FIG. 13—Fracture surface topography of Type 304 smooth-bar tension specimen exposed 24 h and pulled to fracture in 10,000 psi hydrogen. After Vennett and Ansell [41]. Two-stage plastic-carbon replica ( $\times 5300$ ).

This particular type of fracture surface topography has been observed most frequently in cases involving environmentally induced (or enhanced) fracture. Vennett and Ansell [41] have cited examples in tensile fractures of Type 304 stainless steel tested in high-pressure hydrogen, Fig. 13. Similar features have also been observed in stress-corrosion failure of titanium alloys tested in aqueous environments [42]. In the latter case, X-ray diffraction measurements established that the facets were oriented at a small angle (varying from 8 to 20

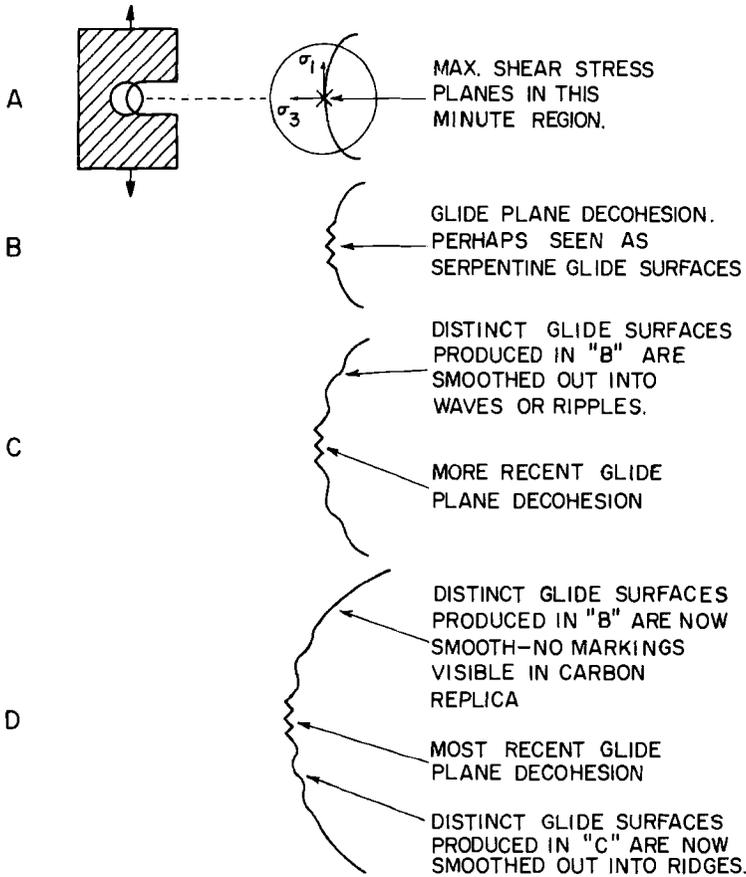
FIG. 4—The production of smooth surfaces by plastic flow. Surfaces definitely produced by glide plane decohesion are smoothed by severe plastic deformation—stretching—until no markings are visible on ordinary replicas. Elongation is vertical, and increases from top to bottom. Crack propagation direction is from right to left.

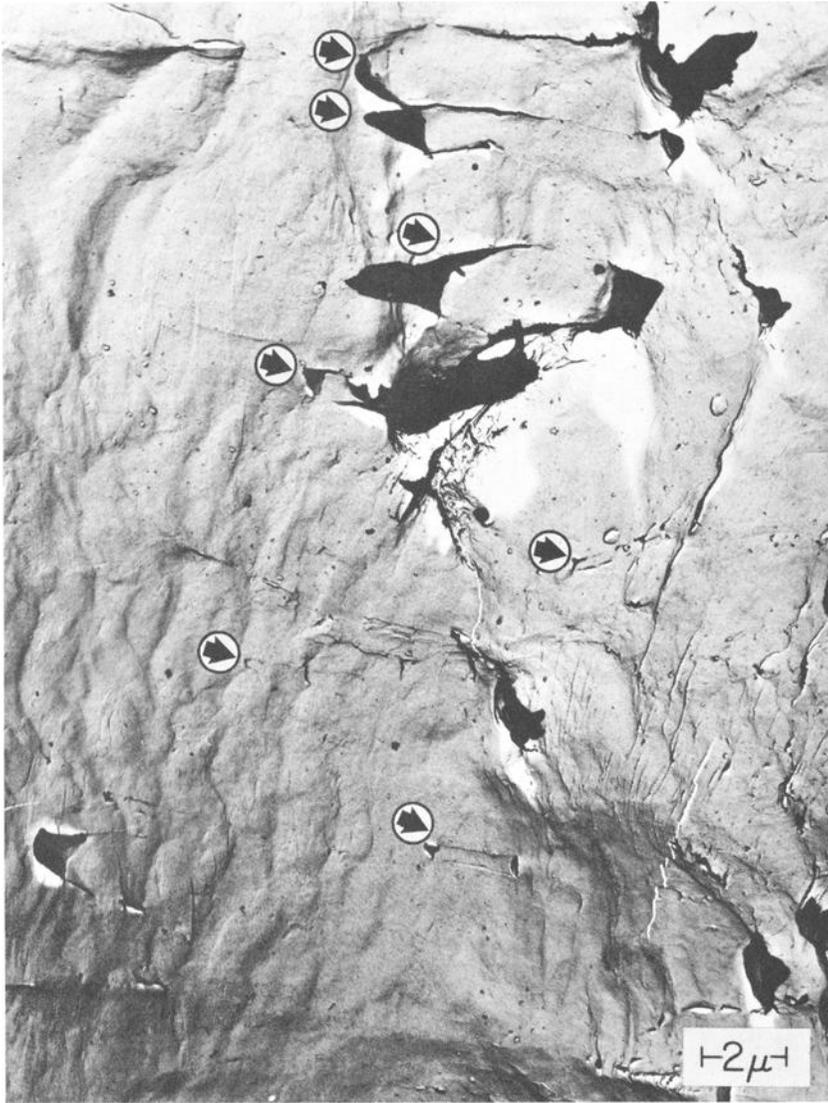
FIG. 6—Stretching at the root of a notch in a 99.999 per cent pure copper wire specimen. Stretching occurred in directions of the arrows after the palladium was deposited, and before the carbon was deposited. Dark areas are palladium, light areas are newly stretched. Direct-carbon replica ( $\times 6000$ ).

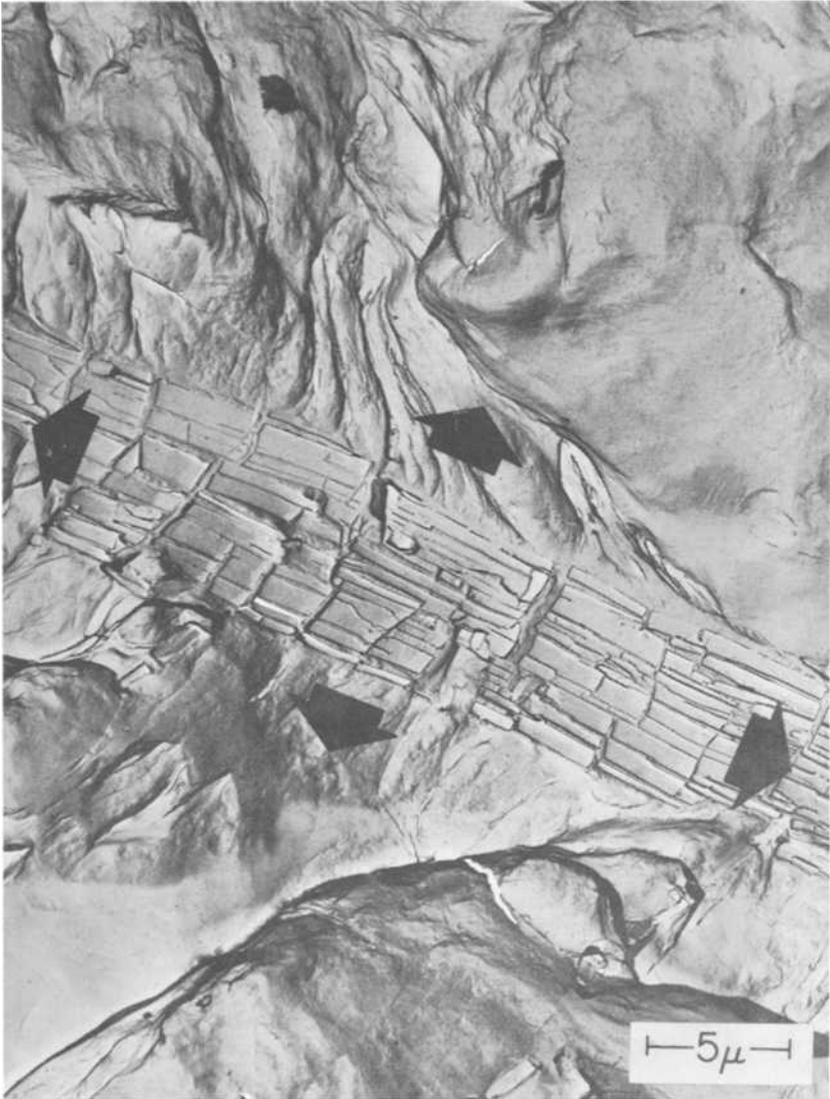
FIG. 8—Stretching in as-cast Ti-2Al-2Zr-2V-1Mo. The flat constituent particles have been expanded in two directions (arrows) on a relatively flat area as a result of stretching of the underlying metal. Surrounding metal is much more severely stretched. Two-stage carbon replica ( $\times 6000$ ).

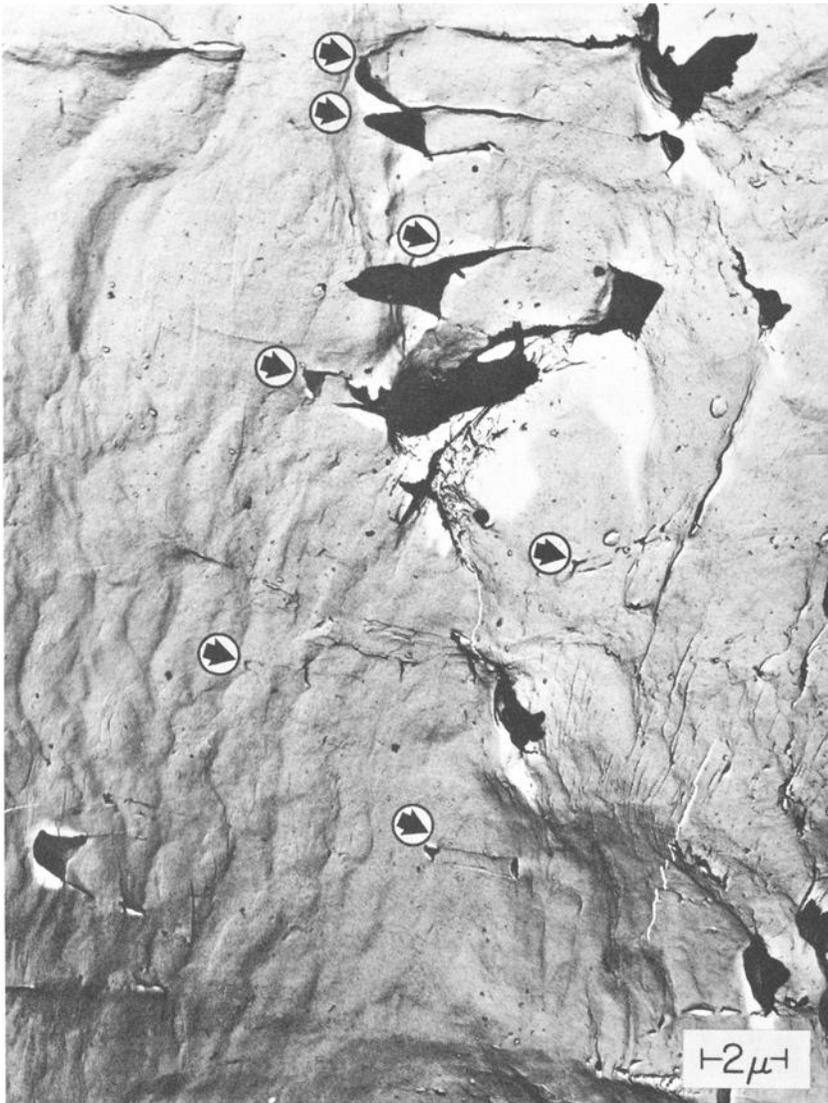
FIG. 10—Ripples (lower left quarter of fractograph), stretching, and oval tear dimples (arrows) in Armco iron. Two-stage palladium-shadowed carbon replica ( $\times 9000$ ).

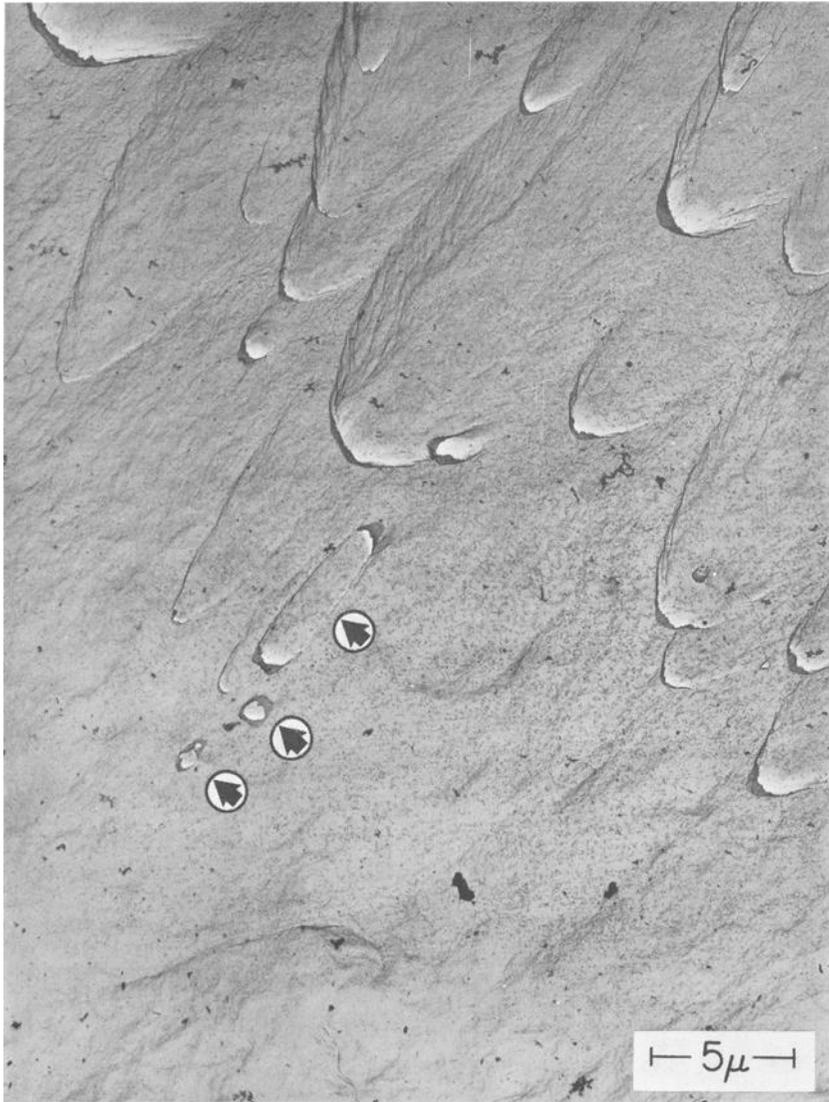
FIG. 11—Stretched regions, shear dimples, and oval tear dimples (arrows) in AISI 304 stainless steel. Palladium-shadowed direct-carbon replica ( $\times 6000$ ).

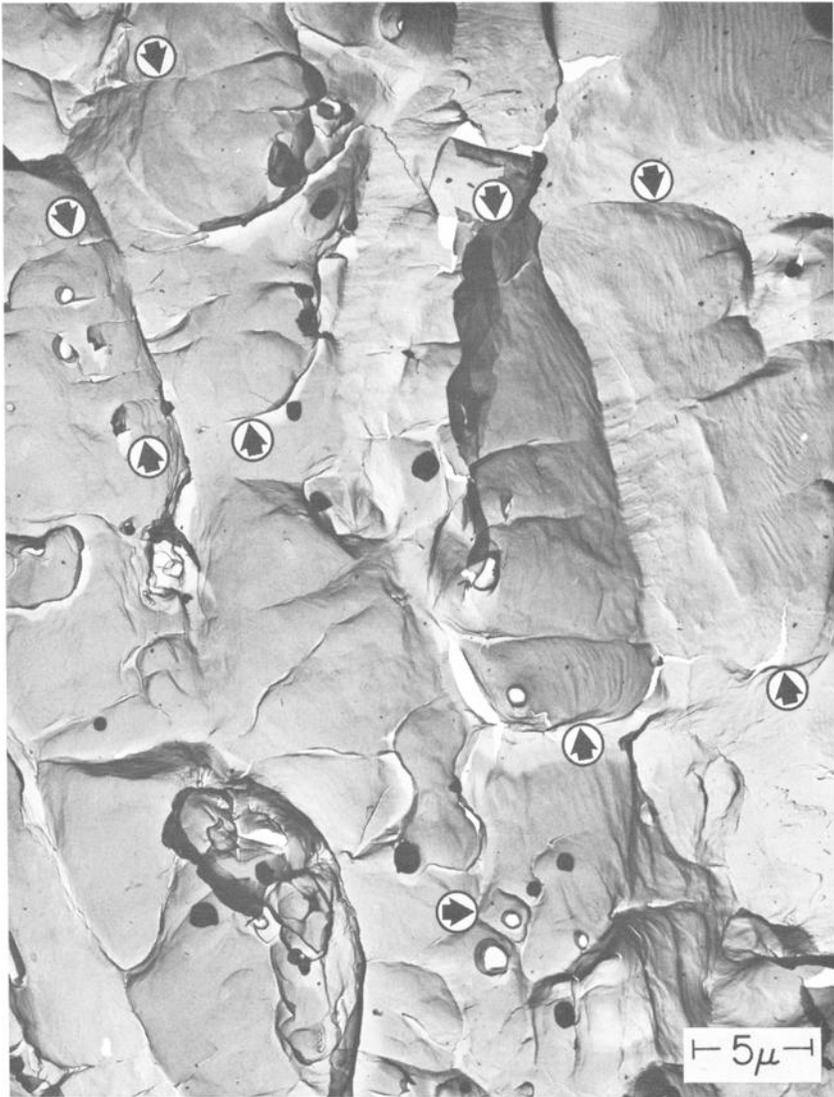
FIG. 12—Examples of serpentine glide in dimples in tough pitch copper. Specimen alligatored due to residual stresses from rolling. An equiaxed dimple is shown by the horizontal arrow. Tear dimples are shown between slanted arrows. Palladium-shadowed direct-carbon replica ( $\times 5000$ ).

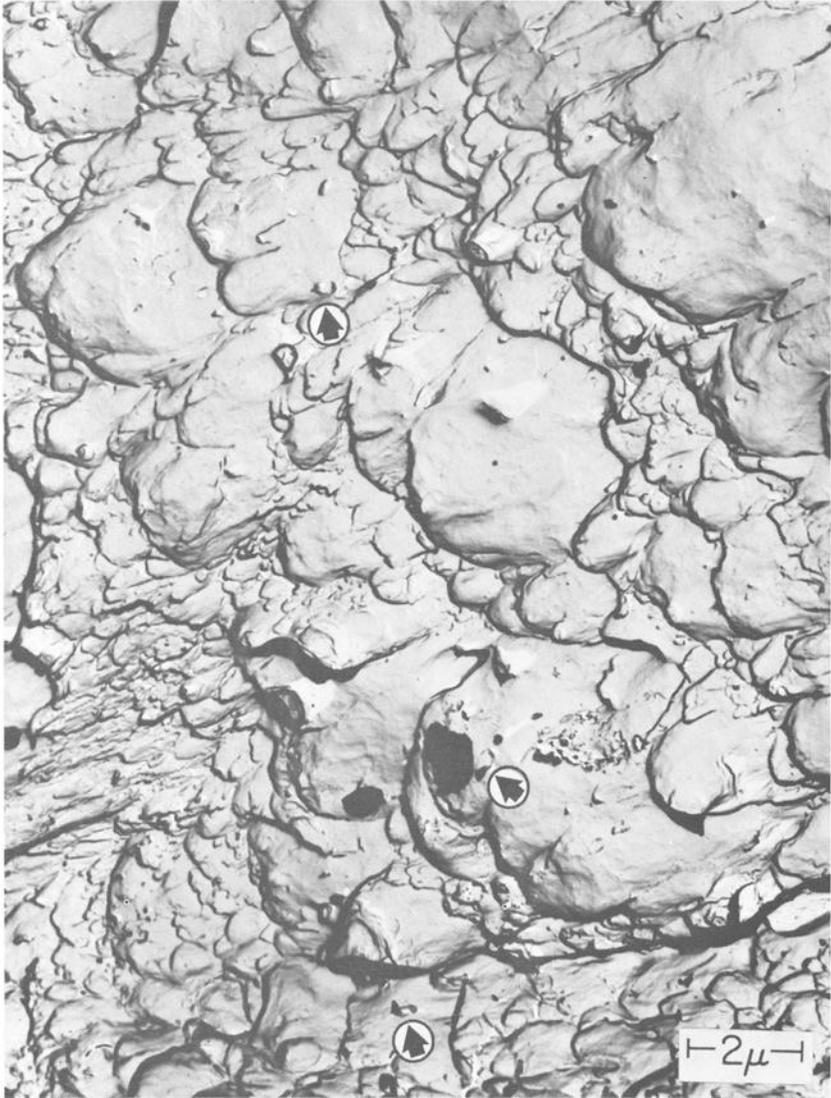
FIG. 13—Tear dimples formed during the early stages of internal fracture of a hardened and tempered AISI 4340 smooth tension test specimen broken in tension. Oval tear dimples are shown by arrows. Palladium-shadowed two-stage carbon replica ( $\times 12,000$ ).

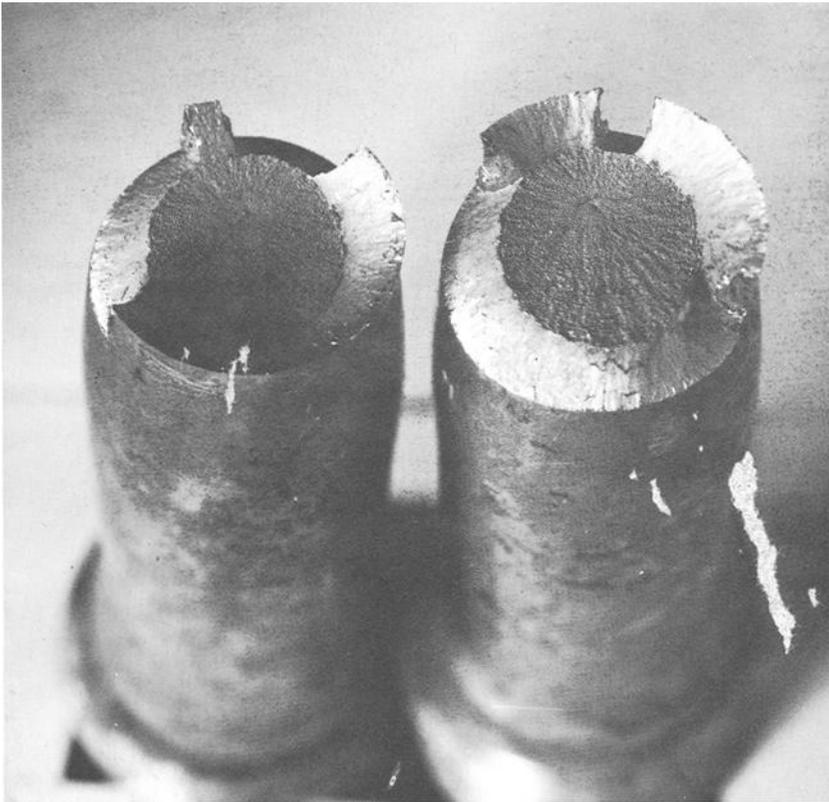
FIG. 14—Macroscopic view of AISI 4340 cup-and-cone fracture surface from which the fractograph in Fig. 13 was made. Fracture initiation region may be seen just above the center of the fracture surface ( $\times 4$ ).

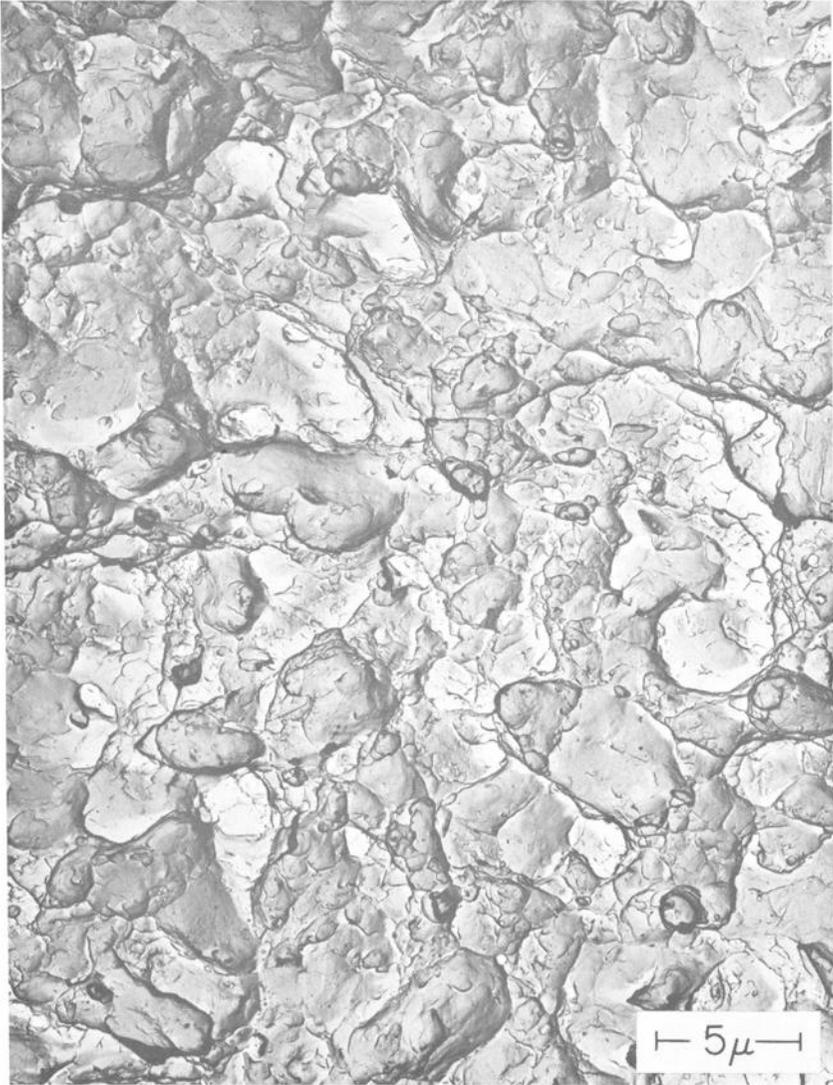
FIG. 16—Equiaxed dimples in the AMS 6434. Two-stage palladium-shadowed carbon replica ( $\times 6000$ ).

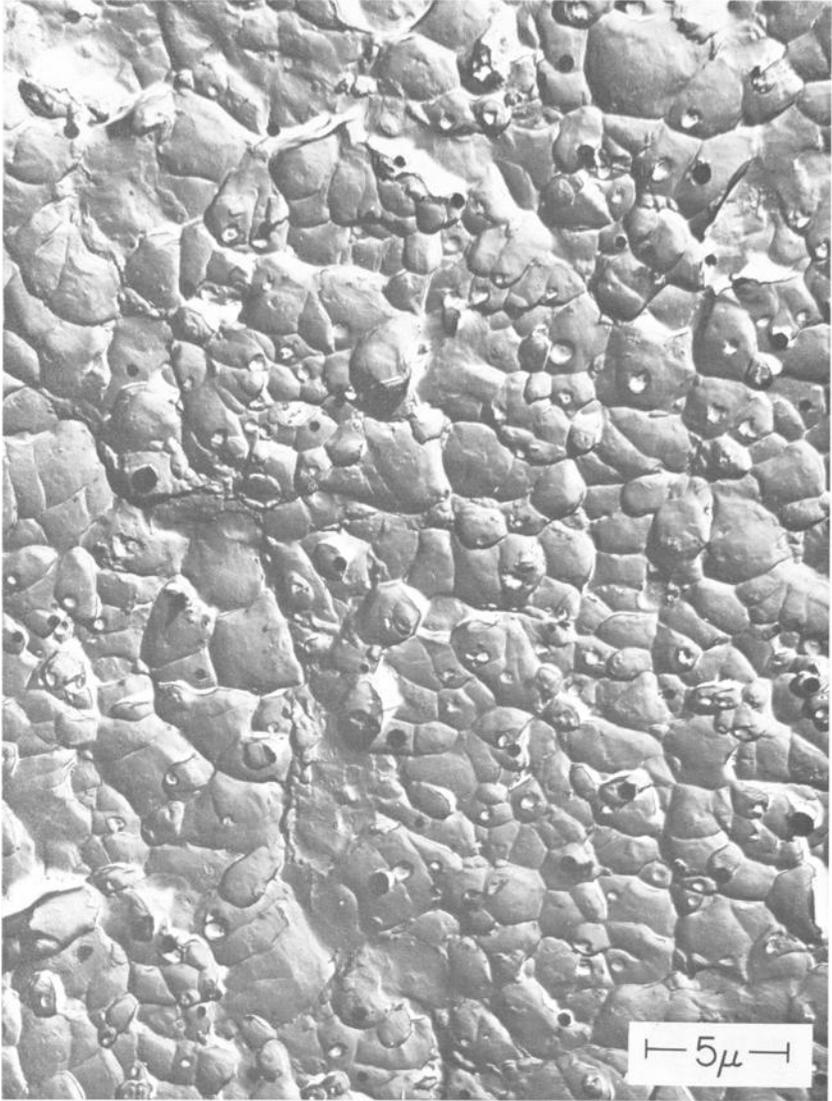
FIG. 17—Equiaxed dimples in a hardened-and-tempered low-alloy steel specimen. Palladium-shadowed two-stage carbon replica ( $\times 6000$ ).

Examples of surfaces formed by normal dimpled rupture are seen in Figs. 16 and 17. Normal dimpled rupture is a mode often operative in running "brittle fractures" of high-strength steels and aluminum alloys. This fracture mode is almost always accompanied by shearing or tearing in neighboring microscopic regions.
