# ELECTRON FRACTOGRAPHY

A symposium  
presented at the  
Seventieth Annual Meeting  
AMERICAN SOCIETY FOR  
TESTING AND MATERIALS  
Boston, Mass., 25-30 June, 1967

ASTM SPECIAL TECHNICAL PUBLICATION NO. 436

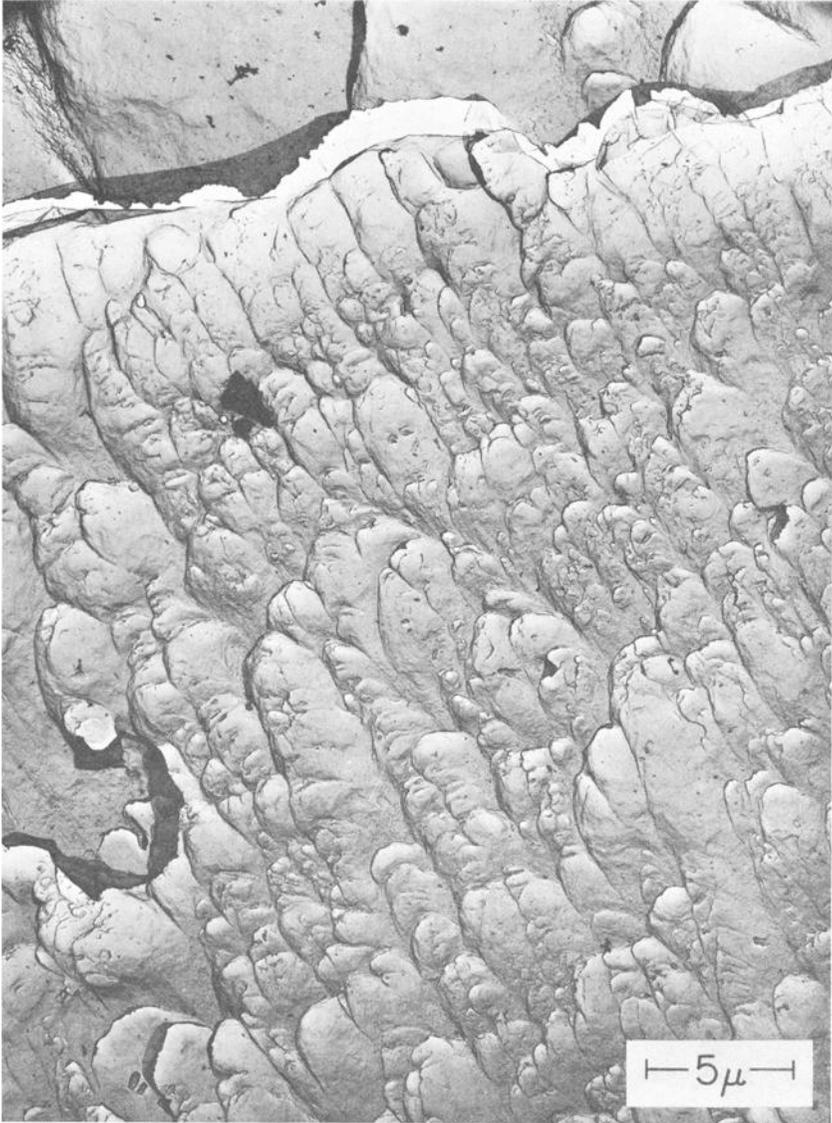
FIG. 18—*Shear rupture dimples in AISI 304 stainless steel "scab" formed by hypervelocity impact. Palladium-shadowed direct-carbon replica ( $\times 6000$ ).*

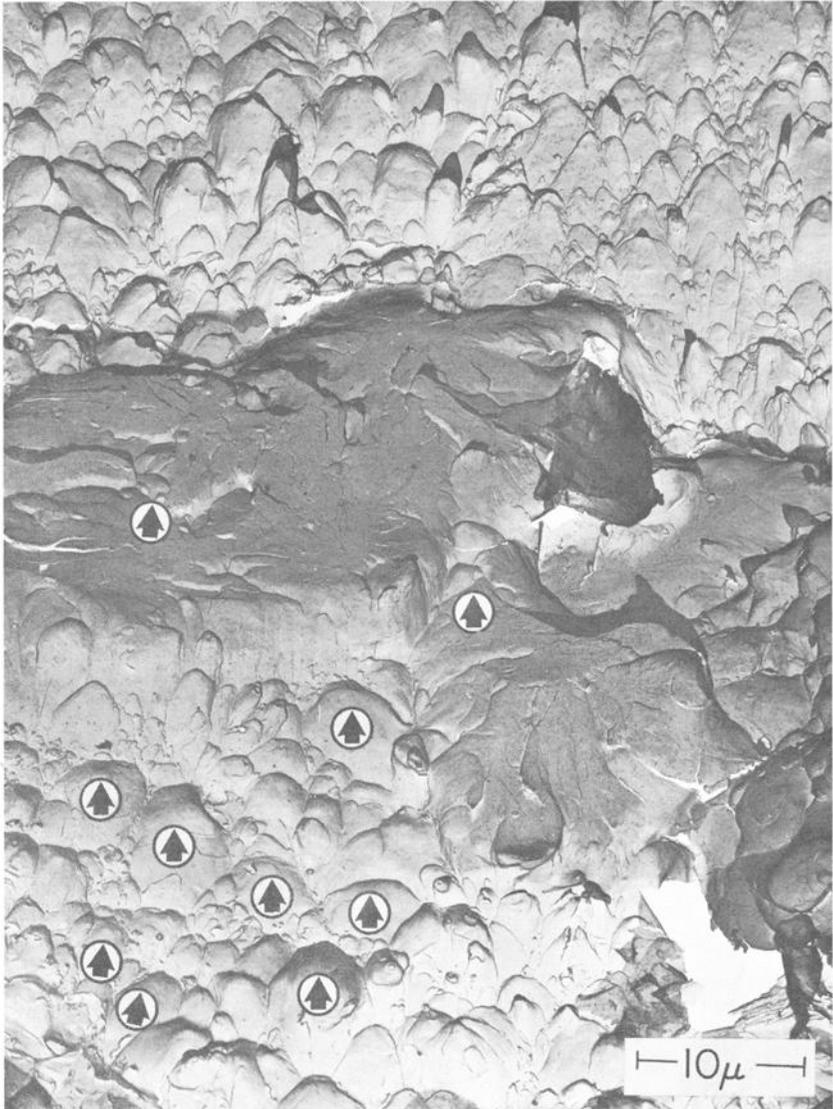
FIG. 19—Shear rupture dimples on two sides of a quasi-cleavage facet. The arrows indicate shear dimples that have mates in Fig. 20. Material is hardened-and-tempered 410 stainless steel. Palladium-shadowed two-stage carbon replica ( $\times 3500$ ).

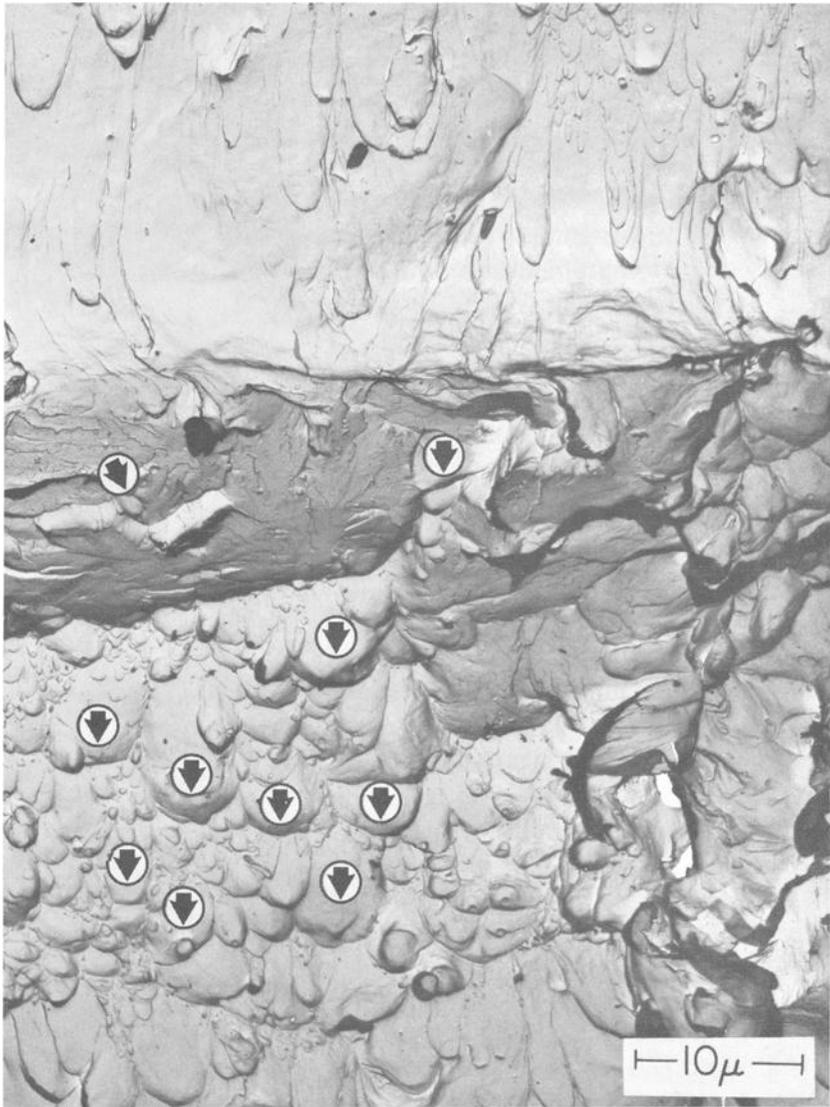
FIG. 20—Fracture surface which matches that shown in Fig. 19. Same replicating conditions ( $\times 3500$ ).

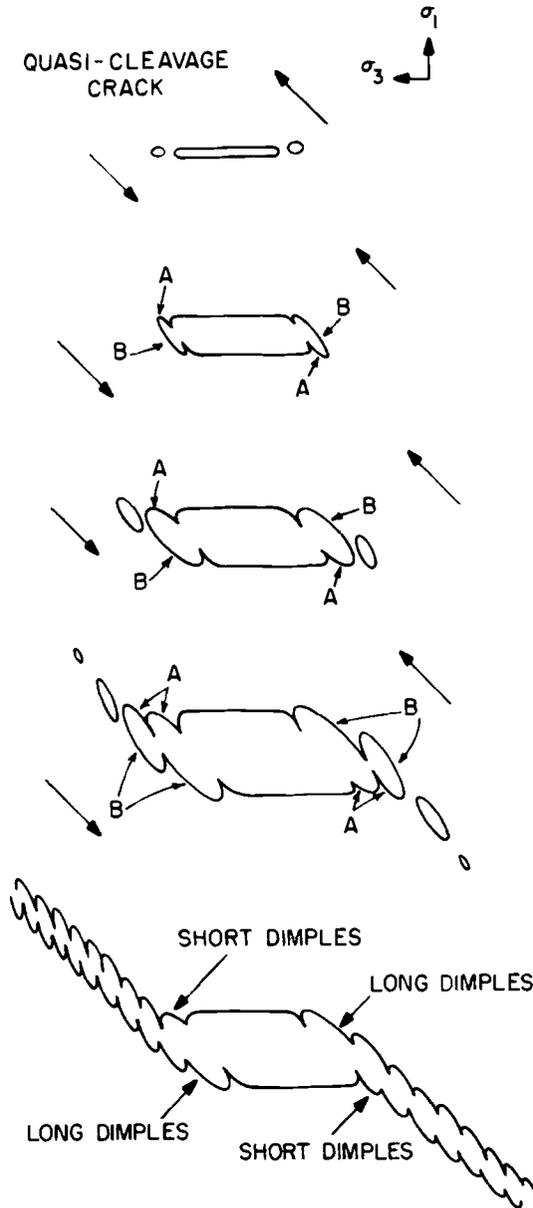
FIG. 21—A simplified model of the formation of the shear rupture dimples shown in Figs. 19 and 20. A slightly opened quasi-cleavage crack is shown at top, and successive stages of shear rupture are illustrated in the lower sketches. The macroscopic principal stresses are shown at the top. Arrows on either side of the crack indicate shear directions. Dimples are stretched more at points B than at points A, particularly after the voids have started to coalesce with the advancing shear rupture crack.

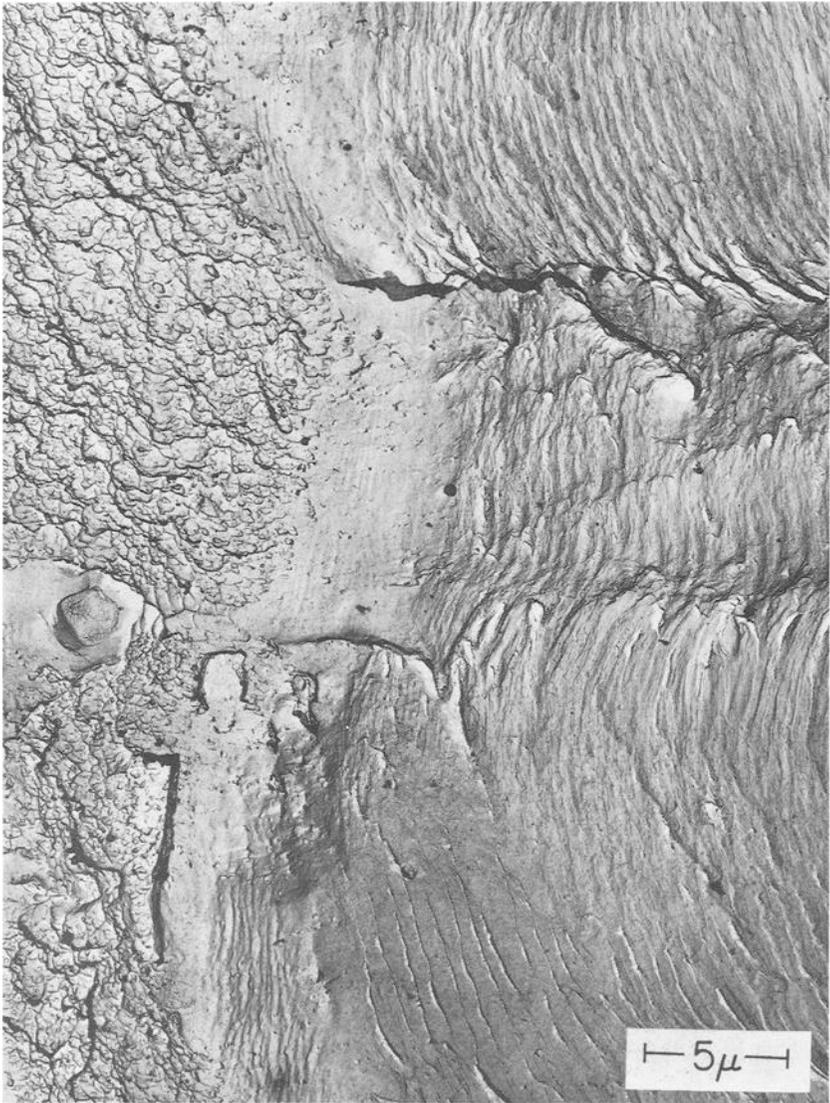
FIG. 24—Stretching, glide plane decohesion and tearing at the tip of a fatigue crack. The fatigue crack was introduced into this 7075-T6 aluminum alloy specimen as a stress raiser from the monotonic test which later produced the plastic rupture. Palladium-shadowed two-stage carbon replica ( $\times 6000$ ).

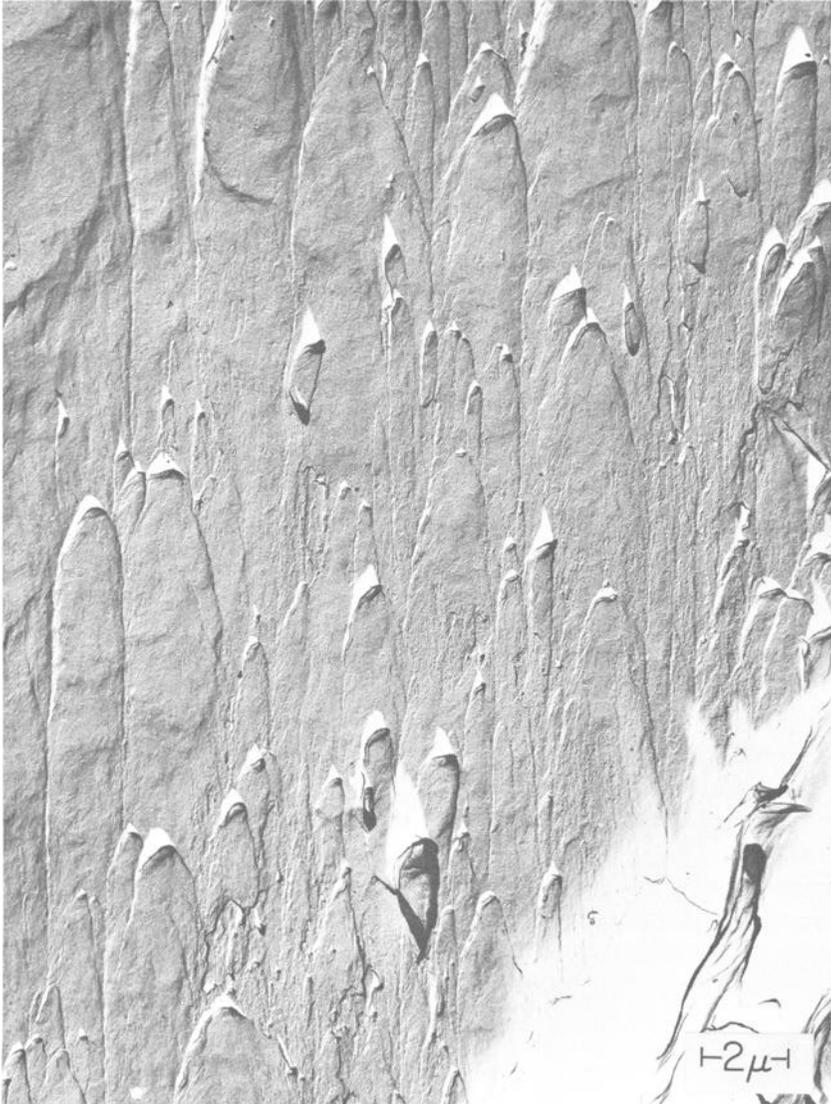
FIG. 25—Long shear rupture dimples in an OFHC copper torsion rupture surface. Two-stage palladium-shadowed carbon replica ( $\times 9000$ ).

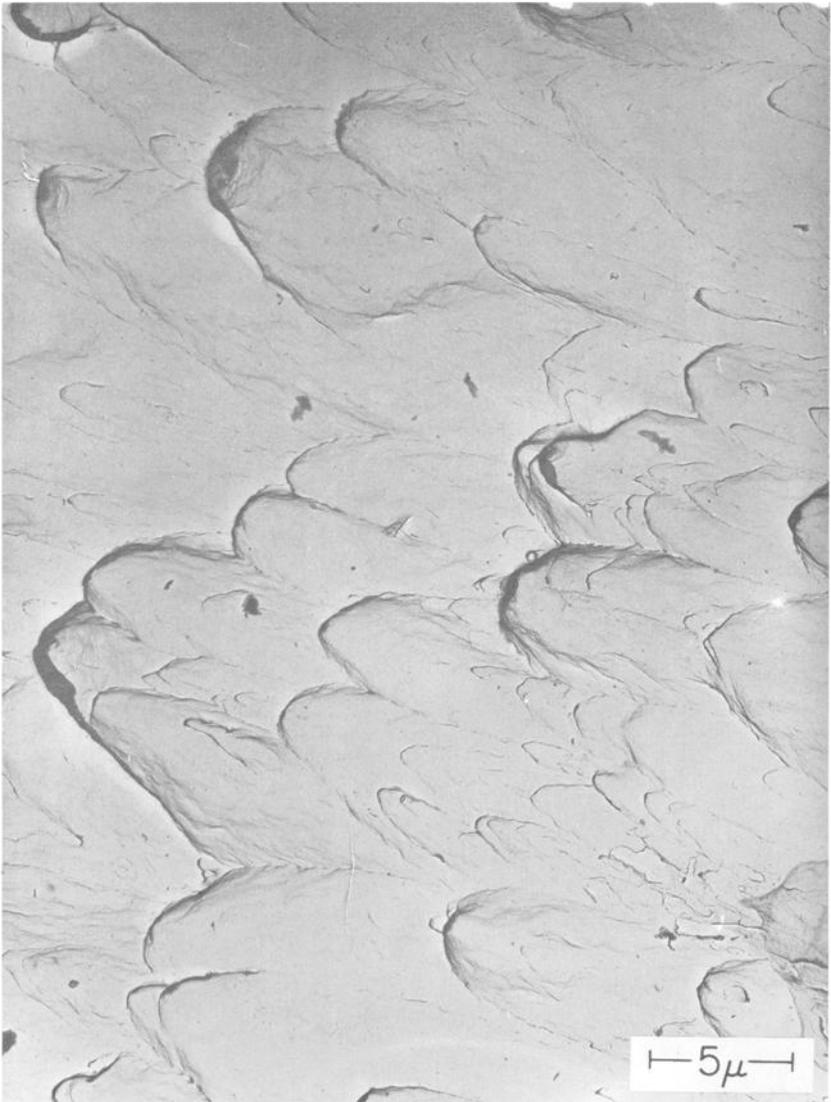
FIG. 26—Shear rupture dimples in 99.999 per cent copper. These dimples were formed by lightly rubbing two mechanically polished surfaces together, causing friction welding and subsequent rupture. Two-stage palladium-shadowed carbon replica ( $\times 6000$ ).

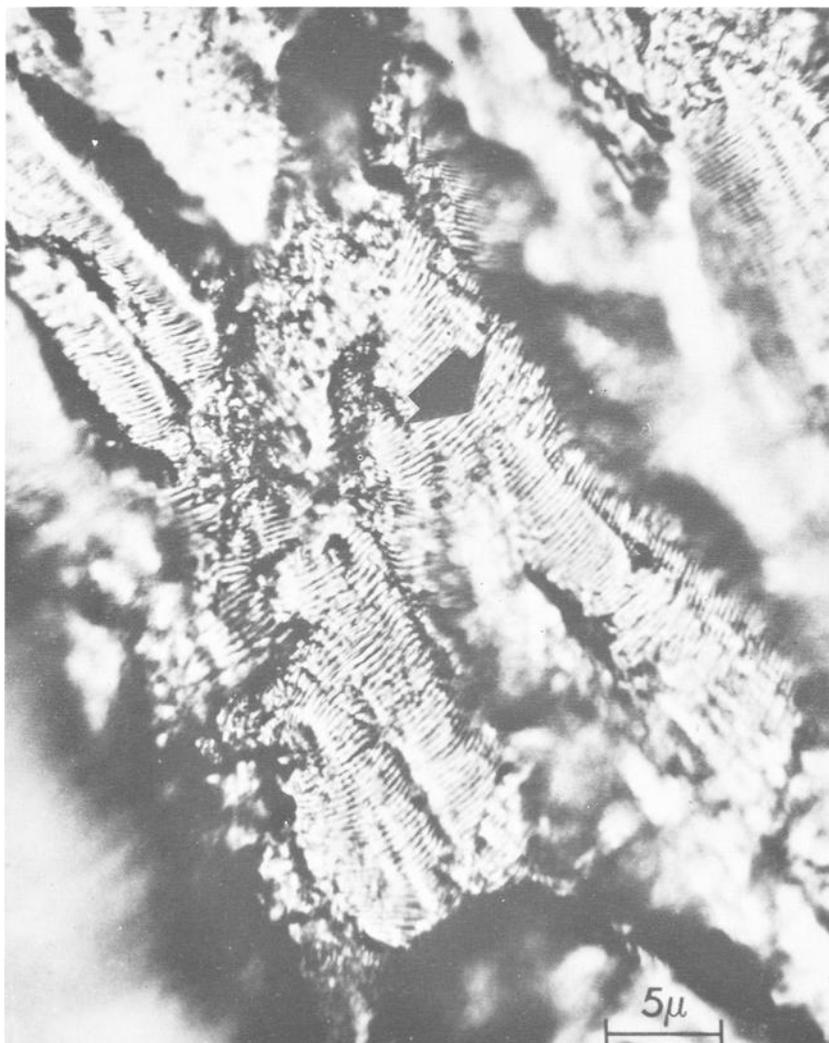
FIG. 1—*Optical fractograph of fatigue striations in an aluminum alloy.*

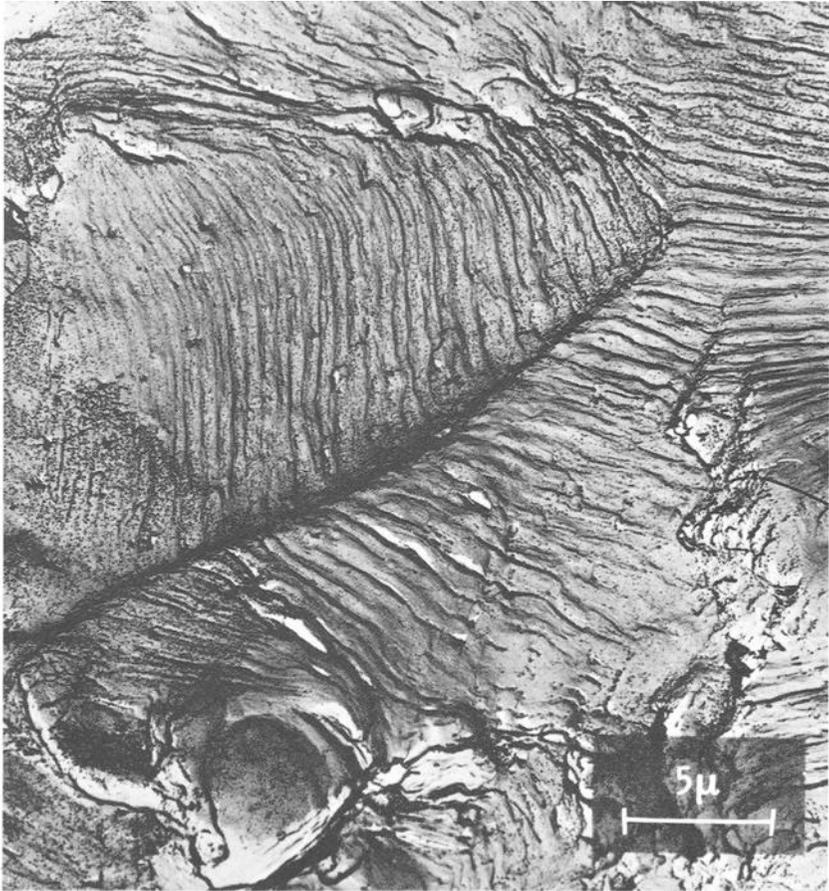
FIG. 2—Large angle between adjacent packets of fatigue striations in an aluminum alloy.

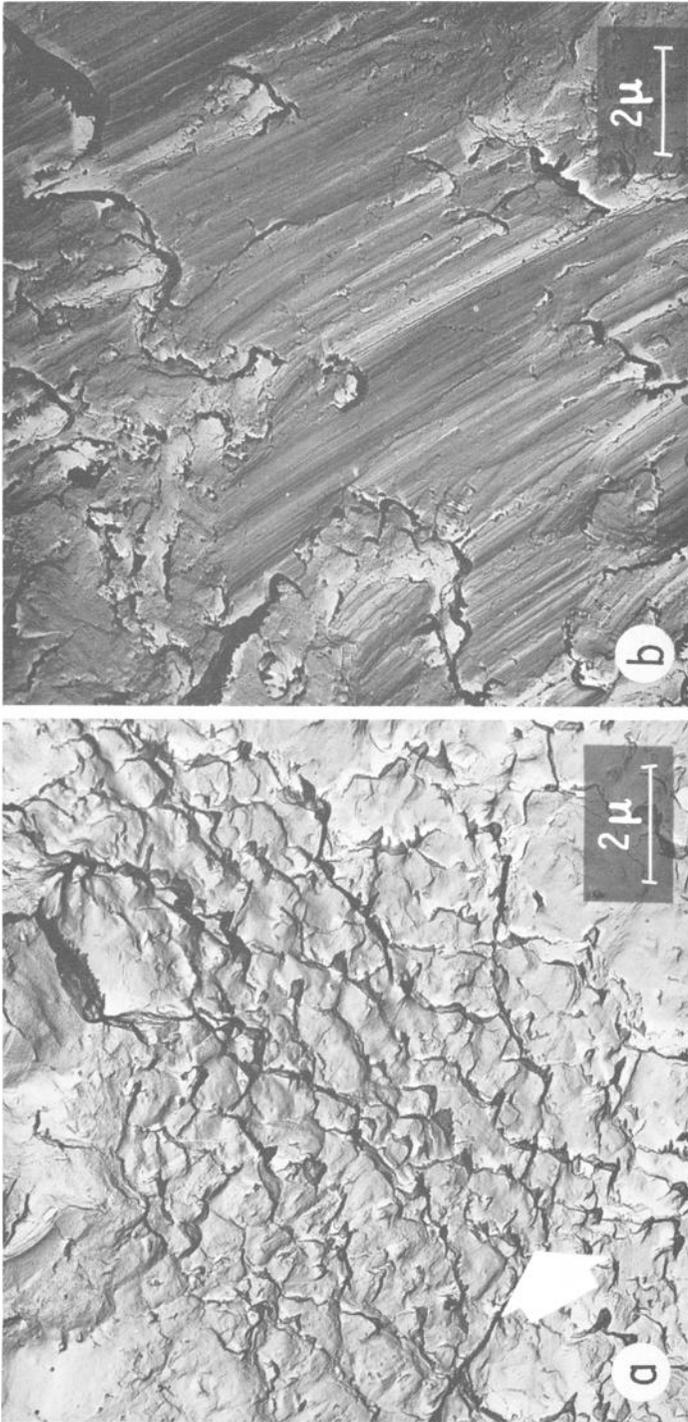
(a) Elongated dimple formation.  
(b) Rubbing marks.  
FIG. 3—Fractographs of plane stress fatigue fracture surface of 2024-T3 aluminum alloy.

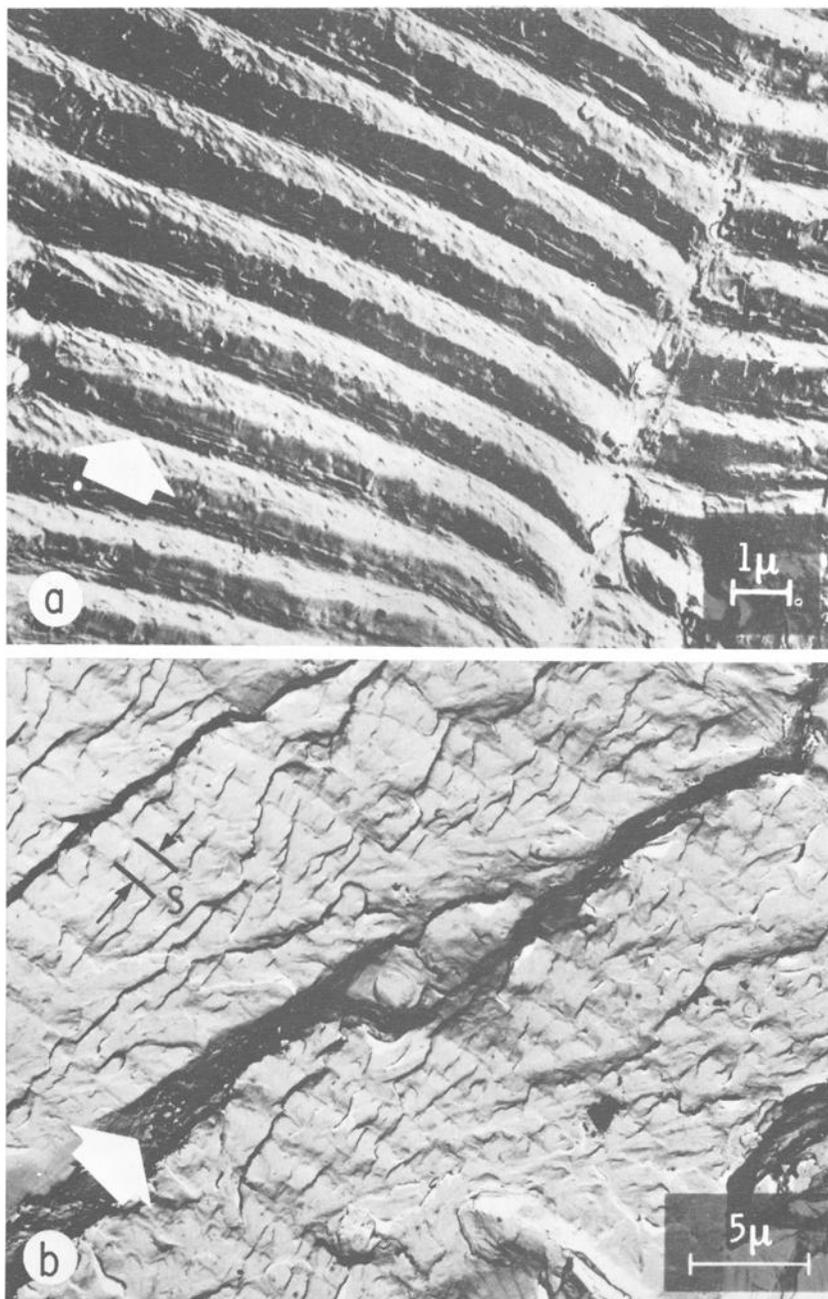
(a) Ductile fatigue striations.  
(b) Brittle fatigue striations.

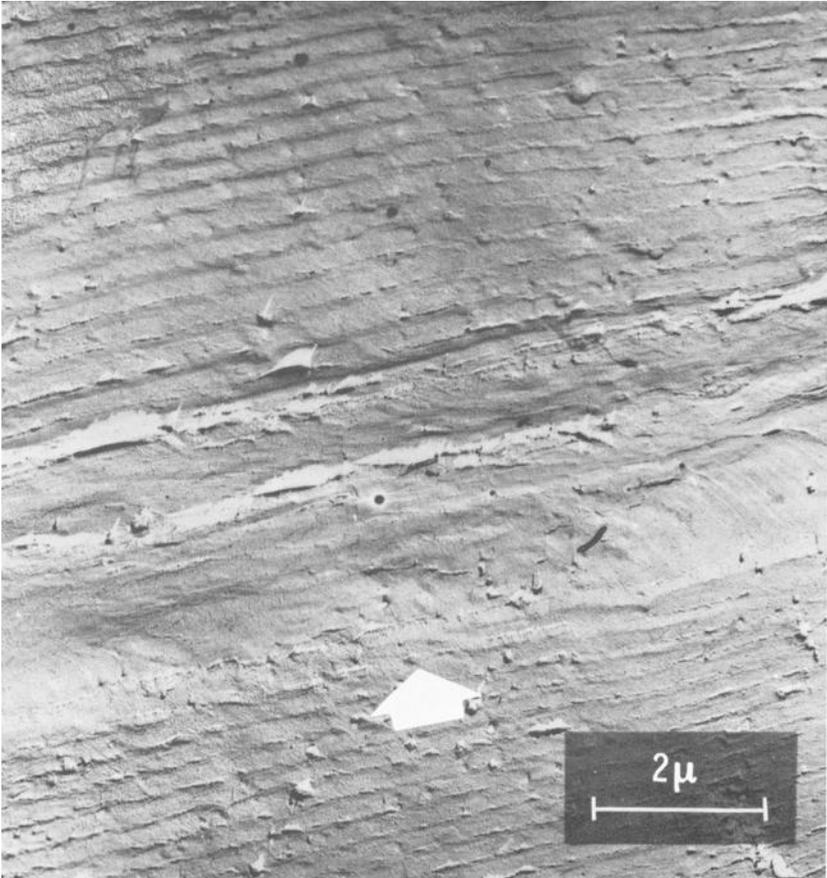
FIG. 5—Fractograph of 7075-T6 aluminum alloy revealing increased striation spacing after peak load cycles.

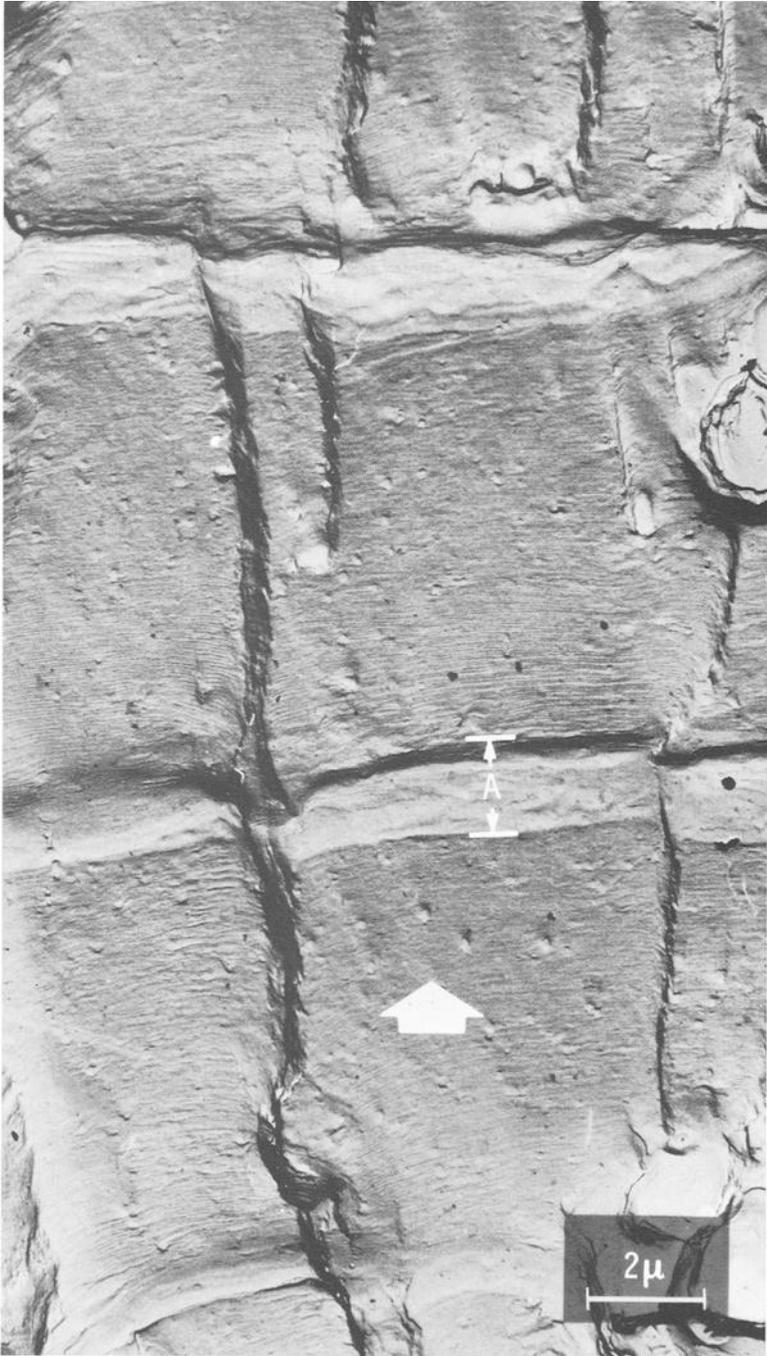
FIG. 8—Fracture topography resulting from application of program P 14.

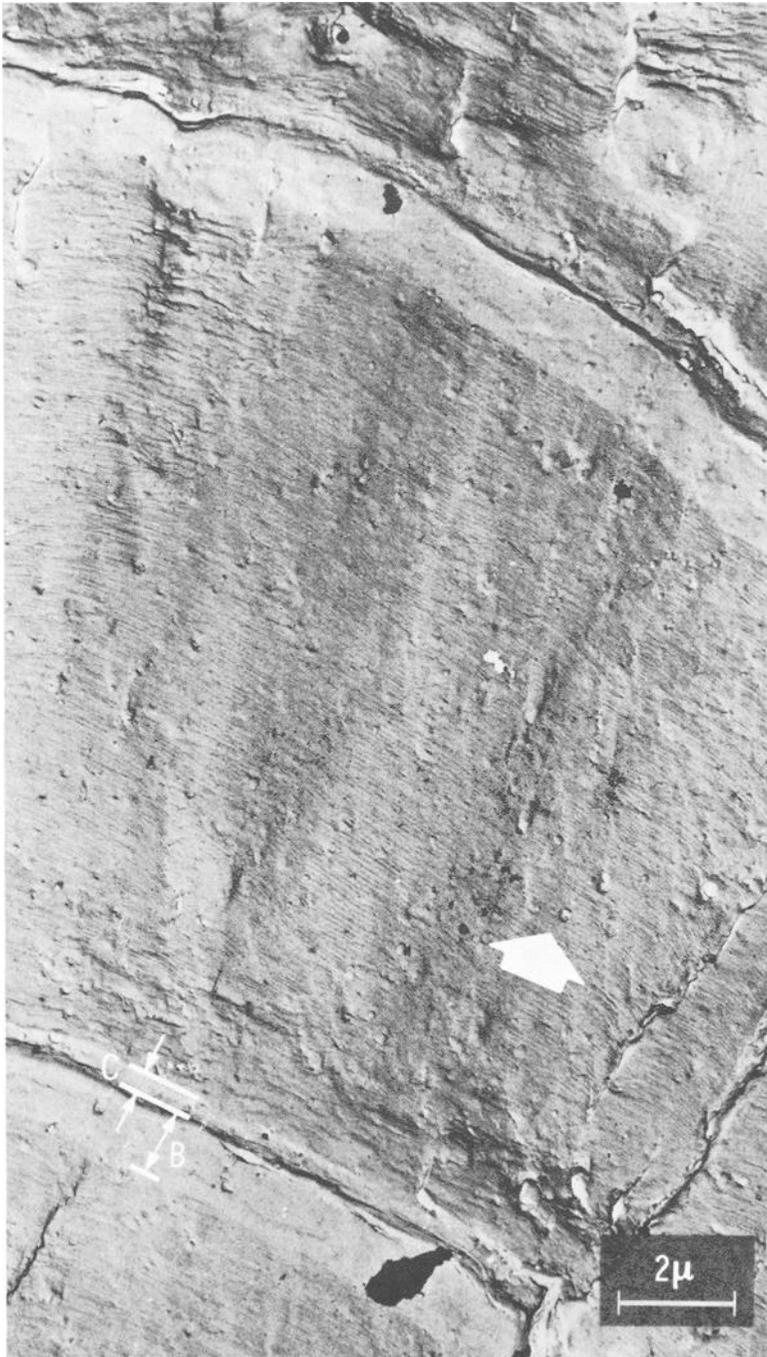
FIG. 9—Fracture topography resulting from application of program P 15.

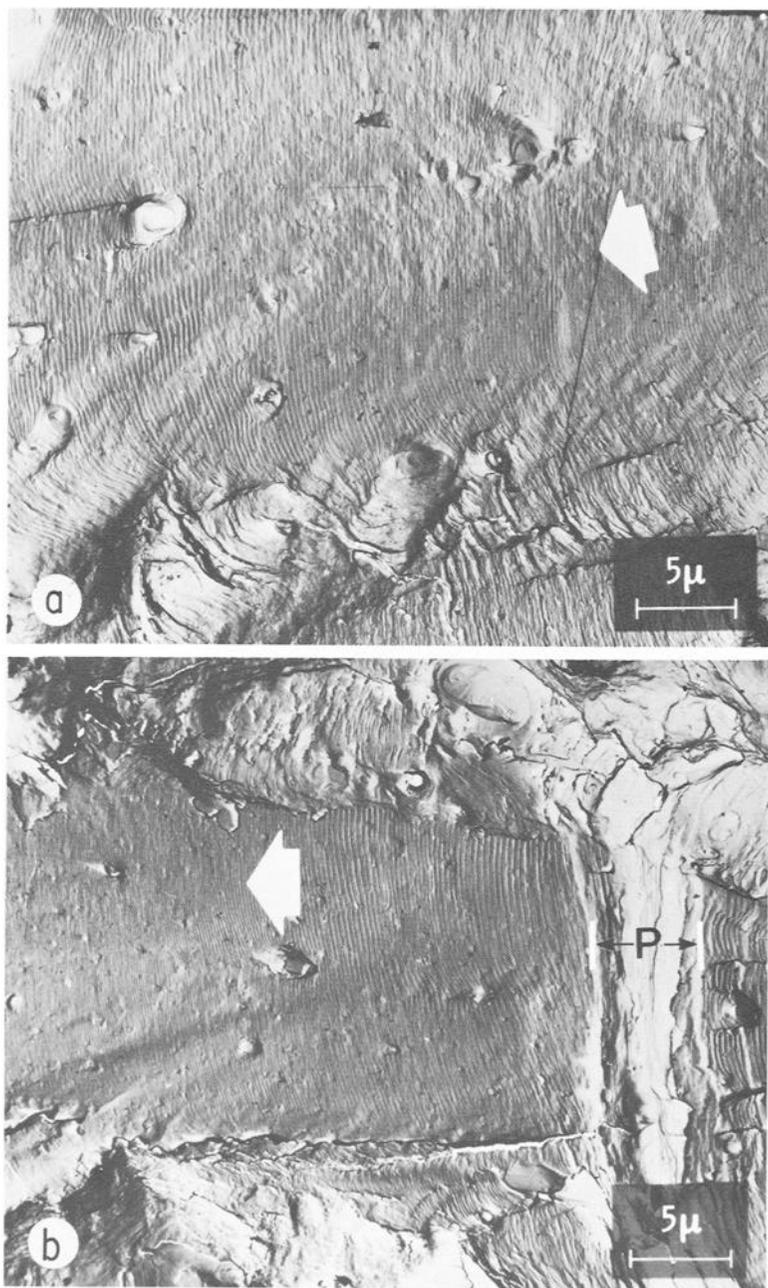
(a) Area 0.003 in. before application of peak load.  
 (b) Crack growth due to peak load application is designated  $P$ . Striation spacing is the same before and immediately after peak.

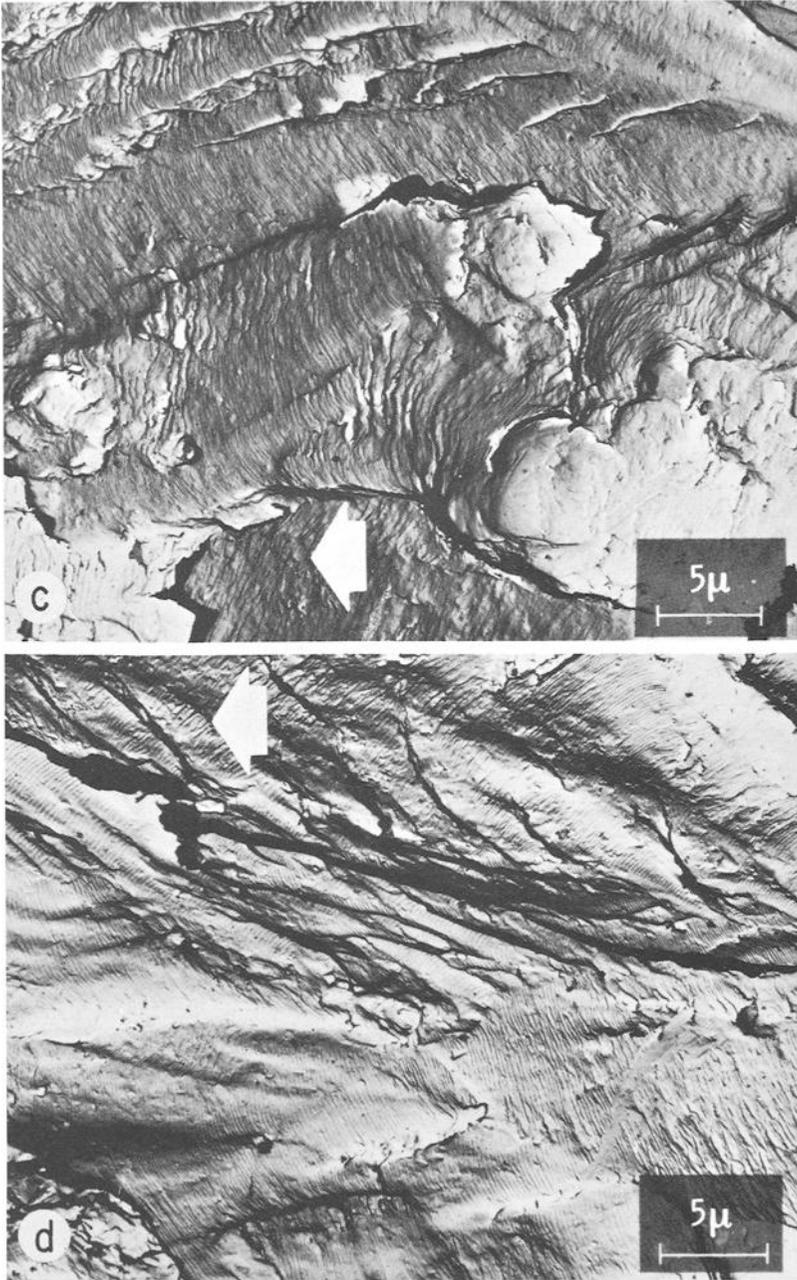
(c) Area 0.007 in. after peak.  
(d) Area 0.034 in. after peak.

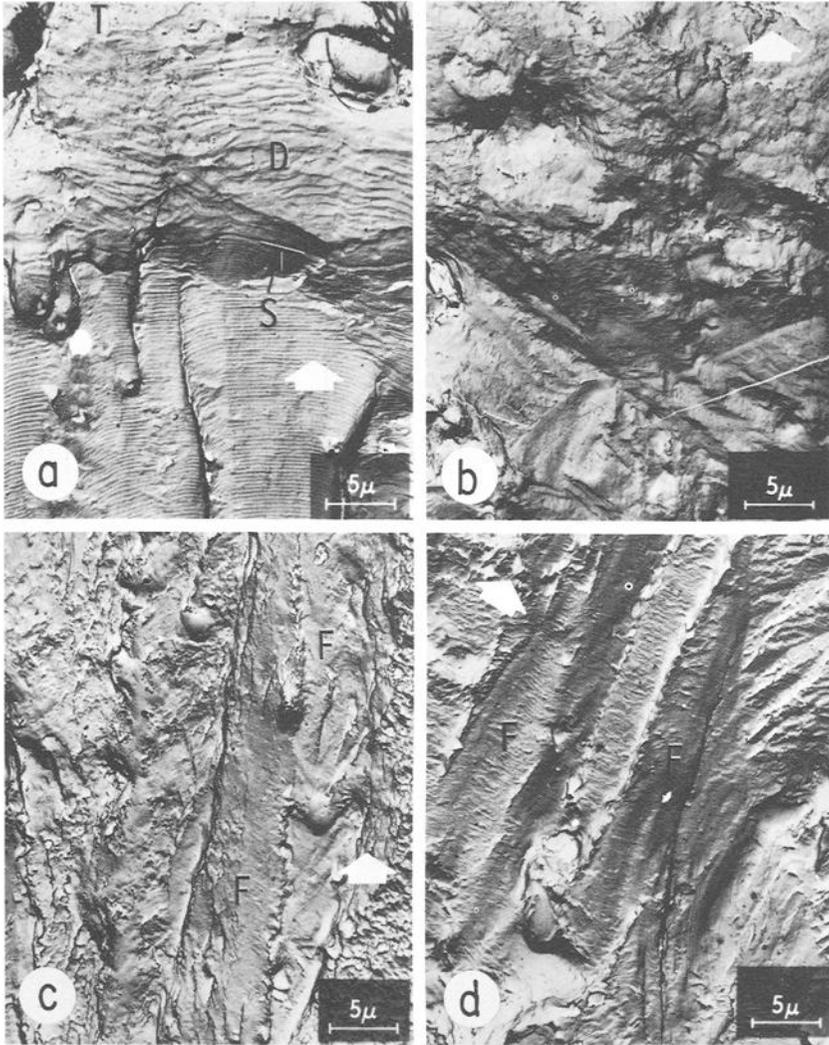
(a) Peak load application line is designated *S*, deformation bands *D*, and matrix tearing *T*.

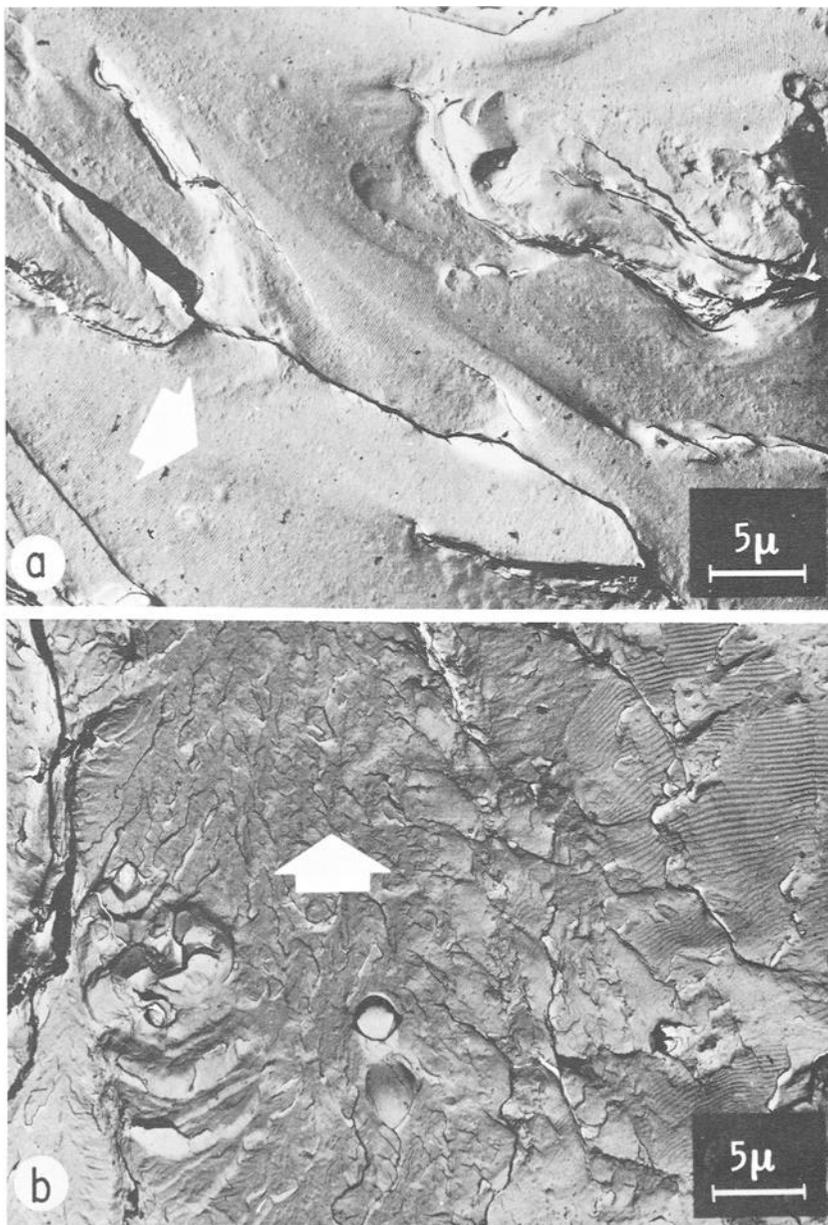
(a) Dry air.  
(b) Wet air.

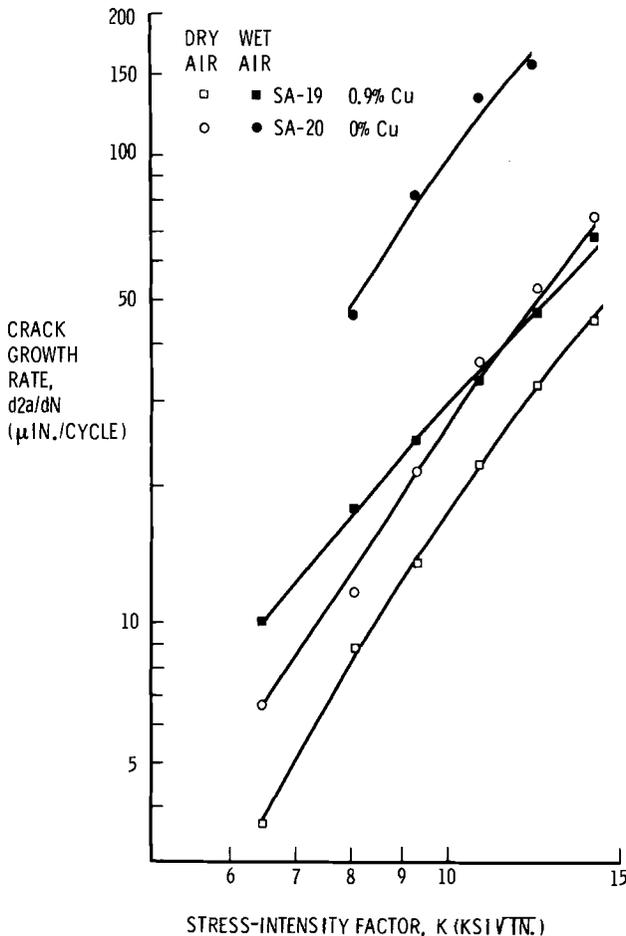
FIG. 18—Effect of environment on crack growth rate of two experimental 7000 series aluminum alloys as a function of copper content (from Ref 40).

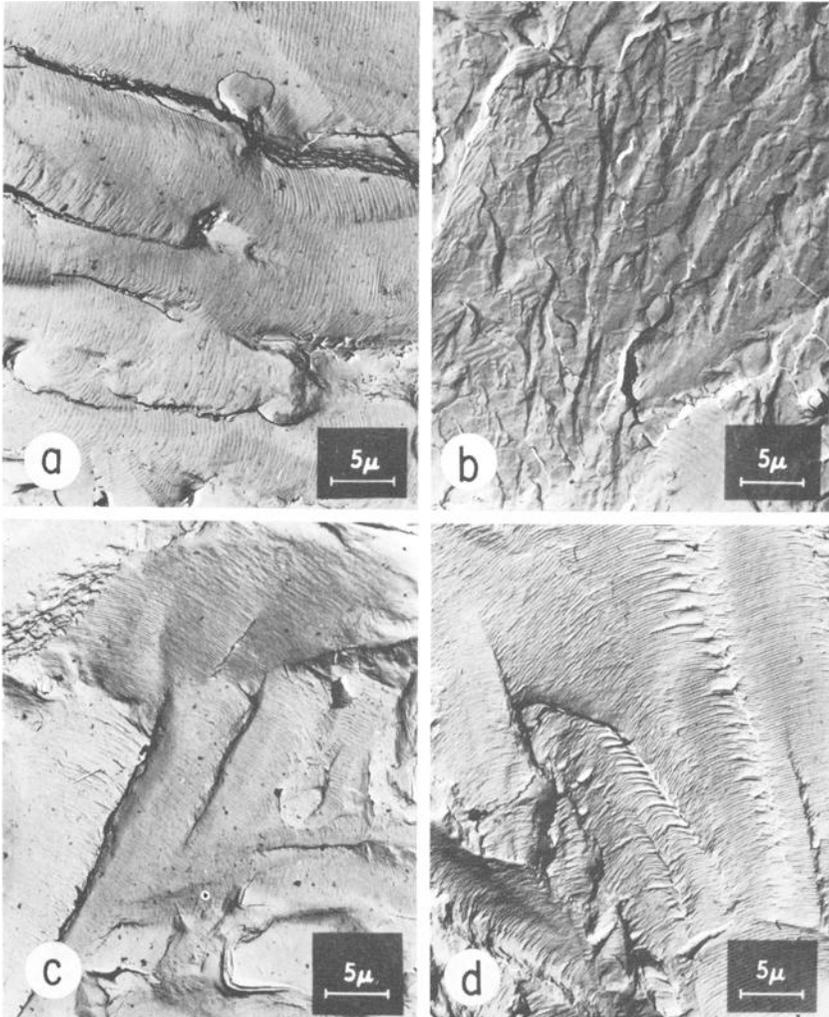
- (a) 0Cu—dry air.
- (b) 0Cu—wet air.
- (c) 0.9Cu—dry air.
- (d) 0.9Cu—wet air.

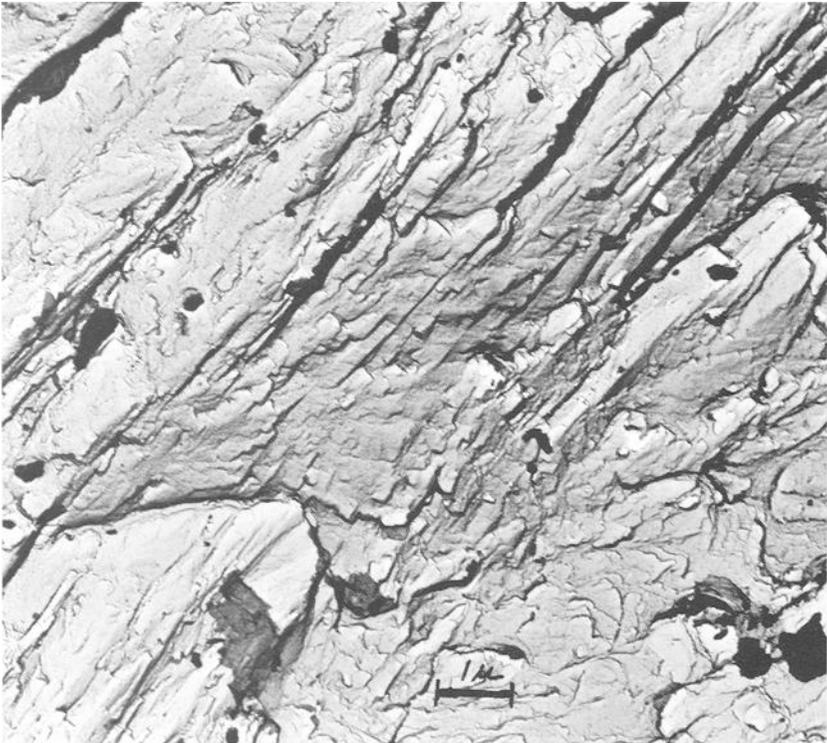
FIG. 1—Stress-corrosion fracture of Type 301 stainless steel in boiling 42 per cent  $\text{MgCl}_2$  ( $\times 9200$ ).

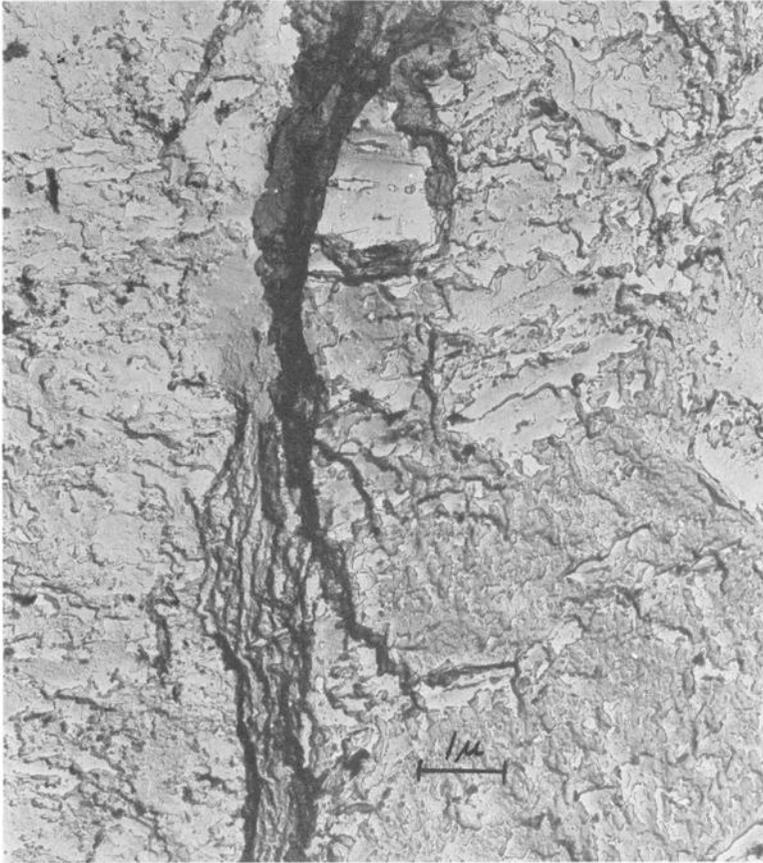
FIG. 2—Stress-corrosion fracture of Type 301 stainless steel in 10 per cent  $\text{FeCl}_3$ , room temperature ( $\times 11,600$ ).

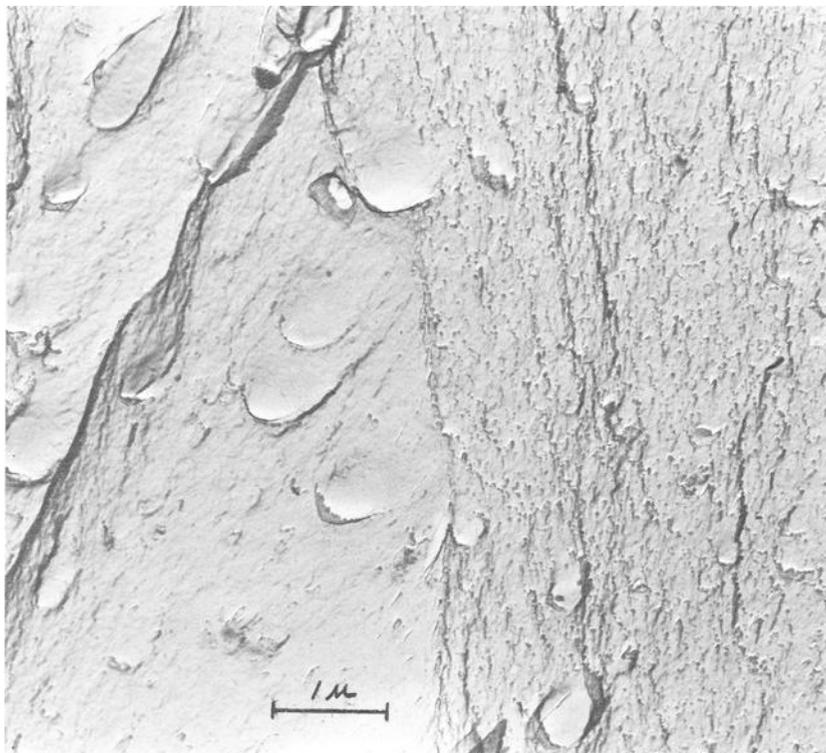
FIG. 3—Stress-corrosion fracture of Type 301 stainless steel in  $MgCl_2 + Na_2S$ , room temperature ( $\times 15,200$ ).

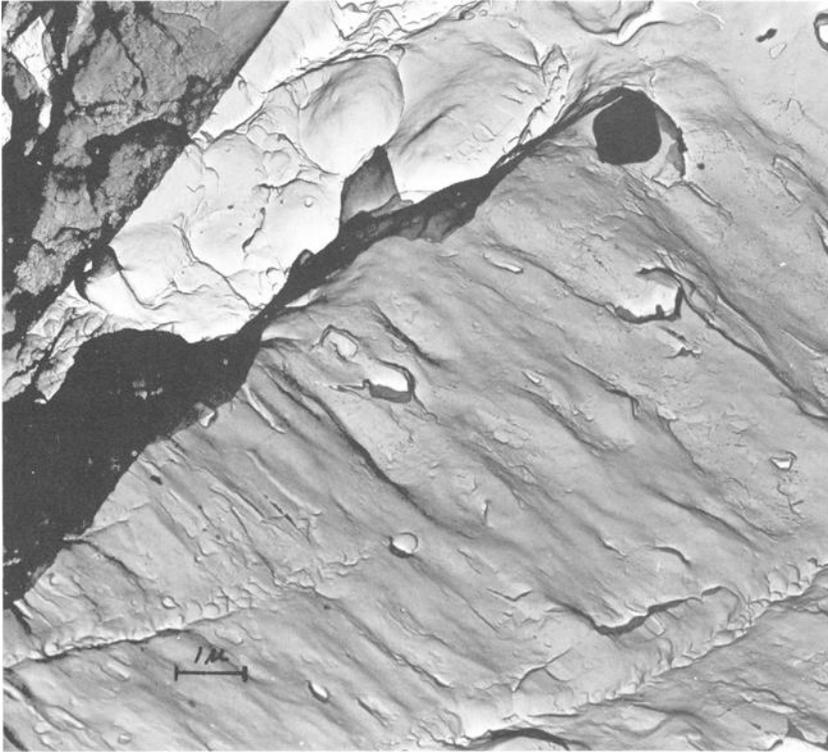
FIG. 4—Hydrogen-embrittlement fracture of Type 301 stainless steel ( $\times 9200$ ).

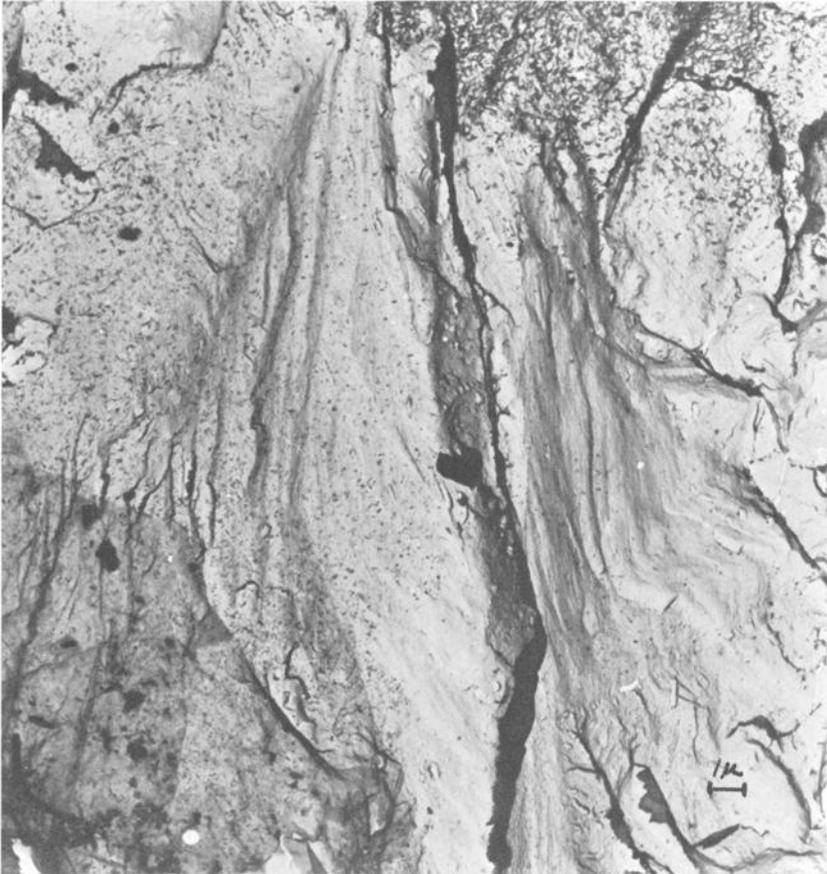
FIG. 7—Electron micrograph of “feather” area of Fig. 7 ( $\times 4000$ ).

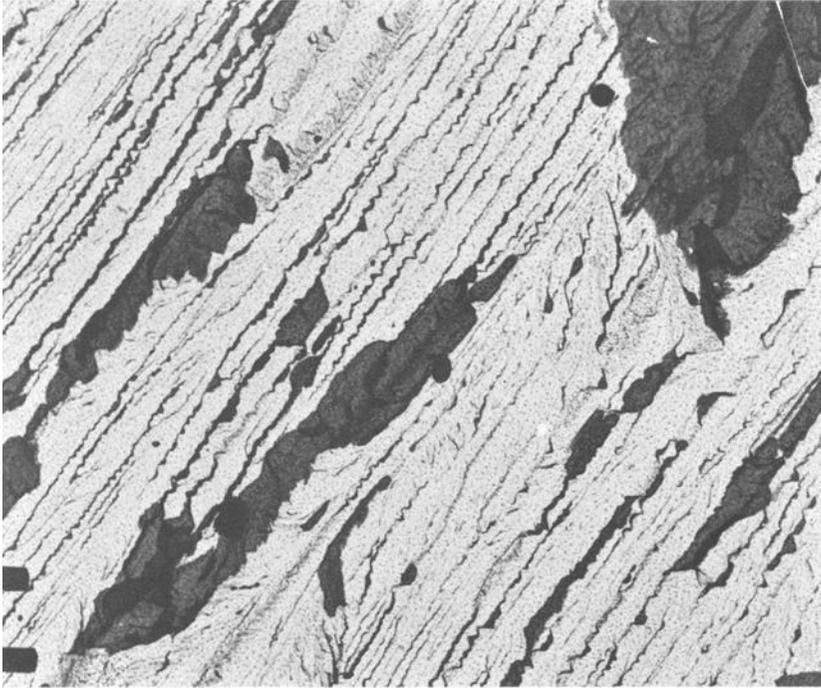
FIG. 10—*Striated fracture surface produced by SCC of Type 304 steel (oxide replica) ( $\times 10,000$ ).*
