# ELECTRON FRACTOGRAPHY

A symposium  
presented at the  
Seventieth Annual Meeting  
AMERICAN SOCIETY FOR  
TESTING AND MATERIALS  
Boston, Mass., 25-30 June, 1967

ASTM SPECIAL TECHNICAL PUBLICATION NO. 436

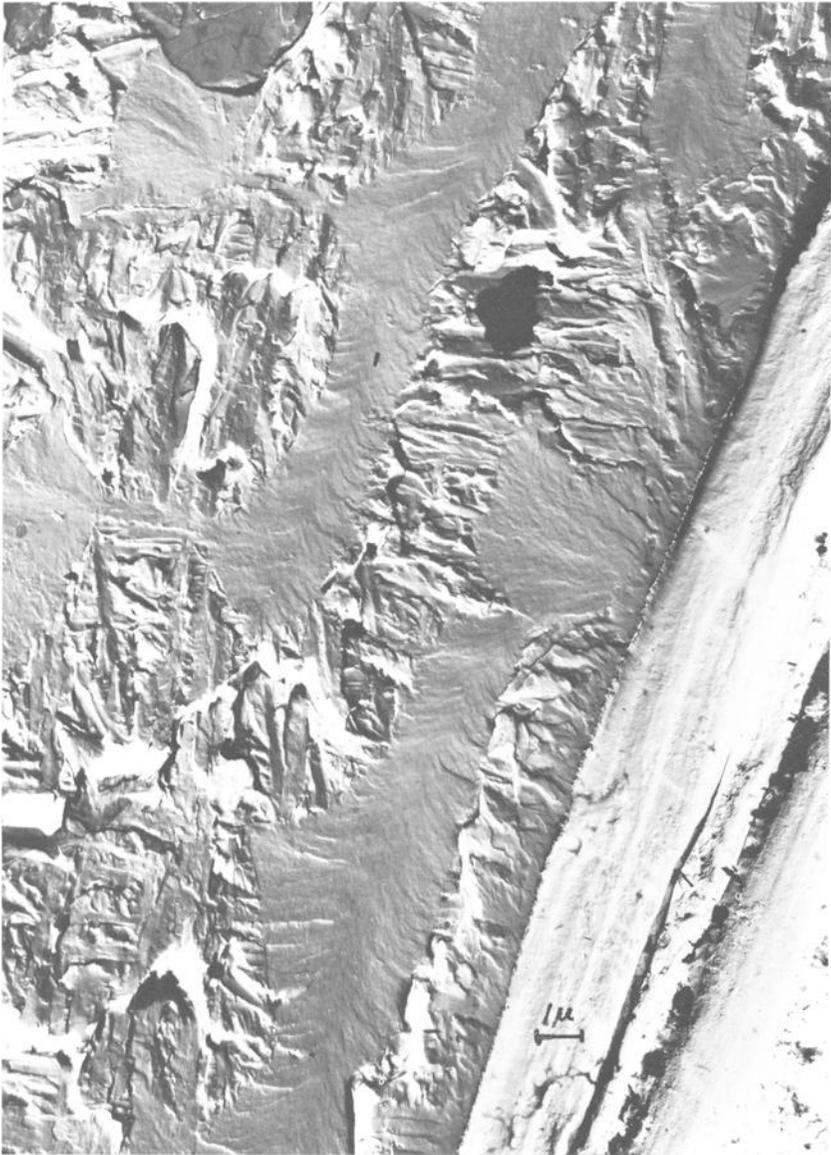
FIG. 11—SCC in Ti-6A-4V alloy exposed to methanol [21] (crack initiated at machining mark on right) ( $\times 6000$ ).

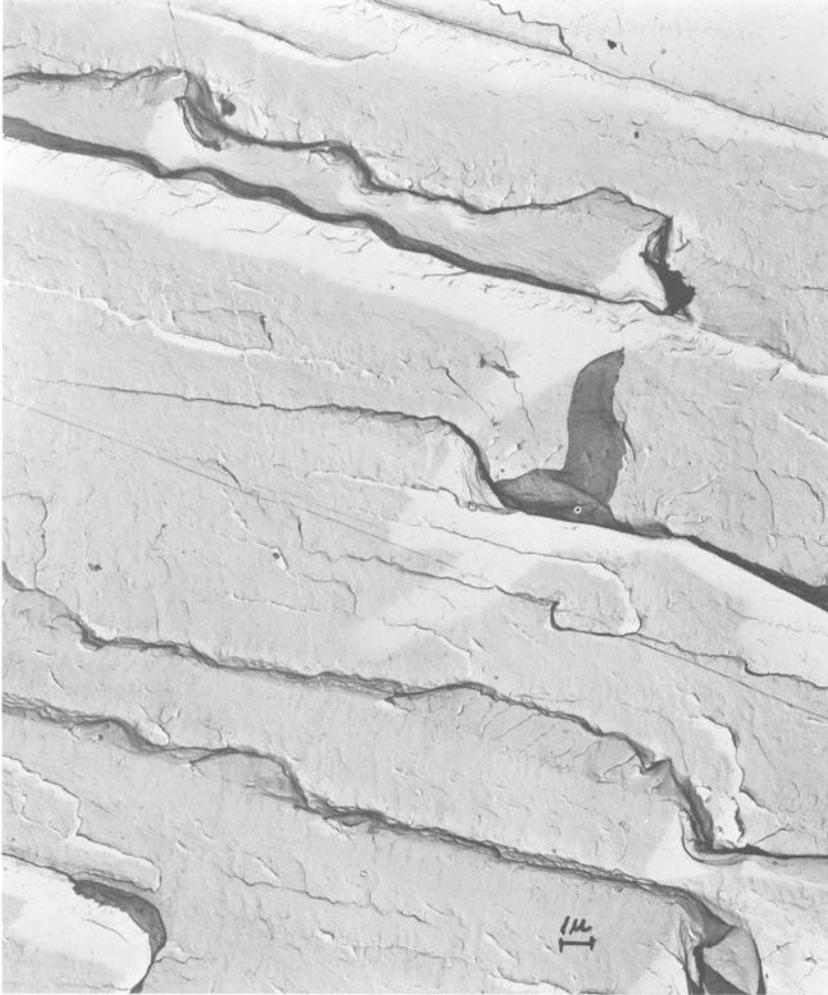
FIG. 12—SCC in Ti-7Al-2Cb-1Ta alloy exposed to distilled water [21] ( $\times 4000$ ).

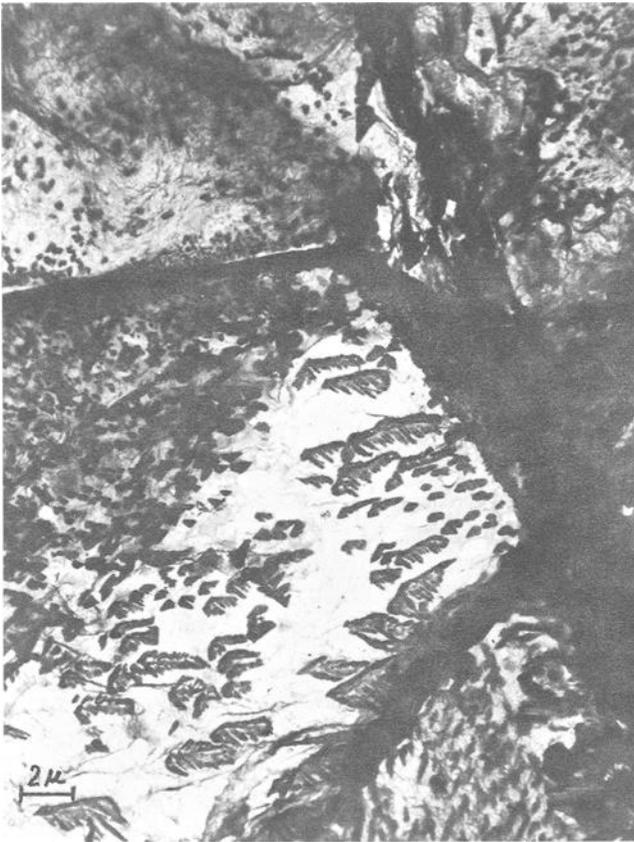
FIG. 18—Fracture of irradiated fuel cladding (Type 304 steel) at 600 C superheat. Extraction replica [32] ( $\times 3750$ ).

served in the irradiated austenitic alloys. Electron fractographs of irradiated Type 304 stainless steel, Incoloy 800, and Inconel 600 appear in Figs. 18 through 21. Carbides of several different morphological forms are shown in the carbon-extraction replicas of Figs. 18 and 19. These fractographs were made at the failure region of Type 304 superheat fuel cladding [32]. Inconel 600 alloy cladding exhibited a completely intergranular fracture when tensile tested at 700 C (Fig. 20). Incoloy 800 showed a partly intergranular, partly ductile fracture on tensile testing at 600 C (Fig. 21) [33].

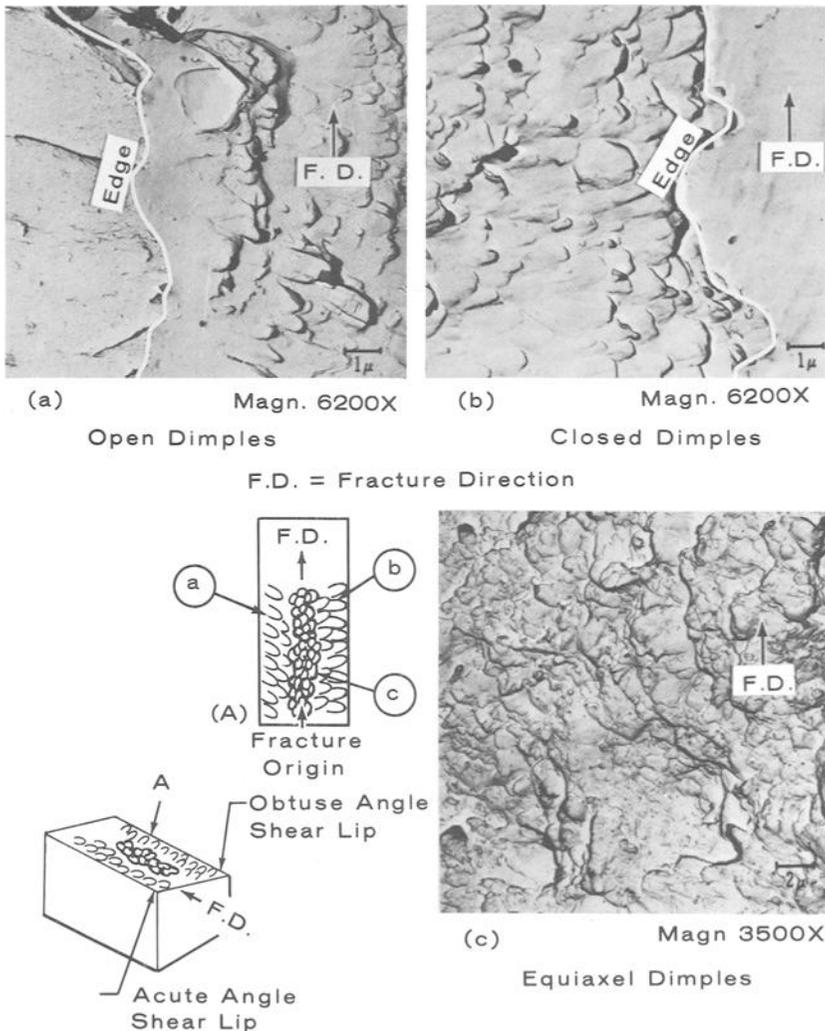
FIG. 3—Relationship between orientation of open dimples along fracture edge and fracture direction.

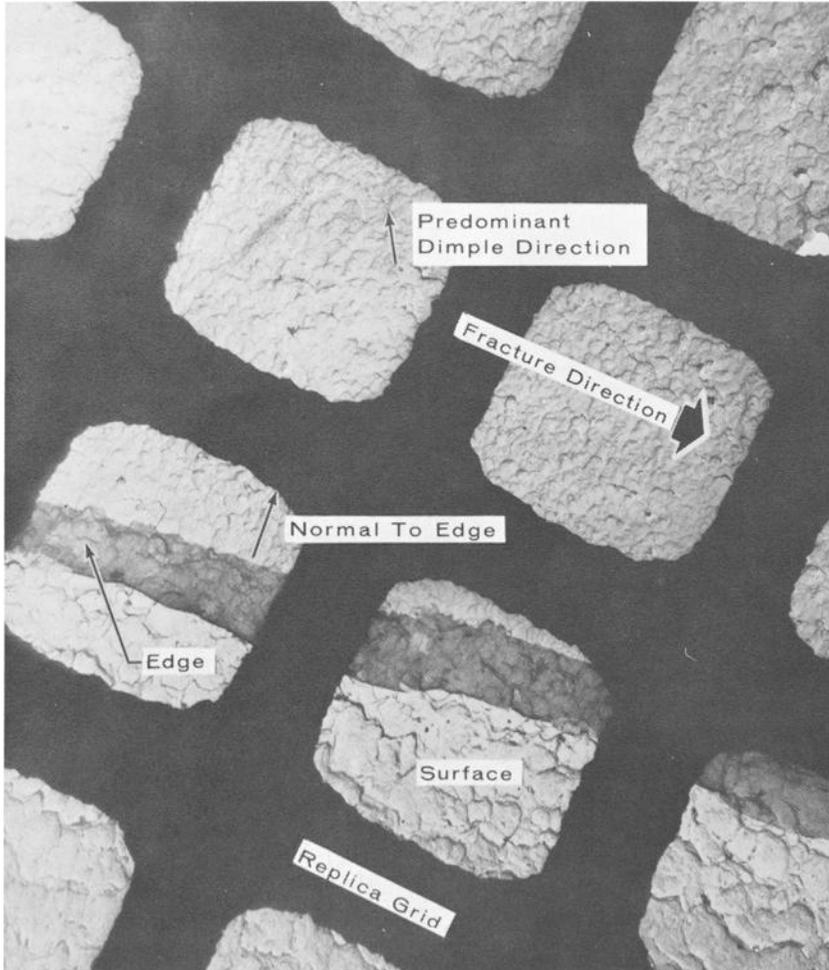
FIG. 5—Open dimples along fracture edge indicate fracture direction ( $\times 400$ ).

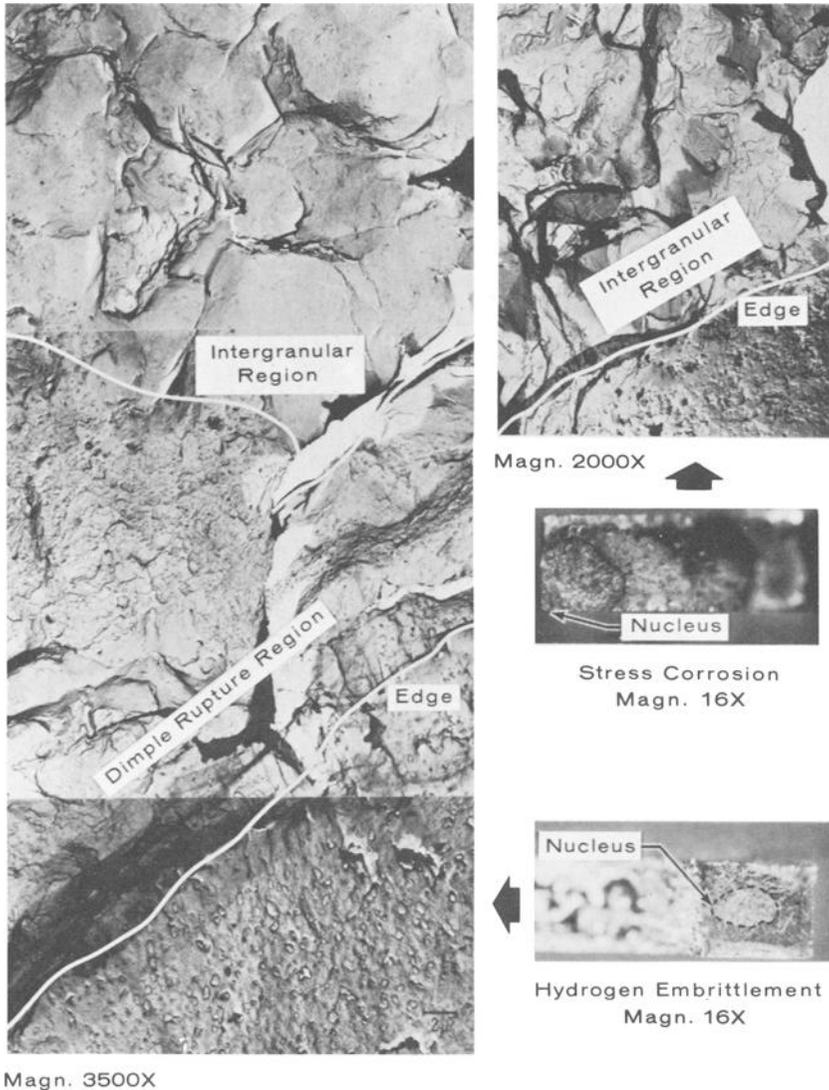
FIG. 8—The nature of nucleus region for stress corrosion and hydrogen embrittlement fractures.

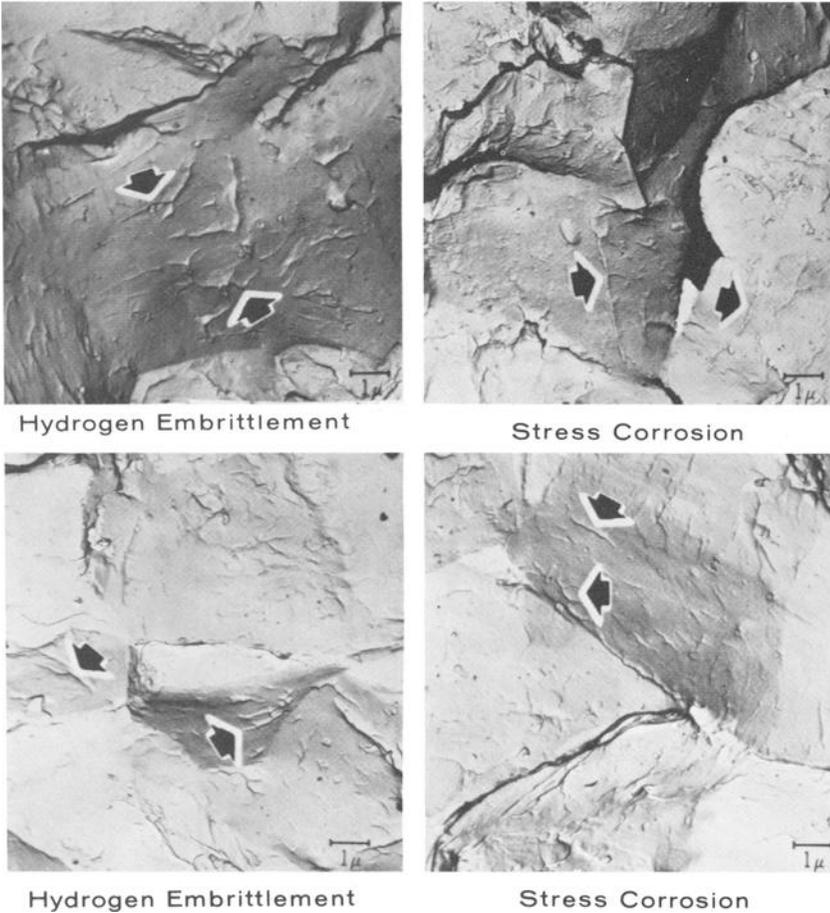
FIG. 10—Illustration of subtle differences between hairline indications (arrows) of stress corrosion and hydrogen embrittlement fractures in 4340, 260/280 steel ( $\times 6500$ ).

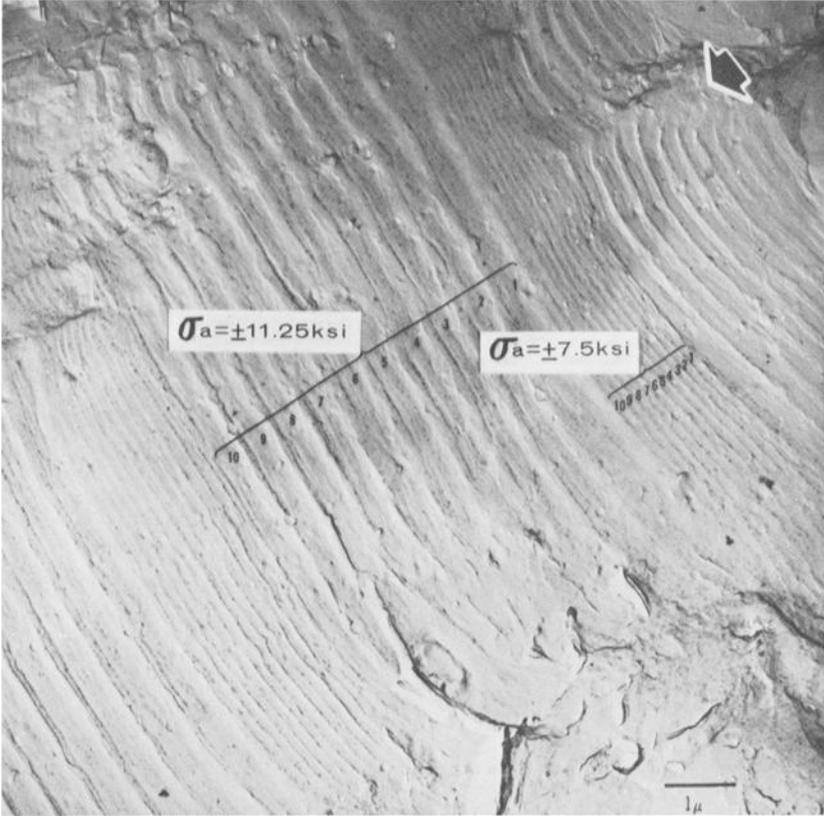
FIG. 13—Characteristics of spectrum loading. Mean stress = 13.75 ksi, three alternating stresses (2.5, 7.5, and 11.25 ksi) applied in 10 cycle intervals. Note lack of striations for lowest alternating stress (2.5 ksi). Arrow indicates fracture direction ( $\times 13,800$ ).

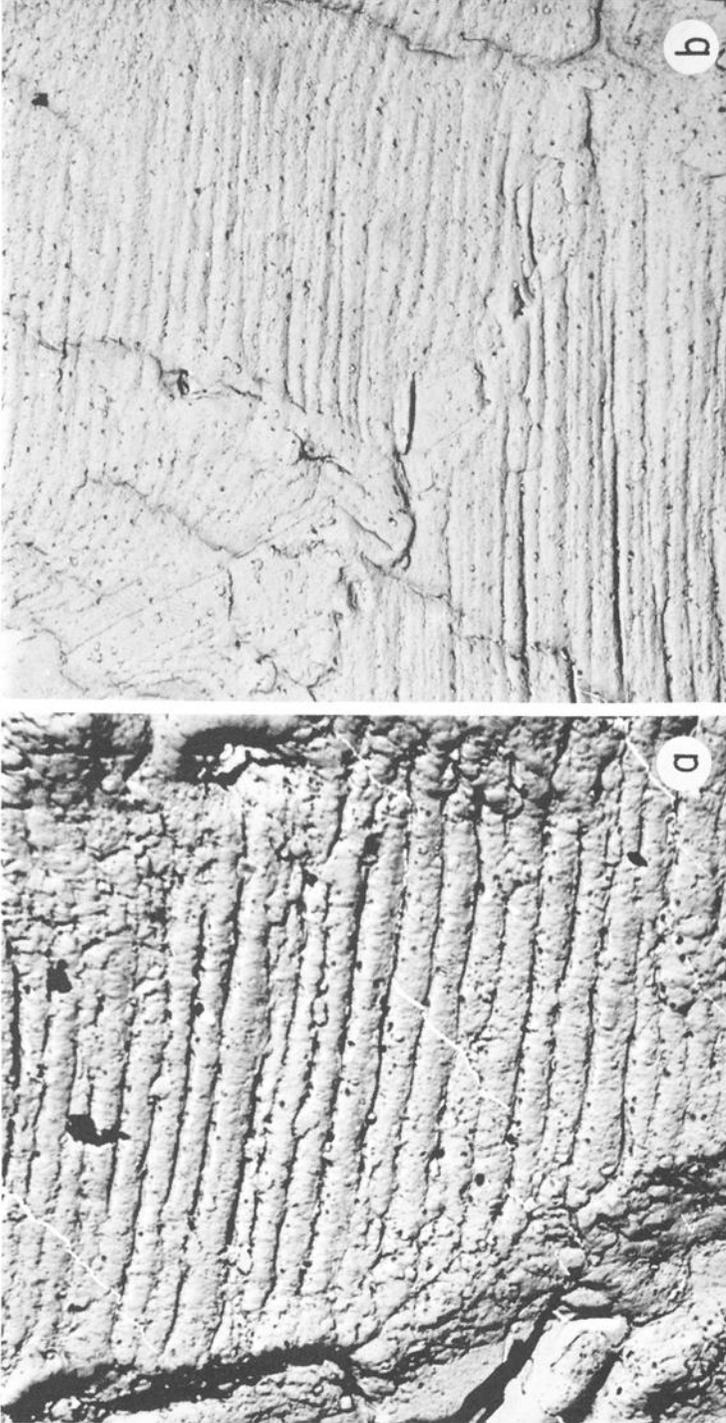
(a)  $\sigma_{ALT} = 106,000$  psi.  
 $N_F = 6000$  cycles.

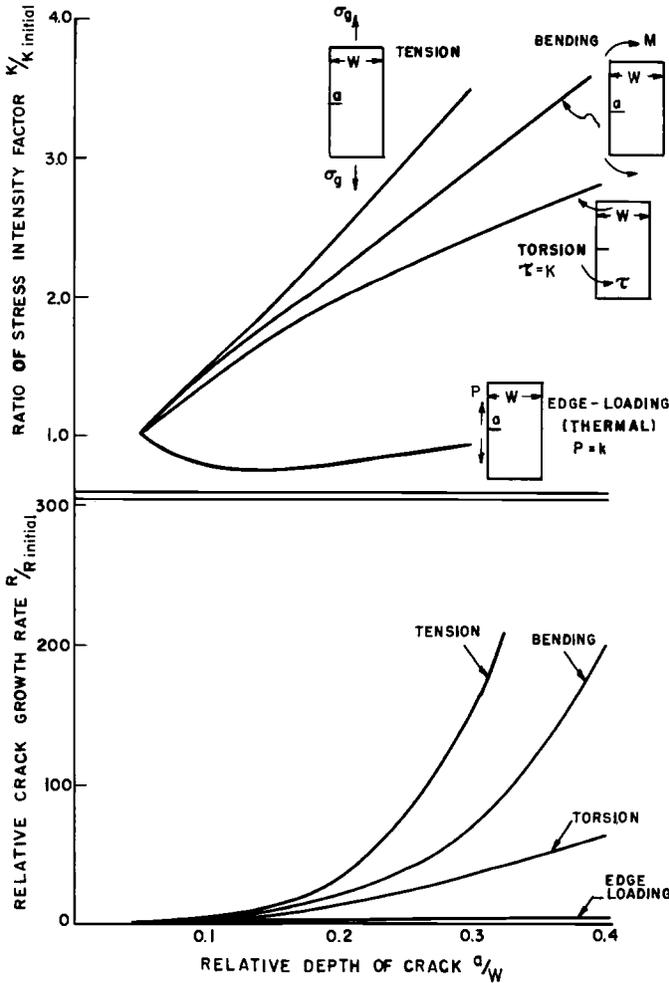
FIG. 8—Illustration of analytical procedures for estimating type of loading in fatigue service failures (schematic).

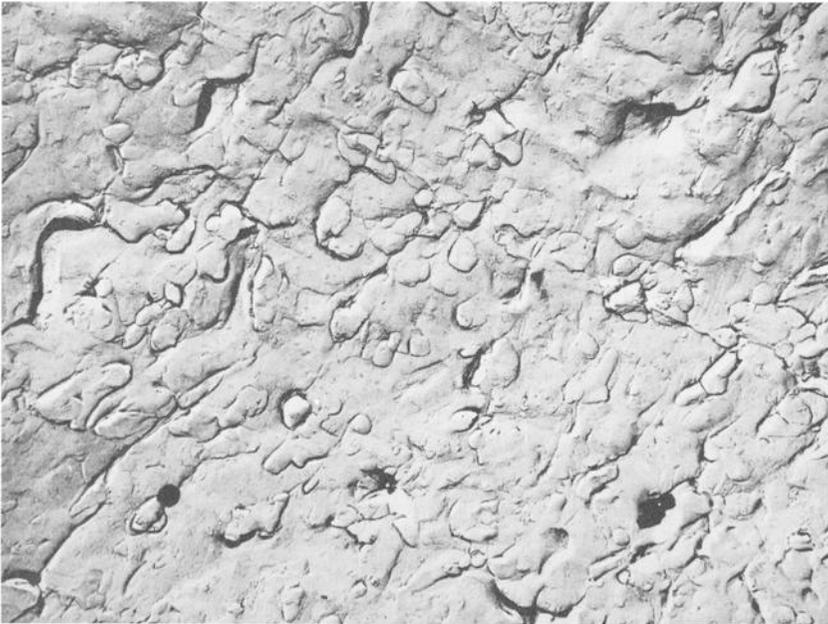
FIG. 13—Fractographic features of exposed microcrack surface showing distribution of particle sites ( $\times 5000$ ).

cedure. By use of electron diffraction techniques, it was possible to isolate these individual particles and to identify their composition. Subsequent replications removed these particles and revealed the features shown in Fig. 13. From the specific measurement of the number and distribution of particles present on these surfaces, it is possible to determine quantitatively those metallurgical features contributing directly to creep fracture on a microscopic scale.

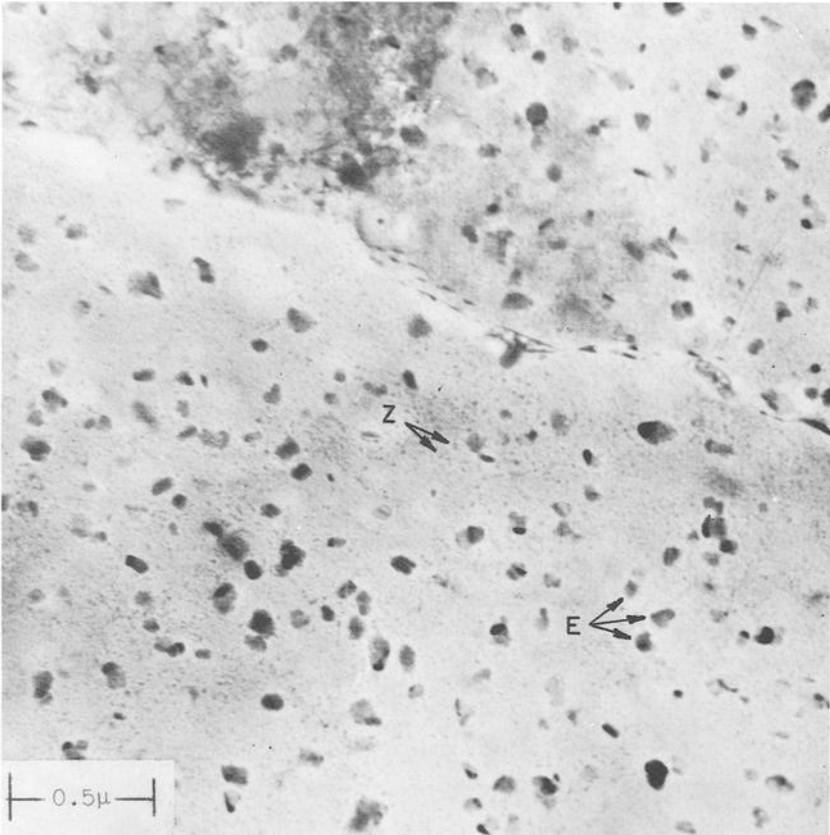
FIG. 1—Electron transmission. Microstructure of 7075-T651 material ( $\times 50,000$ ). E indicates E-phase dispersoids and Z indicates zones.

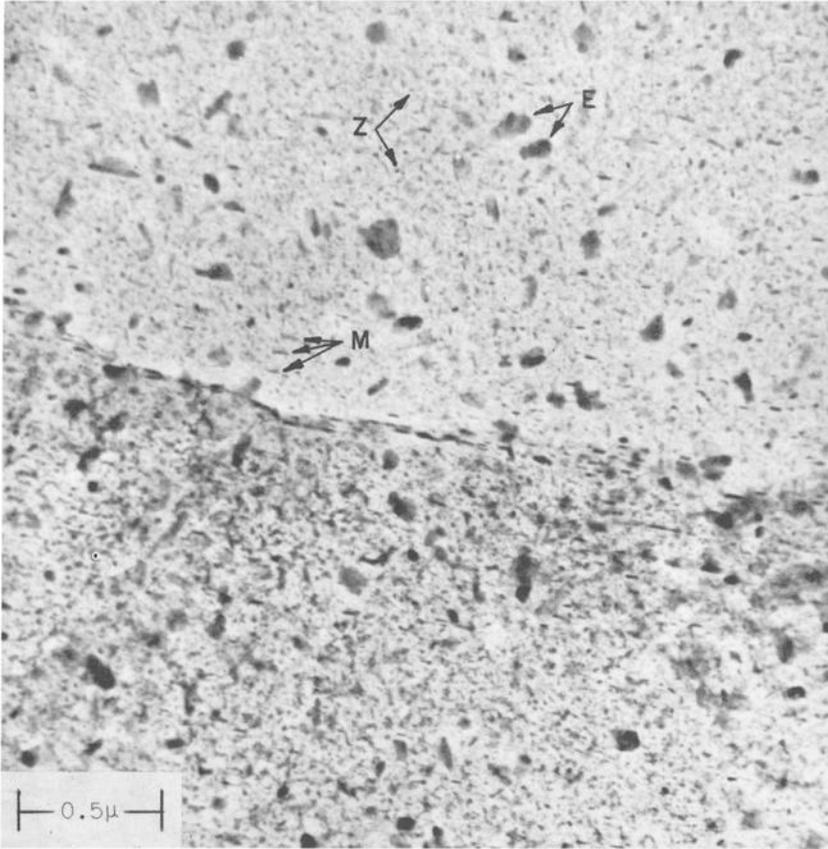
FIG. 2.—*Electron transmission. Microstructure of 7075-T7351 material ( $\times 50,000$ ). Note larger and more distinct zones than T651 temper in Fig. 1. E indicates E-phase dispersoids, Z indicates zones, and M indicates M-phase plates.*

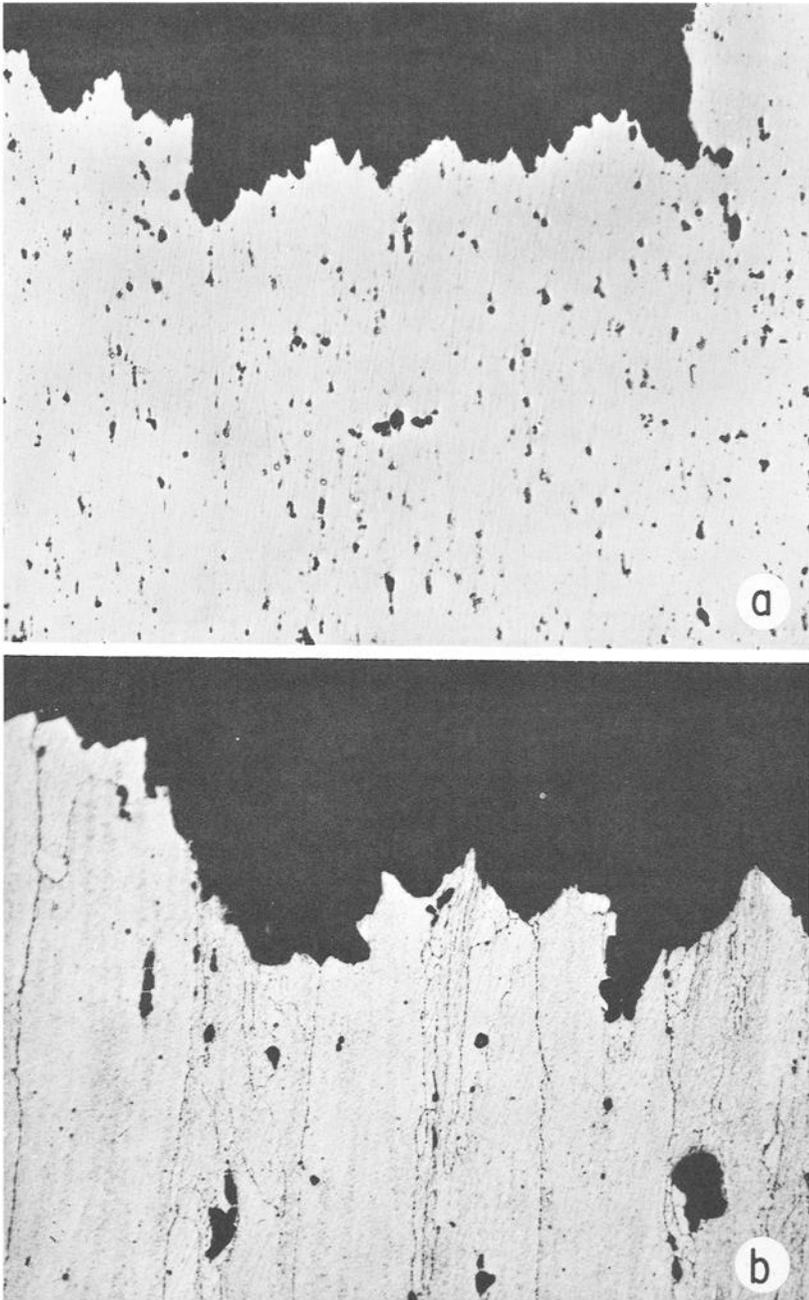
(a) As polished ( $\times 100$ ).  
(b) Keller's etch ( $\times 500$ ).

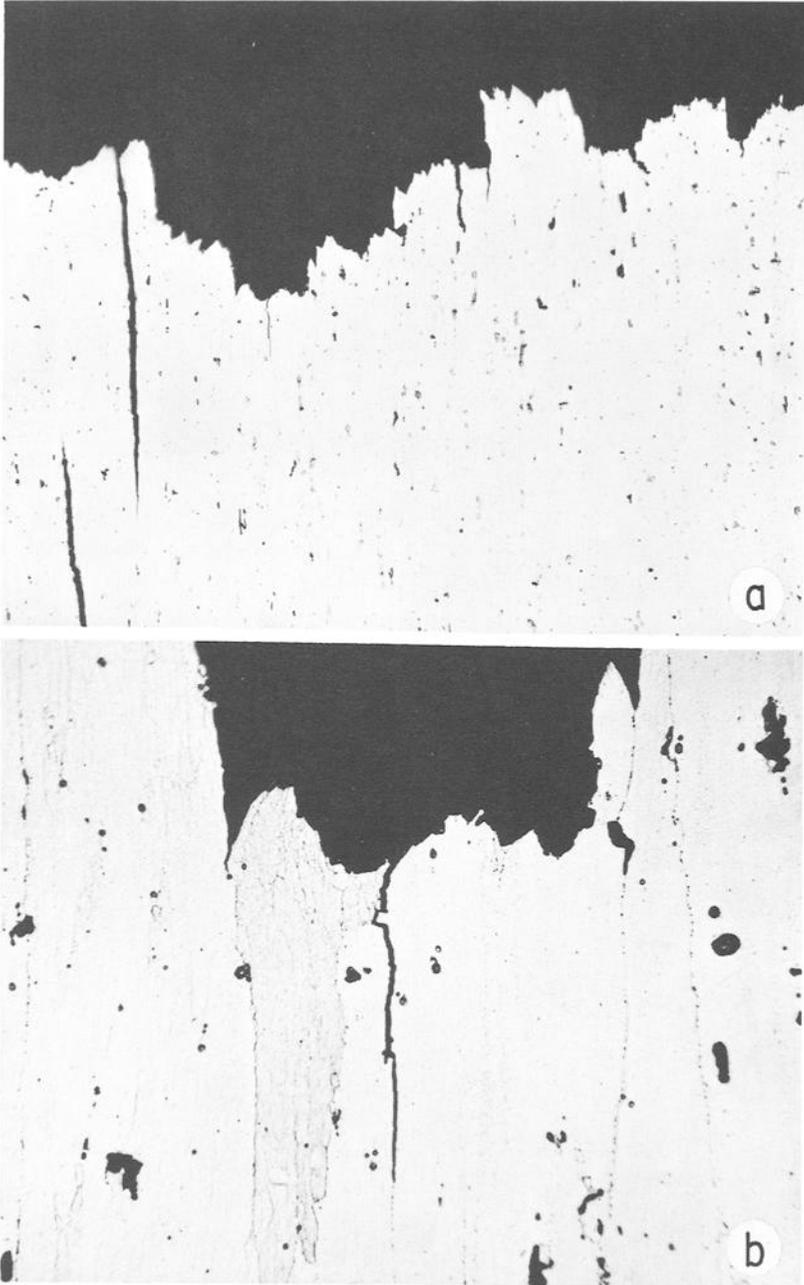
(a) As polished ( $\times 100$ ).  
(b) Keller's etch ( $\times 500$ ).

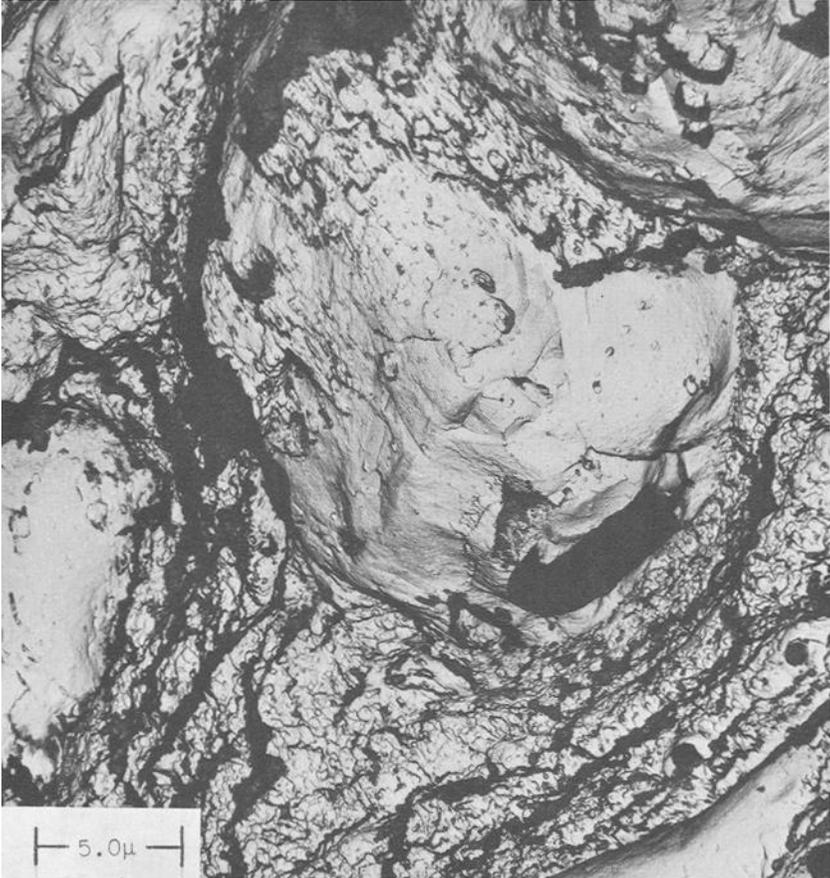
**FIG. 8**—Oxide replica. Typical transgranular fracture appearance in 7075-T7351 specimen ( $\times 5000$ ).

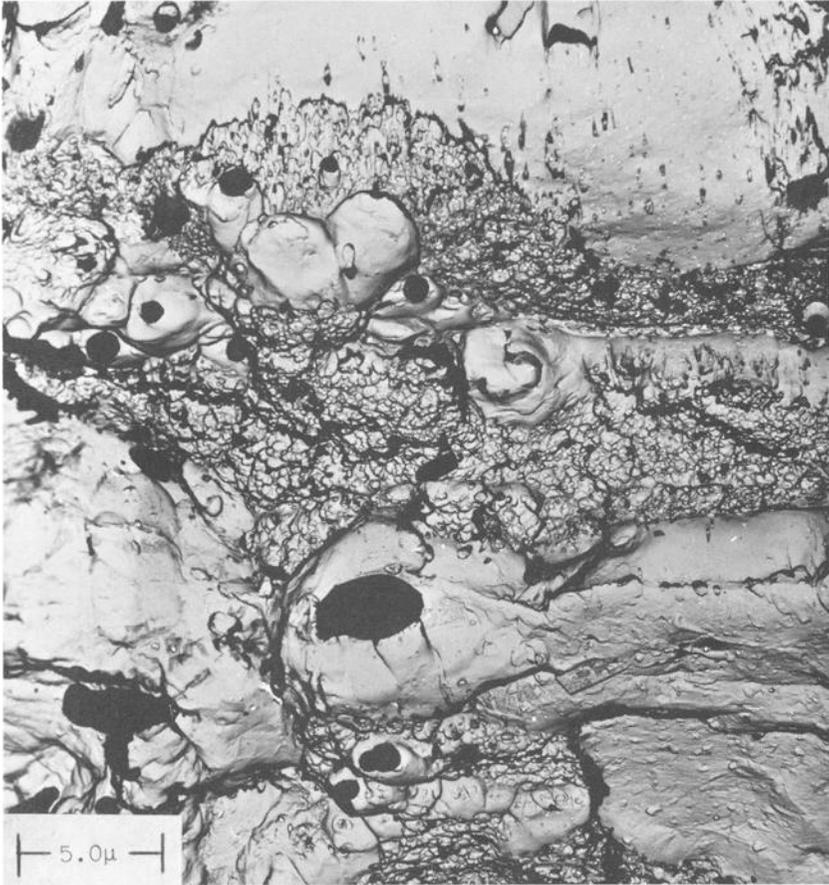
**FIG. 9**—*Oxide replica. Typical transgranular fracture appearance in 7075-T651 specimen ( $\times 5000$ ).*

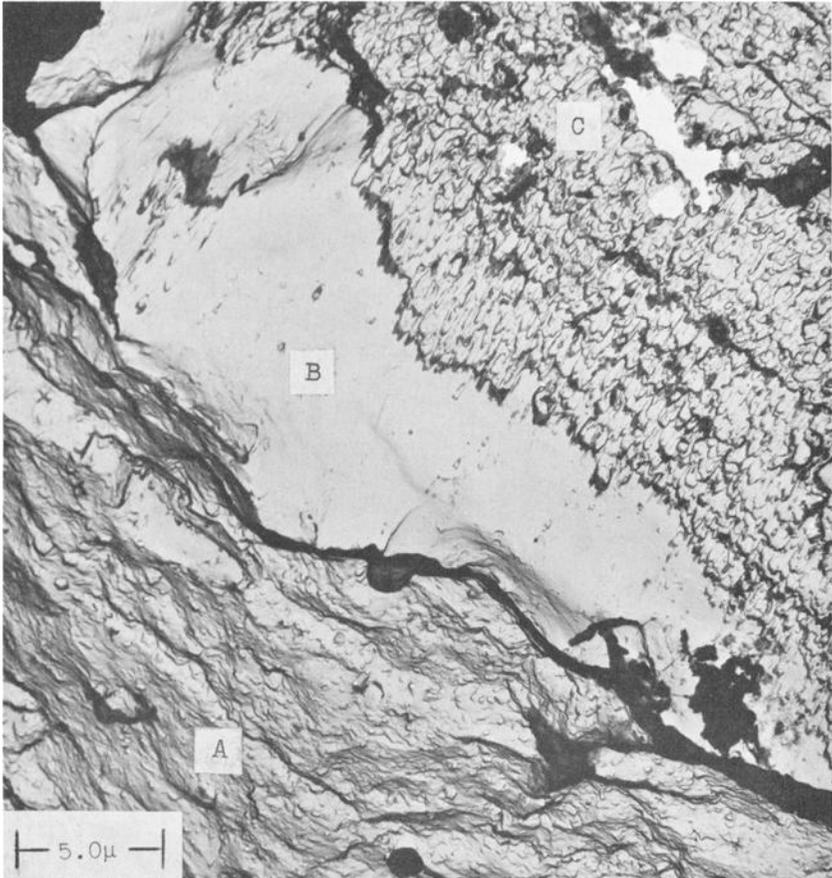
FIG. 10—Oxide replica. Intergranular fracture (a), a stretched region (b), and transgranular dimple rupture (c) in region of longitudinal fissure in 7075-T651 specimen ( $\times 5000$ ).

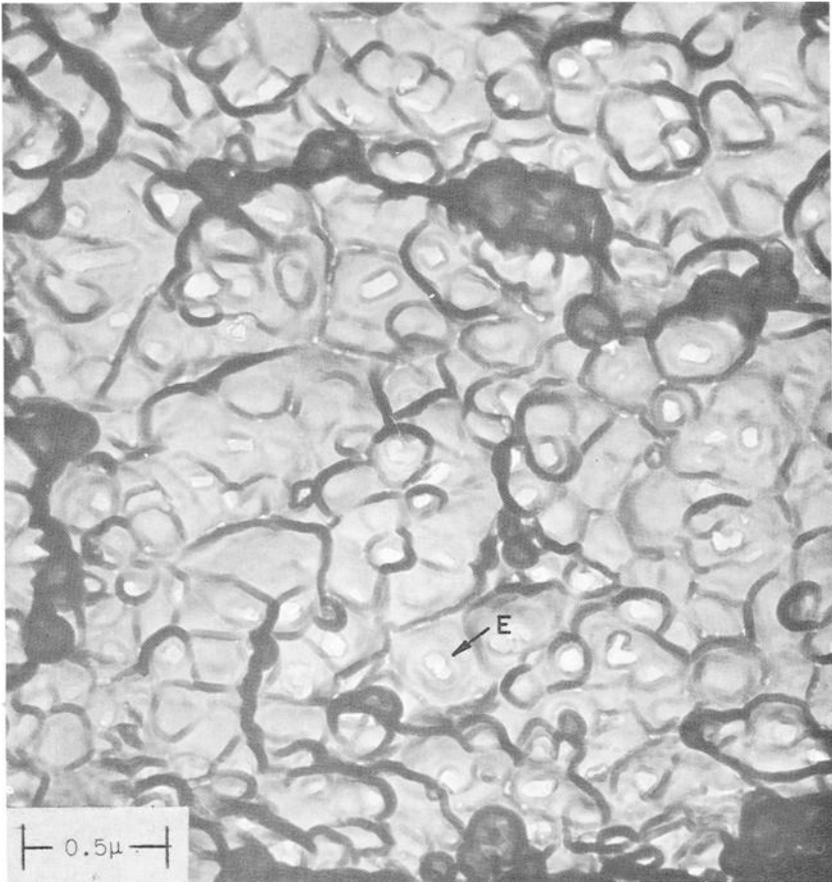
FIG. 11—Oxide replica. Comparatively large dimples associated with dispersoid particles on 7075-T651 fracture ( $\times 50,000$ ). E indicates dimple nucleation site believed to have been an E-phase dispersoid particle.

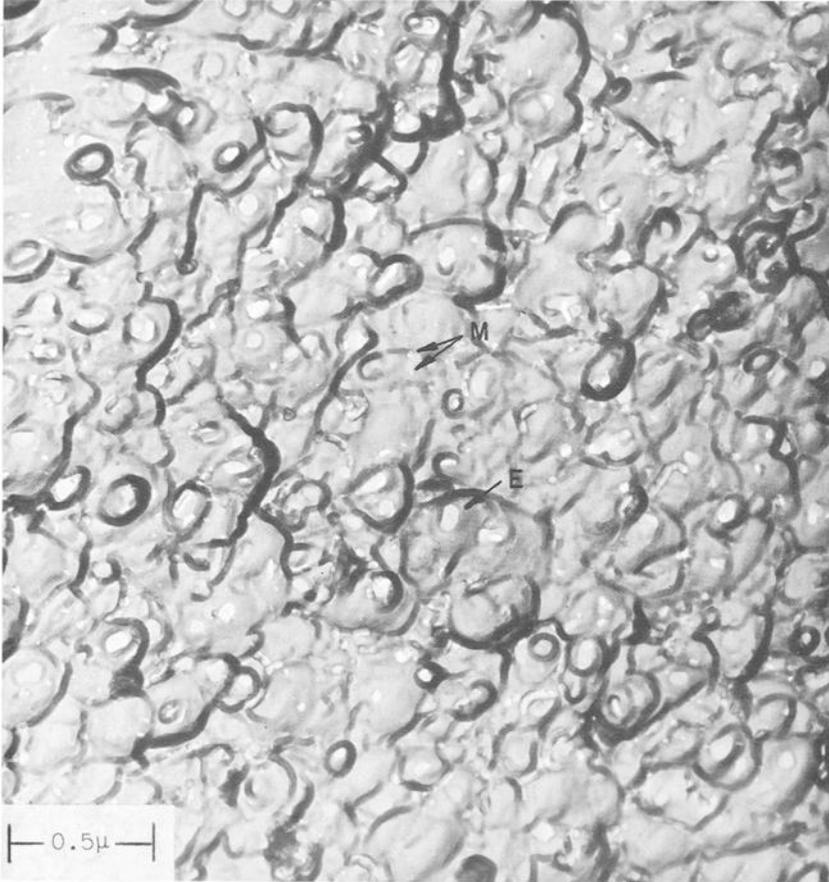
FIG. 12—Oxide replica. Mixture of large and small dimples on 7075-T7351 fracture ( $\times 50,000$ ). *E* and *M* indicate dimple sites believed to have been *E*-phase dispersoid and *M*-phase plates, respectively.
