# **STRESS CORROSION—**

# **NEW APPROACHES**

A symposium  
presented at the  
Seventy-eighth Annual Meeting  
AMERICAN SOCIETY FOR  
TESTING AND MATERIALS  
Montreal, Canada, 22–27 June 1975

ASTM SPECIAL TECHNICAL PUBLICATION 610  
H. L. Craig, Jr., editor  
University of Miami

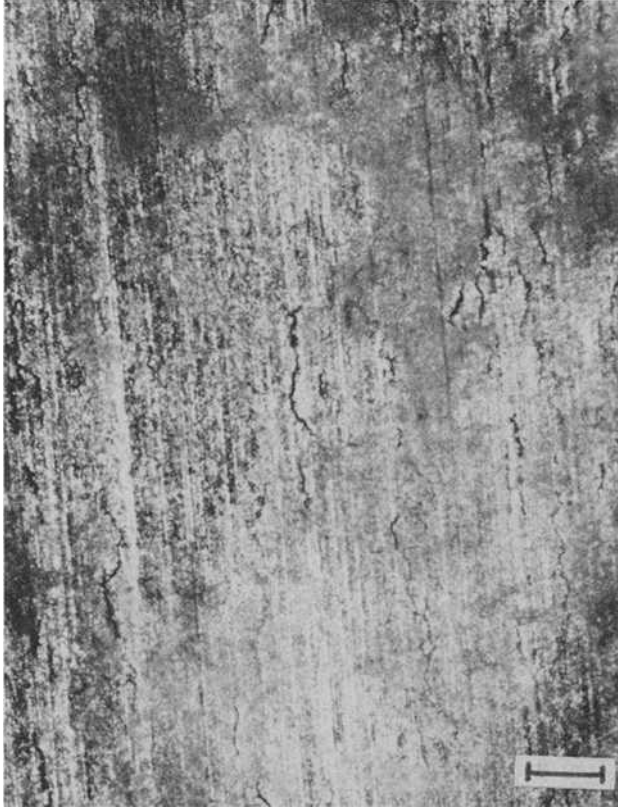
Specimens exposed to the polluted conditions developed small intergranular cracks perpendicular to the stress direction (Fig. 4). The number and lengths of these cracks appeared to be a function of the exposure time, the severity of the environment, and the level of stress. No cracks developed in the unstressed portion of each specimen nor in specimens exposed 1000 h in the clean environments.

FIG. 4—Stress induced intergranular cracks in 7005-T53 after 1000 h exposure to air containing  $\text{SO}_2$  (mark = 1 mm).

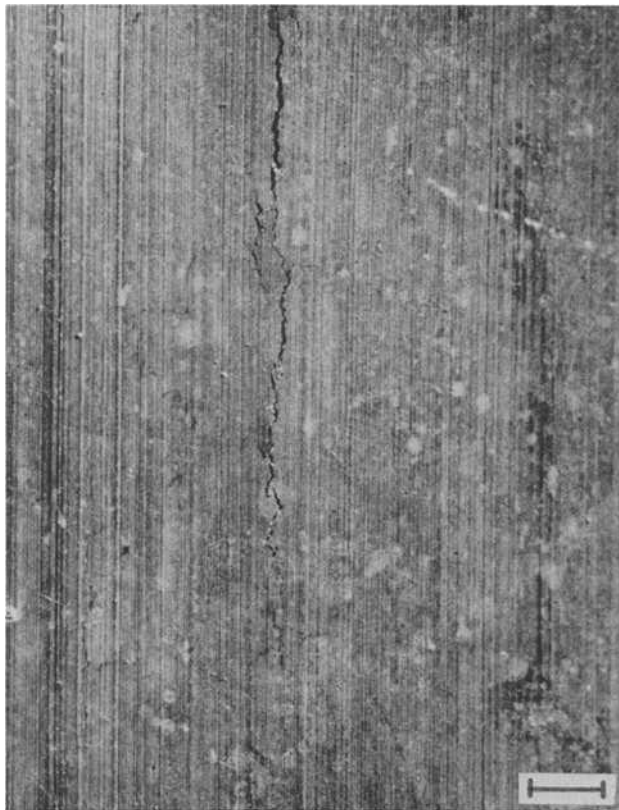
FIG. 6—Stress-corrosion crack after 2000 h exposure to clean air (mark = 1 mm).

Characteristic SCC of 7005-T53 tubing can occur in clean air at high relative humidities. A damage mechanism that by some definitions could be called SCC is enhanced by  $\text{SO}_2$  in air. This mechanism differs from that observed in the clean environment in that many small cracks are formed perpendicular to the applied stress rather than a single primary crack. They are the same in that in both cases intergranular cracks do not form in the absence of tensile stress. The pollution damage mechanism may be better described as stress-induced intergranular corrosion.

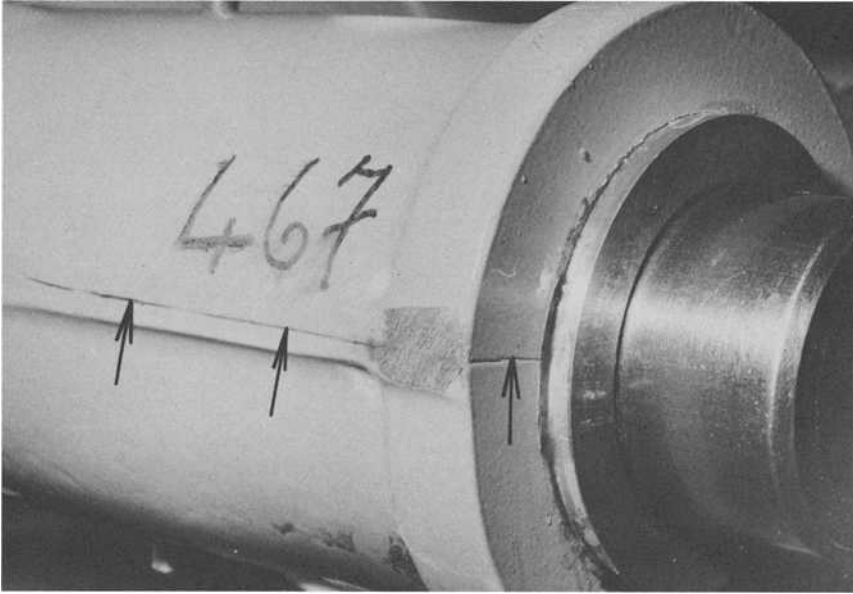
FIG. 4—Stress-corrosion crack in the parting line and through the full-wall thickness of a 7079-T6 aluminum forged landing gear ( $\times 0.8$ ).

and atmospheric contamination, prior to such surface being protected by approved corrosion preventative compounds as per requirements of Specification MIL-STD-649.<sup>5</sup> Since assurances were obtained from the manufacturer that inadvertently long exposures to the atmosphere did not occur, it would seem that the batch factor was responsible for the failures observed.

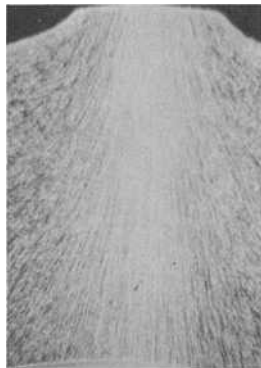
FIG. 6—Macrostructure of a transverse section through the parting line of a 7079-T6 aluminum landing gear forging showing the long thin grains in the immediate vicinity of the parting line ( $\times 3$ ).

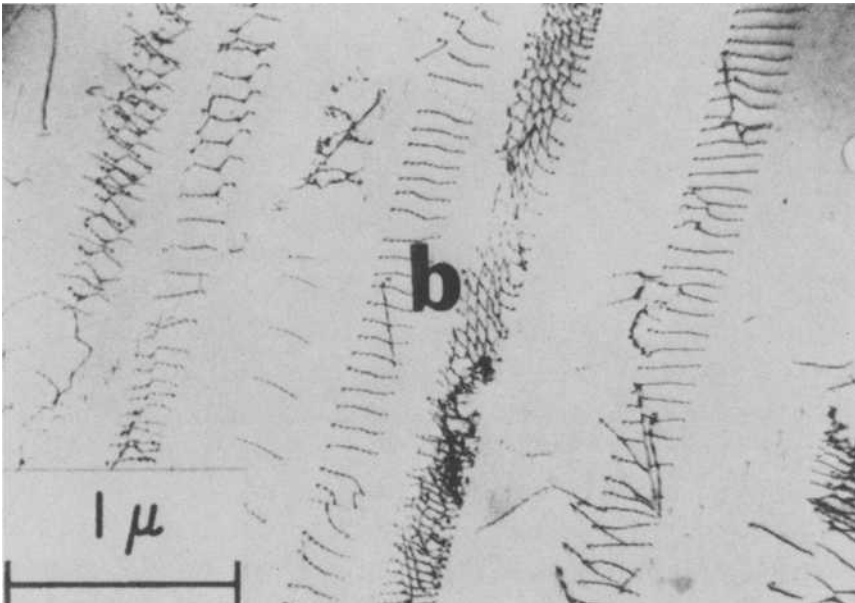
FIG. 10—Electron micrographs of thin-foil specimens of austenitic stainless steels showing dislocation arrays. (b) 12.8 percent nickel, 0.12 percent nitrogen steel showing deformed, planar array; (c) 20 percent nickel, 0.1 percent carbon steel deformed 10 percent showing cellular tangled array [59].

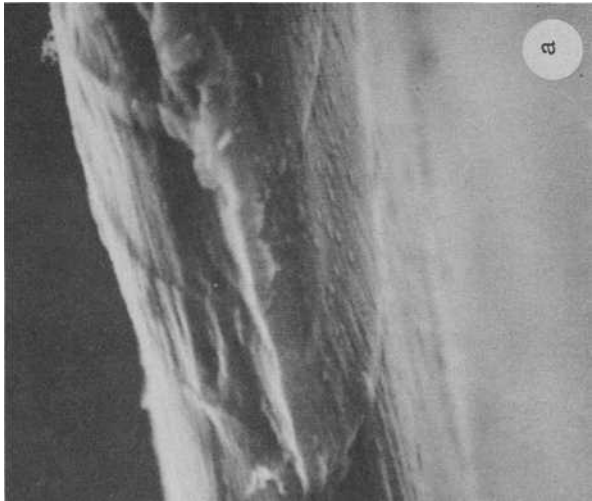
Scanning electron photomicrographs of fracture surfaces are shown in Fig. 5. The specimen fractured in air by overstressing in the absence of charging (Fig. 5a) shows the typical ductile failure associated with a large reduction in area. The specimens which exhibited delayed failures are extremely brittle showing essentially zero ductility. A cleavage type planar

(a) Fractured in air.  
 (b) Delayed failure (126 min) after charging in 1 N  $\text{H}_2\text{SO}_4$ , 5-ppm arsenic at  $-0.560$  V SHE ( $-6$  mA/cm $^2$ ).  
 (c) Same as b.  
 (d) Delayed failure (5.7 h) after charging in 1 N  $\text{H}_2\text{SO}_4$ , 5-ppm arsenic at  $-0.160$  V SHE ( $-100$   $\mu\text{A}/\text{cm}^2$ ).  
 FIG. 5—Scanning electron photomicrographs of fracture surface of T310 stainless steel foils ( $\times 5000$ ).
