STP  
629

# CHLORIDE CORROSION OF STEEL IN CONCRETE

A symposium  
presented at the  
Seventy-ninth Annual Meeting  
AMERICAN SOCIETY FOR  
TESTING AND MATERIALS  
Chicago, Ill., 27 June-2 July 1976

ASTM SPECIAL TECHNICAL PUBLICATION 629  
D. E. Tonini, American Hot Dip Galvanizers Association, Inc.  
S. W. Dean, Jr., Air Products and Chemicals, Inc.,  
editors

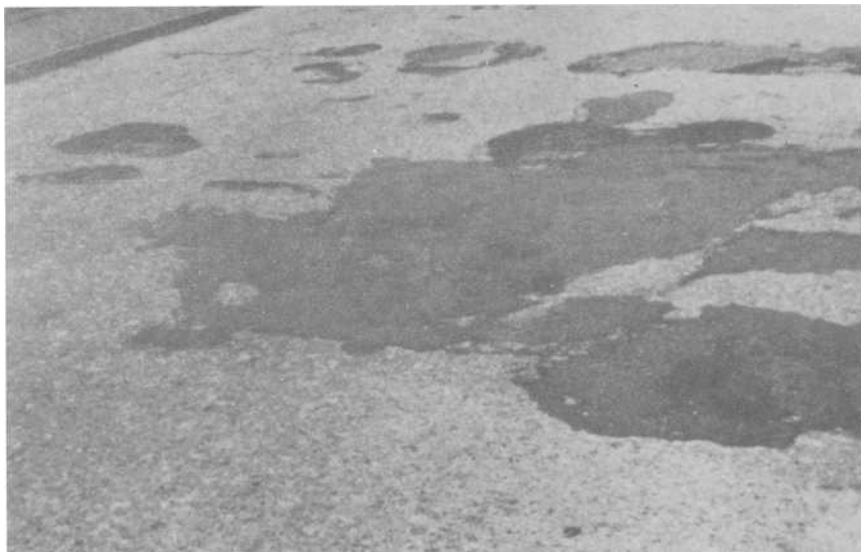
FIG. 1—*Potholes (some patched) on a concrete bridge deck.*

short drive in any of the snow belt states. The type of deterioration shown here is potholing, sometimes called spalling, delamination, or fracture plane. It is the most serious, in terms of structural damage and potential danger to motorists (though not in extent of afflicted area), of the three forms of deterioration found on bridge decks other than cracks. The other two forms are scaling and wear.

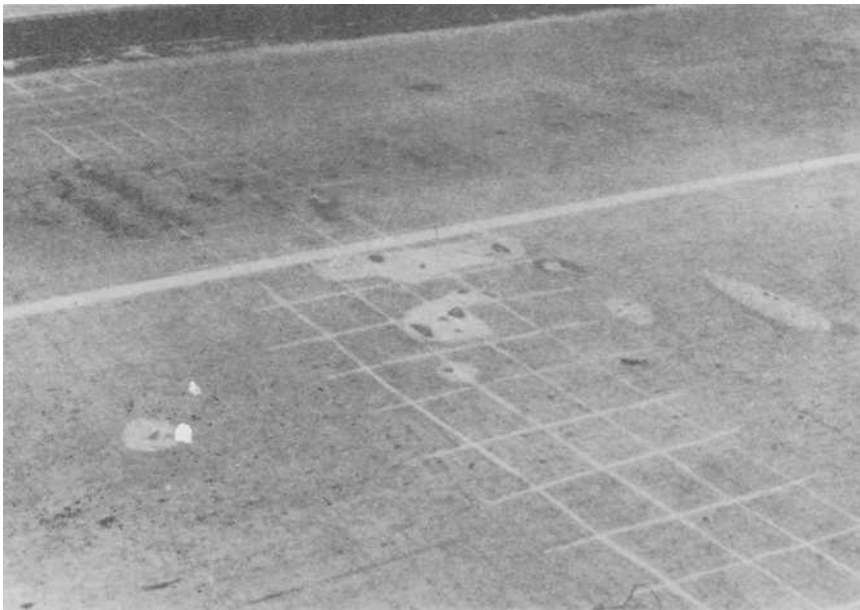
FIG. 2—*Fracture planes and spalls. Extent of the fracture planes and the locations of the reinforcing bars are indicated.*

It has been hypothesized [6] that the genesis of a pothole is as follows. When the concrete was placed, the resistance to subsidence of the fresh concrete afforded by the top mat of reinforcing steel caused small tension cracks to occur over the reinforcing bars. These provided channels for access by water and deicing chemicals (sodium and calcium chlorides) to the reinforcement. Subsequent corrosion of the reinforcing bars generated forces of sufficient magnitude to produce horizontal fracture planes. The layers of concrete above these fracture planes were then removed by the impact of vehicular traffic. It should be evident from this model that the depth of clear cover of concrete over the steel should be an important factor due to its effect on the magnitude of tensile stresses developed during subsidence. This has been shown to be the case in field examinations [7] and has been verified in the laboratory [8]. The relationship between the location of the reinforcing bars and spalls is shown in Fig. 2. Figure 3 shows a core extracted from a fracture plane area. Notice the location of the fracture plane above the top reinforcement. Figure 4 is a photomicrograph showing the shattered concrete in the vicinity of a corroding reinforcing bar.

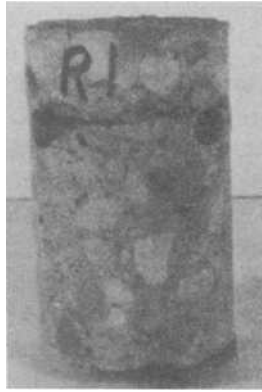
FIG. 3—Core through fracture plane.

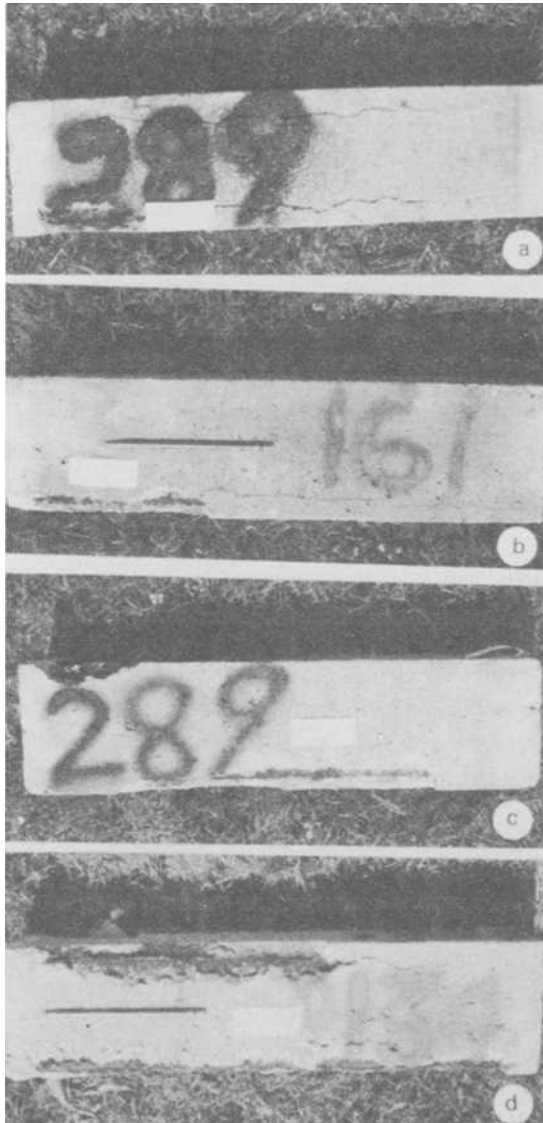
- (a) Very slight spalling.
- (b) Slight spalling.
- (c) Moderate spalling.
- (d) Severe spalling.

FIG. 3 —Photographic standards used to evaluate degree of concrete spalling.

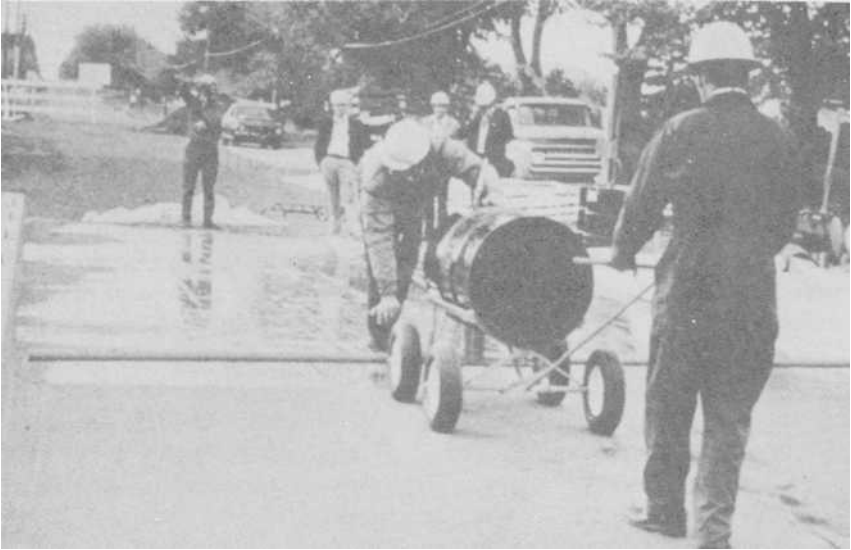
**FIG. 2—***Application of monomer during the partial impregnation of a cast-in-place bridge deck.*

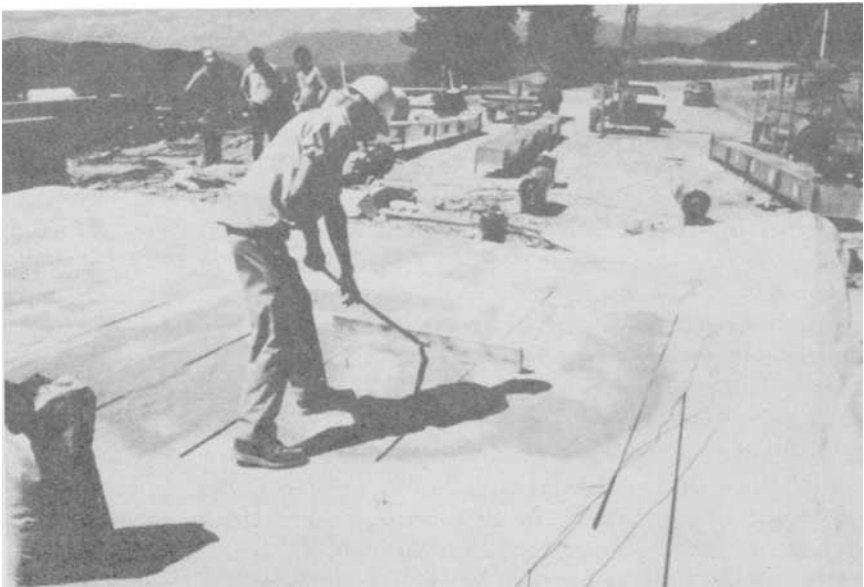
**FIG. 3—***Removal of sand layer after the partial impregnation of a cast-in-place bridge deck.*

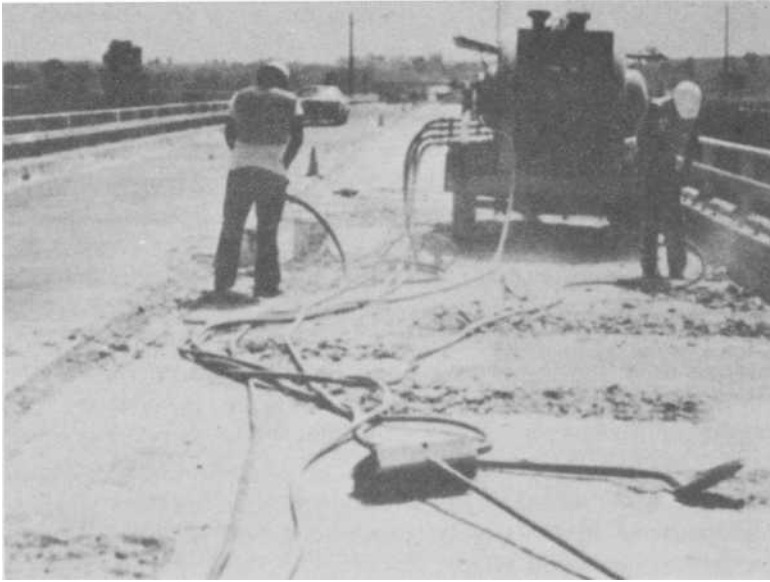
**FIG. 1—Pneumatic hammers (#30 maximum) used in initial removal of unsound concrete.**

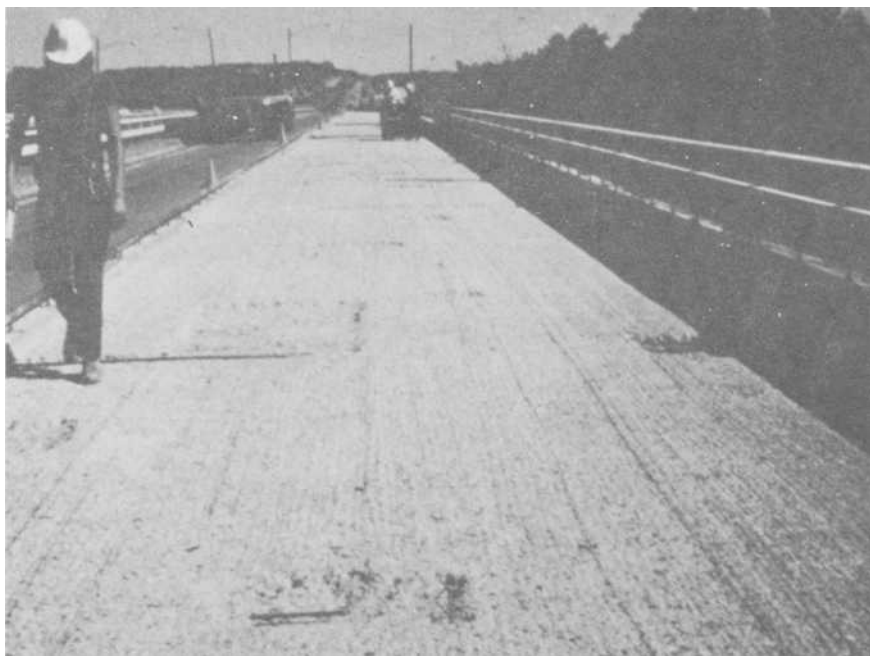
FIG. 3—Floor ready for resurfacing. Areas of unsound concrete removed and remaining concrete scarified.

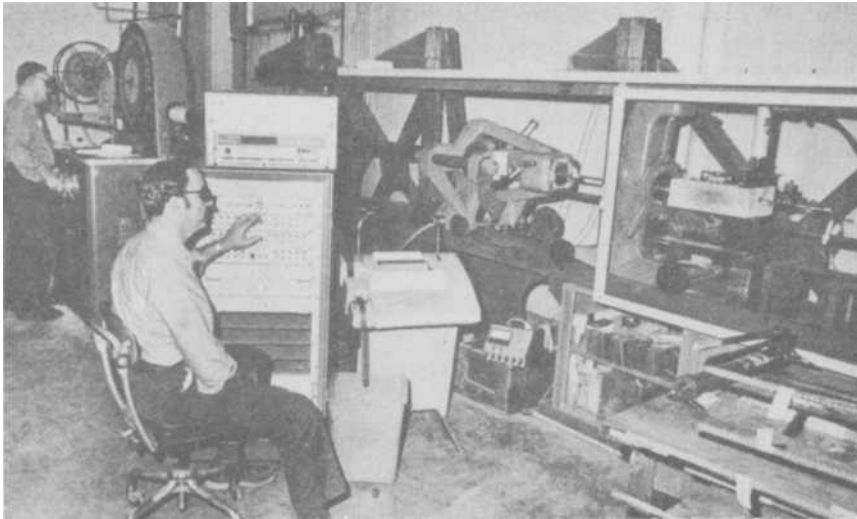
FIG. 4—Overall view of equipment used for conducting load-strength tests on stub-cantilever-beam specimens.

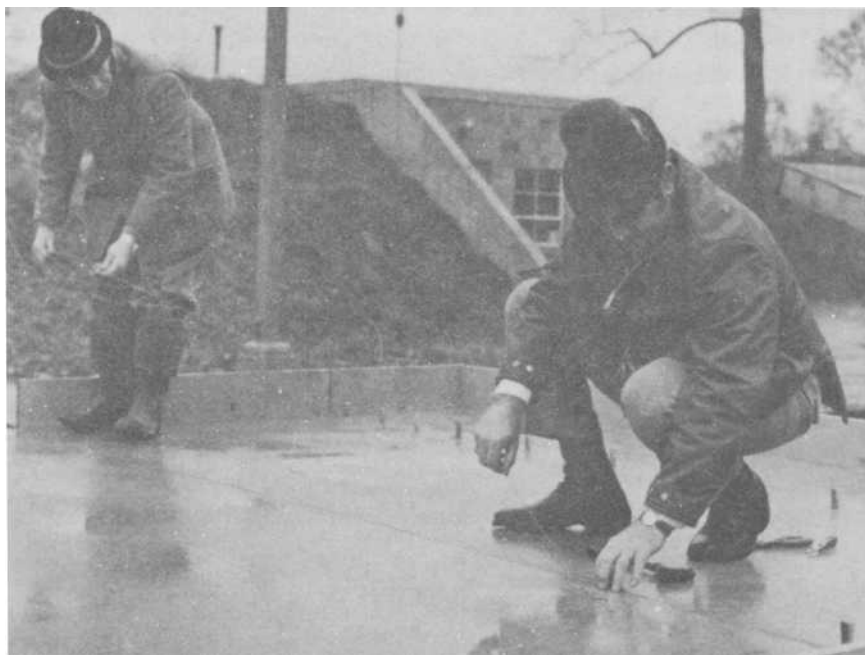
FIG. 12—Installation of the platinum-surfaced niobium wire anode into a groove cut in prototype bridge deck.

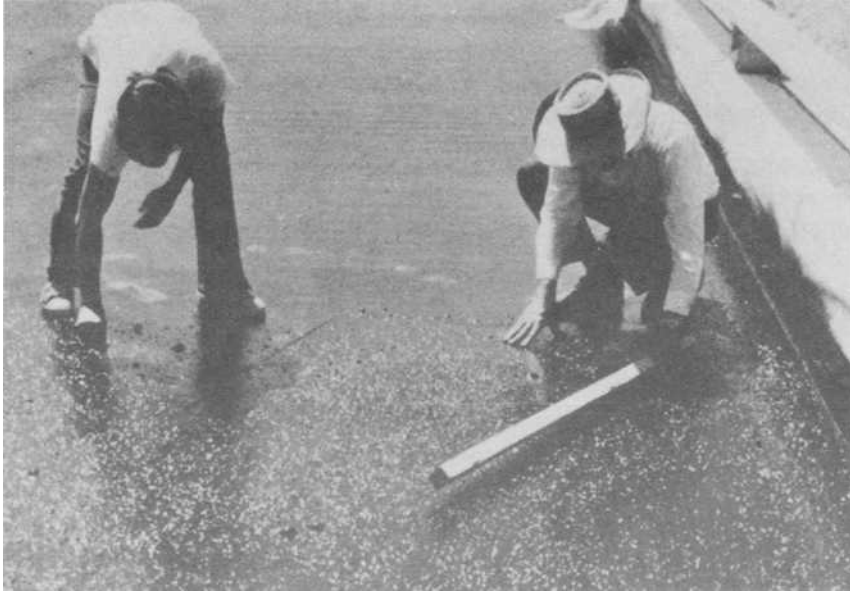
FIG. 2—Comparison of membrane sprayed over heated and unheated deck. Time: 9 to 9:30 a.m.
