# DAMAGE IN COMPOSITE MATERIALS

# DAMAGE IN COMPOSITE MATERIALS: BASIC MECHANISMS, ACCUMULATION, TOLERANCE, AND CHARACTERIZATION

A symposium  
sponsored by ASTM  
Committees E-7 on  
Nondestructive Testing  
and E-9 on Fatigue  
Bal Harbour, Fla., 13-14 Nov. 1980

ASTM SPECIAL TECHNICAL PUBLICATION 775  
K. L. Reifsnider, Virginia Polytechnic  
Institute and State University, editor

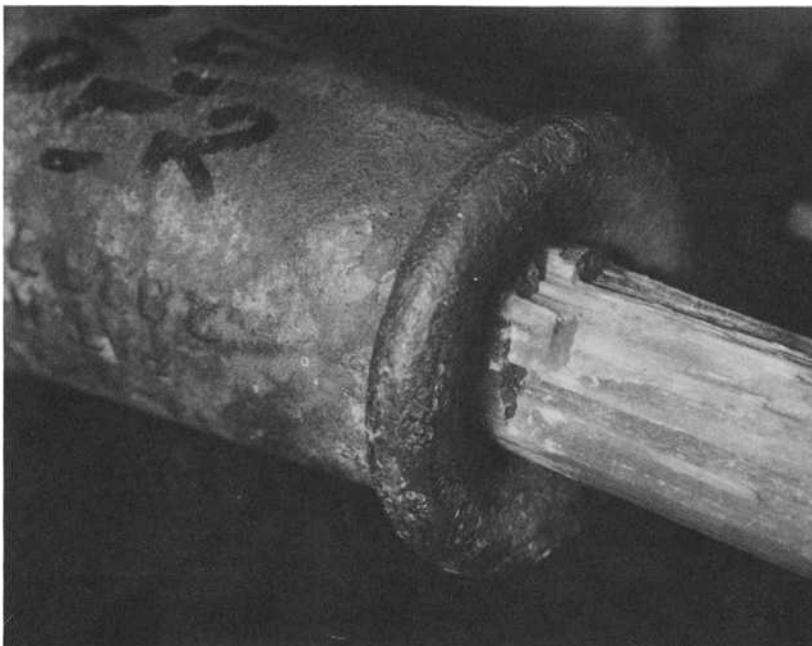
FIG. 2.—*Pultruded guy which failed near one of its end fittings.*

Because of our involvement it was not uncommon that, when failures of rods occurred in service, the failed pieces were sent to us for examination. It was in this way that we became aware of a very unusual failure mode that sometimes appeared. Figure 2 shows one of these, in which the rod fractured near one of its end fittings. Note the surprisingly smooth fracture surfaces normal to the fiber direction. This failure mode is entirely different from anything we had seen in the laboratory, where fracture surfaces were invariably jagged and involved considerable brooming of the fibers.

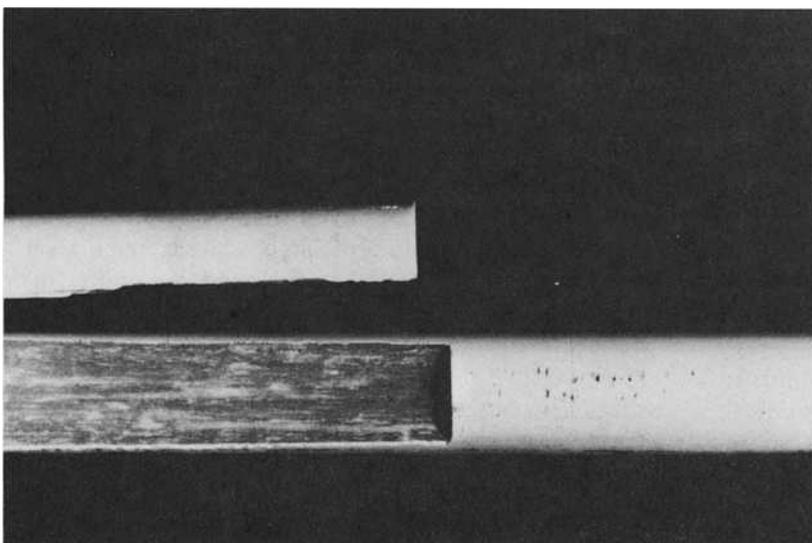
FIG. 3.—*Pultruded guy which failed at some distance from its end fittings.*

Figure 3 shows a pultruded guy which had failed at some distance from its end fittings. The fracture surface normal to the fibers again looks as though it had been made with a fine saw. Upon closer examination, however, it became clear, as shown in Fig. 4, that the fracture surface through the epoxy coating was, in fact, considerably smoother than the fracture surface through the fibers.

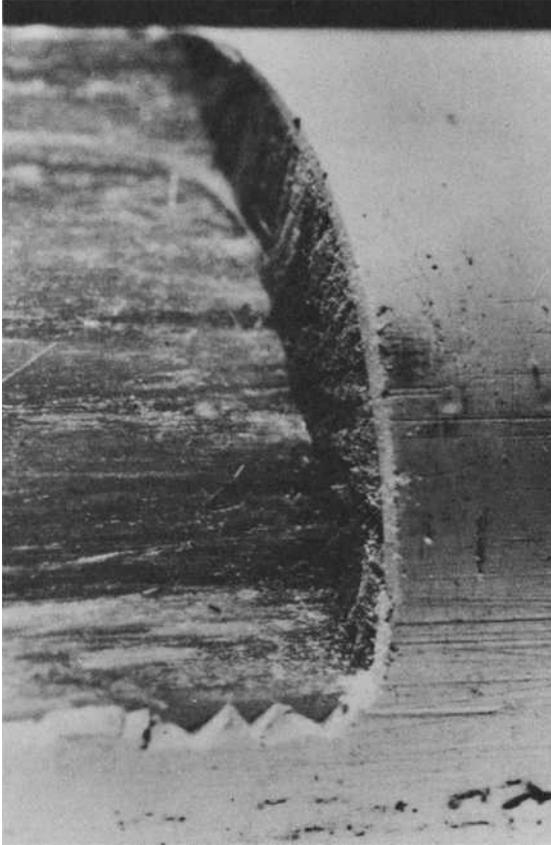
FIG. 4—Fracture surface on the pultruded guy shown in Fig. 3.

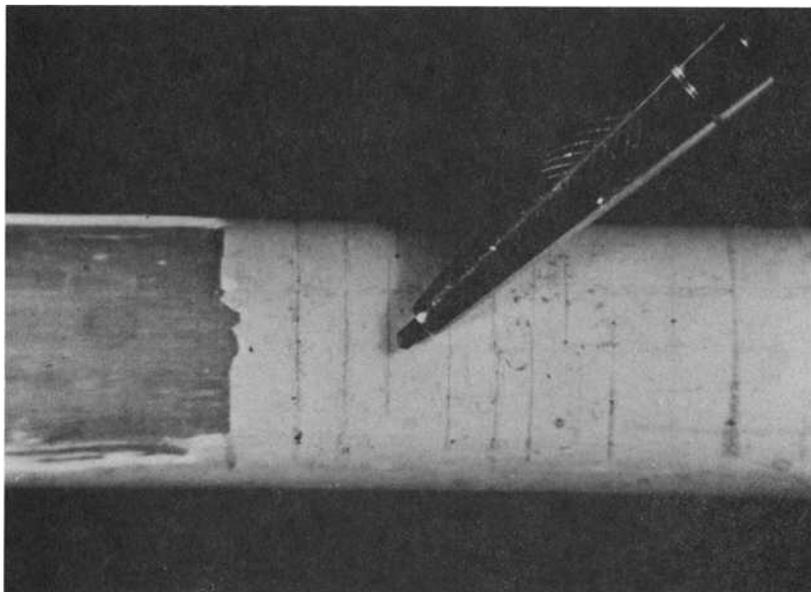
FIG. 5—Pultruded guy which failed at some distance from its end fittings, exhibiting transverse hairline cracks.

bending and buckling tests, and we conducted fatigue and creep rupture tests in all types of simulated environments, but we were unable to reproduce this failure mode in the laboratory. Then, one day, we received from the field the failed rod shown in Fig. 5. This rod exhibited the same type of fracture surface normal to the fibers, but it showed us something we had not noted previously—a series of hairline cracks normal to the rod axis. This led us to suspect that the hairline cracks represented a form of damage which, if undetected, could propagate into relatively smooth transverse fractures. But what caused the hairline cracks?

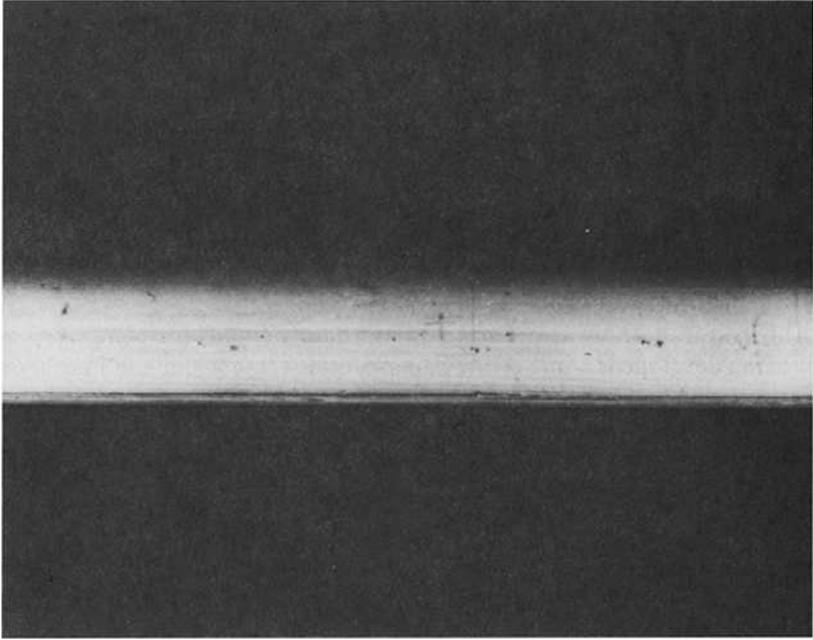
FIG. 6—Pultruded rod specimen with three transverse hairline cracks that were produced in the laboratory by a shock tension load followed by an incubation period. (The horizontal black line along the lower surface of the specimen is a scuff mark.)

The next morning one of our technicians went to remove the rod from the testing machine and found, to our surprise, three transverse hairline cracks in the specimen, as seen in Fig. 6. By applying a gradually increasing tensile load to the rod in this condition, the hairline cracks began to propagate into transverse fractures, shown in Fig. 7, of the kind we had been seeking to generate for so long. In subsequent work we were able to show that the kind of damage represented by the hairline cracks could be produced in certain kinds of coated pultruded rod by a shock tension load followed by an incubation period of several minutes or hours.

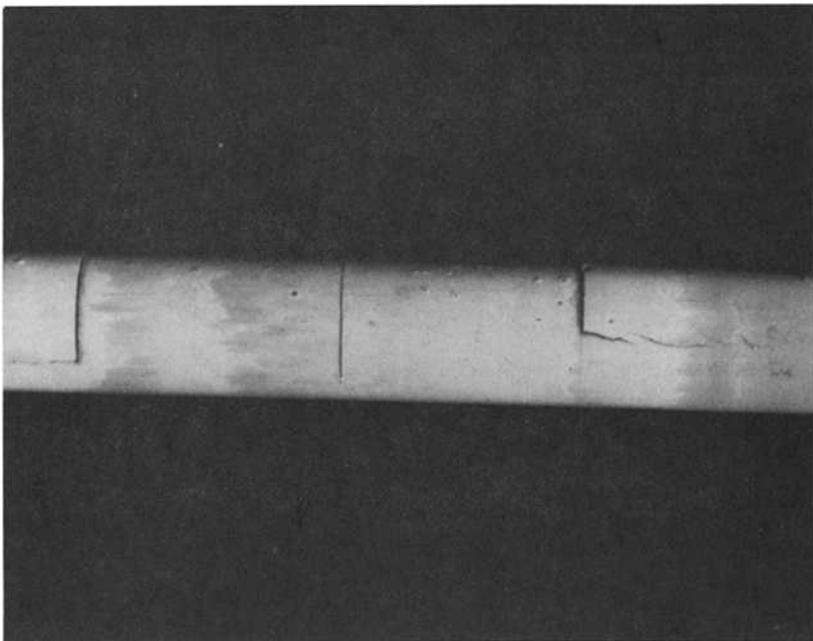
FIG. 7—The pultruded rod specimen from Fig. 6 during a subsequent tension test.

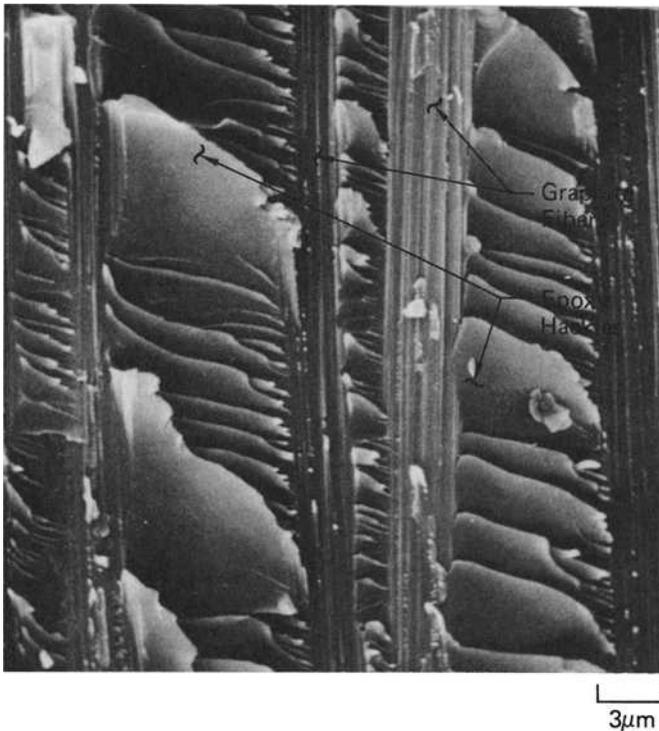
FIG. 1—Hackles (fractured epoxy) and graphite topographic features on an overload fracture surface of graphite/epoxy composite.

One technique has been reported for determining fracture directions and locating fracture origins for Gr/Ep laminates that fail by overload.<sup>2</sup> When Gr/Ep composites fail, the fracture surfaces are comprised of the graphite fiber and epoxy matrix components. For overload failures, the fractured epoxy matrix most often has a characteristic overlapping platelet topographic feature, shown in Fig. 1, that has been termed both hackles and lacerations.<sup>3</sup> The way that hackles overlap has been interpreted to determine the fracture directions for the various exposed plies of a failed Gr/Ep composite. In addition, the fracture directions have been traced back to fracture origin locations. These are the first two required steps for conducting a failure analysis of metals,<sup>4</sup> graphite/epoxy, or any other failed material. Graphite/epoxy components are subjected to the same static and cyclic service loads as the

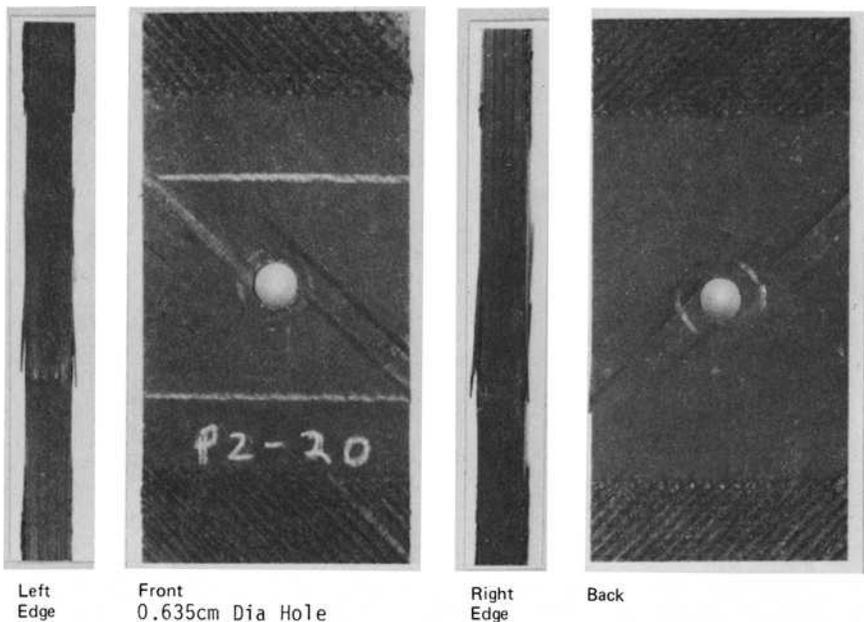
FIG. 3—Four views of the failed graphite/epoxy tension-compression fatigue specimen.

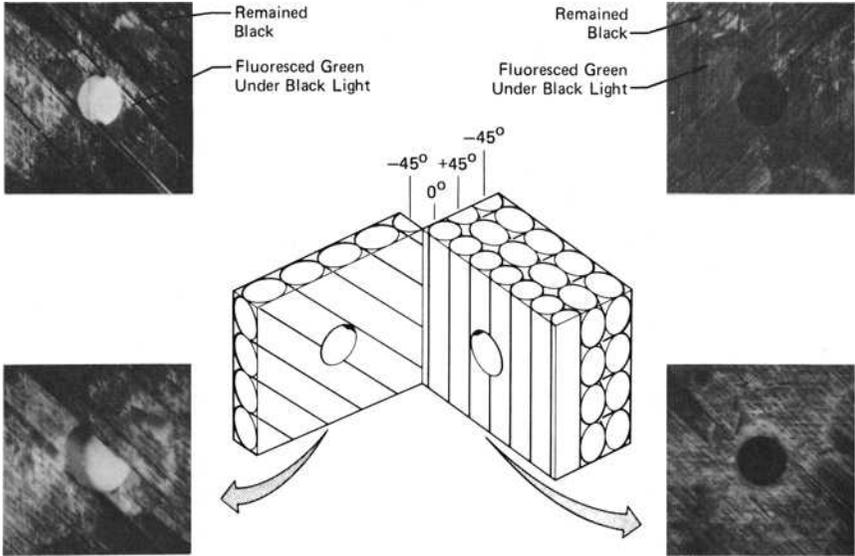
FIG. 6—Comparison between white light (top) and black light (bottom) appearances of mating fracture surfaces of a graphite/epoxy tension-compression fatigue specimen.

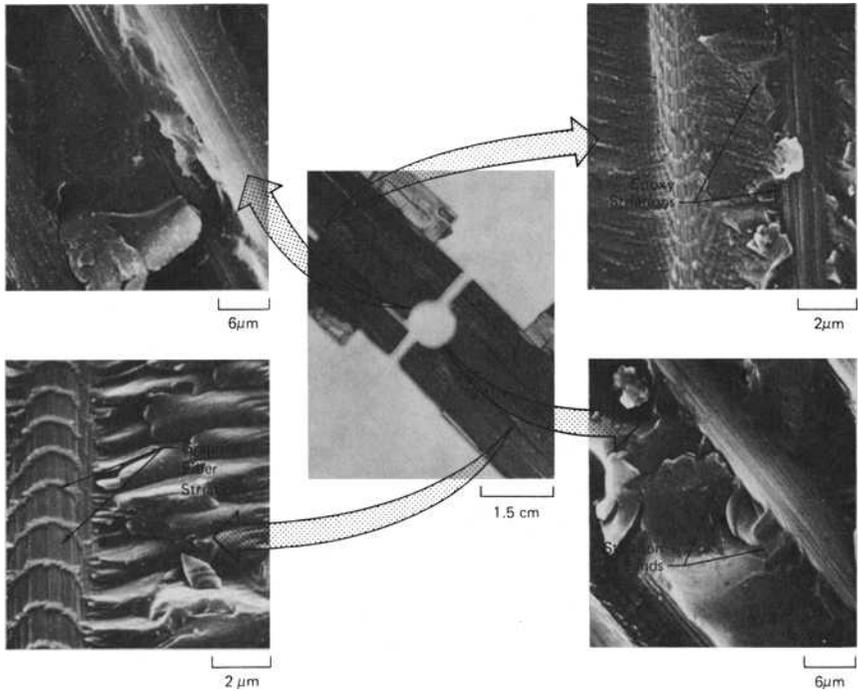
FIG. 7—Variations in fatigue striation morphology.

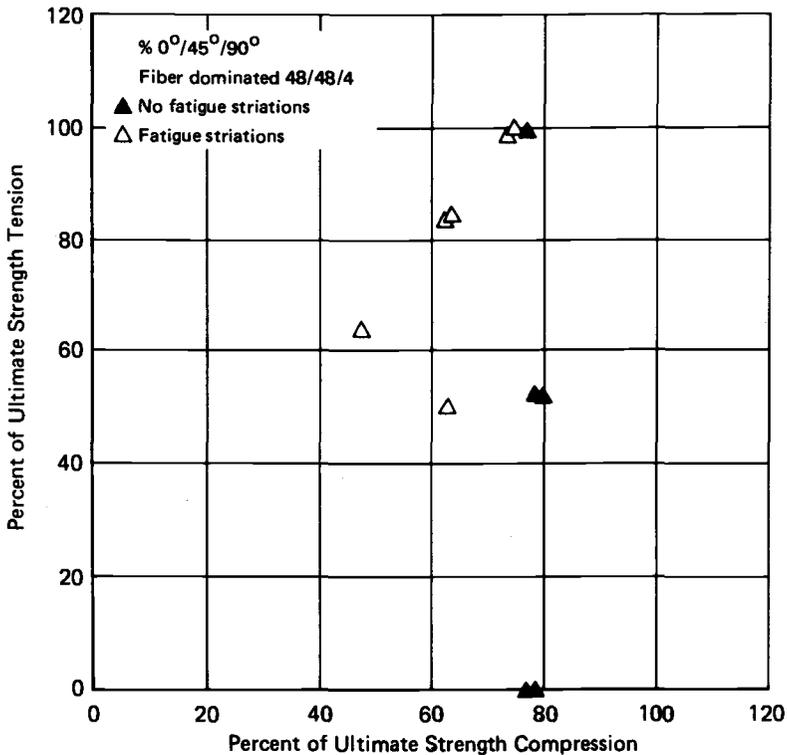
FIG. 9—Graph showing the presence or absence of striation topographic features for fiber dominated fatigue test specimens.

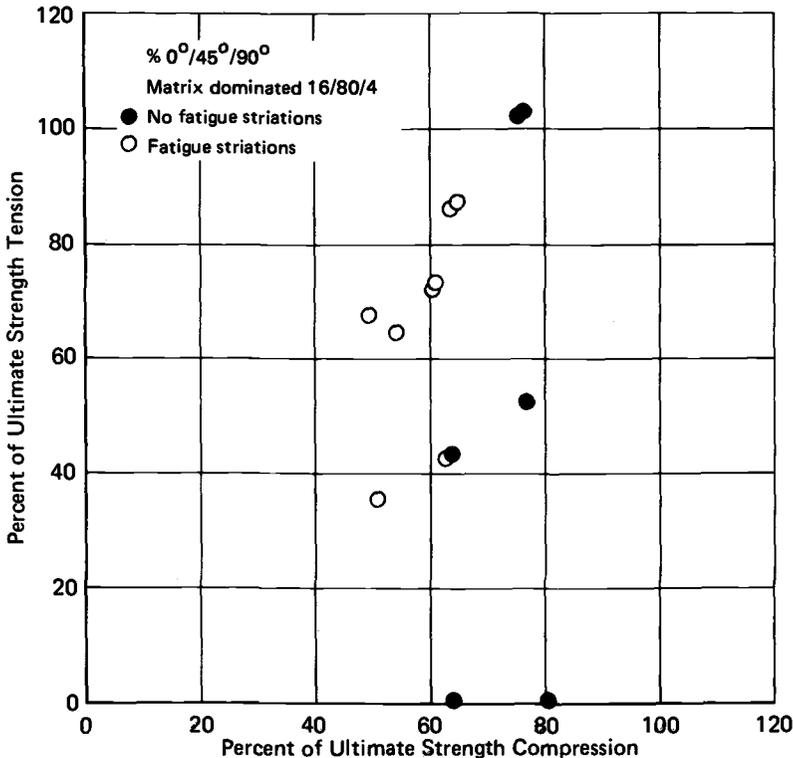
FIG. 10—Graph showing the presence or absence of striation topographic features for matrix dominated fatigue test specimens.

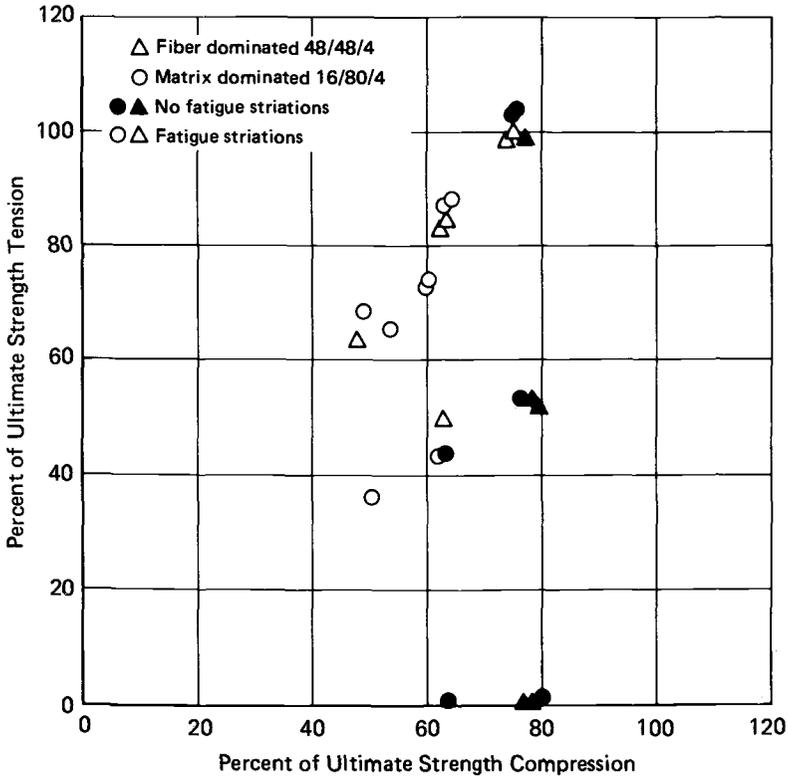
FIG. 11—Plot of combined fiber and matrix dominated fatigue test specimens.

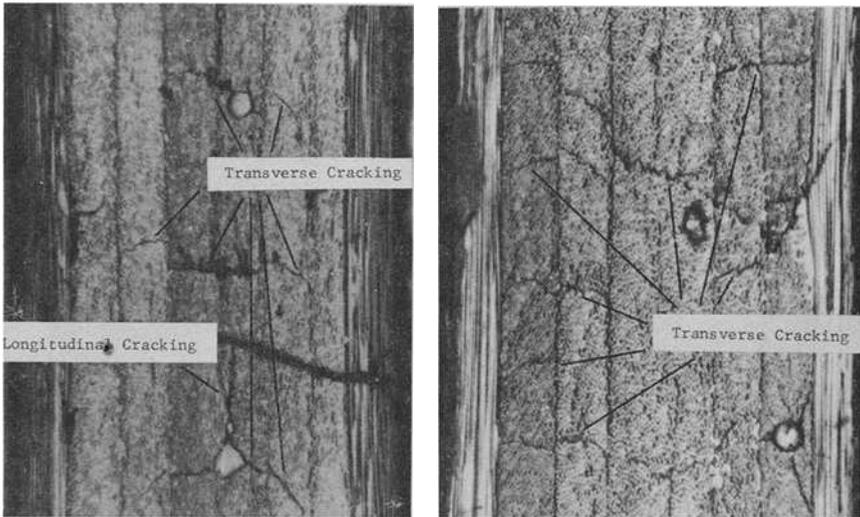
FIG. 2—Photomicrographs of replicas showing details of damage development: (left)  $[0/\pm 45/90]_s$  laminate and (right)  $[0/90/\pm 45]_s$  laminate.

In the  $[0/+45/-45/90]_s$  (Type I) laminates, the number of transverse cracks in the 90-deg lamina increased until a uniform pattern of periodically spaced cracks was formed over the entire length of the specimen. As the load increased, transverse cracks appeared in the  $-45$ -deg laminae (terminating at the lamina interfaces), again reaching a saturation crack spacing (Fig. 2).

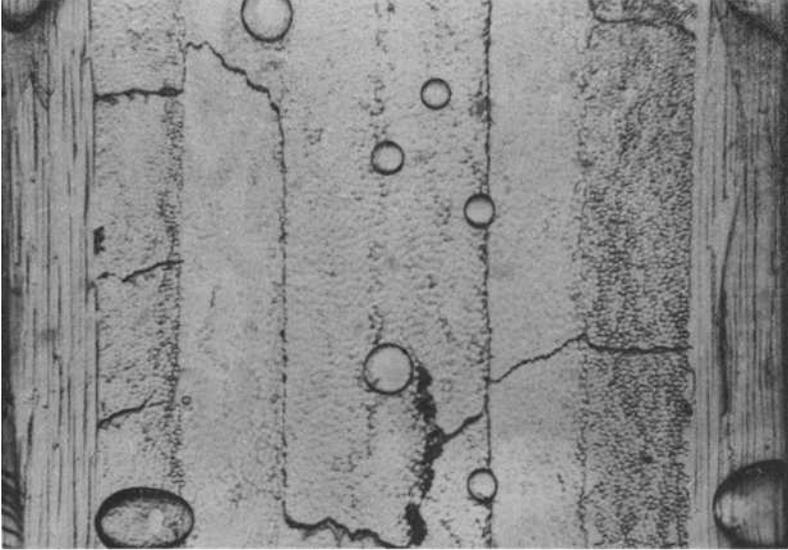
FIG. 5—Fatigue damage features in  $[0/90/\pm 45]_s$  laminate.

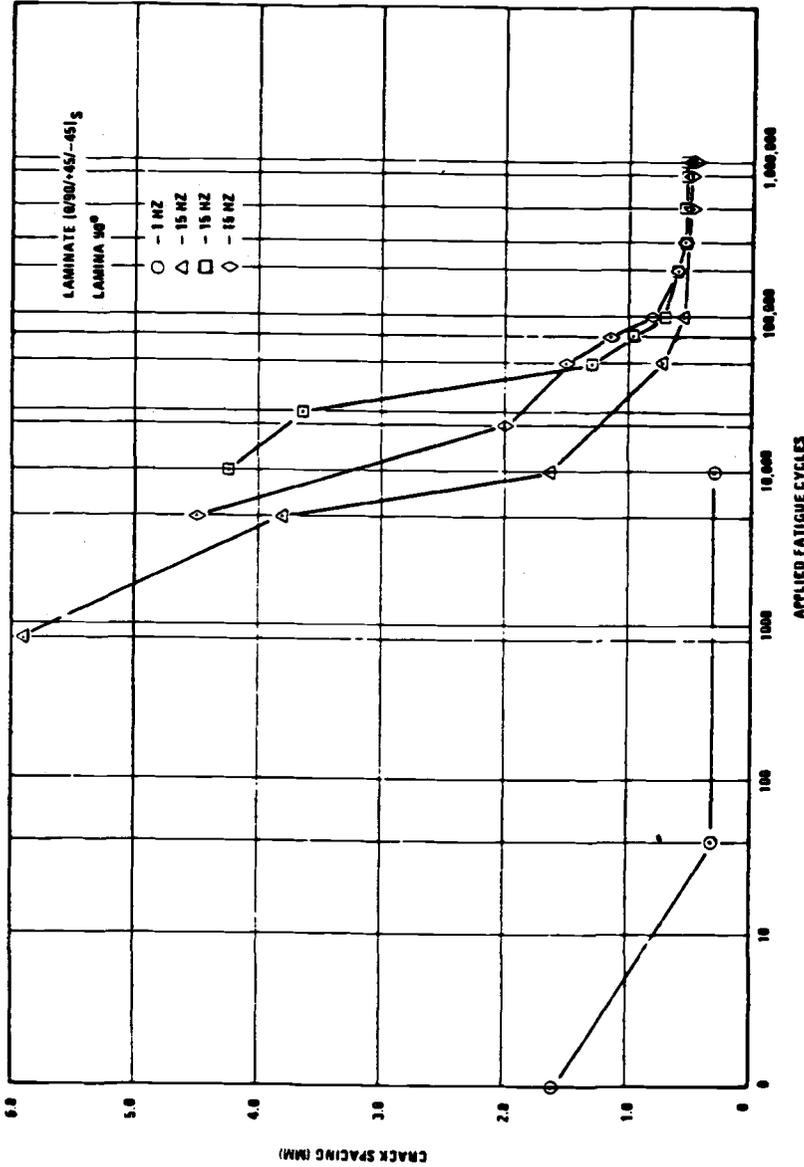
FIG. 22—Frequency dependence of damage development in 90-deg plies of [0/90/±45]<sub>s</sub> laminates.

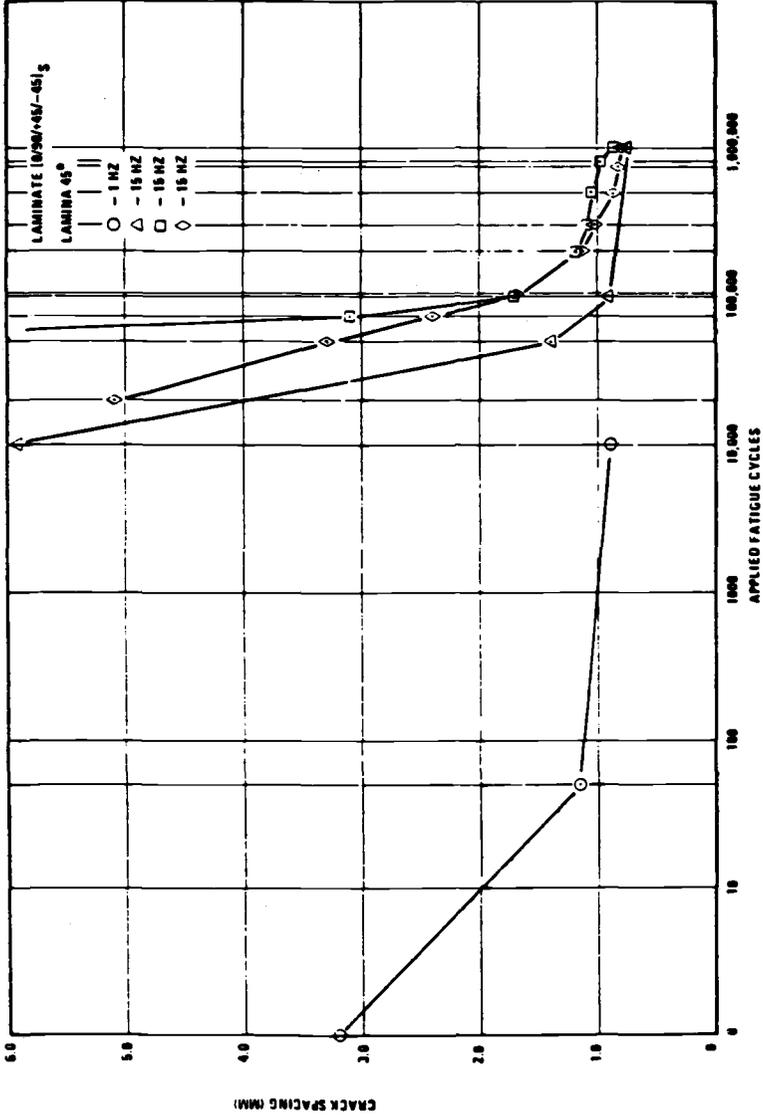
FIG. 23—Frequency dependence of damage development in 45-deg plies of [0/90/±45]<sub>s</sub> laminates.

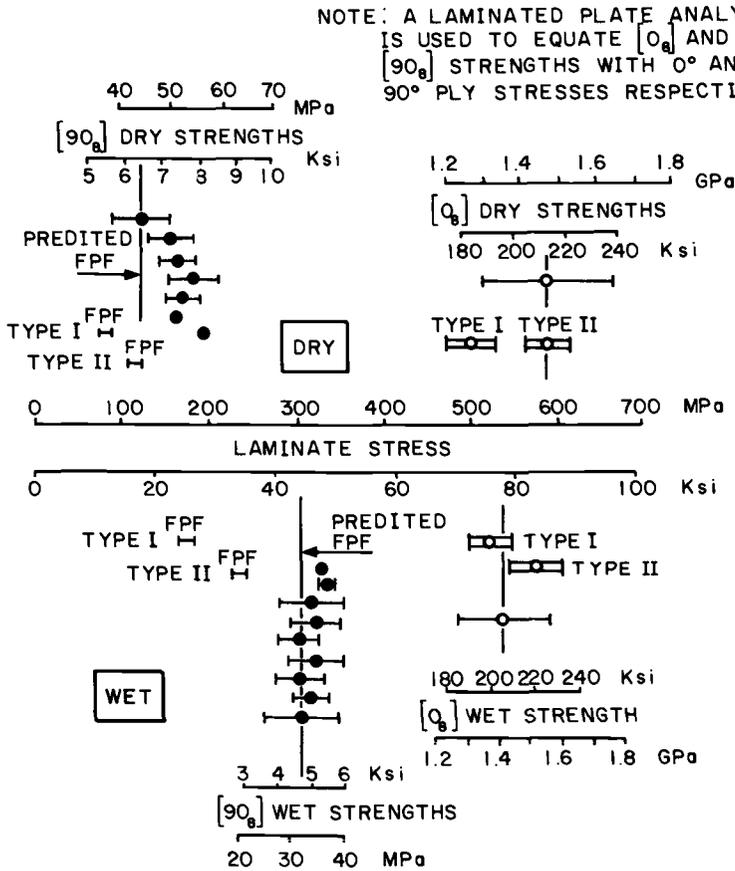
FIG. 4—Correlation of wet and dry  $[0_a]$  and  $[90_a]$  strengths with 0/90 laminate ply stresses.

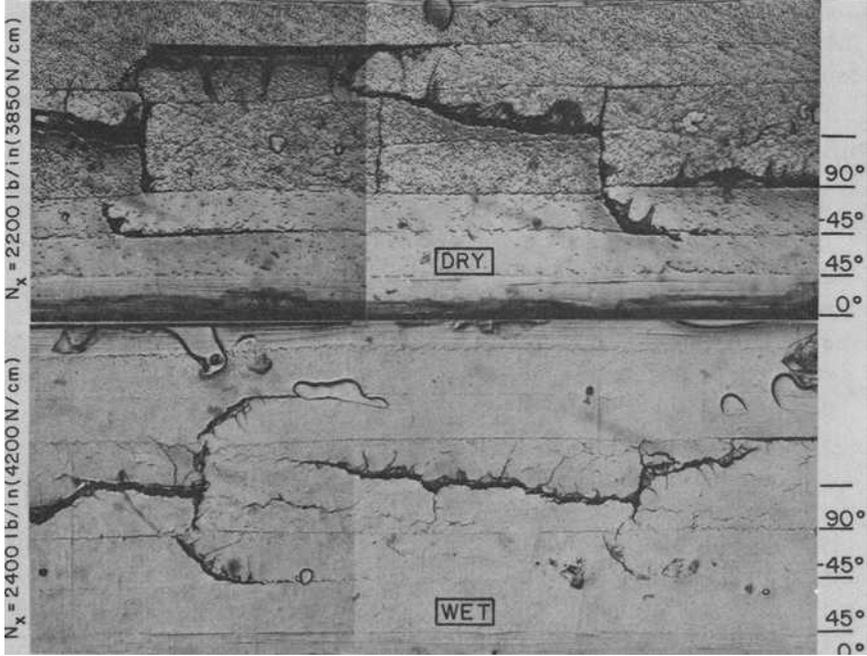
FIG. 7—Wet and dry characteristic damage state at the  $[0/\pm 45/90]$  laminate edge ( $\times 50$ ).

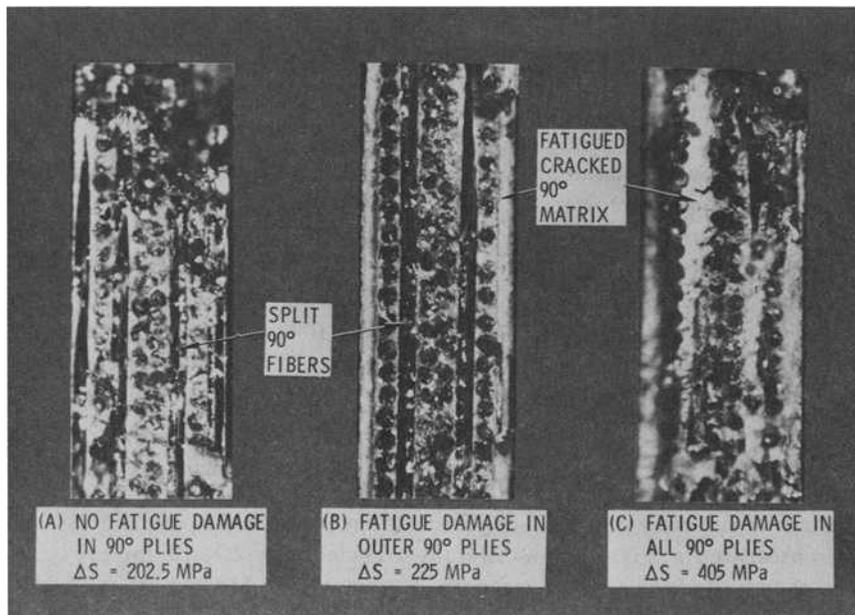
FIG. 11—Fracture surfaces indicating the degree of fatigue cracking present,  $[90/0]_{2s}$ ,  $R = 0.1$ .

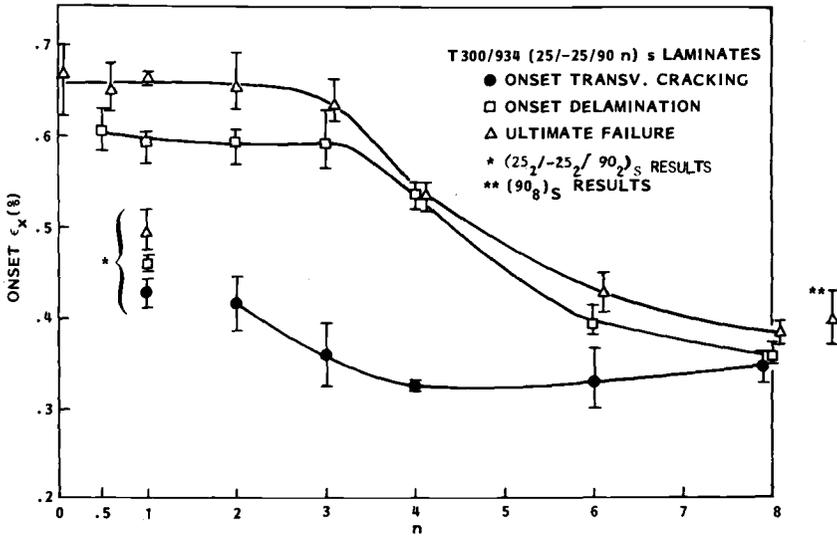
FIG. 1—Observed tensile strain  $\epsilon_x$  for transverse cracking, delamination, and ultimate failure versus the number of 90-deg plies in T300/923 laminates.

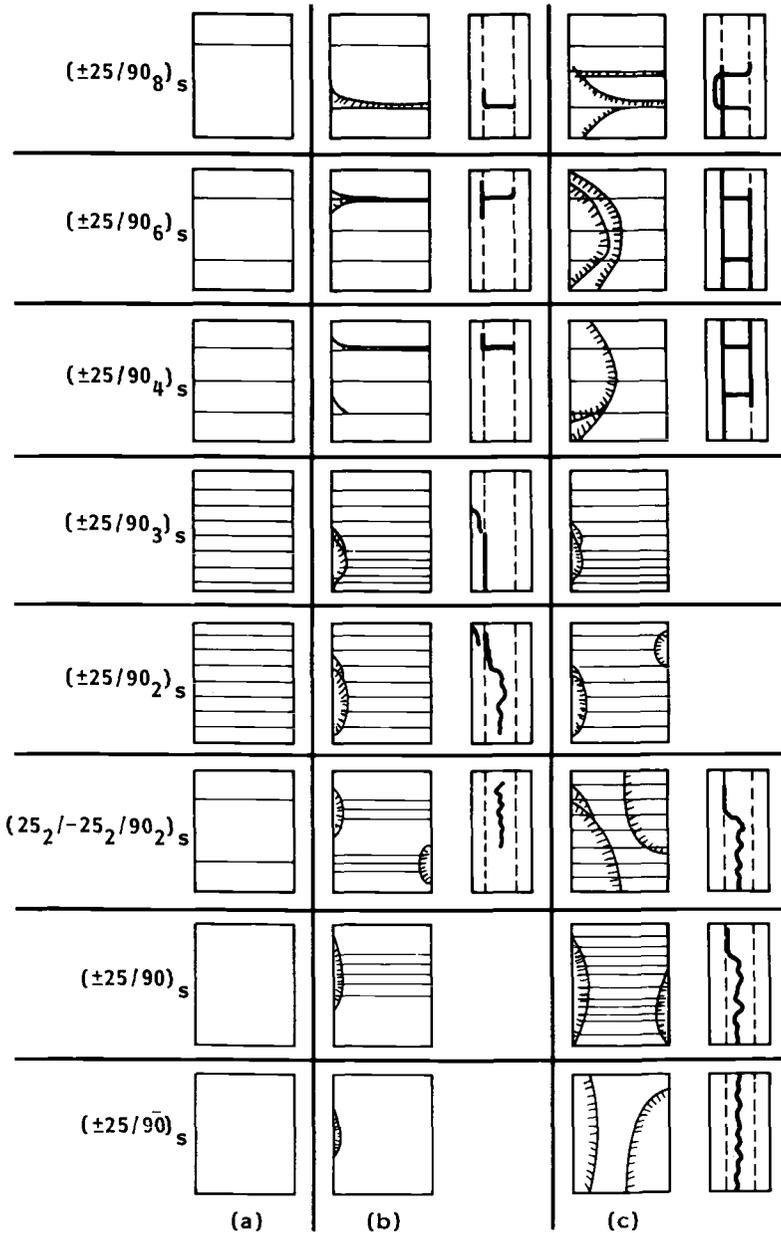
FIG. 2—Schematic of the fracture sequence in  $(25/-25/90_n)_s$  laminates: (a) just prior to delamination; (b) subsequent to delamination; and (c) just prior to final failure.

Figure 2 provides a schematic view of the sequence of fracture in these laminates. Referring to Fig. 1 for the appropriate tensile strain, Column a shows the degree of transverse 90-deg cracking just prior to the initiation of delamination as viewed on radiographs of the specimen width. Column b shows specimen width and edge views (dotted lines are the 25/90 interfaces viewed on edge) immediately after edge delamination is observed. Column c shows the area occupied by delamination and the type of delamination immediately prior to final failure. Transverse cracks are displayed only in the edge views when they are associated with the initiation of a local 25/90 delamination at the transverse crack tip. Before describing the fracture sequence of each laminate in more detail the following general observations are made:

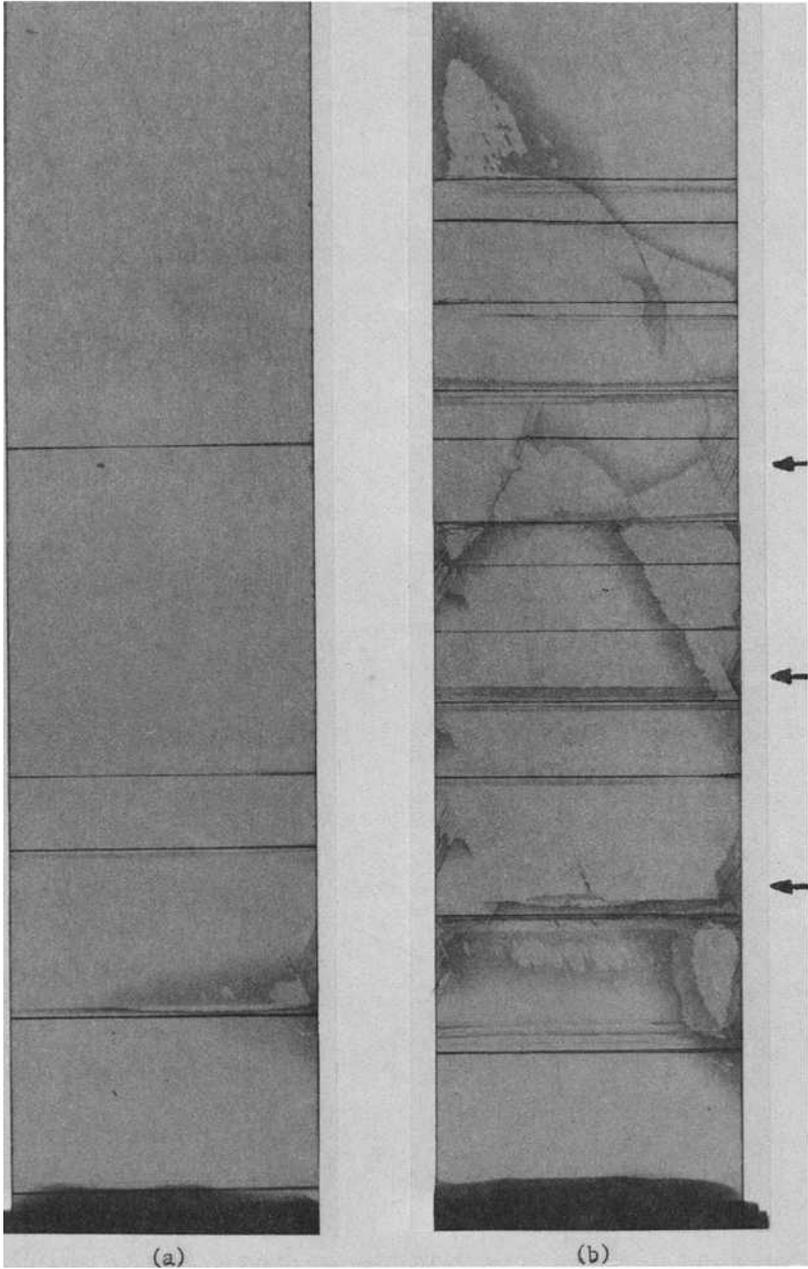
FIG. 3—DIB X-radiographs of  $(25/-25/90)_k$  Specimens A 8-1 and B 8-2 after tensile straining to 0.38 percent. Specimen width is 2.5 cm in all radiographs.

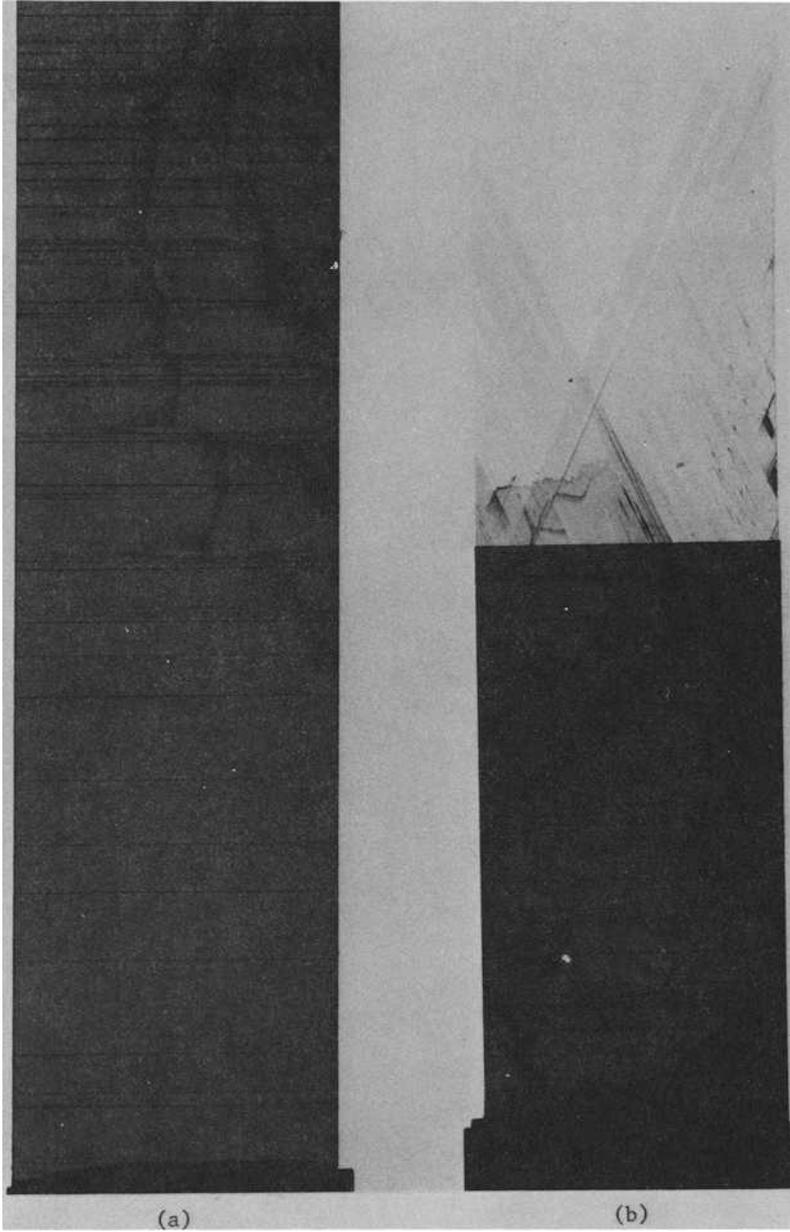
FIG. 4—DIB X-radiograph of  $(25/-25/90)_6$ , Specimens A 6-7 and B 6-9 after tensile straining to 0.41 percent and 0.45 percent, respectively.

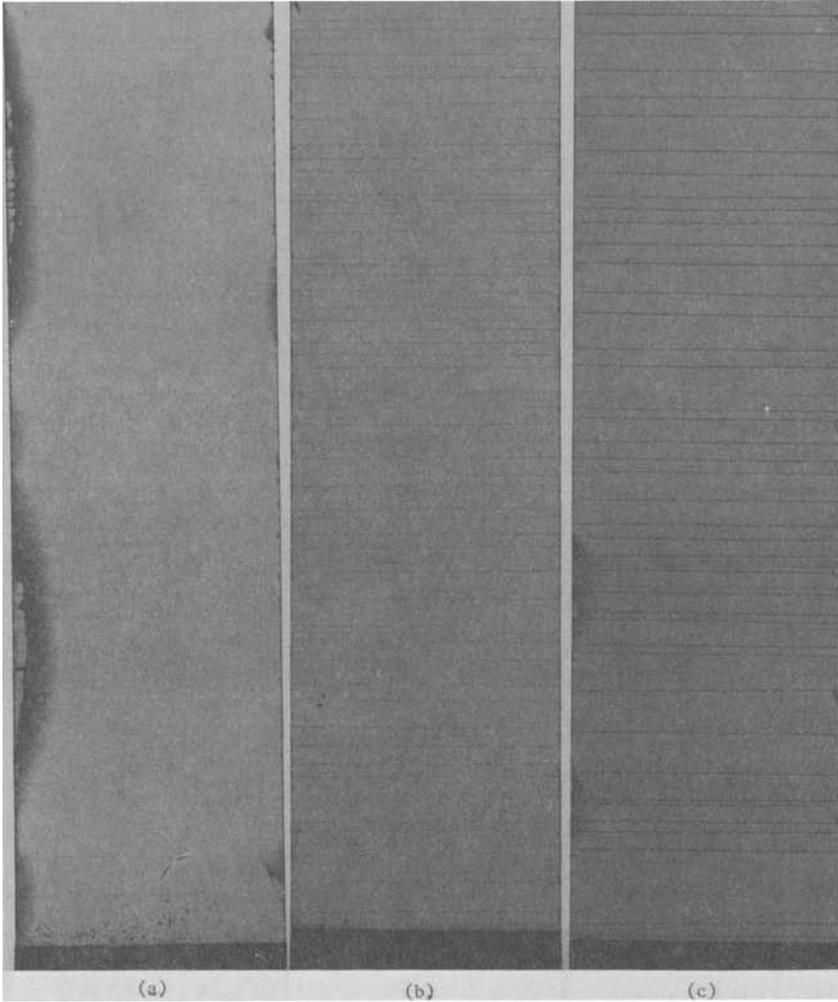
FIG. 5—DIB X-radiograph of (a)  $(25/-25/90)_s$  Specimen 5-4 after  $\epsilon_x = 0.67$  percent, (b)  $(25/-25/90_2)_s$  Specimen 7-4 after  $\epsilon_x = 0.61$  percent, and (c)  $25/-25/90_3)_s$  Specimen 8-4 after  $\epsilon_x = 0.59$  percent.

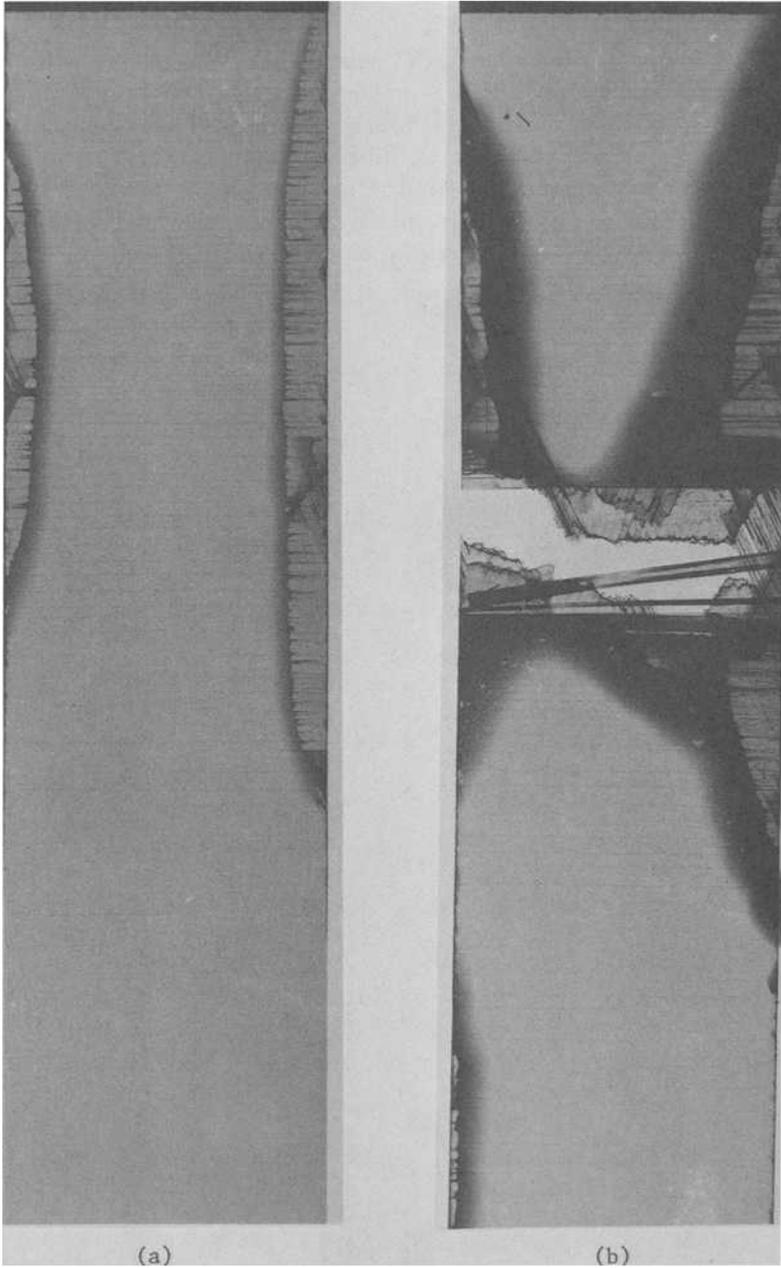
FIG. 6—DIB X-radiograph of  $(25/-25/90)_8$  specimen after (a)  $\epsilon_x = 0.64$  percent and (b)  $\epsilon_x = 0.67$  percent.

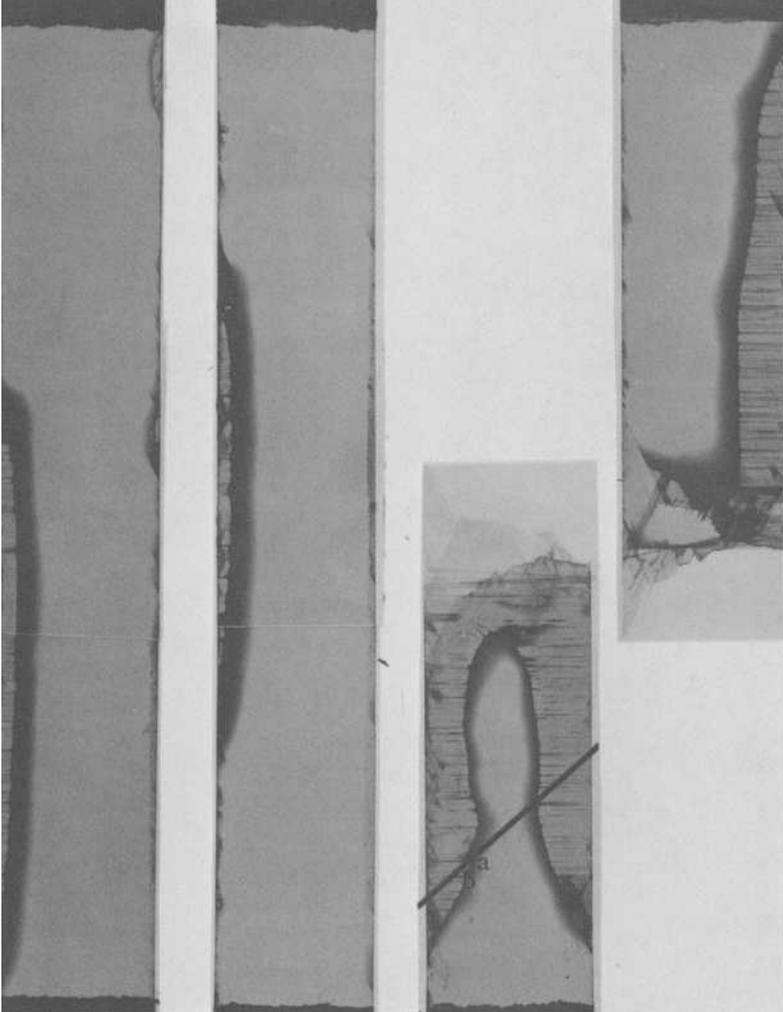
FIG. 7—DIB X-radiograph of  $(25/-25/\overline{90})_n$ . Specimens 11-2, 11-3, and 11-4 (left to right) after  $\epsilon_x = 0.63$  percent. Oblique cut made for microscopic examination of delamination Regions a and b is shown.

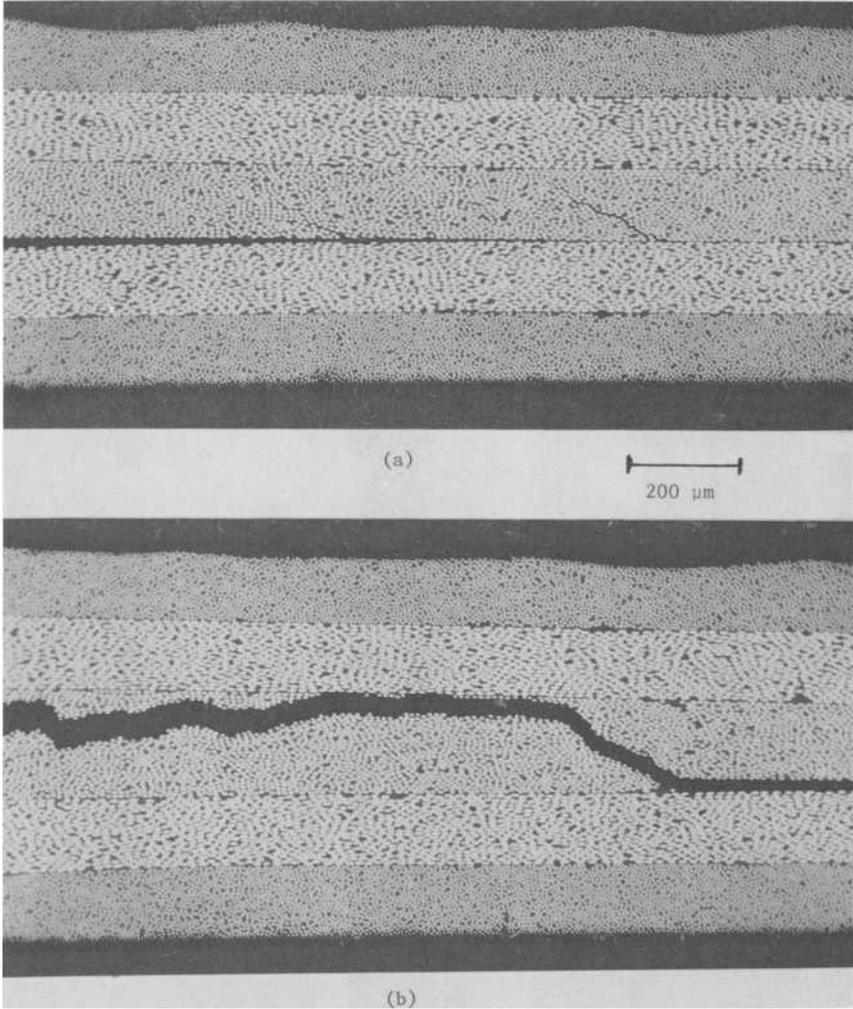
FIG. 8—Microscopic oblique section examination of  $(25/-25/90)_n$ , Specimen 11-4 in delamination Regions a and b. (See Fig. 7.) Original magnification  $\times 100$ .

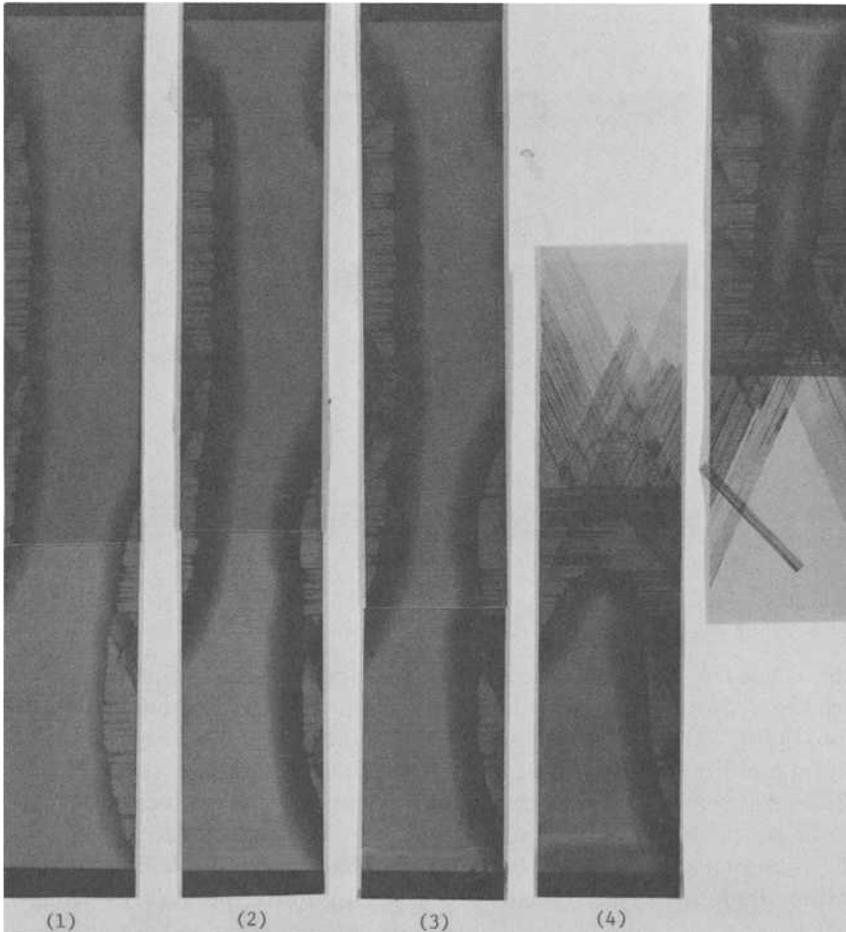
FIG. 9—DIB X-radiographs of  $(25_2/-25_2/90_2)_8$  Specimen D6-6 tensile strained to progressively increasing levels in 13 steps and then cycled 4 times at  $\epsilon_x = 0.49$  percent.

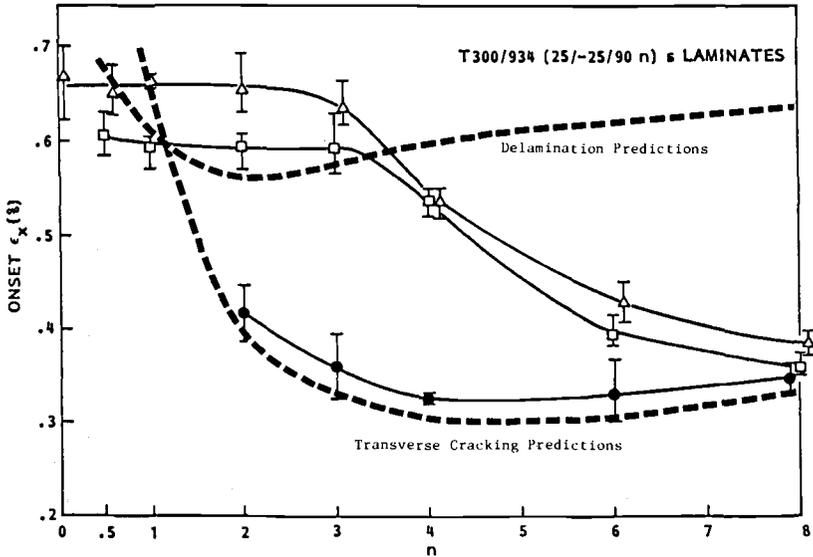
FIG. 12—Comparison of predicted [15] onset strains for transverse cracking and edge delamination to experimental results (see legend in Fig. 1) obtained on  $(\pm 25/90)_n$  T300/934 laminates.

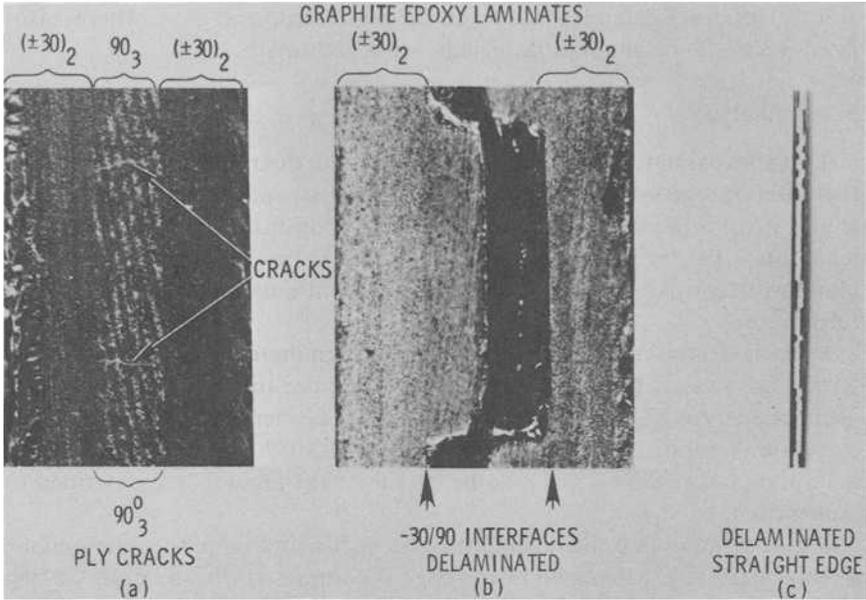
FIG. 3—Damage location through the thickness of  $[\pm 30/\pm 30/90/\bar{90}]_n$  laminates.

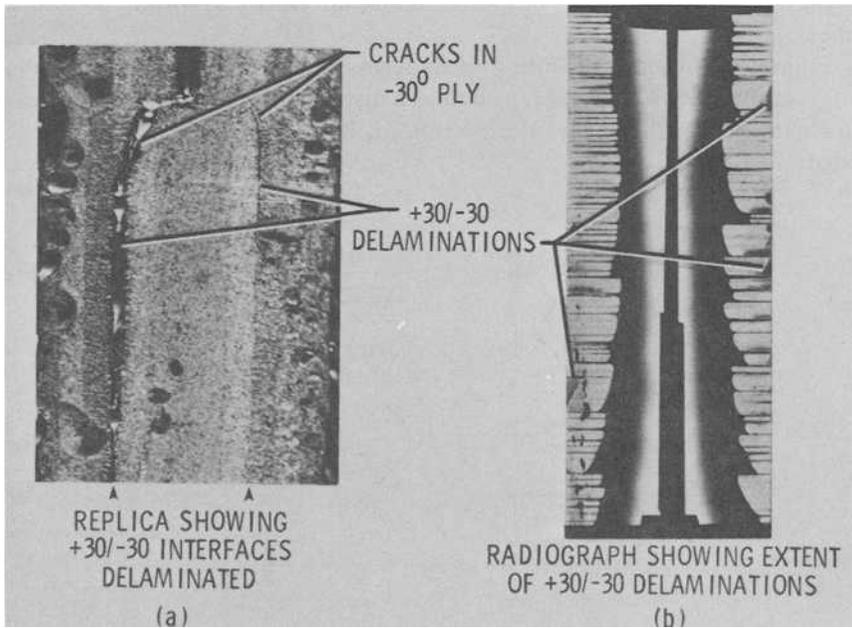
FIG. 4—Delaminations in +30/-30 interfaces.
