# DAMAGE IN COMPOSITE MATERIALS

# DAMAGE IN COMPOSITE MATERIALS: BASIC MECHANISMS, ACCUMULATION, TOLERANCE, AND CHARACTERIZATION

A symposium  
sponsored by ASTM  
Committees E-7 on  
Nondestructive Testing  
and E-9 on Fatigue  
Bal Harbour, Fla., 13-14 Nov. 1980

ASTM SPECIAL TECHNICAL PUBLICATION 775  
K. L. Reifsnider, Virginia Polytechnic  
Institute and State University, editor

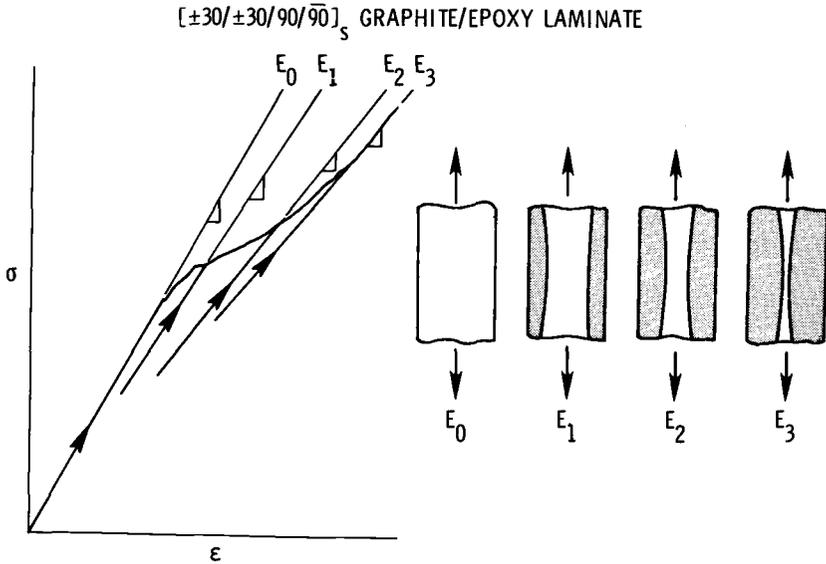
FIG. 8—Delamination size and stiffness data accumulation during quasi-static loading.

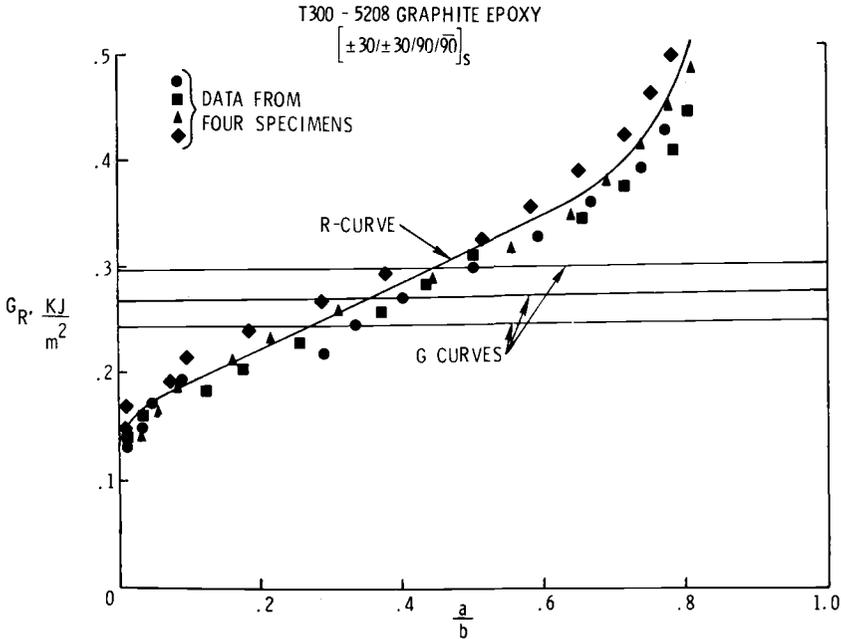
FIG. 13—Delamination resistance curve (R-curve) for  $[\pm 30/\pm 30/90/90]_S$ , T300-5208 graphite-epoxy laminates.

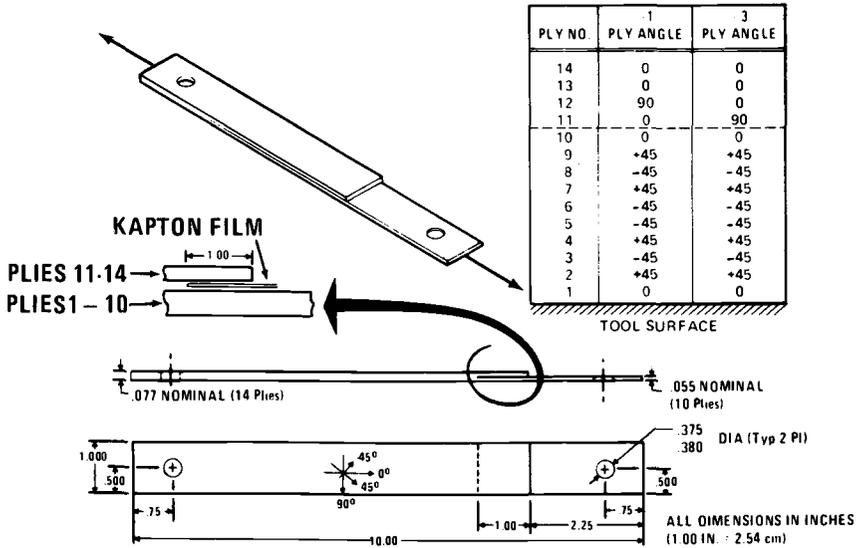
FIG. 2—Mixed-mode coupon.

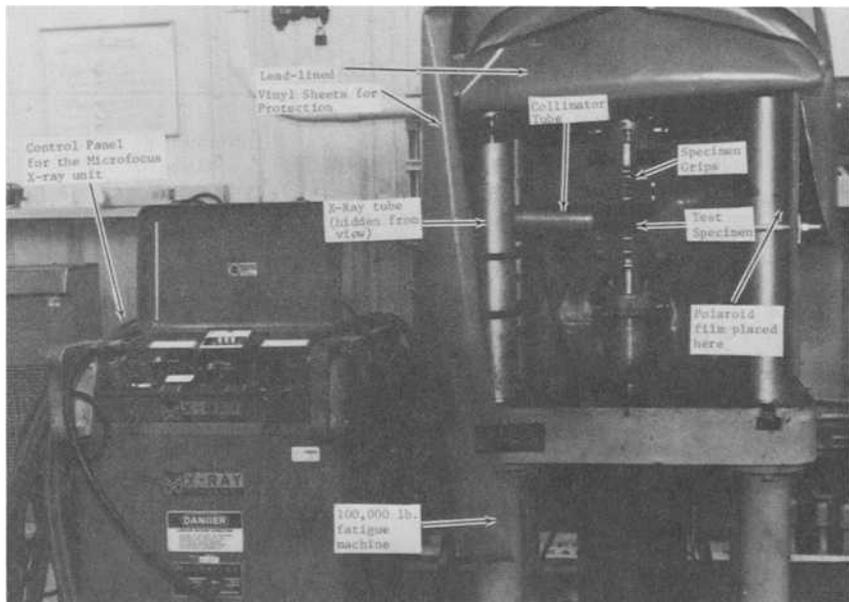
FIG. 2—Compression fatigue test arrangement.

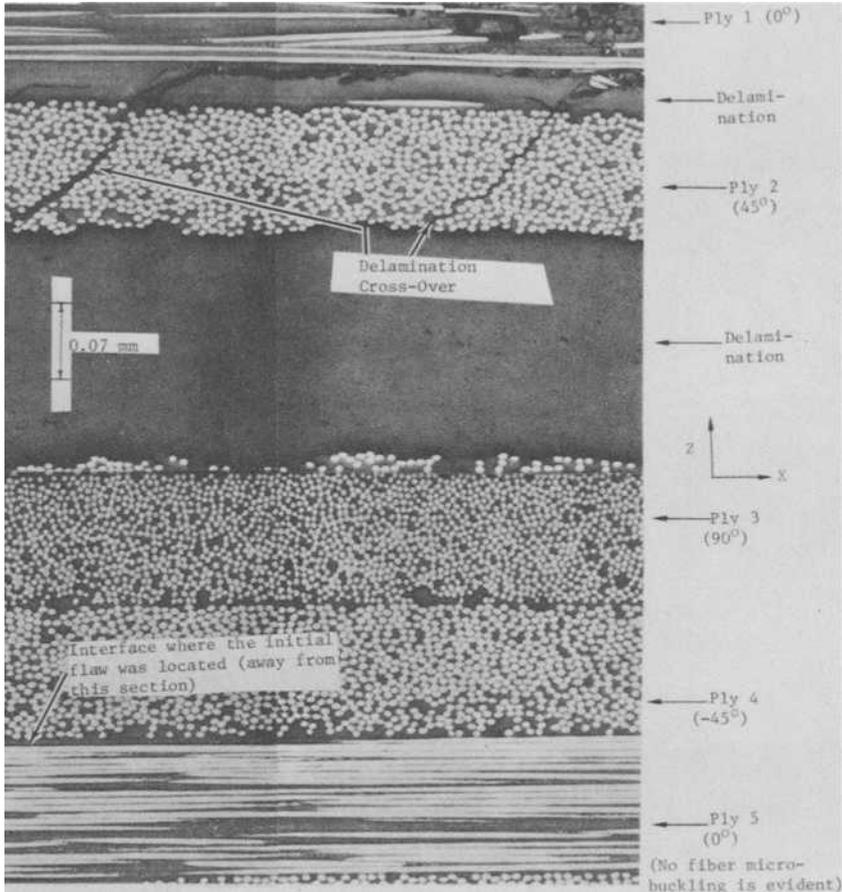
FIG. 3—Photomicrograph of an XZ cross-section of a failed Laminate A specimen (4284-70) from Test Series 14, showing the absence of fiber microbuckling.

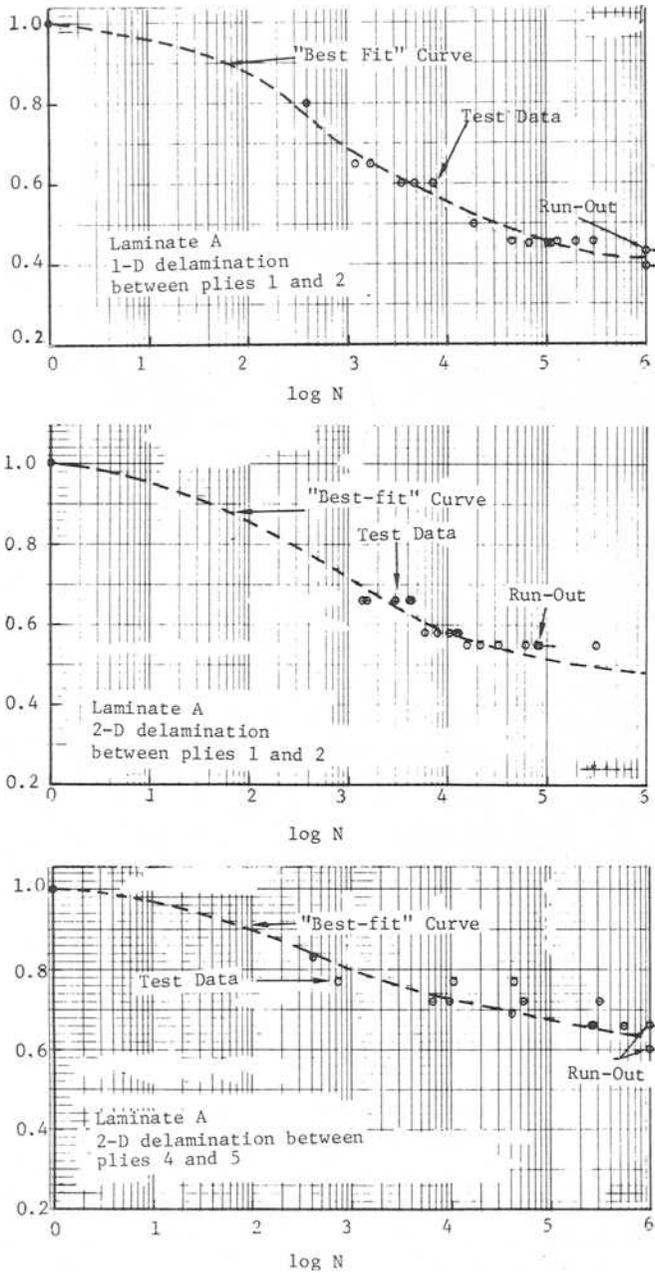
FIG. 4—S-N data for Laminate A.

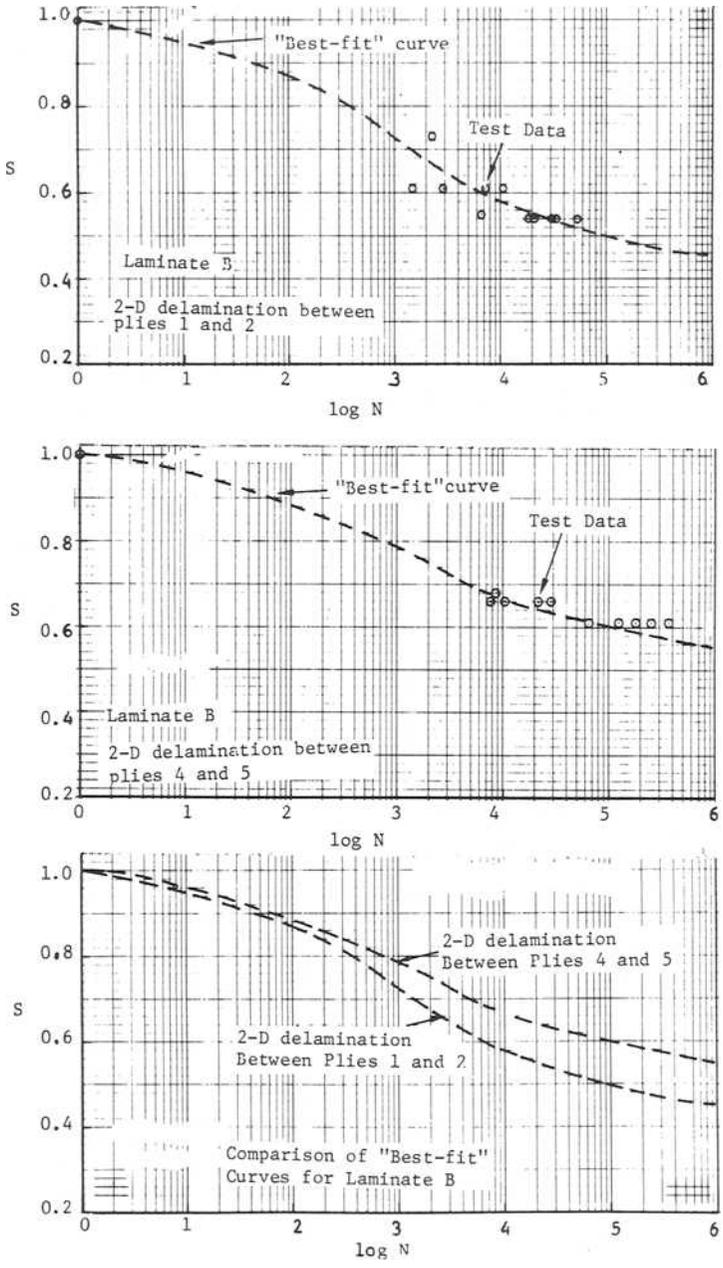
FIG. 6—S-N data for Laminate B.

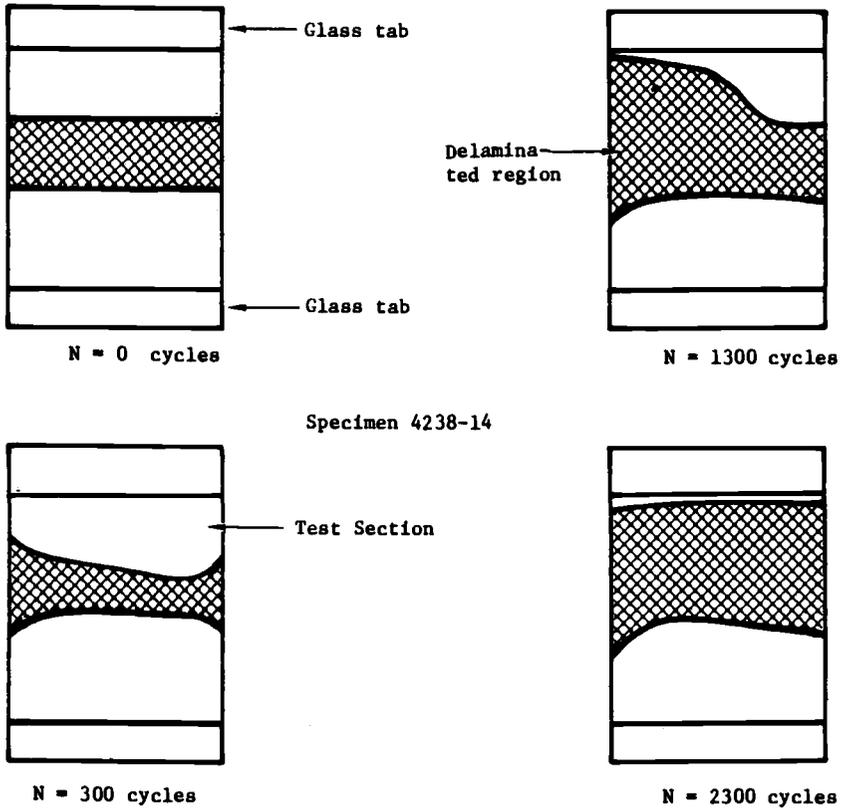
FIG. 8b—Outline of the delamination boundaries in the radiographs shown in Fig. 8a.

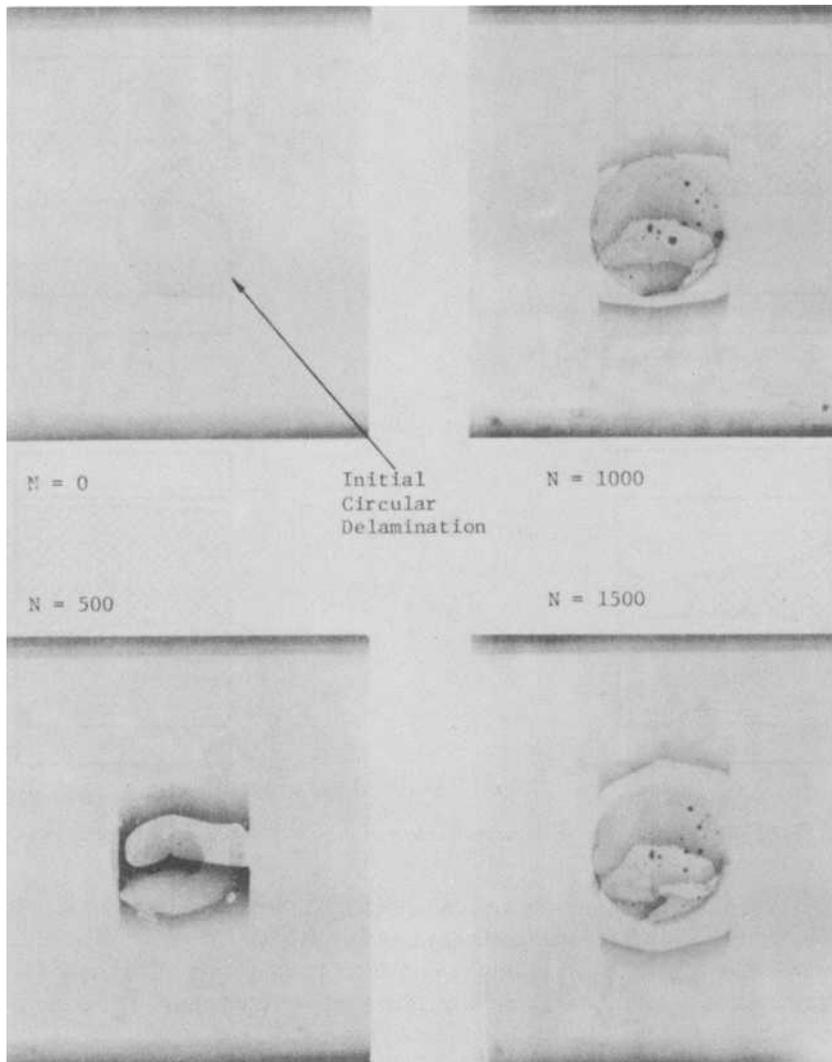
FIG. 9a—Delamination growth in Specimen 4284-55; Laminate A; Test Series 7;  $S = 0.66$ .

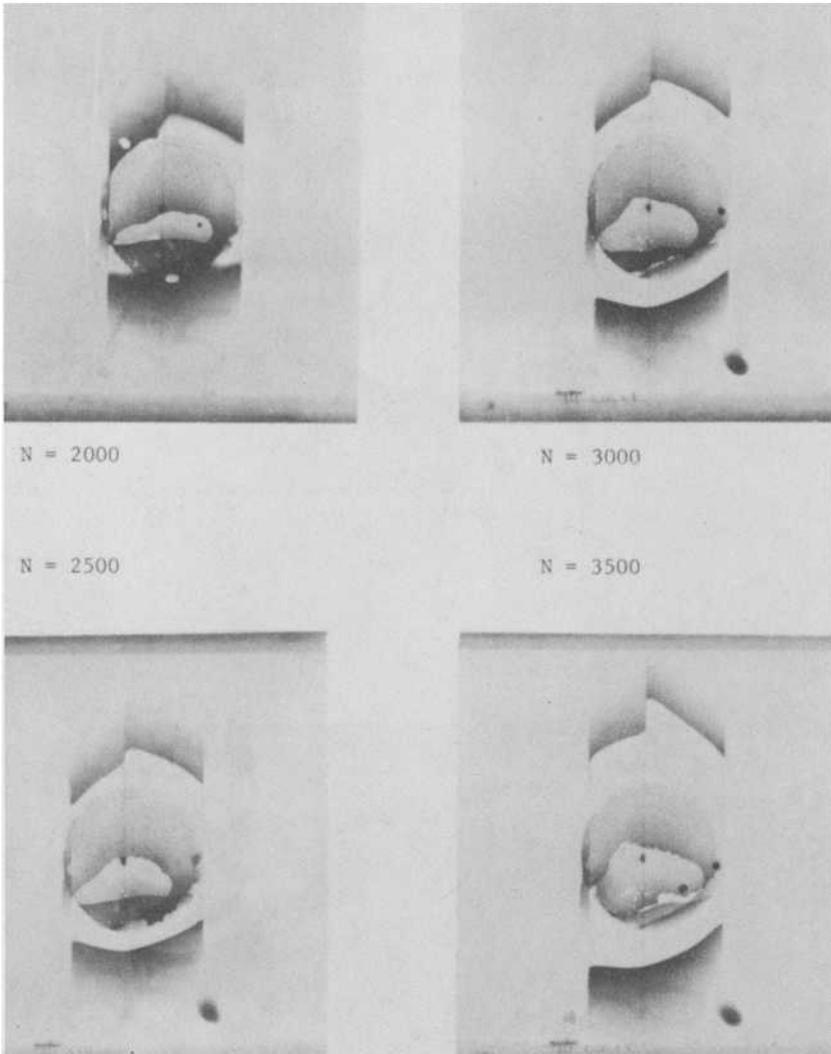
FIG. 9b—Delamination growth in Specimen 4284–55; Laminate A; Test Series 7;  $S = 0.66$ .

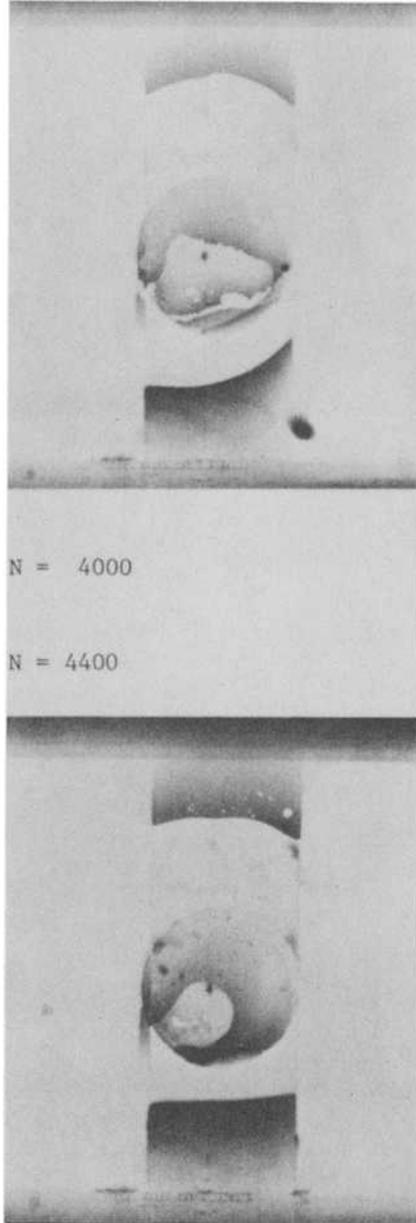
FIG. 9c—Delamination growth in Specimen 4284-55; Laminate A; Test Series 7;  $S = 0.66$ .

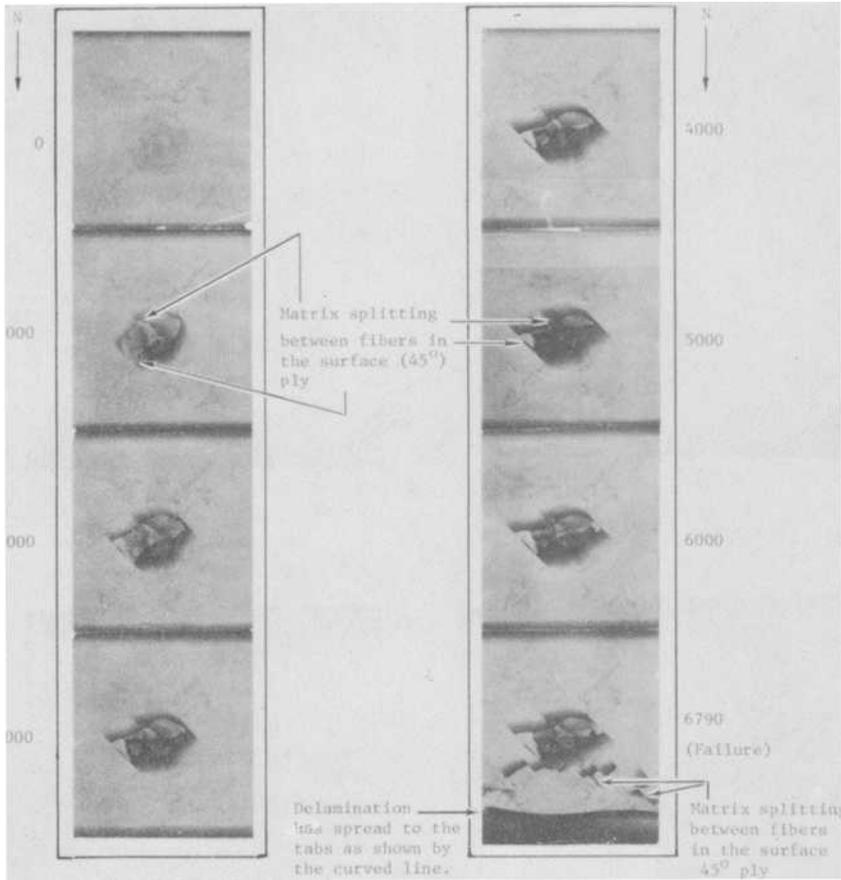
FIG. 11—Delamination growth in Specimen 4255-9; Laminate B; Test Series 7;  $S = 0.55$ .

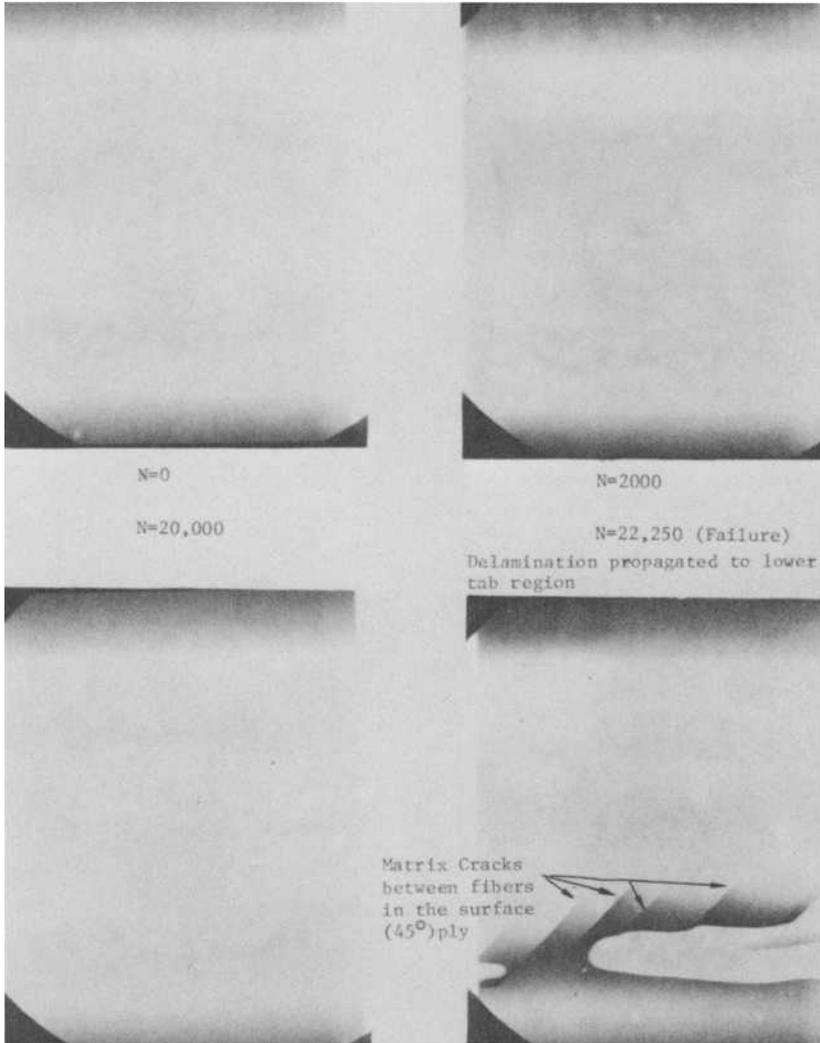
FIG. 12—Delamination growth in Specimen 4256-40; Laminate B; Test Series 14;  $S = 0.66$ ; radiographs taken with a 9.12 kN load.

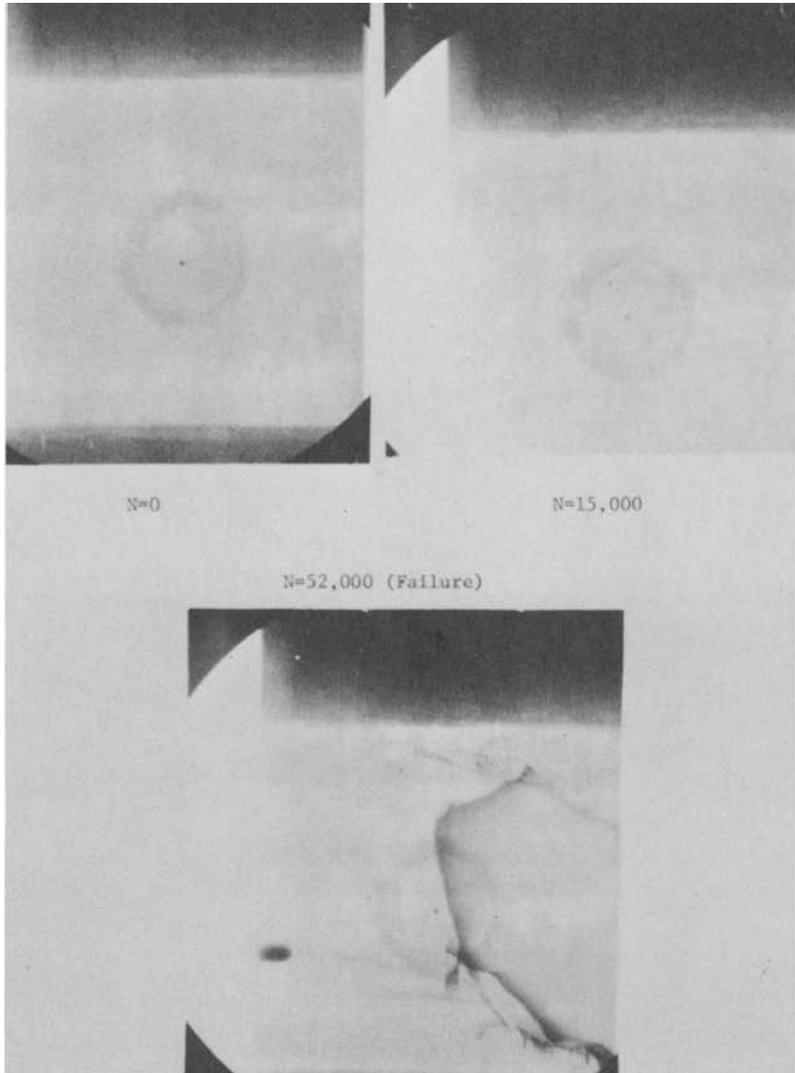
FIG. 13—Delamination growth in Specimen 4282-24; Laminate C; Test Series 8;  $S = 0.49$ .

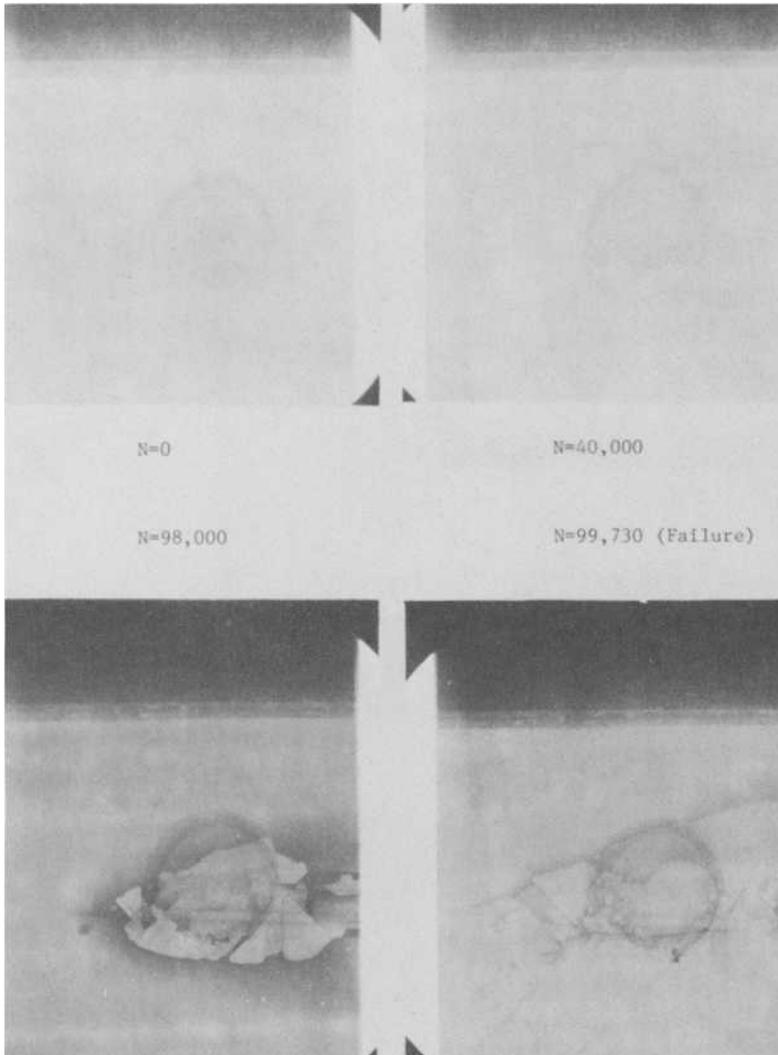
FIG. 14—Delamination growth in Specimen 4282-29; Laminate C; Test Series 14;  $S = 0.75$ .

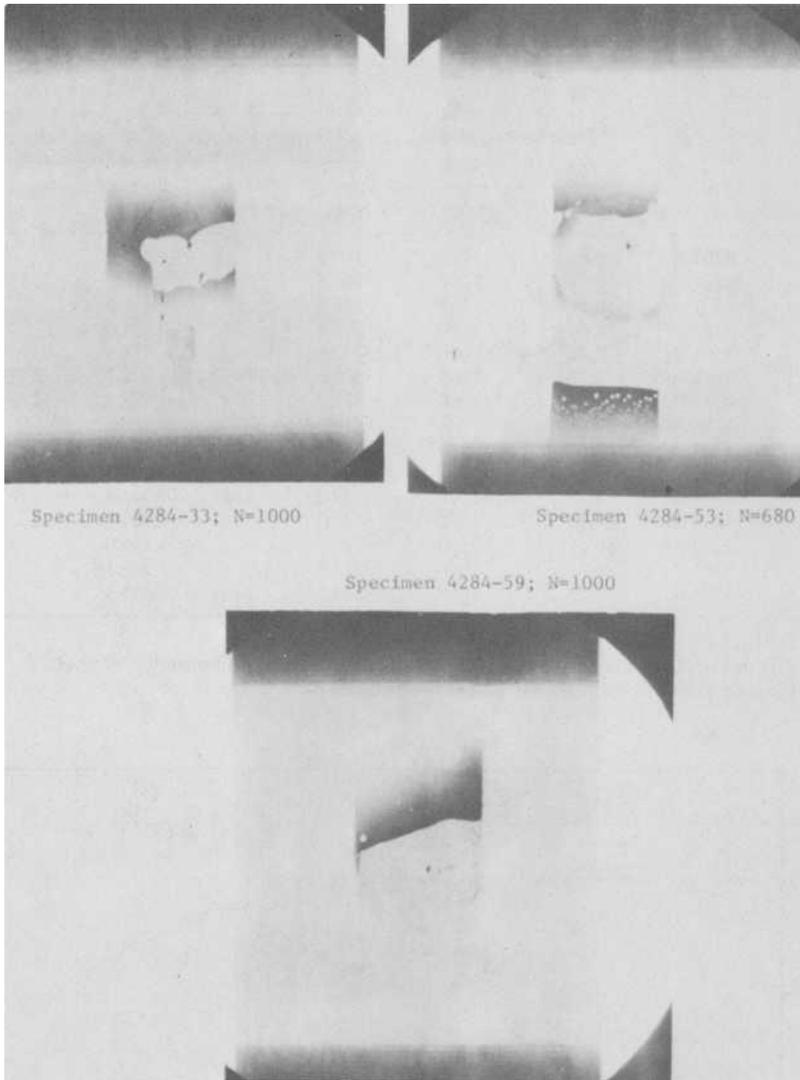
FIG. 15—Radiographs of residual strength test specimens after completing approximately half their lifetimes; Laminate A; Test Series 8;  $S = 0.66$ .

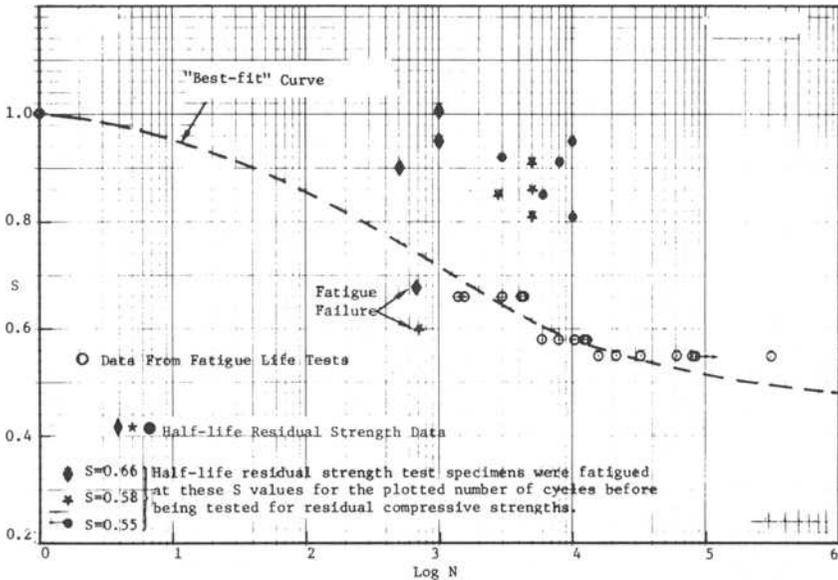
FIG. 16—S-N data and half-life residual strength data for Laminate A specimens with 1.27-cm (0.5-in.) diameter delamination (2-D) between Plies 1 and 2.

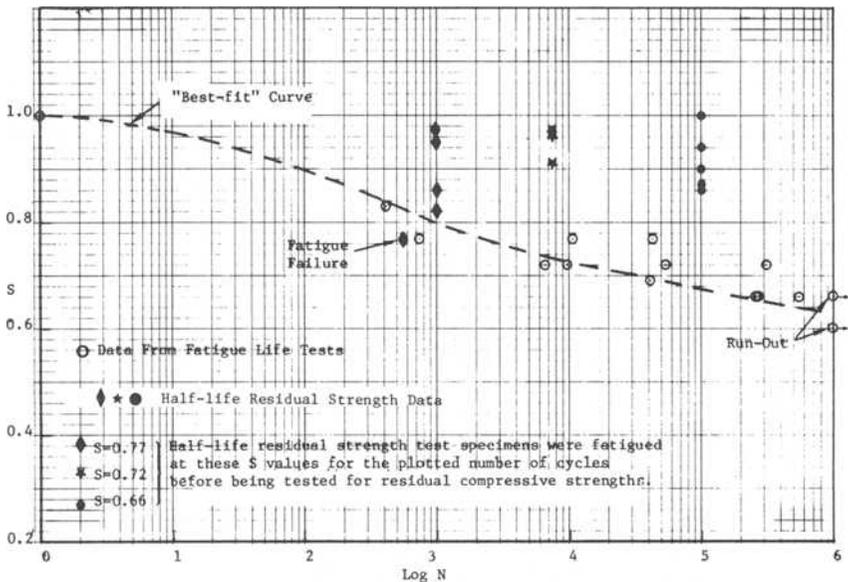
FIG. 17— $S$ - $N$  data for Laminate A specimens with 1.27-cm (0.5-in.)-diameter delamination (2-D) between Plies 4 and 5.

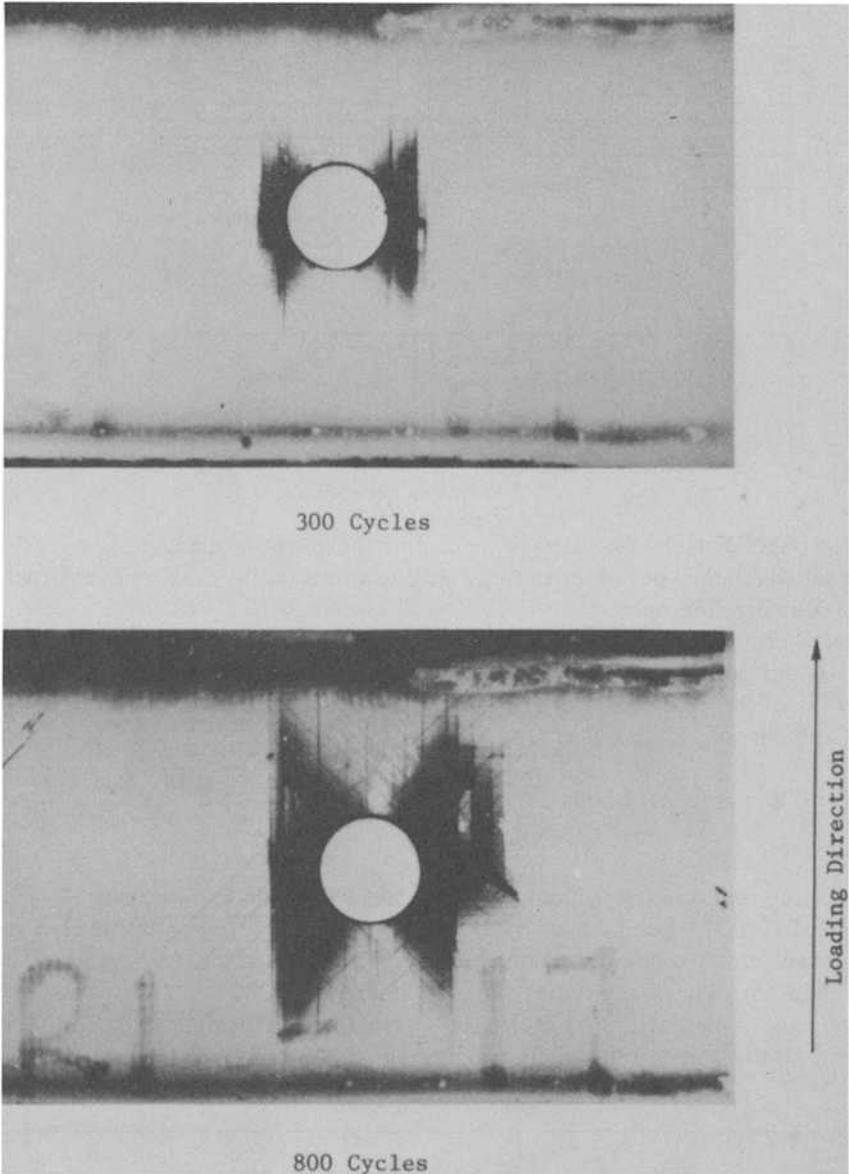
FIG. 2—X-ray radiography of Specimen R1-17 ( $0/\pm 45/90/0_2/\pm 45$ ), laminate, tested at  $R = -1$ ,  $\sigma_{\min} = -427 \text{ MPa}$  ( $-62 \text{ ksi}$ ). Specimen failed at 840 cycles.

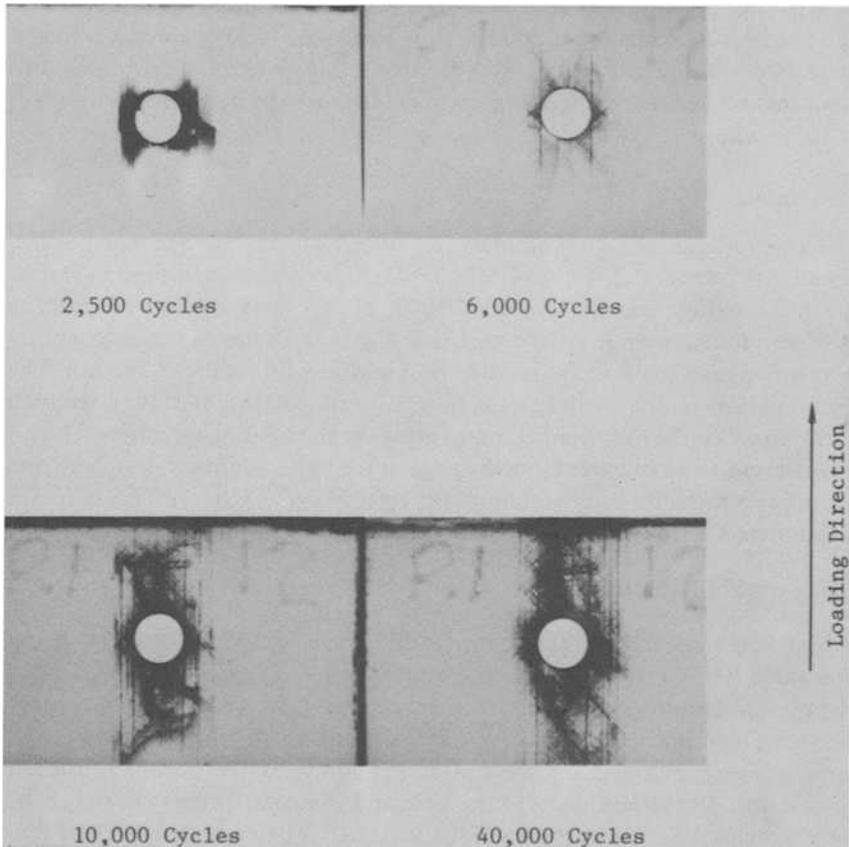
FIG. 3—X-ray radiography of Specimen R1-12 ( $0/\pm 45/90/0_2/\pm 45$ ), laminate, tested at  $R = -1$ ,  $\sigma_{min} = -359$  MPa ( $-52$  ksi). Specimen failed at 44480 cycles.

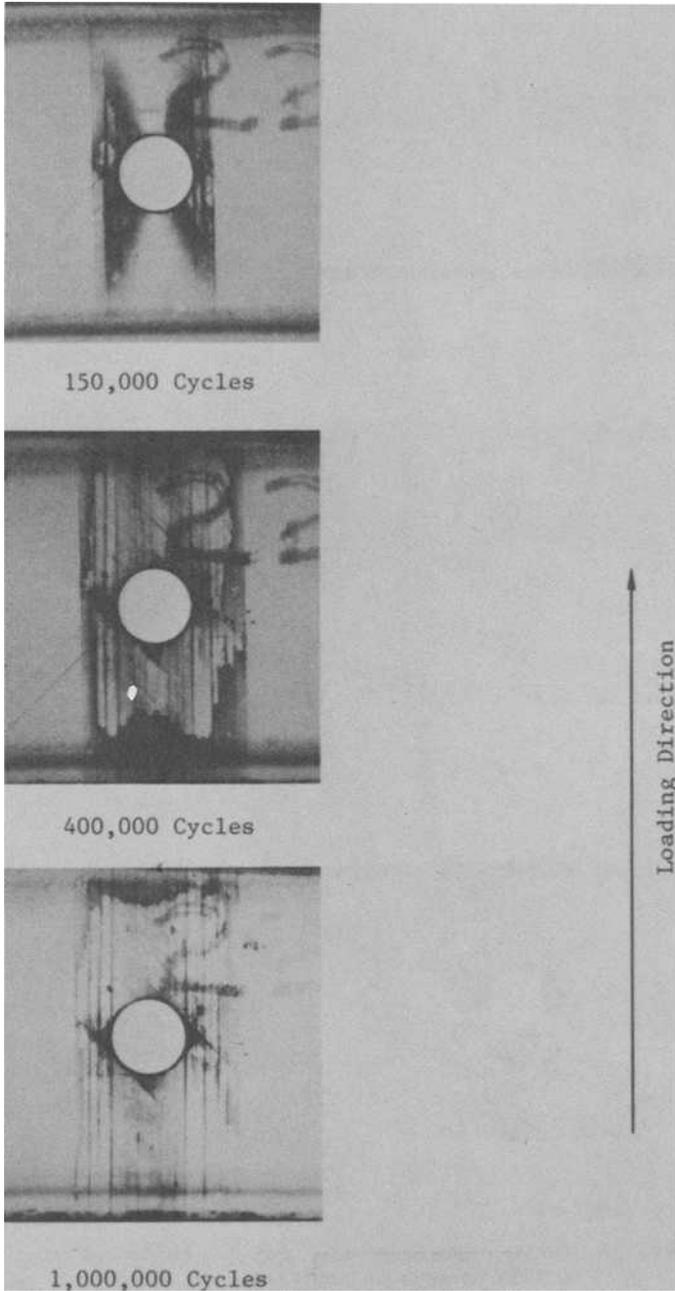
FIG. 4—X-ray radiography of Specimen R1-22 ( $0/\pm 45/90/0_2/\pm 45$ ), laminate, tested at  $R = -\infty$ ,  $\sigma_{\min} = -355$  MPa ( $-51.5$  ksi). Specimen failed at 2 111 000 cycles.

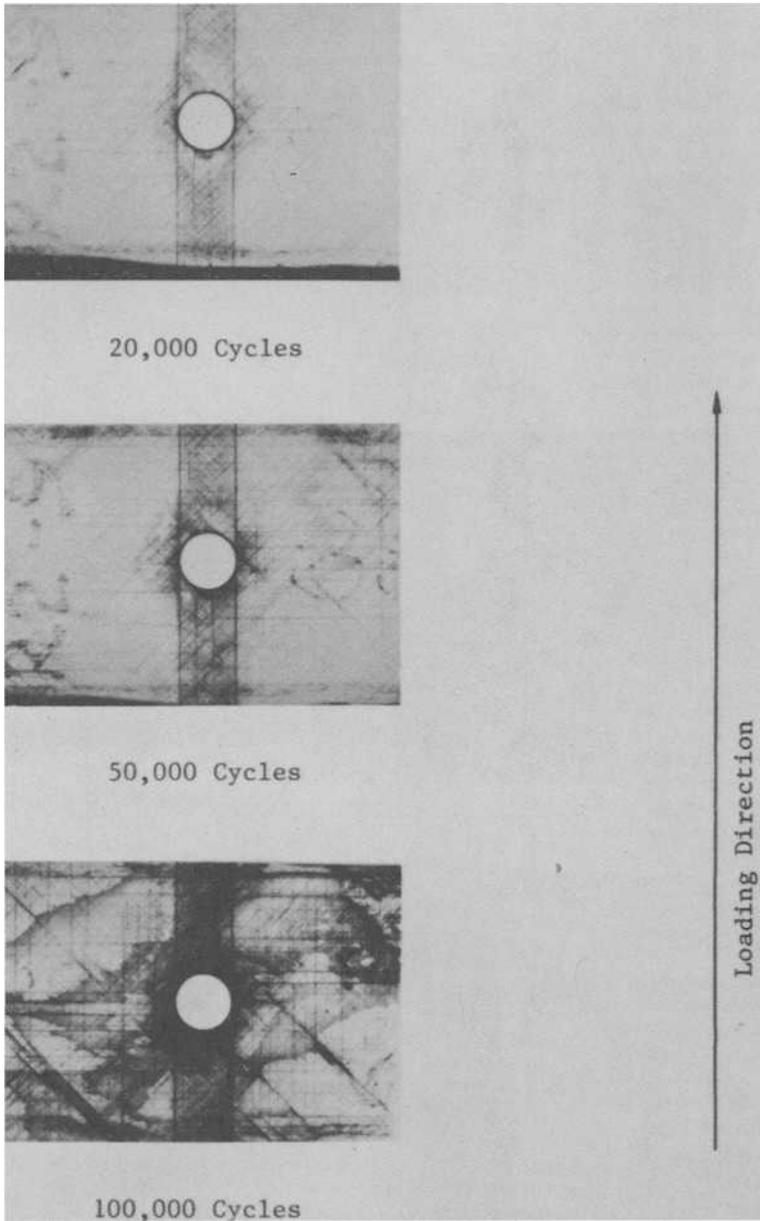
FIG. 5—X-ray radiography of Specimen R2-9 ( $90/\pm 45/0_3/\pm 45$ ), laminate, tested at  $R = -1$ ,  $\sigma_{\min} = -314 \text{ MPa}$  ( $-45.5 \text{ ksi}$ ). Specimen failed at 103 420 cycles.

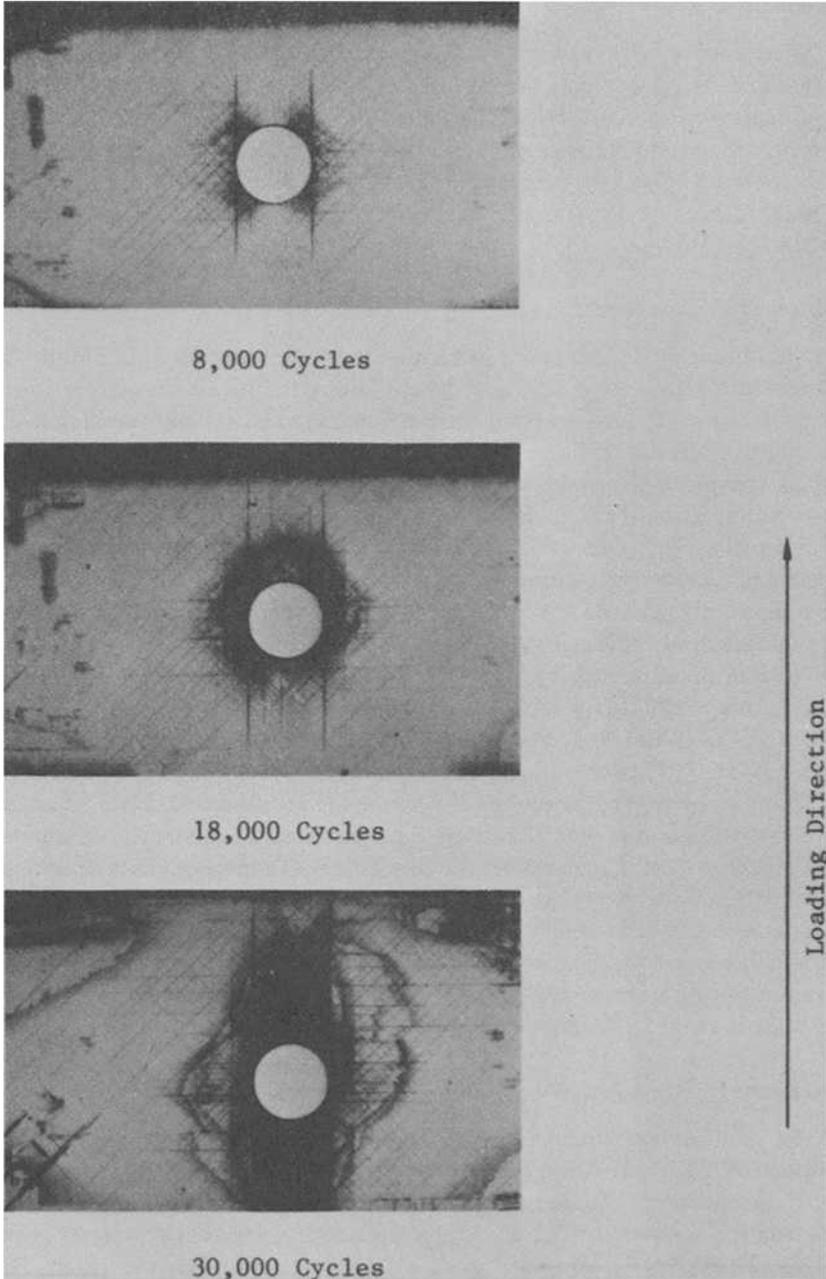
FIG. 6—X-ray radiography of Specimen R3-7 ( $90/0/\pm 45/0/\pm 45$ ), laminate, tested at  $R = -1$ ,  $\sigma_{\min} = -317$  MPa ( $-46$  ksi). Specimen failed at 50 790 cycles.

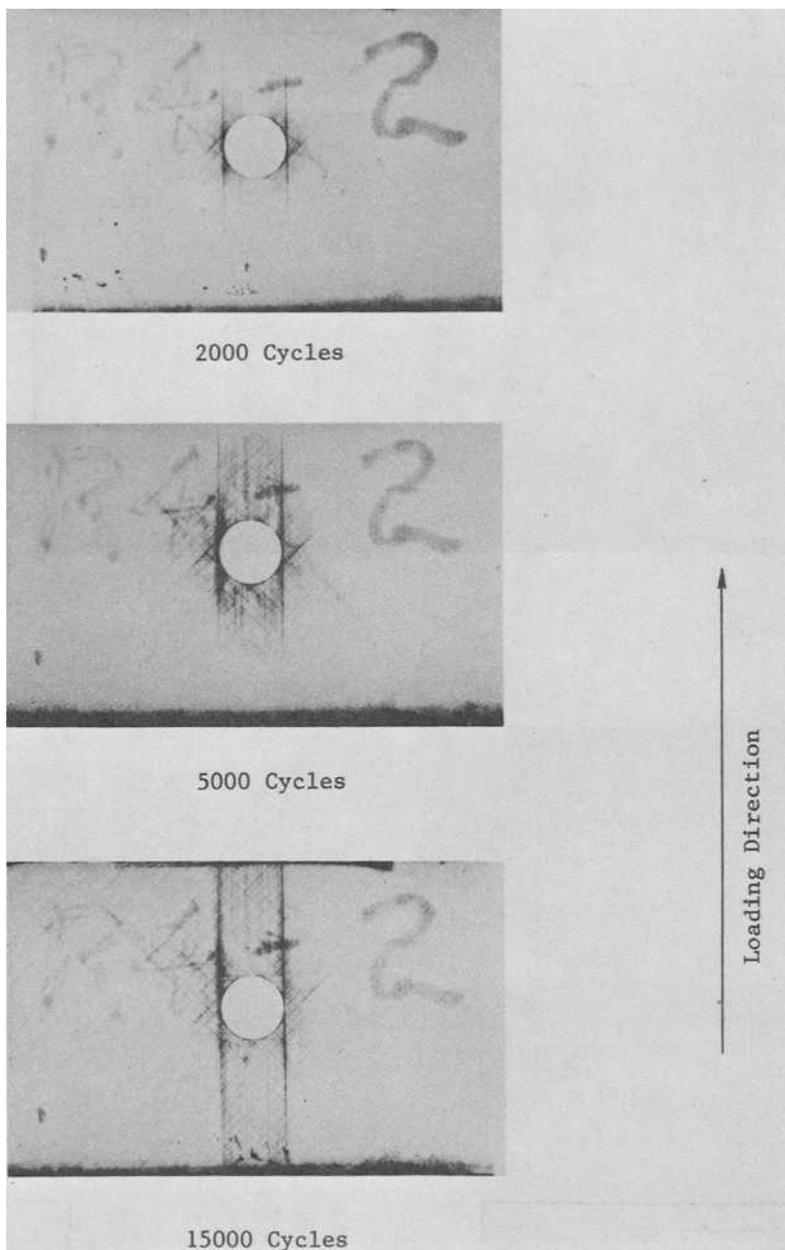
FIG. 7—X-ray radiography of Specimen R4-2 ( $\pm 45/0/90/0_2/\pm 45$ ), laminate, tested at  $R = -1$ ,  $\sigma_{\min} = -362$  MPa ( $-52.5$  ksi). Specimen failed at grips.

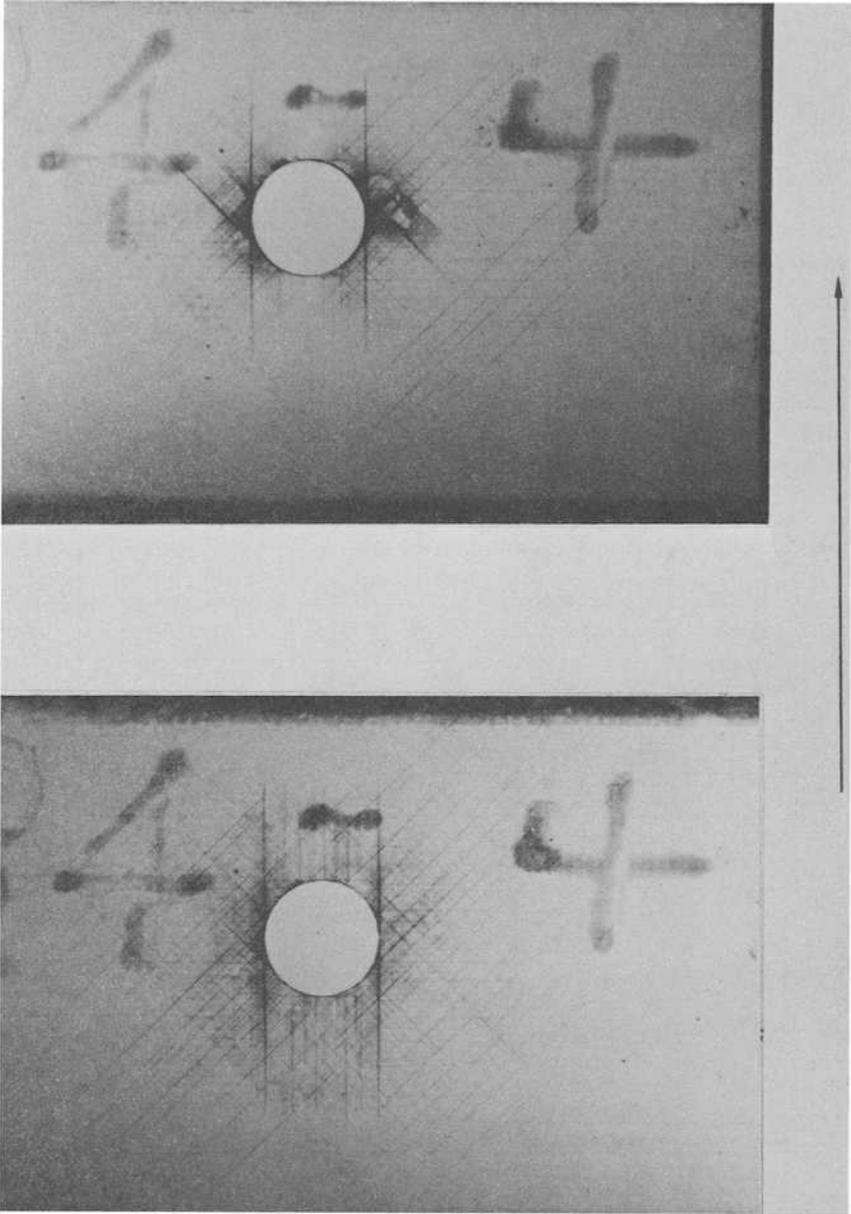
FIG. 8—X-ray radiography of Specimen R4-4 ( $\pm 45/0/90/0_2/\pm 45$ )<sub>s</sub> laminate, after 2000 and 5000 cycles tested at  $R = -1$ ,  $\sigma_{\min} = -362$  MPa ( $-52.5$  ksi). Specimen failed after 8610 cycles.

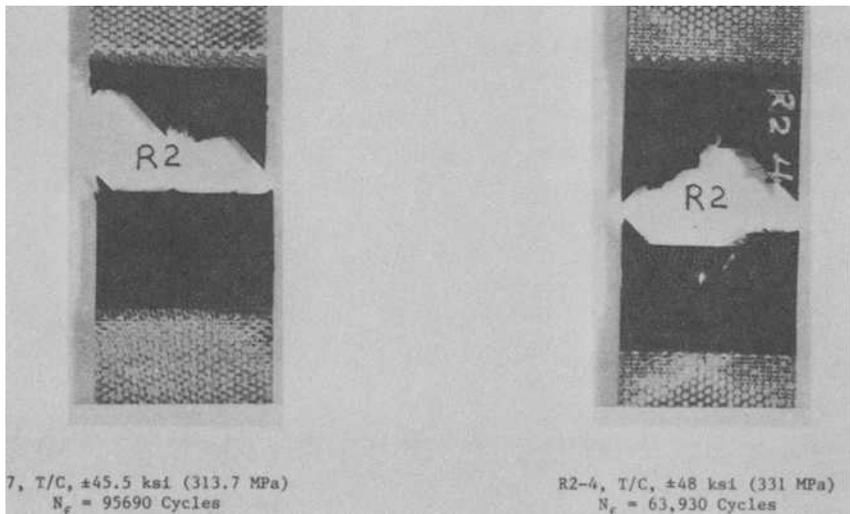
FIG. 10—Failure mode observed in Laminate 2 under constant amplitude fatigue loading.

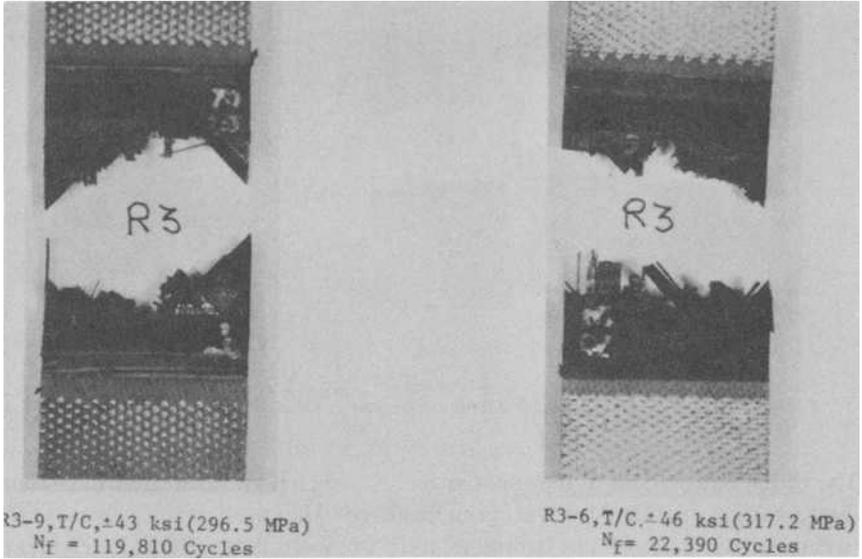
FIG. 11—Failure mode observed in Laminate 3 under constant amplitude fatigue loading.

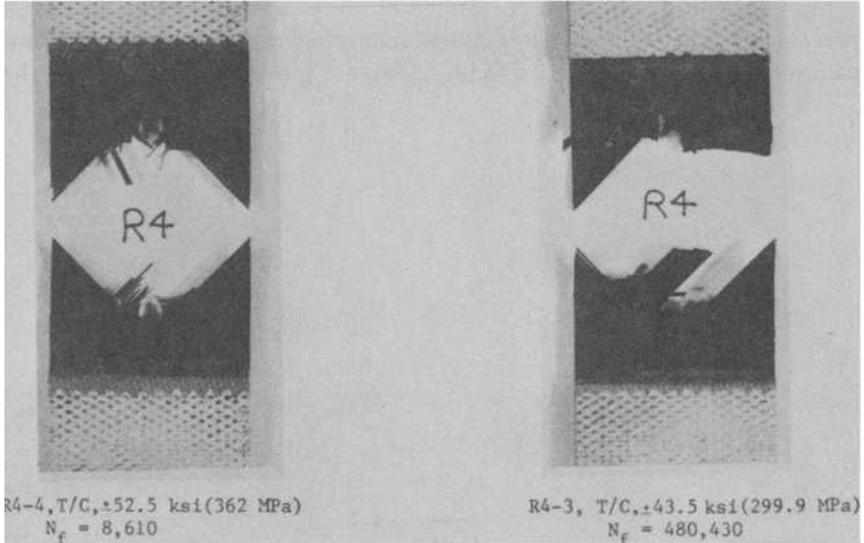
FIG. 12—Failure mode observed in Laminate 4 under constant amplitude fatigue loading.

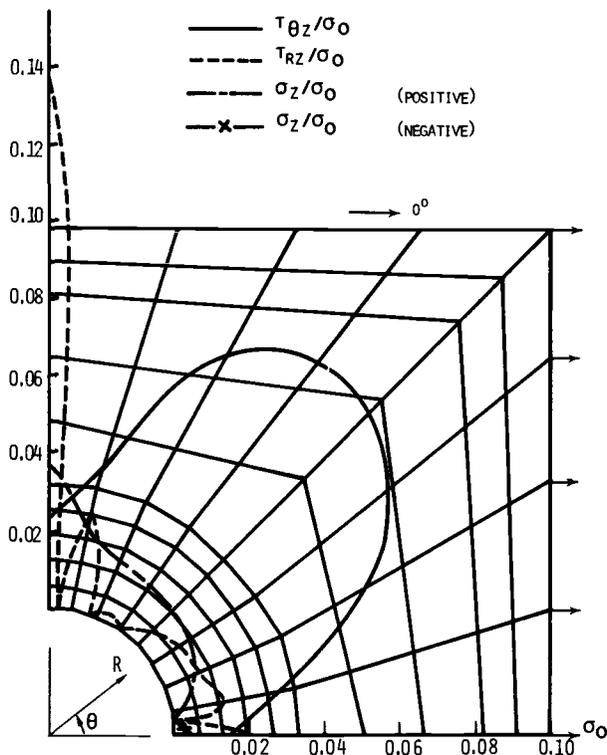
FIG. 13—Interlaminar stresses in the  $(0/\pm 45/90/0_2/\pm 45)_s$  laminate at midplane.

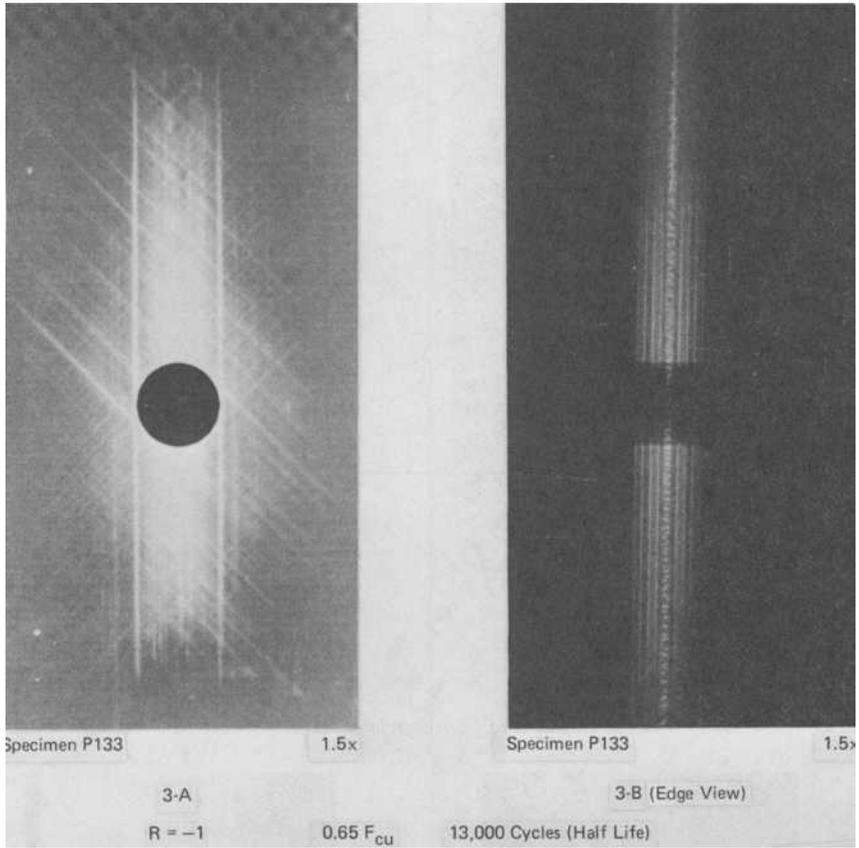
FIG. 3—X-ray photographs of fiber dominated layup with penetrant applied to specimen edges and hole.
