# DAMAGE IN COMPOSITE MATERIALS

# DAMAGE IN COMPOSITE MATERIALS: BASIC MECHANISMS, ACCUMULATION, TOLERANCE, AND CHARACTERIZATION

A symposium  
sponsored by ASTM  
Committees E-7 on  
Nondestructive Testing  
and E-9 on Fatigue  
Bal Harbour, Fla., 13-14 Nov. 1980

ASTM SPECIAL TECHNICAL PUBLICATION 775  
K. L. Reifsnider, Virginia Polytechnic  
Institute and State University, editor

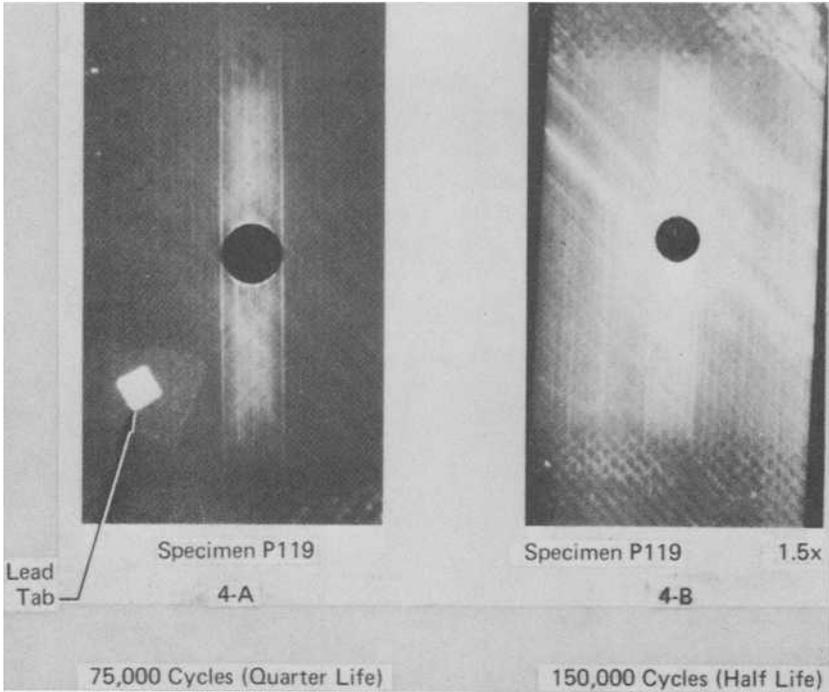
FIG. 4—X-ray photographs of fiber dominated layup at quarter and half life.

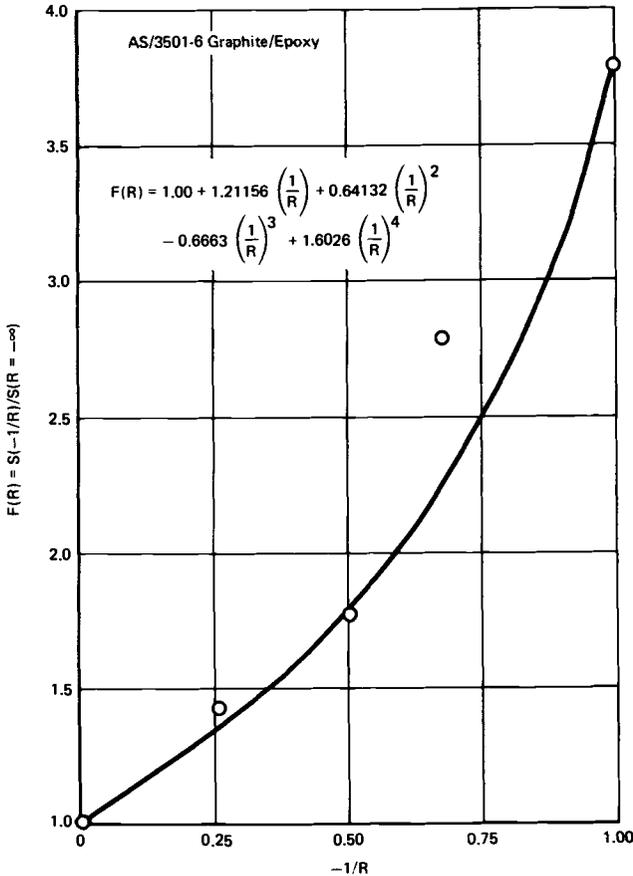
FIG. 8—Stress-ratio correction.

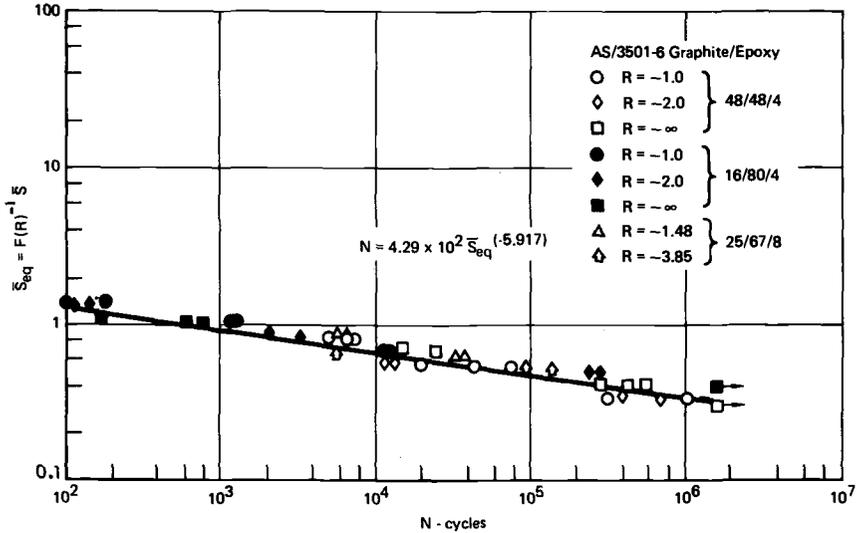
FIG. 9—Correlation of equivalent strain energy density with fatigue life.

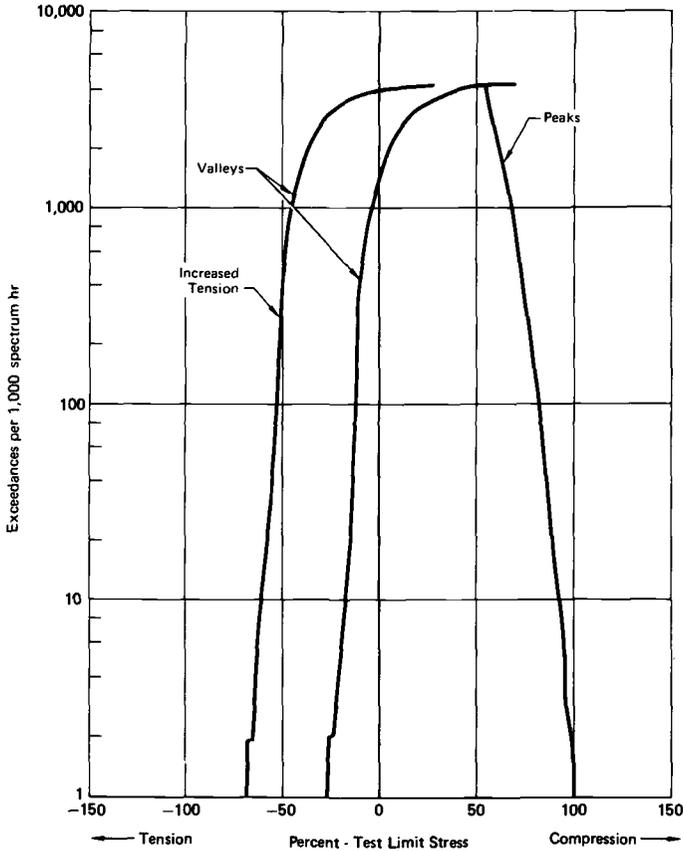
FIG. 11—Methodology development test spectra.

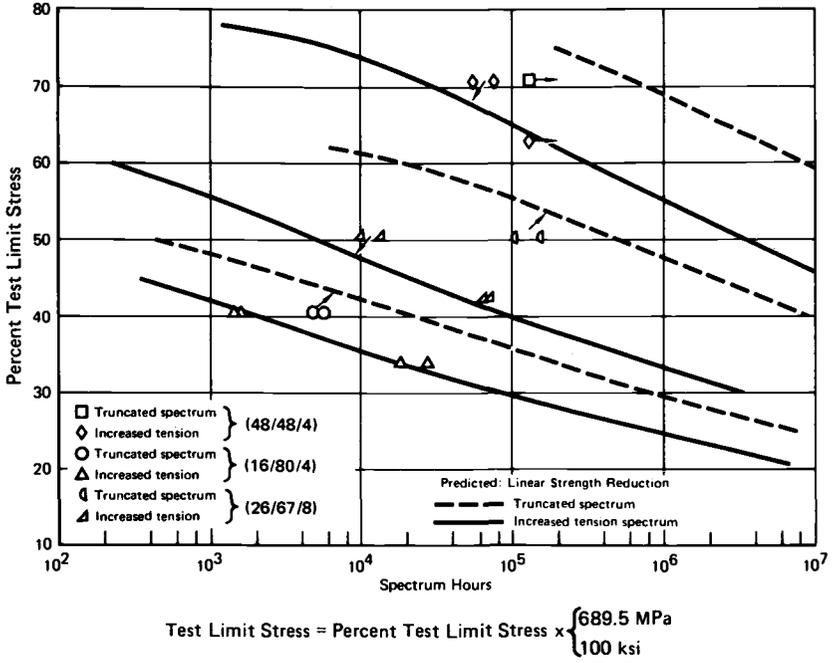
FIG. 12—Methodology development test program—results of spectrum fatigue tests.

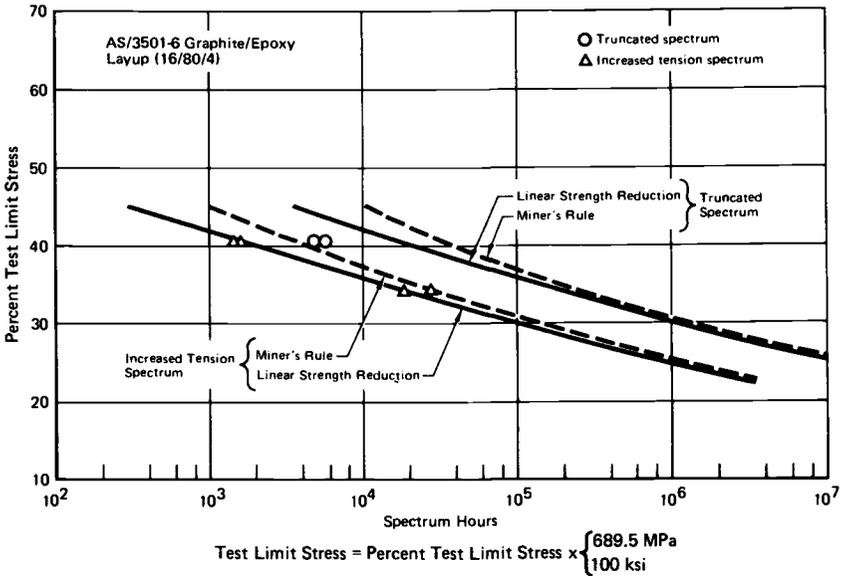
FIG. 13—Comparison of linear strength reduction and Miner's rule predictions.

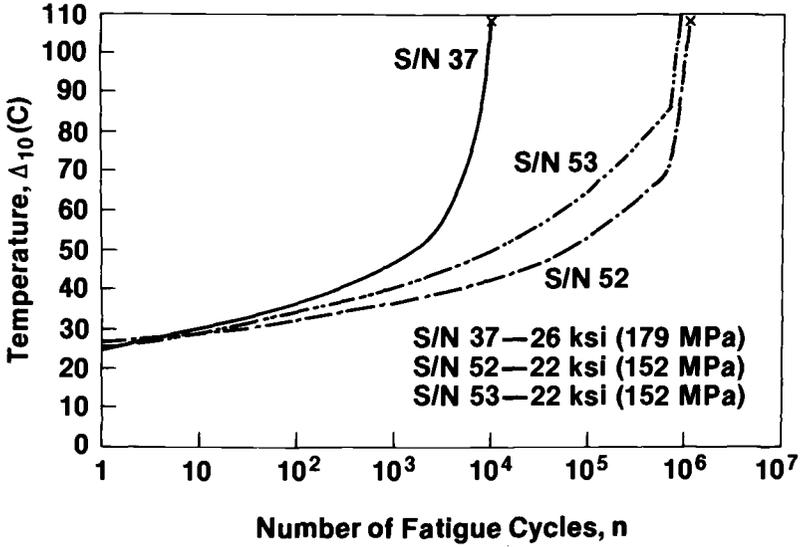
FIG. 12—Damage (temperature increase) versus cycle for  $(\pm 45^\circ)_s$  E-glass/epoxy specimens subjected to tension-tension fatigue loading of stress ratio equal to 0.1 (min/max) and the stress range given as shown. After Ref 16.
