Corrosion of Metals Under Thermal Insulation

CORROSION OF METALS UNDER THERMAL INSULATION

ASTM SPECIAL TECHNICAL PUBLICATION 880
Warren I. Pollock, E. I. du Pont de Nemours
and Company, and Jack M. Barnhart,
Thermal Insulation Manufacturers
Association, editors

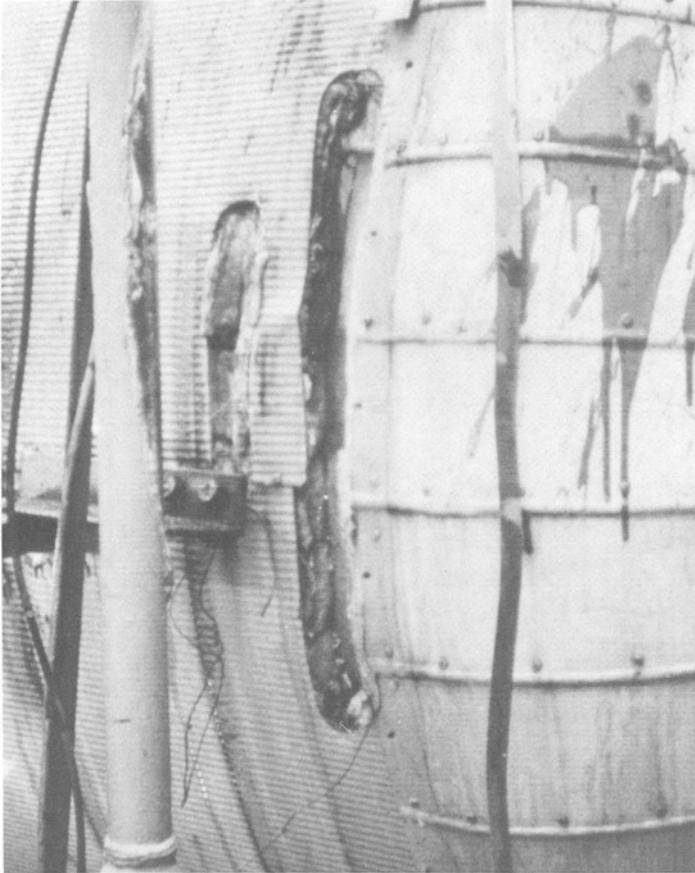
FIG. 1—Opening in metal jacking, cut by insulators to accommodate piping that was run too close to a pressure vessel for the specified thickness. Piping has been moved as part of our effort to rectify deficiencies.

See Figs. 1 and 2.

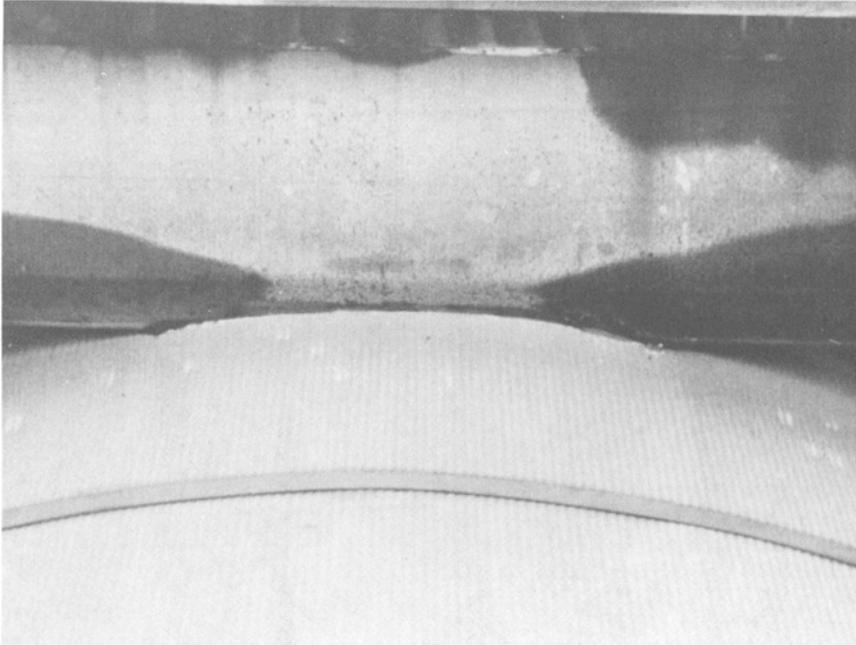
FIG. 2—Jacketing cut by insulators to accommodate I-beam for platform support that was closer to the vessel than the insulation thickness specified. Water can run on the flange and enter the insulation at this point.

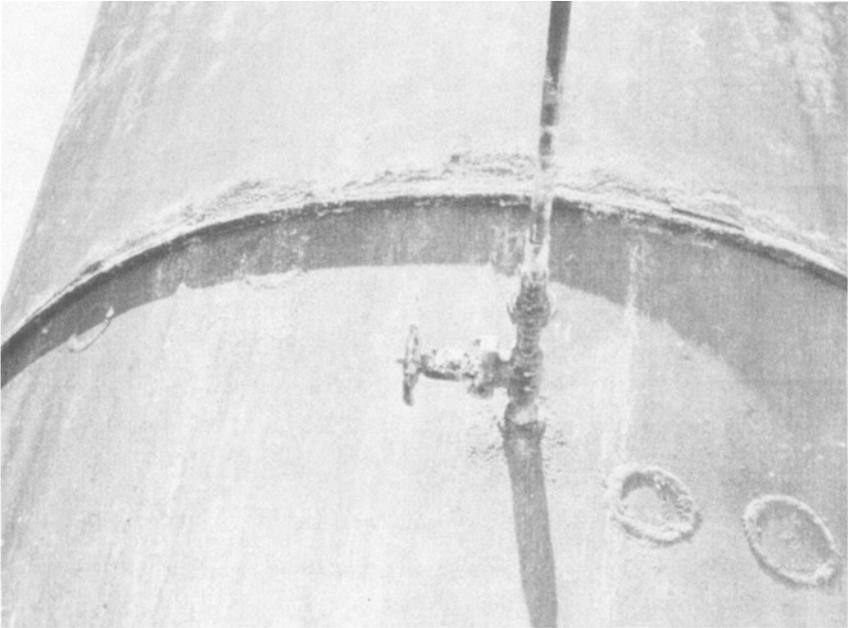
FIG. 3—Corrosion above an insulation support ring and around a small pipe connection. This is a vertical drum that had been heated with a steam coil at one time. Insulation rings act as a hold up for water entering through deficient top head weatherproofing.

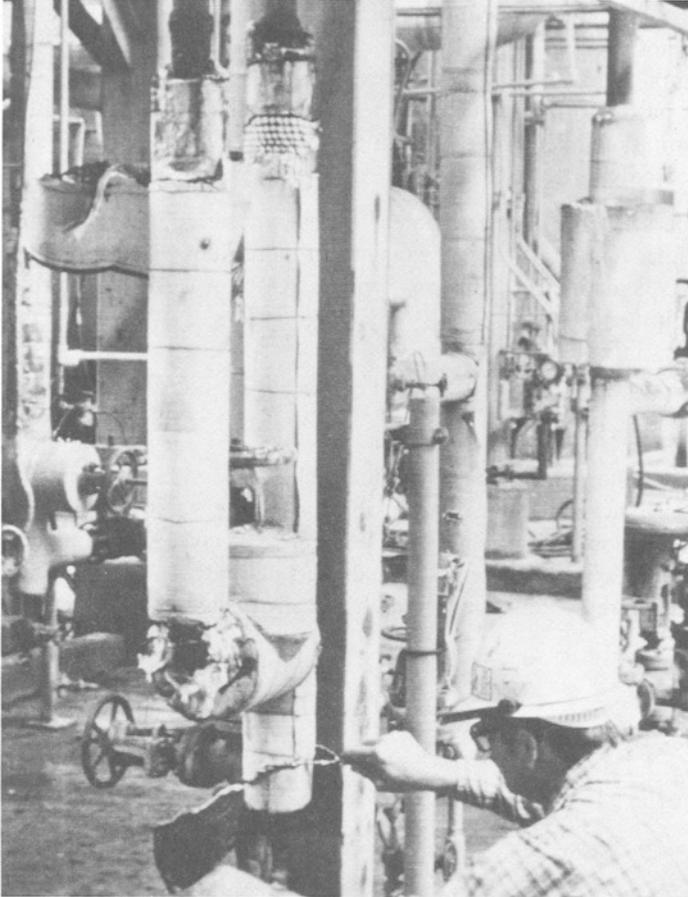
FIG. 4—Insulation for personnel protection has in the past been stopped about 2 m above grade. Severe corrosion at the open end of the insulation system (water entry point) is typical of very hot systems such as steam lines.

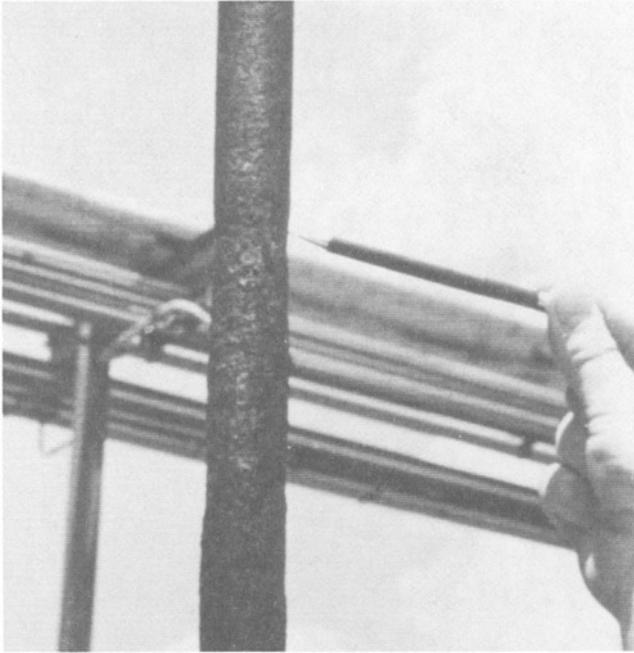
FIG. 5—Another example of the effect of corrosion under personnel protection. Note the reduction in diameter of the pipe where indicated, corresponding to the water entry point.

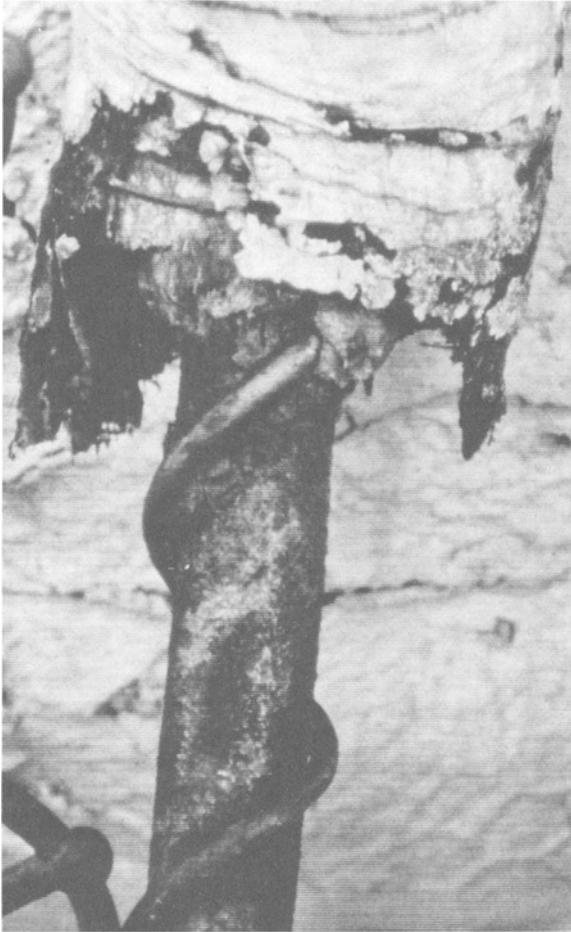
FIG. 6—A steam traced line showing severe corrosion under the tracing tubing. Galvanic corrosion may be a factor between copper tubing and steel pipe, when water frequently enters the system.

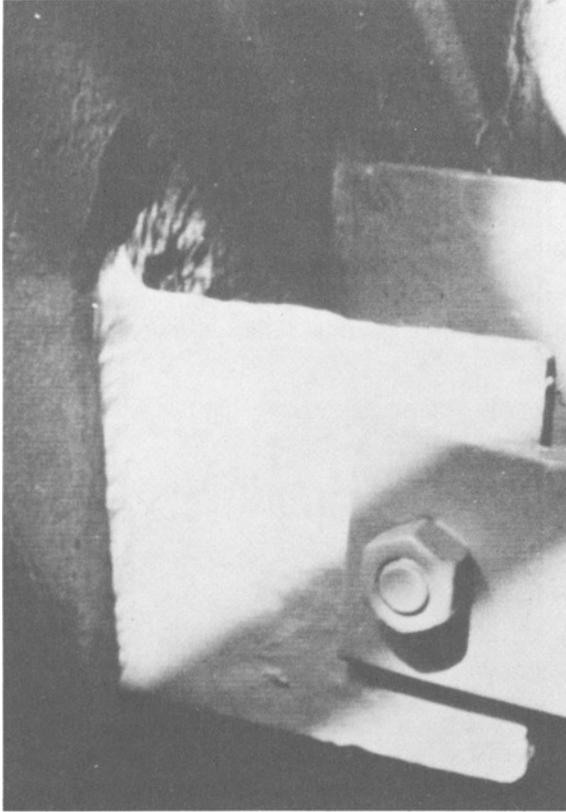
FIG. 7—A ladder bracket on a tower operated at about 80°C. Corrosion at this water entry point is highly concentrated. Surface was abrasively cleaned to remove scale from the corrosion trench around the bracket.

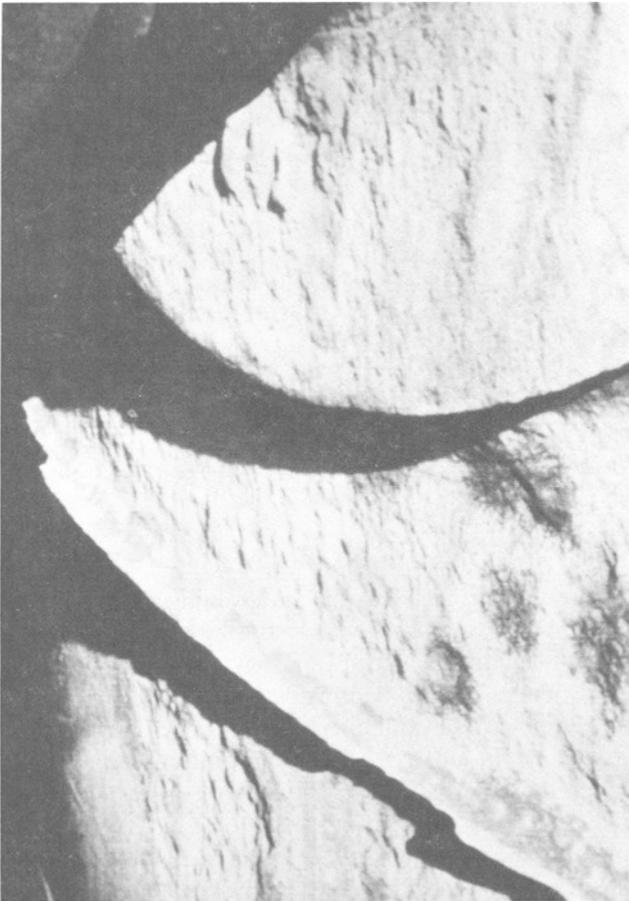
FIG. 8—General corrosion under a manway on a vessel with a moderate operating temperature. General corrosion is characteristic of high water entry capacity compared to heat available for drying.

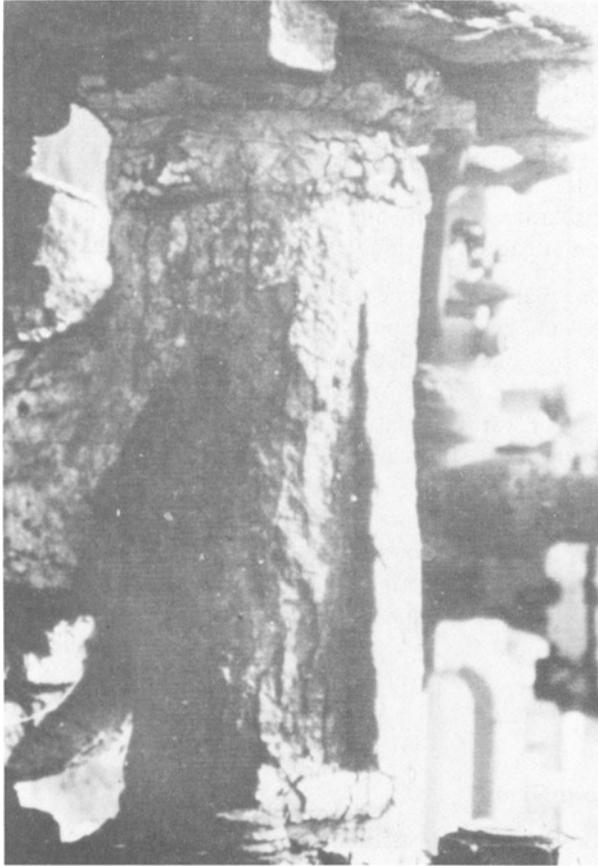
FIG. 9—Corrosion under PUF on an idle unit.

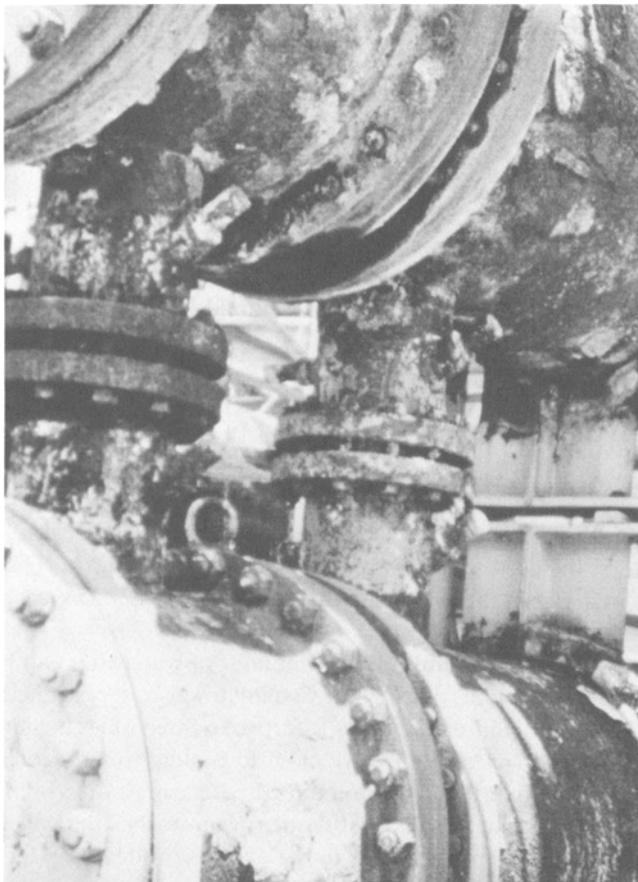
FIG. 10—Corrosion under fibrous insulation on another idle unit. In service, operating temperatures were high enough that paint was not considered necessary.

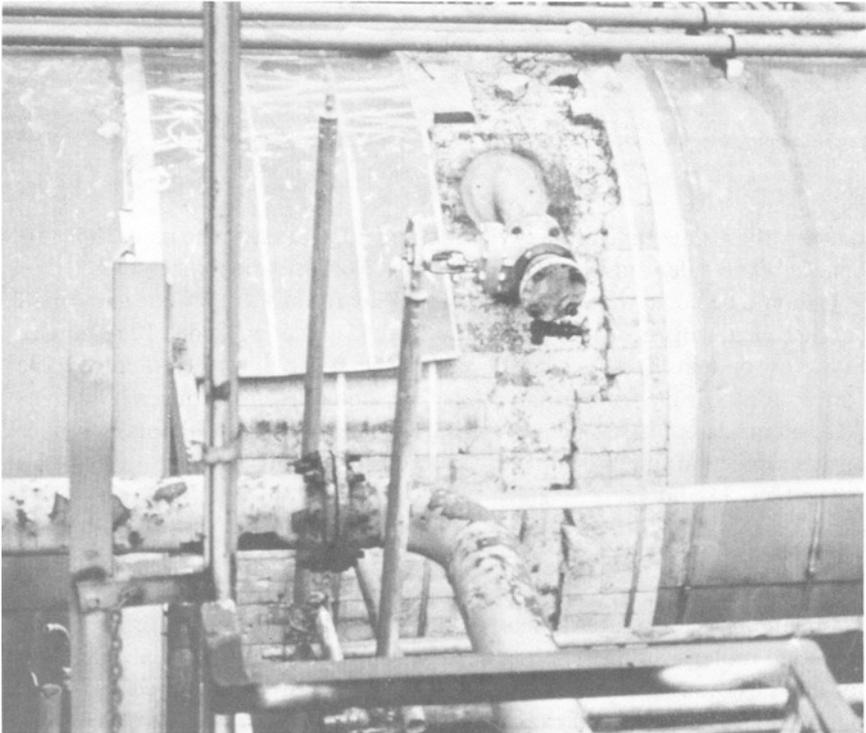
FIG. 11—Mechanical work (a nozzle addition) has been completed. The insulation was left as shown for several weeks before insulation was closed. Note the deteriorating condition of the alkyl primer on the exposed steel surface.

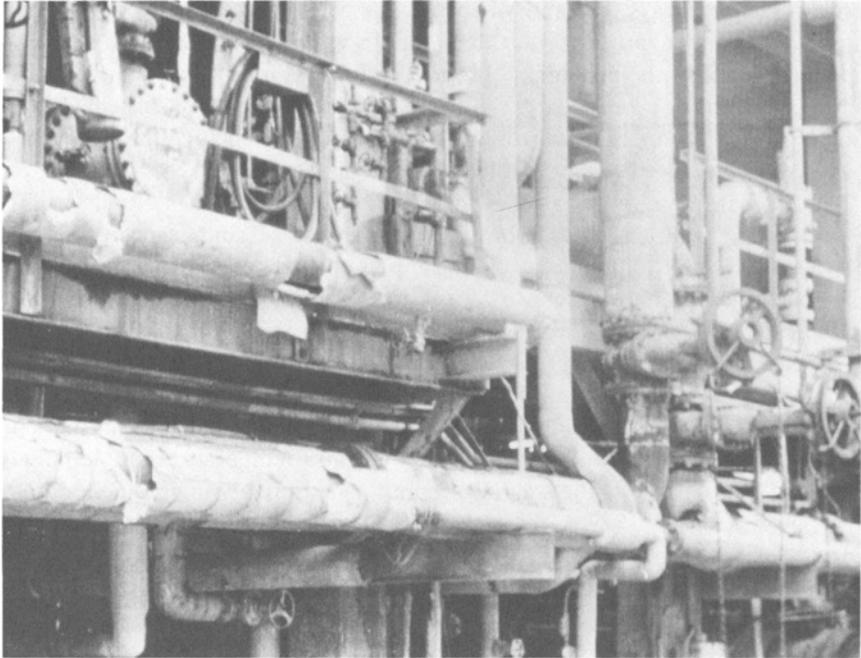
FIG. 12—*Inspection openings and mechanical damage that had been left unrepaired indefinitely until the present program started.*

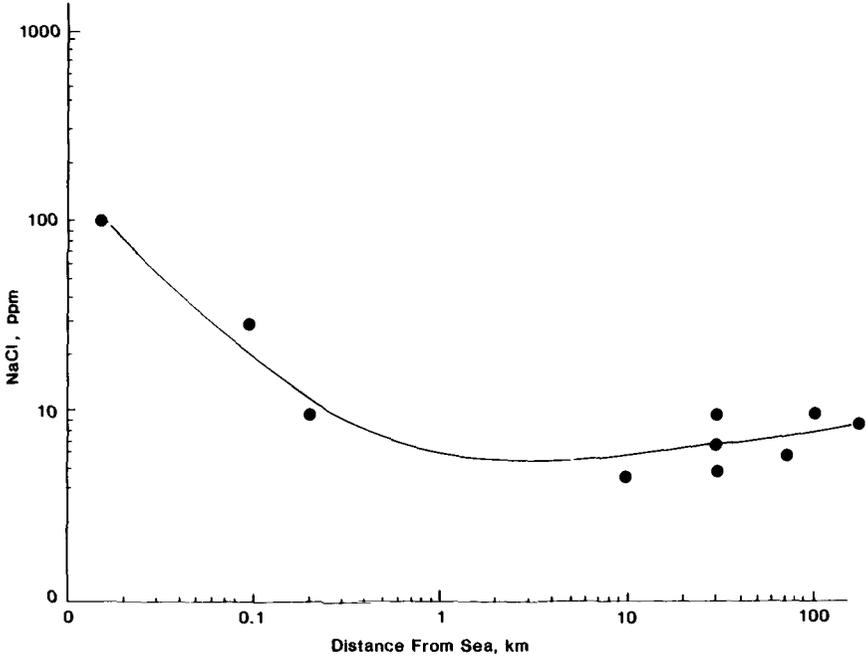
FIG. 1—Sodium chloride in rainwater [2].

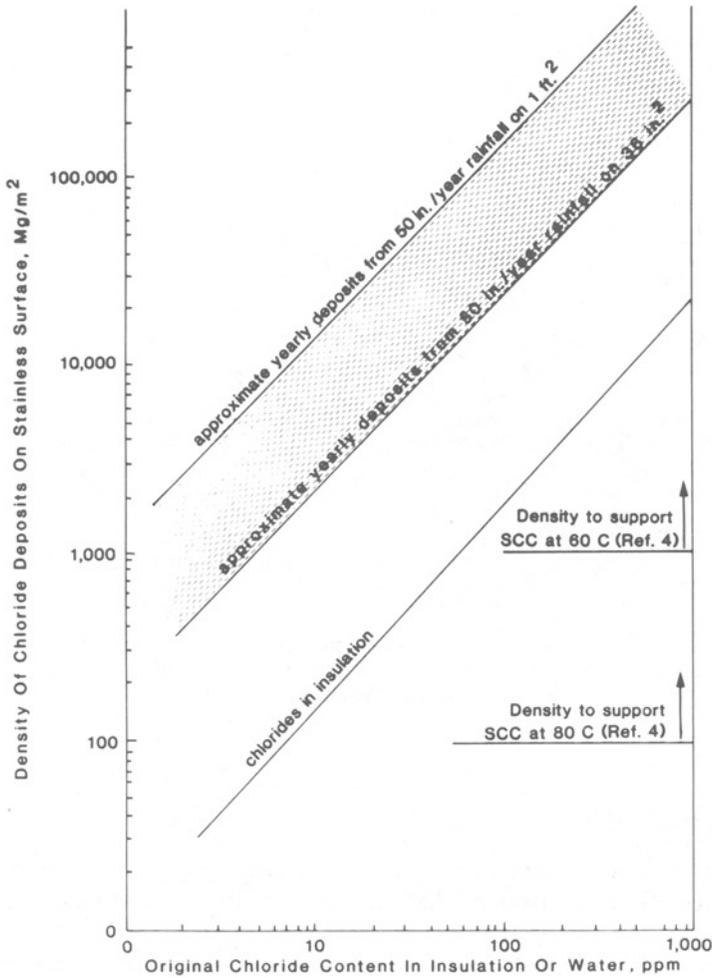
FIG. 2—Potential density of chloride deposits from insulation or rainwater.

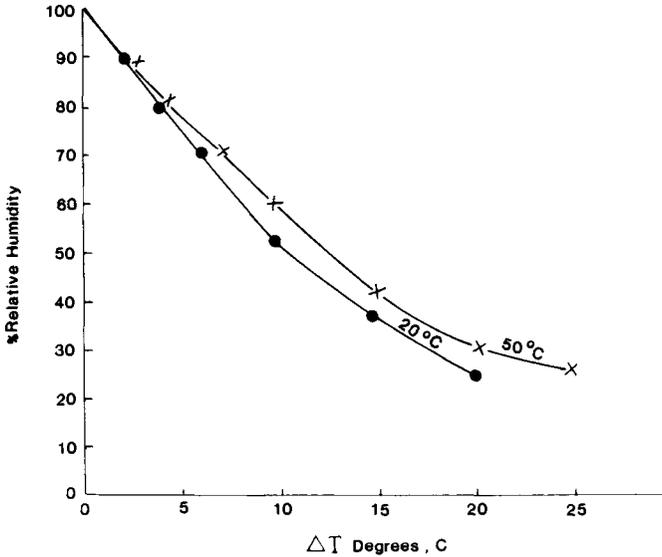
FIG. 3—Temperature difference ΔT between stainless surface and ambient air temperature for droplet condensation [1].

Figure 3 presents a series of curves showing the temperature difference that would cause droplet formation at various relative humidities and ambient temperatures. This effect may be significant on many vessels in cyclic service,

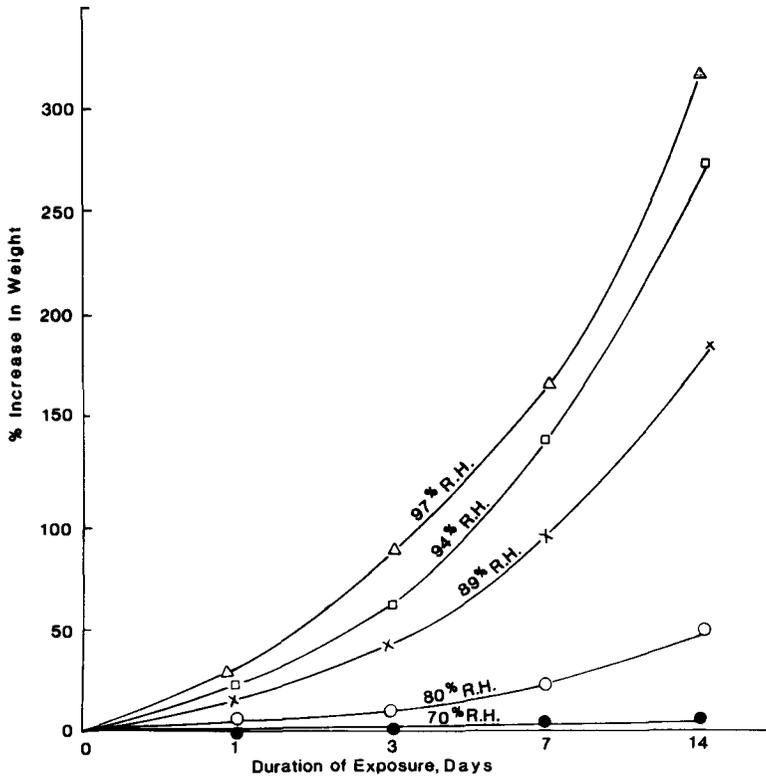
FIG. 4—Water absorption of salt particles as a function of time and relative humidity [2].

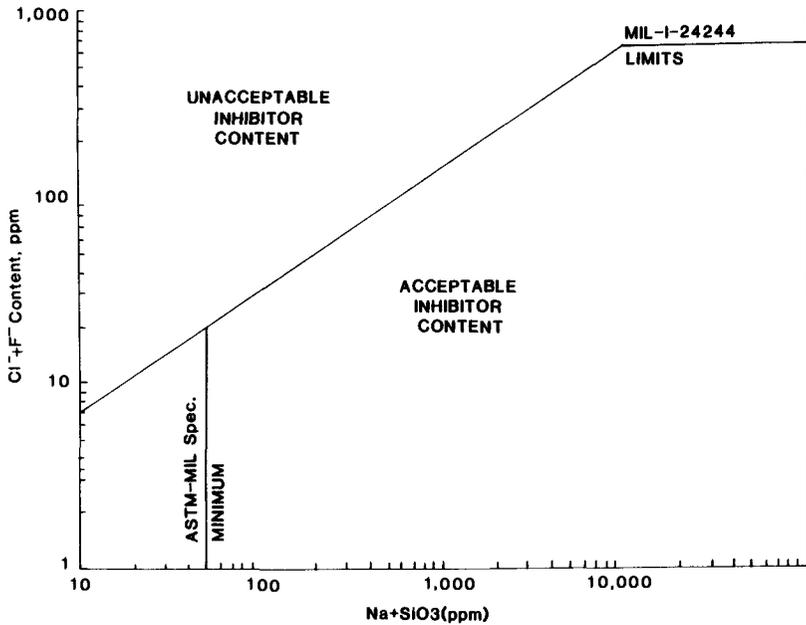
FIG. 5—Inhibitor to halides ratios required by MIL specifications and the U.S. Nuclear Regulatory Agency [5].

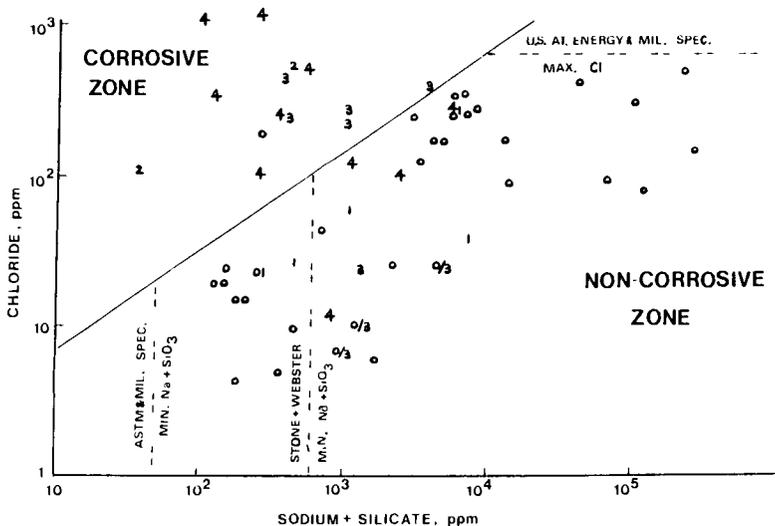
FIG. 2—Karnes' data [2] relating incidence of cracking to silicate/chloride ratio of lagging material. Numbers denote samples cracked out of four, except where stated. Three typical specification constraints are indicated. Presented originally in Paper 7.

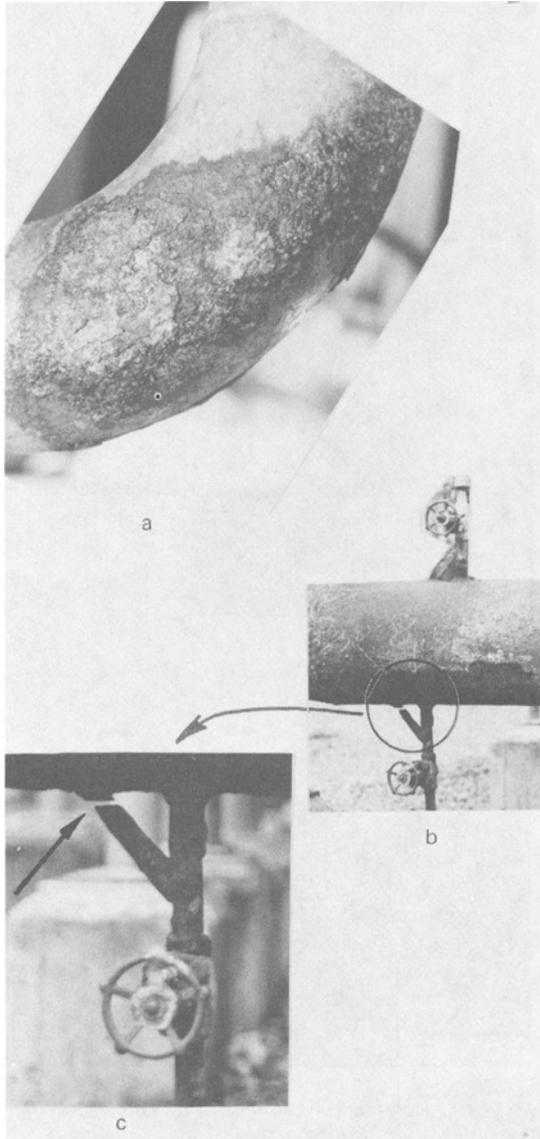
FIG. 1—Examples of typical CUI—trapped water: (a) bottom of bend. (b) and (c) water entrance at vend may cause corrosion at drain. Example of trapped water is also shown on Fig. 8a.

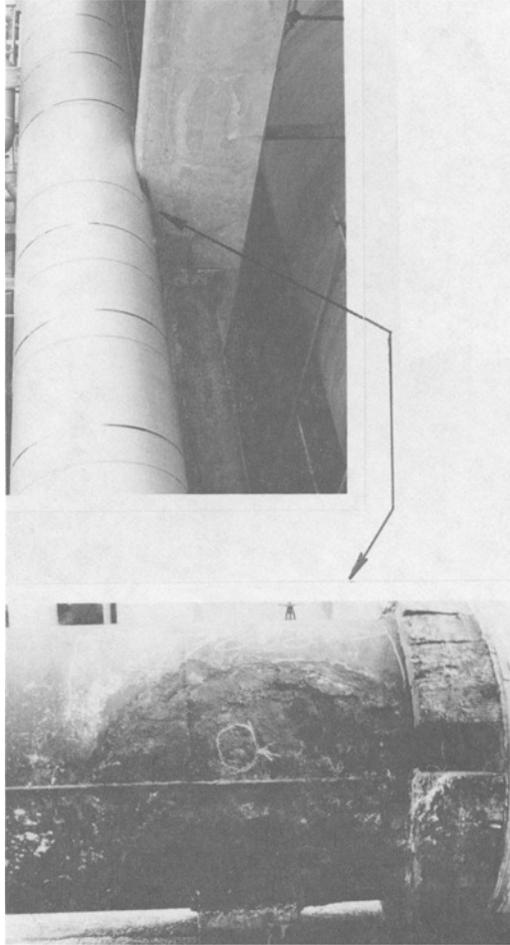
FIG. 2—Example of CUI—jacketing open at support. Insulation jacket open at vertical beam caused severe local corrosion. The line diameter is 900 mm.

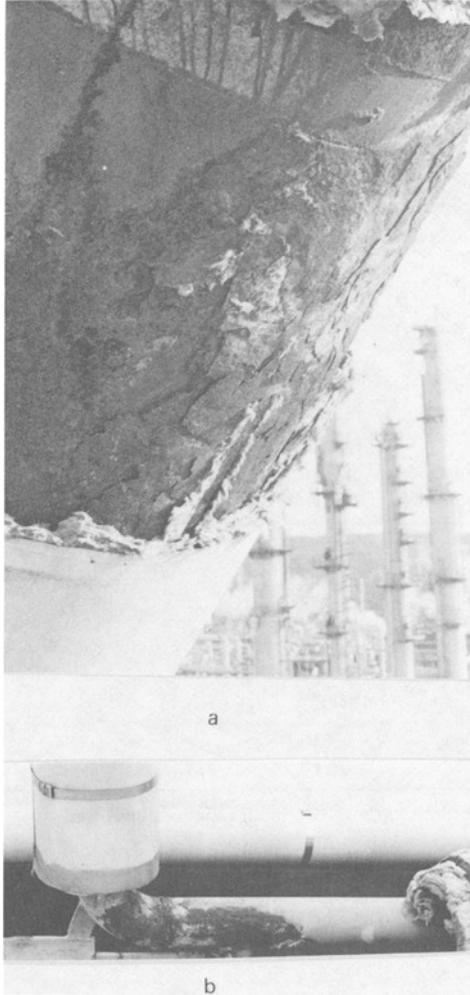
FIG. 3—Examples of typical CUI—effect of painting: (a) band of shop painting locally prevented CUI and (b) inorganic zinc silicate without top coat does not protect for CUI. Insulation removed after four years.

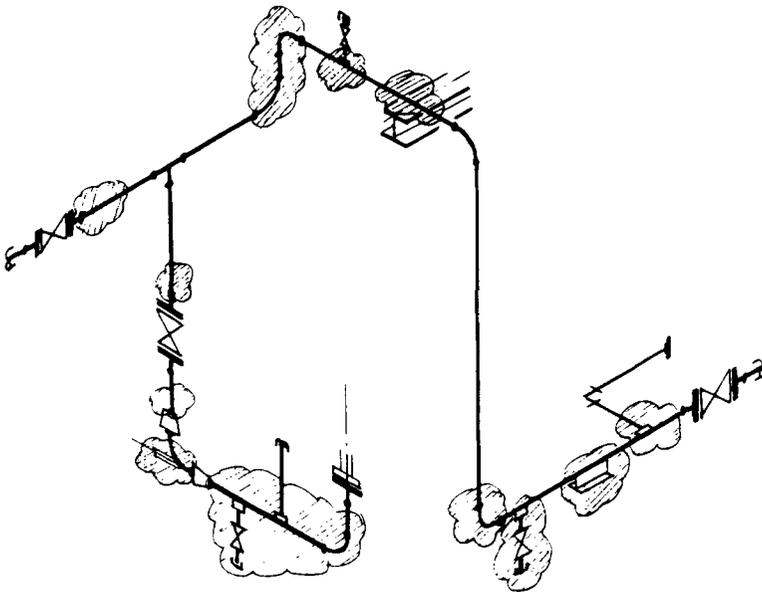
FIG. 5—Areas critical for CUI.

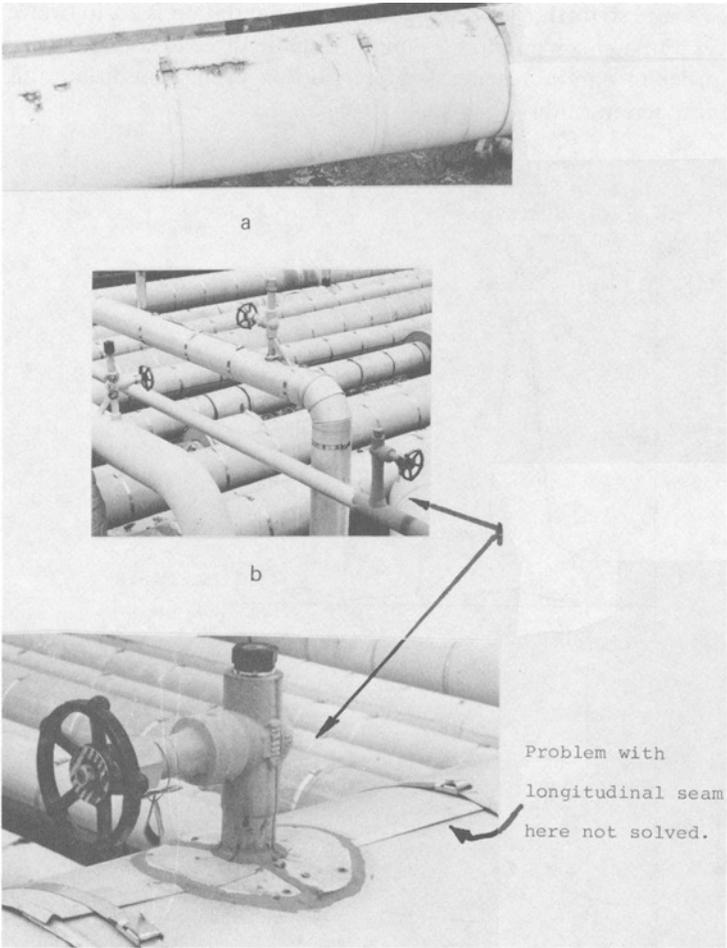
FIG. 7—Examples of designs to prevent CUI: (a) painted galvanized steel jacketing in service 20 years now at the end of life, and (b) valve design without gusset easier to seal.

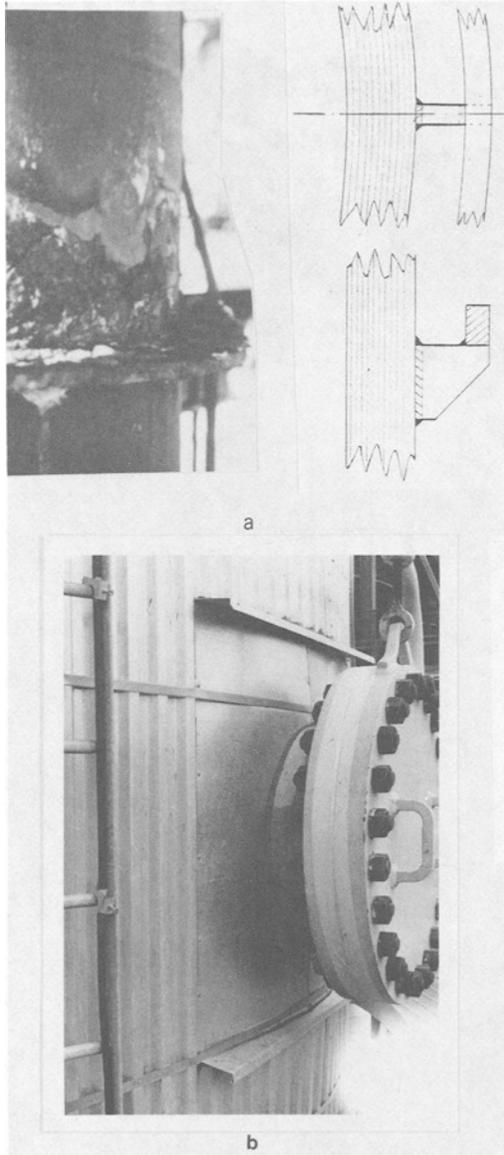
FIG. 8—Examples of designs to prevent CUI: (a) this design of insulation support ring should prevent corrosion shown on the left and (b) jacketing details at manhole.

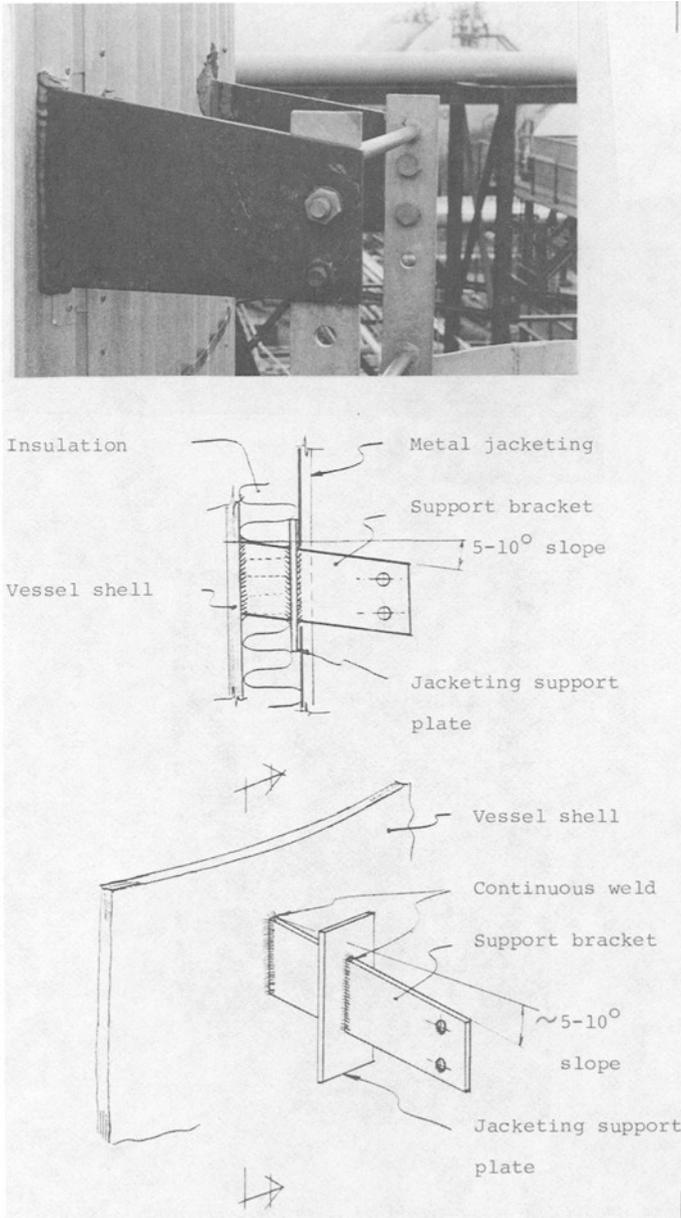
FIG. 9—Example of design to prevent CUI: support bracket.

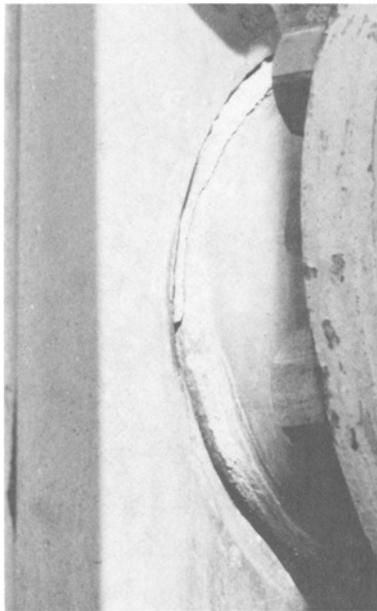
FIG. 1—*Deteriorated caulking, stainless steel vessel.*

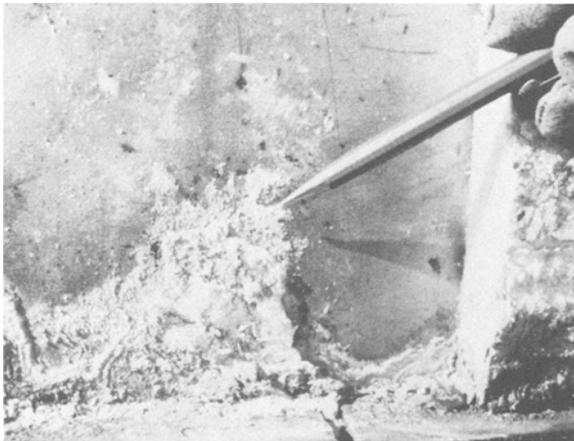
FIG. 3—*Crusty deposits on stainless steel vessel.*

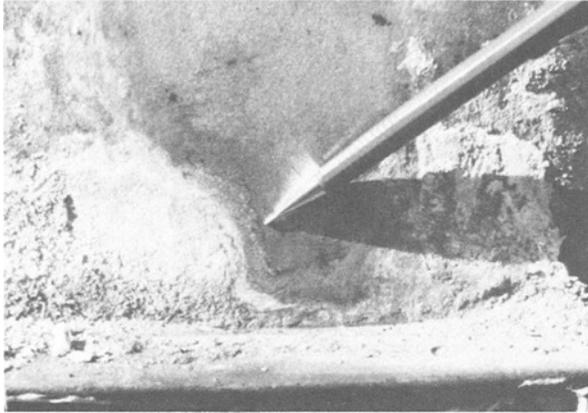
FIG. 4—*Iron stain on stainless steel.*

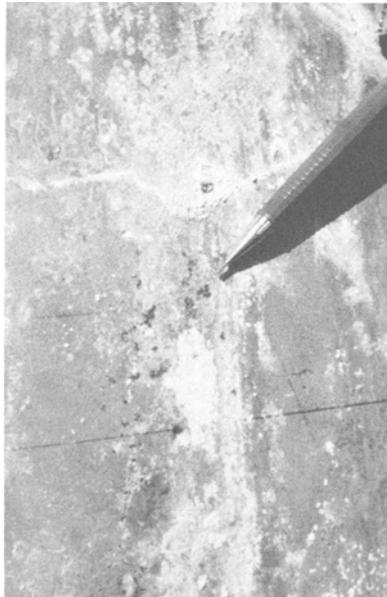
FIG. 5—*Pitting of stainless steel.*

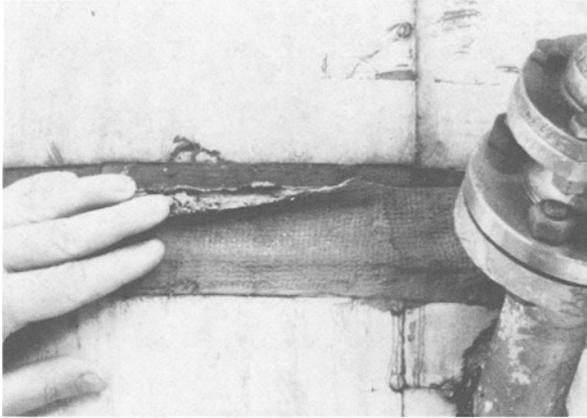
FIG. 8—*Leak point, jacket of a carbon steel vessel.*

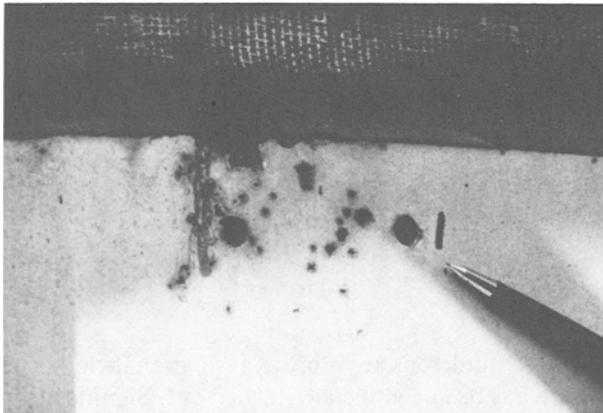
FIG. 9—*Corroded aluminum jacket.*

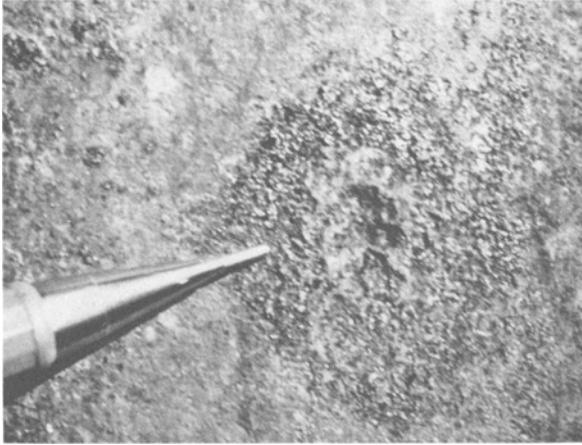
FIG. 10—*Minor pitting of carbon steel.*

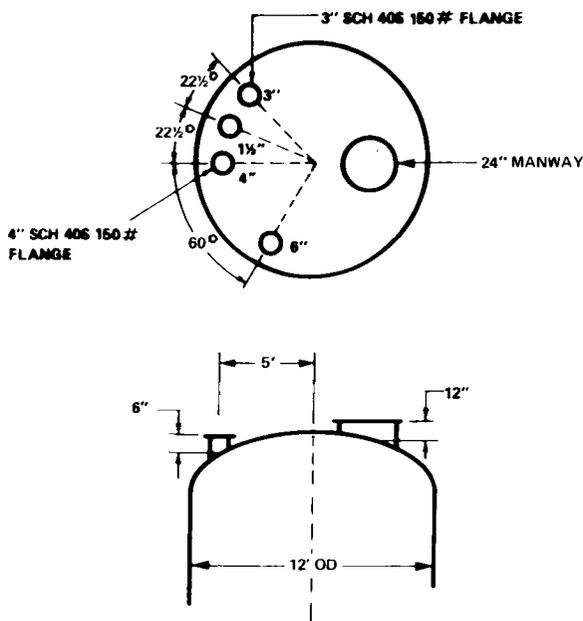
FIG. 1—Sketch showing location of nozzles on vessel head.

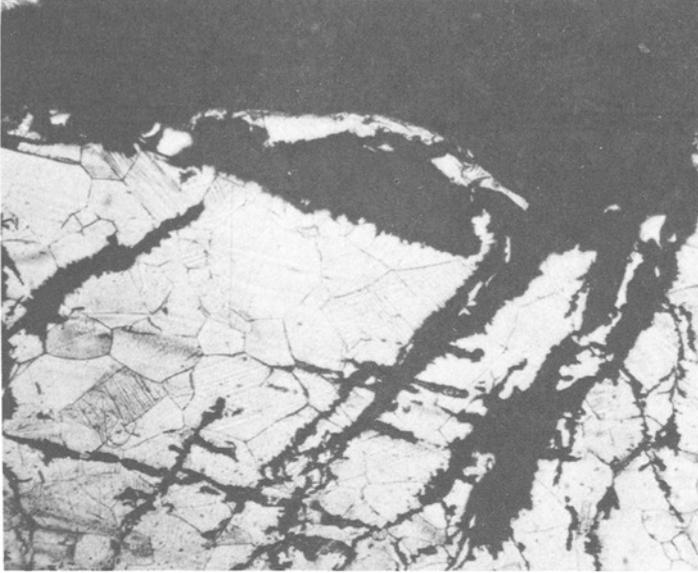
FIG. 4—Section through 10.2-cm (4-in.) nozzle. Corrosion and stress corrosion cracking. (Approximately X100).

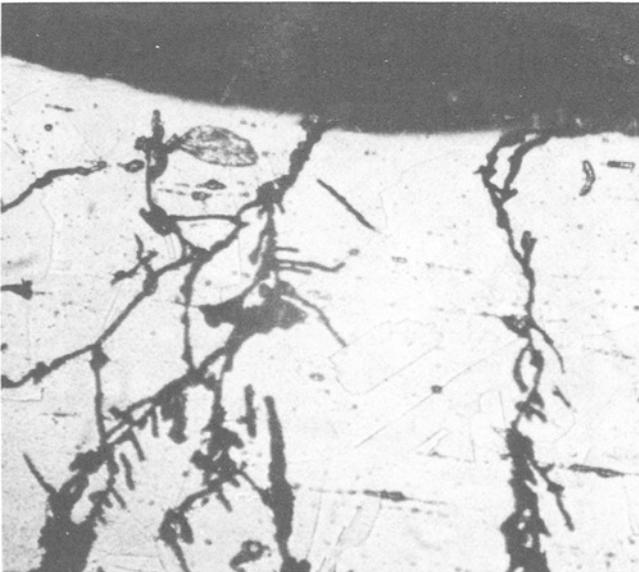
FIG. 5—Section through 7.6-cm (3-in.) nozzle. Stress corrosion cracking. (Approximately X200).

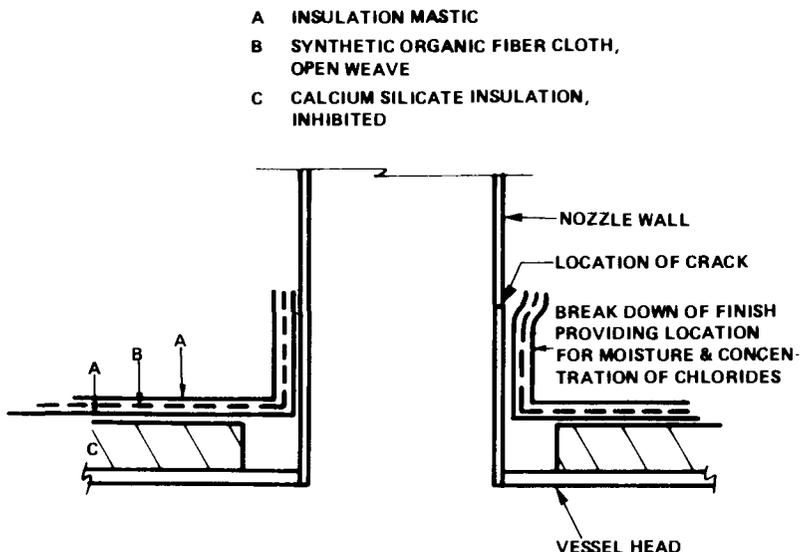
FIG. 6—Insulation system on failed nozzle showing crack location.

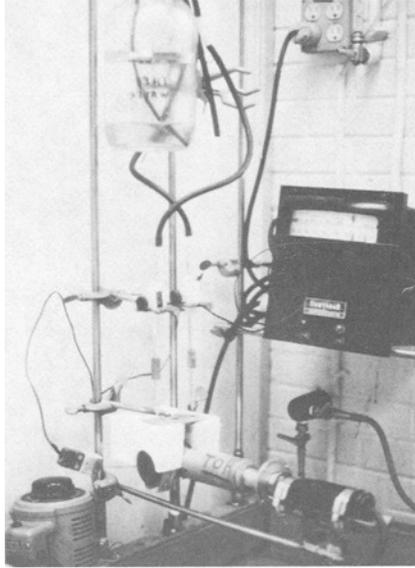
FIG. 3—Lab test apparatus used to determine if insulation materials would cause stress corrosion cracking of Type 316 stainless steel.

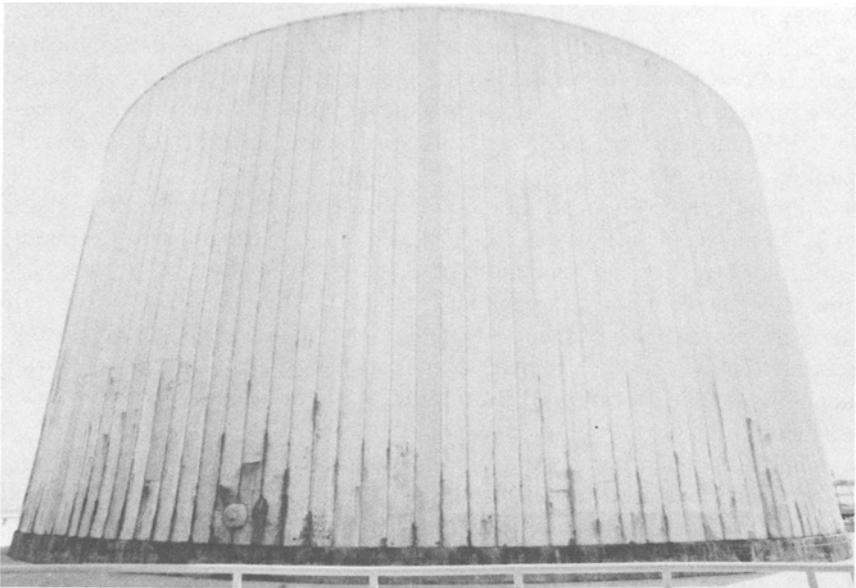
FIG. 1—*Rust breakthrough on vertical foamed in-place urethane insulation.*

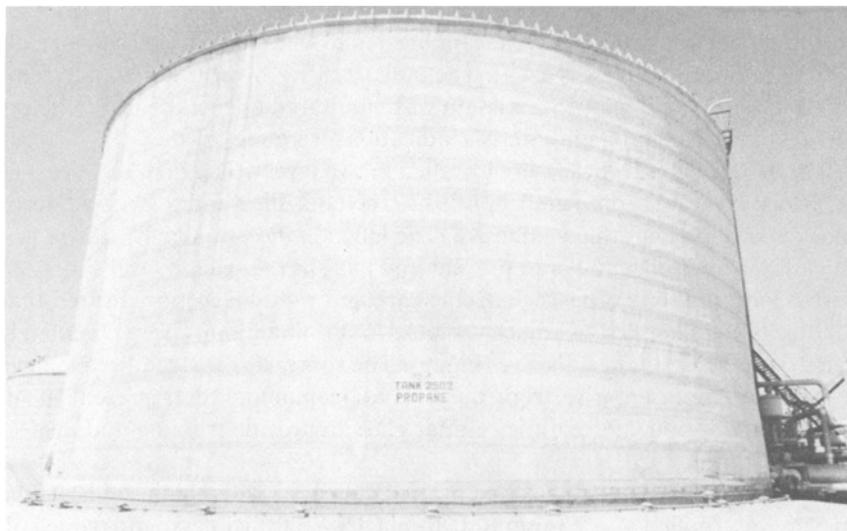
FIG. 3—Rust breakthrough on horizontal foamed in-place urethane insulation.

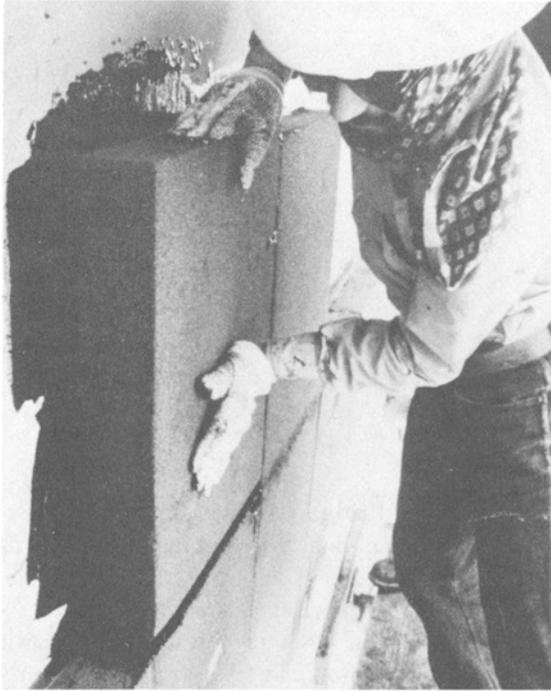
FIG. 5—Application of foam glass, note "battered joints."

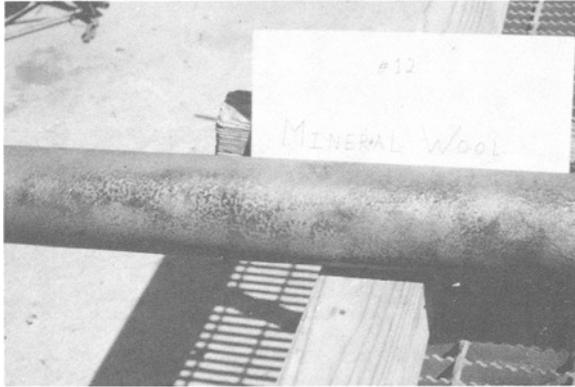
FIG. 8—Part of the pipe after the test and cleanup. Ultrasonic thickness measurements were taken at this time.

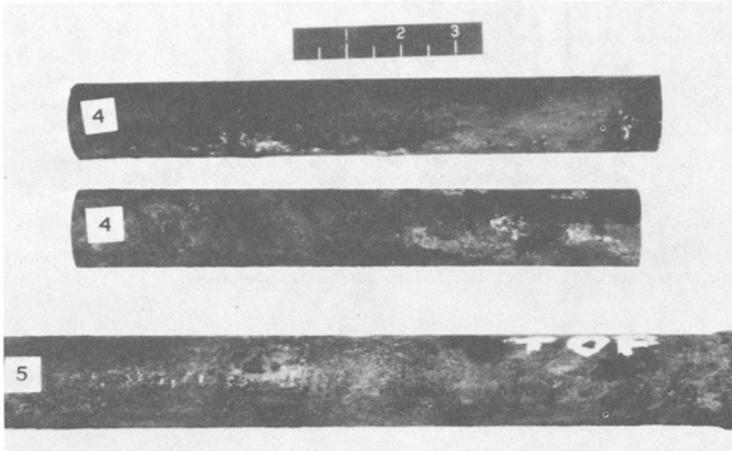
FIG. 1—*External surfaces of corroded underground copper water tube that had been thermally insulated with a natural carbonaceous granular material. The perforation in Specimen 5 (see encircled area) had initiated on the outside surface of the tube (~X0.4).*

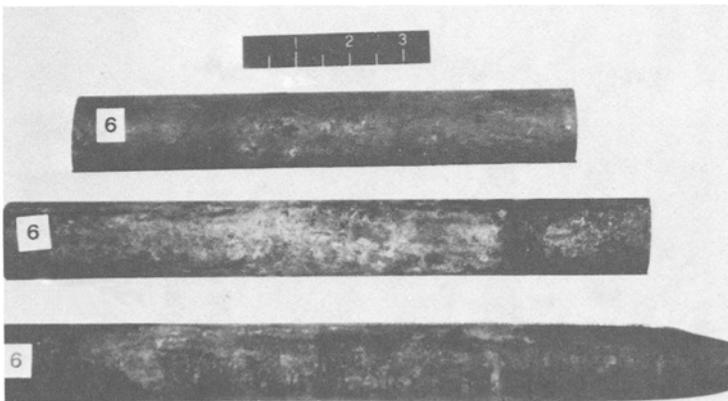
FIG. 2—*External surfaces of additional corroded underground copper water tube that had been thermally insulated with a natural carbonaceous granular material. Typically, the corrosion products consisted of black copper sulfide overlain with green copper sulfate (~X0.4).*

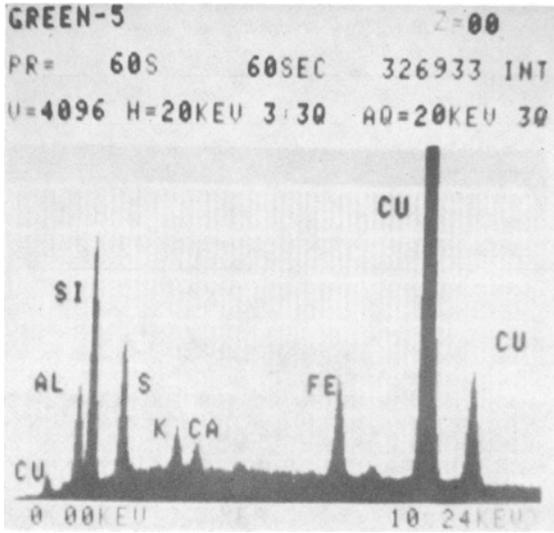
FIG. 3—EDXA and microchemical analyses revealed that the green copper corrosion product on the outside surface of the tube consisted primarily of copper sulfate.

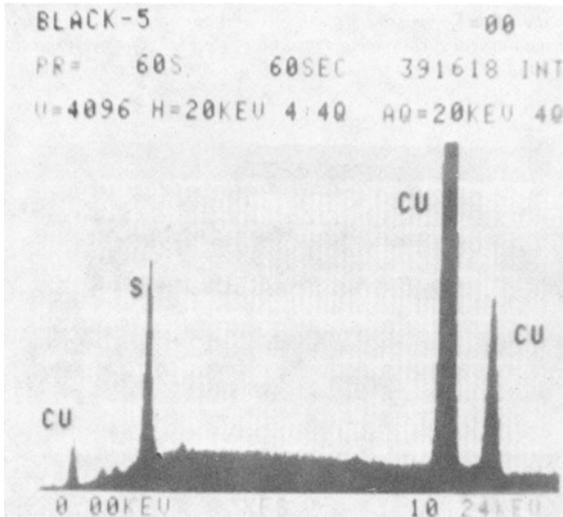
FIG. 4—EDXA and microchemical analyses revealed that the black copper corrosion product on the outside surface of the tube consisted primarily of copper sulfide.

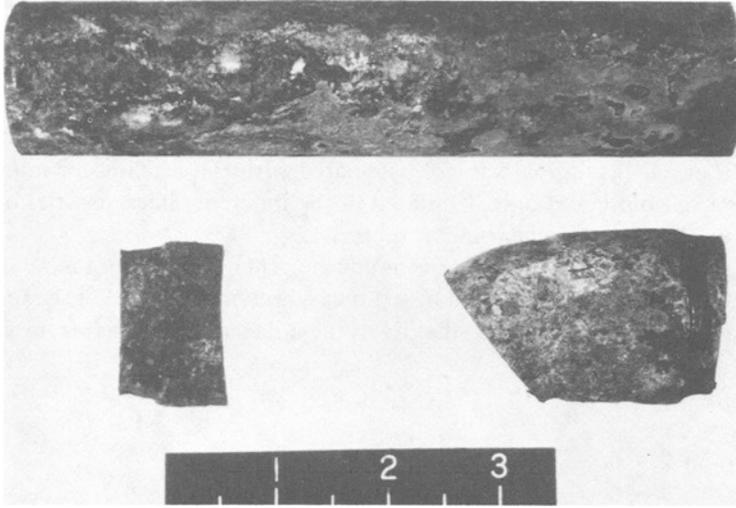
FIG. 5—External surfaces of corroded underground copper water tube that had been thermally insulated with a natural carbonaceous granular material. Typically, the corrosion products consisted of porous reddish-brown cuprous oxide overlain in part with green copper sulfate and copper chloride ($\sim X1$).

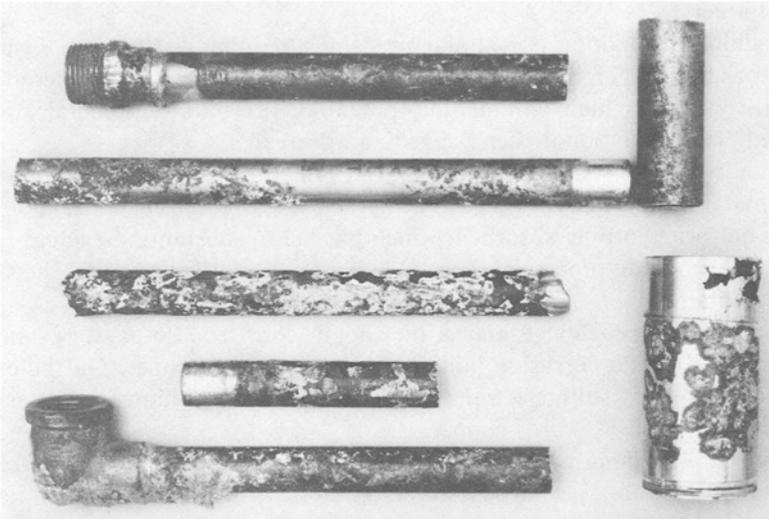
FIG. 6—Outside surface of copper water tube displaying extensive attack caused by aggressive cellulosic insulation ($\sim X1$).
