Corrosion of Metals Under Thermal Insulation

CORROSION OF METALS UNDER THERMAL INSULATION

ASTM SPECIAL TECHNICAL PUBLICATION 880
Warren I. Pollock, E. I. du Pont de Nemours
and Company, and Jack M. Barnhart,
Thermal Insulation Manufacturers
Association, editors

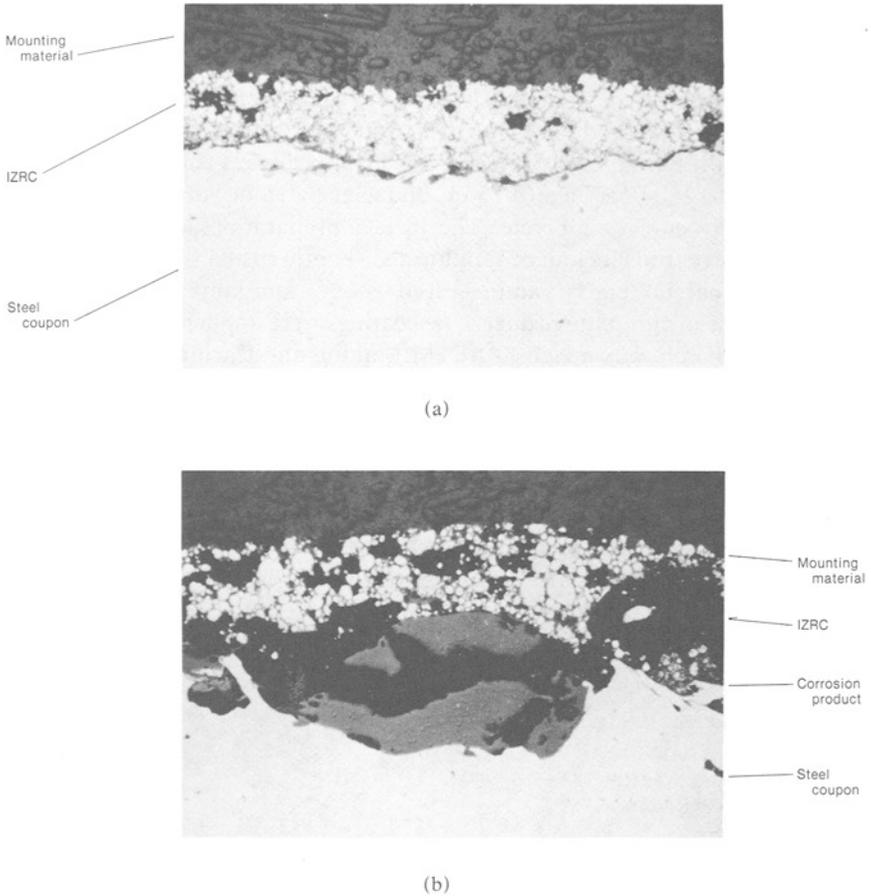
FIG. 2—(a) Cross section of a panel coated with IZRC before testing. The coating is continuous, tightly adherent to the steel substrate, and contained a few isolated pores. (b) Cross section of a panel coated with IZRC after testing under polyurethane foam. Degradation of the coating has occurred with a buildup of corrosion products at the coating/substrate interface. (X150)

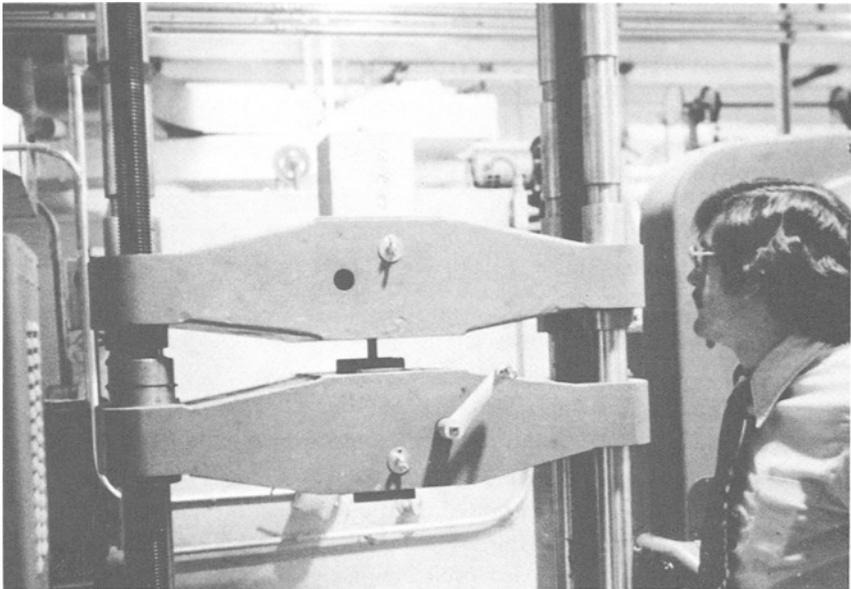
FIG. 3—Apparatus used to measure the bond strength of coated and uncoated steel bars to concrete. The concrete cube was held fixed by the upper arm of the tensile machine, while the lower arm pulled the bar downward. Loads were monitored to the nearest 89 N (20 lb).

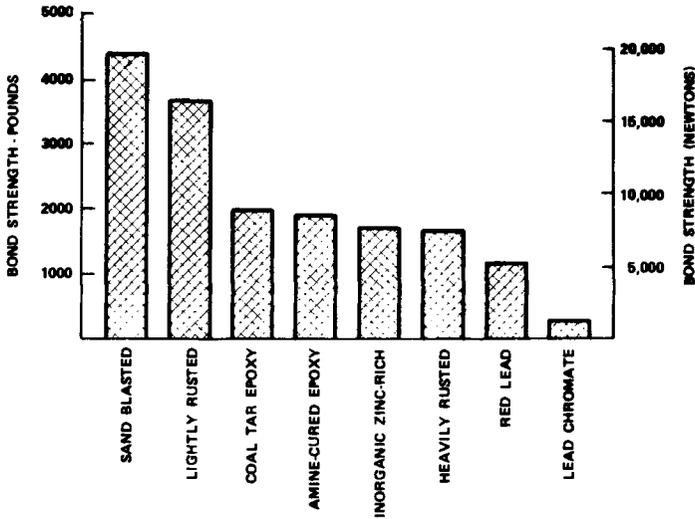
FIG. 4—Pull out test results.

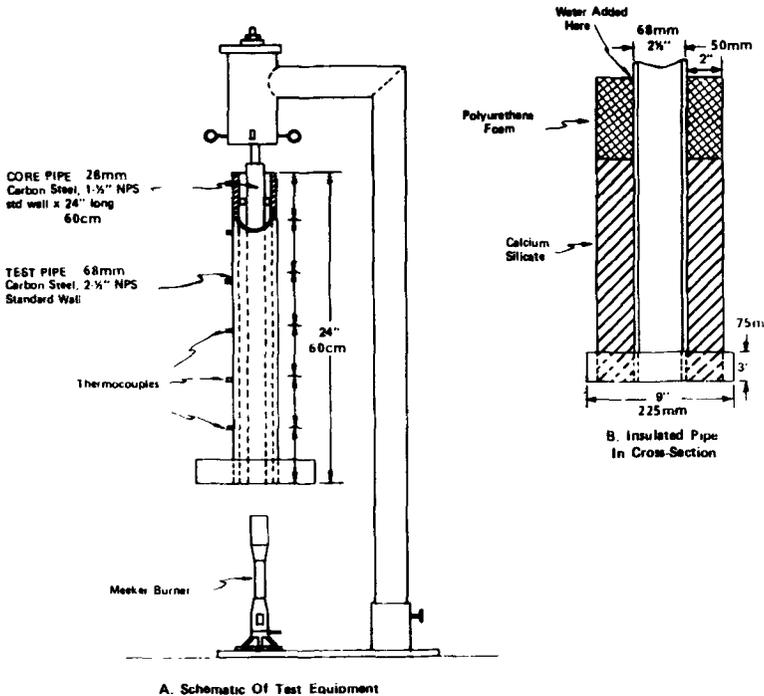
FIG. 5—High-temperature paint testing equipment.

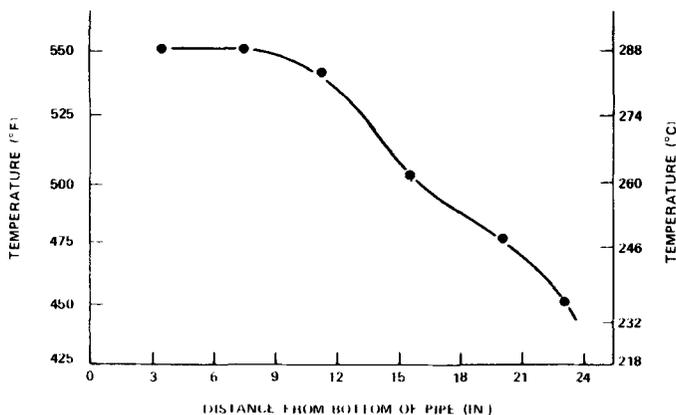
FIG. 6—Temperature profile of test pipes.

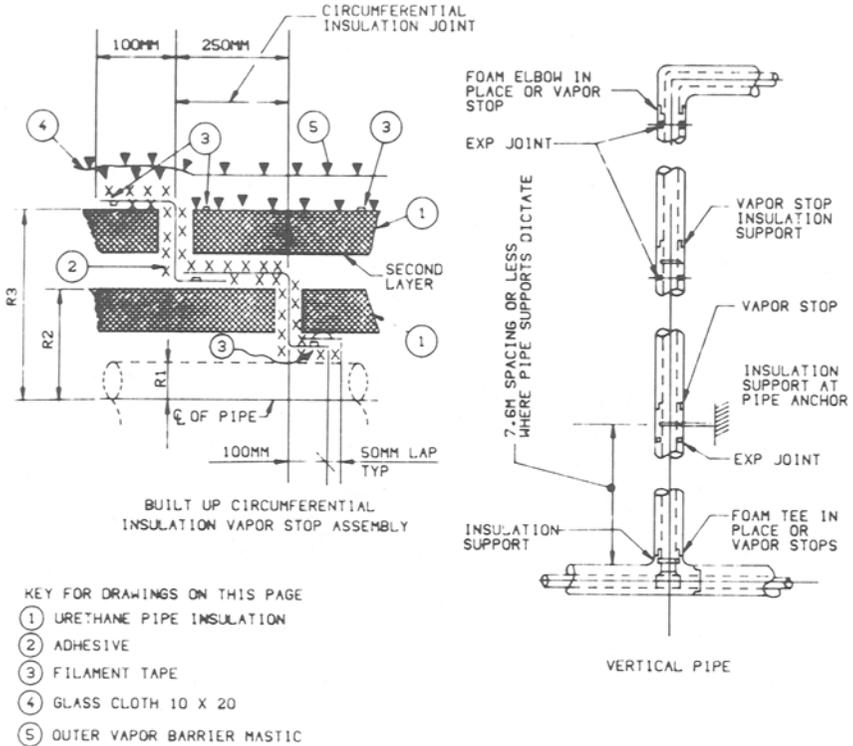
FIG. 7—Design features of the cold insulation.

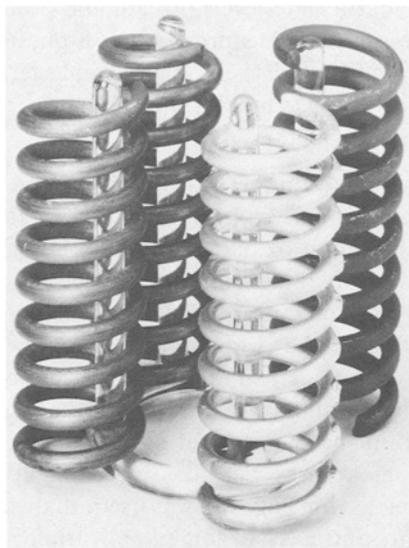
FIG. 1—Coiled spring specimens used in stress corrosion testing.

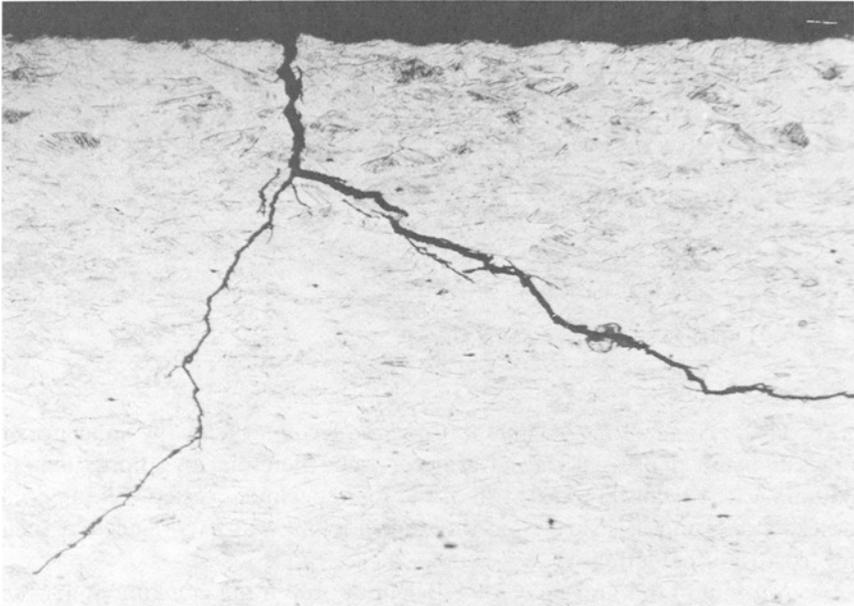
FIG. 2—Microsection of typical stress corrosion crack in coiled spring specimen.

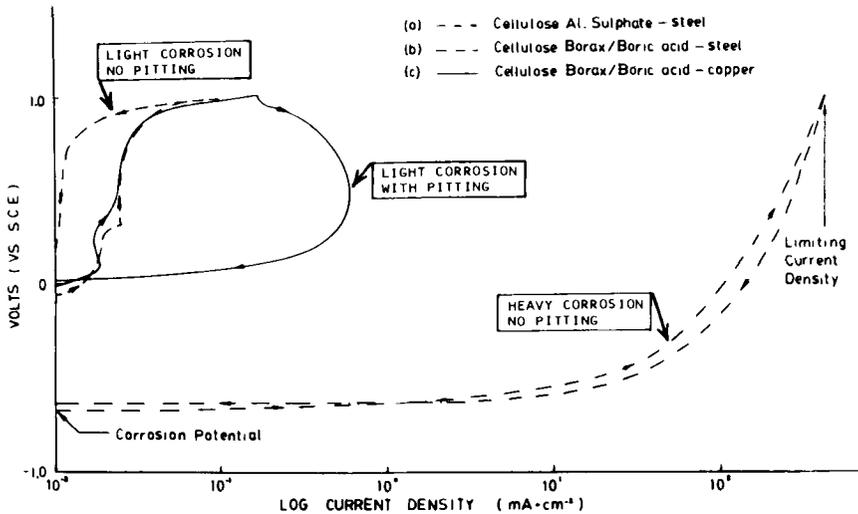
FIG. 1—Typical cyclic voltammetry curves obtained in insulation leachants.
