IEC TR 61000-1-3

Electromagnetic compatibility (EMC) –

General – The effects of high-altitude EMP (HEMP) on civil equipment and systems

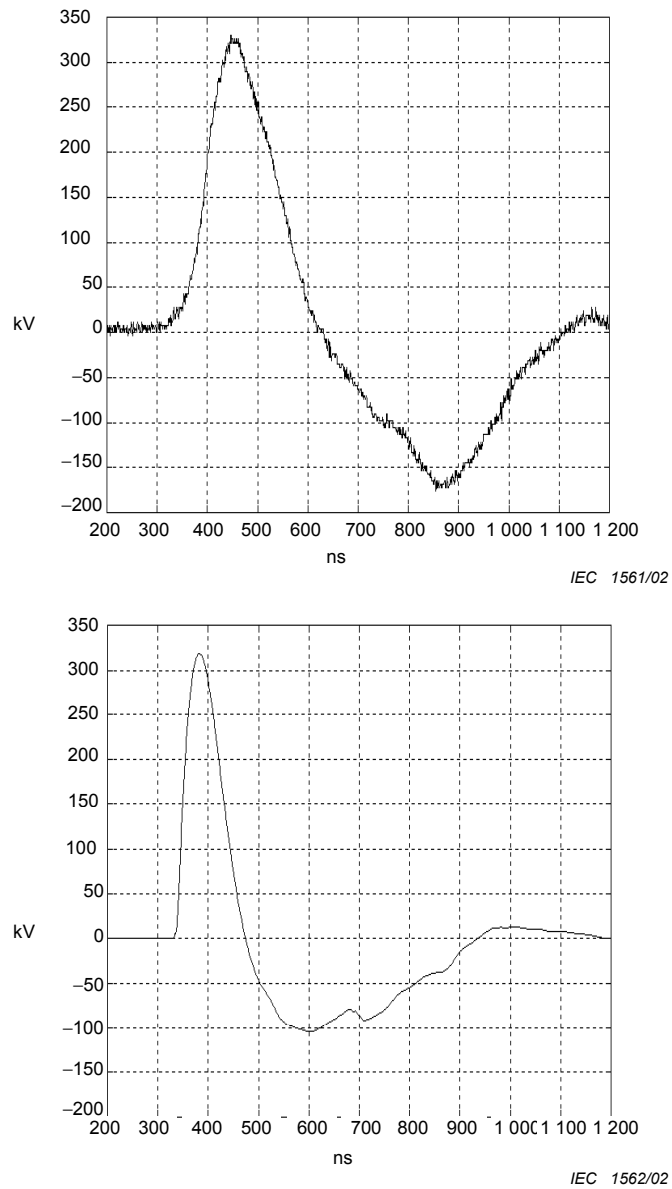
Figure 16 – Comparison of measured (left) and calculated (right) HEMP simulator-induced voltage (line to ground) at position M in figure 15, where the line turns 90°

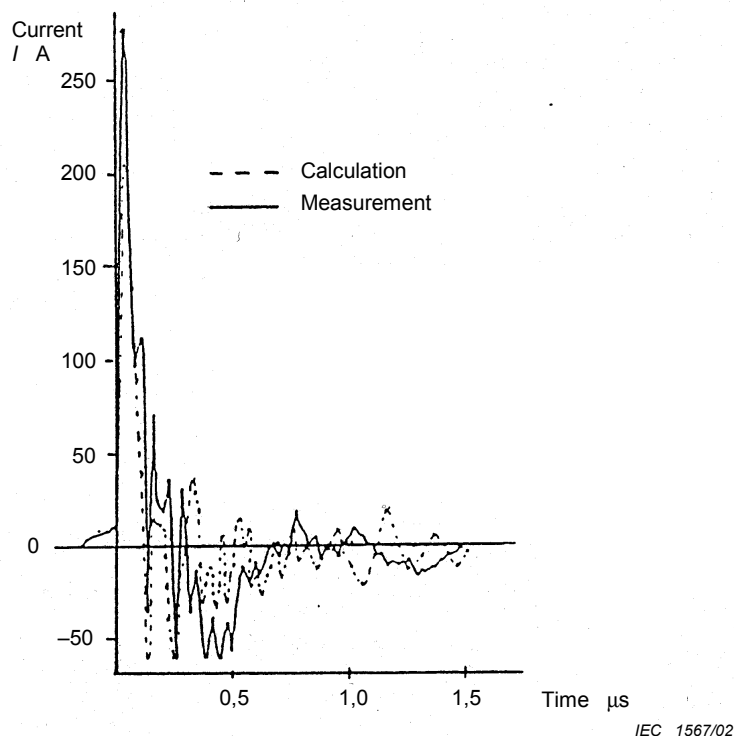
Figure 21 – Comparison of measured (solid line) and calculated (dashed line) currents flowing on the shielding wire

As in previous cases, this experiment illustrates that the coupling of HEMP fields to long lines is well understood and can be predicted well with existing computer models. This supports conclusions derived from atmospheric nuclear test experiments where unexpected effects were observed, but where no measurements were performed. Therefore, for these cases, it has been necessary to compute the conducted transients that caused the reported system effects.
