**Plain bearings — Appearance and  
characterization of damage to metallic  
hydrodynamic bearings —**

**Part 2:  
Cavitation erosion and its  
countermeasures**

Reference number  
ISO 7146-2:2008(E)

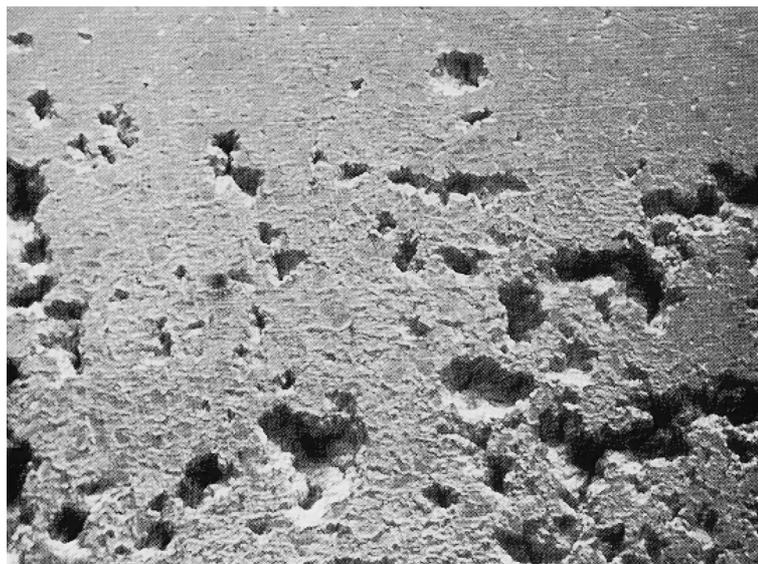
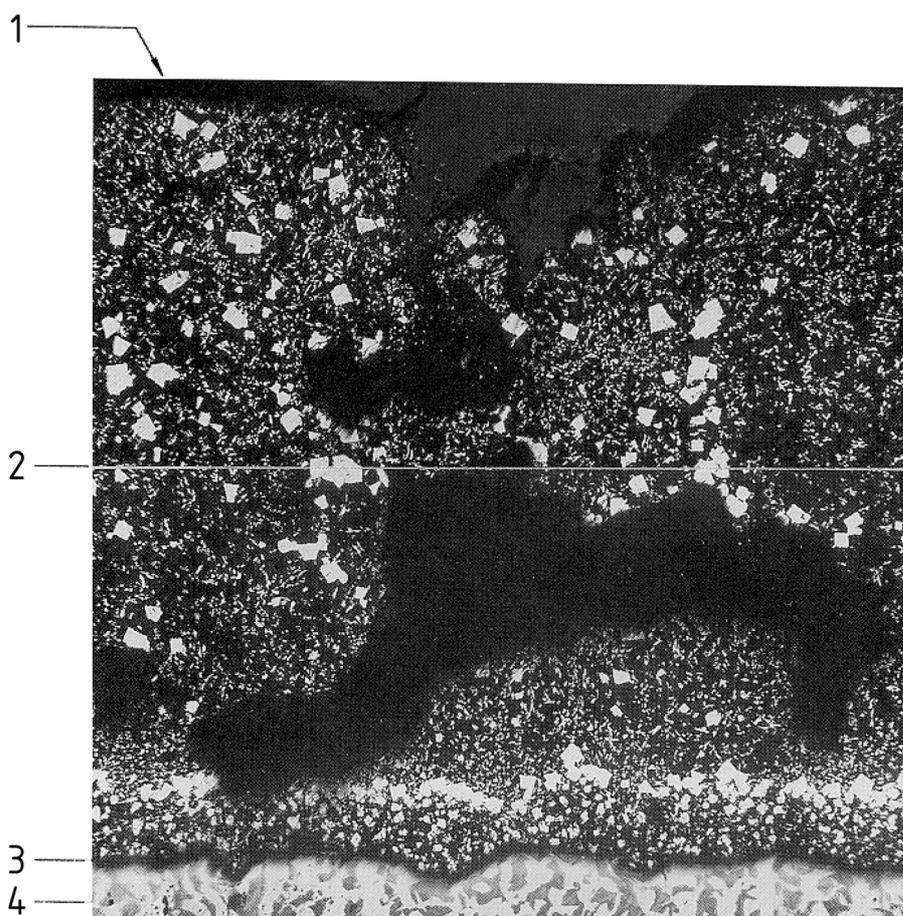
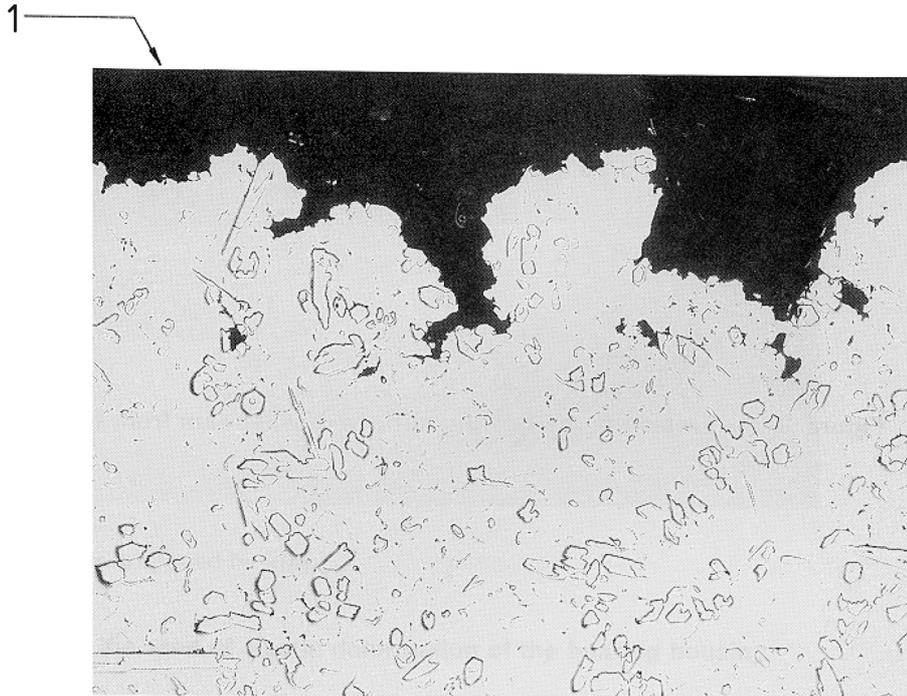
a) view under magnification

b) cross-section under magnification

| 1 sliding surface | 3 bonding area |
| 2 bearing metal (tin-based) | 4 steel backing |

c) cross-section under higher magnification

**Figure 1 — Sliding surface with cavitation erosion**

When a bearing surface is eroded by cavitation, first the colour of the surface changes slightly due to roughening. Then small pores form, and cracks initiate on the surface, especially at grain boundaries. These cracks with sharp edges are spread first on the surface and then deepen according to the properties of the underlying material (see Figure 1). The cracks are joined together leading to break-out and wash-away of small particles of bearing materials.

When the damage is caused solely by collapsing cavities, the attacked areas show a rough texture. Metallurgical section often shows signs of local work-hardening and fatigue cracking due to hammer blows caused by cavity collapse. But if particles are trapped in the damage pockets, the surface can be eroded and exhibits a smooth and polished appearance. The place of cavitation erosion is usually limited locally and spreads seldom to a broader region. The cavitation erosion usually appears in the unloaded areas of the bearing.

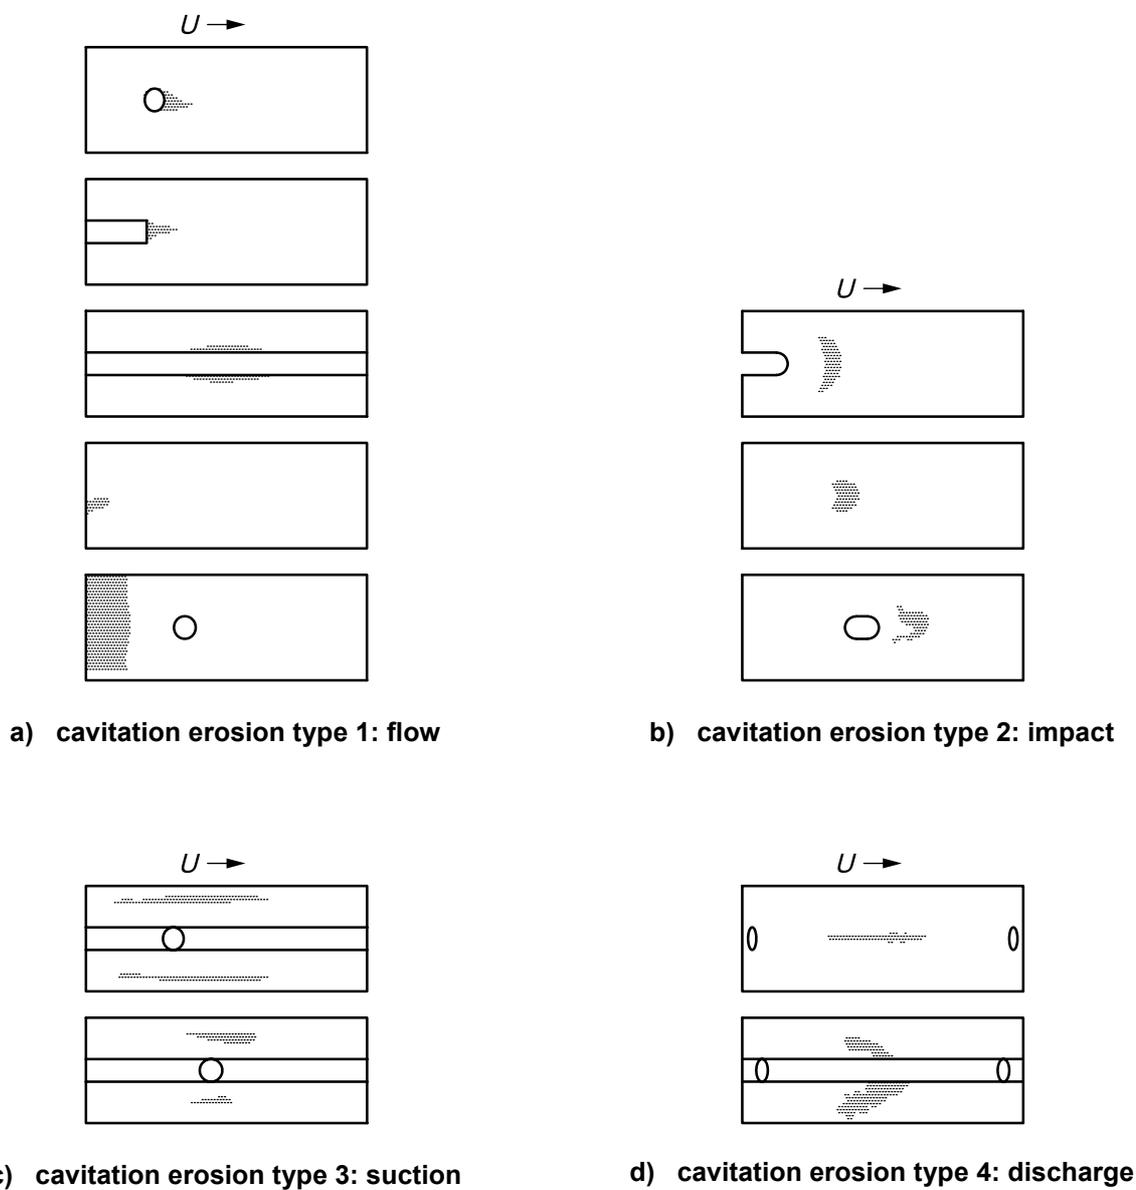
*U* direction of journal rotation

**Figure 2 — Examples of the characteristic appearance of four types of cavitation erosion in journal bearings**

For four types of cavitation erosion, typical damage appearance, possible causes, possible countermeasures and typical examples are given in the following (see Figures 2 and 3). General countermeasures are specified in 4.3. This clause gives some possible additional concrete countermeasures. In addition, some examples for miscellaneous cavitation erosion are given.

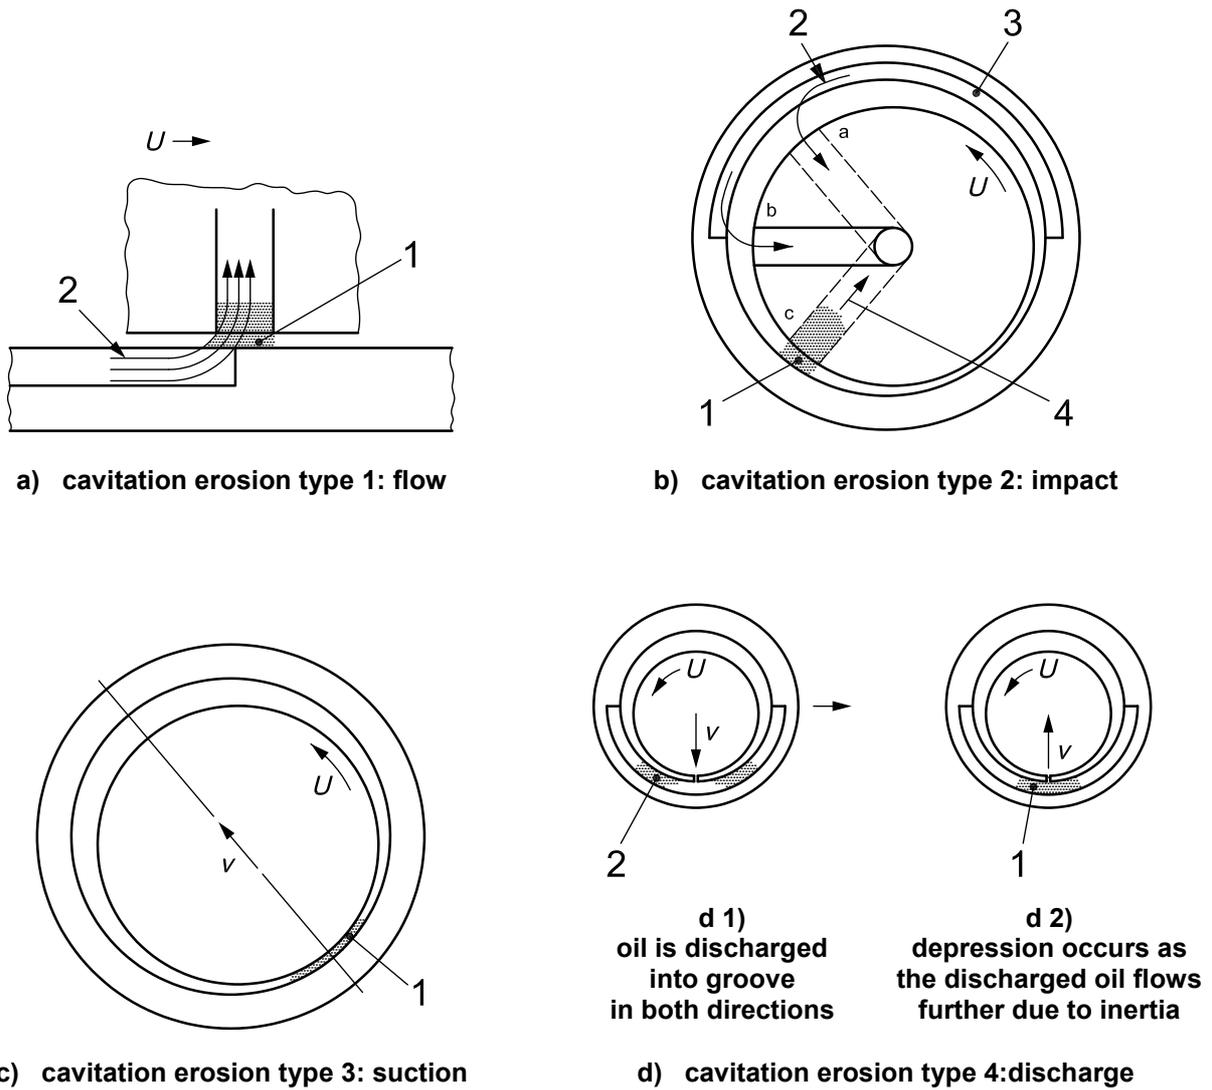
- 1 cavities in oil
- 2 oil flow
- 3 partial oil groove
- 4 oil column
- $U$  direction of journal rotation
- $v$  velocity of journal center
- a Continuous oil flow.
- b Oil flow abruptly stopped.
- c Oil inflow stopped, but oil column flows further by inertia, causing depression.

**Figure 3 — Mechanisms of four types of cavitation erosion in journal bearings**

When the oil flows over discontinuous surfaces as shown in Figure 3 a) at high speed, it cannot follow the discontinuities smoothly and breaks away from the bearing surface, producing high flow velocity and turbulence and consequently local pressure fluctuation. Therefore, high depression and cavitation occur and erosion follows upon implosion. It should be noted that flow cavitation erosion is different from fluid erosion, as the latter takes place without cavitation.

In cases where a journal bearing feeds oil via a partial-circumferential oil groove to an oil drilling in a rotating journal, the continuous oil flow [see Figure 3 b), footnote a] will be stopped instantaneously when the opening of the oil drilling passes the groove end [see Figure 3 b), footnote b]. However, the oil column in the oil drilling flows still further due to its inertia [see Figure 3 b), footnote c] and depression and cavitation take place in the drilling, thus causing erosion by implosion downstream of the oil groove end.

When the journal, in a dynamically loaded journal bearing, moves rapidly away from the bearing surface [see Figure 3 c)], suction or depression occurs behind the journal surface due to the negative squeeze effect, leading to evaporation of oil and then cavitation erosion by implosion.

When the journal, in a dynamically loaded journal bearing with a circumferential oil groove, rapidly approaches the bearing surface, the oil is squeezed out (discharged) from both sides of the bearing into the circumferential oil groove, where it rushes circumferentially in both directions [see Figure 3 d) 1)]. Both flows, due to their inertia, do not cease at the moment at which the journal motion direction reverses and no further oil is discharged into the groove. This leads to depression and cavitation erosion upon implosion [see Figure 3 d) 2)].

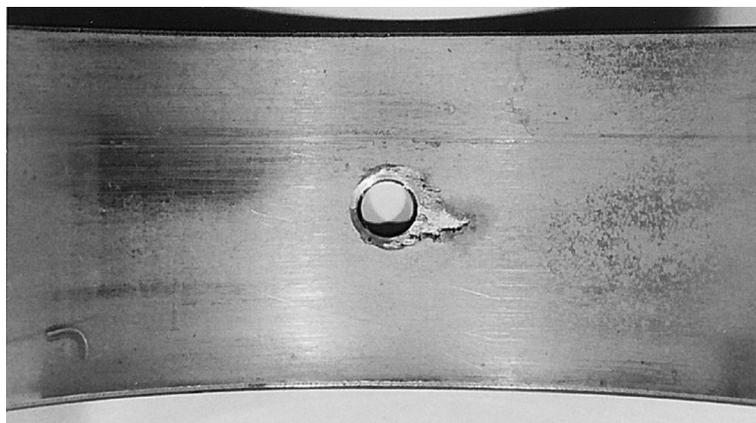
**Figure 4 — Flow cavitation erosion at the oil hole of a rod half big-end bearing in a petrol engine  
(material: steel/Al-Sn)**

- a) at the edge of oil holes (see Figure 4);
- b) at the downstream end of partial oil grooves in big-end bearings (see Figure 5);
- c) on the side faces and adjacent bearing surface of circumferential oil grooves (see Figure 6);
- d) adjacent to the joint face relief of a big-end bearing and a main bearing (see Figures 7 and 8);
- e) in deep scores and indentation in bearing surfaces.

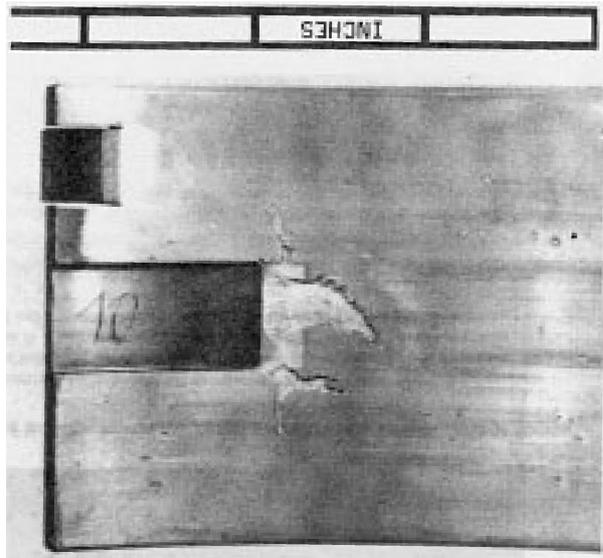
**Figure 5 — Flow cavitation erosion at the downstream end of a partial groove in a big-end bearing**

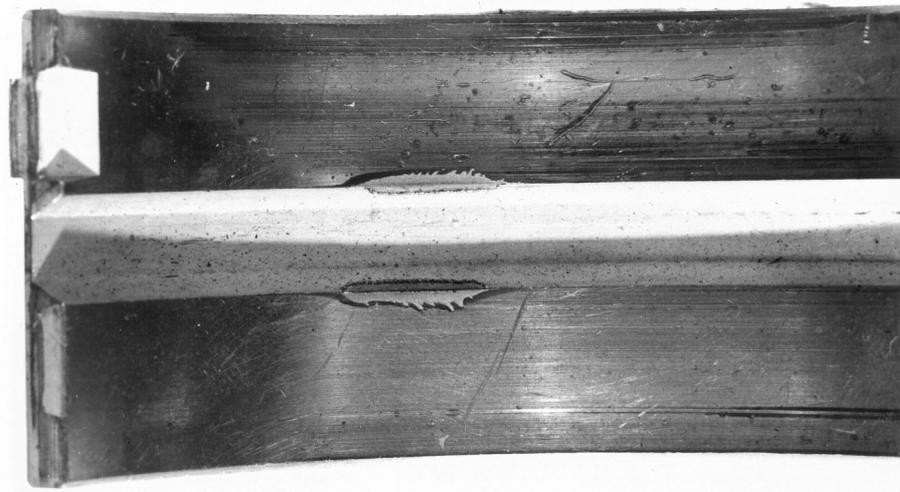
**Figure 6 — Flow cavitation erosion on both groove sides of the lower half of a center main bearing in a turbo charged 6-cylinder diesel engine**

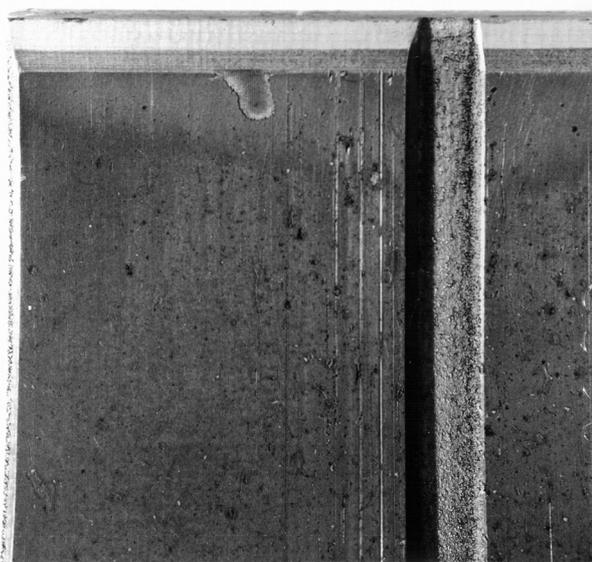
**Figure 7 — Flow cavitation erosion at the joint face relief in a big-end bearing**

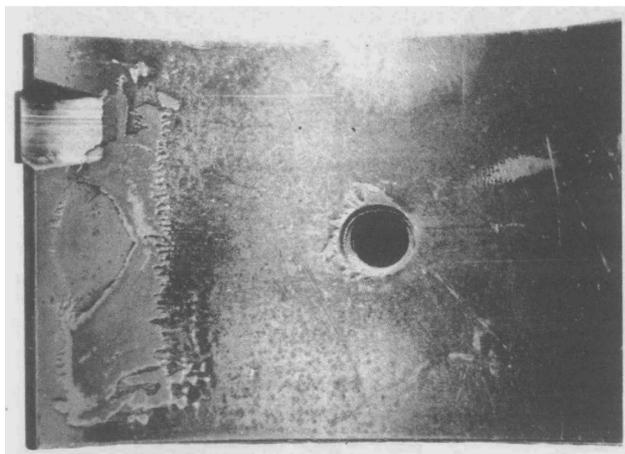
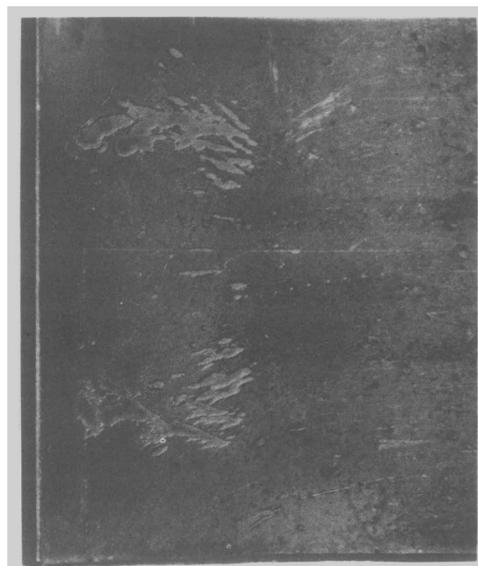
NOTE Only the lining material is damaged.

**Figure 8 — Flow cavitation erosion adjacent to the joint face relief of a main bearing and a big-end bearing of an automotive diesel engine**

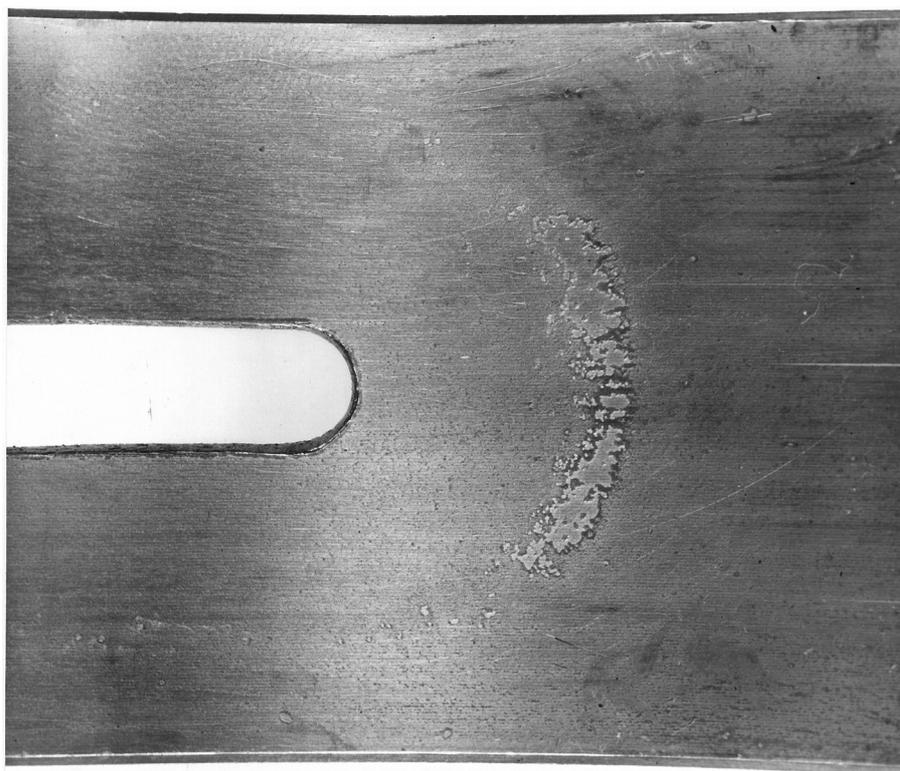
Figure 9 — Impact cavitation erosion at the end of 210° groove in a main bearing

The erosion usually takes the form of a kidney, ring or half-moon. Figure 9 shows a typical example of the impact cavitation erosion behind and at some distance from the downstream end of a partial-circumferential oil groove in a lower half main bearing, where the journal is provided with drillings for supplying oil to a big-end bearing in a high-speed engine. Figure 10 depicts the damage at two circumferentially different spots, as the engine has run at two different constant speeds. Similar erosion has also been experienced near the end of an oil bleed slot in the rod half of a big-end bearing (see Figure 11).

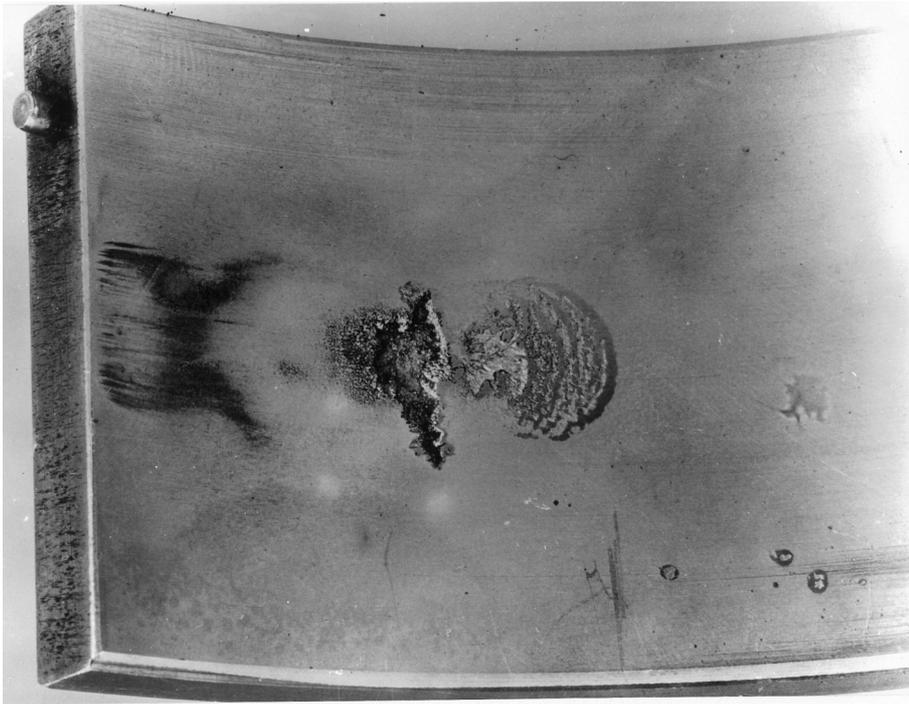
Figure 10 — Impact cavitation erosion behind the end of a 180° main bearing groove

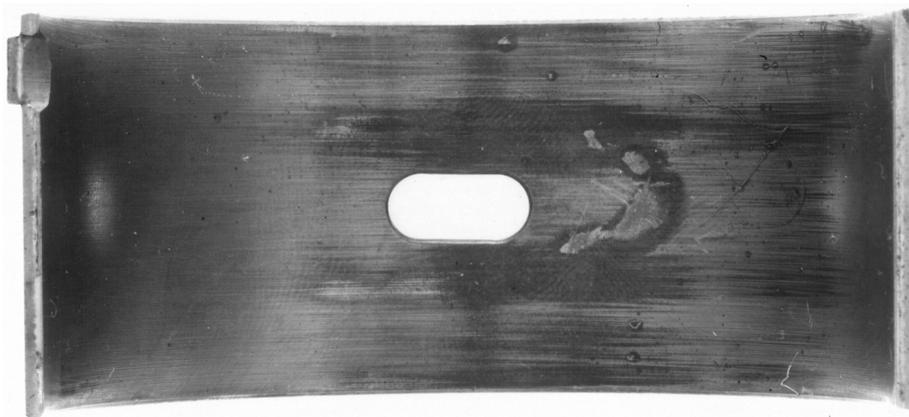
Figure 11 — Impact cavitation erosion near the end of an oil bleed slot in the rod half of a big-end bearing

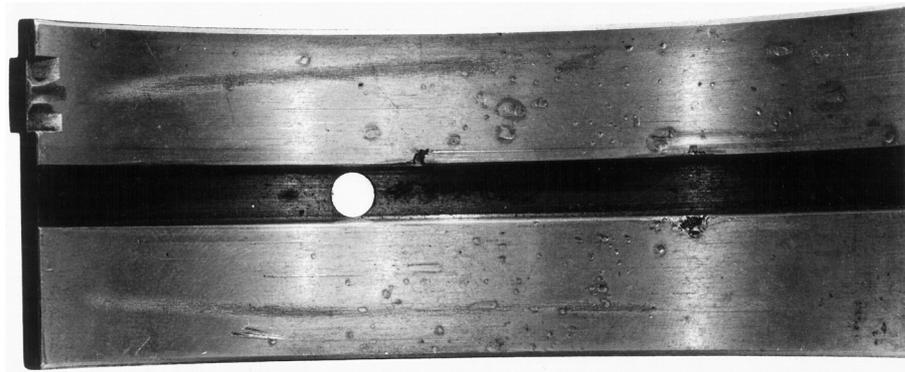
Figure 12 — Suction cavitation erosion in the upper half main bearing of a diesel engine

This erosion takes place only in dynamically loaded bearings. It has been experienced on the upper halves of main bearings and near the circumferential centre lines of the bearing lands. The damage took a long lancet-like form in a mild case (see Figure 12), and other forms (see Figures 13 and 14) in severe cases.

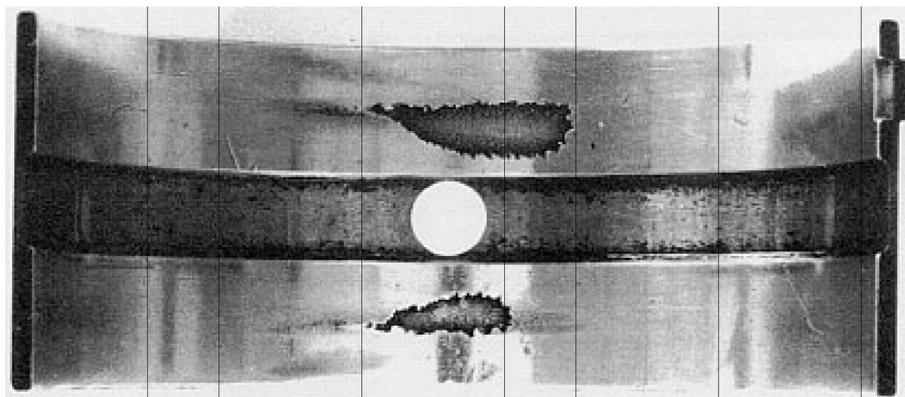
Figure 13 — Suction cavitation erosion in the relatively unloaded upper half of a main bearing in a high-speed diesel engine

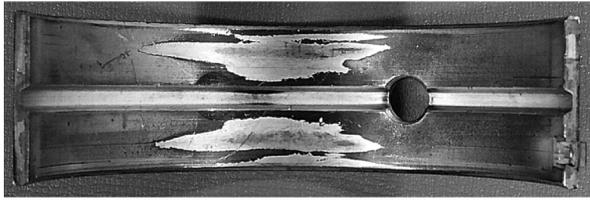
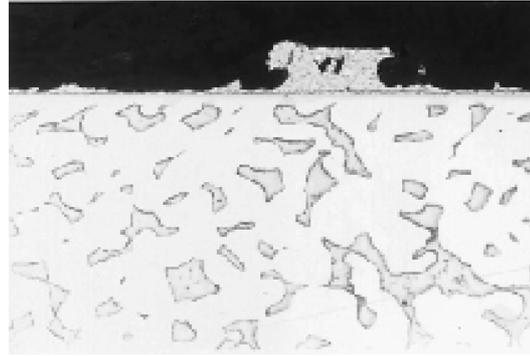
NOTE The overlay was attacked on both lands of the upper half of a main bearing in a diesel engine.

**Figure 14 — Suction cavitation erosion (material: steel/lead bronze/electroplated overlay)**

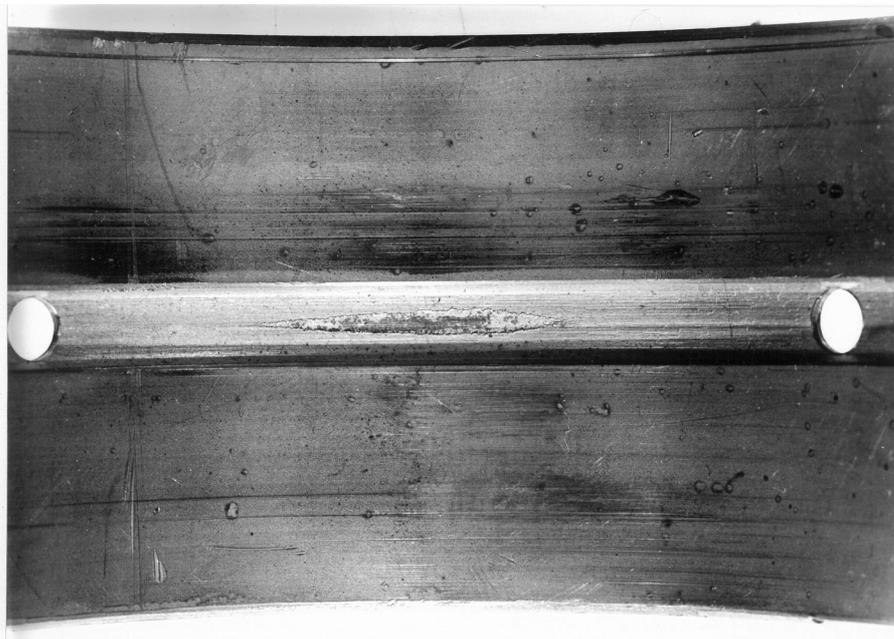
Figure 15 — Discharge cavitation erosion in a groove of the lower half main bearing of a petrol engine

This erosion occurs only in dynamically loaded bearings with a circumferential oil groove. Mild erosion appears in the lower half main bearing groove of a petrol engine, in the form of a long spear (see Figure 15). Severe erosion appears on both bearing lands in the lower half main bearing of a diesel engine, originating from the edges of the groove and progressing in the form of a V against the journal rotation direction (see Figure 16).

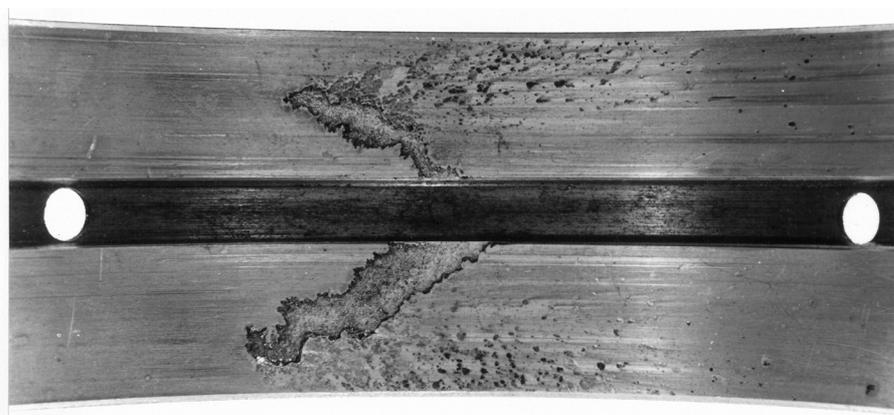
Figure 16 — Discharge cavitation erosion in a lower half main bearing of a diesel engine

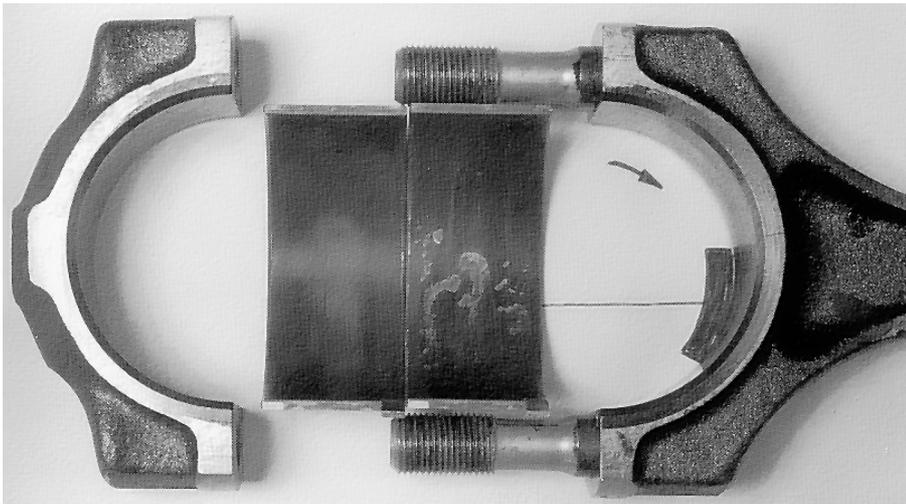
**Figure 17 — Miscellaneous cavitation erosion in the area of elastic deformation of the bearing housing (material: steel/lead bronze/electroplated overlay)**

In a big-end bearing of connecting rod, depression caused by elastic deformation and bending vibration of the big-end bearing housing can lead to cavitation erosion (see Figure 17). Abnormal combustion can also lead to bearing damage similar to that shown in Figure 18. This damage also seems to be partially due to suction cavitation erosion. Providing the connecting rod with more rigid housing may help.

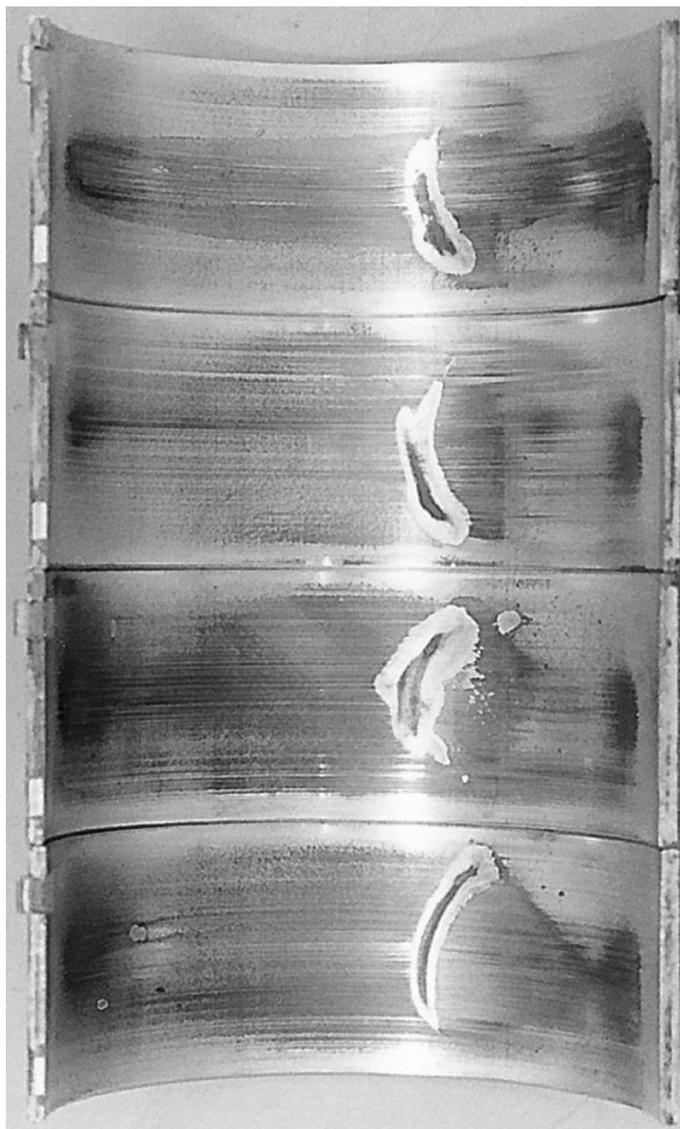
**Figure 18 — Miscellaneous cavitation erosion in a rod half big-end bearing in a diesel engine (material: steel/lead bronze/electroplated overlay)**

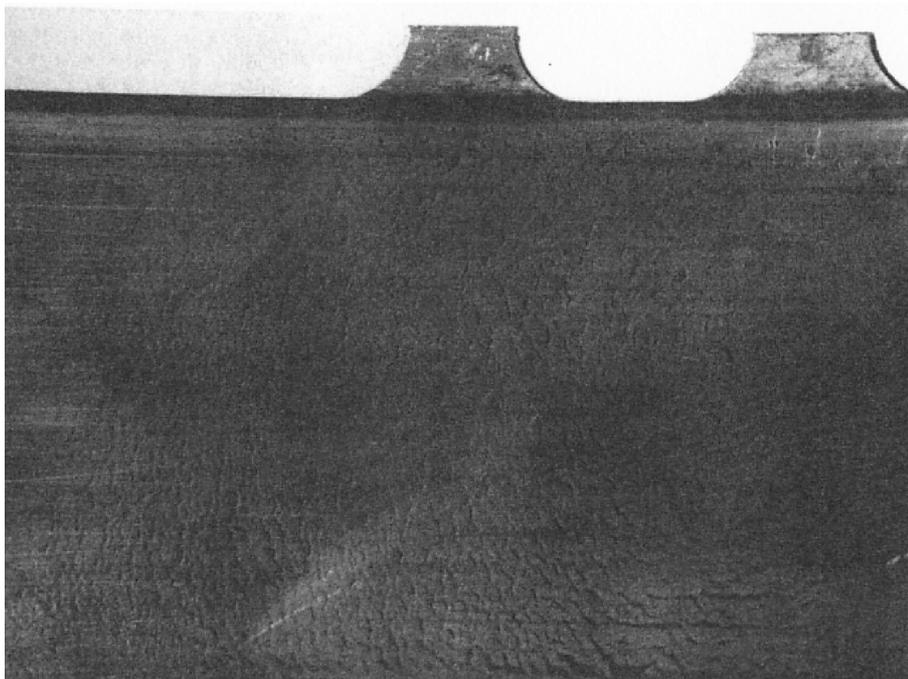
**Figure 20 — Miscellaneous cavitation erosion (rippled overlay in the big-end bearing of a medium-speed diesel engine, associated with dispersed fine cavitation erosion on the blended edge of the groove)**

**5.6.3 Rippling or roughening (see Figures 19 and 20).**

At an initial stage of cavitation erosion, change of colour and roughening occur on the surface attacked. Chemical reaction between constituents of oil and the bearing surface (therefore cavitation corrosion) may be stimulated by the high pressure and temperature caused by cavity collapse.
