**TWIN BOMBINGS AT ZAMBOANGA CITY  
11 AUGUST 2005  
PHILIPPINES**

The aim of this bulletin is to advise bomb technicians, forensics and investigators of the Twin Bombings in Zamboanga City dated 11 August 2005. The result of the Post Blast Reconstruction of evidence recovered and the possible explosive use in the bombing based on the damage assessment at the scene of the crime.

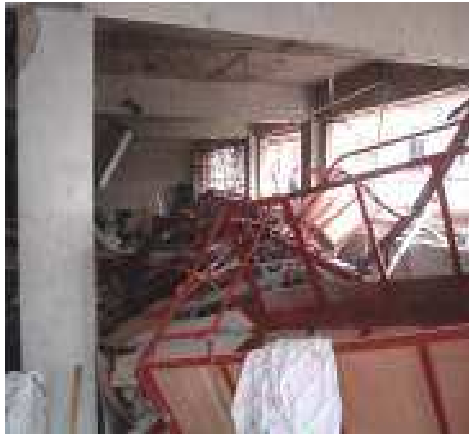
No primary fragment was found at the scene. However, based on the debris, venting of steel bars, pushing of metal from structure and the crater effect on the floor suggest a HIGH EXPLOSIVE was used in the device. A large amount of metal fragments were found scattered throughout the scene. The pushing of the sidewalls and concaving of the floors indicate of a multiplying blast pressure effect due to confinement of the rooms and of the building. The explosive effects are very common to the effects of a chlorate based explosive mixture of Potassium Chlorate mixed with sulfur and alluminum powder also known as the "dirty white powder". No other traces of explosive residue were found by the team from scene of the crime office (SOCO) except positive to the traces of nitrates in both explosion incidents.

Debris at the second floor

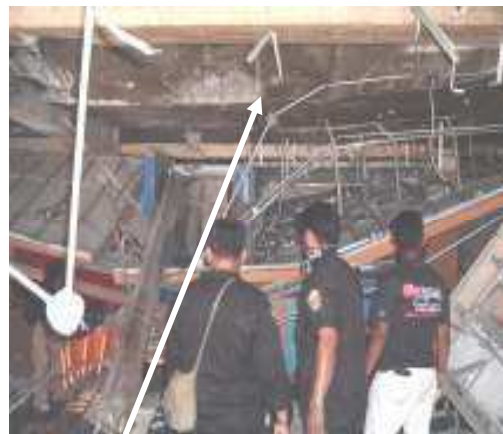
Concave ceiling at the ground floor

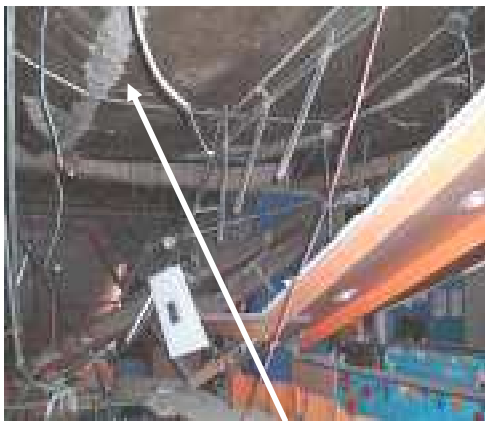
Crack concrete ceiling cause by strong pressure

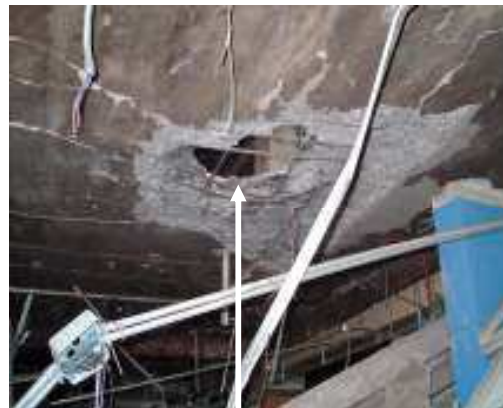
Exit Crater of the seat of explosion

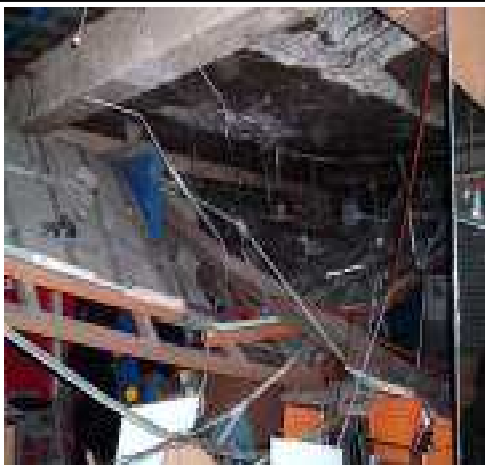
Damaged portion at the ground floor

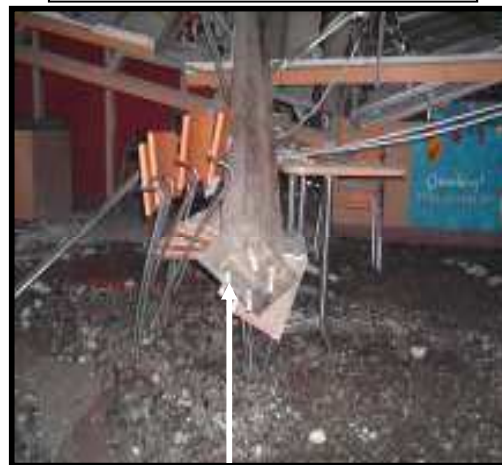
Detached steel beam cause by downward pressure

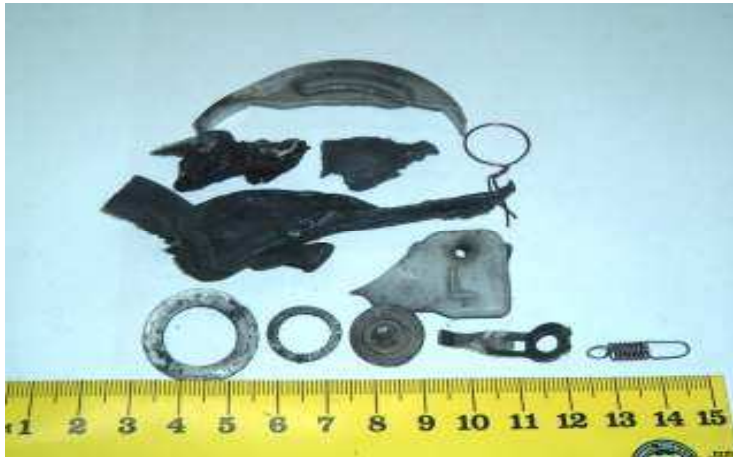
Parts of the Alarm Clock

- a) Several small parts of an alarm clock
- b) Disintegrated parts of possible 9 volts battery
- c) Swab samples taken by PRO 9, SOCO tm from the crime scene for chemical / laboratory analysis

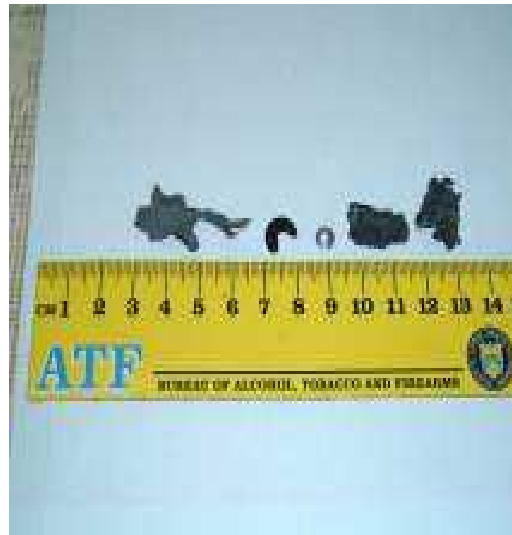
Possible parts of the clock

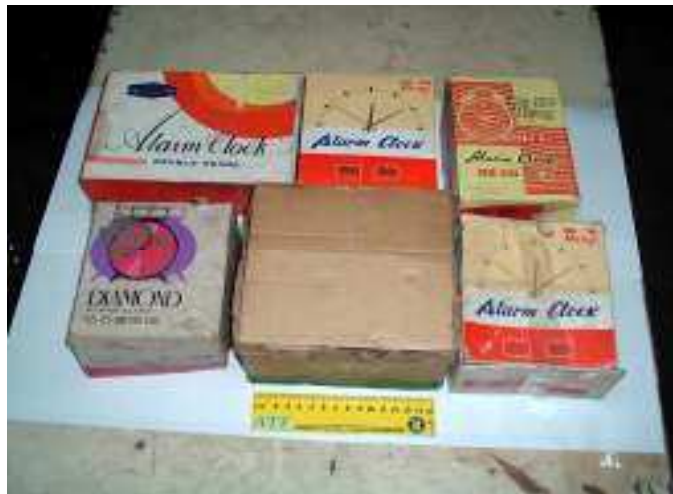
Empty six (6) boxes of alarm clock recovered at the hotel

- a) Several pieces of possible parts of a 9 volts battery
- b) Six (6) empty carton boxes of alarm clock made from Korea, Japan and China respectively.
- c) Twisted and vent metal parts of the steel bed of room 1013
- d) Swab samples taken by PRO 9 SOCO for chemical/laboratory examination.

In addition, a similar incident is perceived to occur in the near future considering the discovery of six (6) empty boxes of alarm clock believed to be the same clock used on the twin bombings.

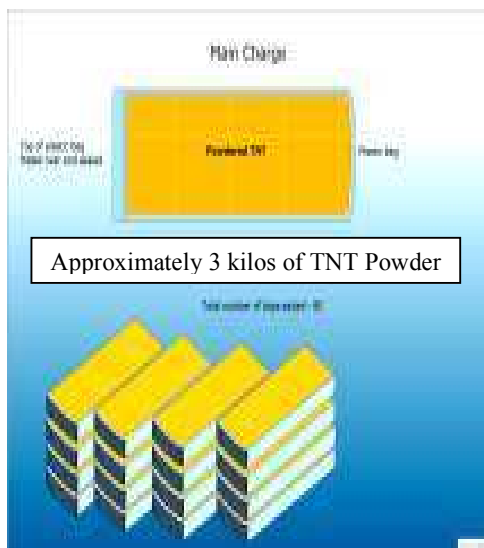
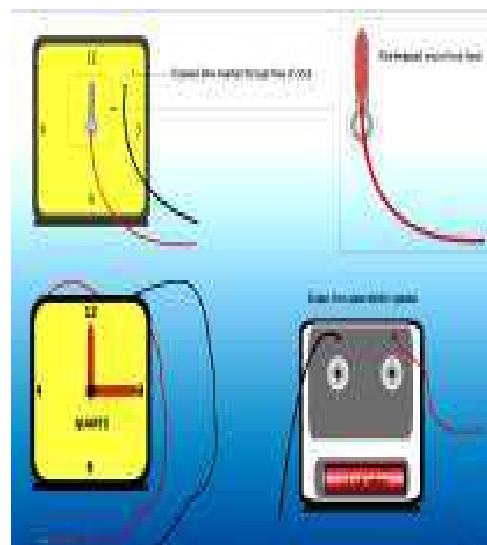
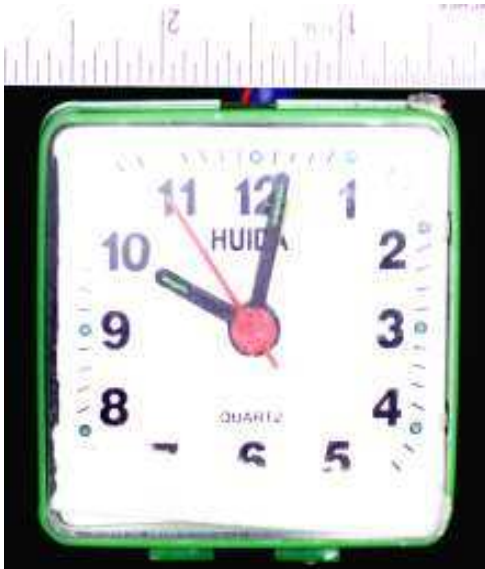
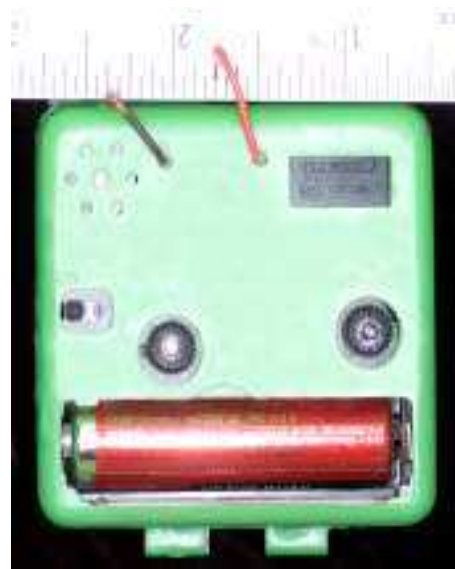
Possible connection from the alarm clock

Close-up of interior of timer...

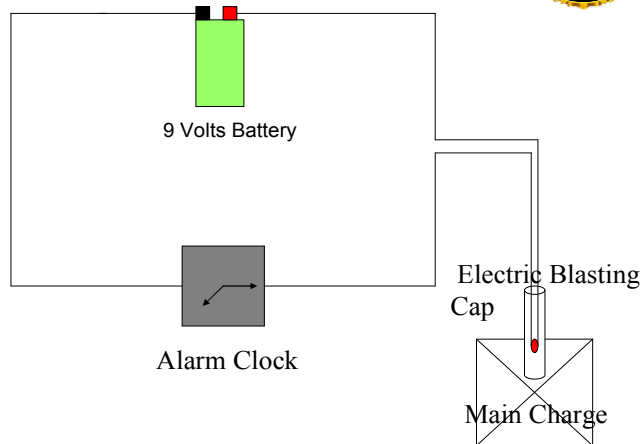
**Circuit Diagram**

The possible lay-out of the circuitry and schematic diagram of the device use based on the evidence recovered at the scene of the crime both on the multi- cab at Campaner St. and at Ann’s Dormitory Pension House located at corner Gov Lim Avenue St. in Zamboanga City.
