1996 API Coke Drum Survey

Final Report

NOVEMBER 2003

**FOR
AMERICAN PETROLEUM INSTITUTE
Subcommittee on Inspection
Coke Drum Task Group**

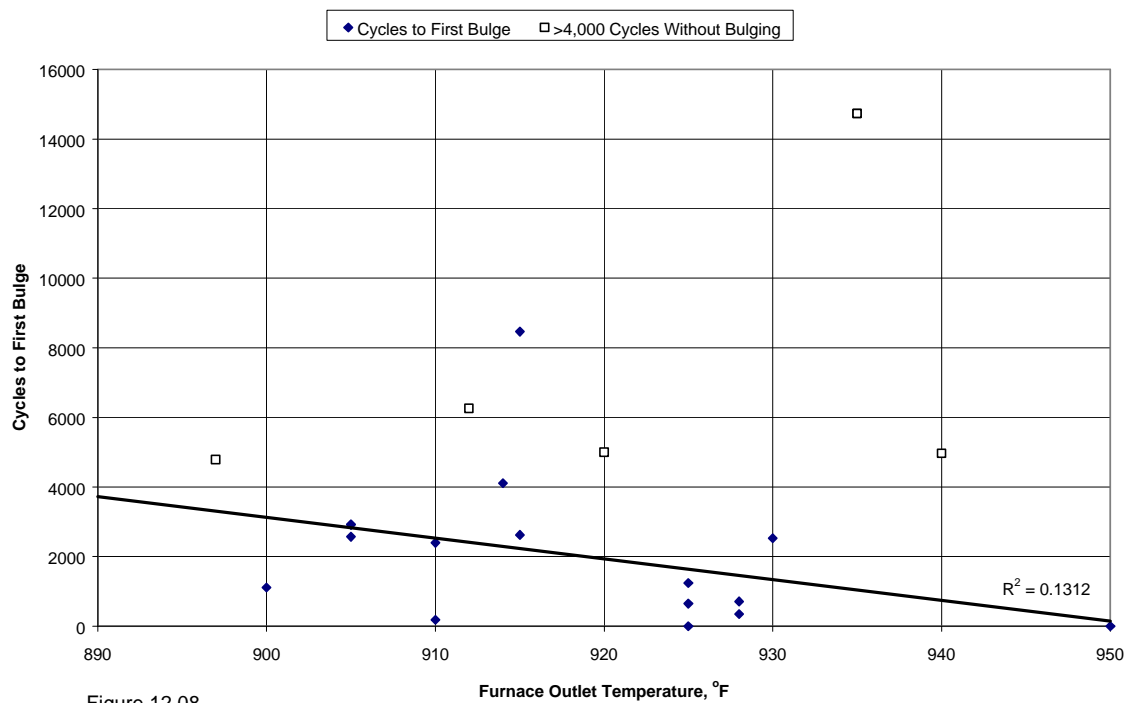
Figure 12.08

Furnace outlet temperature had considerable scatter and opposite trend lines when comparing cycles to first bulge and number of bulges versus the furnace outlet temperature as shown in Figures 12.08 and 12.09.

Cycles to First Bulge vs. Furnace Outlet Temperature
