# fractography in failure analysis

A symposium presented at May Committee Week AMERICAN SOCIETY FOR TESTING AND MATERIALS 1-6 May 1977, Toronto, Canada

ASTM SPECIAL TECHNICAL PUBLICATION 645 B. M. Strauss, Gulf Research and Development Company, and W. H. Cullen, Jr., U.S. Naval Research Laboratory, editors

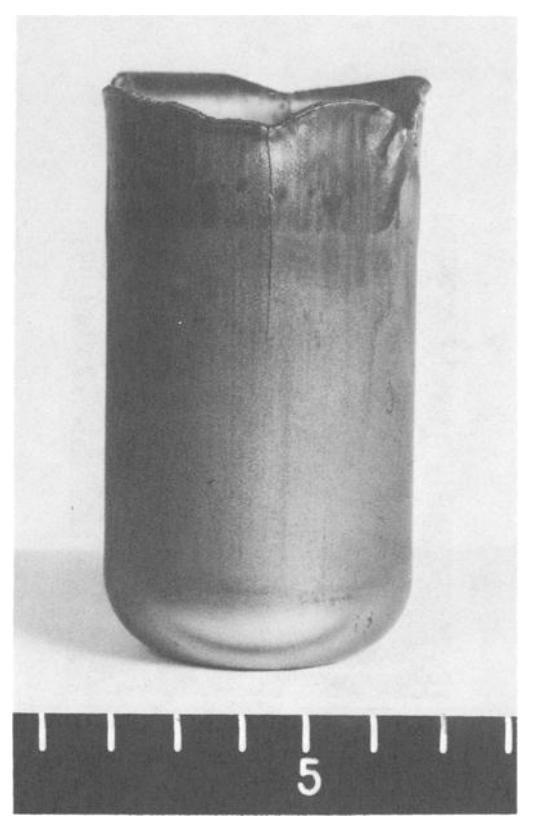
In drawing quality low carbon steels, there is sometimes a tendency for delayed cracking or splitting to occur in severely cold drawn cups. An example of this type of fracture is illustrated in Fig. 1. The fracture initiates at the top and crack propagation occurs in an apparently brittle<sup>4</sup> manner down the cup wall terminating or blunting in some cases with a ductile appearance. Examples of the type of fractographic features which are characteristic of these splits are shown in Fig. 2.

FIG. 1—Photomacrograph showing splitting type fracture in a drawn steel cup. The scale shows the size in centimetres.

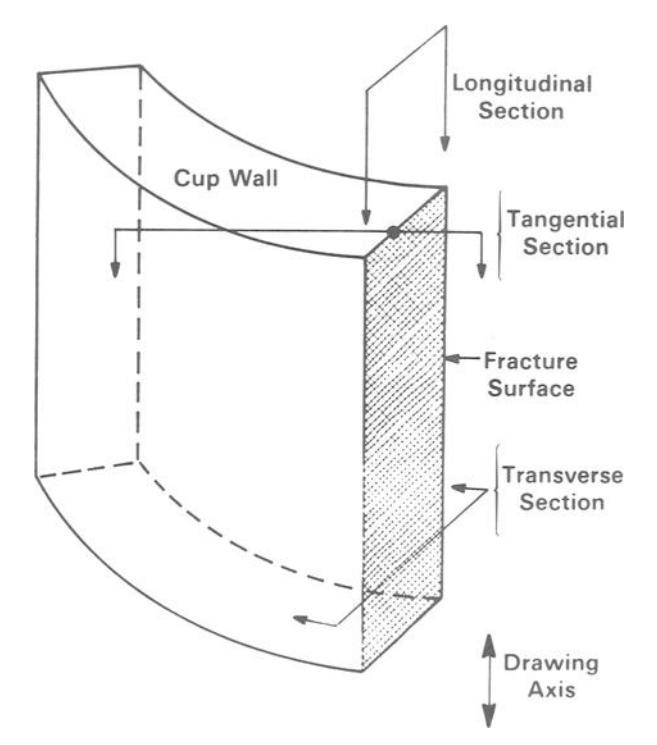
FIG. 3—Diagram indicating orientation of metallographic sections obtained from drawn cup walls relative to the split fracture surfaces.

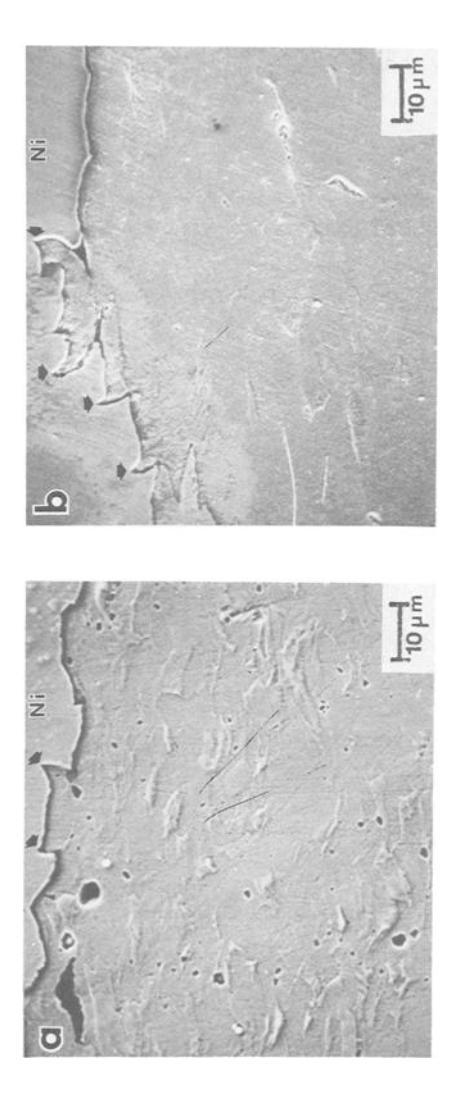
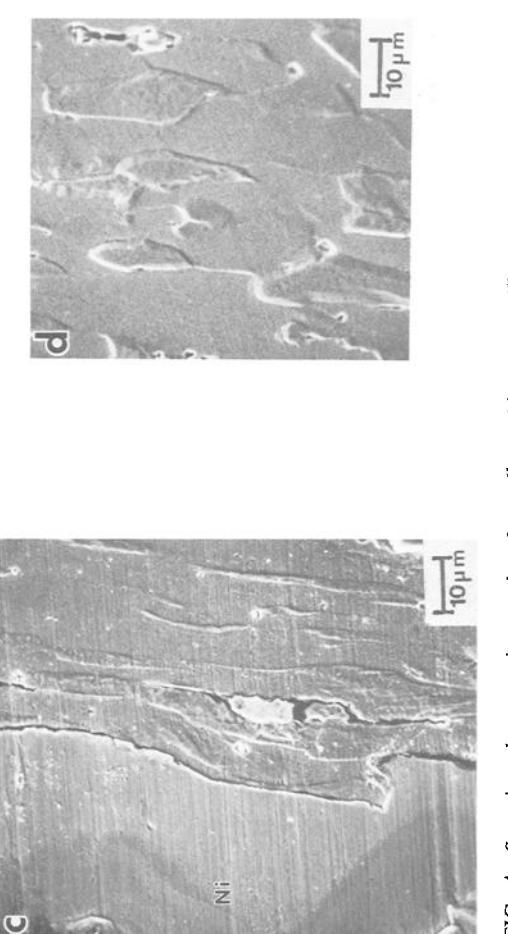
The tangential and transverse sections show that the fracture path is primarily along grain boundaries. They also reveal that features which have the appearance of curled-up knife-edges or lips are present on the fracture surface. These features which are marked with arrows in Fig. 4(a) and (b)are very difficult to identify in the fractographs presented in Fig. 2. The reason for this difficulty lies in the fact that the high secondary electron intensity produced by the knife-edges also is produced by vertical steps and the curled-up knife-edges, in most cases, are associated with vertical steps. This type of SEM image contrast is not unusual since ductile rupture also tends to produce a knife-edge topography between microvoids.

FIG. 4–Scanning electron micrographs of metallographic sections illustrating fracture surface profiles (as retained by nickel plating) and the underlying microstructure. Nital etch: (a) and (b) transverse. (c) tangential, and (d) longitudinal.

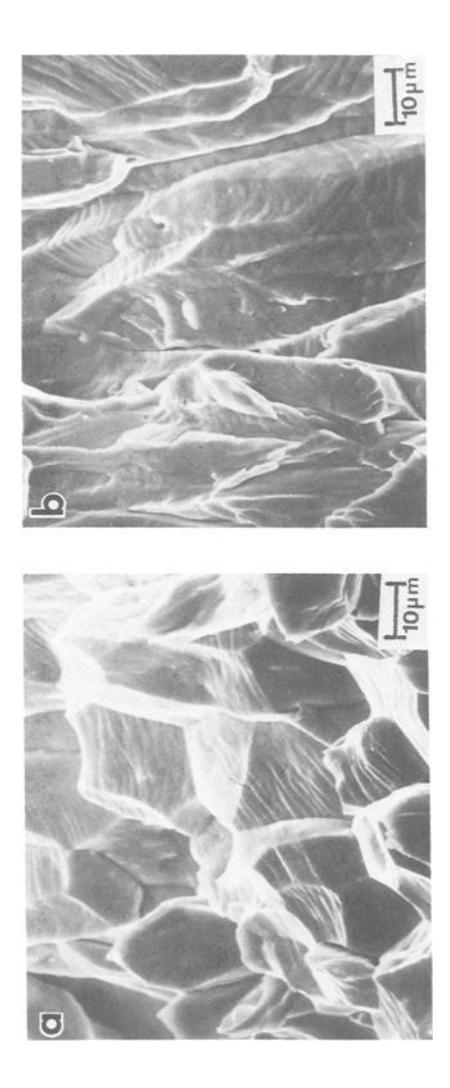
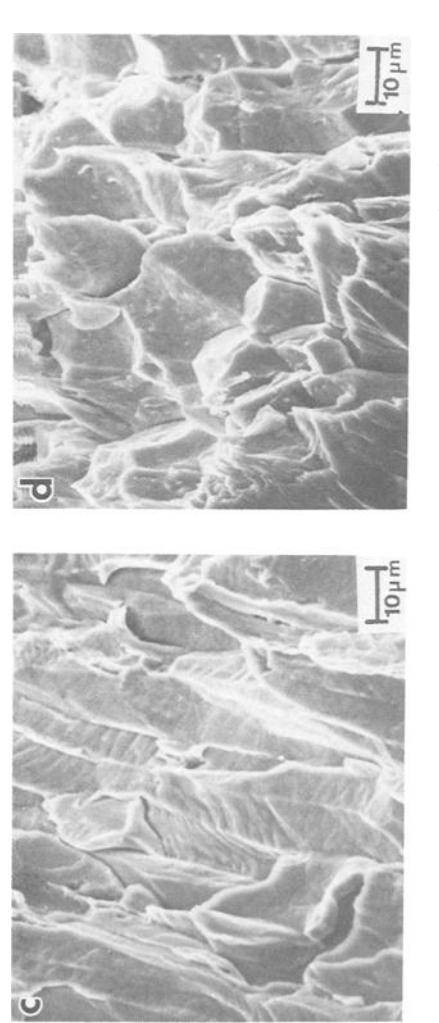
Sheet specimens were also cut from drawn cup walls and charged with hydrogen in an attempt to produce intergranular fracture surfaces using notched slow bend tests. Fractographs from various positions in a cup with a flat top flanged region are presented in Fig. 6(a) through (d). The intergranular nature of these fracture surfaces is apparent, as are the elongated grain shapes which are present in the drawn cup wall when compared to the bottom (Fig. 6(d)) and top flange (Fig. 6(a)).

FIG. 6—Fracture surfaces from hydrogen charged bend fractures from various positions in drawn cup: (a) top flange. (b) and (c) wall areas. and (d) bottom. These illustrate the elongated grain morphology in the cup wall and the strain markings on the facets.

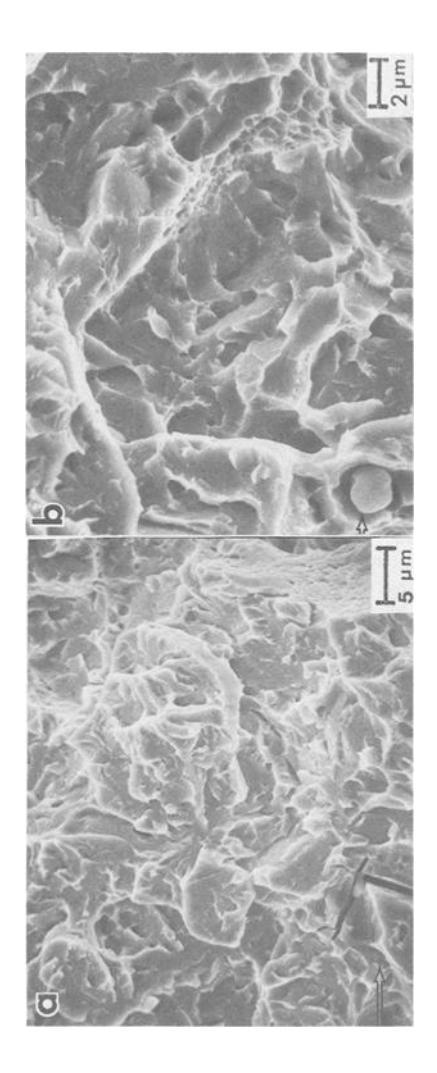
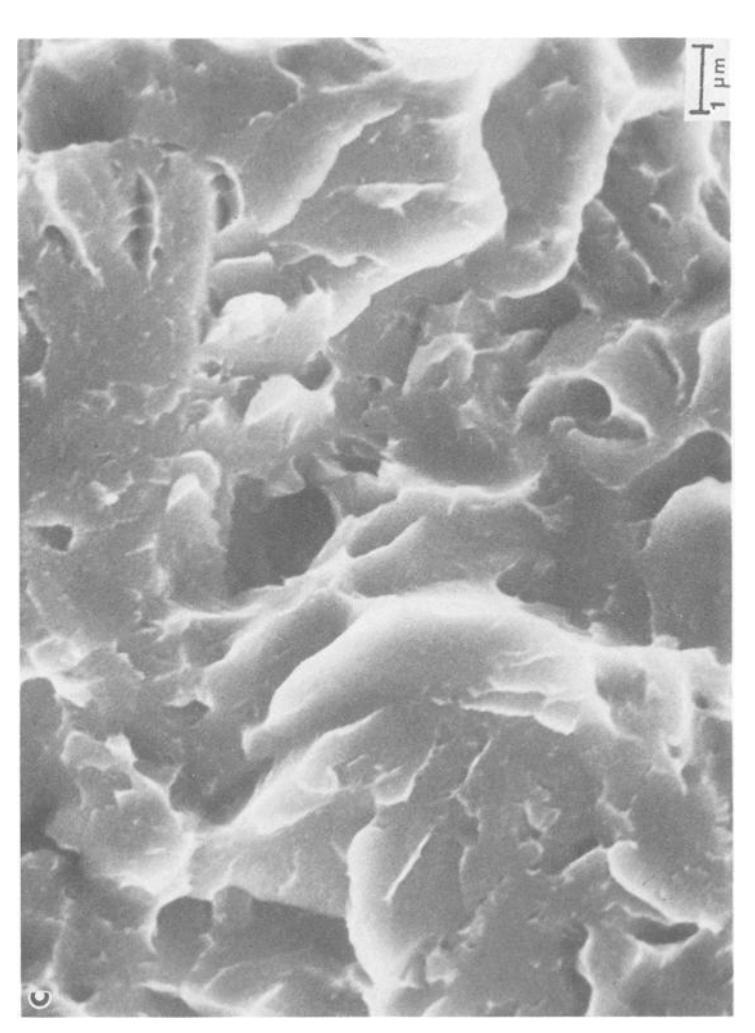
The liquid nitrogen  $(-196 \,^{\circ}\text{C})$  fracture surfaces exhibited morphologies as illustrated in Fig. 9. The SEM micrographs indicate that the surface consists of a multiply faceted blocky texture with some extremely fine river markings which are variable in orientation relative to the macroscopic failure direction. The morphology of these flat blocky regions is controlled by the martensitic lath structure as demonstrated by the cross-section profiles presented in Fig. 10. The fracture and microstructural-feature correlation suggest that crack propagation occurs by the formation and linking of very small clevage cracks ahead of the main front. This is referred to as satellite nucleation by Beacham [9]. Some ductile shear steps also can be observed linking the cleavage cracks in Fig. 9(a).

FIG. 9—Fractographs indicating the morphology of Charpy V-notch and three-point bend specimens fractured at liquid nitrogen temperatures. A titanium carbonitride particle can be observed in (a) and a rare earth sulfide in (b) as marked by arrows.

Two examples of inclusions also are indicated in Figs. 9(a) and (b). A rare earth sulfide is shown in Fig. 9(b) in a rounded crater which is not much larger than the particle itself, whereas the titanium carbonitride shown in Fig. 9(a) (also see Fig. 11(c)) contains distinct internal crystallographic cracking. This is probably cleavage parallel to the faces of the cubical-shaped particles which have a sodium chloride (NaCl) type crystal structure.

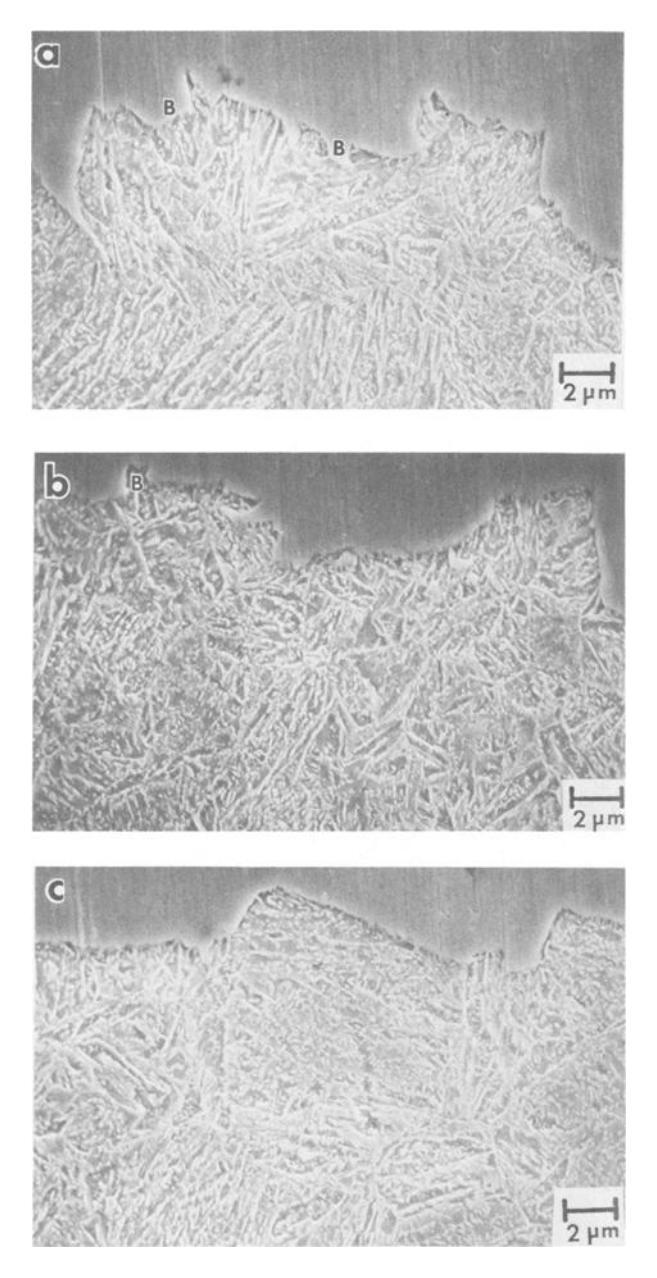
The features characteristic of this type of fracture have led to it being called "quasicleavage" [1,9] because it resembles cleavage with the apparent exception that the facet size extends over much larger regions than the tempered martensite features. In this microstructure, however, the facets tend to coincide with the martensitic packets as indicated by the nickel-plated cross sections presented in Fig. 10.

FIG. 10—Metallographic cross sections of liquid nitrogen fracture surfaces showing profiles and their relationship to the microstructure.

structure within the tempered martensitic packets. These regions have a tendency to exhibit one or more planar sides combined with fine knifeedges. Examples are marked with the letter B in Fig. 10. These do not appear to be "tongues" such as are formed by mechanical twinning [10]. Tear ridges between martensite packets also can be seen in Fig. 9(b) along with the fine dimples and shear surfaces.

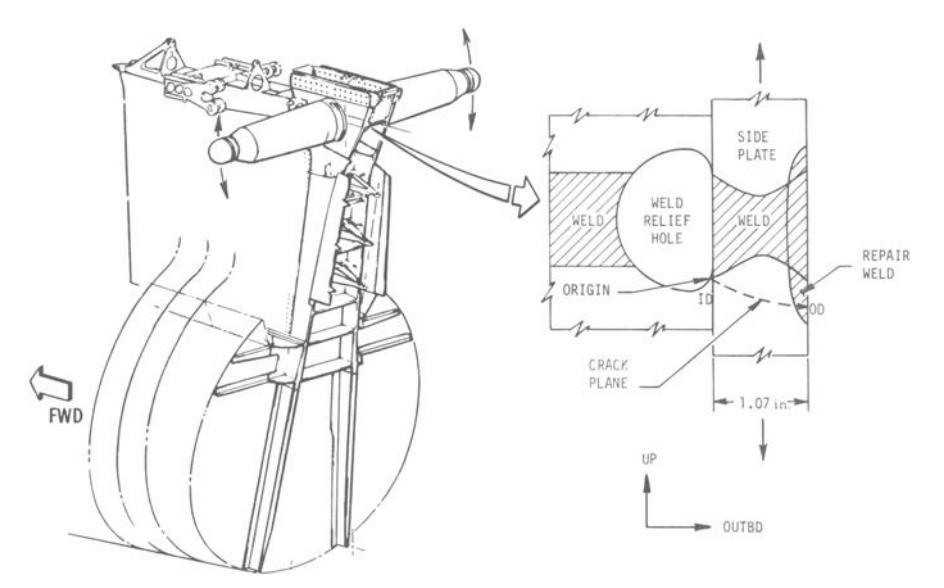
The location of the horizontal-vertical stabilizer spindle support fitting in the aft-fuselage section of the aircraft and the crack path in the R/H side plate are shown in Fig. 1. The thickness of the side plate is 27.2 mm (1.07 in.) and the crack traces on both the internal and external surface were approximately 124 mm (4.875 in.) long. As will be seen later in the text, the crack initiated at the toe of the weld and broke through the outer surface at a repair weld on the side plate.

FIG. 1—Location of horizontal stabilizer spindle support fitting in the aft-fuselage section, and a schematic drawing showing the crack location and the origin.

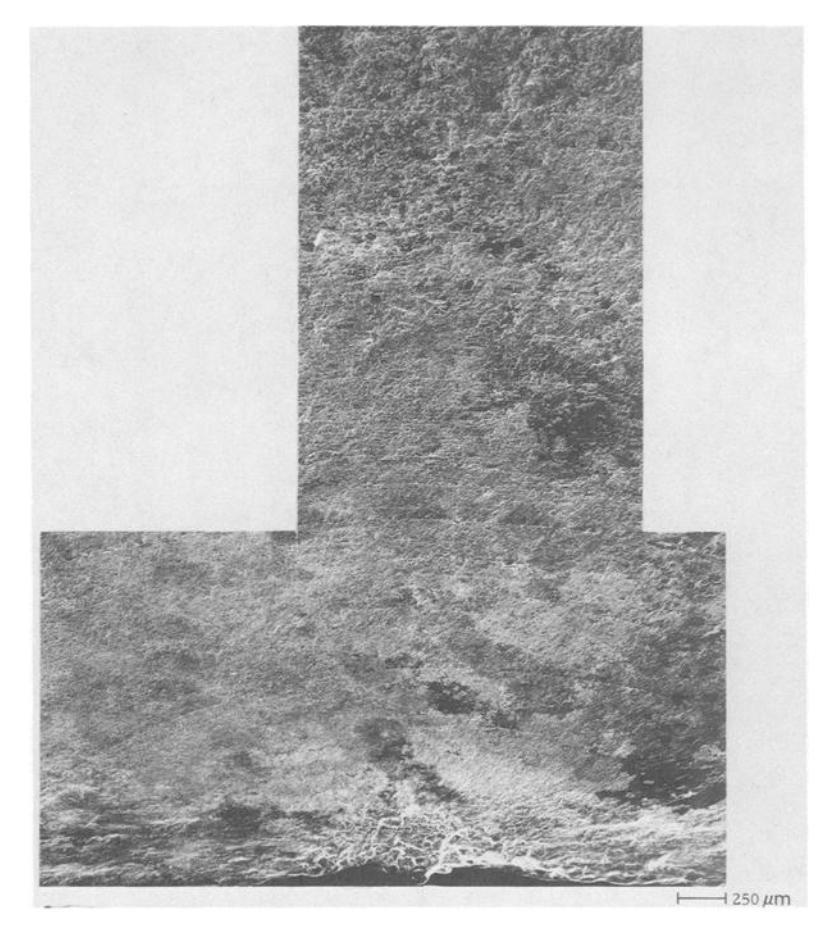
FIG. 2—Scanning electron micrograph showing the intergranular fracture mode at the origin and fatigue striations originating from the intergranular area (origin).

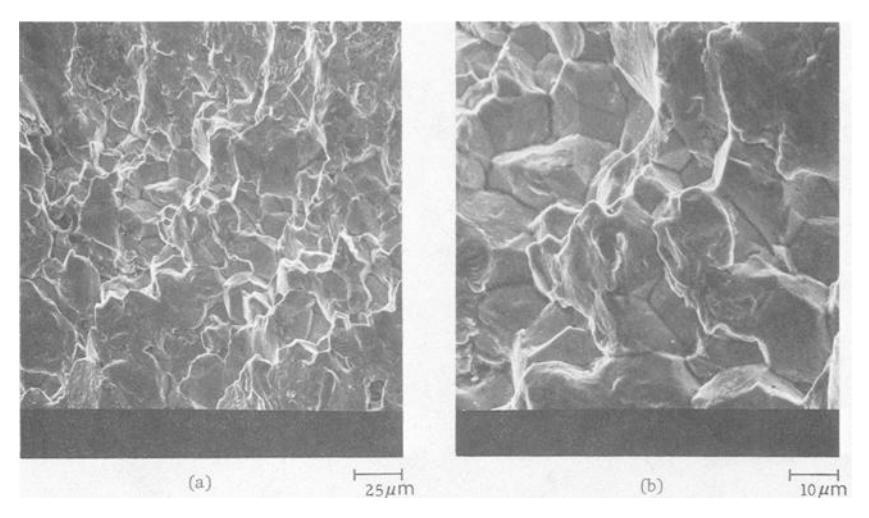
FIG. 4—Intergranular fracture at the origin showing equiaxed grains.

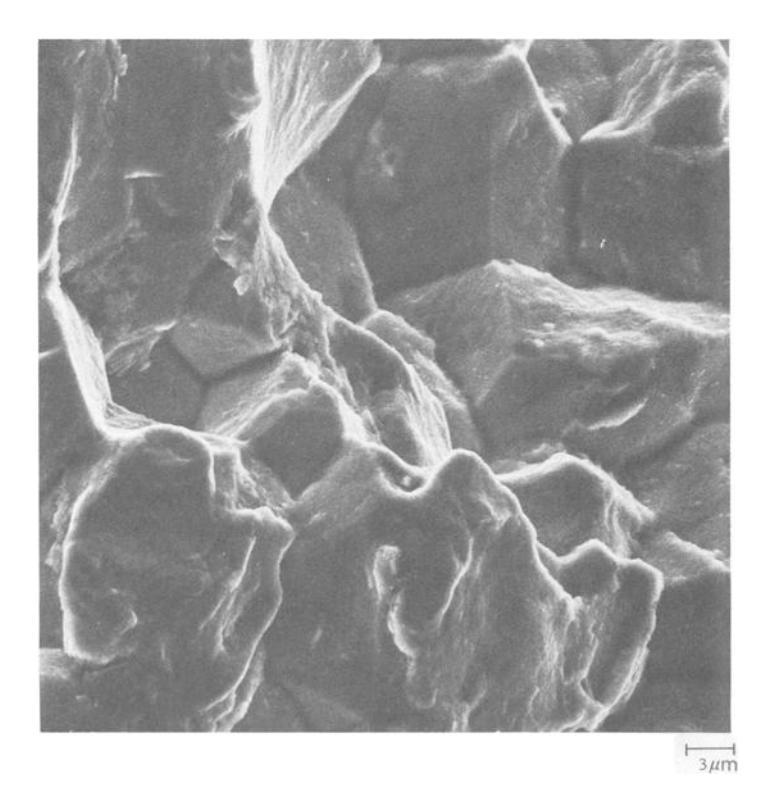
FIG. 5-Detail scanning electron fractograph of the intergranular fracture at the origin.

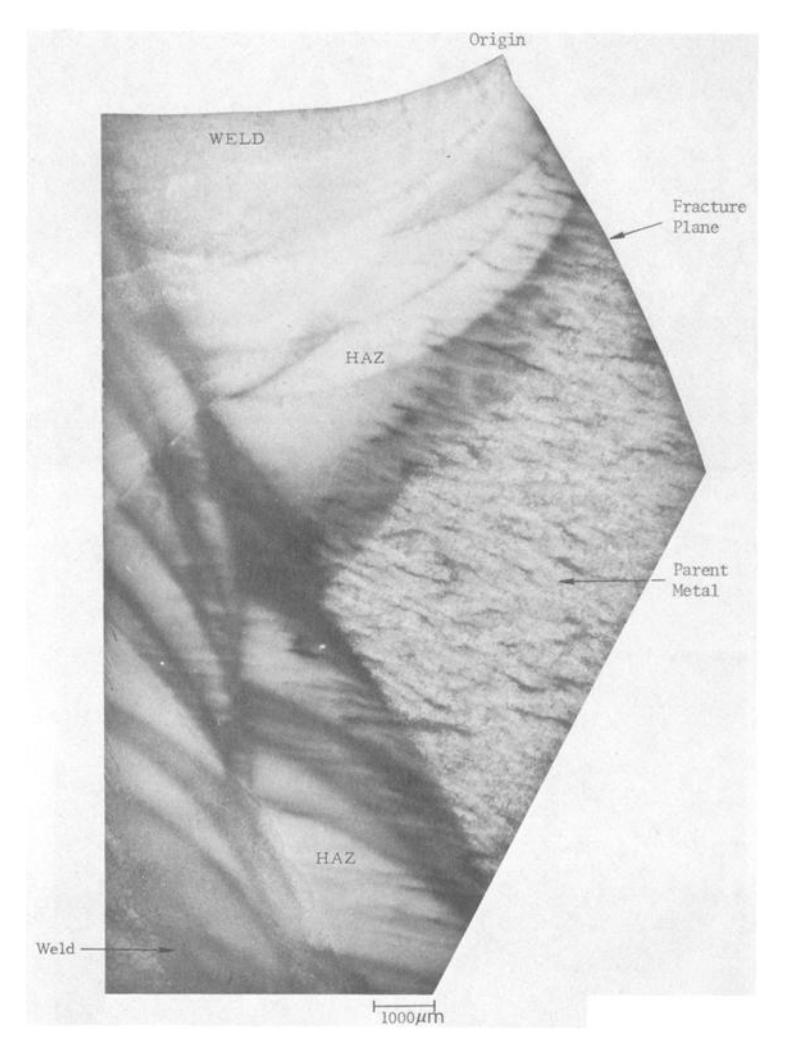
Following fractographic analysis, the fracture specimen was carefully sectioned adjacent to the origin and perpendicular to the side plate. The specimen was mounted and polished to examine metallographically the section (see Fig. 6). The orientation of the specimen and the different structures also are identified. It can be seen that the intergranular portion of the

crack was at the toe of the weld. The parent metal reveals a normal forged structure. Another cast weld metal structure and heat-affected zone can be seen away from the origin. Both heat-affected zones show the so-called weld "eye-brows," which are created by the heat produced by individual weld passes during welding.

FIG. 6-Metallographic microsection through the origin showing the orientation of the specimen and different areas.

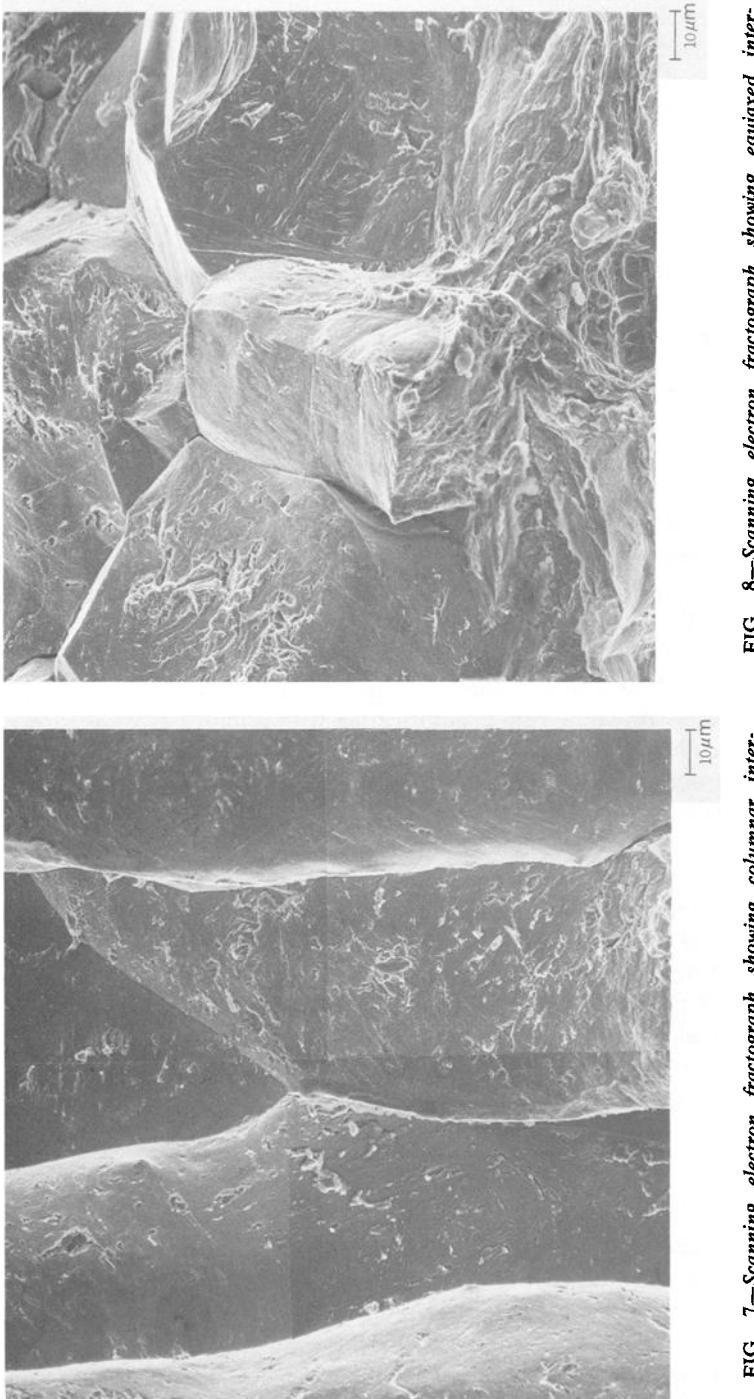
FIG. 8--Scanning electron fractograph showing equiaxed intergranular cracking in weld crater.

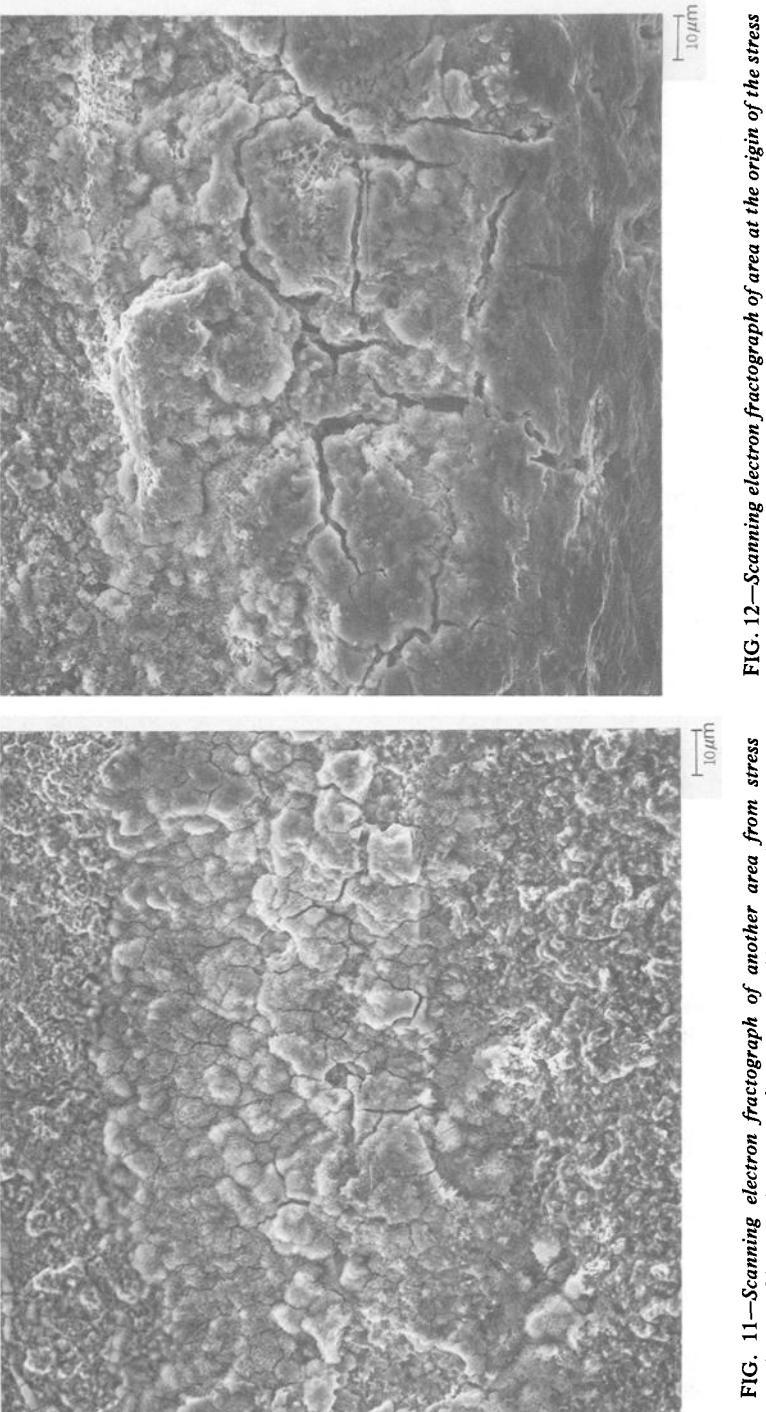
FIG. 12—Scanning electron fractograph of area at the origin of the stress corrosion cracking specimen.

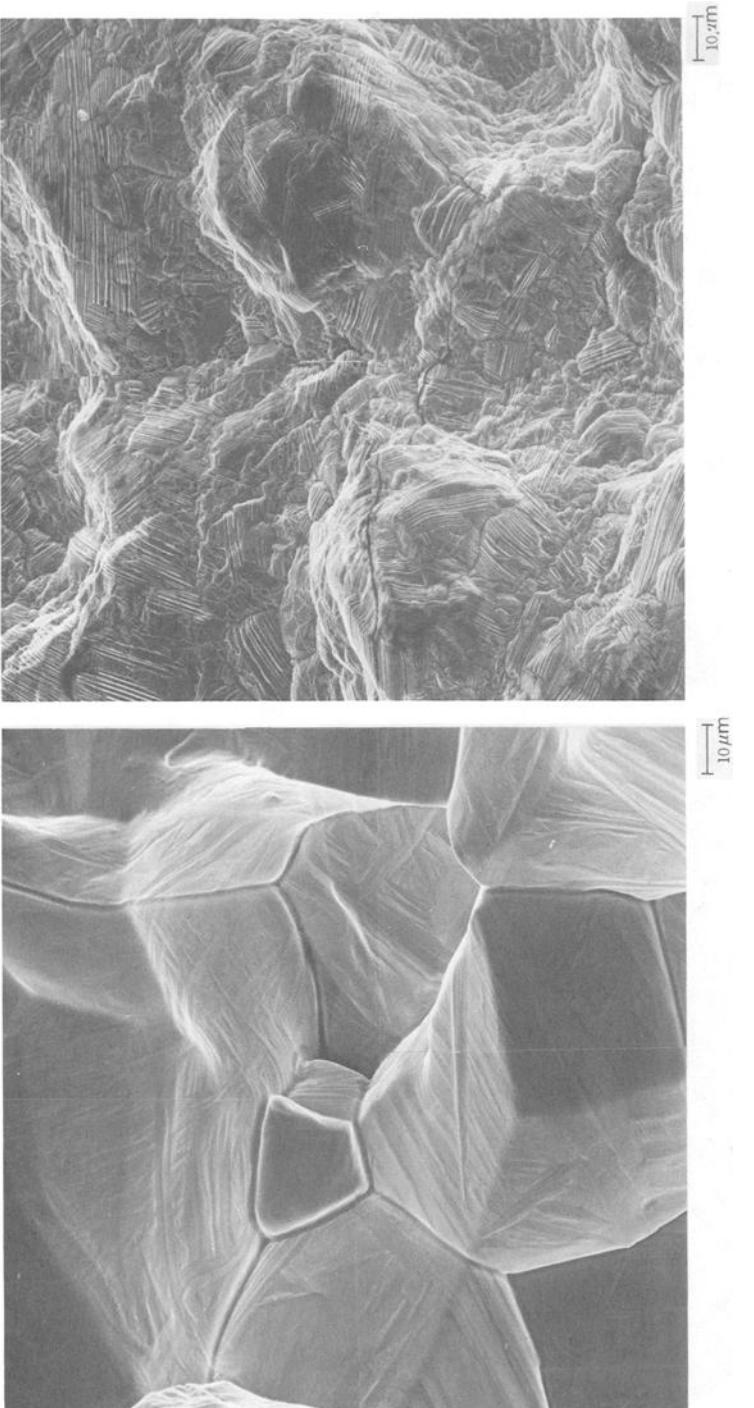
FIG. 16—Scanning electron fractograph of an elevated temperature fracture produced at 1260°C (2300°F) in air. Intergranular crack and oxidized grain facets are evident.

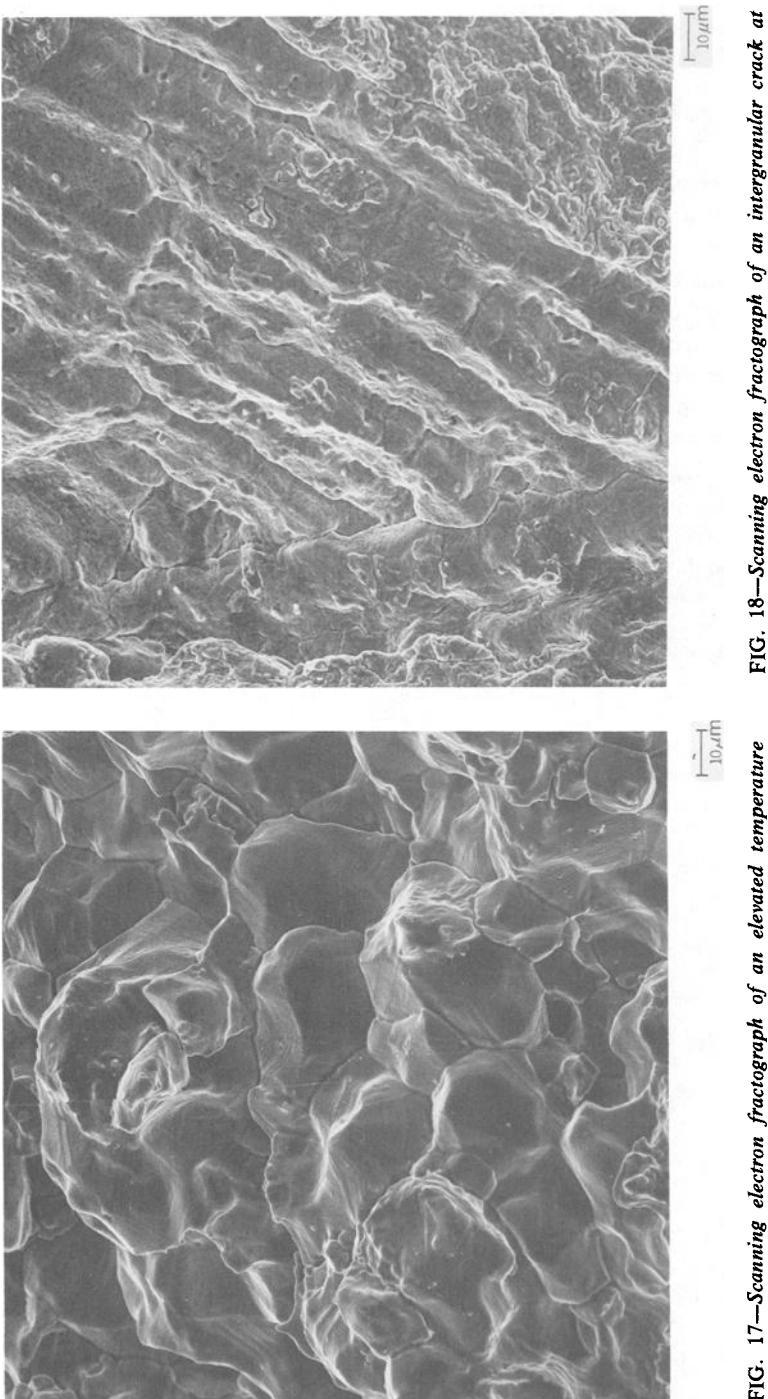
FIG. 18—Scanning electron fractograph of an intergranular crack at a lack of fusion in the weld.

shown in Fig. 18, which reveals a dendritic, rounded intergranular fracture with strong evidence of thermal exposure.

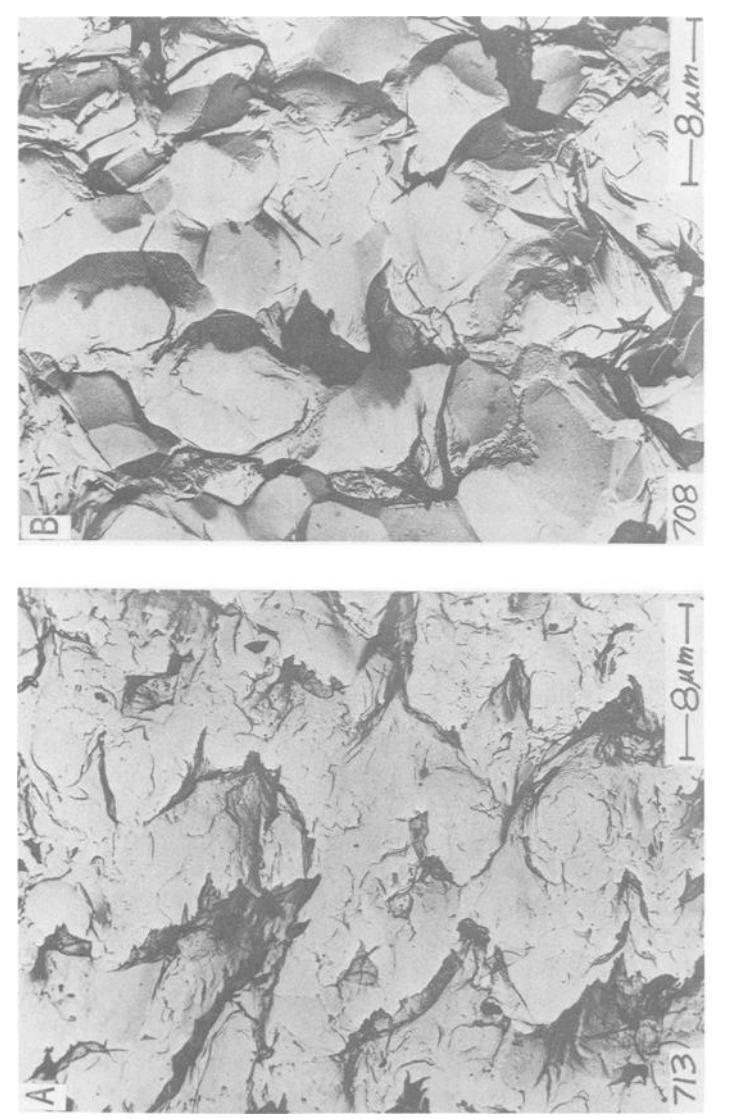
FIG. 1—Tungsten rocket nozzle insert fracture surfaces (two stage replica TEMs). (a) In-Service failure near origin. (b) Room temperature laboratory fast fracture.

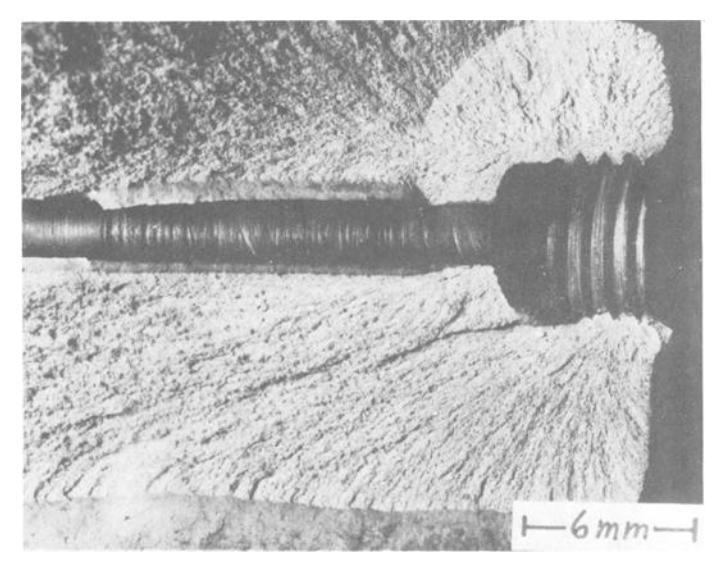
The following failure analysis provided a particularly classic example of the progression of hydrogen embrittlement cracking (HEC)/SCC propagation mechanism as the stress intensity factor increases with crack growth, and changes after the onset of fast fracture in very high strength alloy steels. The broken part was a jet fighter-bomber catapult socket lug which broke during test after 617 simulated launches. The lug was made of AMS6407 (4330Si) steel, heat treated to about 180-ksi yield strength. The fracture, Fig. 3, bisected a threaded lube fitting hole which was filled with grease during testing. No corrosion was evident and although the lug had been cadmium plated, the threaded hole where cracking initiated was not. The cracking mechanism was intergranular at the origin, Fig. 4(a), became mixed with cleavage and dimples further along, Fig. 4(b), and ultimately changed to 100 percent microvoid coalescence at the end of the slow crack area, Fig. 4(c). Some evidence of fatigue was noted in a narrow band near this point, but did not comprise a significant part of the slow crack zone. The remainder of the fracture surface contained a mixture of cleavage, microvoid coalescence, and intergranular cracking which is typical of fast fracture in this steel at this strength level. In the absence of obvious corrosion, the crack initiation and slow growth was attributed to HEC. The hydrogen was probably induced during cadmium plating of the exterior parts of the lug, and diffused into the unplated regions during storage. The initial low stress intergranular cracking may have been caused by overtightening of the grease plug, the remainder of crack propagation and final fracture occurring in increments during simulated launch testing.

FIG. 3—Fracture surface of aircraft landing gear catapult lug which failed after 617 simulated launch load cycles. Slow crack growth area at upper right.

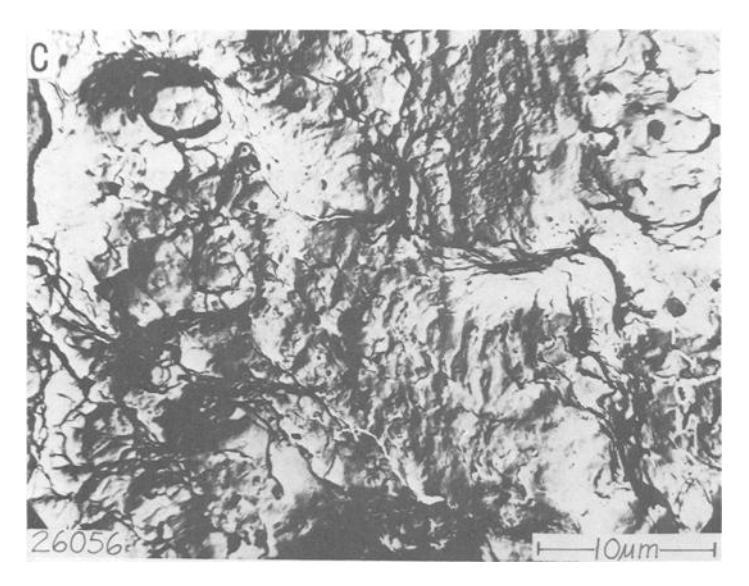
The progression of fracture mechanisms from pure intergranular at the origin through quasicleavage to microvoid coalescence as the crack lengthens and crack tip stress increases is very diagnostic of HEC and SCC failures in low alloy steels of this strength level. The reversion from *pure*

FIG. 4—Catapult lug fracture surface (two stage replica, TEMs). (a) Nearly 100<sup>1</sup> percent intergranular at origin of slow crack region. (b) Mixed intergranular with transgranular cleavage and dimples midway through slow crack area. (c) 100 percent dimples within slow crack area near onset of fast fracture.

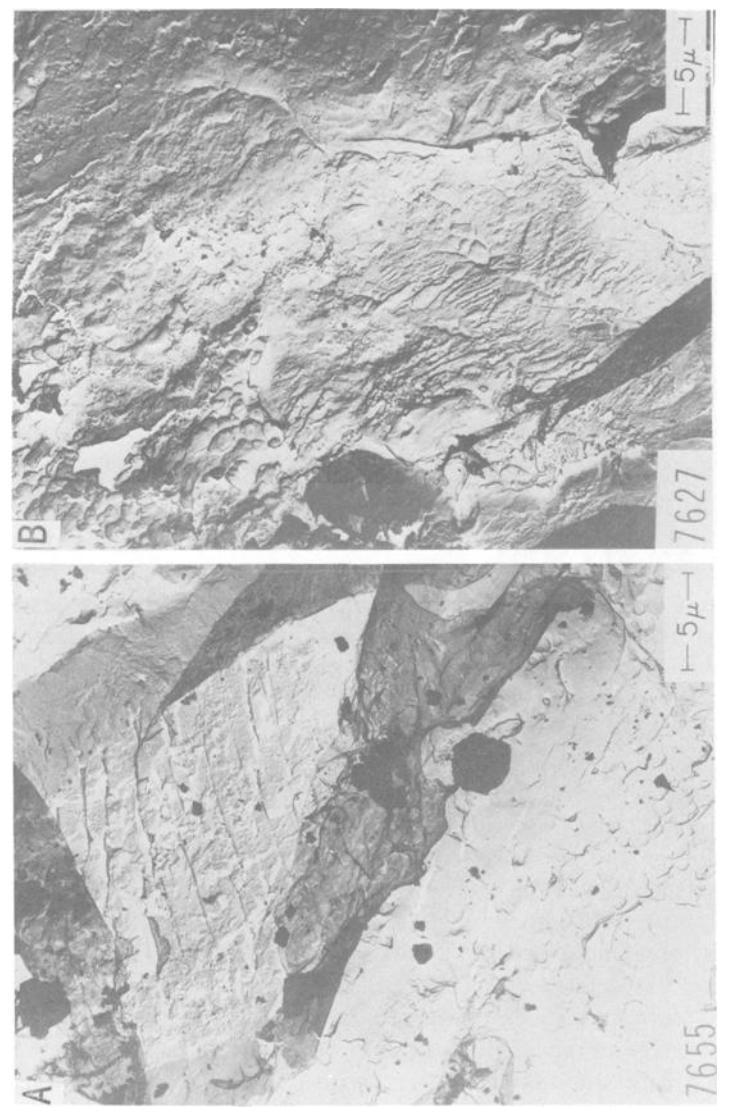
An early fractographic failure analysis that still has something to teach involved a study of an aircraft skin assembly comprising two 7075-T6 aluminum sheets overlapped and spot welded [4]. A through-thickness crack traversed the skin assembly following a line of spot welds. Fractographs of two areas of spot-weld fracture are shown in Fig. 5. Although effects of corrosion are evident, both dimples and striation-like markings can be seen. The investigators were able to prove fatigue was not the cause by breaking other spot welds in the skin assembly by fatigue and fast fracture, respectively, showing that the spot weld fatigue striations, Fig. 6(a), were quite different from the service fracture markings, which were also observed in the laboratory-produced spot weld fast fractures, Fig. 6(b). Such distinctions between other parallel markings and true fatigue striations were not then as obvious as they might seem today and evidently still cause some confusion.

FIG. 5--7075-T6 aircraft skin sheet spot weld fracture surface (two-stage replicas, TEMs). (a) In-service fracture. (b) Same.

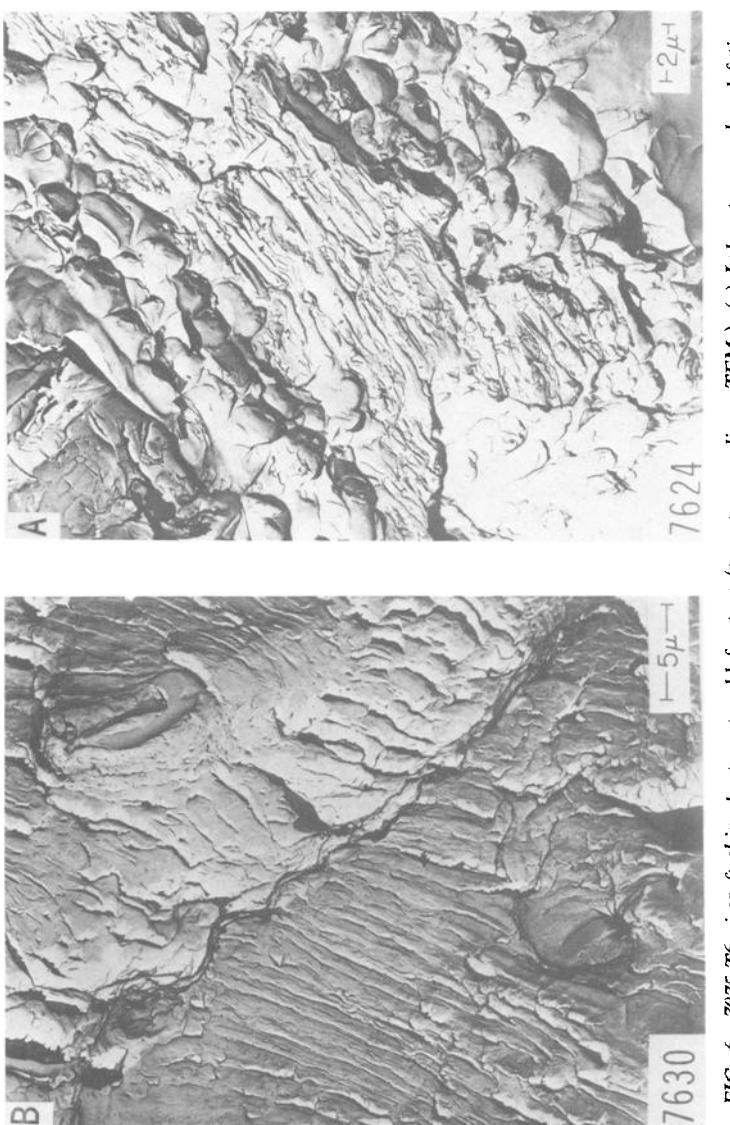
FIG. 6-7075-T6 aircraft skin sheet spot weld fracture (two-stage replicas. TEMs). (a) Laboratory-produced fatigue fracture. (b) Laboratory-produced fast fracture.

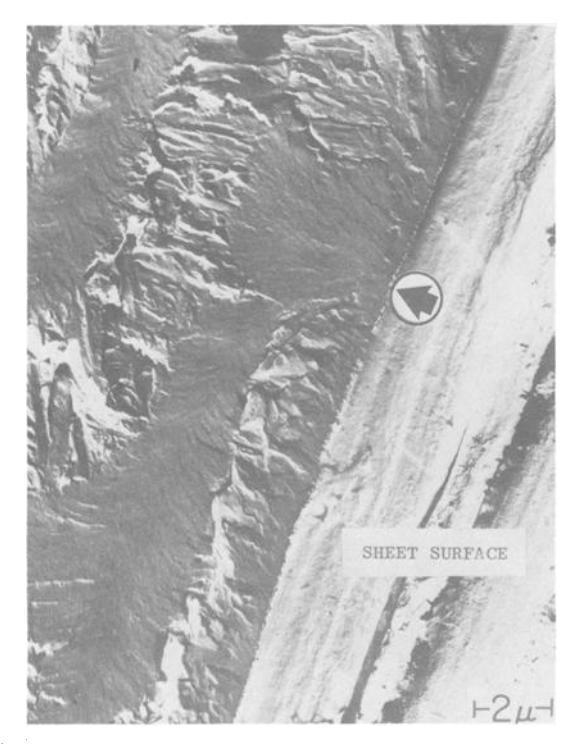
alloys would not be subject to SCC if not precracked, especially in media which did not cause severe pitting. Real shock waves radiated through the titanium metallurgical fraternity when rocket motor tankage made of Ti-6AI-4V (160-ksi yield) filled with reagent quality methanol began fracturing at unexpectedly low stresses. NRL scientists were asked to verify the failure mechanism, which was announced to be SCC in methanol. The original service fractures were found to be a mixture of quasicleavage and microplastic cracking at their origins, typical of aqueous SCC in precracked alpha-beta titanium alloys. Strips of tankage material, carefully screened for flaws, were immersed in reagent grade methanol, stressed to 65 percent of their yield strengths, whereupon they failed within minutes. The fracture surface origin area, Fig. 7, was identical with the service fractures, confirming that the service failures were caused by the same mechanism, SCC.

FIG. 7—Ti-bAl-4V rocket fuel tank stress corrosion failure in methanol, initiating from as-machined unnotched surface (arrow). Two-stage replica, TEM.

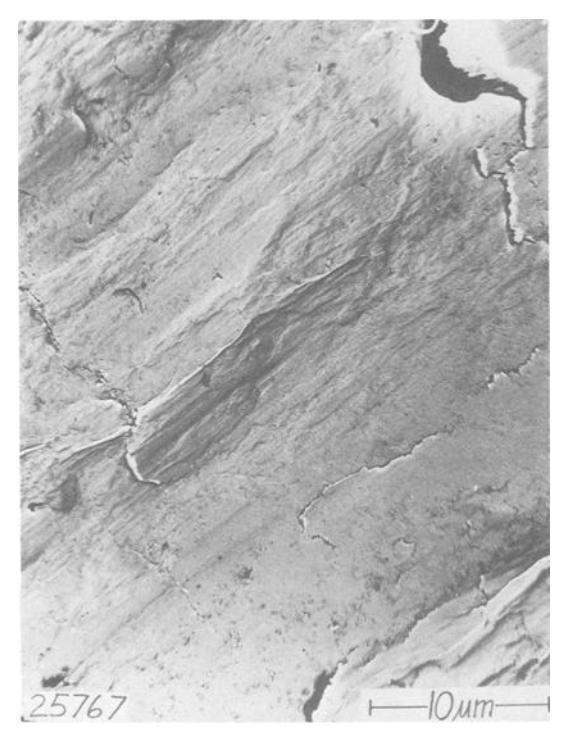
An example of a probable shear fatigue crack was found in the flap torque tube fitting, of Ti-4Al-4Mn, from yet another late model Navy aircraft. The fracture, Fig. 11, shows no striations, but abundant evidence of

FIG. 11—Aircraft wing flap actuator fitting (Ti-4Mn-4Al) crack surface (two-stage replica, TEM).

rubbing and burnishing, and evidence of considerable mutual shearing motion of the surfaces. How does one prove fatigue? Well, one thing is the very tightness of the crack; it is unlikely to have resulted from overload in shear. Furthermore, the broken-open fracture was examined metallographically in cross section. Figure 12(b) shows that the part created by laboratory overloading (to open the crack) shows only somewhat distorted grains at the fracture edge, whereas the service crack, Fig. 12(a), has indications of twinning substructure formation and microcracking underlying the fracture surface. These findings, though not conclusive for lack of laboratory verification of shear fatigue-induced subsurface microstructural changes, pointed to fatigue as the possible cause of cracking.

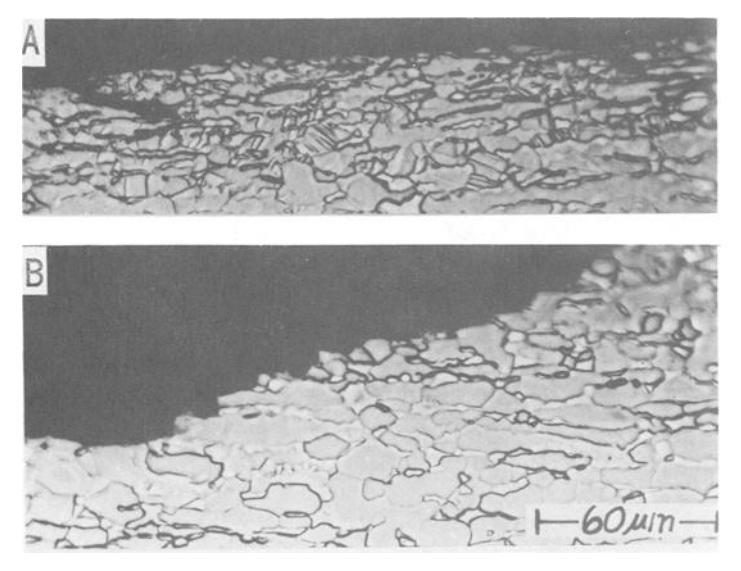
FIG. 12—Aircraft wing flap actuator fitting (Ti-4Mn-4Al) crack cross-sections (polished and etched, light optical micrographs). (a) In-service crack. (b) Laboratory-produced fast fracture.

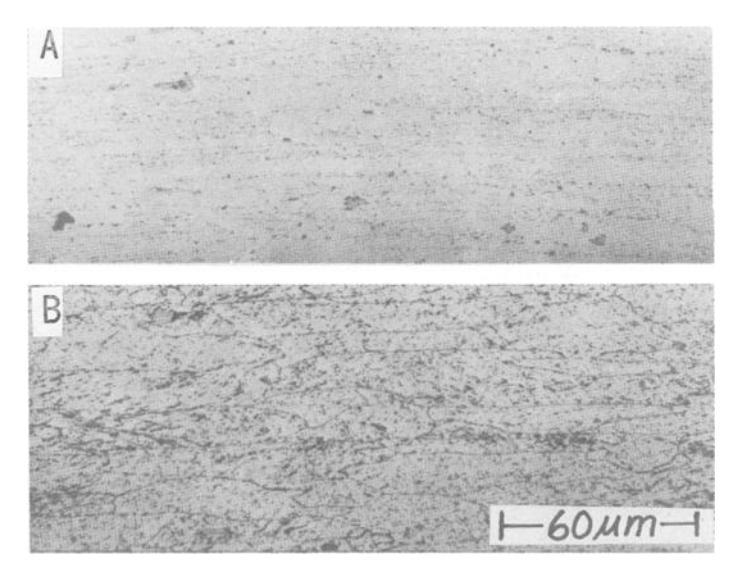
deck plate, which had seen service, cracked readily. The reason became evident on comparing the microstructure of stock 5456-H321 plate with the "used" deck plate, Fig. 15. The deck plate had become further aged and thus "sensitized" to SCC by tropical sun exposure. The obvious moral to be drawn from all this is to avoid using materials which literally change from good to bad under one's feet.

FIG. 15—Small high speed ship deck plate (5456-H321) material (polished and etched, light optical micrographs). (a) Piece of plate from stock. (b) Piece from deck of ship showing over-aging.

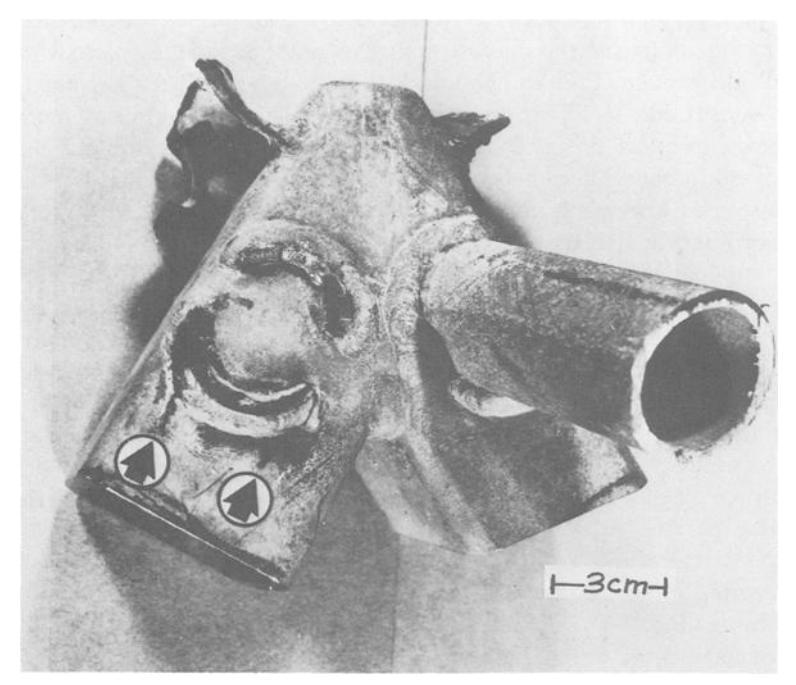
Those who work with advanced structural materials tend to forget that more ordinary materials also cause expensive problems. Many Navy structural applications make use of plain hot rolled galvanized steel tubing, probably the same material used for backyard fences, certainly not exotic, but indispensable for such things as antenna frameworks and mounting supports. The state of the art in producing welded structures of this steel is well established, it is tolerant of error, yet look what can happen. Figure 16 shows the corner section of an antenna support framework, with a fracture surface where a sound weld should have been. A large proportion of this and up to 75 percent of other fractures on the assembly were perfectly coated with zinc, which was applied after welding by hot dipping. The zinc-free areas showed fatigue striations, Fig. 17(a), and the zinc-coated areas, after inhibited acid stripping, showed a rather corroded looking appearance, Fig. 17(b). It is evident that final in-service failure was caused by fatigue, but the original cracks which weakened the structure obviously formed after welding, either before hot zinc coating or during coating. The

FIG. 16—Radio antenna support frame (galvanized hot-rolled low-carbon steel). Arrows point to cracks in box section emanating from weld area.

latter seems quite possible, since liquid zinc cracking is a very well known phenomenon and could be expected to occur if the residual stresses caused by welding were not relieved before dipping. Further, the zinc-coated fracture surface areas showed no signs of dimples to be expected of residual stress cracks.
