# fractography in failure analysis

A symposium presented at May Committee Week AMERICAN SOCIETY FOR TESTING AND MATERIALS 1-6 May 1977, Toronto, Canada

ASTM SPECIAL TECHNICAL PUBLICATION 645 B. M. Strauss, Gulf Research and Development Company, and W. H. Cullen, Jr., U.S. Naval Research Laboratory, editors

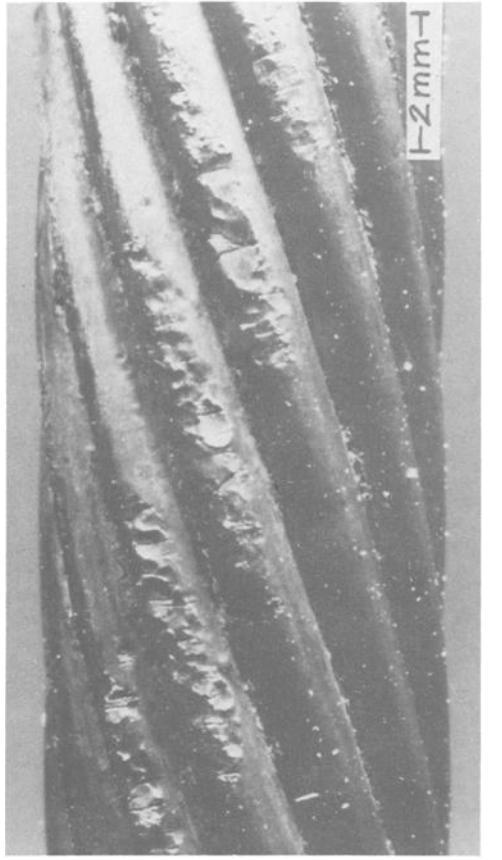
The final example of failure analysis is rather unusual. High power radio transmission generates considerable induced radio frequency (RF) current flow in nearby metal structures, including the supporting structures of the antennas. Damage often occurs at points of intermittent or poor electrical contact between such things as elevator cables and their pulleys, couplings, joints, etc. In two cases antenna tower elevator cables, which are made of cold-drawn high carbon steels, were severely damaged by what are very similar to welding arc strikes, Fig. 18. The damage consists of brittle, untempered martensite formation, pits, extensive metal removal, and cracks, Fig. 19(a). The fractured ends of individual strands exhibited brittle cleavage and intergranular cracking, Fig. 19(b). Very little can be done about such damage except to keep all affected parts clean, and frequently inspect and remove damaged components.

FIG. 18-Radio transmission tower elevator cable RF arc damage.

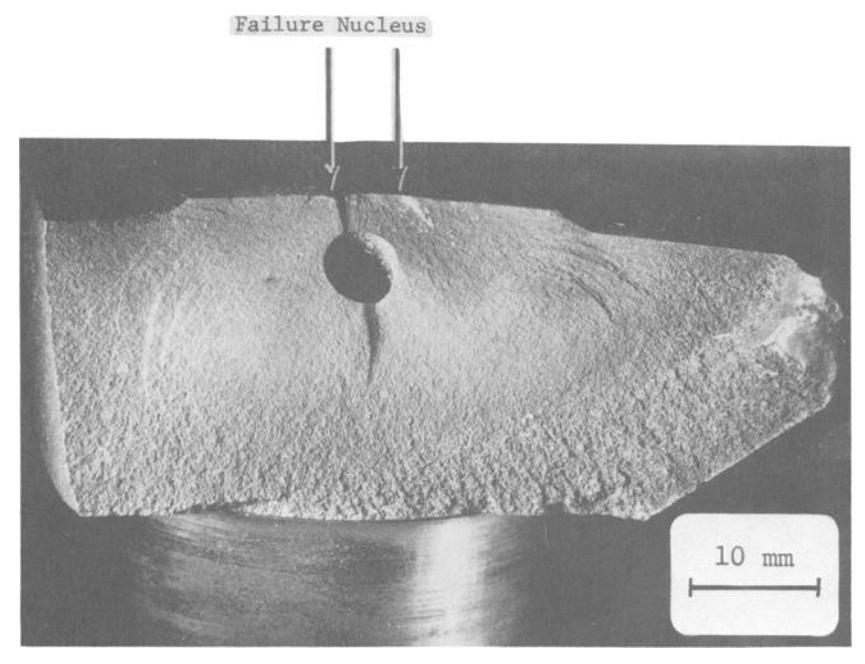
The crankshaft broke through a crank, next to a pin journal, as shown in Fig. 8. The origin of the fracture was in the transition zone between a straight and a filleted section of the crank, where two surface machining operations formed a junction resulting in a step. Scanning electron microscope examination of the origin revealed no material defects which could have been responsible for the initiation of the crack.

The general topography of the fracture was typical of low stress-high cycle fatigue. In order to determine the fatigue striation spacings, a twostage plastic-carbon (platinum shadowed) replica technique was used. The average striation spacing near the origin was 0.1  $\mu$ m (4.7  $\mu$ in.), with a

FIG. 8-Crankshaft fracture.

range of 0.08 to 0.18  $\mu$ m (3.2 to 7.2  $\mu$ in.). Further along the fracture the spacings reached 0.76  $\mu$ m (30  $\mu$ in.).

Substituting the value of  $S = 4.7 \times 0.1 \,\mu\text{m} (10^{-6} \text{ in.})$ , and the Young's modulus  $E = 165.5 \times 10^3 \text{ MPa} (24 \times 10^3 \text{ ksi})$  for ductile iron, we obtained  $\Delta K = 23.3 \text{ MPa} \sqrt{\text{m}} (21 \text{ ksi} \sqrt{\text{in.}})$  near the origin of the fracture.

Substituting the previously found numerical values of the parameters, the stress peak-to-peak amplitude was found to be  $\Delta \sigma = 317$  MPa (46 ksi), that is, 159 MPa (±23 ksi).

Finite element stress analysis indicated an alternating stress of 193 MPa  $(\pm 28 \text{ ksi})$ . Actual stress measurements using strain gages were also performed on a similar crankshaft tested under simulated service conditions. The stress measured at a location corresponding to the crack origin gave an alternating stress 103 MPa (15 ksi) in tension and 138 MPa (20 ksi) in compression.

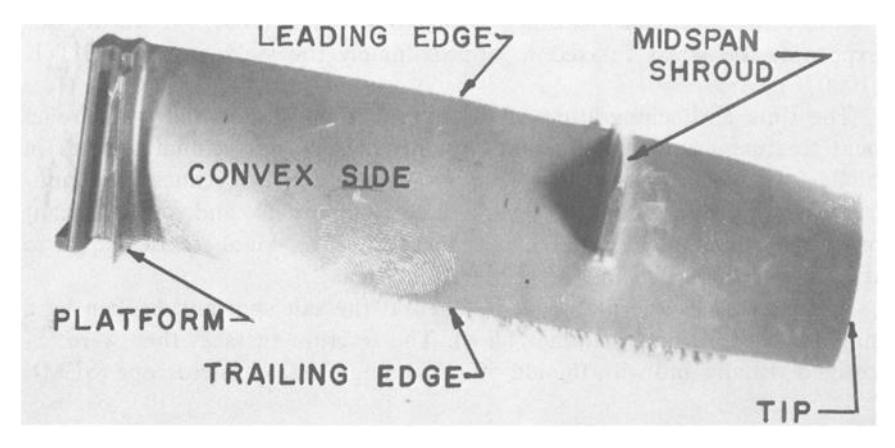
Fan blade fractures often have led to catastrophic failures of engines which have resulted in the loss of the aircraft. On the other hand, they have created interesting fractographic features, characterizing a combination of complex stresses or detrimental environments during manufacture and service. Many times the fractographic features have indicated stress corrosion cracking or fatigue as the fracture mechanism.

FIG. 1-Fan blade.

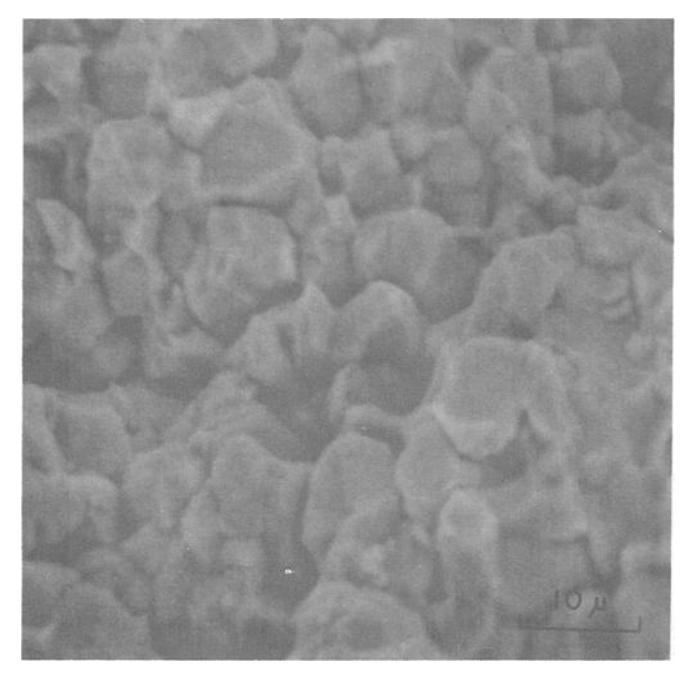
FIG. 3—SEM fractograph of a discolored zone on the fracture surface of Fan Blade A.

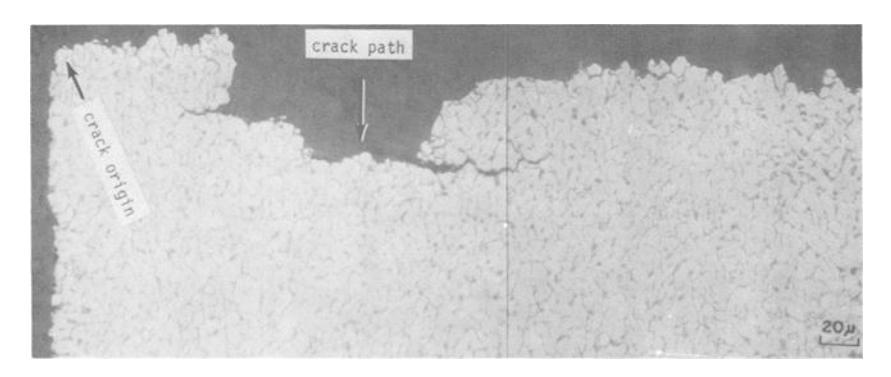
FIG. 4—Optical micrograph of a section through a discolored zone on the fracture surface of Fan Blade A.

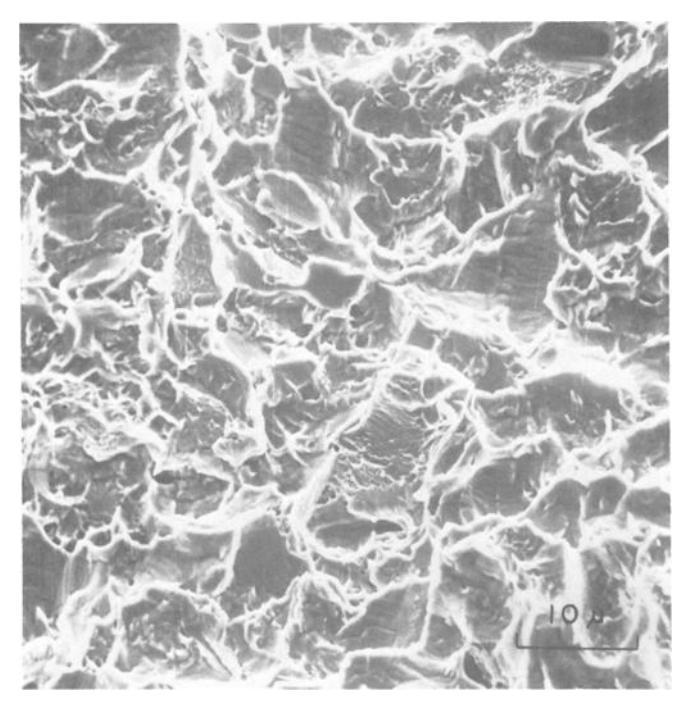
FIG. 6-SEM fractograph near transition from subcritical crack growth to fast fracture in Fan Blade A.

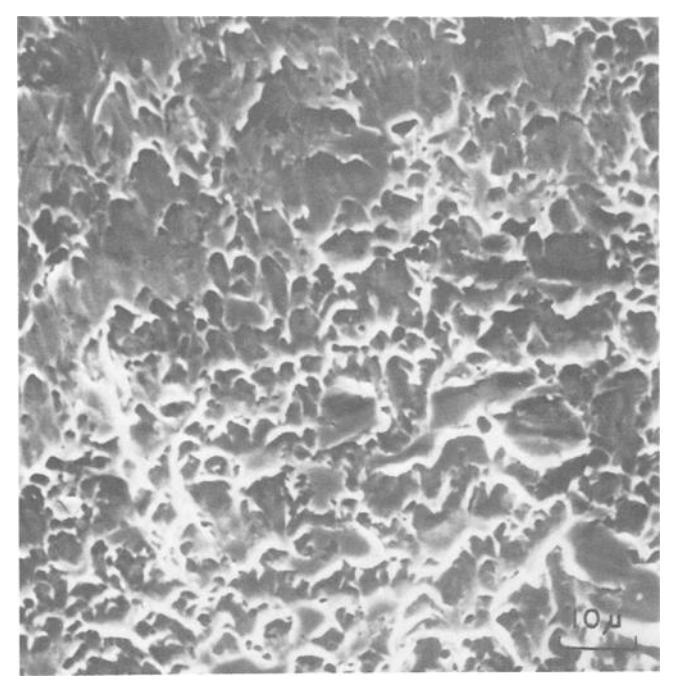
FIG. 7-SEM fractograph of slanted area in fracture surface of Fan Blade A.

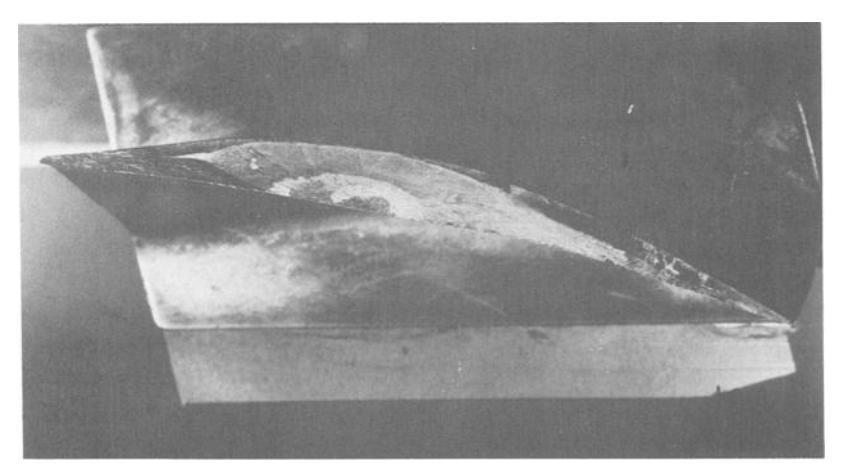
shaped area of subcritical crack growth, 1.78 cm (0.7 in.) long on the concave side and 0.38 cm (0.15 in.) deep, was discolored to white-gray. The rest of the flat portion displayed a rough texture, and the slanted side portions were typical shear lips with a relatively fine texture.

FIG. 8-Fracture surface of Fan Blade B.

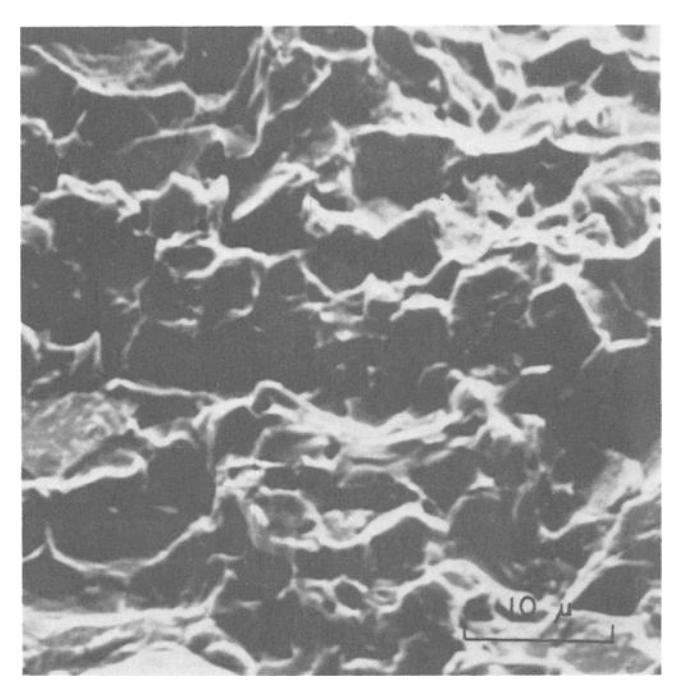
In the immediate vicinity of the crack initiation site, a mixture of intergranular and cleavage facets with some secondary cracks was found (Fig. 9). The intergranular and transgranular crack path and crack branching also were evidenced in the optical micrograph of a section through the fracture. In the remaining area of subcritical crack growth, the SEM fractograph exhibited mostly cleavage-like facets, some of which contained faint striations (Fig. 10). The presence of such striations was verified by the TEM fractograph (Fig. 11).

FIG. 9-SEM fractograph near crack initiation site of Fan Blade B.

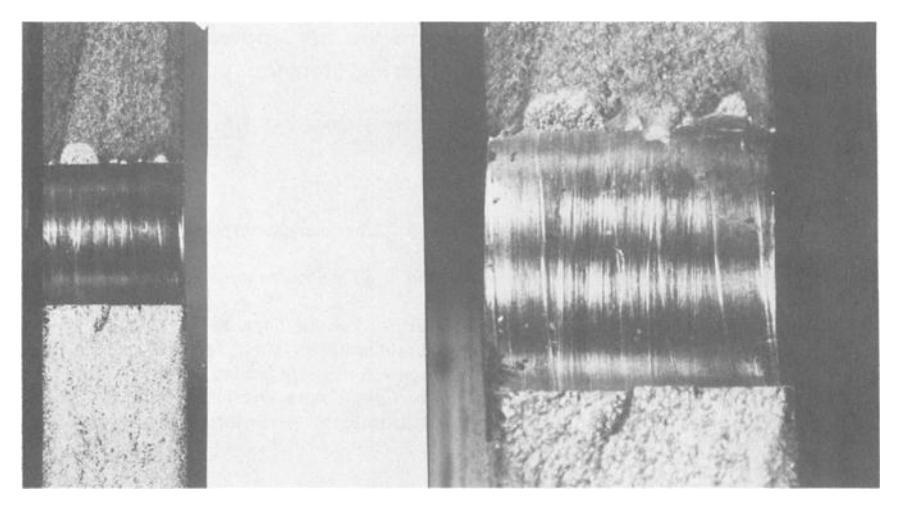
Another aspect of crack initiation that must be mentioned here is the location of crack nucleation sites. Usually it is assumed that cracks initiate at the "corners" of a hole. In this program, most of the cracks started inside the hole, as illustrated in Fig. 12, with a high degree of correlation between crack nucleation sites and the predominant hole machining tool marks inside the hole.

FIG. 12-Crack nucleation sites in the notch hole, Specimen 313.

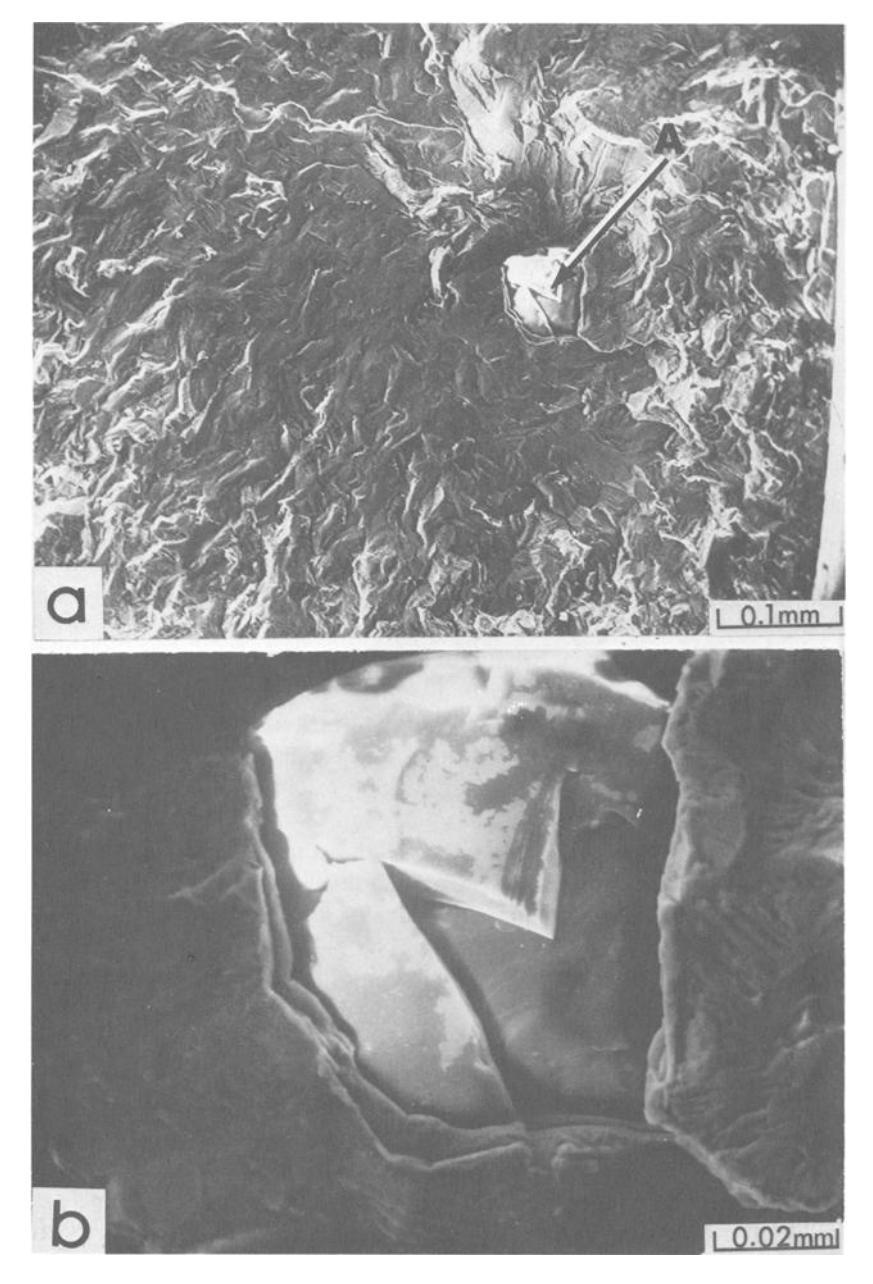
Often it is possible to identify the defect causing the crack initiation merely by examining the fracture surface. Figure 2(a) shows the fracture surface of a  $\beta$ -III titanium alloy (11.5Mo-6Zr-4.5Sn) powder compact, smooth, fatigue specimen. The processing and heat treatment conditions of this and other alloys discussed are listed in Table 1. The average room temperature, high cycle fatigue life of the powder compacts (at 827 MN/m<sup>2</sup> peak load and stress ratio R = 0.1) were found to be more than two orders of magnitude shorter than that for the wrought product, while other properties like tensile strength and fracture toughness remained the same [8]. The SEM image of the fracture surface indicates subsurface initiation in Location A. A higher magnification image (Fig. 2(b)) shows an inclusion lying close to the fracture surface; X-ray scan analysis identified it as being silicon dioxide (SiO<sub>2</sub>).

FIG. 2—(a) SEM image of a subsurface fatigue failure origin, at A, of a  $\beta$ -III powder compact specimen, and (b) a SiO<sub>2</sub> inclusion at the origin site.

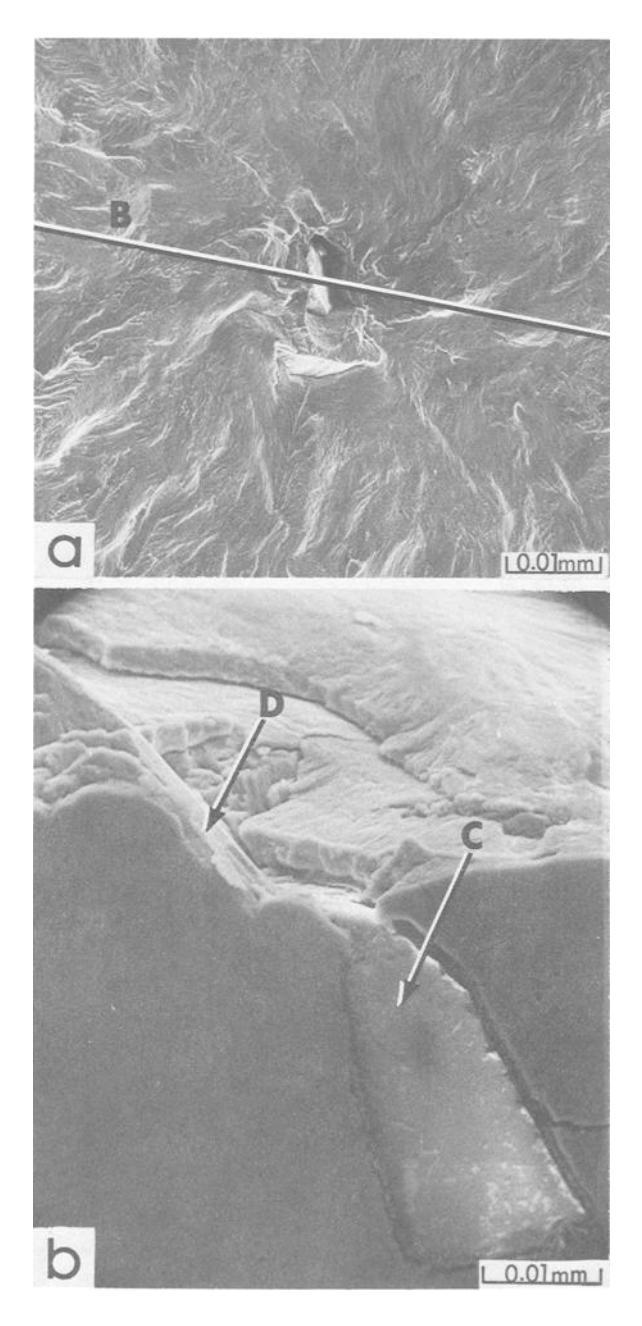
In other cases, the source of the crack initiation is located well under the fracture surface. Such an instance is shown in Fig. 3(a) (same material and test conditions as in Fig. 2(a)). The precision sectioning method [4] involves identifying the fracture origin in the SEM, cutting close to the origin on a plane perpendicular to the fracture surface, measuring the distance from the cut face to the origin, and grinding off this distance in a standard, plastic mold, metallographic technique. After the specimen is polished to the exact location (Line B in Fig. 3(a)) it is possible to obtain a micrograph of the underlying microstructure, showing details that will help in the interpretation of the fatigue failure. The SEM image in Fig. 3(b) is a modification of this method in which the mount material has been dissolved carefully to make it possible to obtain the fracture surface at the origin and the underlying microstructural features in the same SEM picture. The SiO<sub>2</sub> particle that was not visible on the fracture surface can be seen at this stage. It is also seen that the fracture has originated as a shear type fracture on Plane D which lies close to 45 deg to the fatigue tensile axis which is the vertical direction of the photograph. Unlike Fig. 2(b), the sectioned plane image (Fig. 3(b)) can provide more information about the shape and

FIG. 3—(a) SEM image of a subsurface fatigue fracture origin of a  $\beta$ -III powder compact specimen. Using the precision sectioning technique, the fracture surface was sectioned along line B. (b) SEM combined image of the sectioned plane and the fracture surface showing an SiO<sub>2</sub> inclusion (C) located under A. The fatigue crack initiated on shear plane D.

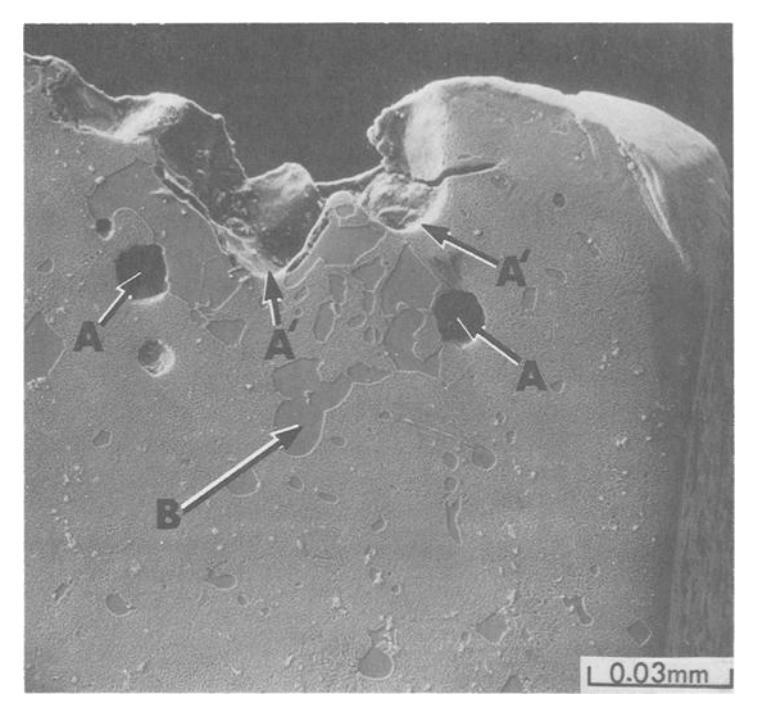
The same fatigue failure analysis was tried and found successful in superalloy powder compacts of an advanced nickel base superalloy, AF-115. These compacts showed subsurface initiation origins when hourglass specimens were fatigue tested at 760 °C (1400 °F), R = -1 and maximum stress = 620 MN/m<sup>2</sup> (90 ksi). Figure 4 is a section through a fatigue specimen at the initiation site. It can be seen that the fatigue crack was initiated from an area containing clusters of unhealed pores (marked A) and large unsolutioned  $\gamma'$  particles (marked B). The two curved fracture segments (marked A') may be the lower part of the pores which initiated the crack.

FIG. 4—SEM image of fatigue crack initiation site in a powder compact of nickel base superalloy AF 115 showing cluster of pores at A and unsolutioned  $\gamma'$  at B. The crack was initiated at A'.

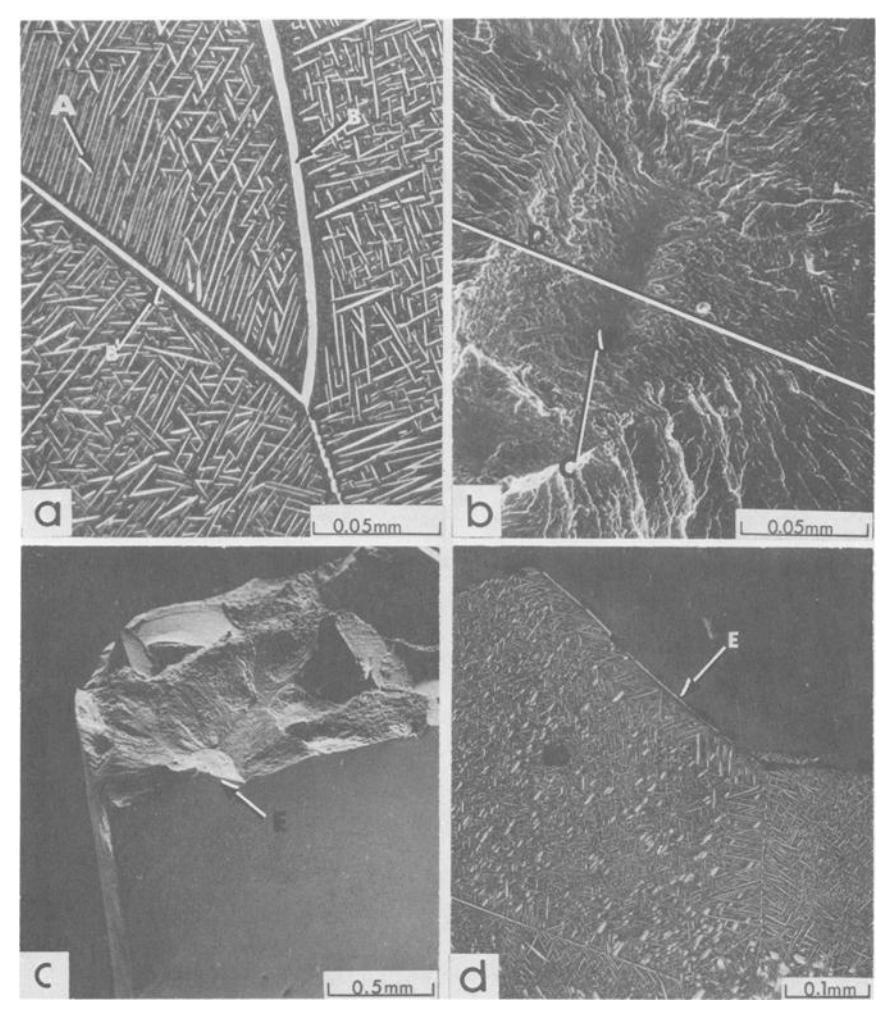
In many cases, the subsurface fatigue origins will result from certain microstructural features rather than from inclusions, pores, or other defects. Figure 5(a) shows the microstructure of a Ti-17 (5Al-2Sn-2Zr-4Mo-4Cr) titanium alloy forged at 1065 °C (1950 °F). This is 200 °F above the  $\beta$ -transus temperature and resulted in an acicular transformed  $\beta$  microstructure. This material was subsequently heat treated as indicated in Table 1. The micrograph shows a *colony* of  $\alpha$  platelets, all oriented in the same direction as at A, as well as longer and wider continuous grain boundary  $\alpha$  film (GB $\alpha$ ) which outlines prior  $\beta$  grain boundaries as at B and B'. The flat cleavage-like facet, C, in the center of Fig. 5(b) is the subsurface fatigue initiation site on an hourglass specimen tested at 1034 MN/m<sup>2</sup> (150 ksi), R = 0.1 at room temperature. This specimen had lower fatigue life than

specimens forged within the  $\alpha + \beta$  temperature range. Figure 5(c) is a low magnification SEM picture of the section along line D in Fig. 5(b); E marks the location of the crack initiation. Figure 5(d) is the light microscope image of the metallographically polished and etched area under the initiation site E. This clearly shows that the fatigue initiated at planar GB $\alpha$ similar to that at B' in Fig. 5(a). This GB $\alpha$  is oriented close to 45 deg to the major tensile axis (the vertical direction of the picture) and thus promoted a slip related fracture on the long  $\alpha/\beta$  interface which was oriented in a direction close to the maximum shear stress. Figure 6(a) is the SEM image of the same location as in Fig. 5(d), after the mount material was dissolved carefully. This picture gives the combined view of the fracture surface and underlying microstructure of the initiation site at higher magnification. Since the GB $\alpha$  forms during slow cooling from above the  $\beta$  transus temperature, it may be possible to eliminate it with fast cooling from the forging press and thus improve the room temperature high cycle fatigue life. The same type of GB $\alpha$  fatigue crack initiation was found associated with large colony structure in Ti-6Al-4V castings (Table 1) fatigue tested at room temperature at 413 MN/m<sup>2</sup> (60 ksi) maximum stress, R = 0.1.

FIG. 5—(a) Ti-17 fatigue specimen with acicular microstructure showing colonies of transformed  $\alpha$  platelets at A and grain boundary  $\alpha$  at B and B'. (b) Flat fracture initiation site at C was sectioned on line D. (c) Low magnification SEM image shows the initiation site at E. (d) Underlying microstructure showing fatigue crack initiation along the GB $\alpha$  phase.

Fatigue origins relating to microstructural features were found in powder, wrought, and cast materials. If low fatigue life is attributed to this type of fatigue initiation, thermomechanical or heat treatment of the alloy may be modified sometimes to eliminate the initiation related microstructural features. The elimination of the grain boundary  $\alpha$  in the Ti-17 alloy (Fig. 5(a)) by fast cooling from the  $\beta$ -phase is a good example.

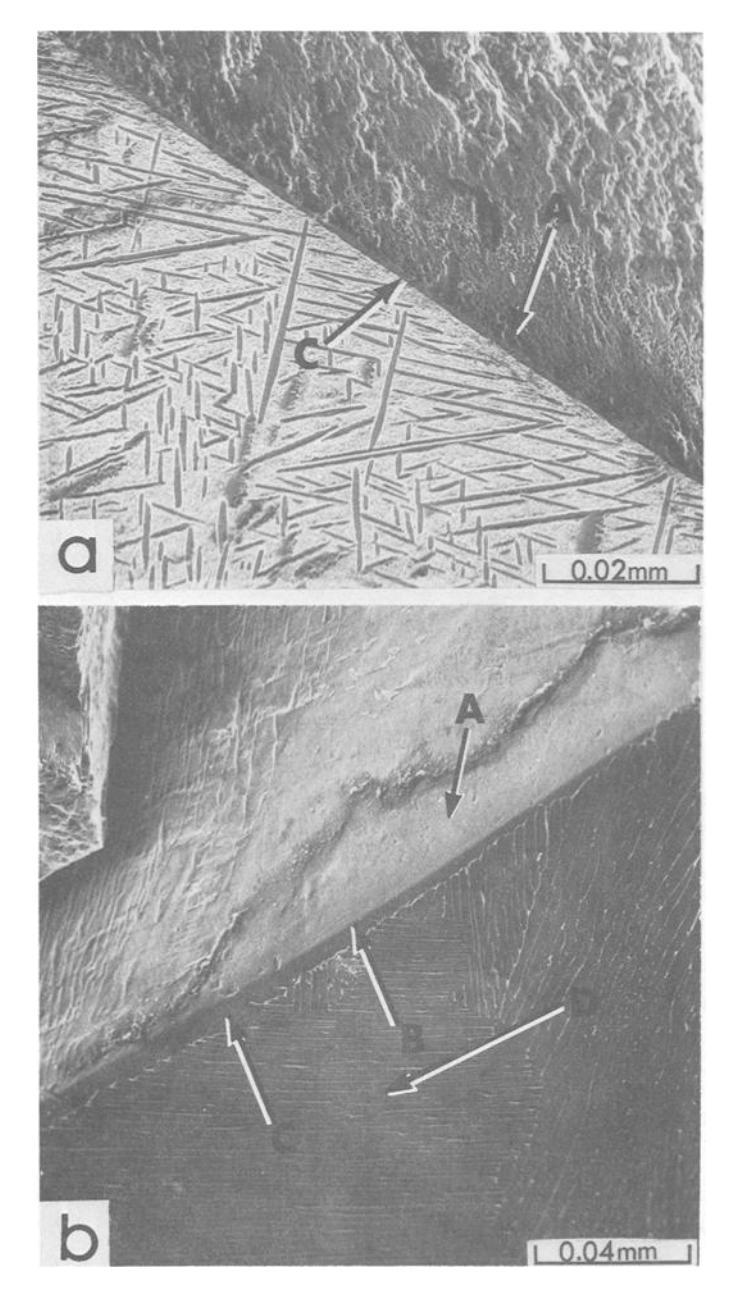
Figure 6(b) clearly shows the shear type fracture origin (A) at the  $\alpha/\beta$  interface (B) of a planar GB $\alpha$  (C) inclined about 45 deg to the major tensile axis.

FIG. 6—(a) High magnification SEM combined image of the fracture initiation site at A along the GB $\alpha$  at C and the underlying microstructure of the specimen shown in Fig. 5. (b) GB $\alpha$  fatigue initiation, at A, along the  $\alpha/\beta$  interphase boundary (B) of the GB $\alpha$  (C) in the large colony (D) microstructure of cast Ti-6Al-4V.

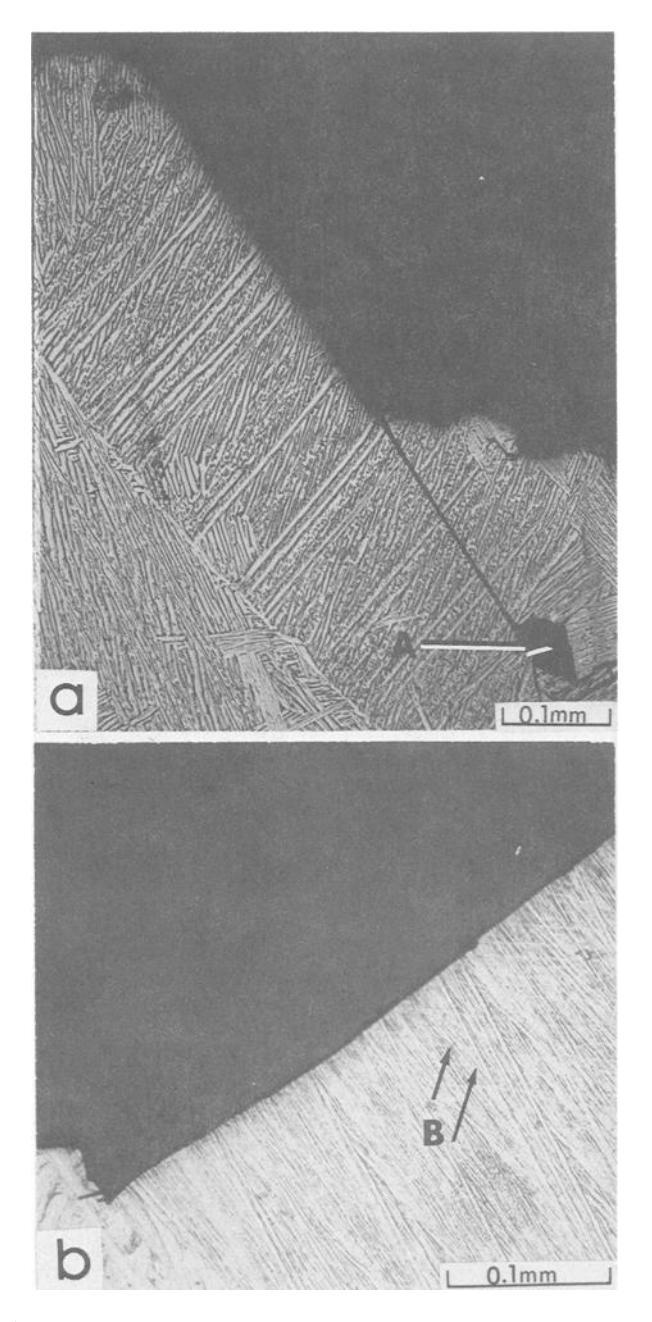
The large colonies of  $\alpha$  platelets (D in Fig. 6(b)) are also typical of ascast microstructure of Ti-6Al-4V alloy and relate to another type of microstructure-related fatigue crack initiation. This is shown in Fig. 7(a) for the test conditions just described. This type of fatigue initiation is associated with the formation of shear bands across the colonies of similarly oriented

FIG. 7—(a) Trans-colony fatigue shear initiation in cast Ti-6Al-4V originated in pore A. (b) Trans-colony shear initiation in IMI 685 titanium alloy showing slip traces in B.

$\alpha$  platelets. In the case of Ti-11 [3] and IMI-685 [9] (6AI-5Zr-0.5Mo-0.25Si) alloys, the trans-colony shear fracture was found to dominate both initiation and the propagation stages of the fatigue failure. In Fig. 7(a), the transcolony fracture may have originated from the small unhealed casting pore (A). Also in this case, the shear type fracture propagated in a direction close to 45 deg to the tensile axis. Figure 7(b) shows a similar trans-colony shear fatigue initiation for IMI-685 titanium alloy (Table 1). Traces of another slip system can be seen across the colony at B. Fatigue crack initiations of this nature were associated with a fatigue life debit [9] only when a 5-min hold time was applied at the maximum stress position of the fatigue cycle.

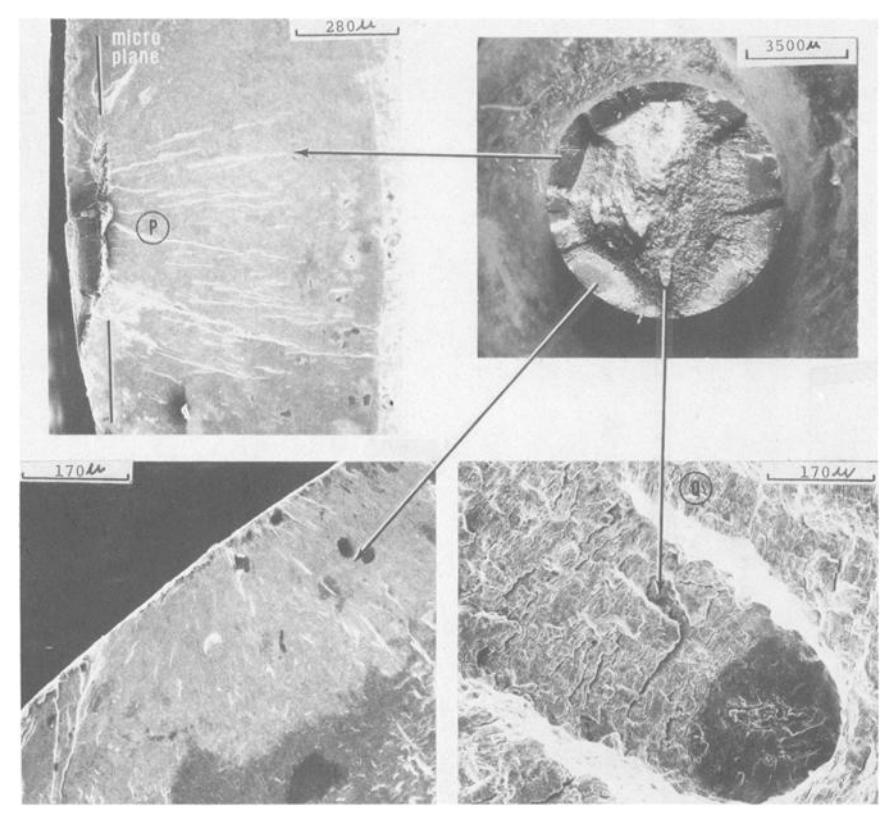
and cycling rate, only the bore specimens which bracket the minimum and maximum strain ranges at 427°C will be discussed. The fractography of the lowest strain range ( $\epsilon_t = 0.5$  percent,  $N_f = 7500$  cycles) 427°C bore specimen is shown in Fig. 4. Surface initiation occurred around 90 percent of the gage circumference (as visually observed at × 60); however, subsurface initiation just adjacent to the surface (Area P) as well as internal initiation (Area Q) both occurred at MnS inclusions. All initiation sites were rubbed mechanically during the reversed ramp loading to zero strain, but propagation topography was highly striated. Surface oxide spiking was not observed. A metallographic section (Fig. 5) along the subsurface inclusion in Area P revealed transgranular initiation with a slight amount of branching at the crack tip. Similar behavior was observed at secondary cracks along the gage length below the main fracture.

FIG. 4—Topography of the minimum strain range (0.6 percent) bore  $427^{\circ}C$  continuous cycling specimen fracture showing internal MnS inclusions (Area Q) near surface MnS inclusions (Area P), and zero defect surface locations which were all initiation sites.

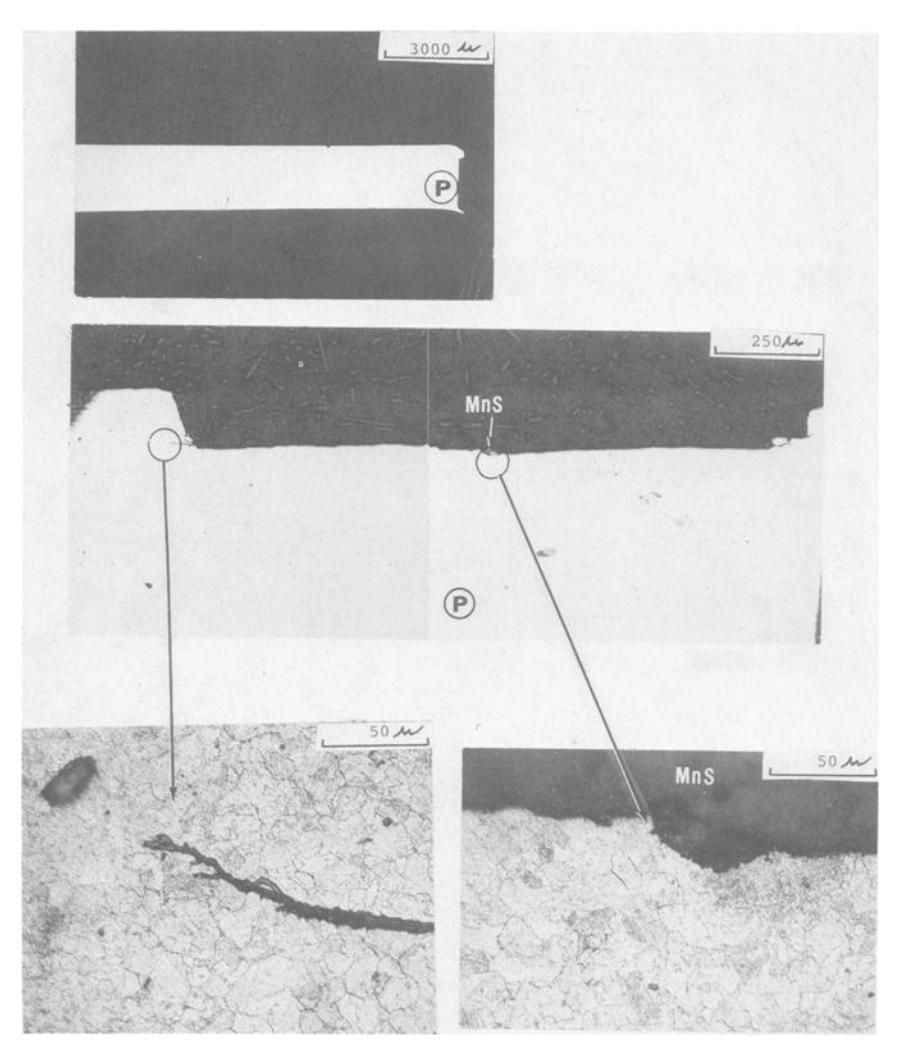
FIG. 5—Selected metallography through Area P in Fig. 4. Sodium tridecyl benzene sulfonate (STBS) for etched microsections.

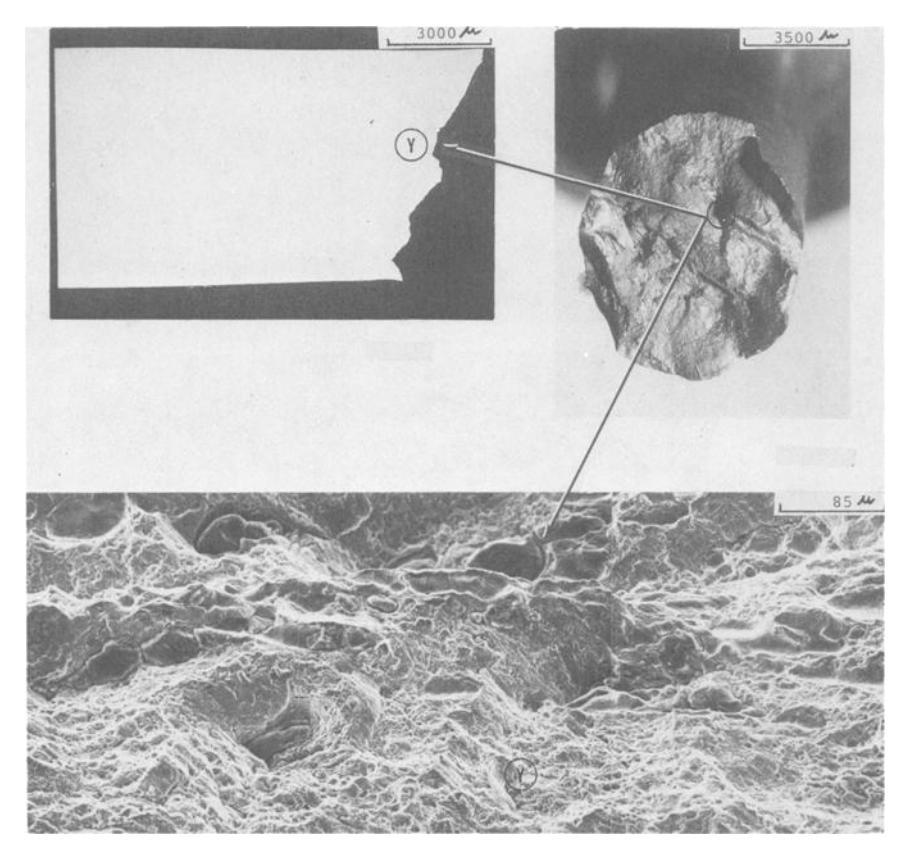
By comparison, the maximum strain range ( $\epsilon_t = 4.3$  percent,  $N_f = 41$  cycles) 427 °C bore specimen solely initiated internally at MnS stringers.

Figure 6 denotes the multiple level fracture surface with each level corresponding to a MnS concentration. Since these inclusions were known to be concentrated in inverse "V" segregation [2], it is not surprising that parallel macroplanes are observed at each cluster concentration. Area Y in Fig. 6 is a typical example of this behavior. SEM fractography indicates that each major inclusion or cluster of minor inclusions has a small patch of transgranular fatigue initiate from each discrete inclusion on a plane exactly normal to the applied stress axis. Once growth proceeds sufficiently to link

FIG. 6—Topography of the maximum strain range (4.3 percent) bore  $427^{\circ}C$  continuous cycling specimen fracture showing planar transgranular linkup of MnS inclusions internal to the gage diameter (for example, at Area Y). Macroscopic observation of the specimen fracture readily shows parallel MnS concentrations corresponding to Area Y.

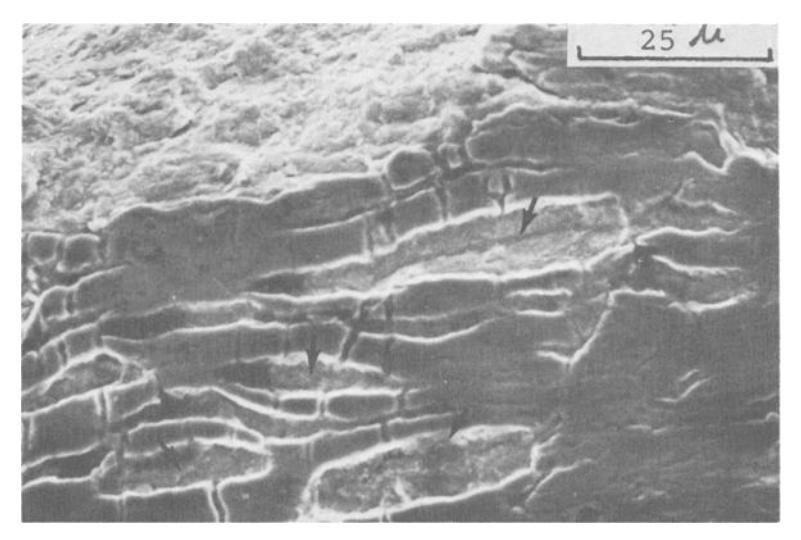
up adjacent stringers, shearing occurs between these planar fatigue cracks. As expected, a relatively small fraction of final topography is fatigue with the bulk being shear dimples. The surface of the gage length was perforated with oxide spikes (Fig. 7); however, this phenomenon was not observed to affect either initiation location nor propagation direction. Metallography revealed transgranular main fracture propagation; however, secondary cracking was significantly more branched than at lower strain ranges (Fig. 8).

FIG. 7—Oxide spiking (arrows) on the gage section surface of Fig. 6.

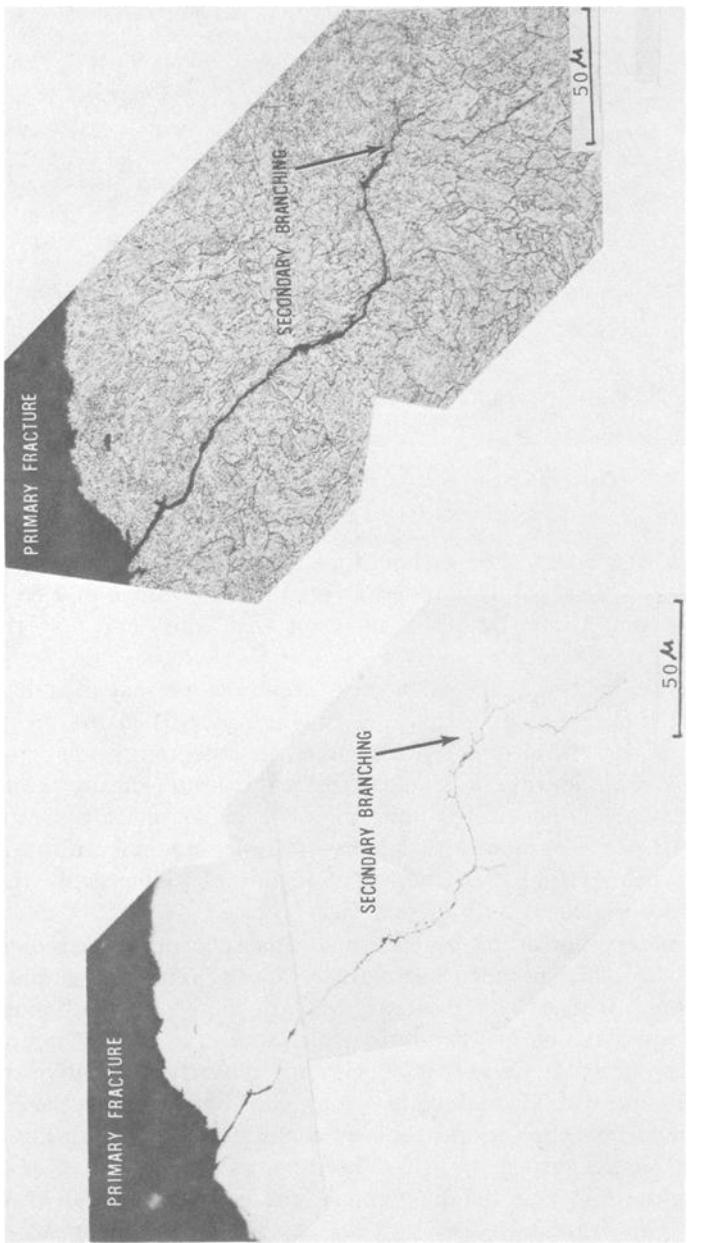
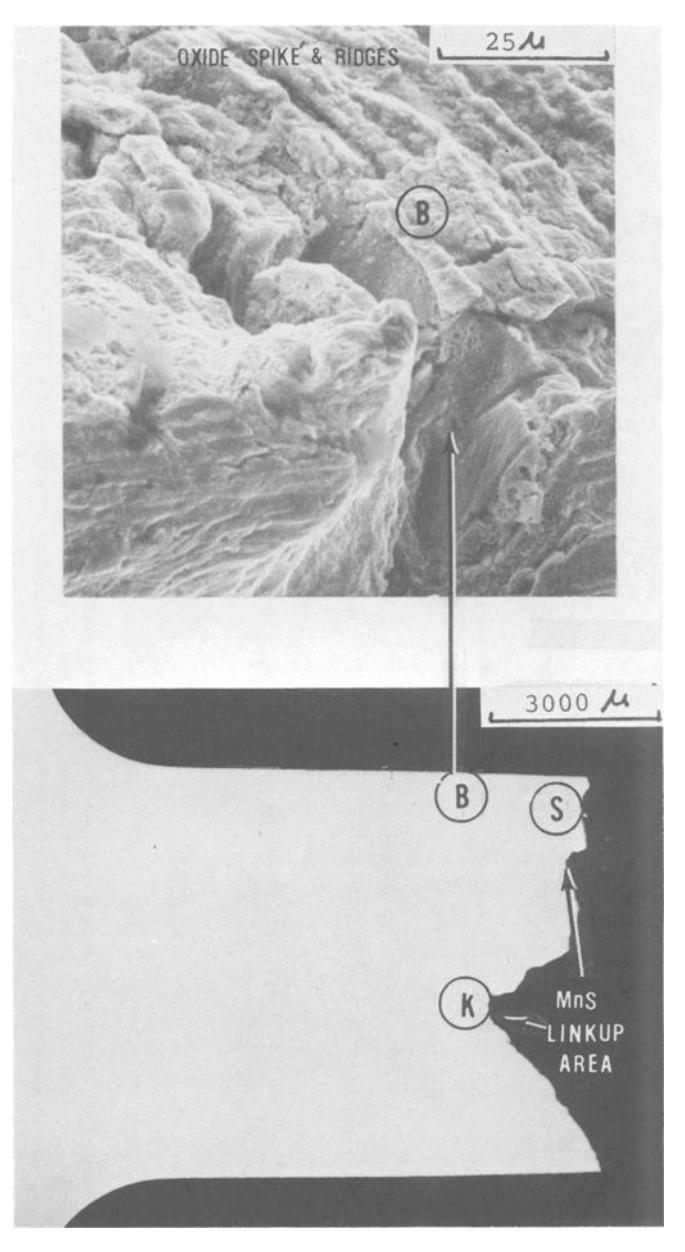
FIG. 9—Internal initiation (Areas K and S) at MnS inclusions and oxide spiking (Area B) in the bore 1-h cycle hold-time specimen tested to failure at  $427^{\circ}C$  and a total strain range of 3.23 percent.

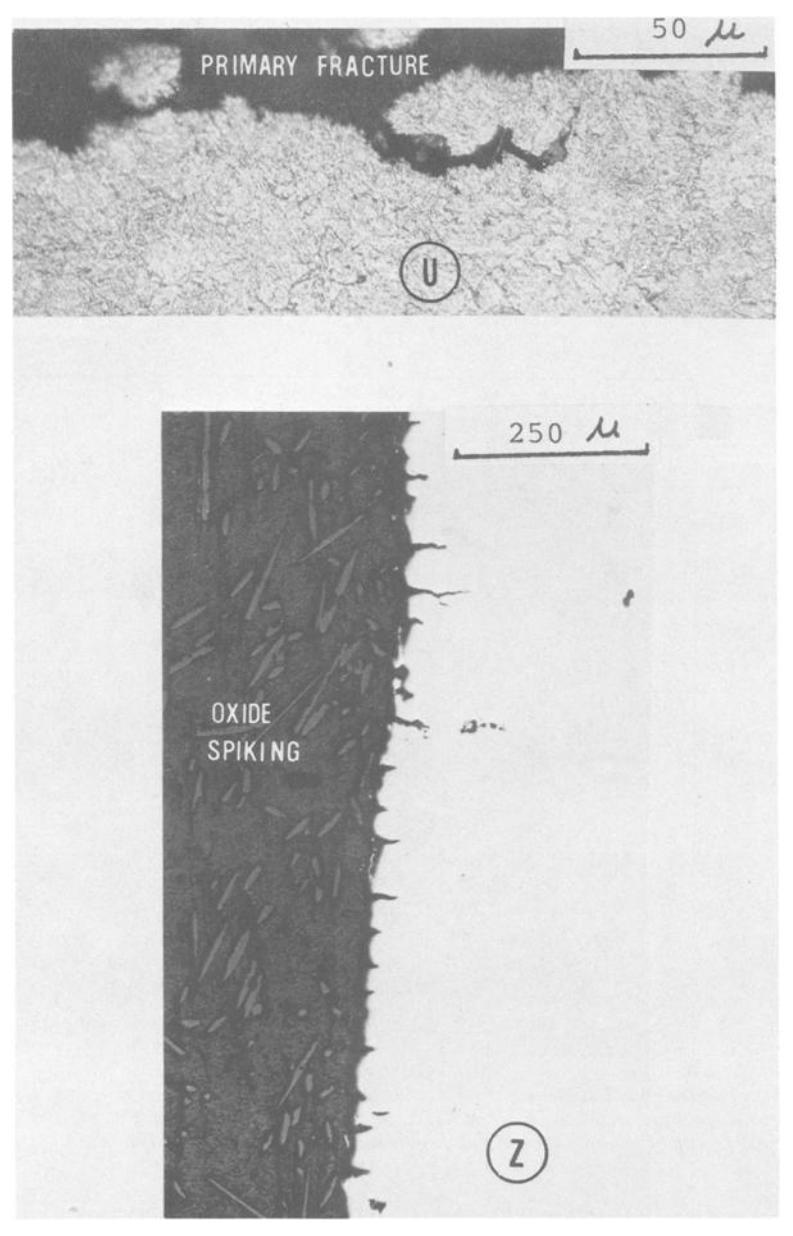
FIG. 12—Selected metallograph of fatigue propagation (Area U) and oxide spiking (Area Z). STBS etchant is used where etched.

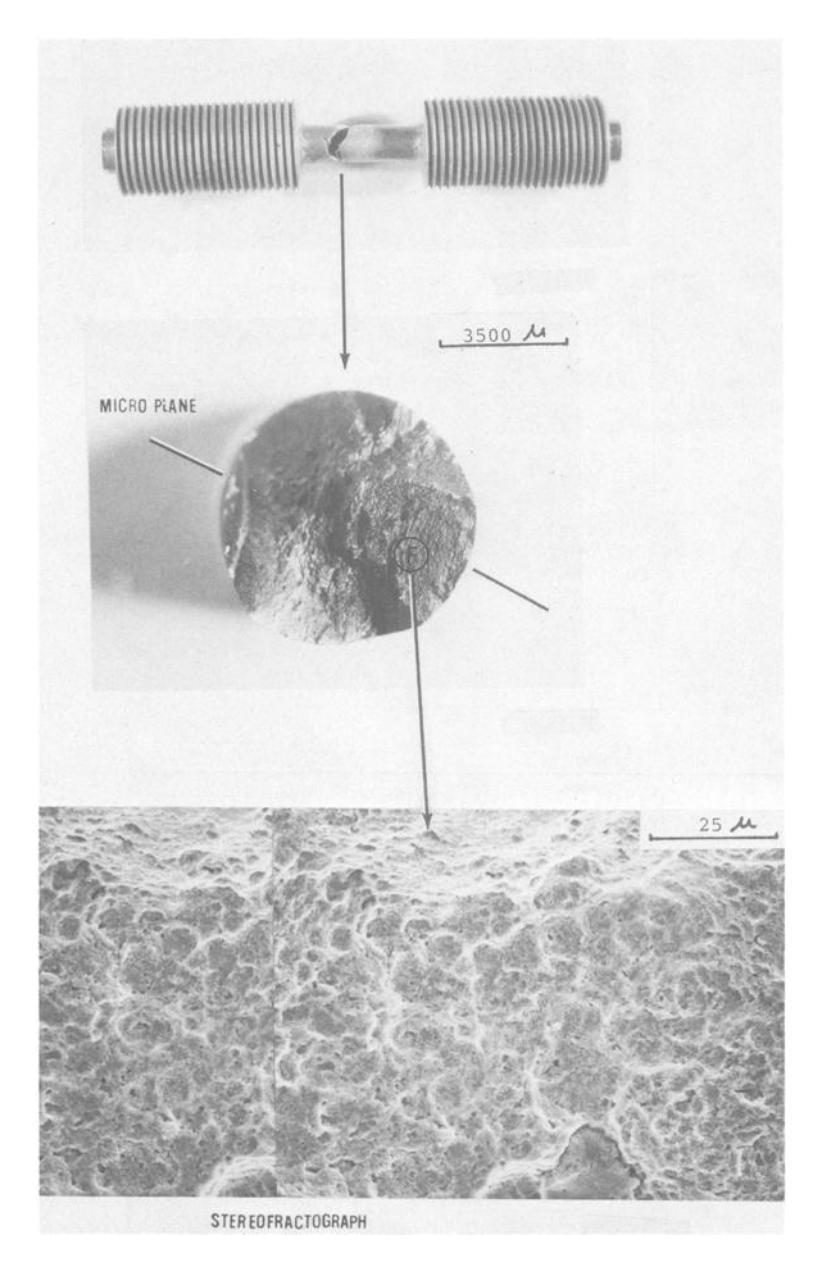
FIG. 13—As-received condition of the bore 24-h cycle hold-time specimen tested to failure at 427°C and a total strain range of 2.98 percent. Even though the fracture had been oxidized severely during testing, a stereo pair shows a distinct remnant of intergranularity.

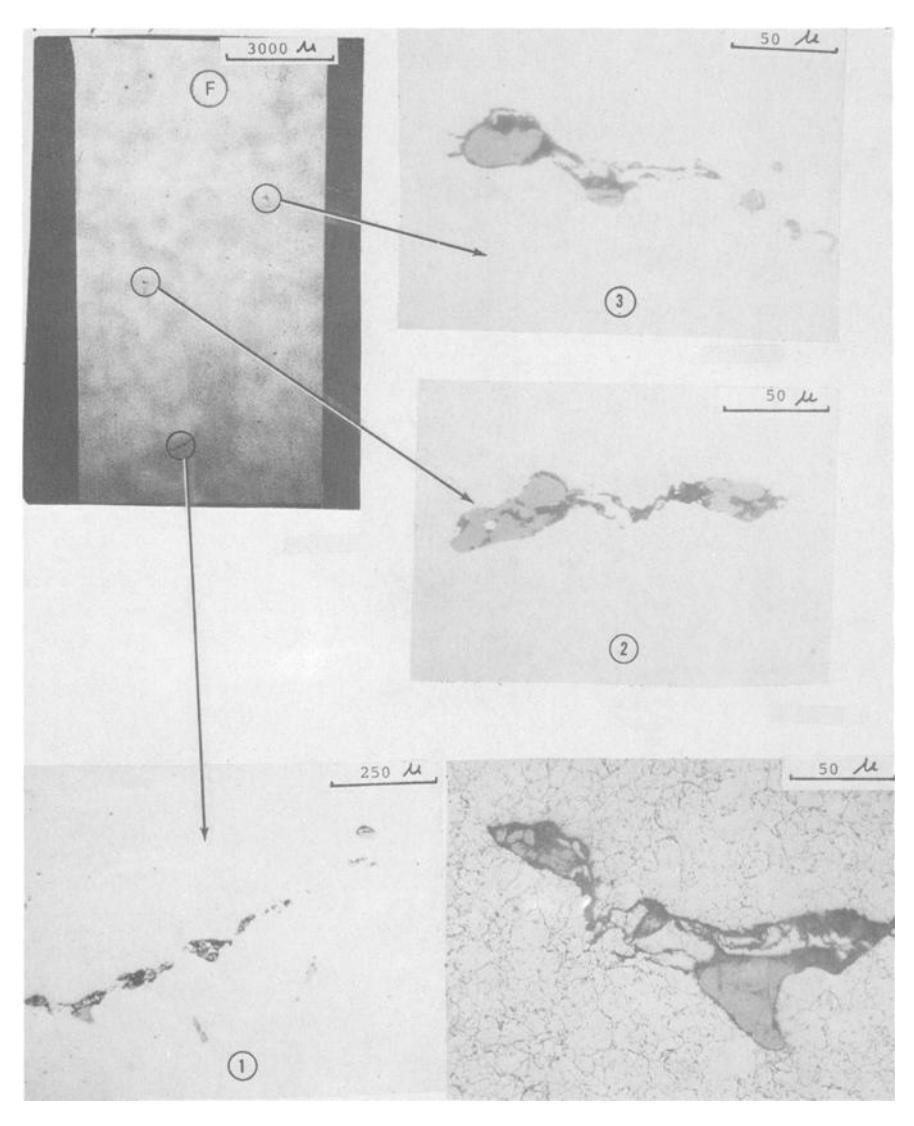
when viewed as a stereo pair. An axial metallographic section (Fig. 14) through this specimen gage section revealed numerous intergranular secondary cracks (Area F, Cracks 1, 2, and 3) below the primary plane of fracture. Each crack corresponded exactly to a dark etching band of positive segregation in a similar manner to cracking at the Gallatin No. 2 origin

FIG. 14—Selected metallography of Fig. 13 showing greater inclusion linkup distances associated with the darker etching, highly segregated Area F (Location 1 compared to Locations 2 and 3) Crack morphology was intergranular. STBS etchant is used where etched.

[2]. The more intense etching banded areas had closer spaced MnS inclusions and thereby longer linkup distances. This statement is corroborated by comparing Locations 1, 2, and 3 in Fig. 14. Detailed metallography of Location 1 (Fig. 14) shows the same inclusion decohesion and branched intergranular cracking observed in Gallatin. This behavior was also reproducible in the 12-cycle early-life specimen which exhibited up to  $1.2 \times$
