# fractography in failure analysis

A symposium presented at May Committee Week AMERICAN SOCIETY FOR TESTING AND MATERIALS 1-6 May 1977, Toronto, Canada

ASTM SPECIAL TECHNICAL PUBLICATION 645 B. M. Strauss, Gulf Research and Development Company, and W. H. Cullen, Jr., U.S. Naval Research Laboratory, editors

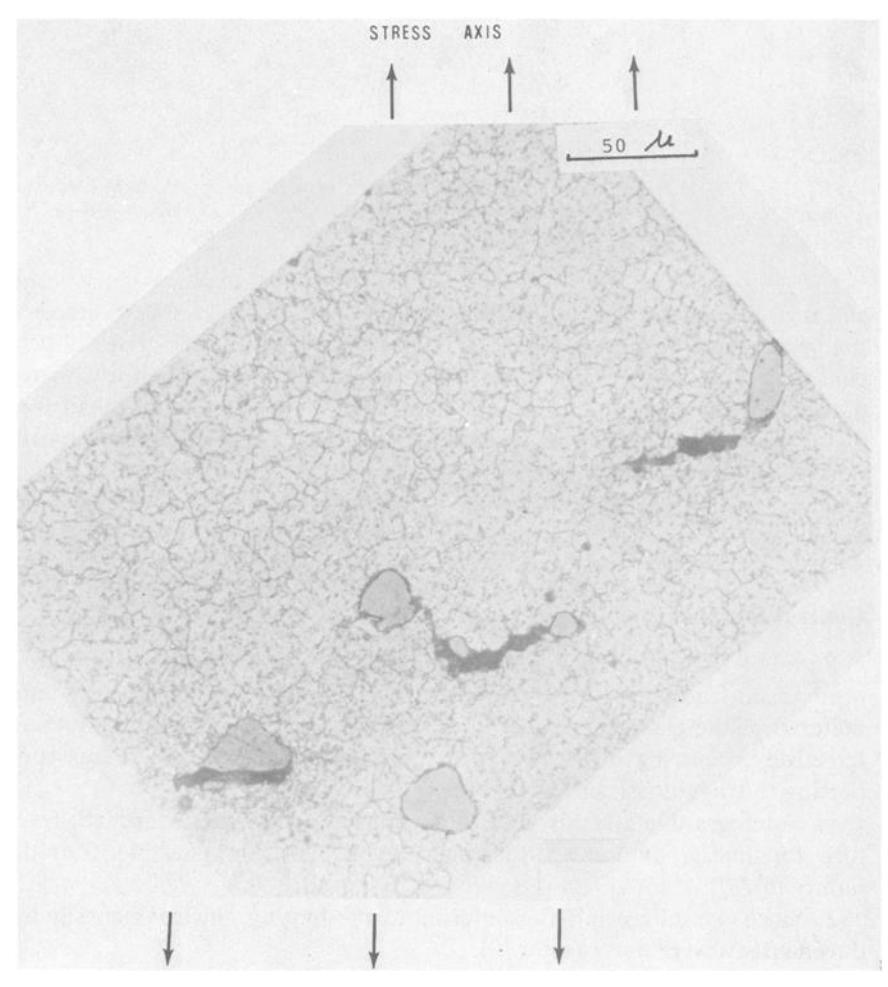
FIG. 15—Similar intergranular initiation between MnS inclusions in another bore 24-h cycle hold-time specimen tested at 427°C and a total strain range of 2.98 percent. Testing was terminated upon reaching 12 strain cycles (16 percent of life). STBS etchant.

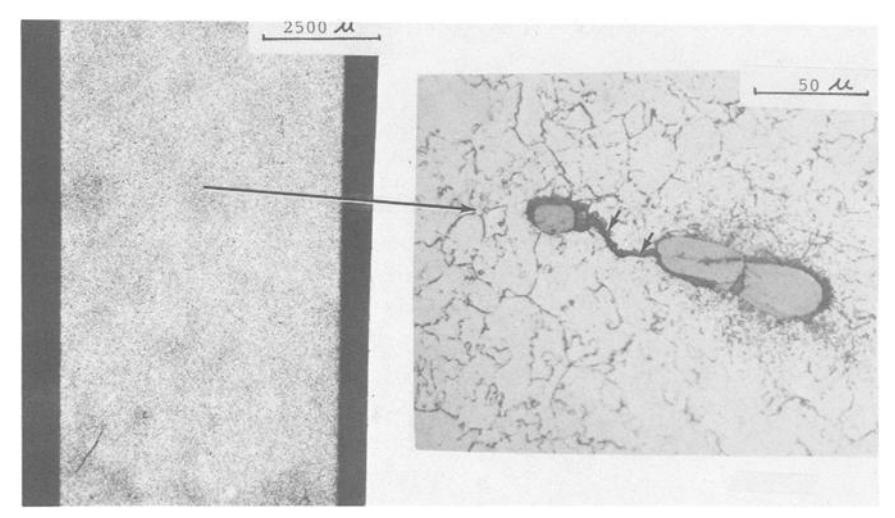
FIG. 16—Transgranular initiation at MnS inclusions in a periphery 1-h cycle hold-time specimen tested to 60 strain cycles (20 percent of life) at a range of 1.75 percent and 427°C. Little segregation is observed at this position in the forging. STBS etchant.

rial microsections of 1-h ( $\epsilon_t = 1.74$  percent) and 23-h ( $\epsilon_t = 2.98$  percent) hold-time specimens after 60 cycles (20 percent of  $N_f$ ) and 7 cycles (9 percent of  $N_f$ ), respectively. In both cases, the structure was much less segregated than the corresponding bore specimens; hence, the MnS mean free distance was larger than previously noted. Slight inclusion-matrix decohesion occurred as well as transgranular linkup between a few adjacent inclusions. No simulation of the Gallatin crack morphology was observed.

5. Given these long hold times in fatigue, the location of material (namely, the microstructure) has a significant effect on MnS inclusion linkup frequency and fracture path. Since the periphery material (Fig. 16) was less segregated, the MnS interparticle distance was greater thereby decreasing the possibility of linkup. Furthermore, the unbanded periphery material was found to be unlike the bore microstructure which was highly duplexed in the bands [2, 6].

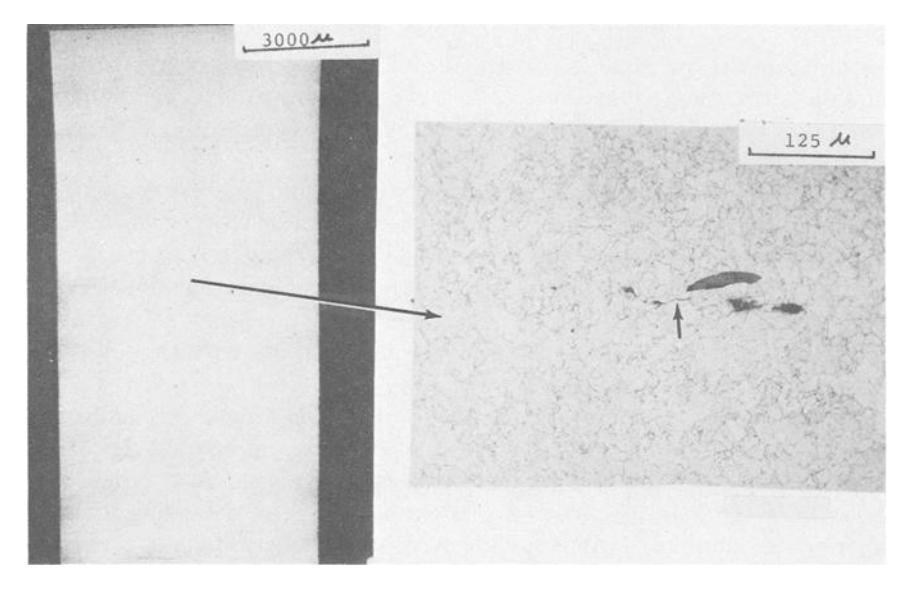
FIG. 17—Transgranular initiation at MnS inclusions in a periphery 24-h cycle hold-time specimen tested to 7 cycles (9 percent of life) at a range of 2.98 percent and 427°C. Again, little segregation is observed at this position in the forging. STBS etchant.

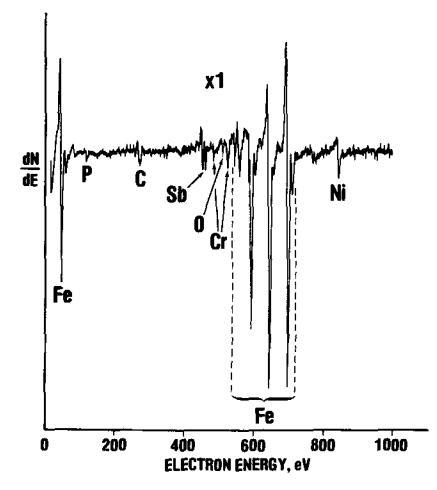
FIG. 6—Auger spectrum obtained from the intergranular fracture surface of a 3340 steel.

richment of not only antimony (~4 atomic percent) but also chromium, nickel, and carbon. The carbon peak shape clearly suggests its occurrence in the form of a carbide. Detailed studies [7] of this alloy system (Fig. 7) also showed that the shift in the transition temperature could be directly correlated to the antimony segregation. The results (Fig. 8) also demonstrate clearly that grain boundary segregation of antimony, nickel, and chromium is increased with increasing bulk antimony concentration suggesting that metalloid-metal (for example, antimony-nickel) interactions predominate leading to segregation. The extent of segregation at the boundary of the metalloid impurities has been studied in conjunction with ion sputtering. Figure 9 shows the summary of such studies [11] in many ferrous systems. In all these cases, metalloid segregation occurred in a very narrow region of less than 5 Å at the grain boundary. While these observations are consistent with the equilibrium models of segregation, presence of a nickel en-

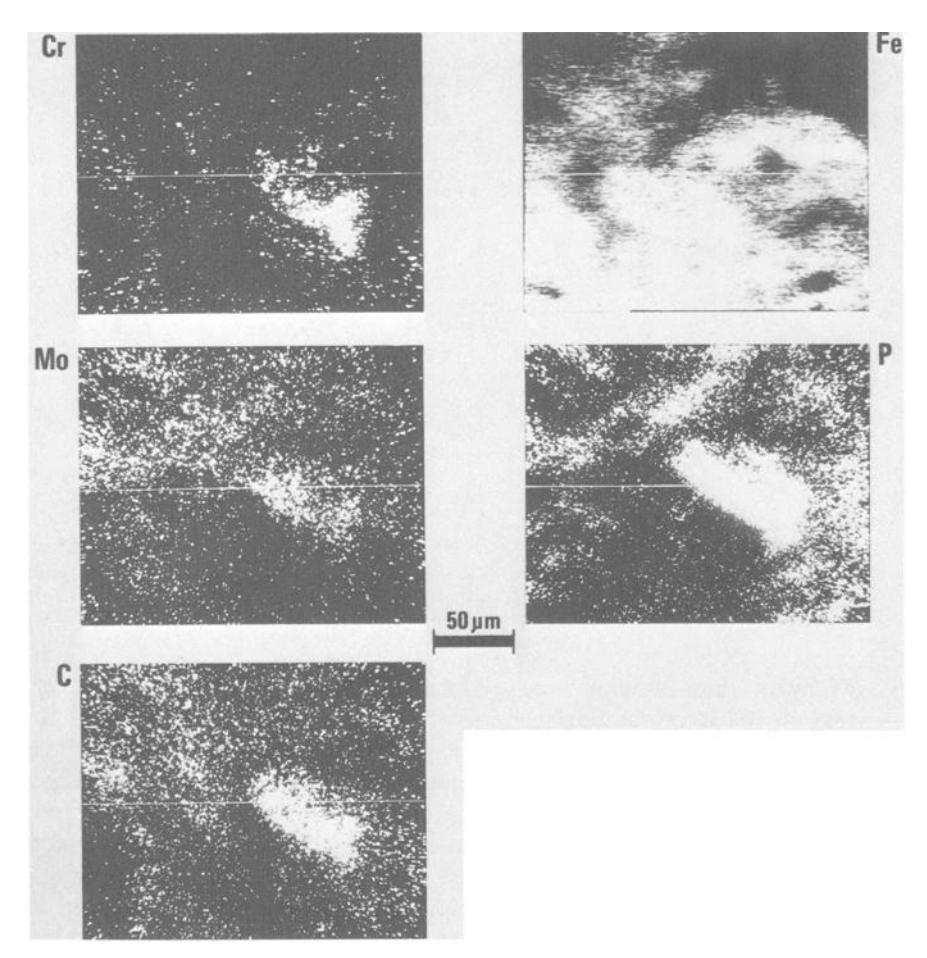
FIG. 10—Auger elemental images of chromium, molybdenum, carbon, and phosphorus obtained from the fracture surface of an embrittled 2.25Cr-1Mo steel.

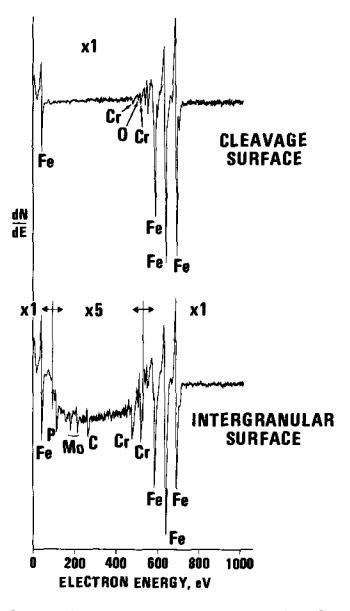
FIG. 11—Auger spectra from cleavage and intergranular fracture surfaces of 2.25Cr-1Mo steel.

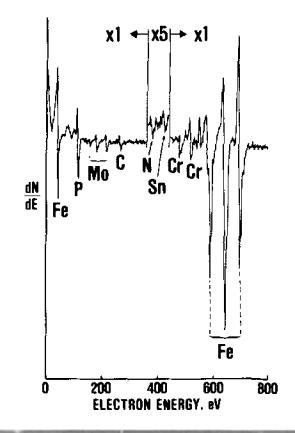
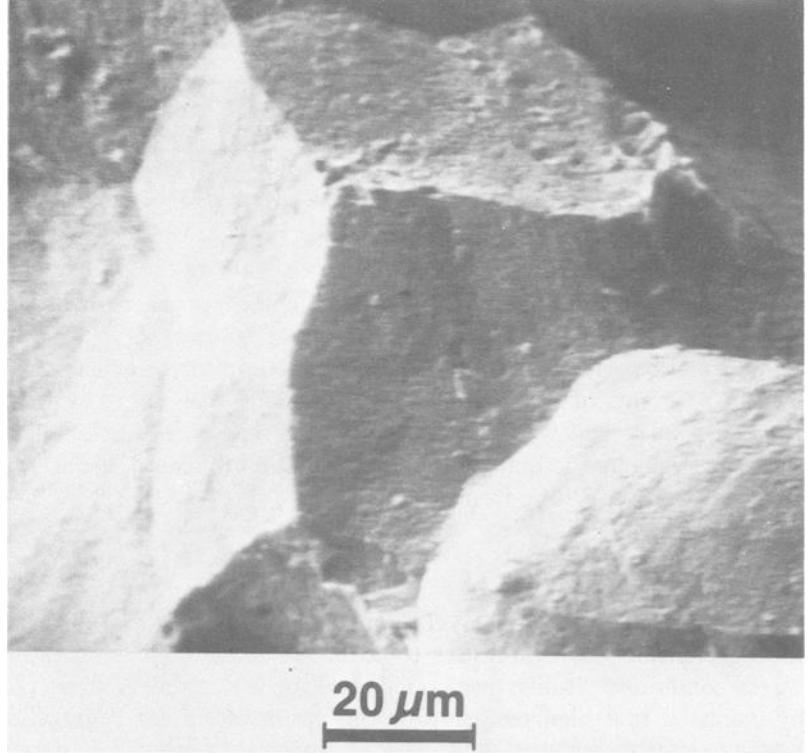
Embrittlement of weld metals and the heat affected zones (HAZ) of the weld have been investigated in few alloy systems. The grain boundary fractures that occur at the welds and HAZs appear to be some form of impurity induced embrittlement. Figure 12 shows an example of a 2.25Cr-1Mo

submerged arc weld metal failed along grain boundaries and characterized by phosphorus and tin enrichment to the interfaces which are also rich in chromium and molybdenum carbides. Small amounts of tin and nitrogen also were detected.

FIG. 12—Fracture surface and Auger spectrum from it depicting grain boundary composition of 2.25Cr-1Mo submerged arc weld metal.

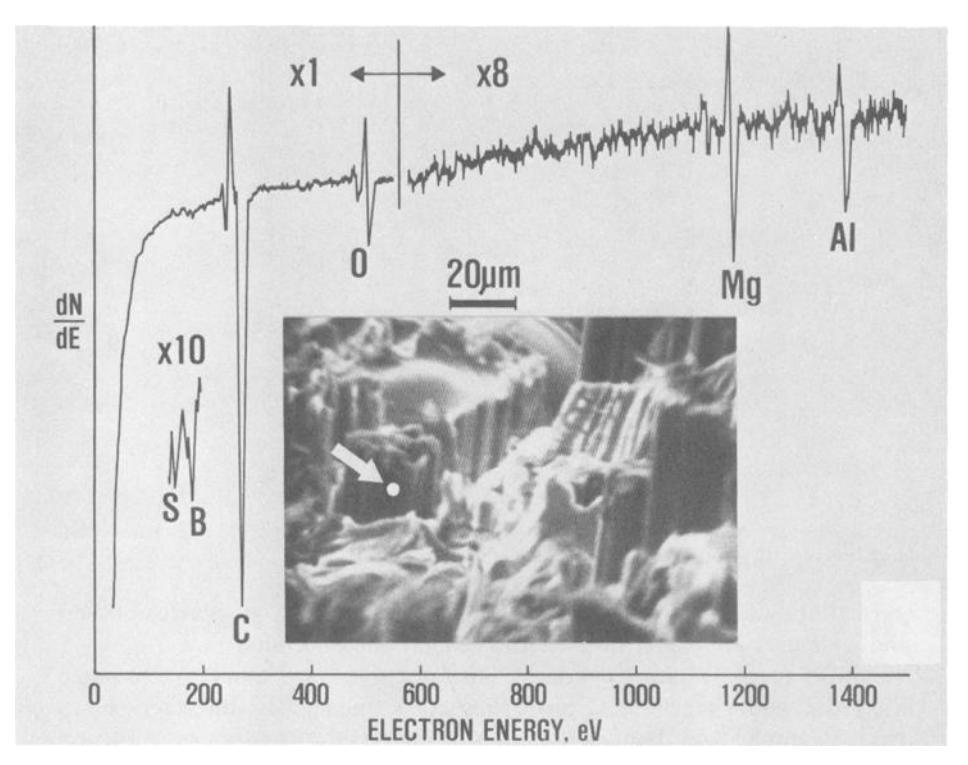
FIG. 13—Auger spectrum showing the interface chemistry of the aluminum/carbon fiber composite material.

carbon fibers was studied by AES analysis of the freshly opened interface. The Auger spectrum in Fig. 13 clearly indicates the enrichment of magnesium and oxygen at this interface. The magnesium Auger fine structure (plasmon loss peaks), characteristic of its chemical environment, is suggestive of existence of magnesium oxide at this interface. The magnesiumoxide layer was believed to be the reason for poor adhesion between the carbon fiber and the aluminum matrix. An examination of the process variables suggested that segregation of magnesium occurs from the aluminum during processing.

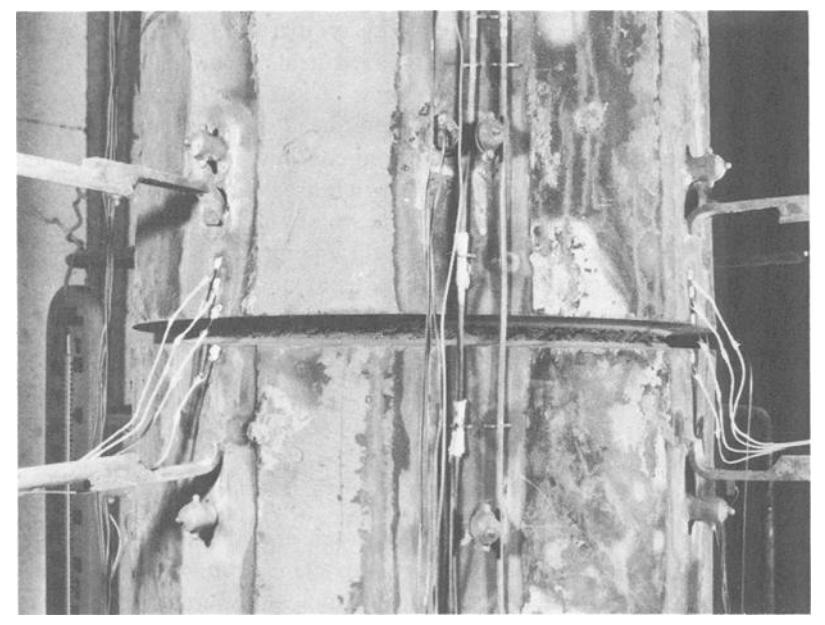
At the first inspection, after 290 h, no crack growth was found at any of the notches. The first indication of growth came from the 30-mm notch after about 700 h when the potential drop and acoustic emission monitoring techniques recorded increased voltages and stress wave emissions, respectively. An inspection at 1192 h confirmed these indications and showed that growth had started at all the notches. Crack growth data continued to be generated during the test and was substantiated by further NDT inspections at 1361 and 1577 h. The ultrasonic inspection also showed that crack growth was asymmetrical at the 30-mm notch and, although for much of the test there was less than 2-mm difference, at the final inspection the average minimum and maximum crack depths were 35 and 38 mm, respectively. This was also accompanied by an increase in the notch edge opening displacement on the side of maximum crack depth, indicating that bulging was taking place in the vessel as cracking extended from the root of the machined notch, as shown in Fig. 2. Failure finally occurred in an explosive manner after 1583 h with the vessel fracturing across the ligament ahead of the 30-mm notch.

FIG. 2—Bulging displacement and crack growth apparent at 30-mm-deep notch after 1361 h at  $565 \,^{\circ}C$  and  $62.5 \, MN/m^2$  internal pressure.

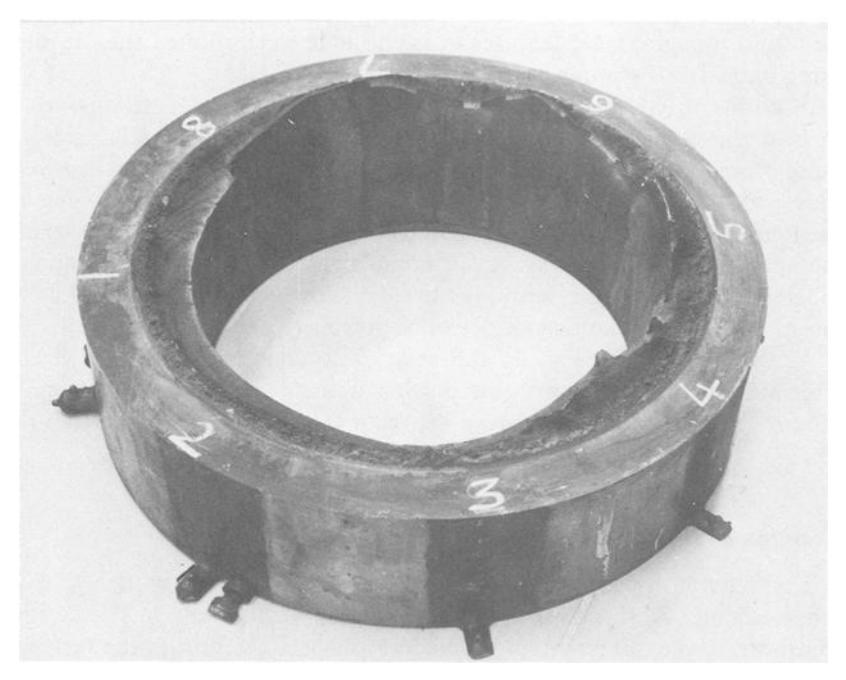
The general appearance of the fracture surface is shown in Fig. 3 and schematically, in Fig. 4. The numbers 1 to 8, which relate to the positions where strain measurements were made at inspections during the test, were used throughout the failure examination as reference positions.

**Region III**—Over the remainder of the failed ligament, the fracture also followed a 45-deg angle but was smooth and less darkened by oxidation. This type of fracture was particularly noticeable between Positions 8 through 1 to 4, where the surface also contained striation type markings as can be seen between Positions 8 and 1 in Fig. 3.

FIG. 3—General appearance of the failed ligament surface.  $\times 1/4$ .

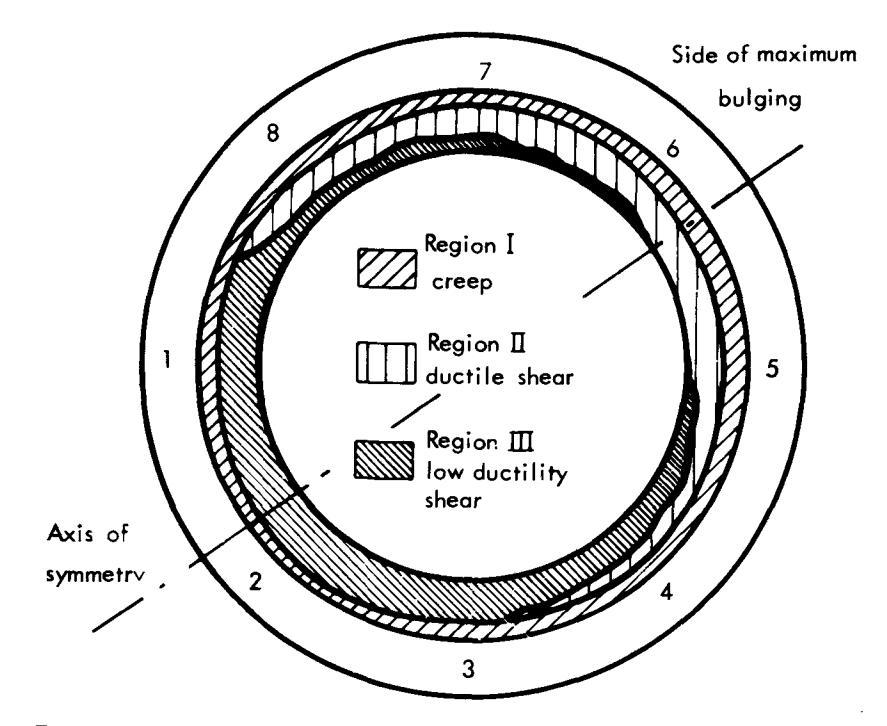
**Region** I—This was a region of oxidized crack growth, coplanar with the notch, extending in from the root, all around the circumference, and varying in depth from about 7 mm at Position 2 to 12 mm at Position 6 as shown in Fig. 4.

**Region II**—The fracture between Position 4 increasing to 8 inclined at a 45-deg angle and had a rough oxidized surface to within a few millimetres of the bore in most places. Between Positions 5 and 6 where bulging was a maximum, as indicated in Fig. 4, this type of fracture was continuous to the bore.

From the distribution of the three fracture regions in Fig. 4, it can be seen that there is a rough line of symmetry about the diameter through Positions 2 to 6. From this representation, the proportion of each region was determined using a QTM. Region I, oxidized crack growth extending from the notch, represented 39 percent of the failed ligament, Region II, the rough 45-deg fracture, 17 percent, with Region III, the smooth 45-deg fracture, accounting for the remaining 44 percent. The symmetry of fracture

FIG. 4—Schematic representation of the three regions of fracture across the failed ligament ahead of the 30-mm-deep notch.  $\times 1/4$ .

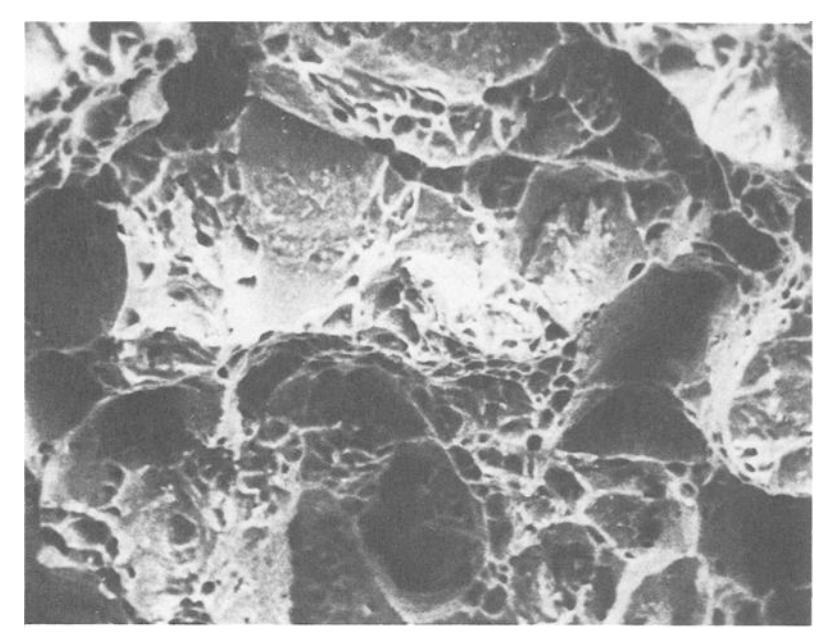
FIG. 5—SEM showing the intergranular creep fracture region immediately ahead of the 30-mm-deep notch.  $\times$  300.

The fractographic and metallographic analyses of the failure revealed that Region I consisted of grain boundary cavitation and intergranular cracking. This was also the only mode observed ahead of the three notches that did not fail. This is typical of intergranular creep fracture and indicates that the pressure vessel experiment has produced the features generally associated with high temperature plant failures, albeit in a normalized and tempered material.

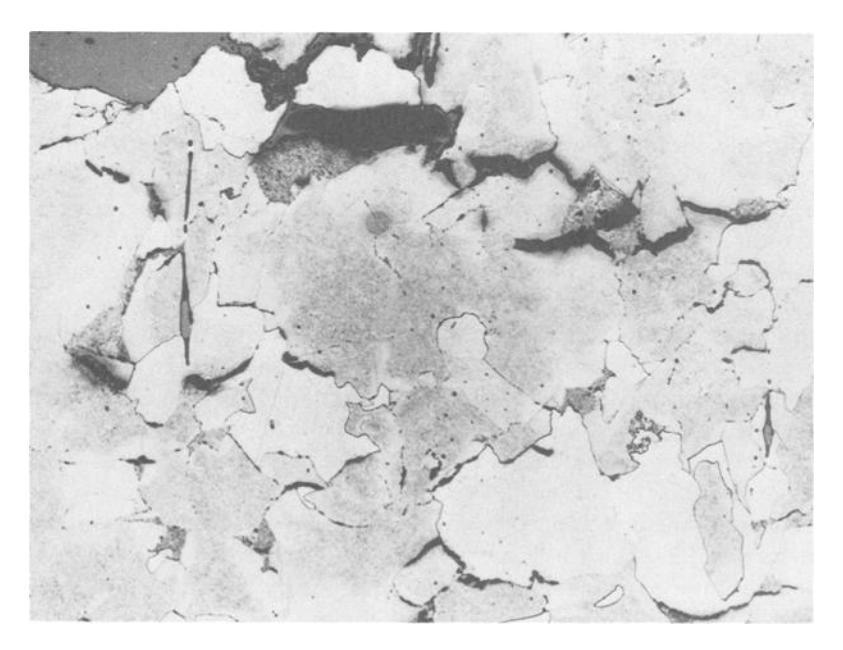
FIG. 6—Optical micrograph showing the grain boundary cavitation and cracking associated with the intergranular creep fracture.  $\times 200$ .

Metallographic examination of sections through the three circumferential notches that did not fracture completely revealed intergranular creep fracture similar to that shown in Fig. 6. The extent of the cracking increased from 2 mm for the 24-mm-deep notch to about 3.5 mm for the 28-mm-deep notch, and in all cases grain boundary cavitation and cracking was confined to within 3 mm of the crack path and tip. There was no evidence of any other mode of fracture and, outside the creep cracking regions, the parent material appeared to be unchanged from the as-received condition.

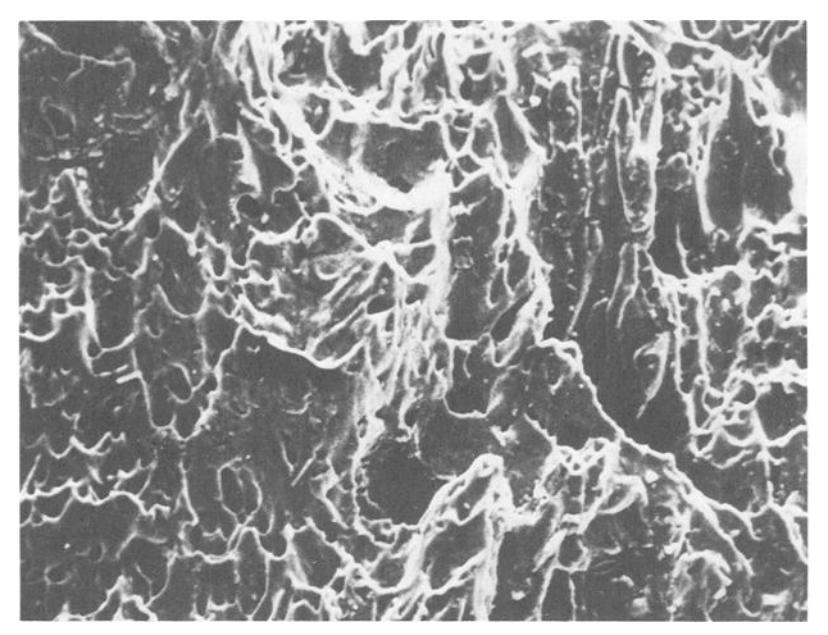
Regions II and III, both 45-deg fractures, exhibited considerable contrast in their fractographic and metallographic features. Region II, on the side of the vessel where bulging occurred, was a ductile shear fracture showing clear evidence of deformation with deep elongated dimples throughout the fracture surface. This is shown in Fig. 7 and is very similar to the appearance of a highly ductile high temperature tension test fracture surface. The microstructure in this area was heavily deformed, parallel to the longitudinal axis of the vessel, and it was apparent that crack propagation occurred in a ductile manner by necking down and linking between the many elongated voids, as shown in Fig. 8. At about Position 5, the ductile shear fracture extended fully to the bore and deformation was still apparent in the bore of the vessel some 30 mm below the fracture tip.

FIG. 7—SEM showing the 45-deg ductile shear fracture surface. ×300.

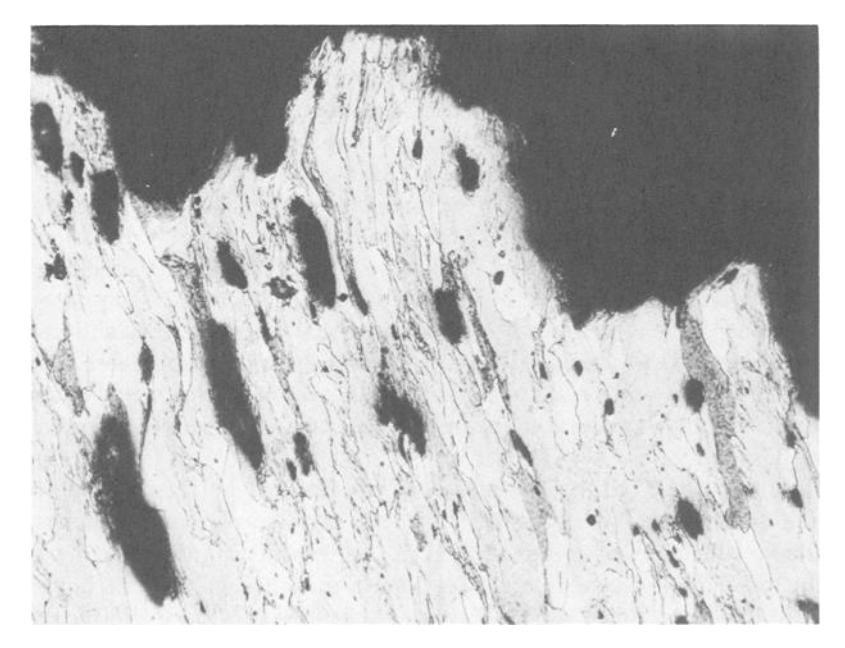
FIG. 8—Optical micrograph showing the heavily deformed microstructure and voids associated with the 45-deg ductile shear fracture.  $\times 200$ .

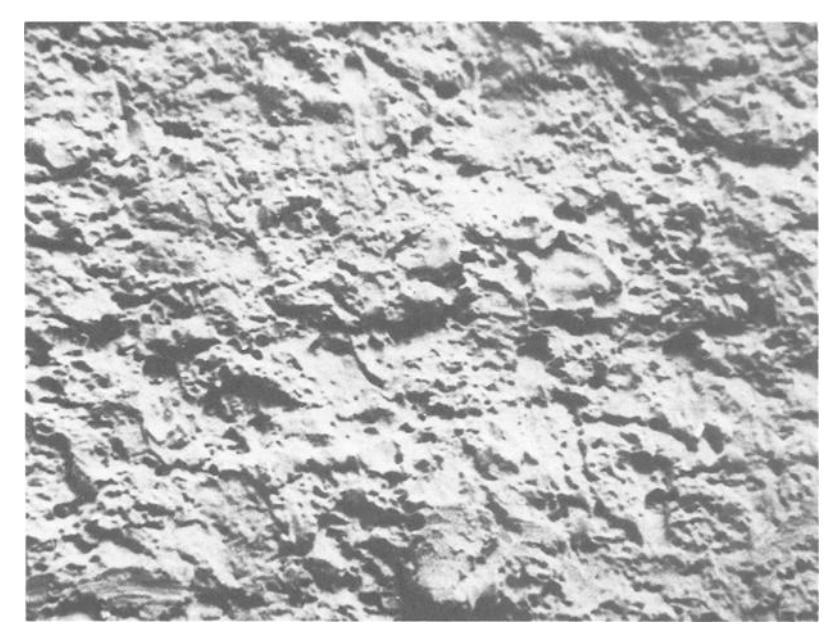
Region III, on the side of the vessel between Positions 8 through 1 to 4 where bulging was not apparent, was a remarkably featureless low ductility shear fracture, as shown in Fig. 9. The fracture surface in general was very flat and contained smooth areas free of detail as well as many shallow dimples that in most cases were less than 10  $\mu$ m in diameter. The striations on the fracture surface appeared as simple steps, and no fractographic features were observed to account for this phenomenon. The metallographic

FIG. 9-SEM showing the smooth 45-deg low ductility shear fracture surface. ×300.

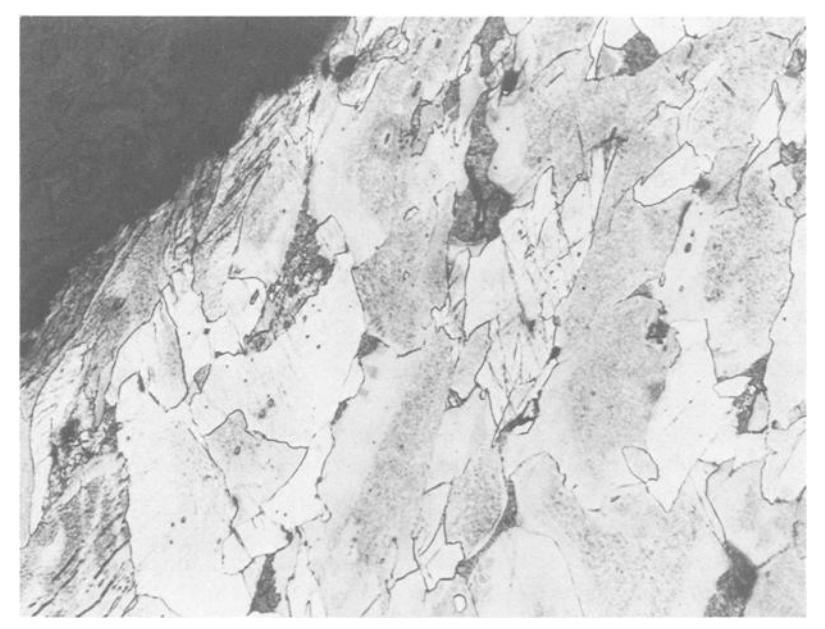
examination revealed a limited amount of deformation immediately adjacent to the fracture surface and to a much lesser extent in a layer about 300  $\mu$ m thick, where deformation appeared as slip bands across the ferrite grains, as shown in Fig. 10. Apart from this, the remainder of the material in the ligament appeared as in the as-received condition.

FIG. 10—Optical micrograph showing the limited deformation closely associated with the 45-deg low ductility shear fracture.  $\times 200$ .

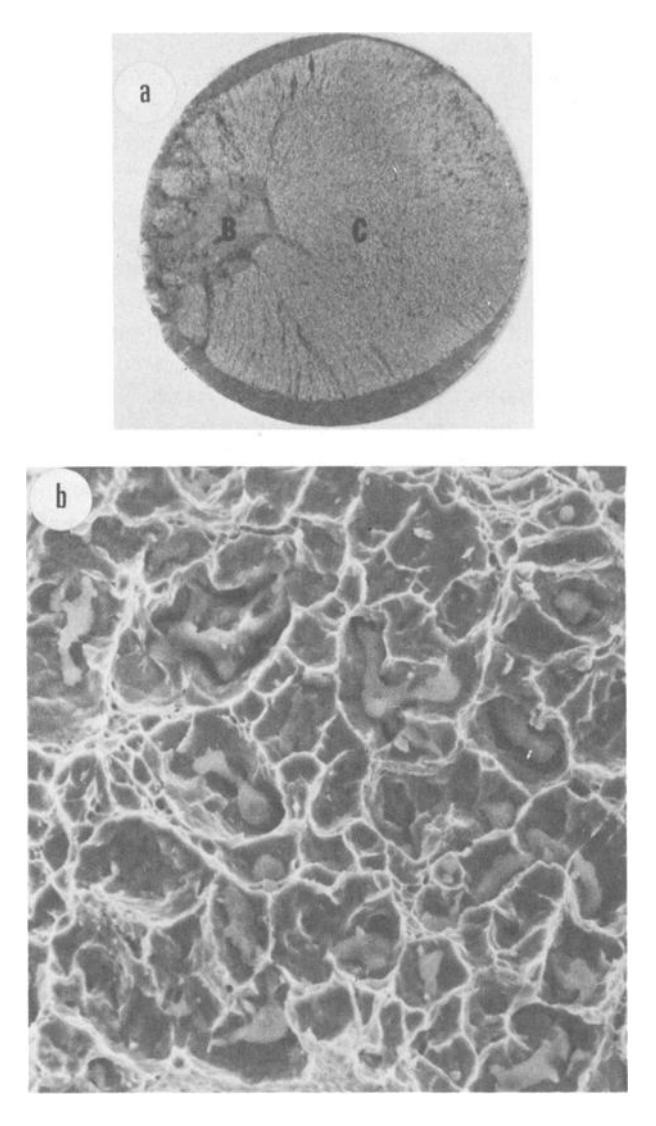
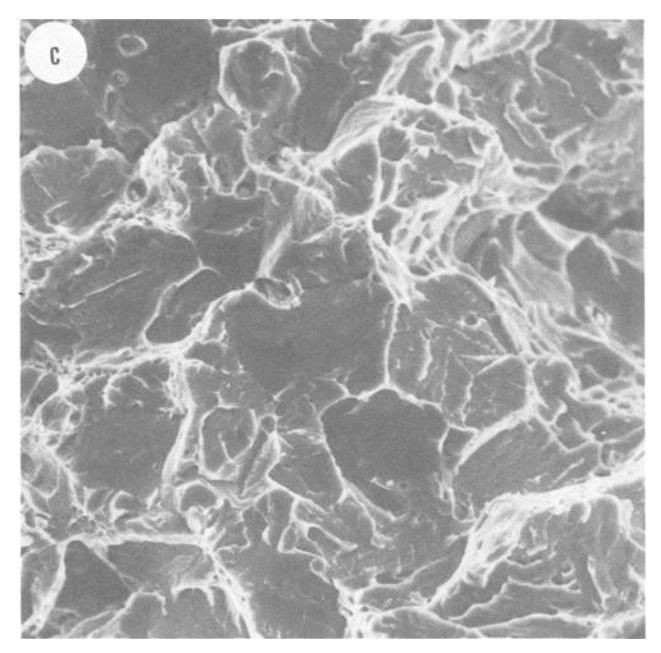
FIG. 9—Specimen Code 166A 25.4-mm (1-in.) Grade 80 chain. Fracture origin (B) exhibits large inclusions and dimple rupture, and the fracture propagated (C) in a cleavage mode. (a) Fracture surface of weld failure of broken link in full-size chain test,  $\times 2$ . (b) Scanning electron fractograph of fracture origin on broken link in full-size chain test,  $\times 1500$ . (c) Scanning electron fractograph of propagating fracture on broken link in full-size chain test,  $\times 1500$ .

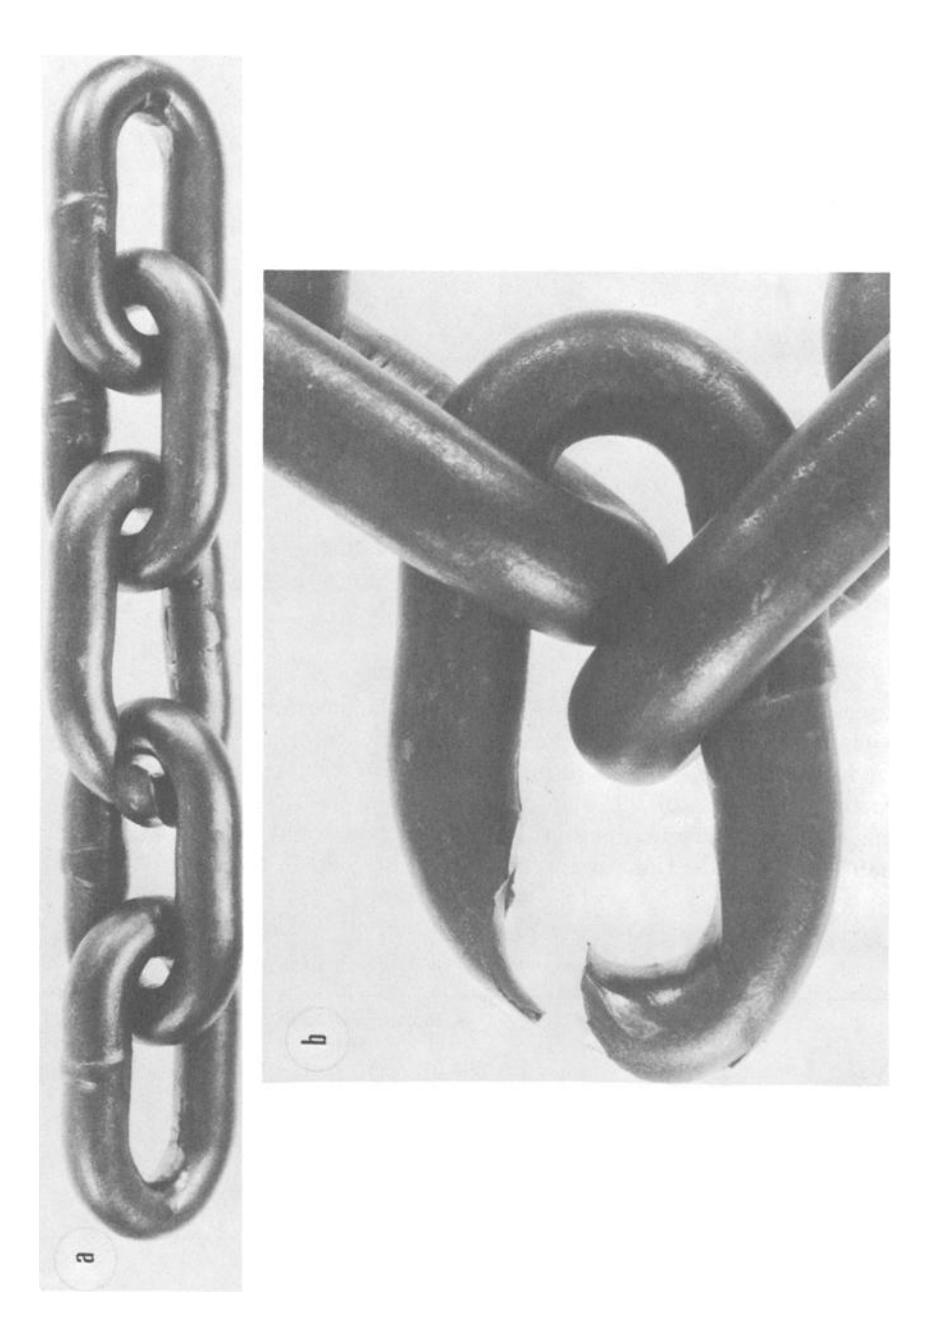
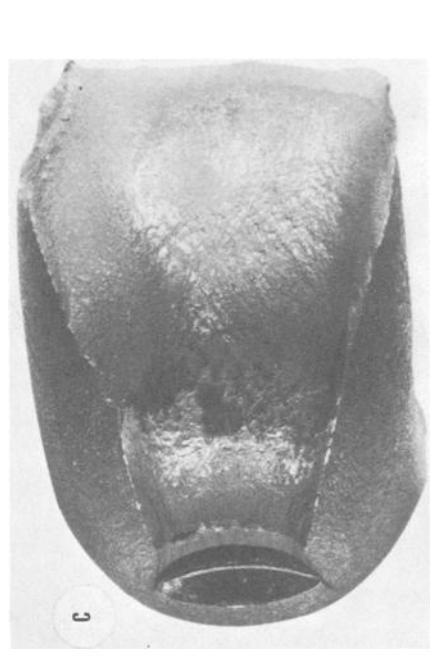
FIG. 10—Photographs of specimen Code 167B 25.4-mm (1-in.) Grade 63 chain. Fracture occurred through the machined notch with evidence of prefracture deformation. (a) Five-link full-size chain test, ×0.3. (b) Fractured link in full-size chain test, ×0.75. (c) Fractured surface showing machined flaw and ductile shear fracture, ×2.0.

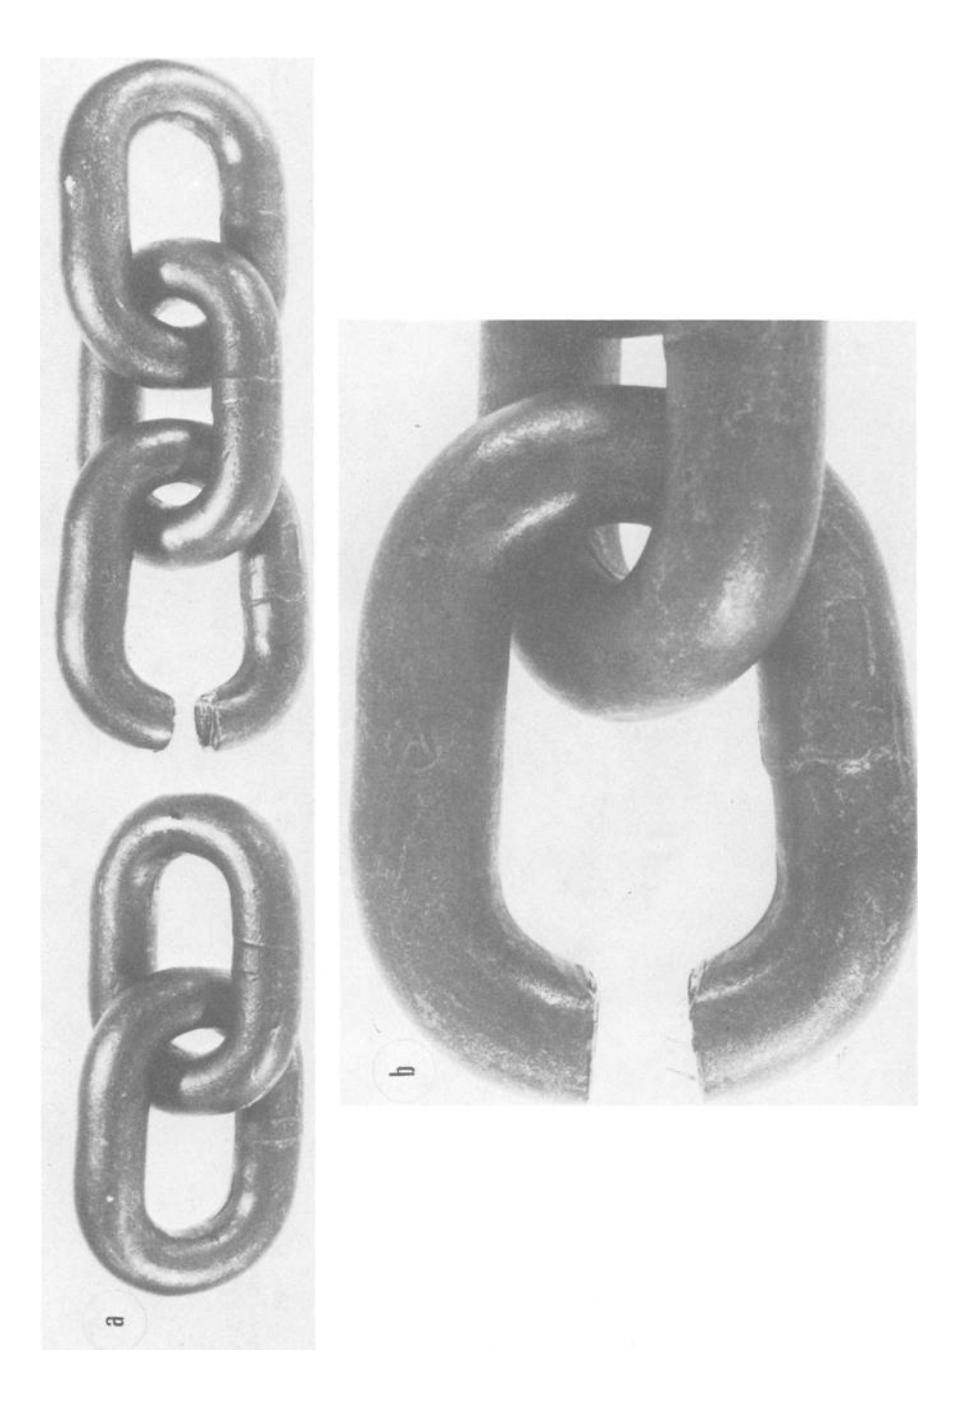
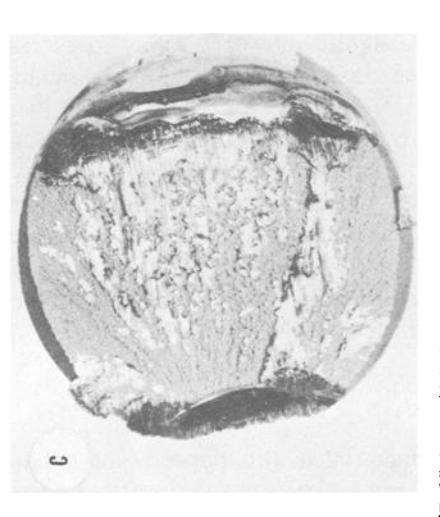
FIG. 11—Photographs of specimen Code 166B 25.4-mm (1-in.) Grade 80 chain. Fracture occurred through the machined notch with little evidence of prefracture deformation. (a) Five-link full-size chain test, ×0.75. (c) Fractured surface showing machined flaw and brittle (cleavage) fracture,  $\times 2.0$ . the toughness of the weld material appears to be the parameter that governs the susceptibility of chain to brittle fracture in service.
