Causation Factors for the Banjar Panji No. 1 Blowout

***Neal Adams Services
September 15, 2006
Jakarta, Indonesia***

RE: Report as Per Consulting Services Agreement
Causation Factors for the Banjar Panji No. 1 Blowout

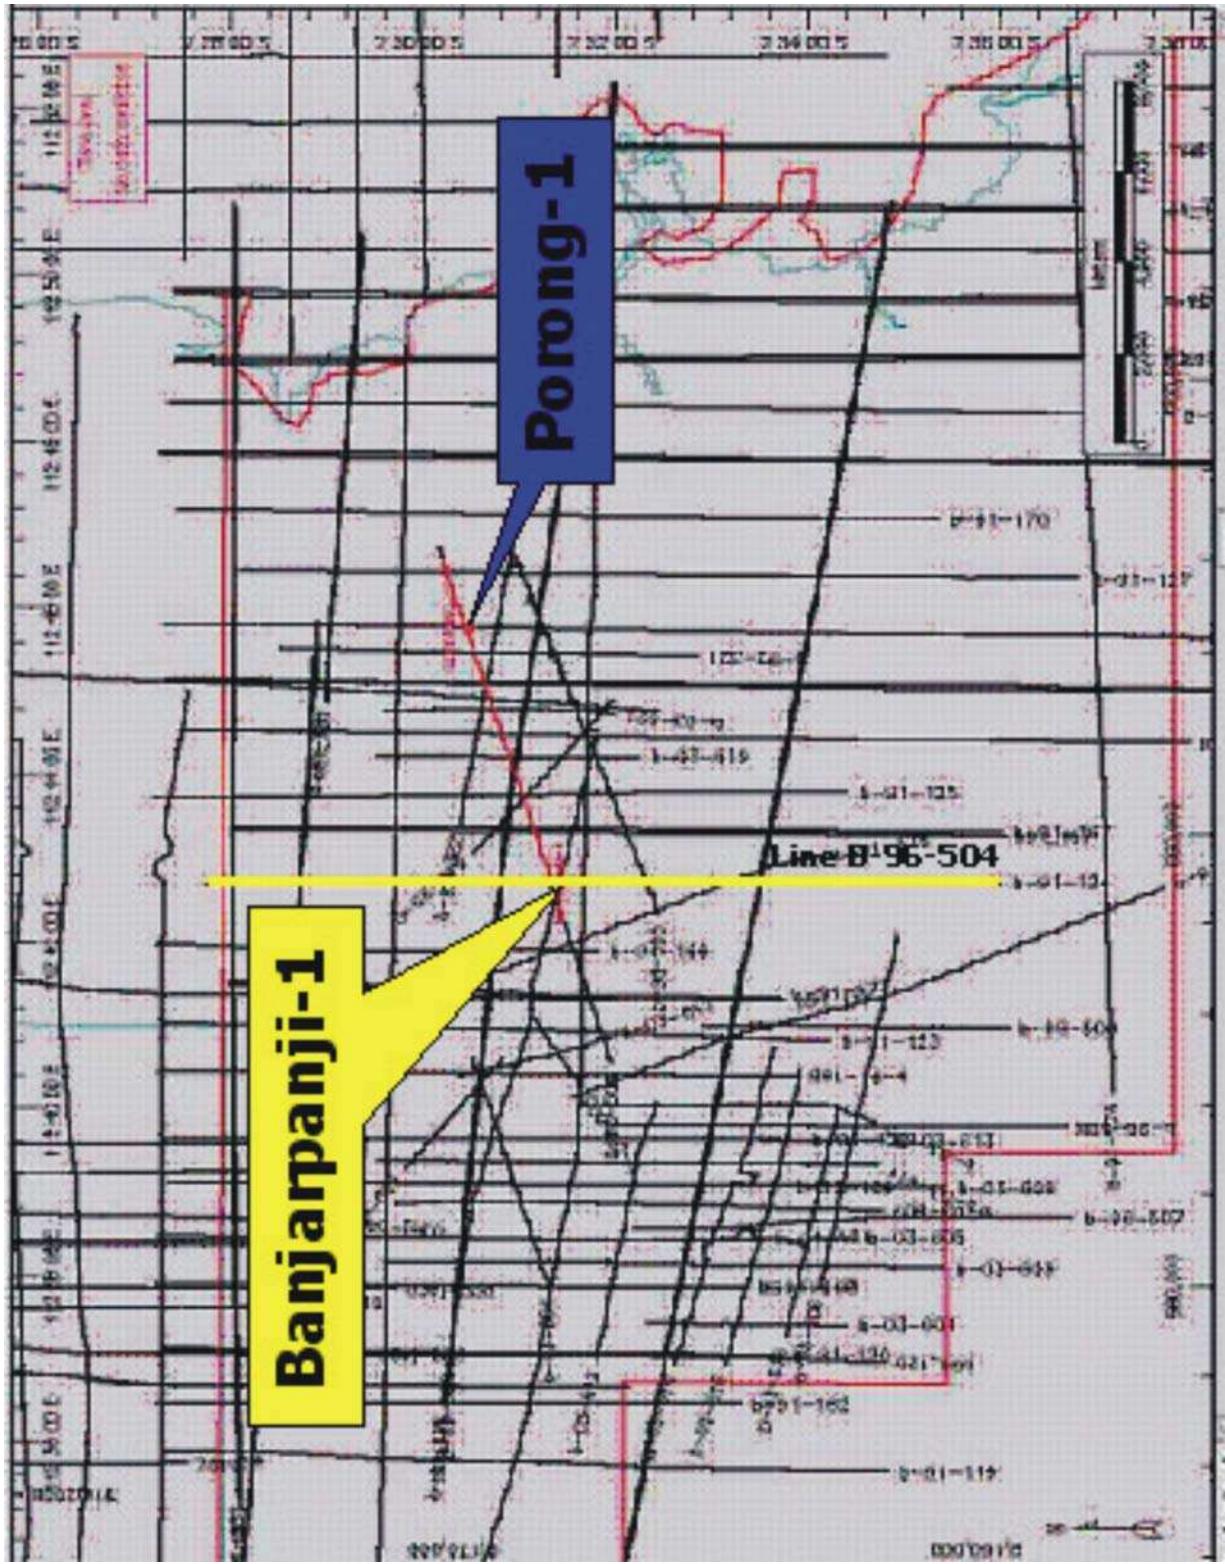
Figure 5.1 Shot Lines in the Brantas Block

A seismic survey and analysis was conducted over part of the Brantas Block at a prior time. Figure 5.1 shows the location of the seismic lines shot in the Banjar Panji – Porong area.

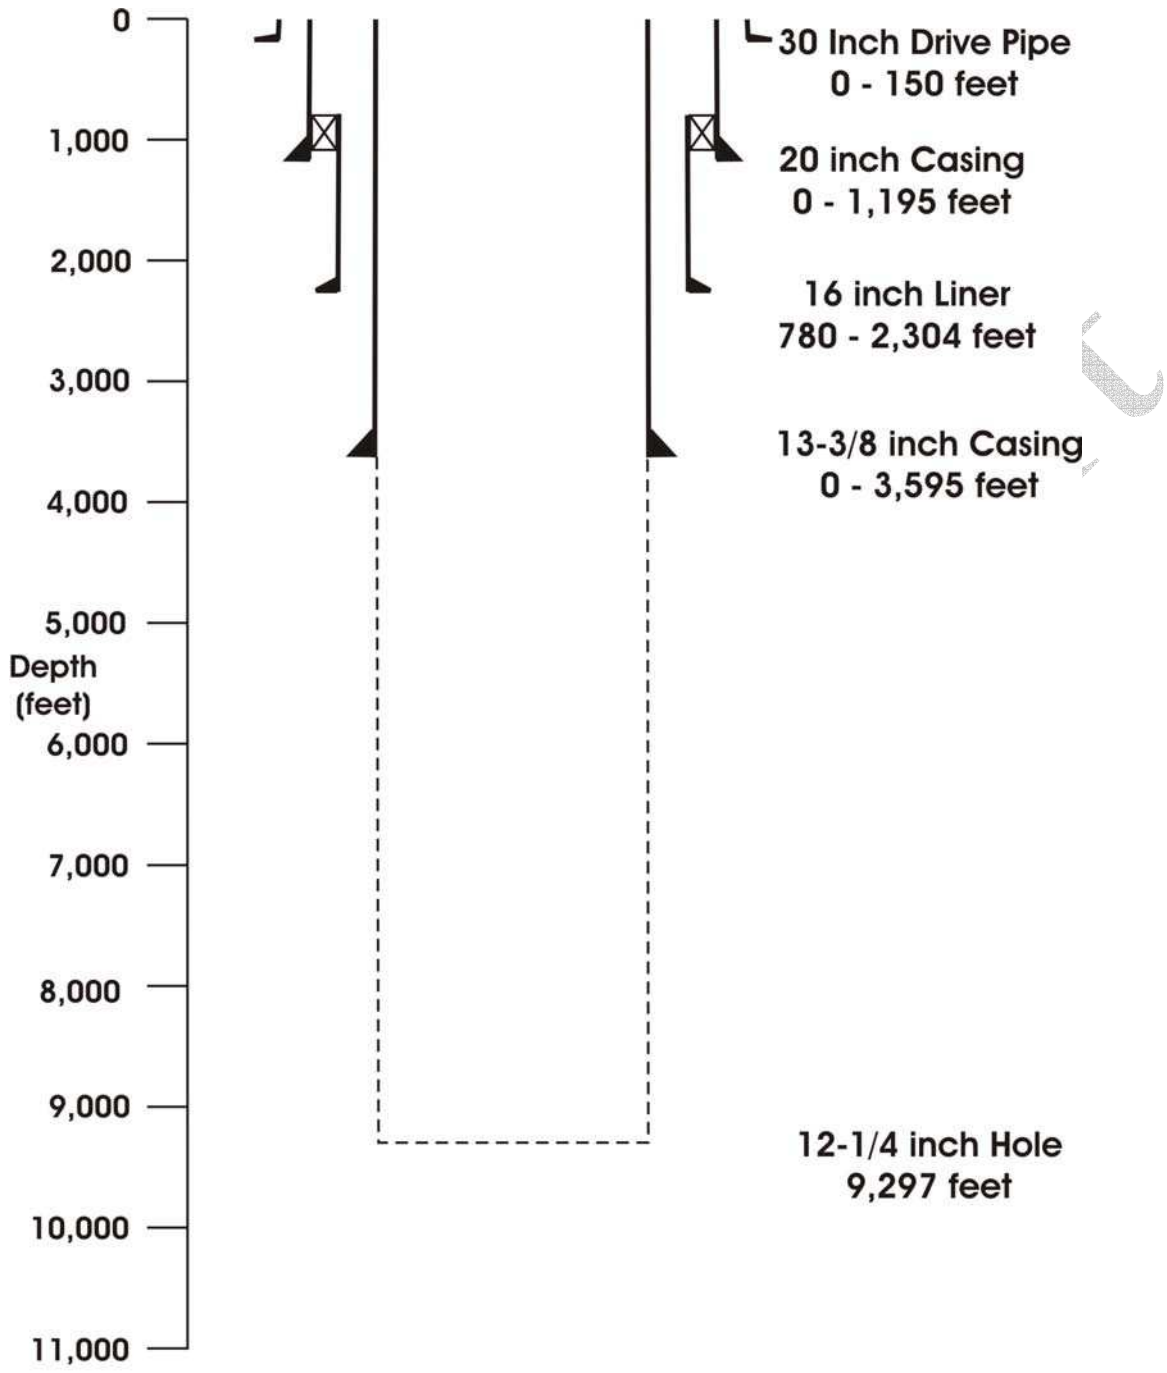
Figure 7.2 "As Drilled" Well Schematic

Figures 7.1 and 7.2 show the “As Planned Well Schematic and the “As Drilled Well Schematic”. (Figures shown at the end of Section 3.) Figure 7.2 can be used to note that the planned casing strings at 6,500 feet and at ~9,000 feet were not run. Running and cementing either or both pipe strings should have prevented the blowout.
