Advances in the Bonded Composite Repair of Metallic Aircraft Structure

VOLUME 2

Chapter 19. Bonded Repair of Acoustic Fatigue Cracking 531

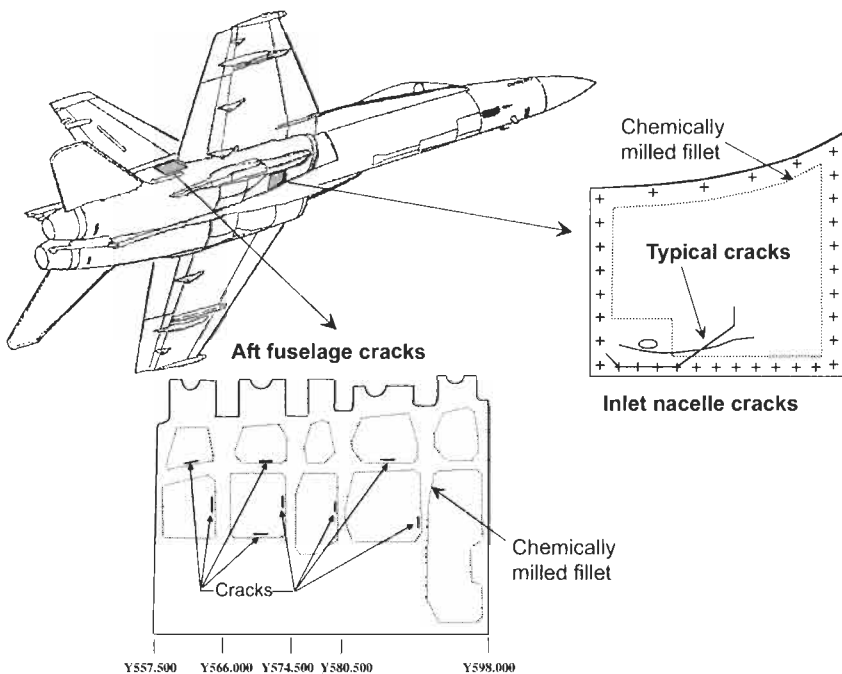
Fig. 19.1. Location of the cracking in the lower nacelle inlet and the aft fuselage skins. (Chemically milled fillets are indicated by dotted line.).

Acoustic fatigue is due to a very high intensity excitation as a result of pressure waves caused by either engine or aerodynamic effects. Acoustically-induced cracking has occurred on the external surface of the lower nacelle and aft fuselage skins on the F/A-18, as illustrated in Figure 19.1. In the former region, overall sound pressure levels greater than 170 dB have been measured in flight [1]. These high sound pressure levels appear to be a result of an aerodynamic disturbance at the inlet lip [1]. Typical cracks occur along a line of rivets or run parallel to the rivet line and may turn into the centre of the panel, as shown in Figure 19.1. Cracking generally occurs along the longer side of the panel where the bending stresses due to out-of-plane vibrations are a maximum. Up to a third of the F/A-18's in the RAAF fleet are affected by these cracks.

The chemically milled steps for panels in the aft fuselage are shown dotted in Figure 19.1. Cracks occur in the chemically milled step region, and are generally parallel to the longest side and midway along the side. The aft fuselage section shown in Figure 19.1 contains a composite of all known cracking locations which occur between fuselage stations Y557.500 and Y598.000. The conventional repair involves removal of the crack and use of a metallic doubler attached by mechanical fasteners. To carry out this type of repair the engine needs to be removed.

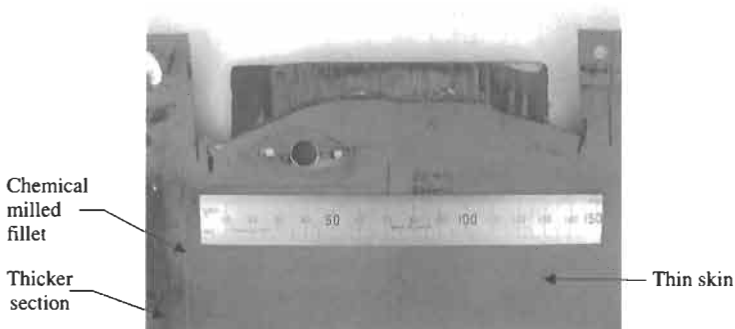
Fig. 19.2. Interior view of cracked panel with boron/epoxy repair [8].

As a result of the failure of the boron/epoxy repair to prevent crack growth, the particular panel was removed from the aircraft for replacement and assessment, [8], of the fracture surface. The inside surface of a section of the cracked panel is shown in Figure 19.2, and the missing section was that used for the examination. It was found that the crack had started on the inside of the thicker section, and developed as a semi-elliptical surface crack, as indicated in Figure 19.3, until it became deep enough to penetrate the thickness of the panel. The crack proceeded as a through crack, with crack fronts being inclined as shown in Figures 19.4 and 19.5 corresponding to a final crack length of 135 mm. The central region of the crack just before the boron/epoxy repair was applied is shown in Figure 19.6 and indicates rubbing of the crack faces due to transverse movement. This would

Both the length of the crack tip after the repair and flight hours are known for the right hand crack tip shown in Figure 19.2, and is 2 mm/flight hour. While the crack growth rate before the repair is unknown it is thought to be considerably less than that after the repair. There is a possibility that before the repair, the rubbing of the crack faces provided some friction damping to the panel, this in turn led to a lower crack growth rate.

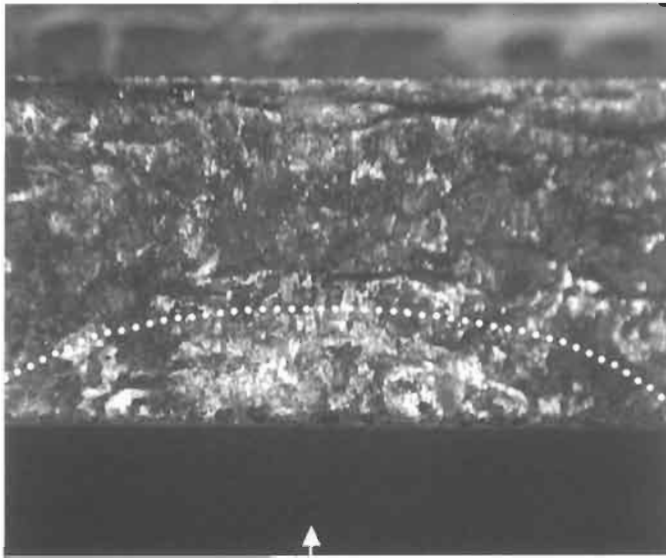
Fig. 19.3. The origin of the crack in the panel (arrowed). The remains of the semi-elliptical surface crack can be seen just below the dotted line. This crack was located on the inside surface of the thicker section of panel. Note the smooth rubbed character of the surface, indicating large relative motions between the two halves of the crack [8].

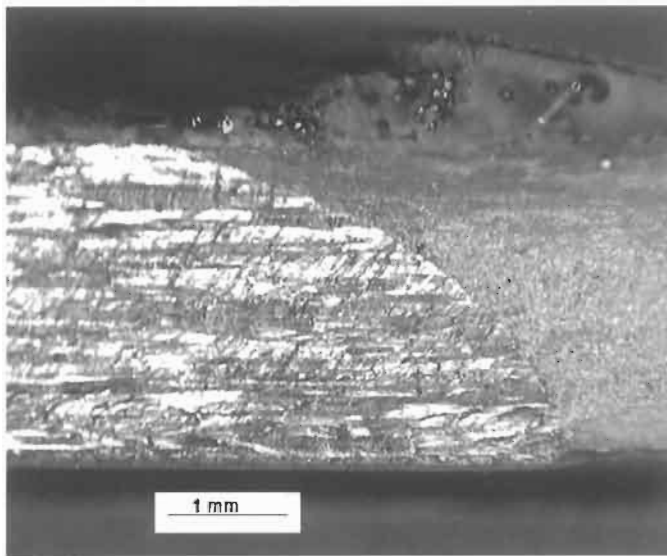
Fig. 19.4. View of the tip of the crack in the thick end of the panel. The fatigue crack surface is the bright faceted region to the left and the deliberately broken surface is the mottled grey area to the right. Note the shape of the crack, much longer along the inside surface of the panel, indicating that a degree of bending was involved in the development of the crack. Also note that the fatigue crack surface is bright and highly detailed, and does not appear to have been rubbing [8].

correspond to a mode III crack tip driving force. However after the patch was applied a change in crack growth mode occurred. This is seen in Figures 19.4 and 19.5 where the crack is bright and highly detailed in comparison to that shown in Figure 19.6. After the repair the shape of the crack front indicates that bending was involved. This is consistent with a neutral axis offset caused by the bending of both the boron/epoxy and panel in which the maximum stress occurred in the inner surface of the panel.

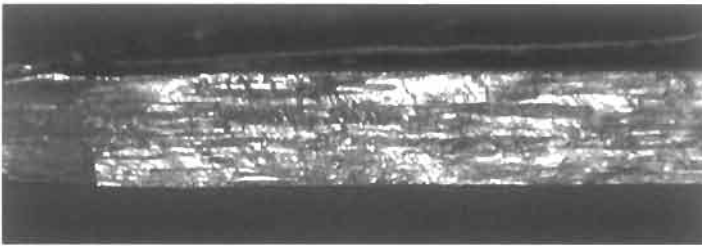
Fig. 19.5. View of the tip of the crack in the thinner part of the panel. The same comments as above for Fig. 19.4 apply here [8].

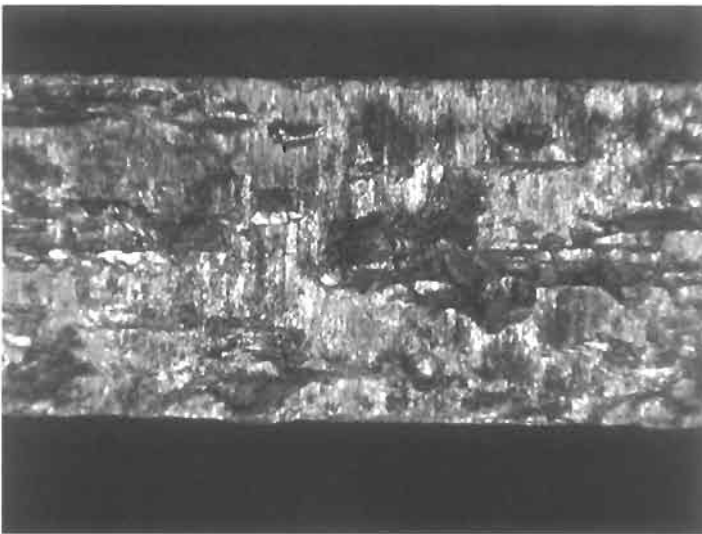
Fig. 19.6. View of the central area of the crack, showing the presence of pronounced rubbing [8].

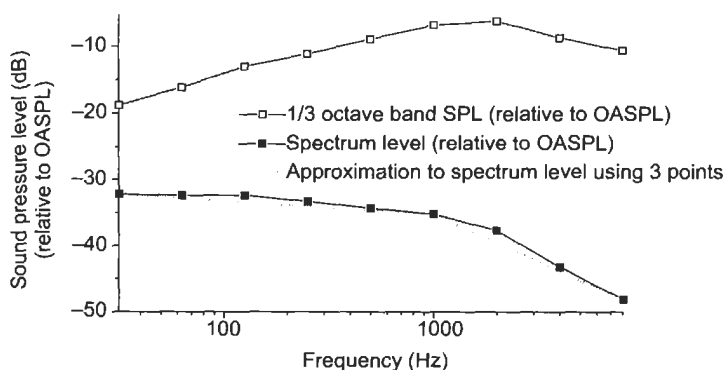
Fig. 19.7. Spectrum and one-third octave band levels of sound pressure over the external nacelle inlet, (where OASPL = 172.2 dB), [1].

One third octave sound pressure measurements have been made in flight [1], using microphones located at the nacelle inlet area, and are plotted in Figure 19.7. The spectrum level, relative to the overall sound pressure level (OASPL), is derived from this data and is also shown in Figure 19.7. In this case the higher than expected sound pressure levels (SPL) were caused by an aerodynamic disturbance at the inlet lip. At present no data exists for the calculation of SPL's in the aft fuselage.

Since the cracking on the inlet nacelle preceded that in the aft fuselage then it is conservative to assume the same PSD, as shown in Figure 19.7. This is greater than the design value of the OASPL of 160 dB for the airframe [1]. Premature acoustic fatigue cracking in the aft fuselage suggests that an additional aerodynamic

The spectrum curve in Figure 19.7 has been approximated with the three points listed in Table 19.1.

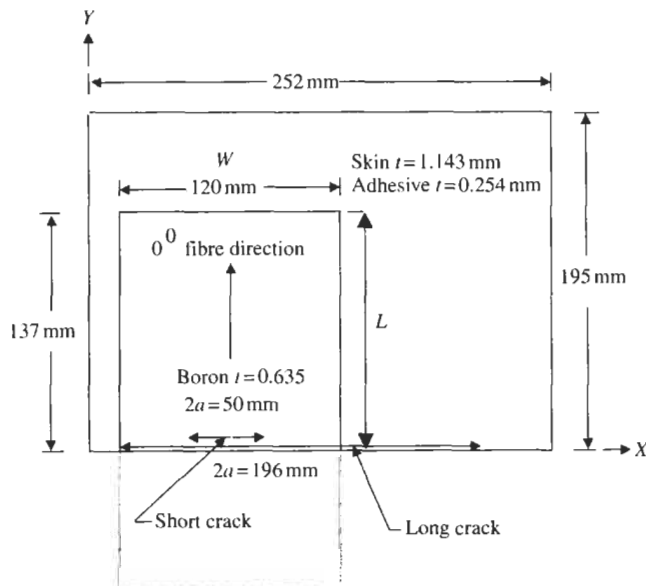
Fig. 19.8. Dimensions of simplified F/A-18 nacelle inlet panel, with crack and patch.

The boundary conditions for this model are considered to be fully clamped except for the crack region which is not restrained. The patch above the crack also remains fully constrained. Clearly crack closure will occur at an increasing distance away from the crack tip, however the complexity in introducing such constraints has not been included in this preliminary study. The crack is initially 50 mm long with it's centre located within the patch. A number of crack lengths have been

the mode shapes of a repaired panel where the long, 196 mm, crack now extends outside the patch (see Figure 19.8). These mode shapes indicate that the unsupported crack tip behaviour will now have significant contributions from mode III stress intensity factor, K_{III} .

It has been established that, Section 19.6.1, the stress intensity in the cracked (un-repaired) plate is as shown in Figure 19.12. Here the right hand crack tip refers to the crack tip located midway along the plate shown in Figure 19.8. The higher stress intensity for the right hand crack tip is due to the larger dynamic bending stresses that occur midway along the panel. For a crack length of 80 mm $K_I = 15 \text{ MPa m}^{1/2}$. Although this is not a high value in comparison with the fracture toughness value, K_{IC} , in an environment of high-cycle fatigue it leads to a high crack growth rate.

The geometry of the structure is shown in Figure 19.8. The mesh size of the skin and viscoelastic structure is 75×60 elements. As shown, the unidirectional boron/epoxy reinforcing patch only extends partially across the panel. It also covers an adjacent panel as shown in the dotted outline. The boron/epoxy repair has length, L , and width, W . In this section the length is fixed at 77 mm, however three widths are considered, viz. 80 mm, 99 mm and 126 mm. The entire panel is covered with the CLD material. Material properties for the skin, adhesive, VEM and boron are shown in Table 19.3.

Stress intensity factors are computed at the inside and outer surfaces of the skin. Since the repair results in a neutral axis shift the maximum values exist at the inner surface. The most critical crack tip position is the tip located midway down the longest side of the panel, as shown in Figure 19.8. The maximum values have been plotted in Figures 19.22–19.25. Various highly-damped patch configurations, involving 0.5, 1.0 and 2.0 mm thick damping VEM, are considered. In all cases the highly-damped patch has a boron/epoxy reinforcement/repair with dimensions 77 mm long and varying widths of 80 mm, 99 mm and 126 mm. Overall the highly damped repairs show a significant reduction in $(K_I)_{rms}$ compared to the low damped repair case. Introducing damping reduces the mode I stress intensity by about a factor of 10. Over the range of damping thickness considered the configuration that give the lowest values of $(K_I)_{rms}$ is for the 77 mm long by 126 mm wide reinforcement/repair with the 1.0 mm thick VEM and [0/90] constraining layer case. Also, the 0.5 mm thick VEM with [0/90] constraining layer case gave similar stress intensities as shown in Figure 19.23.

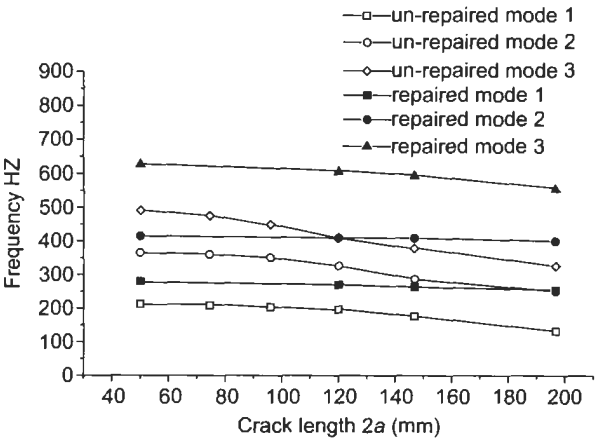
Fig. 19.9. Frequency versus crack length for un-repaired and repaired cases.

Figure 19.9 illustrates the variation of natural frequencies with increasing crack length for the cracked un-repaired panel and also the cracked repaired panel for the first 3 resonant modes. In the case of the cracked un-repaired structure, increasing the crack length significantly reduces the resonant frequencies of the panel. Also as expected, repaired panels have little variation in natural frequencies with crack length. Furthermore, the repaired panels have substantially higher natural frequencies for all modes than the un-repaired panels. The results indicate that the boron repair has a definite influence on the panel stiffness.

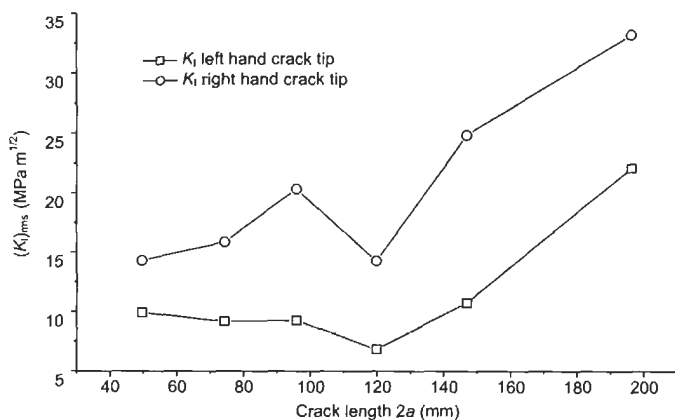
Fig. 19.12. Stress intensity factor $(K_I)_{rms}$ in un-repaired panel for left and right hand crack tips.

The modal analysis indicates that all the mode I, II and III stress intensity factors will be significant. The rms mode I stress intensity factor $(K_I)_{rms}$ for the cracked un-repaired panel is shown in Figure 19.12. As expected, the general response is an increase of $(K_I)_{rms}$ with crack length. The left hand crack tip is always closer to the clamped edge of the panel than the right hand crack tip, and since the bending stresses are a maximum midway along the boundary, the right hand tip gives the highest value of $(K_I)_{rms}$. The values of $(K_I)_{rms}$ in relation to the fracture toughness, are significant and explain crack growth. For crack growth, threshold values of $(K_I)_{rms}$ are shown in Figure 19.26.

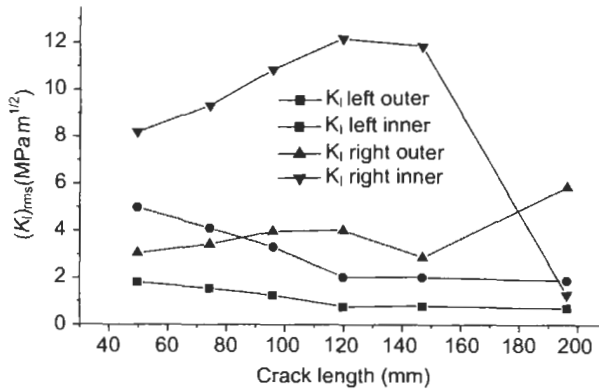
Fig. 19.13. Stress intensity factor $(K_I)_{rms}$ in repaired panel. (Note the change in scale compared to Fig. 19.12.)

In the repaired panel the neutral axis is offset and as a result $(K_I)_{rms}$ is evaluated at both inner and outer surfaces of the skin; the repair being applied to the outer surface. Being a one sided repair the repair is more effective on the outer surface which is more closely restrained [12]. These bending effects are clearly shown in Figure 19.13. The right hand crack results in the highest values for $(K_I)_{rms}$ located on the inner surface. These values of $(K_I)_{rms}$ are significantly high before the crack grows out from under the patch and explain continued crack growth. For a normal "static" repair in which the only significant events are manoeuvre and gust loads, the repair would be successful. However, in the acoustic excitation environment, the resonant frequency of the actual nacelle panel is of the order of 300–400 Hz thus causing the repair to be ineffective.

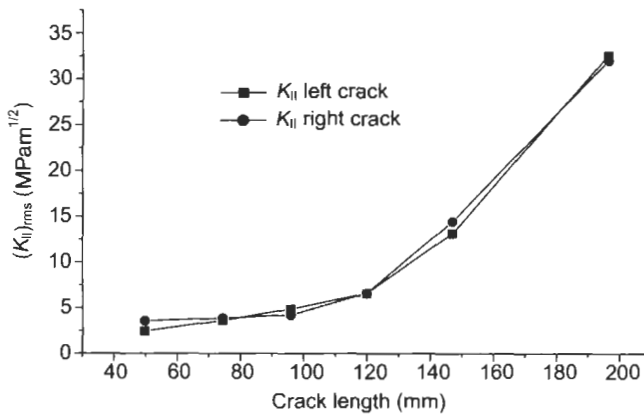
Fig. 19.14. Stress intensity factor $(K_{II})_{rms}$ for un-repaired panel.

The rms mode II stress intensity factor, $(K_{II})_{rms}$ for the cracked un-repaired panel is shown in Figure 19.14. Little through thickness variation of $(K_{II})_{rms}$ has been found, hence only one value is presented for each crack tip. Numerical values are similar to $(K_I)_{rms}$ and the existence of $(K_{II})_{rms}$ explains the tendency of long cracks to turn into the centre of the panel. For the case of the repaired panel shown in

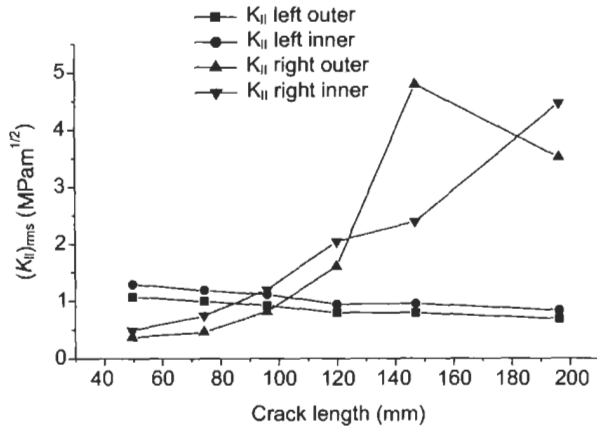
Fig. 19.15. Stress intensity factor $(K_{II})_{rms}$ for repaired panel.

Figure 19.15, $(K_{II})_{rms}$ has been substantially reduced. Note that when the right hand crack tip grows out from under the repair, the value for $(K_{II})_{rms}$ for the right hand outer crack tip exceeds the value for the right hand inner crack tip. This is due to the transverse bending of the higher order vibration modes that can only occur when the crack-length exceeds the width of the patch illustrated in Figure 19.11. Also it would be expected that the right hand inner and outer values would converge approaching the right hand boundary. The transverse bending is also shown by the values of $(K_{III})_{rms}$ in this region, Figure 19.17.

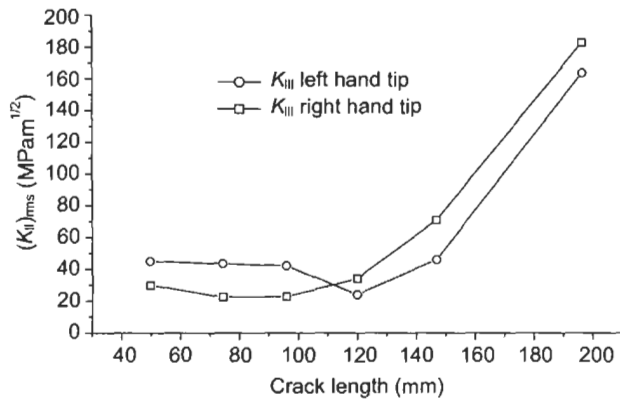
Fig. 19.16. Stress intensity factor $(K_{III})_{rms}$ for un-repaired panel.

The rms of the mode III stress intensity factor $(K_{III})_{rms}$ for the cracked un-repaired panel is shown in Figure 19.16. The values of $(K_{III})_{rms}$ increase significantly with crack length for both left and right hand crack tips, and the

numerical value of $(K_{III})_{rms}$ is greater than $(K_I)_{rms}$. Clearly $(K_{III})_{rms}$ will contribute significantly to crack growth. In the case of the repaired panel, shown in Figure 19.17, the values of $(K_{III})_{rms}$ for a crack tip under the patch are low, but not zero. However, once the crack grows outside the patch (i.e. for crack lengths > 120 mm) $(K_{III})_{rms}$ increases significantly.

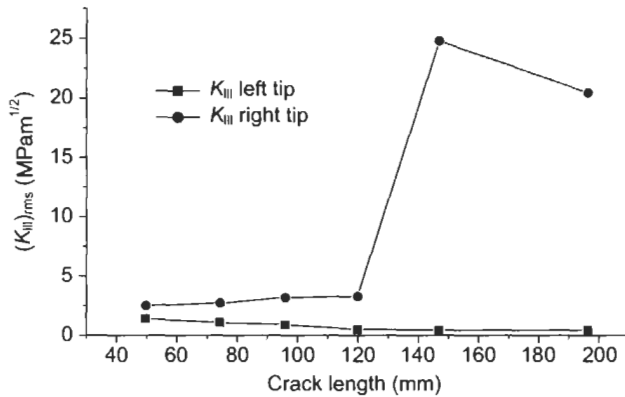
Fig. 19.17. Stress intensity factor $(K_{III})_{rms}$ for repaired panel. (Note change in scale compared to Fig. 19.16).

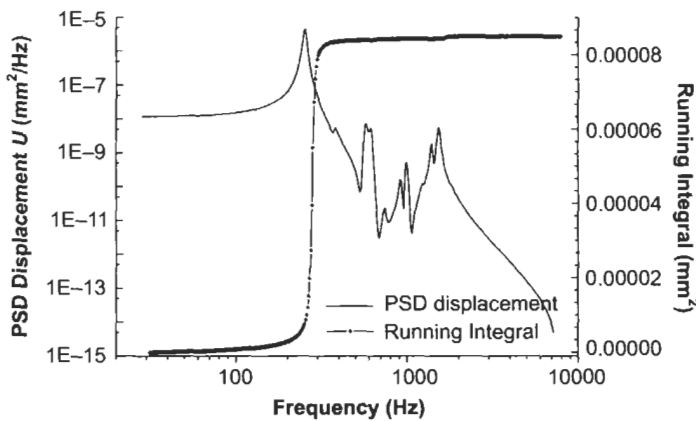
Fig. 19.18. PSD of displacement u ($\propto (K_I)_{rms}$) and running integral of the PSD for repaired panel of crack length $2a = 50$ mm.

The PSD of the displacement response, u , behind the right hand crack-tip is shown in Figure 19.18. Equation (19.3) implies that the u displacement behind the crack-tip is proportional to $(K_I)_{rms}$. Similarly the displacement response for w is proportional to $(K_{III})_{rms}$. Therefore the PSD shown in Figure 19.18 indicates the relative response of K with increasing frequency. Although not shown the PSD has been computed for the two different crack lengths for both un-repaired and repaired cases.

Figure 19.18 shows the PSD for the case of a repaired panel with $2a = 50$ mm. In this case each peak will correspond to the resonant frequencies illustrated in Figure 19.10. For example the fundamental resonant mode occurs at a frequency of 280 Hz in Figure 19.10 which corresponds to the maximum response in Figure 19.18. Absence of peaks at certain resonances, e.g. Mode 2 at 414.5 Hz, indicates that the crack tip is located at or near the nodal line of the corresponding mode shape. A running integral of the PSD response will indicate the relative contribution of each of the modes to the overall K_{rms} and is also shown in Figure 19.18. This shows that 98% of the overall $(K_I)_{rms}$ is due to the first mode.

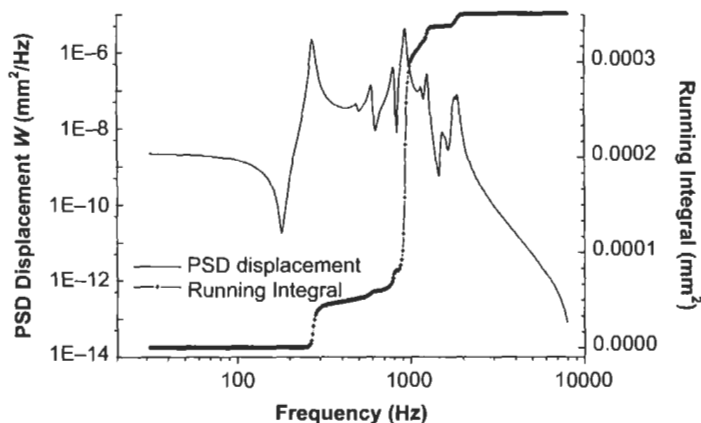
Fig. 19.19. PSD of displacement $w(\alpha(K_{III})_{rms})$ and running integral of the PSD for repaired panel of crack length $2a = 196$ mm.

In all other cases, with one exception, mode 1 makes the major contribution to the overall $(K_I)_{rms}$ or $(K_{III})_{rms}$ response. The exception is shown in Figure 19.19 for

a repaired panel with a crack length of 196 mm and shows that mode 6 makes the major contribution to the overall $(K_{III})_{rms}$ response.

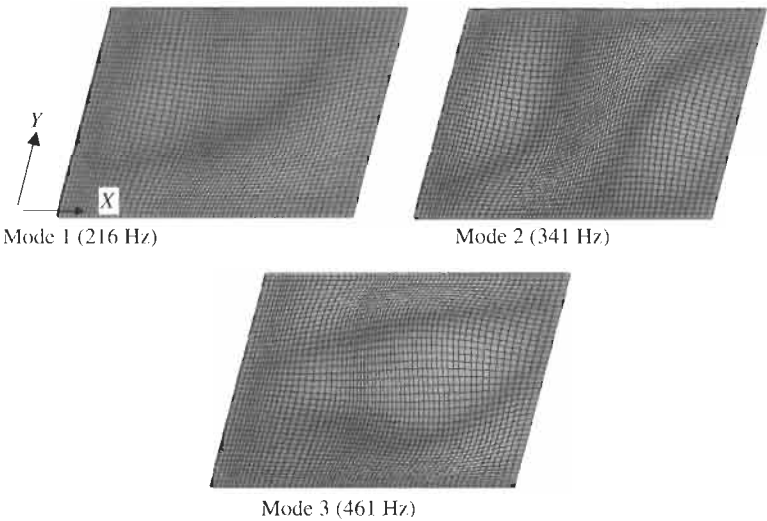
Fig. 19.20. Mode shapes for cracked panel with highly damped repair ($w = 126$ mm, $t_{\text{vem}} = 1.0$ mm and [0/90] boron/epoxy constraining layer).

As previously mentioned, one of the main concerns regarding a particular repair is the change of frequency of the plate to the excitation frequencies. The first three frequencies of the original uncracked un-repaired plate are shown in Table 19.6. For a highly-damped patch consisting of a 1.0 mm thick damping layer with a [0/90] boron/epoxy constraining layer the variation of resonant frequencies with increasing patch width (W) is shown in Table 19.7. The reinforcing patch length (L) is 77 mm. In all cases the addition of the highly-damped patch configuration resulted in a reduction of frequency. The resonant frequency increases by 5%, 10% and 13% for vibration modes 1, 2 and 3, respectively, when the patch width increased from 80 to 126 mm. Typical modes of vibration predicted by the F.E.A. are shown in Figure 19.20. The resonant frequencies for a 2.0 mm thick damping

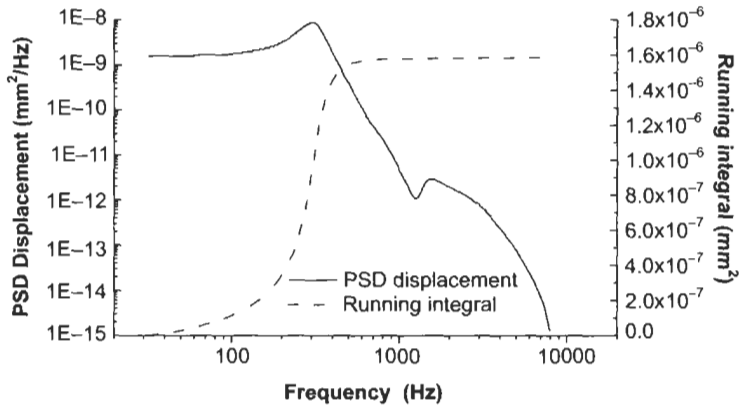
Fig. 19.21. PSD of displacement $u(x) (K_I)_{rms}$ and running integral of the PSD for a cracked panel with a 1.0 mm thick damping layer with [0/90] boron/epoxy constraining layer and an 80 mm wide by 77 mm long boron/epoxy reinforcement.

Since the area under the displacement PSD curve is the mean square displacement response, then a running integral of the displacement PSD illustrates the contribution of each vibration mode to the overall displacement response, as shown in Figure 19.21. Since the stress intensity is proportional to the crack opening displacement, then a running integral of the displacement response will indicate the contribution of each vibration mode to the overall stress intensity. Figure 19.21 shows the PSD displacement response at the right hand (inner side) crack for the case of a 1.0 mm thick damping layer with [0/90] boron/epoxy

constraining layer and a 80 mm wide by 77 mm long boron/epoxy patch. This figure shows that vibration mode 1 contributes up to 99% of the overall stress intensity $(K_I)_{rms}$. Similar results were found for all the other highly damped repair configurations investigated.

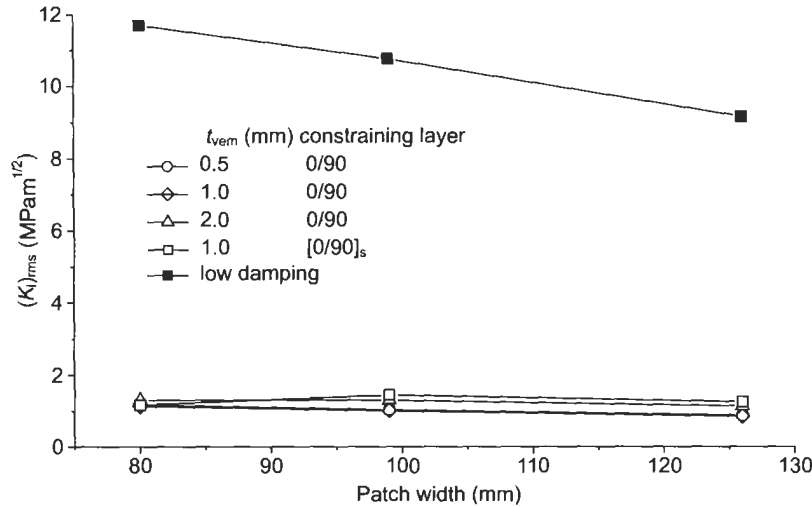
Fig. 19.22. Stress intensity factor, $(K_I)_{rms}$, for various highly-damped and low damped patch configurations.

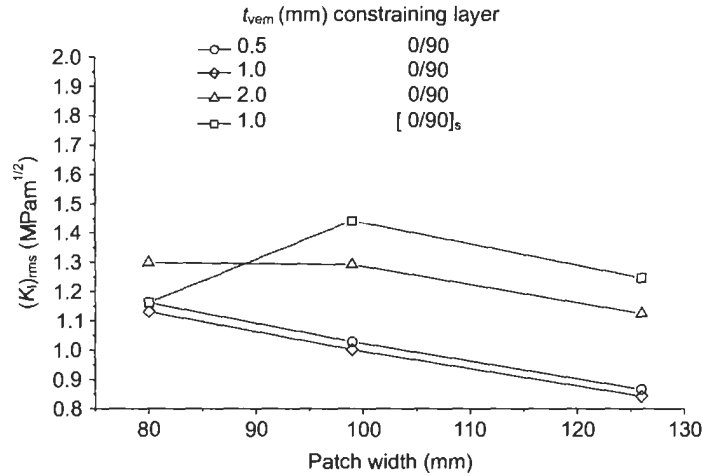
Fig. 19.23. Stress intensity factor, $(K_I)_{rms}$, for various highly-damped patch configurations.

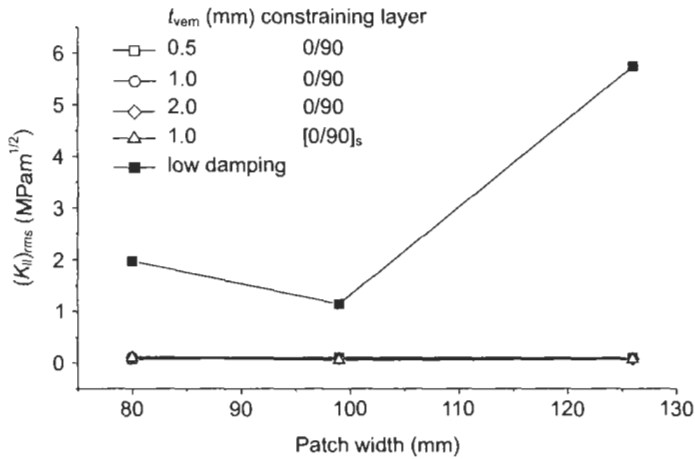
Fig. 19.24. Stress intensity factor, $(K_{II})_{rms}$, for various highly-damped and low damped patch configurations.

Although no crack growth data corresponding to $(K_{II})_{rms}$ or $(K_{III})_{rms}$ stress intensities are available, the numerical values of $(K_{II})_{rms}$ are lower than those for $(K_I)_{rms}$, as shown in Figure 19.24. Also, the numerical values for $(K_{III})_{rms}$, as shown in Figure 19.25, are numerically comparable to $(K_I)_{rms}$. All of the damped repairs are equally effective in reducing $(K_{II})_{rms}$, and show a considerable reduction in comparison to the low damped design. Also the results for $(K_{III})_{rms}$ show that all

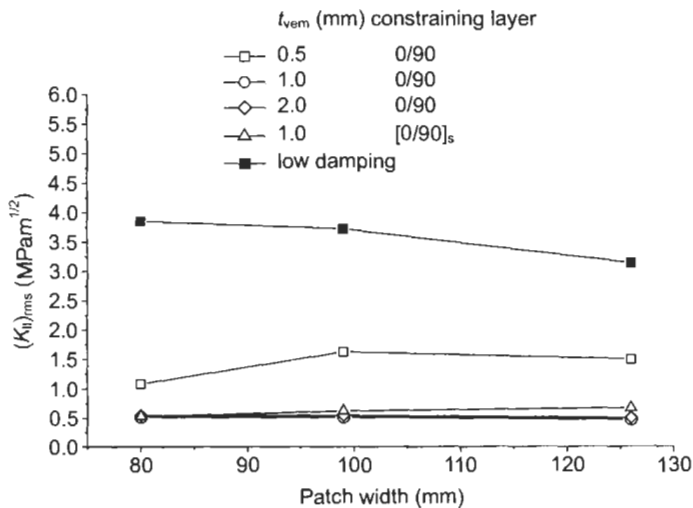
Fig. 19.25. Stress intensity factor, $(K_{III})_{rms}$, for various highly-damped and low damped patch configurations.

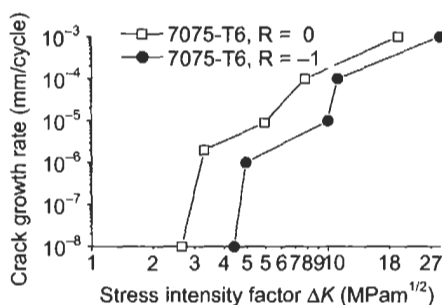
Fig. 19.26. Crack growth rate for 7075-T6 with increasing K_I , [16].

The crack growth data shown in Figure 19.26 is for 7075-T6 aluminium alloy corresponding to long crack growth data for panels tested subject to uniaxial loading [16]. As a result of the neutral axis offset the curve of $R=0$ most closely represents the crack growth curve for the bending fatigue case. While these data are for low frequency loading conditions, evidence exists that high frequency testing results in slightly lower crack growth rates [17,18]. In our case high frequency

bending is involved, therefore taking crack growth rates from Figure 19.26 will lead to conservative estimates of crack length. The curve in Figure 19.26 has been extrapolated to determine the approximate crack growth rate for cases less than 10^{-8} mm/cycle. Using these data insignificant crack growth has been calculated, after the 6000 h, for all the highly-damped patch configurations considered. Crack growth data for 4% Cu-Al alloy subjected to high frequency bending, given in [16], also indicates negligible crack growth for all the highly-damped patch configurations considered. Although no crack growth data corresponding to K_{II} or K_{III} stress intensities are available the K_{III} results shown in Figure 19.25 indicate possible crack growth for the 0.5 mm [0/90] configuration. Note that the above results are highly dependent on the material loss factors used in the modelling. This loss factor is also dependent on the operating temperature. Therefore in order to design an effective highly damped repair knowledge of the temperature condition when the high SPL are generated is required.

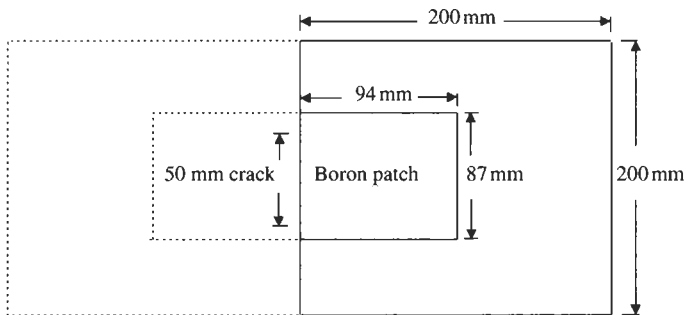
Fig. 19.27. Dimensions of repair, plan view.

In order to study the cracking mechanisms of the cracked and repaired/cracked aft skin cases, a simplified model has been developed in which the skin is considered to be a flat rectangle. Most of the skin panels in which cracking occurs have a chemical milled step in which the panel is reduced in thickness to 0.91 mm. While the width and height dimensions of each panel vary, the F.E. model has representative dimensions as shown in Figure 19.27. The mesh is shown in Figure 19.28. Since the crack lies near the boundary, the repair will continue across the adjacent panel as outlined in Figure 19.27. In order to more accurately represent the bending of the panel, two layers of 20 noded brick elements have been used through the thickness. A local boron/epoxy repair [O₃] has been applied to make up for material lost as a result of the crack, but does not cover the entire

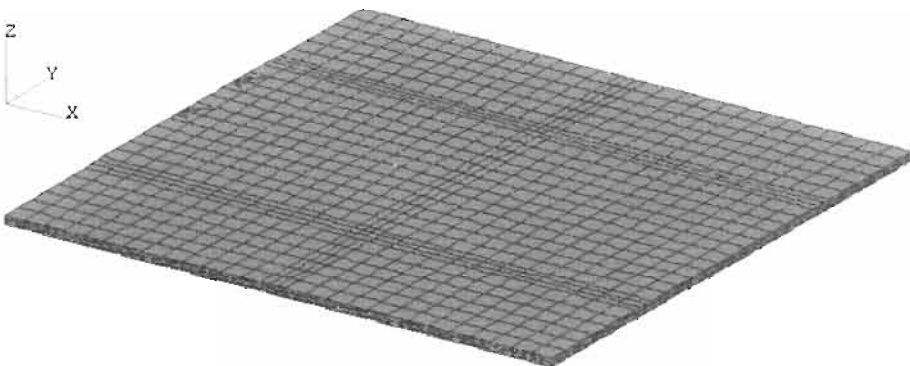
Fig. 19.28. Finite element model of multi-layer highly damped repair, containing a 50 mm long crack.

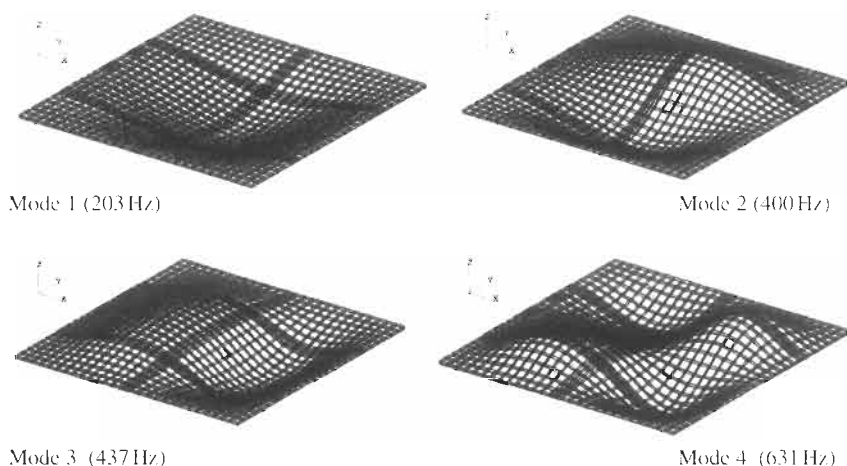
Fig. 19.30. Modes and frequencies for aft fuselage repaired skin.

A modal analysis has been carried out using NASTRAN program, [11], to determine the mode shapes and frequencies. The first four mode shapes are shown in Figure 19.30. The PSD of the response is plotted in Figure 19.31. From this curve it is clear that mode 1 provides the greatest contribution to the response at a frequency of 203 Hz. The mean square contribution of the other modes is more than one order of magnitude smaller than that for mode 1.

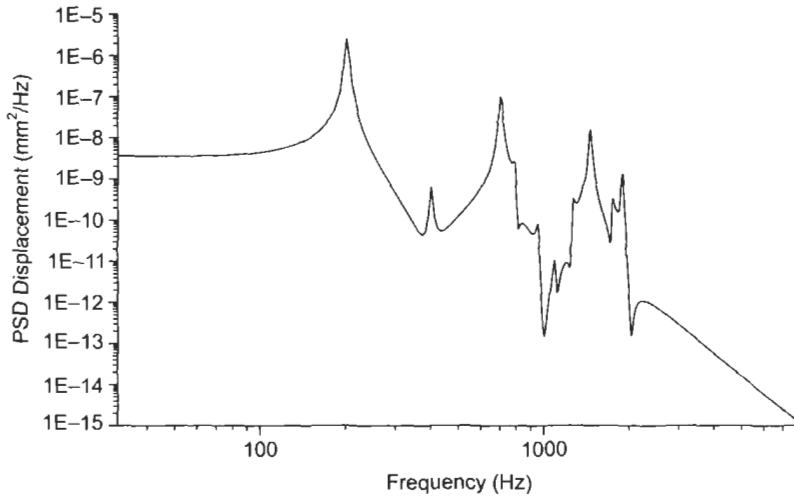
Fig. 19.31. PSD of the response (i.e. mean square of the displacement near the crack tip).

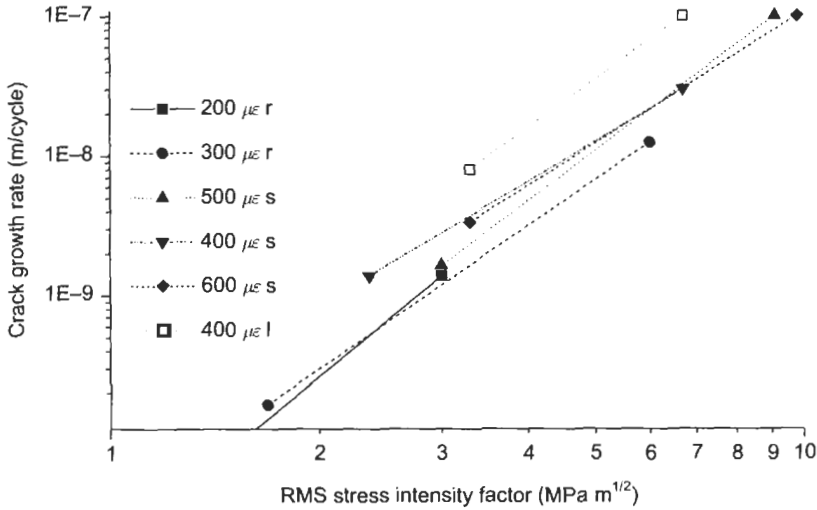
Fig. 19.32. Acoustic fatigue crack growth data for clad 2014-T6, ($\mu\epsilon$ denotes micro-strain, r denotes random, s denotes sinusoidal and l denotes low reversal rate, [18]).

In this study, it has been necessary to show that standard crack growth laws can be applied to structures subject to high frequency out-of-plane bending excitation. While acoustic fatigue data is very limited a comparison has been made with L73 data (U.K. spec.) and a standard crack growth law. The L73 (clad) alloys, [18], shown in Figure 19.32, is equivalent to 2014-T6. The crack growth law for 2014-T6 is given by [19] as:

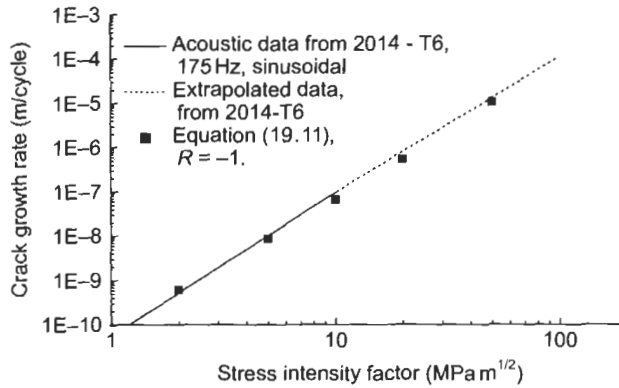
Fig. 19.33. Crack growth data and crack growth law, [18].

The crack growth law is usually determined from testing at a frequency of typically 4–10 Hz. Also Eq. (19.11) is only valid for a range of 6–50 MPa m^{1/2}. A comparison between the crack growth law prediction and the 2014-T6 data is shown in Figure 19.33. The experimental data corresponds to a sinusoidal data at 175 Hz and shows surprisingly good agreement. The random data has not been used since the slopes of the curves show significant disagreement, with similar strain levels.

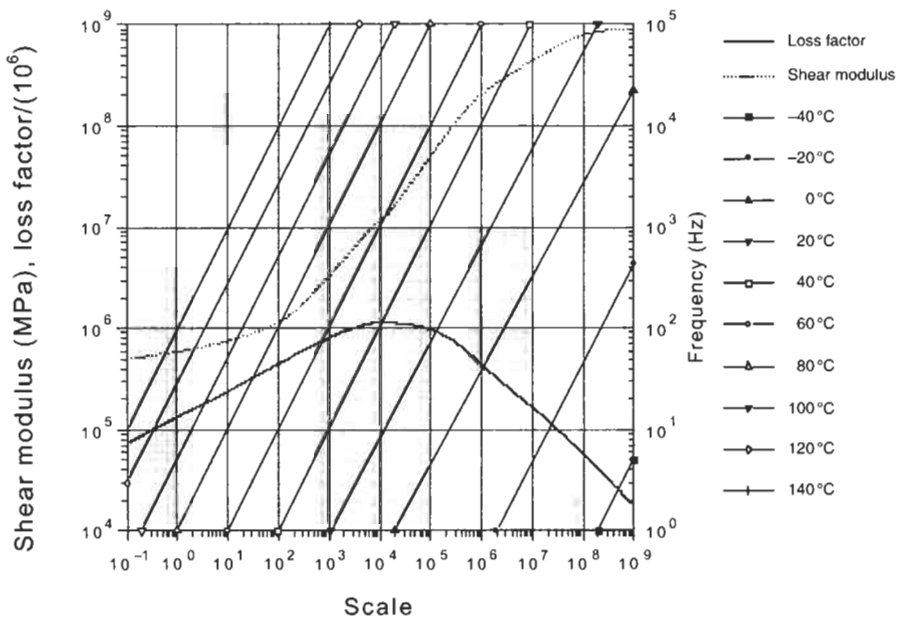
Fig. 19.34. Dyad 606 material data. (To obtain loss factor divide shear modulus scale by 10^6).

Two commercially available structural damping materials have been evaluated such as Soundcoat and Isodamp. From this testing the Soundcoat Dyad 606 and 609 [20], have been chosen as being the most suitable materials that are available for this application. The manufactures data for Dyad 606 and 609 are shown in Figures 19.34 and 19.35. A combined plot for Dyad 606 and 609 is shown in Figure 19.36 for a frequency of 200 Hz and gives a guide for the expected performance using a combination of 606 and 609.

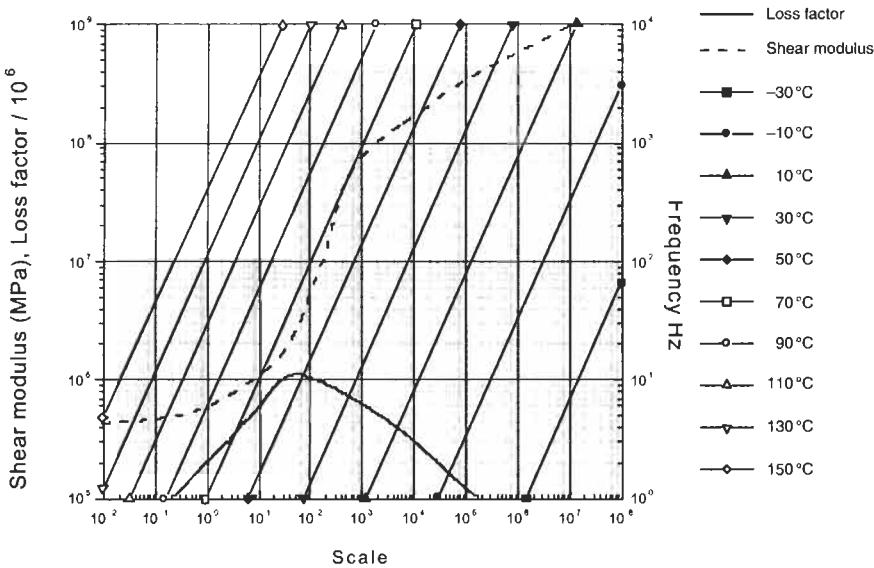
Fig. 19.35. Dyad 609 material data. (To obtain loss factor divide shear modulus scale by 10⁶.)

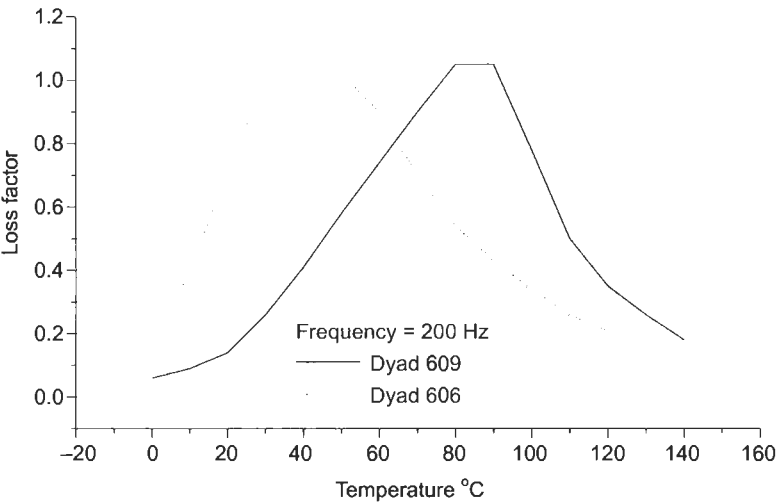
Fig. 19.36. Comparison of Dyad 606 and 609 over the entire temperature range.

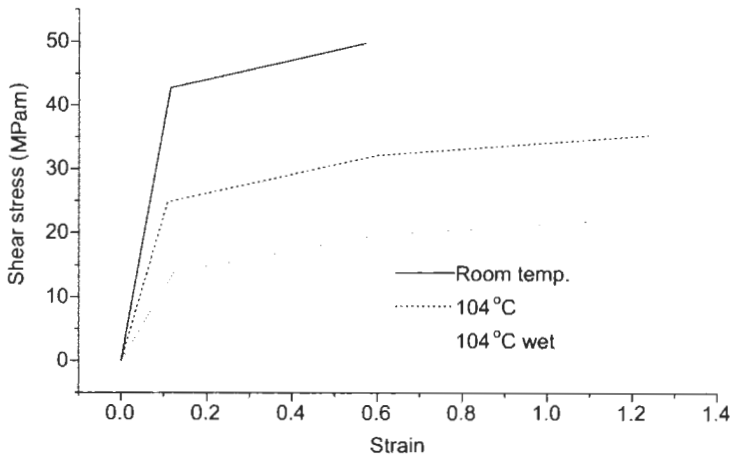
Fig. 19.37. Stress strain diagram for FM300 for the temperature range shown.

Stress strain data is available for FM300, [21], and is shown in Figure 19.35 as a function of temperature. The service temperature for this adhesive ranges from -55°C to 150°C . Only two data points exist for each temperature case, as a result values for shear modulus have been extrapolated. Using dry data the shear modulus is given by: $G = 1281 - 7.419T$ (MPa), where T is the temperature in $^{\circ}\text{C}$.

The adhesive shear and peel stresses bonding the boron repair to the aluminium are shown in Figure 19.41 corresponding to room temperature. In comparison with Figure 19.37, it is evident that for room temperature at this particular SPL the stresses are relatively low and no yielding will occur under peel or shear.

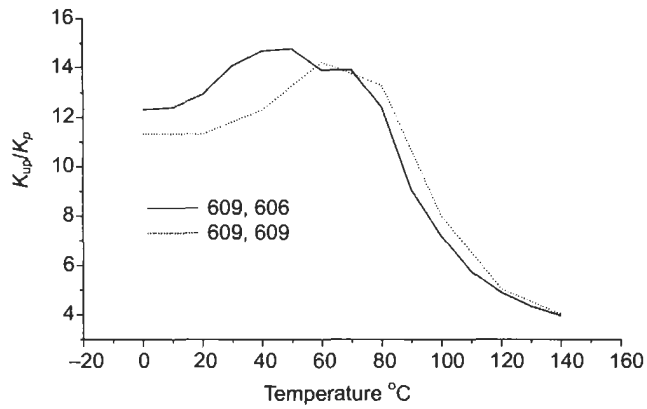
Fig. 19.38. Plot of K_{up}/K_p versus temperature for configurations using 609 and 606.

In Figure 19.38 a plot is shown for the ratio of stress intensity factor for the cracked unpatched plate to the stress intensity of the repaired plate. This includes the thermal residual stress contribution and softening effect of the adhesive. A

significant reduction of K_{up} is shown over the complete temperature range. Results using two layers of 609 are also shown in Figure 19.38. These results show a slight improvement at the higher temperature range but reduced performance at temperatures below 60 °C.

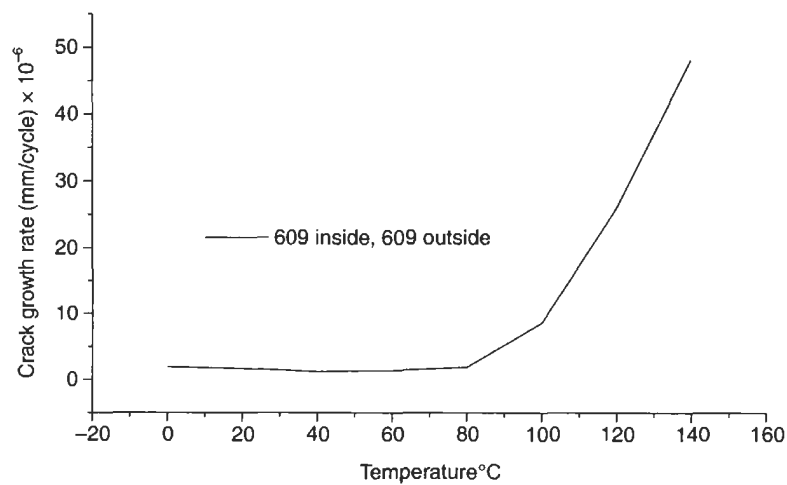
Fig. 19.39. Crack growth rate for highly damped repair.

Figure 19.39 shows the crack growth rate for 7075-T6, over the temperature of interest. Equation (19.11) is used to obtain the crack growth rates, with relevant coefficients, including both thermal residual stresses estimated from a closed form solution and adhesive softening. The crack growth rate is relatively low for temperatures of 80 °C, beyond this the crack growth increases significantly. In

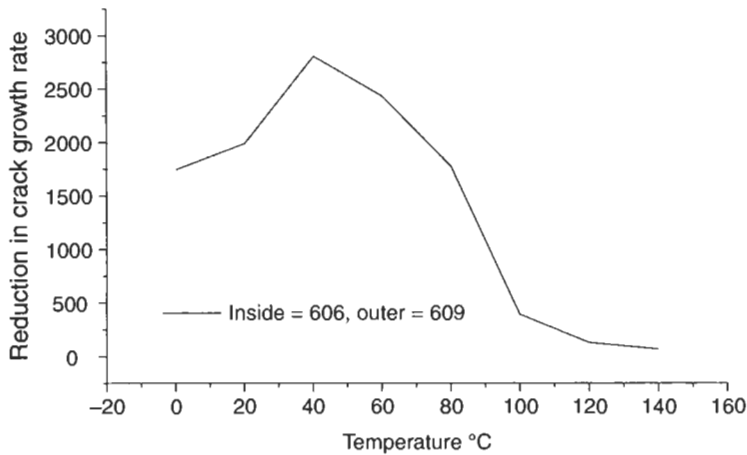
Fig. 19.40. Reduction in crack growth rate for highly damped repair compared to cracked un-repaired plate.

comparison Figure 19.40 shows that the crack growth rate for the cracked un-repaired panel to the repaired panel is approximately 2700 times greater for temperatures up to 40°C. Even at 140°C the crack growth rate of the cracked un-repaired panel is 70 times the crack growth rate of the repaired panel.

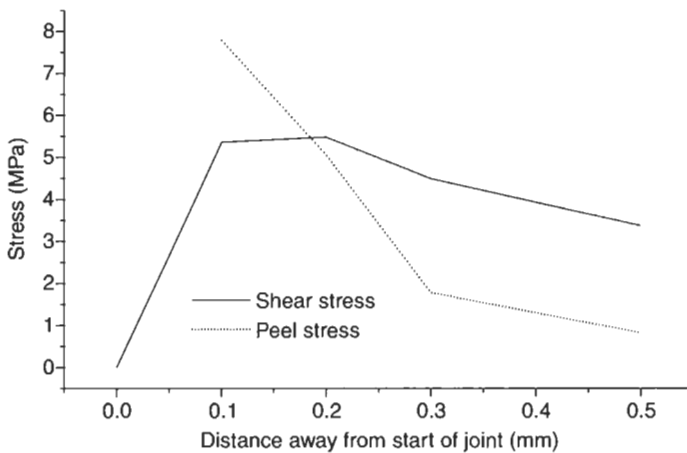
Fig. 19.41. Adhesive stresses bonding boron to aluminium at room temperature.

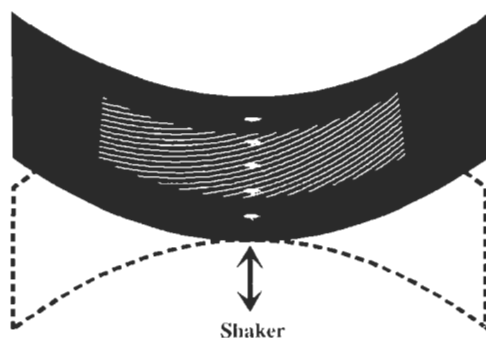
Fig. 19.42. Flexing motion for butterfly specimen provided by an electrodynamic shaker.

Limited experimental work has been carried out in [23–25] in support of the analytical work. While differences exist between the aft fuselage geometry and specimens, similar experimental trends are expected. This work covers testing butterfly specimens which involve the flexing or bending motion shown in Figure 19.42, provided by a shaker, in order to simulate the acoustic excitation. The specimen is excited at the first resonant frequency and the geometry of the specimen is shown in Figure 19.43. These specimens consist of bare aluminium specimens with boron/epoxy patches and Dyad 609 and 606 VEM layers with $[0,90]_s$ constraining layers. The highly damped repair was applied using RT curing adhesive Hysol EA9320. All panels were pre-cracked with a crack length of 25 mm. The damping materials are the same as those used in the aft fuselage F.E. model. In each case the maximum force applied to the specimen by the shaker was 90 N. This forcing level achieved a nominal rms strain of about $1000 \mu\epsilon$ ahead of the crack. Comparative results are shown in Figure 19.44. In the case of bare aluminium specimens approximately 100000 cycles were obtained before the resonant frequency dropped by 15%. A 15% drop in resonant frequency was used as a criteria to indicate extensive crack growth. For boron/epoxy repairs approximately 1000000 cycles were obtained before the resonant frequency of the specimen dropped by 15%. In the case of the highly damped repair the first test with a shaker force of 90 N gave no reduction in frequency at 10000000 cycles, as shown by the dotted line. A second run was made with the shaker force increased to 180 N. The results for this run are shown in Figure 19.44. At approximately 10000000 cycles a 15% reduction of resonant frequency has occurred. The highly damped repair tested is slightly different to that analysed above in Section 19.8.0 in that the constraining layers of $[0/90]_s$ are used in the experimental test rather than the $[0/90]$ plies in the aft fuselage F.E. model. However the experimental results indicate that highly damped repairs are very effective in reducing the crack growth rate.

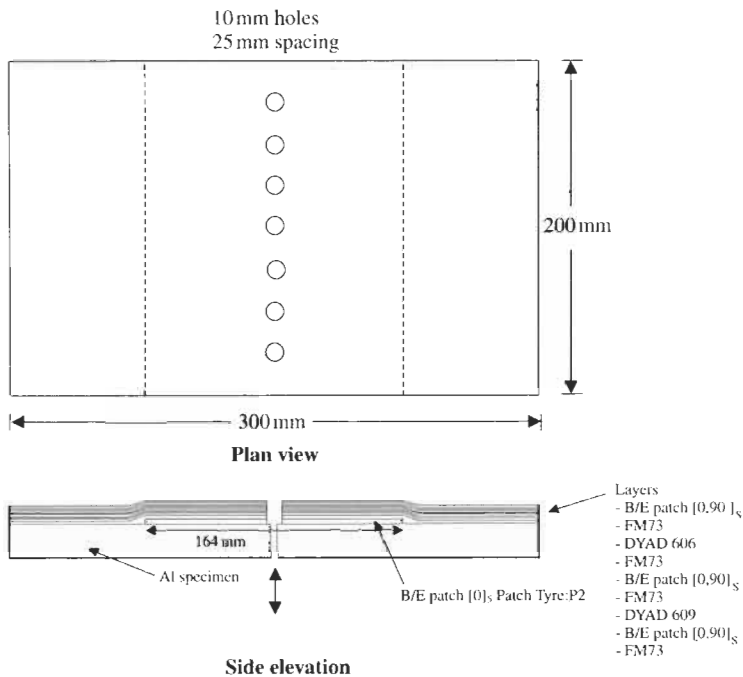
Fig. 19.43. Highly damped repair specimen configuration, from [24].

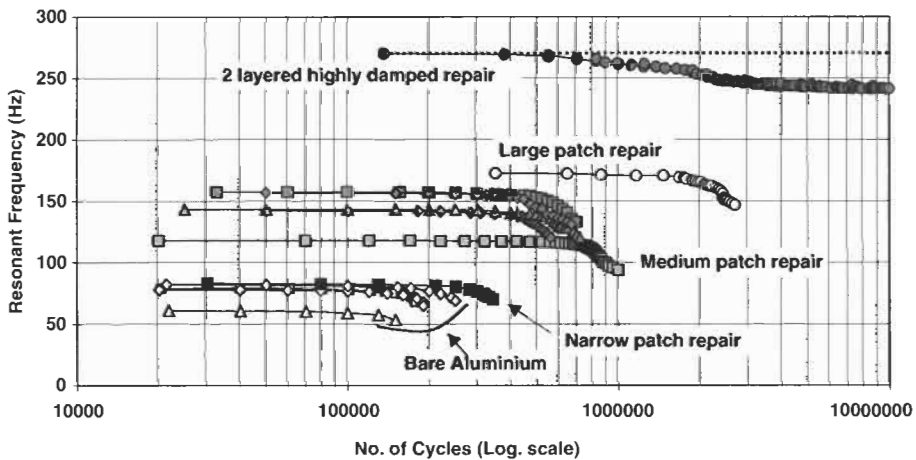
Fig. 19.44. Comparative test lives for various specimens, from [24]. (Narrow, medium and large patch repair refers to reinforcing patch lengths of 56 mm, 164 mm and 210 mm respectively).

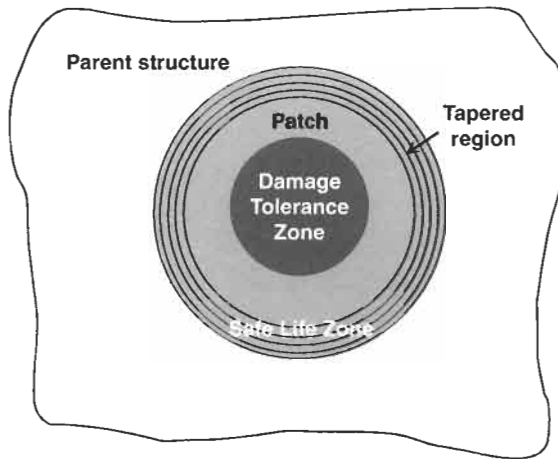
Fig. 20.1. Schematic of a generic external bonded repair showing safe-life zone (no disbonding allowed in this zone) and damage tolerant zone (stable disbonding growth allowed in this zone) [2].

Figure 20.1 illustrates the safe-life and damage tolerant zones at the ends and in the middle, respectively, of a generic patch.

The generic patch system, shown in Figure 20.1, consists of (1) a safe life region where disbands in the adhesive grow rapidly, leading to repair failure, and (2) a
