Advances in the Bonded Composite Repair of Metallic Aircraft Structure

VOLUME 2

Chapter 19. Bonded Repair of Acoustic Fatigue Cracking 531

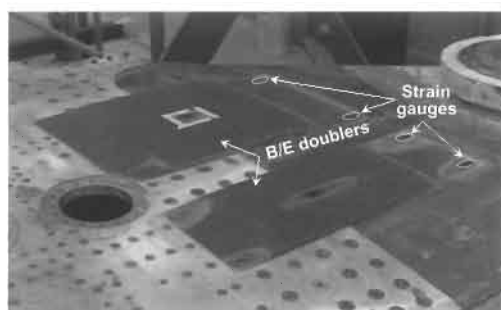
Fig. 20.4. (a) (top) Photograph of b/ep doublers on an F-111 with the location of resistance-foil strain gauges for doubler health monitoring and (bottom) schematic showing location of critical area and the 120 ply thick doubler [9]. (b) Plot of strain ratio reduction due to disbond growth as a result of fatigue cycling (bottom) and representative bonded joint specimen showing strain gauge positions (top). The F gauge results plotted are on the corners of the doubler [9].

An important early potential application was in the large (120 + ply) boron/epoxy (b/ep) doubler reinforcement for the wing pivot fitting (WPF) of Australian F-111 aircraft (Figure 20.4). Fatigue cracks can initiate in the upper-skin of the F-111 wing pivot fitting (WPF) stiffener runout region shown in Figure 20.4(a). A strain reduction of over 30% is required in this region to avoid plastic yielding during cold proof load testing (CPLT), [21] and also to increase the in-service

inspection interval. The required strain reduction is particularly challenging because of the thick steel structure and high loading and was achieved by designing and implementing b/ep doublers, as depicted in Figure 20.4(a) (see Chapter 29) [9,22]. The approach taken to monitor patch health was to apply resistance-foil strain gauges (see Figure 20.4(b)) on the ends of the tapered section of the b/ep doubler and on the surface of the steel WPF away from the doubler and monitor the ratio (doubler strains) / (strain in the steel fitting) during service life. Any decrease in this ratio is an indication of disbonding of the doubler. Figure 20.4(b) shows results obtained from tests on F-111 representative bonded joint specimens (representing a section through the doubler) subjected to CPLT loads and the F-111 loading spectrum. Disbonding is indicated by the reduction in relative strain, where disbands initiated and grew mainly from the corners of the doubler and growth was very much less in the centre. In the aircraft doubler system the sides are tapered normal to the doubler axis, so stress concentrations in these corners will be much less severe; however, the results amply demonstrate the effectiveness of the monitoring approach proposed. This early attempt at in-service monitoring of the doubler gauges, although highly effective for aircraft undergoing the CPLT, proved too cumbersome for in-flight use (but should be possible with the current “smart patch” approach). A similar approach is being used to monitor the structural integrity of a large (5 m × 1 m) 6 mm thick doubler used to reduce cracking around welds in the aluminium deck of an Royal Australian Navy Frigate as described in Chapter 42 [23].

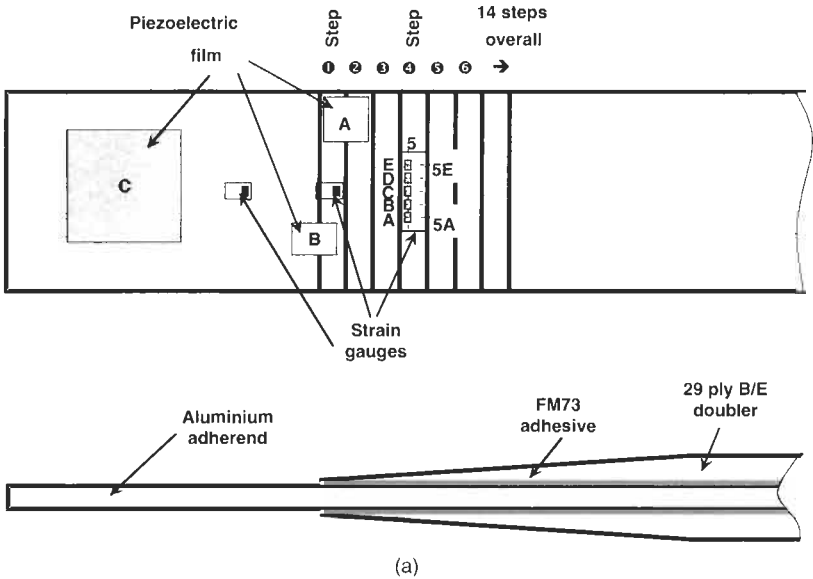
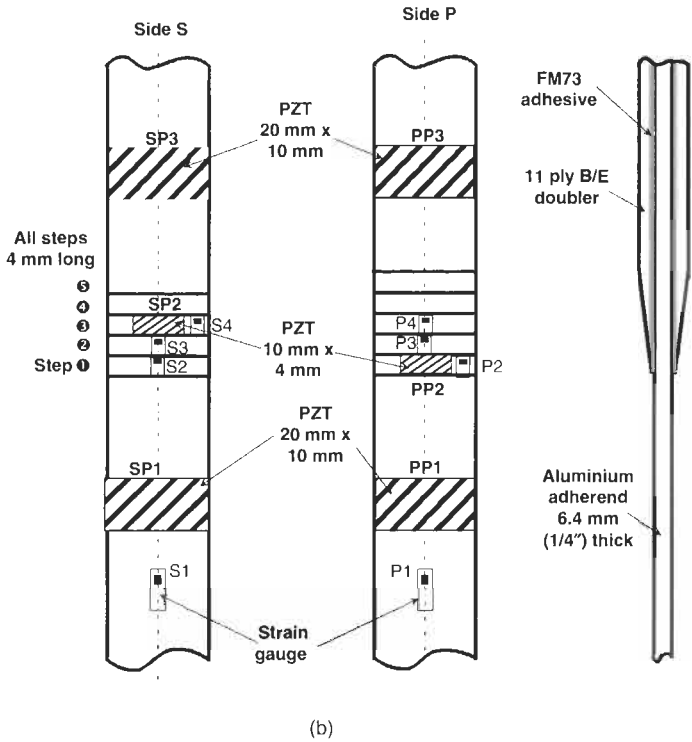
Fig. 20.5. Schematic of skin-doubler (SD) specimens with transducer locations for (a) Type I specimen and (b) Type II specimen.

Piezoelectric films. Figure 20.4(b) shows the results using conventional resistance-foil strain gauges on an F-111 representative bonded joint (skin doubler) specimen. Similar experimental results were achieved on other skin doubler specimens, shown in Figure 20.5, using both resistance-foil strain gauges and piezoelectric film sensors. These specimens reflect the important structural features around region E of the representative bonded joint specimen shown in Figure 20.4(b). In this case both resistance-foil strain gauges and 28 μm thick piezoelectric polyvinylidene fluoride (PVDF) film sensors were used to detect and monitor damage growth in the tapered region of the bonded doubler.

Sensors were located on the taper of the b/ep doubler and on the surface of the aluminium inner adherend, away from the doubler, (sensors A and C, respectively, in Figure 20.5(a)) in order to monitor the ratio (doubler strains) / (strain in the far-field). Any decrease in this ratio is an indication of disbonding of the doubler. A notable advantage of this approach is that there is no requirement to measure the actual loading. In these studies the piezofilm sensor was used in a manner similar to that for the resistance-foil strain gauge: by monitoring (loss of) load transfer over the tapered region of the patch. However, in the piezofilm case, the sensing area was generally much larger compared to the resistance-foil strain gauge, thus this sensor monitors damage progress over a larger area. In this case a 10 mm by 10 mm sensor was used on the first two steps of the doubler (sensor A in Figure 20.5(a)) [12]. The specimen used in this study was a skin-doubler (SD) Type I specimen consisting of a 3.13 mm thick aluminium inner adherend with tapered 29 ply unidirectional b/ep doublers bonded to each side to retain symmetry as shown in Figure 20.5(a). The doublers are bonded to the aluminium substrate using FM73 epoxy structural adhesive. The boron doublers were tapered at a step-up rate of two plies every 4 mm, with the first step consisting of a single ply. The uniaxial loading was applied at a frequency of about 4 Hz.

Another approach using PVDF sensors was to place the sensor over the edge of the patch, as indicated by sensor B in Figure 20.5(a) [6]. This approach uses the fact that as the disbond between the patch and the aluminium adherend initiates and grows there is an increase in relative movement between the edge of the patch and the adherend. Therefore a piezofilm sensor placed across this region detects disbonding by monitoring an increase in strain. In this study a 7 mm by 4 mm sensor was placed over the patch edge, at a location indicated by sensor B in Figure 20.5(a). However, in this case, the specimen used was a skin-doubler (SD) Type II specimen consisting of a 6.4 mm thick aluminium inner adherend with tapered 11 ply unidirectional b/ep doublers bonded to each side to retain symmetry as shown in Figure 20.5(b). As for the previous specimen, the doublers were bonded using FM73 epoxy structural adhesive. This specimen had a similar ply drop off rate as the Type I specimen. The uniaxial loading was applied at a frequency of about 3 Hz. A more detailed description of the specimen and experimental set-up is given in Chapter 5.

To illustrate this technique strain measurements were undertaken during the fatigue studies on skin-doubler specimens Types I and II, see Figure 20.5(a) and (b) [6]. The doublers are bonded to the aluminium substrate using FM73 epoxy structural adhesive at a cure temperature of 80 °C, respectively. Figure 20.14(a) and (b) show the residual strain (strain at zero load) response, with increasing number of loading cycles, measured using resistance-foil strain gauges, 5A and 5E, on the 4th step of Type I specimen (Figure 20.14(a)), and, P3, on the 2nd step of Type II specimen (Figure 20.14(b)). Both figures show an increase in residual strain due to the disbonding process, reaching a constant level of about 300 and 400 $\mu\epsilon$, respectively. The higher value of residual strain for the sensor on the 2nd step compared to sensors on the 4th step is due to the high stiffness of the aluminium substrate compared to the patch at these locations. Consequently, higher residual strains, and hence better sensitivity, to disbonds is expected for regions on the outer, thinner, portion of the patch. The strain levels measured in these studies can be easily detected using either optical fibre sensors or resistance-foil strain gauges. Therefore, it appears that these studies illustrate the feasibility of residual strain measurements as an alternative method of monitoring patch health.

Figure 20.5(b) shows a schematic drawing of the skin-doubler Type II specimen, considered in this experimental study, as well as the transducer locations. In this case the piezoceramic material was PZT (Lead Zirconate Titanate) wafers. A constant-amplitude sinusoidal load, with a fixed frequency of 5 Hz, was applied to the specimen. The maximum cyclic load started at 15 kN (minimum load was 0.1 kN) and was increased in 1 kN steps every 50000 cycles until damage was observed, after which the loading level was kept constant. During the experiments the disbond growth was monitored on Side P using element PP2 on step one and resistance-foil strain gauge P3 on step two (see Figure 20.5(b)). The electrical impedance of PP2 was measured at discrete frequencies in the range 400 Hz – 5 kHz, using an impedance analyser with a constant rms excitation voltage of 2 V.

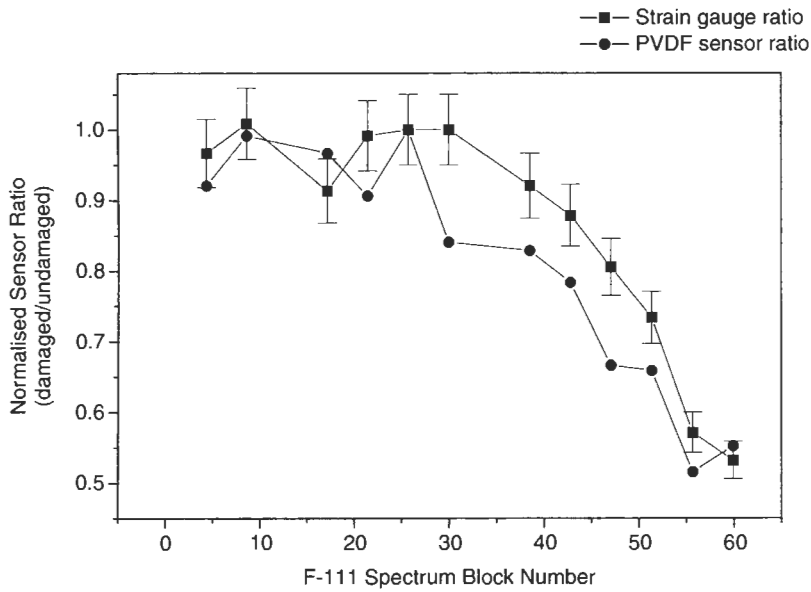
Fig. 20.6. Results for piezoelectric film sensors and resistance-foil strain gauges on skin doubler Type I specimen: (a) Sensor ratio A/C and (b) Sensor B (see Fig. 20.5(a)).

Figure 20.6(a) and (b) shows the piezofilm response with increasing loading cycles. In Figure 20.6(a) disbond growth under the sensor was indicated by a significant reduction in piezoelectric film voltage ratio (sensor A / sensor C), which correlates well with the resistance-foil strain ratio results. Figure 20.6(b) shows the results for the piezofilm sensor when positioned over the patch edge, and indicates a significant increase in sensor output (approx 60% increase in signal compared to the non-damaged case) due to the presence of damage. The magnitude of the increase in sensor signal will depend on the relative proportion of the sensor area over the patch edge compared to the total sensor area. As indicated in this figure, this technique detects disbond initiation, and reaches a maximum sensor output well before the resistance-foil strain gauge detects any sign of damage – as would be expected.

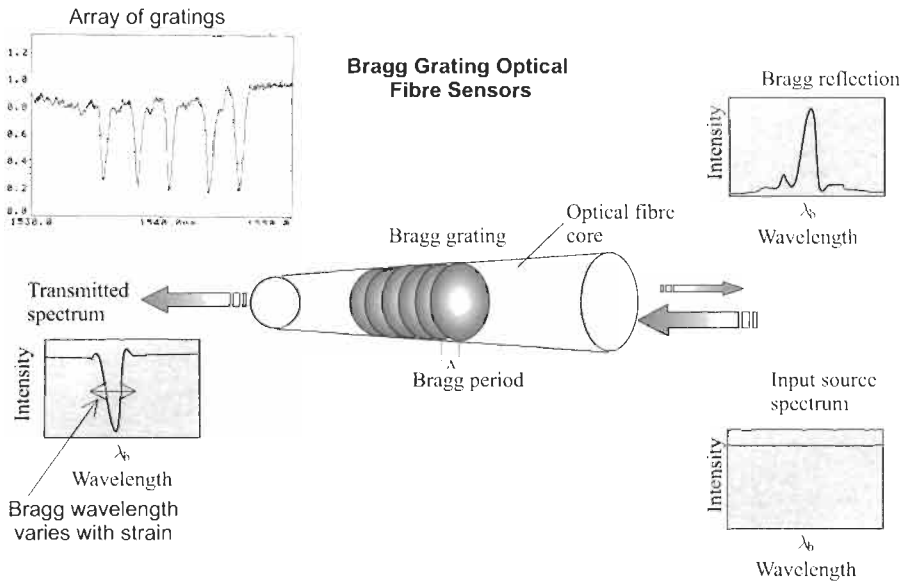
Fig. 20.7. Schematic of a fibre Bragg grating.

An optical fibre-based intrinsic distributed sensing technique, viz. fibre bragg grating (FBG), was used here to monitor damage in composite bonded patch systems. A FBG sensor consists of a periodic modulation of the core refractive index of an optical fibre. Such a sensor is fabricated by forming defect sites in the glass matrix through exposure to intense UV light [24]. The effect of this periodic refractive index variation on propagating light is to reflect a narrow band of wavelengths back down the fibre, as is illustrated in Figure 20.7. The peak wavelength of this reflected light is the Bragg wavelength of the grating (λ_B) and is given by

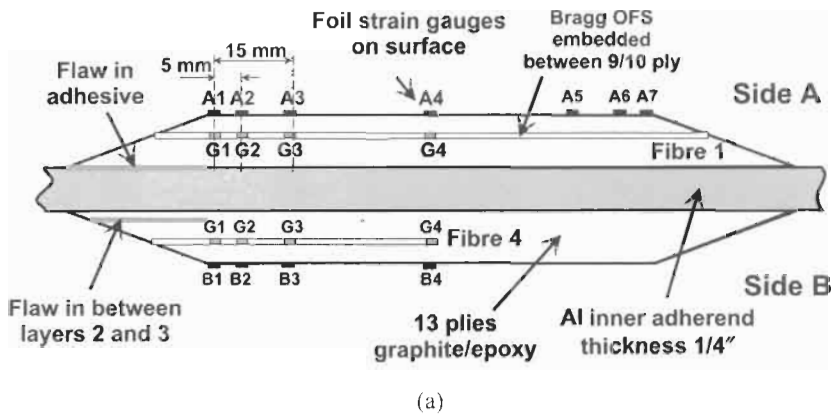
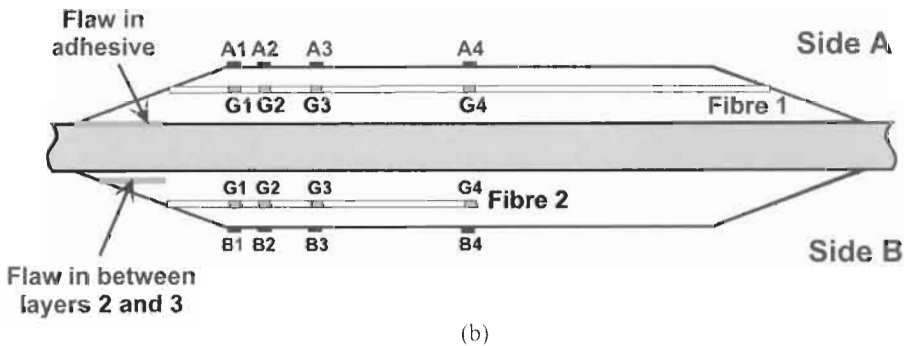
Fig. 20.8. Schematic showing specimen details and position of sensors for specimen (a) TTCP 1 and (b) TTCP 2.

A theoretical and experimental study on the use of embedded FBG sensors in measuring strains and structural-health of bonded composite repairs was reported on in [6,15]. The specimens and sensor positions, considered in these studies, are shown in Figure 20.8. The specimen consisted of a 6.35 mm thick aluminium inner adherend with two 140 mm long 13 ply graphite/epoxy (gr/ep) doublers with the tapered ends consisting of a ply drop-off of 3 mm/step. A 0.2 mm thick layer of Hysol EA 9320, room temperature curing, adhesive was used to bond the reinforcements onto the aluminium. There are two artificial damage regions within the specimen, one is in the adhesive/aluminium interface within the tapered region of the reinforcement (on side A), which is referred to as a disbond, and the other is between plies two and three of the patch within the tapered region (on side B),

which is referred to as a delamination (see Figure 20.8). Specimen TTCP one and two had disbonds and delaminations along the full length and half-length of the taper (about 41 mm and 18 mm long), respectively. Figure 20.8 also shows the locations of FBGs, between the 9th and 10th plies, and surface mounted conventional strain gauges. The grating lengths (i.e. the sensing lengths) were typically 3–4 mm long and the surface mounted resistance-foil gauges were 2 mm long. The experimental program consisted of strain surveys conducted under static-loading. These strain measurements were then compared to finite element predictions. Finally, a fatigue study was undertaken to evaluate the performance of these sensors in monitoring damage growth.

Measured surface and embedded sensor strains were also compared with predicted strains. In this case specimen TTCP 1, shown in Figure 20.8(a), was modelled by an elastic stress analysis using the linear static analysis code of MSC.NASTRAN. Figure 20.12 shows the predicted and measured longitudinal strains on side A for a static load of 24 kN (before the disbond propagated) for the

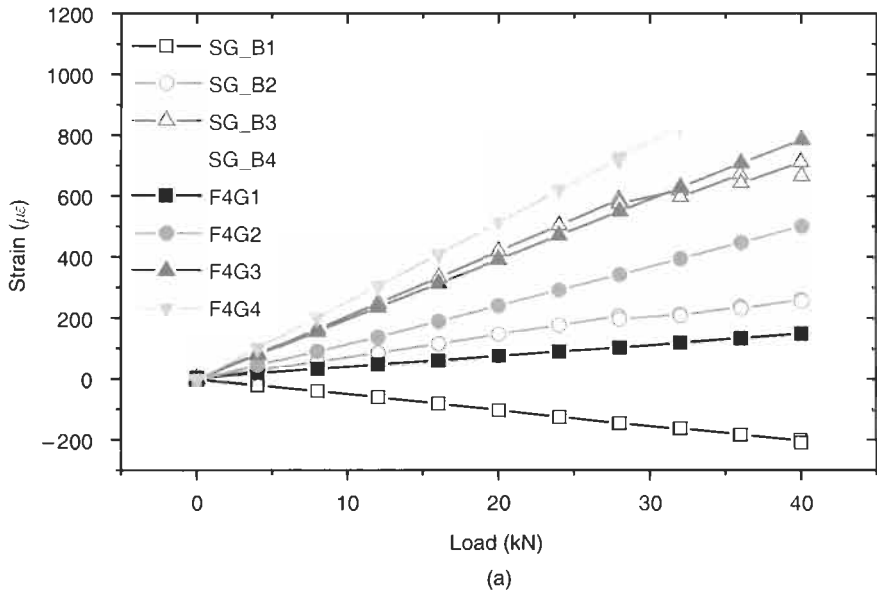
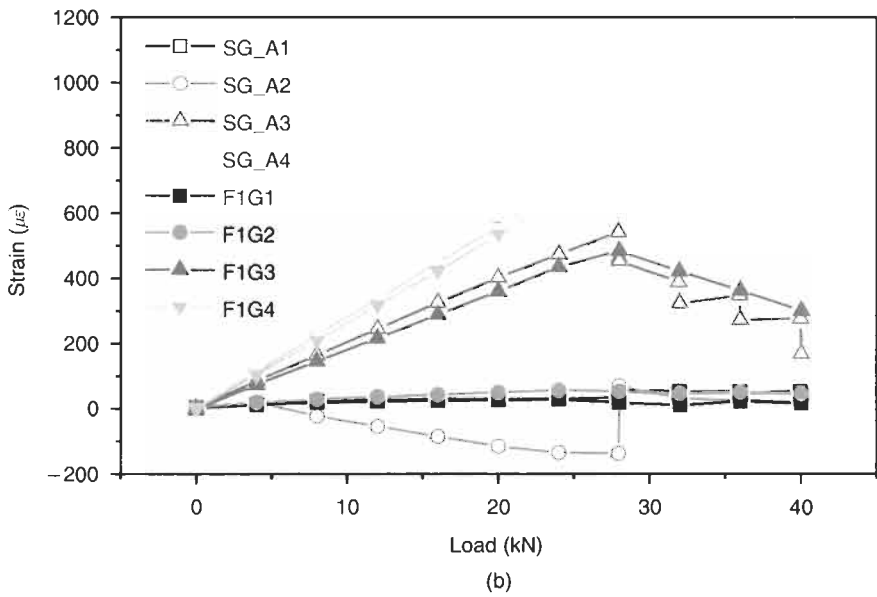
Fig. 20.9. Response of FBG from (a) fibre 4 and (b) fibre 1, with corresponding surface gauge measurements, with increasing loads for specimen TTCP 1.

Figure 20.9(a) and (b) shows a comparison between the measurements taken from fibres four and one, respectively, and corresponding surface strain gauges with increasing applied load for specimen TTCP 1. All gratings of fibre four showed positive linear responses, increasing in magnitude from grating G1 to grating G4. Good agreement was observed between sensors B4 and G4. Note that, each corresponding pair of sensors, at positions 1, 2 and 3, (i.e. B1/G1, B2/G2 and

B3/G3, respectively) showed a higher response for the Bragg grating than for the surface strain gauge – this was due to the shear lag effect. Although not shown here, similar trends were observed for gratings G1, G2 and G3 of fibre two compared to gauges A7, A6 and A5 respectively for specimen TTCP 1 at the non-damaged end [15]. For fibre one (see Figure 20.9(b)), gratings G1 and G2 showed little response, consistent with the response at surface gauge A1, since no load has yet been picked up by the patch due to the presence of the artificial disbond. Grating G3 showed a significant reduction in response at 28 kN, consistent with the response of gauges A2 and A3. This drop in signal (and hence-forth a null response) when the load exceeded 28 kN is indicative of the formation of a disbond, in the adhesive layer, located outside the initial artificial disbond under sensors A2/G2 and A3/G3. These observations were confirmed by an NDI examination consisting of manual ultrasonic A-scans in this region, as shown in Figure 20.10.

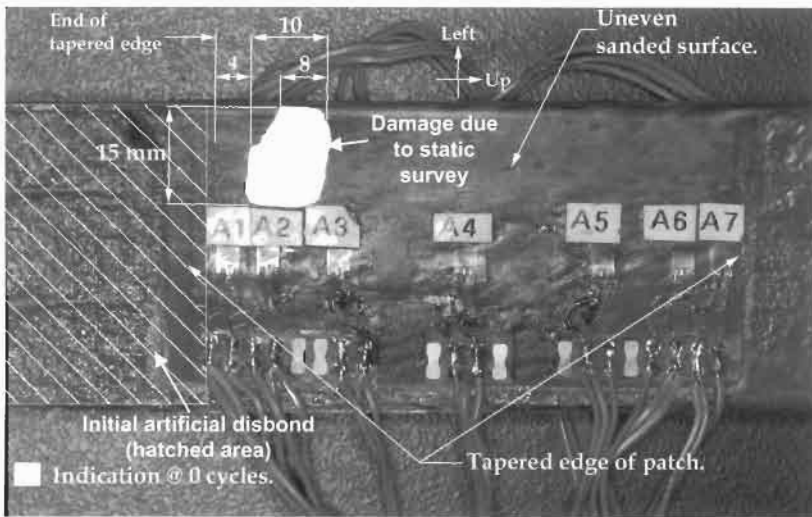
Fig. 20.10. Damage indicated by the ultrasonic A-scan of specimen TTCP 1 after the static strain survey.

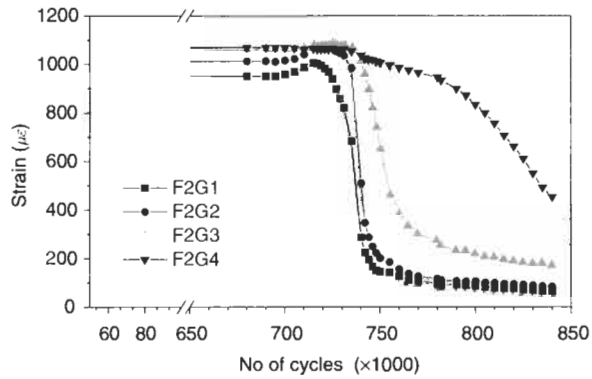
Fig. 20.11. Strain response of Bragg gratings of fibre 2 (at 40 kN), on Side B of specimen TTCP 2, with increasing number of applied loading cycles.

The fatigue study also showed that embedded FBGs could easily monitor damage in the adhesive layer of a bonded composite patch specimen. Figure 20.11 shows the strain response of gratings in fibre two, on side B of specimen TTCP 2. This figure illustrates the excellent sensitivity of embedded FBGs in monitoring damage growth. These results confirm the ability of strain measurements within the reinforcement (as a measure of load transfer) to reflect damage growth in high load transfer regions of composite bonded repairs.

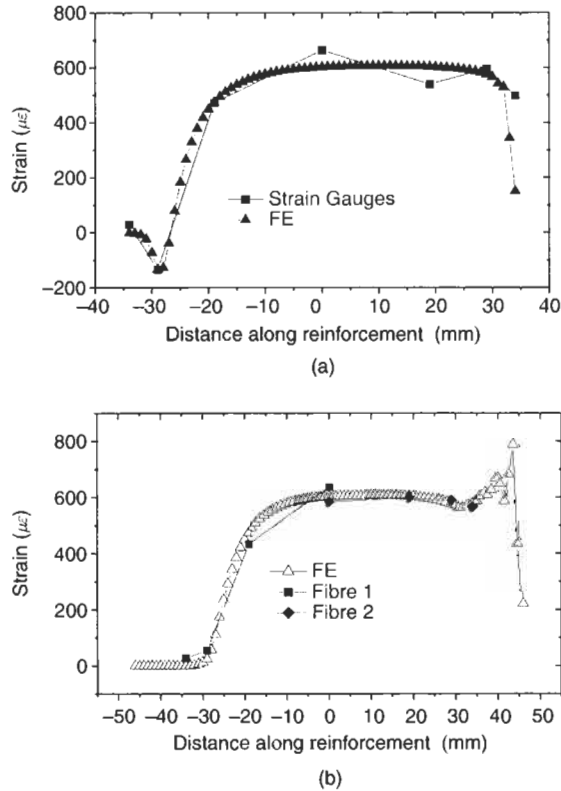
Fig. 20.12. Comparison of measured and predicted FEA strains, from (a) surface mounted strain gauges and (b) Bragg grating optical sensors embedded between the 9th and 10th plies, for a load case of 24 kN and for an initial disbond length of 41 mm on side A of specimen TTCP 1.

first strain survey. The maximum predicted value of strain on sides A and B compares reasonably well with the measured values from both the surface gauges and the Bragg gratings. Figure 20.12 shows the excellent correlation between the measured and predicted longitudinal strains at both the surface and 9th/10th ply interface. In general, the measurements from the surface electrical-resistance foil strain gauges and the embedded FBG sensors correlated well with the finite element analysis. In conclusion, these results indicate that the embedded FBG measure, with reasonable accuracy, the longitudinal strain in a composite patch.

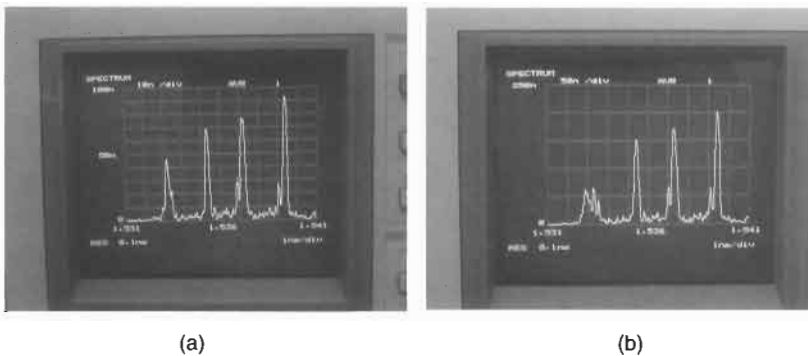
Fig. 20.13. Optical spectra from an array of Bragg gratings (a) before and (b) after the crack passed under the sensor.

One cautionary note, however, is that the measurement of strain from the Bragg grating spectral response can be complicated when the grating is located in regions of high strain gradients. These high strain gradients can substantially distort the Bragg reflected spectral shape, thus leading to strain conditioning problems with certain demodulation techniques. However, such distortion to the spectra can be minimised by the use of short gratings, and where possible apodising the grating to suppress sidelobe structure. This distortion can be clearly seen in Figure 20.13, which shows the response for an array of gratings in a fibre surface mounted on a bonded composite repair (i.e. a repair to a cracked aluminium skin as shown in Figure 20.15(a)). The fibre is placed perpendicular to the direction of crack growth and the sensor with the spectrum with the lowest Bragg wavelength (i.e. peak on the left in Figure 20.13(a) and (b)) is located over the crack (see sensor 7 in Figure 20.15(c)). The broadening of the response and the appearance of sub-peaks reflects a chirping of the grating caused by high strain gradients (due to severe local secondary bending) induced by the crack. In this case what was originally a fairly standard Bragg reflection spectra (Figure 20.13(a)) has become a complex spectra containing multiple peaks (Figure 20.13(b)). Such complex spectra are poorly handled by standard Bragg grating interrogation instruments, which typically rely on simple peak detection algorithms (viz. zero crossing of the reflected Bragg wavelength spectra). However, this feature could be exploited to enable optic fibre technology to monitor delamination under the patch [5,16].

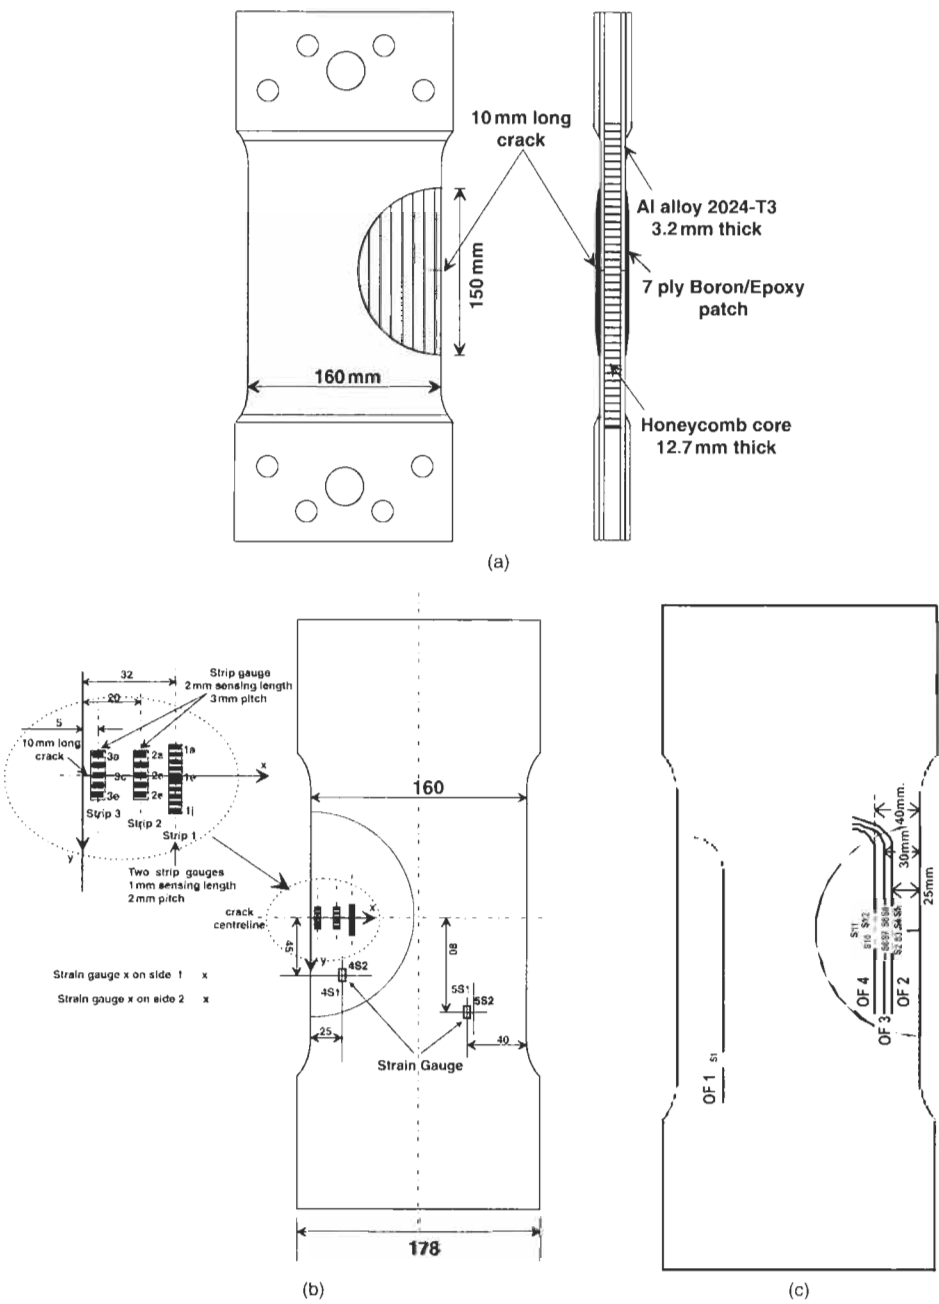
In order to study the surface strain behaviour of the patch as the crack grows, strain gauges and optical fibres were attached as shown in Figure 20.15(b) and (c), respectively. One specimen had resistance-foil strip gauges attached at three x stations along the crack centreline (see Figure 20.15(b)). The strain gauge strips 1, 2 and 3 were located at 32 mm ($x = 32$), 20 mm and 5 mm from the specimen edge, respectively. The centreline of each strip of gauges was aligned perpendicular to the crack centreline. The second specimen had an array of FBG sensors on four optical fibres OF1 – OF4 attached as shown in Figure 20.15(c). OF1 contained a single far-field sensor, S1, and was bonded to the aluminium skin using a cyno-acrylate adhesive. The remaining three optical fibres, containing sensors S2–S12, were bonded to the top surface of the repair also using a cyno-acrylate adhesive. Sensors

S2–S5, S6–S9 and S10–S12 were located in OF2, 3 and 4, respectively. These fibres were aligned perpendicular to the crack centreline and located 25, 30 and 40 mm from the specimen edge, respectively. The fibres were completely buried beneath a thick layer of room temperature curing adhesive so as to protect the optical fibres and to also provide a smooth surface for eddy current measurement of the crack length.

Residual strains were also successfully used to detect and monitor fatigue cracks in the metallic substructure of patched-cracked specimens. The experimental program was conducted on similar cracked-patched specimens to that used for the b/ep patching efficiency studies discussed in Chapter 13. The cracked-patched specimens consist of two 3.14 mm thick 2024 T3 skins with 10 mm long starting cracks. These specimens were repaired with unidirectional boron/epoxy 7 ply (0.9 mm) thick semicircular patches. A layer of FM 73 film adhesive was co-cured onto the boron/epoxy bonding surface. The patches were then bonded onto the aluminum cracked skin with adhesive FM 73 at 120 °C, following surface treatment of the metal using the silane process and of the boron/epoxy patches by blasting with alumina grit on the co-cured adhesive layer [1]. The aluminium skins were tested in a back-to-back honeycomb sandwich arrangement by bonding each skin onto aluminium honeycomb as shown in Figure 20.15(a). More details on this specimen can be found in Chapter 13.

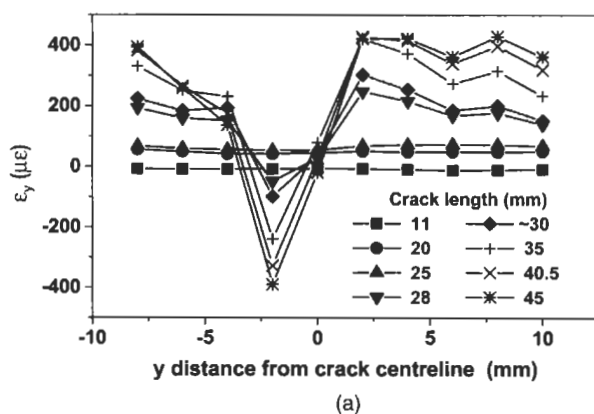
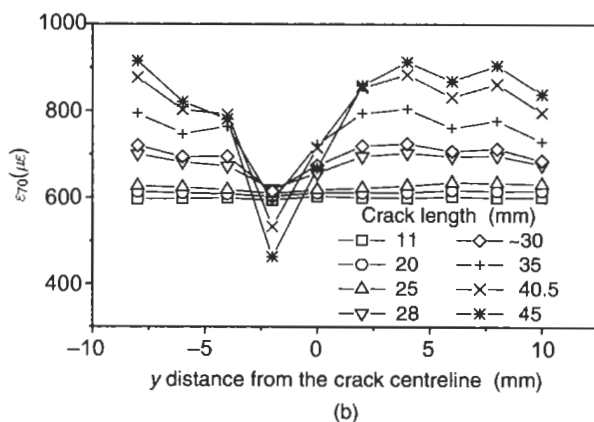
Fig. 20.17. Variation of (relative) strain distributions normal to the crack at $x = 32$ mm (for resistance-foil strip strain gauge 1), with increasing crack length: (a) residual strain distributions (i.e. 0 kN load case) and (b) strains at 70 kN (strains at 0 kN have been set to zero).

The results for both types of sensor arrays show that the residual strain over the crack (minimum strain response) drops by $-400\mu\epsilon$ and the strains above and below the crack (maximum strain response) increase by $400\mu\epsilon$ as the crack passes under the sensor array. Changes in residual strains, due to the presence of the crack, appear to occur when the crack tip is about 5–7 mm from the sensor – this is consistent with the strains measured under load. Figure 20.16 shows that, for this particular repair system, the residual strains are sensitive to changes in crack length. The degree of sensitivity will be determined by issues such as adhesive cure temperature, adhesive type, substructure stiffness, the geometry of the repair, *etc.* These results do indicate that the measurement of residual strains may be an alternate method for detecting and monitoring crack growth in the cracked substructure.

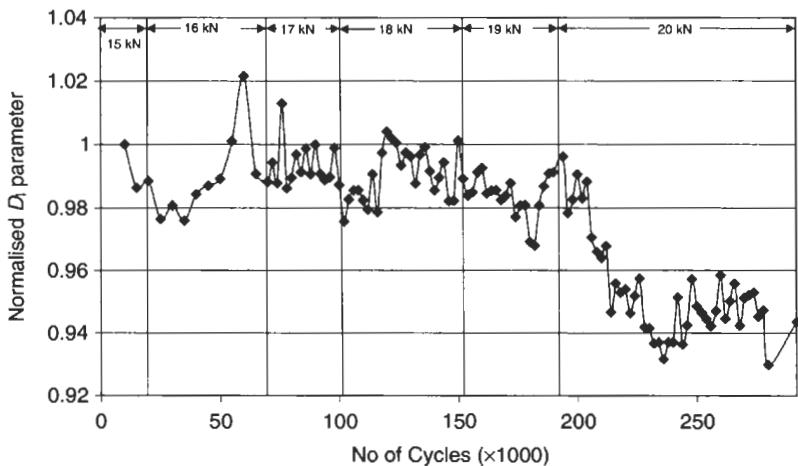
Fig. 20.18. Variation of D_I (of piezotransducer PP2) with increasing number of loading cycles.

The variation in D_I measurements, with increasing loading cycles, for transducer PP2 are shown in Figure 20.18 [6,20]. This figure suggests that disbond growth commenced at about 200000–205000 cycles, relatively soon after increasing the load amplitude to 20 kN after exposure to some 200000 loading cycles at lesser amplitudes. A systematic drop in the D_I -parameter was observed until about 210000–215000 cycles, whereafter the response remains relatively constant indicating, presumably, that the disbond had progressed past the PZT element where further disbond growth would have no effect on the element impedance. Note the overall drop in D_I is nominally about 4% relative to the initial value. Sensor P3 showed a reduction in strain after 205000 cycles reaching a minimum value at about 215000 cycles, indicating that the disbond does exist and had

nominally progressed passed the first step after about 215000 cycles. Sensor PP2 detects growth of a disbond (under step one) before it is detected by sensor P3 (on step two) – as would be expected. Even though the measured response is broadly consistent with the behaviour measured for similar bonded repair scenarios [19], the reduction in D_I is not as significant as previous studies. Currently a detailed numerical investigation of this specimen configuration is being undertaken to understand the behaviour of the transducer with varying position and amounts of damage.

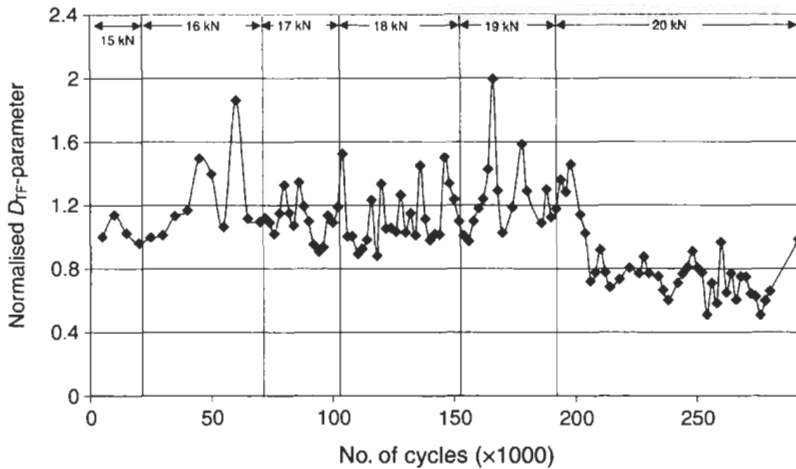
Fig. 20.19. Variation of D_{TF} (of actuator PP3 and sensor PP2) with increasing number of loading cycles.

Figure 20.19 shows the D_{TF} , with actuator PP3 and sensor PP2 [6,20]. As damage initiated at around 200000 cycles the value of D_{TF} decreases by about 30% after about 210000 cycles, indicating that damage had progressed past step one. This result was consistent with the impedance and strain gauge measurements described above. Similar results were observed for the piezotransducer pair PP1 (actuator) and PP2 (sensor), however after about 230000 cycles the D_{TF} parameter was observed to increase. The results using element pairs PP3 (actuator) and PP1 (sensor) showed no significant changes in D_{TF} with damage growth after about 210000 cycles. Further experimental and theoretical studies are underway with the view of establishing optimal transducer spatial distributions whilst maintaining adequate damage detection sensitivity.

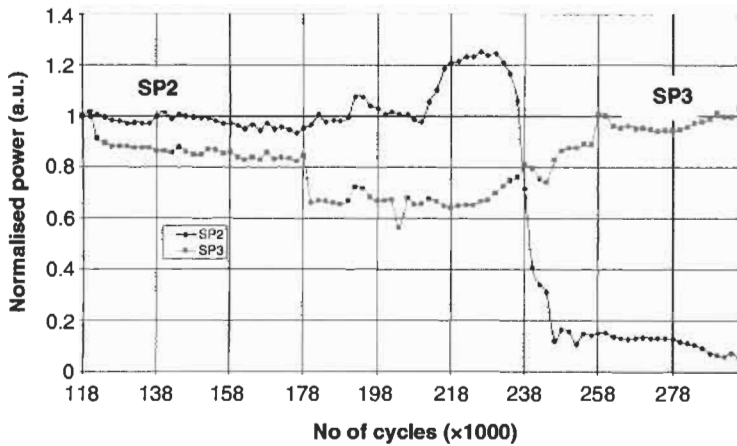
Fig. 20.20. Signal power versus number of cycles for piezosensor SP2 and SP3.

Computations of the power of the received signal were made at frequent intervals in the course of fatigue testing. The signal power at both sensor stations is plotted as a function of the number of loading cycles in Figure 20.20 [6,20]. Several interesting observations can be made here. Firstly, the response at sensor SP2 reflects a higher level of sensitivity to disbond growth than that recorded at sensor SP3. This is an intuitive result since the former element is located directly above the region where disbond growth occurred. It should be noted here that the results presented show good correlation with the strain results observed by strain gauge S3. Another interesting aspect is the markedly superior noise-effective sensitivity relative to that of the impedance and transfer function measurements (see Figures 20.18 and 20.19). In the case of SP2 for example, disbond growth through the sensor footprint results in a systematic drop in signal of some 90%, compared to 4% and 30% for the impedance and transfer function measurements, respectively. One potentially concerning aspect of these measurements is the apparent complexity of the relationship between disbond growth and the evolution of signal power. In the case of SP3 for example this is demonstrated by the 20% increase in power immediately preceding the more substantial long-term decline in signal. Such complexities are attributable to wave propagation physics and will include diffraction and mode conversion. Work is presently underway to try to understand such behaviour with a view to exploiting it for the quantitative assessment of disbond growth.

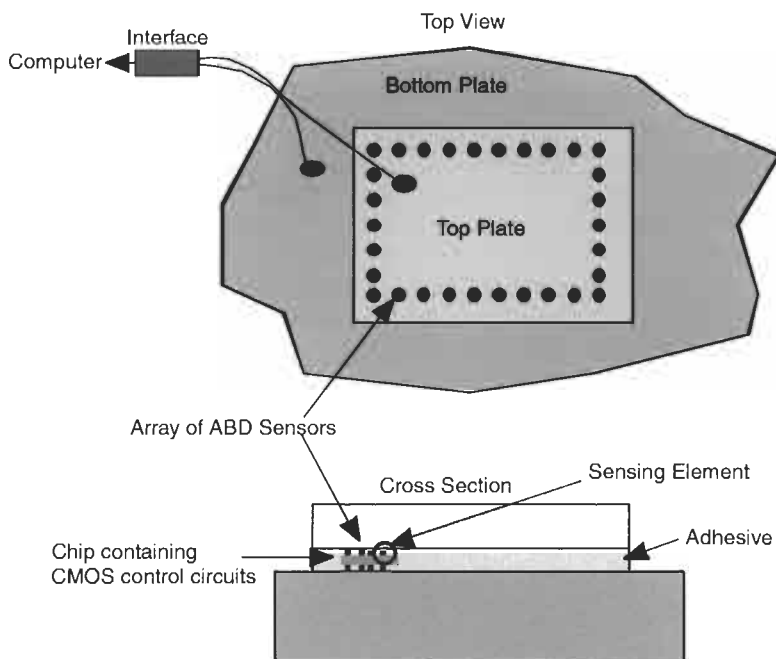
Fig. 20.21. Schematic of a bonded repair with an upper metal plate over a lower metal plate and an array of ABD sensors in the adhesive bond-line. In the metal/metal implementation the sensors have metal studs, which contact the metal plates to make these plates the power and communications “wires” [7].

Another more direct approach of monitoring bond-line degradation and failure is by the use of the adhesive bond degradation (ABD) sensor developed by DSTO and Analatom [7] and consists of a number of small, independent, wireless sensors that can be mounted within the adhesive bond-line. The basic concept is shown

schematically in Figure 20.21. A number of the ABD sensors would be included in any bonded repair or component to monitor the condition of the whole bond.

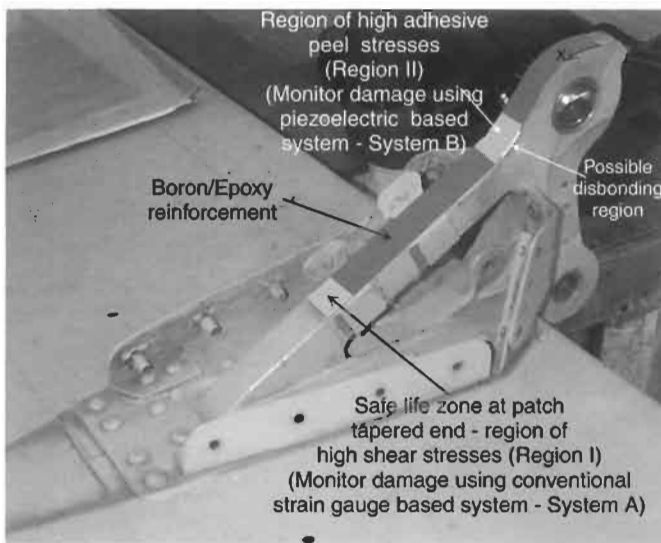
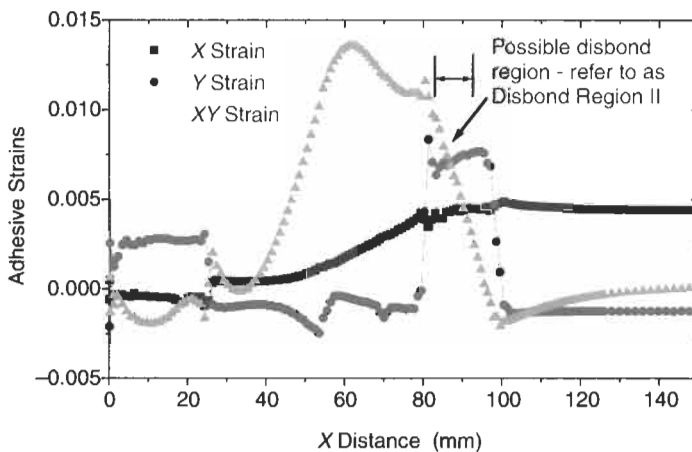
Fig. 20.26. Smart patch reinforcement flight trial on F/A-18 aileron hinge: (a) regions of high adhesive peel and shear stresses are indicated on the hinge reinforcement and (b) predicted adhesive stresses in the reinforcement with no blending and no disbonds present (Note disbond to be modelled in region II is indicated here).

A finite element analysis of the hinge with a b/ep reinforcement was undertaken to determine the most likely regions of damage and to assess various damage detection techniques [30]. Figure 20.26(b) shows the peel, shear and longitudinal stresses in the adhesive of the reinforcement. These results indicate that two critical regions exist, viz., the tapered region at the end of the repair on the hinge strut (Region I in Figure 20.26(a)) and the region of high adhesive shear/peel stresses in the mid-section of the reinforcement (Region II in Figure 20.26(a)). Figure 20.26(b) does not show the high adhesive shear stresses at the end of the patch (Region I) since this region was not modelled here. Also note that the repair termination on the top of the lug (at $x=0$) is not under load and therefore the adhesive shear

- ii Region II – damage at the adhesive high peel stress region: Significant increases in surface strains compared to the no damage case are predicted, for both load cases, indicating that damage detection is possible using surface strain sensors. Figure 20.27(a) shows a distinctive sharp peak in the surface strains (peak occurs over a 5–6 mm length for the 10 mm long disbond). However, the sharpness of the peak means that it may be difficult to detect if the sensor is not carefully positioned with respect to the damage. Also, the presence of a strain trough means that the averaging effect due to finite length of the strain sensors may mask the peak. Thus sensors will only detect the damage if the sensing length is small, compared to the peak-trough distance, and if the sensors are positioned over the damage or when the damage reaches a substantial size. Also, it is quite likely that the damage will initiate on one side without growing through the width to the other side. Therefore, in order to achieve a reasonable chance of detecting damage an array of sensors, on both sides of the reinforcement, is required. In order to reduce the number of sensors required then one approach may be to have a staggered array as shown in Figure 20.27(b). However this would require several dual channel devices or one multi-channel device to cover a reasonable area of about 20–30 mm long. Another approach is to make use of the disbond opening under load, which appears to be substantial, and use a piezoelectric film bonded on the edge of the aileron (over the repair, adhesive layer and some of the aluminium), as shown in Figure 20.27(b), to detect disbond opening. FEA and experimental studies are evaluating the performance of the sensor for different sensor positions and sizes. In summary two regions are to be monitoring during the flight demonstrator, viz. Region II: the region of high peel stresses located at the region of high curvature, and Region I: at the end of the doubler, and are indicated in Figure 20.26(a).

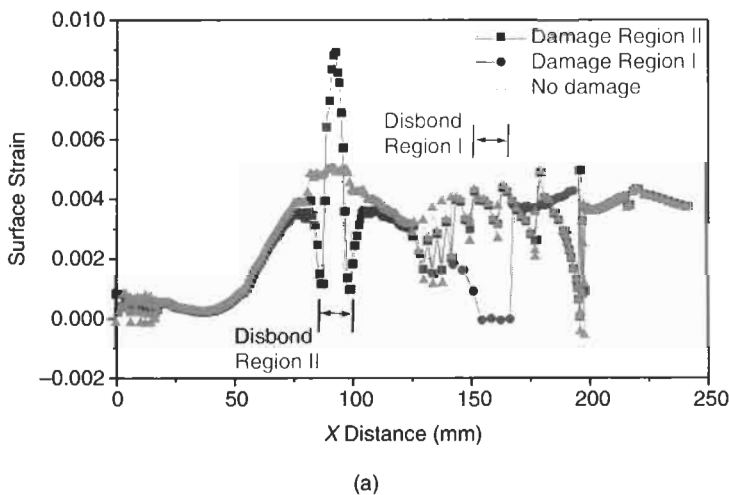
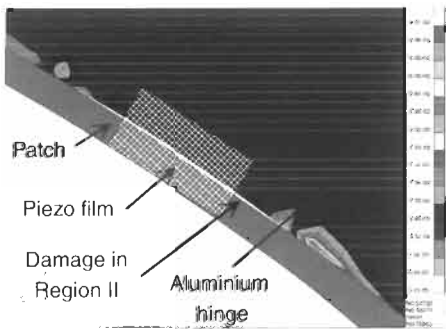
Fig. 20.27. Smart patch reinforcement flight trial on F/A-18 aileron hinge: (a) longitudinal surface strain profile on a b/ep doubler, applied to an aileron hinge, due to 10 mm disbond in the various regions indicated and (b) damage detection schemes for damage in Region II (top) sensor array and (bottom) piezoelectric film placed over the disbond (i.e. the piezoelectric film basically measures the amount of disbond opening).

damage cases considered were disbonds in the (1) high adhesive peel stress region of the reinforcement (Damage case II) and (2) tapered region of the reinforcement (Damage case I). The damage was simulated by introducing a 10 mm long disbond in the adhesive layer. Two load cases were considered in the FE analysis, viz., load case WO39 a tensile design ultimate load condition and WO42 a compressive design ultimate load condition. The results shown here are for the former case only. Plots of surface strains are given in Figure 20.27(a) for the various disbond

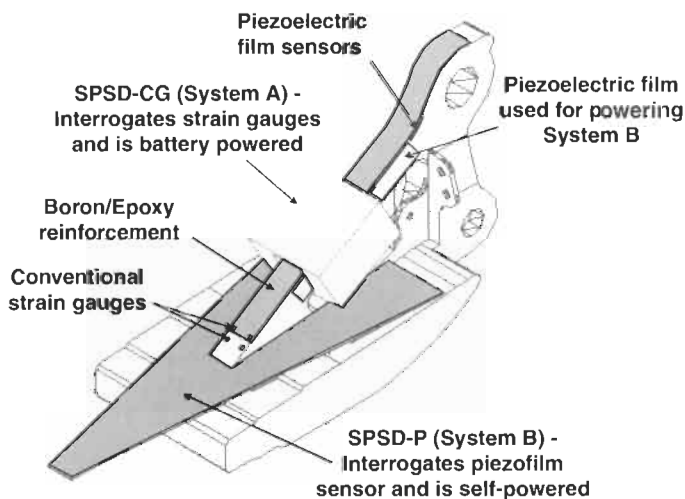
Fig. 20.28. Sketch of the aileron hinge with proposed smart patch demonstrator arrangement.

Some of the main broad specifications of these systems are that they need to be small low-powered devices capable of operating in a nominally autonomous manner. The device should be robust enough to survive in the harsh operational environments likely to be encountered, with the main concern being that the device should be able to tolerate a temperature range of -40°C to about 80°C . (Note that, operator data [30] suggests that the F/A-18 hinge operates in temperatures in the range -40°C to 60°C .) The current smart patch system arrangement is shown in Figure 20.28. The systems consist of surface mounted solid-state electrical

standard CMOS technology. Figure 20.28 shows the size and mounting arrangement of the SPSD-P system, and the location of the transducers on the aileron hinge. The sensors used with this part of the system are also made from PVDF sheet. The three main factors influencing this choice being, no excitation power required, modest signal conditioning requirements and high fatigue life. These virtues however come at a cost, in this case, in the form of poor low frequency response. As there is a high probability of a substantial amount of the strain being in the low frequency region it is important to ensure the frequency roll-off characteristics are fairly accurately matched. This in itself can be tedious, but as high impedances are involved the greater challenge is ensuring that they remain matched in an adverse environment. To assist with this problem buffer amplifiers with low input leakage were incorporated, but the need for thorough protection against moisture ingress remains a critical issue.

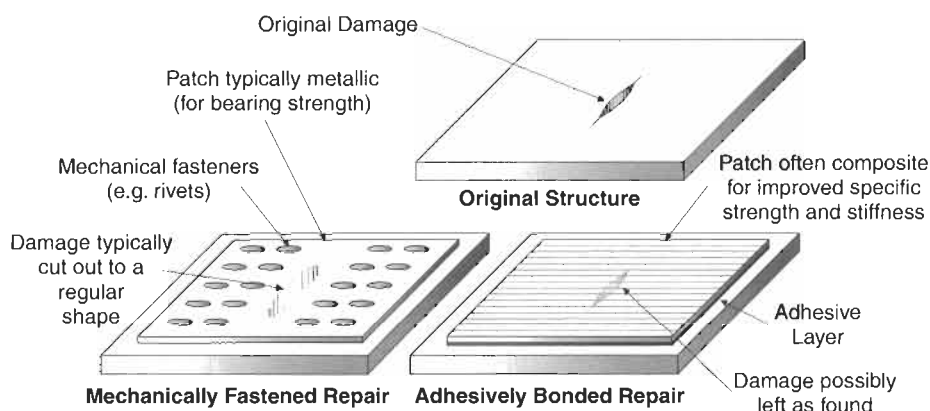
Fig. 21.1. Comparison between traditional and adhesively bonded repairs.

The use of bonded repairs should create much less of an impact than the introduction of composite materials but nonetheless, requires a similar review of the standards. To repair an aircraft implies that the resultant configuration will still meet the original certification basis (i.e. the standards to which the production aircraft have been shown to comply). The review must address the significant differences between traditional mechanically fastened repairs and those adhesively bonded including (see Figure 21.1):

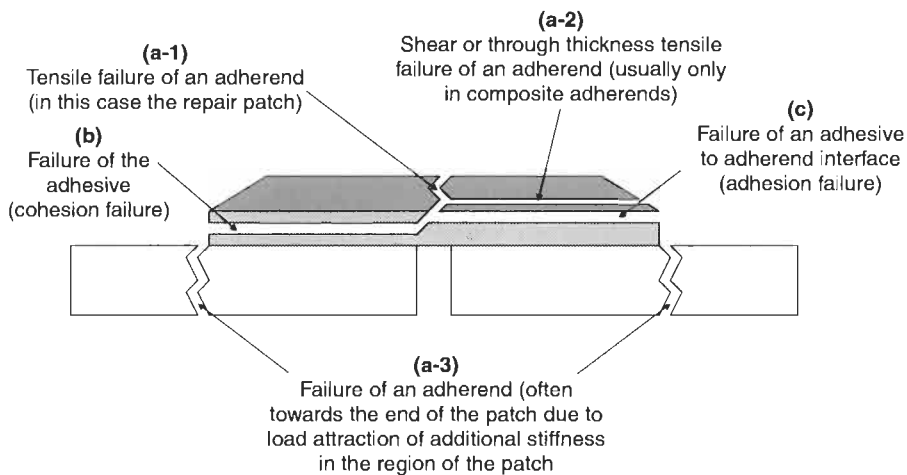
Fig. 21.2. Failure modes in an adhesively bonded repair.

The potential failure modes that can occur in a structure repaired by a bonded patch are shown in Figure 21.2. With the benefit of hindsight we now know that some of the adhesive bonding procedures used in the past on production aircraft were inadequate and did/will not provide long term durability against adhesive to adherend interfacial failure (Figure 21.2 mode (c)). Yet these techniques must have passed the required tests to gain regulatory authority approval. The problem has most likely arisen from utilising regulations written to cover traditional mechanically fastened procedures but which are inadequate to ensure the required

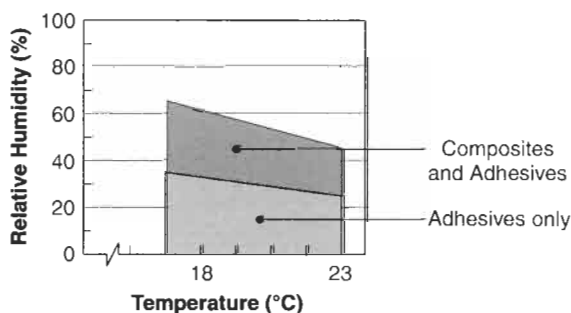
Fig. 21.3. RAAF engineering standard [26] bonding environment.

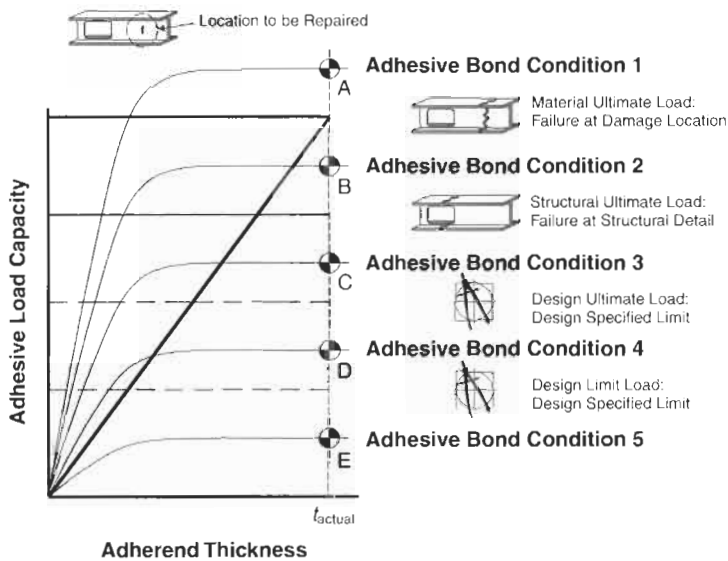
Fig. 21.4. Design conditions for an adhesively bonded repair.

In the absence of pre-existing test data the minimum extent (i.e. number and type of specimens⁴ of the test program should be based on the predicted adhesive load capacity of the repair although additional testing may be required if the critical failure is found to be other than cohesion failure in the adhesive. Any static testing should ideally be done at representative service conditions. However, it may be acceptable to perform the testing in an ambient atmosphere provided the effects of the environment on the materials are treated in the same manner as accepted by the original certification basis for the aircraft. The adhesive load capacity at a given location (with a given thickness t_{actual}) can be compared to the original structural design loads and found to be (see also Figure 21.4):

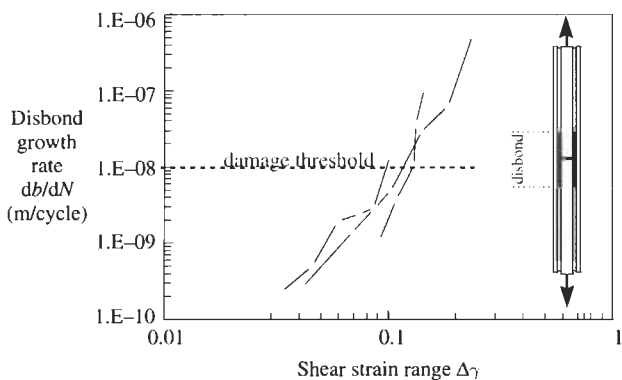
Fig. 22.2. Plot of disbond growth rate in the adhesive versus shear strain range obtained from tests on a double-overlap joint, shown inset. The adhesive is FM73, around 0.3 mm thick, the inner adherend is 2024 T6 aluminium, around 3 mm thick, and the outer adherends are b/ep, around 1 mm thick.

To characterise the allowable strains in the double-overlap joint, representing the crack region, an approach evaluated is to use the theoretical or the measured strain range in the adhesive $\Delta\gamma$ as the damage severity criteria. This is plotted against disbond growth rate db/dN , as shown in Figure 22.2, where b is the disbond width and N the number of cycles. The dotted line is arbitrarily defined as the initiation threshold in this case.

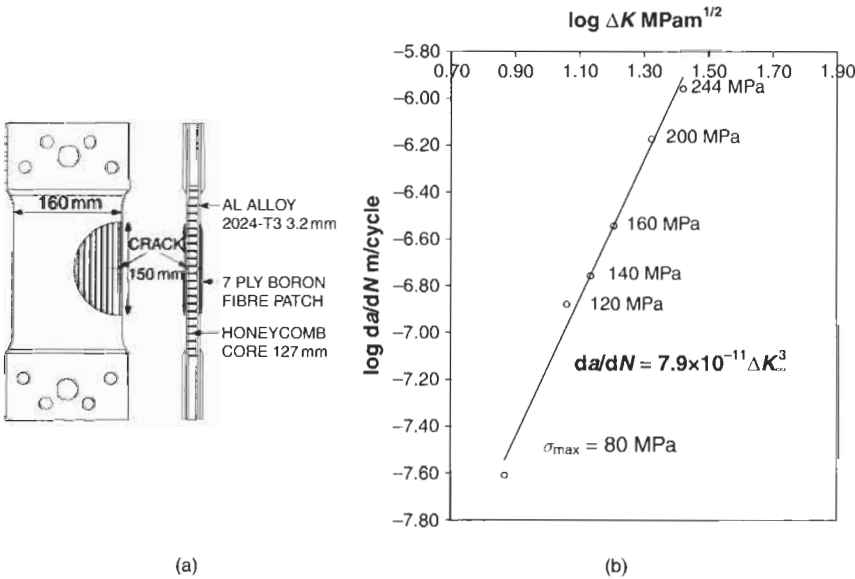
Fig. 22.3. (a) Generic structural detail test specimen for patched cracks in metallic structures used to validate the patching model and obtain crack-growth parameters and (b) plot of experimental $\log da/dN$ versus $\log \Delta K$, predicted from Rose's [10] analytical patching model.

Figure 22.3(a) depicts a structural detail specimen tested under constant-amplitude loading and Figure 22.3(b) plots $\log da/dN$ versus $\log \Delta K$ predicted using Rose's patching model [10]; where a is the crack length and K the stress intensity. These and other results help to validate use of this model as a practical approach for predicting K in simple cracking geometries. The growth of disbonds in the damage-tolerant zone can be incorporated in the model based on data from the generic joint tests [Chapter 5].
