Advances in the Bonded Composite Repair of Metallic Aircraft Structure

VOLUME 2

Chapter 19. Bonded Repair of Acoustic Fatigue Cracking 531

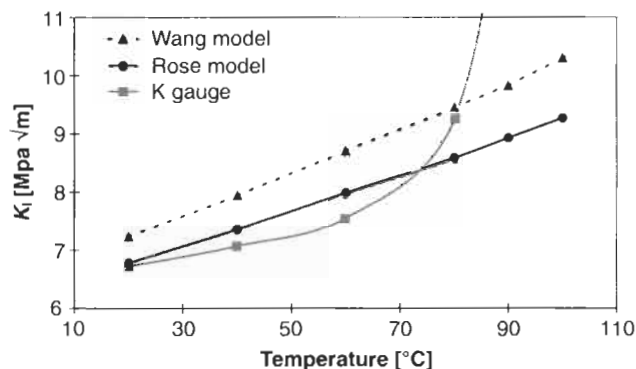
Fig. 22.4. Comparison of experimental and theoretical results for K_I for $a = 30$ mm, patched specimen. The models used for the theoretical predictions are Rose's model and a related model developed more recently by Rose and Wang. See Chapter 18.

As discussed in Chapter 18, in addition to the fatigue studies, for direct comparison with model predictions the stress intensity K was measured using K gauges bonded at the tip of a patched crack. As shown in Figure 22.4 agreement between measured and predicted K is quite good up to a temperature of around 70°C.

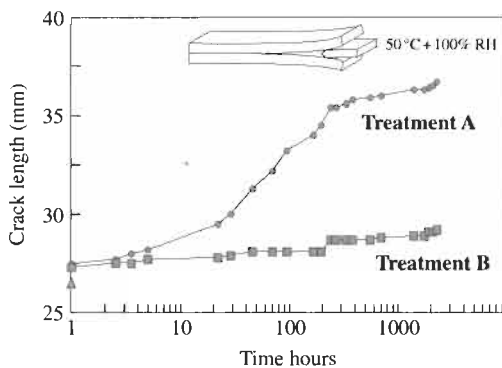
Fig. 22.5. Boeing wedge test to assess bond durability. The metallic adherends are made the aluminium alloy under investigation, generally about 3 mm thick bonded with the appropriate adhesive. The wedge is driven in under standard conditions.

It is proposed that the Boeing Wedge Test (BWT), depicted in Figure 22.5, fulfils this requirement for the following reasons:

Australia uses a severe version of the standard BWT. For example, an acceptable test result is generally less than 19 mm growth of the disbond in 1 h; while the requirement is less than 5 mm growth in 24 h or 7 mm in 48 h.

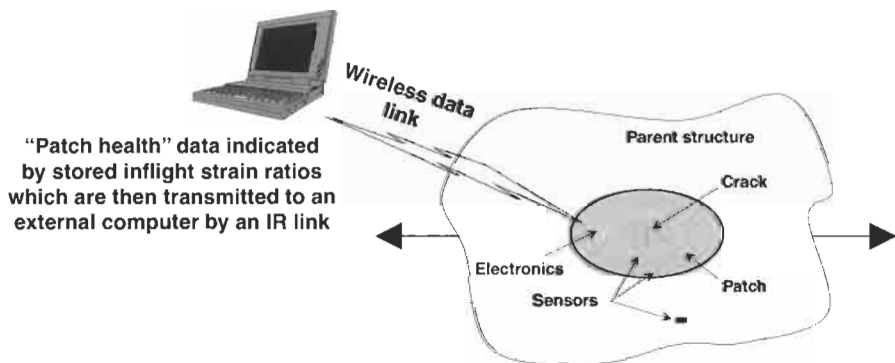
Fig. 22.6. Schematic diagram of the smart patch concept.

An alternative to certification procedures based on testing is the “Smart Patch” approach [1,16] Figure 22.6 – see also Chapter 20. The aim here is to develop a capability for continuous autonomous (self) monitoring of patch performance to ensure that the patch is performing in service as required. Although the need to follow the correct patch design and process procedures is unchanged, the “smart” approach should allow considerable relaxation in the certification requirements. However, failure of the patch system will still be a costly and therefore a highly undesirable event.

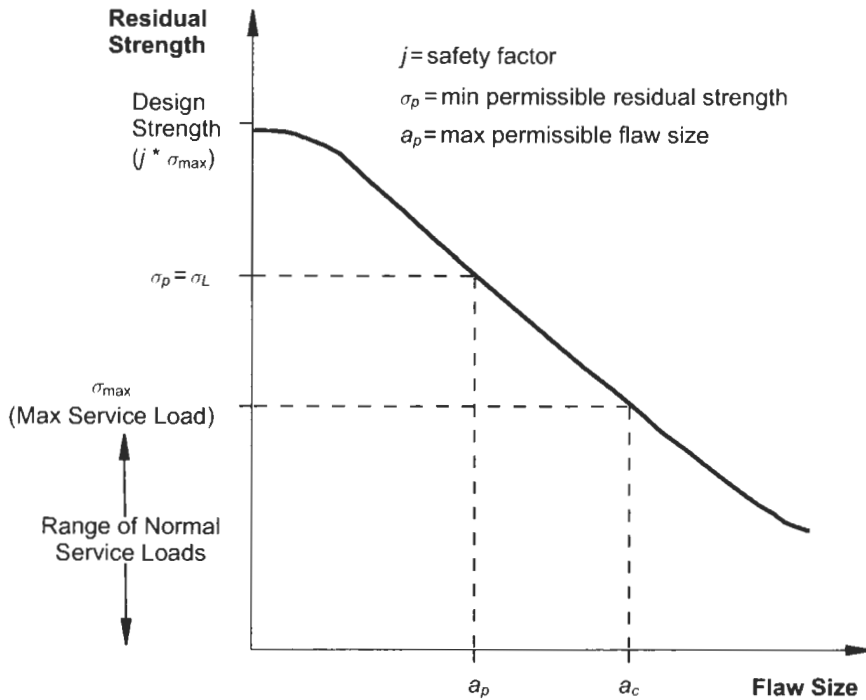
Fig. 23.1. Residual strength curve.

Damage tolerance is the ability of an aircraft structure to sustain damage, without catastrophic failure, until such time that the component can be repaired or replaced. The U.S. Federal Aviation Requirements (FAR 25) specify that the residual strength of the component shall not fall below, σ_L , the component stress at limit load, P_L . The limit load is anticipated to occur once in the life of an aircraft. This establishes the minimum permissible residual strength $\sigma_P = \sigma_L$. To varying degrees, the strength of composite doubler repairs is affected by crack, disbond, and delamination flaws. The residual strength as a function of flaw size can be calculated using fracture mechanics concepts. Figure 23.1 shows a sample residual

strength curve. The residual strength curve is used to relate the minimum permissible residual strength, σ_p , to a maximum permissible flaw size, a_p .

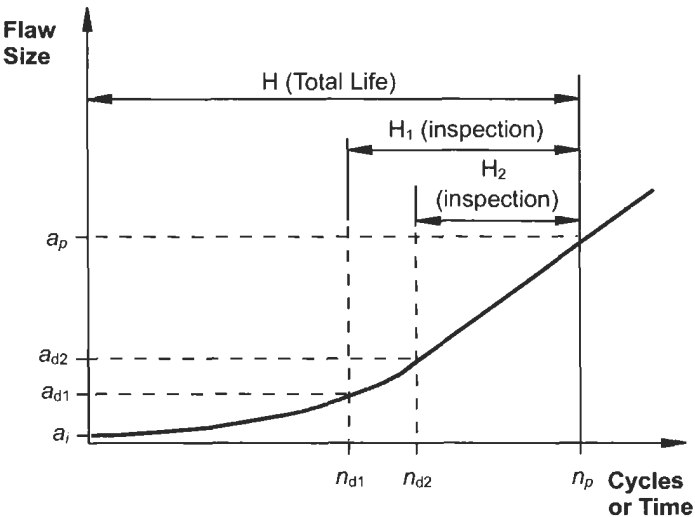
Fig. 23.2. Crack growth curve showing time available for fracture control.

An important NDI feature highlighted by Figure 23.2 is the large effect that NDI sensitivity has on the required inspection interval. Two sample flaw detection levels a_{d1} and a_{d2} are shown along with their corresponding intervals n_{d1} and n_{d2} . Because of the gradual slope of the flaw growth curve in this region, it can be seen that the inspection interval $H_1(\text{inspection})$ can be much larger than $H_2(\text{inspection})$ if NDI

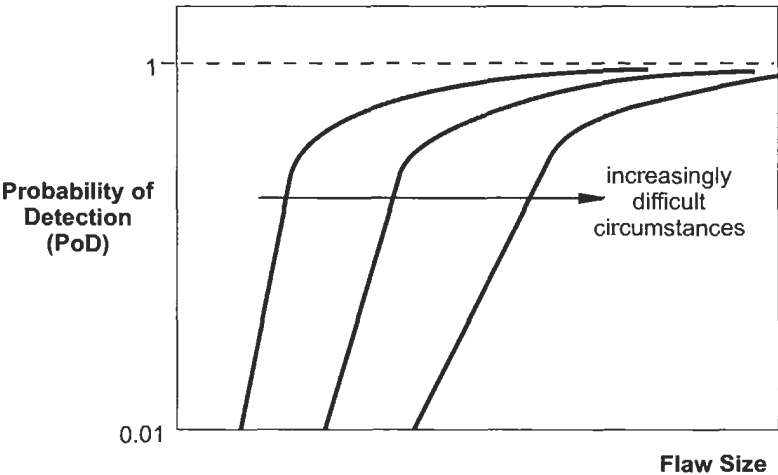
Fig. 23.3. Effect of circumstances on probability-of-detection.

at a_p . For any given inspection task, the POD is affected by many factors such as: (1) the skill and experience of the inspector, (2) accessibility to the structure, (3) exposure of the inspection surface, and (4) confounding attributes such as underlying structure or the presence of rivets. Thus, the effects of circumstances on POD must be accounted for in any NDI study. Figure 23.3 shows how increasingly difficult circumstances can degrade the POD of an NDI technique.

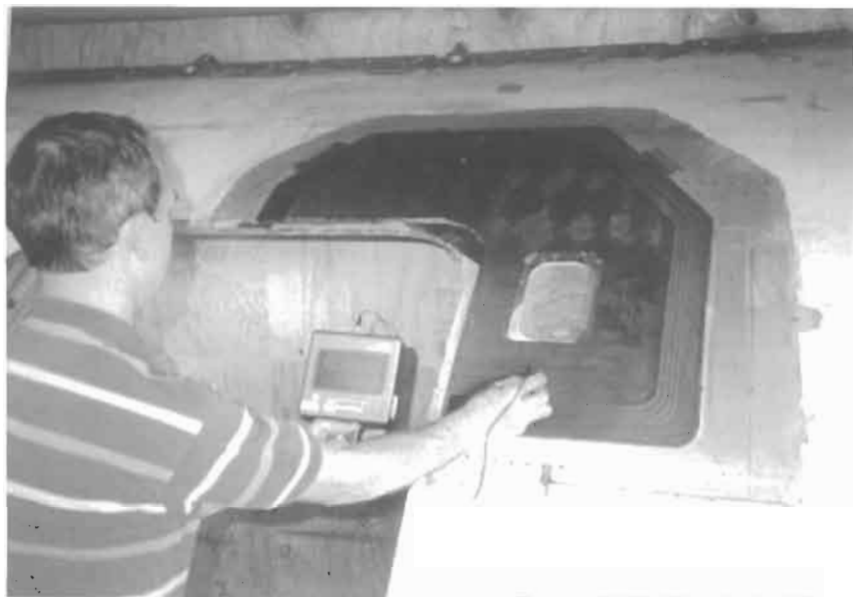
Fig. 23.4. Pulse-echo ultrasonic inspection of door corner composite doubler using a Quantum A-scan device.

Figure 23.4 shows a Quantum device being used to perform a PE UT bondline inspection of a composite doubler bonded to an L-1011 fuselage structure. Figure 23.5 contains two A-scan signals produced by the hand-held transducer inspection

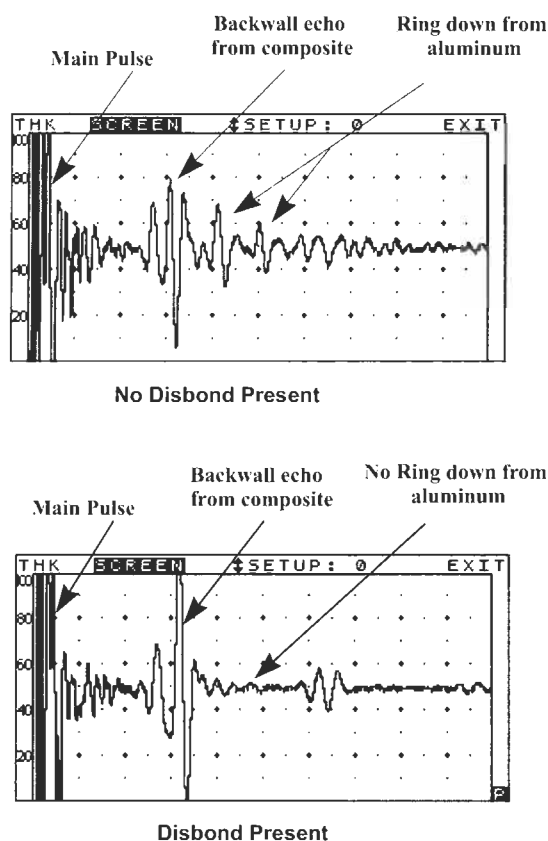
Fig. 23.5. A-scan waveform from bonded and disbonded portions of a composite doubler test specimen.

(gel couplant) of another doubler specimen which contained intentional, engineered flaws at discrete locations. Changes in the A-scan signal (i.e. lack of reflected signal from aluminum back wall), caused by the presence of the disbond, are clearly visible. The primary items of note in Figure 23.5 are: (1) the unique signature of the amplitude vs time waveform which allows the user to ascertain the transmission of the ultrasonic pulse through various layers of the test article and which indicates a good bond, and (2) the absence of signature waveforms indicating a disbond.

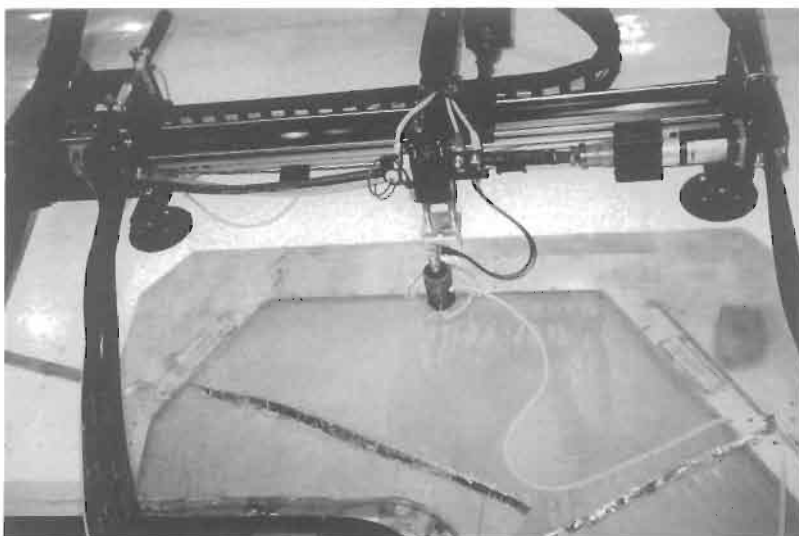
Fig. 23.6. Ultrasonic scanner system inspecting a tapered region of the L-1011 door corner doubler.

A basic C-scan system (SAIC/Ultra Image Inc.) that has been used to inspect bonded composite doublers is shown in Figure 23.6. The scanning unit containing the transducer is moved over the surface of the test piece using a search pattern of closely spaced parallel lines. A mechanical linkage connects the scanning unit to X-axis and Y-axis position indicators which feed position data to the computer. The echo signal is recorded, versus its X-Y position on the test piece, and a color

coded image is produced from the relative characteristics of the sum total of signals received. The entire ultrasonic C-scan device is attached to the structure using suction cups connected to a vacuum pump. The unit is tethered to a remotely located computer for control and data acquisition. Pneumatic pressure is used to maintain a constant transducer force against the part being scanned.

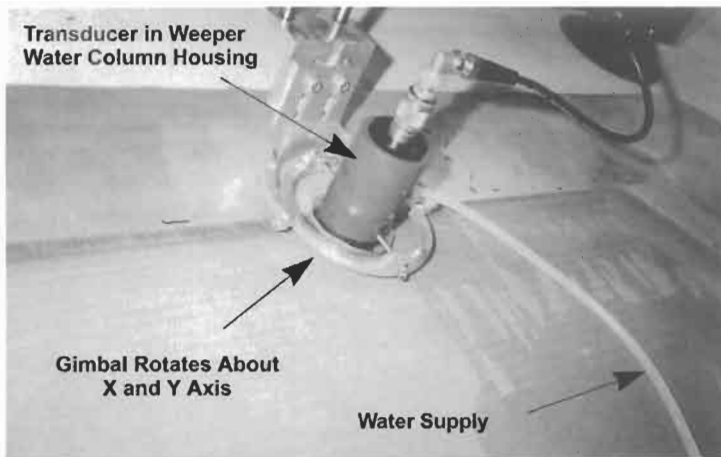
Fig. 23.7. Close-up view of ultrasonic transducer and weeper system for optimized coupling.

Scanner systems can be enhanced through the use of, for example, “dripless bubbler” [11] or “weeper” systems to optimize ultrasonic coupling. A weeper system integrated with the Ultra Image scanner is shown in Figure 23.7. The weeper forms the transducer arm of the scanning unit and consists of a UT emitter/receiver transducer in a water column. The weeper body is a cylinder with a plastic membrane at the base. Within the weeper body, a column of water is contained between the membrane and the transducer. The membrane is pierced several times to produce a suitable water flow between the membrane and the inspection surface. Water is continuously pumped into the weeper body in order to maintain the water column and the water couplant “pool” between the weeper body and the inspection surface. This water column and associated water pool beneath the membrane

provides very uniform and consistent coupling for the ultrasonic waves moving into and out of the test article. This eliminates data irregularities, provides more energy at the inspection point, and produces better output signals (less dispersion). The end results are: (1) improved signal-to-noise (amplitude), (2) better time-of-flight data, and (3) greater flaw detection resolution.

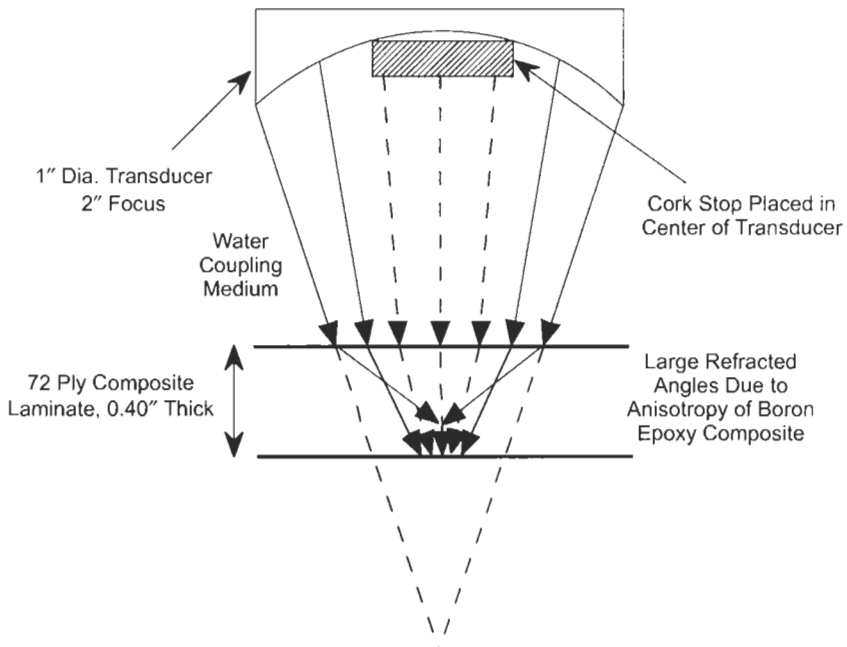
Fig. 23.8. Ray traces for a 1.0" (25 mm) diameter, 2" (51 mm) focus transducer and a 72-ply boron-epoxy sample.

The diagram in Figure 23.8 shows ray traces, drawn from the 1" (25 mm) diameter transducer, which focus on the aluminum bondline interface of a 72-ply boron-epoxy repair patch. The large refracted angles for the outer rays of the ultrasonic beam are due to the elastic anisotropy of the composite that changes significantly from the thickness direction to the transverse direction of the composite. The refracted angles in the composite shown in Figure 23.8 were calculated using L-wave velocity values that were measured in a small 72-ply boron-epoxy laminate coupon.

From Figure 23.8 it is seen that by placing a stop comprising a 0.38" (9.7 mm) diameter, 0.25" (6.4 mm) thick, cork button in the center of the transducer, the zero degree ray together with all low angle rays are blocked so that only the faster velocity rays are transmitted in the sample at large refracted angles. The faster

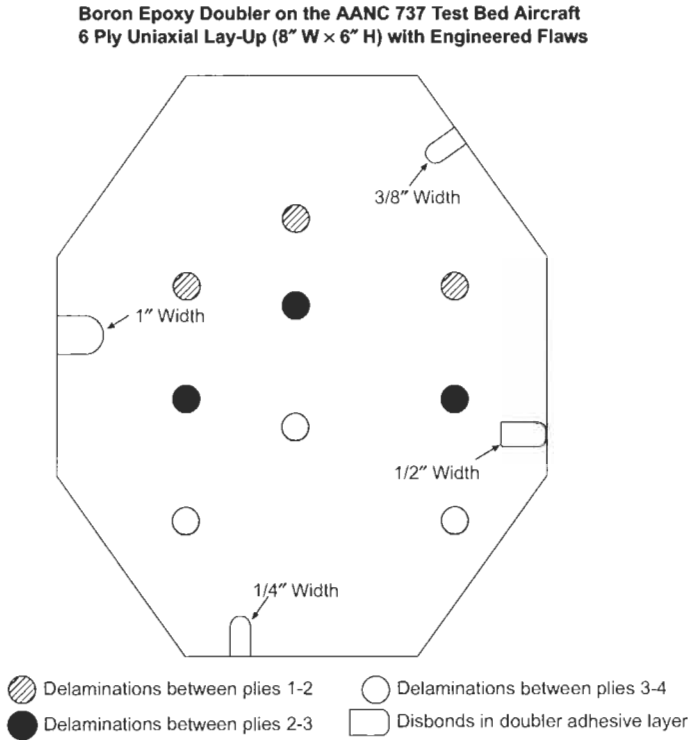
Fig. 23.12. Schematic of 737 testbed doubler showing engineered flaws.

The Ultra Image scanner system was deployed on the 737 Transport Aircraft Testbed at the AANC hangar to inspect a 6-ply thick octagon shaped doubler. Figure 23.12 shows a schematic of the doubler depicting the size and location of the implanted flaws while Figure 23.13 shows a C-scan image produced by the scanner system. (A similar result was obtained with another scanning system which employed a dripless bubbler transducer arrangement [14].) In the gray-scale image, the flaws are shown as the brighter colored areas within the dark baseline. It can be

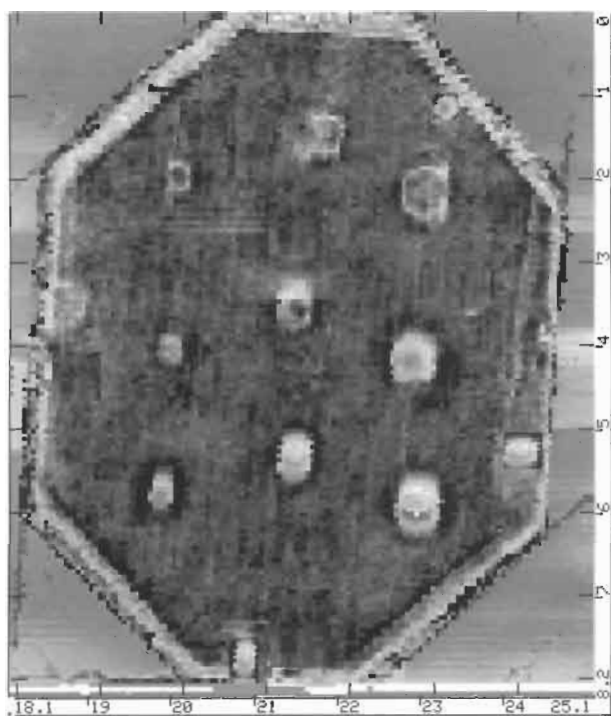
Fig. 23.13. Grey-scale C-scan image of 737 doubler produced by the scanner system.

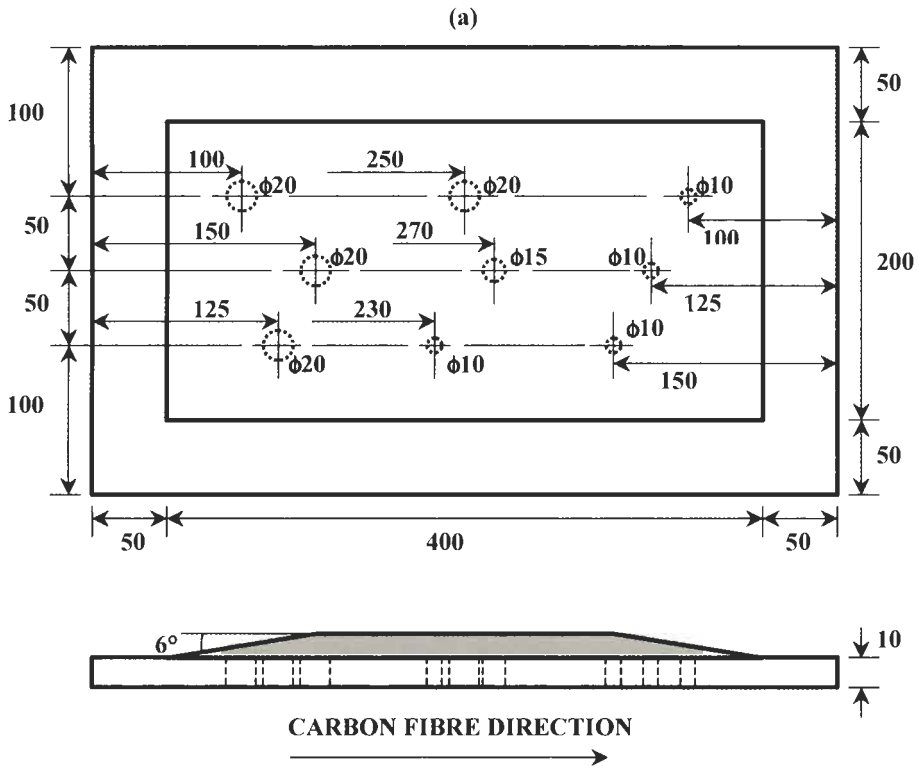
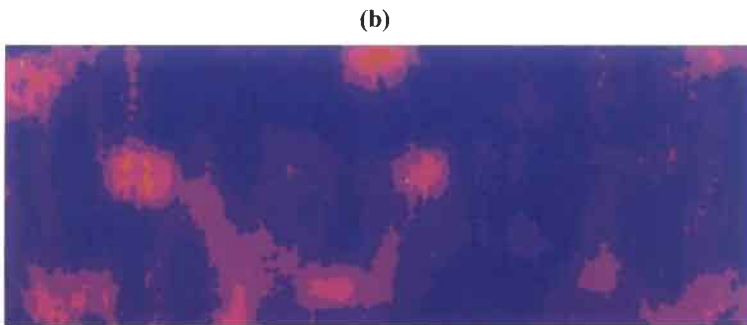
Fig. 23.14. Simulated specimen II: (a) severe disbands between composite reinforcement and frigate deck simulated using through-thickness holes in the 10 mm thick substrate; (b) corresponding C-scan result for the scanned region. (The color scale in order of decreasing ultrasonic sensor amplitude is blue to orange.) [15]

- Specimen I was manufactured as a control specimen and did not contain any simulated defects.
- Specimen II (Figure 23.14) was made to study severe composite reinforcement disbonding. Drilled holes in the decking at the reinforcement/deck interface were used to represent the case where the disbonded surfaces are well separated, resulting in an air gap. The holes ranged in diameter from 10 mm to 20 mm and were located at a range of positions under the reinforcement.

Figure 23.14 shows the *C*-scan results from Specimen II containing holes in the decking material at the reinforcement/deck interface to simulate air-gap disbonds. Comparison of (a) and (b) in Figure 23.14 shows that all holes were detected with the exception of a 10 mm diameter hole whose location coincided with the change in reinforcement profile from uniform thickness to a wedge, making probe coupling difficult. The ultrasonics results also indicate that some disbonding was present in the specimen, particularly near the edges of the reinforcement and in some cases associated with the presence of the holes.

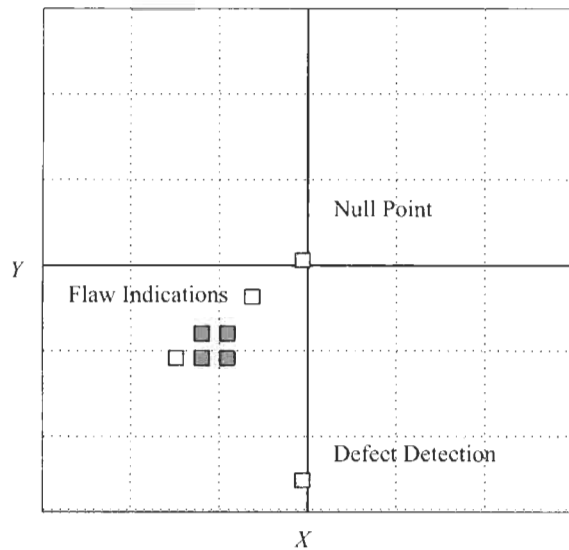
Fig. 23.17. Representative bondtester output for disbond and delamination inspections on 13-ply fatigue coupons.

High frequency ultrasonic resonant bond inspection was evaluated at the FAA/AANC on an array of composite doubler test specimens. A Staveley Sonic Bondmaster instrument was used to perform the inspections. A narrow banded 0.5" (12.7 mm) diameter transducer was driven at its resonant frequency of 330 kHz and placed on the composite doubler with the use of gel couplant [25]. The boron-

epoxy had a damping effect on the transducer. The primary results were increased bandwidth, shift in resonant frequency, and change in signal amplitude. The transducer was nulled on an unflawed composite area on a calibration standard. The transducer was then moved to the composite doubler being inspected. Changes in the acoustic impedance of the transducer as it moves over a flawed area were detected. The flaw changed the standing wave pattern in the material. These changes were subsequently detected as differences in the acoustic impedance at the surface of the material caused by loss of material damping.

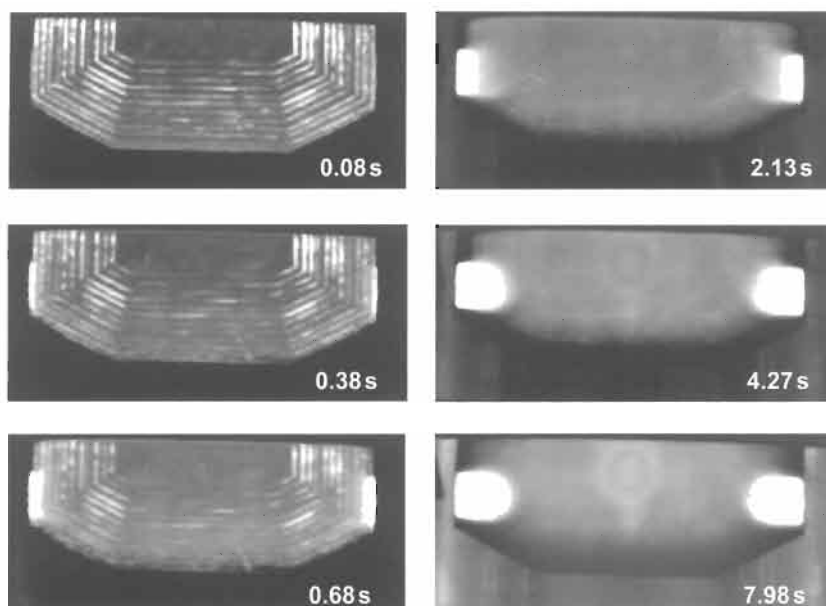
Fig. 23.19. Sequence of thermal wave images for a composite doubler coupon with embedded flaws.

disbond and crack flaws installed on an aluminum fatigue coupon while a sequence of images produced at different times during TWI inspection of this test specimen are shown in Figure 23.19. The early time images following the flash clearly resolve the ply drop-off at the edges of the 13-ply composite doubler. Beginning at around 0.68 s, intentionally placed disbonds between the doubler and the aluminum at the left and right edges (where the doubler is thinnest) begin to appear. As time progresses, these disbonds begin to show in thicker and thicker layers of the doubler. Between 4 and 8 s it is possible to see the circular disbond which was implanted over the crack tip and a "tail" extending downward along the induced

fatigue crack. The circular disbond was located 13 plies deep in the doubler installation. The disbond tail was also located between the 13-ply doubler and the aluminum skin and was associated with a cohesive fracture of the adhesive layer immediately adjacent to the crack growth.

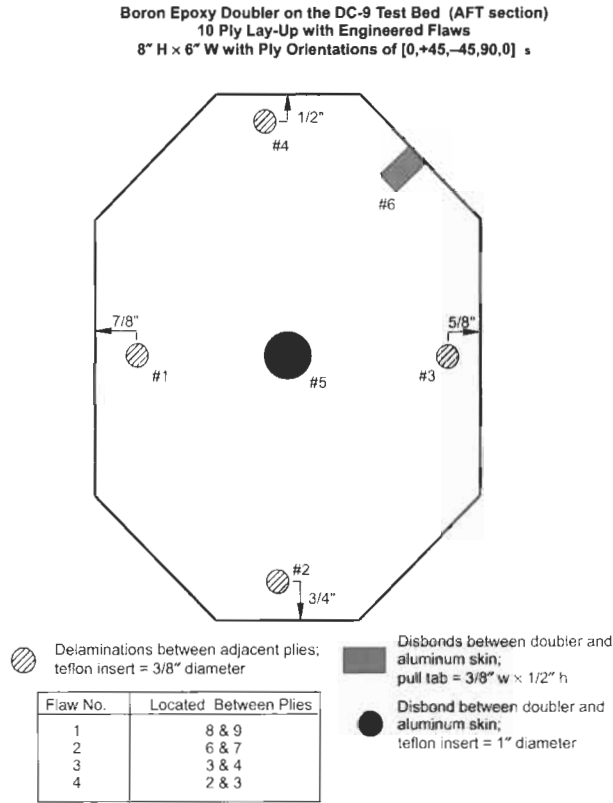
Fig. 23.20. Composite doubler installation on DC-9 testbed.

TWI was also applied to a boron-epoxy doubler which was installed on a DC-9 fuselage section in the AANC hangar. Figure 23.20 shows a schematic of the 10-ply doubler installation which identifies the size, shape, and location of the embedded flaws. The resultant sequence of images produced by a TWI inspection are shown in Figure 23.21. The features seen at early times are defects closest to the outside surface of the doubler (note appearance of flaws #1 and #2 in the first few frames). The disbonds, located at the base of the 10-ply doubler, and the deeper delaminations appear in the later frames corresponding to their delayed effect on the thermal field. All six embedded flaws were identified in the TWI images and flaws smaller than 0.5" (12.7 mm) in diameter could be detected. Another item of note is that the flaws around the perimeter of the doubler, at its thinnest region, are clearly imaged and do not induce the imaging difficulties observed in the UT C-scan results.

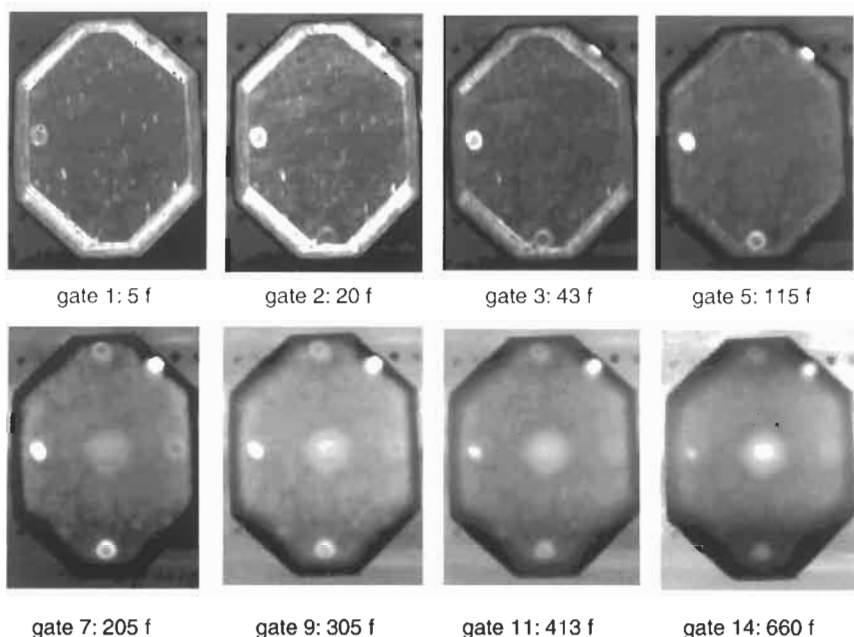
Fig. 23.21. Sequence of thermal wave images from DC-9 composite doubler inspection. (Frame time, $f = 1/60$ of a second.)

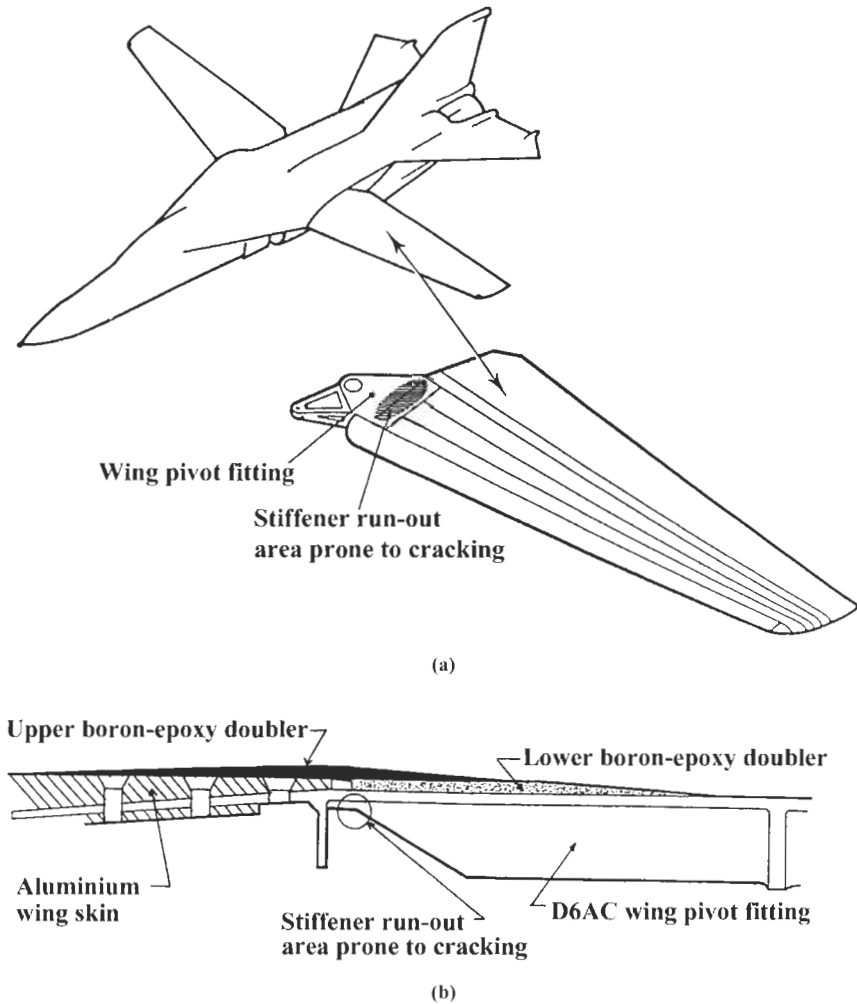
Fig. 23.22. (a) F-111C aircraft wing pivot fitting (WPF); (b) cross-section of the WPF and wing skin showing boron-epoxy doublers deployed over the region prone to cracking. [36]

challenging boron-epoxy reinforcement applications, viz. reinforcement of the complex wing pivot fitting (WPF) region in the F-111 aircraft. Fatigue cracking in the upper WPF of F-111 aircraft had led to the catastrophic failure of several wings during cold-proof testing. Conventional repair methods were impractical due to fitment problems. Therefore, an all boron-epoxy bonded external doubler repair was proposed in 1988 to extend the life of the WPF (Figure 23.22).

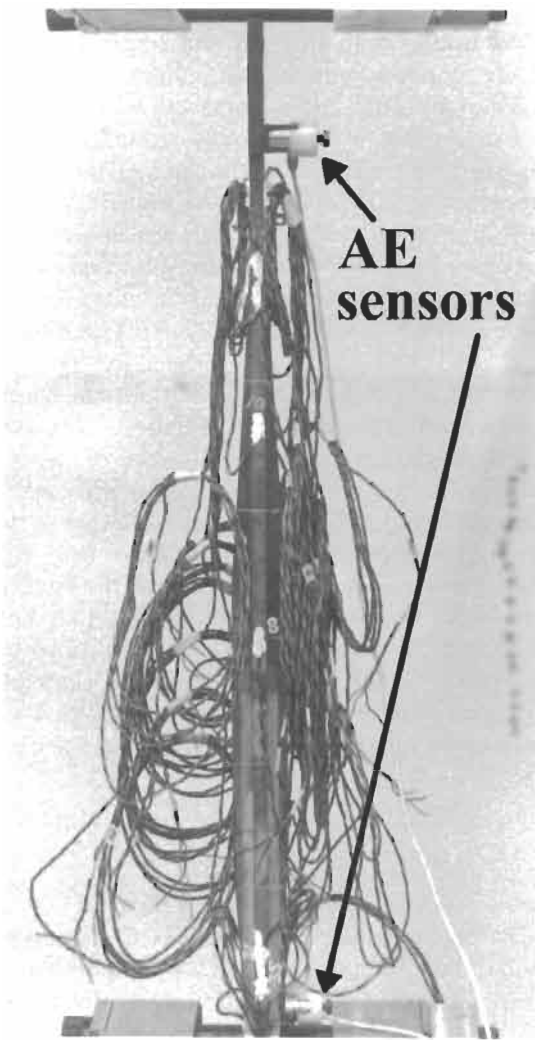
Fig. 23.23. Simulated WPF specimen. [36]

At the time of stage (ii) AE monitoring, the DART was required for other AE testing. Therefore, an AET-5000 locator was selected for AE signal processing. The locator allowed linear location of AE from two sensors which were attached at both ends of the long simulated WPF specimen (Figure 23.23). Acceptance/rejection criteria for AE from disbonding were specified in terms of arrival times of signals at the two sensors. Stage (ii) AE monitoring of possible disbonding in the simulated WPF specimen was carried out during two series of fatigue cycling and cold-proof testing. No AE events were detected during either series of fatigue cycling. A comparison of the AE results from the two cold-proof tests indicated that more AE events were detected in the second test, which suggested that damage had occurred in the latter test. The damage predicted by AE was confirmed by visual inspection of the specimen after the second cold-proof test – considerable disbonding in a tapered section of the reinforcement was apparent. Given the promising results obtained, AE is considered to be a promising technique for disbond detection for future applications.

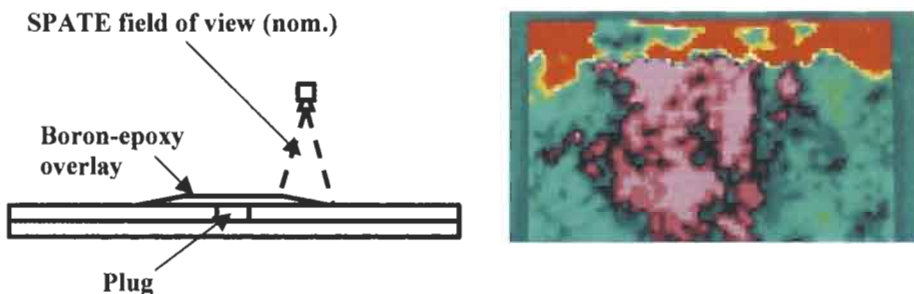
Fig. 23.24. Bonded plug simulated repair coupon and SPATE image. [38]

A study [38] employing a SPATE (stress pattern analysis by thermal emission) system was undertaken for a number of specimen types. The SPATE system was a single detector system which detected the infrared radiation emitted from a specimen surface as a result of the minute temperature changes during cyclically stressing of the specimens. For specimens with boron-epoxy overlays over surface cracks, SPATE image data and numerical modelling data indicated the possibility of using thermal emission techniques to monitor crack growth or delamination beneath the overlays. The study also considered corrosion occurring on wing skins, particularly on or adjacent to skin splices. Of interest were corrosion repairs where the corroded region is cut out and replaced by a metal plug with a composite overlay bonded over the plug and the surrounding region. Bonded plug simulated repair coupons (Figure 23.24) were fabricated from aluminum substrates and boron-epoxy overlays. During fatigue testing of these coupons, SPATE images were employed not only for stress analysis but also for indicating delamination and its growth after defined increments in the load spectrum. A SPATE image indicating minor delamination near one end of the overlay as well as a delamination region in from the end is shown in Figure 23.24.

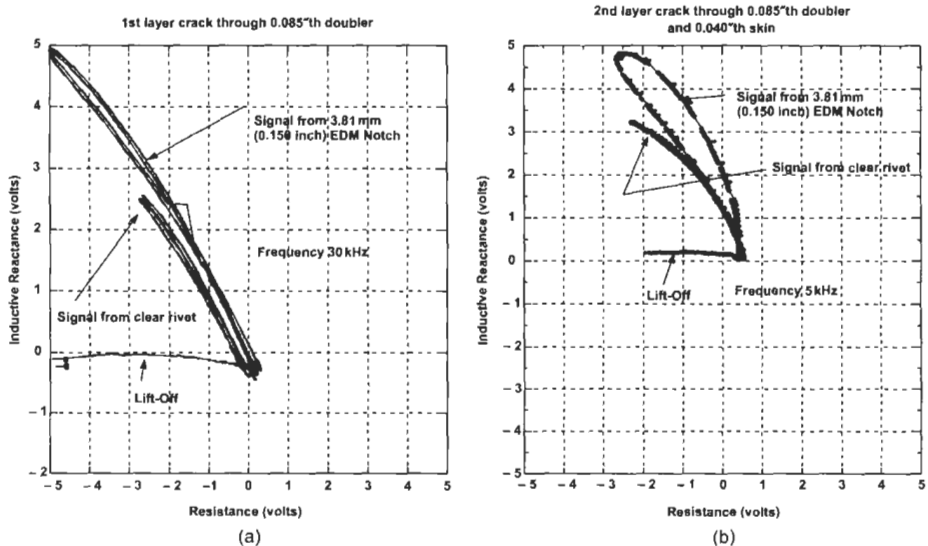
Fig. 23.26. EC signal for (a) 1st layer crack through 0.085" (2.2 mm) thick doubler and (b) interlayer crack through 0.085" (2.2 mm) thick doubler and 0.040" (1.0 mm) thick skin.

Figure 23.26 shows representative EC signals from cracked structure located beneath boron-epoxy doublers. Two variations are shown to demonstrate the ability of EC to detect both first (surface) and interlayer (substructure) cracks in aircraft structure. Initial testing conducted by the AANC on composite doubler specimens with cracks in the parent aluminum skin established the following general limits of crack detectability through composite doublers:

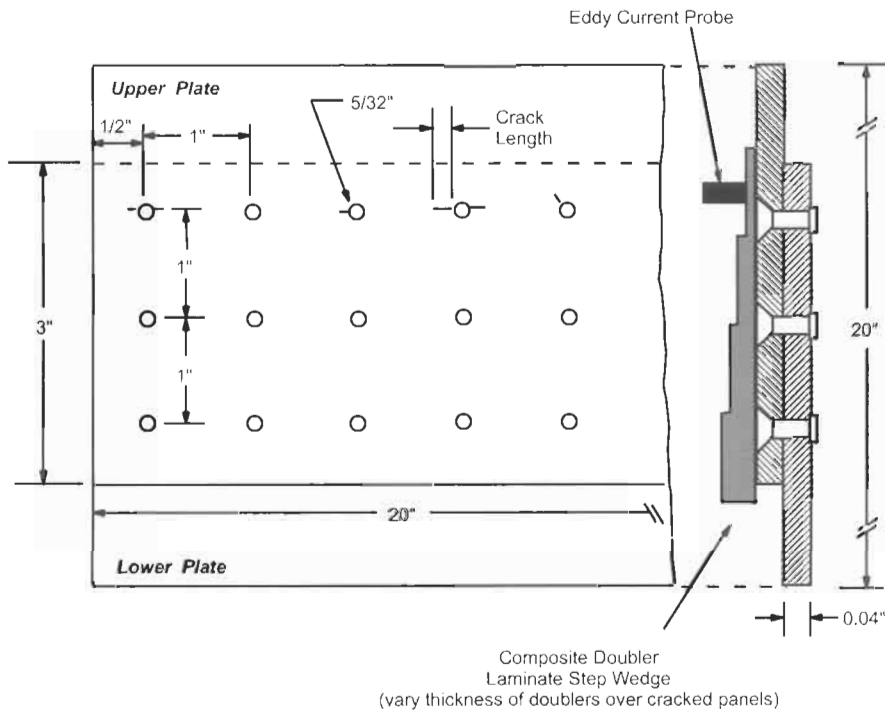
Fig. 23.27. Test set-up for detection of surface cracks through composite doublers.

The POD study utilized a series of surface crack and subsurface crack aircraft panels. These panels, which mimic a Boeing lap splice joint, contained an assortment of fatigue cracks with specific lengths which were carefully engineered in the upper or lower skins [43]. To determine the limits of crack detectability through composite doublers of various thicknesses, a composite laminate step wedge was superimposed over the lap splice crack panels as shown in Figure 23.27. In these specimens, the cracks were located in the upper rivet row of the outer skin (i.e. surface cracks).

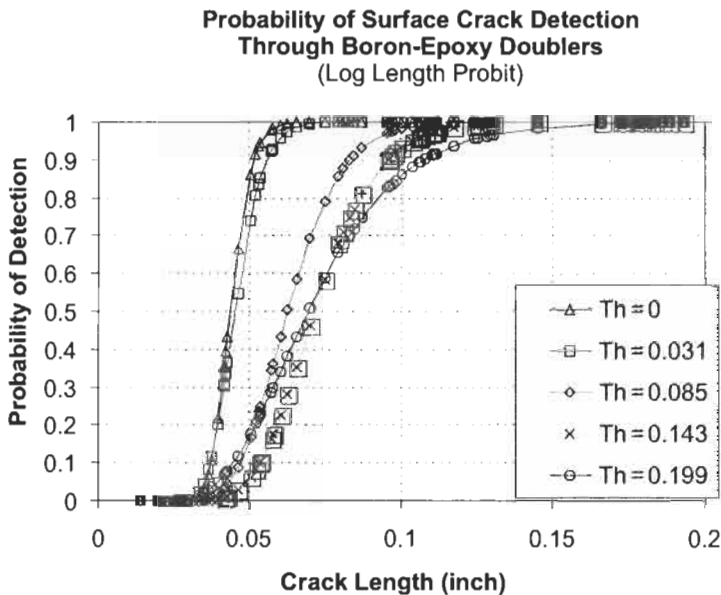
Fig. 23.28. Probability-of-detection curves for eddy current surface crack inspections through different thicknesses of composite doublers.

A suite of 18 lap splice panels was inspected through four laminate thicknesses (Table 23.1). Figure 23.28 shows the resulting POD curves which were generated from the inspections on surface crack panels using a sliding probe. It can be seen that all cracks of 0.17" (4.3 mm) length and greater were found regardless of the thickness of the composite doubler. Also, the family of curves follow the general trend presented earlier in this chapter where the POD performance diminishes with increasingly difficult circumstances (Figure 23.3). Thus, as the doubler becomes thicker the POD drops off slightly. These results are quite good in light of the damage tolerance requirement to find fatigue cracks beneath doublers before they

reach 1" (25 mm) in length. The EC detection capabilities corresponding to the standard 95% POD goal are summarized in Table 23.1.

Composite doubler thickness	Number of plies	Surface crack length at 95% POD threshold
No doubler	0	0.053" (1.3 mm)
0.031" (0.79 mm)	5	0.059" (1.5 mm)
0.085" (2.2 mm)	15	0.091" (2.3 mm)
0.143" (3.63 mm)	25	0.103" (2.61 mm)
0.199" (5.05 mm)	35	0.121" (3.07 mm)

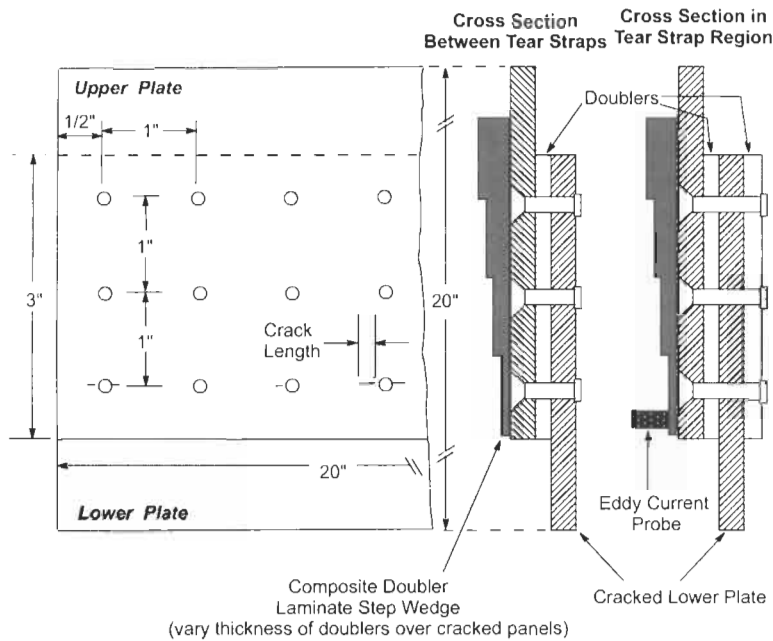
Fig. 23.29. Test set-up for detection of subsurface cracks through composite doublers.

A second POD study was performed to assess eddy-current crack detection of subsurface cracks through composite doublers. The subsurface crack test panels were also lap splice joints with two different skin thickness sets: (1) top plate, bonded doubler, and bottom plate were all 0.40" (10.2 mm) thick, and (2) top plate, bonded doubler, and bottom plate were all 0.36" (9.1 mm) thick. Figure 23.29 shows the lap splice configuration where the cracks are in the lower row of the inner skin (third layer). The major difference between these specimens and the surface crack panels shown in Figure 23.27 is the presence of the bonded aluminum doubler between the upper and lower skins. Thus, this experiment challenged eddy-current inspections to detect third layer cracks through either 0.80" (20.3 mm) thick material comprising two 0.40" (10.2 mm) thick layers or 0.72" (18.3 mm) thick material comprising two 0.36" (9.1 mm) thick layers.

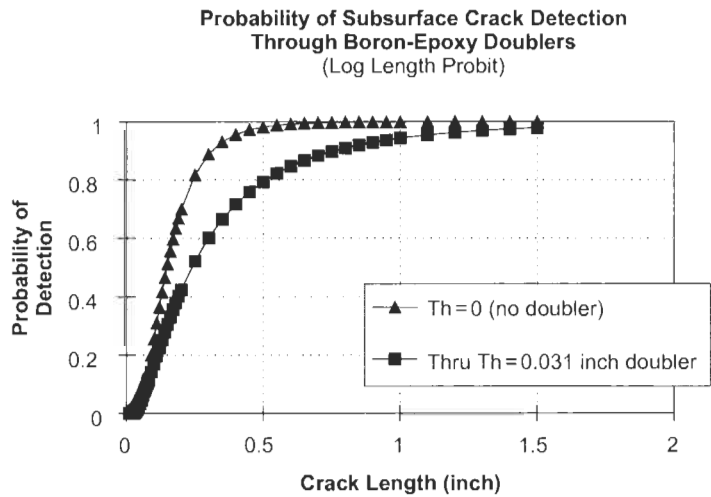
Fig. 23.30. Probability-of-detection curves for eddy current subsurface crack inspections through different thicknesses of composite doublers.

A suite of 17 lap splice panels was inspected without a doubler in place and then again after placing the 0.031" (0.79 mm) thick (5 plies) doubler over the cracked panels. Figure 23.30 shows the resulting POD curves which were generated from

the inspections on the interlayer crack panels, again using a sliding probe. The interlayer crack detection is shifted to the right relative to the surface crack POD curves because of the added depth of penetration required for the eddy current (and the associated loss in resolution). However, the curves do infer that cracks of 1" (25 mm) and greater can be detected in subsurface structures beneath composite doublers. It should be noted that the curves were generated by producing a fit through the data. There were insufficient crack detections to fully populate the curve and thus portions of the curves are extrapolations using accepted POD curve fitting algorithms. Therefore, a table of 95% POD values, which would be primarily extrapolation numbers, is not presented for the interlayer POD study.

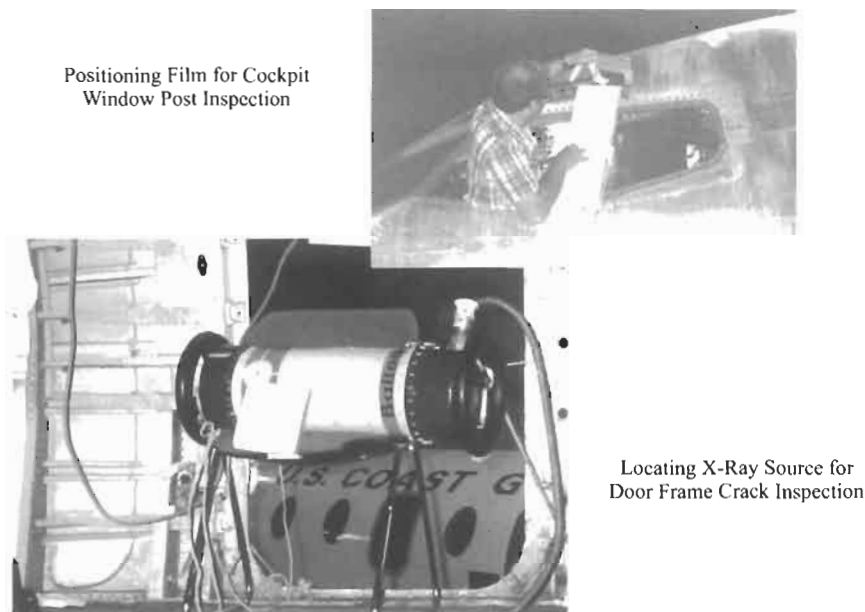
Fig. 23.31. Aircraft fuselage inspection for cracks using X-radiography.

Radiographic inspection is a nondestructive method of inspecting materials for surface and subsurface discontinuities [41]. The method utilizes very short wavelength radiation in the form of either X-rays or gamma rays. The waves penetrate the material and are absorbed depending on the thickness or density of the material being examined. By recording the differences in absorption of the transmitted waves, variations in the material can be detected. Figure 23.31 shows an application of X-radiography in a hangar environment.

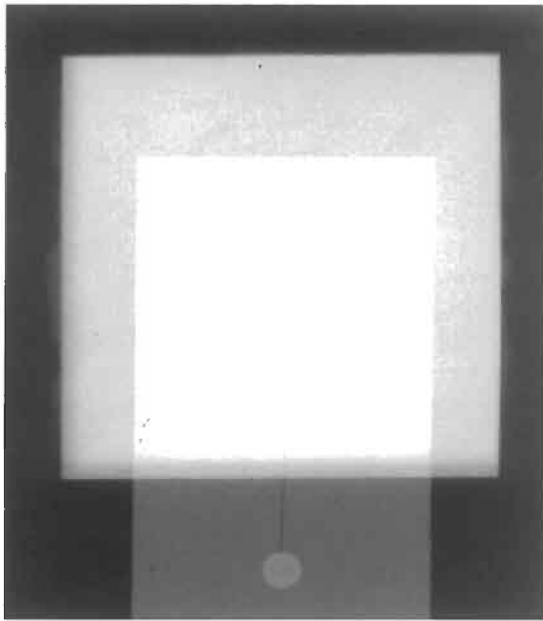
Fig. 23.32. Sample X-radiograph of a cracked aluminum structure beneath a 72-ply composite doubler.

The specified damage detection threshold for cracks under the doubler is 1.0" (25 mm) (for L-1011 application). Test results showed the ability to detect cracks less than 1" (25 mm) in length. The EDM notches, length range of 0.25" to 1.0" (6.4 mm to 25 mm), were readily apparent in the X-radiographs. Further, fatigue cracks of the order of 0.38" (9.7 mm) in length were found under 0.41" (10.4 mm) thick (72 ply) boron-epoxy doublers. A sample X-radiograph of a crack imaged through a 72-ply composite doubler is shown in Figure 23.32. (Note that significant resolution is lost in translating the X-radiograph to a black and white graphic.) Comparisons with X-radiographs taken without composite doublers revealed that while the doubler may darken the X-radiograph image slightly it does not impede

the X-radiographic inspection. Power and exposure times were adjusted in order to restore the desired contrast and maintain the specified film density of between 2 and 3. The initial set-up, employing 80 kV, 12 mA, 6'' (150 mm) source-to-film-distance, 30 s exposure time, and medium speed film, produced a film density of 0.98. Increasing the exposure time to 90 s produced a film density of 2.64. Image quality indicators (IQI), inserted into the field of view, verified the resolution and sensitivity of the radiographic technique. IQI lines with widths of 0.010'' (0.25 mm) and dots with diameters of 0.10'' (2.5 mm) were clearly imaged on the X-radiograph. These results showed that X-radiographic inspections are as effective as before a doubler is installed.

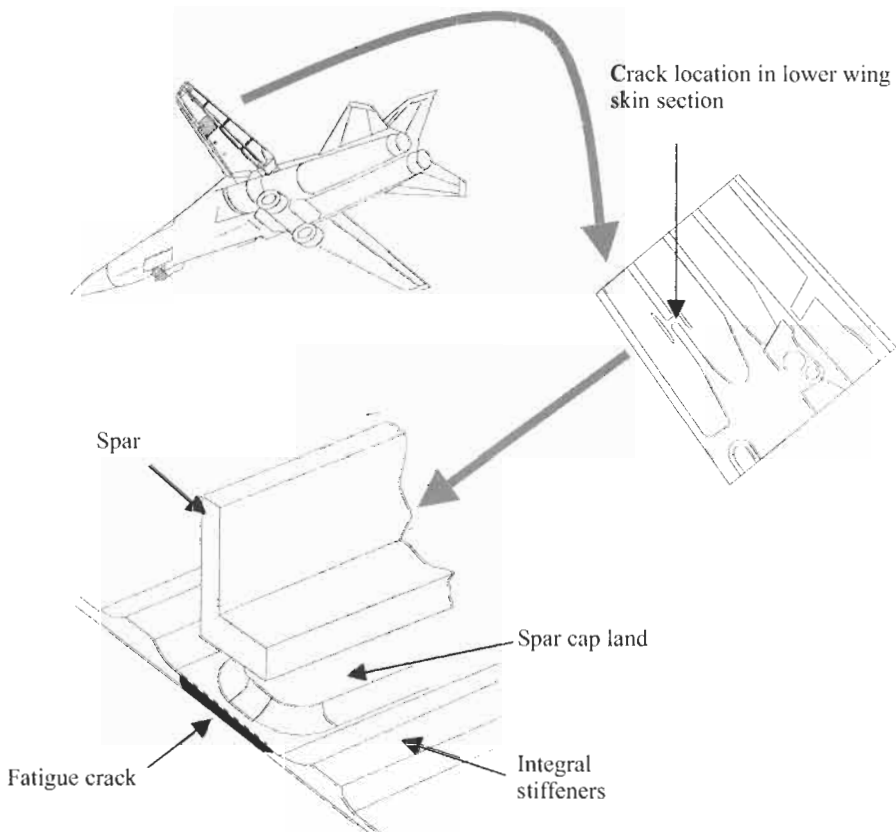
Fig. 23.33. Fuel flow passage area of F-111 lower wing skin.

Experimental testing was undertaken at DSTO to verify a bonded boron-epoxy repair to a 48 mm long through-thickness fatigue crack in a fuel-flow passage area of the lower wing skin of an F-111C aircraft of the Royal Australian Air Force (RAAF) as shown in Figure 23.33. The crack had reduced the residual strength of the wing to below the Design Limit Load. This was the first time that a bonded composite repair had been applied to a critical defect in a primary aircraft structure and represented the most critical application of bonded repair technology yet undertaken anywhere in the world.

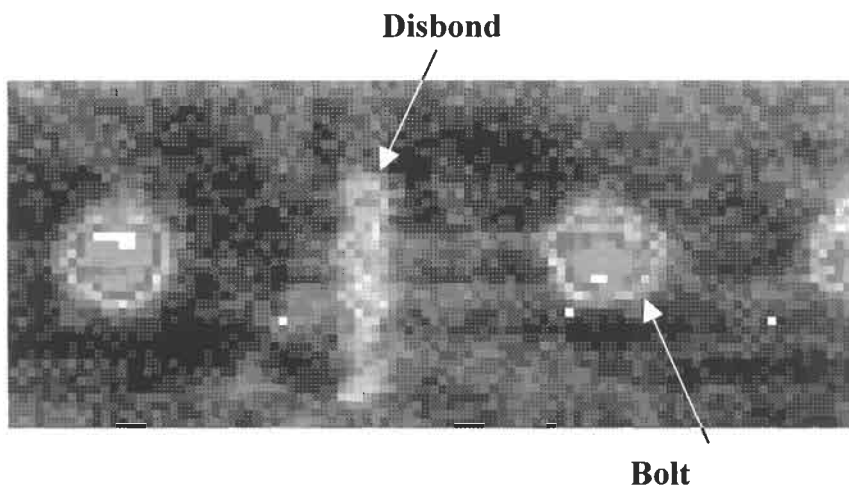
Fig. 23.34. Ultrasonic C-scan of central region of a box specimen showing disbonding around crack. [47]

RAAF eddy-current techniques were used to measure the through-thickness crack lengths to within 1 mm through the reinforcements on both the panel and box specimens and were used to monitor crack growth behavior during fatigue testing. Ultrasonic C-scan inspection was performed on the boron-epoxy reinforcements after specimen fabrication to confirm reinforcement and bond integrity. Ultrasonic C-scan inspection was also employed to verify the location and size of simulated disbonds (teflon inserts) in a number of the coupon specimens. Ultrasonic A- and C-scan inspection of fatigue loaded panel and box specimens indicated disbonding along the cracks for widths up to ~6 mm (Figure 23.34) and, for the box specimens, also some disbonding at the ends of the reinforcements. Teardown inspections were performed but were inconclusive as to the extent of disbonding.

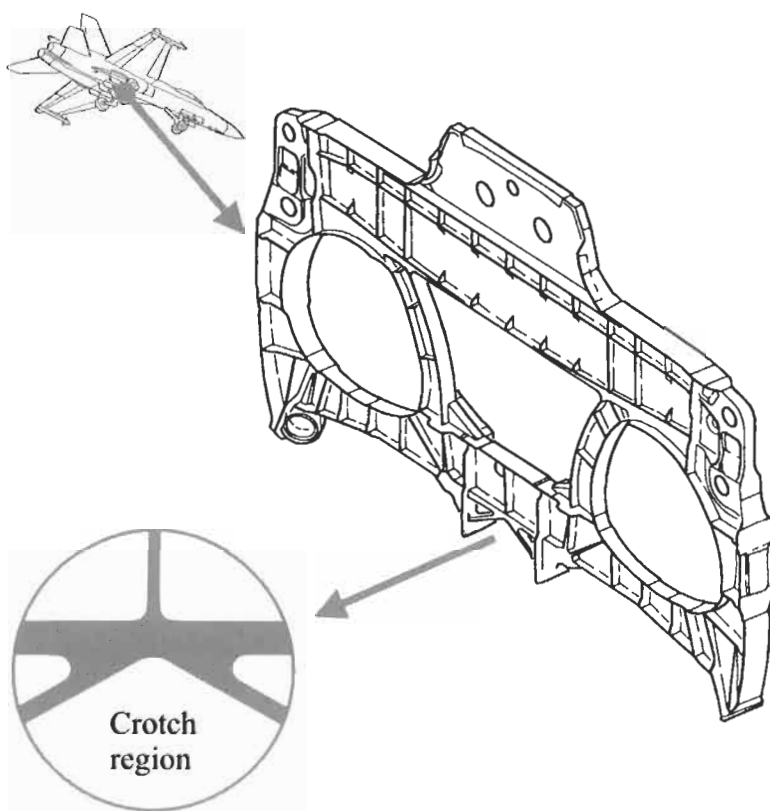
Fig. 23.35. Crotch region of Y470.5 bulkhead of F/A-18 aircraft.

The crotch region of the Y470.5 bulkhead (made from aluminum alloy 7050 T7451) was identified as a potential site for fatigue cracks early in the life of the F/A-18 aircraft (Figure 23.35). The RAAF requested DSTO to investigate the use of a bonded composite reinforcement that could be applied to this region to extend the life of the bulkhead. This also necessitated NDE research associated with the bulkhead reinforcement. The NDE research was carried out in conjunction with the full-scale testing of an F/A-18 aircraft using test article FT-55 in Canada.
