Advances in the Bonded Composite Repair of Metallic Aircraft Structure

VOLUME 2

Chapter 19. Bonded Repair of Acoustic Fatigue Cracking 531

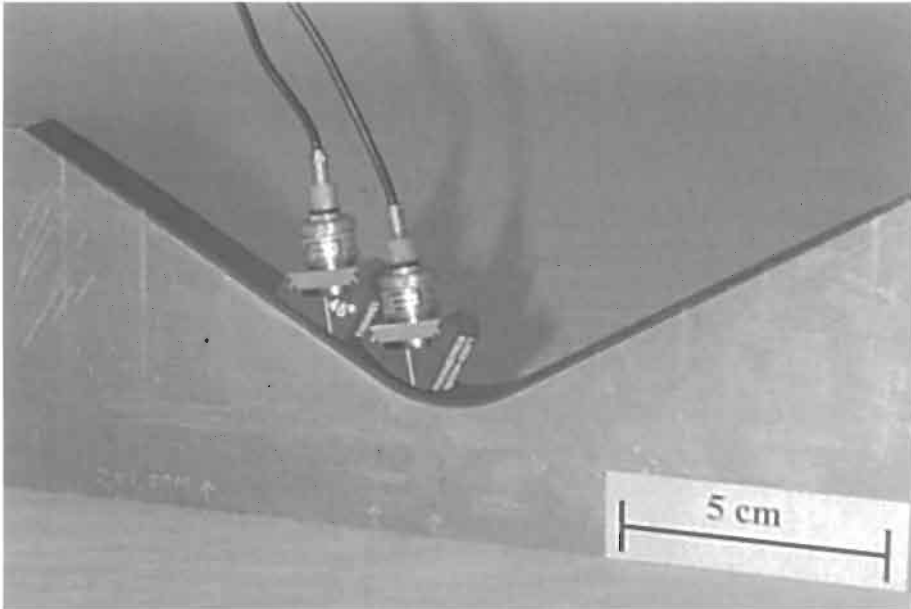
Fig. 23.36. Generator and detector transducer configuration applied to the crotch region of a simulated specimen.

The transducers were scanned in tandem with the first transducer used as generator and the second as detector. The transducers were applied as close together as their geometry allowed (Figure 23.36). The transducers were used in conjunction with a Krautkramer USIP20 pulser/receiver. When the transducer used for generation was applied in the proximity of the crack, a strong signal was reflected back to the detector, following leakage of energy back along the metal/adhesive/composite system.

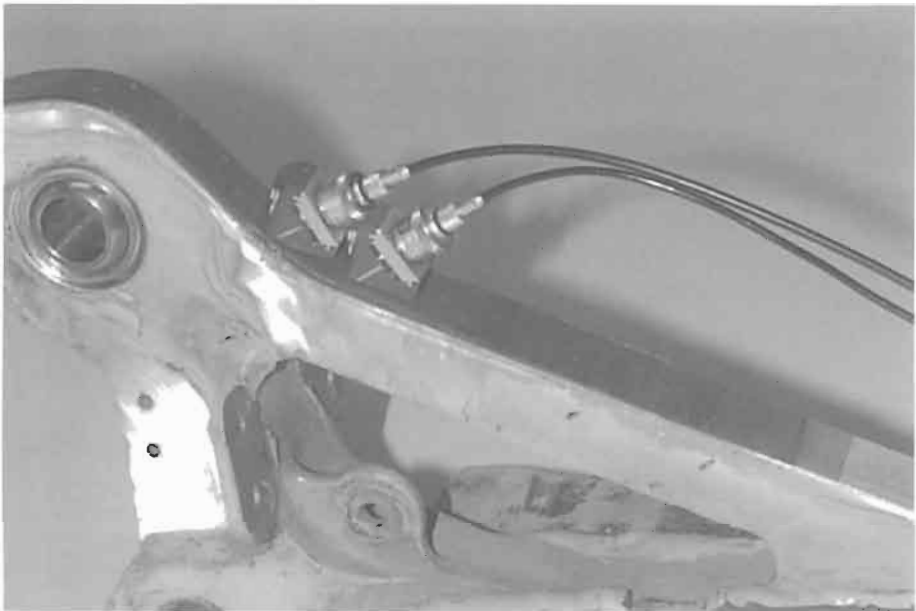
Fig. 23.37. Generator and detector transducer configuration applied to an aileron hinge.

US Navy and more recently RAAF experienced fatigue cracking in the aft strut fillet of inboard aileron hinges (Figure 23.37). Options considered were either replacement of the hinges or composite reinforcement of uncracked hinges or hinges from which the fatigue cracks have been removed [48]. NDE research formed an integral part of the program to develop a composite reinforcement for the hinges.

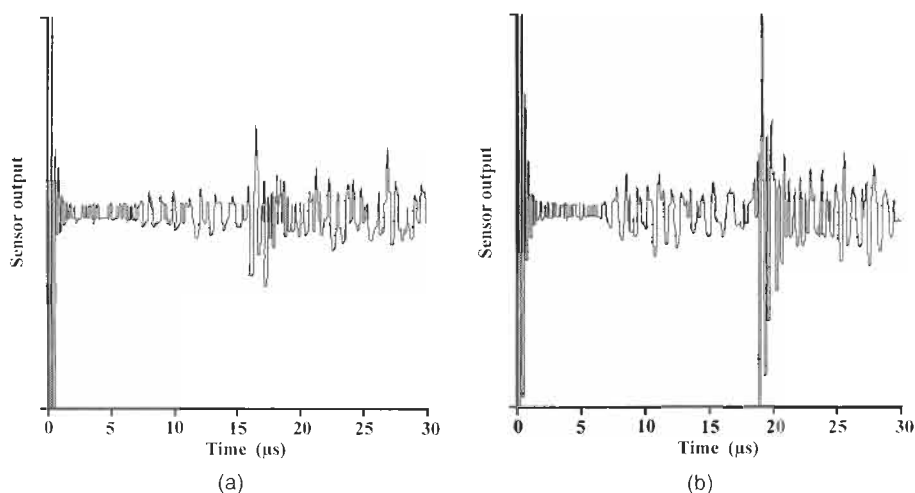
Fig. 23.38. (a) A-scan waveform for Specimen no. 9 with strong signal evident from the crack around 17 μ s; (b) A-scan waveform for Specimen no. 7 with strong signal evident from slot B around 19 μ s.

A strong ultrasonic signal from the crack was evident for each of the cracked hinge specimens (denoted 1 and 9) as illustrated in Figure 23.38 for Specimen no. 9. In addition, each of the slots in Specimen no. 7 were also detected (Figure 23.38), indicating that differences in curvature did not affect the effectiveness of the ultrasonic technique. However, small variations in time for which crack/slot signals were observed in the three Specimens was attributed to the impossibility of maintaining a constant generator-detector separation with the curvature on different parts of the specimen (see notes above and suggestions for modifications to procedures given below). There were also significant differences in adhesive thickness in the three specimens tested which caused differences in wave propagation times.

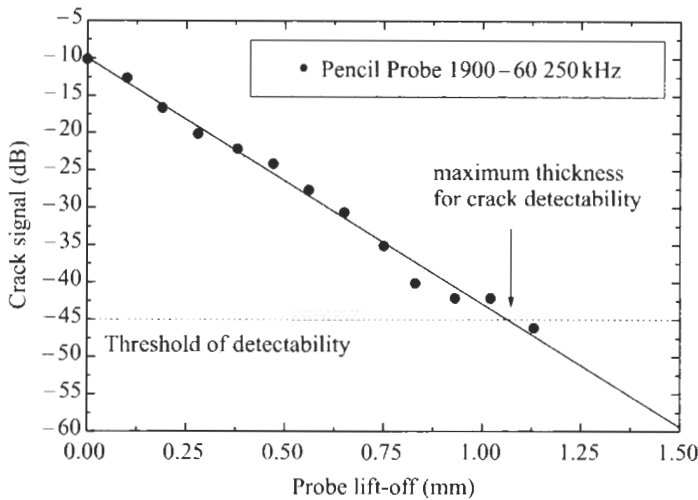
Fig. 23.39. Eddy current signal due to 3 mm long fatigue crack in an aileron hinge (Specimen no. 3) as a function of probe lift-off from the metal surface. [49]

The combined effect of the relatively small defect signal and reinforcement thickness is illustrated in Figure 23.39 where the eddy-current signal due to the 3 mm fatigue crack in an un-reinforced aileron hinge (Specimen no. 3) is plotted as a function of probe lift-off from the metal surface, or equivalently, as a function of the thickness of the reinforcement. (As the reinforcement is a poor electrical conductor, varying the probe lift-off from the metal surface is equivalent to varying

the thickness of the reinforcement with the probe on the upper surface of the composite.) The probe was a shielded 90° pencil probe (Zetec 1900-60) and the crack signal is defined as the maximum excursion in the impedance plane perpendicular to the lift-off locus. The plot shows that this particular crack would be detectable if the thickness of the reinforcement was less than or approximately equal to 1.0 mm.

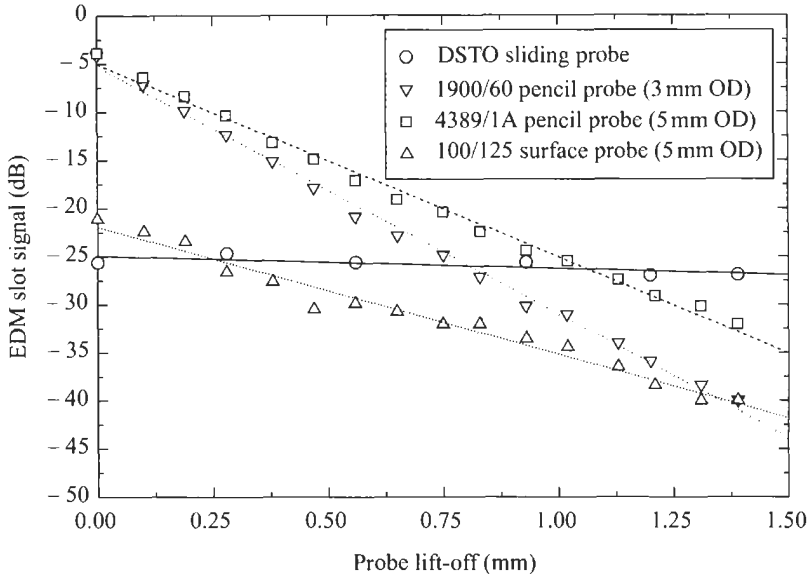
Fig. 23.40. Eddy current signal due to a 5 mm \times 1.2 mm EDM slot in 2024-T3 aluminum alloy as a function of probe lift-off for a range of eddy current probes. The signal from the sliding probe is insensitive to lift-off and hence reinforcement thickness. [49]

The effect of reinforcement thickness on crack detectability was investigated in more detail using a model system consisting of a 2024-T3 Al alloy plate containing a 5 mm long \times 1.2 mm deep EDM slot. Four probes were used: three were conventional ferrite-cored probes with varying diameter, and one was a DSTO eddy-current “sliding probe”. The sliding probe was a driver-pickup type probe where the driver and pickup coils are arranged side-by-side. The DSTO prototype sliding probe consisted of two 4 mm ferrite-cored probes with a center-center spacing of 7.5 mm. As shown in Figure 23.40, the signal due to the crack decreases rapidly with probe lift-off for the three conventional probes, the rate of decay increasing with decreasing probe radius. In contrast, the signal detected by the sliding probe decreases only slowly with lift-off, albeit with a smaller initial signal than for the conventional probes. The relative insensitivity to lift-off, and hence reinforcement thickness, suggests that the sliding probe concept may be a potential solution to the problem of eddy-current detection of cracking under the hinge reinforcement. Work is currently in progress to design, manufacture and test the performance of a range of eddy-current sliding probes.

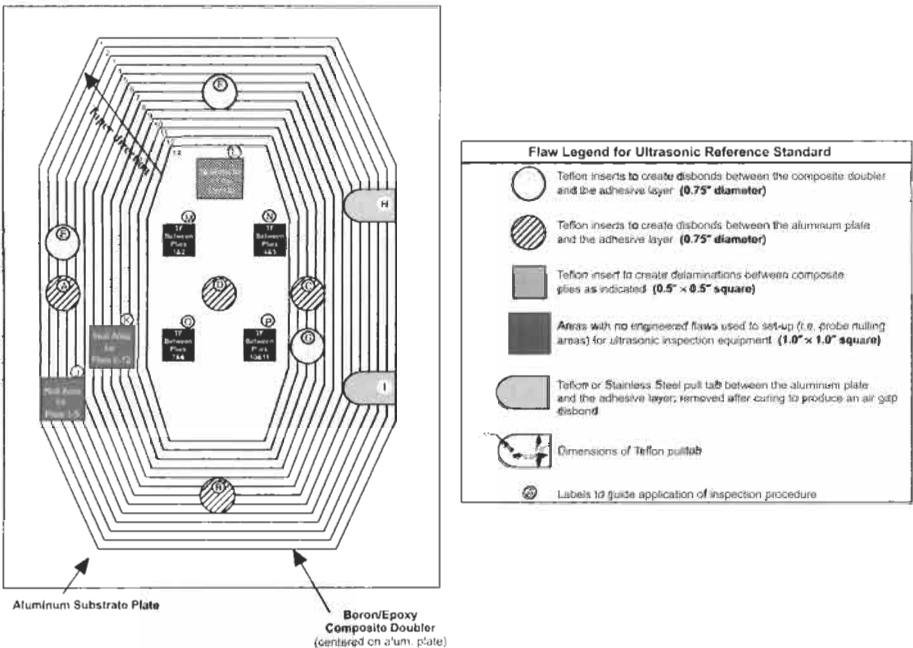
Fig. 23.41. Configuration of composite doubler reference standard to support disbond and delamination inspections.

The initial reference standard developed by the FAA/AANC for 13-ply fatigue coupon inspections did not possess a taper in the laminate. The inspection null point was created using an unflawed 13-ply thick area. In the case of the Bondmaster (resonance mode) inspection device this moved the dot to the center of the screen. The transducer was then placed on a 13-ply area with an engineered disbond. The instrument gain and rotation were used to position the dot three divisions away from the center of the screen and on the axis. When the tapered sections of the fatigue samples were inspected – especially areas with only a few plies – low signal indications were found. The low signal levels provided a less than desirable detection reliability. To obtain better inspection results on the taper sections of the test specimens a new inspection standard was designed. Figure 23.41 shows this reference standard which can be used to support UT inspections in composite doublers up to 15 plies thick. This reference standard contains disbonds between the composite doubler and aluminum skin, delaminations between adjacent composite lamina, and nulling areas in both the full thickness and tapered/thin regions.

Special precautions must be taken in order to produce a good inspection in areas where the doubler thickness changes (taper regions). Thickness variations require the user to track the front surface of the doubler and set the depth gates as appropriate. By employing a series of gates in one scan, it is possible to collect data over a wide range of depths. However, in the case of extremely thick doublers (the L-1011 doubler was 72 plies thick) it may be necessary to use several different scans each containing their own unique set of gates. For example, on the L-1011 doubler, separate scans may be obtained for 30-ply, 50-ply, and 72-ply thicknesses. This process improves the resolution in the area of interest and avoids the acquisition of potentially misleading signals.

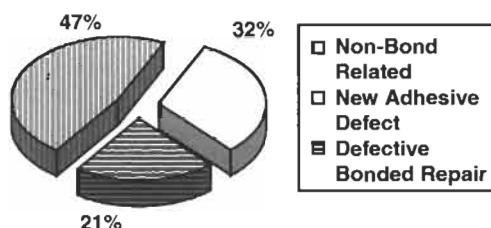
Fig. 24.1. Results of a 1992 survey of defect reports at a major RAAF Base.

While the main focus of this book is on repair of cracks in metallic structure, adhesive bonded repairs have been used on sandwich panels for some considerable time. Many of the repair application methods for sandwich panel repairs are used for repair of cracked metallic structure. In general, service experience with adhesive bonded repairs on sandwich panels has been extremely varied, with some structural repairs providing excellent service and others failing or requiring early replacement after a comparatively short service life. A survey of bonded repairs at one Deeper Maintenance facility in the Royal Australian Air Force (RAAF) [1] has shown that 53% of significant defects on structures such as F-111 were associated with adhesive bond failures (see Figure 24.1). The survey also showed that in 1993 43% of all bond defects (21% of the total defects) were associated with failures of previous bonded repairs.

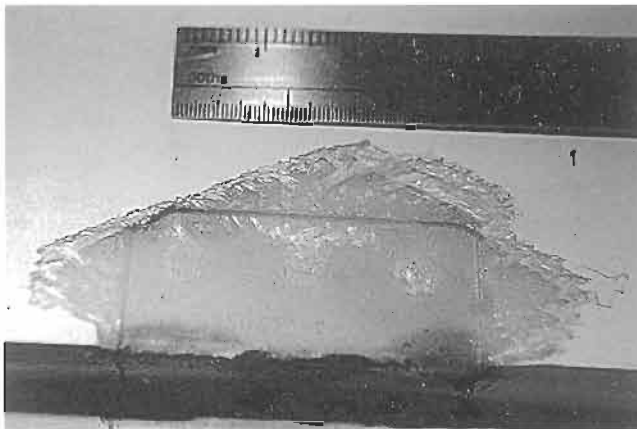
Fig. 24.3. A photograph of an interfacial failure of a bond in an aircraft elevator trim tab hinge. Note the replication of the part serial number and the smooth surface, clearly indicating an interfacial failure due to poor production processes. (Photograph courtesy Steve Emery, civil aviation safety authority, Canberra.)

The difference between a design deficiency and a processing deficiency can often be determined by examination of the failure surface produced when the bond breaks [9]. *Design deficiencies* are typically characterised by fracture of the adhesive (cohesion failure) with adhesive material present on both surfaces (see Figure 24.2). Cohesion failure is typical of the failure surfaces observed from adhesive strength tests such as lap-shear or peel tests. The adhesive would also contain minimal voids and obvious defects. *Processing deficiencies* are usually characterised by interfacial (adhesion) failure of the bond such that adhesive remains on only one of the adherend surfaces, with the matching surface being free of adhesive, or by the presence of voids or other bondline defects in the adhesive. Although interfacial failures occasionally occur due to contamination, the most usual cause of in-service adhesion failures is poor environmental durability due to the inadequacy of the surface preparation used when the bond was formed (see Figure 24.3).

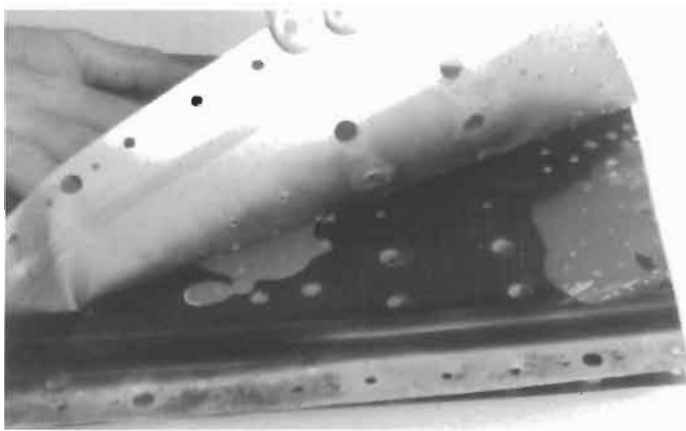
Fig. 24.5. An in-service disbond of a panel fabricated using the sealed chromate anodising process. Note also the failed injection "repairs".

There are three basic groups of surface modification methods for aluminium alloys; etchants, anodising processes and coupling agents. Etchants remove surface oxides and generate a micro-rough surface with a large number of active bond sites, at the same time as forming oxides which are relatively resistant to hydration. Anodising in chromic or phosphoric acid solutions produces a thin oxide film, with a high degree of micro-roughness and an oxide form that is highly resistant to hydration. Phosphoric acid anodising produces the most durable adhesive bonds of the variety of anodising methods [20] and field experience has shown that the "sealed chromate" anodise method is not sufficiently durable (see Figure 24.5).

from injection repairs can be identified. Restoration of strength is not achieved so a defective component is returned to service with an unjustified airworthy rating. The injected adhesive bond in the component almost always fails again. (See the repeated injection repairs in Figure 24.5, where there were at least nine attempts to repair the panel by injection of adhesive.)

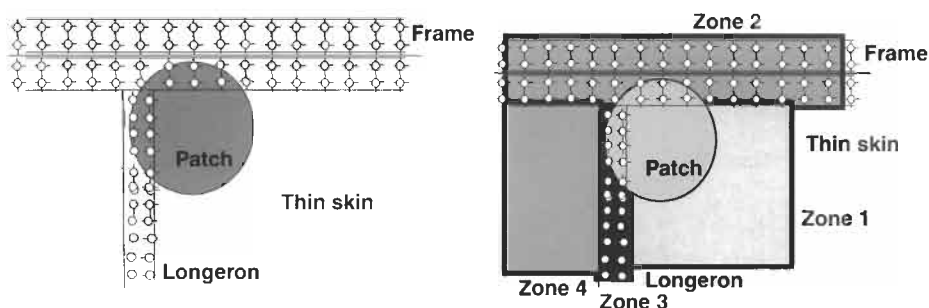
Fig. 24.7. The zoned methodology for heating a relatively complex structure.

To effectively heat a structure for repair, that structure must be divided into separate zones on the basis of the thermal conductivity combined with the mass of material to be heated. Each zone is then to be heated by a separate heat source with a power capacity selected to match the thermal mass within the zone. For example, consider a thin aluminium skin attached to a relatively thick spar and a moderately thick longeron (see Figure 24.7). This structural configuration would necessitate separate heated zones for each structural element. The blankets over the thin skin would only provide a relatively small amount of power while the smaller blankets over the longeron and frame would be required to provide significantly more power.

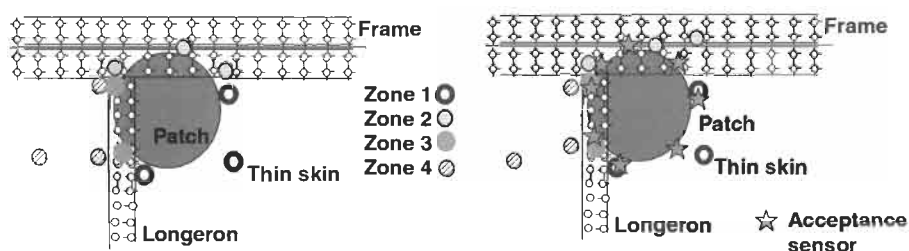
Fig. 24.8. Configuration of temperature sensors (a) for temperature control by estimation of the hottest point in each heated zone and (b) for cure assurance by location at the anticipated coldest points around the repair.

The location of the sensors for control must be at the point in each zone where the heated zone is expected to be hottest. Sensors for acceptance of the repair must be located around the repair such that the coldest point is measured (see Figure 24.8). A common error in setting up heating systems is to use a “standard” sensor configuration, such as three sensors located 120 degrees apart around the repair. Such a standard system will never guarantee to meet the basic principles of temperature measurement and control because there is no assurance that the hottest/coldest points will be those where the sensors are located. A further error is to control the system by the coldest point in an effort to drive the minimum temperature up to the required cure condition. Such a practice will risk overheat damage to the existing structure. There are more reliable ways of ensuring the adhesive experiences the required cure cycle, based on the time to cure the adhesive at the minimum observed temperature around the repair.

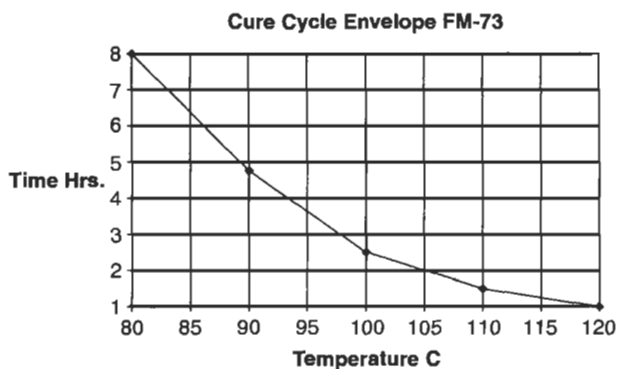
Fig. 24.9. A typical cure cycle envelope for a common film adhesive.

Testing at AMRL has shown that many epoxy adhesives can be cured at temperatures below the manufacturer’s recommended cure cycle, provided the time of the cure cycle is appropriately extended to suit. A typical “cure cycle envelope” is shown in Figure 24.9. By controlling the system by the hottest temperature in each

zone, overheating damage is avoided. The lowest temperature is then used to determine the cure cycle duration from the cure cycle envelope.

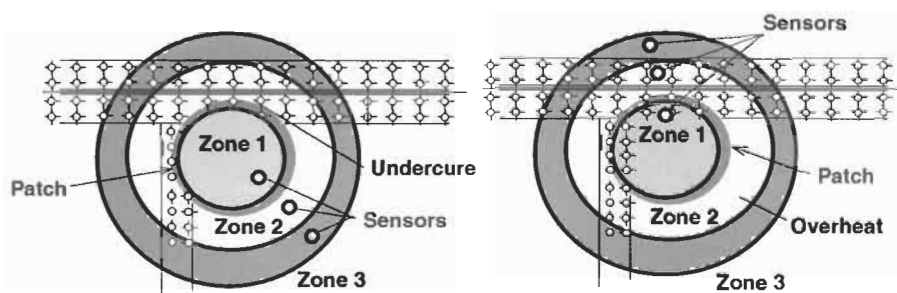
Fig. 24.10. Different outcomes for the same multi-zone heater system, depending on the location of the embedded sensors relative to the heat sinks.

Another issue in connection with heating systems that needs to be addressed is that of multi-zone heater blankets. A number of manufacturers sell these items with the claim that they provide a more uniform temperature distribution. These blankets usually consist of a number of concentric separately controlled zones (circular or rectangular) and usually have thermocouples embedded in the blanket. Some also feature a self-sealing vacuum system. In practice, these systems are unsuited to even moderately complex structure, because the distribution of the heat sources rarely match those found on practical aircraft structure (see Figure 24.10 for example).

demonstrated by the two conditions shown; either the adhesive in the repair over the thicker structure is undercured, or that over the thinner structure is overheated. The self-sealing vacuum system is susceptible to leaks at fasteners. A loss of vacuum will result in a defective repair and possibly, for repairs performed on lower surfaces of a component, the entire heating system may fall away from the part, creating a difficult (if not dangerous) situation for the operator. In comparison, the conventional vacuum bag system usually holds the assembly in place even with significant vacuum leaks.

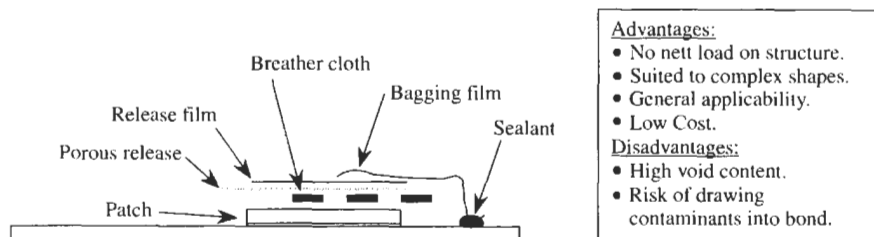
Fig. 24.12. The vacuum bag method for pressurisation of repairs.

In the vacuum bag method (see Figure 24.12) a conformable heat-resistant plastic membrane is located over the repair area and the air within the sealed region is evacuated. Atmospheric pressure acting on the outside of the plastic and on the back face of the structure will apply pressure over the repair. Vacuum bagging has the advantages of simplicity, flexibility of application, the ability to conform to

complex shapes and the process does not cause distortion because there is no net load on the structure. A major disadvantage of the process is that the low pressure enhances the release of volatiles and where volatile gasses are trapped, the low pressure increases their volume. This causes a significantly higher void content than would occur under positive pressure. Current RAAF practice is to apply maximum vacuum to a repair during the heat-up phase so that as many volatiles are drawn out as possible. When the lowest cure temperature for the adhesive is achieved (see Figure 24.9) the vacuum is backed off to 250 mm Hg. This causes a reduction in the size of trapped volatiles.

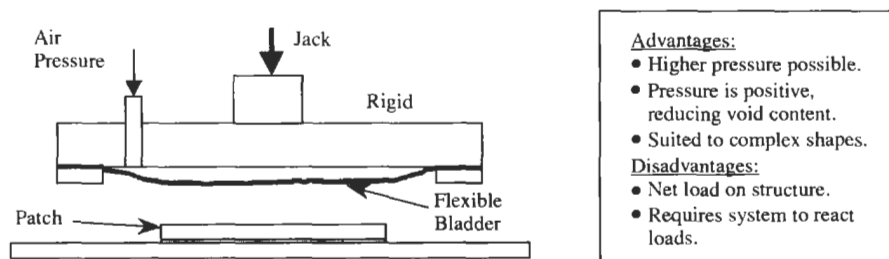
Fig. 24.13. The inflated bladder method for pressurisation of repairs.

The inflated bladder method (see Figure 24.13) of pressurisation has much of the flexibility of the vacuum bag method with the added advantage of the use of positive pressure to reduce the void content in resins and adhesives. In this pressurisation method, a flexible bladder that is in contact with the repair area is attached to a rigid plate which in turn is held in place by a clamping device to hold the assembly against the surface to be repaired. The space between the bladder and the rigid plate is pressurised using compressed air. This forces the bladder against the repair surface and provides the pressure required for repair installation. A major limitation in the inflated bladder method is that the system will produce a net load on the structure, and care is required to avoid damage by overloading the region. The system also requires some clamping method to react out the pressure loads.

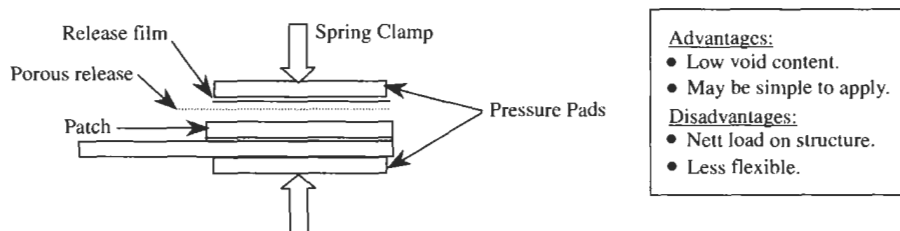
Fig. 24.14. Mechanical clamping methods for pressure application.

Mechanical clamping, (see Figure 24.14) may be an effective method for pressure application during repair. The method of clamping will depend upon the geometry of the structure surrounding the repair. If access to both the front and back faces is possible, a simple “C-clamp” may suffice. In other cases, the ability to react loads from an adjacent piece of structure (or even a hangar floor) will enable the use of hydraulic or screw jacks. This method of pressurisation is not as flexible as the vacuum bagging or inflated bladder methods, because some form of pressure distribution plate will be required. Care must be exercised to avoid local over-pressurisation of the region directly under the clamp. This can be verified by performing a flow check before applying the repair. (A piece of adhesive is sandwiched between thin Teflon film and cured in the same manner as is proposed for the repair. Examination of the cured adhesive will show regions of deficient pressurisation.) Care is also required to avoid damage to the structure from the pressure loads.

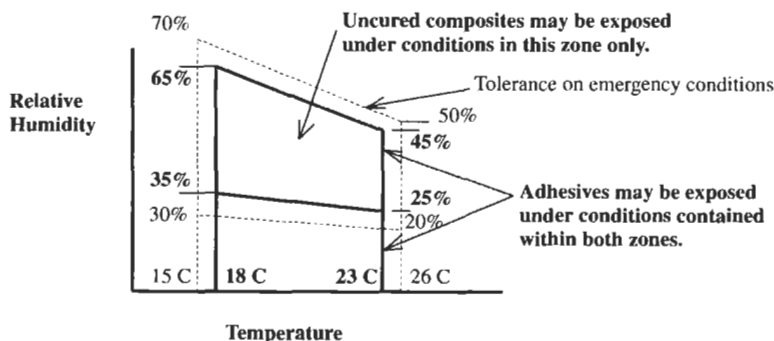
Fig. 24.15. Humidity and temperature requirements for adhesive bonding.

Film adhesives must be handled in controlled environments (see Figure 24.15) where the humidity levels are within limits because epoxy film adhesives absorb atmospheric moisture that boils off during elevated temperature cure, forming micro-voids. Exposure of FM300 adhesive to 30 °C for 1 h can result in over 60% void content in adhesive bonds, with a subsequent reduction of peel and shear strength of approximately 50% [18].

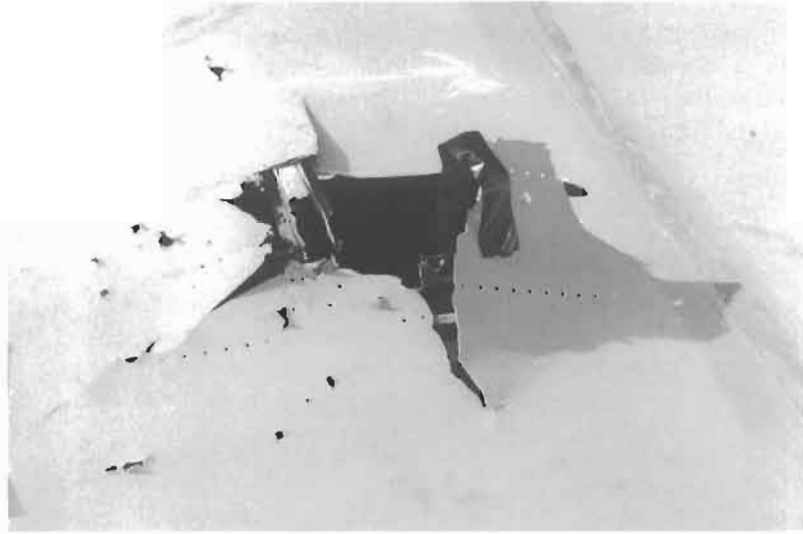
Fig. 25.1. Battle damage in a Lockheed Hercules C130 aircraft caused by penetration of a high explosive impact projectile. The total area of damage is approximately 1 m in diameter.

During operational missions aircraft are prone to a range of damage, many of which do not result in catastrophic failure. This can include ground fire (Figure 25.1), missile strike, foreign object damage, shrapnel and component degradation induced by excessive “g” manoeuvres. In most cases damage can be classed into four main categories [2]:

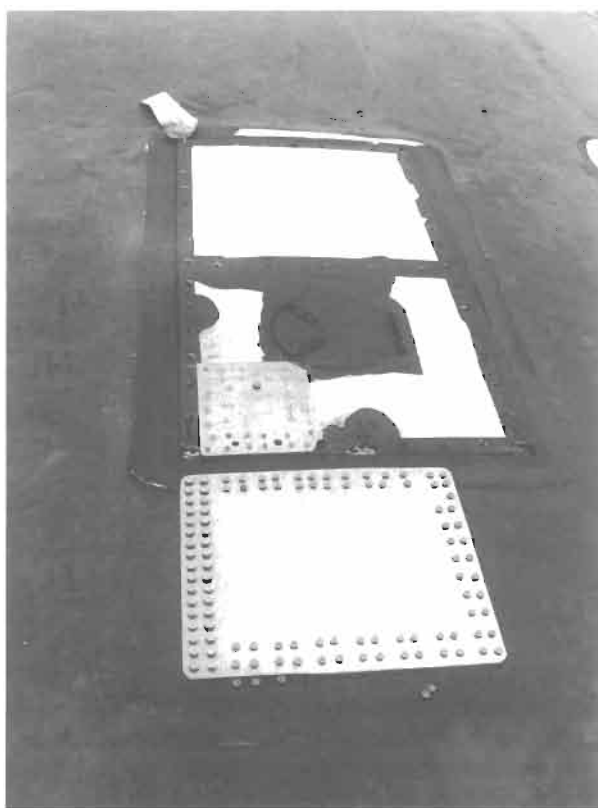
Fig. 25.2. A mechanical repair applied to damage on a Lockheed Hercules C130 wing skin caused by a high explosive impact round typical of ground fire.

ABDR for airframes is currently mainly based on mechanical fasteners and metallic patches (Figure 25.2). The advantages of this approach are:

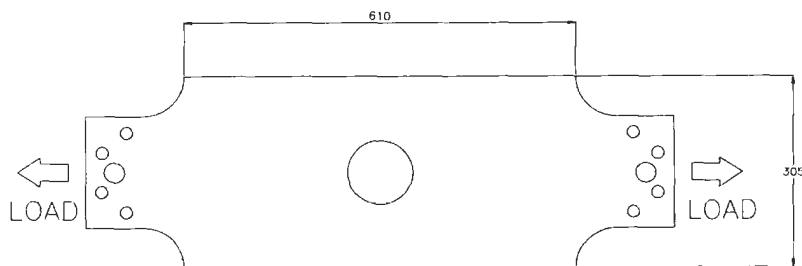
Fig. 25.3. Representative specimen used for comparative testing of ABDR. The central hole, diameter 102 millimetres, was representative of the battle damage. All dimensions in millimetres.

To demonstrate the effectiveness of bonded composite repairs, an experimental program was undertaken to compare the performance of traditional mechanically fastened, metallic ABDR to a bonded-composite battle damage repair as developed at DTSSO. The two techniques were compared by tests including static strength and fatigue durability. The tests were carried out on 7075-T6 aluminium alloy panels, provided by the United States Air Force (USAF) as part of a collaborative program, representative of thin-skinned metallic aircraft fuselage (see Figure 25.3).

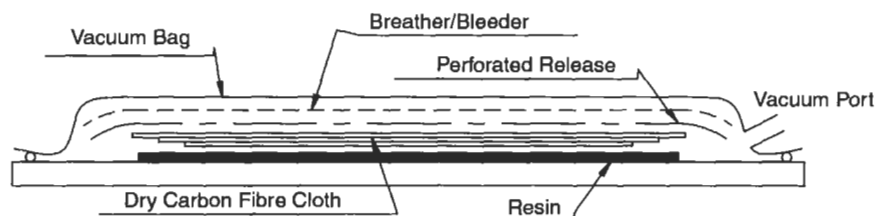
Fig. 25.4. Schematic view of bonded composite repair being formed and bonded to specimen.

The bonded composite repairs were either simultaneously formed and bonded under a vacuum bag using the vinyl-ester resin (Figure 25.4) or pre-cured with the epoxy resin and subsequently bonded with the acrylic adhesive. The average time for application of the repairs was approximately 100 min¹ for both cases, however, both the vinyl-ester and epoxy resins used in this program cured in 24 h at room temperature, which would be considered too slow for ABDR. Increasing the cure

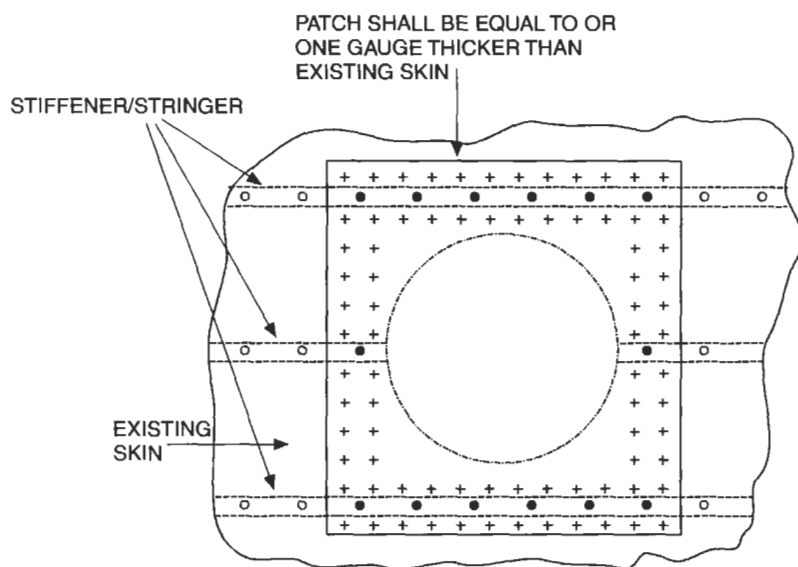
Fig. 25.5. Schematic drawing of mechanically fastened, metallic repair.

The mechanically fastened repairs (Figure 25.5) were 1.6 millimetre thick 7075-T6 aluminium alloy (to match skin stiffness), and the patch measured 178 by 178 millimetres in size. The patch was fastened to the test panel using blind rivets. The USAF tradesmen required only 64 min to apply each repair on average.

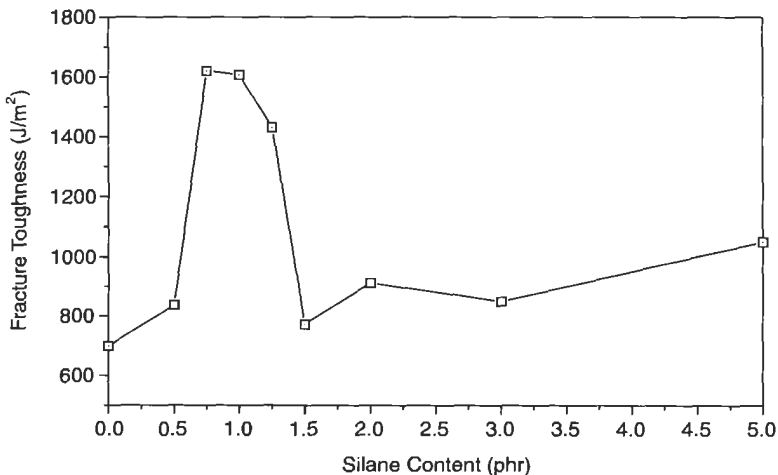
Fig. 25.6. The effect of the epoxy-silane concentration on the CCBT fracture toughness of AMORLUX 1310.

A series of CCBT specimens were prepared with epoxy-silane concentrations in the resin varying from 0 to 5%. The hardener was then added to the resin and epoxy-silane mixture, stirred and the prepared metal surfaces bonded together (surfaces treated at Level Two). The results (Figure 25.6) showed that for concentrations of 1% of epoxy-silane in the liquid resin the fracture toughness was comparable to that for the tests with the epoxy-silane applied to the surface in aqueous solution. In addition, the failure surfaces indicated cohesive failure of the bond.

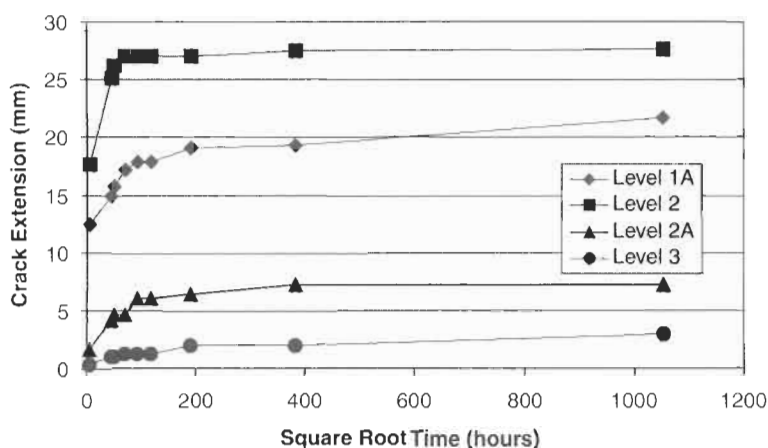
Fig. 25.7. Results of BWT's for AMORLUX 1310 resin with varying Levels of surface treatment procedures. The Level 1A and 2A treatments indicate the addition of epoxy silane to the resin mixture prior to bonding.

BWT specimens were also manufactured and bonded with AMORLUX 1310 with 1% epoxy-silane mixed into the resin as detailed above. The results of the BWT for all Levels of surface treatment (see Figure 25.7) show that the addition of epoxy-silane to the resin improved the environmental durability of the bond when compared to grit blasting or pad abrading alone.

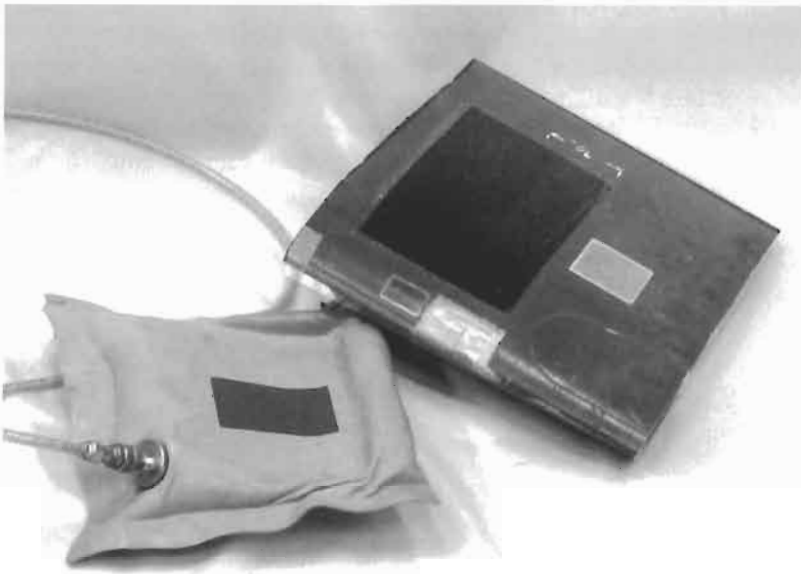
Fig. 25.8. Photograph of vacuum moulding tool demonstrating manufacture of a composite repair for the leading edge of a rotor blade.

A high-temperature silicone-rubber bladder is filled with small ceramic microspheres, sealed and a vacuum port attached to one side. The tool is shaken to loosen the filler material and is then applied to the surface. A vacuum can then be applied to the bladder and as the air evacuates the tool becomes rigid and forms to the shape of the structure underneath. The pliable nature of the silicone rubber ensures that even small contours are reproduced faithfully. A repair patch may then be produced from this tool or the tool may be applied on the external side of the patch during the patch application process. This tool was found to be compact, reusable, durable and effective (see Figure 25.8).

Once formed to the shape of the damaged structure the tool will maintain this shape at temperatures up to 200 °C and pressures up to 700 kPa. The tools can be used to cure composite repairs in either an autoclave, by using a mechanical press, or under a vacuum bag for field use.

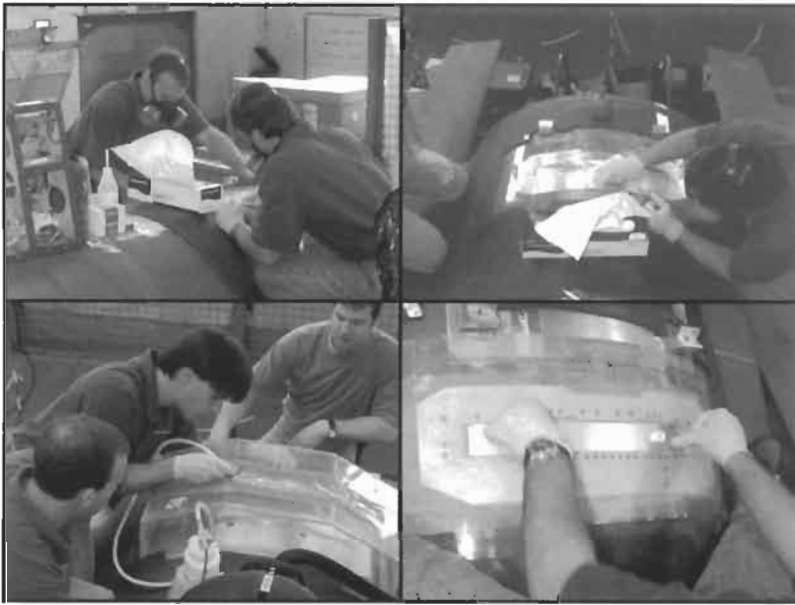
Fig. 26.1. ARTI technicians in a typical hangar environment performing (a) solvent scrub, (b) water wipe, (c) grit blast and (d) laminate application for repair of an F-16 FS 479 bulkhead.

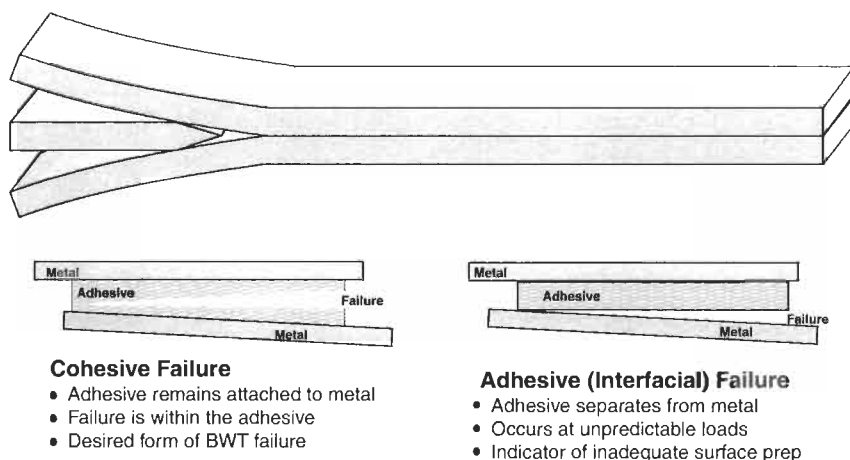
Fig. 26.2. A schematic representation of the Boeing wedge test, showing the desired and undesired modes of induced failure.

BWT specimens are fabricated by performing surface prep on two 6 by 6 inch (150 by 150 mm) aluminum plates and applying a structural adhesive between them. Before putting the plates together a strip of mylar type 0.75 inch wide (20 mm) is applied between them to make one unbonded edge. After the adhesive is cured under heat and pressure, the resulting panel is cut into 1 inch wide (25.4 mm) coupons as illustrated in Figure 26.2. Into the unbonded end of each coupon a

metal wedge is inserted and forced between the adherends using a slow press or vice. This starts a crack in the adhesive layer.

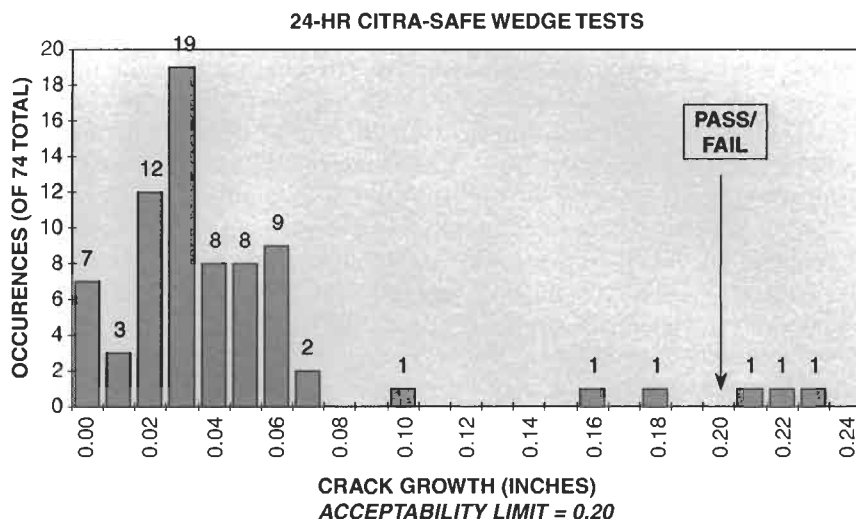
Fig. 26.3. Results of 74 Boeing wedge tests to evaluate a new solvent. The failing specimens were produced by a technician who had not performed surface preparation for over a year.

Wedge tests are often used to evaluate process details or to compare different materials. An effective solvent used in surface preparation is MEK (methyl ethyl ketone), which is a hazardous material and environmentally unfriendly. Figure 26.3 is a histogram of 74 Boeing wedge tests performed on a proposed MEK substitute, Citra-Safe. The *x*-axis shows the crack growth during 24 h in an environmental chamber. The *y*-axis shows the total number of specimens reaching various crack lengths. Since almost all the specimens fall well within the 0.20 inch limit, the results indicted that Citra-Safe may be an acceptable substitute for MEK. However, the figure is included here for *another reason*.

Note that three of the samples failed the test. These specimens were fabricated by a trained technician who had successfully installed dozens of repairs in the field and was known to be a very conscientious worker. However, due to other assignments, he had not performed surface preparation for over a year when he was asked to assist in laying up these test samples.¹ The disappointing result of this technician's first coupons after an absence from the bonded repair team underscores the “art” of surface preparation and the absolute importance of keeping skills honed through practice.

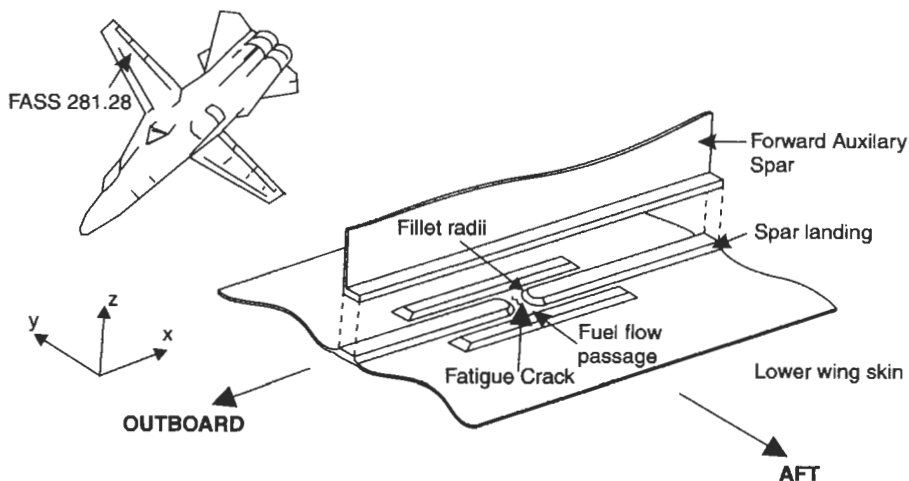
Fig. 27.1. Location of cracking on the F-111 lower wing-skin, at FASS 281.

Figures 27.1 and 27.2 indicate the location of cracking on the lower wing-skin. The raised portions serve as integral stiffeners and as attachment lands for spars [4]. The cracking occurred in an area lying below the forward auxiliary spar, at the spar station FASS 281.28, where the thickness of the integral stiffener is reduced from

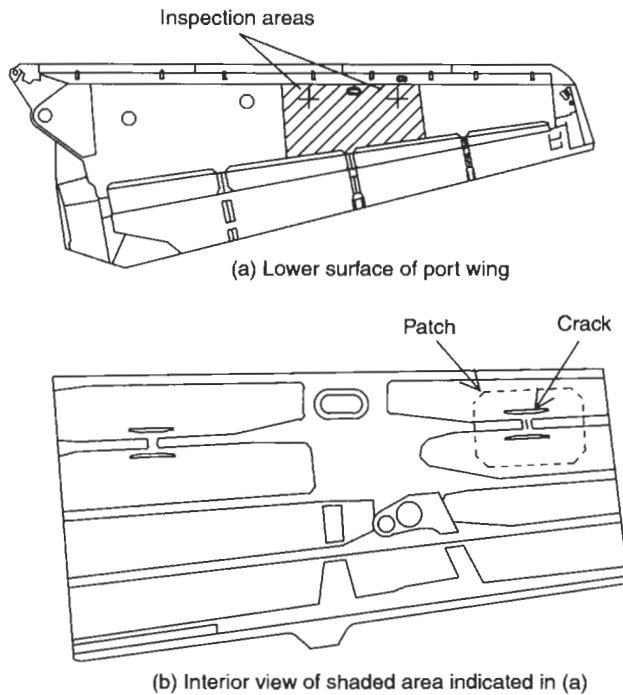
Fig. 27.2. Location of cracking on the F-111 lower wing-skin, at FASS 281, showing also the outline of the repair patch.

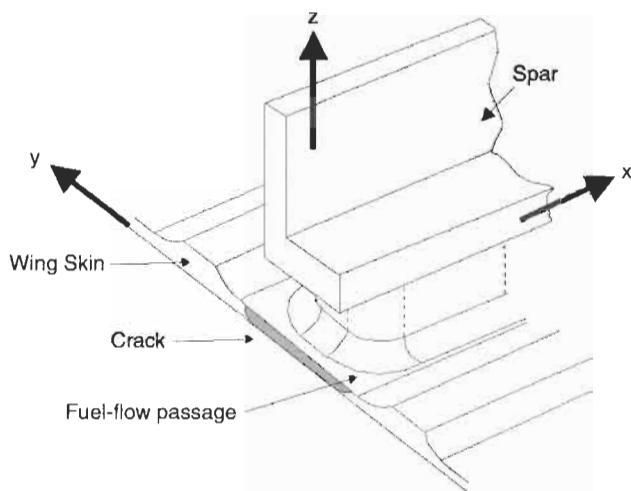
Fig. 27.3. Local geometry of the wing skin in the vicinity of the fuel-flow passage, showing the location of cracking and the coordinate axes used in the text.

The first two levels (the box and panel specimens) are intended to serve as representative test articles. They employ wing skins which contain the structural detail as shown in Figure 27.3. In the case of the box specimens, the restraint due to the spar is also included and the specimens can accommodate the full compressive loads encountered in service. The representative bonded joint (RBJ) specimens were used to quantify the effects of peel stress and extremes of temperature, moisture and simulated damage. The FE analysis provided a theoretical basis for correlation between these various levels of testing and for interpretation of the results.

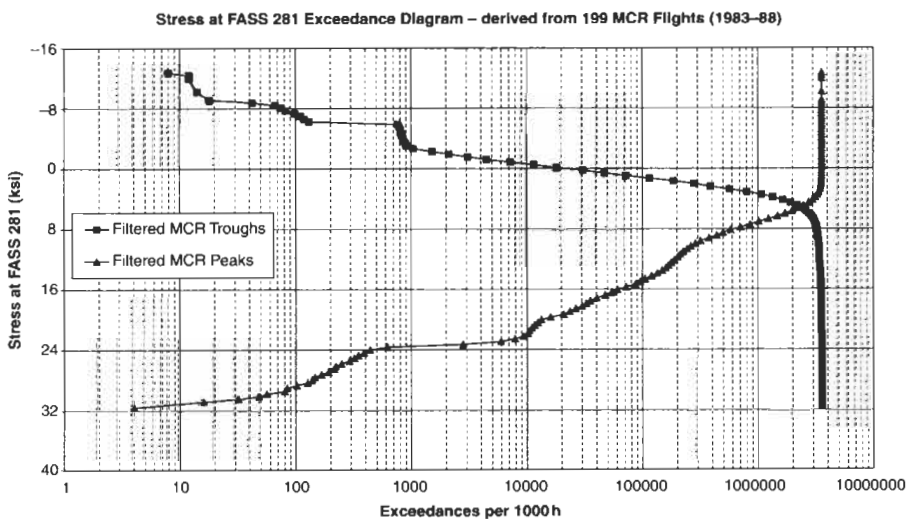
Fig. 27.4. Stress exceedance diagram at FASS 281.

The specified fatigue loading was based on a detailed cycle-by-cycle load spectrum available from multi-channel recorders fitted to RAAF F-111 aircraft. This spectrum is representative of RAAF usage and is currently used for structural management of the F-111 fleet. The loads expressed in terms of the wing-pivot bending moment were converted to nominal stresses at FASS 281 using a stress equation which was verified as part of the development of a detailed 3D FE stress analysis [5–7]. The spectrum from [9] is shown in exceedance diagram form in Figure 27.4 below.

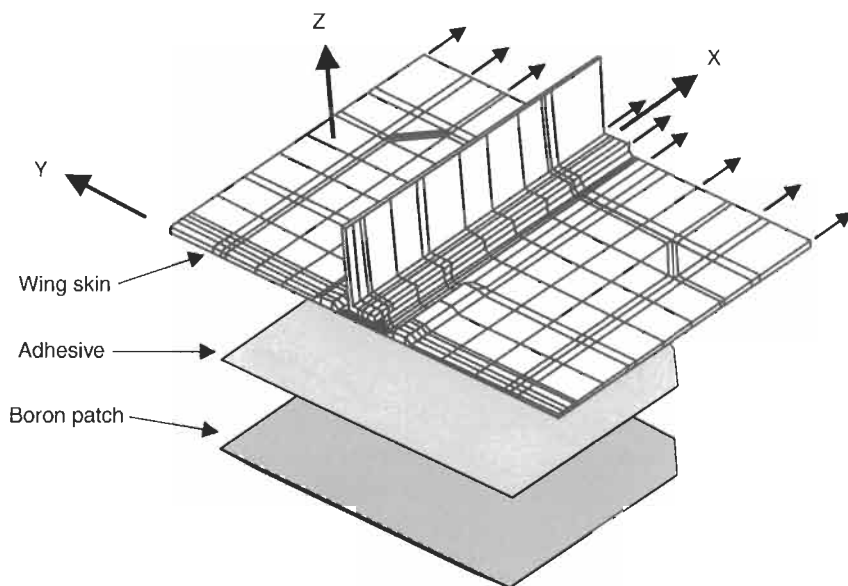
Fig. 27.5. Skin/spar FE model with outline of adhesive and boron patch.

A 3D finite element model (see Figure 27.5 below) of the wing skin, supporting spar, adhesive and patch was developed and refined [8].

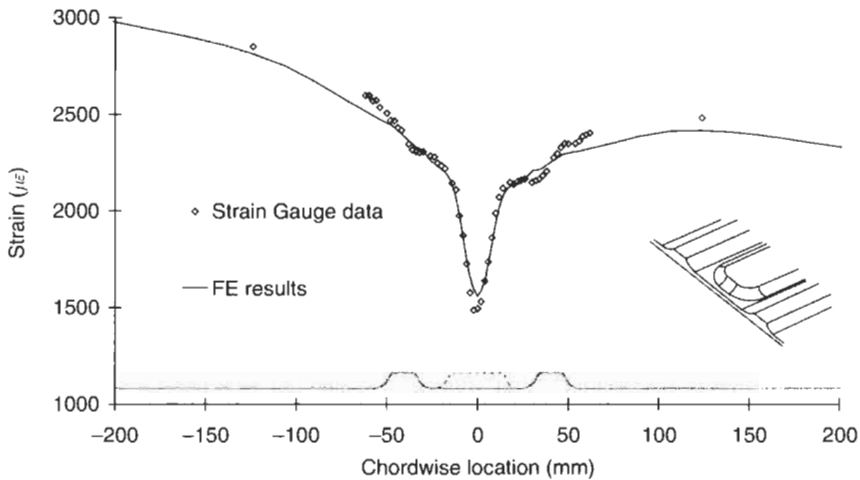
Fig. 27.6. Comparison of strain-gauge data from a static strain survey of a full-scale test wing with predictions from a 3D finite-element model of the region shown in Fig. 27.3. The FE results include a correction for the chordwise variation of the wing-box section. The strains correspond to limit-load (CPLT).

The model without the crack or patch was calibrated to data available from a strain survey undertaken on a full-scale (uncracked) wing. It was found that the stress distribution prior to cracking is sensitive to the precise thickness variation around the fuel flow passage. Considerable mesh refinement and attention to detail of the local geometry was required to obtain a good correlation. Figure 27.6 below illustrates the excellent correlation obtained, which provides confidence in the

adequacy of the FE model to reproduce the complex stress state around the fuel flow passage at FASS 281.

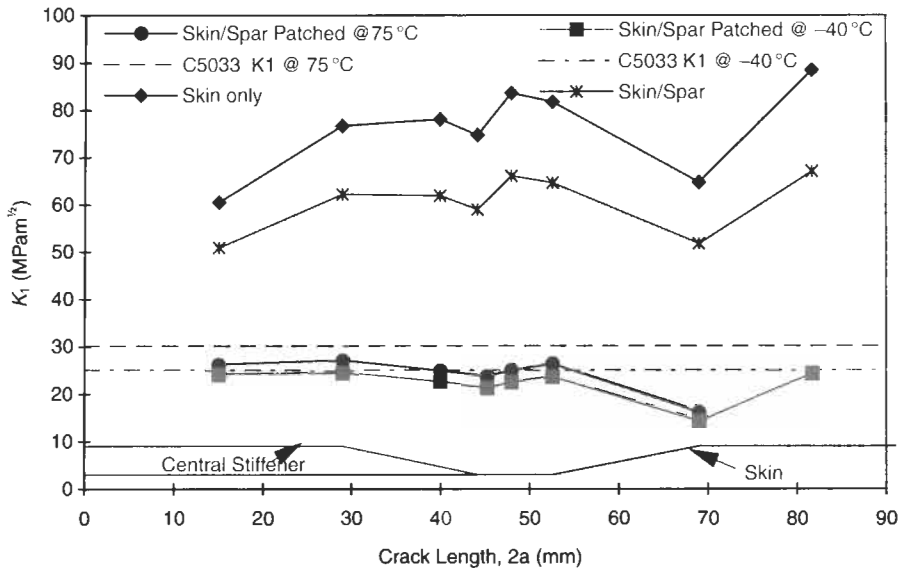
Fig. 27.7. Stress intensity factor versus crack length at design limit load.

The cracked, patched FE model was analysed at the extremes of temperature (-40°C and $+75^{\circ}\text{C}$) including thermal mis-match effects [1]. The significant factors to consider are the stress intensity in the repaired structure, and the shear stress in the adhesive near the crack. The stress intensity factor FE results compared with the C5033 [1] design analysis are shown in Figure 27.7 below.

These results demonstrate that the original design procedures [1] gave conservative results that compare well with the FE.

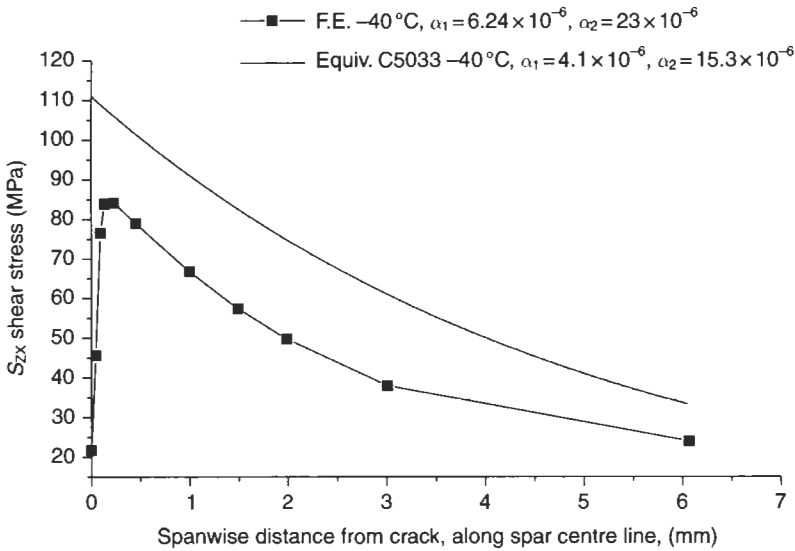
Fig. 27.8. Adhesive shear stress (τ_{zx}) near crack, -40°C, at DLL.

The adhesive shear stress results are shown in Figure 27.8 and 27.9 below for the -40°C and $+75^{\circ}\text{C}$ cases respectively.

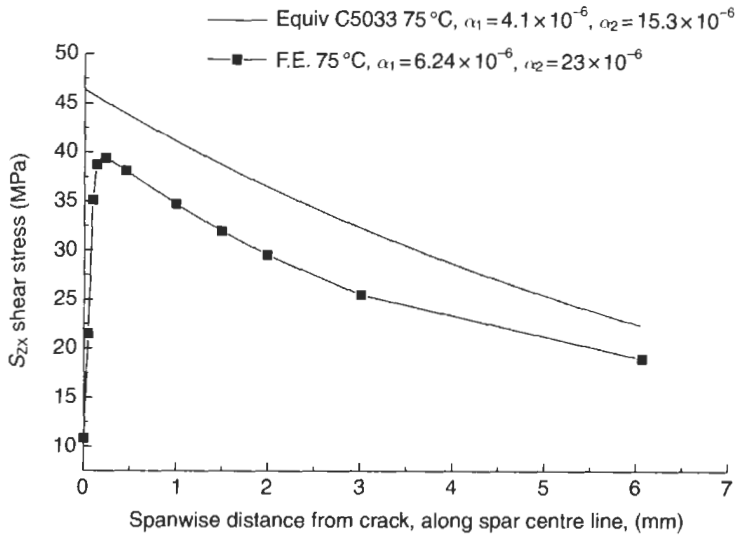
Fig. 27.9. Adhesive shear stress (τ_{zx}) near crack, + 75 °C, at DLL.
