Advances in the Bonded Composite Repair of Metallic Aircraft Structure

VOLUME 2

Chapter 19. Bonded Repair of Acoustic Fatigue Cracking 531

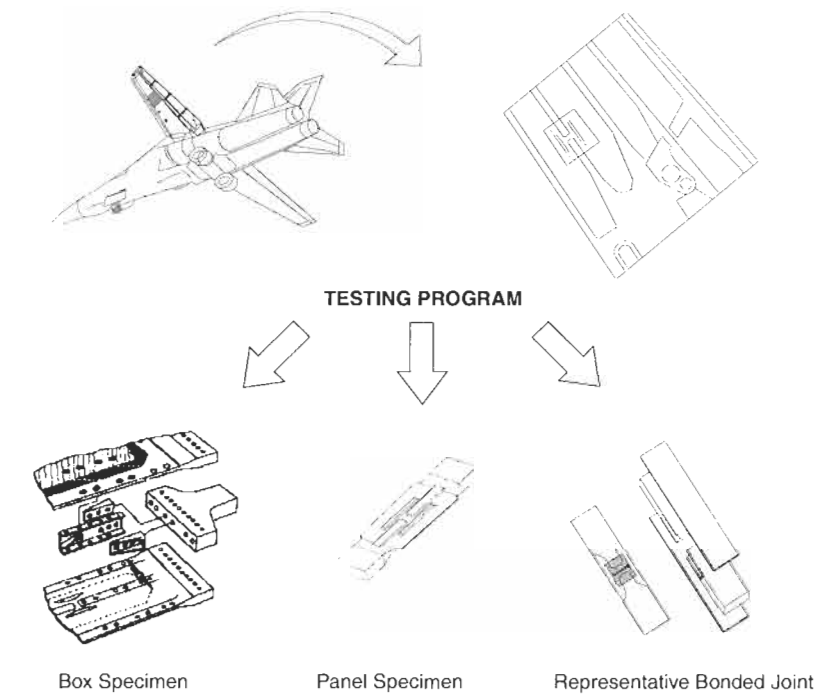
Fig. 27.10. Three levels of representative specimen testing.

Three levels of structural testing were undertaken. Figure 27.10 below details the three levels of testing which are discussed in this section.

The RBJ specimens consisted of two 2024-T851 aluminium alloy inner adherends joined and sandwiched between two boron patches to form a double sided bonded joint as shown schematically in Figures 27.10 and 27.11. The specimen was intended to simulate faithfully the combination of adhesive shear and peel stresses that occurs near the crack.

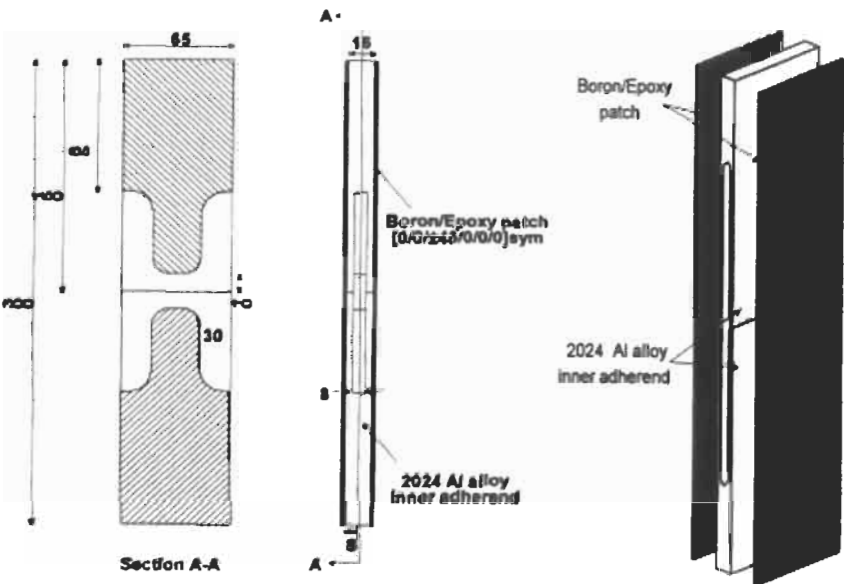
Fig. 27.11. Representative bonded joint specimens.

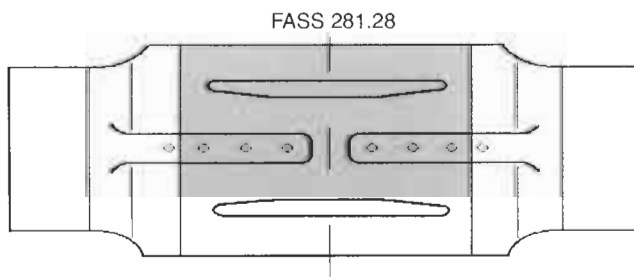
Fig. 27.12. Panel specimen.

The panel specimens (Figure 27.12) contained a test section which was representative of the structural detail at the crack location. They were used to quantify the performance of the repair in terms of the following:

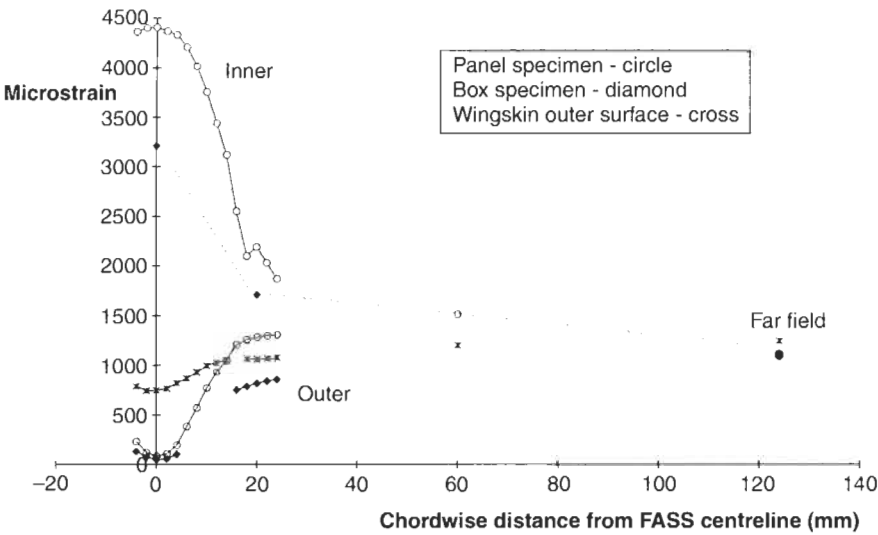
Fig. 27.13. Chordwise strain distribution at 50% DLL.

The first objective was to verify that the stress and strain distribution in the panel specimen was representative of the full scale wing structure. The results of a strain survey comparison of the uncracked and unpatched panel and box specimens [14] compared with the full scale wing is shown in Figure 27.13 below.

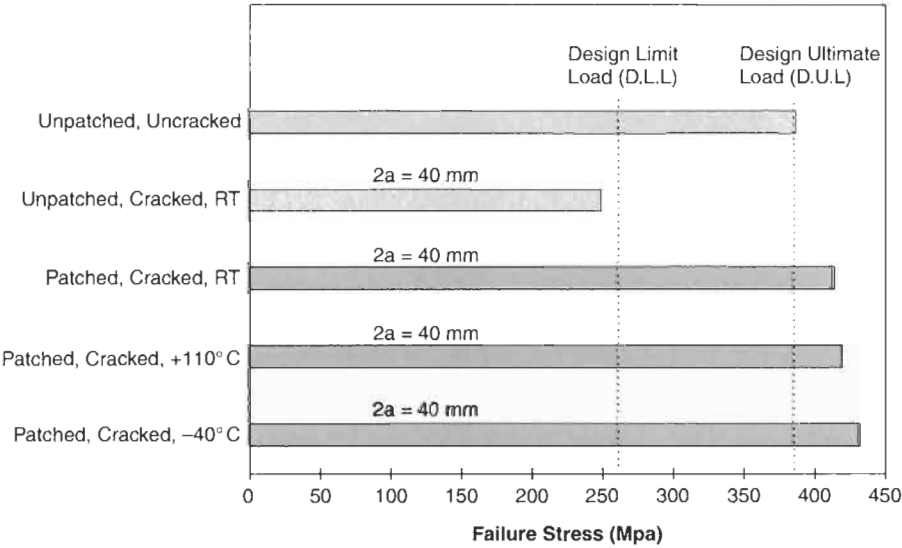
Fig. 27.14. Results of static strength tests on panel specimens.

The results of the static load testing [14] are shown in Figure 27.14 below.

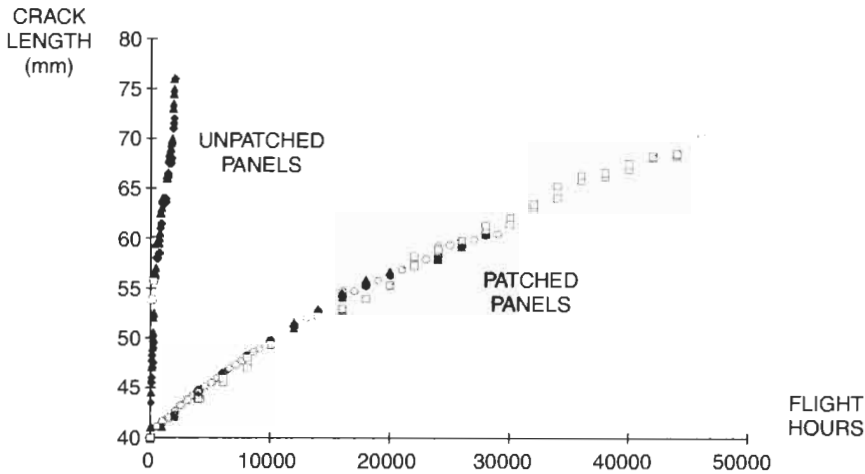
Fig. 27.15. Comparison of patched and unpatched crack growth in the panel specimens.

A comparison of the crack growth rates in the panel specimens in the patched versus unpatched condition under spectrum loading [14] is shown in Figure 27.15 below.

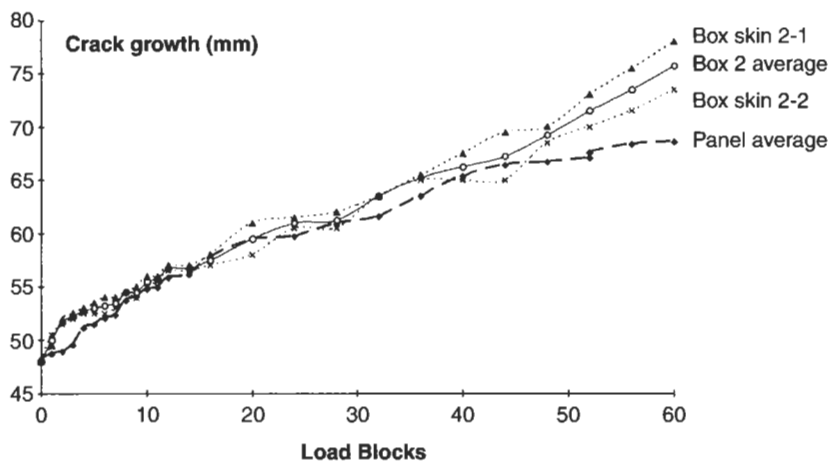
Fig. 27.17. Comparison of box and panel specimen crack growth (1 Block = 500 h).

The box specimen was designed to incorporate the out of plane support and thermal mass provided by the complete built up wing structure, and is large enough to install a full size repair patch. The specimen arrangement is shown in Figure 27.16. The results of the box specimen testing were consistent with the panel specimen as shown in the crack growth comparison in Figure 27.17.

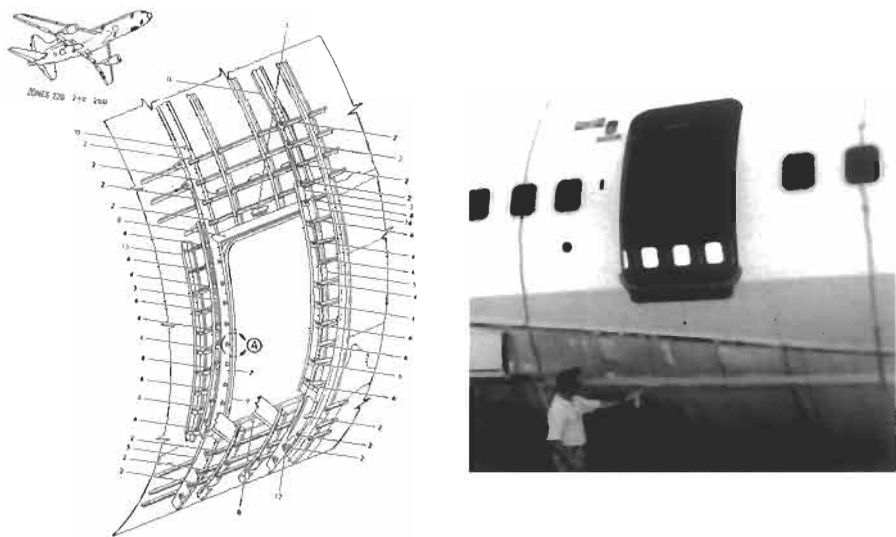
(a) Structural Configuration of Passenger Door Area

(b) Section Cut from Retired L-1011 Aircraft for Full Scale Tests

Fig. 28.1. L-1011 Door surround structure test article.

The primary test article was a large fuselage section cut from a retired All Nippon Airways (ANA) L-1011 aircraft. The fuselage test article included a passenger door (P3 passenger door) cut-out and contained all substructure frame, longeron, and stringer elements. The fuselage cross section has a radius of 117.5 in. and the nominal thickness of the 2024-T3 skin in the P-3 door area is 0.68". Figure 28.1 shows the basic L-1011 structure and a photograph of the door surround structure section prior to being cut from the L-1011 fuselage. The door surround structure test article contained eight circumferential frames and six longitudinal stringers, as well as, the upper and lower longeron around the door cut-out. This test bed was instrumented with strain gages and subjected to simulated fuselage pressure differential loads using a customized fuselage test fixture.

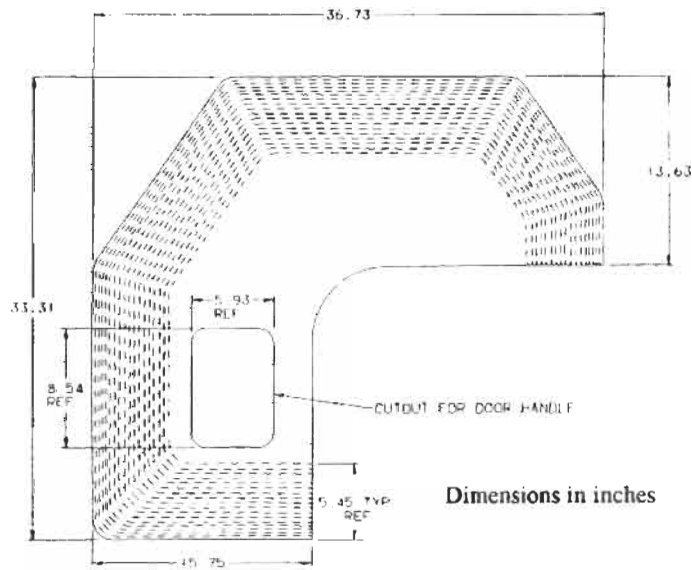
Fig. 28.2. L-1011 Door corner boron-epoxy repair doubler.

The important test article modification involved the installation of a Boron-Epoxy doubler to the upper, forward corner of the P3 door surround structure. The door surround structure was tested before and after the doubler was installed to evaluate strain field improvements produced by the composite doubler. The Boron-Epoxy doubler design discussed in this analysis is shown in Figure 28.2. The doubler consists of 72 plies oriented in a quasi-isotropic lay-up of sequence [45, 0, -45, 90]. This type of lay-up is the most effective at reducing inter-laminar peel stresses. In addition, peel stresses in the adhesive bond line are reduced by tapering the edges of the doubler away from the door corner. The rectangular cutout in the doubler is required to facilitate the existing emergency door release handle. Following composite doubler installation, the door surround structure was visually

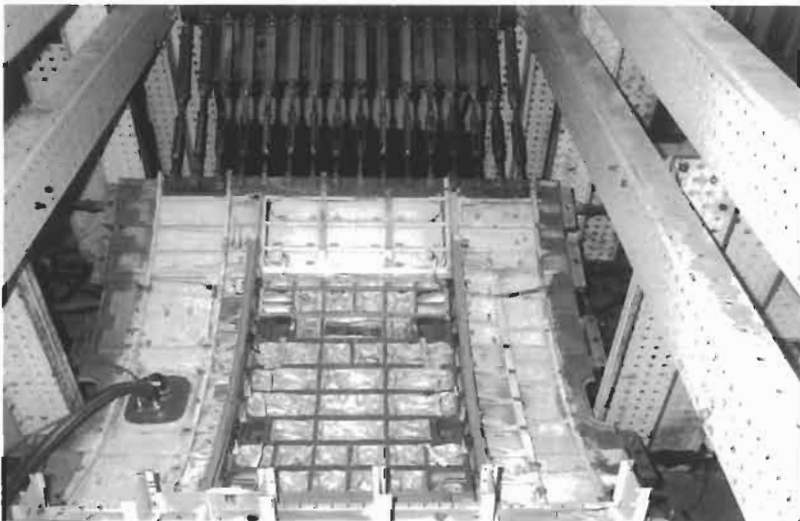
Fig. 28.4. Door surround structure mounted in the biaxial test facility.

uniform load across the width of the door surround structure. As the vacuum load was applied, hoop and axial loads were developed in the test article. Figure 28.4 shows the door surround structure mounted in the biaxial test facility. It shows one

side of the hoop restraints and the longitudinal whiffle trees attached to the test article.

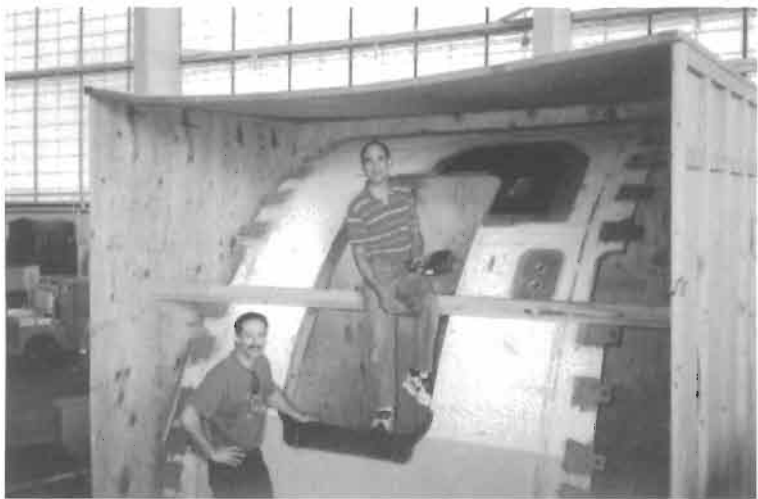
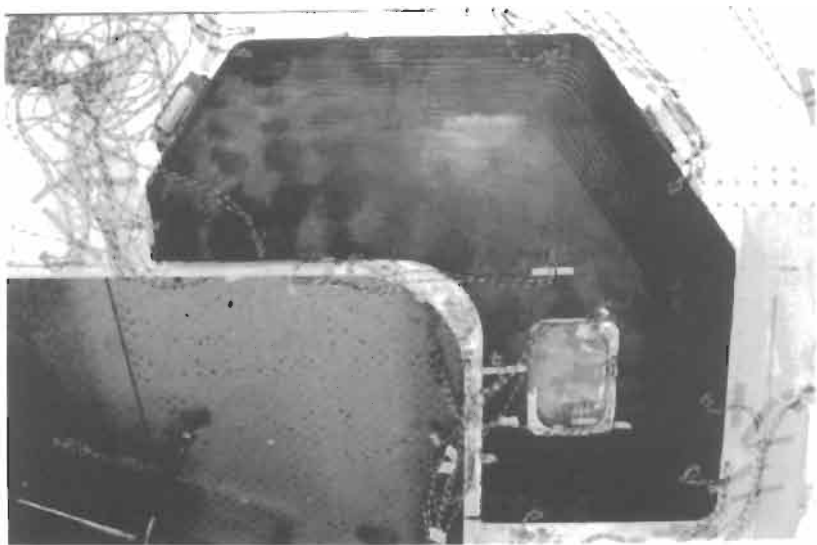
A. Fuselage Test Article with Composite Doubler Installed; Note Reinforcing Plates Around Perimeter of Fuselage Section for Load Application

B. Close-Up View of Doubler with Strain Gages Installed

Fig. 28.5. Door surround structure test article with strain gages mounted.

Upon completion of the structural tests on the fuselage section in its original condition, the 72-ply, door corner repair doubler was installed on the test article. The photos in Figure 28.5 show an overall view of the doubler on the fuselage test article and the strain gages installed on the composite doubler and surrounding aluminium skin. Figure 28.6 shows the 74 channels of strain that were used to monitor: (1) the strain field throughout the composite laminate and aluminium parent material, and (2) the load transfer into the composite doubler.

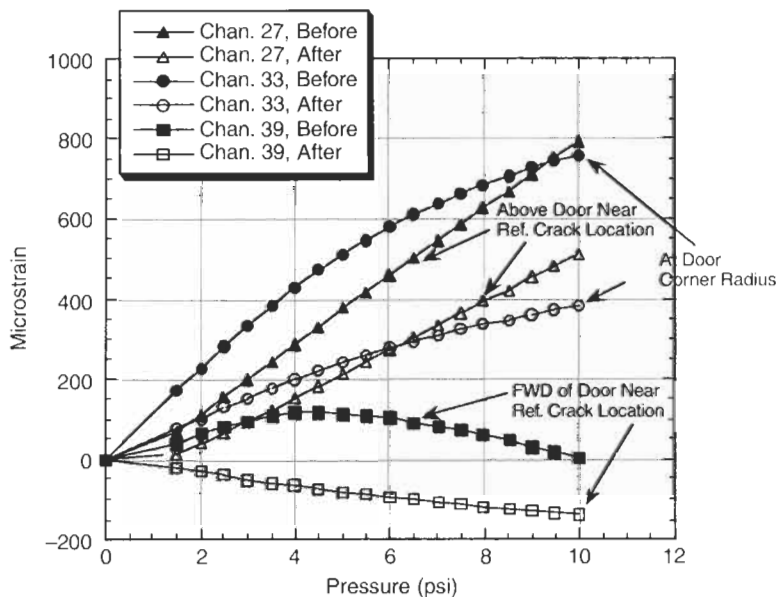
Fig. 28.7. Comparison of strains before versus after doubler installation around door corner radius (Axial Strain Reduction).

These strain reductions, along with the fact that the doubler did not induce any undesirable stress risers in the door corner area, quantify the realization of the basic doubler design goals: (1) to uniformly reinforce the area (global reduction in door corner strains), and (2) achieve the proper stiffness ratio between the parent skin and composite laminate (excessive stiffness would attract undesirably large loads). Figure 28.7 is a plot of data obtained before and after the doubler was installed and show hoop and axial strain reductions around the door corner radius. The strain reductions were primarily in the 40%–60% range.

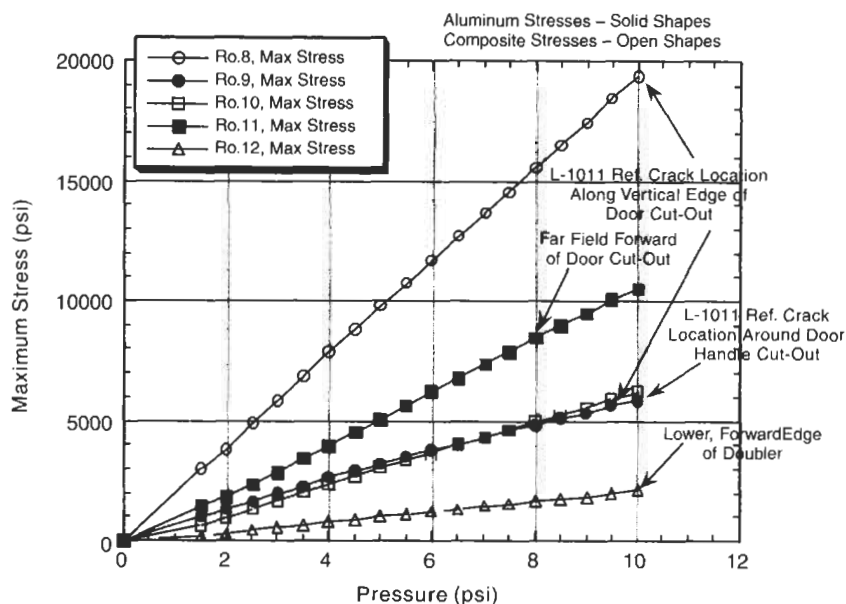
Fig. 28.8. Principal stresses in region of doubler vertical leg.

The maximum principal stresses for Rosettes R-8 through R-12 are plotted in Figure 28.8. The largest stress in the aluminium skin was found at R-7 (inside skin) at the door corner radius. The magnitude was 10.6 ksi, down from the 15.3 ksi recorded at that same location before the doubler was installed. The largest Boron-Epoxy stress was 19.3 ksi at the R-8 Rosette gage. This is less than the 22.4 ksi

measured at that same location before the doubler was installed. Similar comparisons of aluminium stresses before the doubler versus aluminium/boron stresses at the same locations after the doubler revealed the stress reductions summarized in Table 28.1. It can be seen that the stresses were reduced by as much as 53% through the application of the reinforcing doubler.

These bending strains account for 30% to 50% of the total strain in the structures being monitored. Figure 28.8 also shows the significant amount of bending that occurs across the fuselage skin at R-8/R-9. While the principal stress on the inside skin (R-9) was only 5.9 ksi, the principal stress on the outside skin (R-8) was 19.3 ksi. These results are similar to those obtained during the “before doubler” tests, however, the magnitudes of the bending strains are lower. This shows that the doubler reduced the stress risers in the door corner area.

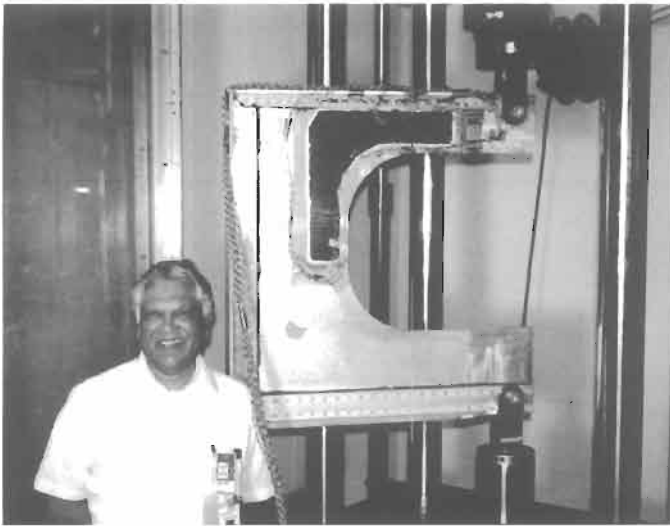
Fig. 28.9. Photograph of door corner test article mounted in a uniaxial test machine.

Figure 28.9 is a photograph of the test specimen mounted in the uniaxial test machine. It is important to note that the composite doubler did not have any edge taper along the horizontal and vertical legs and around the door corner radius. This created a 90° drop off from the full thickness of 72 plies down to the parent aluminium skin. While this does not follow normal doubler design guidelines it does represent the L-1011 door corner repair. Since the doubler needed to have maximum strength in the critical door corner region, it was not possible to utilize a

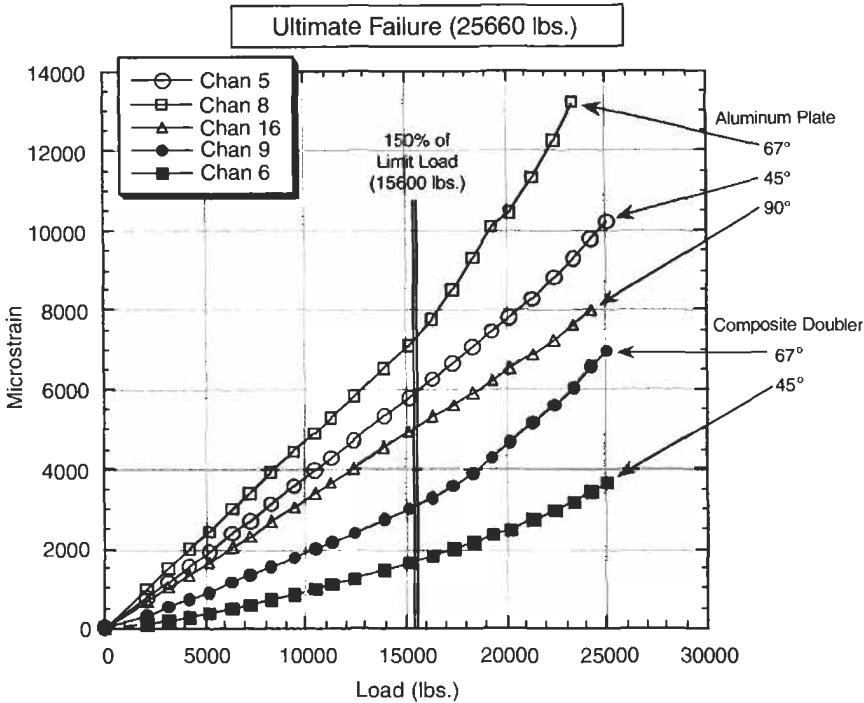
Fig. 28.12. Comparison of critical strains in aluminium and composite material showing load transfer into doubler.

Figure 28.12 compares the aluminium and Boron-Epoxy strains for the critical area around the cut-out radius in the Door Corner Test Article. The strain field in the composite doubler was similar to that of the parent aluminium plate with nonlinear behavior noted in the gages located around the radius of the door cut-out (Channels 6 and 9). Note that due to strain hardening applied during the 150%

Limit Load Test, subsequent yielding in the Ultimate Failure Test did not occur until the strain levels corresponding to the previous 15600 lb. test load were exceeded. This yield onset point is indicated in Figure 28.12 by the 150% limit load line. Since Boron-Epoxy material does not normally exhibit the nonlinear stress-strain response or yielding indicated in the figure, the nonlinearities in the curves probably stem from the yielding in the aluminium substrate and the corresponding nonlinear load transfer into the composite doubler. This conclusion is supported by the fact that the onset of the composite's nonlinear response (at the 15600 lbs., 150% Limit Load level) matches the one noted for the aluminium plate.

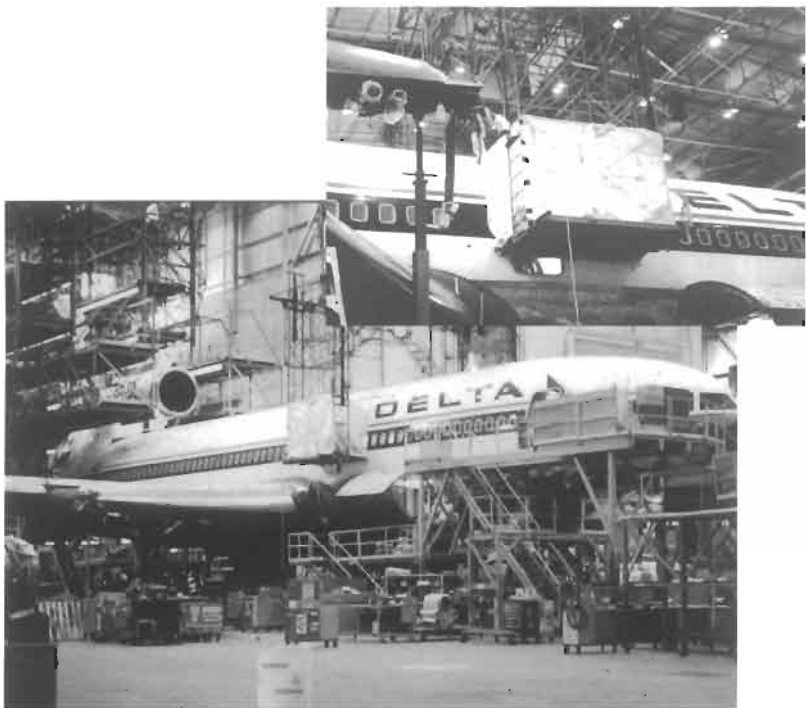
Fig. 28.13. Delta L-1011 aircraft during installation of composite doubler (inset – work stand positioned next to the right side passenger door).

Figure 28.13 shows the Delta aircraft undergoing maintenance and the doubler installation staging area at the right side, P3 passenger door. Figure 28.14 shows the aircraft skin section which was cleaned and anodized – via a phosphoric acid non-tank anodize (PANTA) process – to support the doubler bonding process [12]. The doubler was placed in an autoclave (150 °F, 80 psi) to debulk/densify the doubler and to bleed out excess resin. The 72 ply Boron-Epoxy composite laminate (post-debulk) is shown in Figure 28.15. The contour around the door corner radius, the cut-out to accommodate the emergency door handle access port, and the tapered edges around the perimeter are evident.

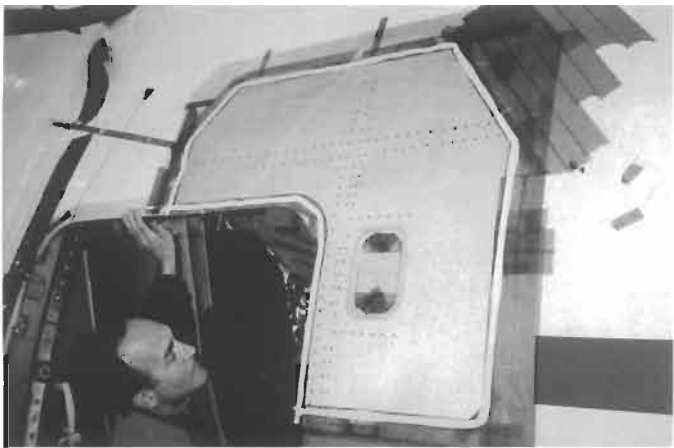
Fig. 28.14. Anodized door corner prepared for doubler bonding process.

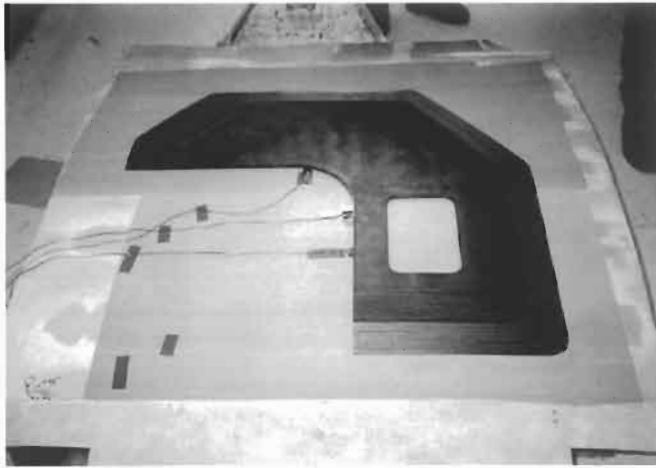
Fig. 28.15. Boron-Epoxy laminate following autoclave debulk process.

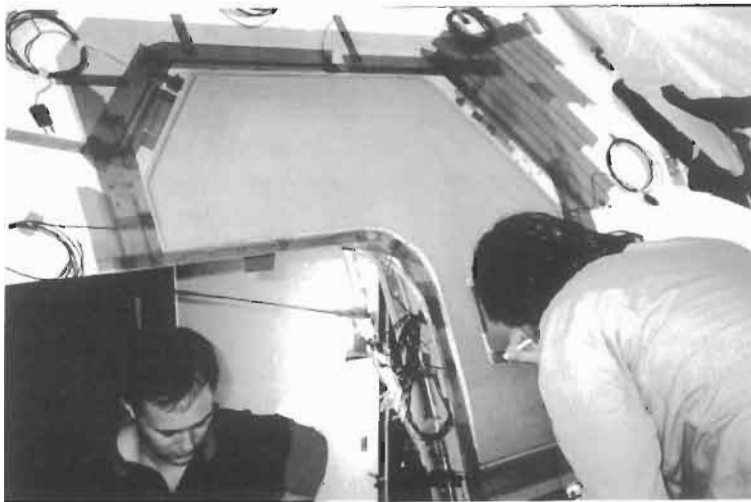
Fig. 28.16. Composite doubler positioned on door for cure process.

A fiberglass environmental protection ply and a copper mesh lightning protection ply were installed on top of the Boron-Epoxy laminate. Figure 28.16 shows the complete doubler lay-up as it was positioned on the L-1011 door frame. The doubler was placed on the fuselage followed by bleeder cloths, heater blankets, insulation and a vacuum bag assembly. Twenty two thermocouples were installed

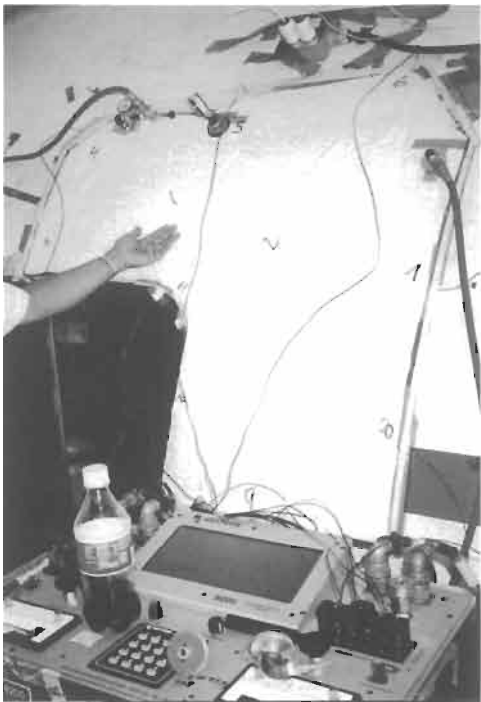
Fig. 28.17. Cure process – doubler beneath heat blanket, insulation, and vacuum bag assembly; heat controller is shown in foreground.

After the heat blankets were turned on, the temperature ramp-up process, which included the placement of heat lamps on the back side of the skin and insulation over heat sink areas, took 2 1/2 h. Figure 28.17 shows the vacuum bag arrangement and the Heat Con blanket controller during the cure process. Figure 28.18 shows the inside structure of the door corner area and the heat lamps that were positioned to minimize the effects of the various heat sinks. In order to optimize the

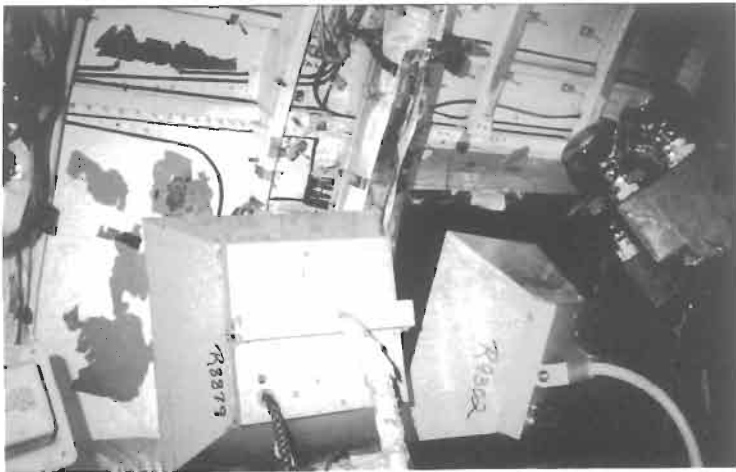
Fig. 28.18. Heat lamps positioned inside aircraft to help maintain cure temperature on back skin.

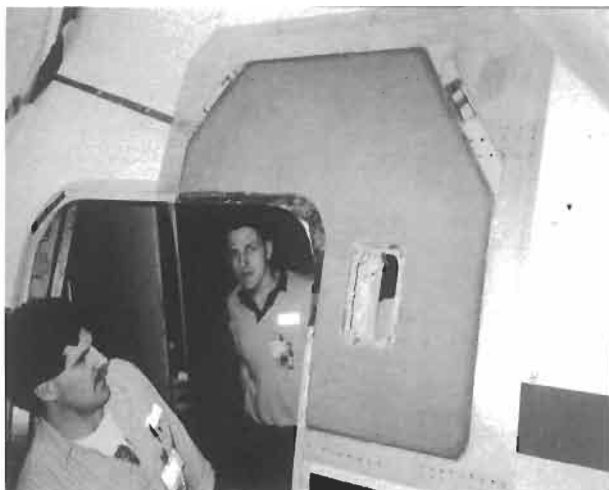
Fig. 28.19. Composite doubler following cure process (prior to application of delta paint scheme).

uniformity and stability of the temperature field, the 190 °F, 6 h cure cycle was used instead of the 210 °F, four-hour cure cycle. Temperature fluctuations were less than 5 °F at any location inside and outside the aircraft. The maximum and minimum temperatures were separated by approximately 25 °F. A close-up view of the completed composite doubler installation is shown in Figure 28.19. To contrast this doubler with the conventional approach, Figure 28.20 shows the series of riveted, metallic plates that are traditionally used to repair the L-1011 door corner. The light colored strip running diagonally across the doubler is a rain gutter.

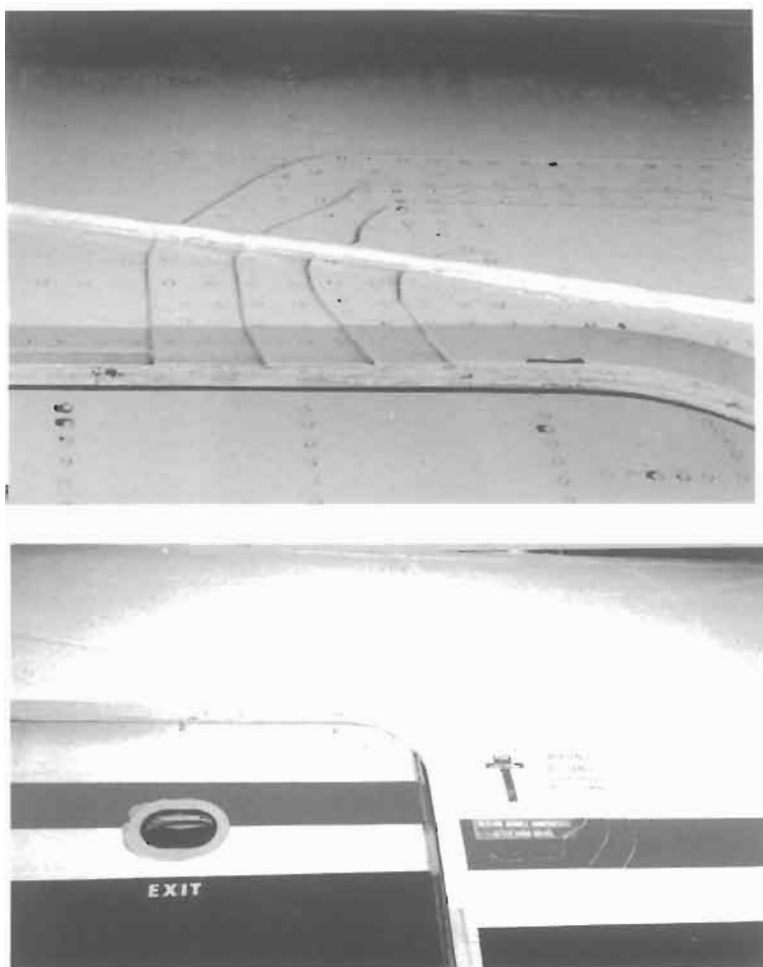
Fig. 28.20. Conventional door corner repair with four, riveted metal plates; close-up view (inset) shows intricate rivet pattern and complex shape of quadrupler plates.

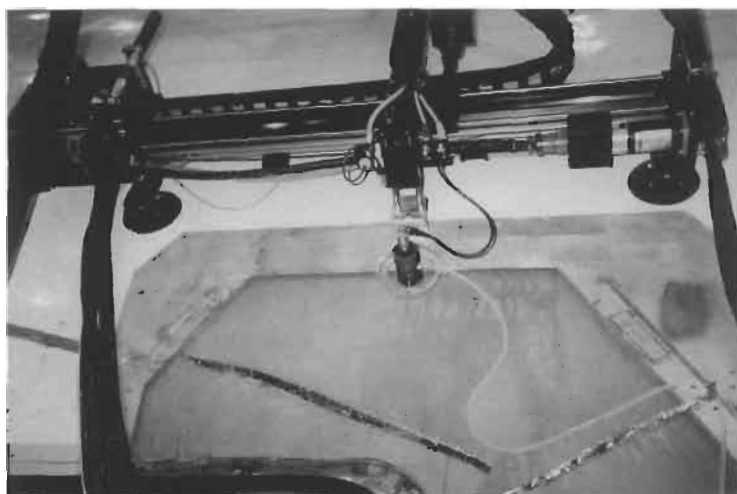
Fig. 28.21. Ultrasonic scanner system inspecting a tapered region of the L-1011 door corner doubler.

Periodic field inspections of the composite doubler for disbonds and delaminations (from fabrication, fatigue, or impact damage) is essential to assuring the successful operation of the doubler over time. After the doubler was installed, disbond and delamination inspections were performed using the Sandia Labs AANC ultrasonics inspection procedure for bonded composite doublers[11]. This procedure is required by reference [14] for the L-1011 application. The doubler was inspected using pulse-echo ultrasonics (UT) and an X-Y scanner system [8]. Most of the flaw detection effort was focused on the critical 1.5" wide strip around the perimeter of the doubler. A 0.5" diameter flaw is the allowable flaw size in this load transfer region. Scans were also produced in the internal region to assure that there were no flaws in excess of the size allowed by the damage tolerance assessment. Away from the doubler edge taper region, the maximum allowable contiguous flaw is equal to 5% of the total, full-thickness area of the doubler. Figure 28.21 shows the ultrasonic scanner system inspecting the upper, tapered region of the door corner doubler. The inspection did not reveal any flaws in the L-1011 doubler. Chapter 23 provides a comprehensive examination of inspection methods for composite doublers.

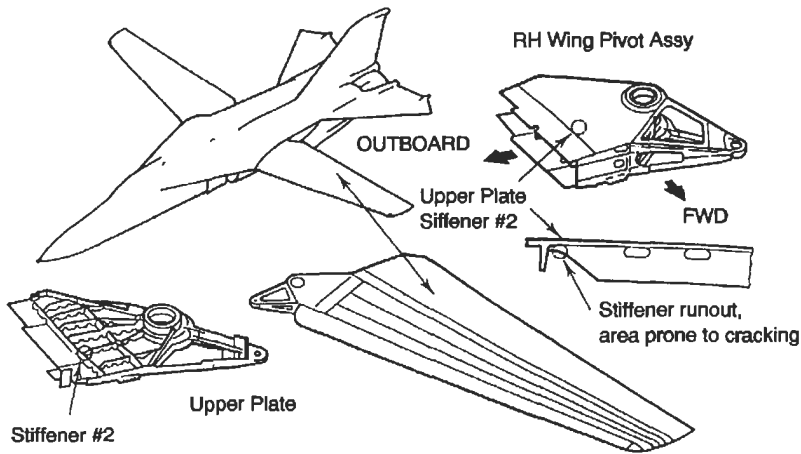
Fig. 29.1. View of F-111 aircraft and wing showing location of critical area.

The region prone to cracking, depicted in Figure 29.1, is in the upper surface of the wing in the D6ac steel WPF which is close to the bolted splice with the aluminium alloy wing skin. Cracking can develop in the stiffener runout, indicated in Figure 29.1.

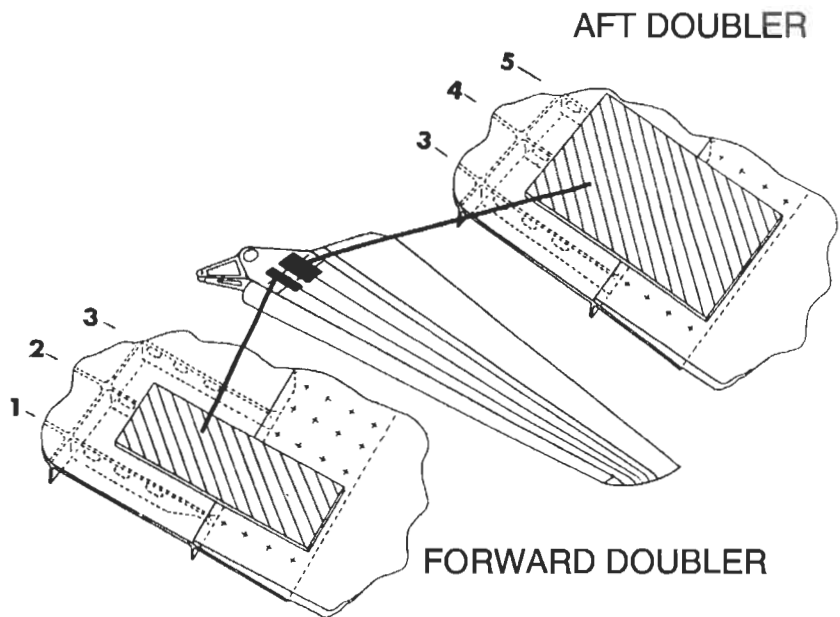
Fig. 29.2. Doubler locations on the F-111 steel WPF and aluminium alloy wing skin.

As shown in Figure 29.2 and Figure 29.3, the reinforcement consists of two boron/epoxy doublers (over 120 plies, or 15 mm of unidirectional boron), adhesively bonded to the upper surface of the WPF over the stiffeners known to develop high levels of strain during the CPLT. One large doubler covers stiffeners numbers 4 and 5 and a smaller doubler covers stiffener number 2. Structural aspects of the design of the doublers are covered in more detail in [4].

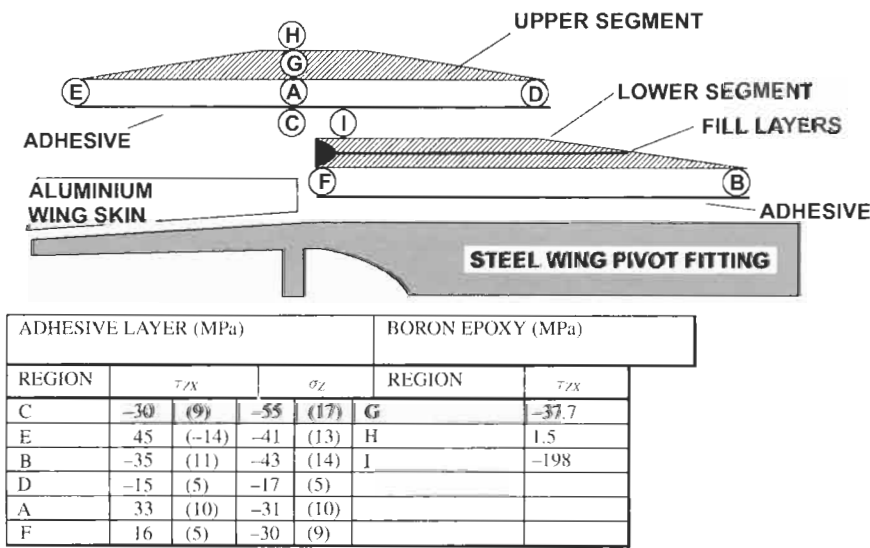
Fig. 29.3. Exploded view of doubler indicating regions where approximate through-thickness stress (σ_z) and shear stress (τ_{xz}) values were estimated. The tabulated values are for the nominal +7.33 g proof load and those inside the brackets are estimated for the -2.4 g proof load.

Some results of the finite-element analysis of the doubler are provided in Figure 29.3 (taken from reference [5]) in which only elastic behaviour is considered in the adhesive and reinforcement. Critical shear and through-thickness stresses in the adhesive layer and shear stresses in the boron/epoxy-adhesive interface are indicated. Considering these results and the material's properties provided in Table 29.1 the following comments are made:

- i Comparison of the typical shear yield stress for the adhesive, Table 29.1(a), with the shear stresses predicted by the finite-element analysis Figure 29.3, indicates that the adhesive would not yield during the CPLT. However, modest yielding would have occurred at room temperature around regions A, B and E.
- ii The high shear stress in the boron/epoxy at location I is of concern. However, as it is very localised, failure should not occur since the strain energy density criterion as used in [4] is not exceeded.
- iii Through-thickness stresses under the high +7.33 g load are compressive and are therefore not of concern and only modest tensile stresses arise under the -2.4 g load.

Measurements were made of the mode I fracture energy (G_{IC}) using the double cantilever beam test [6]. The initial work of fracture was 230 J/m² at ambient temperature and 150 J/m² at -40 °C. The significant decrease in G_{IC} with decrease in temperature results from the reduction in strain capacity of the epoxy matrix. This result indicates that the -40 °C condition could be critical for growth of delamination damage in the boron/epoxy doubler under tension which occurs in the wing during the minus g loading. However, other than region I, Figure 29.3, positive σ_z stresses are expected to be modest.

one another in curvature and in the depth of the step created by the joint between the aluminium alloy wing skin and steel WPF, Figure 29.3.

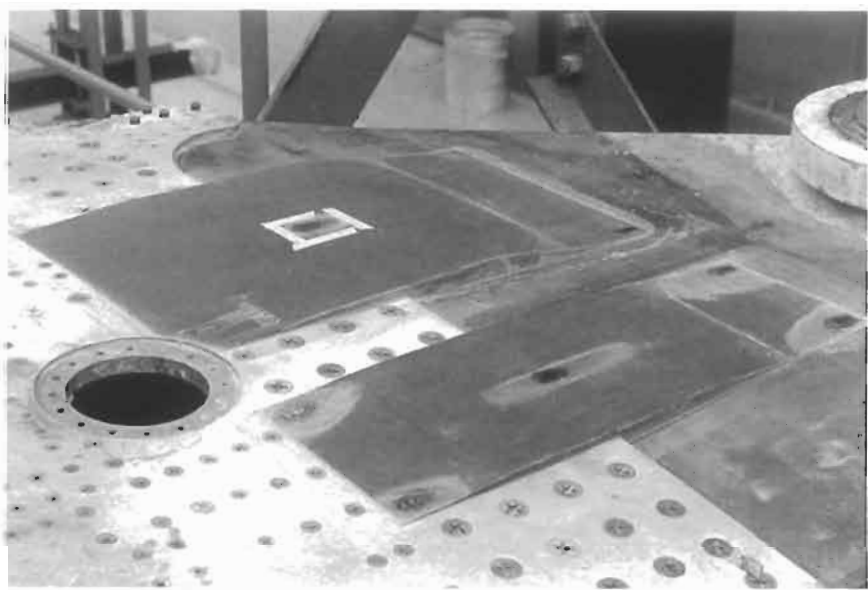
Fig. 29.4. Photograph of the installed doublers; note the step between the aluminium wing skin on the left and the steel WPF on the right.

with the aluminium skin at the step, and the upper segment is bonded to the aluminium skin (over the fasteners) and the lower segment. Each segment consists of about 60 plies tailored (by ply drop-offs) to fit the step and the curved surface of the wing skin and tapered (also by ply drop-offs) to achieve single plies at the extremities of the doublers. The lower segment contains a cut-out region with a

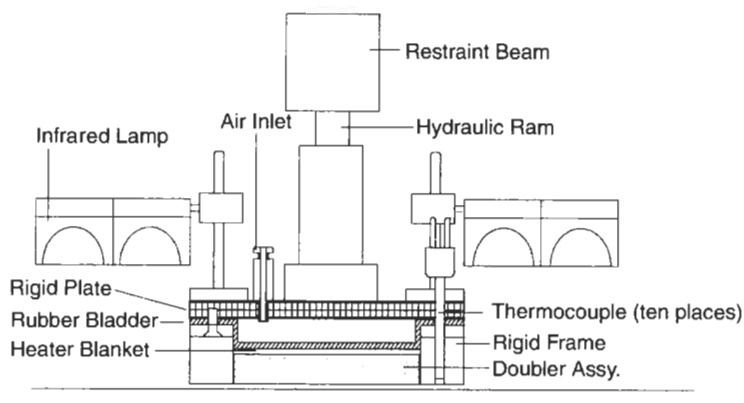
Fig. 29.5. Schematic of the rig employed to form and bond the boron/epoxy doubler to the wing skin (not to scale).

release layer over the repair. The region between the bladder and a stiff plate is pressurised using air to force the bladder down onto the repair. The plate is held firmly against a surrounding frame which also acts as an edge dam, preventing transverse distortion during cure. Loads generated by the pressure were reacted out at hard points on the wing. Figure 29.5 is a schematic of the rig employed in bonding the doubler.

The standard vacuum-bag approach can be a very successful method of developing pressure to bond a reinforcement onto a surface that contains no perforations or discontinuities. However, the danger with using a vacuum bag on the F-111 WPF is that contaminants may be drawn into the repair region from either the step at the wing skin or from under the fasteners. Instead, a method to apply direct pressure, based on the use of a rubber bladder, was chosen to overcome these problems. In this approach, the bladder is in direct contact with a

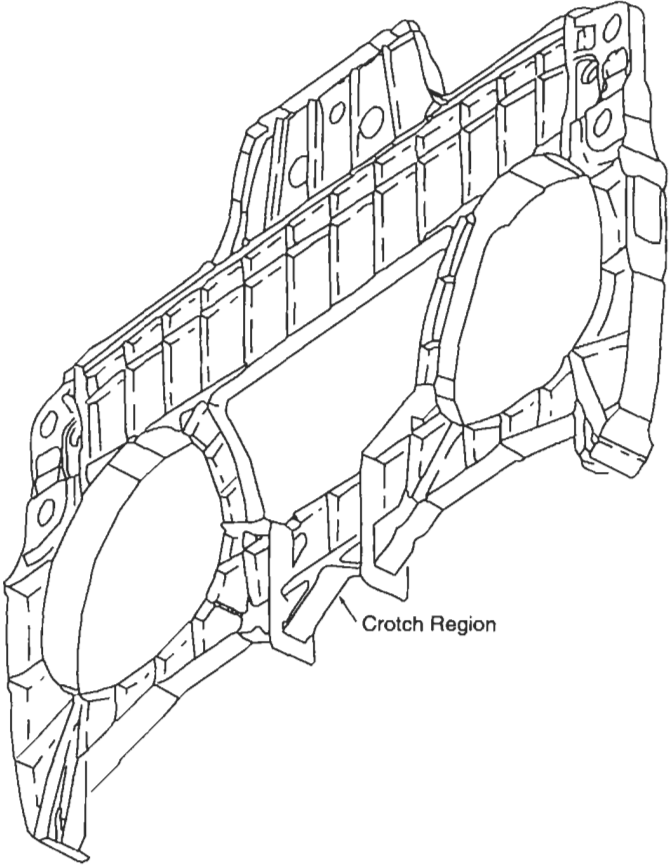
Fig. 30.1. The Y470.5 centre fuselage bulkhead showing location of crotch region.

The crotch region of the Y470.5 bulkhead was identified as a potential site for fatigue cracks early in the life of the FA-18 aircraft (see Figure 30.1). The current full-scale fatigue test of the aircraft centre section in Canada showed that cracking will occur in this region under the flight loads likely to be experienced by the RAAF fleet at approximately 6600 test flight hours. Northrop/McDonnell Douglas recommend that an ECP be implemented to the bulkhead to remove any fatigue damaged material and to reduce the stress concentration caused by the present sharp angle (see Figure 30.2). This ECP is planned to be implemented to the RAAF fleet by 2200 flying hours (test life to cracking divided by a safety factor of three) so that the aircraft can safely meet its full design life of 6000 flying hours.

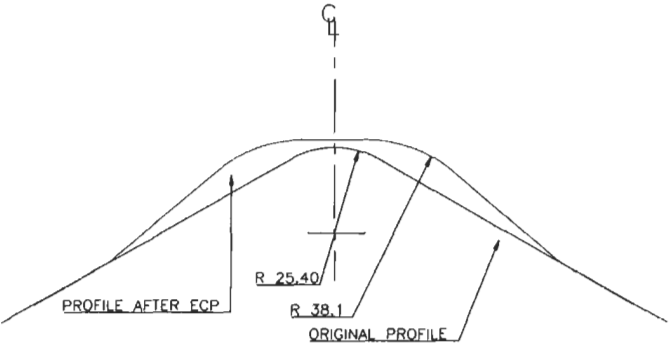
Fig. 30.2. Detail of crotch centreline showing the original and the profile after ECP. All dimensions in millimetres.

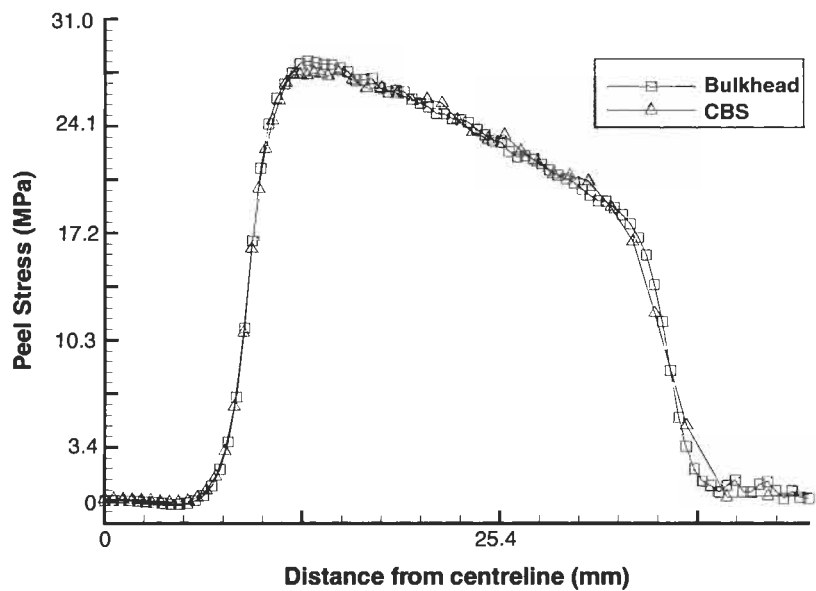
Fig. 30.3. Through-thickness (peel) stress distribution in adhesive post ECP and reinforcement at DUL for both the bulkhead and the CBS.

The models of the bulkhead were run to determine the stress state in the adhesive at the ultimate load condition for both the pre and post ECP cases. The results for the pre ECP case are summarised in Table 30.1. Figures 30.3 and 30.4 show the adhesive shear and through-thickness stress for the post ECP case.

The CBS was designed to reproduce the stress distribution in the reinforcement and bulkhead material. The two specimens represent the shape of the F/A-18 Y470.5 bulkhead crotch region pre and post ECP, the adhesive and the proposed boron/epoxy reinforcement. Figure 30.5 shows the CBS for the post ECP case. The model of the CBS was analysed at DUL (note that for the pre ECP case DUL is equivalent to a pin load of 72.3 kN and for the post ECP case DUL is equivalent to a pin load of 53.3 kN) and was able to accurately reproduce the midplane bending stresses, the adhesive peel stresses and the adhesive shear stresses when compared with the corresponding bulkhead model. The adhesive shear and through-thickness stress distributions for the CBS post ECP are shown in Figures 30.3 and 30.4 respectively.

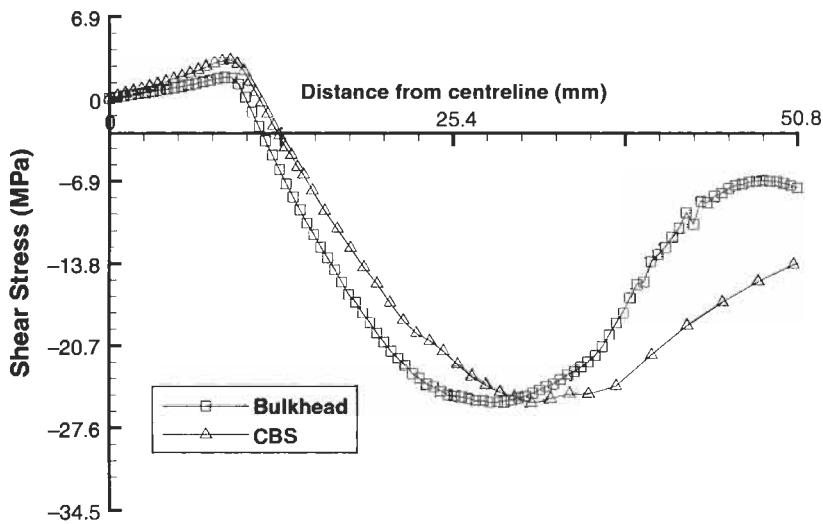
Fig. 30.4. Shear stress distribution in adhesive post ECP and reinforcement at DUL for both the bulkhead and CBS.

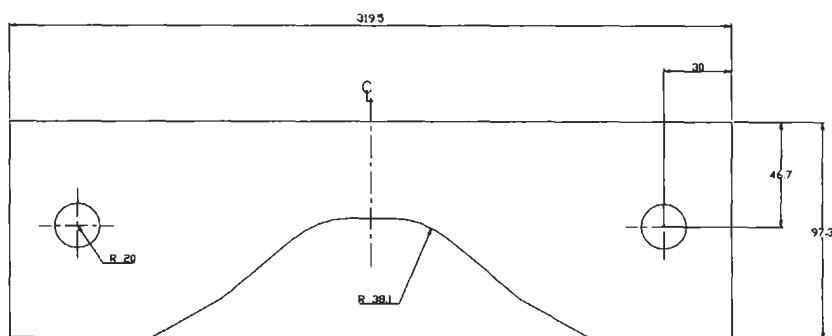
Fig. 30.5. Drawing of CBS for the post ECP case. All dimensions in millimetres.

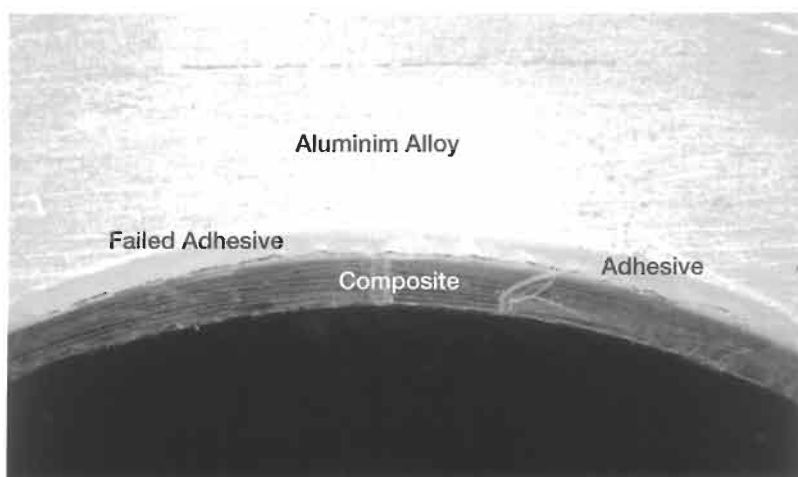
Fig. 30.6. Detail photograph of crotch region in CBS after failure of bondline.

for the static testing it was decided to test the reinforcement at both room temperature and at 60 °C. For all the tests, the specimens were pin loaded in a servo-hydraulic test machine and load versus strain information was measured using a computer-based data acquisition system. The failure pin load was measured when the strain in the boron/epoxy reinforcement was observed to drop indicating adhesive failure. The results of the static test program are given in Table 30.2 and Figure 30.6 shows a typical failure mode in the radius of the crotch in the CBS.

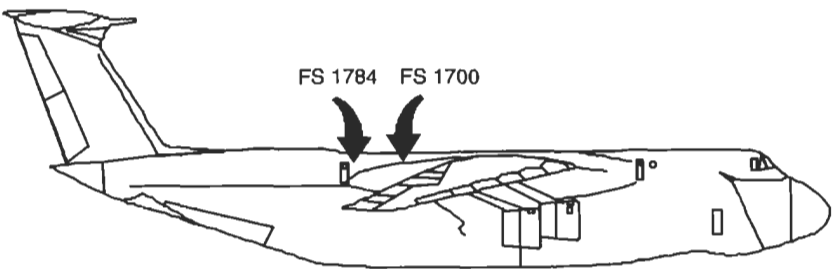
Fig. 31.1. Crack locations in crown section of C-5A.

One of the problems in the aging C-5A fleet is multiple small-cracks in the upper aft-crown section of the fuselage skin. These cracks are possibly caused due to the usage of stress corrosion sensitive 7079-T6 aluminum. The crown section experiences significant longitudinal tensile bending in addition to biaxial tension due to internal pressurization. Multiple short cracks (25 to 50 mm/1 to 2 inch long) were found (Figure 31.1) in the crown of several aircraft. In the fall of 1995 two bonded-composite repairs were applied at fuselage stations 1700 and 1784 by a team of Wright Laboratory, San Antonio-Air Logistics Center, and United States Air Force Academy personnel [1].

The cracks are believed to have nucleated from the rivet holes of the 7079-T6 aluminum skins due to high fit-up stresses induced in manufacturing and the bending moment caused by the T-tail.

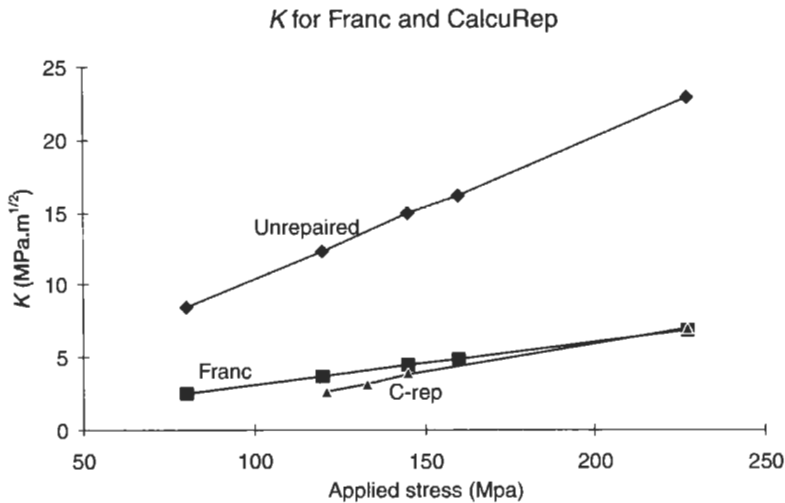
Fig. 31.5. K_{repaired} for Franc and CalcuRep models.

Both analysis methods have weaknesses. CalcuRep does not model the substructure properly and therefore overestimates the applied stress in the repaired area. Franc does not model the thermal issues. A comparison of the results for K_{repaired} between the two methods is given in Figure 31.5.
