Advances in the Bonded Composite Repair of Metallic Aircraft Structure

VOLUME 2

Chapter 19. Bonded Repair of Acoustic Fatigue Cracking 531

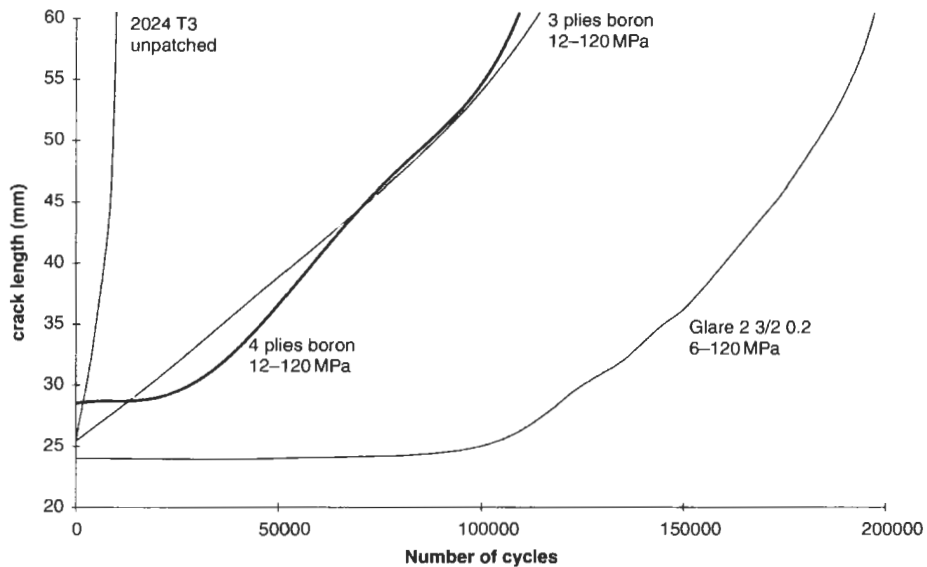
Patch performance of low and moderate CTE patches on 2024 T3

Fig. 31.6. Performance of bonded repairs using GLARE[®] and boron patches.

Figure 31.6 shows the results for an unpatched panel and both Glare and Boron patched panels. Both patch materials extend the fatigue life of the panels considerably. The Glare repair results in a lower K_{repaired} . The now lower $\Delta K_{\text{repaired}}$ in more load cycles for the crack to reinitiate.

The boron repair results in a relatively higher K_{repaired} than the Glare repair, and it takes fewer cycles for the crack to reinitiate. These tests were all run at room temperature. At lower temperatures these differences might even be more

pronounced due to the increasing thermal stresses. On the other hand, the repairs were applied to unstiffened panels. An actual structure (with substructure and only partly heated) will have a lower CTE than an unrestrained panel, and therefore the lower CTE of the boron will better match the effective CTE of the actual structure [2].

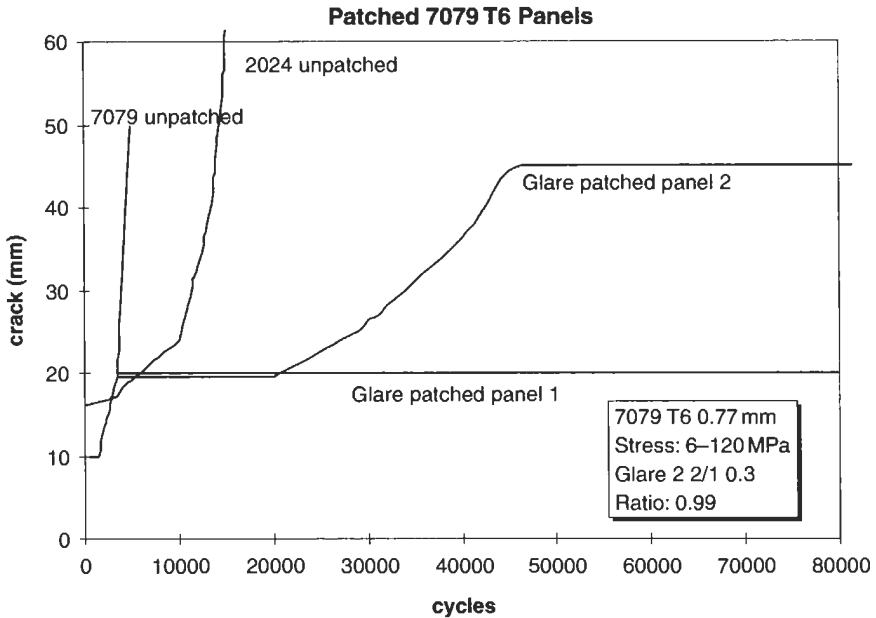
Fig. 31.7. GLARE[®] patched 7079-T6.

The next test was to evaluate the performance of the repairs on the actual fuselage skin, 7079-T6. Since this material is not available, some scrapped panels from a C-5A were used to prepare the specimens. The panels had multiple rivet holes from installation on the aircraft. All the holes outside the patched area were filled with rivets. The configuration of the specimens was similar to the earlier tested specimens. A pre-crack was cut and fatigued up to the initial starter length after which the patches were bonded to the panels. The results of these fatigue tests are given in Figure 31.7.

The first noticeable (and expected) difference between 2024-T3 and 7079-T6, is the higher unrepaired crack-growth rate in 7079 at the same fatigue level. This indicates that an effective bonded repair is necessary. The first patched panel gave no fatigue crack growth after the bonded repair was applied. The second panel gave an initial retardation period, after which the crack slowly grew until it terminated in one of the existing rivet holes under the patch.

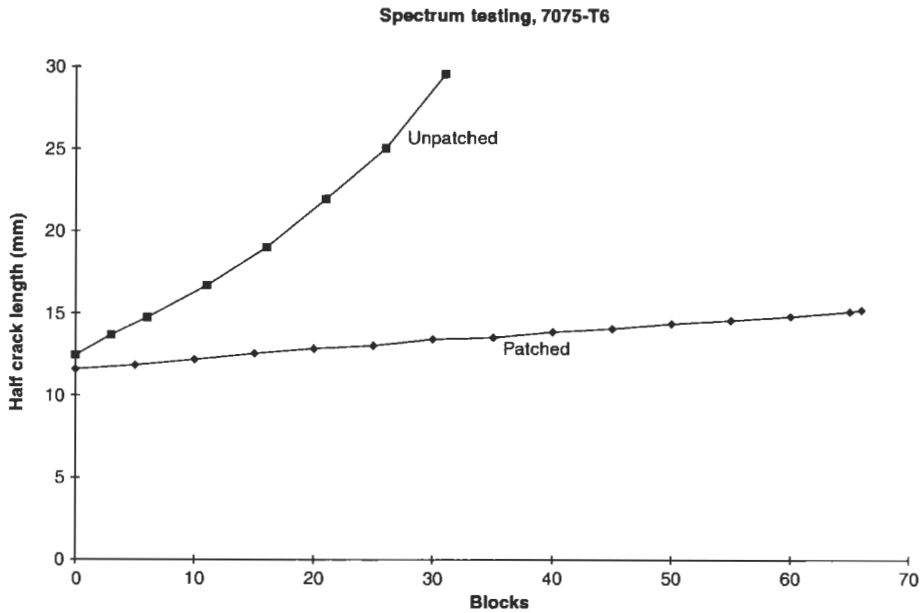
Fig. 31.8. Crack growth under spectrum loading.

The results from patched specimens under spectrum loading are given in Figure 31.8. The data shows that the bonded repair can easily provide the life extension needed for the C-5A.

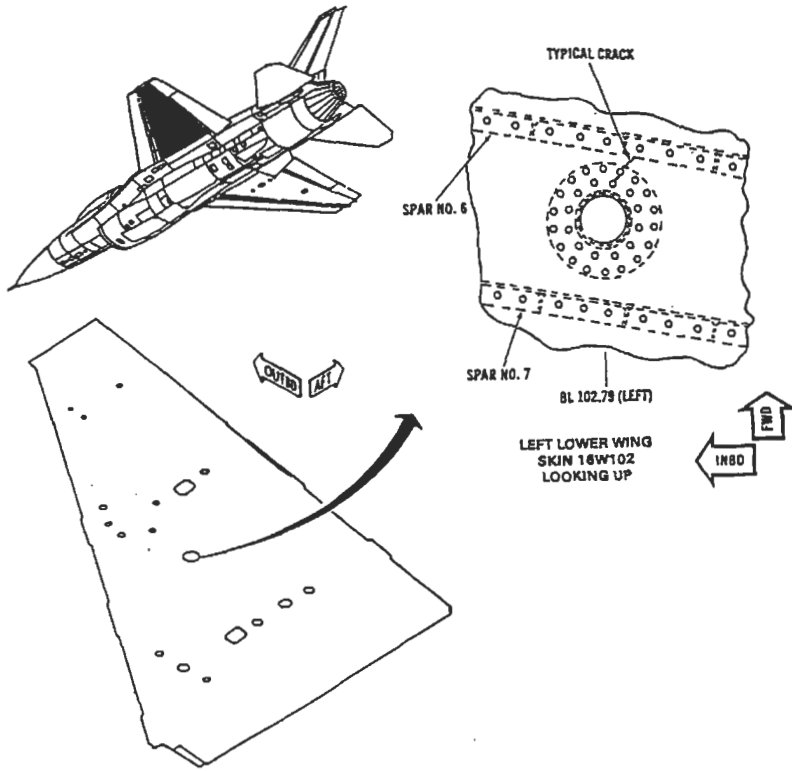
Fig. 32.1. Typical crack location.

Several F-16 aircraft developed cracks, between 2500 and 3500 flight hours, forward and aft of the fuel vent hole in the lower left wing skin, which is about 5 mm (0.2 in) thick. These cracks (Figure 32.1) occurred in the first 144 aircraft prior to a modification requiring the use of interference fit fasteners in the fuel vent hole area.

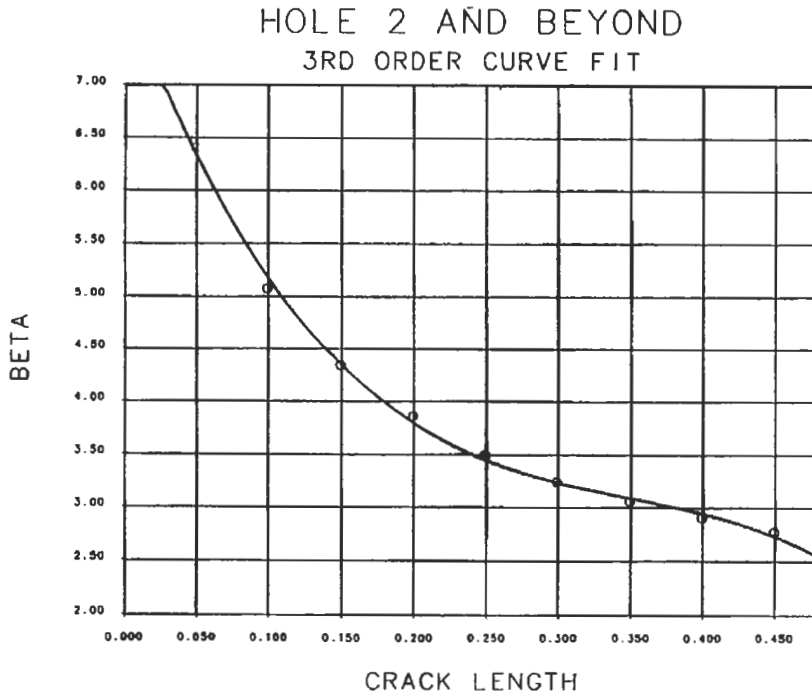
Fig. 32.2. β -factor for different crack lengths (inch) beyond the second row [2].

1. Crack growing from the first fastener row towards the cutout.
2. Crack between the first and second row of fasteners.
3. Crack beyond the second row of fasteners.

Cracks 90 software was used to perform the crack growth analysis. In this program, several (standard) β -solutions were given, but none of them matched the situation around the fuel vent hole. NASTRAN was used to model the geometry and determine the proper β -factor. The stress intensity at a crack tip element was then calculated. With the applied stress and the crack length known, the β -factor could be calculated for several crack lengths (see figures 32.2 and 32.3). This was done for three situations:

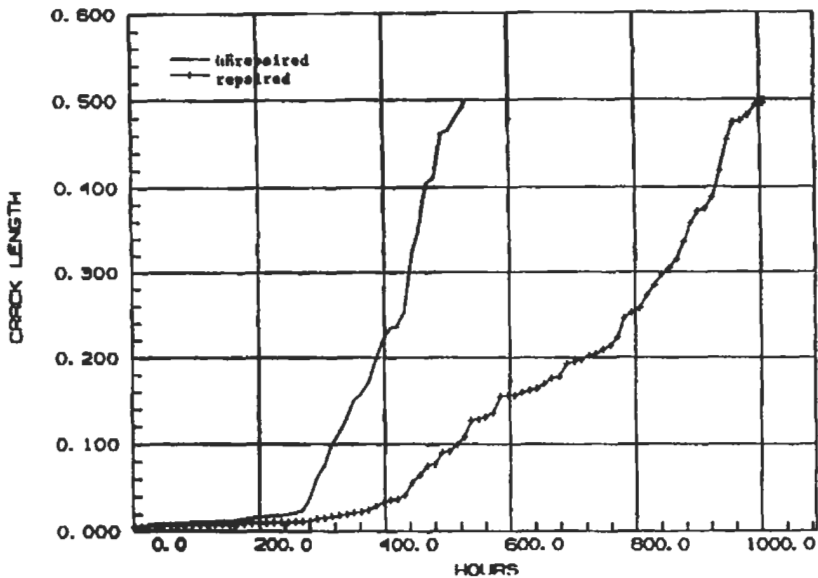
Fig. 32.3. Crack growth prediction in inches (Cracks 90) beyond second row, using calculated β -factors [2].

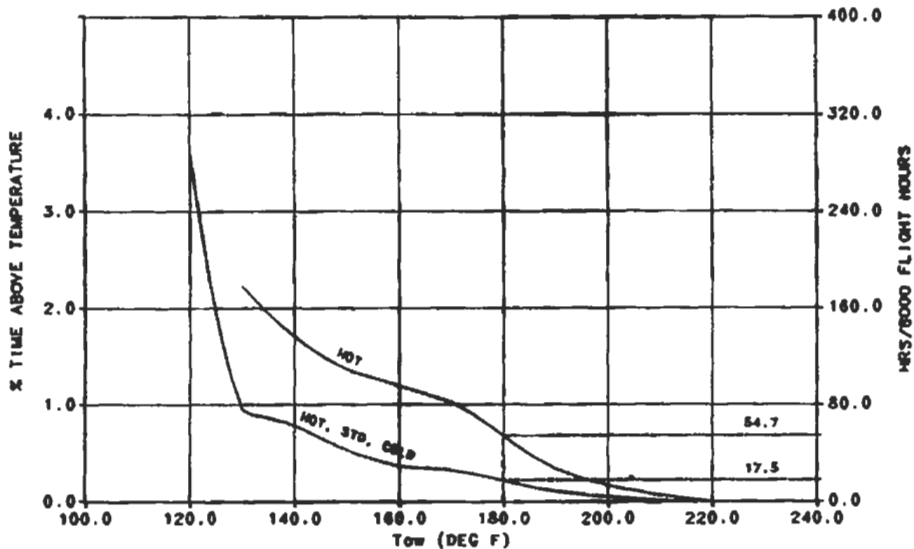
Fig. 32.5. Total flight hours above indicated temperature [2].

The cumulative temperature of the bondline (total time above a temperature) was predicted over the 8000 h service life by using a computer procedure named "life time temperature spectrum (LTTS)." This program predicts the adiabatic wall/skin temperatures depending on the mission mix and conditions during the flight. Two types of conditions were analyzed: one with a normal mix of hot, standard and cold conditions, and one with only hot conditions. The output of the program is a table of specified skin temperature exceedances over the life of the aircraft (see Figure 32.5). The bondline temperature was assumed to be equal to the skin temperature.

The result of the analysis was that the bondline temperature was over 82°C (180°F) for 17.5 h per 8000 h during the lifetime of the aircraft in a normal mix of conditions. With only hot conditions (warm weather), the result was 54.7 h above 82°C . These results led to the selection adhesives that had slightly higher service temperatures than traditional 121°C (250°F)-curing adhesives. Two adhesives from Cytec, FM 87-1 and FM 300-2, were considered acceptable for the repair.

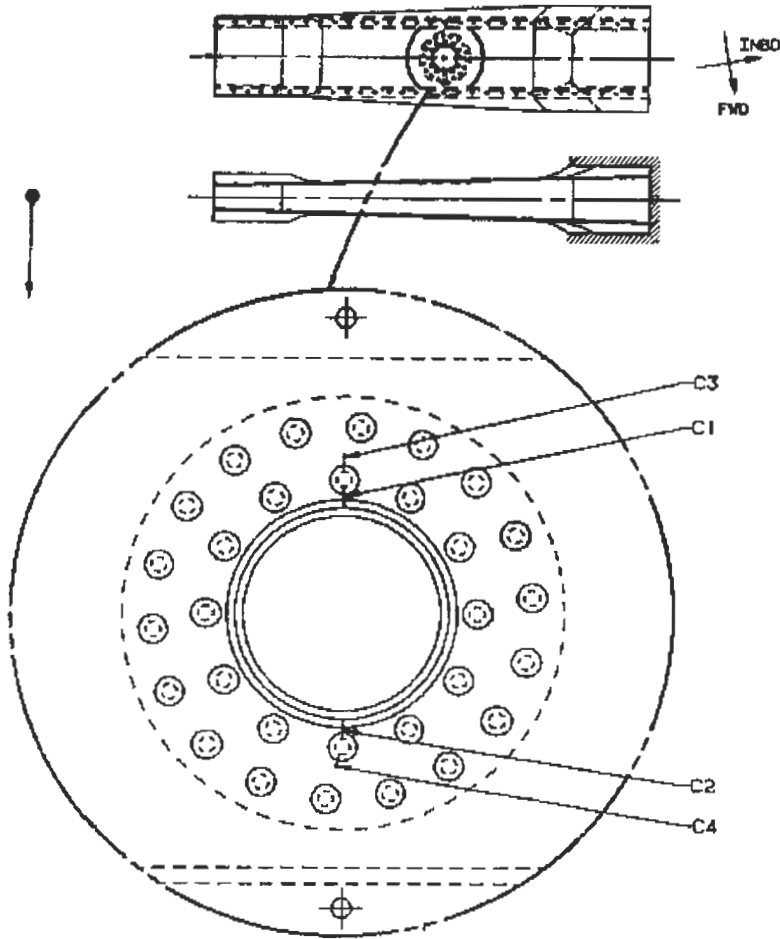
Fig. 32.6. Crack locations and specimen configurations [2].

Two component-size test articles were produced, and boron/epoxy patches were applied to the precracked fuel vent hole. The specimen size was limited to roughly the width of the patch, even though it is preferred to use specimens wider than the patch to allow for load attraction into the patched area. The spectrum used for both the precracking and the testing of the patched fuel vent hole was a normal severity usage spectrum for the Block 30 fleet. The spectrum represented 500 flight hours and 38257 load points ranging from 100% tension, down to –32.4% compression. The precracking was stopped when a crack had grown from the first row of fasteners to the fuel vent hole, and then from the first row of fasteners half way towards the second row of fasteners around the fuel vent hole. At this point the boron/epoxy patches were applied.

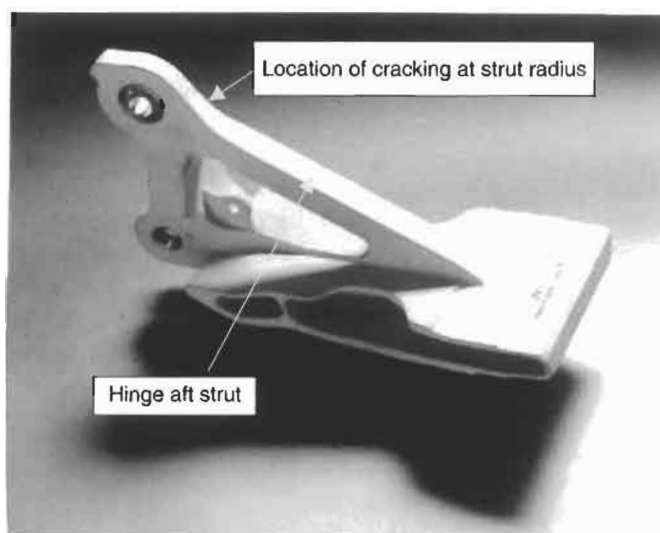
Fig. 33.1. Photograph of the aileron, showing the hinge aft strut and location of fatigue cracking.

F/A-18 inboard aileron hinges are susceptible to fatigue cracking in the aft strut fillet due to higher than originally expected flight loads. The hinge and the location of cracking are shown in Figure 33.1. The cracks are normally detected at less than half the anticipated life of the hinge and there is currently no repair possible for cracked hinges. The only currently accepted solution is to replace the cracked hinge. This procedure is difficult for some operators of this aircraft as the entire aileron has to be sent to the US for the hinge replacement to be undertaken. Because of the lengthy delays and costs involved for these replacements, the present investigation was undertaken to see if it would be possible to repair some of the cracked hinges without removing them from the aileron.

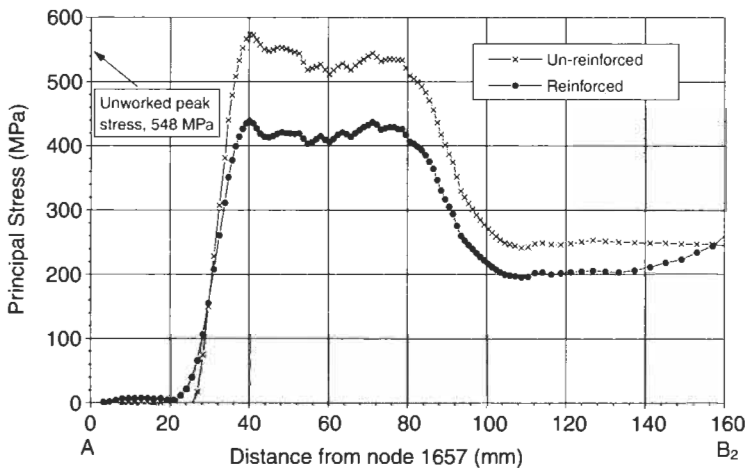
Fig. 33.4. FE prediction of principal stress along the strut edge for the OSR 2 mm rework geometry for the WO 39 load case. A and B₂ are the points shown in Fig. 33.2(a).

geometry shows the peak in tensile stress at 67 mm as described previously in the stress analysis section. The effect of the 2 mm deep rework can be seen as the region of high stress is broadened and the location of peak stress shifts closer to the lug end (compare Figure 33.7 with Figure 33.4). The subsequent effect of reinforcement is seen to significantly reduce the strain at all locations in the critical radius region with the peak stress having been reduced by 16% compared with the original uncracked hinge geometry.

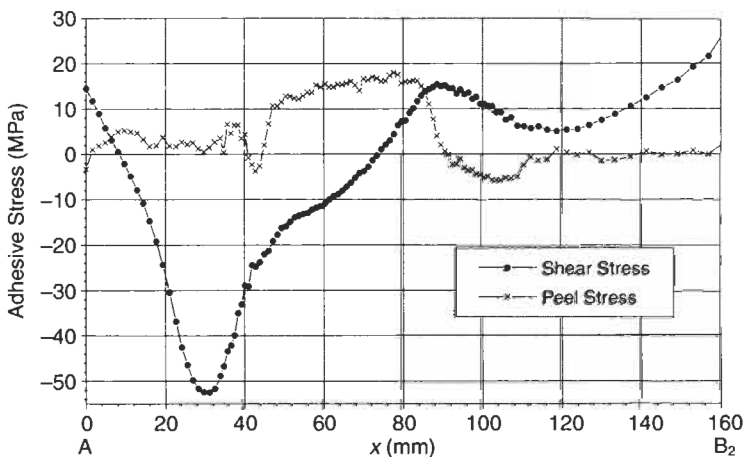
Fig. 33.5. Adhesive stresses occurring along the adhesive bondline for the OSR 2 mm rework hinge for the WO 39 load case. A and B₂ are the points shown in Fig. 33.2(a).

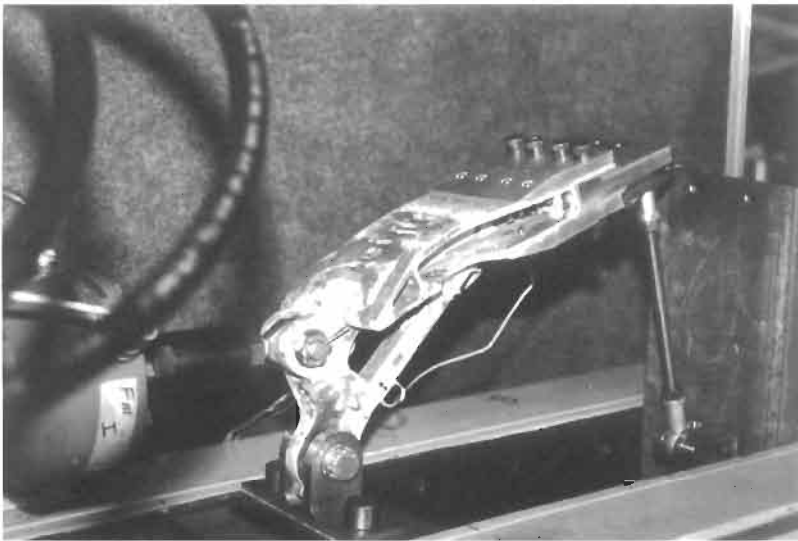
Fig. 33.6. Close up photograph of test article in WO42 configuration. Test fixtures can be seen at the end of the hinge.

To validate the FEA, a static test program was undertaken on a series of hinges using both the WO 39 and WO 42 load cases. A test rig was constructed in which the hinges could be loaded at the correct angles as shown in Figure 33.6. The required series of fittings were fabricated and attached to the end of the hinges through which the applied loads were reacted. Strain gauges were applied to the hinges to measure the strains in the radius region during the test. One new hinge was tested in the original condition to validate the base FE model and very good correlation of strain in the critical region was achieved. Further tests were conducted on hinges which had been reworked to a variety of different rework depths as reported in [7] and then again after the composite reinforcement had been applied.

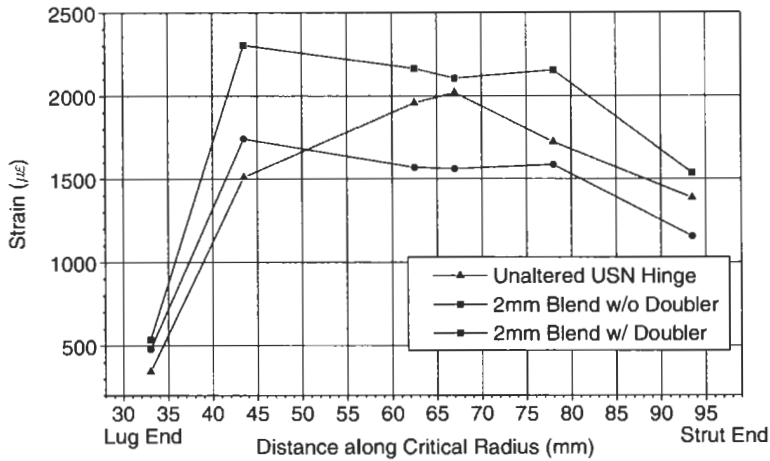
Fig. 33.7. Measured strains for the unaltered, 2 mm blended without reinforcement and 2 mm blended with reinforcement ex-USN hinge at 50% DLL in the WO39 load configuration. These strains were measured along the side of the strut.

The strain behaviour of the hinge under the different test configurations can be seen in Figure 33.7, where the strains along the radius can be seen. The original

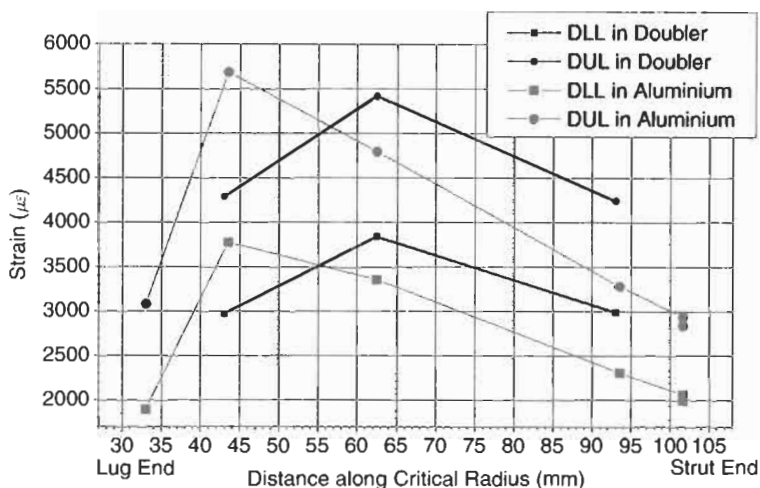
Fig. 33.8. Measured strains from DUL test (WO 39) showing strains on both the aluminium (side of strut) and boron at $1.06 \times \text{DLL}$ (14800lbs) and DUL (21000lbs).

The measured strains in the boron/epoxy composite reinforcement are shown in Figure 33.8, where the results from strain gauges mounted on the surface of the composite are compared with strains measured on the side of the aluminium hinge strut for both the DLL and DUL WO 39 load cases. The strains shown in this figure are higher than the strains that would normally be expected for a composite-reinforced aircraft component, however, this is often the case for repairs where less design freedom is available and geometrical constraints are more severe. On the other hand during the design of composite repairs there is often less uncertainty about the stress state than there is during the initial design of a much larger component, and therefore it is sometimes possible to use higher design allowables for a repair than for component design. The strains in the boron at DUL are around 75% of the ultimate material strain and no failure was observed during the DUL testing. Both WO 39 and WO 42 load cases were applied during these tests.

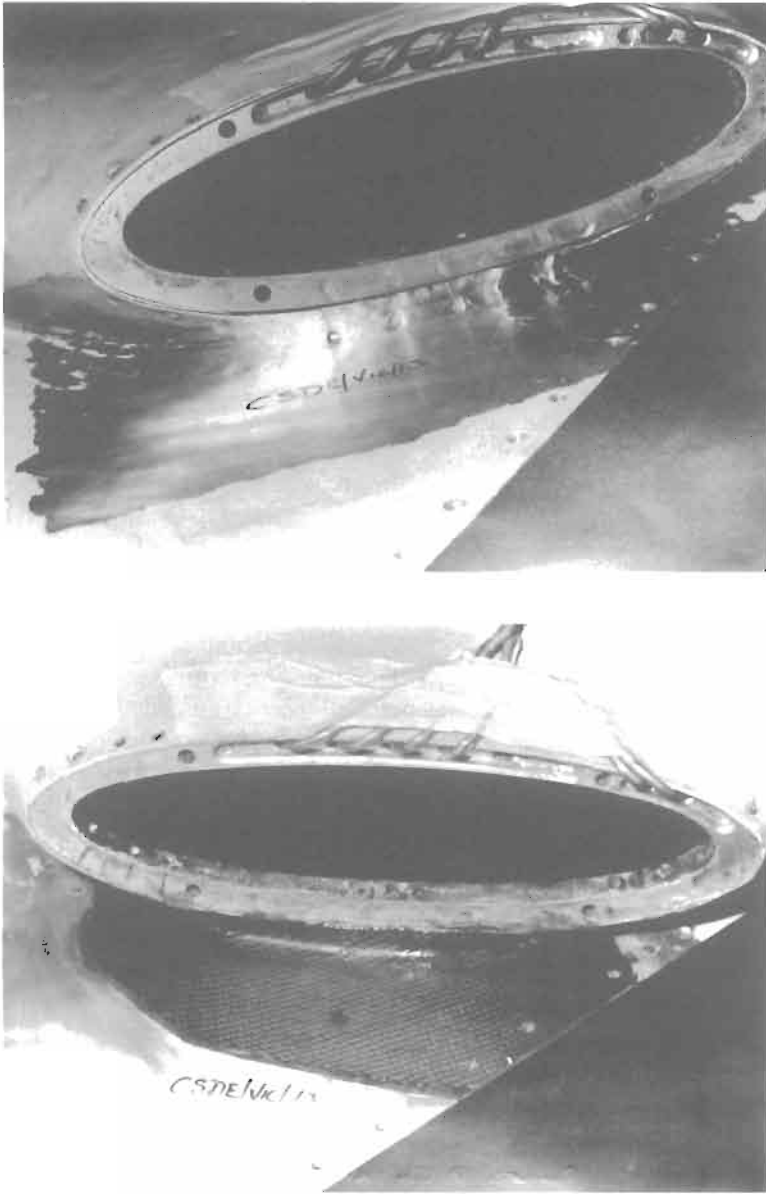
Fig. 34.1. Victor CSDU air intake before and after patching.

The RAF has used gr/ep patches to repair a variety of secondary structures [4]. In general, patches were applied by wet lay-up and cured under pressure at 60–80 °C using vacuum bags and heater mats. One of the earliest repairs concerned the CSDU air intake fairing on Victor aircraft [4]. Wet laminated woven gr/ep patches were used to repair cracked, double curvature aluminium alloy skins, as illustrated in Figure 34.1. The first trial repair was very successful and most Victor aircraft were subsequently repaired in this way. These repairs were extremely cost effective,

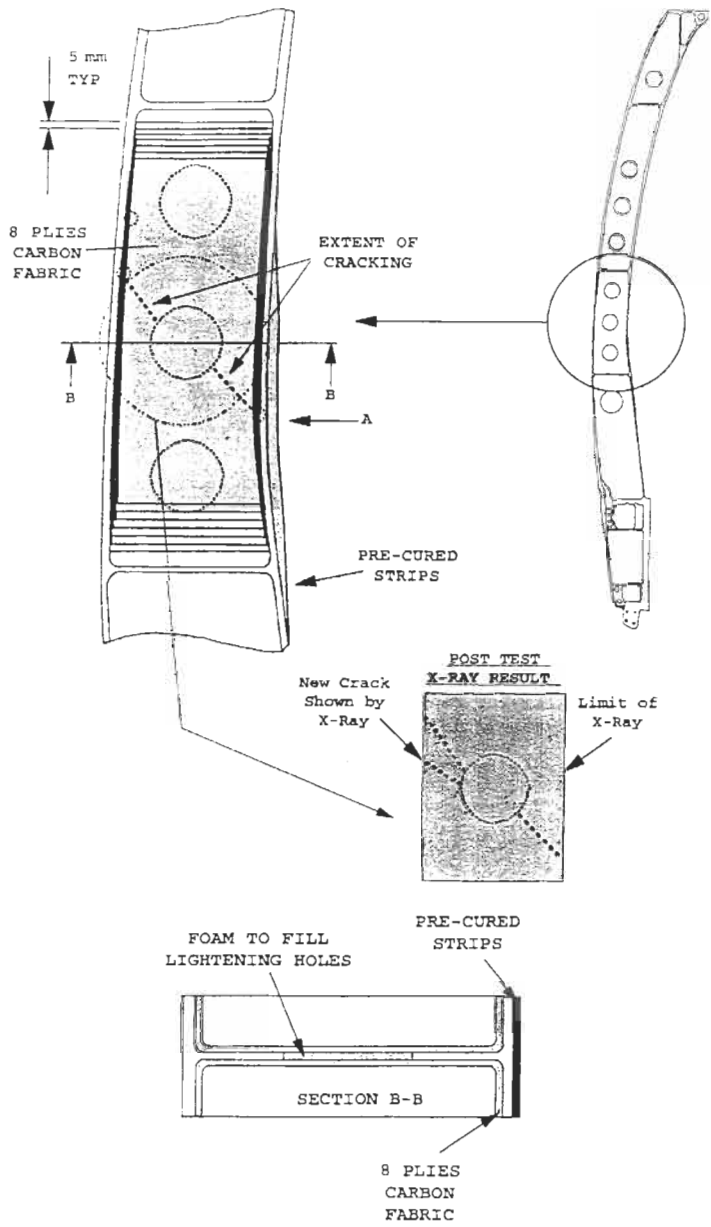
Fig. 34.2. Repair details of X8875 port side frame WL2121 unflanged lightening hole failure.

During the test a number of primary structure fatigue failures occurred, mainly at lightening holes and curved and tapered flanges on side and roof frames. These fatigue cracks were repaired with gr/ep patches applied by wet lay-up or by bonding precured patches with a paste adhesive [6,7]. Three-dimensional finite element analysis and strain gauge measurements were used to determine the stresses that resulted in cracking and to develop bonded patch repair designs. In general, shear webs were repaired using $\pm 45^\circ$ Brochier 833 graphite fabric applied by wet lay-up with a room temperature curing epoxy paste adhesive. Patches of similar thickness to the web were applied to both sides of the web. In cases where the crack had reached the edge of the web or propagated into or along the flange, 0/90° woven graphite plies were used to form a nested angle between the web and flange before the $\pm 45^\circ$ plies were applied. Flanges were repaired by bonding precured unidirectional gr/ep [XAS/913] patches with a paste adhesive, using a vacuum bag to apply pressure. Patch thickness was approximately 70% of flange thickness. All patches were applied within 3 h of reactivating the surface anodic film. The main features of repairs to a shear web lightening hole failure and to a curved flange failure are shown in Figures 34.2 and 34.3, respectively.

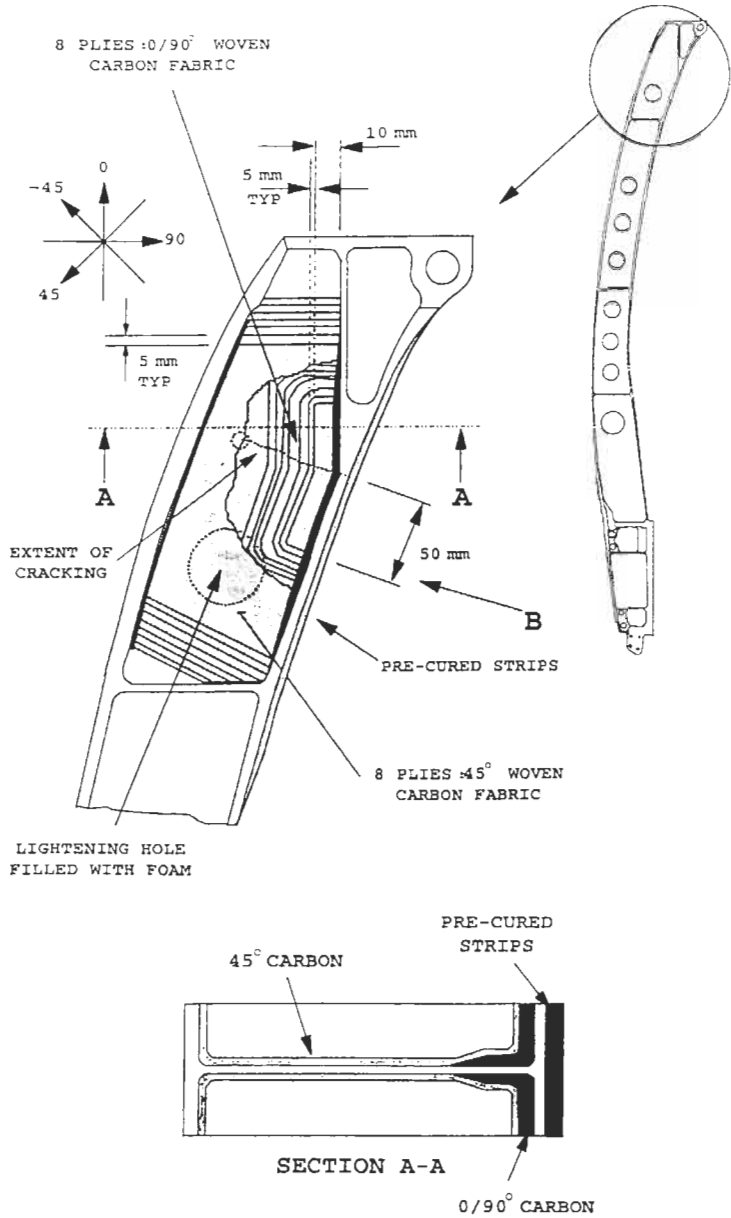
Fig. 34.3. Repair details of X7875 port side frame WL3038 flange failure.

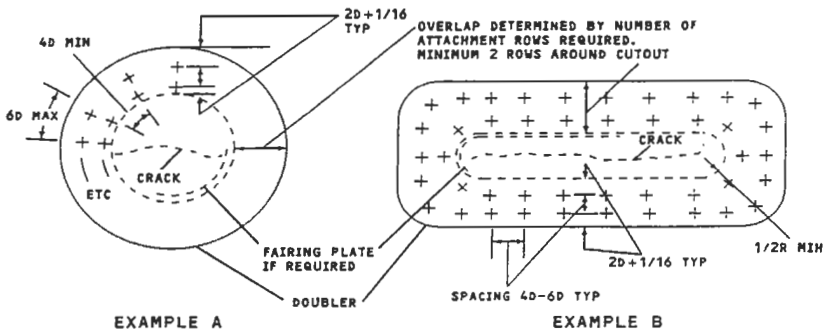
Fig. 35.2. Typical fuselage skin crack damage to be repaired by composite doublers.

Following a successful pilot program, the plan is to accommodate the routine use of composite doublers by adding their designs alongside the riveted metallic repair tables commonly found in OEM Structural Repair Manuals (SRM). Using these look-up tables, maintenance facilities can have the option of choosing the traditional metallic repair or the "equivalent" composite doubler repair. Examples of existing SRM riveted metallic repairs that can be replaced by the family of composite doublers developed in this DC-10 program are shown in Figures 35.1 and 35.2.

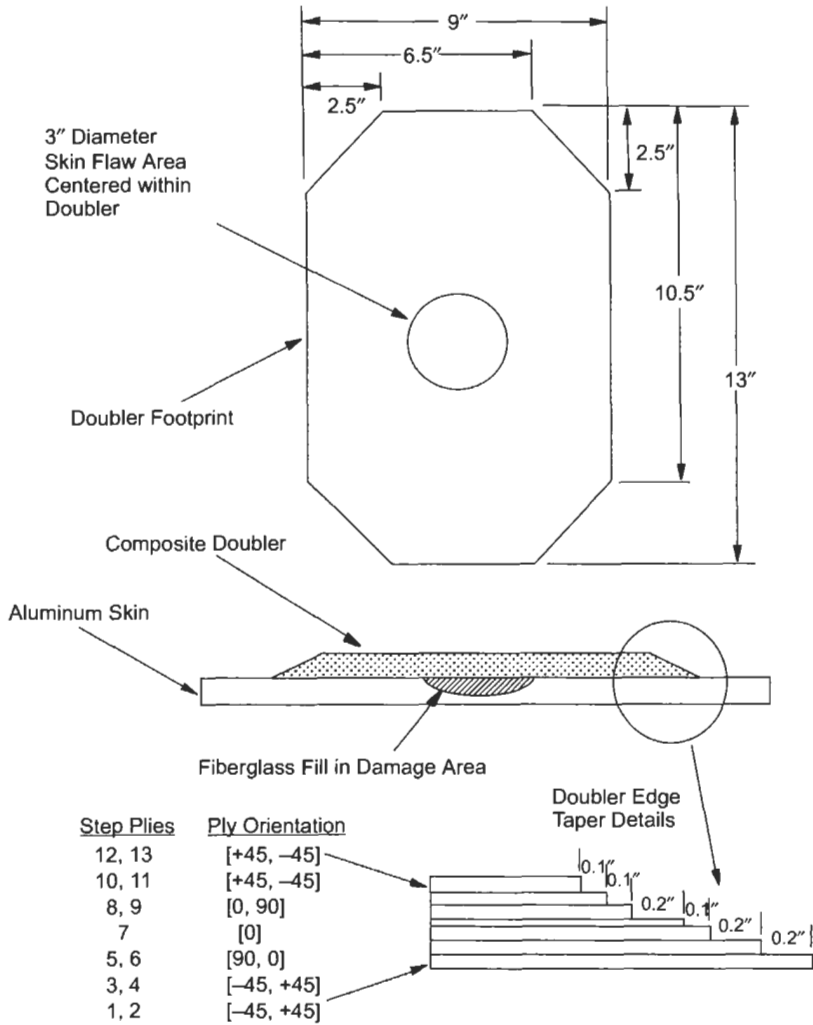
Design for 3" Diameter Repair

Skin: Aluminum 2024-T3

Patch: Boron/Epoxy, nominal lamina thickness = 0.0057

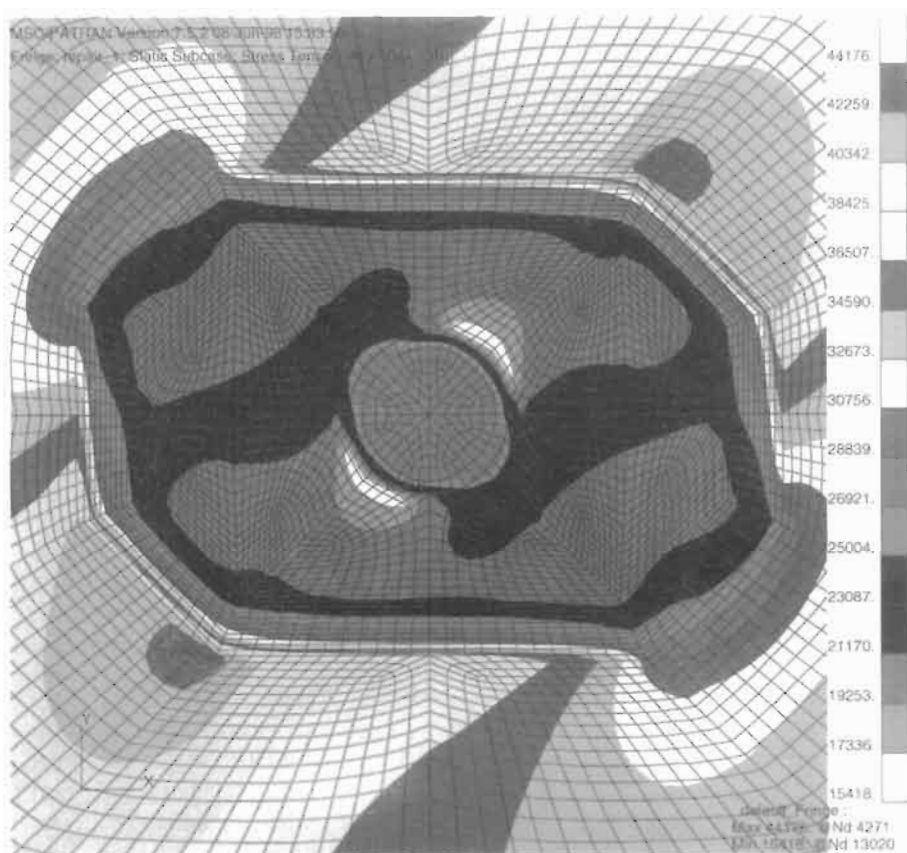
Fig. 35.4. Maximum principal stress tensor σ_1 in composite doubler and aluminum skin for 3" diameter repair design and worst case load spectrum.

- A sample contour plot for a Maximum Principal Stress tensor is shown in Figure 35.4. The significant effects of the shear loading are evident. Note that the peak doubler stresses are confined to a small region where the doubler has its full thickness. Furthermore, the stresses in the critical tapered region of the doubler (primary load transfer zone) are 30% to 50% of those found in the surrounding skin. This type of load transfer matches general design goals for stress distribution around aircraft skin repairs.

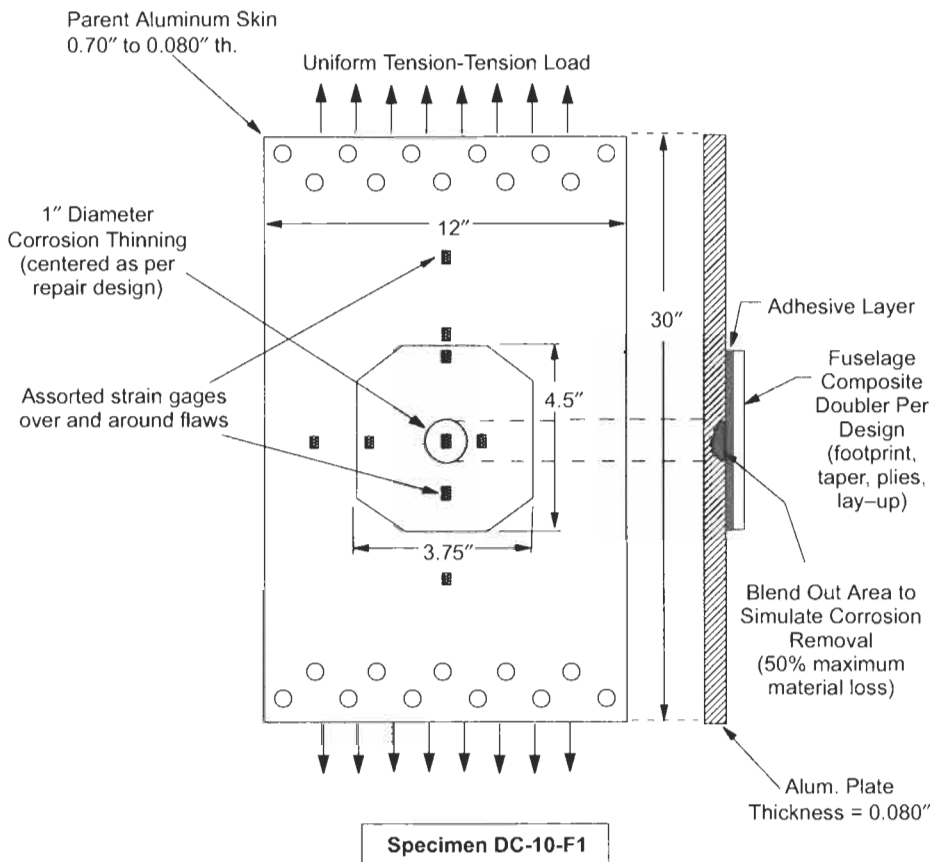
Fig. 35.5. Design and NDI validation test specimen for family of DC-10 composite doubler skin repairs (corrosion skin flaw).

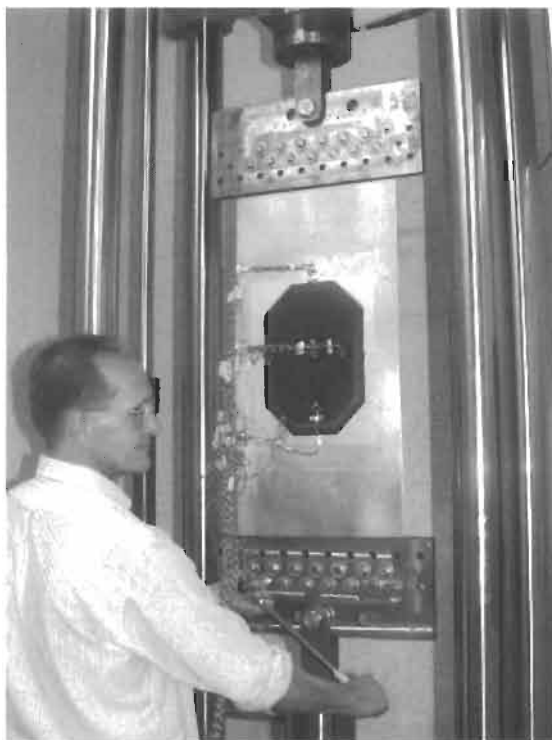
Fig. 35.7. Set-up for DC-10 composite doubler validation test.

performance of composite doubler, (4) frequently apply ultrasonic resonance (Bondmaster) NDI to each test specimen, and (5) follow fatigue tests with a static ultimate test (residual strength) to determine design margins and performance of composite doublers when the parent material yields (plastic strain regime). Figure 35.5 shows one of the design validation test articles for the extreme skin corrosion flaw and Figure 35.6 shows the associated strain gage layout. Results highlighted in this section will focus on the corrosion flaw repair. The validation specimens contained representative, yet upper extreme, flaws and the corresponding Boeing-designed doubler. Figure 35.7 shows a DC-10 doubler design validation test article undergoing fatigue and strength testing.

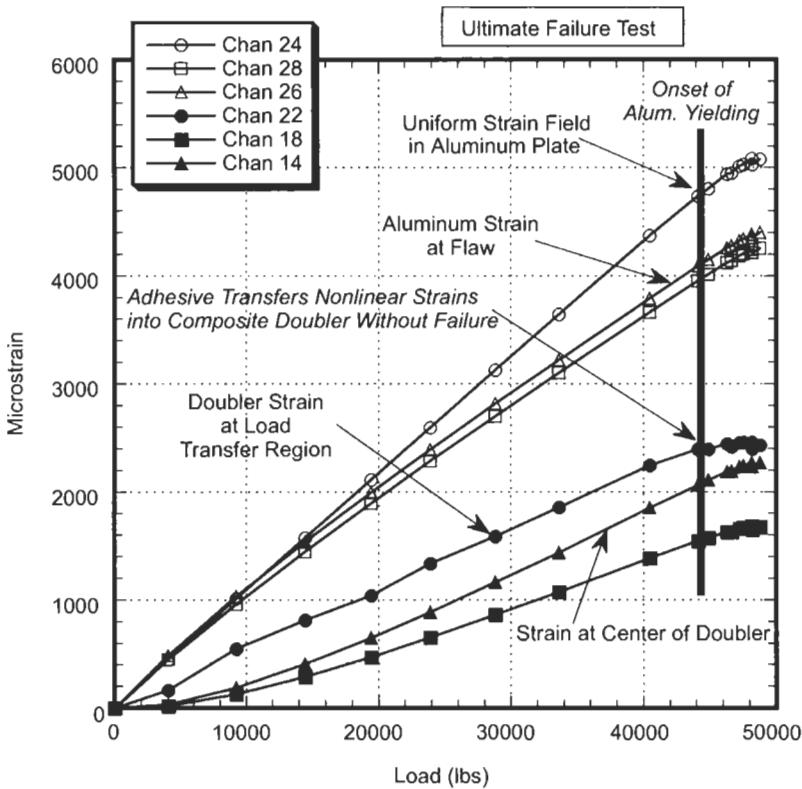
Fig. 35.8. Axial strain field during ultimate failure test of DC-10-F1 design (repair of 1" diameter flaws – 50% material thinning flaw).

Ultimate Strength Results – Attempts were made at subjecting the design validation test specimen to ultimate tensile strength tests following the 160000 cycles of fatigue loading. The uniaxial load was uniformly increased until the specimen failed. Failure was defined as the point at which the structure could no longer sustain an increasing load. Figure 35.10 shows the strain field in specimen DC-10-F1 up through failure. The aluminum plate away from the doubler

(channels 24) began to yield at approximately 44000 lbs (45.8 ksi), while the doubler continued to increase its load in a linear fashion. Unfortunately, failure occurred at the holes used to grip the specimen (55.7 ksi) and ultimate strength values for the repaired area could not be achieved. However, the ultimate strength tests were successful in loading the DC-10-F1 specimen into the plastic regime (past yielding).

The aluminum began its nonlinear response at the yield point indicated in Figure 35.8. Similarly, the composite doubler showed a slightly nonlinear behavior at this same load level. But the Boron-Epoxy laminate did not yield. The material properties for Boron-Epoxy indicate a yield stress of 185 ksi. Further, after specimen failure, the strain gages on the doubler returned to zero

indicating that the doubler did not undergo any plastic deformation. Thus, the nonlinear response in the doubler strain gages shows that the doubler is absorbing more strain and mirroring the response of the parent aluminum skin. Figure 35.8 illustrates an important performance feature of bonded composite repairs in that the adhesive is able to transmit stresses in the plastic regime and that yielding/loading beyond the initial aluminum yield level is required to fail the repair installation.

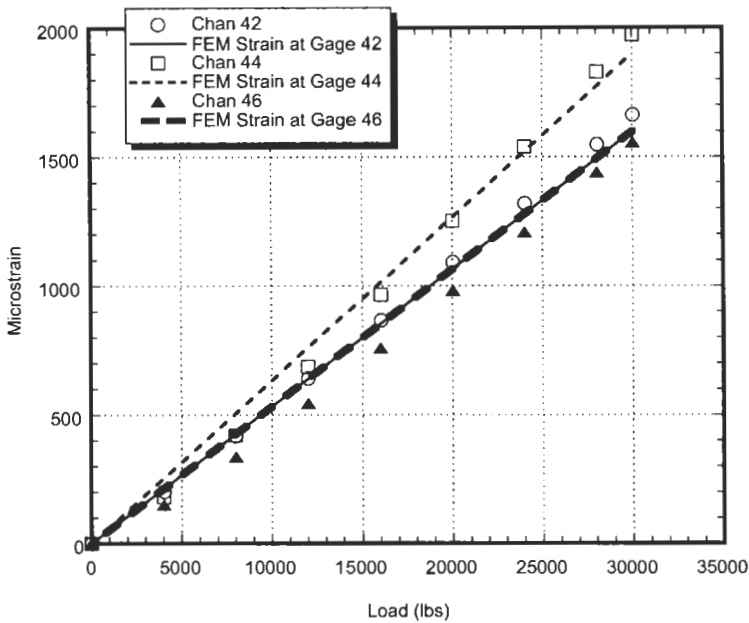
Fig. 35.10. Comparison of experimental and analytical (FEM) strains in the composite doubler.

Validation of Analysis – The performance of the composite doubler repairs was analyzed using a finite element model (FEM) of the fuselage structure and Boron-Epoxy laminate. Results from the validated FEM were then used to predict the doubler stresses and the reduction in stress in the aluminum skin during maximum/extreme flight load scenarios. In general, comparisons with experimental data indicated that the FEM had sufficient accuracy (and conservatism) to support the Boron-Epoxy doubler design and analysis. Figure 35.10 compares experimental and analytical strain levels in the composite doubler and aluminum skin. In both cases the FEM is able to accurately predict the stress/strain field. The FEM predictions were particularly good in the area of greatest concern around the flawed region of the skin. The computer analysis and test data both verified the primary goal of the reinforcing doubler: reduce stress risers. Furthermore, the FEM was able to assess the damage tolerance and crack mitigation capabilities of the doubler using the full flight load spectrum. The associated damage tolerance analysis showed that the doubler exhibits sufficient strength to provide adequate fatigue enhancement over the full spectrum of environmental conditions.

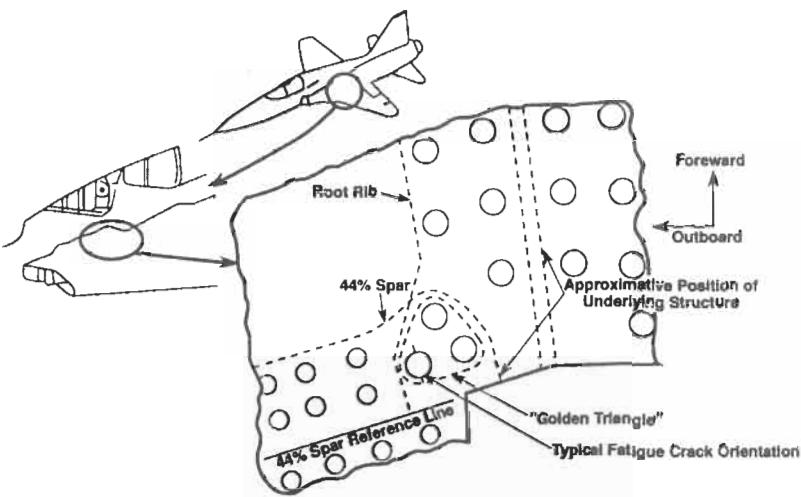
Fig. 36.1. CF116 and location of upper wing skin fastener hole cracks.

locations. Figures 36.1 and 36.2 show the location and details of the “golden triangle” fastener holes.

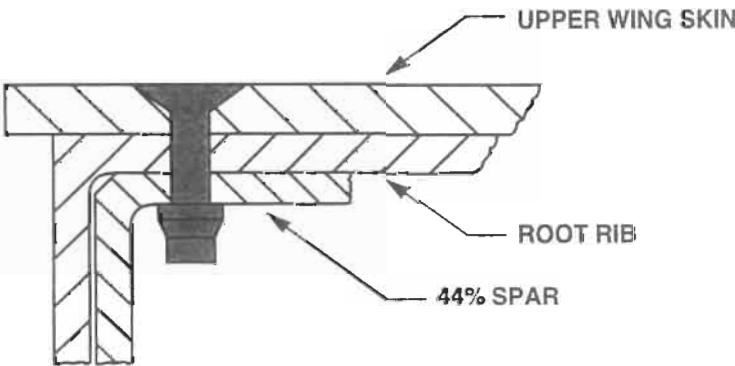
Fig. 36.2. Fastener hole configuration.

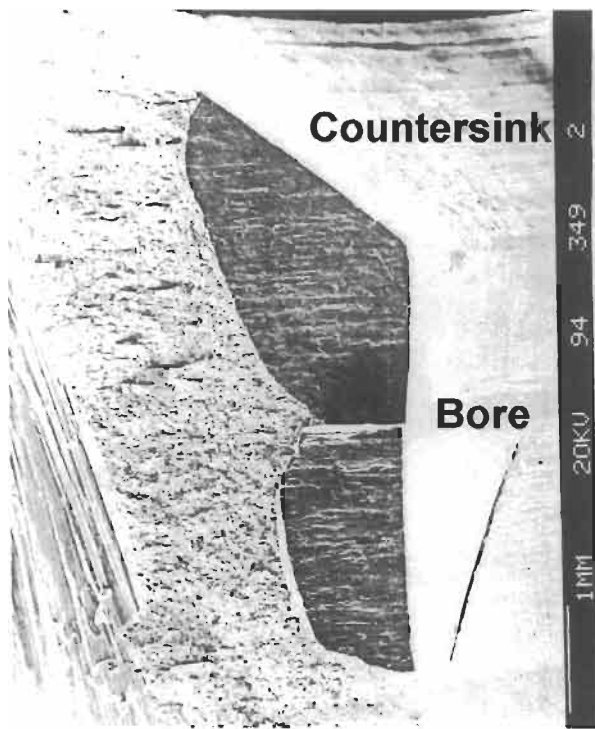
Fig. 36.3. SEM photograph showing orientation and size of fastener hole fatigue cracks.

Using eddy current and liquid penetrant inspection techniques, fatigue cracks were found in 8 of 18 aircraft inspected. The cracks in the bore and countersink of the fastener holes ranged in length from 0.030 to 0.105 in. (0.76 to 2.67 mm). In Figure 36.3 the orientation and size of a typical fatigue crack in this area are shown. Fractographic analysis [2] confirmed that the crack propagation mechanism was fatigue. The crack initiation mechanism was assumed to be a tensile residual stress zone caused by a compressive overload – high positive “g” maneuver.

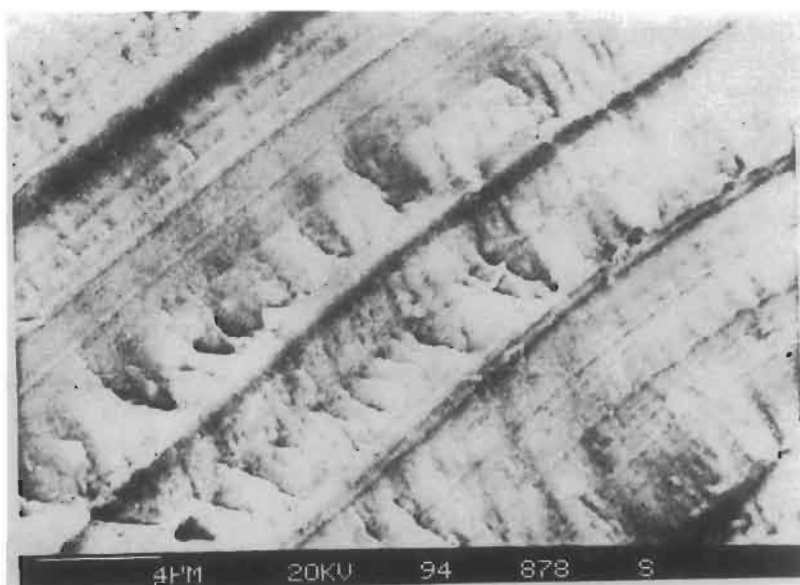
Fig. 36.4. (SEM) striation spacing at crack front, 0.025 in. (0.64 mm) from countersink face.

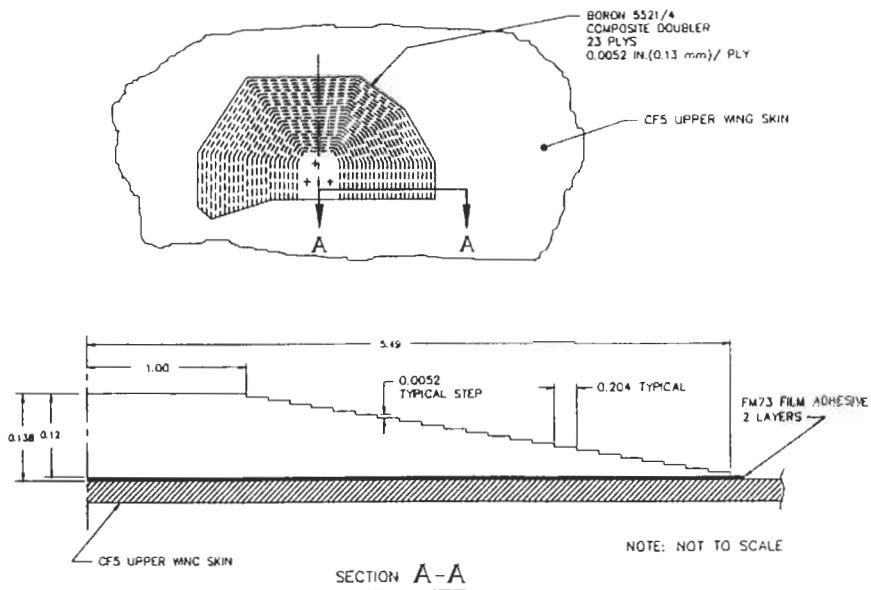
Fig. 36.5. Details of boron doubler.

analysis was carried out to predict the effect of the doubler on the stress level in the wing skin. The details of the final doubler design are provided in Figure 36.5.

An L_R of 2.0 inches (50.8 mm) was selected for the CF-116 doubler that was unconservative based on the above criteria. The “undersizing” of L_R was balanced by the selection of the doubler taper angle. A doubler must be tapered from the full section thickness t_p in order to minimize adhesive peel stresses and to gradually transfer the load into the doubler. A taper angle of 1.25° was selected that corresponds to a 5.5 inch (140 mm) taper length. For the CF-116 doubler there were 23 single ply drop-offs spaced 0.2 in. (5.08 mm) apart (see Figure 36.5).

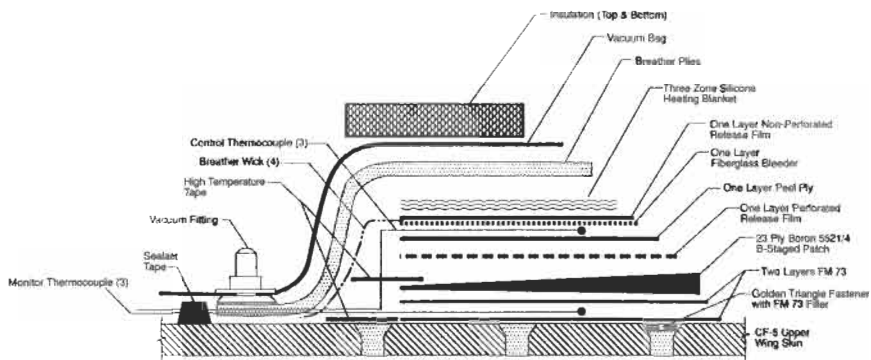
Fig. 36.6. Boron doubler bagging sequence. (Note location of embedded thermocouples in bondline.)

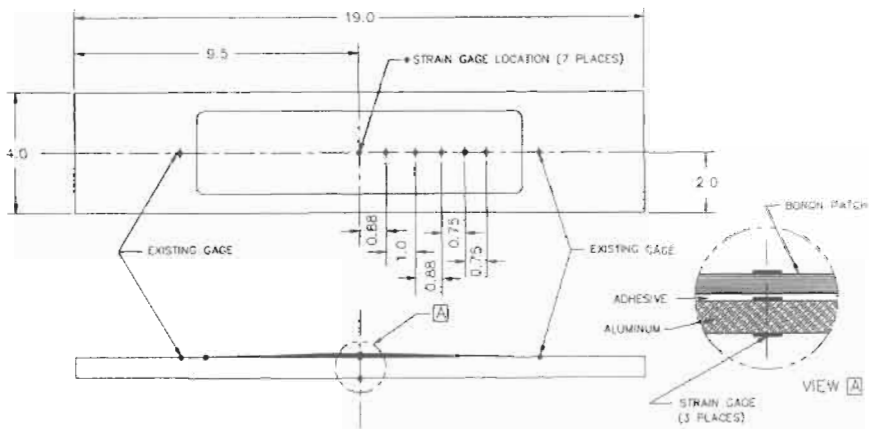
Fig. 36.7. Static and fatigue test coupon.

The CF-116 upper wing skin doubler was structurally qualified in two stages. The first stage was a coupon test program. An instrumented test coupon, shown in Figure 36.7, was used to verify the A4EI analysis and to measure the fatigue resistance of the bondline. The test coupon was strain gauged in the bondline and on the boron doubler to verify the strain reduction in the aluminum plate. For the bonding procedure the aluminum plate was constrained to limit the amount of thermal expansion and out-of-plane bending that simulated the constraint on the wing skin. The test coupon was loaded to $N_{ultimate}$ ($-6600 \mu\text{in/in}$) in a -35°F enclosure. Fatigue testing included 3000 cycles from 0 to P_{limit} and 50000 cycles from 0 to $0.5P_{limit}$. The test coupon passed both the static and fatigue testing and the measured strain levels approximated those predicted by the A4EI analysis. Given the conservative allowables/knockdown factors used in the A4EI analyses failure of the test coupon was not expected.
