Advances in the Bonded Composite Repair of Metallic Aircraft Structure

VOLUME 2

Chapter 19. Bonded Repair of Acoustic Fatigue Cracking 531

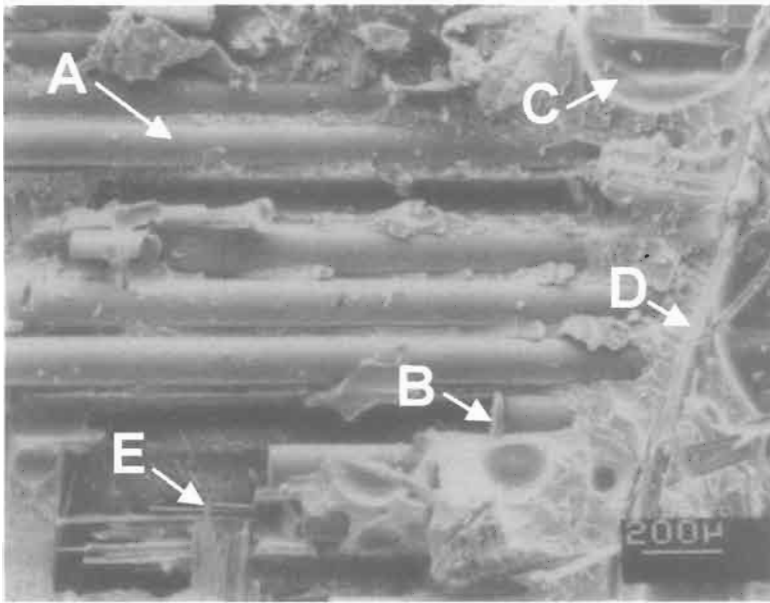
Fig. 36.12. (SEM) Key fracture features (a) fiber/matrix interfacial failure (b) fiber fracture (c) adhesive porosity (d) adhesive carrier (e) prepreg carrier.

A scanning electron microscope (SEM) examination was then carried out on selected locations. The dominant fracture mechanism is illustrated in Figure 36.12 –

interfacial failure between the boron prepreg matrix and the boron fiber. There are no significant hackles in the matrix, which indicates that the interfacial failures occurred before a general fracture in the matrix could develop. The majority of the fracture plane was on or in the doubler ply adjacent to the FM73 adhesive. The fracture surface of the locally exposed matrix in the second and third doubler plies (Figure 36.13) looks different from the dominant fracture surface on the first ply discussed earlier. Here the fiber/matrix bond remained generally intact and the matrix fracture shows shallow hackle and cusp formations. This indicates that the boron fiber/matrix interfacial failure observed in the first ply had not progressed into the adjacent plies.

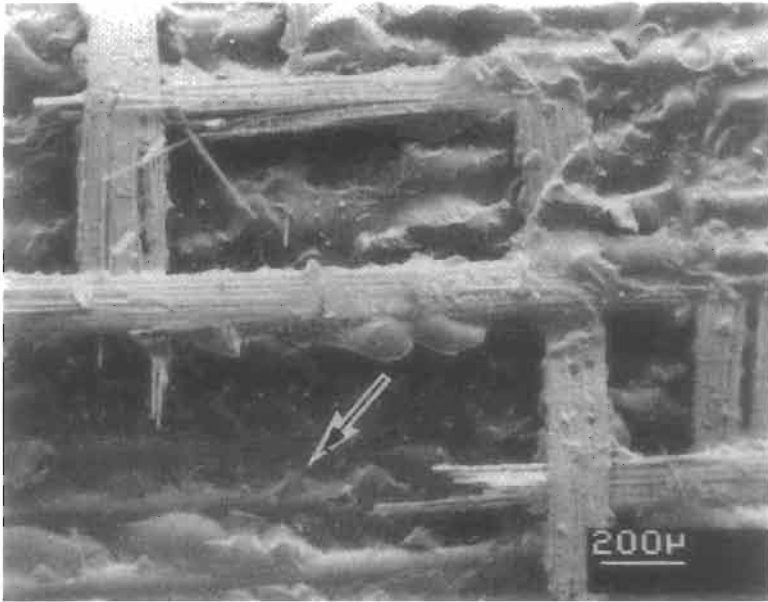
Fig. 36.13. (SEM) Matrix hackles and cusps on top of second boron ply.

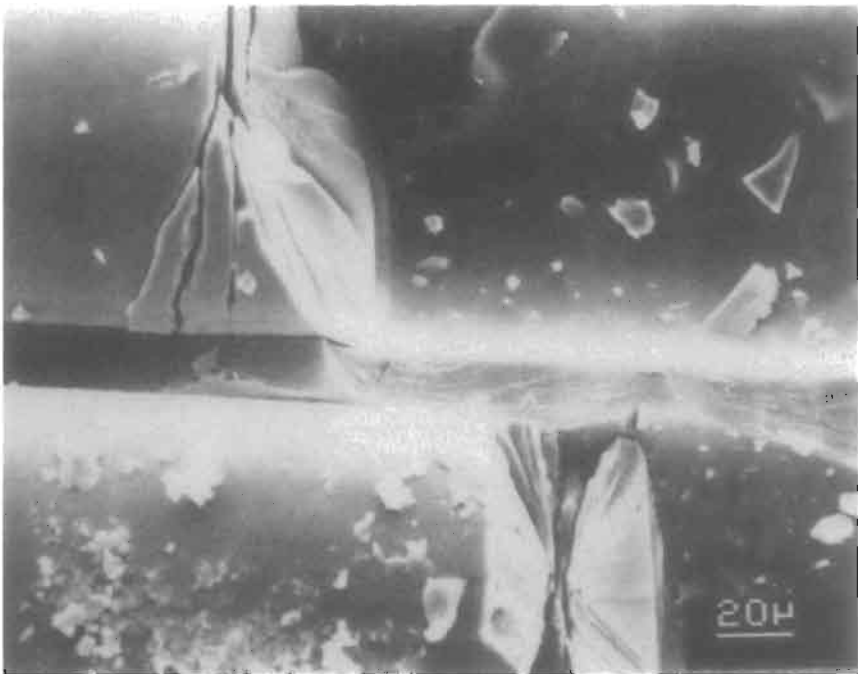
Fig. 36.14. (SEM) fracture faces from two boron fibers.

There is a limited amount of fractured boron fibers, as shown in Figure 36.14. The exposed cross sections of these fibers show conical fractures with radially oriented lamella-like surface ridges. The flush light spot in the fiber centers is the remnant of the tungsten wire on which the boron was deposited during the production of the fiber. The radial ridges or river markings on the fracture face indicate the locations of the initiation sites on the circumference of the fiber.

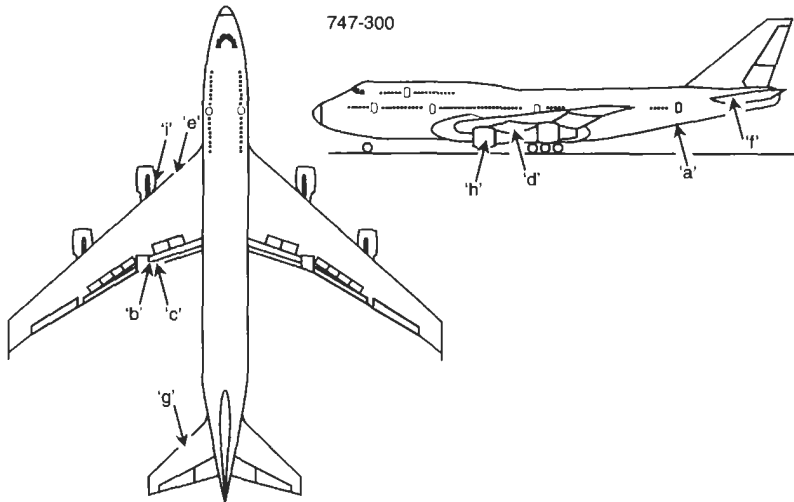
Fig. 37.1. Location of doublers on QANTAS B 747-300 aircraft.

As mentioned earlier, the demonstrator doublers were applied to areas exposed to severe service environmental conditions. Referring to Figure 37.1 [1], the locations were:

- (a) The external fuselage-skin longitudinal lap-joint located at BS 2050 at stringer 46L.
- (b) Left hand side, inboard trailing edge midflap. Located on the upper, aft midspar panel 300 mm from the outboard edge and 150 mm aft of the teflon rubbing strip.
- (c) Left hand side inboard trailing edge midflap. Located on the lower forward midspar-panel, 460 mm from the outboard edge and 150 mm aft of the forward edge.
- (d) Number two engine-pylon aft fairing on the hydraulic bay access door 150 mm forward of the aft edge.
- (e) The left-hand side wing, fixed leading-edge nose, located at inboard leading edge station 395.
- (f) The lower leading-edge skin panel of the left hand horizontal stabiliser, station 397, 300 mm forward of the front spar.

- (g) The leading-edge nose skin panel of the left-hand horizontal stabiliser, station 390.
- (h) The thrust reverser cowl, translating-sleeve number two engine, serial number 12758, located outboard at the eight o'clock position (looking forward), on the external skin, at the aft edge of the sleeve.
- (i) The thrust reverser cowl, translating-sleeve number two engine, serial number 12758, located inboard at the four o'clock position (looking forward) on the external skin at the aft edge of the sleeve.

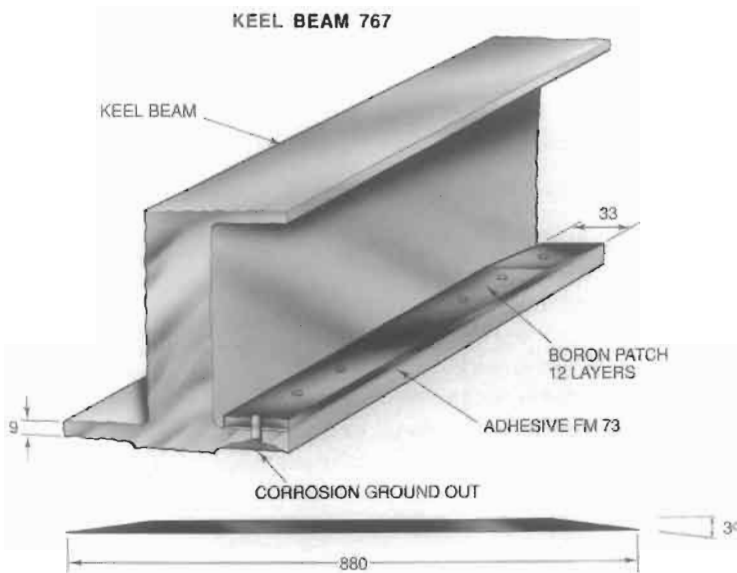
Fig. 37.2. Reinforcement applied to Ansett airlines B767-300 keel beam.

Corrosion damage found in a keel beam of an Ansett Airline, B767-200, was found to be out of limits and two demonstrator reinforcements were applied to reduce the stress in the region. The corrosion damage was located in an extremely severe service environment due to the presence of hydraulic fluids and the overflow from the toilets. It was believed that this would provide a very demanding environment for a bonded repair and as such the demonstrators were applied. Subsequently, the location was re-analysed by Boeing and the limits for corrosion damaged increased. Although no longer required as reinforcement the repairs were left on the aircraft and monitored to determine durability over time. The reinforcements were made up of 12 layers of boron epoxy, one of the doublers was bonded with FM73 epoxy adhesive and the second doubler was bonded with Versilok 201 acrylic paste adhesive (see Figure 37.2).

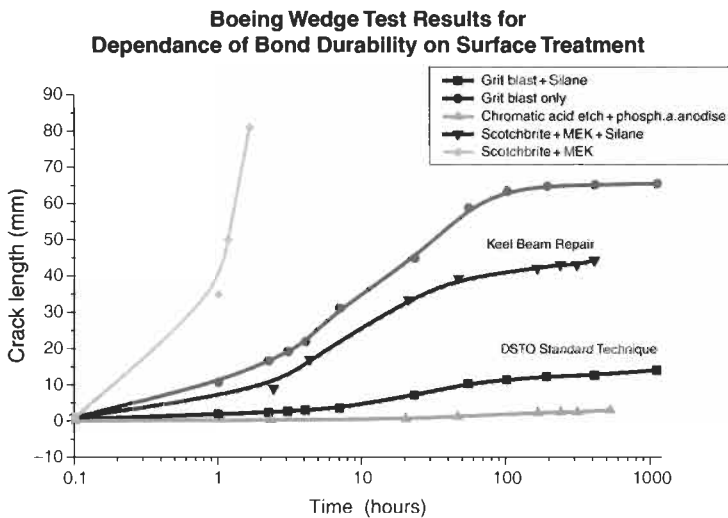
Fig. 37.3. Boeing wedge test results showing durability of bond versus different surface preparation techniques [4].

Bond durability and surface treatment has been discussed elsewhere and it is well understood that surface treatment is the major factor when determining bond durability. Arnott, *et al.* [4], have compared different surface treatment methods by using the Boeing wedge test, and Figure 37.3 clearly shows the advantages of the DSTO standard preparation that includes solvent cleaning, mechanical abrasion (in the form of grit blasting) followed by application of the silane-coupling agent. Other work has shown that the addition of a corrosion inhibiting primer further improves the bond durability [5] and for the QANTAS demonstrator program the standard DSTO preparation followed by the application of a primer was used to treat the metallic aircraft structure prior to bonding. In the ANSETT keel beam demonstrator program, a less durable treatment was used, that included only solvent cleaning, abrasion with pads and application of the silane-coupling agent.

The reinforcement on the Ansett keel beam was applied following a very basic surface treatment procedure, this being solvent cleaning, abrasion with pads and then application of the silane coupling agent. Figure 37.3 shows that this pre-bonding treatment is not as durable as that used on the QANTAS demonstrator program. Additionally the reinforcement was located in an extremely severe environment for adhesive bonds, where it was soaked in hydraulic fluid and overflow from the toilets with no protection. This explains the bond failure of the reinforcement and implies that bonding in such environments should be undertaken only if the most durable surface treatments are applied and some form of protection is provided for the repair.

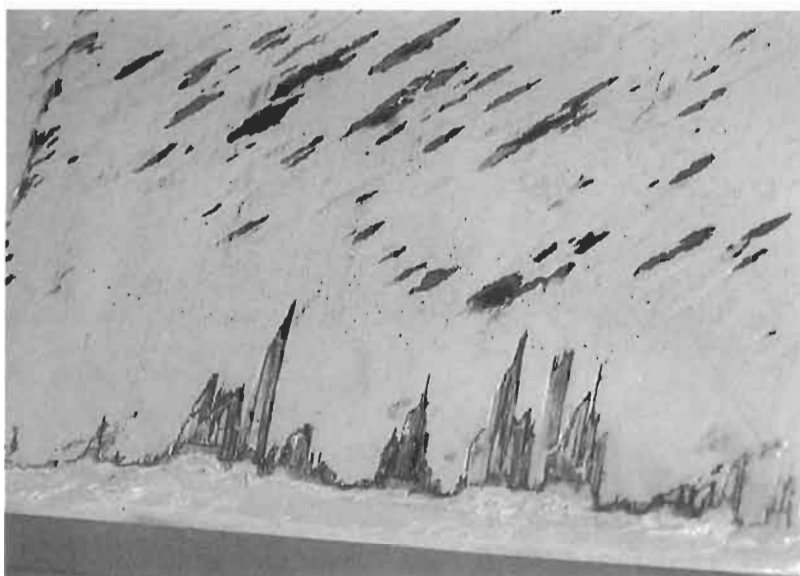
Fig. 37.4. Erosion damage at leading edge of doubler.

Figures 37.4 and 37.5 show the sort of damage that was found on the doublers. Figure 37.4 shows the extent of erosion damage that was seen on some of the doublers. The damage was seen particularly on the leading edge of the doublers where in this case the adhesive flash and the first 10 mm of the doubler had eroded completely away. Figure 37.5 shows a doubler with some of the fibres in the outer layer of the composite patch completely removed.

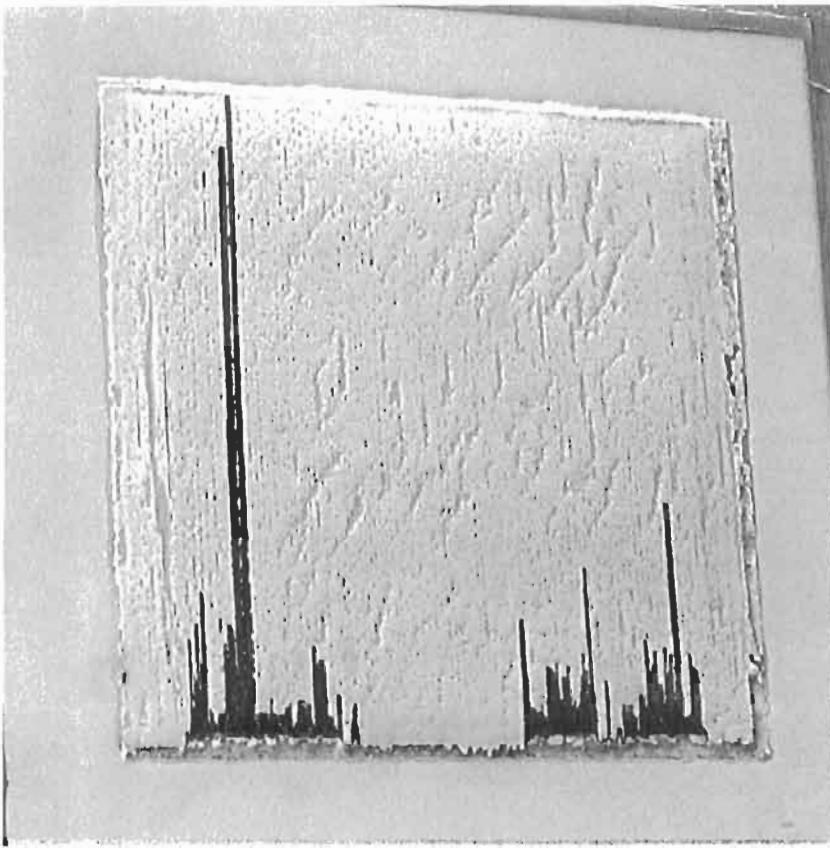
Fig. 37.5. Lower stabiliser repair showing missing fibres along the length of the repair.

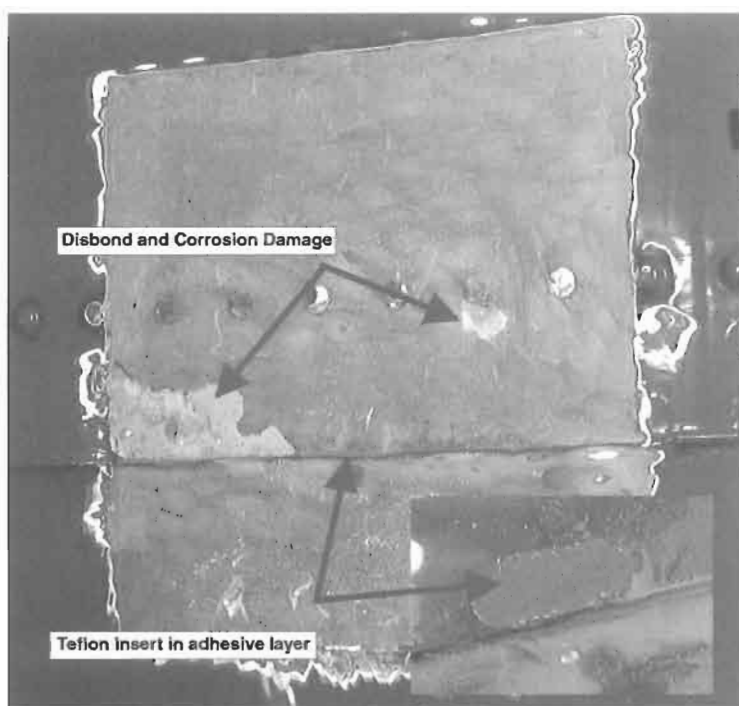
Fig. 37.6. Lapjoint doubler showing disbond and corrosion damage with a close up of the teflon insert in the centre of the doubler in the adhesive layer.

The remaining doublers were removed by DSTO staff. The composite plies of each doubler were carefully removed using a grinder. On exposure of the adhesive layer it was inspected for damage in the form of disbonds or corrosion. Some disbonding and surface corrosion was evident under the lap-joint doubler (see Figure 37.6). During installation of the Lap Joint doubler, a teflon insert was also placed in the adhesive layer in the centre of the doubler to simulate a disbond. The adhesive around this region was carefully removed so that any disbond growth could be identified. Figure 37.6 shows the location of the insert and the close-up view of the disbond. No disbond growth was evident after adhesive removal and inspection of the area.

The disbond under the lap-joint doubler initiated from a region where the adhesive flash had eroded at the leading edge of the doubler near the lap-joint step. The eroded adhesive layer exposed the bond to moisture and a disbond slowly grew under the doubler. The small disbond at the rivet head can be similarly explained. Holes were made in the doubler to allow the dome head rivets used to install the lap-joint to protrude through. It is believed that moisture worked its way in through one of the holes and caused a small disbond to grow.

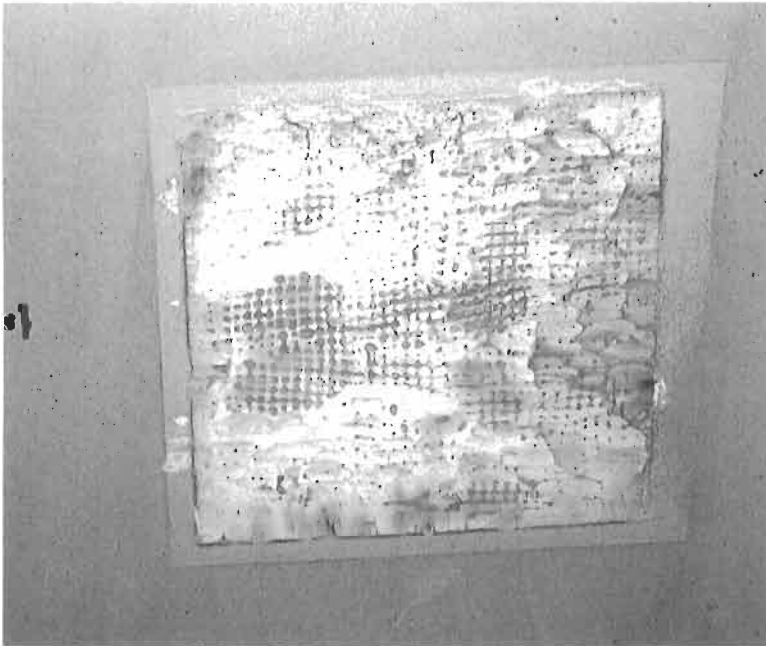
Fig. 37.7. V201 adhesive layer under doubler "c" on the lower mid flap.

Figures 37.7 and 37.8 show the exposed adhesive layers for two doublers bonded with V201 and FM73 respectively. The adhesive layer was then removed using Rollock sanding disks. The bare metal was inspected for signs of damage. For the Lap-joint doubler, whilst removing the adhesive layer the disbonded region was also lightly sanded removing all signs of the surface corrosion.

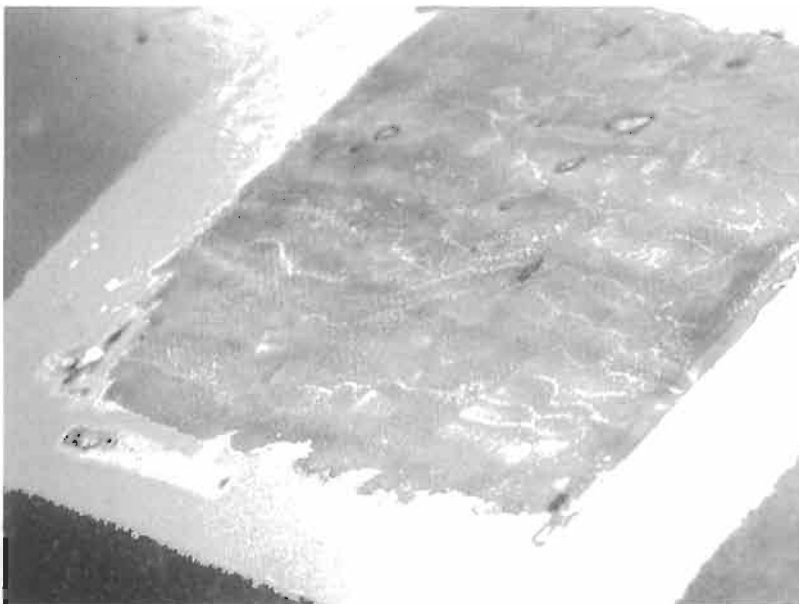
Fig. 37.8. FM73 adhesive layer under doubler "g" on the upper horizontal stabiliser.

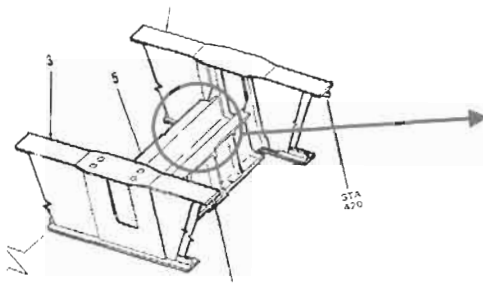
Fig. 38.1. Crane support beam and adjacent floor frames.

A corroded region was identified on the forward cargo hook beam of a CH-47 aircraft. The beam is shown in Figures 38.1 and 38.2. Standard maintenance practice required that this beam be removed and replaced at considerable labor and material cost. An alternative to replacing the component was to repair it *in situ* with a hot-bonded composite doubler. The doubler was sized to carry loads derived from the material ultimate strength of the beam. This chapter provides the analytical justification for the sizing the doubler and presents margins of safety on the repair components. It should be noted that a bonded repair on primary structure requires careful surface preparation in accordance with controlled process specifications. The analysis in this paper assumes that the repair is installed in accordance with ARTI process specifications by certified personnel.

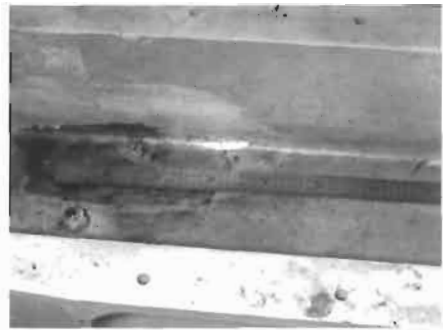
Fig. 38.2. Corrosion on support beam.

The damage consisted of a single corrosion pit as shown in Figure 38.2. After the corrosion was blended in accordance with standard practices to remove all visual signs, the defect was as shown in Figure 38.3. The defect is an ellipsoid with a maximum depth of 5.59 mm length of 38.1 mm and width of 25.4 mm. It is located nearly on the centerline of the beam with the long axis aligned with the longitudinal axis of the part. A 3D drawing was generated to verify that the blend did not leave excessively thin substructure. As shown in Figure 38.5, the minimum edge distance between the defect and the edge of the part is 6.35 mm.

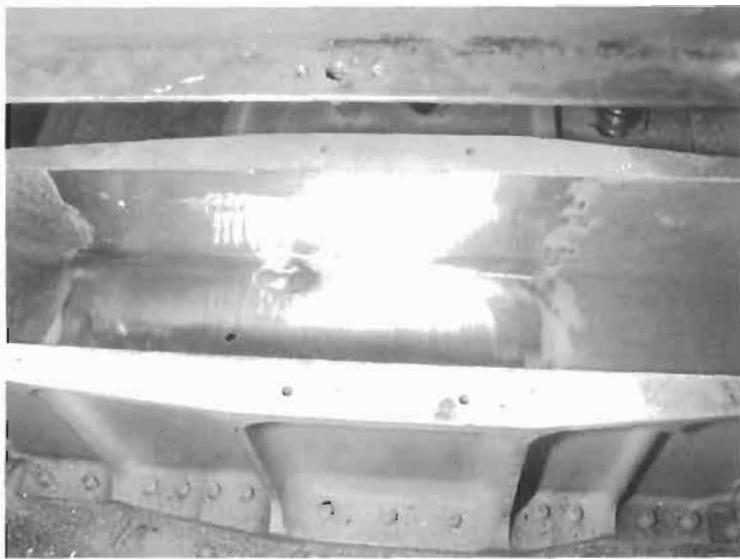
Fig. 38.3. Defect after blending to remove visual corrosion.

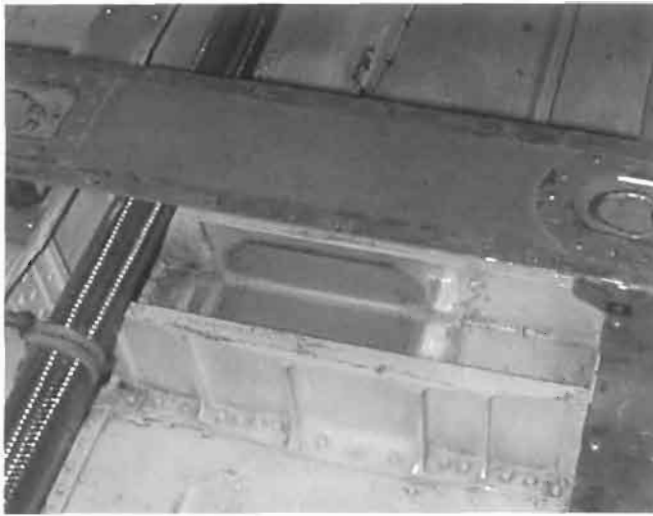
Fig. 38.4. Bonded repair before sealing.

- The finished repair installation is shown in Figure 38.4.

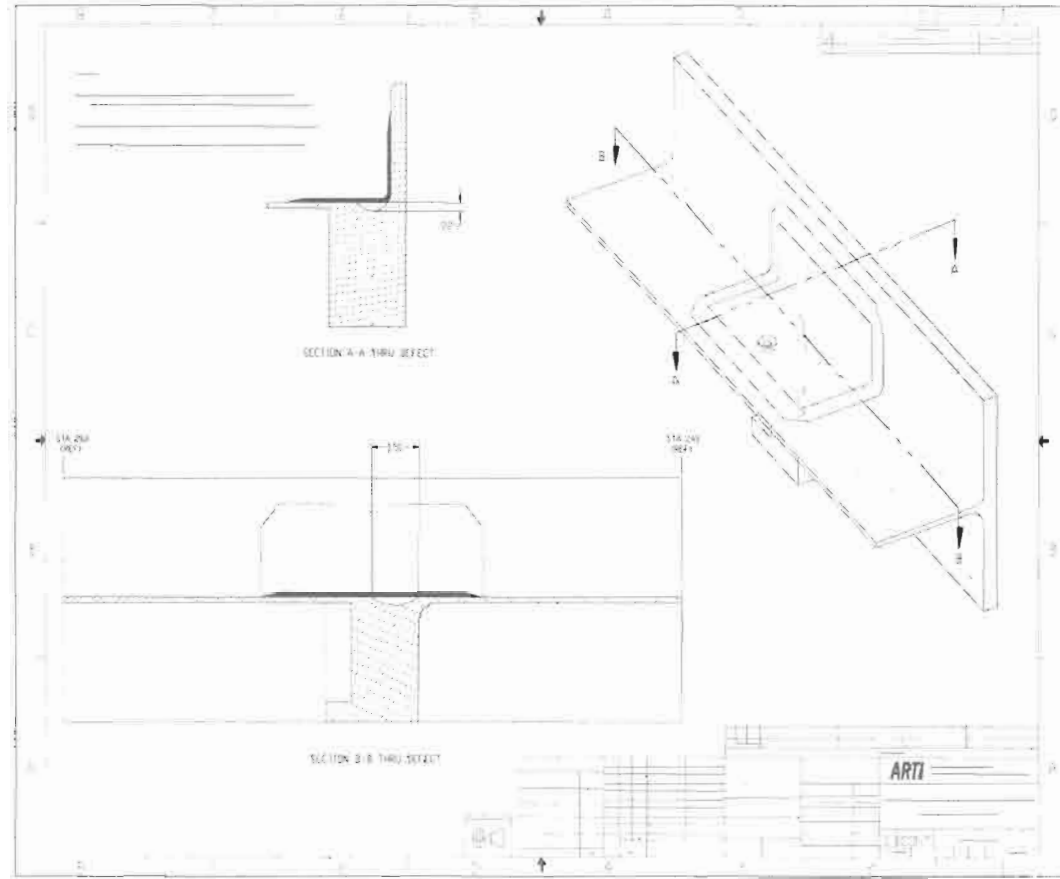
Fig. 38.5. Defect layout drawing.

Cross sections of the support beam at the defect location are shown in Figure 38.5. The corrosion is located on a 3" wide support that forms the attach point for the crane hook. As such, there is ample material at the defect site. The beam is in bending due to the crane loads, but the caps, not the horizontal web, carry this force because the horizontal web is nearly on the neutral axis of the beam. The horizontal web is present mainly to support the vertical webs and provide a barrier to the external environment. Any loads present at the defect location would therefore be minimal. The main purpose of the repair is to eliminate the stress concentration caused by blending the defect, prevent future growth of damage, and seal the area from future environmental ingress.

An elastic-plastic bondline analysis was performed to determine adhesive stresses, parent stresses, and doubler stresses. As shown in Figure 38.5, the local thickness at the defect is substantial. To facilitate repair sizing, the defect was analyzed as a through hole in the web. The repair is sized to restore adequate load capability in the presence of this defect. The analysis tools have been well substantiated by Royal Australian Air Force (RAAF) experience [1]. Features of the analysis are:

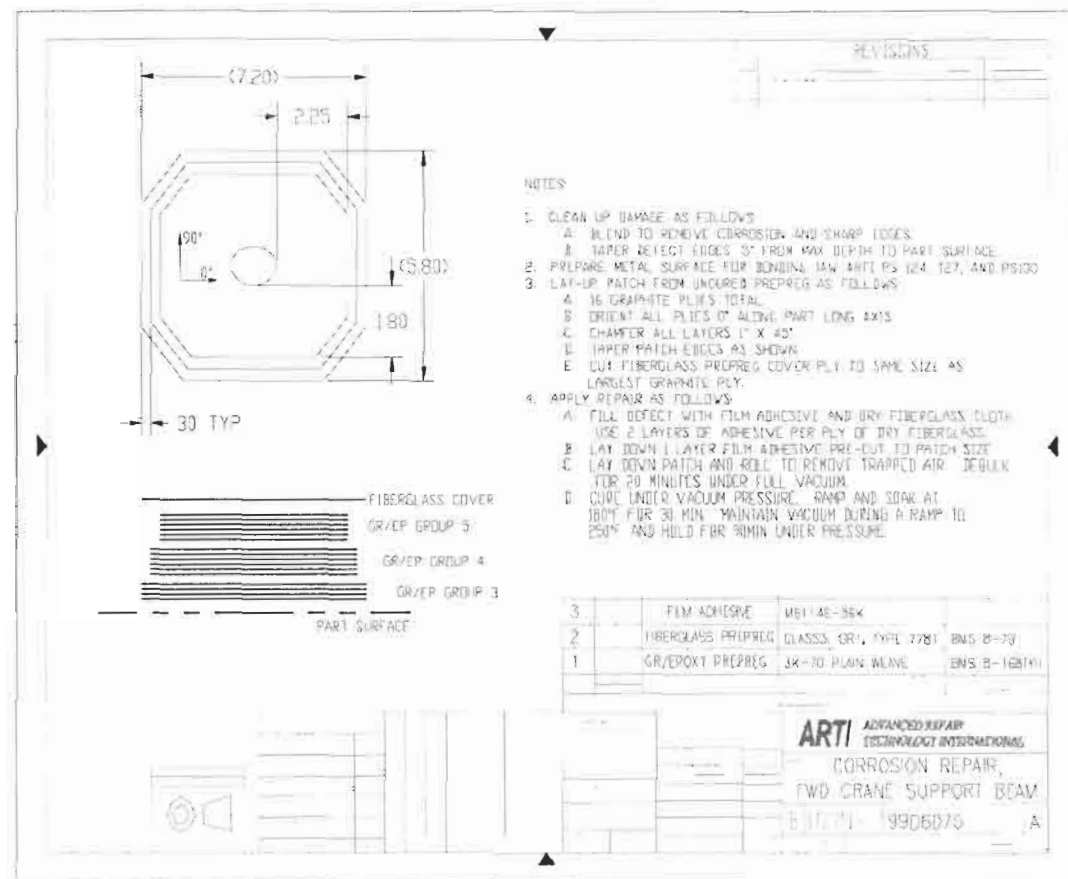
Fig. 38.6. Repair doubler drawing.

The repair procedure is provided on the doubler drawing contained in Figure 38.6. An overview of the repair procedure is as follows:

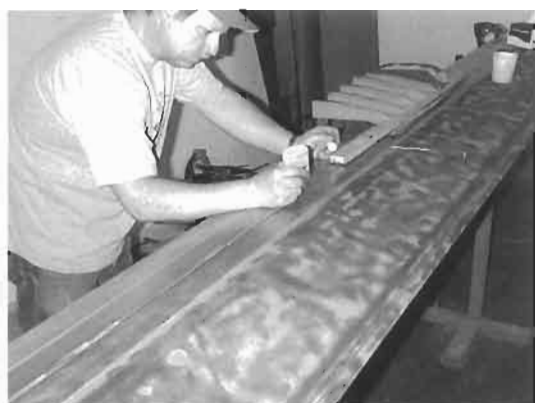
Fig. 39.1. Disbond repairs.

Figures 39.1–39.10 detail the steps involved in this repair process. When blades arrive at the facility, they are inspected for disbonds. Once the disbonds are located, the old adhesive is removed and the area cleaned. The disbonds are then shot with an anaerobic adhesive and clamped in place to cure. Since the bonded repair will completely replace the old load path along the blade, the disbond fills serve only to provide a good bonding surface and reinforce the blade. If very low areas exist along the spar seams, they are filled with room temperature cure adhesive before patches are applied. This minimizes the risk of disbonds later on.

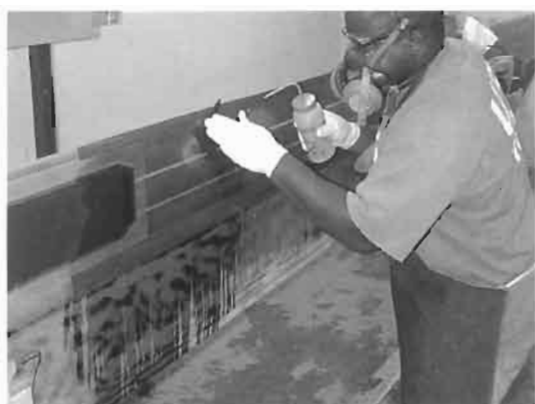
Fig. 39.2. Solvent scrub process.

Each blade is hand scrubbed using MEK and Scotchbrite to remove gross contamination, shed oxide layers and provide a water break free surface. The metal blade surface is then grit blasted to reveal fresh chemically active metal and provide a rougher surface to encourage mechanical interlocking of the adhesive. Silane is applied by hand to the blade and then cured using non-contact infrared ovens. The blade temperature is monitored by infrared thermocouples mounted on the top of the heating ovens. A very fine layer of corrosion inhibiting primer is applied and cured using the same ovens that cured the silane. Film adhesive is applied to the patches which are then placed on the rotor blades. Thermocouples are arranged on

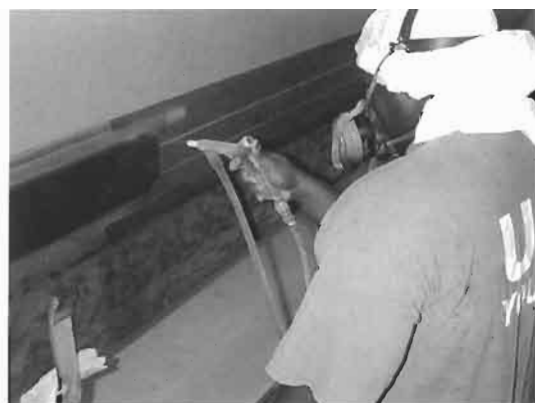
Fig. 39.3. Rotor blade in grit blast chamber.

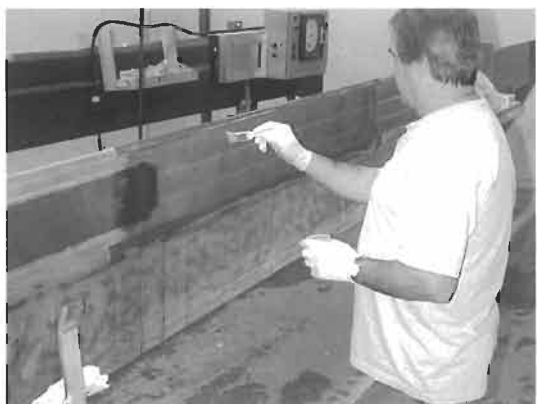
Fig. 39.4. Silane application.

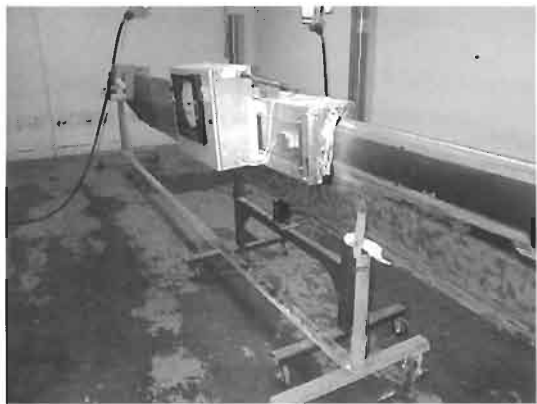
Fig. 39.5. Non-contact heating oven.

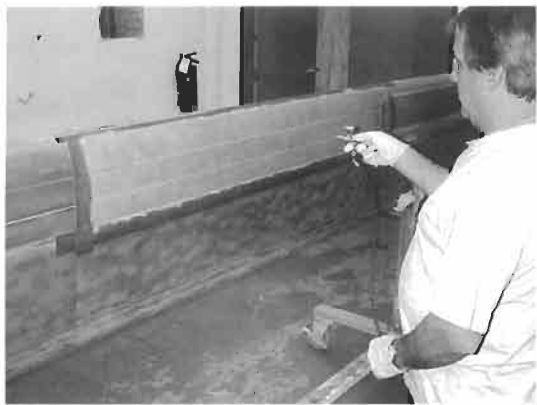
Fig. 39.6. Primer application.

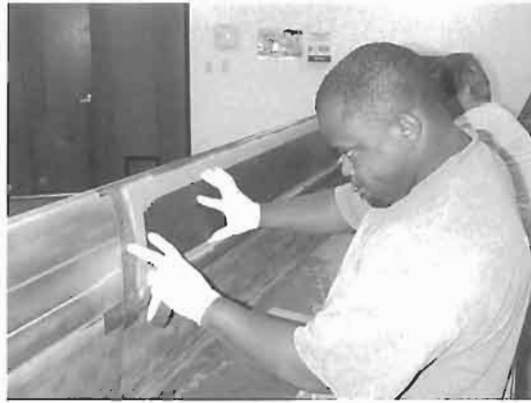
Fig. 39.7. Patch application.

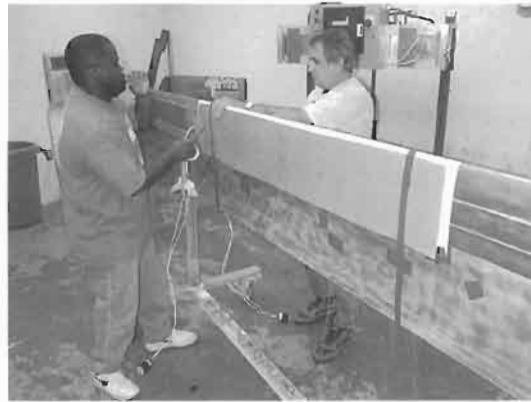
Fig. 39.8. Heater blanket positioning.

the patches and the surrounding blade surface to ensure proper heating control and monitor cure conditions. A large heating blanket is draped over the blade surface and the pressure tool, complete with heating controllers is lowered onto the blade. The repair cure is done in two steps to protect the delicate fiberglass and honeycomb portions of the blade. First, a low temperature, high pressure step allows the adhesive to flow and fill any uneven areas. Second, the pressure is reduced and the blades are heated to ensure adequate performance at elevated temperature.

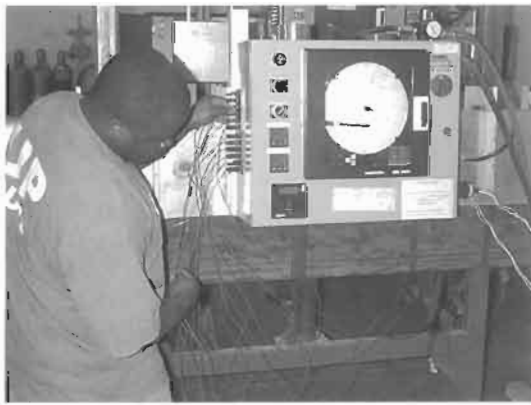
Fig. 39.9. Pressure bladder tool.

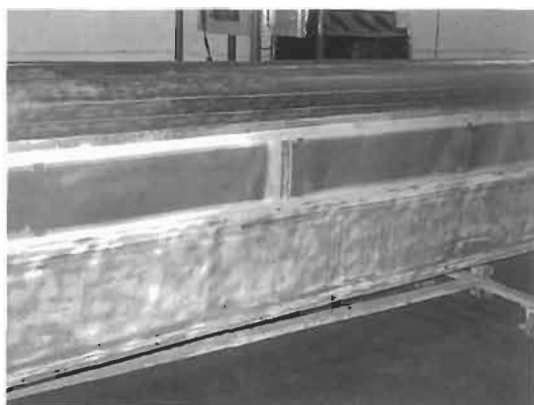
Fig. 39.10. Finished patch.

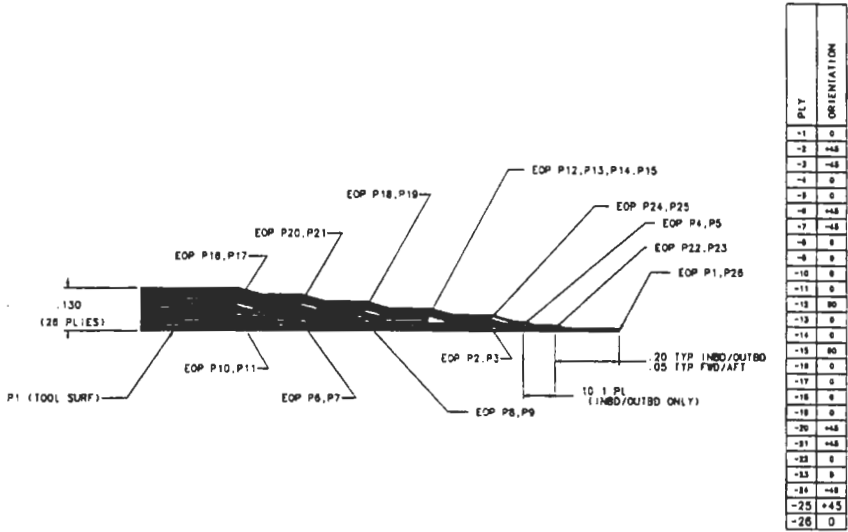
Fig. 40.1. Composite patch repair definition.

best load transfer and life extension prospect. A detailed design and analysis of the bonded boron concept was carried out. A 26-ply boron/epoxy patch, shown in Figure 40.1, was selected. The potential location of the boron reinforcement on the wing skin is shown in Figure 40.2. Due to the complexity of the structural configuration (pocket area with variable skin thickness) it was considered necessary

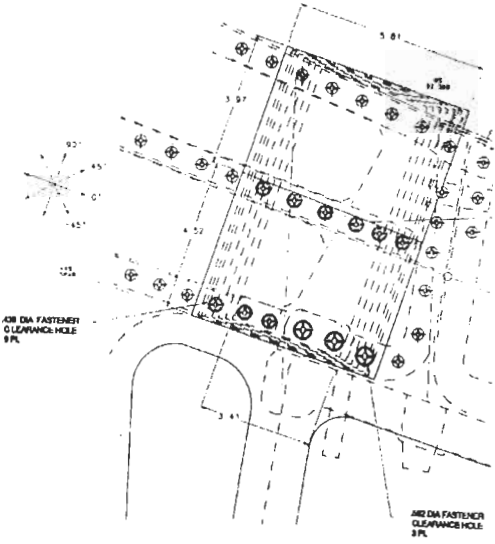
Fig. 40.2. Composite patch repair on the T-38 wing structure.

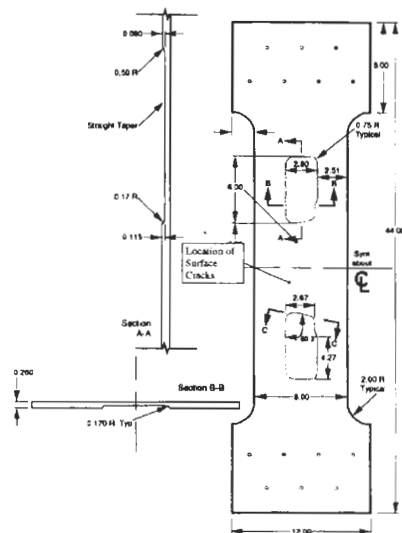
Fig. 40.3. Wing skin test specimen configuration.

The test specimen configuration is shown in Figure 40.3. The pocket area in the test specimen was designed to represent the cracking location in T-38 lower wing skin pocket between 39% and 44% spars at WS 78. The thickness and pocket dimensions were representative of the actual dimensions in the wing skin. Each specimen had two pockets so that two sets of data can be obtained from each specimen. The cracks in the two pockets were sufficiently apart so that there was no interaction between the cracks in each specimen. Two specimen were fabricated, one to be used as a baseline specimen without composite reinforcement and other to be repaired with composite reinforcement.

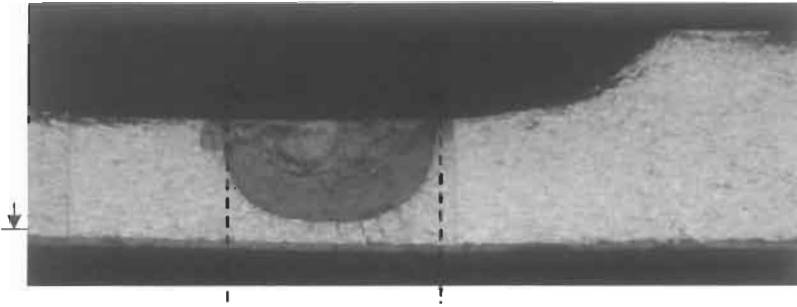
Fig. 40.4. Photomicrograph of EDM area in failed test specimen.

depth of flaw through the specimen thickness being 0.125 inch. The flaws were introduced by electric discharge machining (EDM) process to produce a flaw 0.005-inch thick. Figure 40.4 shows a photomicrograph ($7.5\times$) of the EDM machined area from the tested specimen.

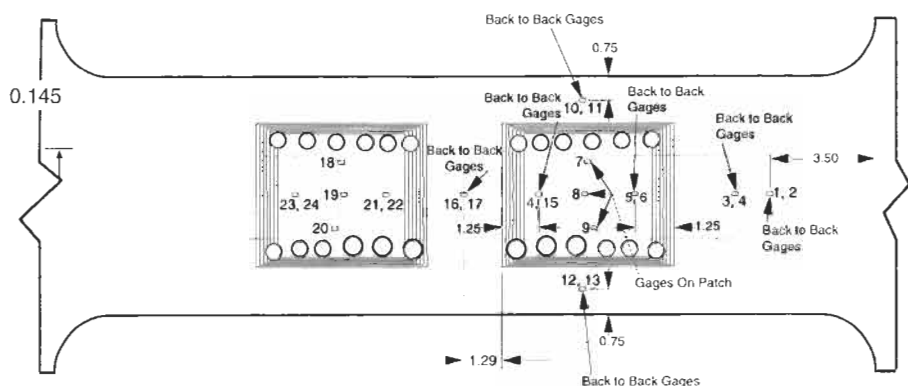
Fig. 40.5. Strain gage locations on test specimen.

Nine strain gauges were installed on the baseline specimen without the composite patch and twenty four gauges were installed on the test specimen with the boron patch at the locations shown in Figure 40.5.

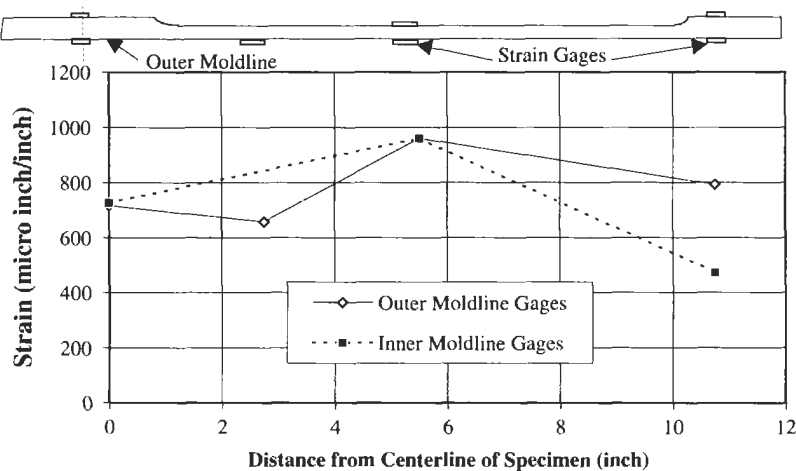
Fig. 40.6. Strains in baseline specimen without composite reinforcement.

The observed strains at 29% of the maximum spectrum load in test specimen without composite reinforcement are shown in Figure 40.6. The figure shows that the strains in the center of test specimen are almost the same on both surfaces i.e. the surfaces representing inner and outer moldline of the wing skin, indicating no bending in the center of the specimen. Also, the back to back gauges in the center of the pocket area show identical strains, indicating no local bending in the center of the pocket. The gauge near the grip area on the surface of the specimen representing inner moldline of the wing skin shows lower strains compared to the

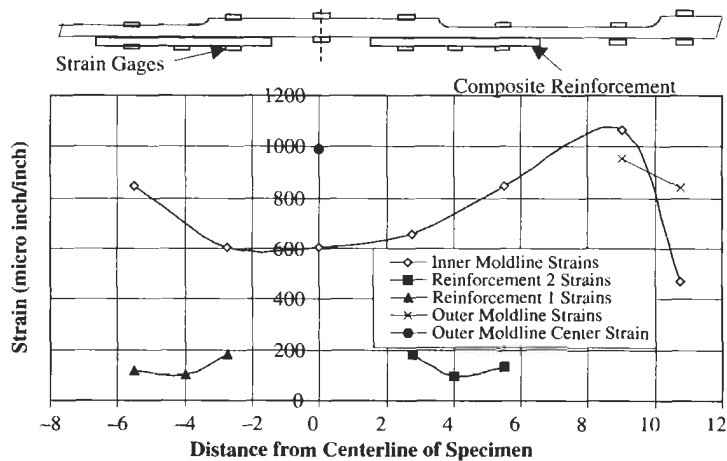
Fig. 40.7. Strains in specimen with composite reinforcement.

The strains in the test specimen with composite reinforcement are shown in Figure 40.7. These strains are shown at 29% of maximum spectrum load. The strain gauge data shows that the strain in the center of specimen is not the same on both surfaces of the specimen. The strain gauge on the composite reinforcement side shows strains that are 60% higher than those on the side without reinforcement. This indicates significant amount of bending caused by the composite reinforcement.

A comparison of metal strains in the pocket at locations where there is no composite reinforcement (9 inches from specimen centerline) and location where there is reinforcement (5.5 inches from specimen centerline) indicates that the strain in metal is reduced from 1065 micro inch/inch to 848 micro inch/inch. This represents a reduction of about 20% in strain. Thus, the effect of composite reinforcement is to reduce pocket strain by 20%. Figure 40.7 shows relatively small strains in composite reinforcement compared to skin strains. It may be noted that the modulus of composite reinforcement in loading direction is 20.5×10^6 psi compared to 10×10^6 psi for aluminum.

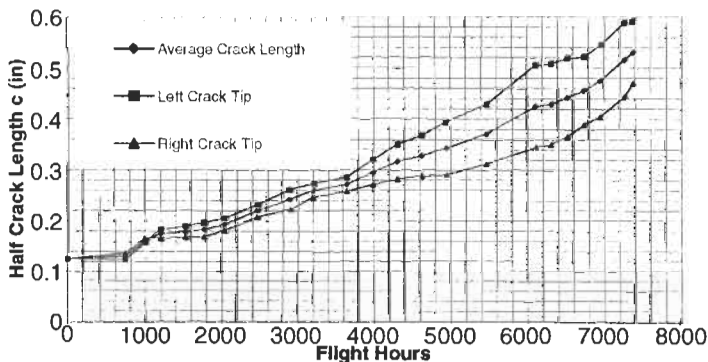
Fig. 40.8. Crack growth in baseline test specimen without composite reinforcement (upper pocket).

The half crack length as a function of flight hours for the left and right crack tips is shown in Figure 40.8 for upper pocket. The half crack length is measured from the centerline of the EDM flaw. The figure also shows average crack length. It is seen that after about 1200 flight hours the right crack tip is growing considerably slower as compared to left crack tip. At 7000 flight hours the half-crack length at the left crack tip is 50% longer than that at right crack tip. The slower crack growth of the crack tip adjacent to the edge of machined pocket is attributed to the stiffening provided by the thicker skin out side the pocket and there by reducing the

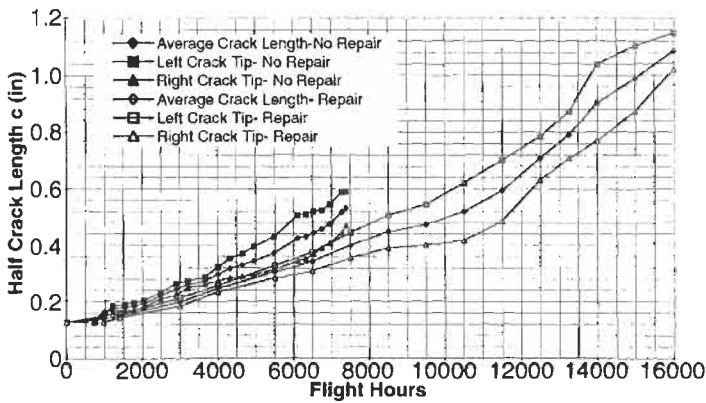
Fig. 40.9. Comparison of crack growth in test specimens with and without composite reinforcement (upper pocket).

The crack growth in the upper pocket of the specimen with composite reinforcement is shown in Figure 40.9. The figure also shows crack growth in the specimen without composite reinforcement for comparison. It is seen that once again the right crack tip closer to the machined pocket edge grows considerably slower as compared to the crack tip away from the pocket edge. Each of the crack tips in the specimen with reinforcement grows slower as compared to the crack in specimen with no reinforcement. The presence of reinforcement significantly increases crack growth life.

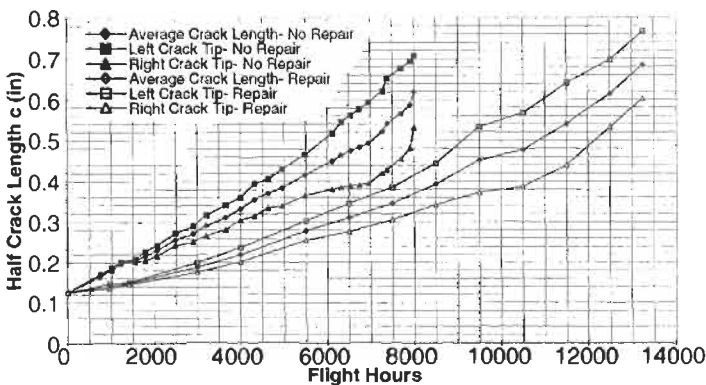
Fig. 40.10. Comparison of crack growth in test specimens with and without composite reinforcement (lower pocket).

The crack growth in the lower pocket for the specimens with and without reinforcement is shown in Figure 40.10. The figure shows significant increase in crack growth life. It is seen that at 8000 flight hours the average crack length in the specimen with reinforcement is about half of that in the specimen without reinforcement even though the starting crack lengths in both the specimens were the same.

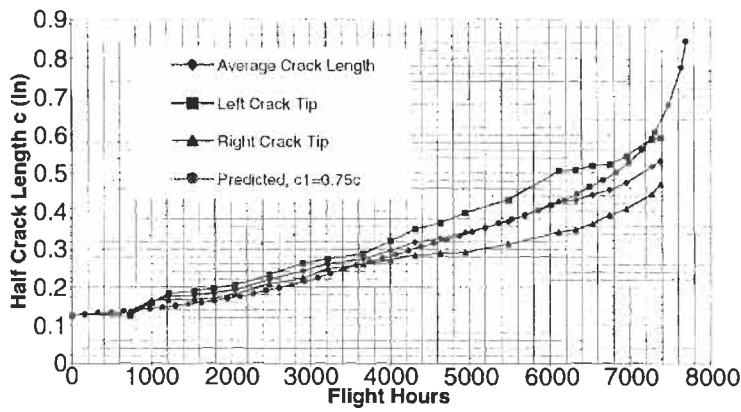
Fig. 40.11. Comparison of test and predicted crack growth in specimens without composite reinforcement (upper pocket).

A comparison of predicted crack growth and observed crack growth is shown in Figure 40.11 for upper pocket. The figure shows a good correlation between predicted and observed average crack length.

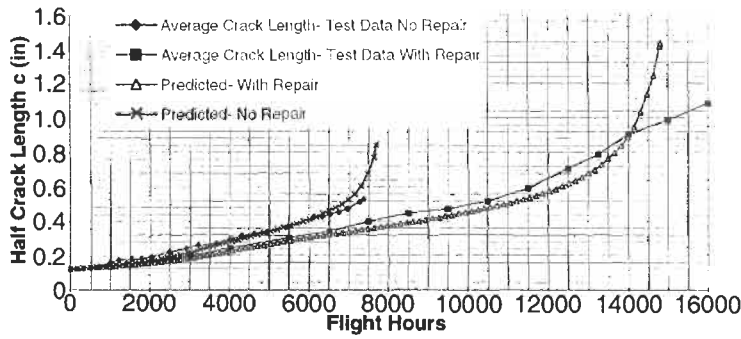
Fig. 40.12. Comparison of test and predicted crack growth in specimens with and without repair (upper pocket).

To make crack growth predictions in test specimen with composite reinforcement the stress intensity factors for the test specimen without reinforcement were modified to account for the influence of the reinforcement. The modification was done using the analytical techniques developed in reference [10] and incorporated in the Air Force computer code AFGROW [11]. The AFGROW code was used to obtain stress intensity factors for a cracked sheet with bonded repair. These stress intensity factors were multiplied by the stress intensity factors for pocket area with no reinforcement. The stress intensity factors thus obtained were used in Forman equation to predict crack growth life. The constant c in Forman equation was taken as 0.75 times the normal value for 7075-T73 aluminum to compensate for unequal crack growth at two crack tips. The predicted and observed average crack growth in the upper pocket of the specimen with composite reinforcement is shown in Figure 40.12. The figure also shows predicted and observed crack growth in

specimen without composite reinforcement for comparison. The comparison between predicted and observed crack growth is excellent. The composite reinforcement doubles the crack growth life.

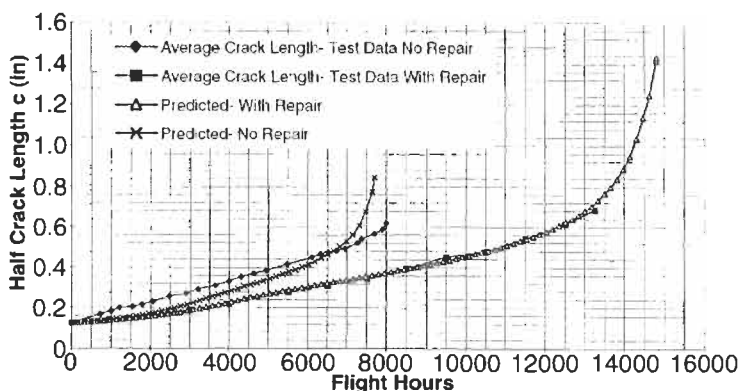
Fig. 40.13. Comparison of test and predicted crack growth in specimens with and without composite reinforcement (lower pocket).

The comparison of predicted and observed crack growth behavior in lower pocket is shown in Figure 40.13 for specimens with and without composite reinforcement. Once again comparison between predicted and observed crack growth for specimen with composite reinforcement is excellent. These results indicate that the analysis of references [10,11] can be used with confidence for damage tolerance analysis of metallic structures bonded with composite reinforcement.

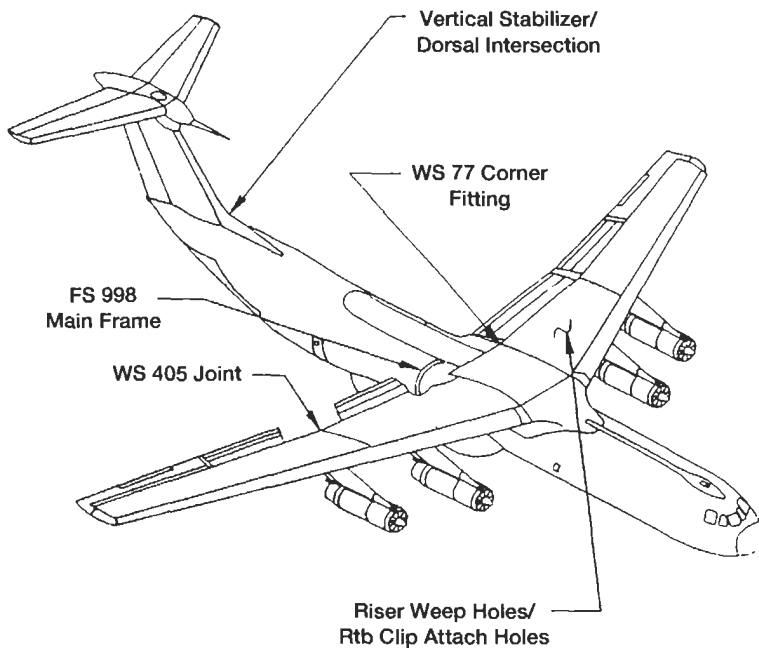
Fig. 41.1. Lockheed selected potential composite repair sites for the C-141.

In 1986, Warner Robins Air Logistics Center (WR-ALC) contracted with LMAC to evaluate and demonstrate the viability of using bonded advanced composite repairs for a priority group of areas selected from the original 121. Five candidate repair locations were identified (Figure 41.1). Composite repair designs were developed and finite element analysis (FEA) was accomplished on all five areas. Application procedures were developed and necessary equipment identified. Both boron and graphite were identified as candidate repair materials, and two demonstration repairs were applied using both materials. The LMAC effort [1] was quite extensive and proved that advanced composite repairs were definitely a viable repair option from a structural standpoint.

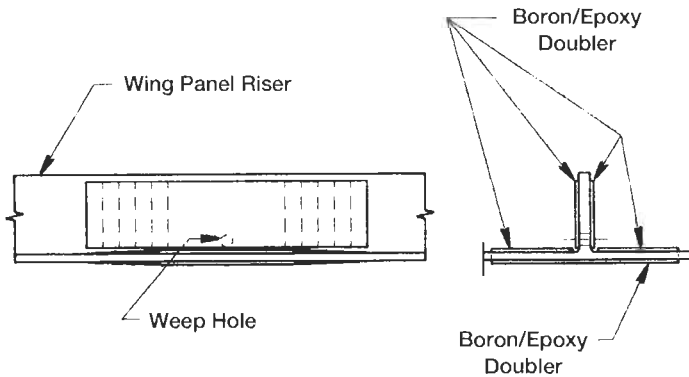
Fig. 41.3. View of C-141 wing panel section showing original planned five doubler repair scheme and eliminated inner doublers.

Substantial FEA was accomplished for both the repair and the parent structure. The stress field for the lower wing surface is well known and is a near uniaxial condition spanwise with nearly equal loads in tension and compression. LMAC's original analysis had clearly shown that a composite repair would significantly reduce the stress at the crack location. The initial WR-ALC effort was to look quickly at the issue of proximity in that it would not be a single repair but the possibility of several repairs in close proximity to one another. A coarse two panel wide shell element analysis was accomplished to evaluate the proximity issue. Using this coarse model, initial evaluations were also made on the overall repair concept to simplify the repair by eliminating the two internal wing surface doublers of the original five planned in the LMAC study (Figure 41.3) and using only three doublers and increasing the number of plies in the external wing surface doubler.

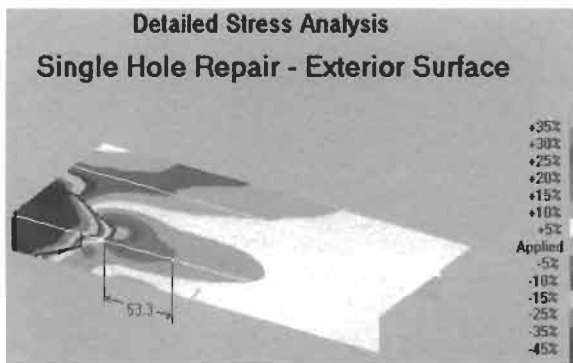
Fig. 41.4. 3D finite element analysis of C-141 wing plank showing estimated wing plank stress levels with boron doubler repairs.

With favorable initial results, a considerable amount of additional very detailed 3D FEA was accomplished (Figure 41.4) to further evaluate repair size, shape, stress reduction, and impact on surrounding structure. Results of the 3D analysis were very similar in many respects to the 2D shell FEA, but it was found to be more accurate, realistic and less conservative than the shell FEA. To validate the 3D FEA model, a segment of an actual wing plank was repaired to identically match the model (Figure 41.5), instrumented, and statically tested. Correlation between
